Bridge 05679 Inspection Report

US 371 S-7 LM 3.79 over BIG CREEK

Location: 1.8 MI W JCT SH 19

Team Lead: John Parks Inspection Date: 05/13/2024

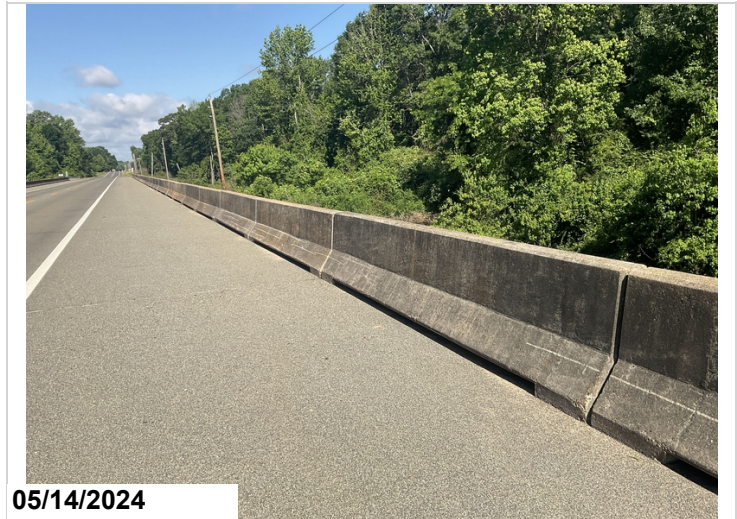
The superstructure is rate 6 due to the edges of the slab having minor cracks with efflorescence, the underside having minor cracks with efflorescence, few moderate spall with exposed rebar scattered throughout, and the slabs have up to 1/2" creep at midspan.

Right side, all spans have upto 1/2" creep.

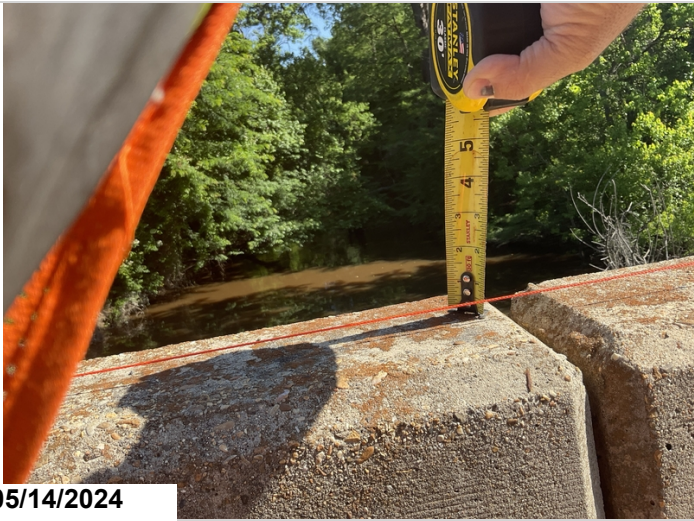
Span 4, right side, 1/2" creep at mid span. All spans have creep, span 4 is the worst.

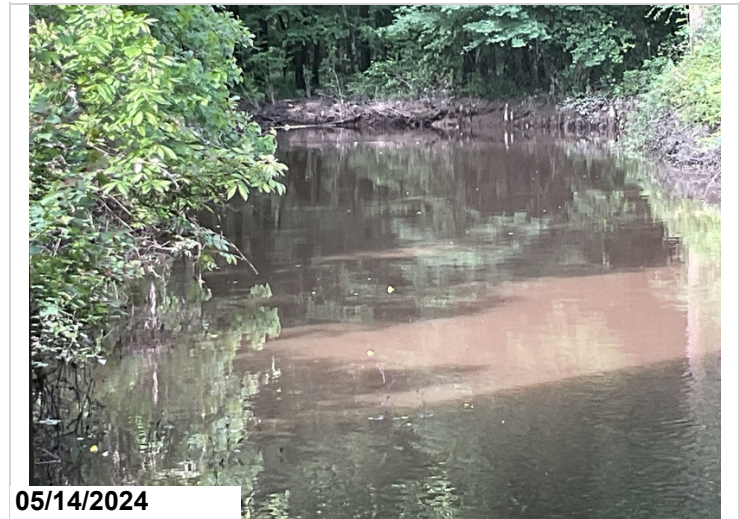
61 - Channel/Channel Protection (6 - Bank is beginning to slump. River control devices and embankment protection have widespread minor damage. There is minor stream bed movement evident. Debris is restricting the channel slightly.) Channel is rated 6 due to minor migration towards Bent 4 and the banks are slumping.

Channel left side downstream

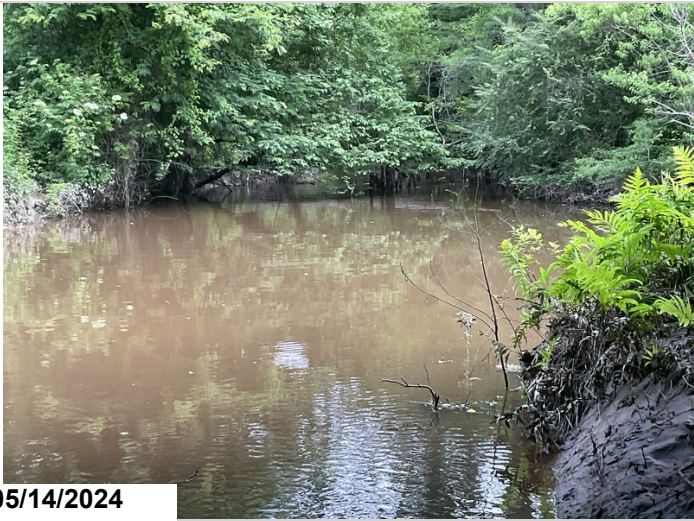
Channel right side upstream

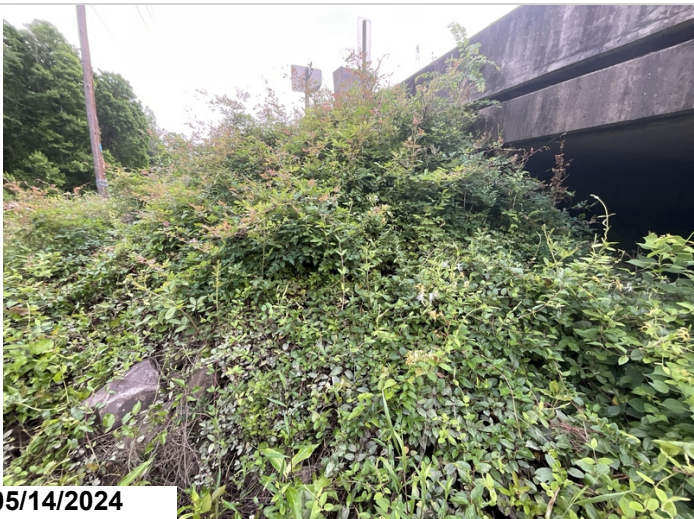
Vegetation

A-64 - Vegetation Removal Requested (Yes)

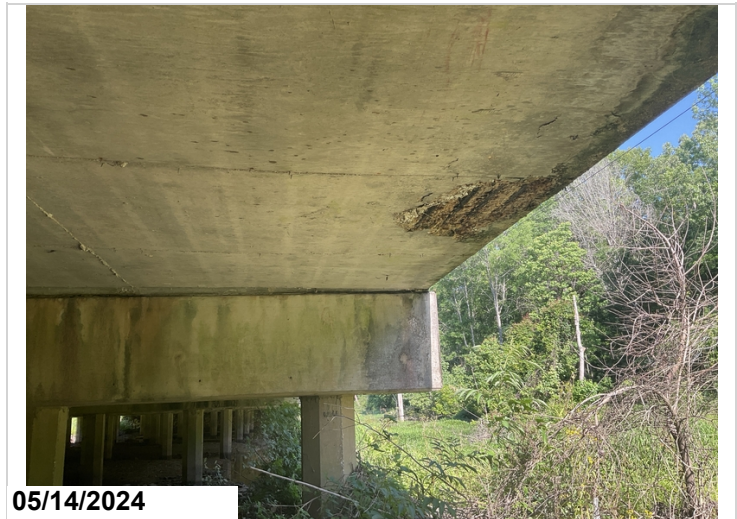
Span 11 Under surface, right side 6' back of Bent 12, 30" x 20" x 3" spall with exposed rebar, rebar has minor section loss. 6SF exposed rebar CS3

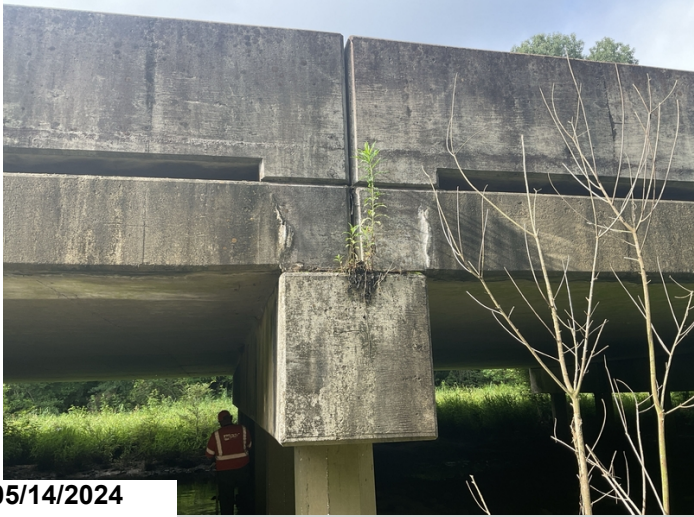
Spans 2 and 3 right side at bent 3 cracks with efflorescence, typical at both sides of all spans.

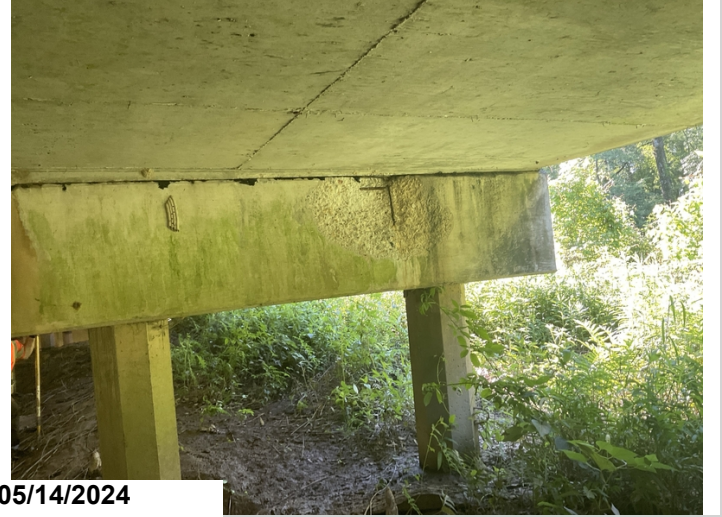
The substructure is rated 6 due to piles having minor abrasion and local scour, and a moderate spall in the cap of Bent 9.

Bent 9 Ahead side 4' right of the left end, 30" x 24" x 3" spall with exposed rebar.

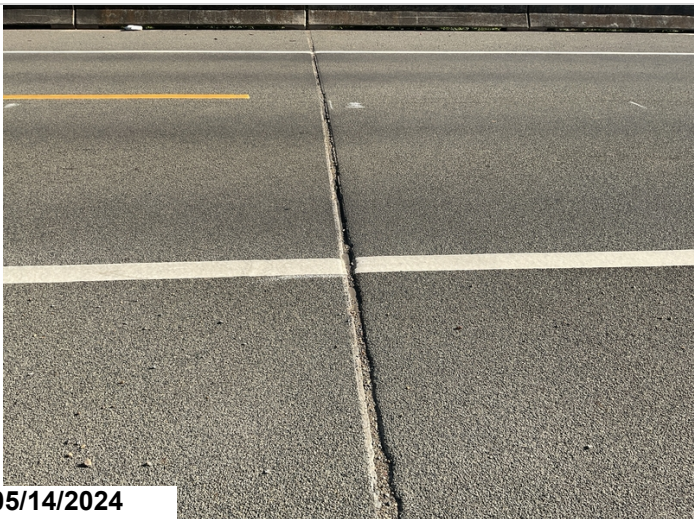
Bridge joints rated 8 due to no defects observed.

Typical of all joints, joint rehab has been performed and expansion material is in good condition.

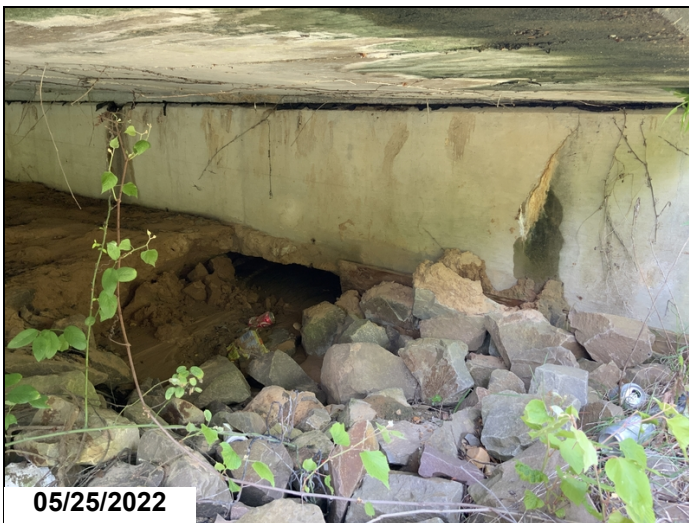
Bent 18:
Right end, 8' of embankment has been eroded 10" below the stub.

Priority: C - Important

Type of Work: Repair (General)

Status: Monitor

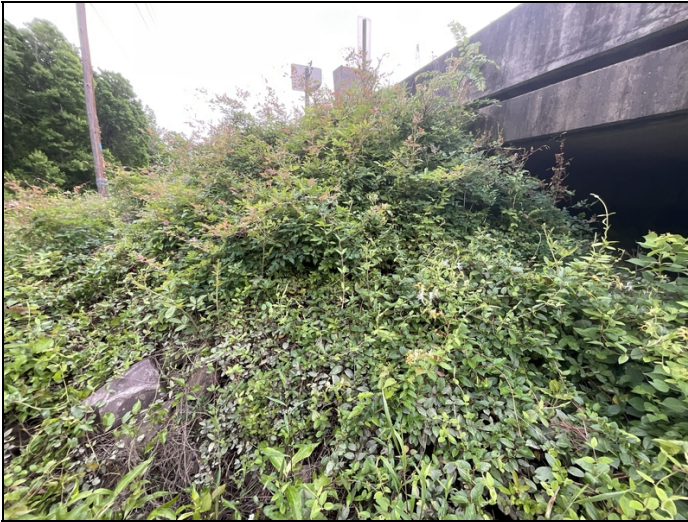
Vegetation
