Bridge #05143(Routine, Underwater type 2)

SH 89 over Lake Conway

Team Lead: William Wood **Inspection Date:** February 10, 2020

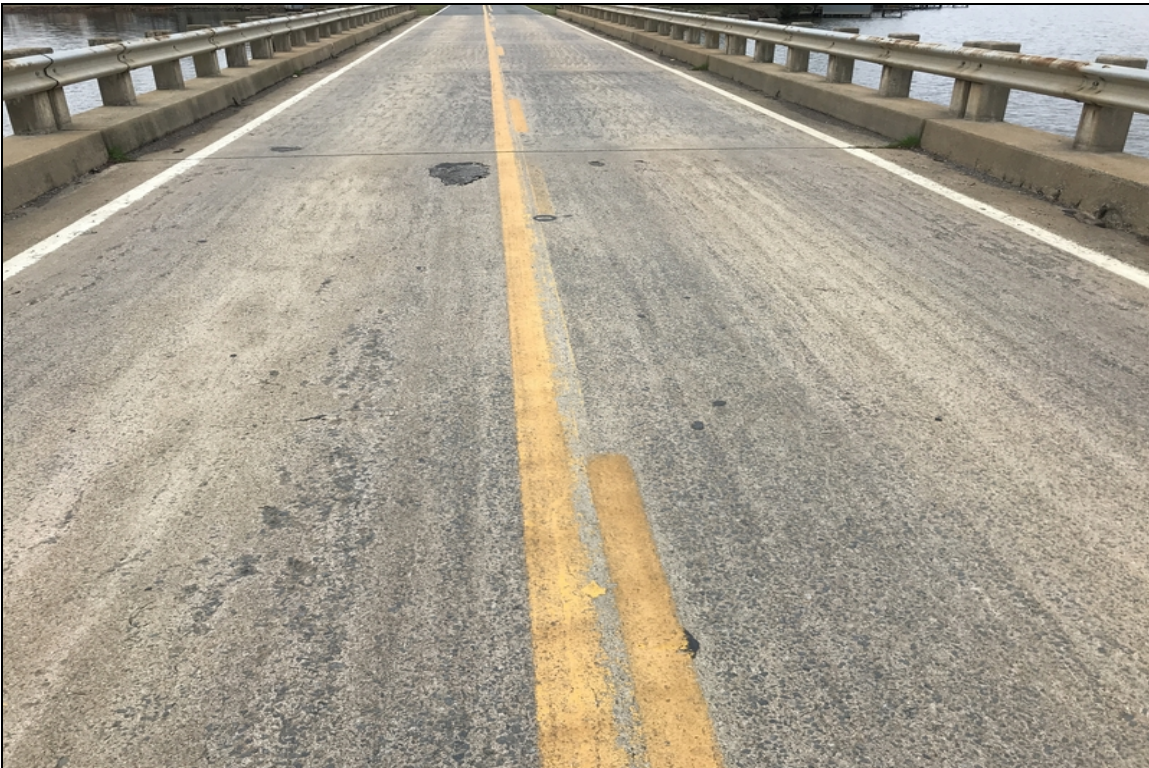
(38)	MINOR TO MODERATE DELAM, CRACKING, SCALE & MINOR SPALLING IN DECK. MINOR DIAGONAL CRACKING IN SIDES OF SLAB IN SPAN 3 AT PIER 4 RT. SIDE. SOFFIT IS GOOD. MINOR SPALLING W / REBAR EXPOSED IN BT. OF CURB AT DECK AT VARIOUS LOCATIONS DUE TO REBAR TOO CLOSE TO SURFACE.						
215	Reinforced Concrete Abutment	LF	50	25	25	0	0
6000	Scour	LF	25	0	25	0	0

Typ. Condition of Deck.

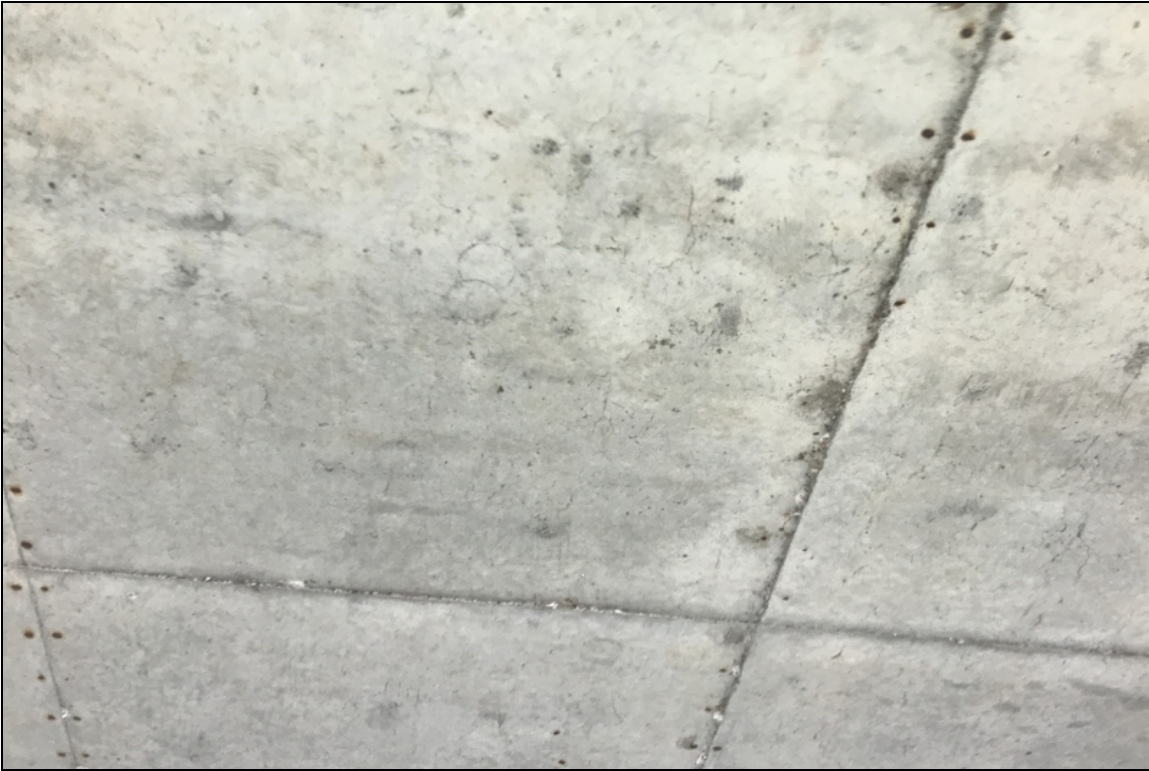
Typ. Condition of Soffit.

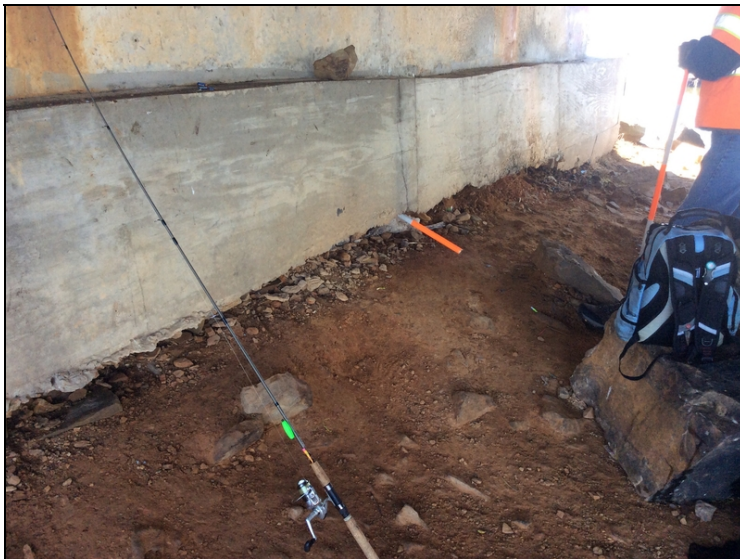
Abut. #1 - Has undermining the full length of the abutment that extends back under abutment approx. 3 ft. in places.

Abut. #1 - undermining full length of abut. Extends back under abutment approx. 3 ft in places.

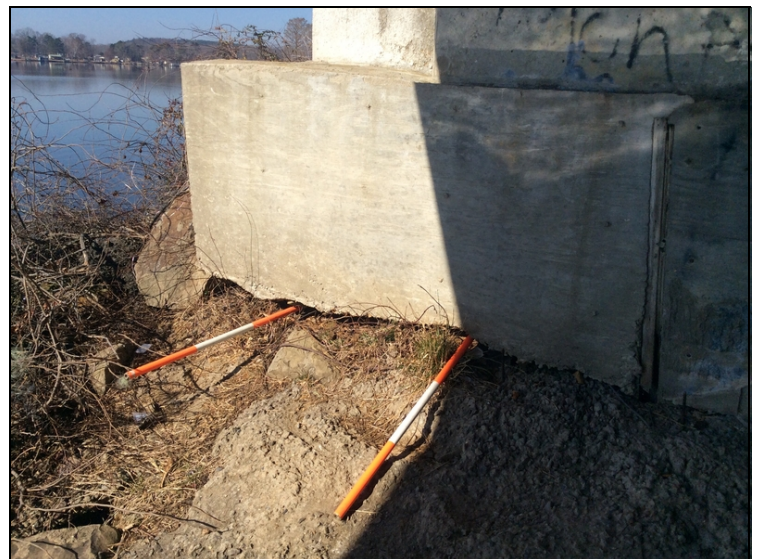
Abut. #7 - Has minor undermining on the left end of the abutment that extends back under abutment approx. 1-2 ft. in places.

Abut. #7 - minor undermining on the left end approx. 7 ft.

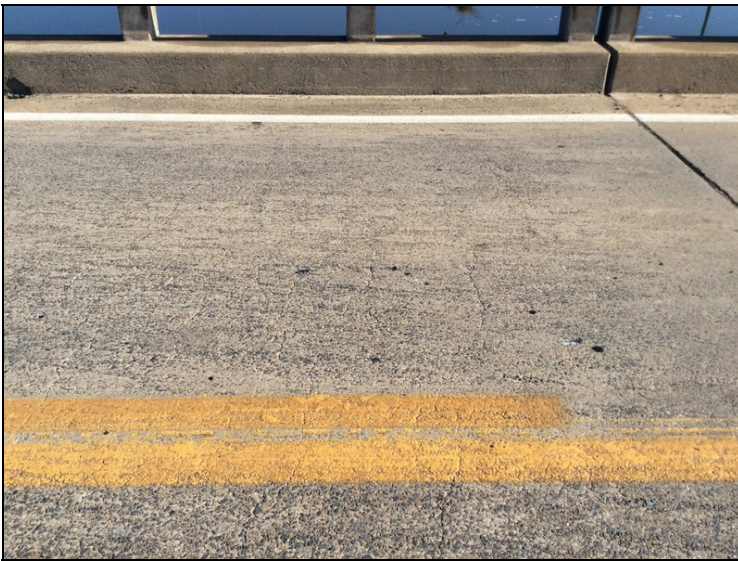
Span #2 - unsealed cracks.

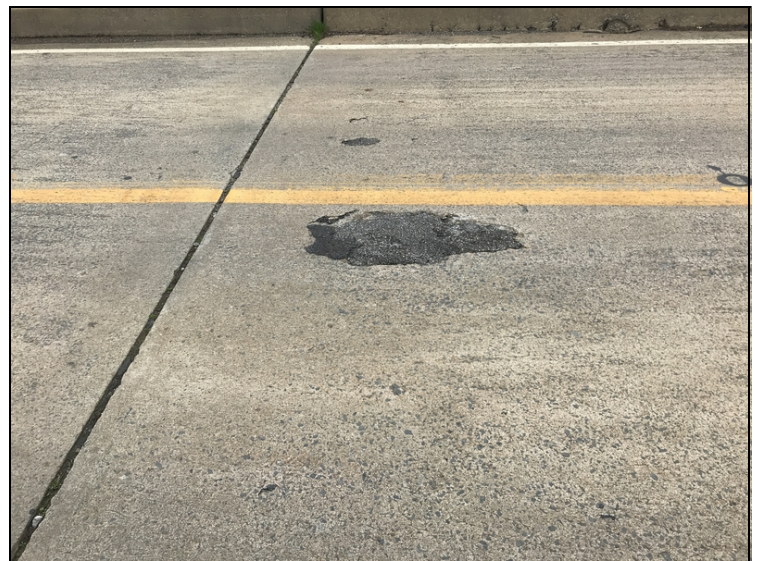
DECK / SLAB - MINOR TO MODERATE DELAM, CRACKING, SCALE & MINOR SPALLING IN DECK. MINOR DIAGONAL CRACKING IN SIDES OF SLAB IN SPAN 3 AT PIER 4 RT. SIDE. SOFFIT IS GOOD. MINOR SPALLING W / REBAR EXPOSED IN BT. OF CURB AT DECK AT VARIOUS LOCATIONS DUE TO REBAR TOO CLOSE TO SURFACE.

Typ Spalling in Deck.

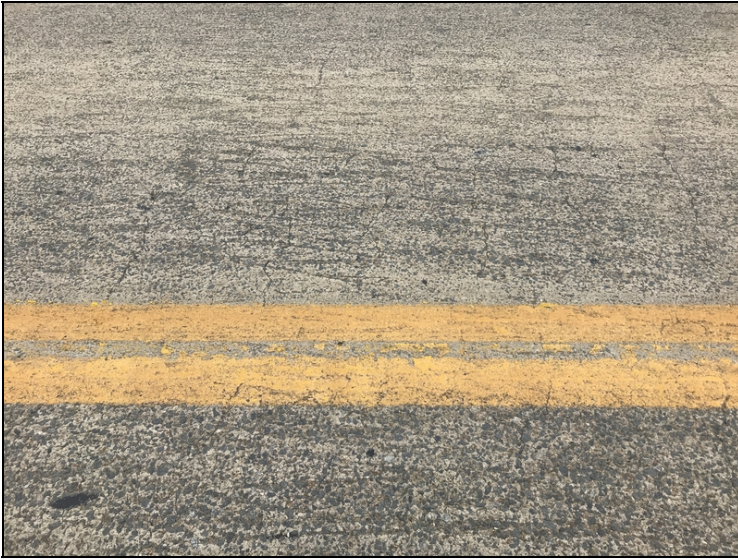
Typ. Cracking in Deck.

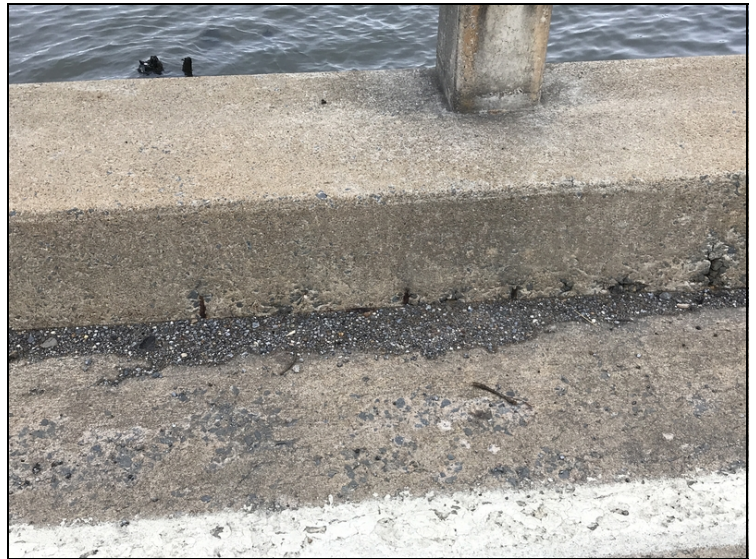
Minor Spalling in Bt. of Curb at Deck due to Rebar to close too Surface.

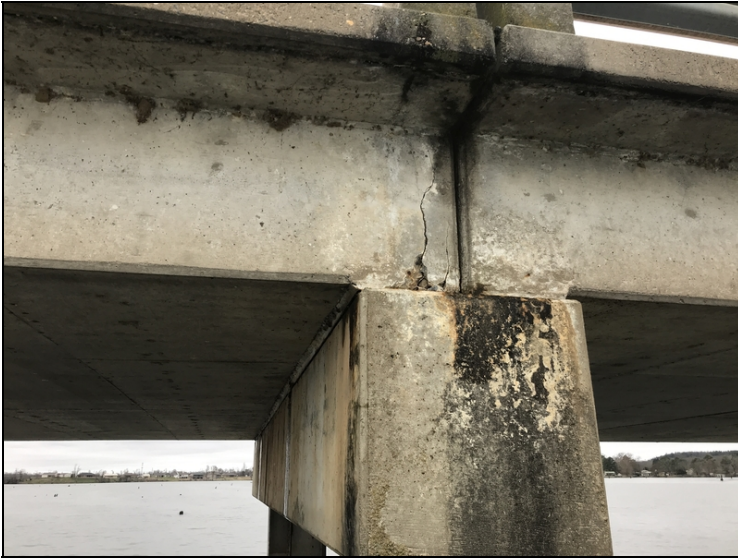
Delam, Cracking & Spalling in Side of Slab in Span
3 at Pier 4.

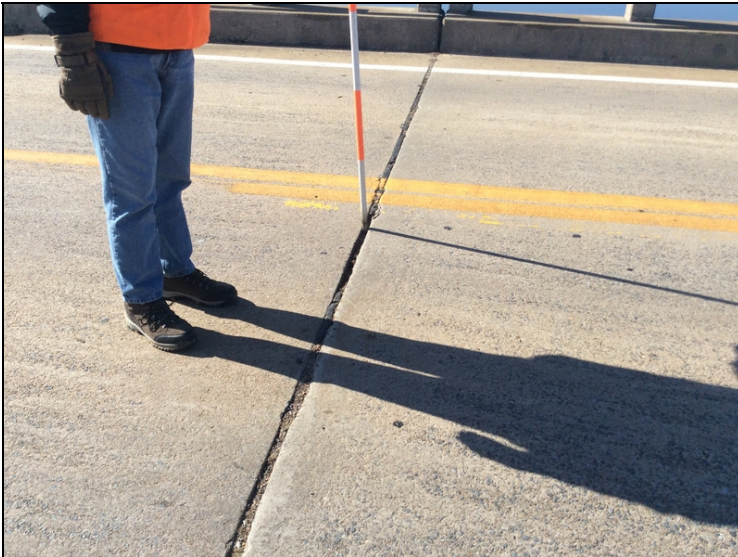
Joint material is missing at several locations
Pier #2 - 15 ft. of joint material is missing.
Pier #3 - 18 ft. of joint material is missing.
Pier #4 - 24 ft. of joint material is missing.
Pier #5 - 15 ft. of joint material is missing.
Pier #6 - 12 ft. of joint material is missing.

Joint at beginning of span 6 - 12 ft missing joint material

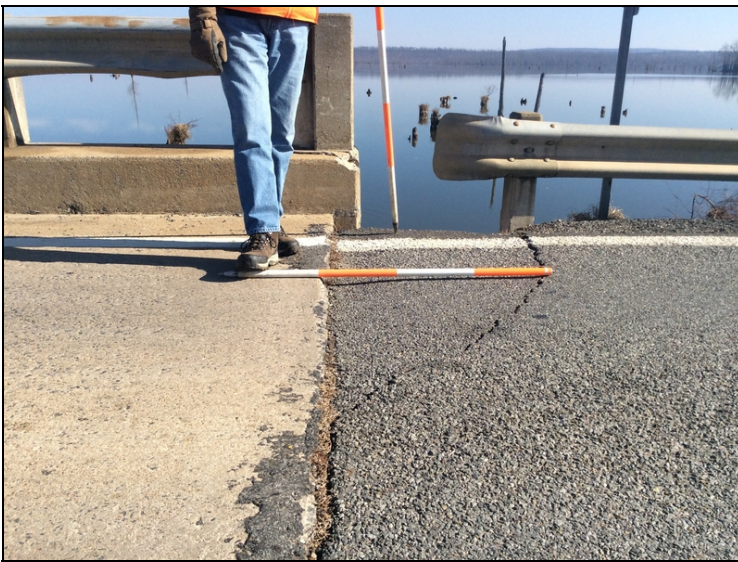
The approach roadway at the SE end of bridge is settling possibly due to erosion under the abutment.

Abut #1 (SE end of bridge) Roadway settling.

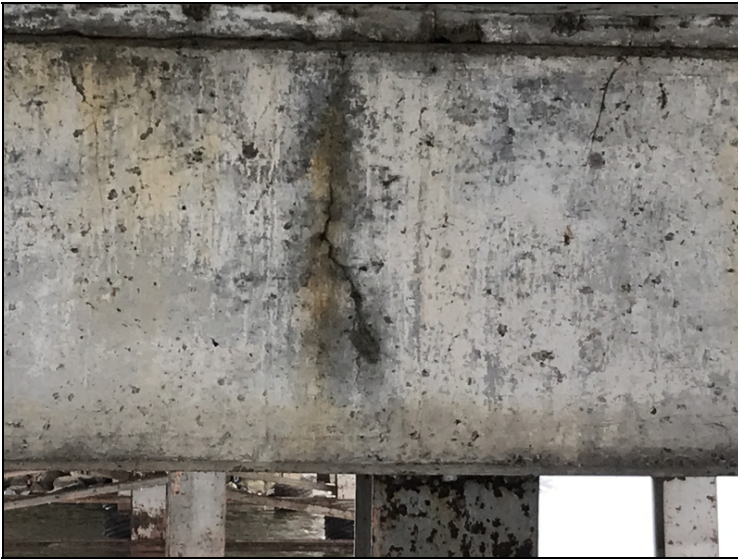
CAPS - MINOR TO MODERATE CRACKING & MINOR SPALLING IN AHD FACES OF CAPS 2, 3, 4 & 6. REBAR EXPOSED IN CAP 3.

Typ. Vertical Cracking in Caps.

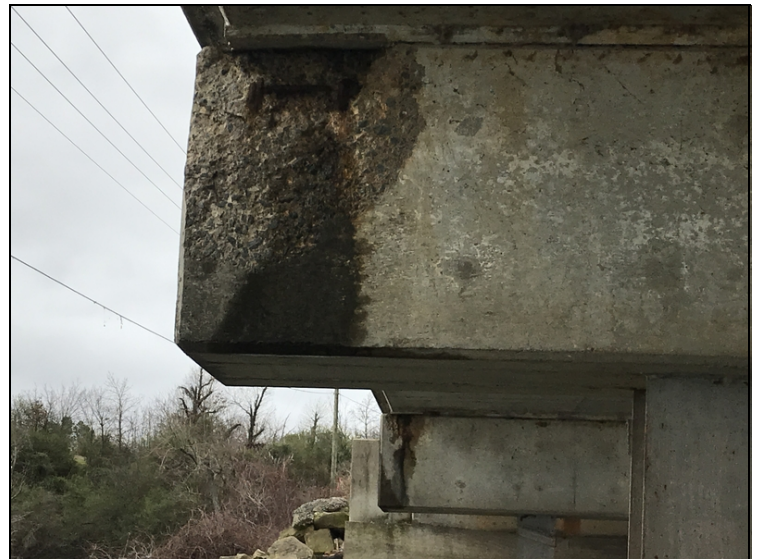
Typ. Spalling in Caps.

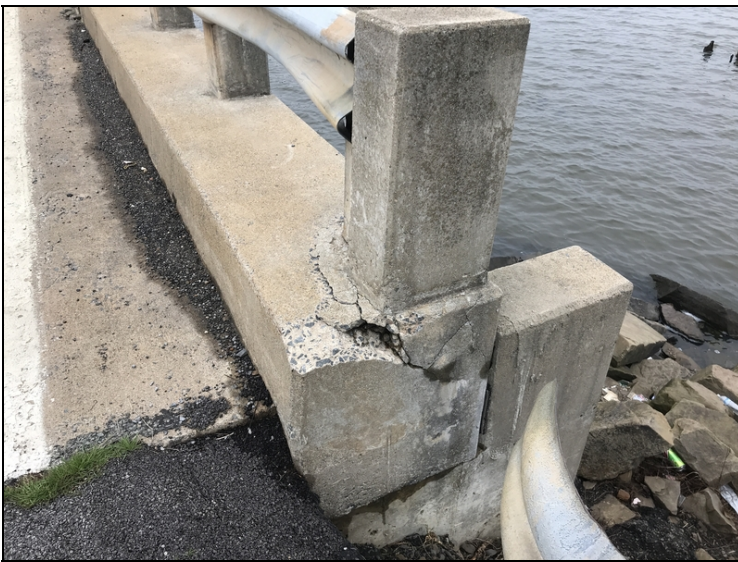
RAIL - MINOR RUST ON RAIL. POST AT ABUTMENT 1 RT. SIDE IS BROKE FROM IMPACT.

Post Broken at Abutment 1 Rt. Side.

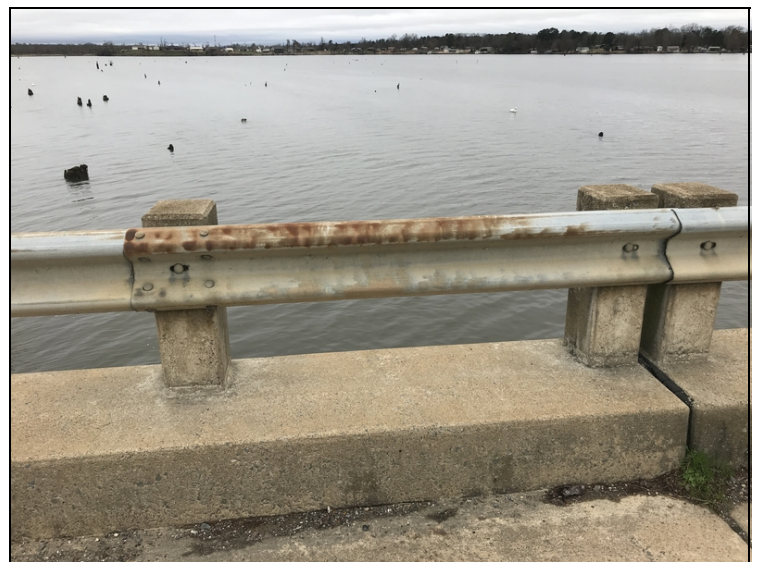
Typ. Rust on Rail.

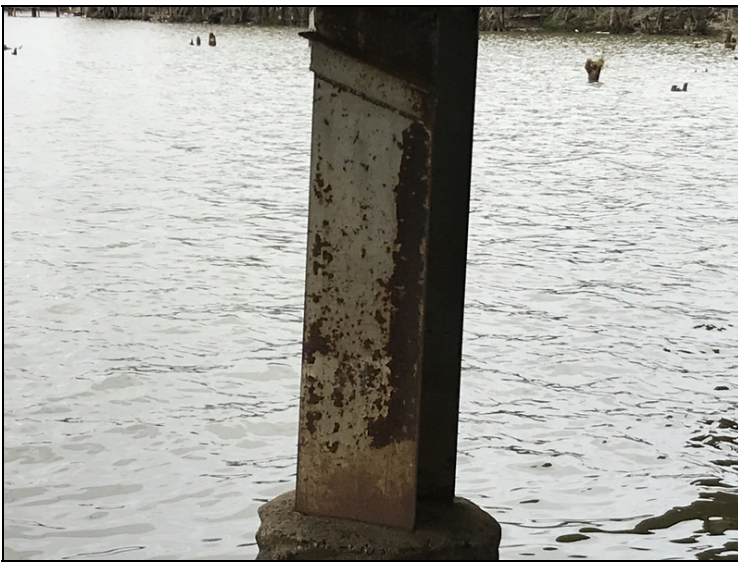
STEEL PILES - MINOR CHALKING & PEELING OF PAINT & RUST ON EXPOSED SECTIONS OF PILES.
MINOR SCALE ON ENCASEMENTS.

Typ. Rust on Piles.
