Bridge #M4000(Routine, Underwater type 2)

SH 333 over Branch

Location: 5.5 I W Jct SH 7 & 333

Team Lead: William Wood Inspection Date: November 04, 2021

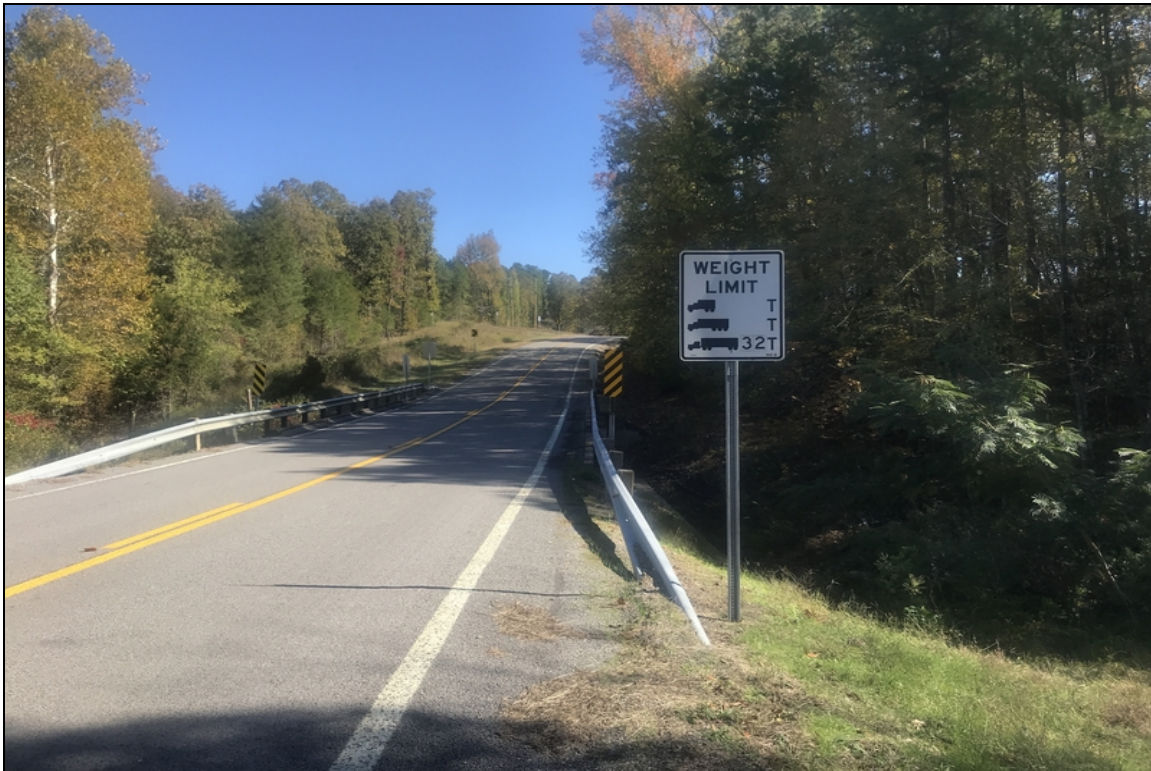
Weight Limit Sign in Place at Beginning of Bridge.

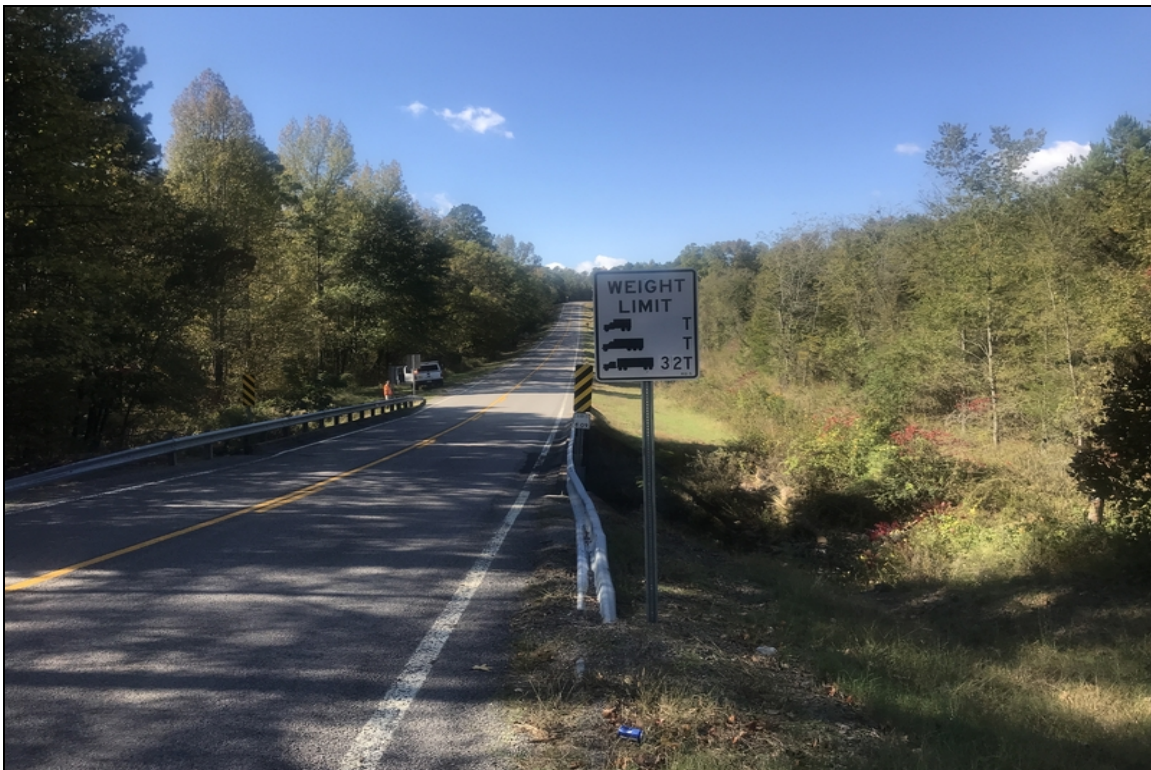
Weight Limit Sign in Place at End of Bridge.

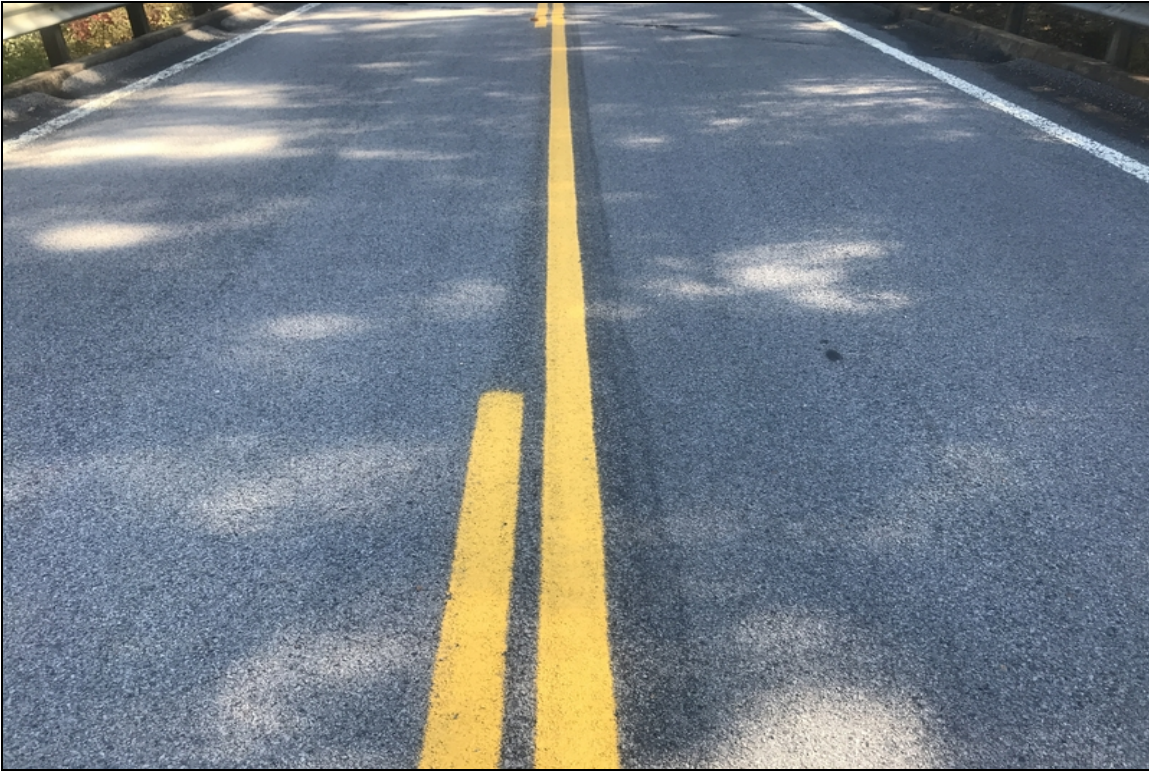
Typ. Condition of Deck.

DECK - MINOR TO MODERATE CRACKING THROUGHOUT OVERLAY. MINOR CRACKING & SPALLING IN OVERLAY AT JOINTS. MINOR CRACKING W / EFFLOR THROUGHOUT SOFFIT. MINOR TO MODERATE LONG. CRACKING W / EFFLOR. IN SPAN 1 IN SOFFIT.

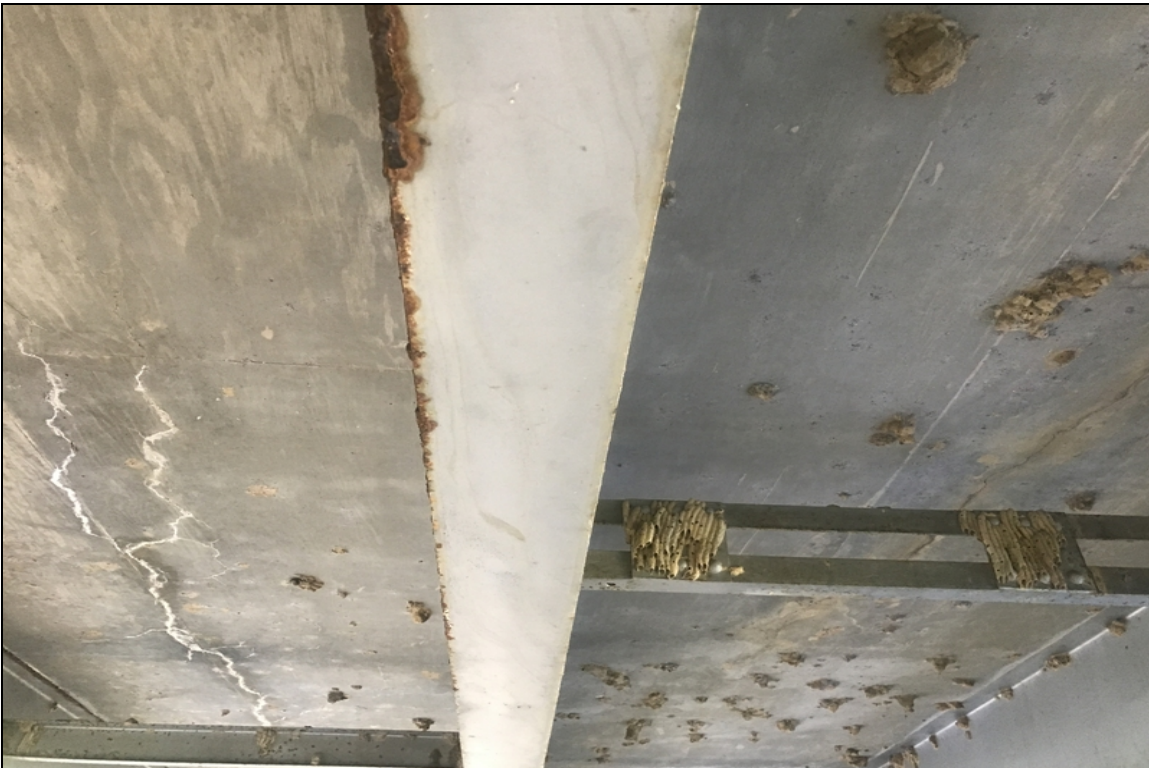
Typ. Condition of Soffit.

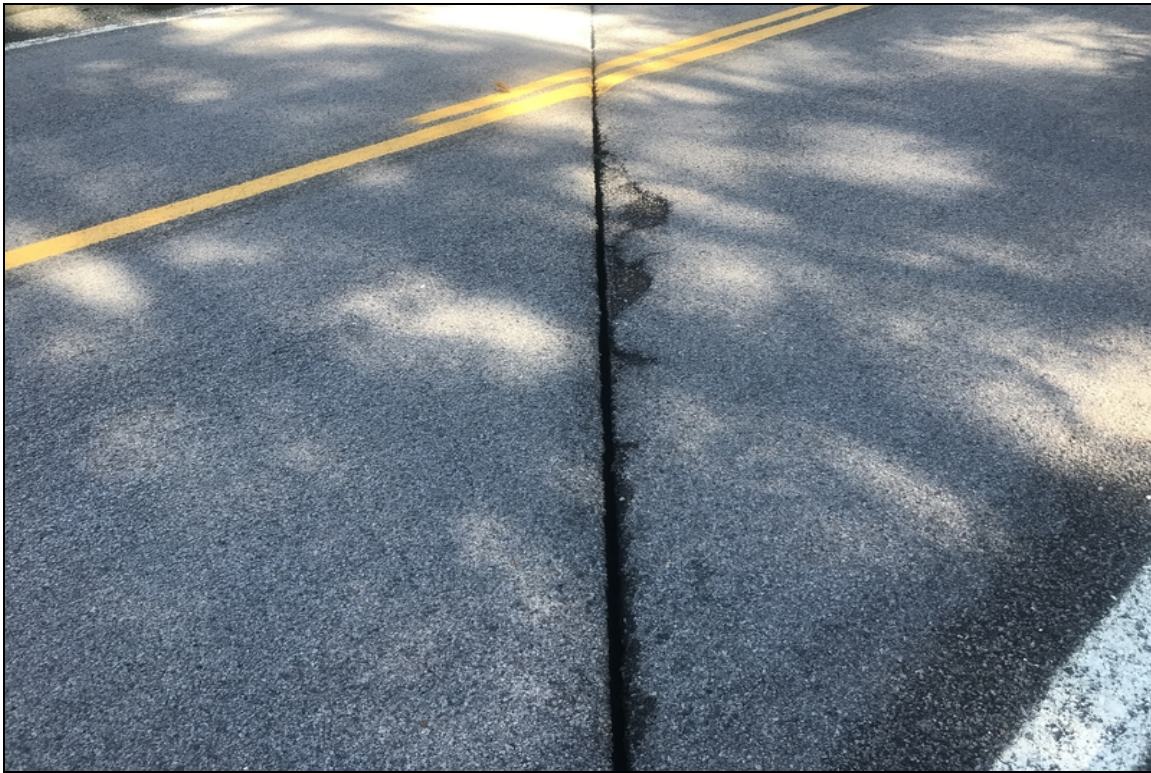
Typ. Condition of Joint.

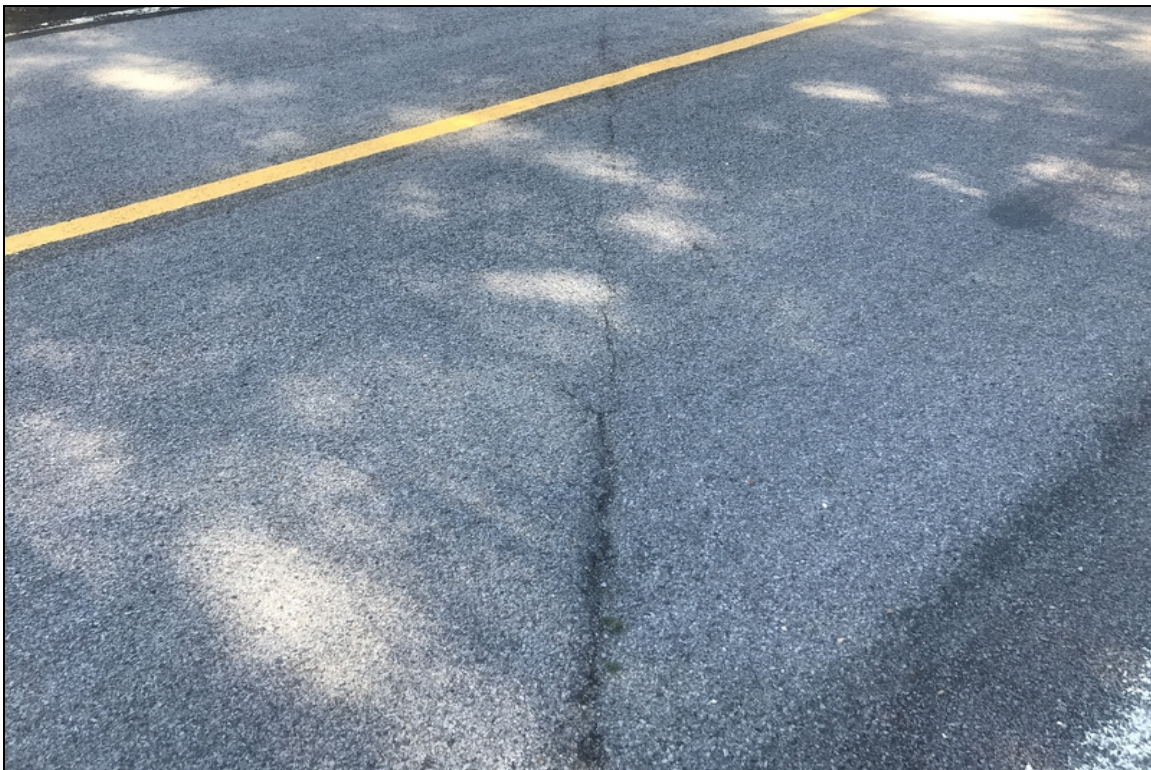
Typ. Cracking in Overlay at Abutments.

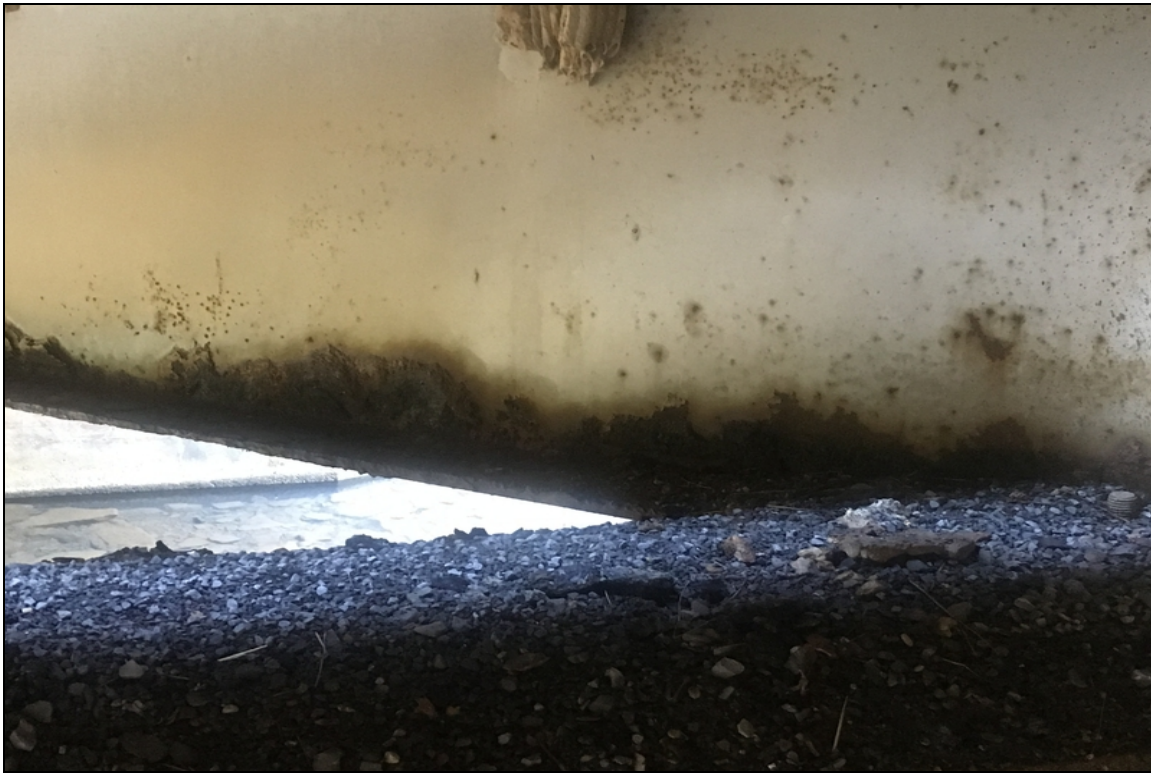
Typ. Rust on Ends of Beams.

4 BEAM PAINTED STEEL MULTI BEAM - MINOR SURFACE & FRECKLED RUST THROUGHOUT BEAMS. MINOR TO MODERATE

RUST ON ENDS OF BEAMS. MODERATE TO MAJOR RUST & SECTION LOSS ON ENDS OF BEAM 4 AT ABUTMENT 1, BEAMS 2 & 3 AT PIER 2 ON BK. & AHD. SIDES, HOLE RUSTED THRU WEB AT BOTTOM FLANGE ON BEAM 3 AHD. SIDE OF PIER 2 APPROX. 2' AHD OF PIER.

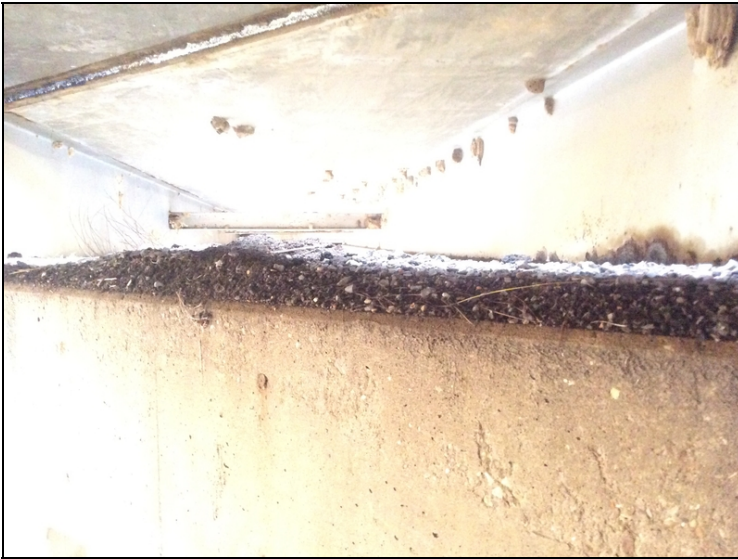
Open joint over pier #2 is allowing gravel, asphalt and dirt to buildup on top of the cap of pier #2 which may be contributing to the accelerated rusting of the ends of some beams. Asphalt overlay also has some minor to moderate spalls at the joint.

Pier #2 - Gravel, asphalt and dirt buildup on top of the cap full length.

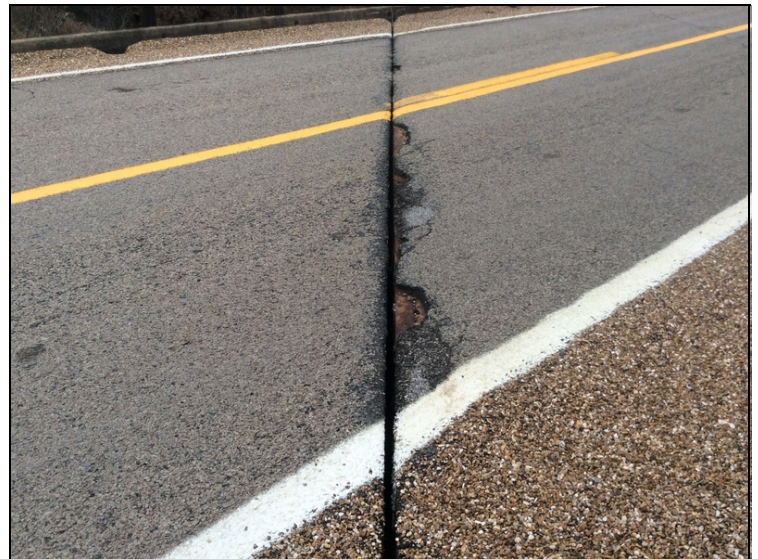
Open joint over pier #2. Asphalt overlay has some minor to moderate spalls at the joint.

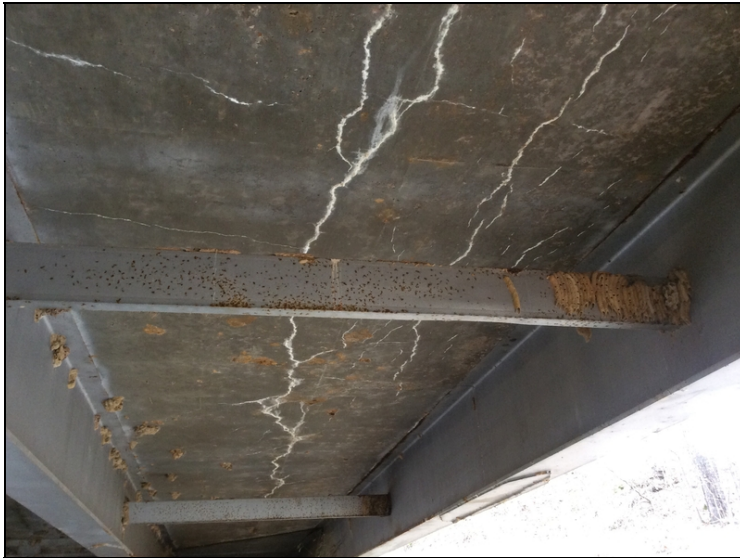
All Spans, Between beams 3 and 4 - minor to moderate cracks with efflorescence the full length of bridge.

Span #1 between beams 3 and 4 minor to moderate cracks with efflorescence. Span #2 is typical.

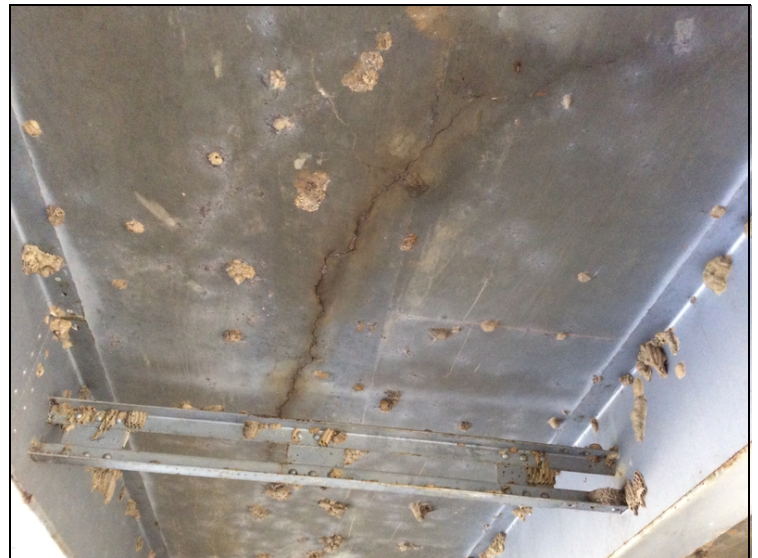
Span #1, between beams 2 and 3 has moderate crack. Approximately 15 sf. C2 cracks

Span #1 between beams 2 and 3 has moderate crack. Approximately 15 sf. C2 cracks

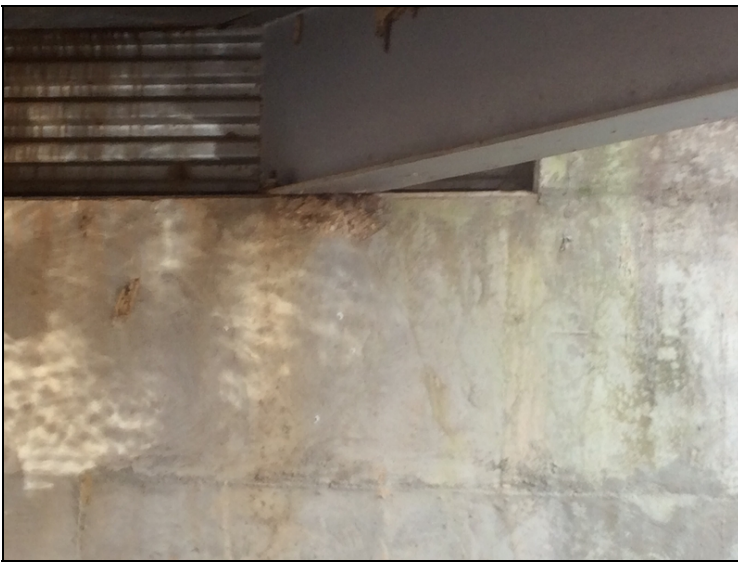
Abut #1 - Minor cracks with efflorescence in a few places throughout.  
Abut #1 - Minor spall with no rebar exposed in bearing area under beam #'s 1, 2 & 3

Abut. #1 - minor spall with no rebar exposed in bearing area under beam #1. Typical under beams 2 and 3.

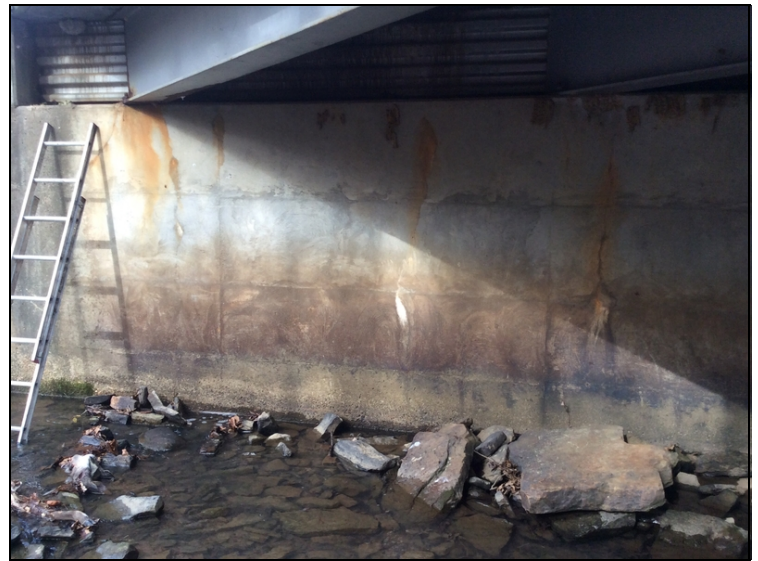
Abut #1 - Minor cracks with efflorescence in a few places throughout . 6 Lf. C2 efflorescence

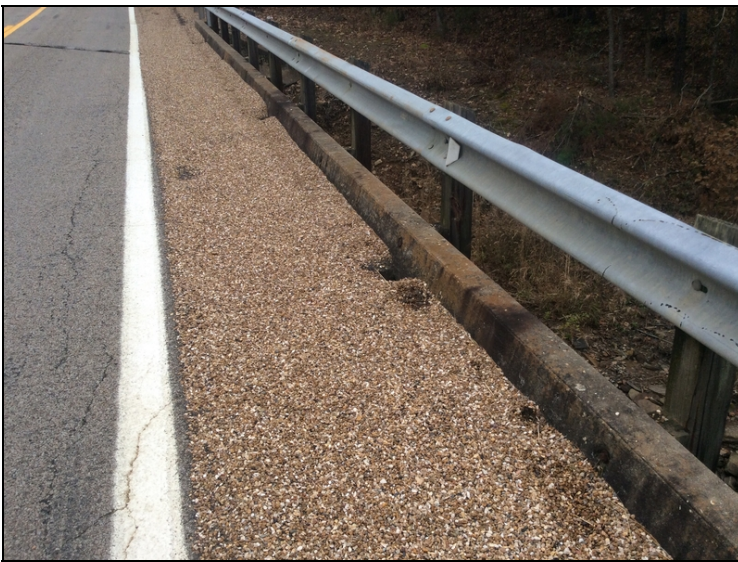
There is approximately 4" of gravel build up in the gutter against the curbs on both sides of the bridge.

Approximately 4 inches of gravel build up in the gutter against the curbs on both sides of the bridge.

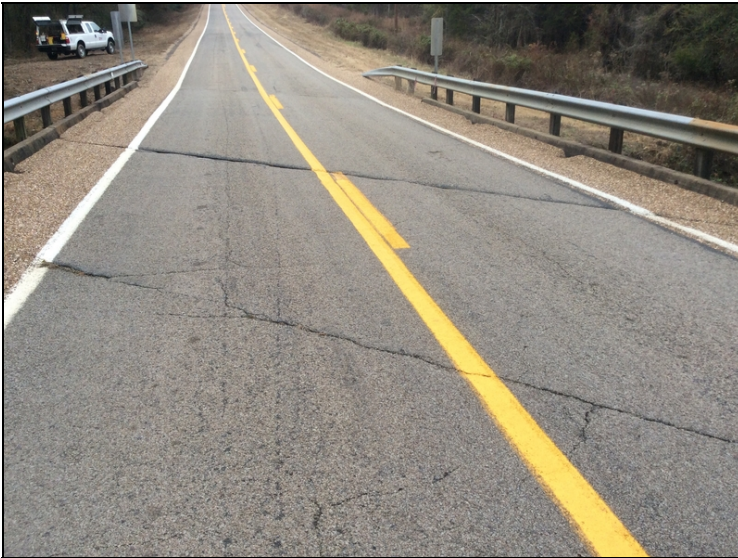
Wearing surface  
Moderate to large cracks in overlay.  
Minor spalls along joint over pier #2

Minor to moderate cracks in overlay in span #3.

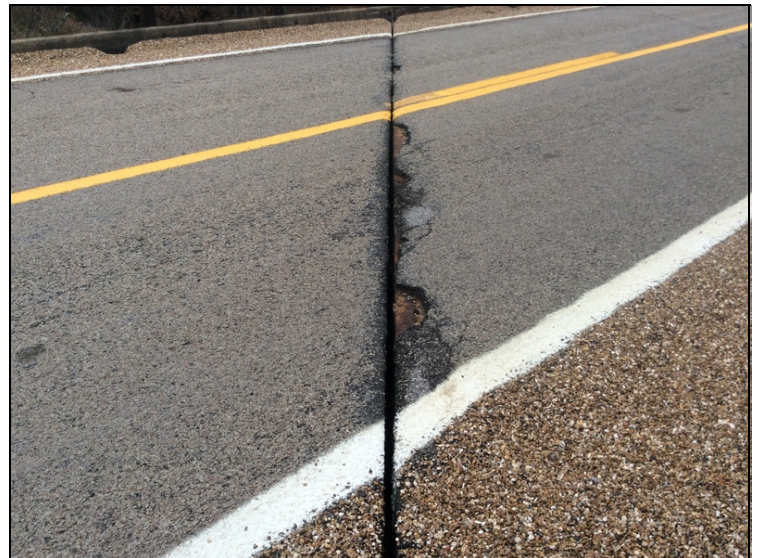
Open joint over pier #2. Asphalt overlay has some minor to moderate spalls at the joint.

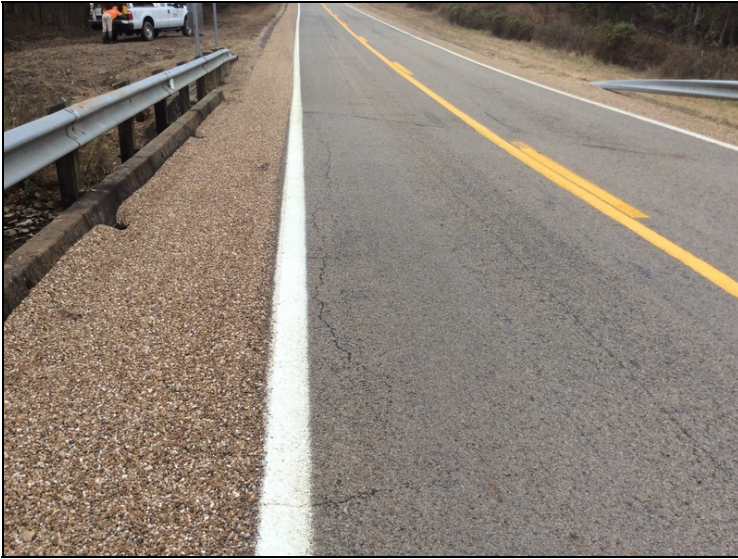
Span #1 has moderate longitudinal crack full length of the span. C3 crack

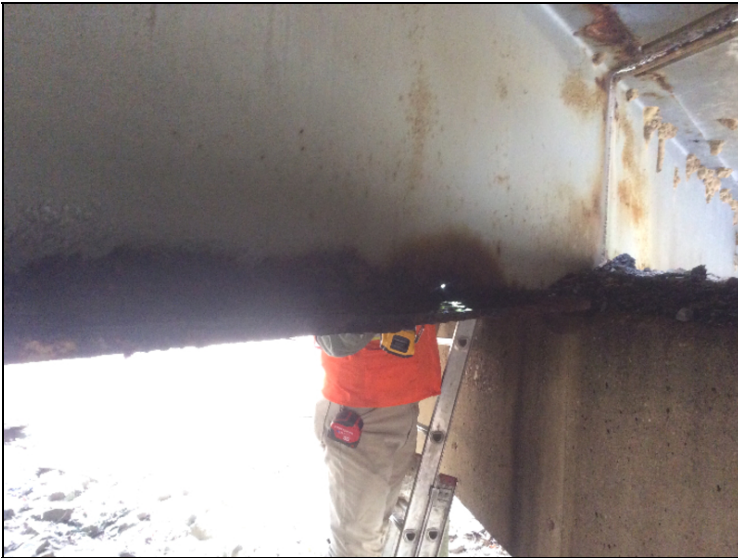
Beam #3 on the ahead side of pier #2 now has complete section loss (hole) in the lower web near the end of the beam.  
New pictures have been added.

Beam #3, ahead side of pier #2 has moderate pack rust in lower web and top of the bottom flange. There is complete section loss (hole) in the lower web approx. 2' back from the end of the beam.

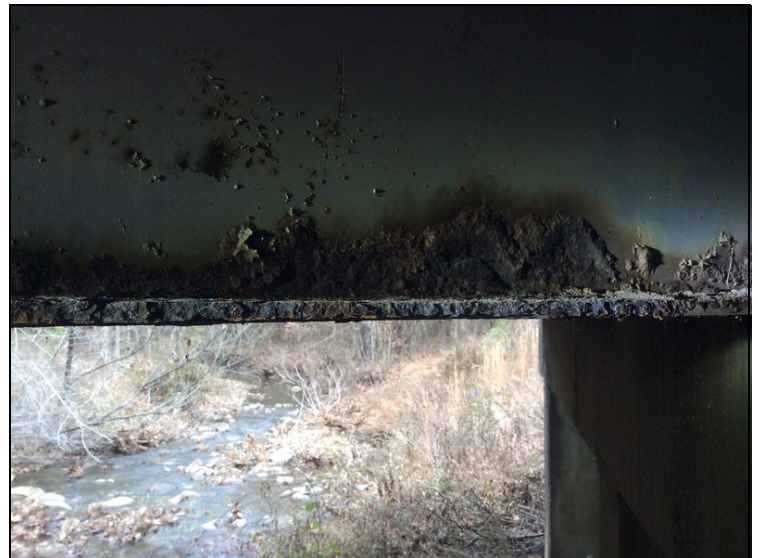
Beam #s 2 and 3 at each side of pier # 2.  
Section loss in the lower part of the web and on the bottom flange.

Beam #3 backside of pier #2 has moderate pack rust and moderate section loss in the lower web and the bottom flange.

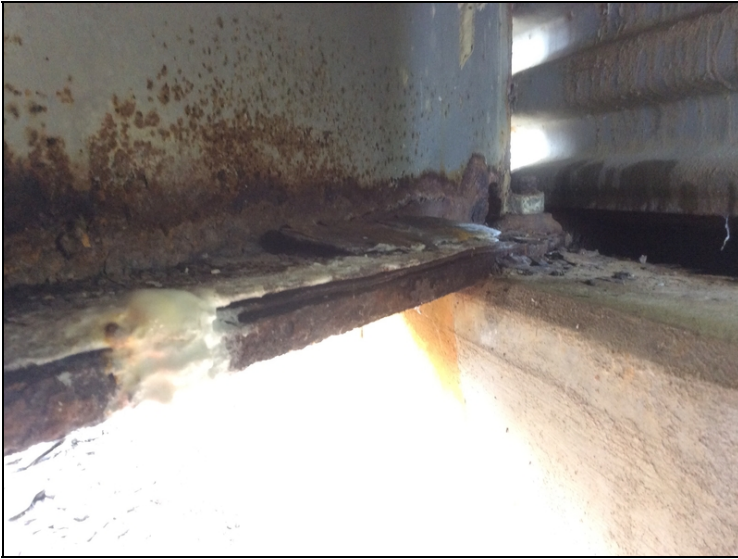
Beam #4 at abutment #1 has minor to moderate pack rust and minor section loss on the top of the bottom flange on both sides of the beam for approximately 2 ½ ft. back from the end of the beam.

Beam #4 at abut. #1 - moderate to heavy pack rust with minor section loss.

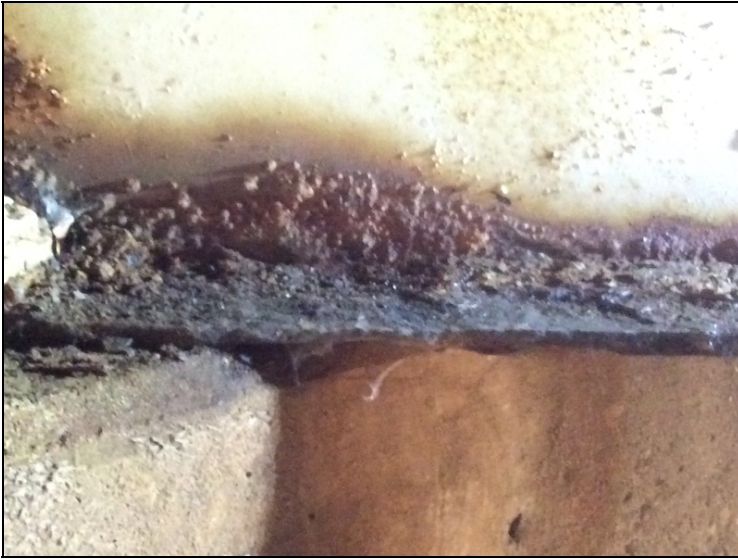
Beam #2 ahead side of pier #2 has moderate to major section loss on right side of the bottom flange.

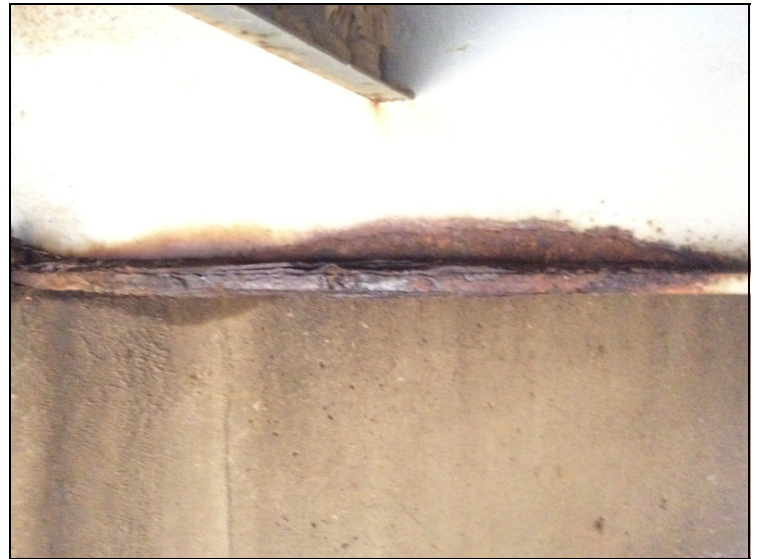
Beam #3, ahead side of pier #2 has some minor pack rust with minor section loss in the top of the bottom flange and moderate rust in the lower web.
