Bridge #06182(Routine)

US 270 over Williams Creek

Team Lead: William Wood Inspection Date: July 22, 2020

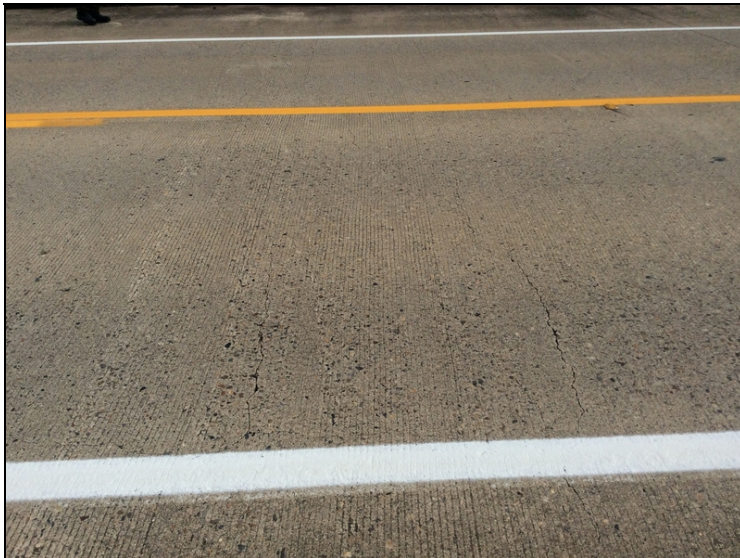
DECK - MODERATE TO MAJOR CRACKING THROUGHOUT DECK. MINOR SCALE THROUGHOUT DECK. MODERATE CRACKING W / EFFLOR IN SOFFIT.

Span #3, right lane - Moderate and major transverse and longitudinal unsealed cracks, typical throughout.

**Date Reported:** 07/16/2012  
**Priority:** B - Pressing; 6 month completion goal  
**Type of Work:** Repair  
**Status:** Open  
**Component:** 12 - Reinforced Concrete Deck

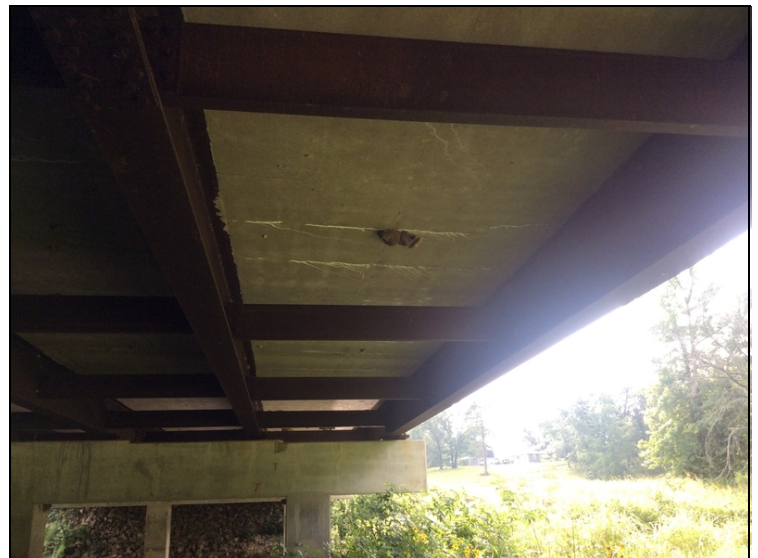
Span #2, underside - cracks with efflorescence. Typical throughout.

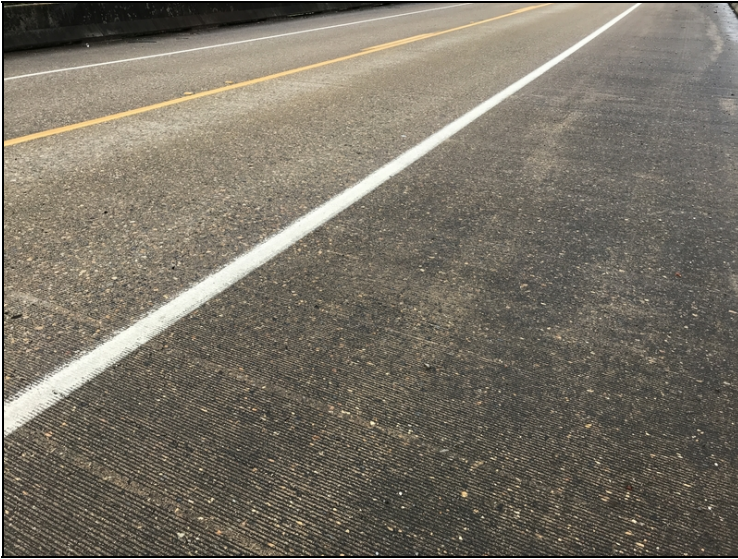
Spans 1 - 3: Minor abrasion.

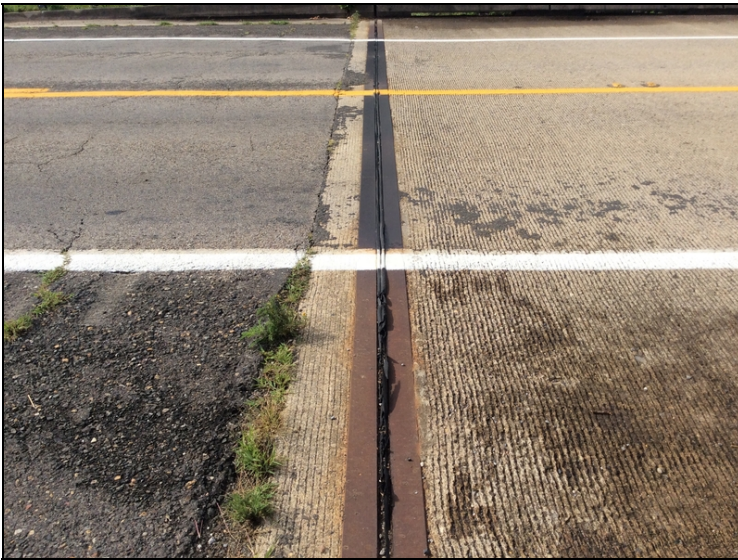
SEALS - MINOR TO MODERATE CRACKING THROUGHOUT SEALS.

Joint #2 over abut #5 - seal material has rips and tears.

**Date Reported:** 07/22/2020  
**Priority:** D- Routine  
**Type of Work:** Repair  
**Status:** Open  
**Component:** 302 - Compression Joint Seal

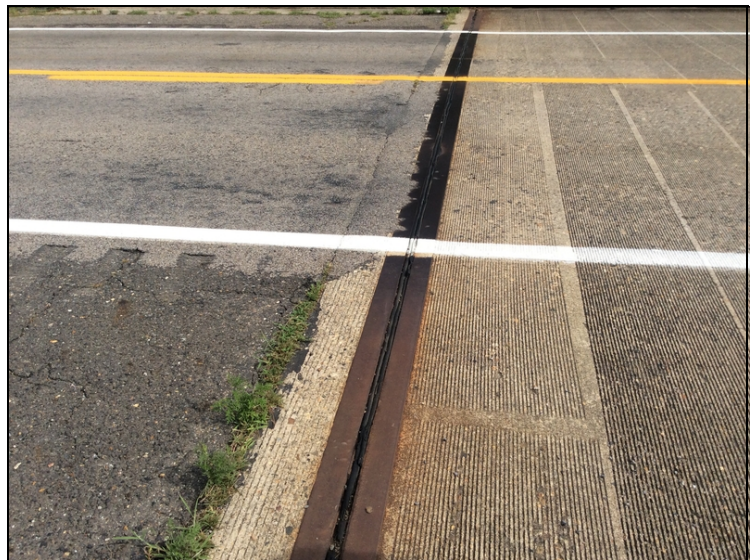
Joint #1 - moderate deterioration of seal material.

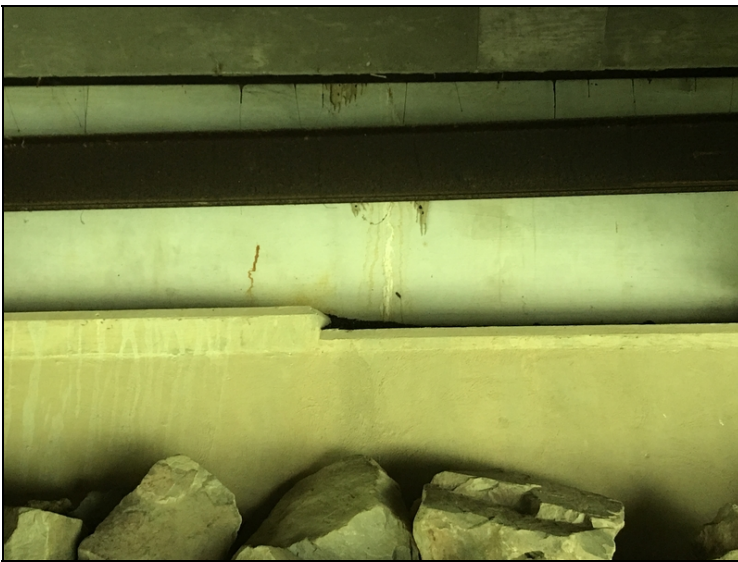
ABUTMENTS - MINOR VERTICAL CRACKING W / EFFLOR IN BACK WALLS.

Abutment 1: Cracking with efflorescence.

**Date Reported:** 07/22/2020  
**Priority:** D- Routine  
**Type of Work:** Repair  
**Status:** Open  
**Component:** 215 - Reinforced Concrete Abutment
