Bridge #06183(Routine)
US 270 over Rogers Creek
Location: 2.67 M E of Mt. Ida

Team Lead: William Wood Inspection Date: July 22, 2020

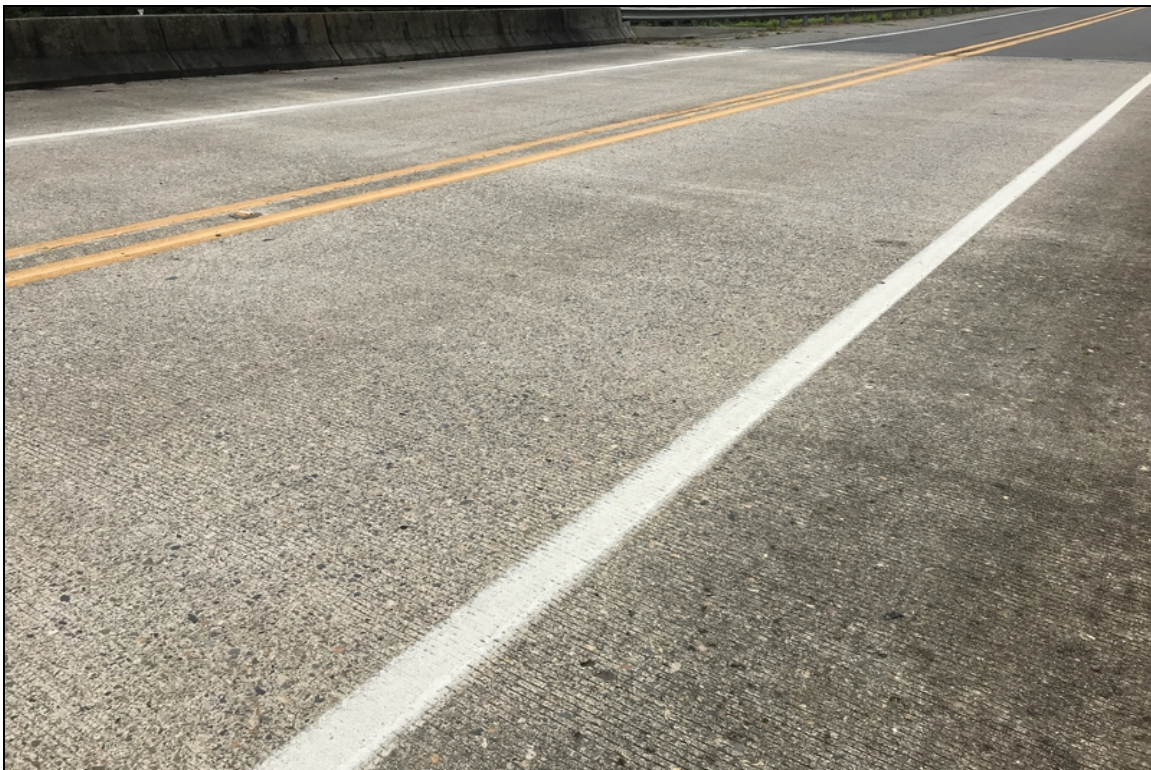
Typical deck.

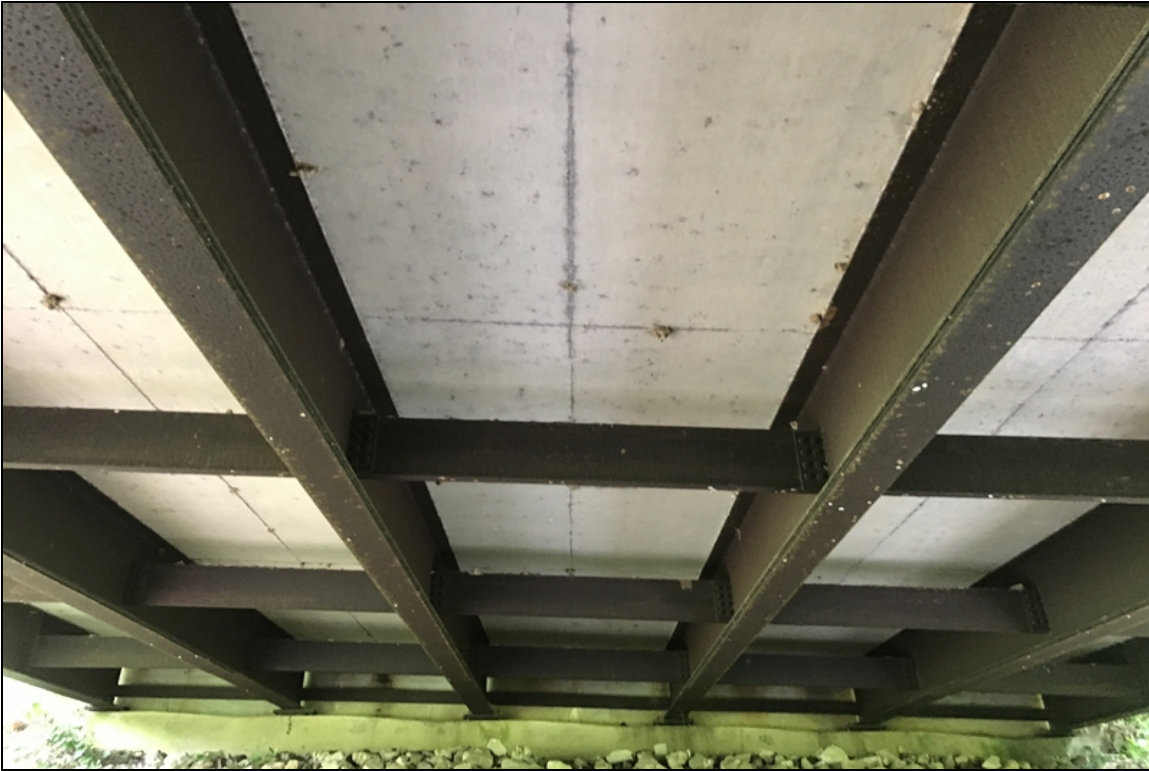
Typical undersurface.

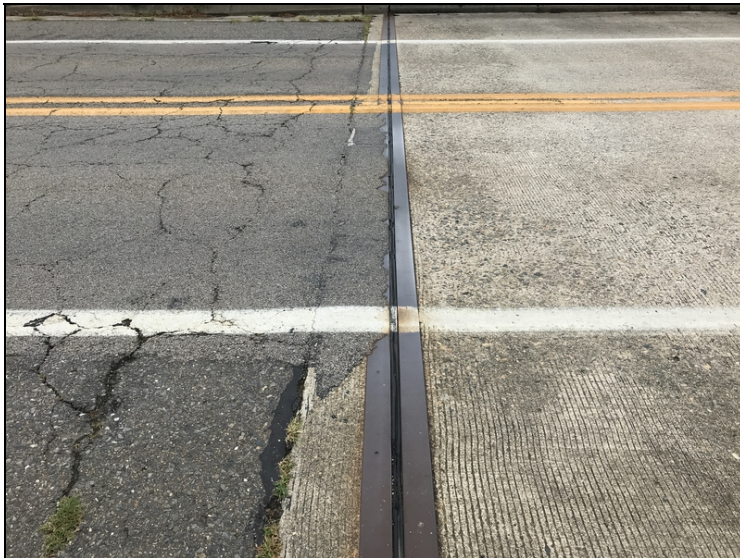
(302)	MINOR TO MODERATE CRACKING.						
310	Elastomeric Bearing	EA	12	6	6	0	0
1000	Corrosion	EA	6	0	6	0	0
515	Steel Protective Coating	SF	24	12	6	6	0
3430	Oxide Film Degradation Color/Texture Adherence(Steel Protective Coatings)	SF	12	0	6	6	0

Both Joints - moderate deterioration of seal material includes rips and tears.

Joints: Typical damage.

Date Reported: 08/15/2018
Priority: D- Routine
Type of Work: Repair
Status: Open
Component: 302 - Compression Joint Seal

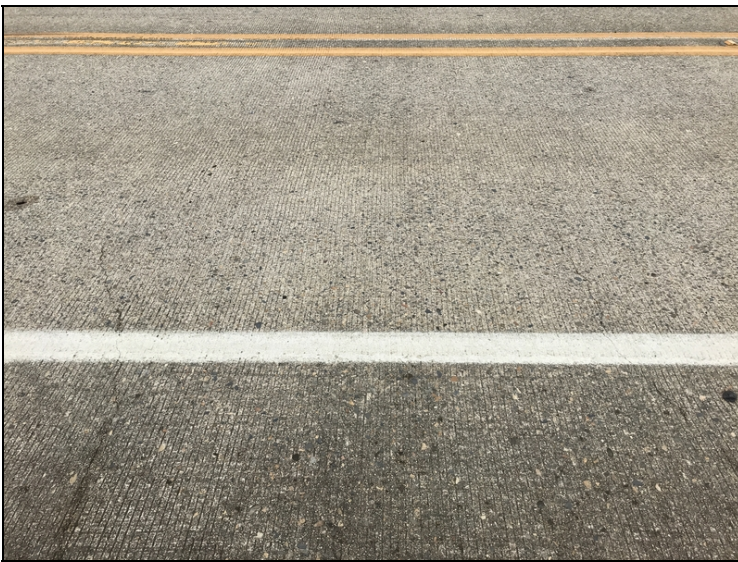
DECK - MINOR TO MODERATE CRACKING & SCALE THROUGHOUT DECK.
MINOR CRACKING W / EFFLOR IN SOFFIT.

Deck: Typical moderate cracking.

Date Reported: 07/22/2020
Priority: D- Routine
Type of Work: Repair
Status: Open
Component: 12 - Reinforced Concrete Deck

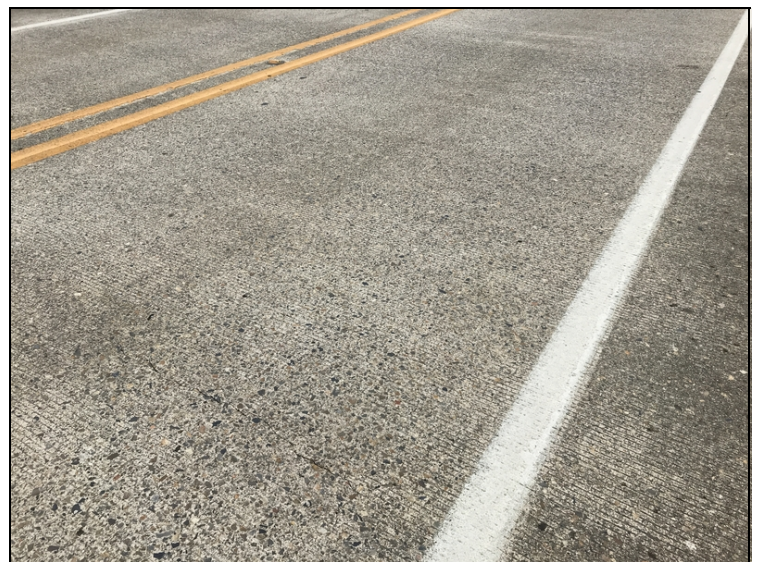
Deck: Typical minor abrasion in wheel paths.

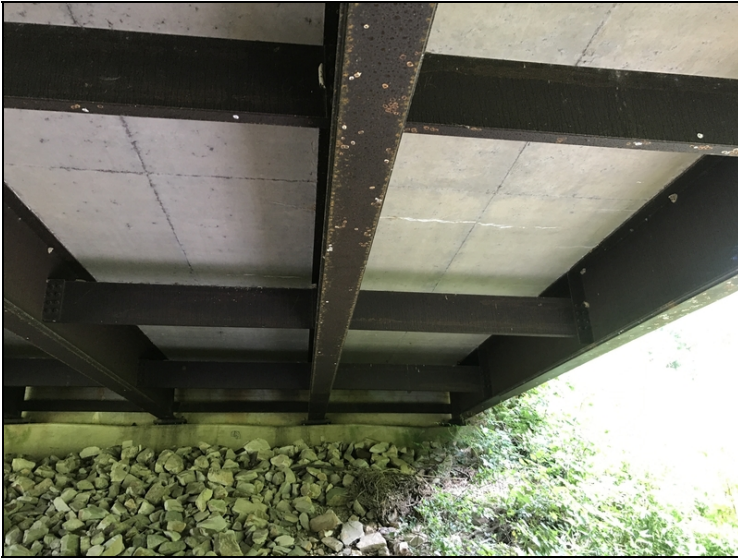
Deck, Undersurface: Cracking with efflorescence.

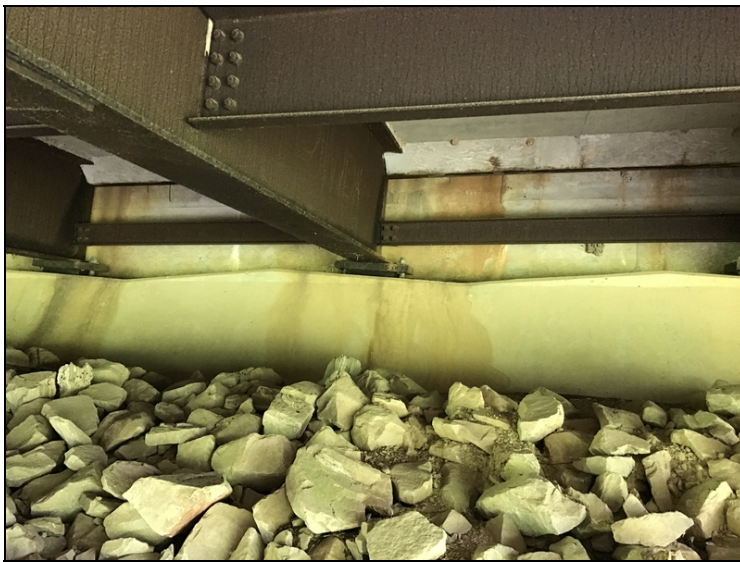
ABUTMENTS - MINOR VERTICAL CRACKING W / EFFLOR IN THE BACK WALLS.

Abutments: Typical cracking with efflorescence.

Date Reported: 07/22/2020
Priority: D- Routine
Type of Work: Repair
Status: Open
Component: 215 - Reinforced Concrete Abutment

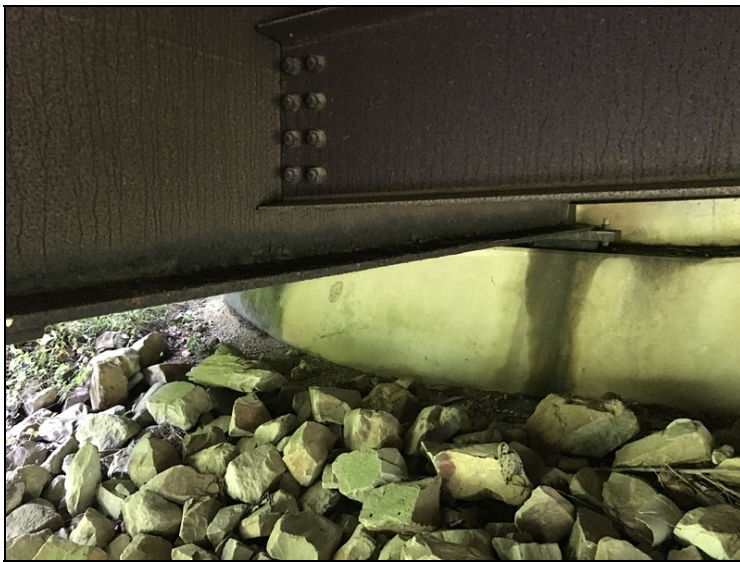
BEAMS - MINOR FLAKE RUST AT VARIOUS LOCATIONS.

Girder 5: Flaking rust.

Date Reported: 07/22/2020
Priority: D- Routine
Type of Work: Repair
Status: Open
Component: 107 - Steel Open Girder/Beam

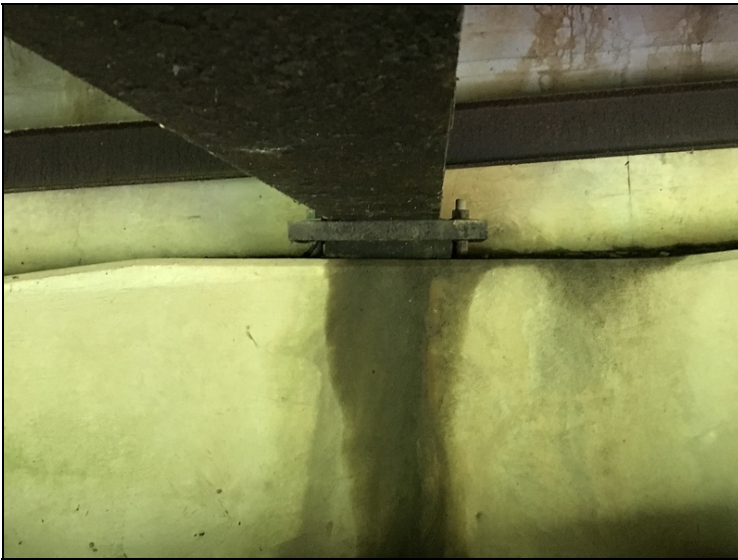
BEARINGS - MINOR FLAKE RUST AT VARIOUS LOCATIONS.

Bearings: Rust In scattered locations.

Date Reported: 07/22/2020
Priority: D- Routine
Type of Work: Repair
Status: Open
Component: 310 - Elastomeric Bearing
