Bridge #06184(Routine)

US 270 over Shady Creek

Team Lead: William Wood Inspection Date: July 22, 2020

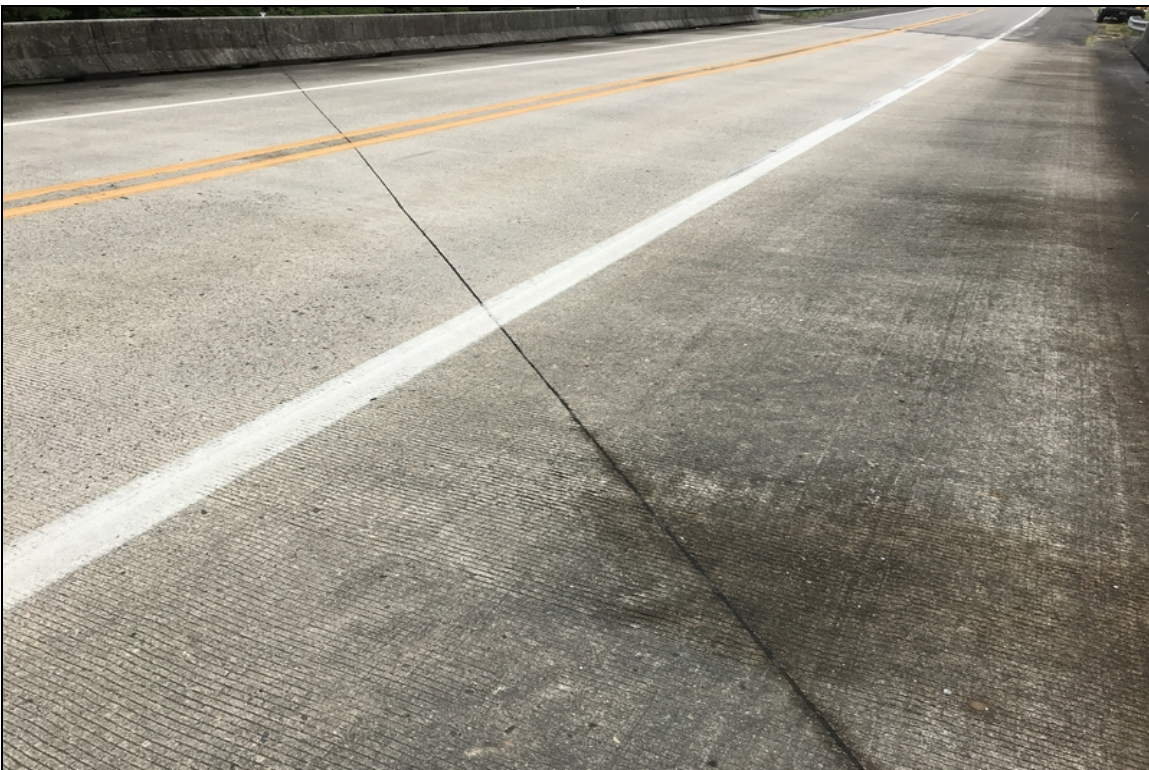
Typical deck.

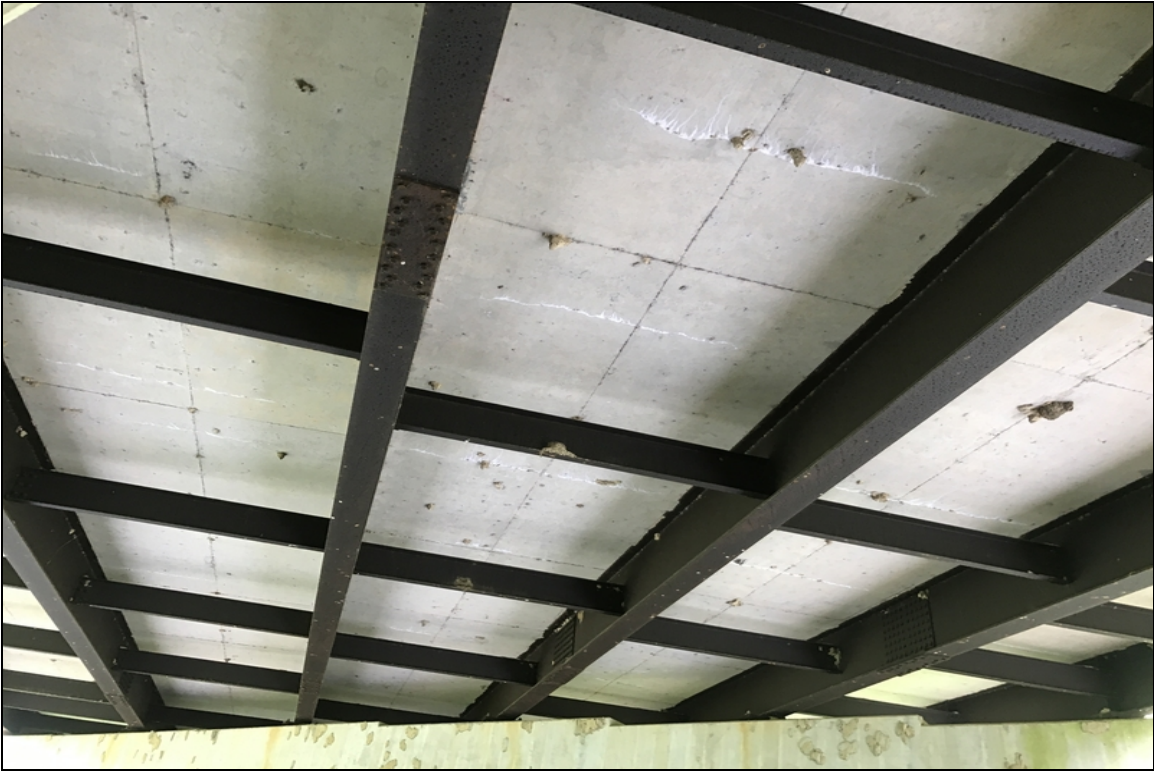
Typical undersurface.

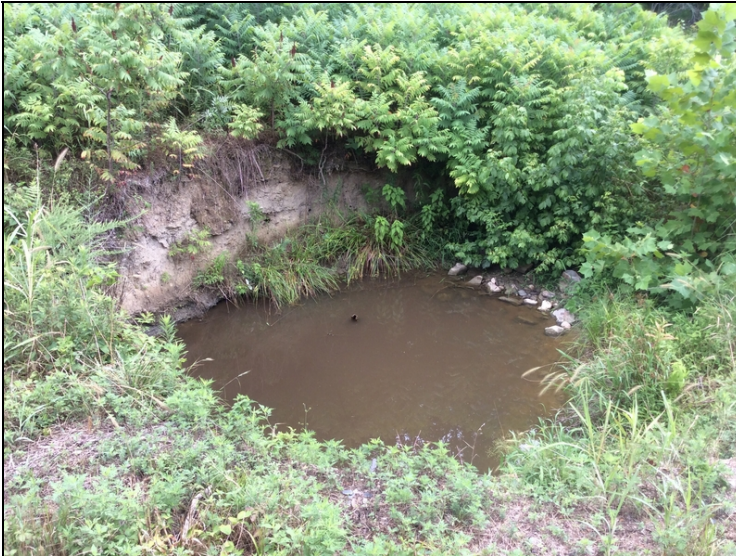
A LARGE HOLE HAS DEVELOPED IN THE DITCH LINE AT ABUTMENT 1 LT. SIDE.

NW of Bridge - Scour in ditch line.

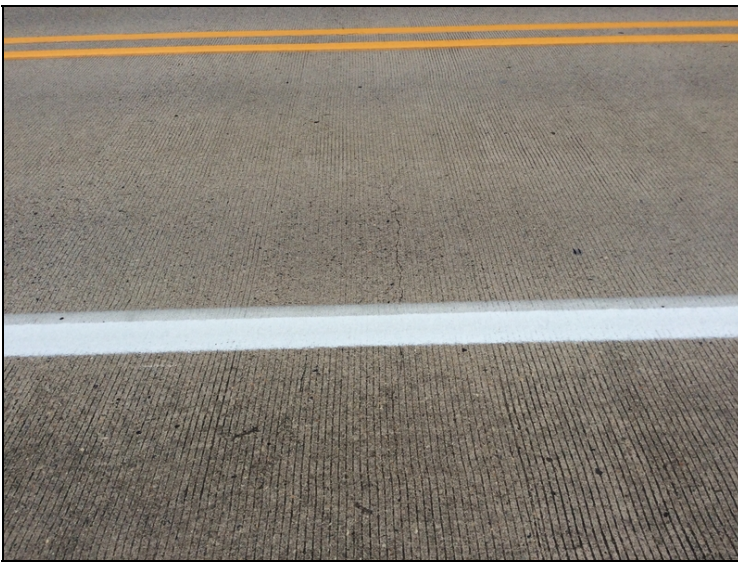
A few moderate unsealed transverse cracks in Deck.

Deck - A few moderate transverse cracks. 300 SF
C2
