Bridge #06185(Routine)

US 270 over Twin Creek

Team Lead: William Wood Inspection Date: July 22, 2020

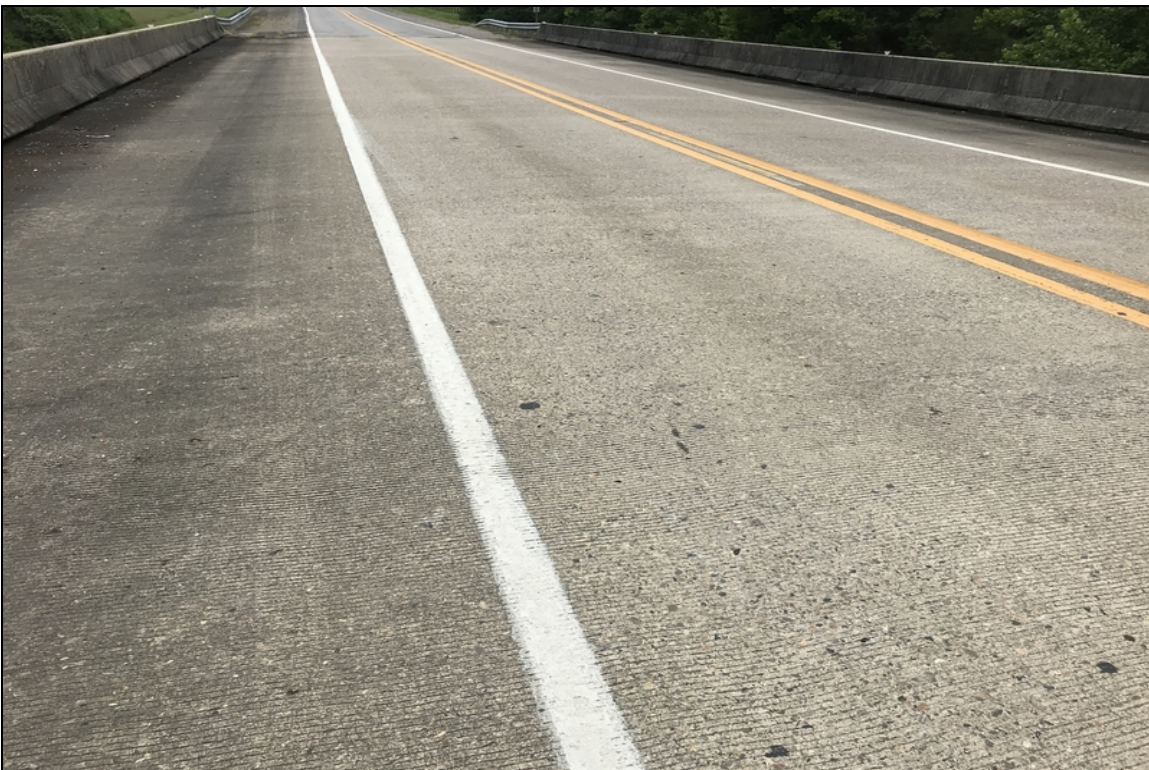
Typical deck.

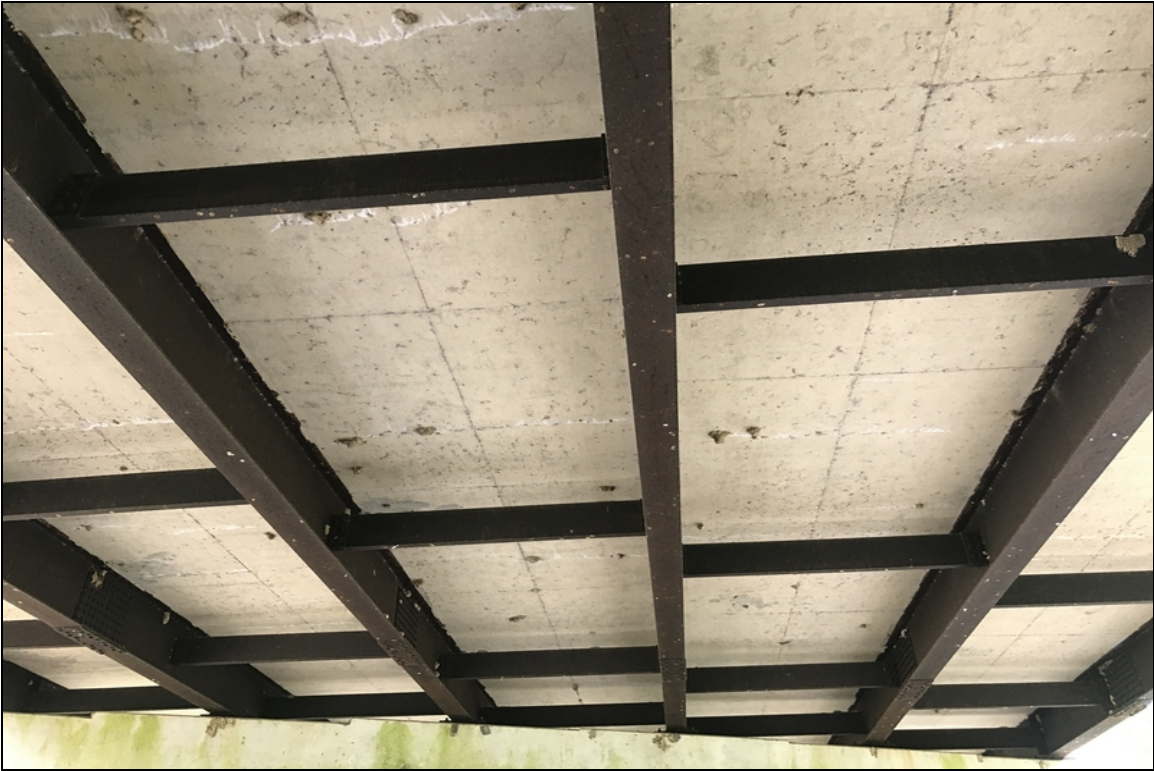
Typical undersurface.

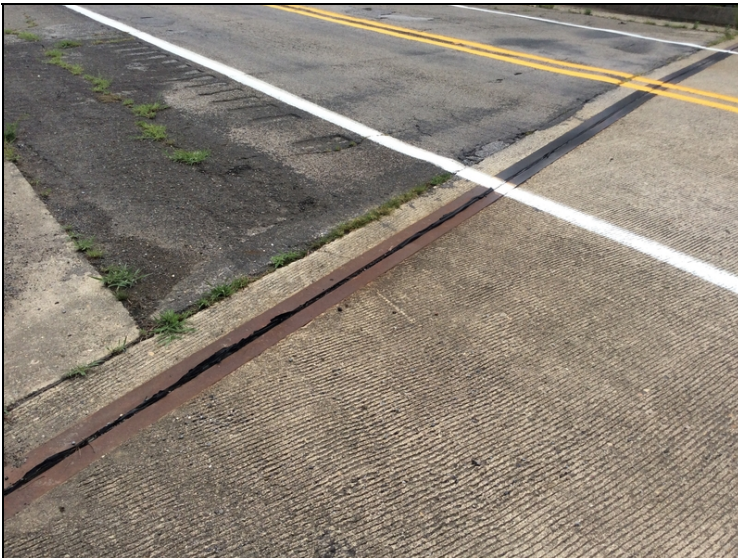
(215)	MINOR VERTICAL CRACKING IN ABUTMENT 4. MINOR VERTICAL CRACKING W / EFFLOR IN BACK WALLS. MINOR HORIZONTAL CRACKING IN WING WALL AT ABUTMENT 4 LT. SIDE.						
234	Reinforced Concrete Pier Cap	LF	96	96	0	0	0
302	Compression Joint Seal	LF	100	35	28	37	0
2330	Seal Damage	LF	65	0	28	37	0

Joints have minor to moderate deterioration of seal material.
Joint #2 is bulging in some areas with rips and tears.

Joint #2 - rips and tears.

Date Reported: 08/16/2018
Priority: D- Routine
Type of Work: Repair
Status: Open
Component: 302 - Compression Joint Seal

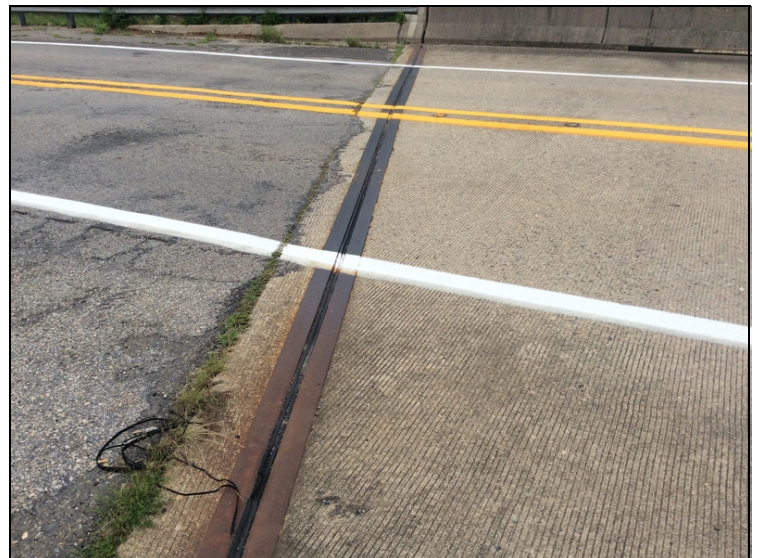
Joint #1 - deterioration of seal material.

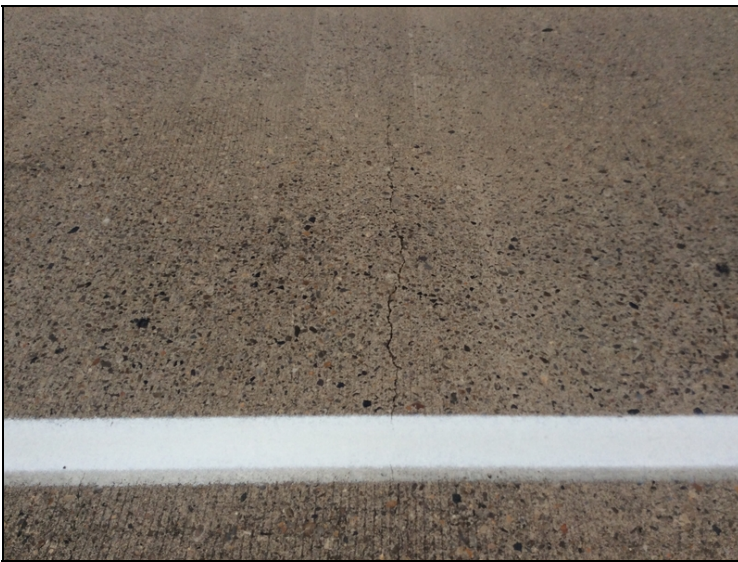
DECK - MINOR TO MODERATE CRACKING & MINOR SCALE THROUGHOUT DECK. MINOR TO MODERATE CRACKING W / EFFLOR IN SOFFIT.

Moderate unsealed cracks.

Date Reported: 08/16/2018
Priority: D- Routine
Type of Work: Repair
Status: Open
Component: 12 - Reinforced Concrete Deck

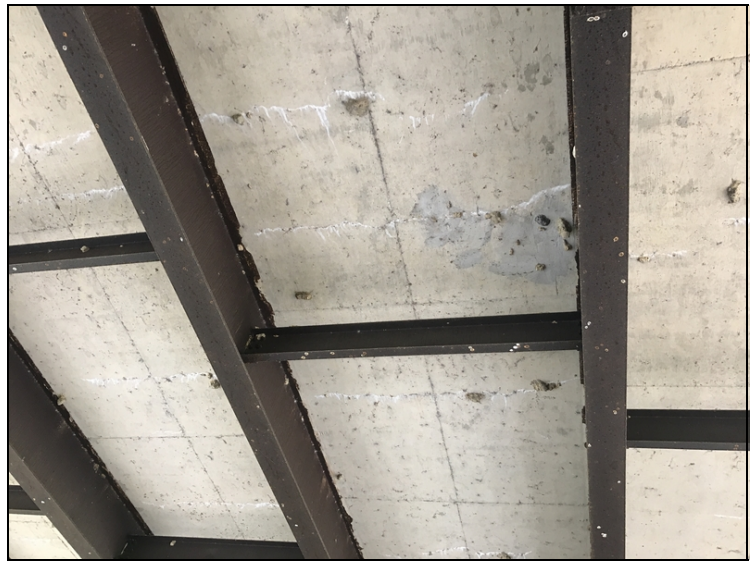
Deck, Undersurface: Typical cracking with efflorescence.

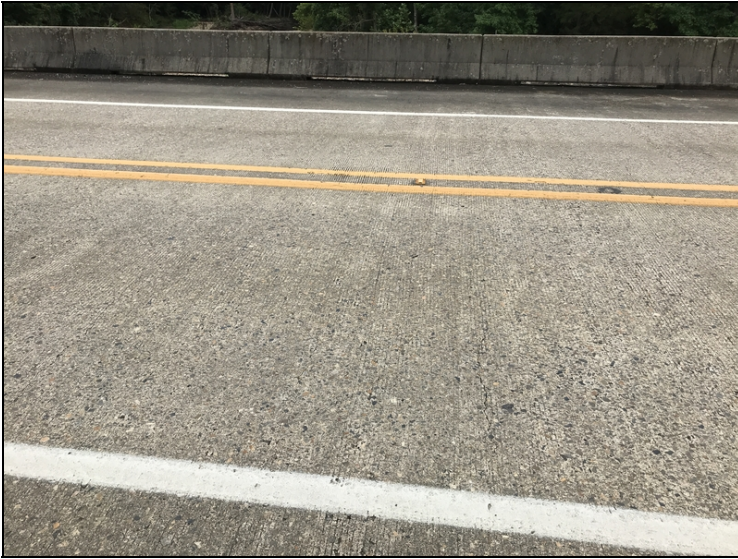
Deck: Typical moderate cracks.

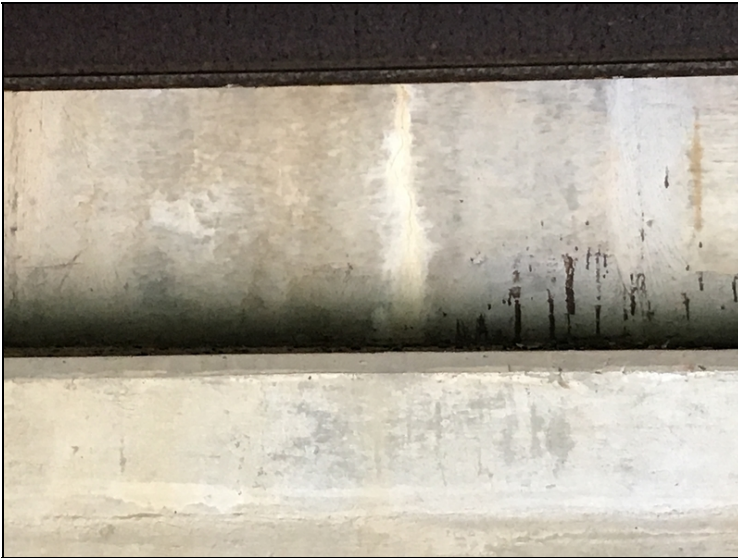
ABUTMENTS - MINOR VERTICAL CRACKING IN ABUTMENT 4. MINOR VERTICAL CRACKING W / EFFLOR IN BACK WALLS. MINOR HORIZONTAL CRACKING IN WING WALL AT ABUTMENT 4 LT. SIDE.

Typ. Cracking W / Efflor in Back Walls.

Date Reported: 07/22/2020
Priority: D- Routine
Type of Work: Repair
Status: Open
Component: 215 - Reinforced Concrete Abutment

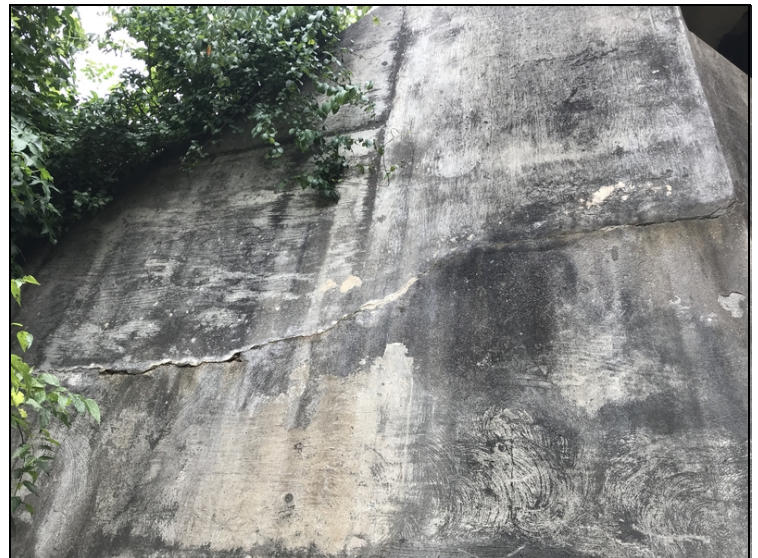
Abutment 4, Left, Wing Wall: Cracking.

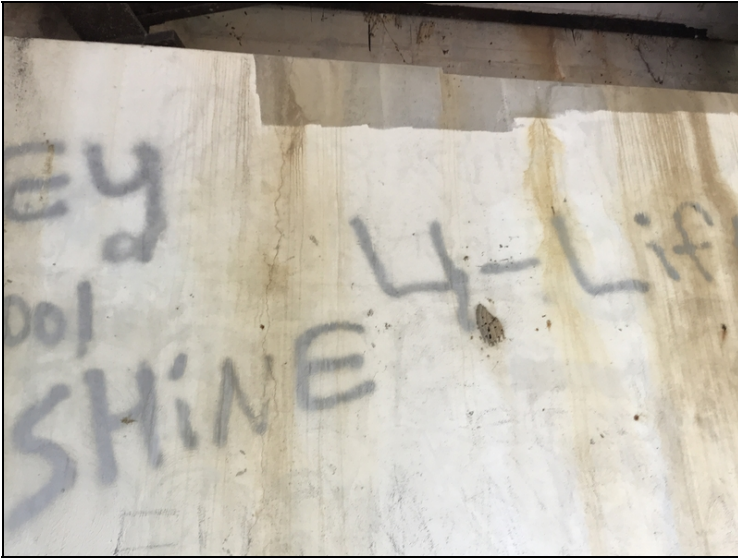
Abutment 4: Cracking.

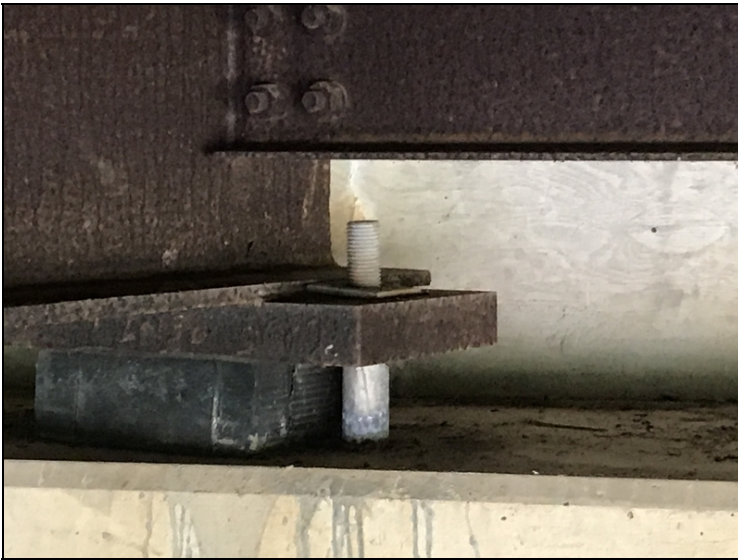
BEARINGS - SEVERAL ANCHOR BOLT NUTS MISSING AT ABUTMENTS & PIERS.

Typ. Anchor Bolt Nut Missing.

Date Reported: 07/22/2020
Priority: D- Routine
Type of Work: Repair
Status: Open
Component: 310 - Elastomeric Bearing

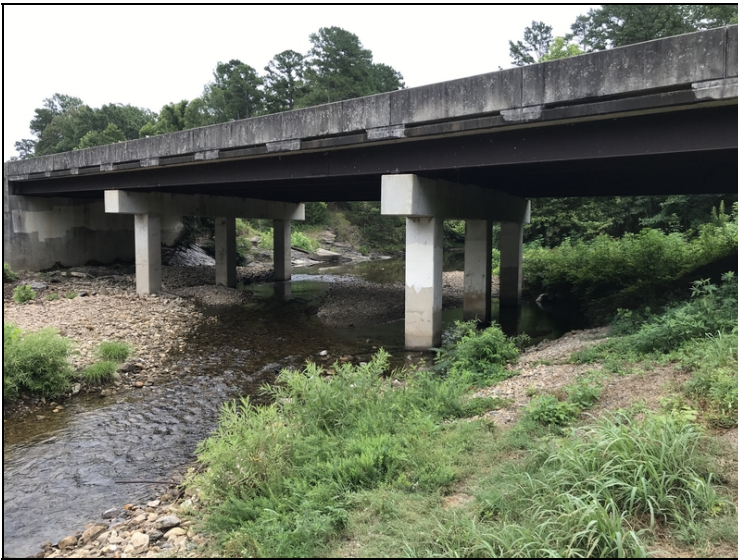
CHANNEL - MINOR SCOUR & EROSION AT PIER 2.

Pier 2: Minor scour.

Date Reported: 07/22/2020
