Asset #00355(Routine, Underwater type 2)

SH 22-Logan Co. over Six Mile Creek Relief

Location: 3.54 MI E OF FRANKLIN CO

Team Lead: Bob McEntyre, Inspection Date: 06/20/2023

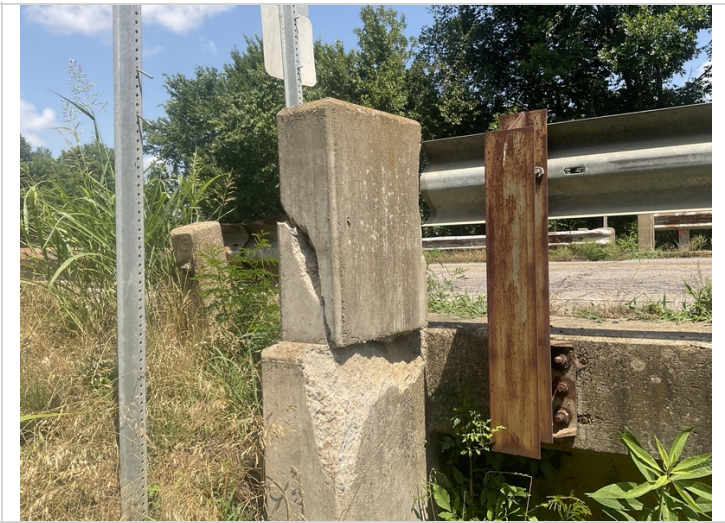
Abutment 1 right end post-Fractured

The right end post at abutment #1 (West abutment) is fractured at the base and has exposed reinforcing steel.

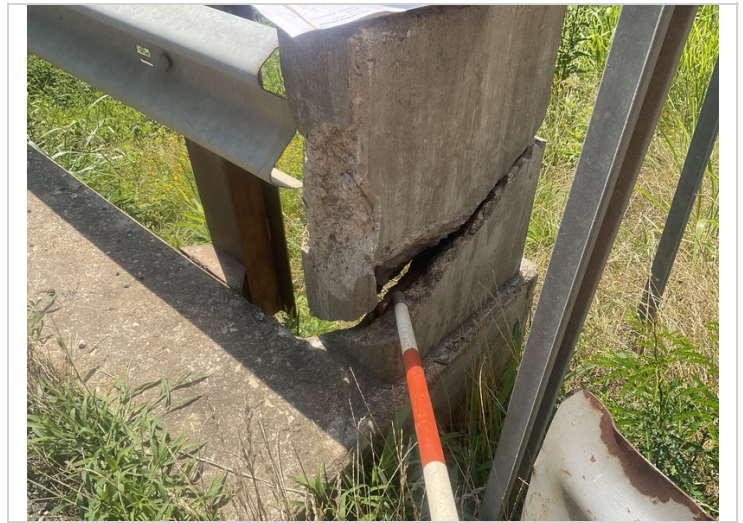
Abutment 1 right end post fractured

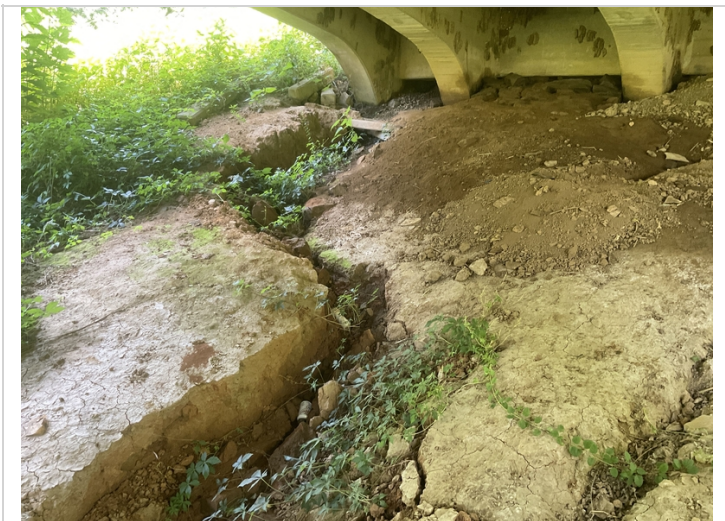
06/20/2023 - RSM & SPC: Underwater Type II Inspection conducted this date. Visual observation in dry conditions revealed no apparent scour problems at this inspection. The east embankment at abutment # 2 has minor erosion that appears to be from approach roadway drainage.

East embankment at abutment 2 has erosion

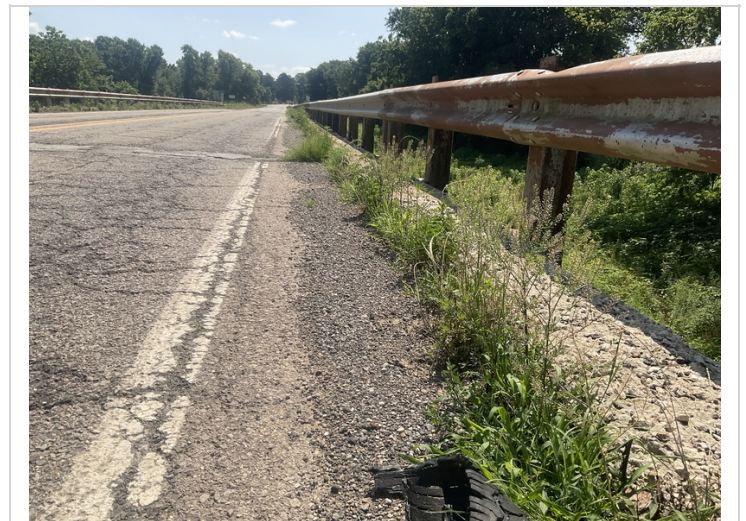
06/20/2023 - RSM - The shoulders have dirt and debris with vegetation growing.

Dirt, debris with vegetation growing in shoulders

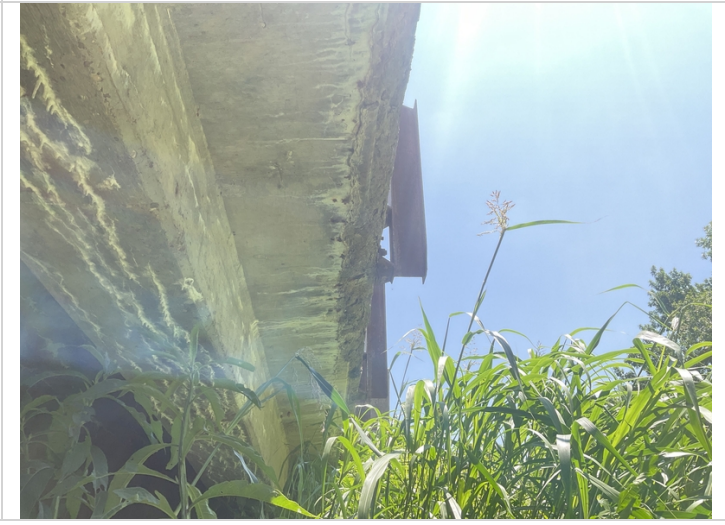
Span 10, right exterior edge of deck-Concrete deteriorating / spalling

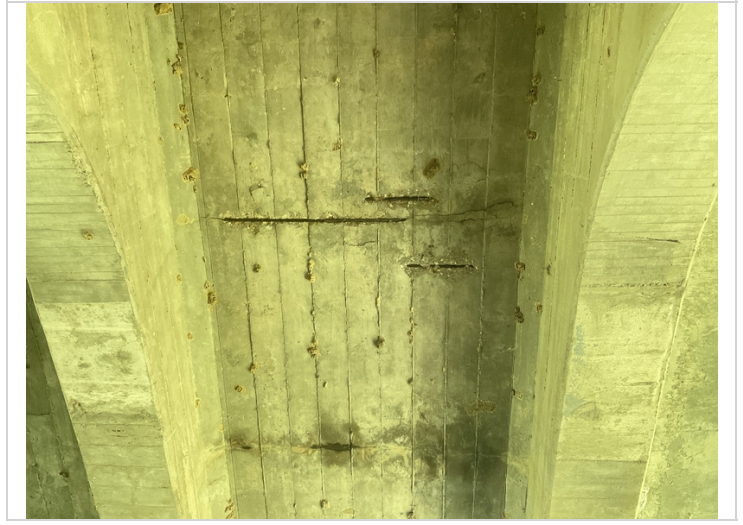
- Bay 3 has spalling with exposed reinforcing steel adjacent to bent 9
- Bay 2 & 3 has transverse cracking with efflorescence
- Bay 4 has efflorescence along the construction joint

Span 9, bay 3 deck undersurface at bent 9-Spalling with exposed reinforcing steel

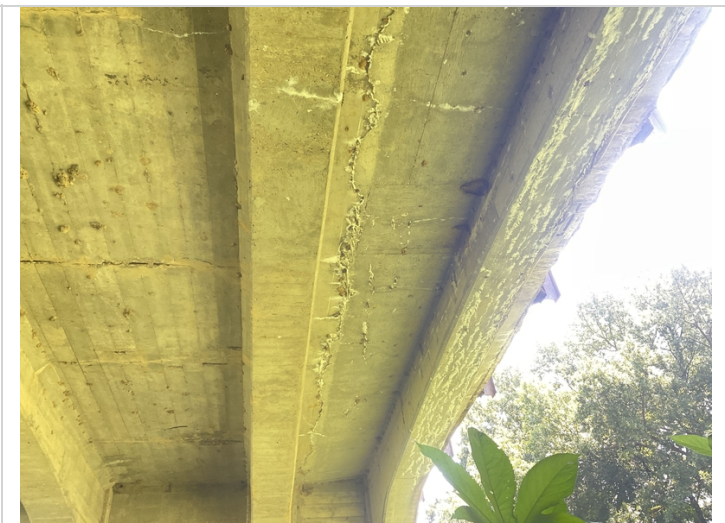
- Bays 2 & 3 have multiple locations of exposed reinforcing steel with active corrosion
- Bay 4 has a buildup of efflorescence along the construction joint

Span 6, bay 4-Efflorescence along longitudinal construction joint

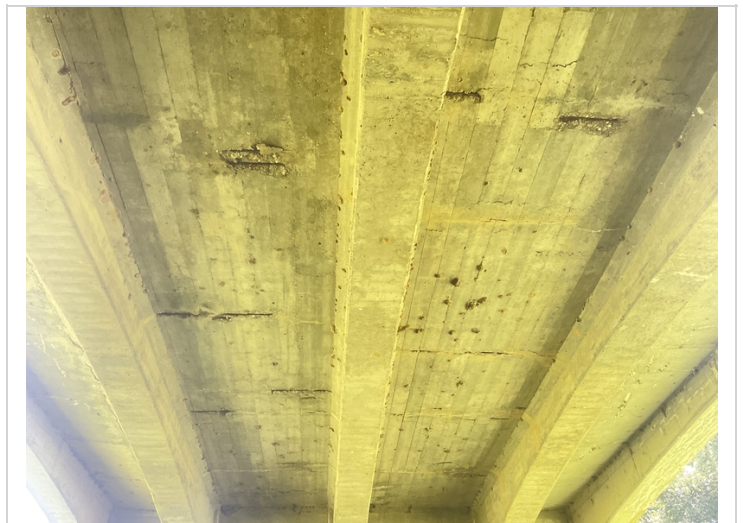
Span 6 undersurface-Shallow spalling with exposed reinforcing steel

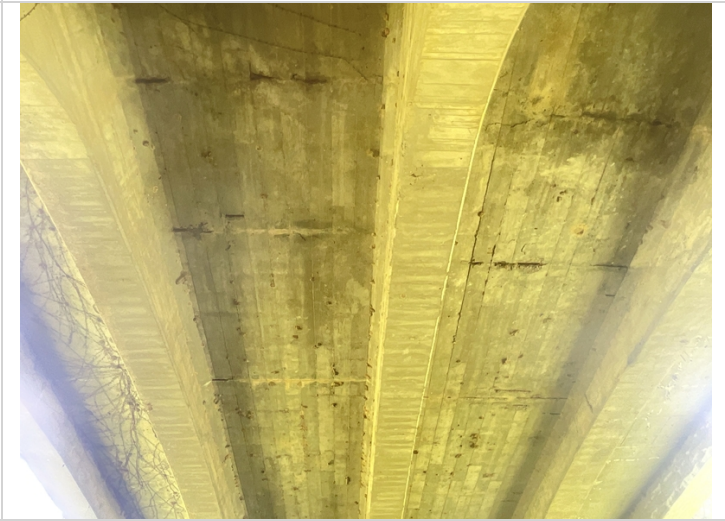
- Bays 2 & 3 have areas of exposed reinforcing steel with active corrosion and transverse cracking with efflorescence
- Bay 4 has a heavy accumulation of efflorescence along the construction joint

Span 5 deck undersurface-Shallow spalling with exposed reinforcing steel

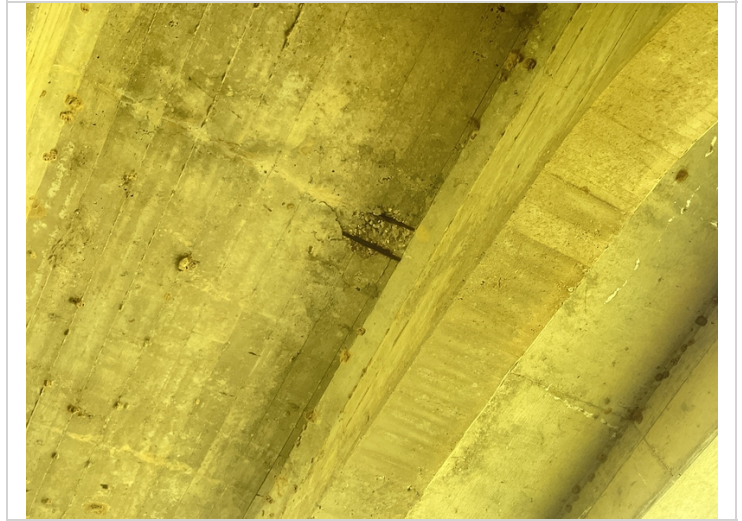
- Bays 2 & 3 have spalling with exposed reinforcing steel and transverse cracking with efflorescence
- Bay 4 has longitudinal cracking (appears to be a construction joint) with a heavy accumulation of efflorescence full length of the span

Span 3, bay 3-Spall with exposed reinforcing steel

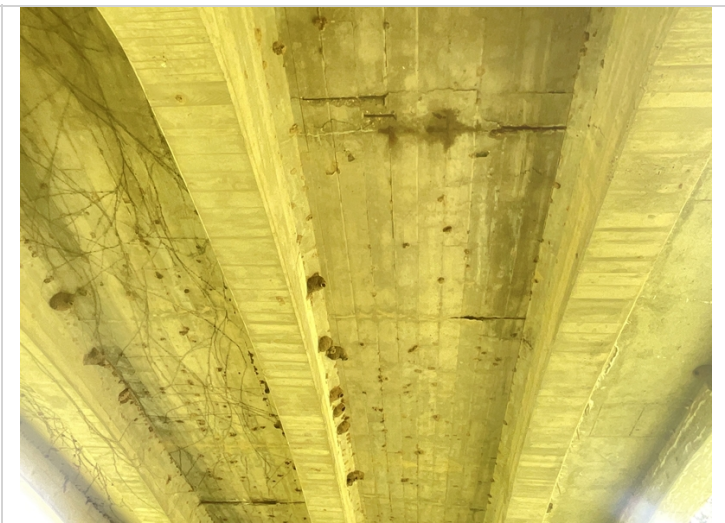
- Bays 2 & 3 have spalling with exposed reinforcing steel and transverse cracking with efflorescence
- Bay 4 has longitudinal cracking (appears to be a construction joint) with heavy efflorescence accumulation full length of the span.

Span 2, bays 2 and 3 have shallow spalling with exposed reinforcing steel in deck undersurface

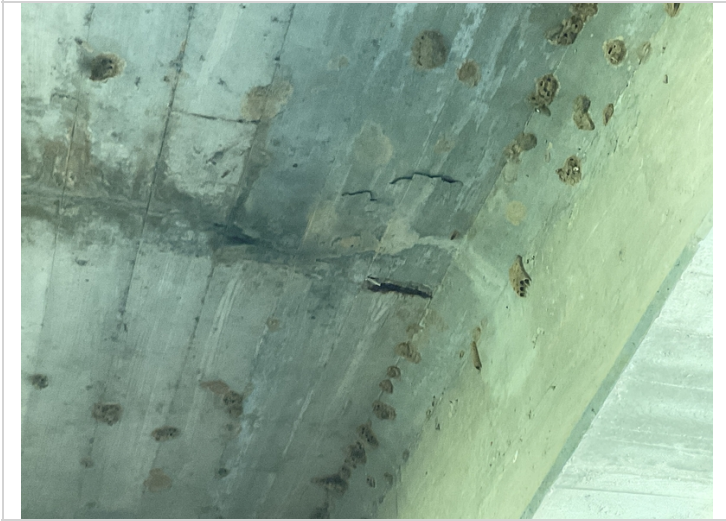
- Bays 2, 3 and 4 have a couple of transverse cracking with rust staining and efflorescence
- Bay 3 has a couple shallow delaminated areas and an area of exposed reinforcing steel with corrosion adjacent to bent 2.

Span 1, bay 3-Delaminated areas and shallow spall with exposed reinforcing steel

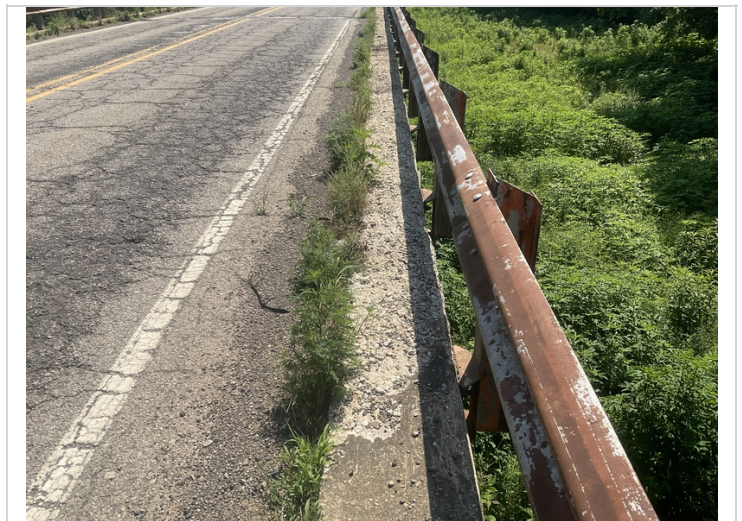
Span 2 right curb-Concrete deterioration

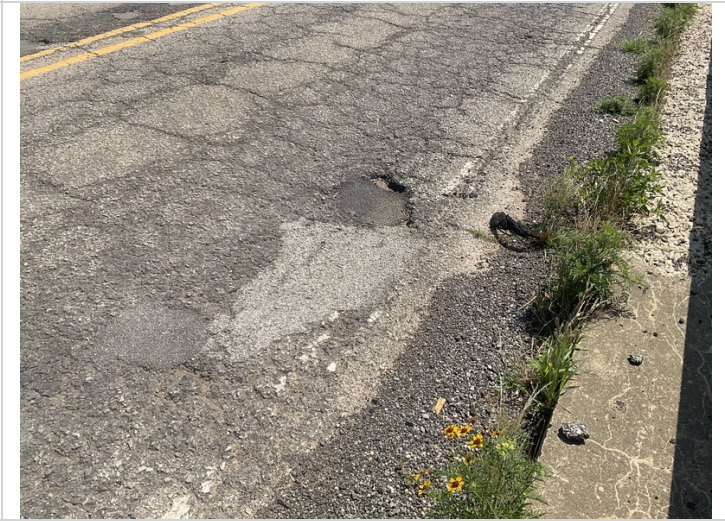
Span 8, right lane-Failing repair

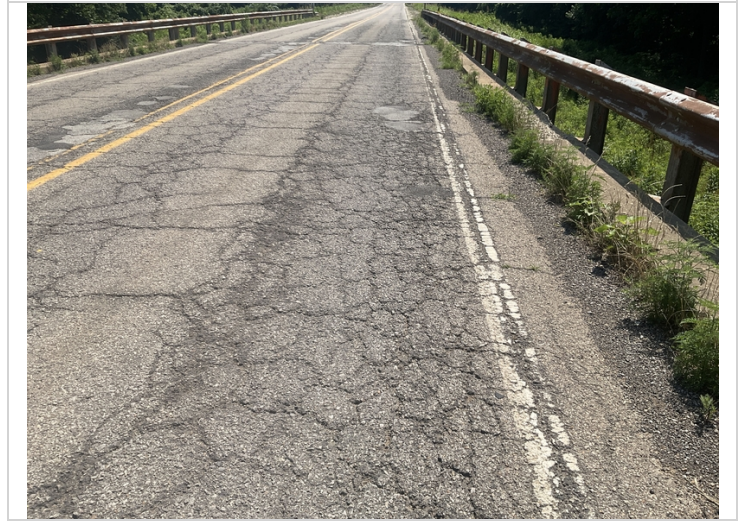
(510-16) - The asphalt overlay has heavy deterioration with map cracking throughout with potholes forming along centerline and over expansion joint assemblies.

Mapcracking in wheel paths

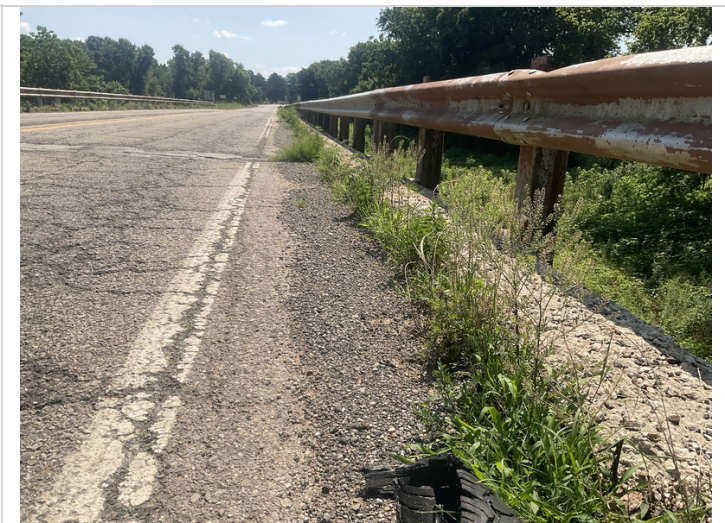
Dirt, debris with vegetation growing in shoulders

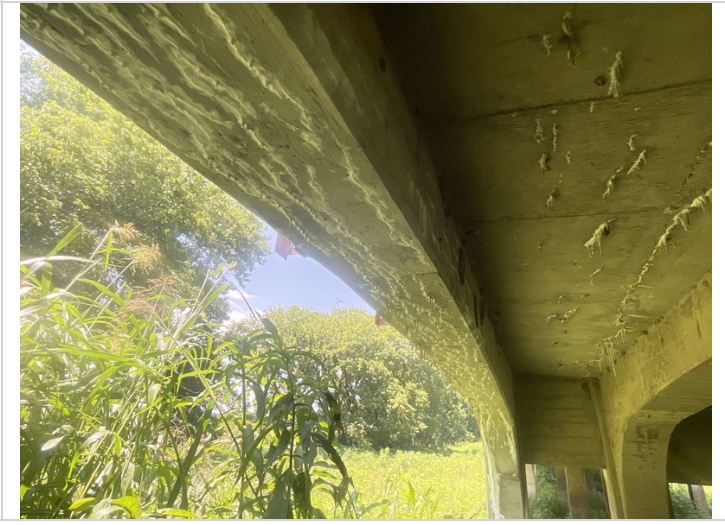
Span 10, girder 5-Mapcracking with efflorescence

Span 10, girder 5 has map cracking with efflorescence

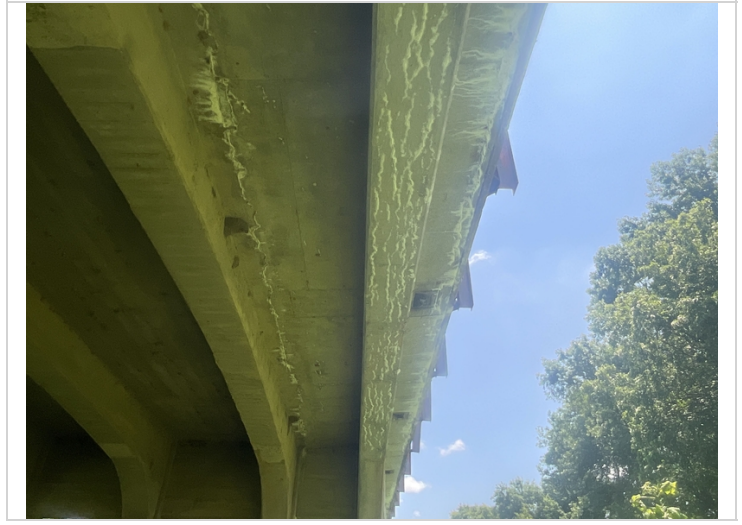
Span 8 right side-Mapcracking with efflorescence in girder 5 and deck undersurface

Span 8, girder 5 has map cracking with efflorescence

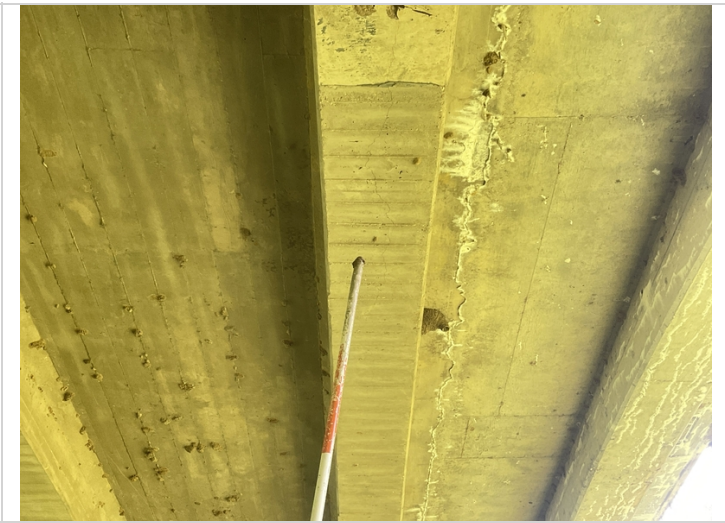
Span 8, girder 4 undersurface has a narrow width longitudinal crack that begins approximately 4' from bent 8 and extends approximately 5' towards mid-span.

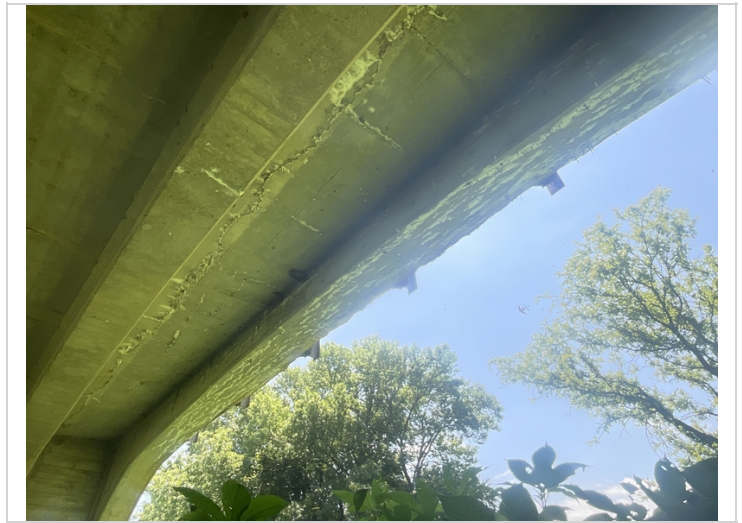
Span 6, girder 5-Mapcracking with efflorescence

Span 6, girder 5 has map cracking with a heavy buildup of efflorescence

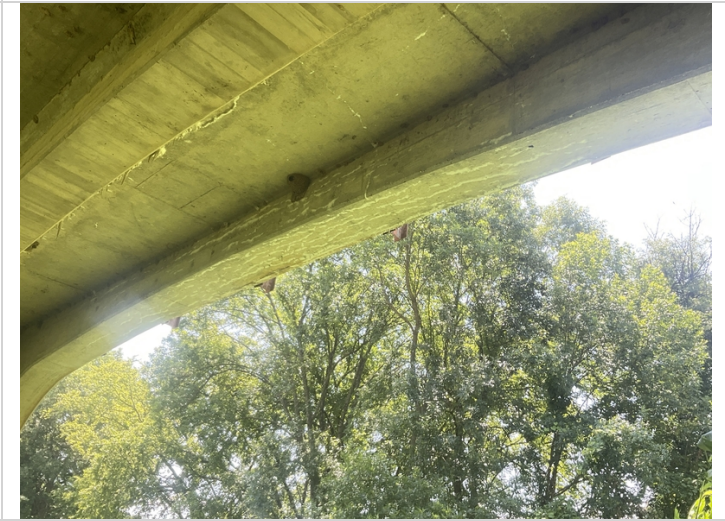
Span 2, girder 5-Mapcracking with efflorescence

Span 2, girder 5 has map cracking with efflorescence.

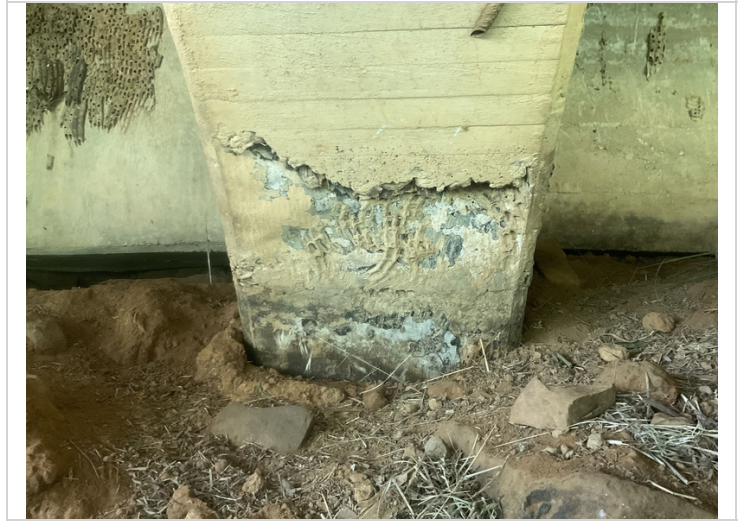
Span 1, girder 4 at abutment 1-Spalling in haunch portion of girder

Span 1, girders 2, 3 and 4 at abutment 1 have shallow spalling with no exposed reinforcing steel in undersurface of haunch section of girders.

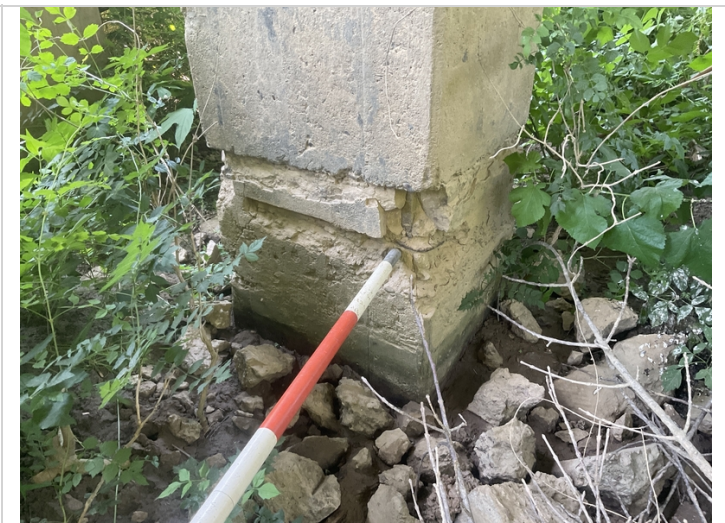
Bent 9, column 4-Spalling with exposed reinforcing steel

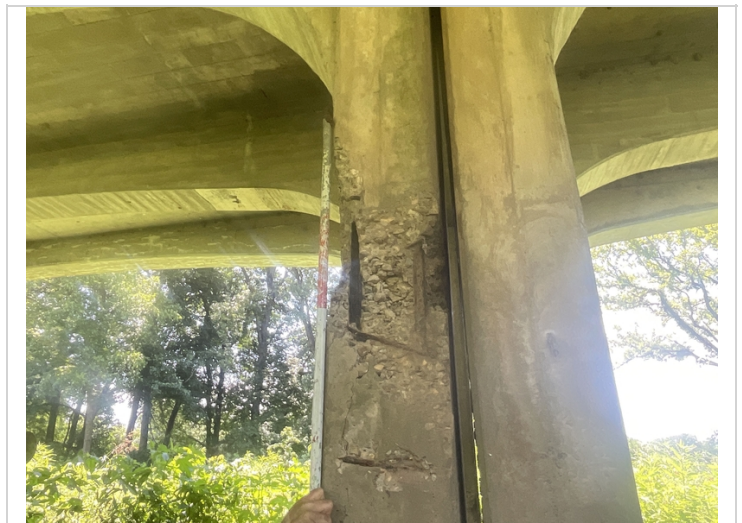
Bent 8, column 3 of span 8-Spalling with concrete section loss and exposed primary reinforcing steel. Exposed reinforcing steel has measurable section loss.

Bent 8: (span 8), columns 3 & 4 have spalling with exposed reinforcing steel

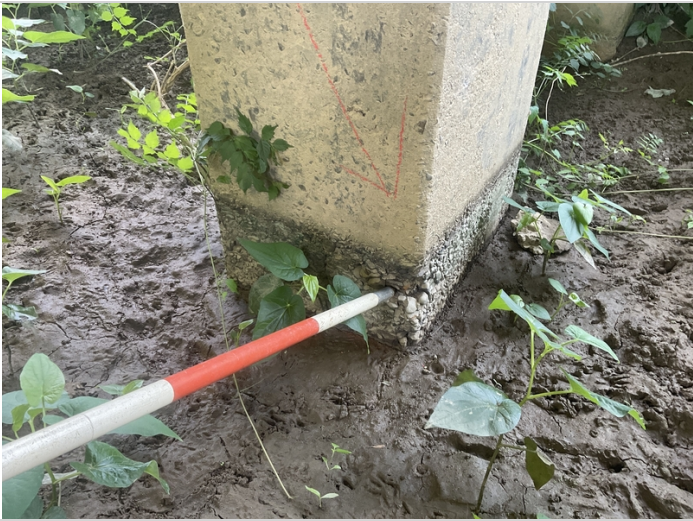
Bent 7, column 2 has light abrasion with a 4" area of concrete deterioration approximately 1" deep at base of column.

Bent 7, column 2 has abrasion with a 4" area of concrete deterioration approximately 1" deep at base of column.

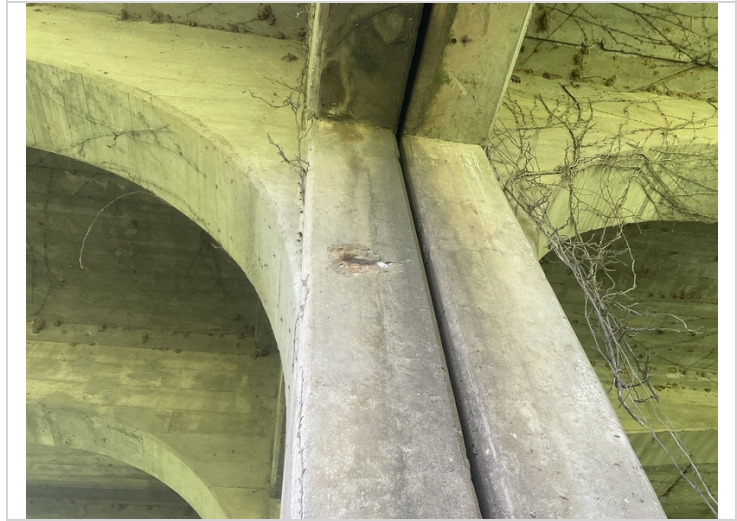
Bent 4, span 4, column 2-Shallow spall with exposed reinforcing steel

Bent 4: (span 4), columns 2 & 4 have spalling with exposed reinforcing steel.

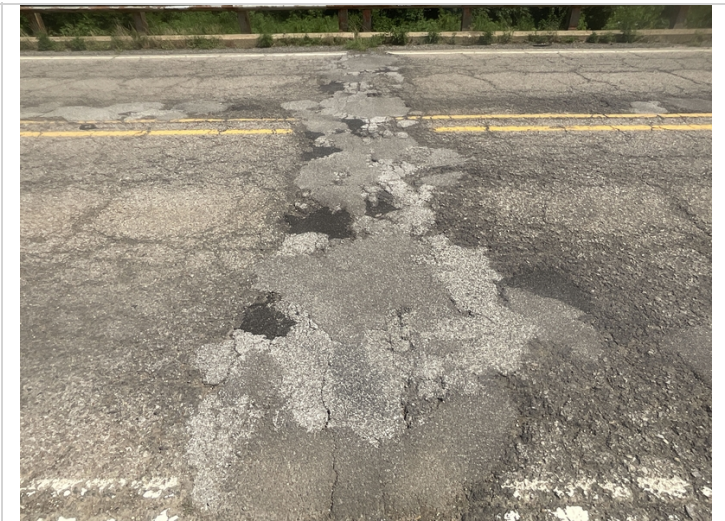
(305) -The expansion joint assemblies are covered in asphalt and not visible. -Asphalt driving surface is deteriorating and breaking apart over the expansion joint assemblies at bents # 4 and 8.							
330	Metal Bridge Railing	LF	724	700	24	0	0
7000	Damage	LF	24	0	24	0	0
515	Steel Protective Coating	SF	2608	261	2086	261	0
3420	Peeling/Bubbling/Cracking	LF	2347	0	2086	261	0

Expansion joint over bent 8

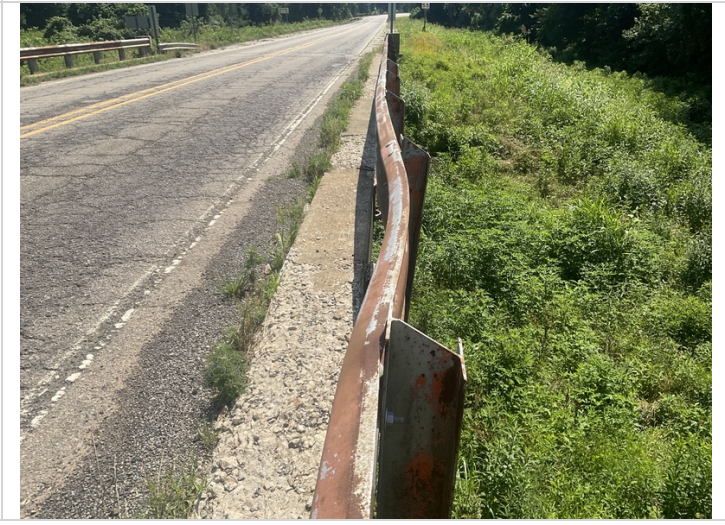
Span 8 right railing at bent 9-Collision damage

Collision damage on the right side of span # 8. Bridge railing is bent out of plane with damage to two bridge railing post.

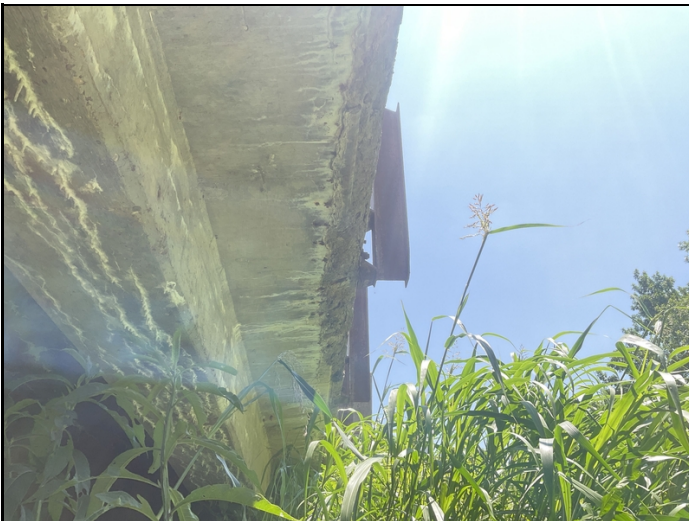
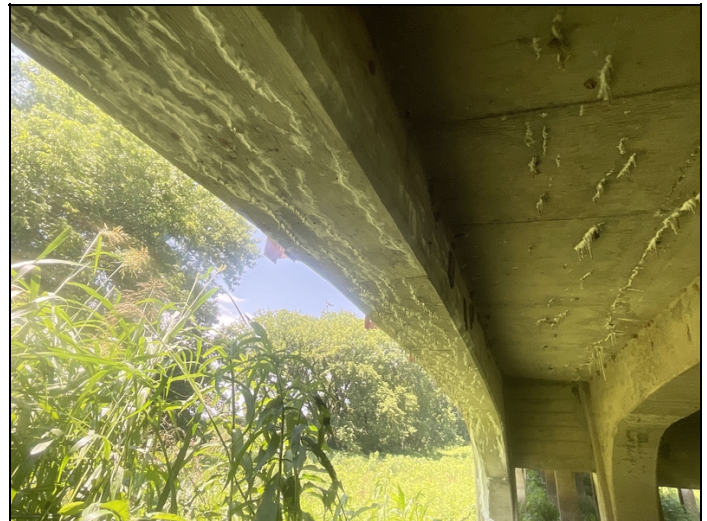
Span 10, girder 5-Mapcracking with efflorescence.

Type of Work: Superstructure Repair

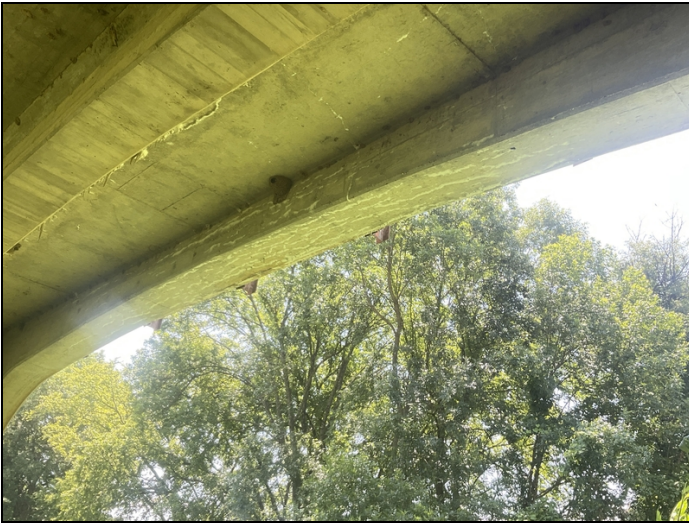
Span 2, girder 5-Mapcracking with efflorescence.

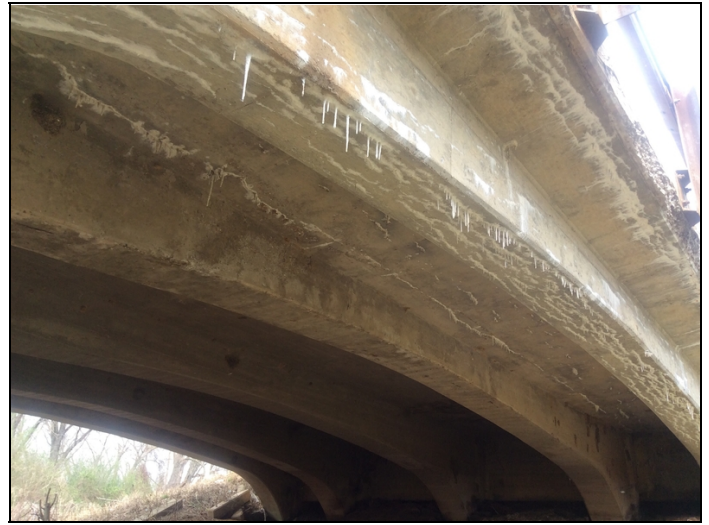
Span 11 right map cracking with efflorescence and leaching.

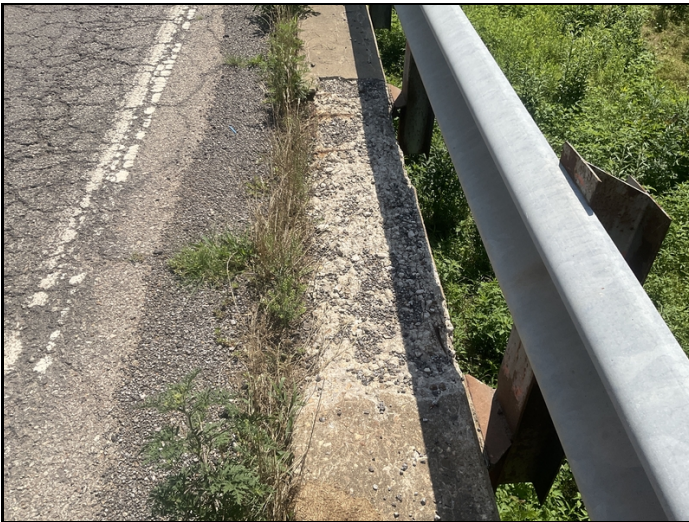
Curbs on both sides of the bridge has multiple areas of soft deteriorated concrete with exposed reinforcing steel.

Curbs on both sides of the bridge has multiple areas of soft deteriorated concrete with exposed reinforcing steel.
Span # 5, right curb pictured.

Type of Work: Repair (General)

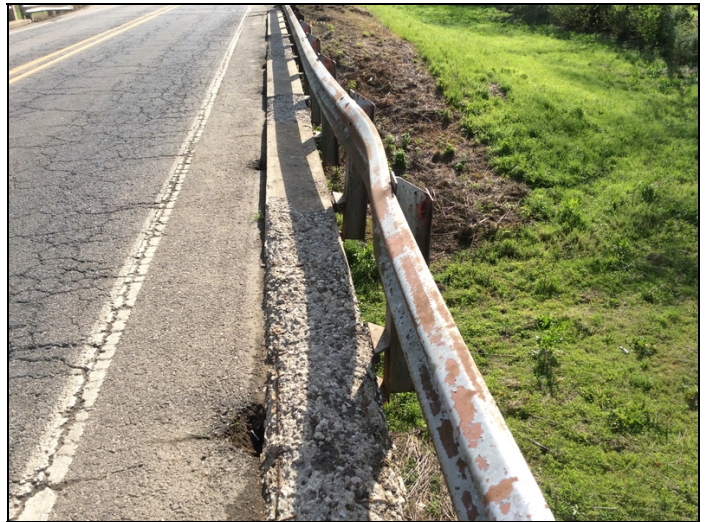
Concrete deterioration in the curbs with exposed reinforcing steel.

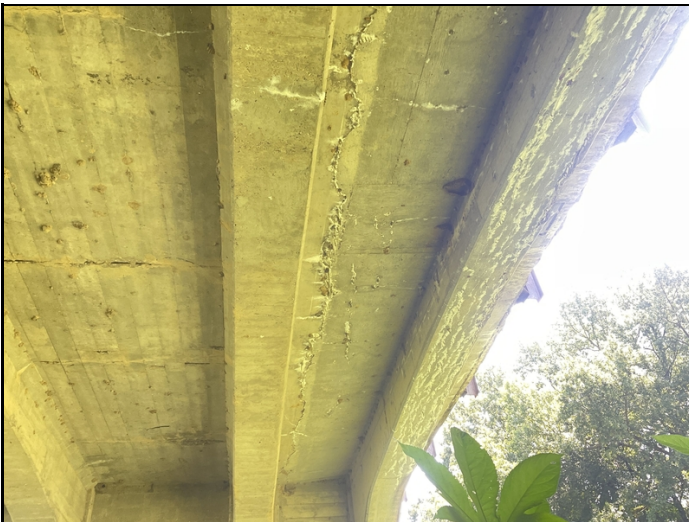
Span 6, bays 2 & 3 have multiple locations of exposed reinforcing steel with active corrosion. Bay 4 undersurface has efflorescence accumulation along the construction joint.

Span 6, bay 4-Efflorescence along longitudinal construction joint

Type of Work: Deck Repair

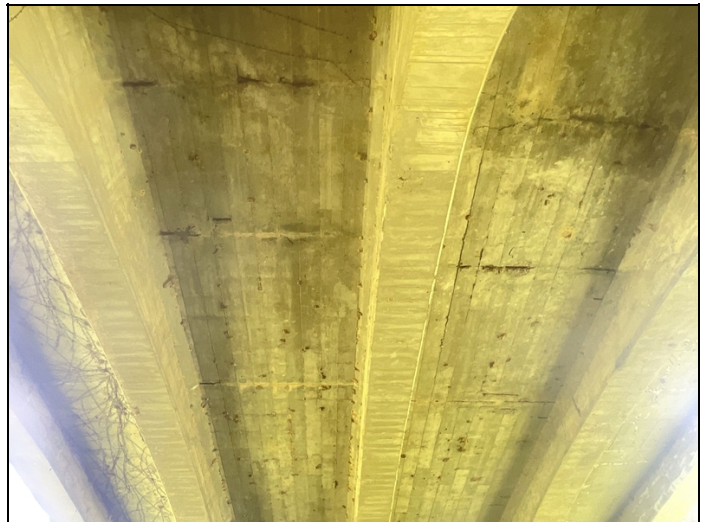
Span 5, bays 2 & 3 have areas of exposed reinforcing steel with active corrosion and transverse cracking with efflorescence. Bay 4 has a heavy accumulation of efflorescence along the construction joint.

Span 5 deck undersurface-Shallow spalling with exposed reinforcing steel

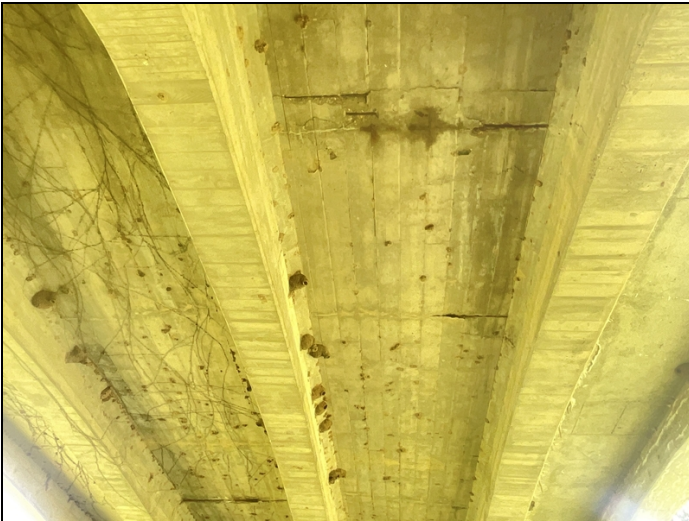
Span 2, bays 2 & 3 have spalling with exposed reinforcing steel and transverse cracking with efflorescence. Bay 4 has longitudinal cracking (appears to be a construction joint) with a heavy accumulation of efflorescence full length of the span.

Span 2, bays 2 and 3 have shallow spalling with exposed reinforcing steel in deck undersurface

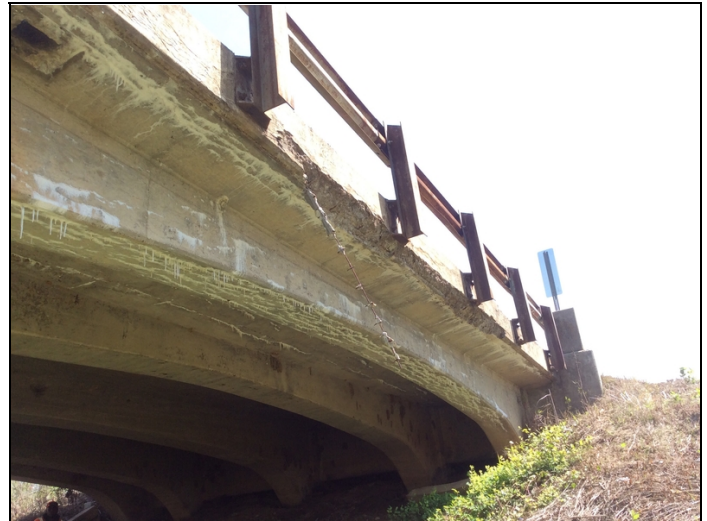
Span 10, bay 2 has exposed reinforcing steel adjacent to abutment # 2. Bay 4 has efflorescence along the construction joint.

Span # 10 Right concrete deterioration with exposed reinforcing steel.

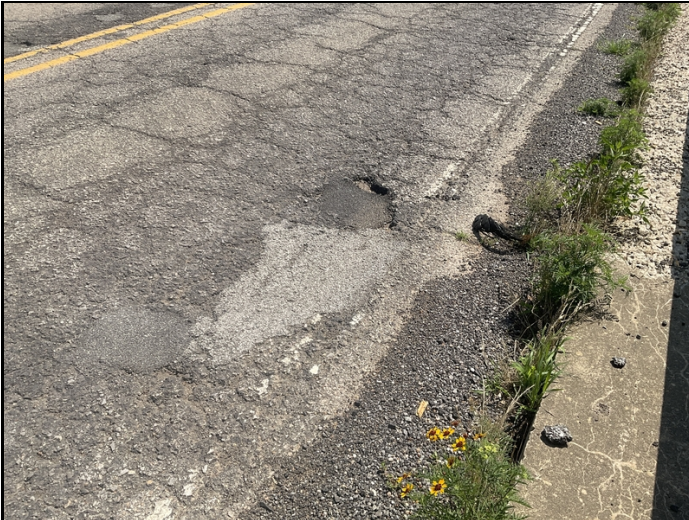
Span # 8, right lane-Failing repair.

Type of Work: Repair (General)

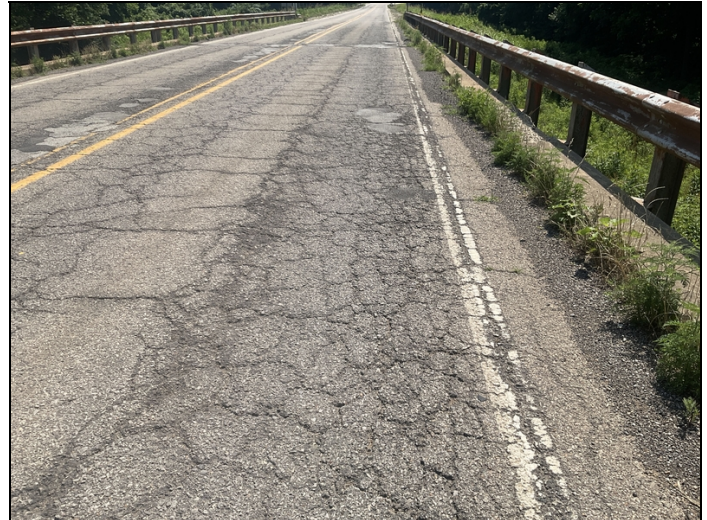
Mapcracking in wheel paths

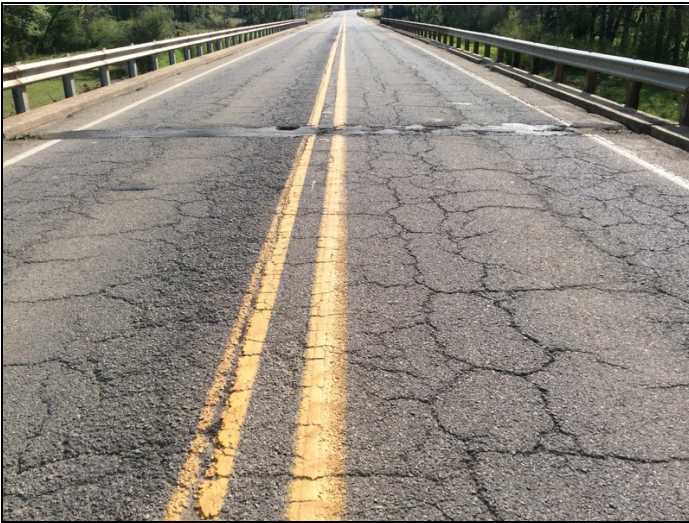
The asphalt driving surface has heavy deterioration with map cracking throughout the structure with failing repairs and potholes forming in the driving surface. The asphalt wearing surface is breaking apart over the deck joint assemblies at bents # 4 and 8.

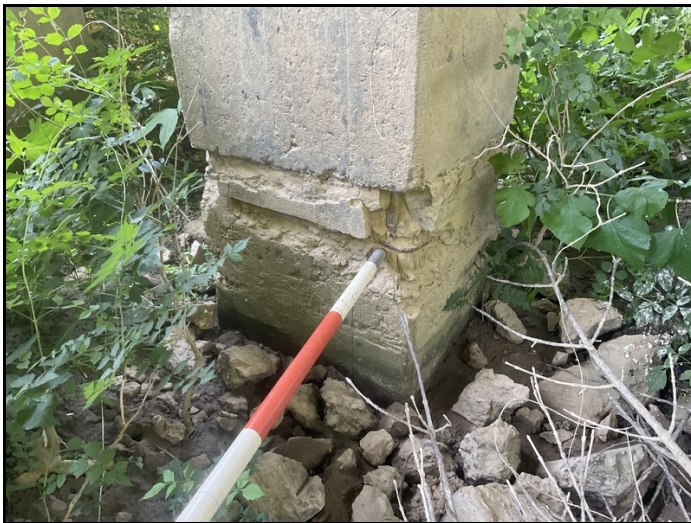
Bent 9, column 2 has soft deteriorated concrete along the base. column 4 has spalling at the base.

Bent 9, column 4-Spalling with exposed reinforcing steel.

Type of Work: Repair (General)

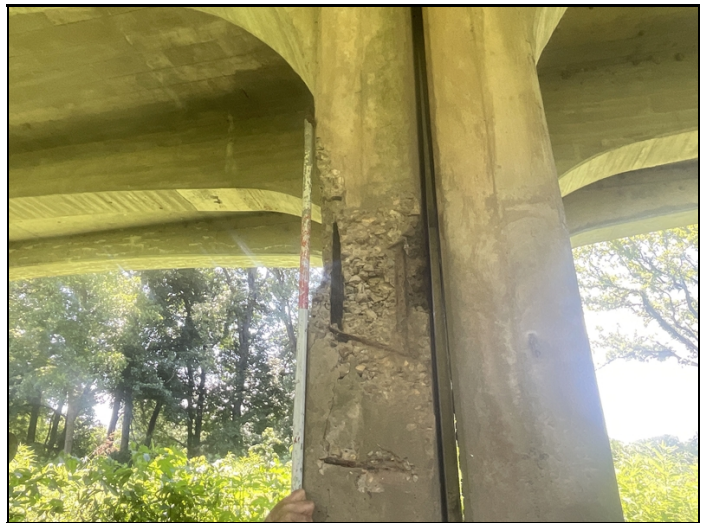
Bent 8, column 3 of span 8-Spalling with concrete section loss and exposed primary reinforcing steel. Exposed reinforcing steel has measurable section loss.

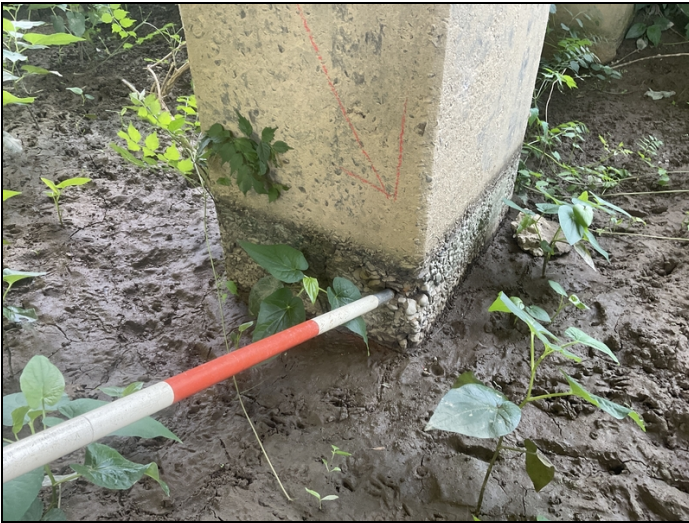
Bent 7, column 2 has light abrasion with a 4" area of concrete deterioration approximately 1" deep at base of column.

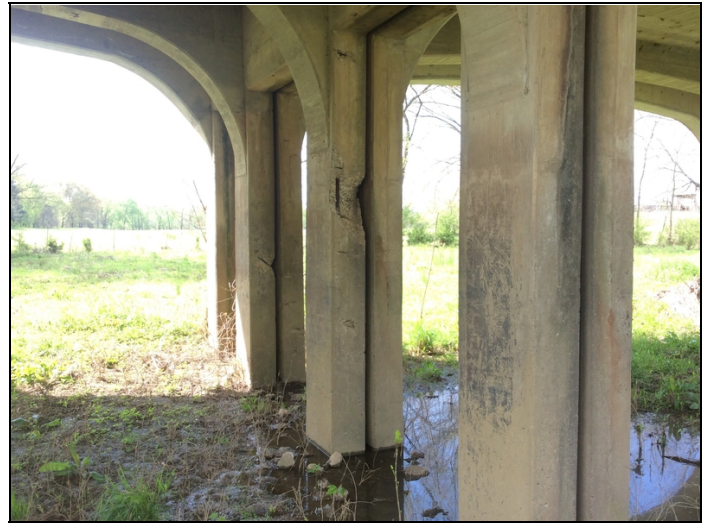
Bent # 7 Columns # 3 & 4 spalling with exposed reinforcing steel.

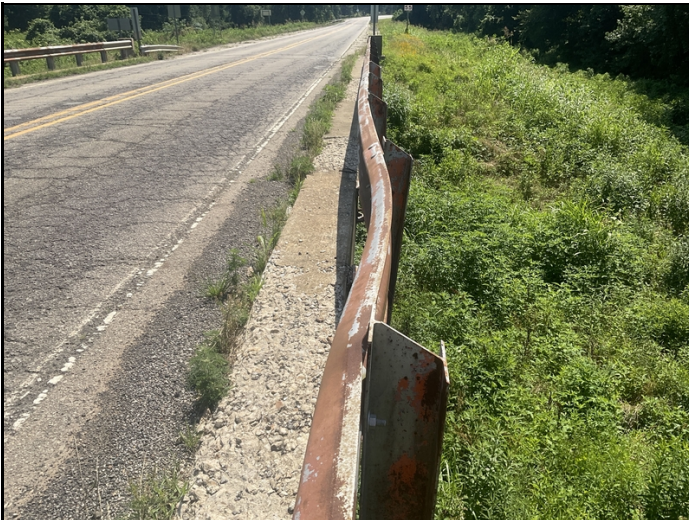
Span 8 right railing at bent 9-Collision damage

Type of Work: Repair (General)

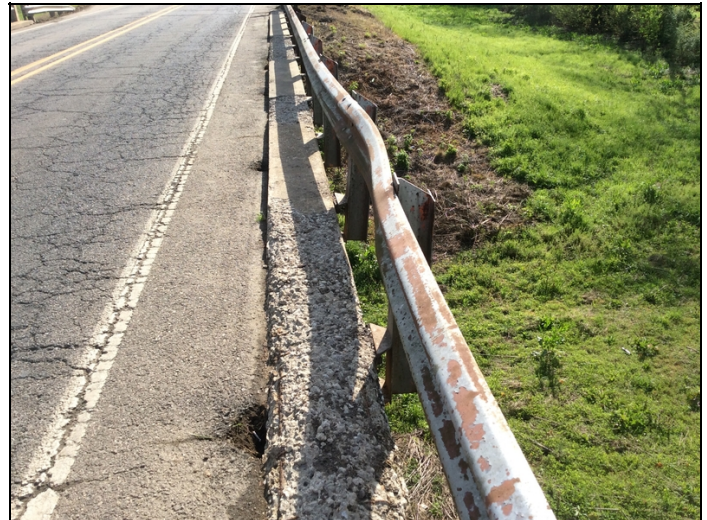
Span # 8 RT collision damage in the bridge rail and concrete deterioration in the curbs with exposed reinforcing steel.

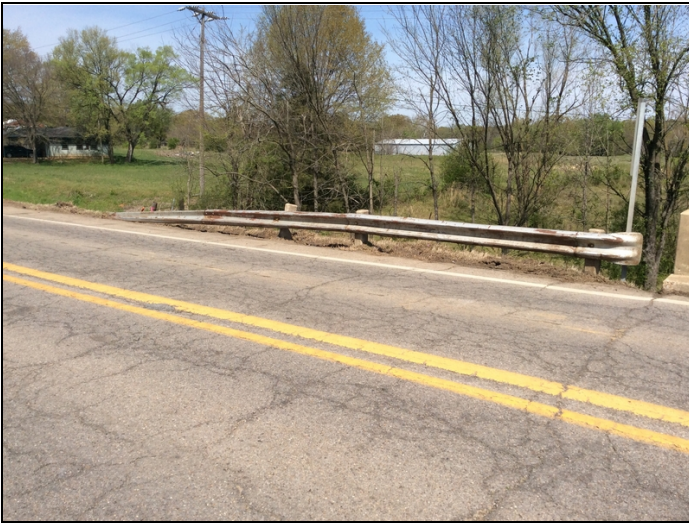
Northwest approach guardrail.

The Northwest approach guardrail has one post with collision damage that has caused the post to lean out of plumb and break the railing loose from the post.
