Asset #00356(Routine, Underwater type 2)
State Highway 22 over Six Mile Creek-Logan Co.

Location: 0.5 MI E JCT SH 23

Team Lead: Bob McEntyre, Inspection Date: 08/24/2022

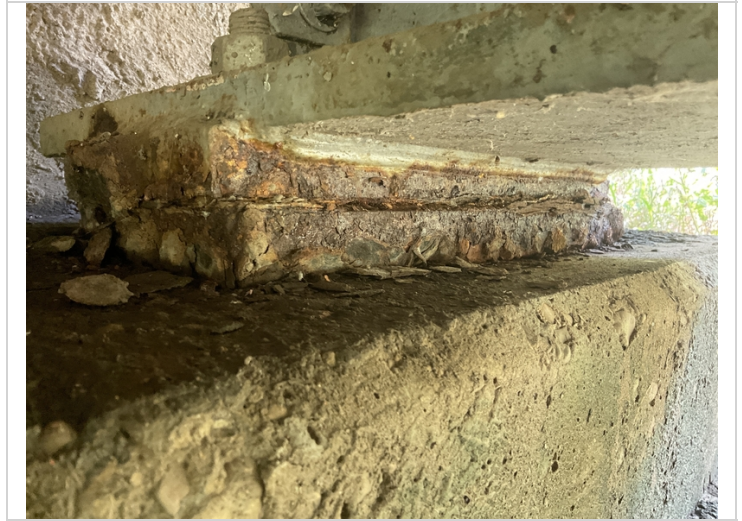
Abutment 2, bearing 4-Corrosion

The fixed bearings at abutment # 2 have corrosion with flaking rust.

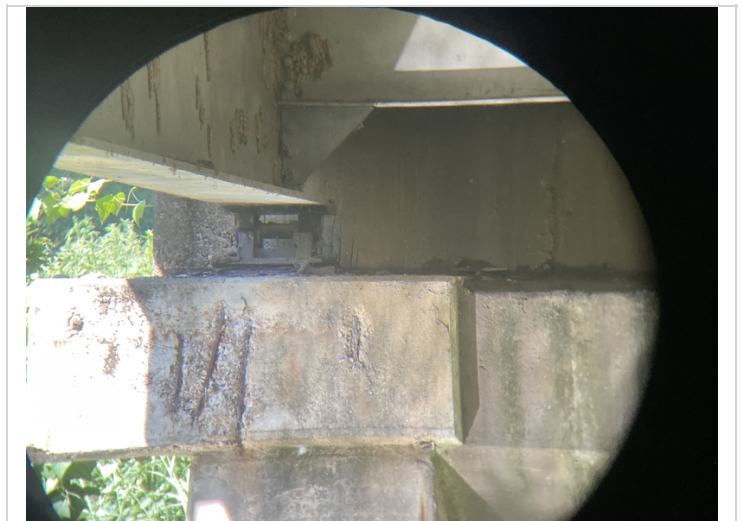
(311) -Span # 3 movable bearings over bent # 3 have heavy corrosion with thick pack rust between the rockers and masonry plates possibly restricting movement.							
313	Fixed Bearing	EA	4	0	0	4	0
1000	Corrosion	EA	4	0	0	4	0
515	Steel Protective Coating	SF	4	0	0	1	3
3440	Effectiveness (Steel Protective Coatings)	EA	4	0	0	1	3

Movable bearings at bent 3-Corrosion with pack rust between rockers and masonry plates.

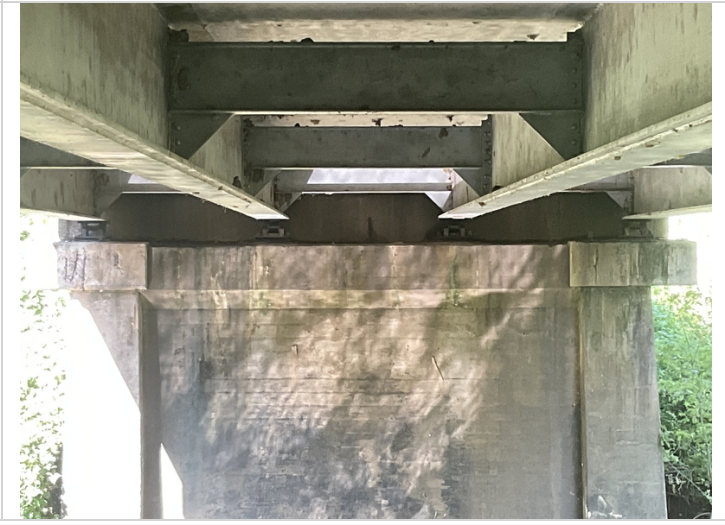
Movable bearings at bent 3-Corrosion with pack rust between rockers and masonry plates.

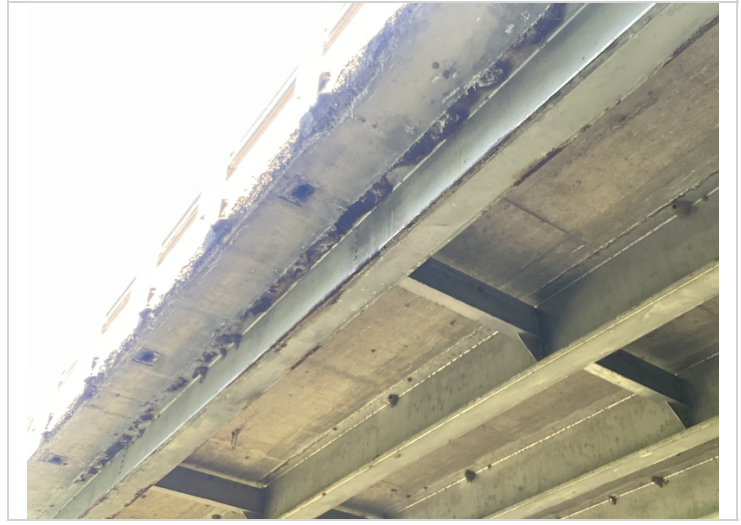
Span 3, beam # 4 has numerous areas of corrosion to the interior and exterior sides of the top and bottom flanges.

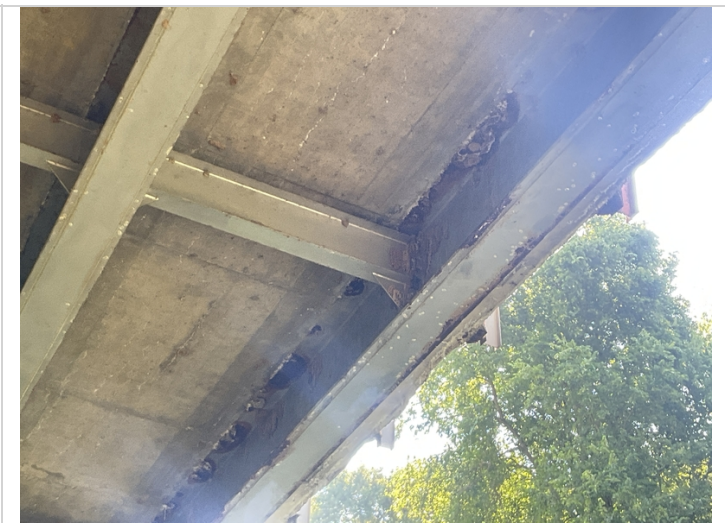
Span 3, beam # 4 has numerous areas of corrosion to the interior and exterior sides of the top and bottom flanges.

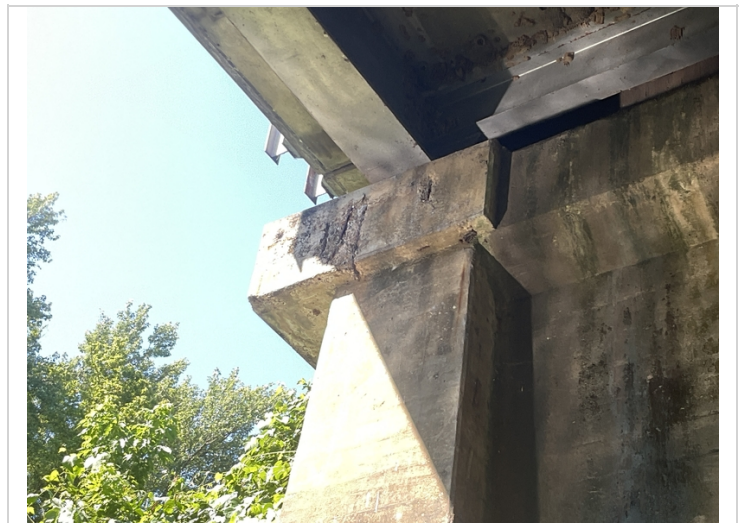
Bent 3 cap aheadface, right side-Spalling with exposed reinforcing steel

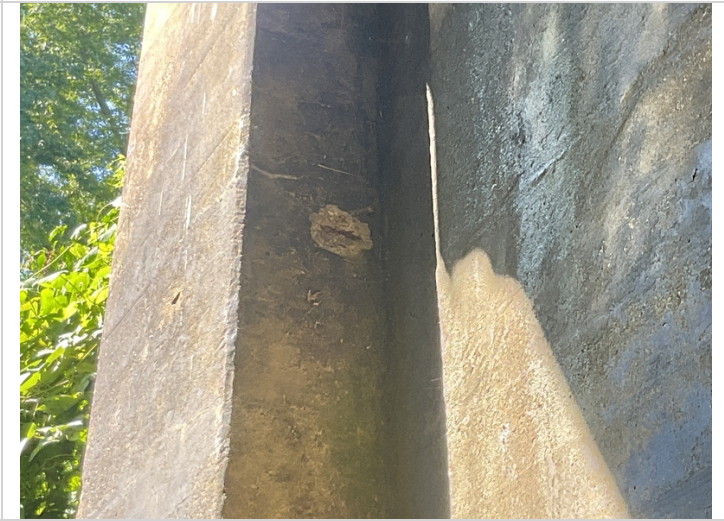
Bent 3, column 1 aheadface-5" spall with exposed reinforcing steel

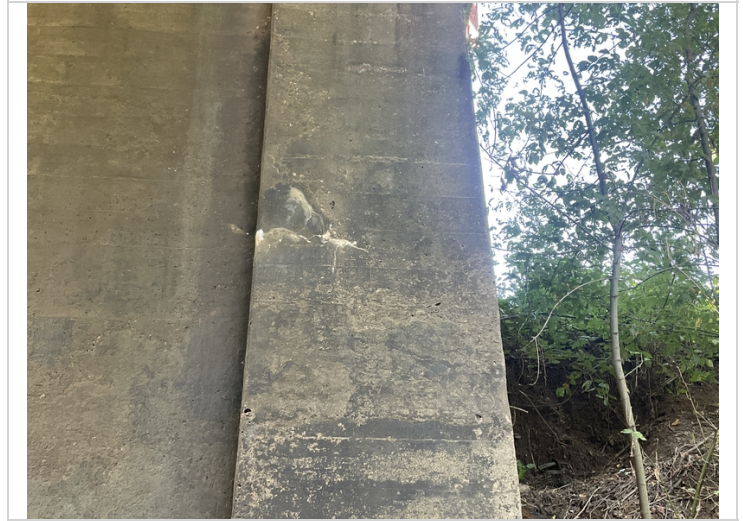
Bent 3, columns # 1 and 2 have a hairline horizontal crack with light efflorescence in the aheadface mid-way up the column.

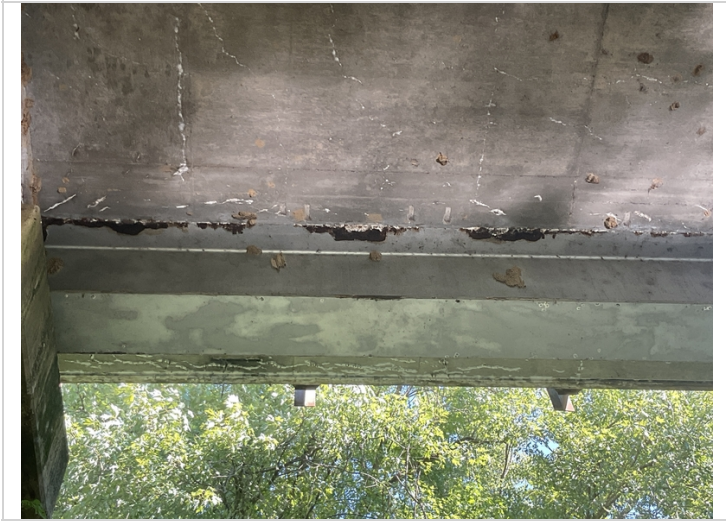
Span 3, beam 1 at bent 3-Corrosion to top flange

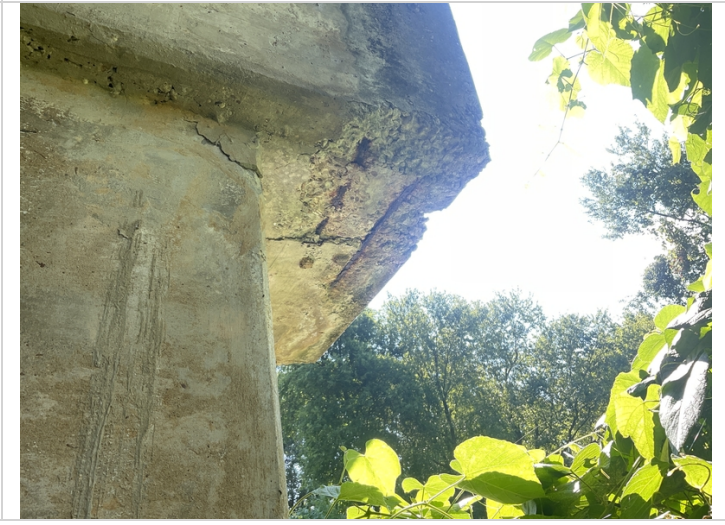
Bent 3 cap, right side-Spalling with exposed reinforcing steel

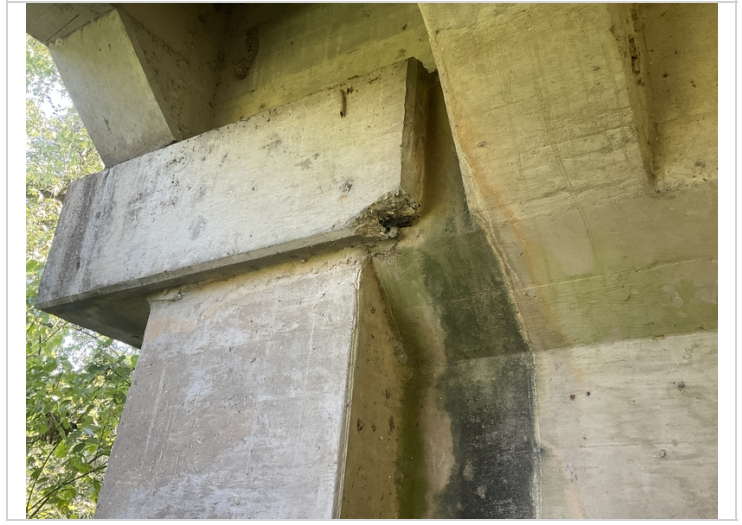
Bent 3 cap backface, left side-Spall with exposed reinforcing steel

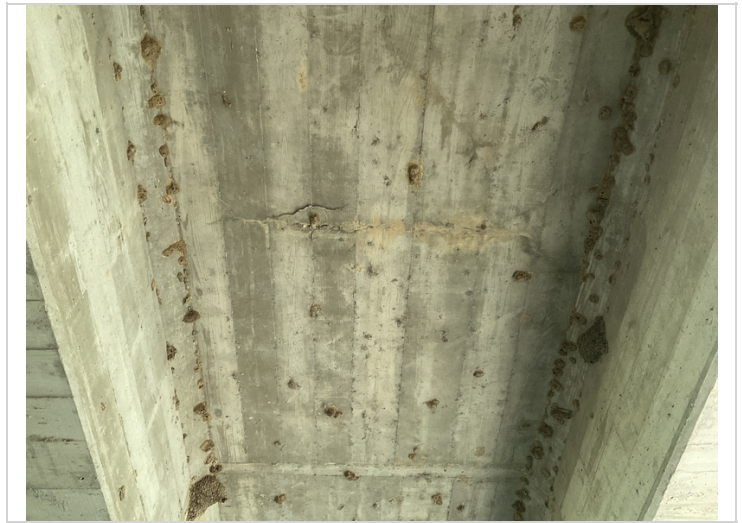
Span 2, bay 3-Transverse crack in deck undersurface with shallow spalling

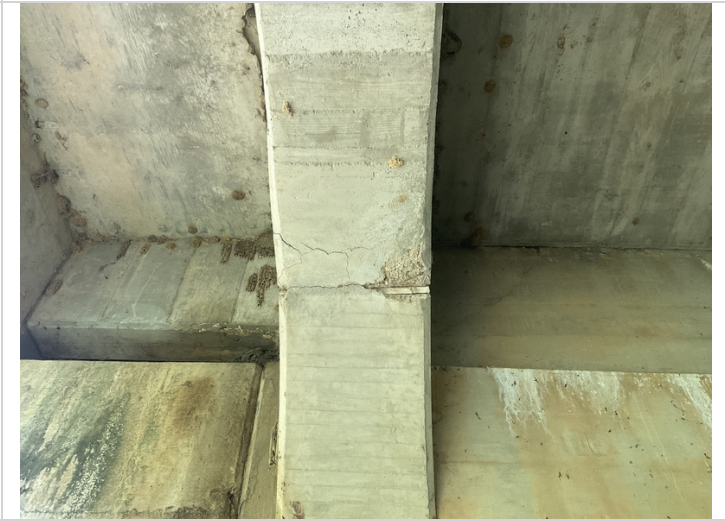
Span # 2, girder/# 4 at bent.# 2 has a delaminated area in the haunch portion of the girder.

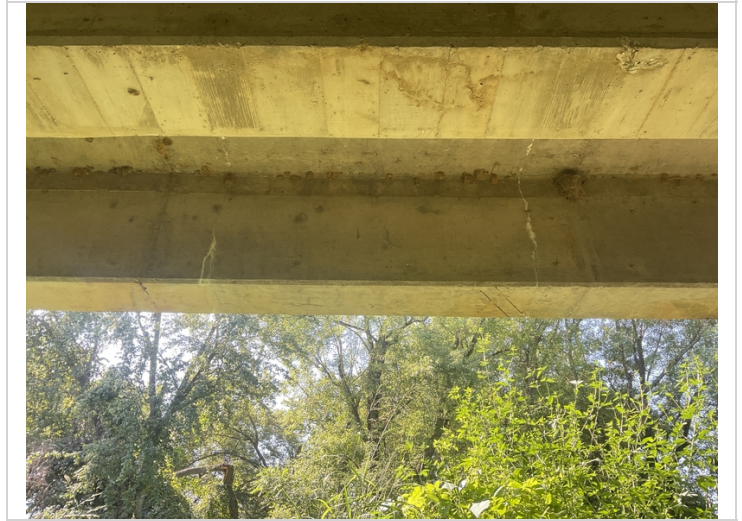
Span 2, girder 5-Vertical cracking with efflorescence

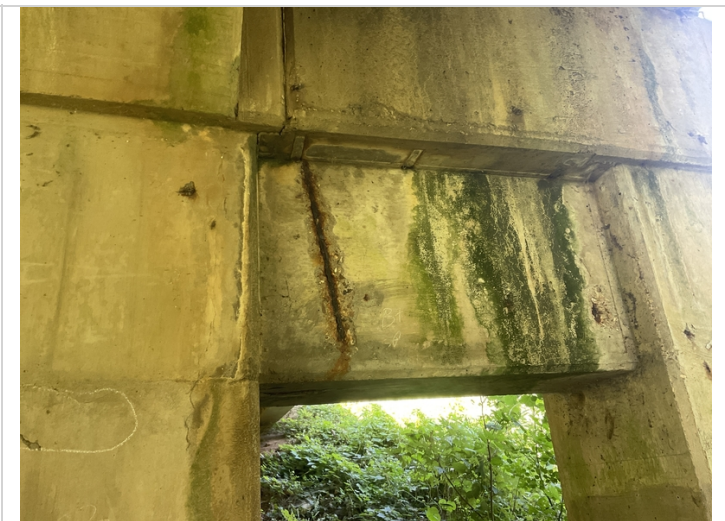
Bent 2 cap haunch, left side-Spalling with exposed reinforcing steel in ahead side

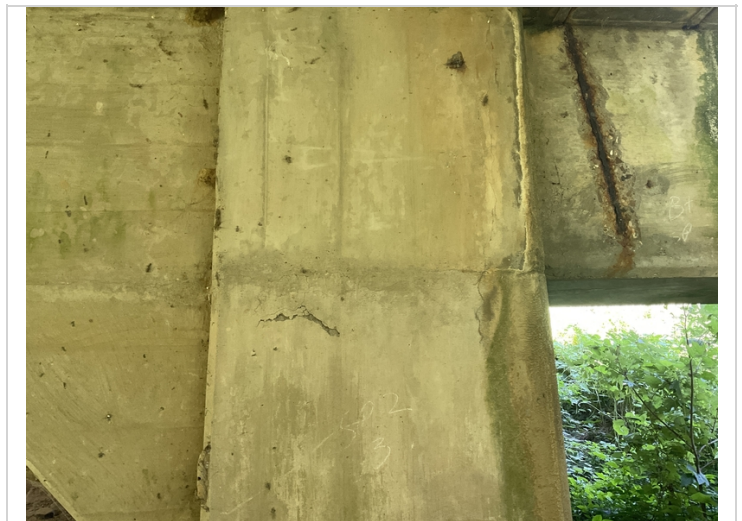
Bent # 2, column # 2 aheadface has vertical cracking and minor delaminated area at cap juncture.

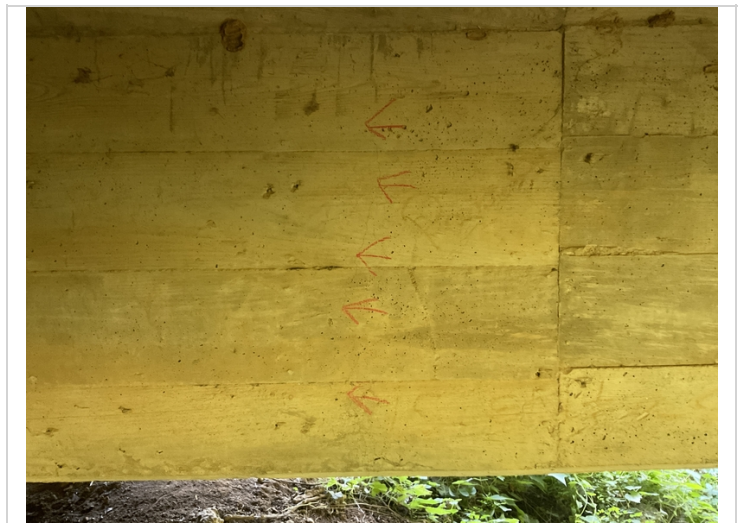
Typical of vertical flexure cracks in girders

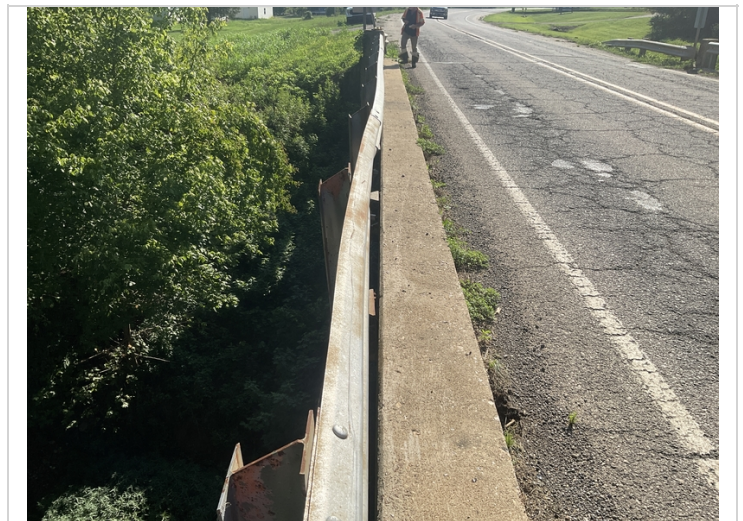
Span 3, right railing-Collision damage

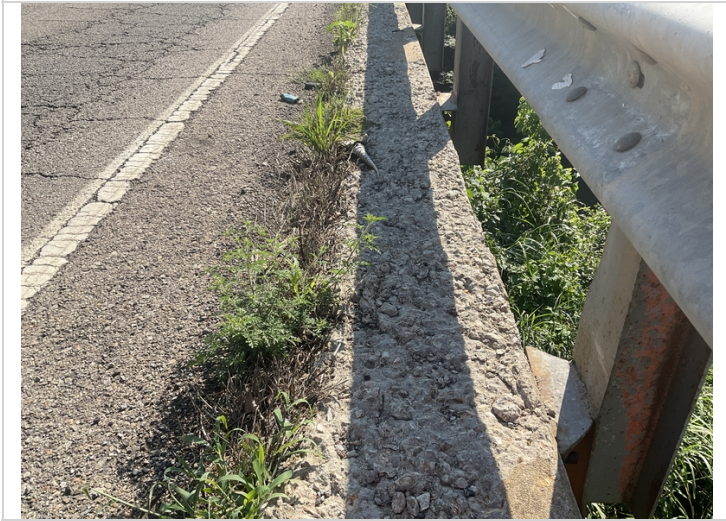
Span 2, right side-Concrete deterioration to curb

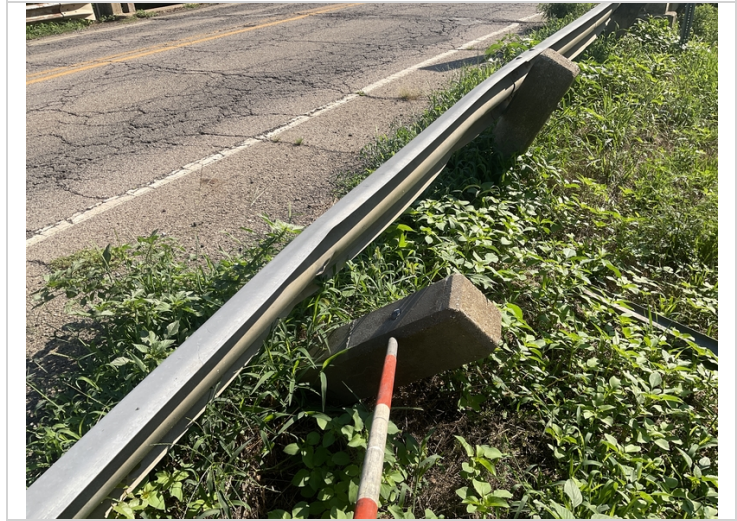
Abutment # 1, right approach railing has collision damage that has broken the bolted connection to one of the posts and caused the railing and posts to lean away from the roadway.

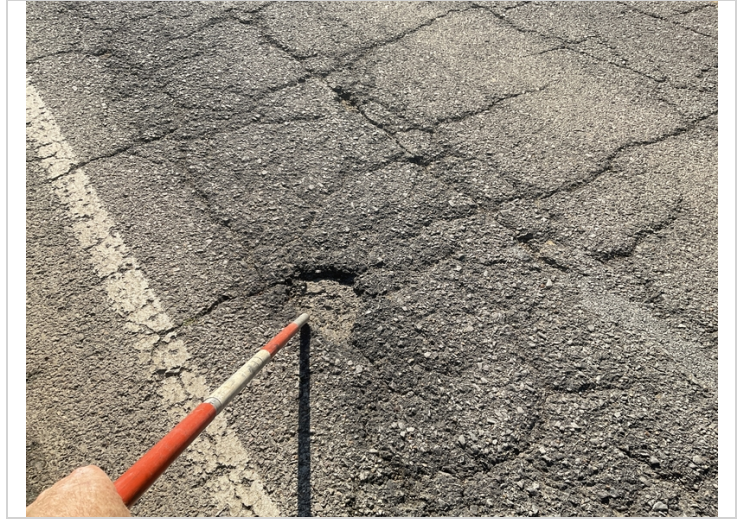
Span 3, left lane-Potholes forming in asphalt wearing surface.

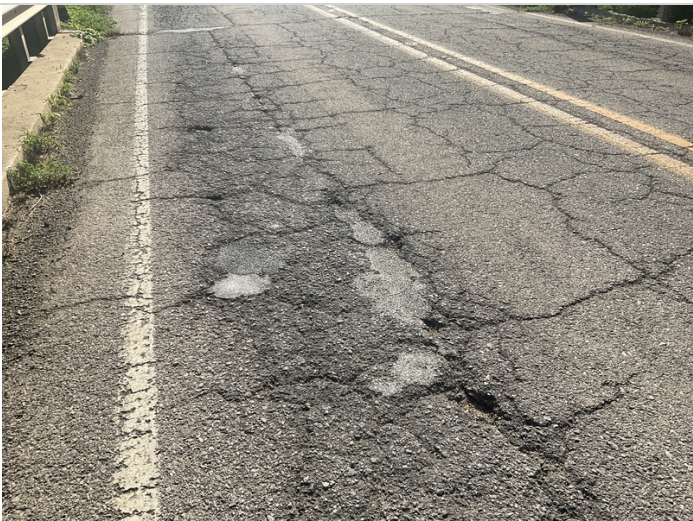
Span 3, left lane-Potholes forming in asphalt wearing surface.

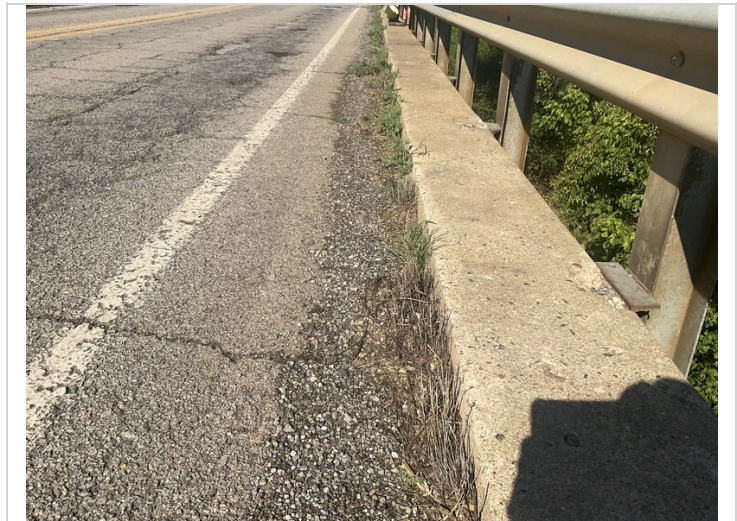
Dirt and debris in gutters

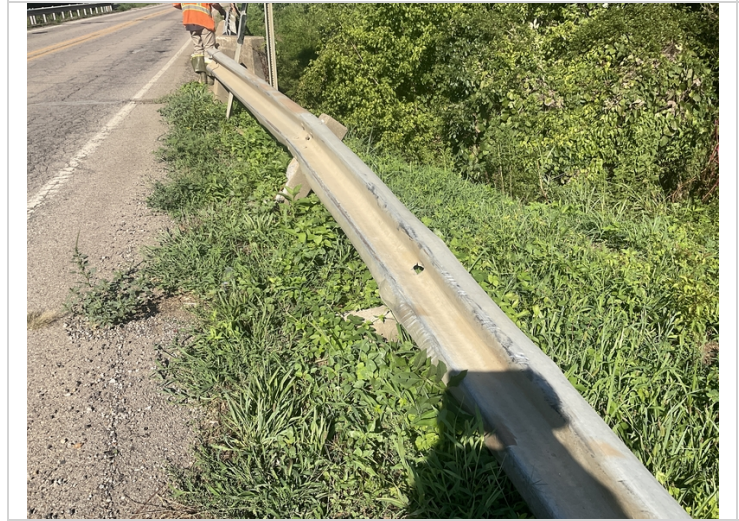
Abutment # 2, left approach railing has collision damage that has fractured two of the railing post.

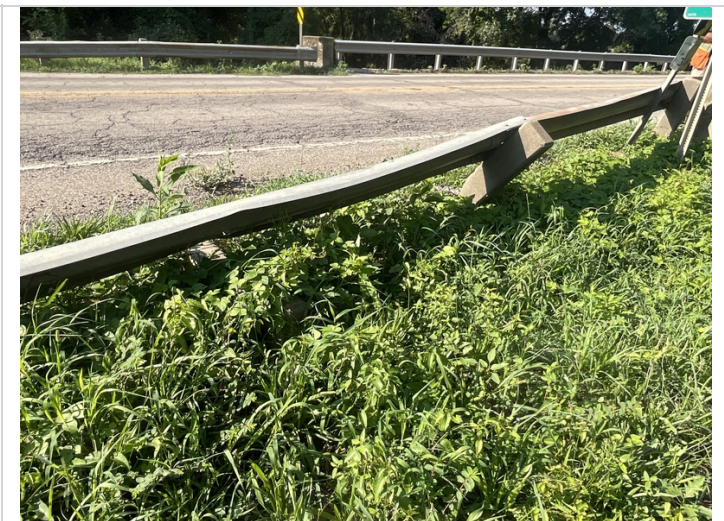
Abutment # 2, left approach railing has collision damage that has fractured two of the railing post.

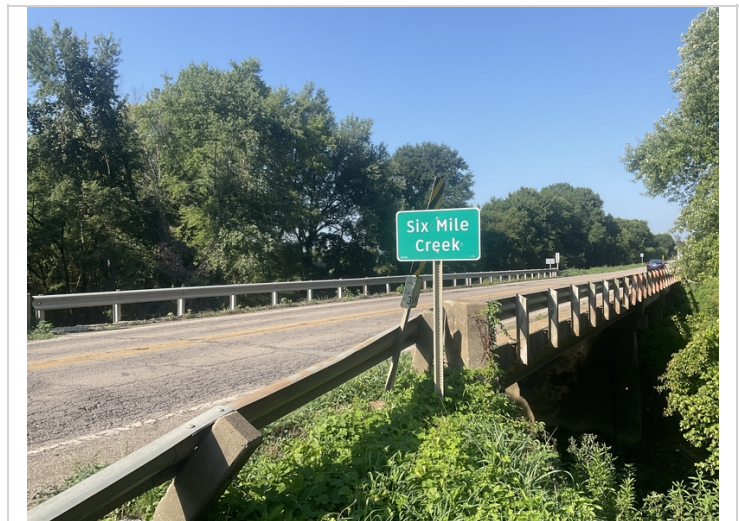
The flare board sign on the left side of abutment # 2 is twisted away from the roadway.

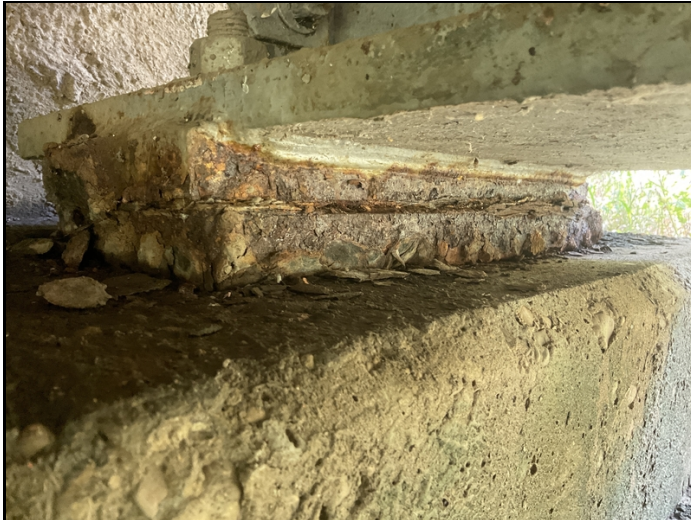
Abutment # 2, bearing # 4-Corrosion.

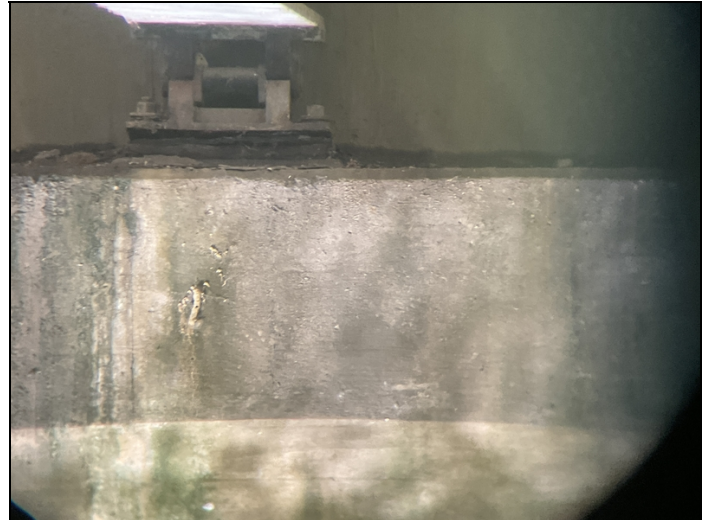
Movable bearings at bent # 3-Corrosion with pack rust between rockers and masonry plates.

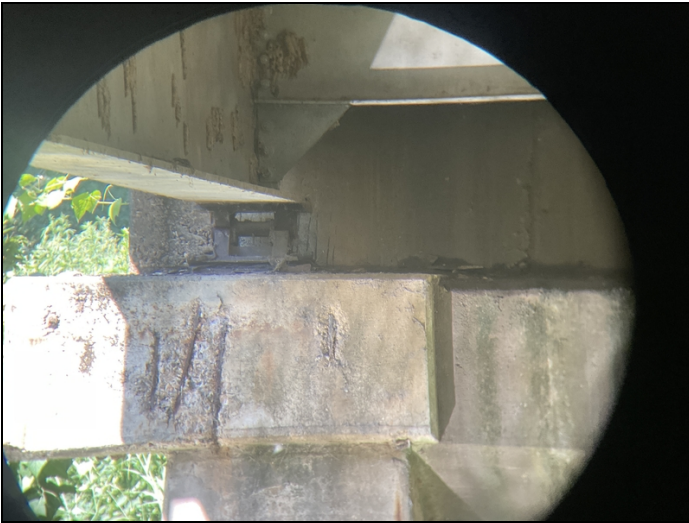
Movable bearings at bent # 3-Corrosion with pack rust between rockers and masonry plates.

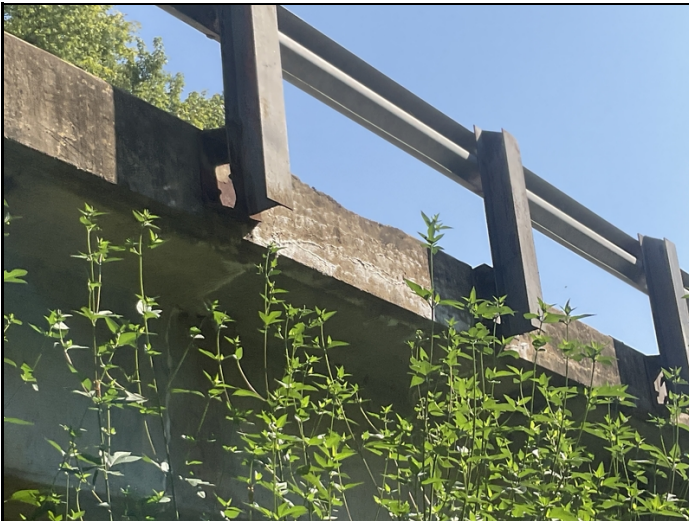
Span # 2, right side-Mapcracking with efflorescence.

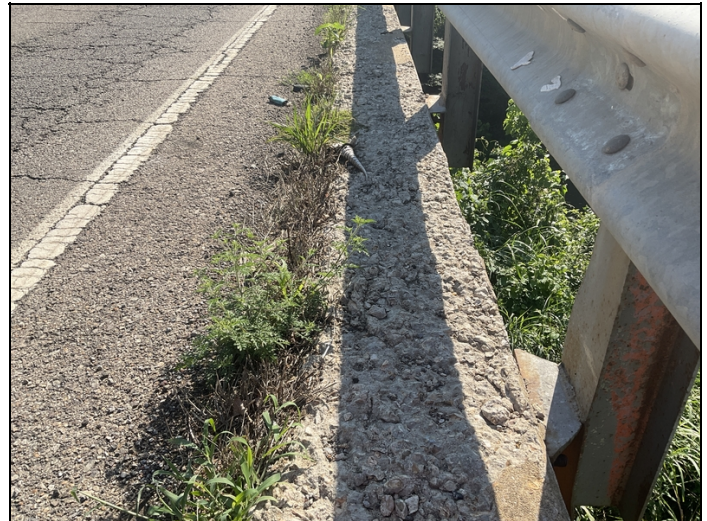
Span # 2, right side-Concrete deterioration to curb.

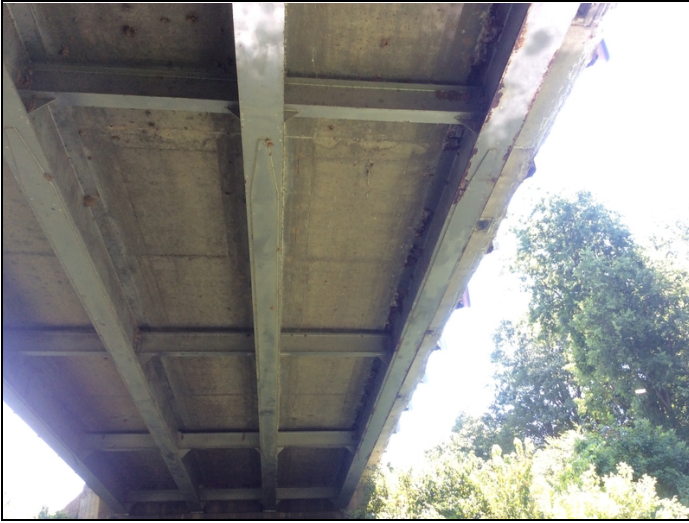
Span # 3 efflorescence leaching through the deck.

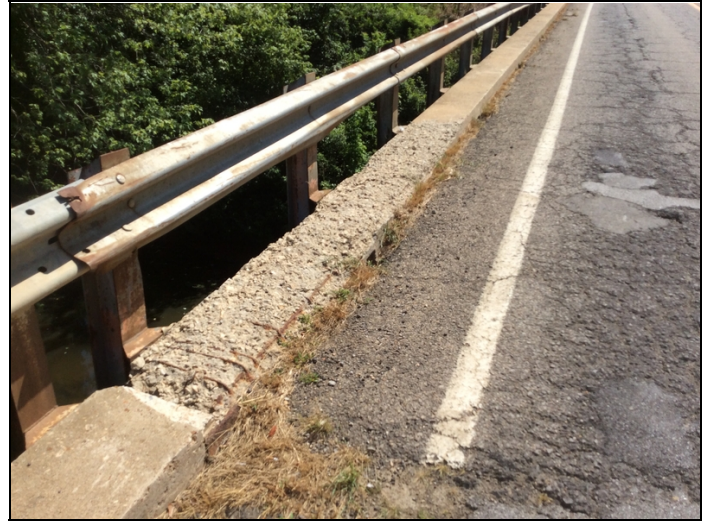
Left concrete curb-Deterioration with exposed reinforcing steel.

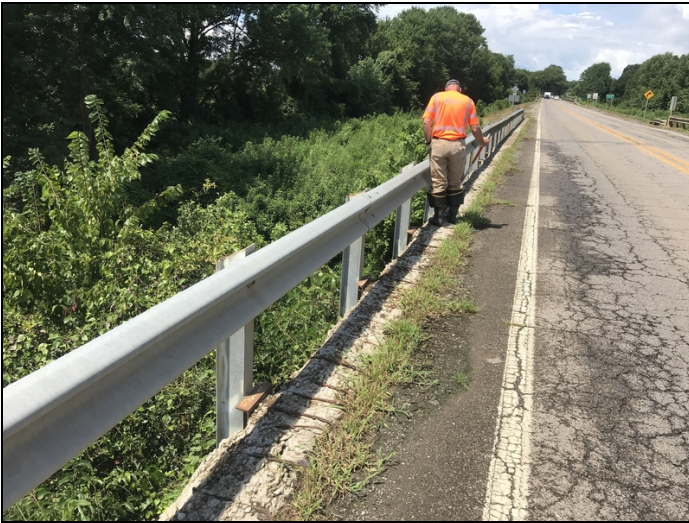
Right curb-Concrete deterioration with exposed reinforcing steel.

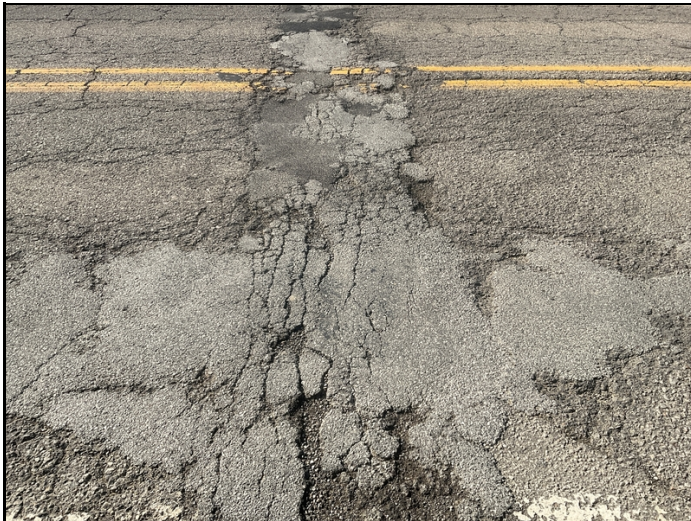
Asphalt breaking apart over bent # 3.

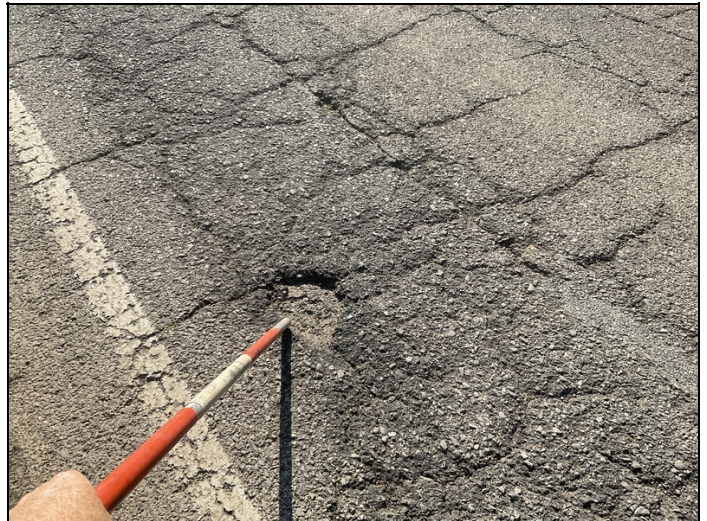
Span # 3, left lane-Potholes forming in asphalt wearing surface.

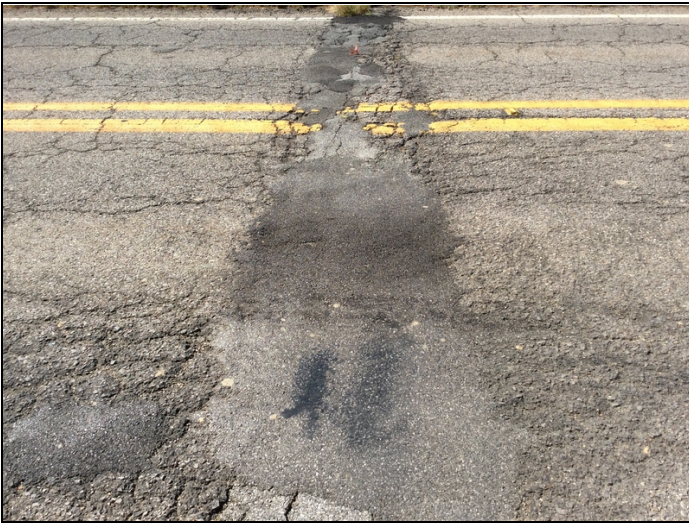
Bent # 3 asphalt breaking apart over the bent.

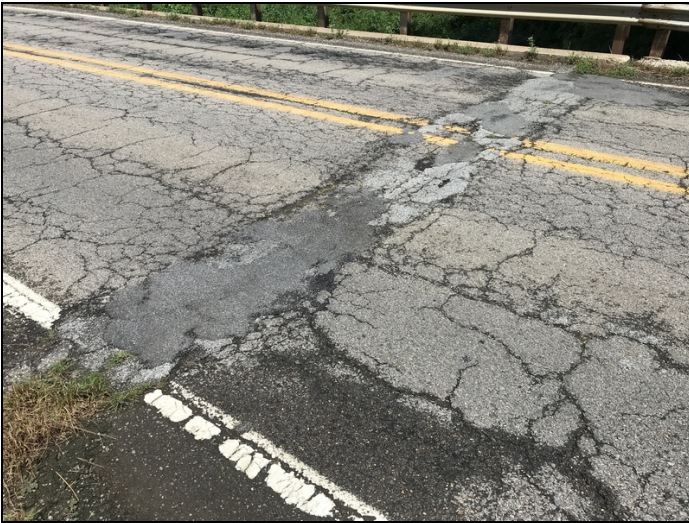
Asphalt wearing surface over bent # 3 is breaking apart.

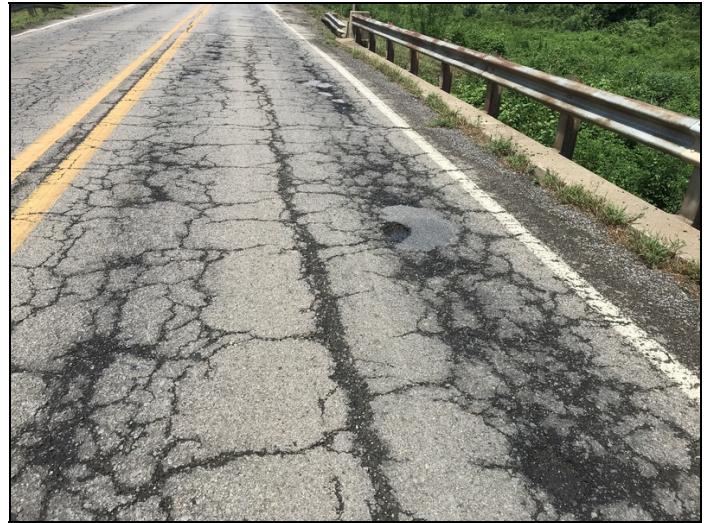
Asphalt wearing surface of the deck is breaking apart in the wheel paths and over the intermediate bents with potholes forming. The asphalt wearing surface has heavy map cracking throughout.

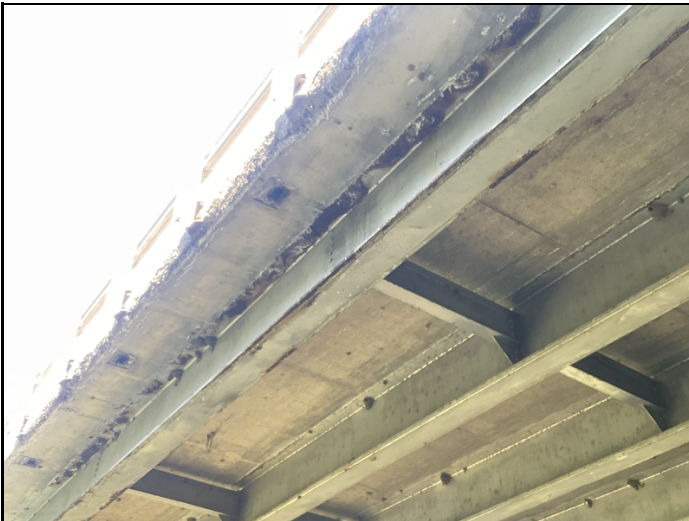
Span 3, beam # 4 has numerous areas of corrosion to the interior and exterior sides of the top and bottom flanges.

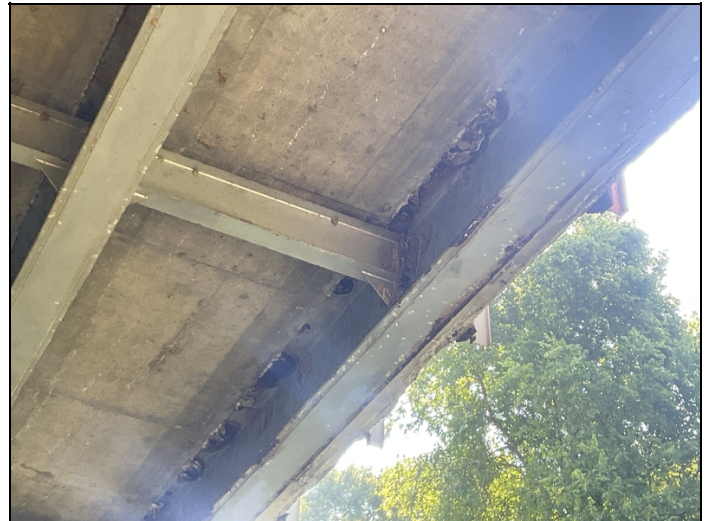
Span 3, beam # 4 has numerous areas of corrosion to the interior and exterior sides of the top and bottom flanges.

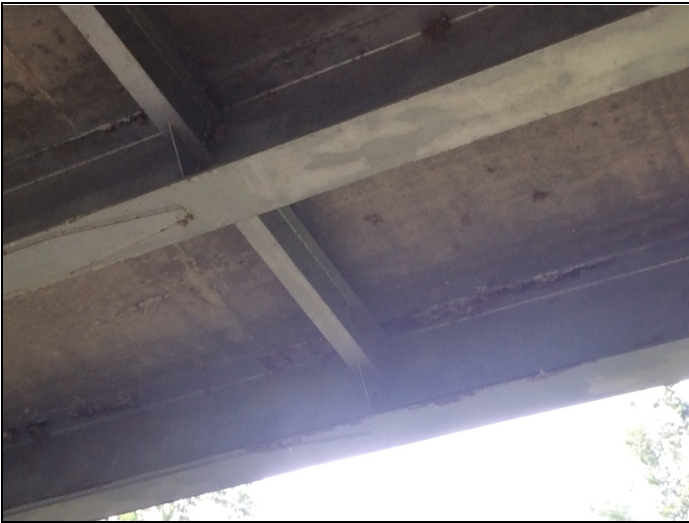
The steel beams have areas of corrosion with flaking rust. Beam # 4 is the most notable area with numerous areas of corrosion with flaking rust along the interior and exterior sides of the beam.

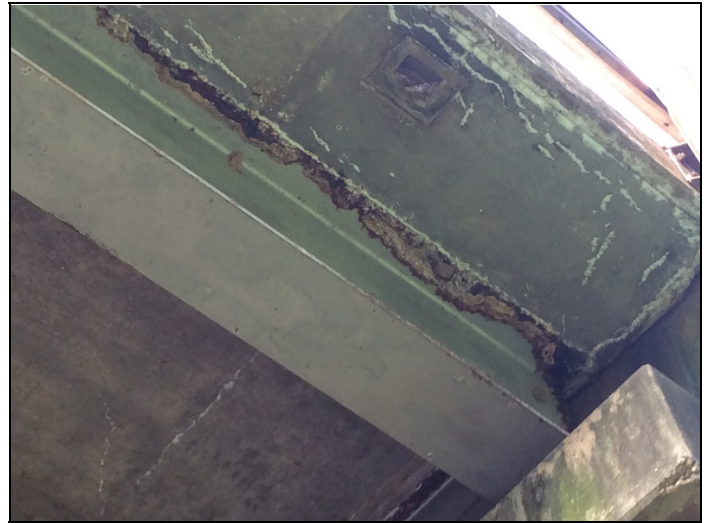
Active corrosion, layers of rust and initial section loss along the top flanges in Span # 3 adjacent to Bent # 3.

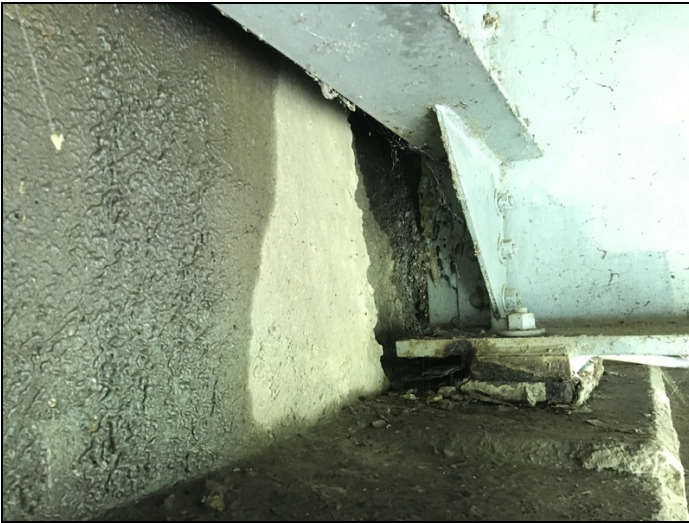
Active corrosion in beam ends and bearings at abutment # 2.

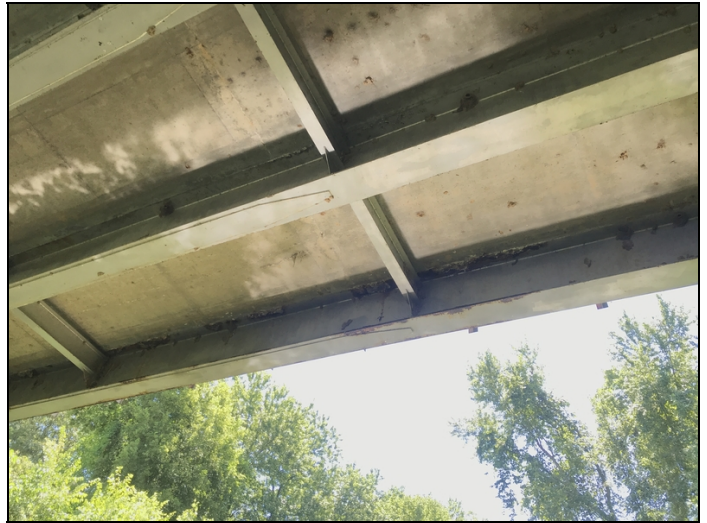
The steel beams have areas of corrosion with flaking rust. Beam # 4 is the most notable area with numerous areas of corrosion with flaking rust along the interior and exterior sides of the beam.

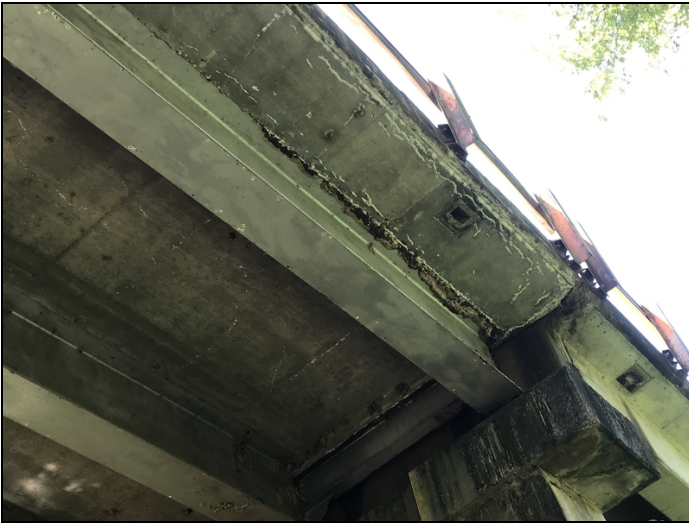
Span # 3, beam # 1 at bent # 3-Active corrosion in the top flange with layers of flaking rust.

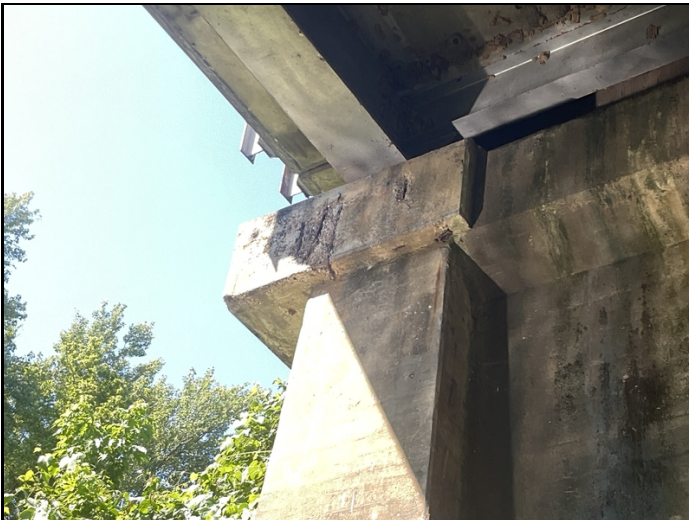
Bent # 3 cap aheadface, right side-Spalling with exposed reinforcing steel.

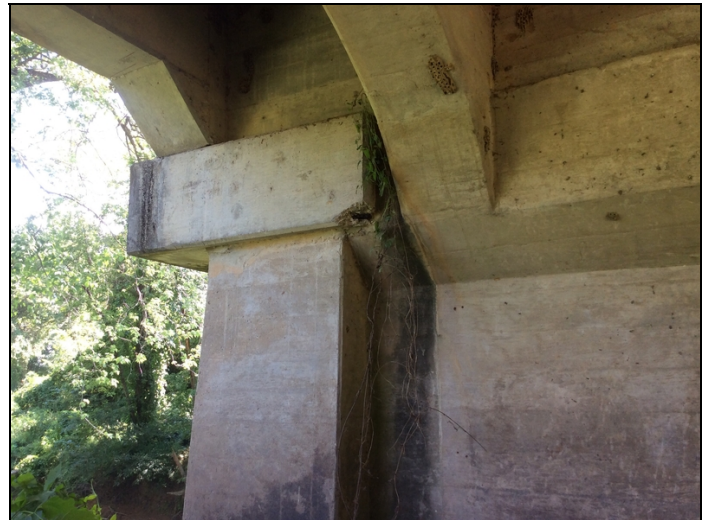
The concrete caps have random areas of shallow spalling with exposed reinforcing steel.

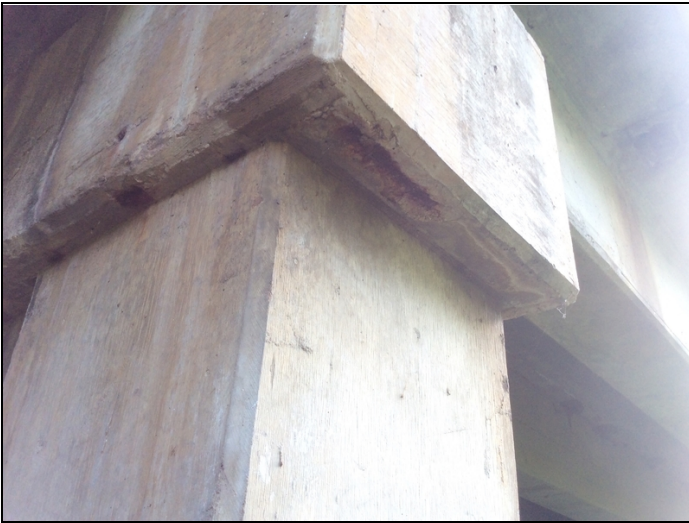
The concrete caps have random areas of shallow spalling with exposed reinforcing steel.

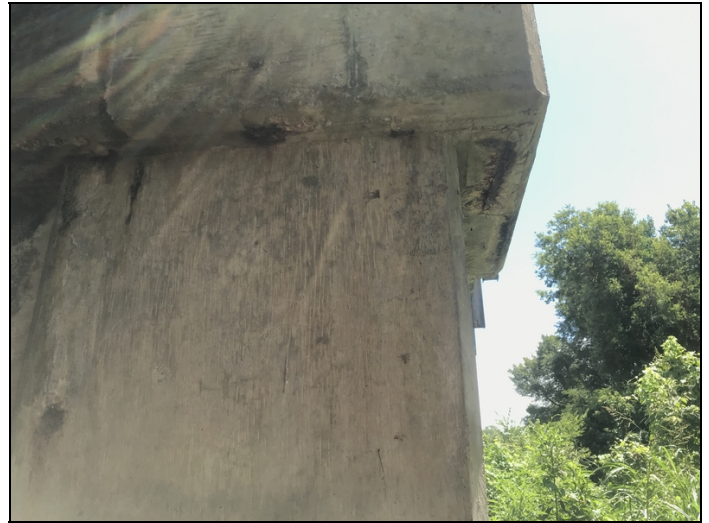
The concrete caps have random areas of shallow spalling with exposed reinforcing steel.

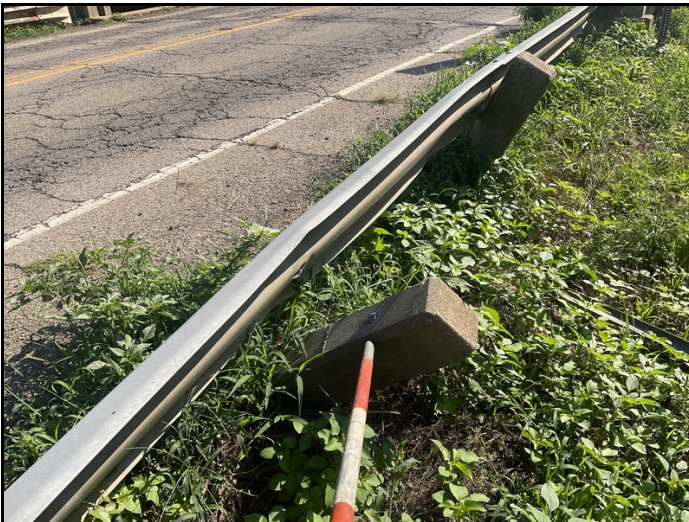
Abutment # 1, right approach railing has collision damage that has fractured two of the railing post and has broken the bolted connection to one of the posts. The railing is leaning away from the roadway.

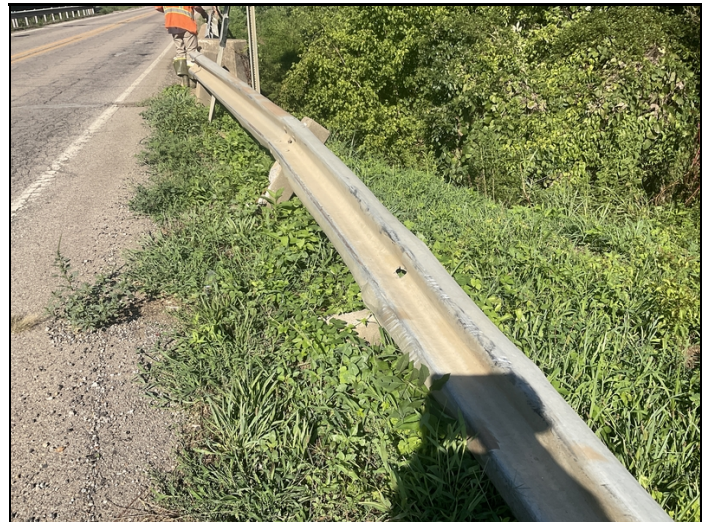
Abutment # 2, left approach railing has collision damage that has fractured two of the railing post.

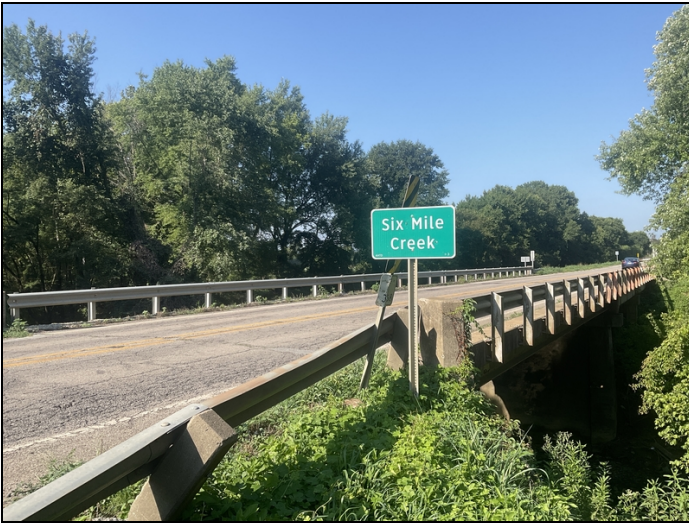
The flare board sign on the left side of abutment # 2 is twisted away from the roadway.

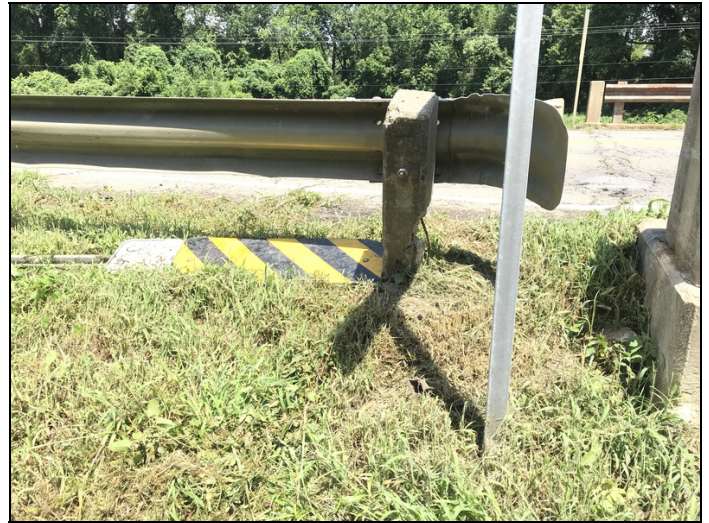
Fractured approach guardrail post.

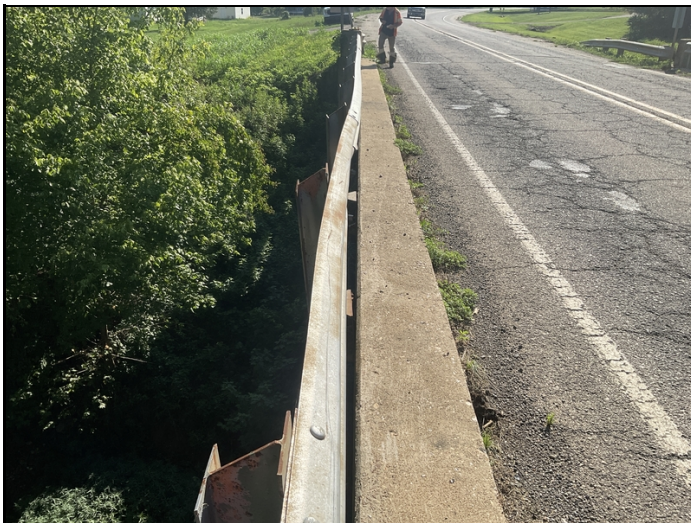
Span 3, left railing-Collision damage.

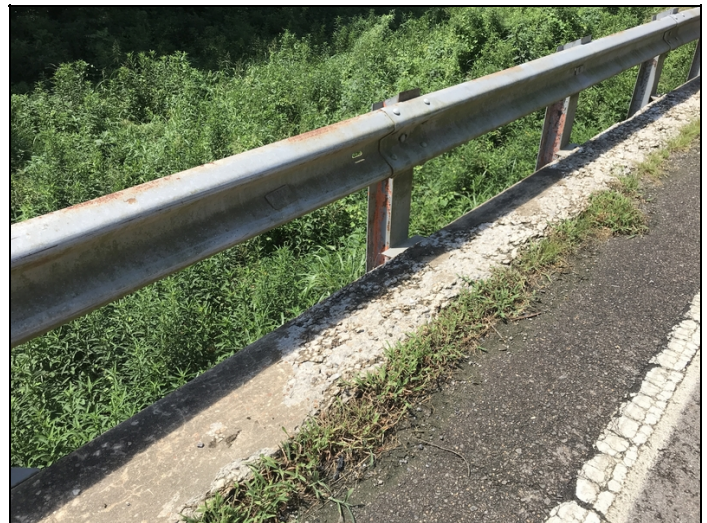
The left bridge railing in span # 3 has minor collision damage.

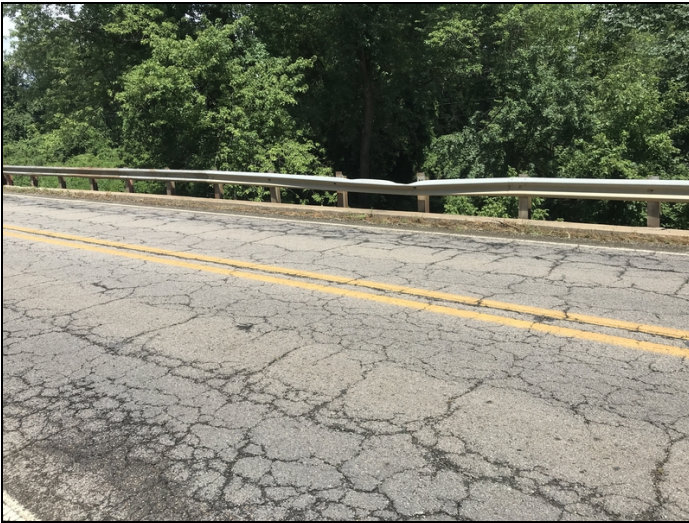
The left bridge railing in span # 3 has minor collision damage.

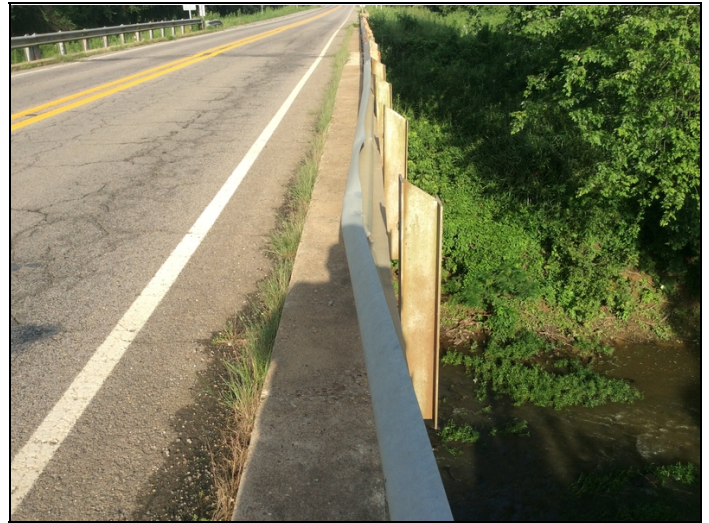
The left bridge railing in span # 3 has minor collision damage.
