Asset #00356(Routine, Underwater type 2)
State Highway 22 over Six Mile Creek-Logan Co.

Location: 0.5 MI E JCT SH 23

Team Lead: Bob McEntyre, Inspection Date: 08/24/2022

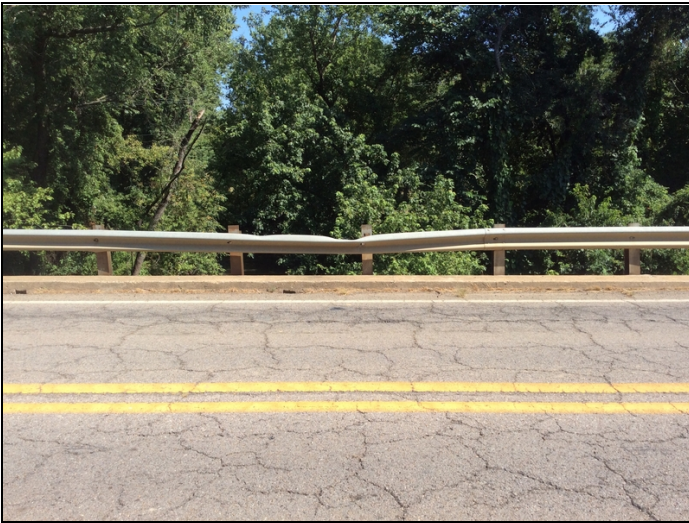
The left bridge railing in span # 3 has minor collision damage.
