Asset #00378(Routine)

State Highway 22 over Gack Creek-Logan Co.

Location: 6.64 MI E of Franklin Co.

Team Lead: Bob McEntyre, Inspection Date: 06/15/2022

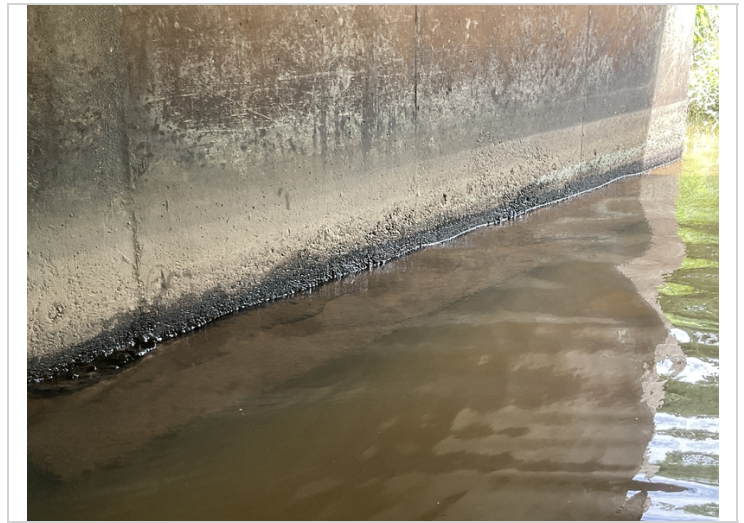
(215) -Both abutments have light abrasion at the water elevation. -Abutment # 1 has a few vertical and diagonal cracks in the stem wall. -There is some staining under the bearing area of several girders. -Vertical and map cracking with efflorescence in the bearing area of girders # 3 and # 5 of both abutments. -Abutment # 2, right wing wall has a moderate width diagonal crack and map cracking with efflorescence at the abutment juncture. -Abutment # 2 stem wall has diagonal and mapcracking on the right side at the wing wall juncture. There is a delaminated area in the concrete placed on top of the abutment adjacent to girder # 7 on the exterior side.							
220	Reinforced Concrete Pile Cap/Footing	LF	100	44	56	0	0
1190	Abrasion/Wear (PSC/RC)	LF	56	0	56	0	0

Abutment 2-Light abrasion

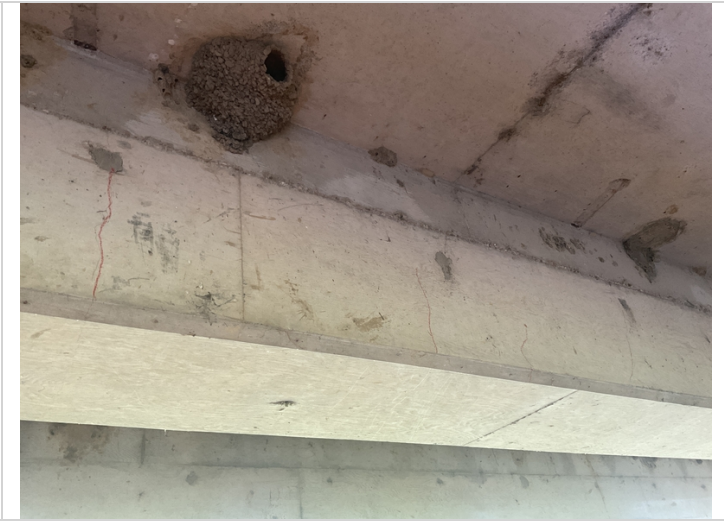
Girder 3-Hairline vertical flexure cracks

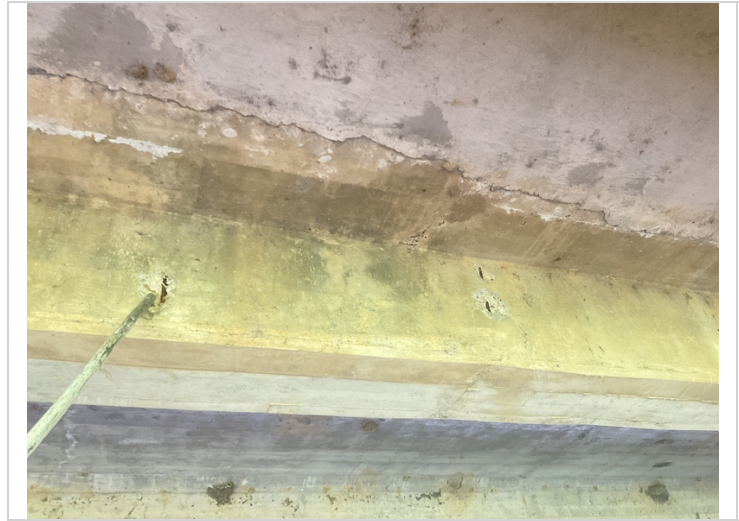
(110) -Vertical hairline flexure cracking at variable spacing typical. -Girder # 3 has 4 small diameter spalled areas with exposed reinforcing steel in the left vertical face of girder.. Exposed reinforcing steel has no apparent noteworthy section loss during this inspection. -A few areas of shallow honeycombing in the base of girders # 3, 4, and 5 from the construction process.							
215	Reinforced Concrete Abutment	LF	100	35	65	0	0
1080	Delamination/Spall/Patched Area	LF	2	0	2	0	0
1120	Efflorescence/Rust Staining	LF	13	0	13	0	0
1190	Abrasion/Wear (PSC/RC)	LF	50	0	50	0	0

Girder 3, left vertical face-Shallow spalls with exposed reinforcing steel

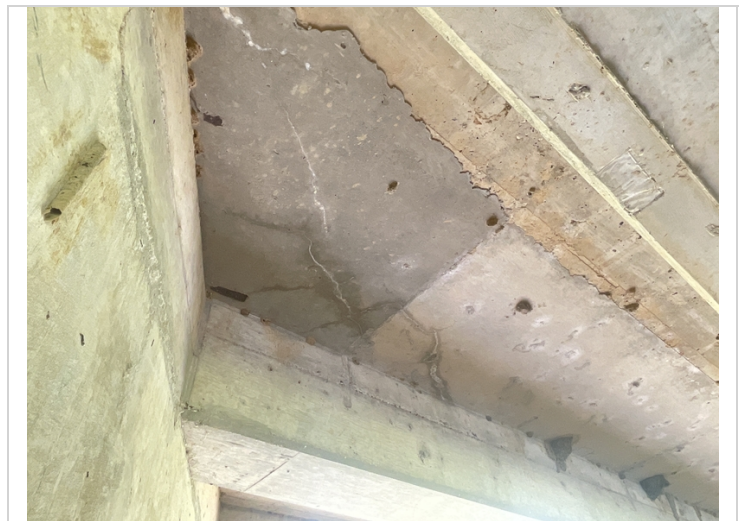
(16) -Concrete Tee Beam with an asphalt wearing surface. Wearing surface has mapcracking throughout. -Transverse cracking with light efflorescence visible from the undersurface of the deck.							
110	Reinforced Concrete Open Girder/Beam	LF	210	169	41	0	0
1090	Exposed Rebar	LF	4	0	4	0	0
1130	Cracking (RC and Other)	LF	37	0	37	0	0

Deck undersurface, bay 5-Diagonal cracking with efflorescence

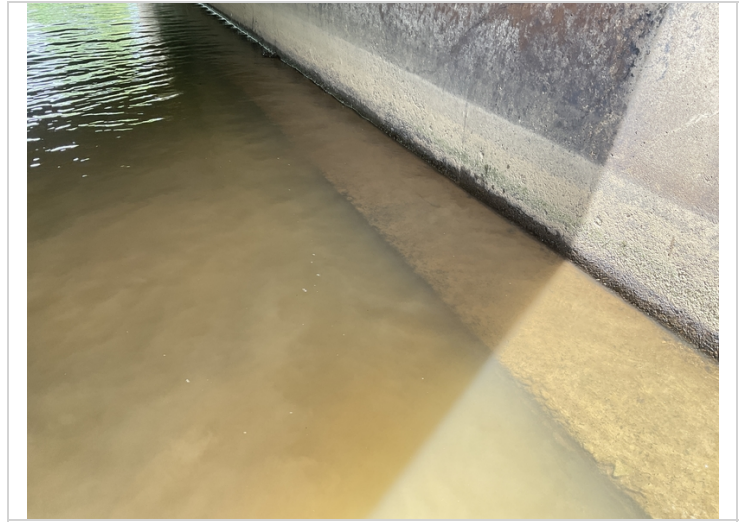
(220) -Footings are exposed where substructure was widened at abutment # 2. -Footings appear to be cast on solid shale channel. -Abutment # 1 footings have cover during this inspection.

Wading and probing during low and turbid water conditions indicate that the top of Bent # 2 footing is exposed in the widened portions of the structure.

The top of Bent # 2 footing is 1'-3" above the solid shale channel that is exposed in areas with no apparent scour problems during this inspection.

Abutment 2 footing exposed

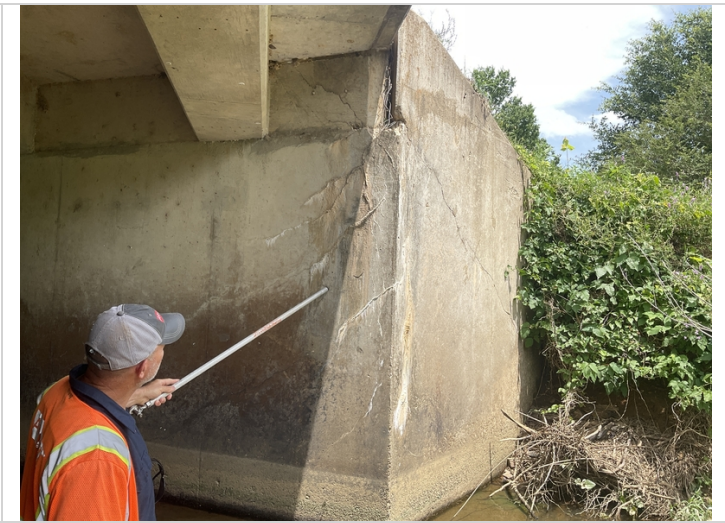
Abutment 2, right side-Cracking with efflorescence

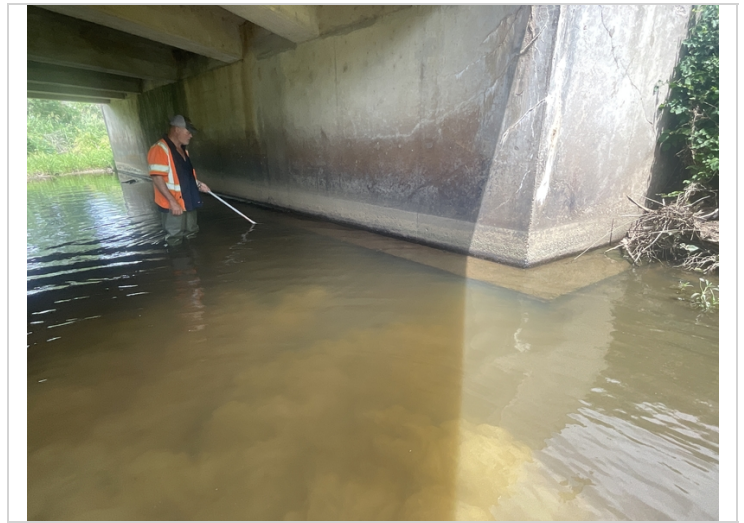
Probing abutment 2

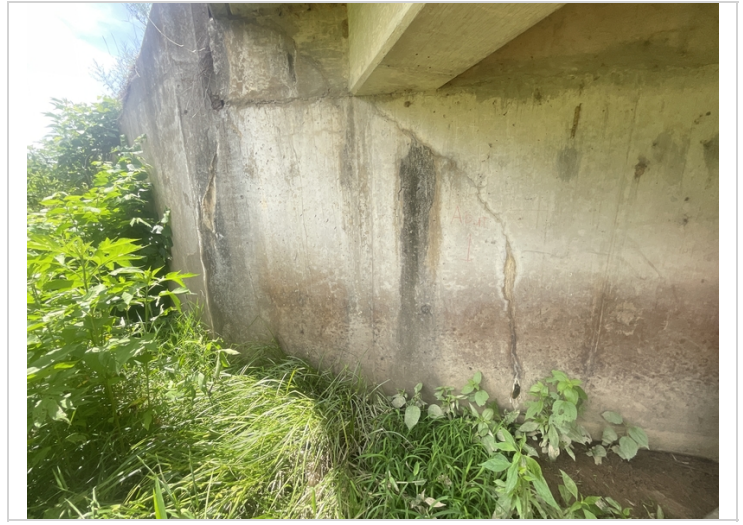
Abutment 1, right side-Diagonal cracking

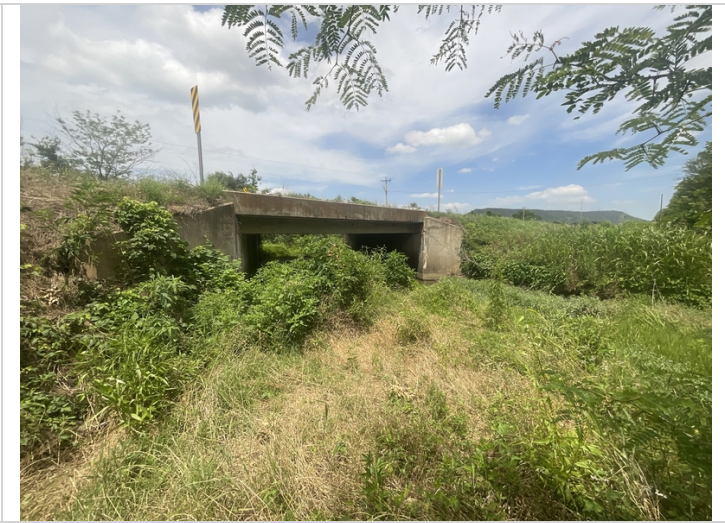
Vegetation and streambed material accumulation restricting channel

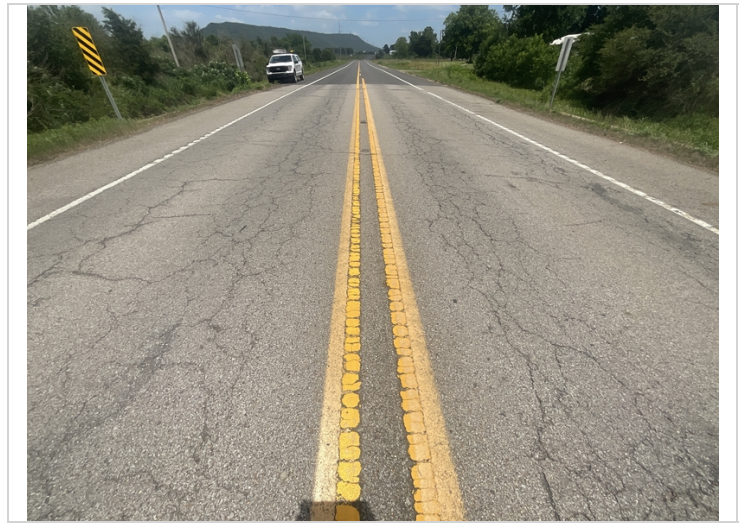
Driving surface-Mapcracking

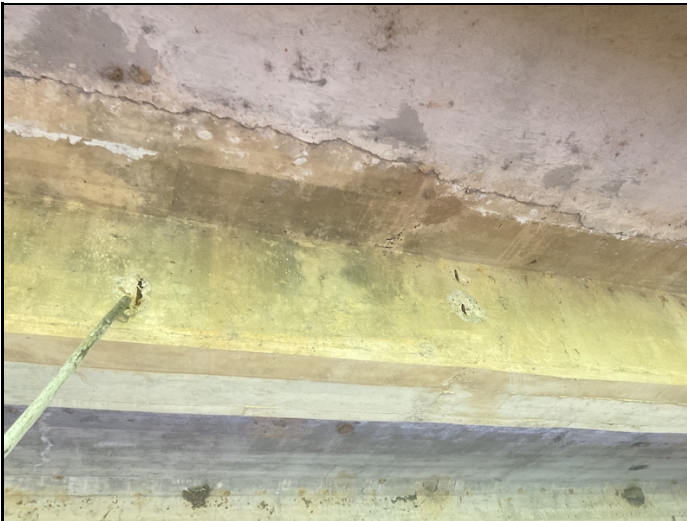
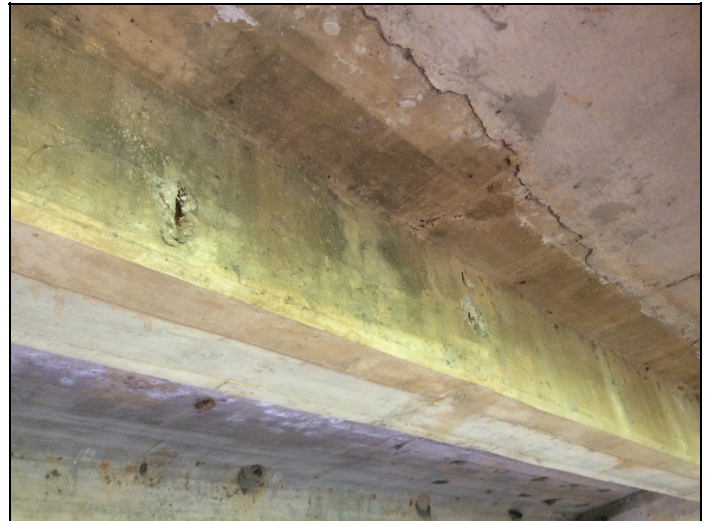
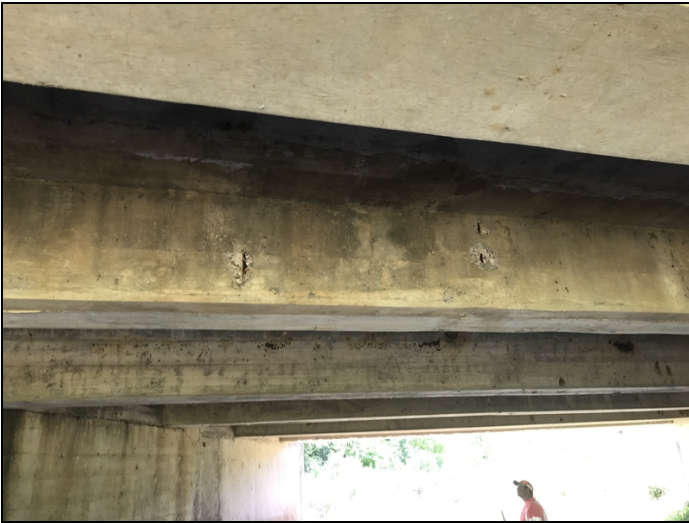
Girder # 3 has 4 small diameter shallow spalls with exposed reinforcing steel in the left vertical face of girder. Exposed reinforcing steel has no apparent noteworthy section loss during this inspection.

Type of Work: Repair (General)

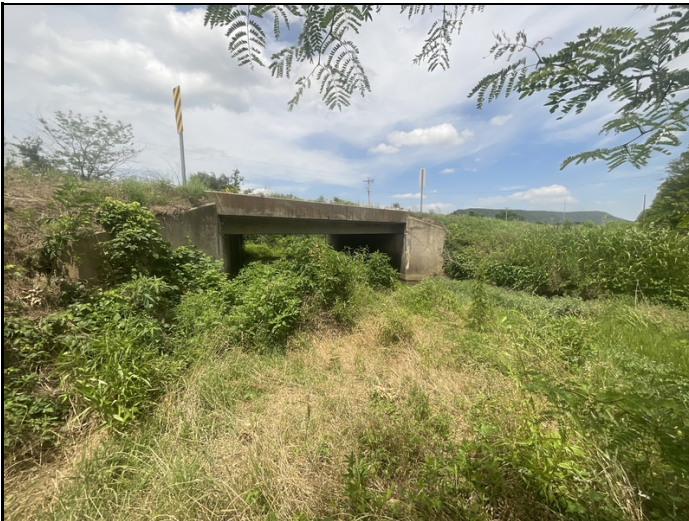
Inlet end of the channel has silt and vegetation accumulation that is causing the channel to migrate to the East directing stream flow into the East abutment and causing erosion to the Southeast embankment.

Type of Work: (Inactive) (Inactive) 1 - Clean

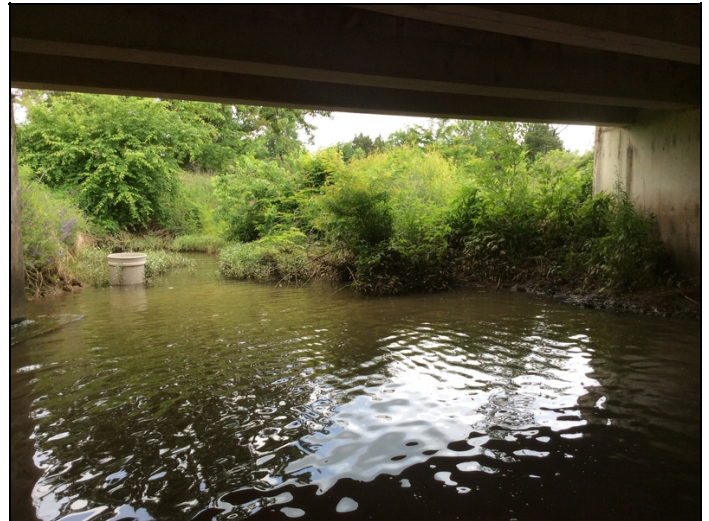
Inlet end of the channel has silt and vegetation accumulation that is causing the channel to migrate to the East.

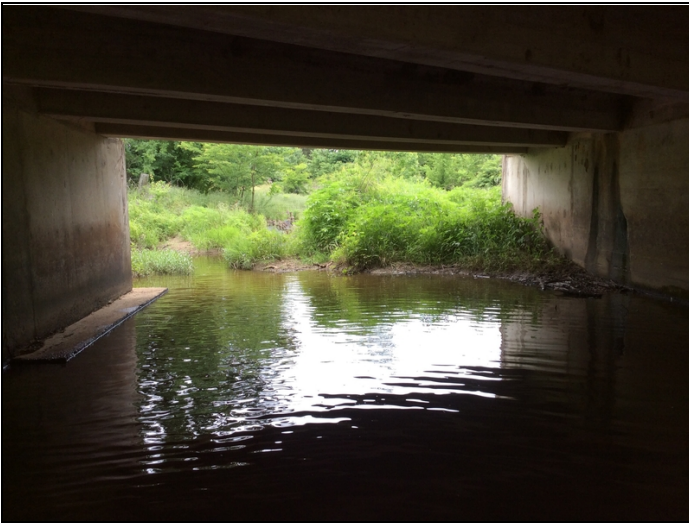
Channel restricted.
