Bridge 03356 Inspection Report

Route:109 Section:03 Log:4.939

National Bridge Inventory Data Sheet

Team Lead: Rhett Franks, Inspection Date: 04/08/2025

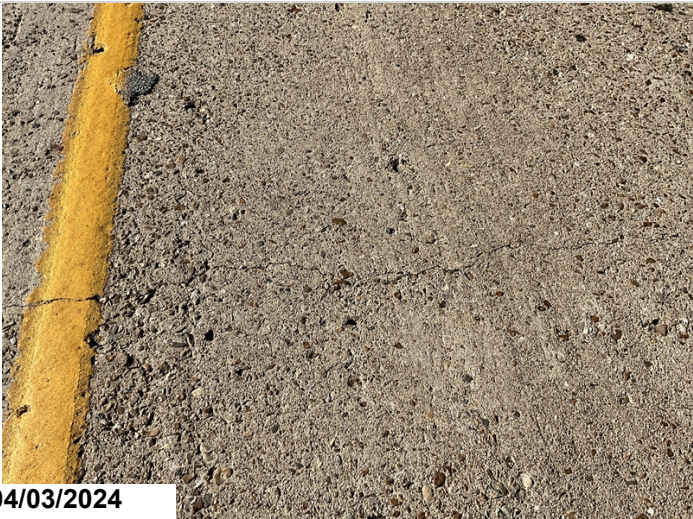
Sealable deck cracking

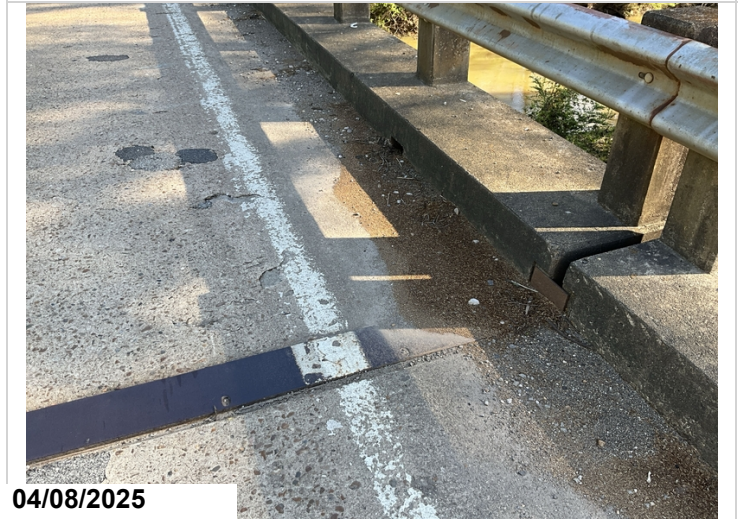
Typical debris restricts the deck drains.

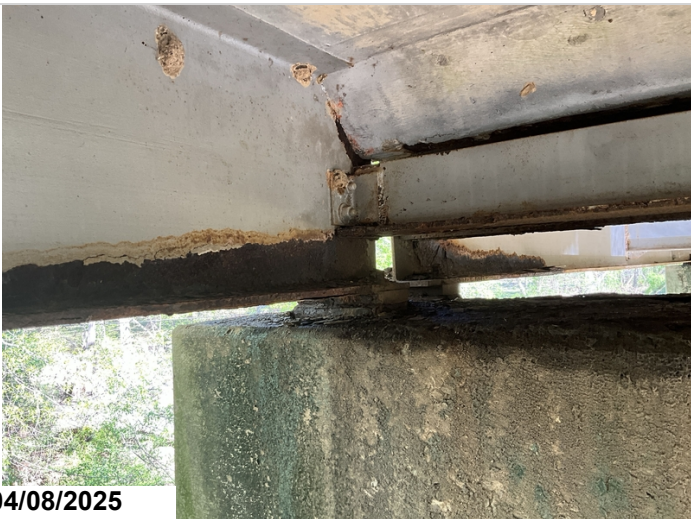
Span 1 Bent 1 Girder 1 Active corrosion with flaking rust
typical on girder ends. CS3 8 LF

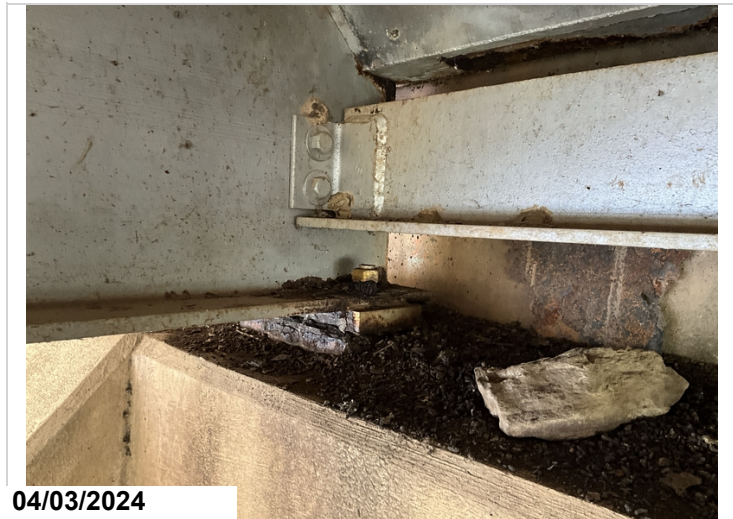
Beam ends could use a painting.

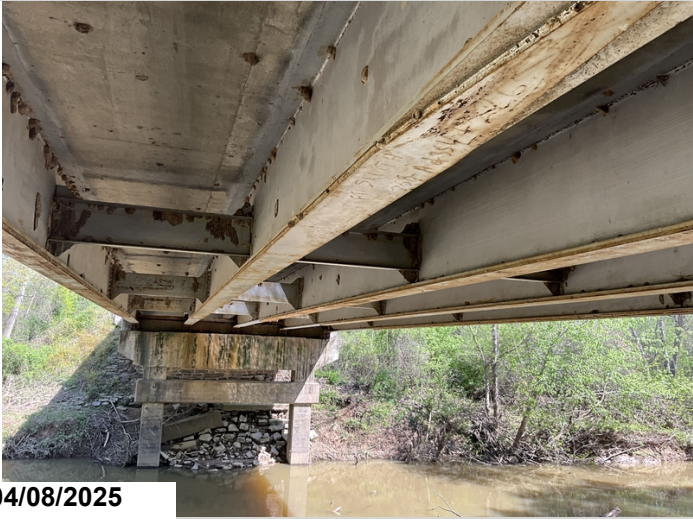
Girder have a failing paint system.

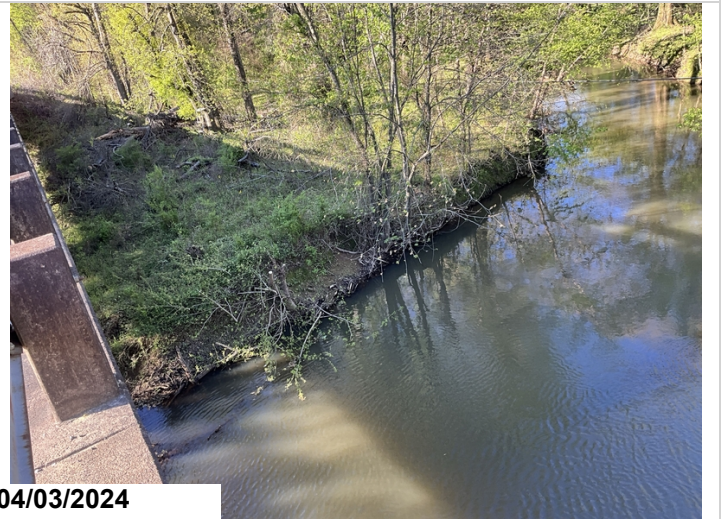
Typical trees and brush left side

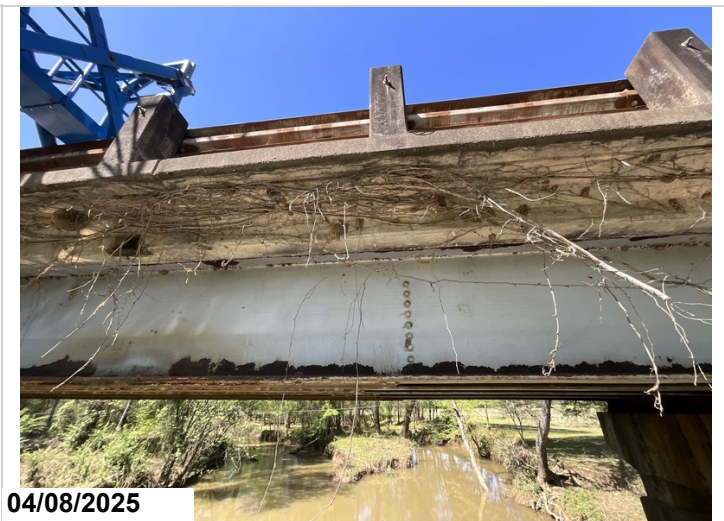
Span 4 Right edge of deck cracking with efflorescence. CS2
20 SF

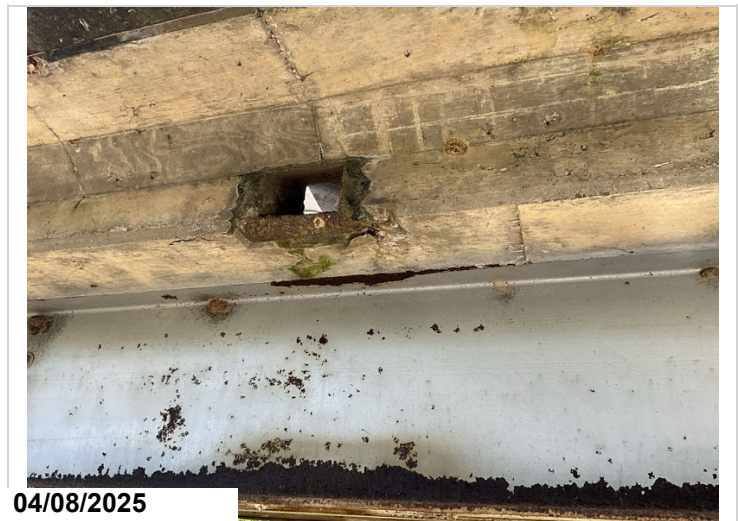
Span 3 Right spalling in the deck drain. CS2 2 SF

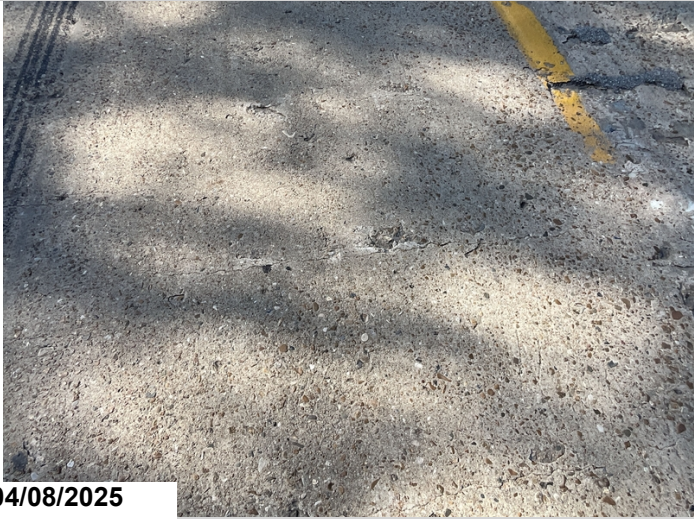
Typical transverse cracking in all spans.

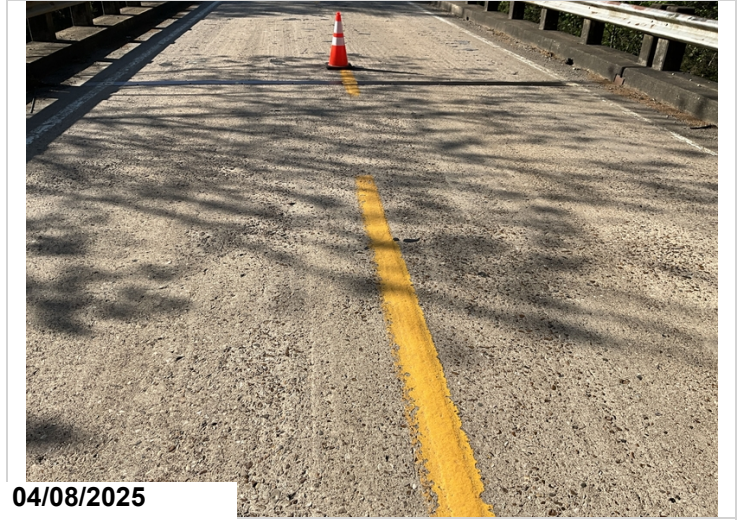
Typical wear in all spans.

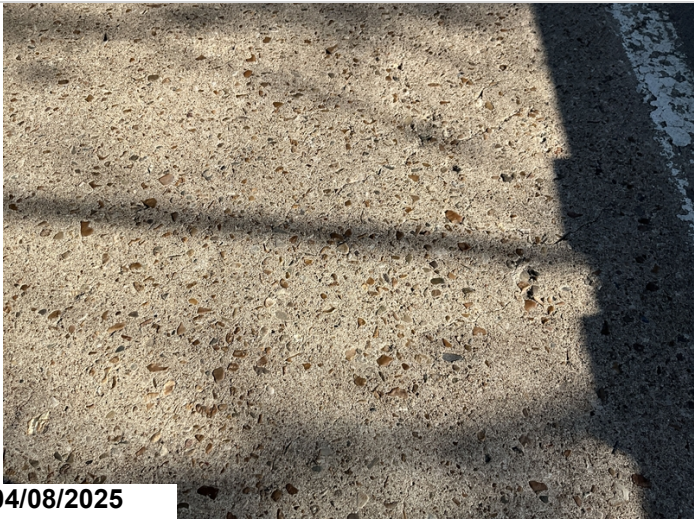
Typical map cracking in all spans.

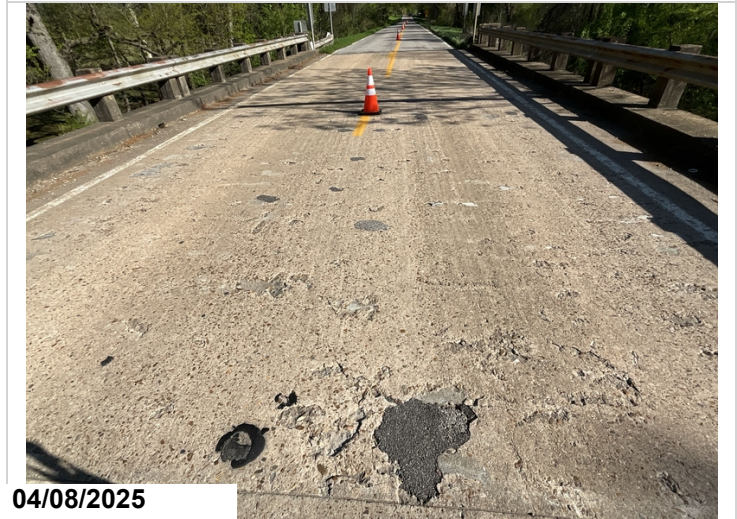
Span 4 Large areas of delamination. CS3 80SF

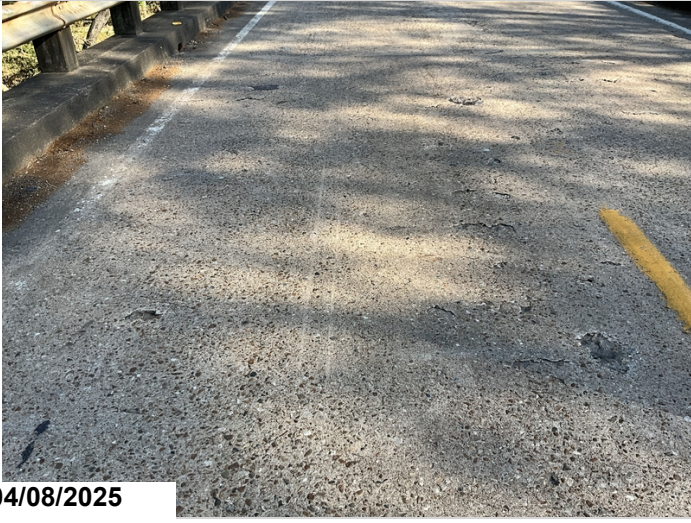
Span 4 Left lane large delaminated areas, potholes with temporary repairs. CS3 85 SF

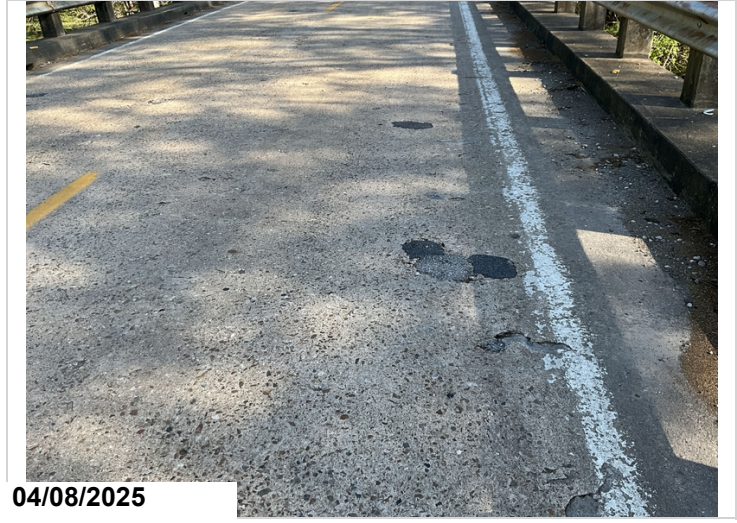
Span 4 Right lane large delaminated areas, potholes with temporary repairs. CS3 60 SF

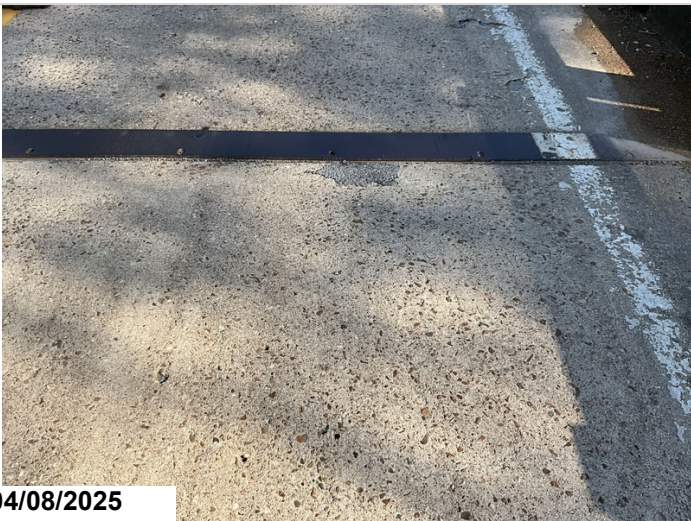
Span 3 Right lane right wheel paths spalling. CS3 2 SF

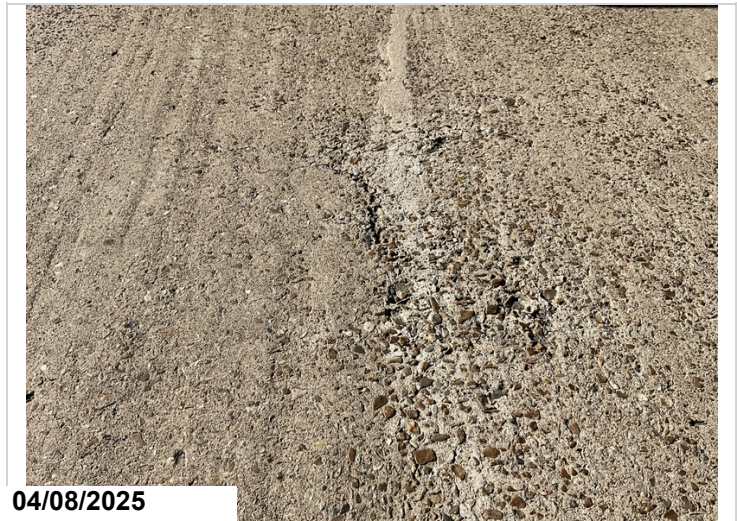
Span 2 Right lane delaminated area. CS3 8 SF

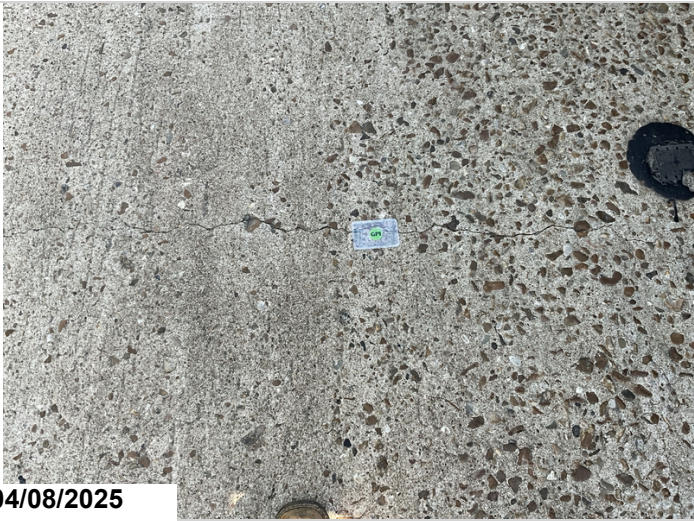
Span 1 left lane transverse cracking. CS3 .070 30 SF

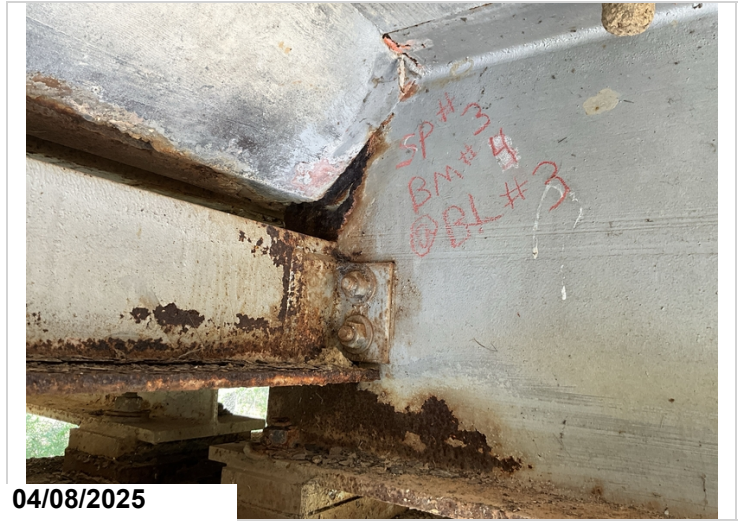
Span 3 Bent 3 Girder 4 active corrosion with flaking rust and advanced section loss 4" hole in web CS3 2 LF

Span 3, girder 4 at bent 3 has a 3" long x 1" wide hole rusted through the web at the expansion dam.

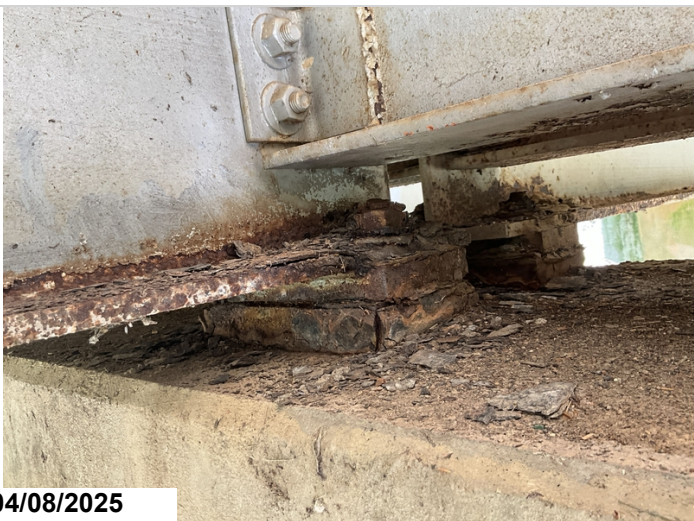
Span 2 Bent 3 Girder 3 active corrosion with flaking rust and section loss up to 1/16" and 1/4" section loss to bottom flange CS3 2 LF

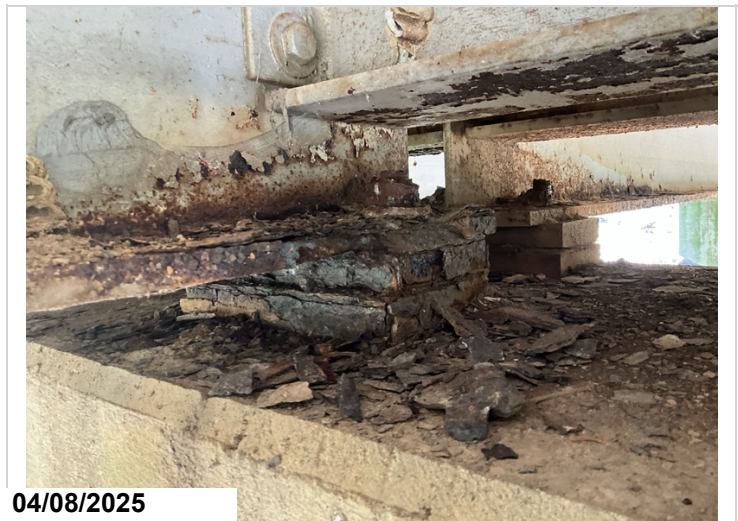
Span 2 Bent 3 Girder 2 active corrosion with flaking rust and section loss up to 1/16" and 1/4" section loss to bottom flange CS3 2 LF

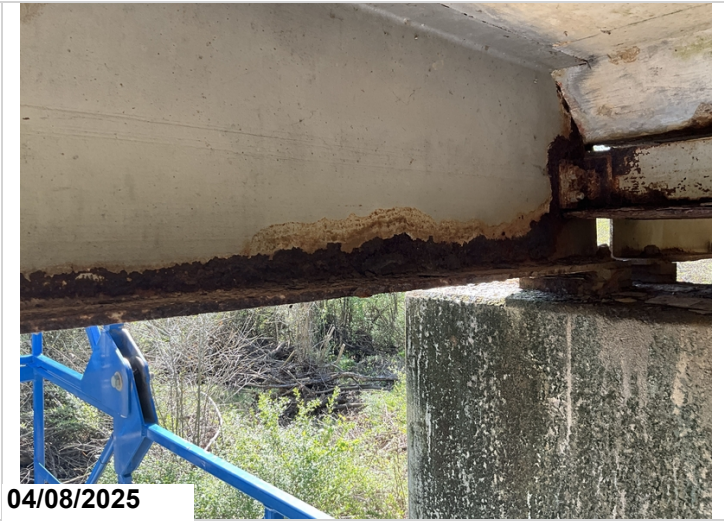
Span 2 Bent 2 Girder 5 active corrosion with flaking rust and section loss up to 1/16" CS3 8. LF

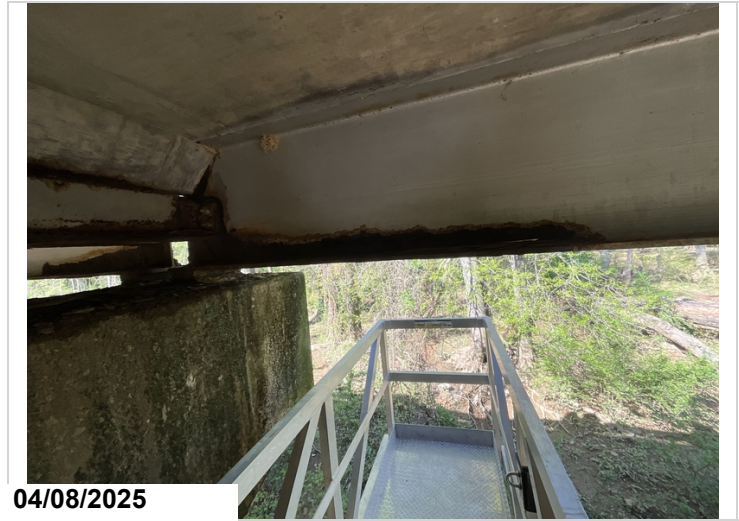
Span 2 Bent 2 Girder active corrosion with flaking rust and section loss up to 1/16" CS3 8 LF

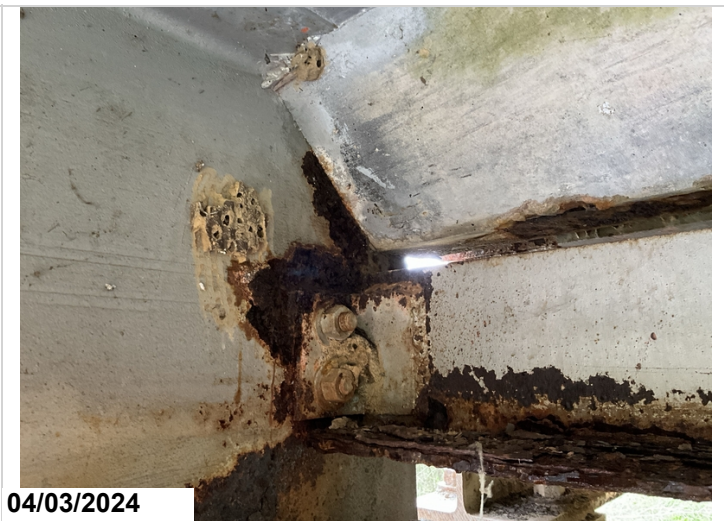
Span 3, bent 3, ahead side, girder 5, has active corrosion and advanced section loss in bottom flange. CS3 1/4

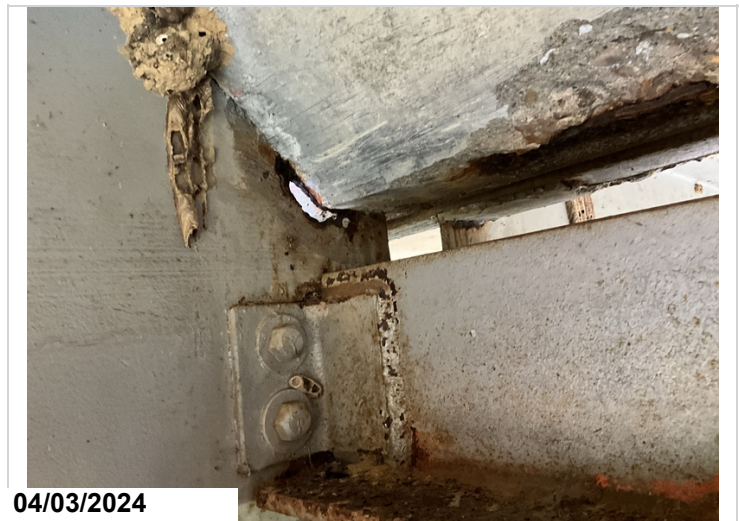
Span 3, bent 3, ahead side, girder 4, has a hole in the web at the haunch. CS3

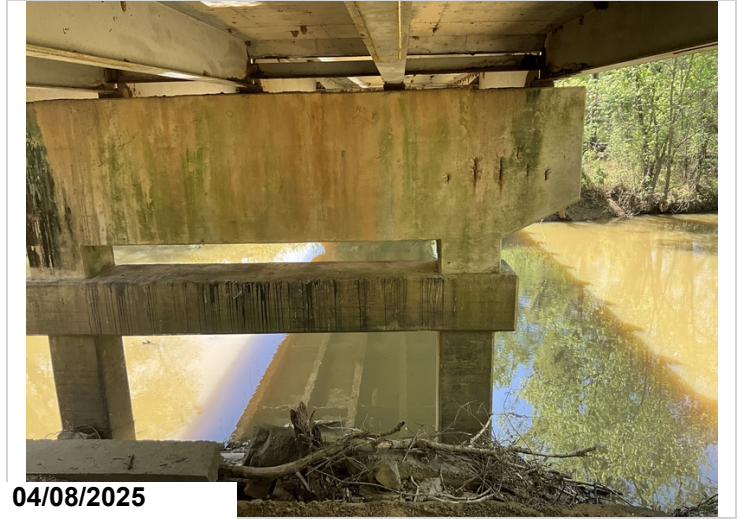
Span 5 Bent 5 Spalling with exposed reinforcing steel. CS3
4 LF

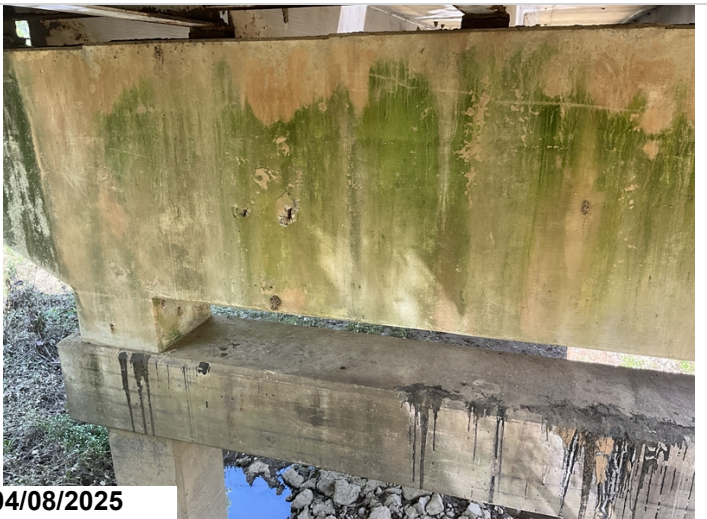
Span 3 Bent 4 Spalling with exposed reinforcing steel in face
of cap. CS3 2 LF

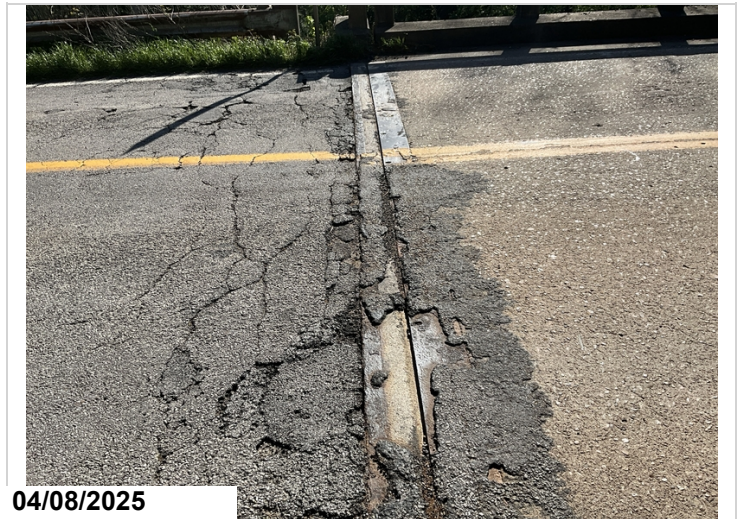
All joints have debris impaction. CS2 full length

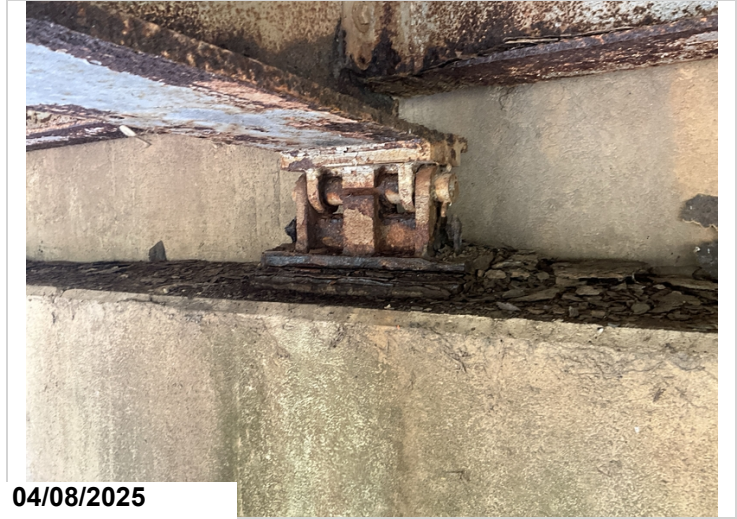
Span 4 Bent 4 Girder 3 Active corrosion with flaking rust.
CS3 1 EA

Span 4, girder 3 at bent 4 has heavy corrosion with thick flaking rust to base of web and bottom flange with 50% section loss to web adjacent to bearing with 1/2" remaining section.

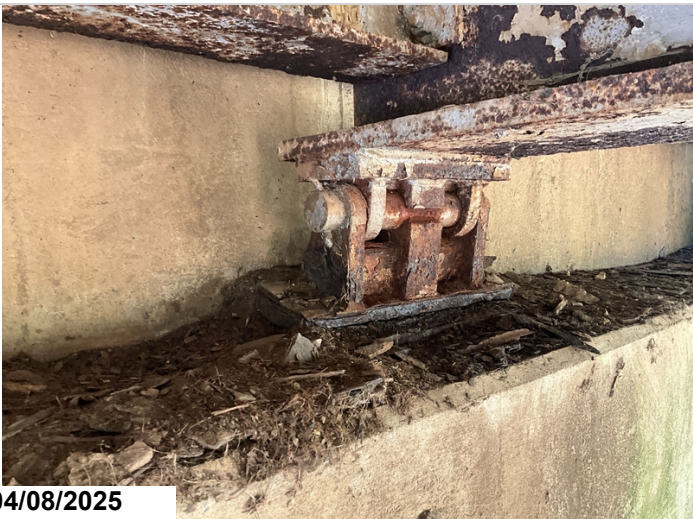
Span 4 Bent 4 Girder 2 Bearing fully extended at 60 degree
CS3 1 EA

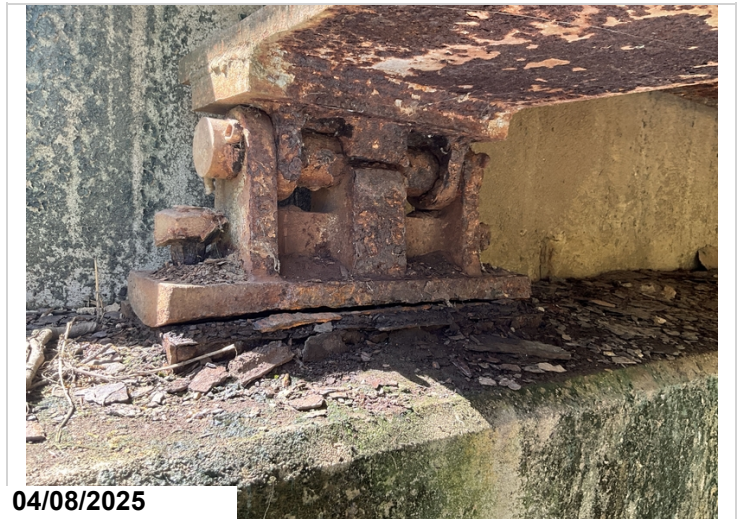
Span 4 Bent 4 Girder 5 Active corrosion with pack rust. CS3
1 EA

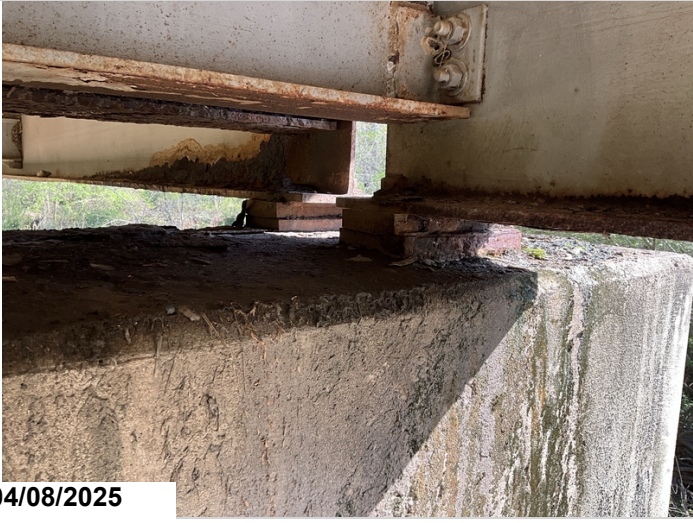
Span 1 Bent 1 Girder 5 Bearing has active corrosion with flaking rust. CS3 1 EA

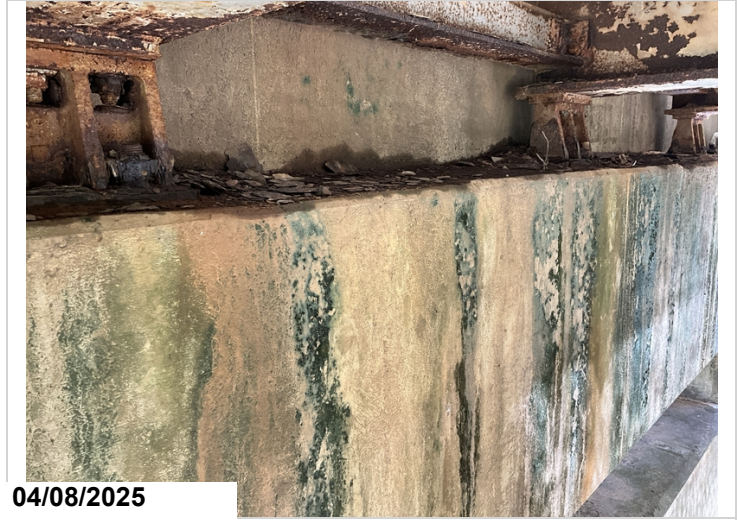
Span 4 Bent 5 fixed bearings have active corrosion with flaking rust. CS3 1 EA

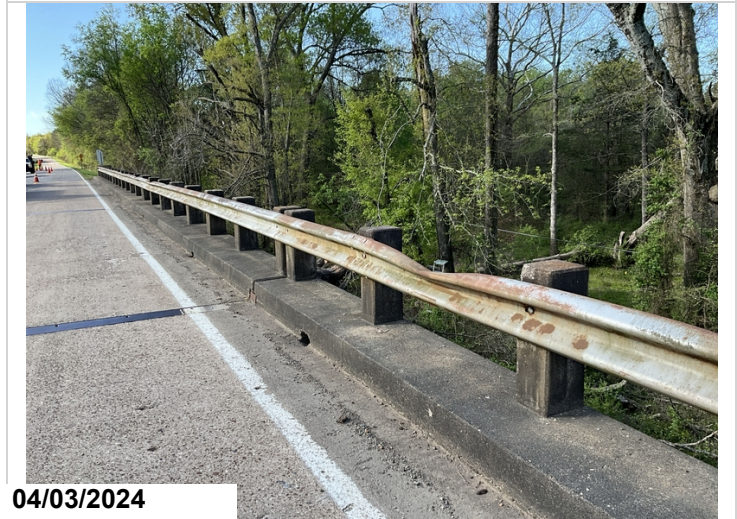
Spans 2, 3, and 4, left side, has damaged guard rail. 11 LF

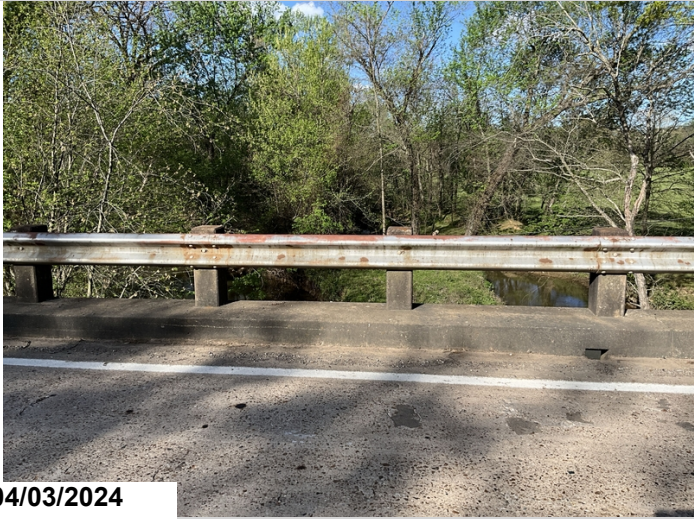
Typical paint failure on rail.

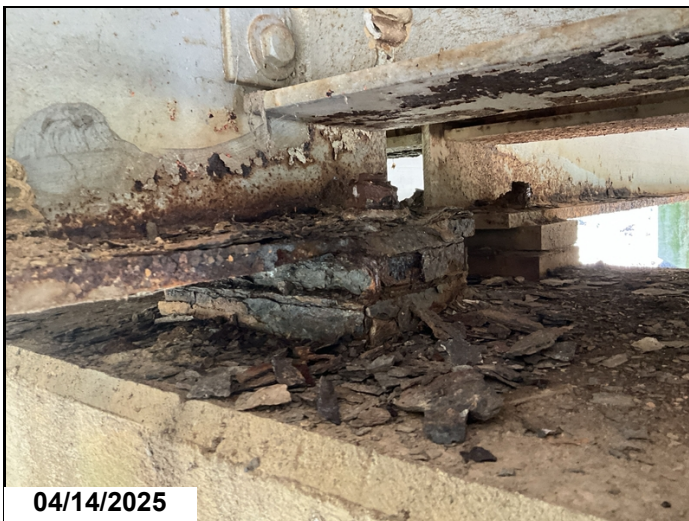
Span 2 Bent 3 Girder 2 active corrosion with flaking rust and section loss up to 1/16" and 1/4" section loss to bottom flange CS3 2 LF

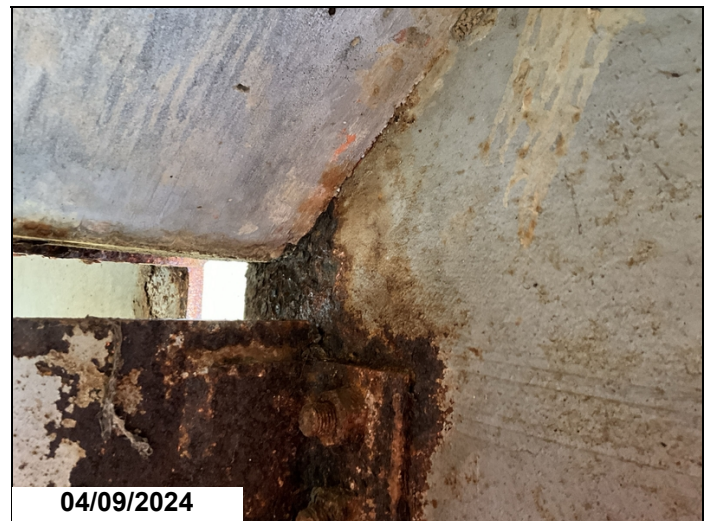
Span 3, bent 4, girder 5, has active corrosion and advanced section loss in haunch area. CS3 3/16"

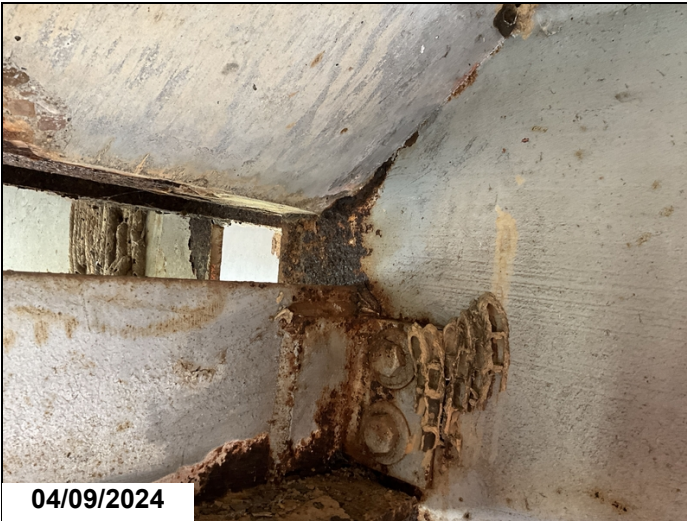
Span 3, bent 4, girder 4, has active corrosion and advanced section loss in haunch area. CS3 1/16

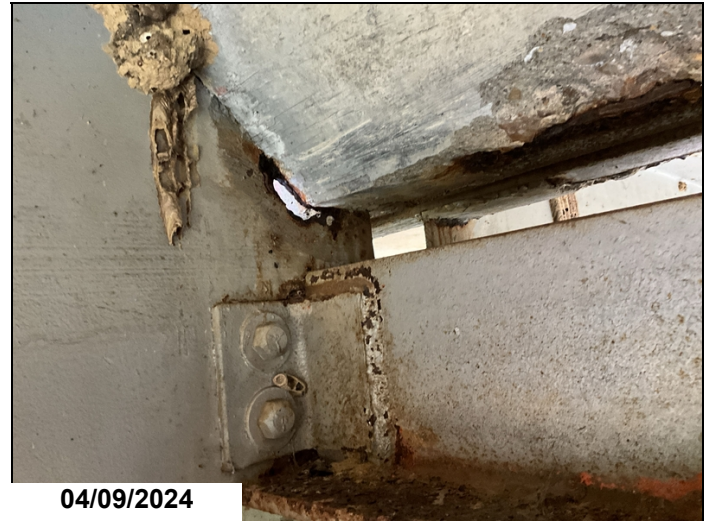
Span 3, bent 3, ahead side, girder 4, has a hole in the web at the haunch. CS3

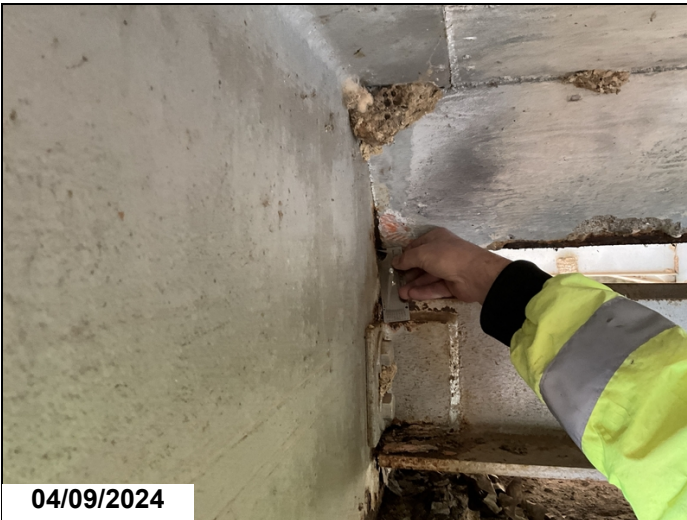
Span 2, bent 2, ahead side, girder 4, has active corrosion in haunch area with section loss. CS3 1 LF

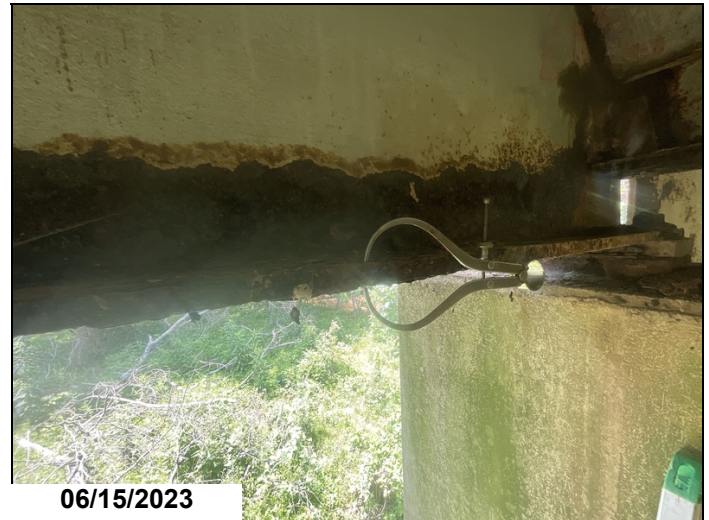
Span 3, girder 1 at bent 4 has heavy corrosion to base of web and bottom flange with 7/16" section loss to web at expansion dam.

Span # 3, Girder 1 at bent 4-Section loss to bottom flange.

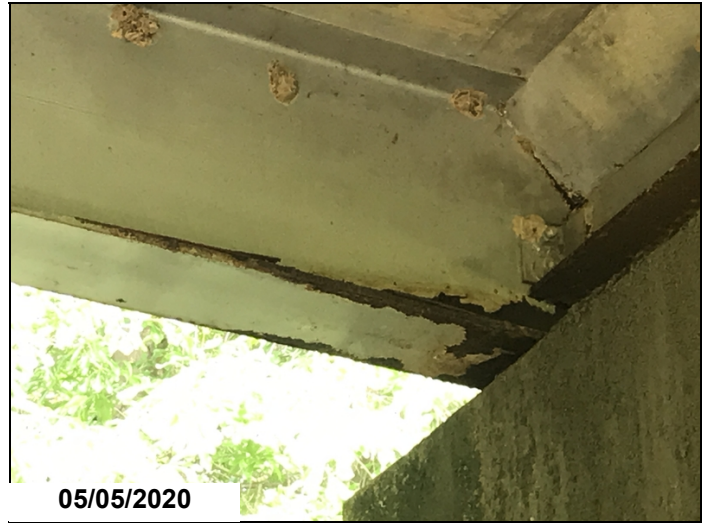
Beam # 1 at bent # 2-Active corrosion.

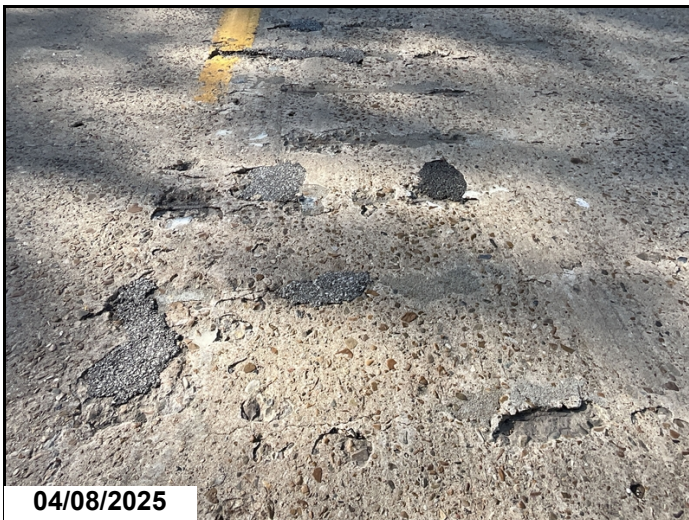
04/08/2025

Span 4 Spalling with exposed reinforcing steel. CS3 40 SF

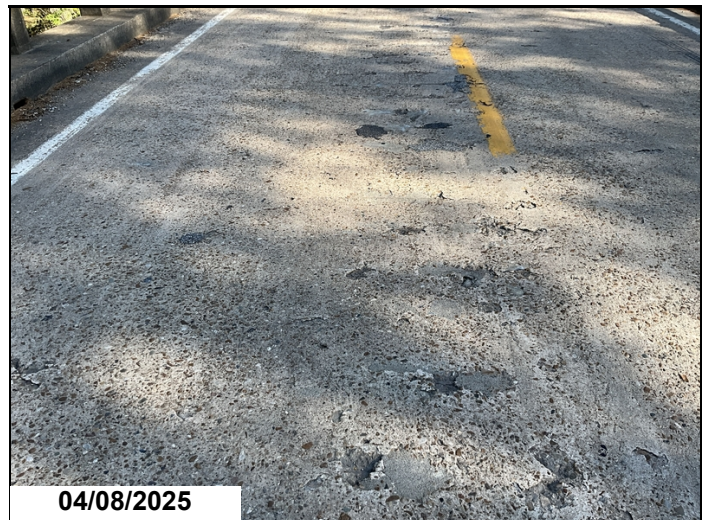
04/08/2025

Span 4 Right lane spalling with exposed reinforcing steel and temporary patching. CS3 80 SF

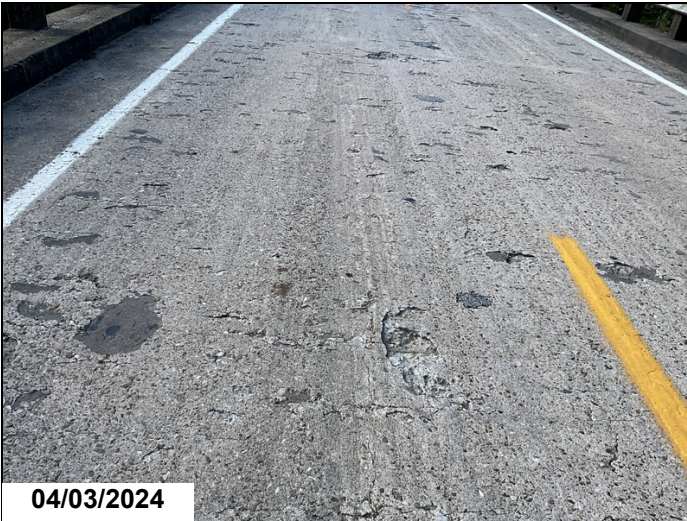
Span 4-Spall with exposed reinforcing steel

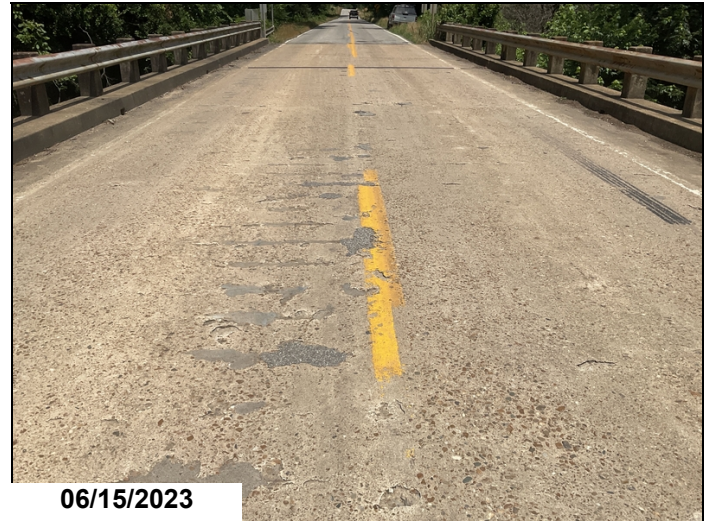
Span 4-Spall with exposed reinforcing steel

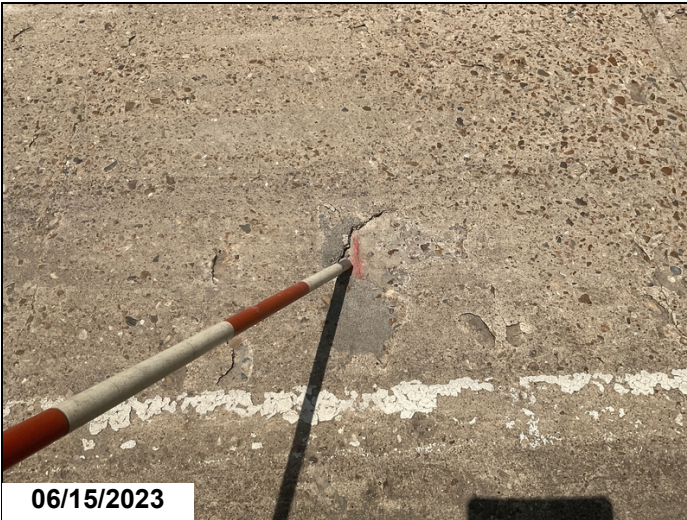
Span 4-Spall with exposed reinforcing steel

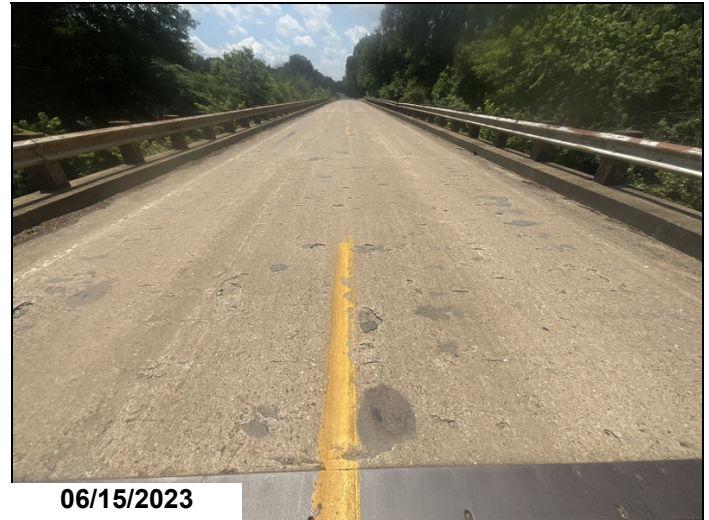
Span 4-Numerous spalls / delaminated areas

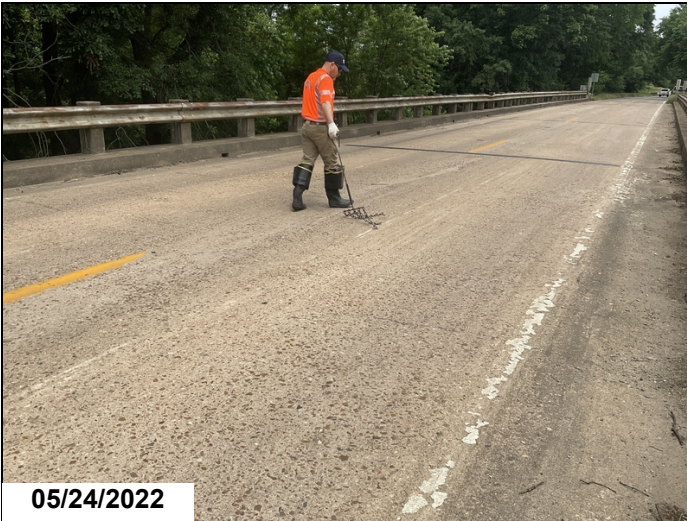
The majority of span # 4 is delaminated with numerous spalls in the driving surface. The spalled areas have exposed reinforcing steel in several locations. The gutters in all spans have numerous delaminated areas.

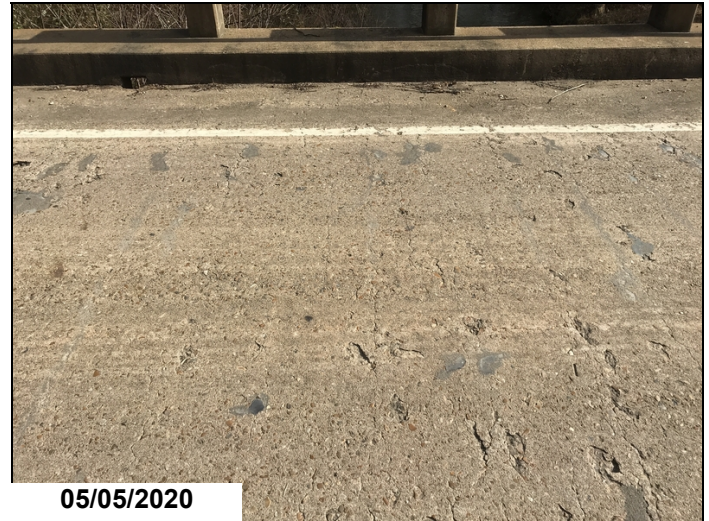
Sealable cracks that are beginning to delaminate.

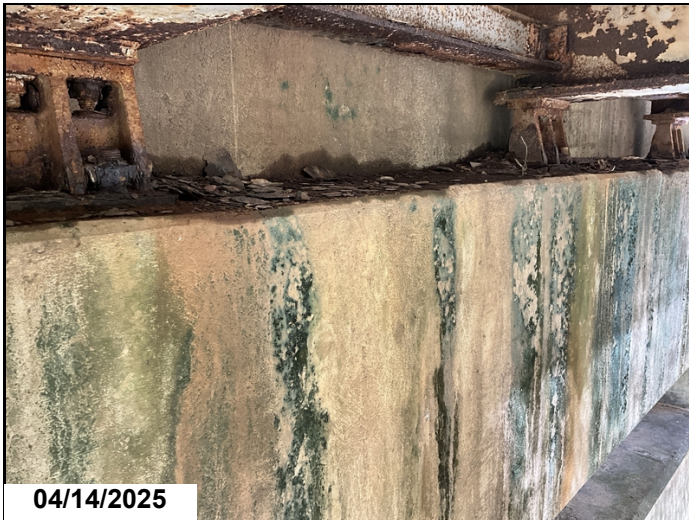
04/14/2025

The bearings have heavy corrosion in areas with pack rust between the bearing plates that appear to restrict movement.

Span 4 Bent 5 fixed bearings have active corrosion with flaking rust. CS3 1 EA

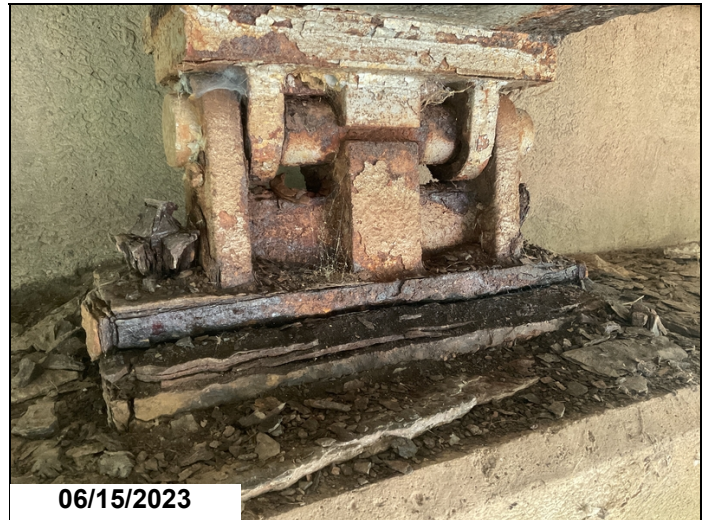
06/15/2023

Span # 4, bearing # 4 at bent # 4-Heavy corrosion with pack rust between rocker and masonry plate.

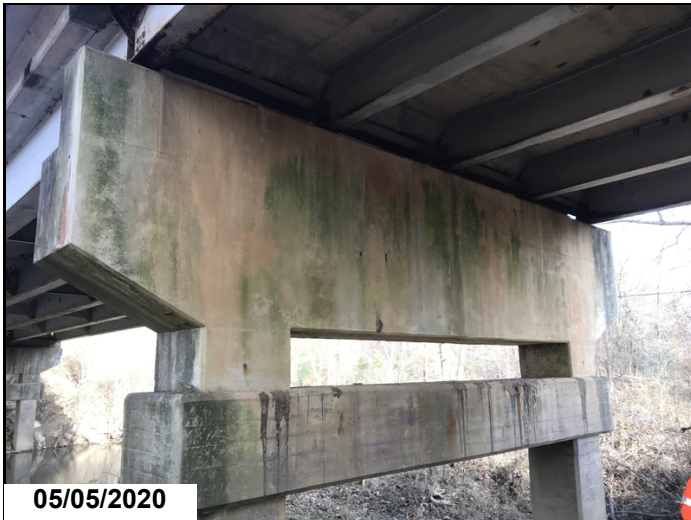
The caps of bents # 4 and # 5 have areas of shallow spalling with exposed reinforcing steel.

Bent # 4 cap-Spalling with exposed reinforcing steel.

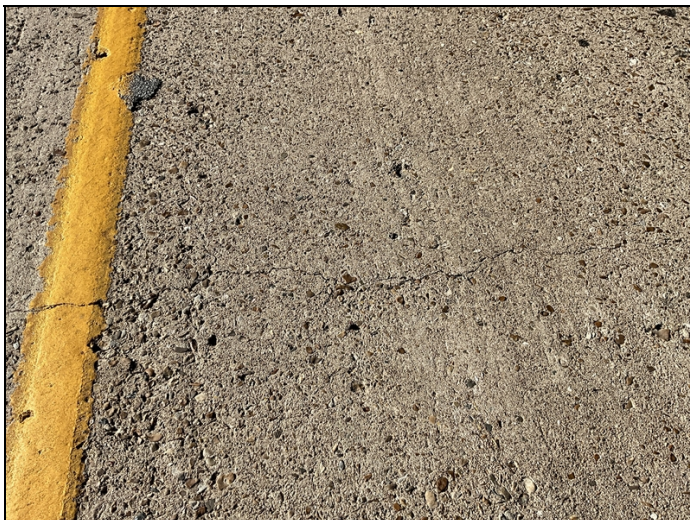
Sealable cracking in all spans.

Sealable deck cracking

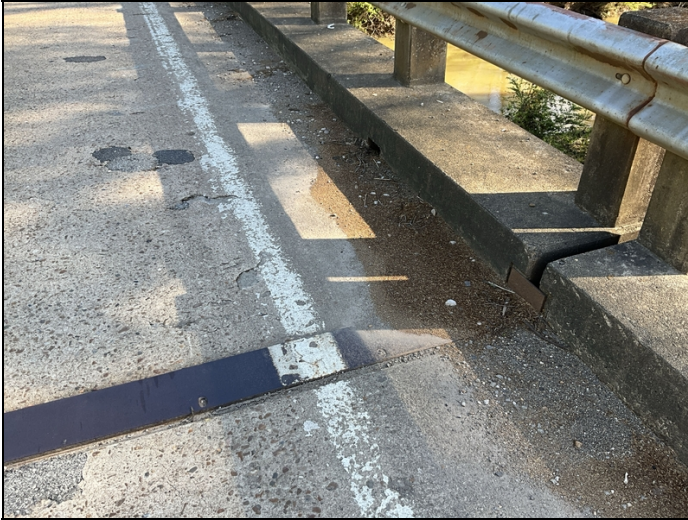
Typical debris restricts the deck drains.

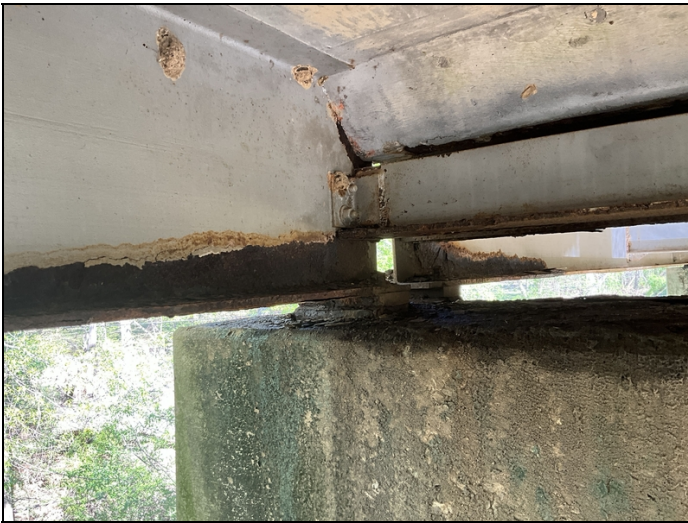
Span 1 Bent 1 Girder 1 Active corrosion with flaking rust typical on girder ends. CS3 8 LF

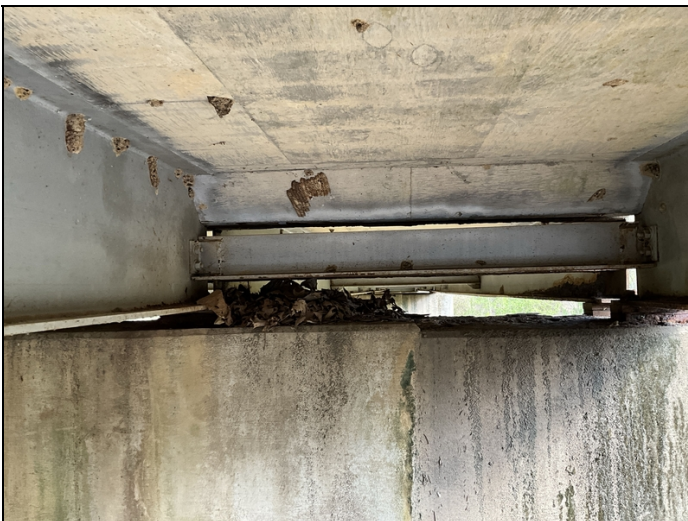
Caps have debris built up on top of them.

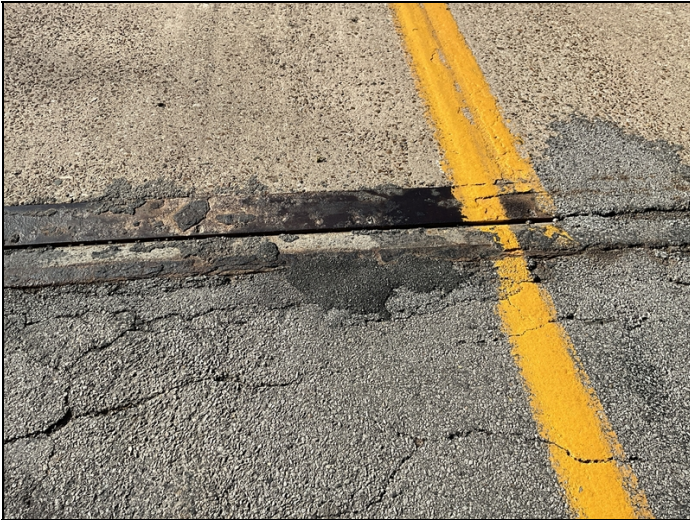
Typical debris impact in joints.

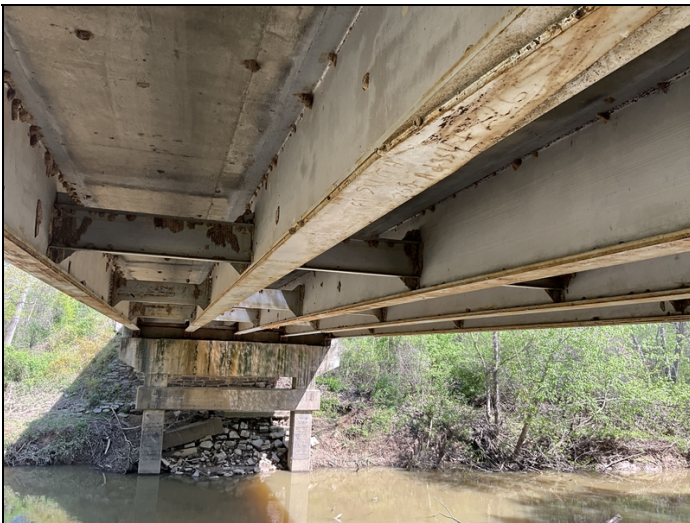
Girder have a failing paint system.
