Bridge 05600 Inspection Report

Route:109 Section:03 Log:7.849

National Bridge Inventory Data Sheet

Inspection Photos and Notes

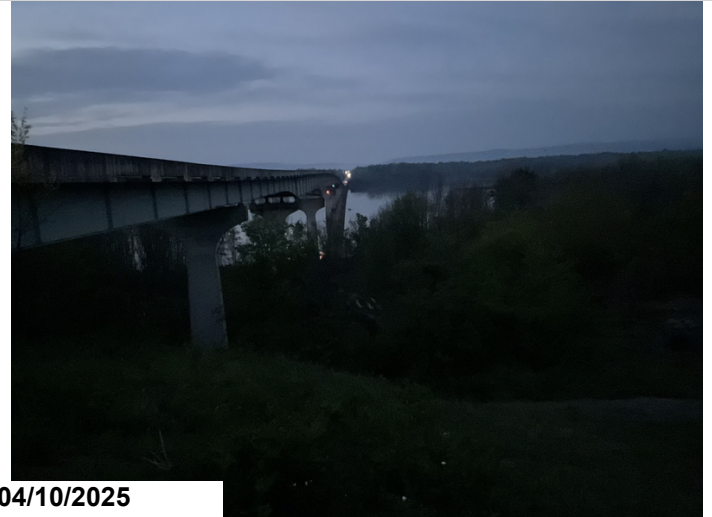
Navigation lights on the left/upstream side: first red light is out. We put out a lane closure and replaced this bulb. Corrosion had caused a short.

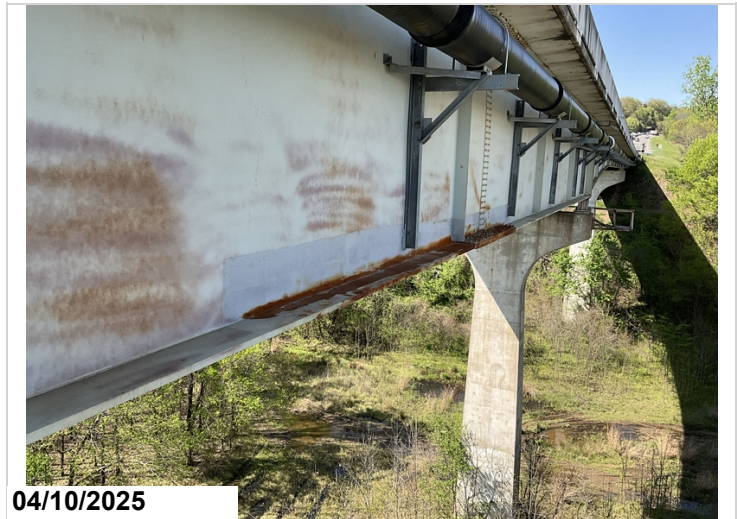
Span 58, girder 2, right side, at 3rd splice connection:
surface corrosion, 20LF CS2

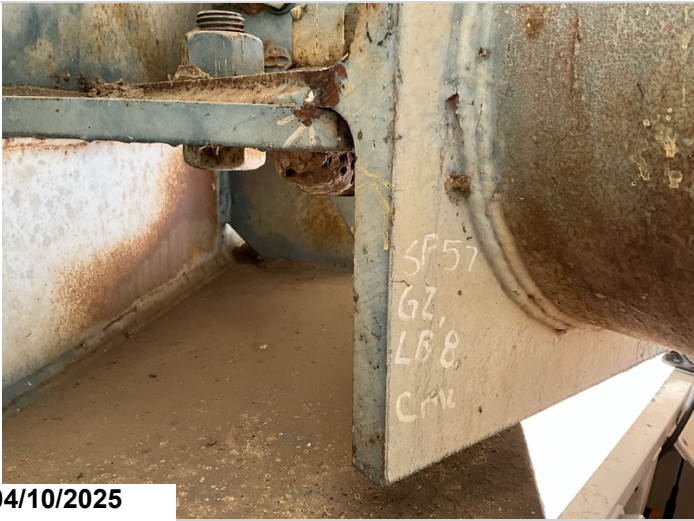
Span 57, girder 2, left, floorbeam 26, ahead side, diagonal connection plate: not a crack.

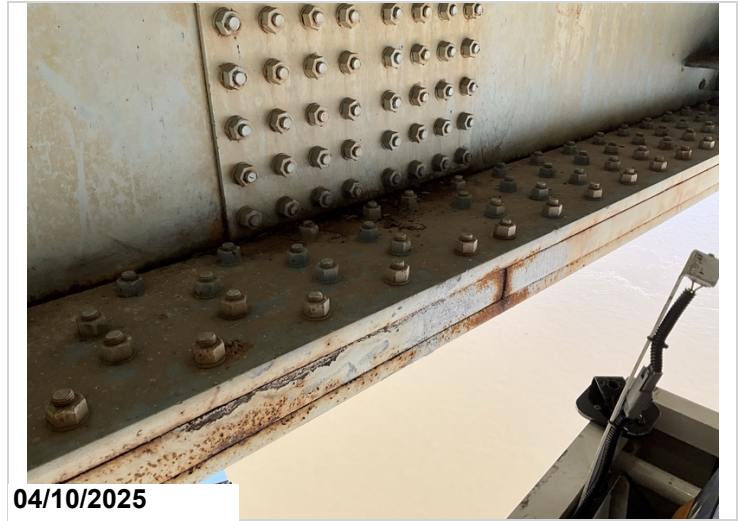
Span 57, girder 2, left side, 2nd splice plate: up to 1/8" section loss, 15LF CS3. Girder 1, left side, 3rd splice connection: 1/16" section loss, 12LF CS3 3LF CS3 for the rest of the splice connections in this span and span 58

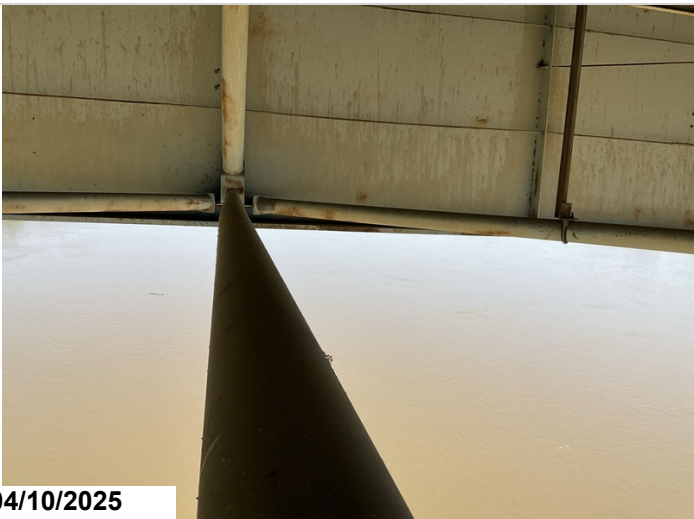
Span 57, floorbeam 20, bottom transverse member: out of plane bending, 10LF CS2.

| ELEMENTS | DESCRIPTION | UNITS | TOTAL | CS1 | CS2 | CS3 | CS4 |
|---|---|---|---|---|---|---|---|
| | <p>(152) The floor beams have scattered areas of surface corrosion, no areas of measurable section loss was found at this inspection.</p> <p>Span 57, floor beam 20, bottom transverse member: out of plane bending, 10LF CS2.</p> | | | | | | |

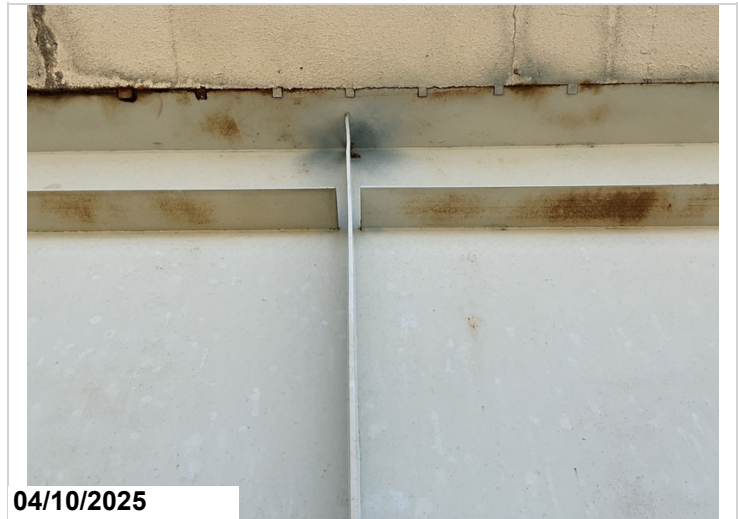
Span 57, girder 1, left, floorbeam 15, vertical stiffener: out of plane bending, 1LF CS2..

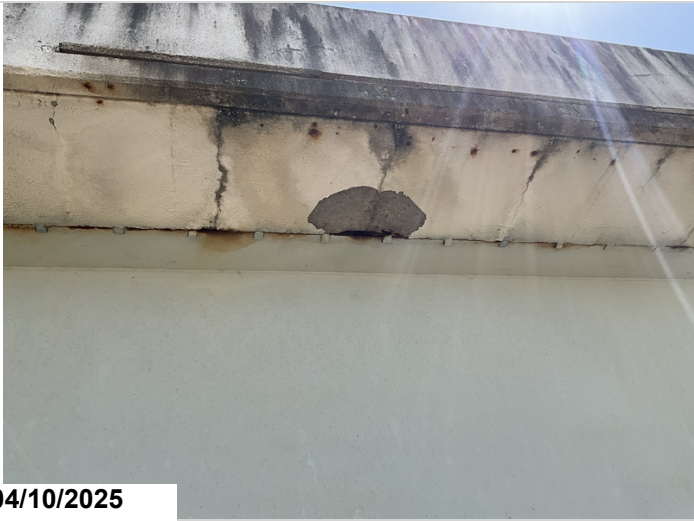
Span 57, girder 1, outside, between floorbeam 13 & 14: 1/8" section loss, 2LF CS3.

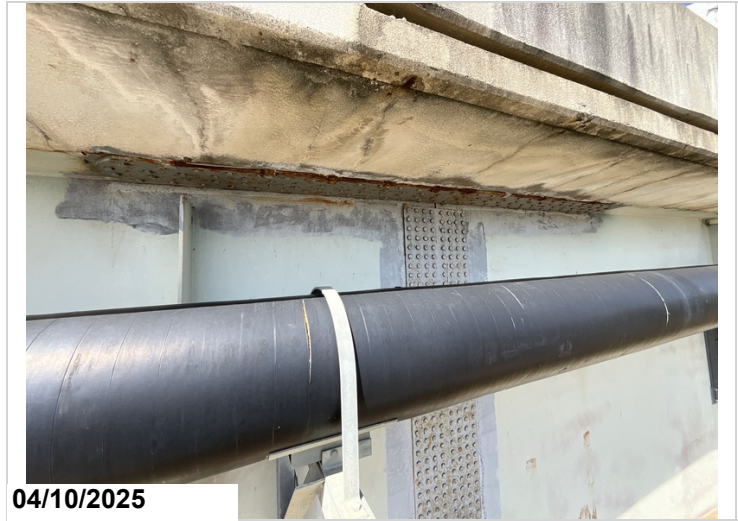
Span 56, girder 2, right side, 3rd splice plate connection: active corrosion, 10LF CS2.

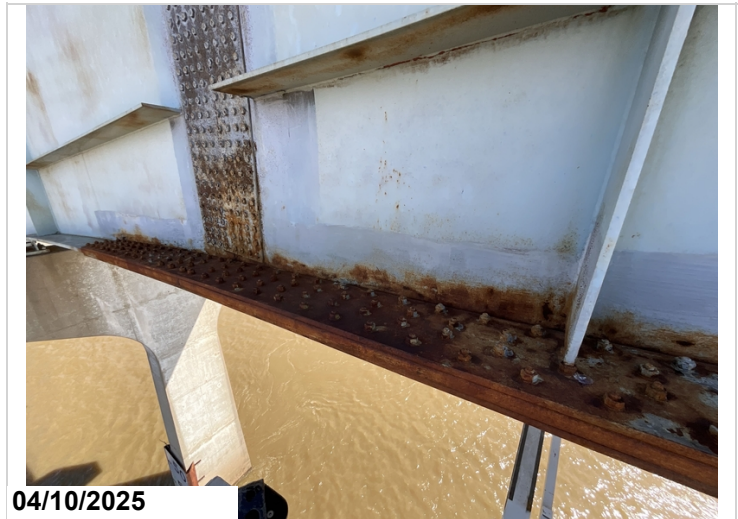
Span 56, girder 1, left side, 3rd splice plate connection: active corrosion, 10LF CS3.

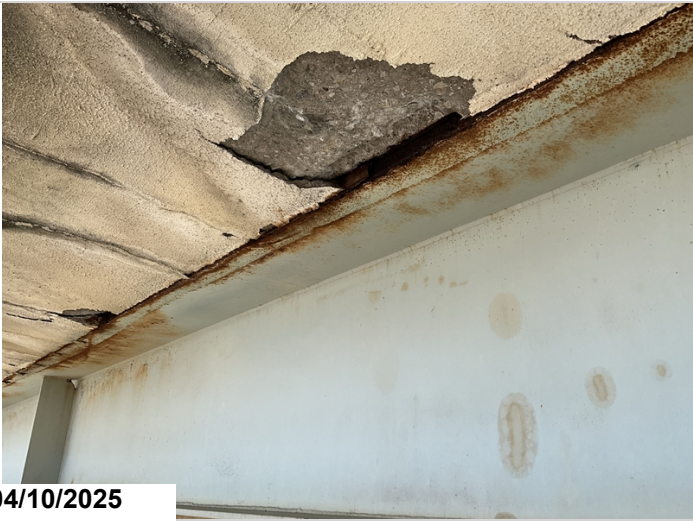
Span 56, girder 2, right side, top flange, between floorbeams 6 and 7: active corrosion with section loss up to 1/8" 7LF CS3.

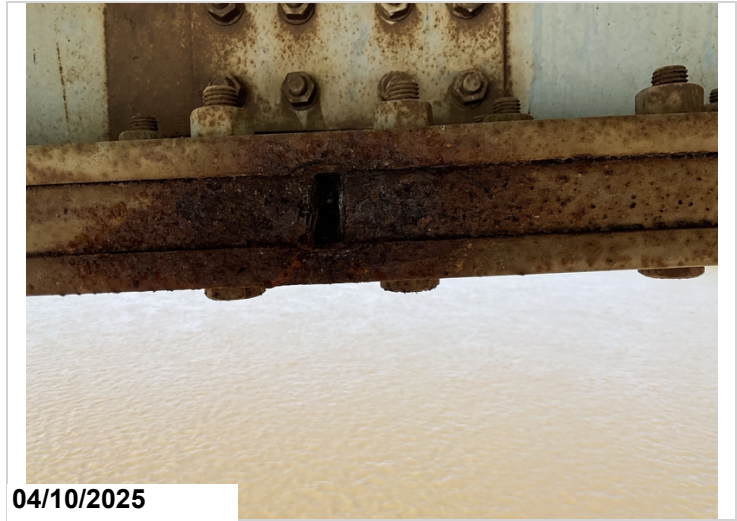
Span 56, girder 1, right side, 2nd splice plate connection: active corrosion with section loss, 1LF CS3. Up to 1/16" section loss, this typical at girder 2.

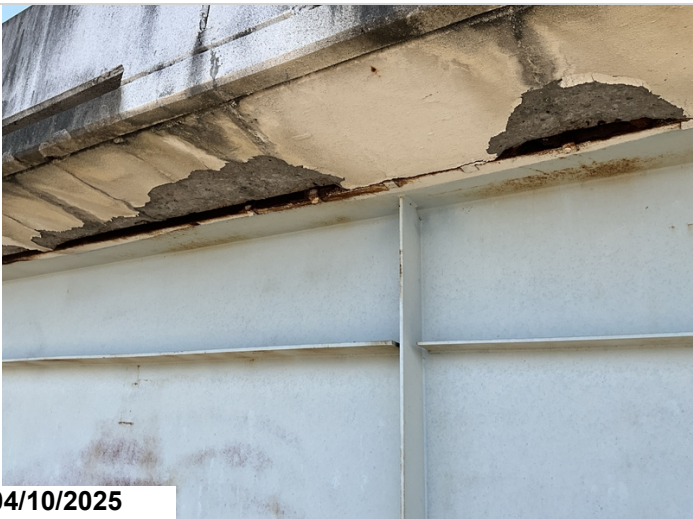
Span 56, girder 1, left side, floorbeam 6, top flange: corrosion with section loss 15LF CS3. Up to 1/8 section loss.

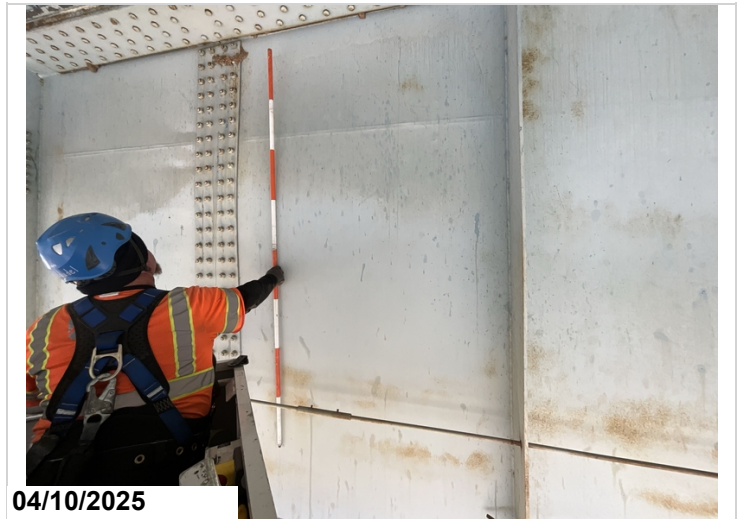
Overall, the superstructure was found to be in satisfactory condition. Minor surface corrosion is common throughout, and isolated instances of section loss up to 1/4" are present. Out-of-plane bending is also present in girders 1 and 2 in span 56. Due to these findings, the superstructure was rated 6.

Span 56, girder 2, 1st splice connection: out of plane bending, 13LF CS3

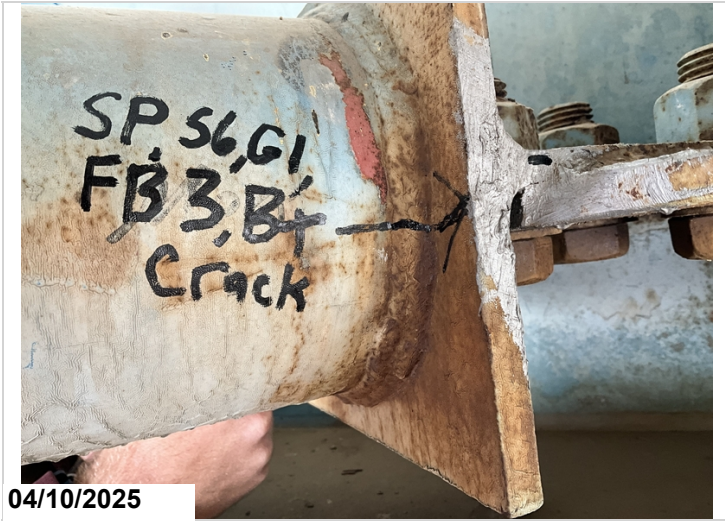
Span 56, floorbeam 3, girder 1, bottom, back side, diagonal connection plate: crack on both sides of plate, cracks are 1/4", CS3.

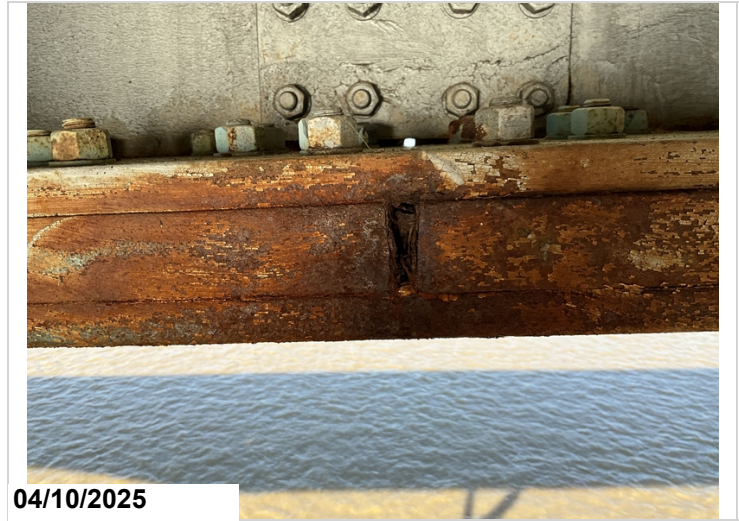
Span 56, girder 1, 1st splice plate connection, right side: active corrosion, 1/16" section loss, 1LF CS2.

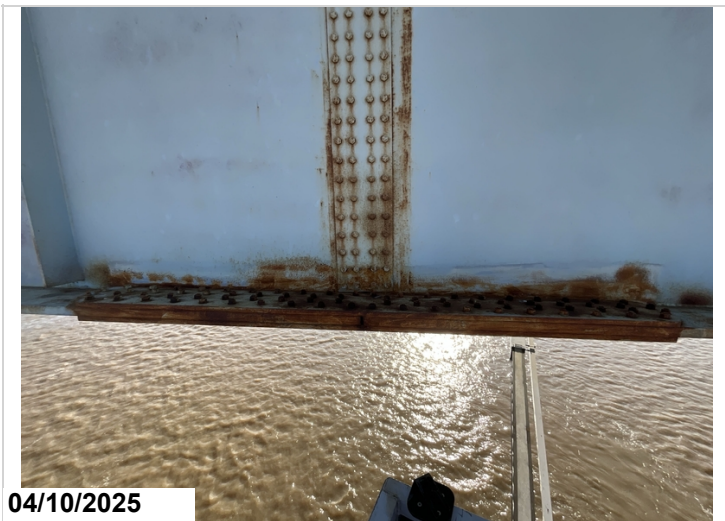
Span 56, girder 1, 1st splice plate connection, left side: active corrosion, 10LF CS2.

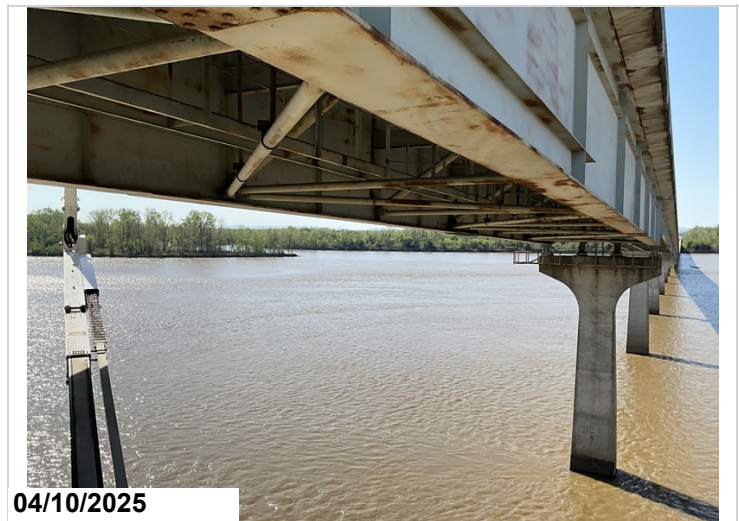
Span 56, typical condition of protective coating.

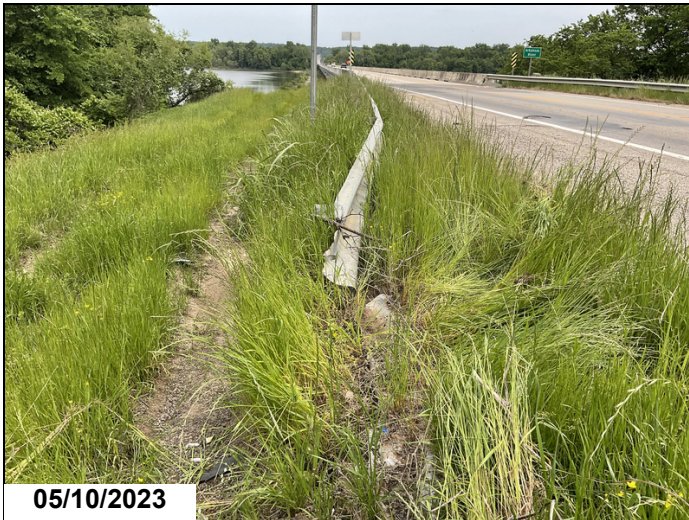
Approach Railing left side beginning of structure has collision damage first 25'. Railing is torn apart and detached in this area with missing, and bent post.

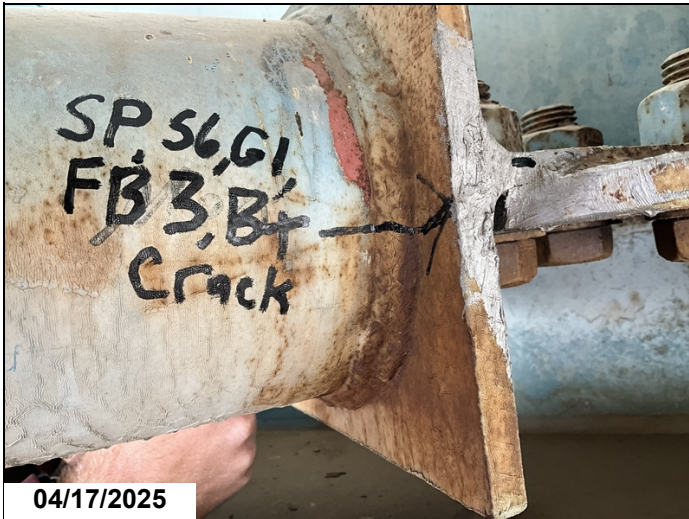
Crack in diagonal bracing connection plate.

Span 56, floorbeam 3, girder 1, bottom, back side,
diagonal connection plate: crack on both sides of plate,
cracks are 1/4", CS3.

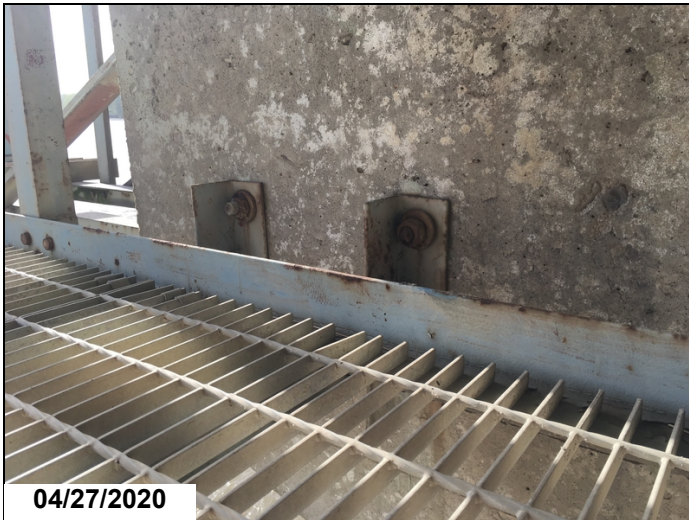
Span 52, Girder 4: Two Inspection handrail brackets are loose. The bolts are missing.

Inspectors - coordinate with Sam during next inspection to have a couple of maintenance guys on site to show and repair the location. KAW 5/24/2024

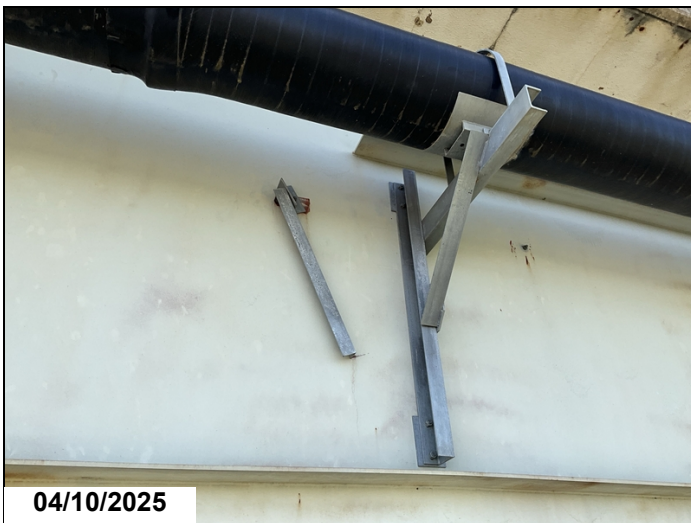
04/10/2025
Span 58, girder 2, floorbeam 32, right side, utility
connection: diagonal bracing on water pipe is no longer
connected

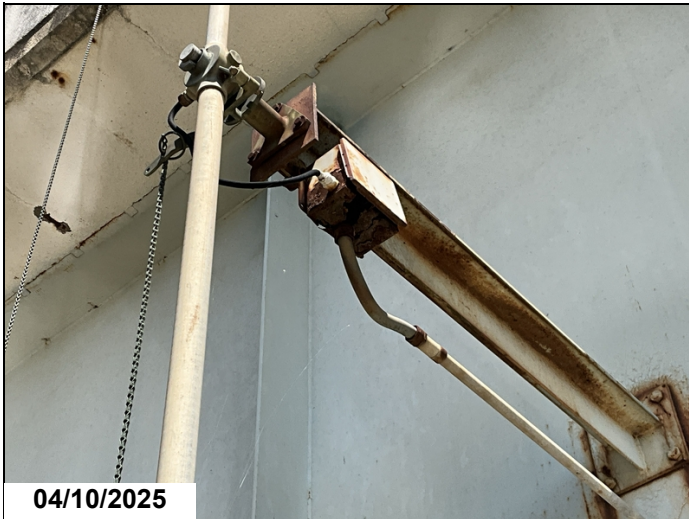
Span 57, left side, 3rd nav light: electrical junction box is completely rusted through, typical at all other nav lights

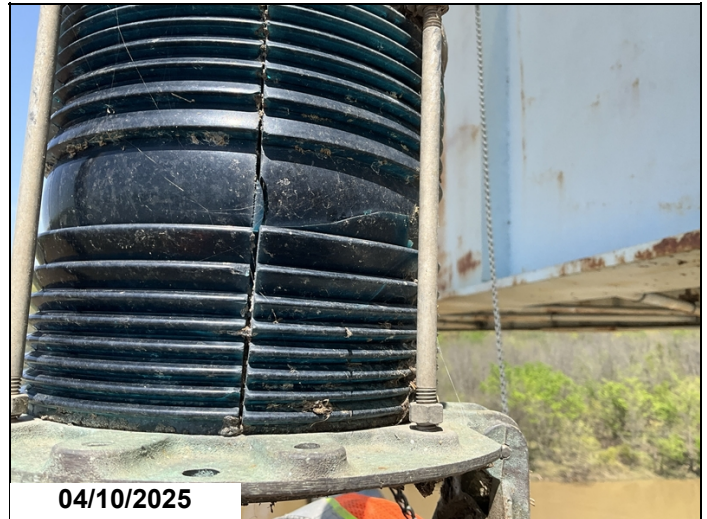
Span 57, left blue navigation light has broken fixture which allows moisture inside .
