## Bridge 05653 Inspection Report

**State Highway 109 over Russ Creek-Logan Co.**

**Location: 3.26 MI S JOHNSON CO LINE**

**Team Lead: Bob McEntyre Inspection Date: 08/09/2022**

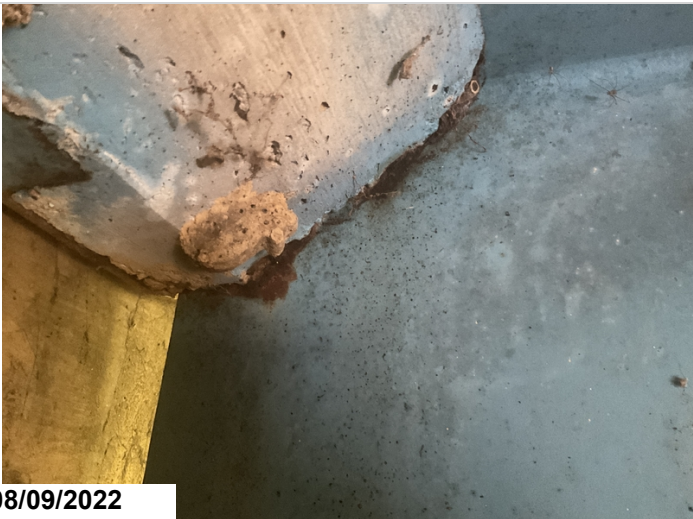
(107) -The paint system is beginning to chalk. -Light corrosion on the end of beam # 4 at bent # 2. -The exterior web of beam # 4 has two areas with freckled rust that appear to be from shotgun pellet impacts. -No visible cracks apparent during this inspection.							
215	Reinforced Concrete Abutment	LF	80	76	4	0	0
1130	Cracking (RC and Other)	LF	4	0	4	0	0

Abutment 2, beam 4-Corrosion at expansion dam

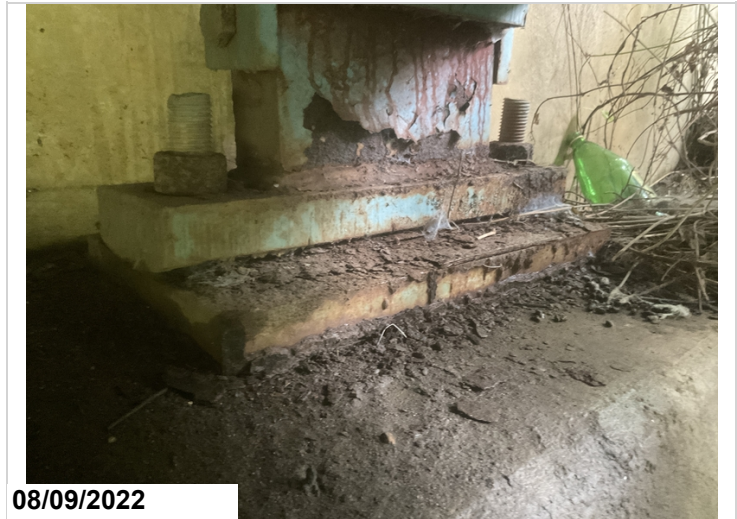
(311) -Abutment # 2 bearings have red rust leaching from the tops of the rockers due to apparent fretting. -Bearings have a failing paint system with pack rust forming between the rockers and masonry plates. Bearings # 3 and 4 are the most extreme with heavy corrosion pack rust between rockers and masonry plates.							
313	Fixed Bearing	EA	4	0	0	4	0
1000	Corrosion	EA	4	0	0	4	0
515	Steel Protective Coating	SF	4	0	0	2	2
3440	Effectiveness (Steel Protective Coatings)	SF	4	0	0	2	2

Abutment 2, bearing 4-Corrosion with pack rust between rocker and masonry plate.

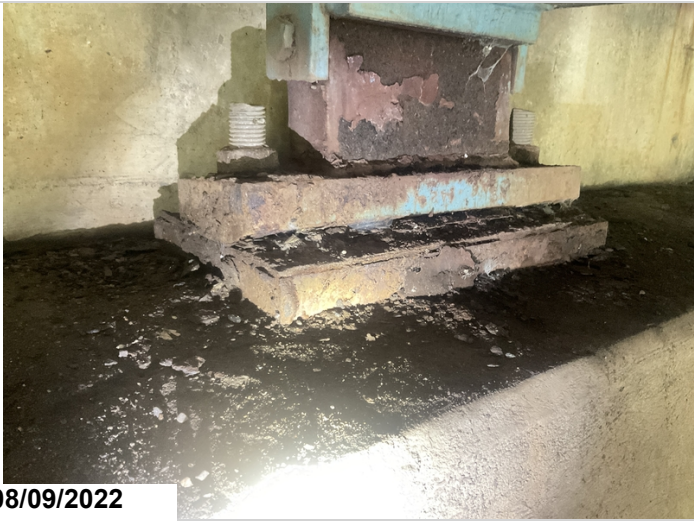
Abutment 2, bearing 3-Corrosion with pack rust between rocker and masonry plate.

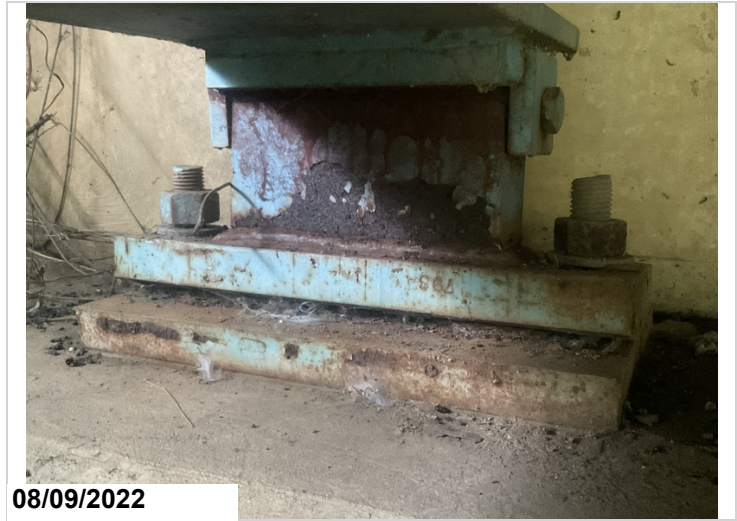
Abutment 2, bearing 1-Corrosion

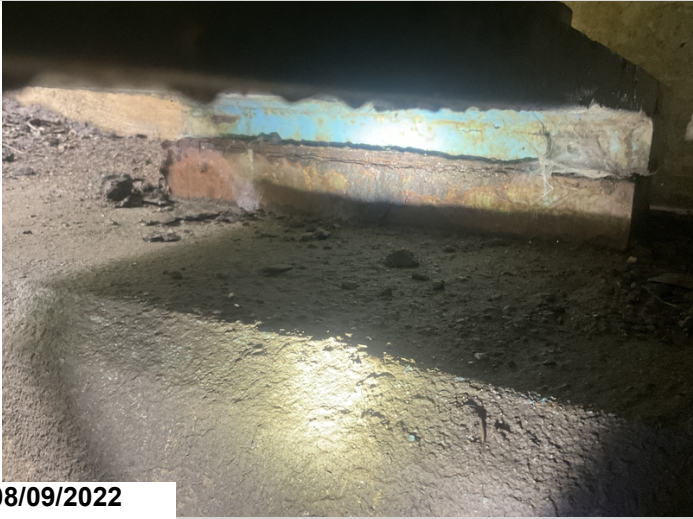
Abutment 1, bearing 4-Corrosion

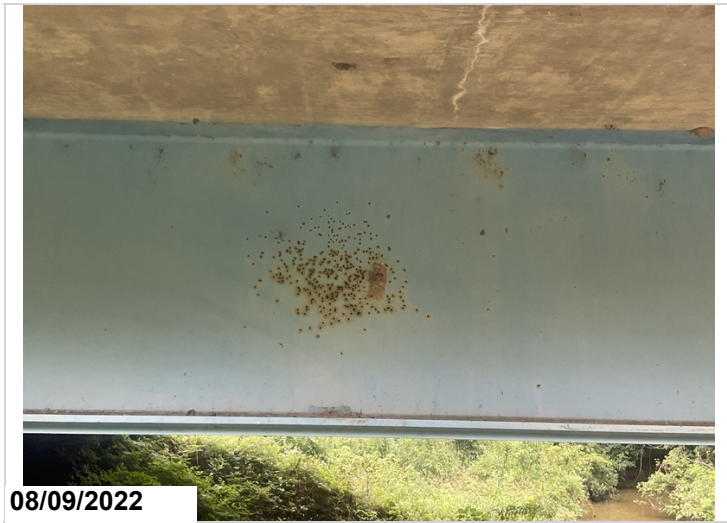
Beam 4 exterior side-Apparent impact from shotgun

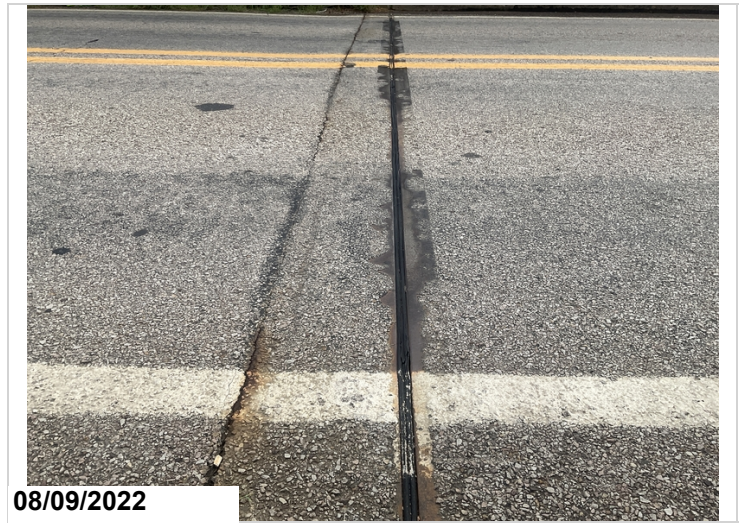
(302) -The compression joint seals have rips and tears and appear to leak water. -The joint assembly anchorage appears to be sound during this inspection.							
311	Movable Bearing	EA	4	0	1	3	0

Abutment 2 expansion joint

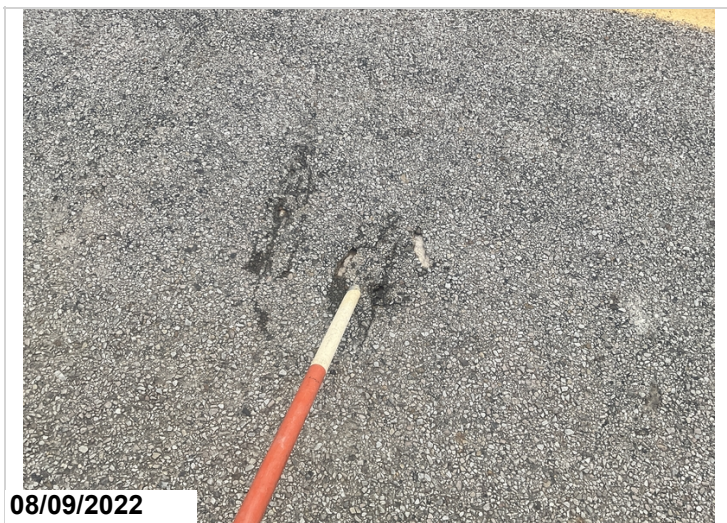
Chip and seal wearing surface has areas of scrape marks and gouges in the left lane.

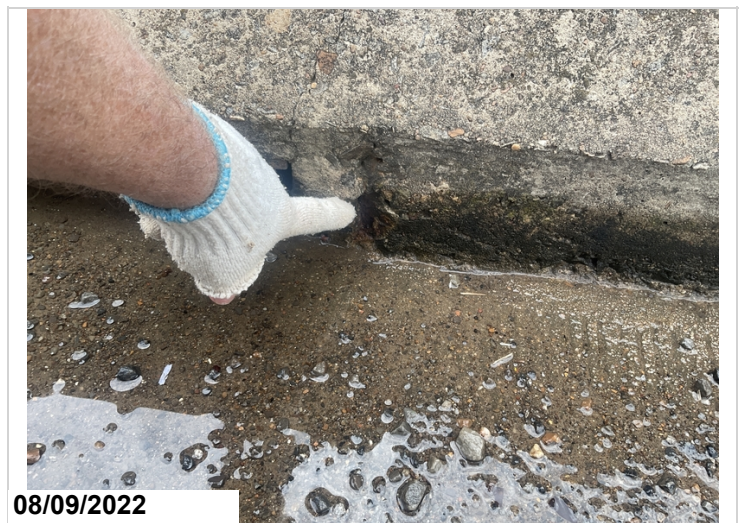
(331) -Baseball sized spalls with exposed reinforcing steel in the base of the parapet walls. Exposed reinforcing steel has initial section loss during this inspection.

Right parapet-Shallow spall with exposed reinforcing steel

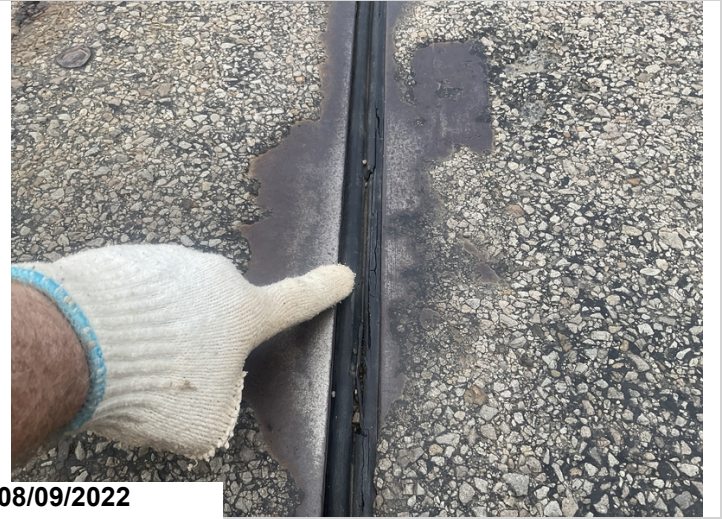
Abutment 1 expansion joint-Cracking with rips

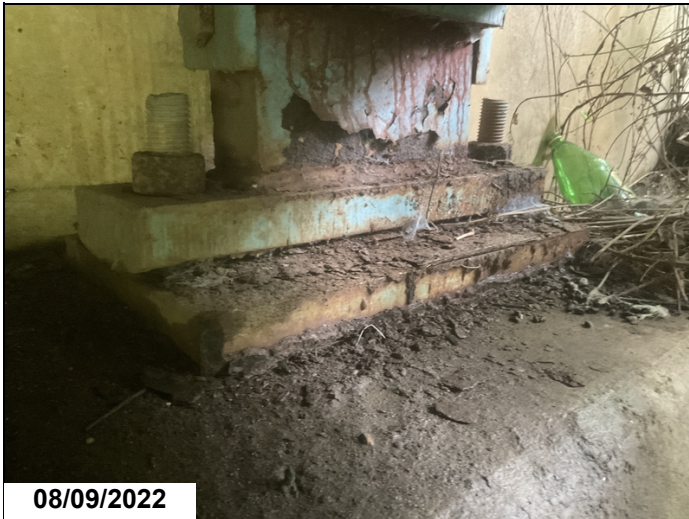
The bearings have a failing paint system with active corrosion. The bearings at abutment # 2 have heavy corrosion with pack rust between the rockers and masonry plates.

Abutment # 2, bearing # 4-Corrosion with pack rust between rocker and masonry plate.

**Type of Work:** Repair (General)

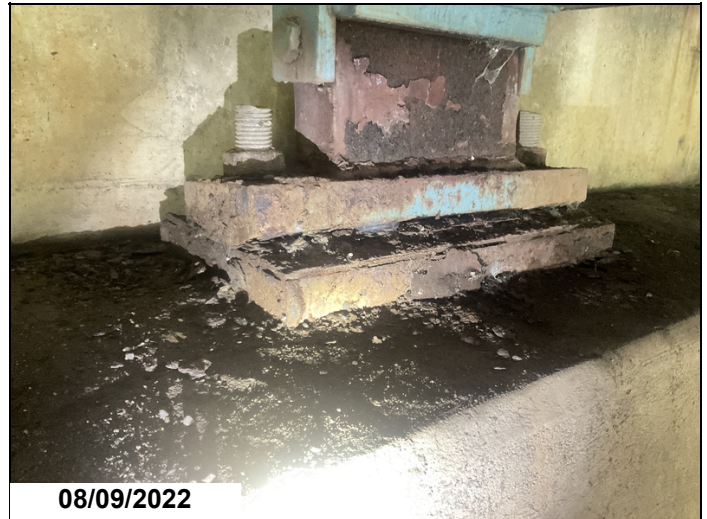
Abutment # 2, bearing # 3-Corrosion with pack rust between rocker and masonry plate.

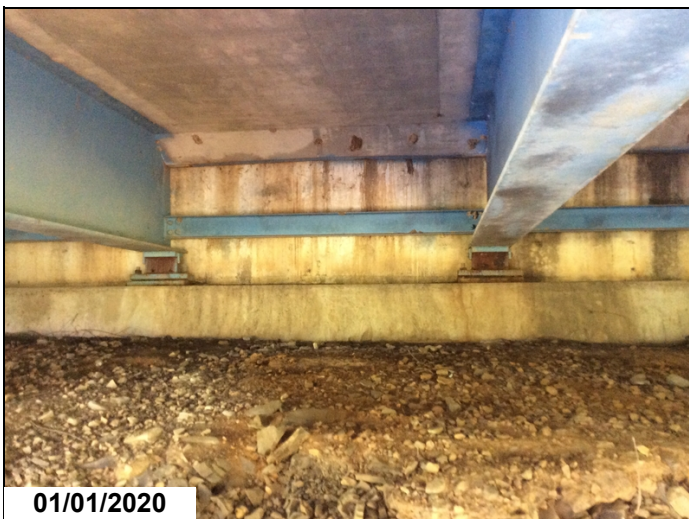
Corrosion on the bearings.

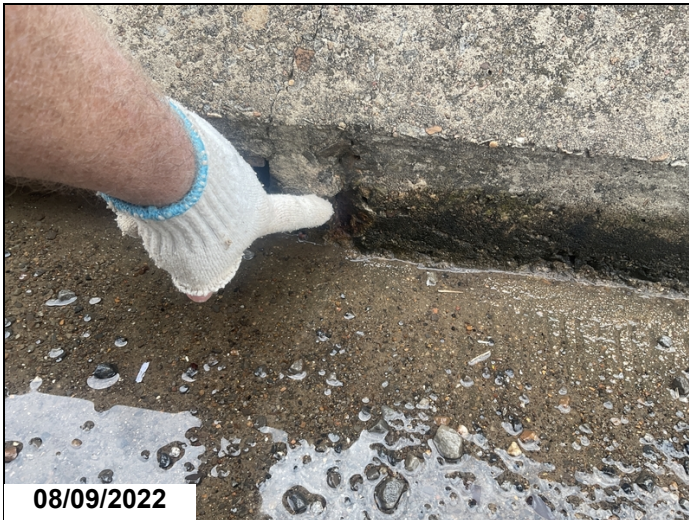
The base of the concrete parapets have areas of shallow spalling with exposed reinforcing steel.

Right parapet-Shallow spall with exposed reinforcing steel.

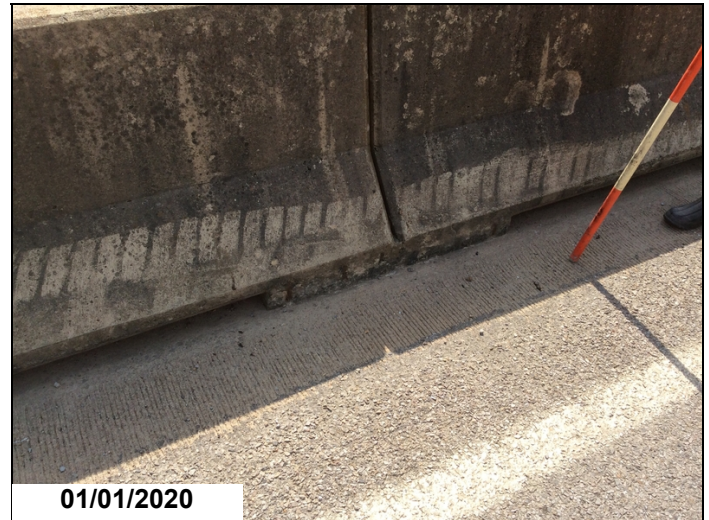
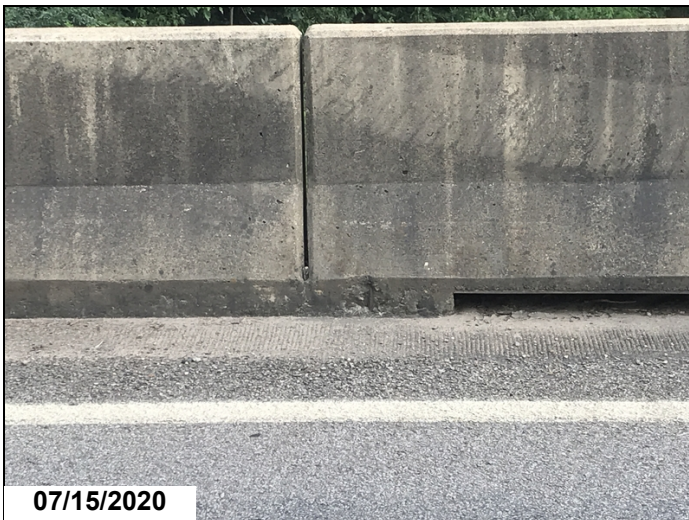
The base of the concrete parapets have areas of shallow spalling with exposed reinforcing steel.

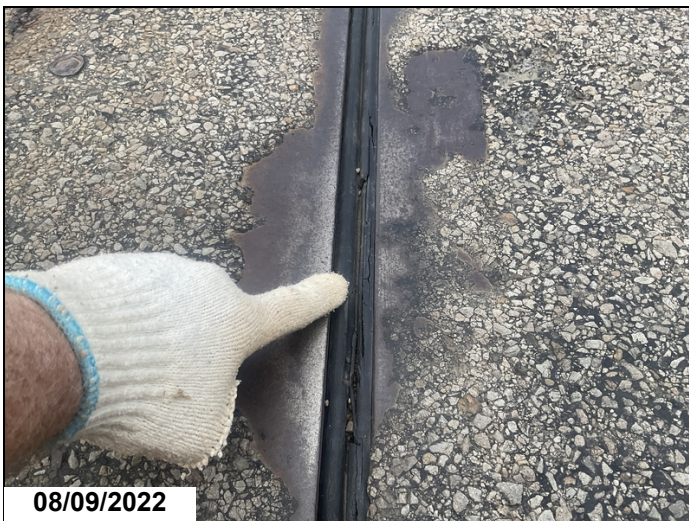
The expansion joint seals are deteriorated with rips / tears allowing water to leak onto the superstructure and substructure.

The expansion joint seals are deteriorated with rips / tears allowing water to leak onto the superstructure and substructure. Abutment # 1 pictured.

Type of Work: Replace (General)

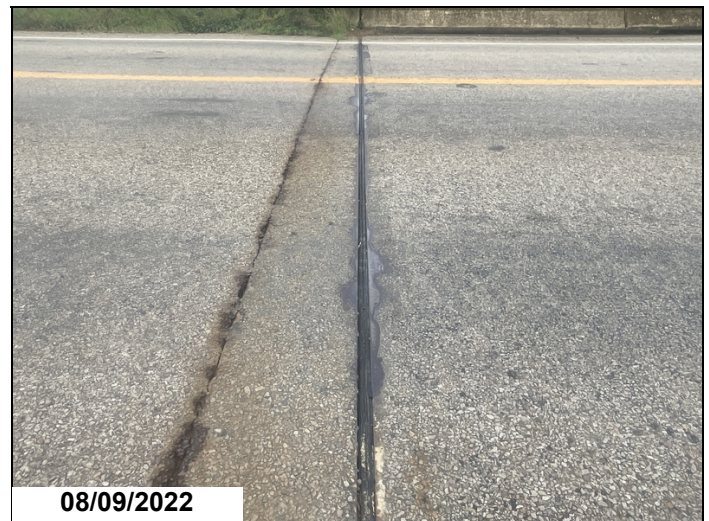
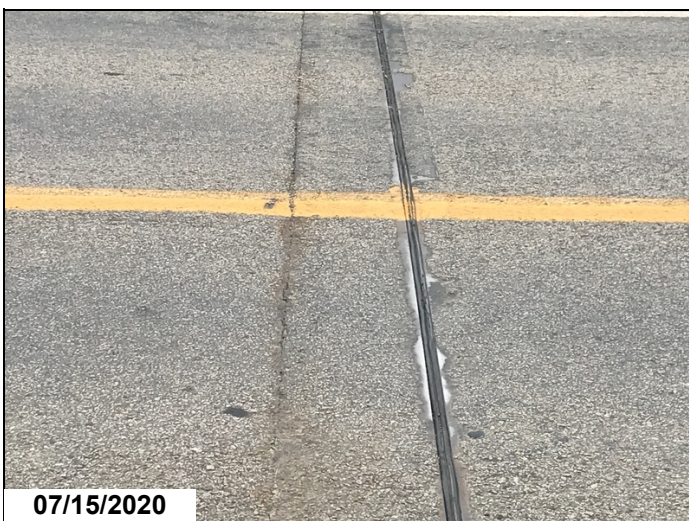
The expansion joint seals are deteriorated with rips / tears allowing water to leak onto the superstructure and substructure.
