Bridge #06058(Routine)
US 62/412 Marion over FALLEN ASH CR
Location: 11.36 MI EAST OF SH 14

Team Lead: Benjamin Smith Inspection Date: March 04, 2020

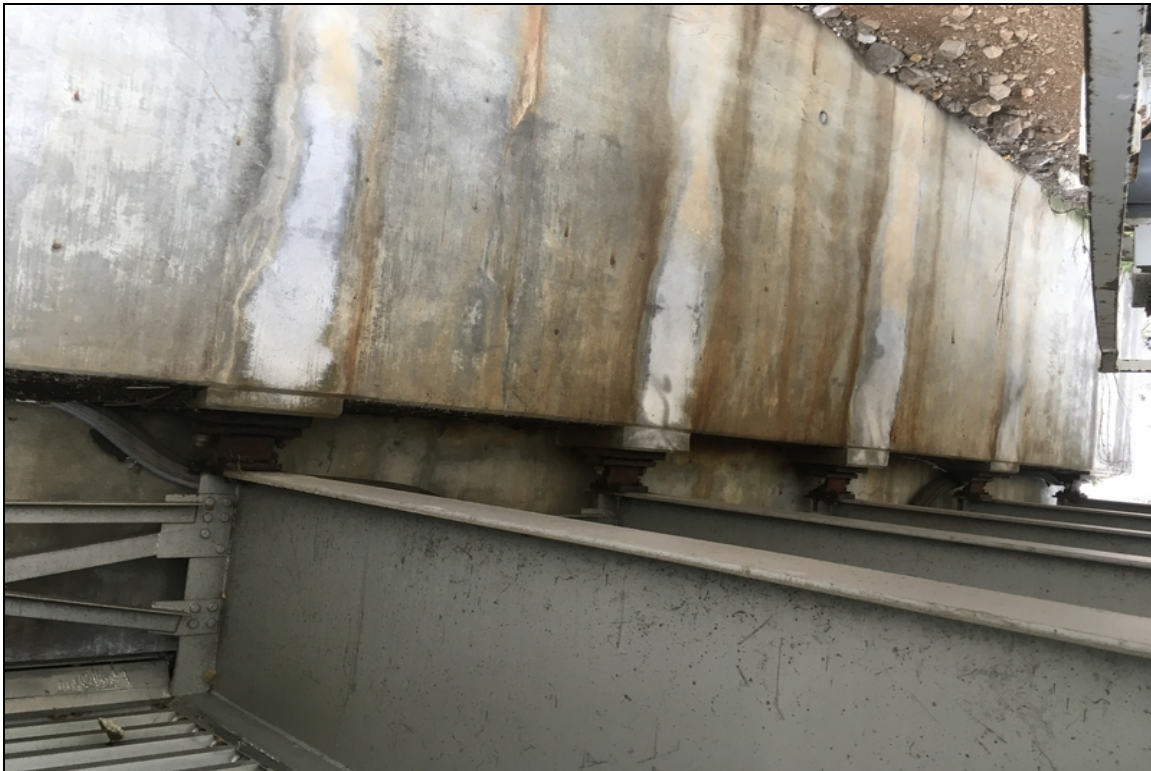
Bearing and joint seal condition at abutment 2.

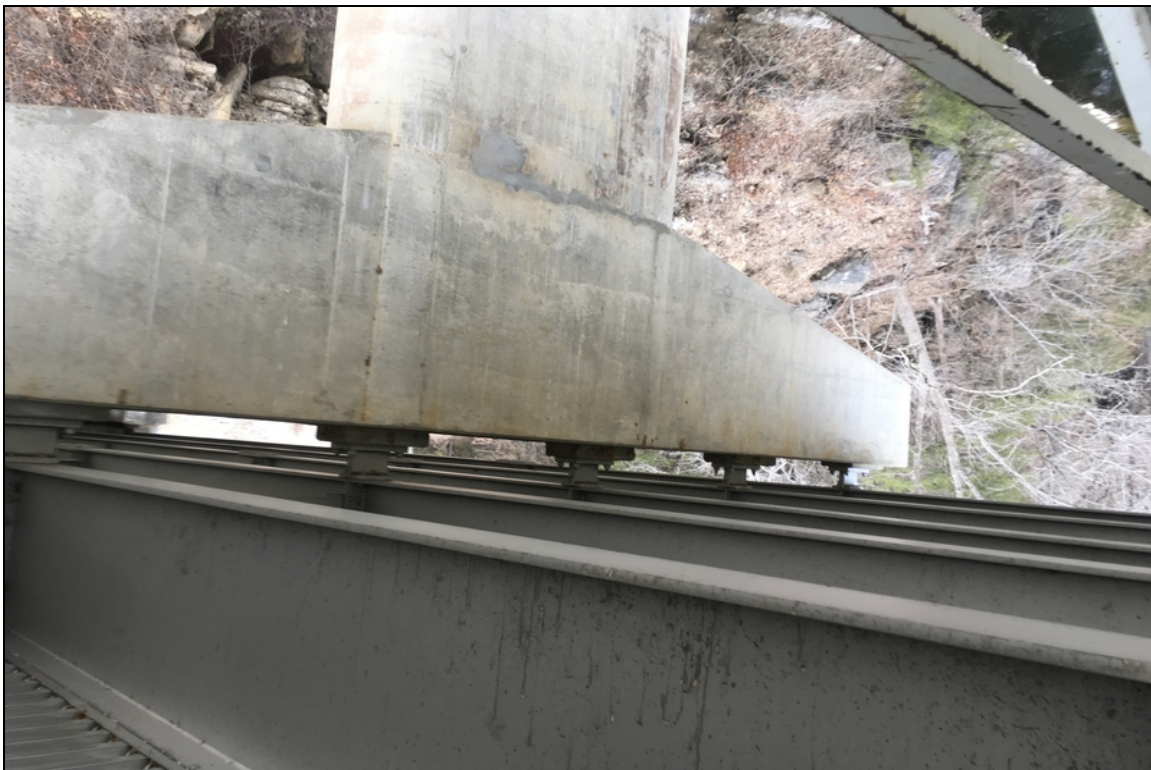
Bearing condition pier 2. Typical.

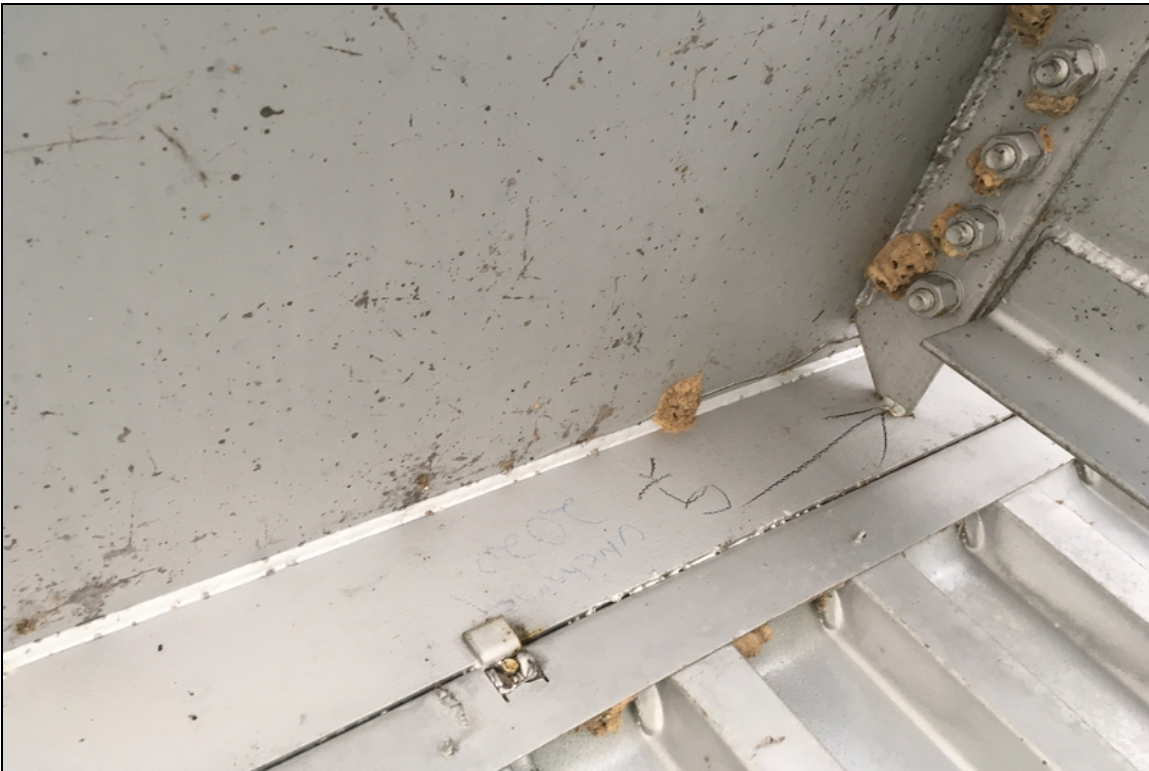
Cracked upper diaphragm weld in bay 5 in span 2 at diaphragm 4 ahead of pier 1. Unchanged since last inspection.

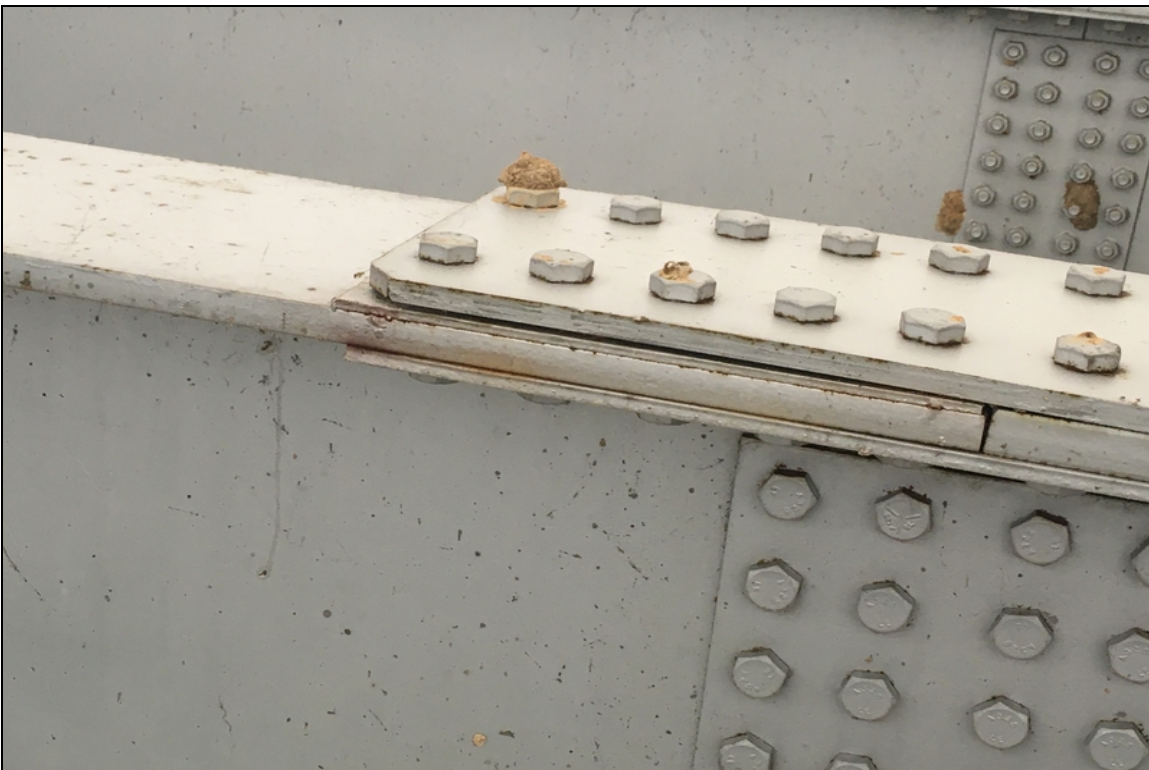
Cracked tack welds on beam 3 in span 2 at the first splice panel.

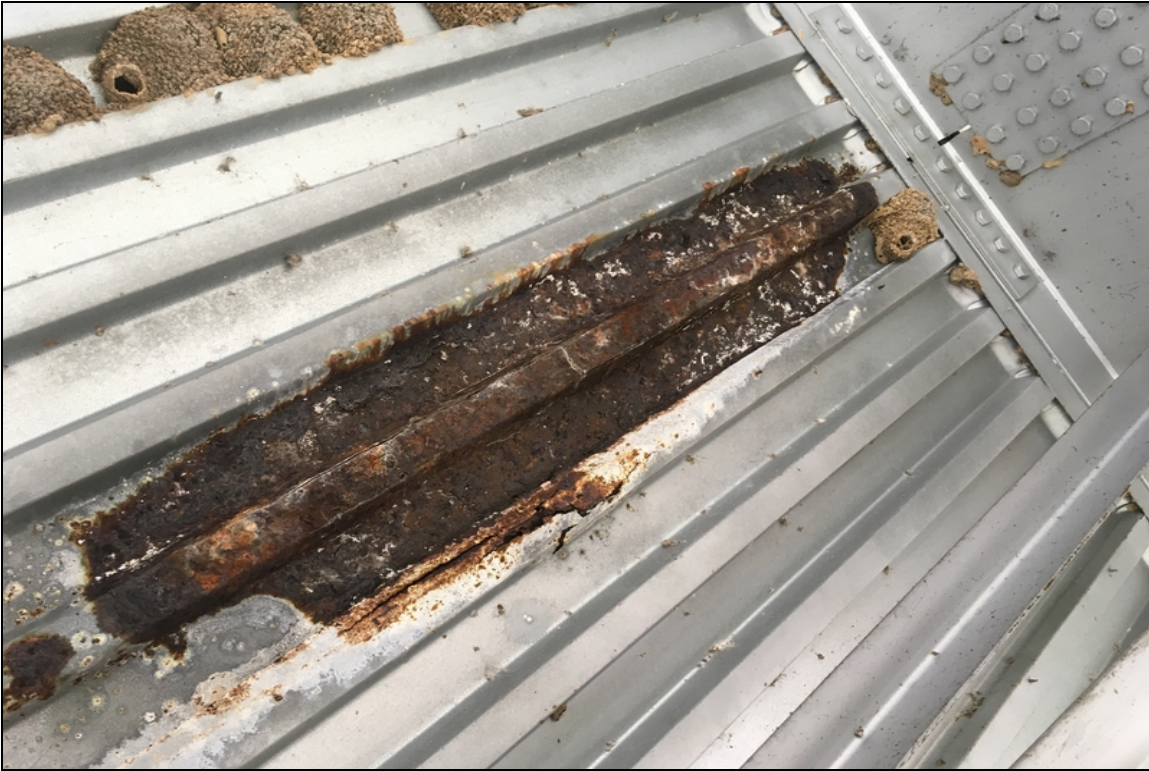
Sip corrosion in bay 5 of span 2.

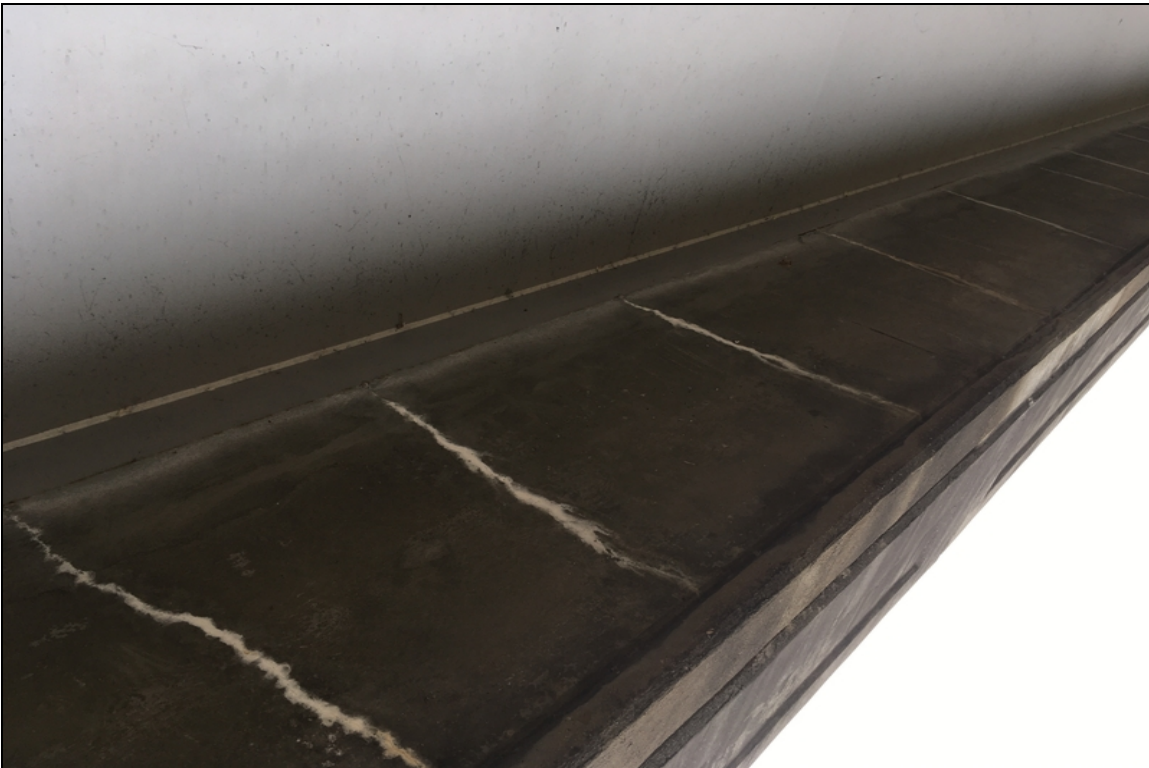
Efflorescence in the overhangs

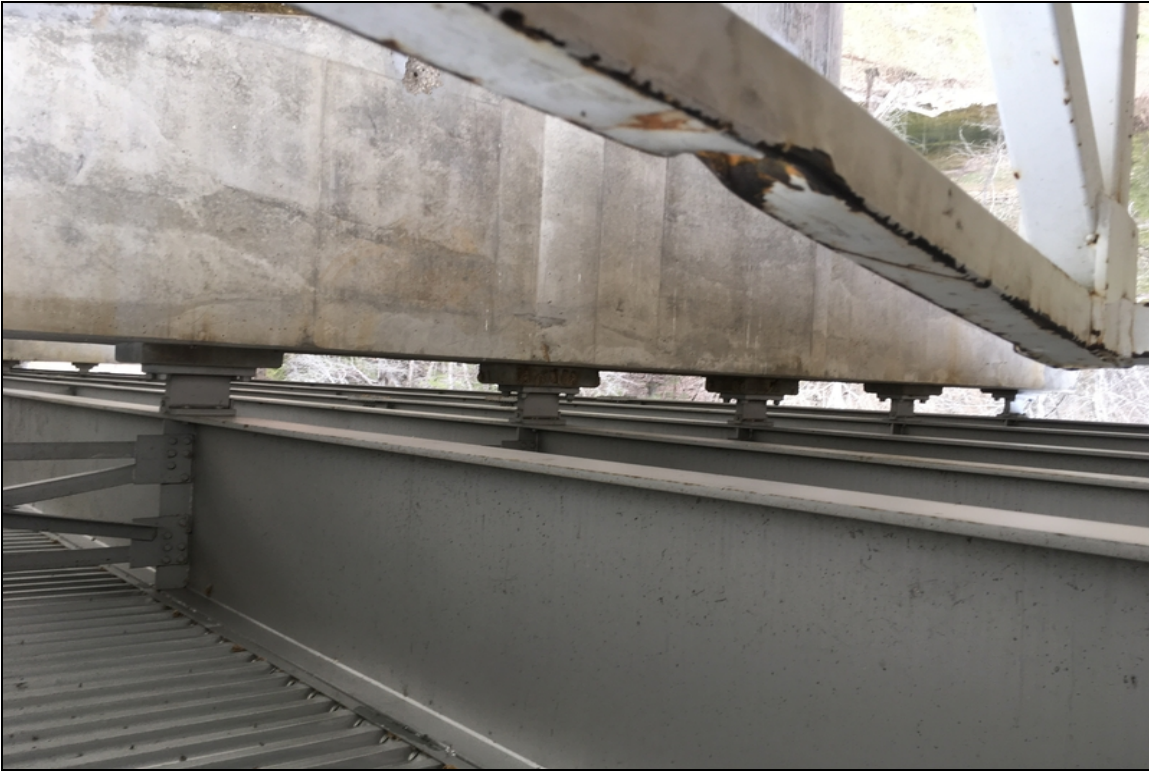
Bearing condition at pier 1.

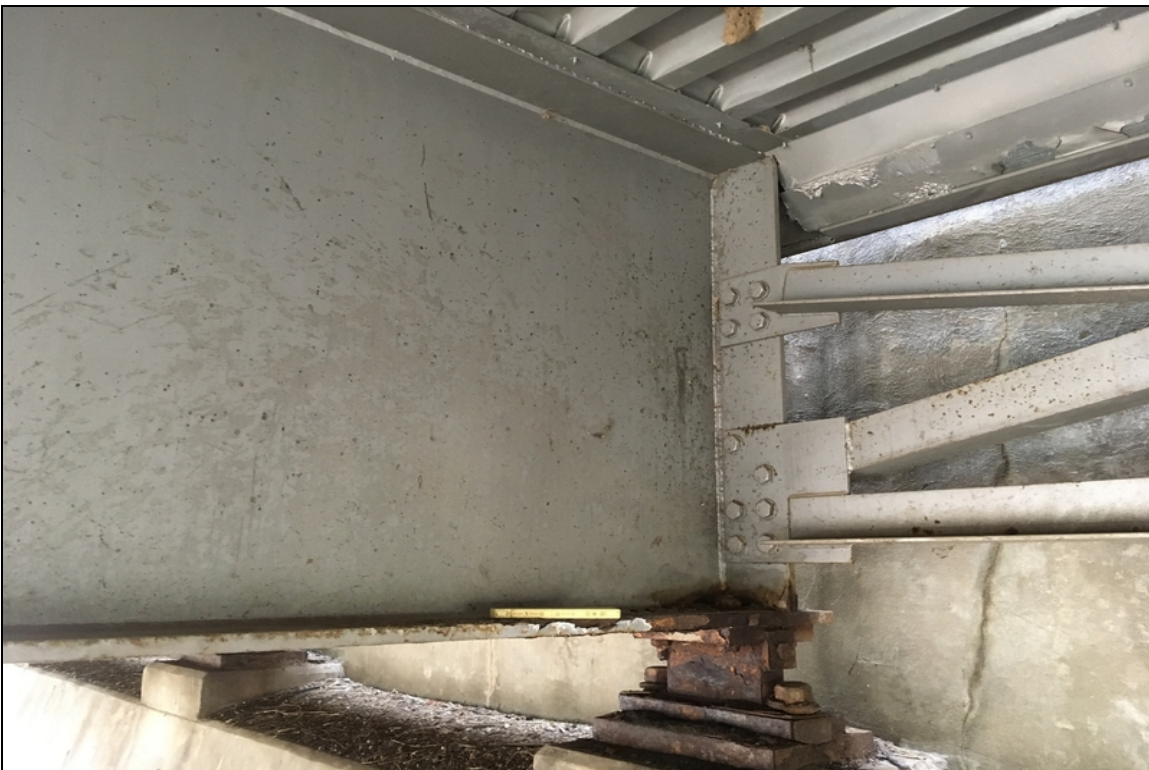
Typical beam end corrosion at abutment 1 from missing joint seal.

The beam ends also have varying degrees of corrosion at abutments #1,2.

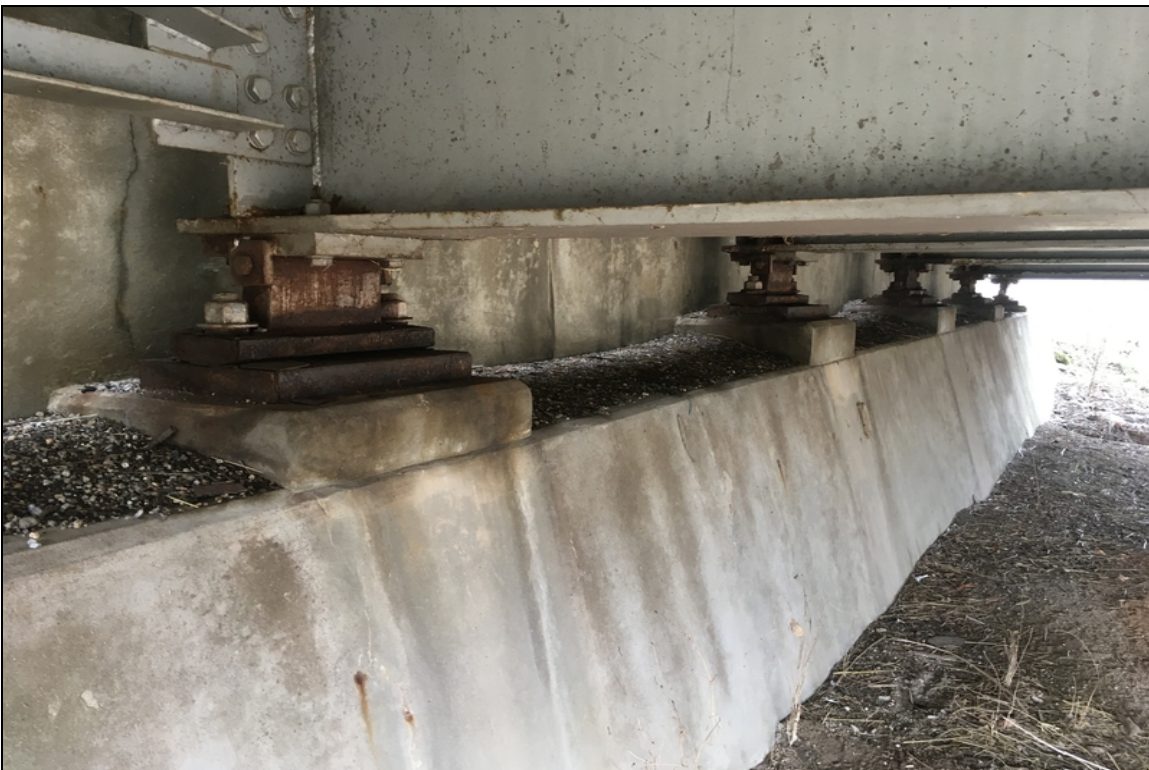
Bearing condition at abutment 1.

Abutment #1 moveable bearings- bearings #2-5 have corrosion with flaking rust and minor section loss, bearings #1 and #6 have a light rust coating due to free flow of water at the joint seals and debris build up. Bearing #6 at abutment #1 has the outer anchor bolt missing due to corrosion.

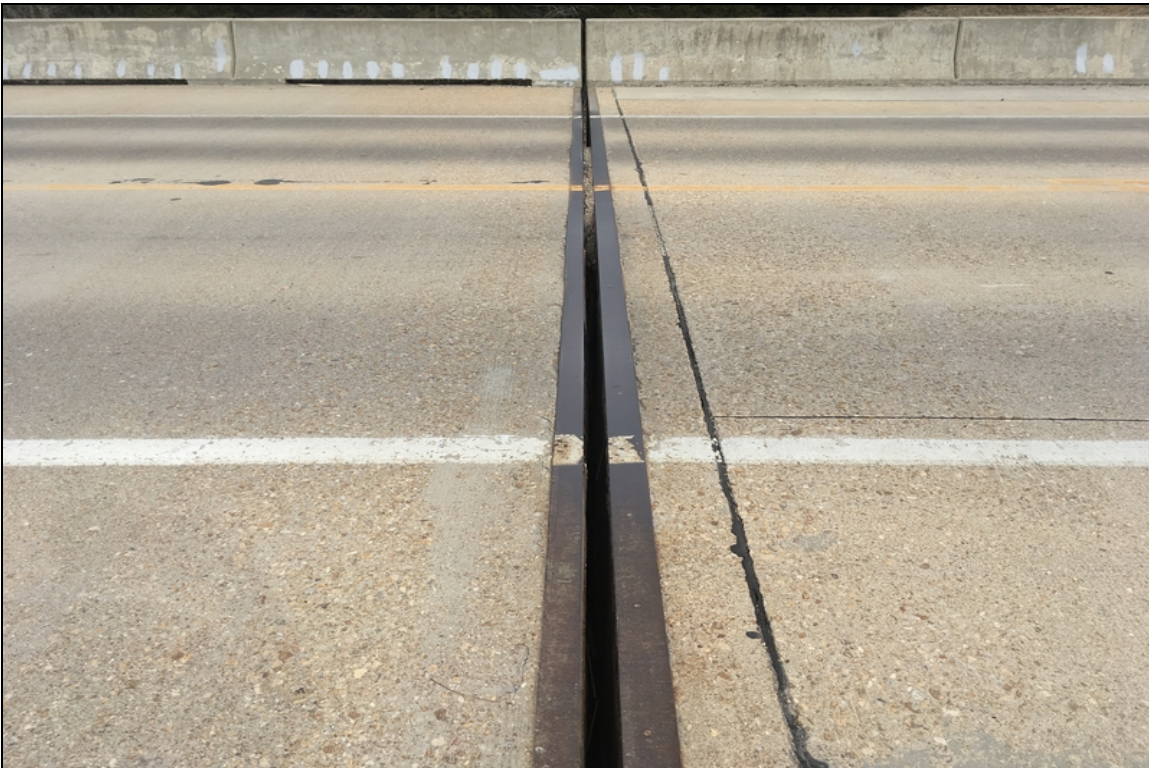
Compression joint seal is completely missing at abutment 2 except for 10' at the center line that is debris impacted.

Abutment #2- 33' of the compression joint seal is unattached and laying on the bridge seat. 10' of the seal at the centerline is in place, but has debris impaction.

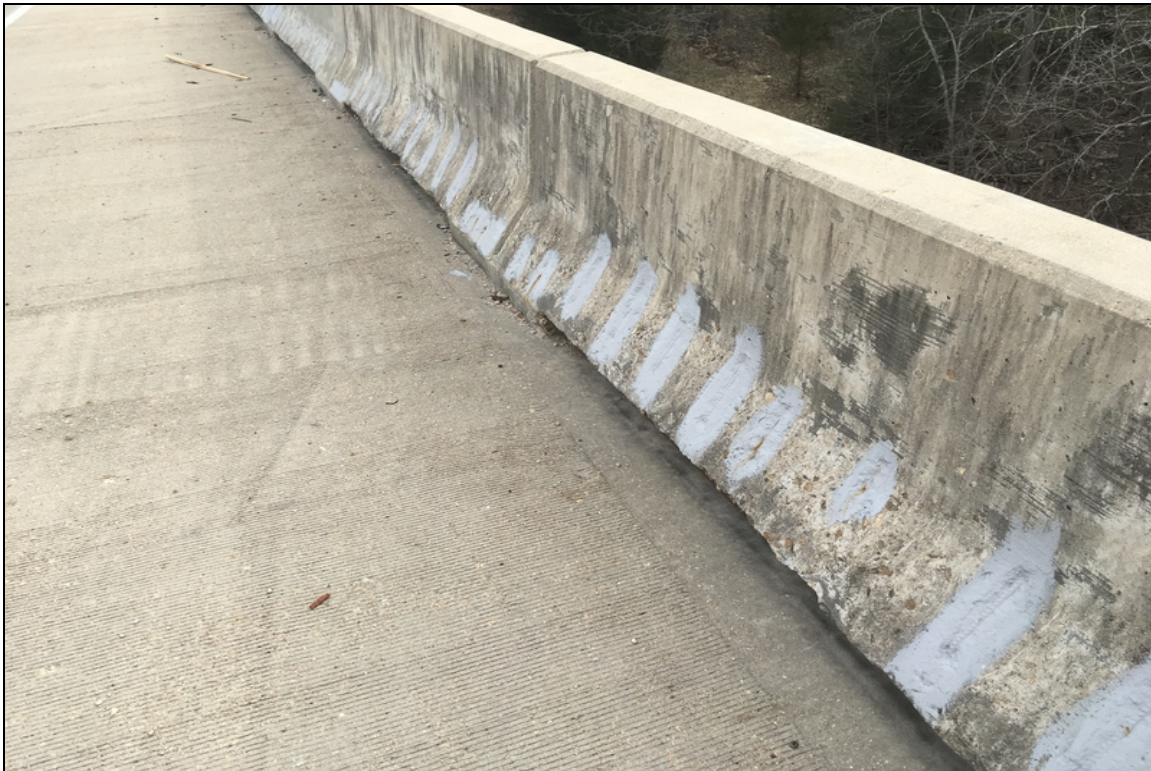
Left side bridge parapet wall has 157' of exposed rebar that has been painted over. It has 18' of hairline vertical cracking at random locations.

View of exposed rebar that has been painted on the parapet wall. Typical

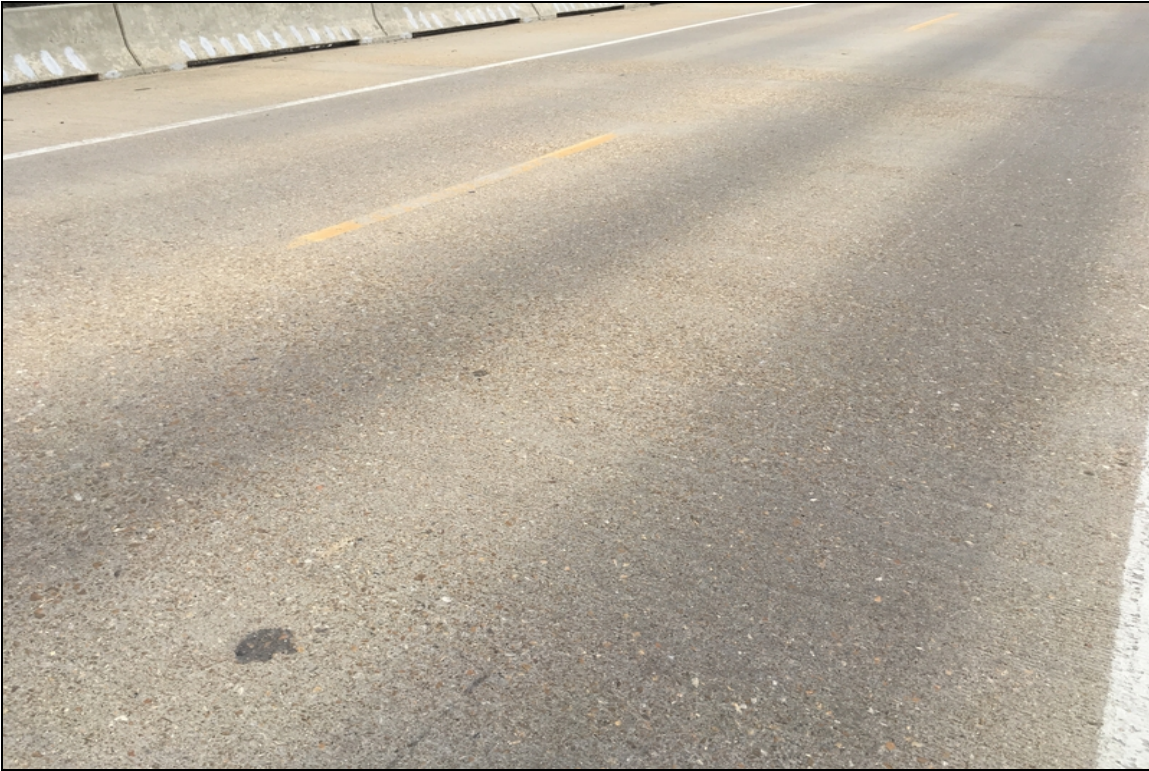
Typical view of driving surface.

The driving surface of the deck has sealable transverse and longitudinal cracks in all spans.

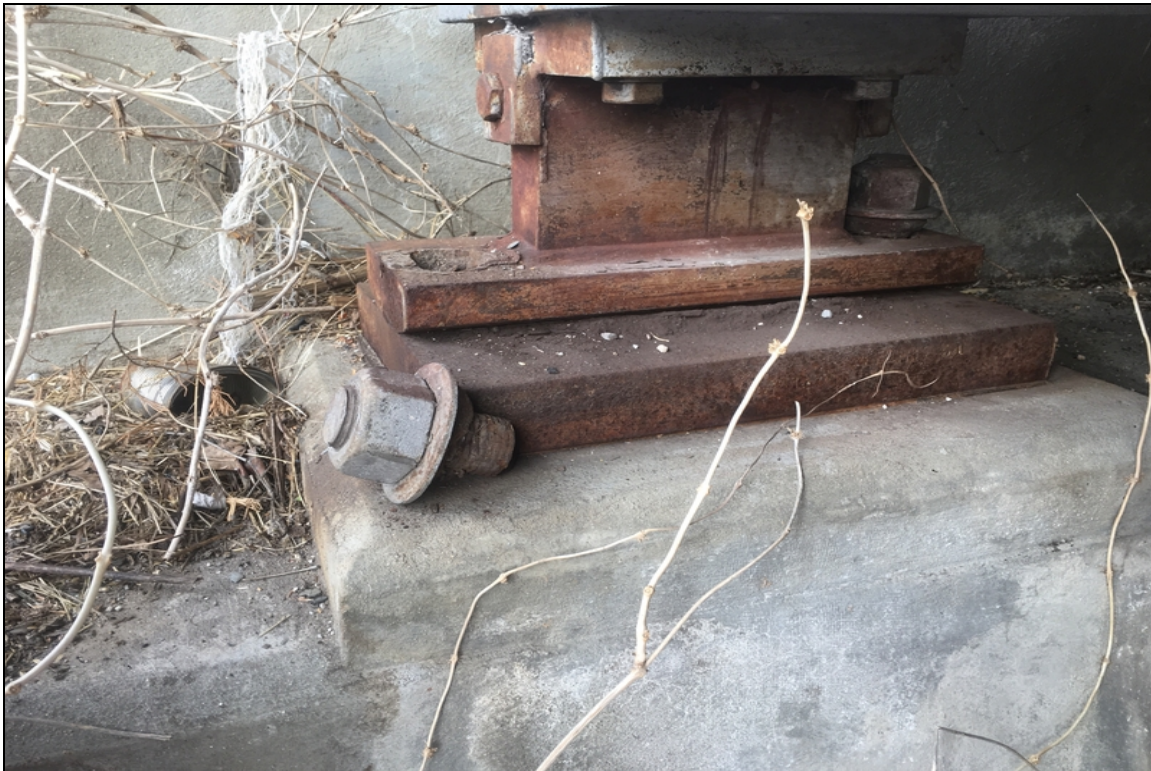
Abutment #1 beam #6 anchor bolt broken.

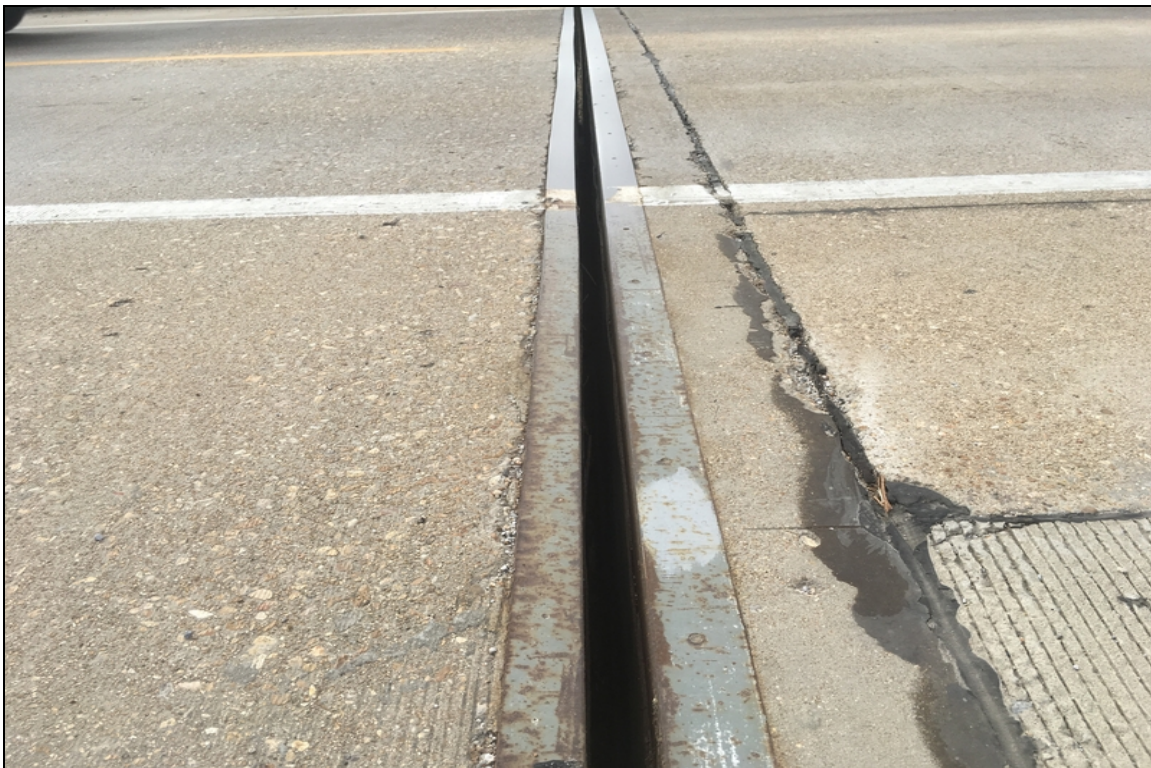
Abutment #1 compression joint seal condition.

Abutment #1- The compression joint seal is missing completely.

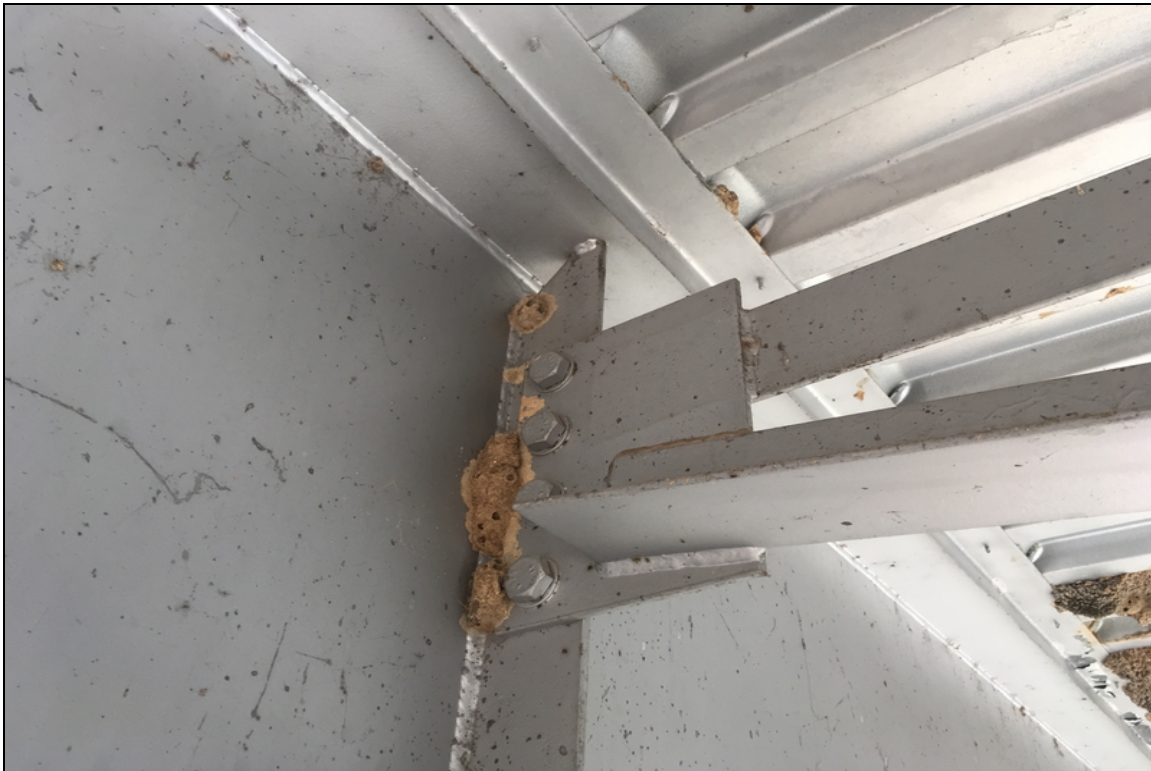
Tack Weld detail at the top of the diaphragm connections. Typical of all diaphragm connections at all locations. Only the #2,3 diaphragms are welded at the top in span #1.

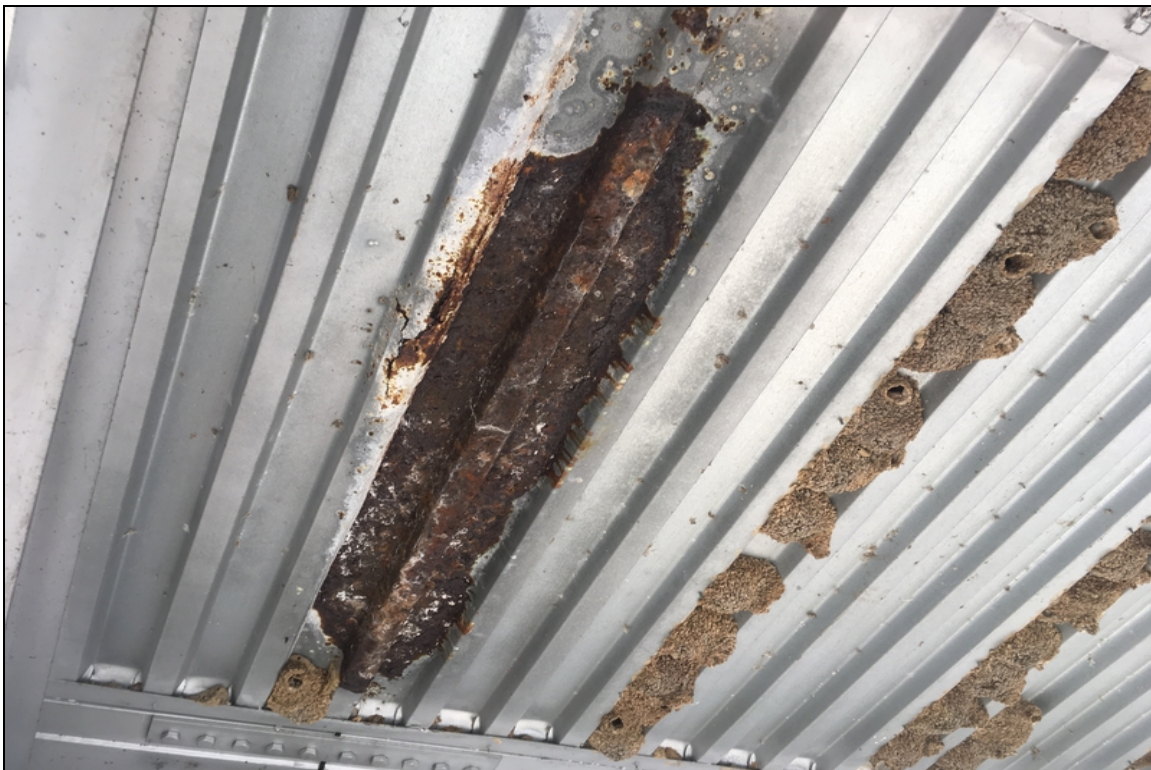
Sip corrosion in span #2 bay #5 over the first field splice area.

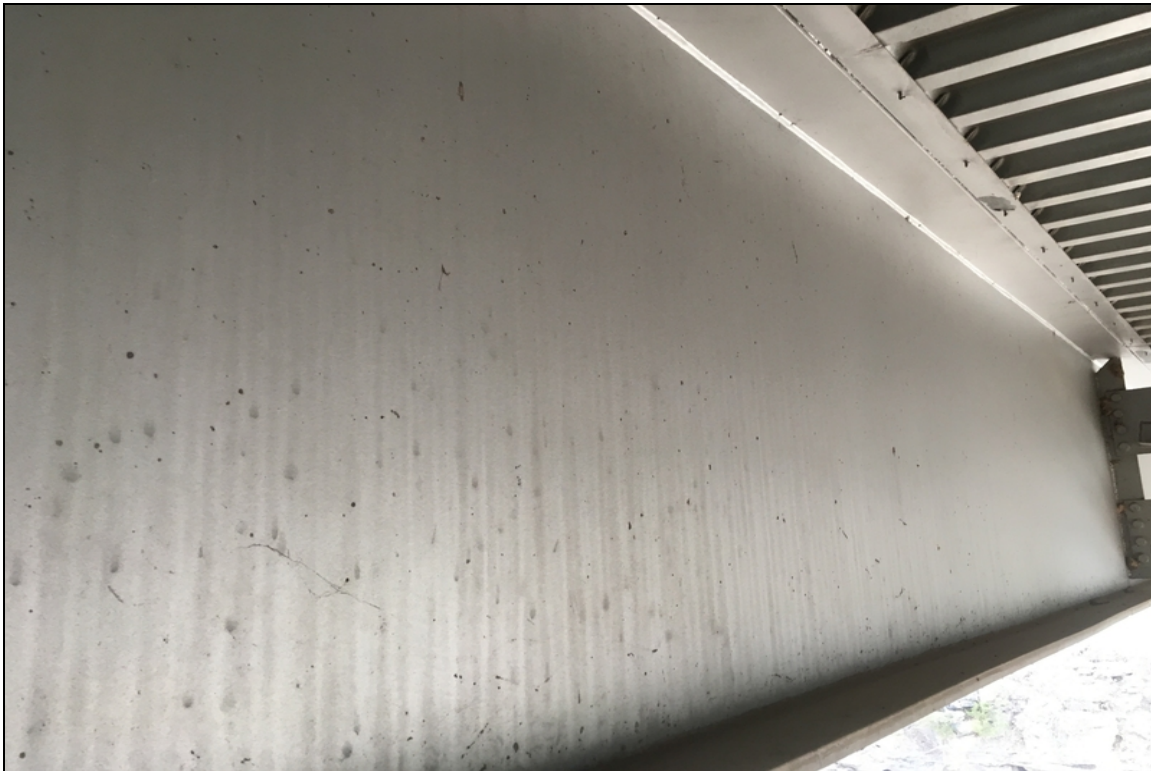
Typical paint condition. Loss of gloss with no chalking.

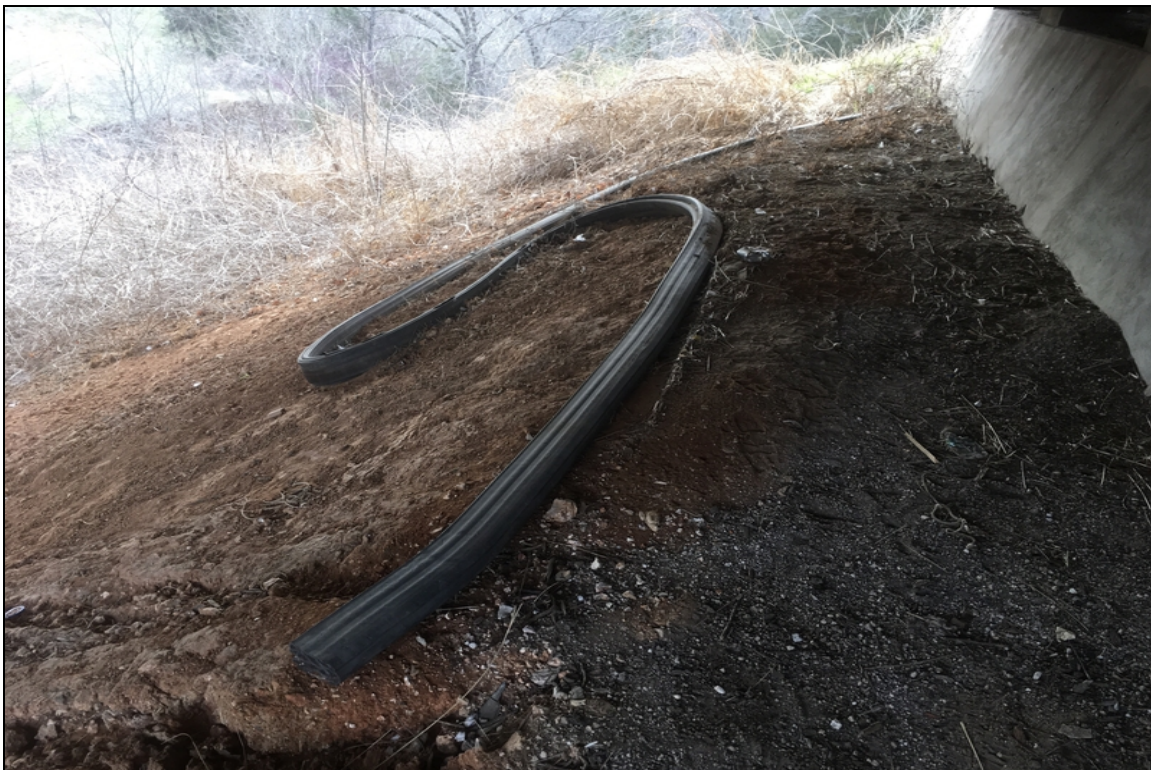
(302)							
Abutment #1 compression joint seal- the joint seal is completely missing at abutment #1 and is laying on the abutment embankment. The armoring plate has areas of pack rust on the vertical face.							
Abutment #2 compression joint seal- 33' of the seal is unattached and laying on the bridge seat. 14' of the seal at the centerline is in place, but has debris impaction. The armoring plate has areas of pack rust on the vertical face.							
311	Movable Bearing	EA	12	0	2	10	0
1000	Corrosion	EA	12	0	2	10	0

Compression joint seal on the abutment #1 embankment.

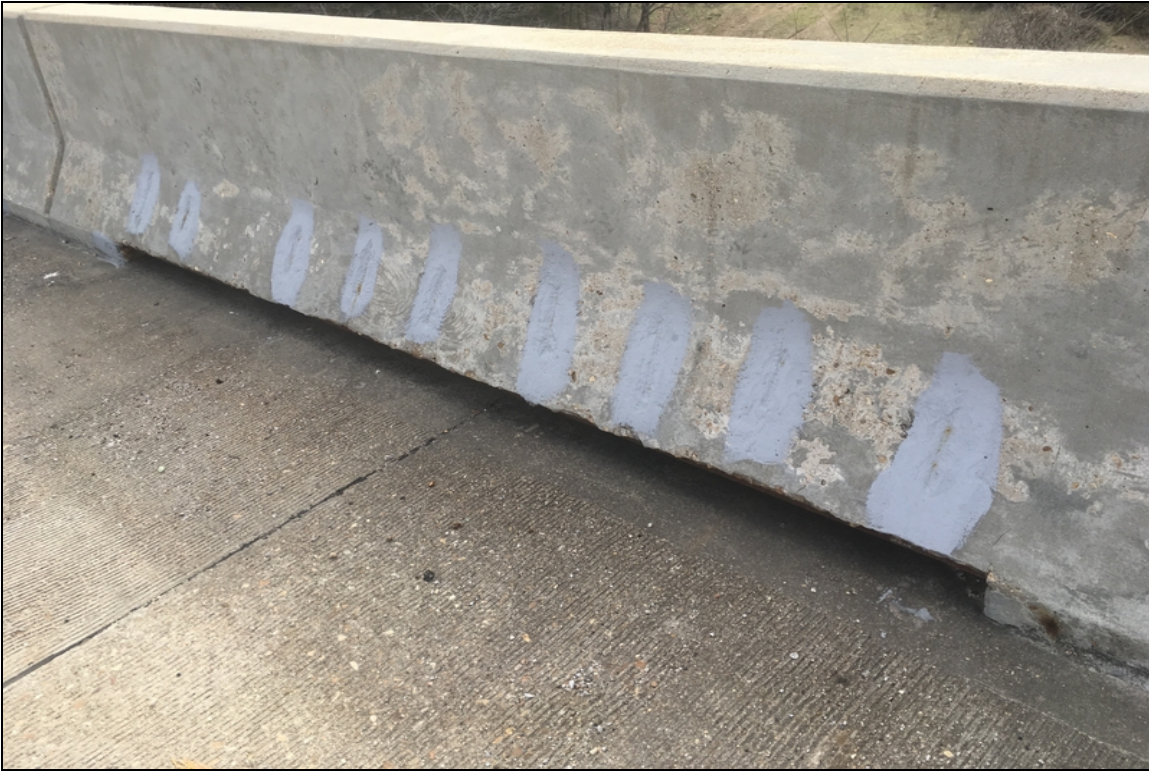
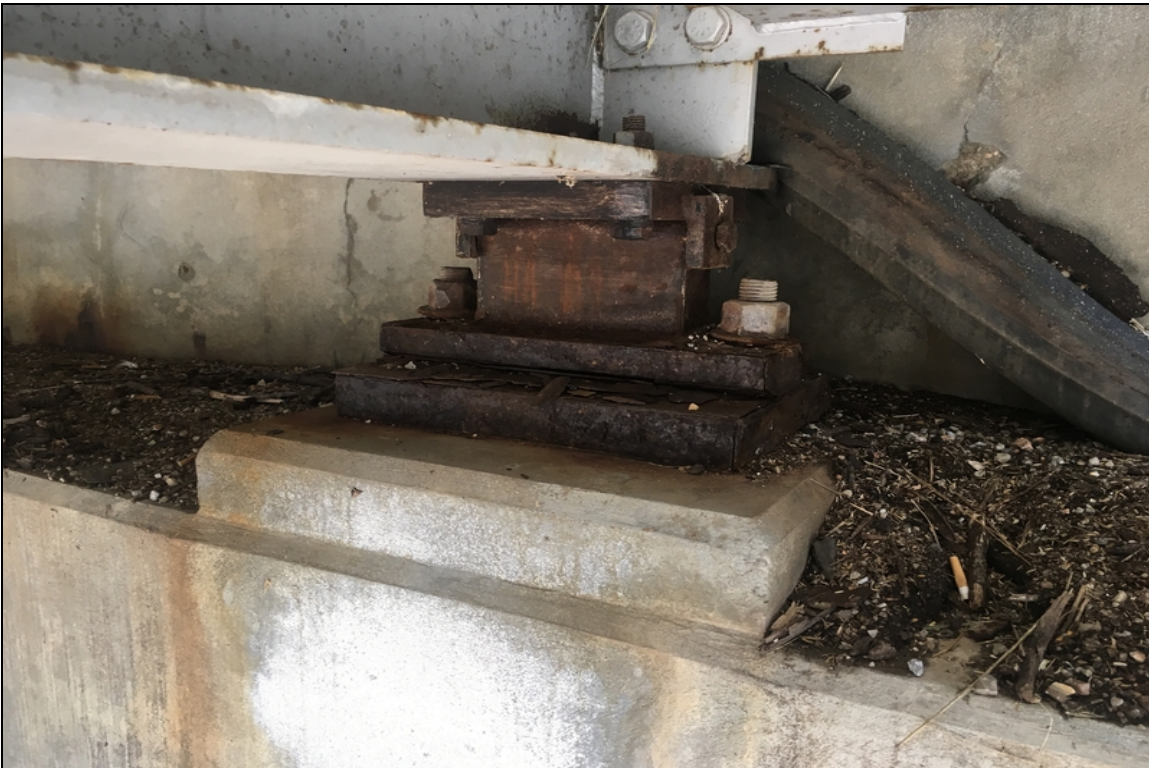
Moveable bearing condition at abutment #2. Typical of all 6 bearings.

Abutment #2 moveable bearings- all 6 bearings have corrosion with flaking rust and minor section loss due to leaking joint seals and debris build up.

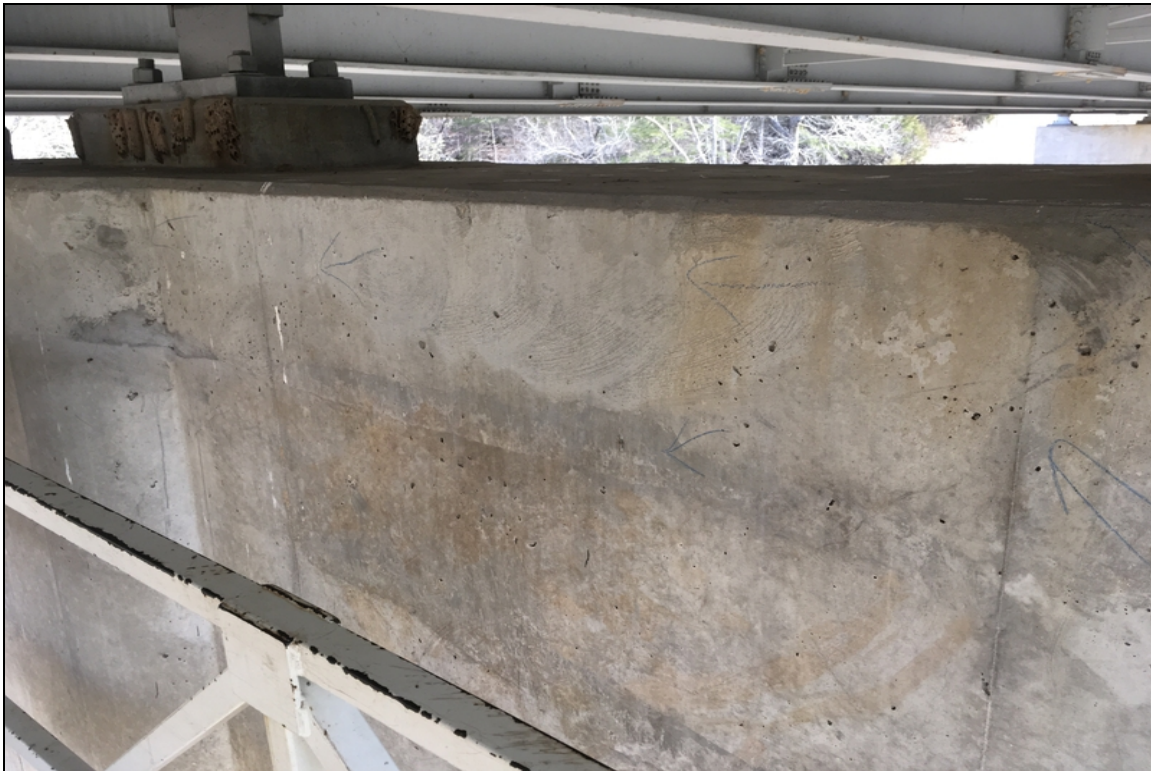
(234)							
Pier cap #1- has 15 hairline vertical cracks that extend down from the top edge of the cap. The cap has a shallow spall on the right side of the pier cap on the span #1 side.							
Pier cap #2- has 17 hairline vertical cracks that extend down from the top edge of the cap.							
302	Compression Joint Seal	LF	94	0	0	10	84
2310	Leakage	LF	84	0	0	0	84
2350	Debris Impaction	LF	10	0	0	10	0

Typical hairline cracking in the pier caps.

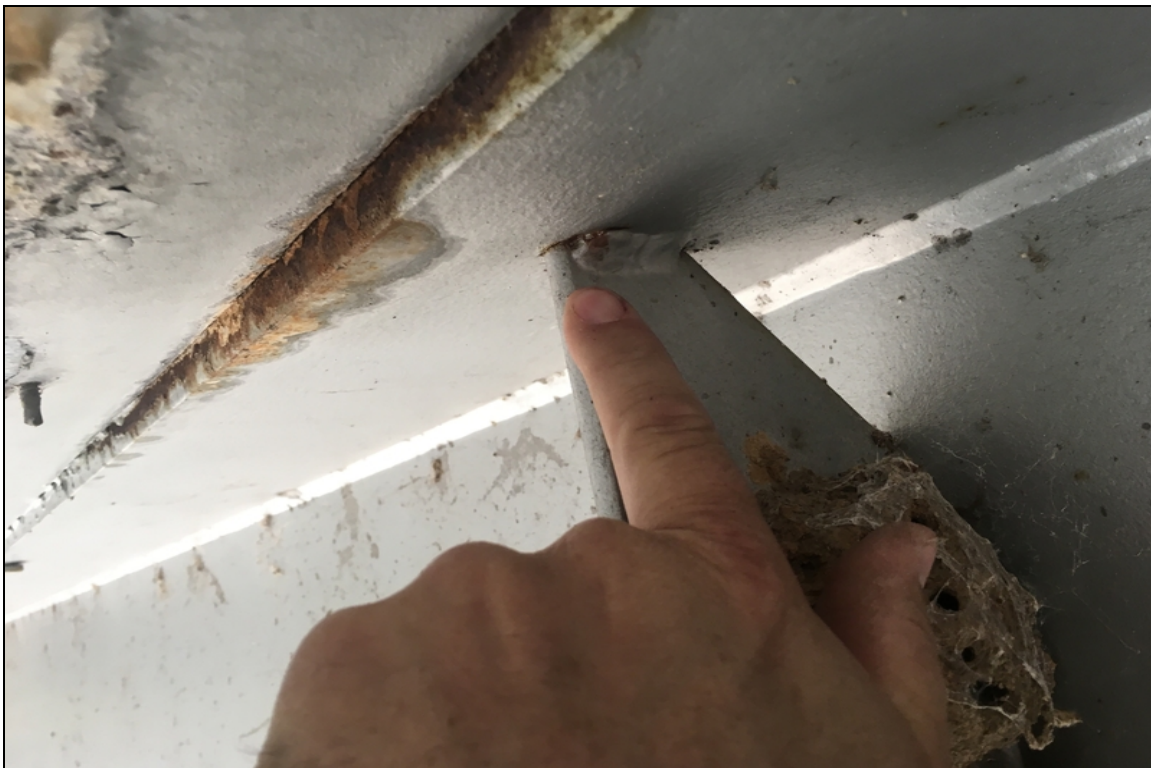
Cracked tack weld at the top of the #3 diaphragm connection in span #1 bay #5. Typical also of diaphragm 3, in bay 5 and dia. 4 in bay #4 span #2,

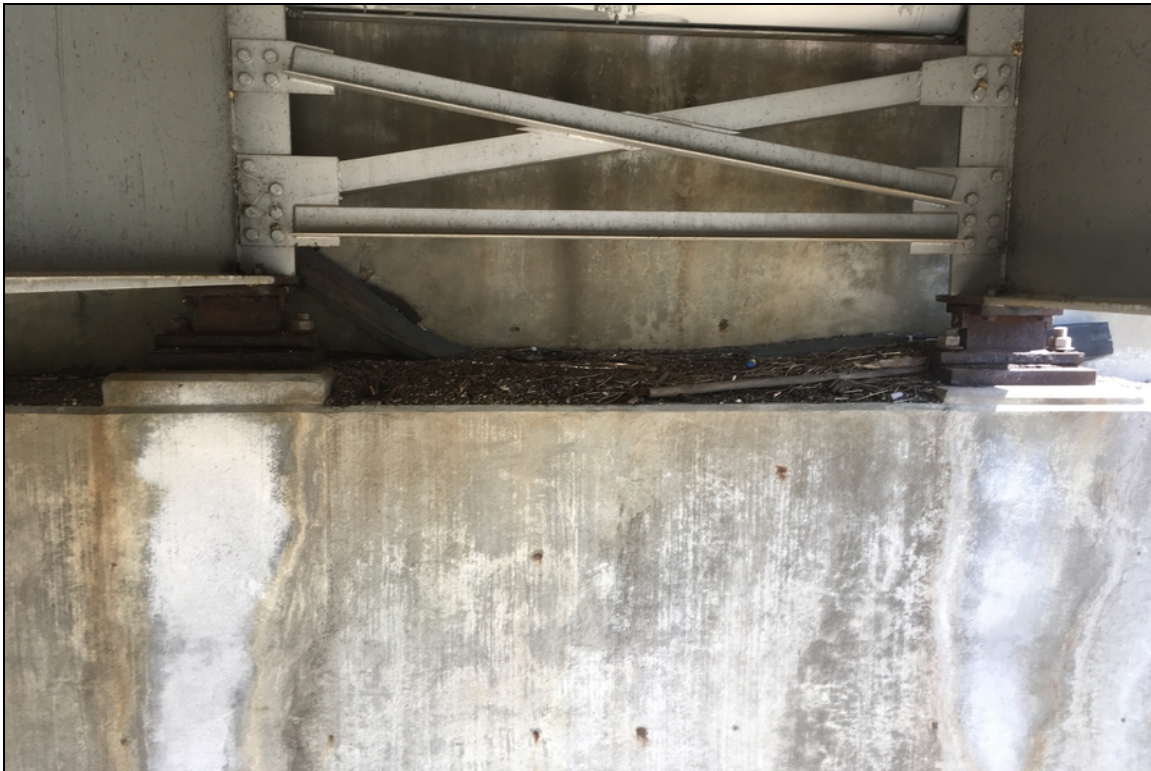
View of build up on the bridge seat at abutment #2.

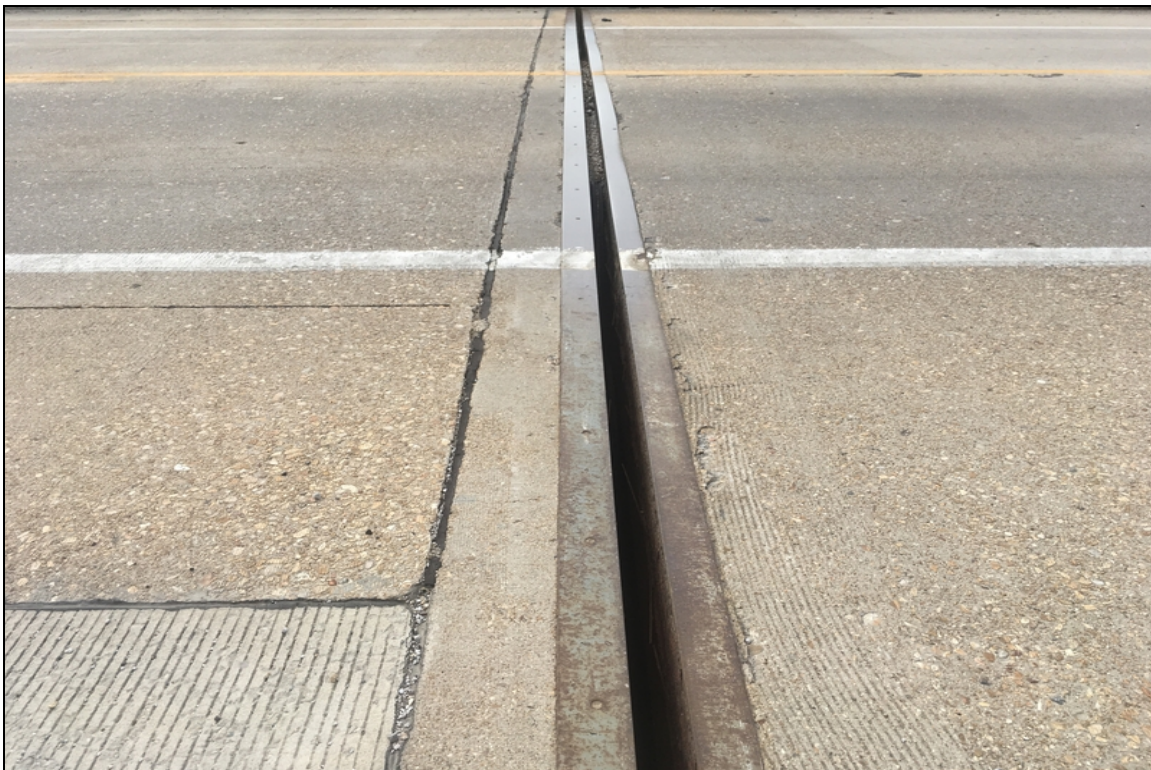
Abutment #2 compression joint seal condition.

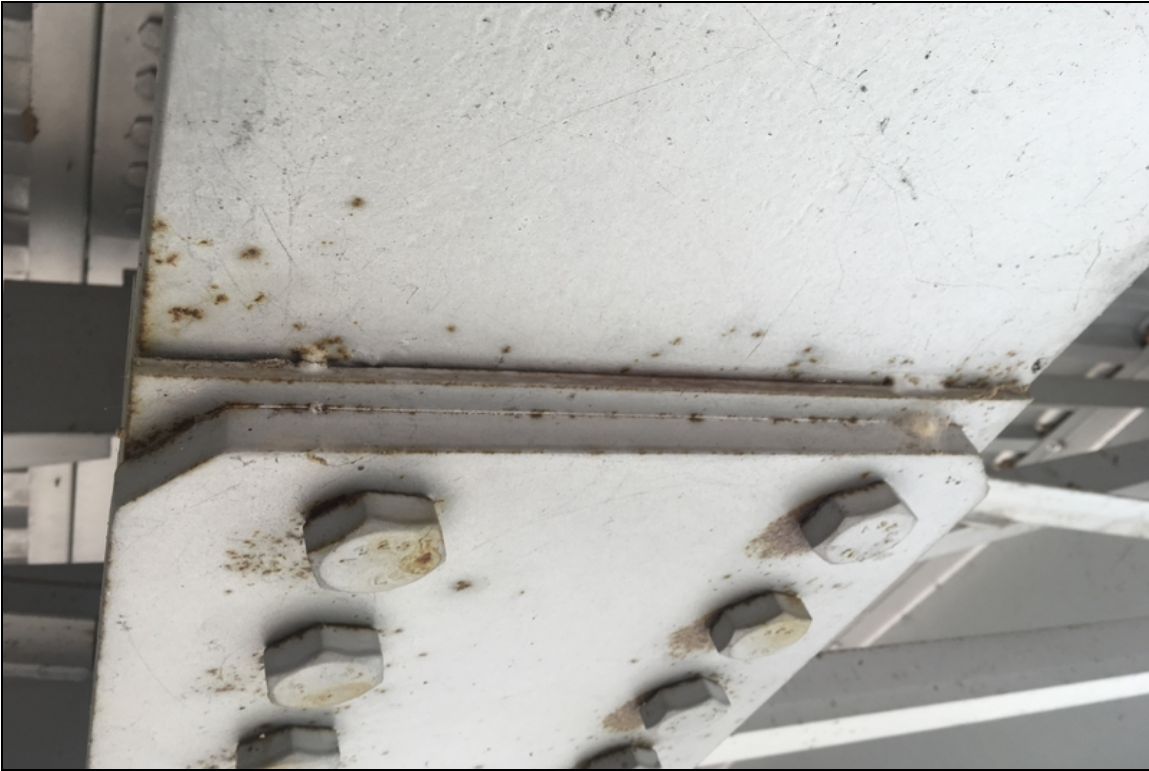
Cracked tack weld at the bottom plate of the field splice in span #1 beam #5. Typical also of beam#4 in span #1.

Span #2- beam #5 also has a cracked tack weld at at the bottom connection plate of the second field splice.

Span #3- beam 4 also has a cracked tack weld at at the bottom connection plate of the first field splice.
