Bridge #06058(Routine)
US 62/412 Marion over FALLEN ASH CR
Location: 11.36 MI EAST OF SH 14

Team Lead: Benjamin Smith Inspection Date: March 04, 2020

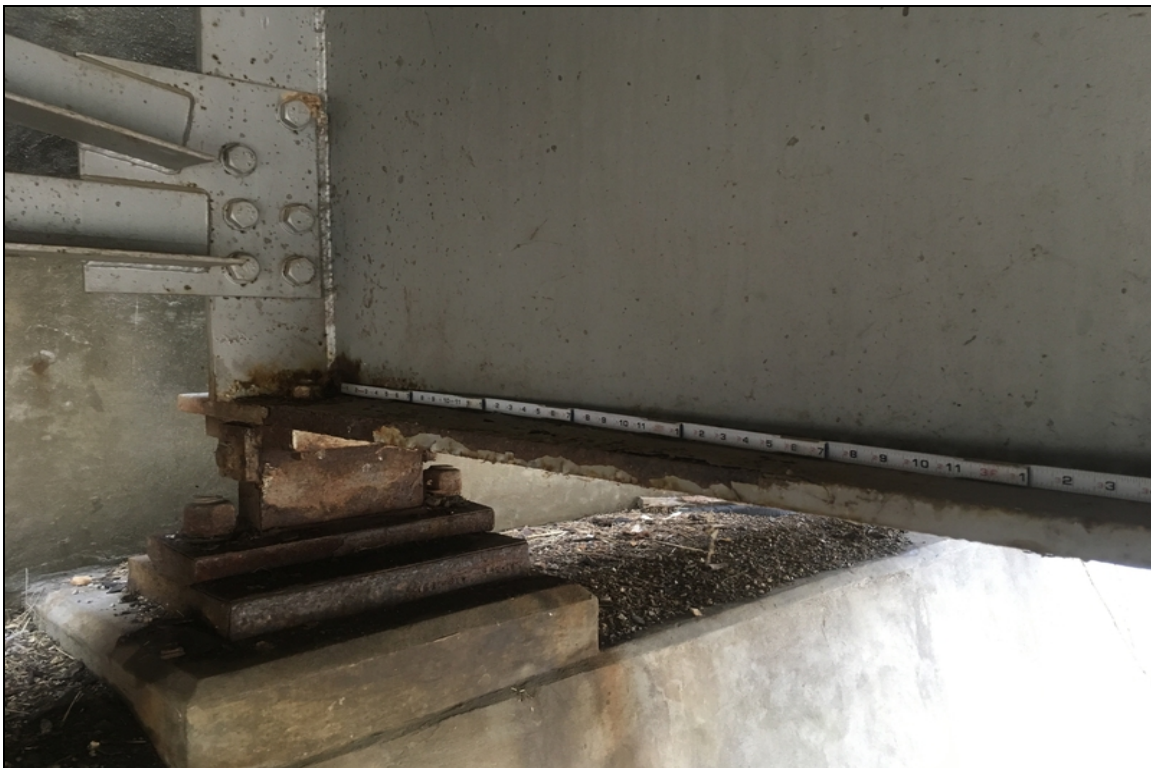
Corrosion on the bottom flange of beam #2 over abutment #1. Typical of beams 2-4.

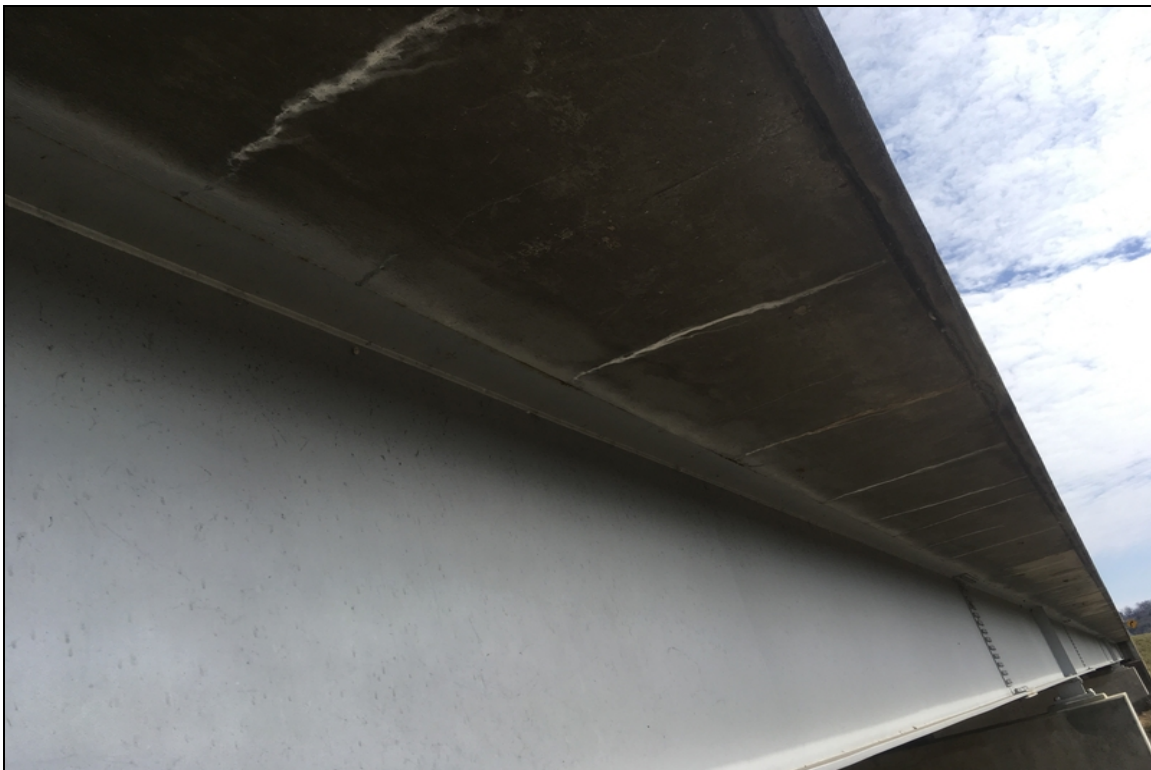
Transverse efflorescence on the left and right deck overhangs.

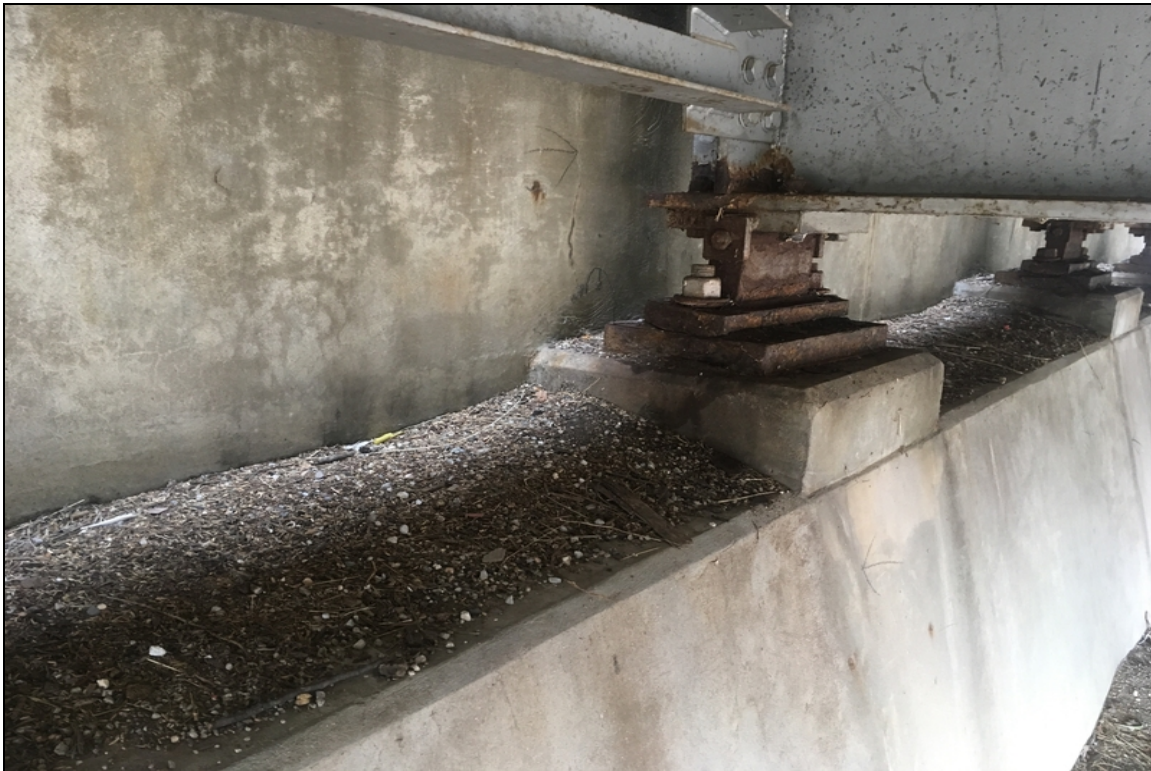
Build up on the bridge seat at abutment #1 due to missing joint seal.

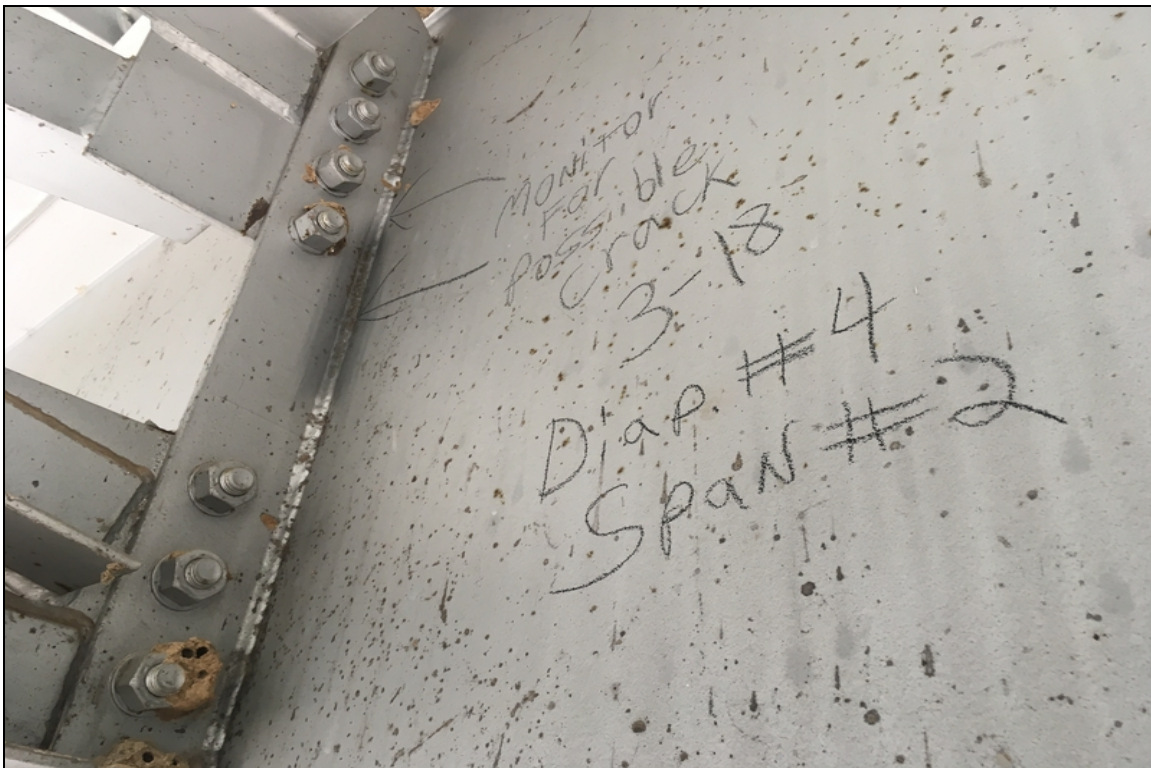
Possible vertical crack in the diaphragm connection plate at diaphragm #4 span #2, bay #3.

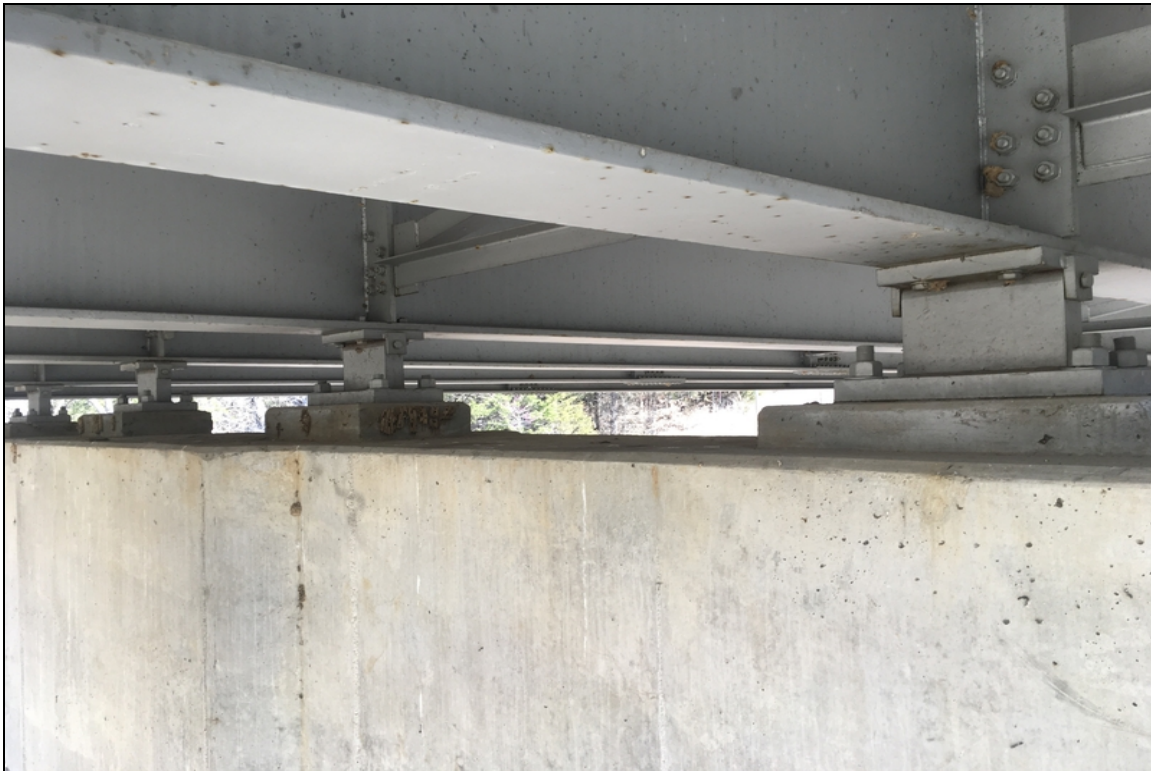
Fixed bearing condition at pier #2.

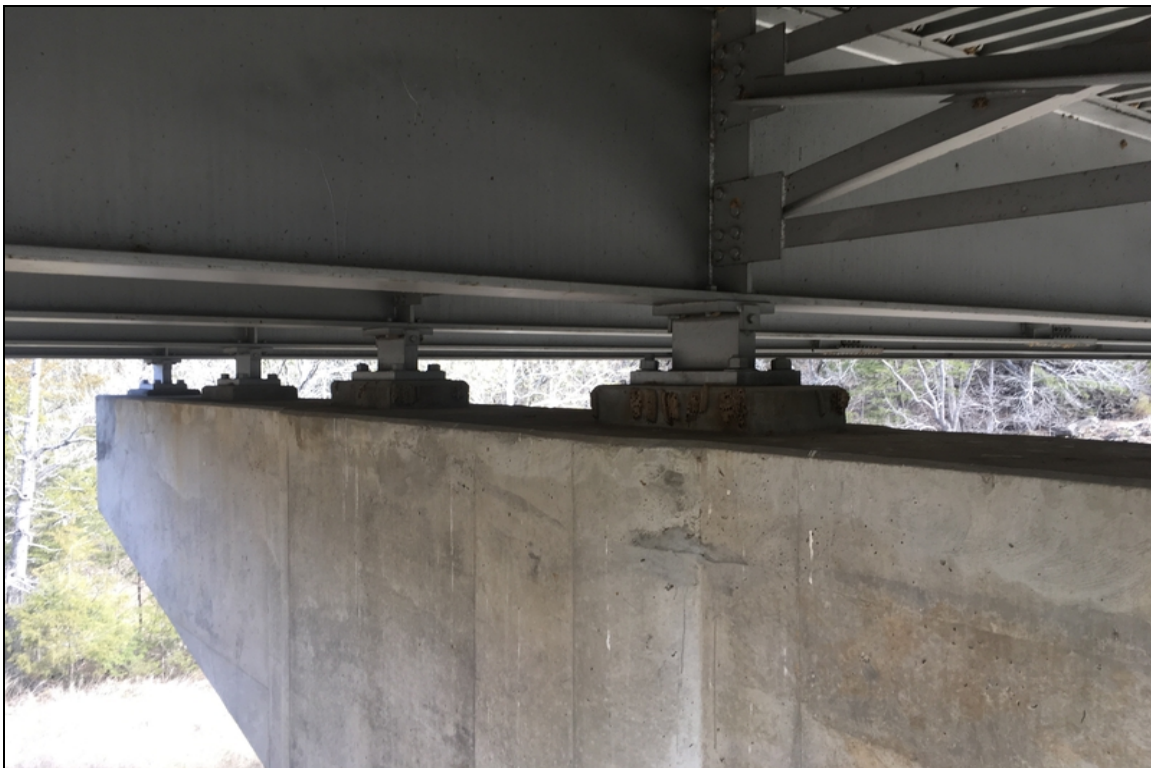
Fixed Bearing condition at pier #1. Typical of all 6 at this location.

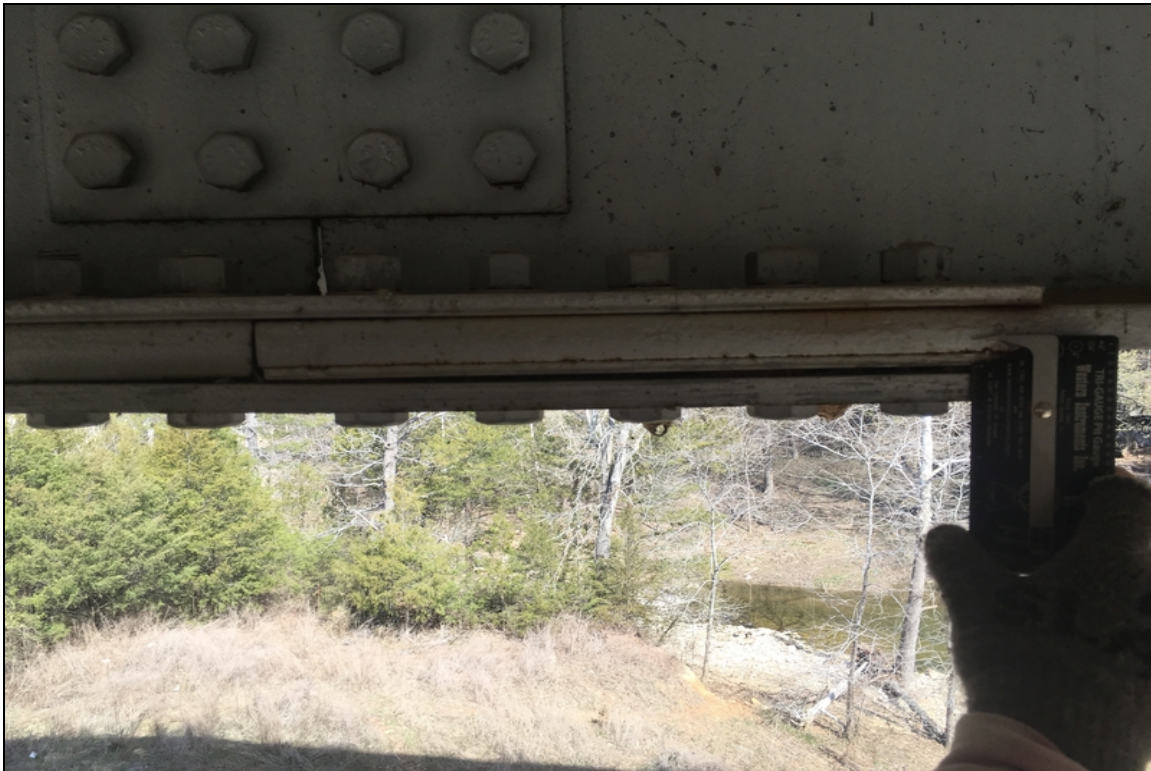
1/8" gap on the bottom flange connection plate at the first field splice on beam #4 in span #2.
Due to not being completely tightened.

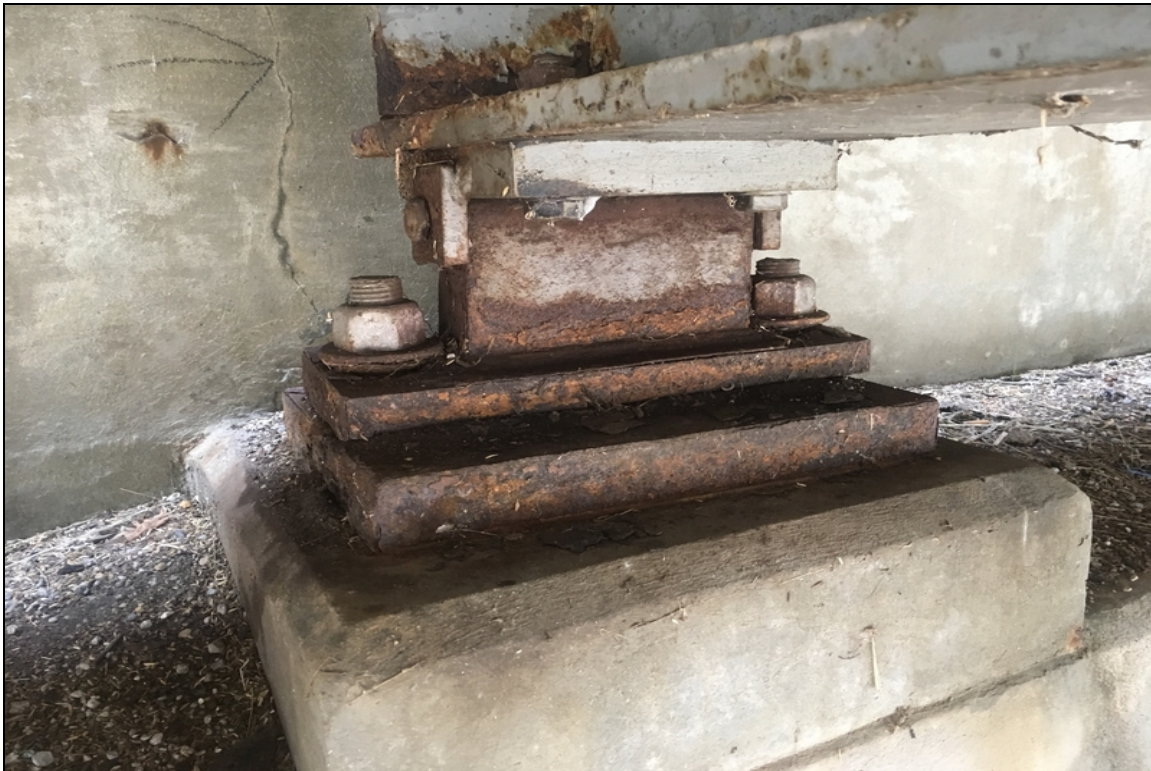
Moveable bearing condition at abutment #1. Typical of all 6 bearings at this location.

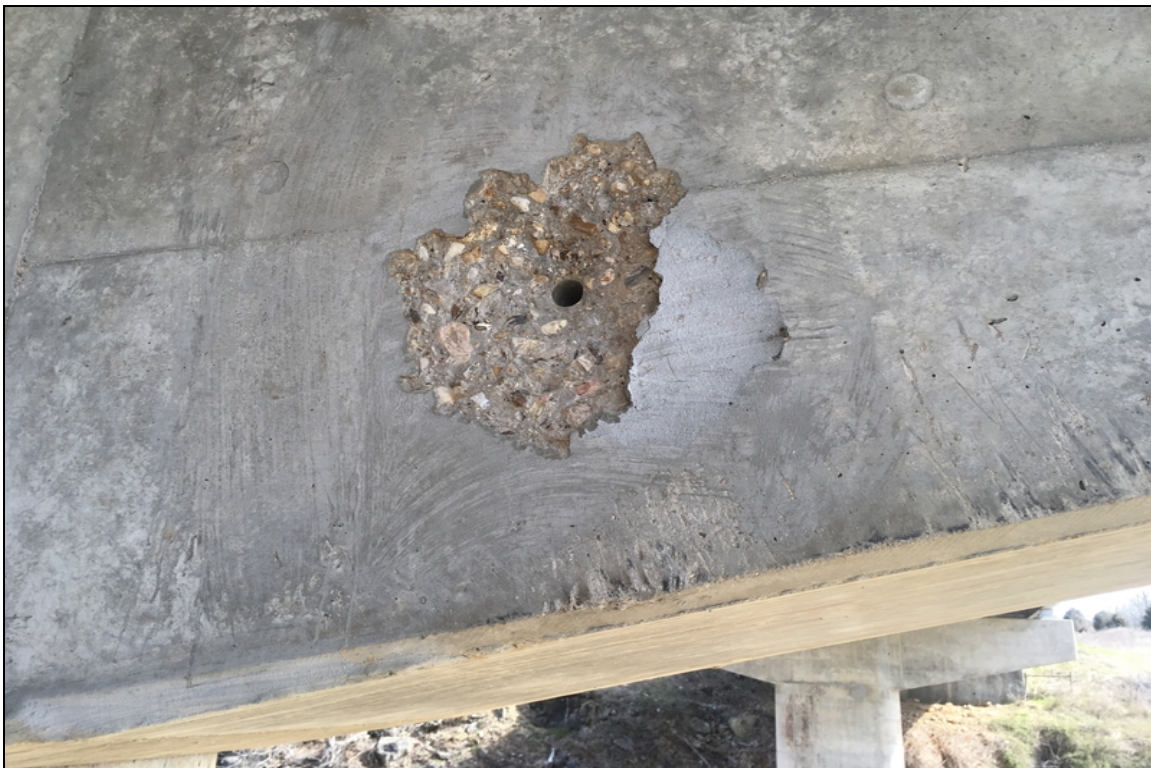
Spall on the right pier cap end of pier #1 on the span #1 side.
