Bridge #06059(Routine)

US 62/412 Marion over WHITE RIVER

Team Lead: Benjamin Smith Inspection Date: June 17, 2020

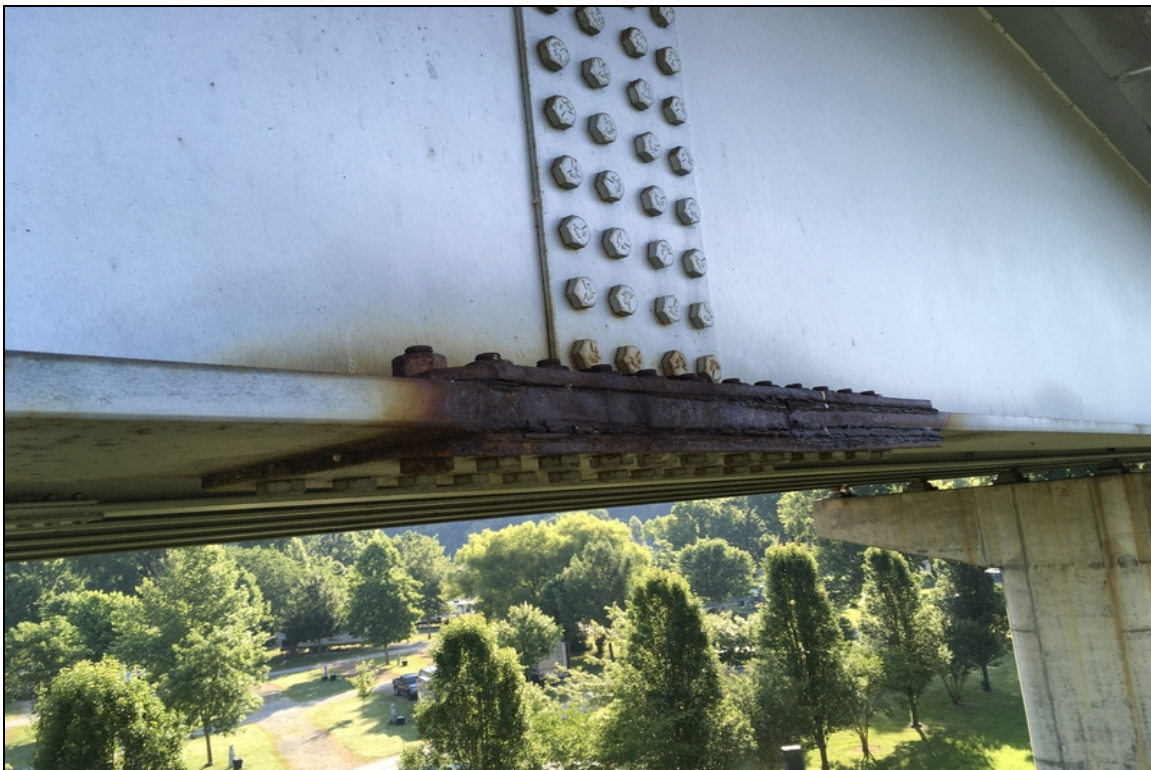
Splice panel corrosion on beam 6 in span 3 due to deck drainage.

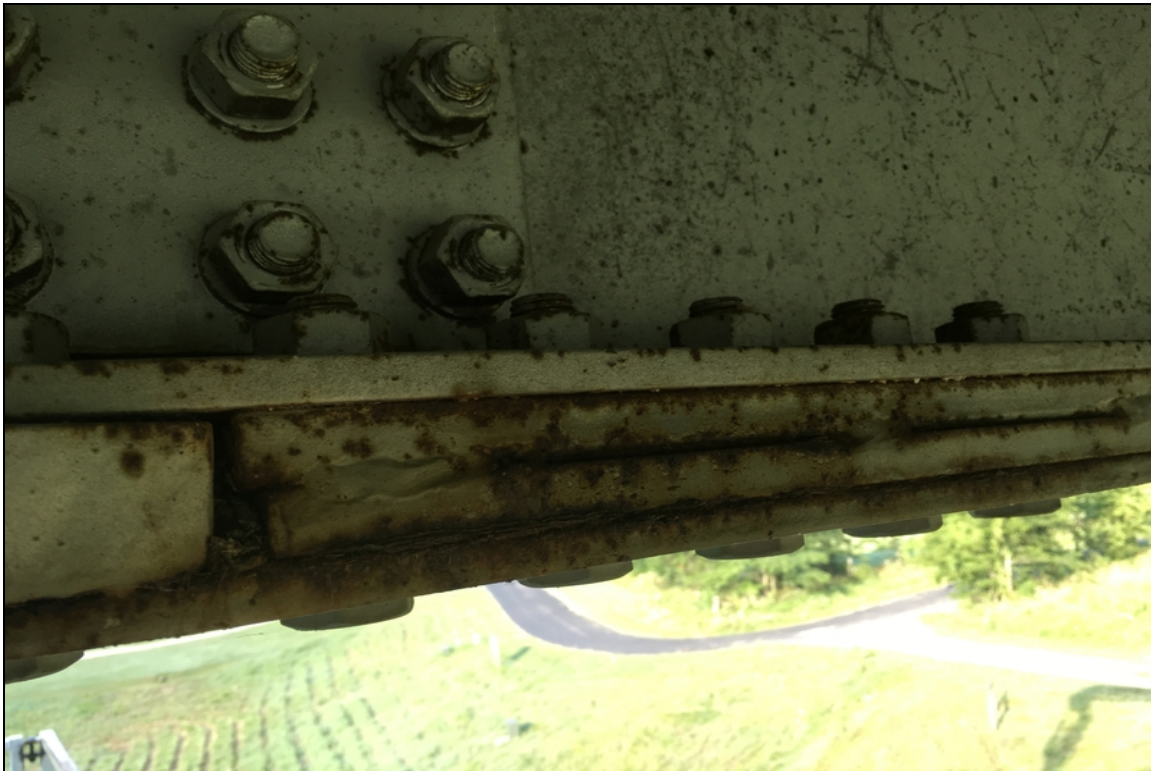
Pack rust is beginning to form at splice panel 2 on beam 6 in span 2

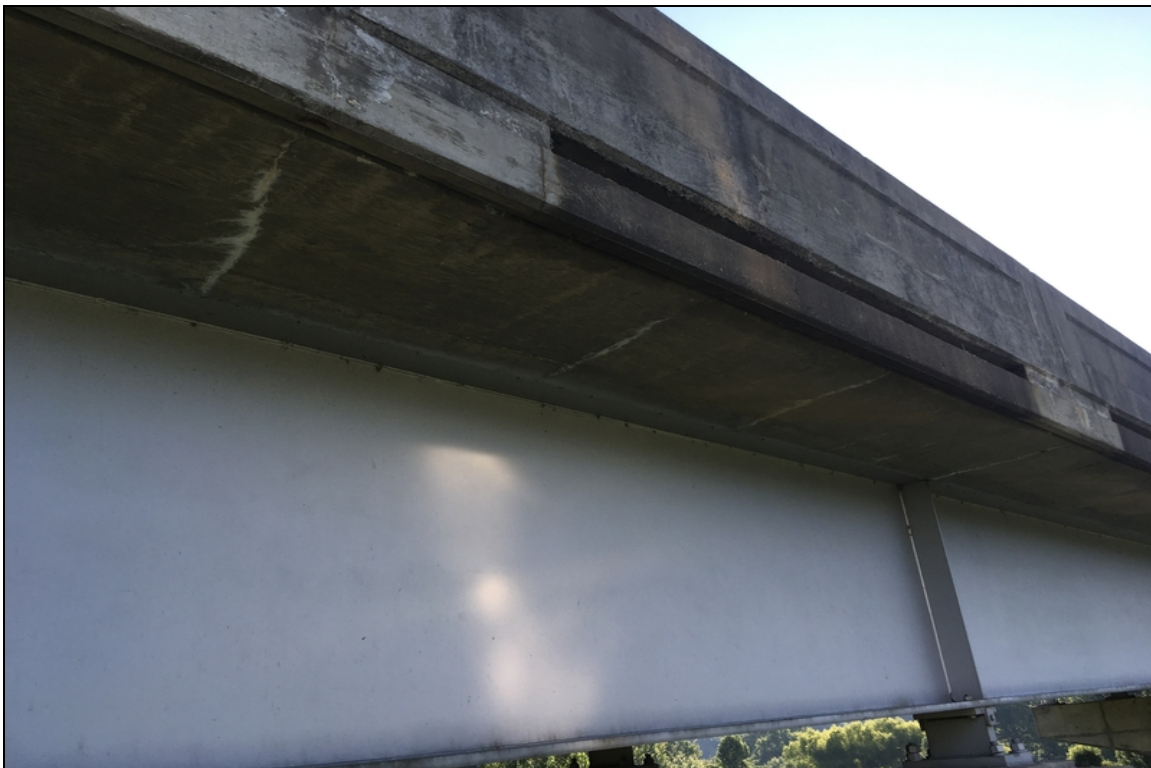
Efflorescence in the deck overhangs.

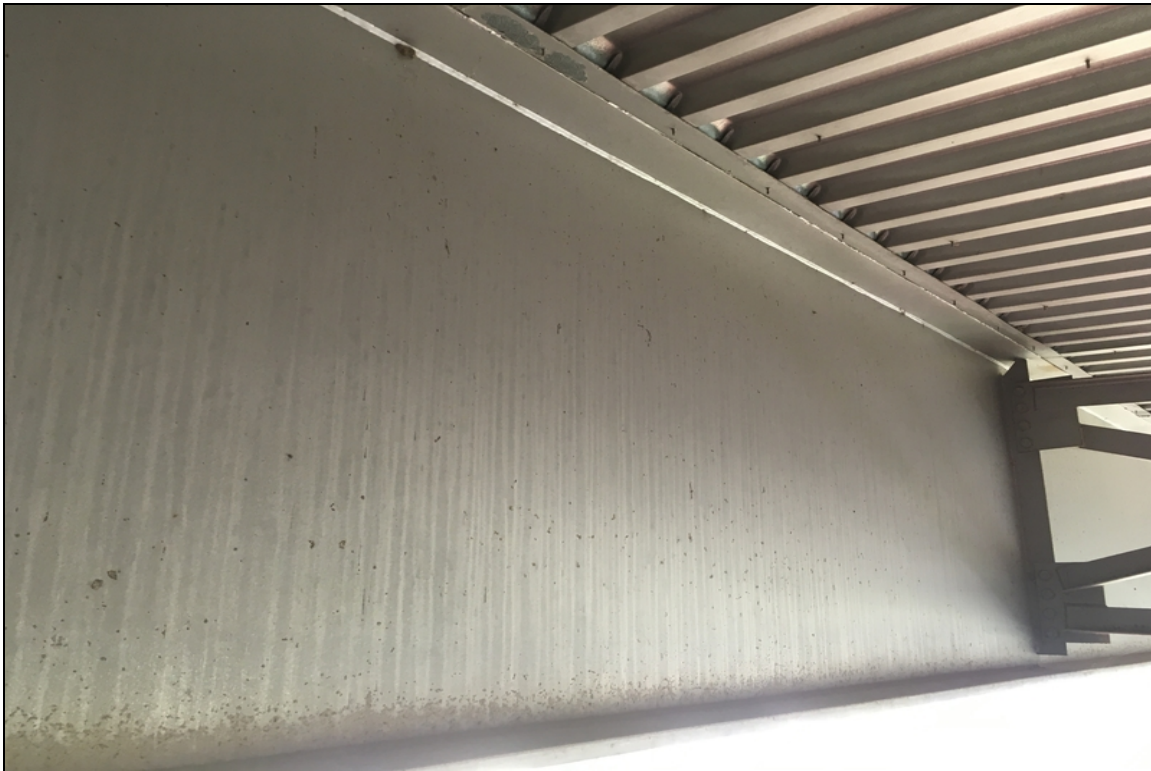
General paint condition.

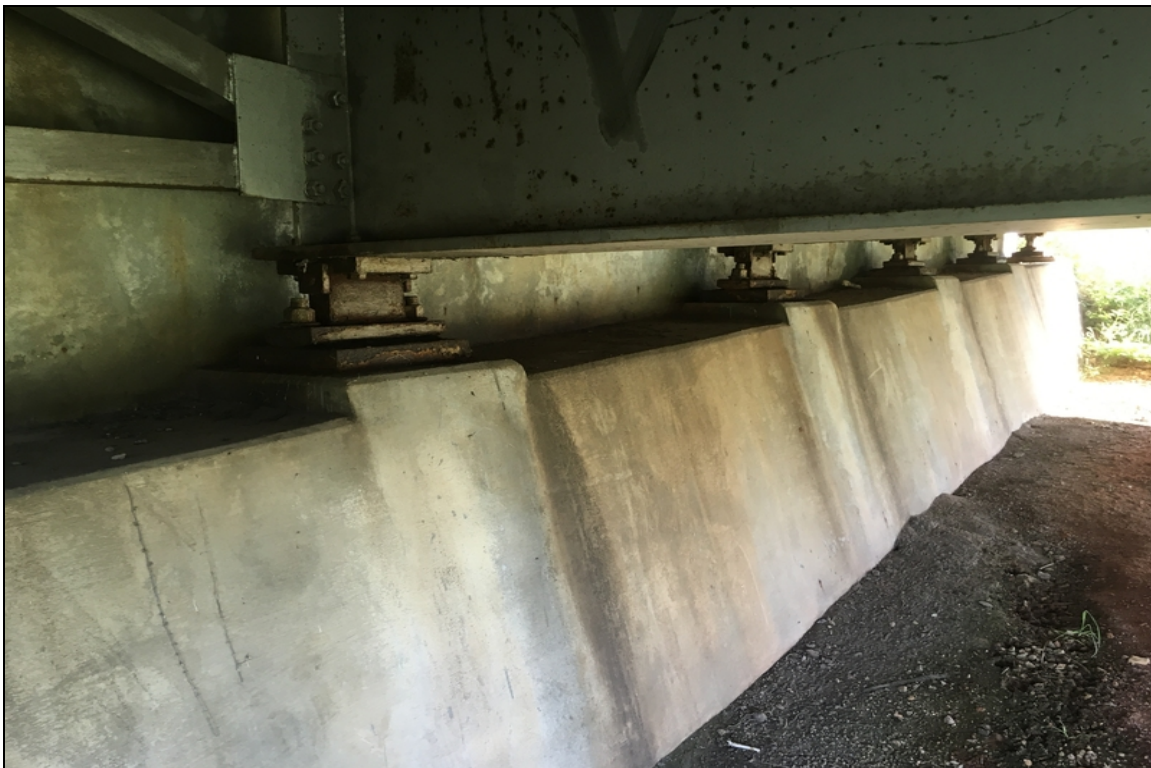
Bearing condition at abutment 1.

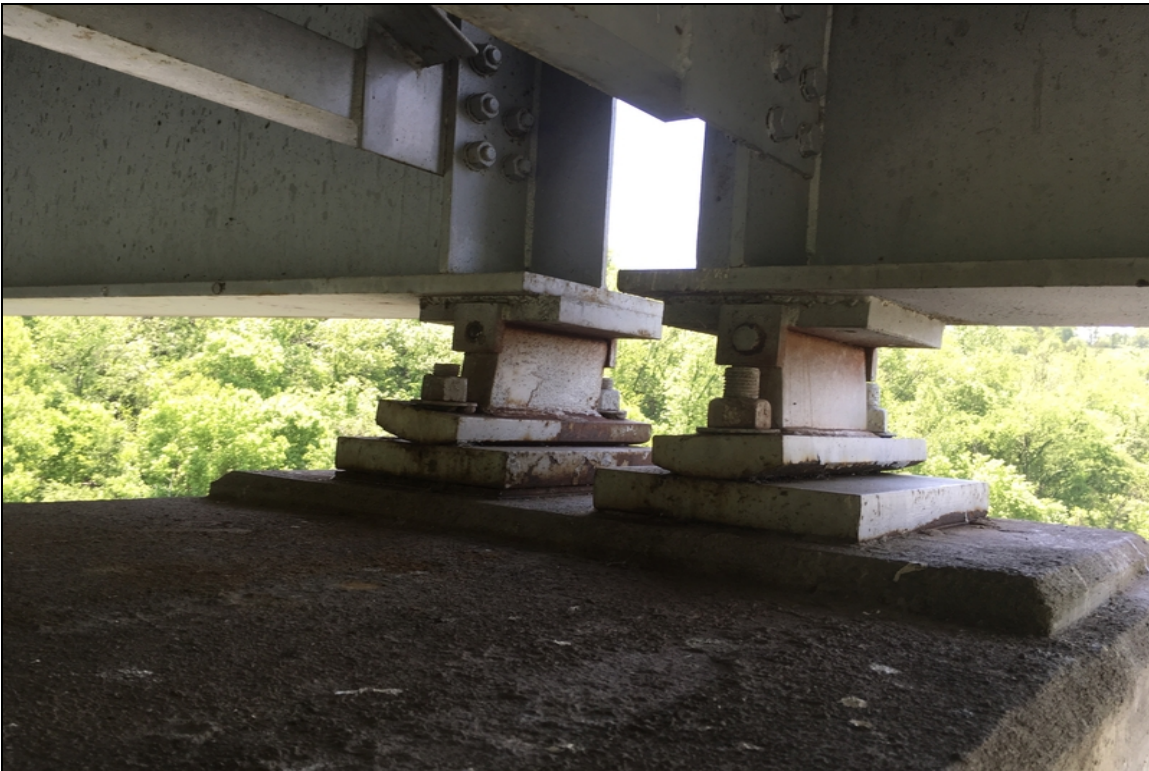
Exterior bearing condition at pier #9. Typical of the 4 outside bearings. Note the sheared sole plate connection bolt at beam #6. The sole plate bolt is missing on both sides of the bearing.

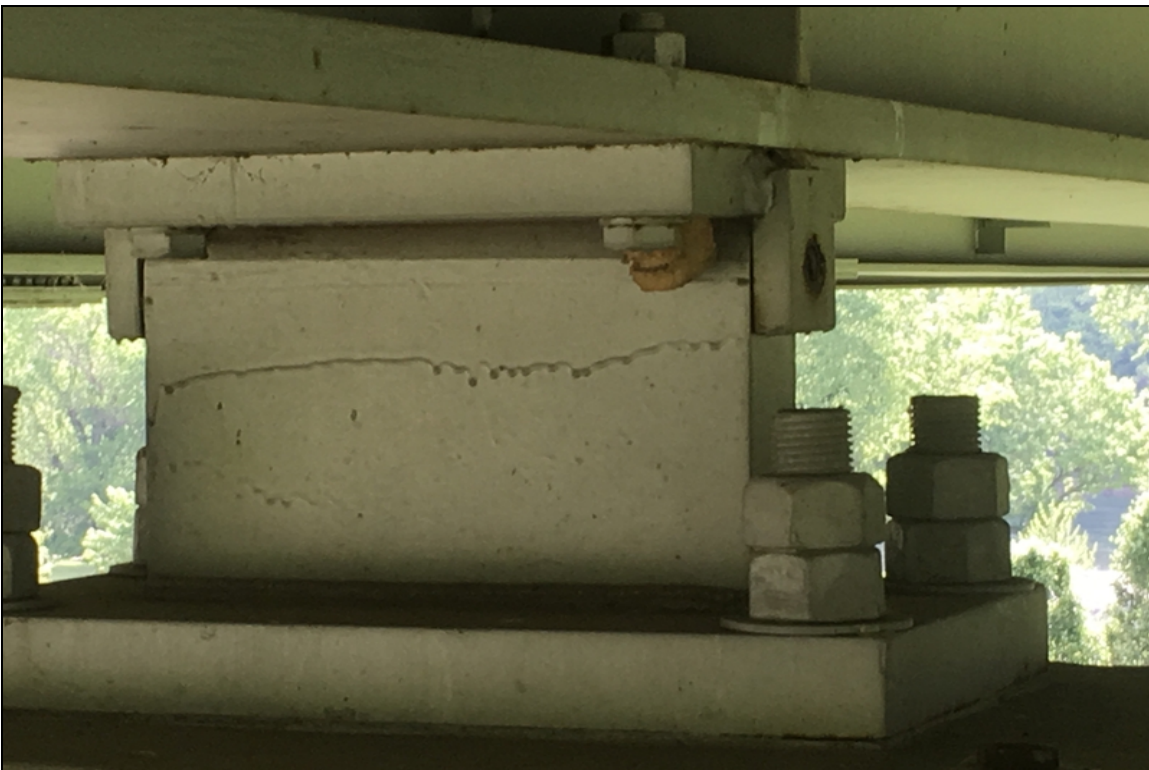
Sole plate bolt is missing on the right side of girder #3 at pier #2.

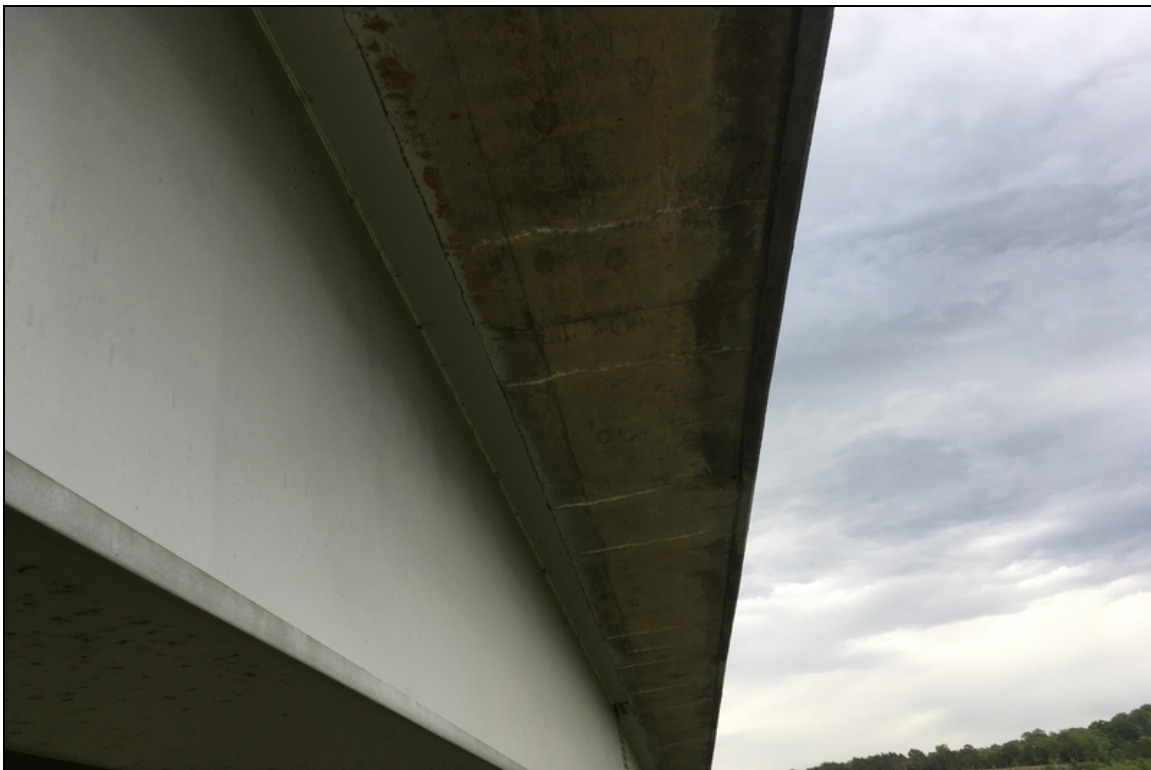
Efflorescence cracking in the left and right deck overhangs.

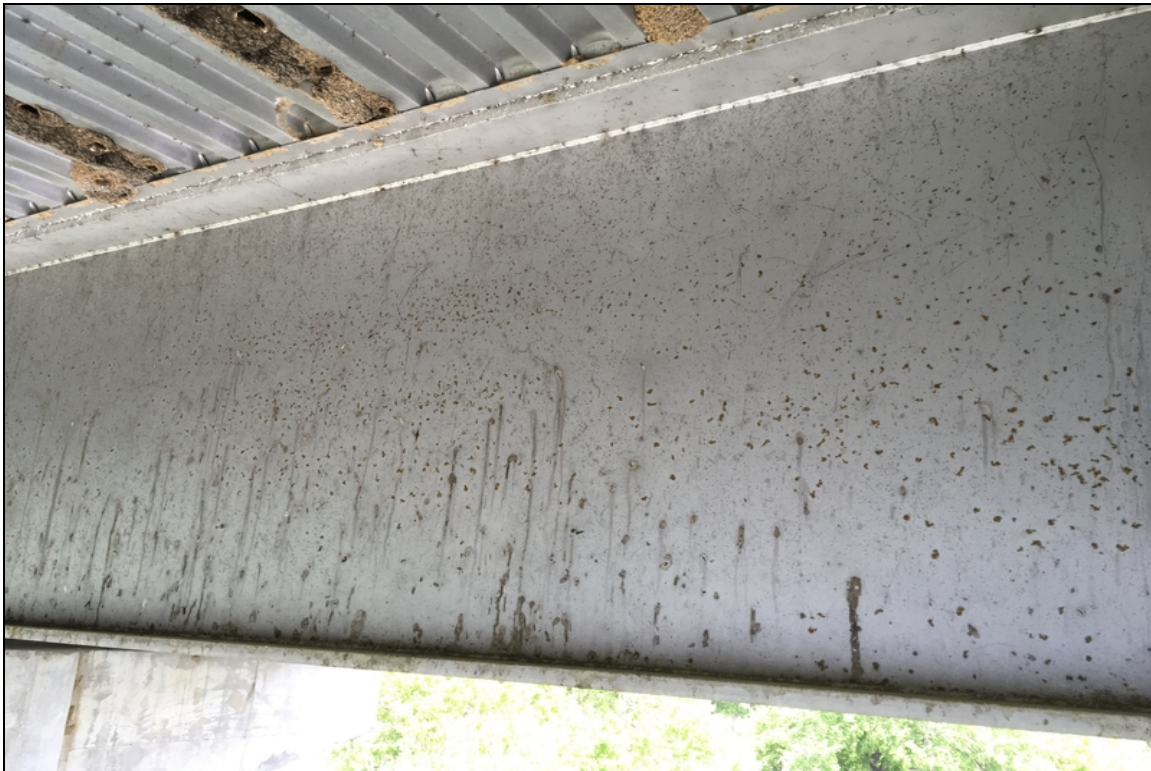
Pin point rusting in span #8 interior beams.

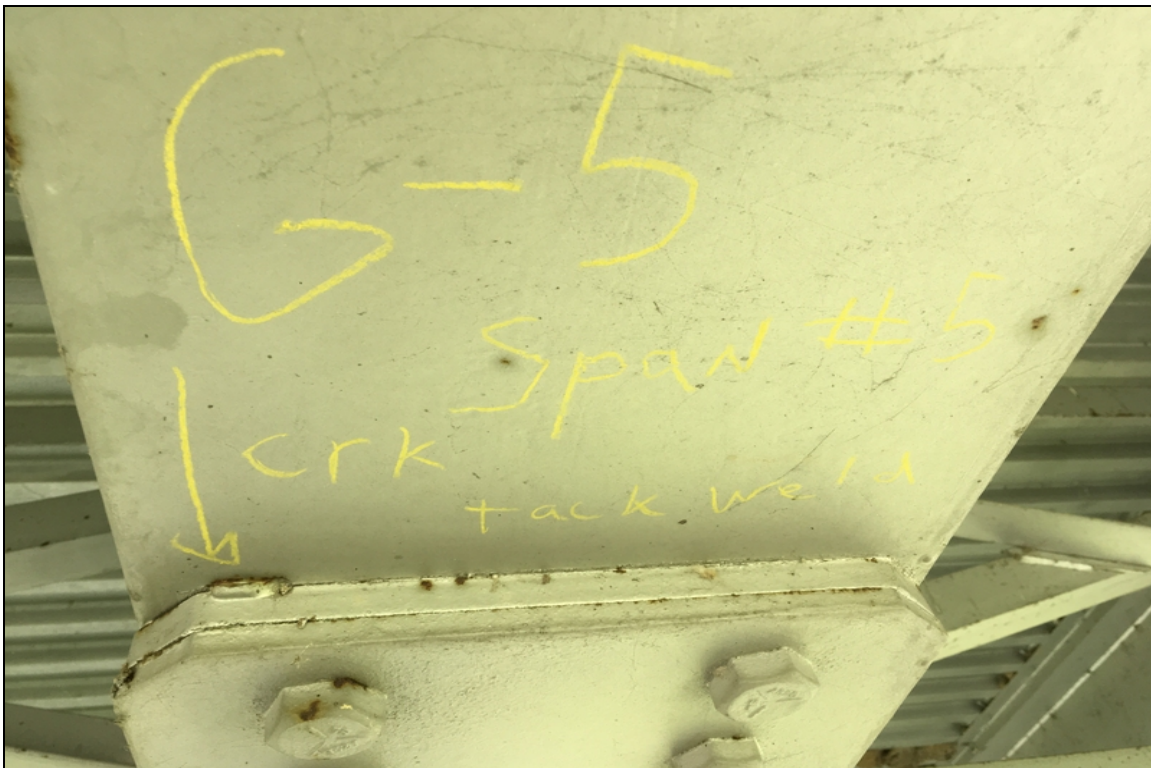
Cracked tack weld on the bottom plate of the splice panel on girder #5 in span #5.

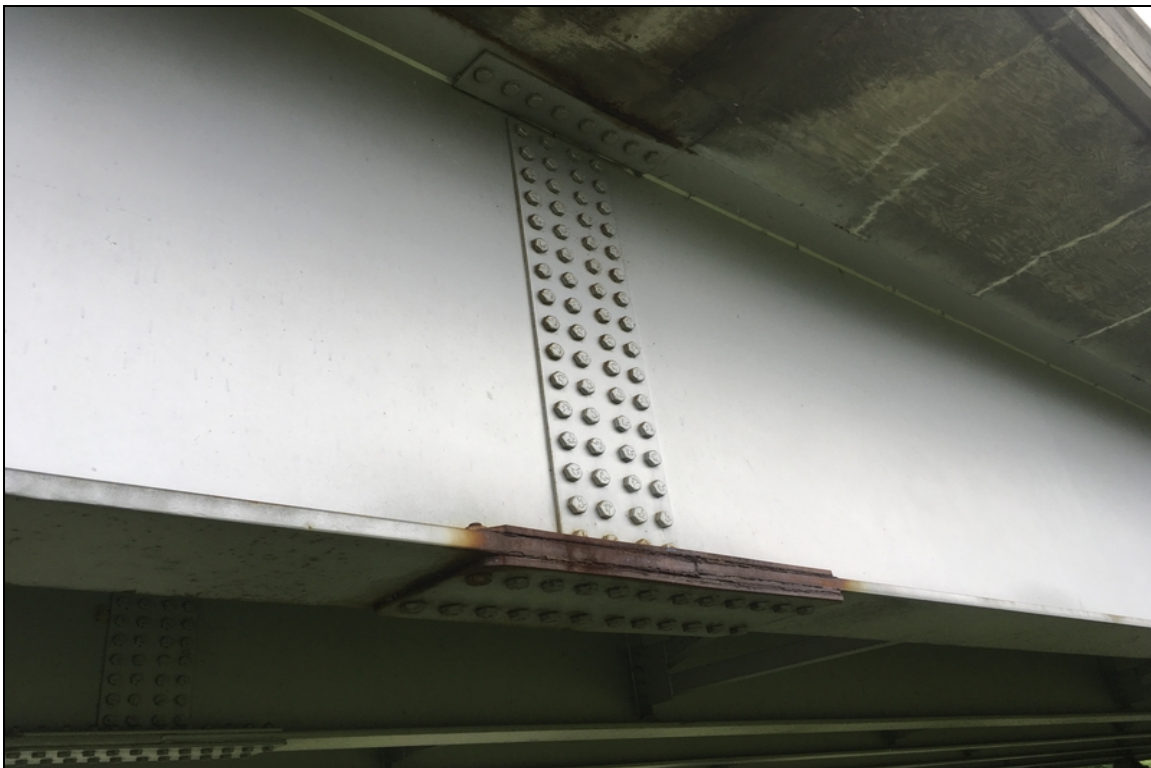
Corrosion with pack rust on the splice panel of beam #6 span #3.

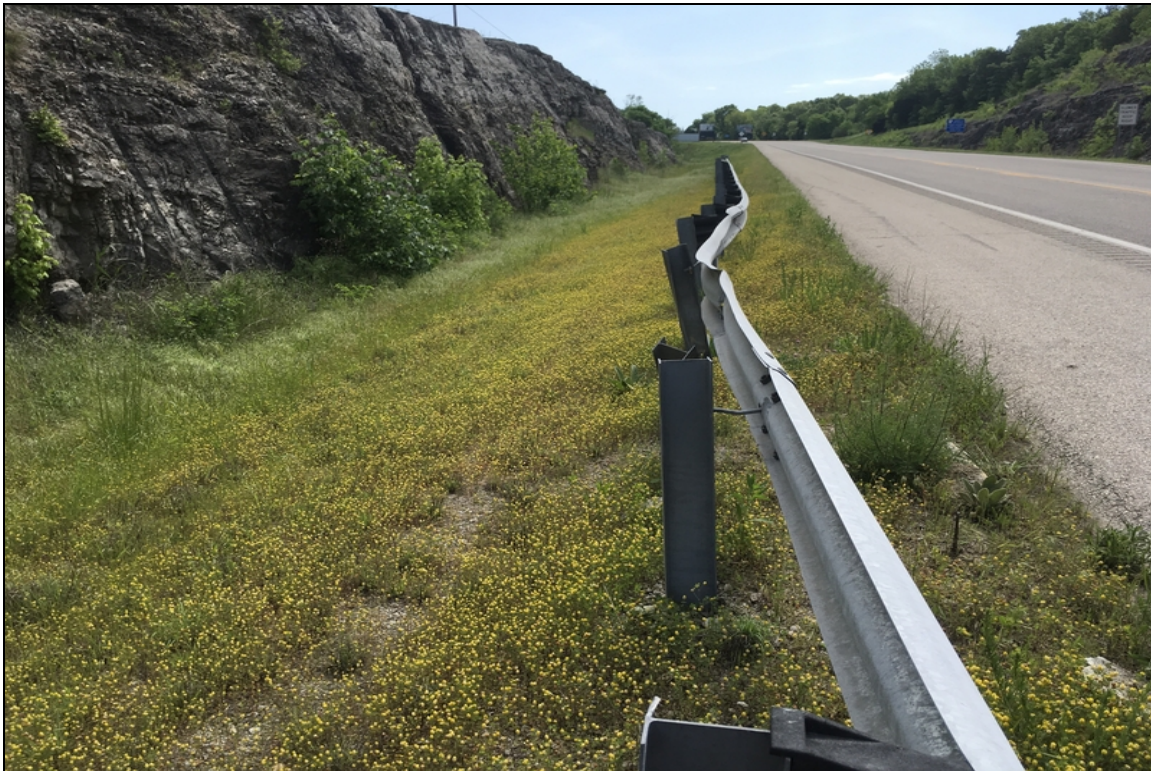
The left ending approach railing has 26' of vehicle damage.

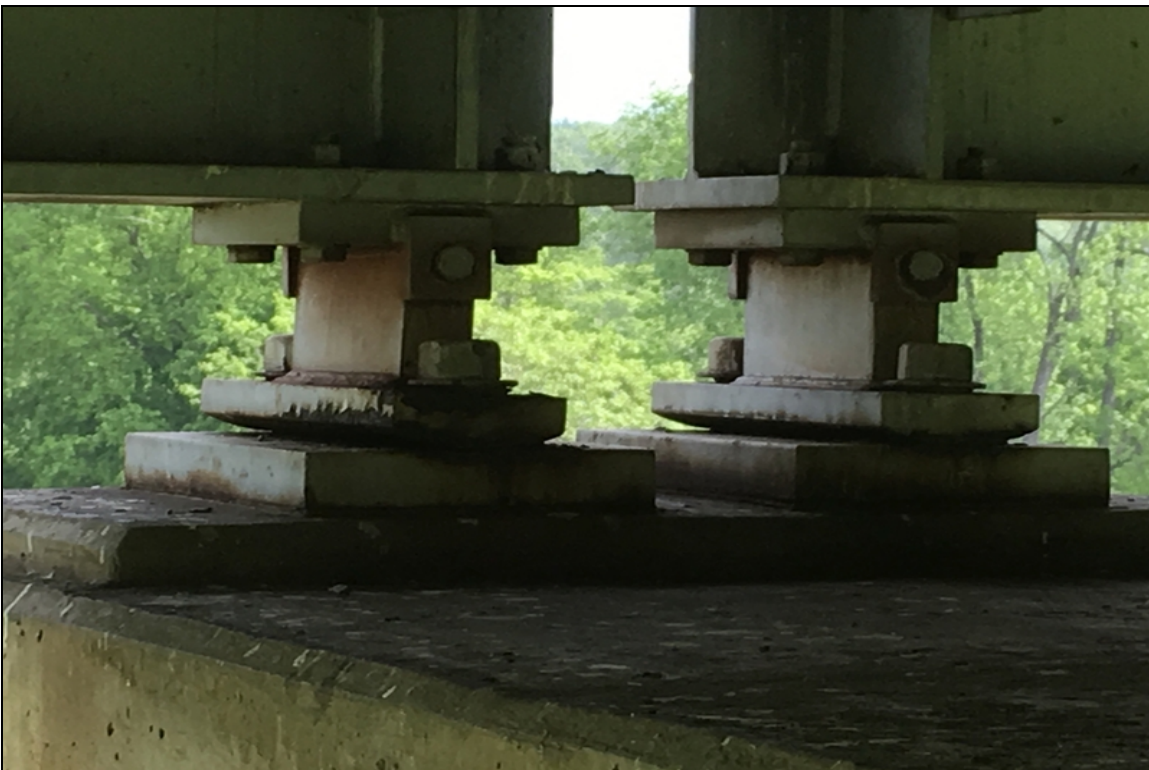
Bearing condition at pier #3 under girder #1. Showing corrosion at the rocker area.

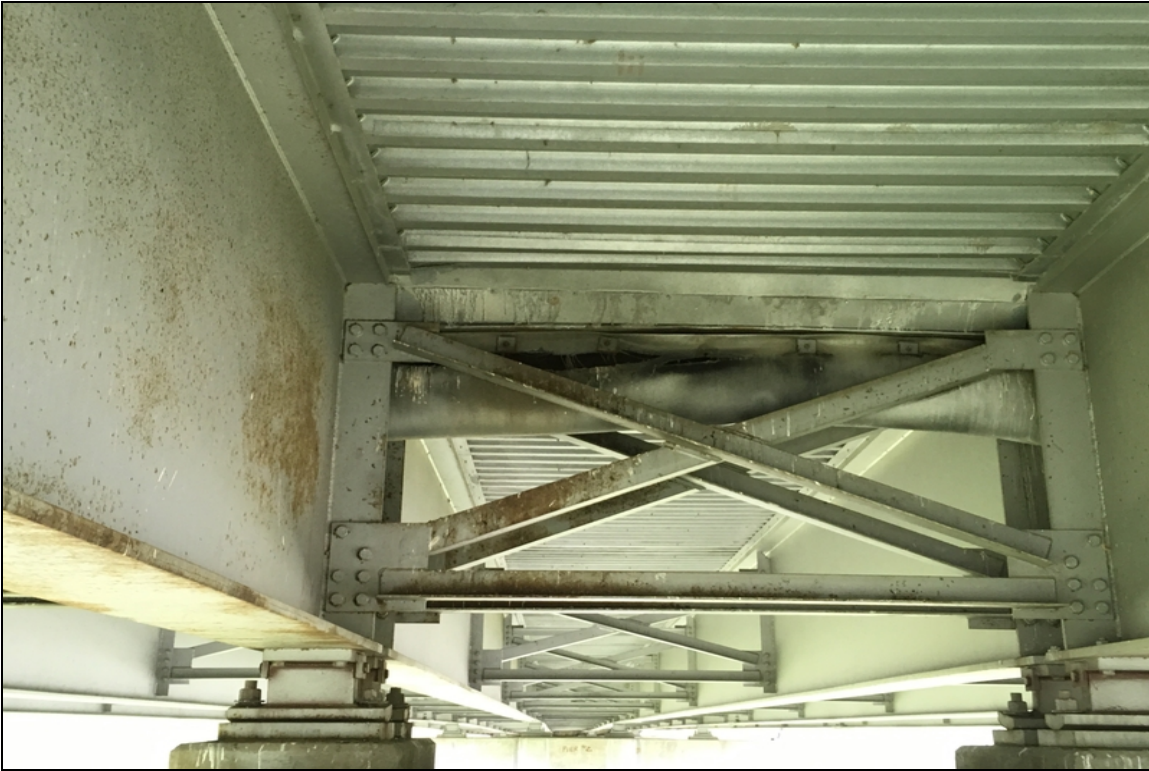
(303)							
Pier #3 assembly joint- is completely full of debris. The trough has tears at the connections and large horizontal rips in the trough.							
Pier #6 assembly joint- is completely full of debris. The trough has tears at the connections.							
Pier #9 assembly joint- is half full of debris. No tearing was noted at the connections.

Large tear in the assembly joint trough over pier #3 on the span #4 side.

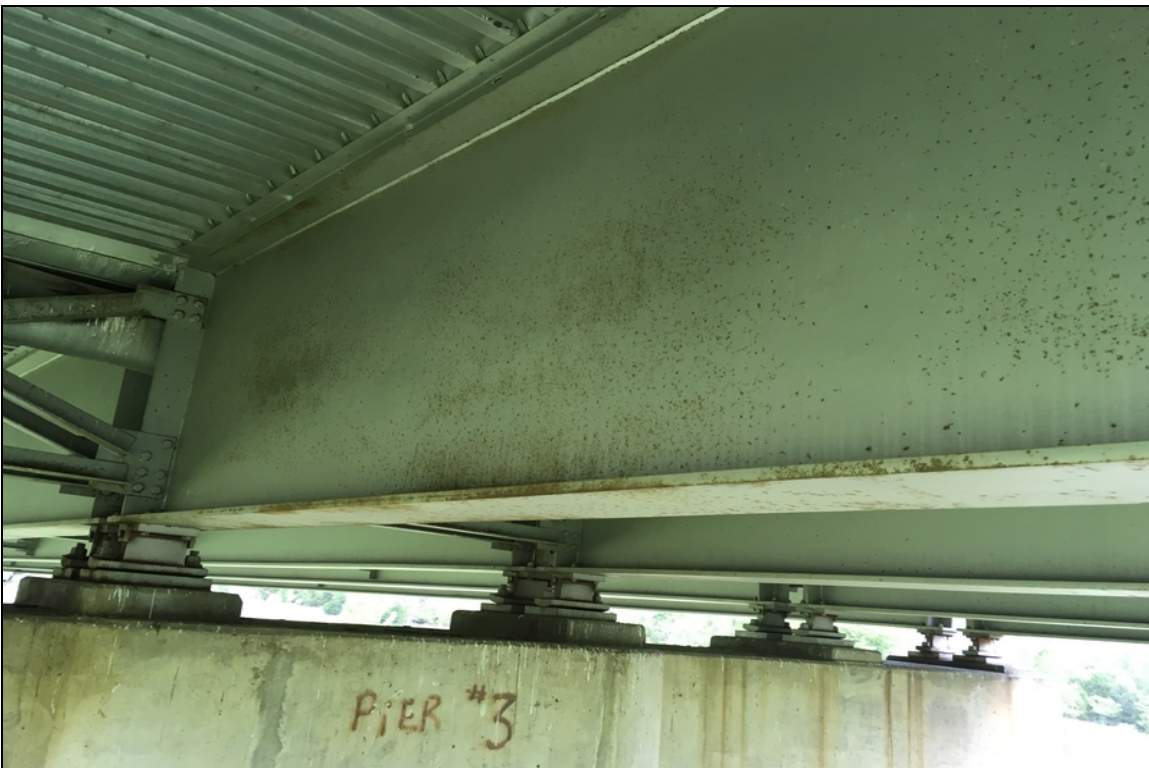
Minor corrosion for 20' on beam #4 in span #4.

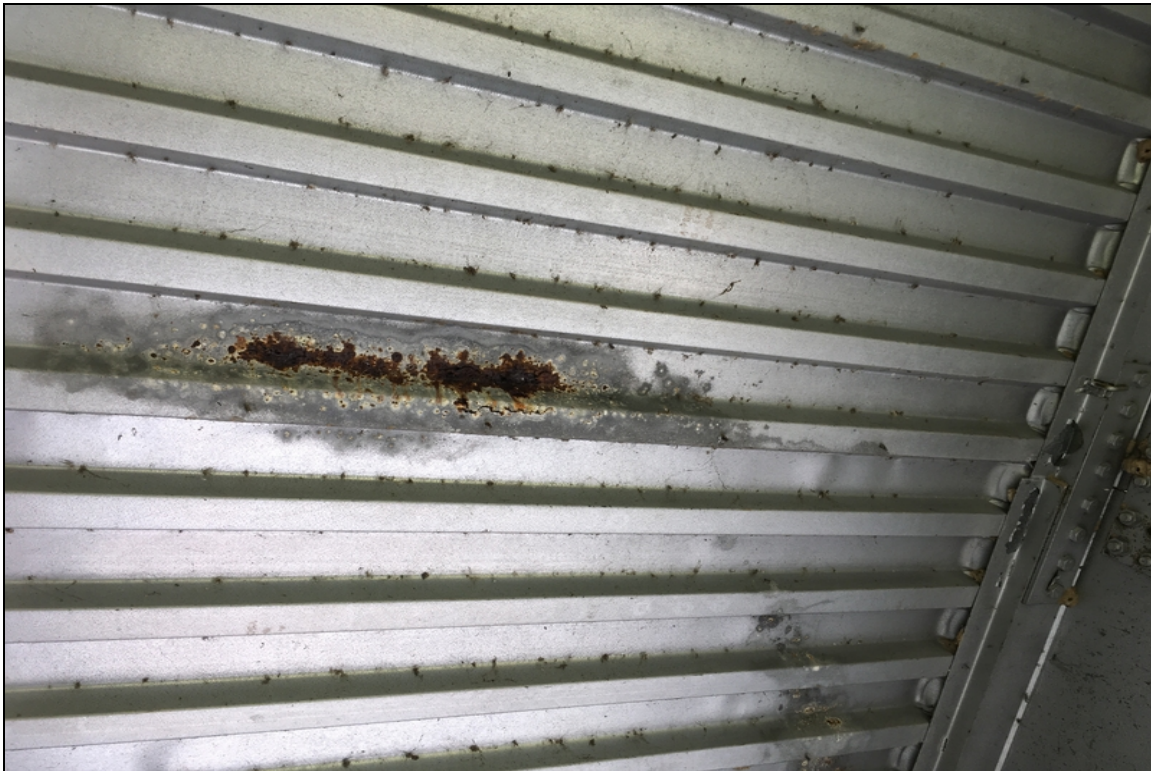
Corrosion on the sip forms in span #7. Typical of several bays in several spans.

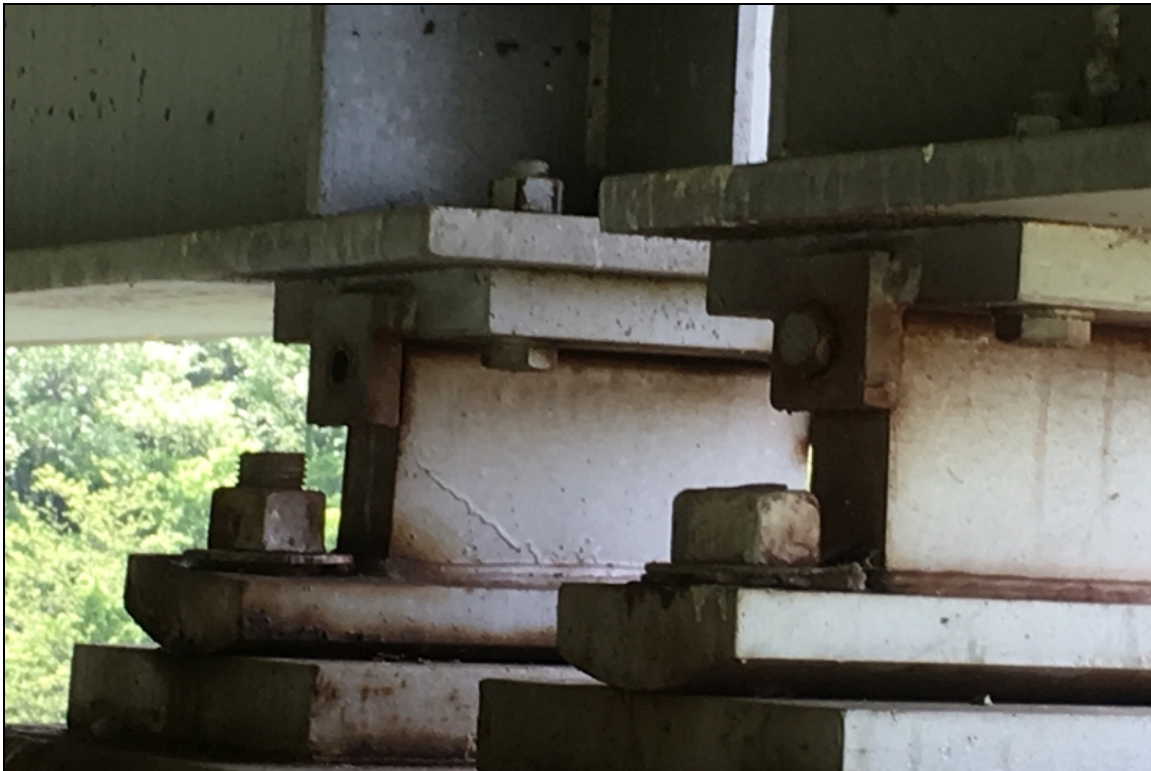
Moveable bearing at pier #6 girder #6 has a missing sole plate connection bolt.

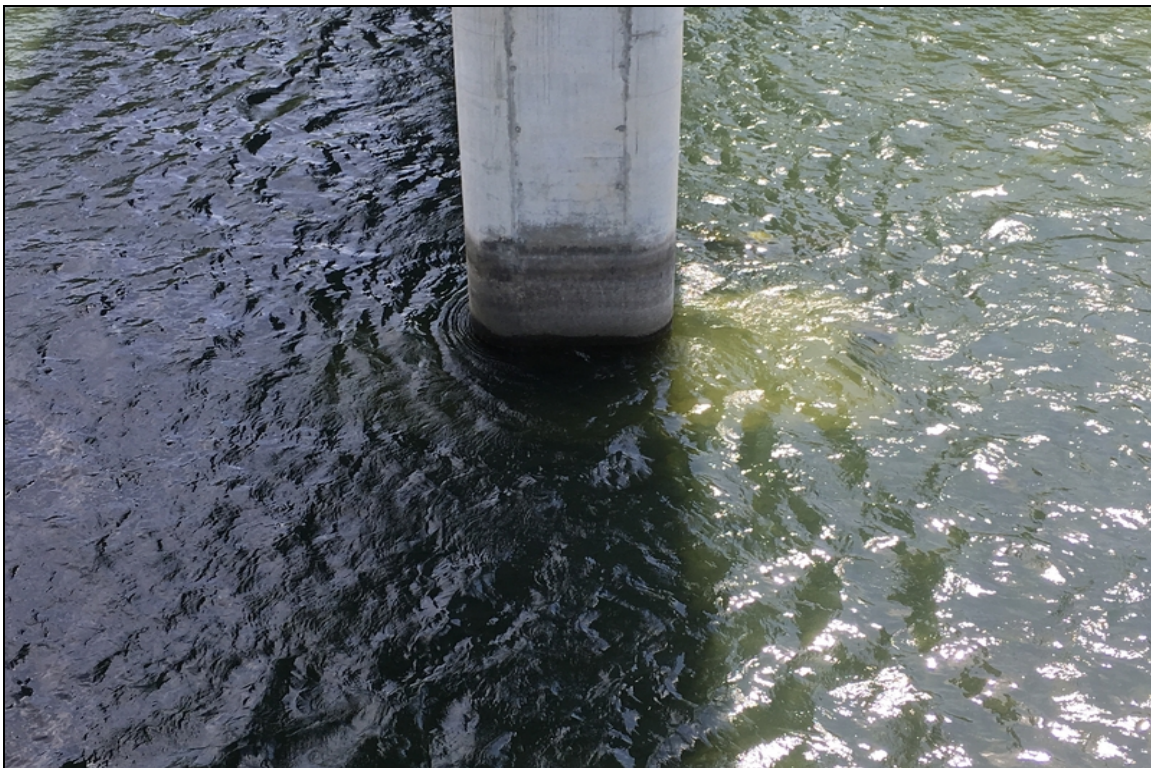
The top of the footing is fully exposed at pier #9.

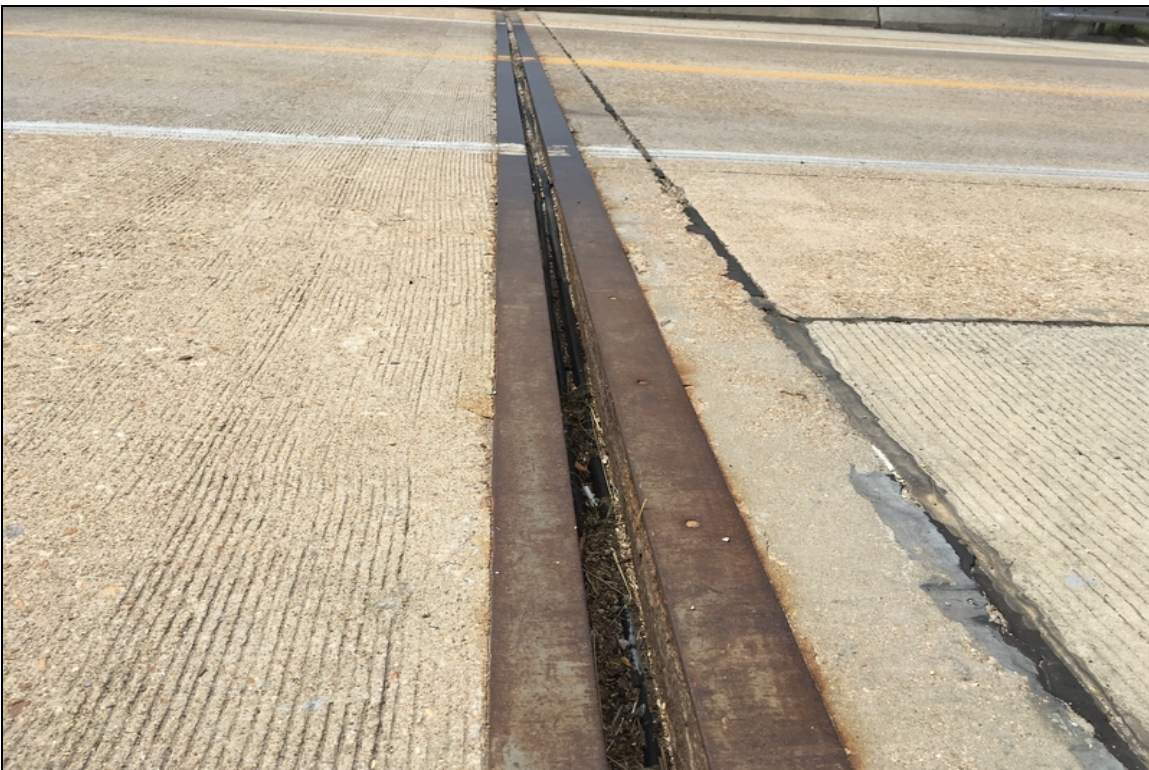
Condition of compression joint seal at abutment #1.

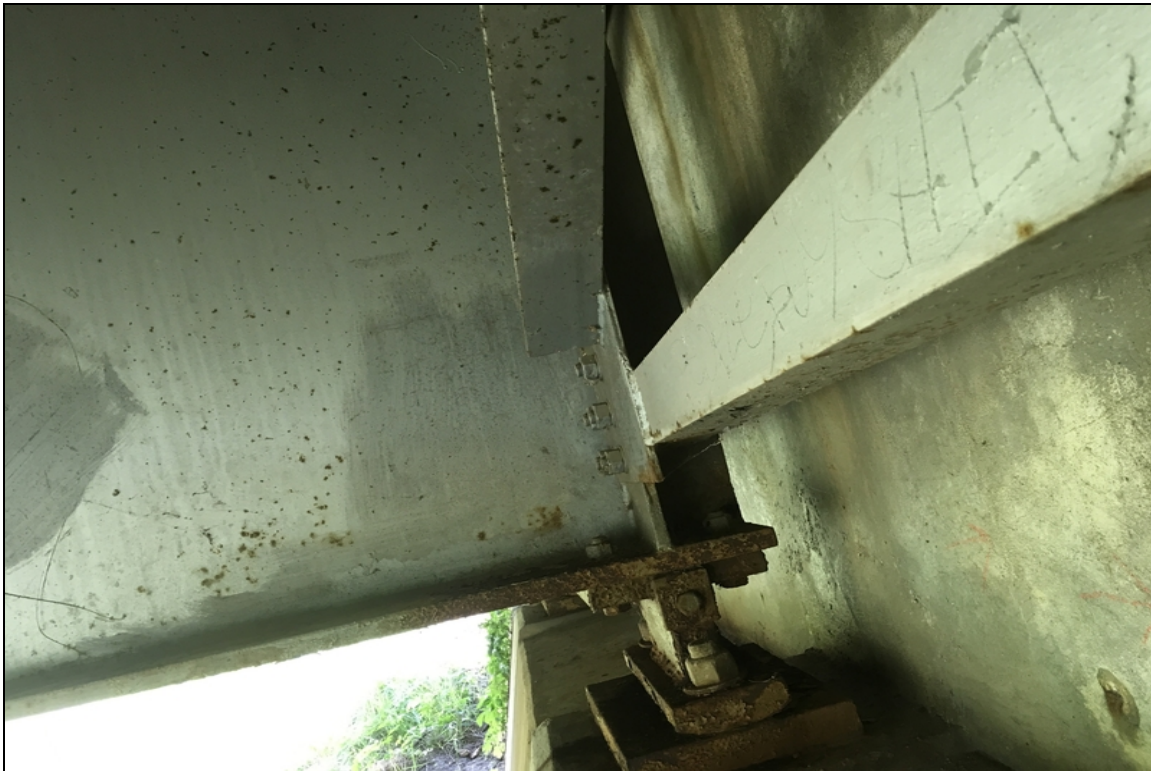
Beam end corrosion at abutment #1 due to leaking joint seals.

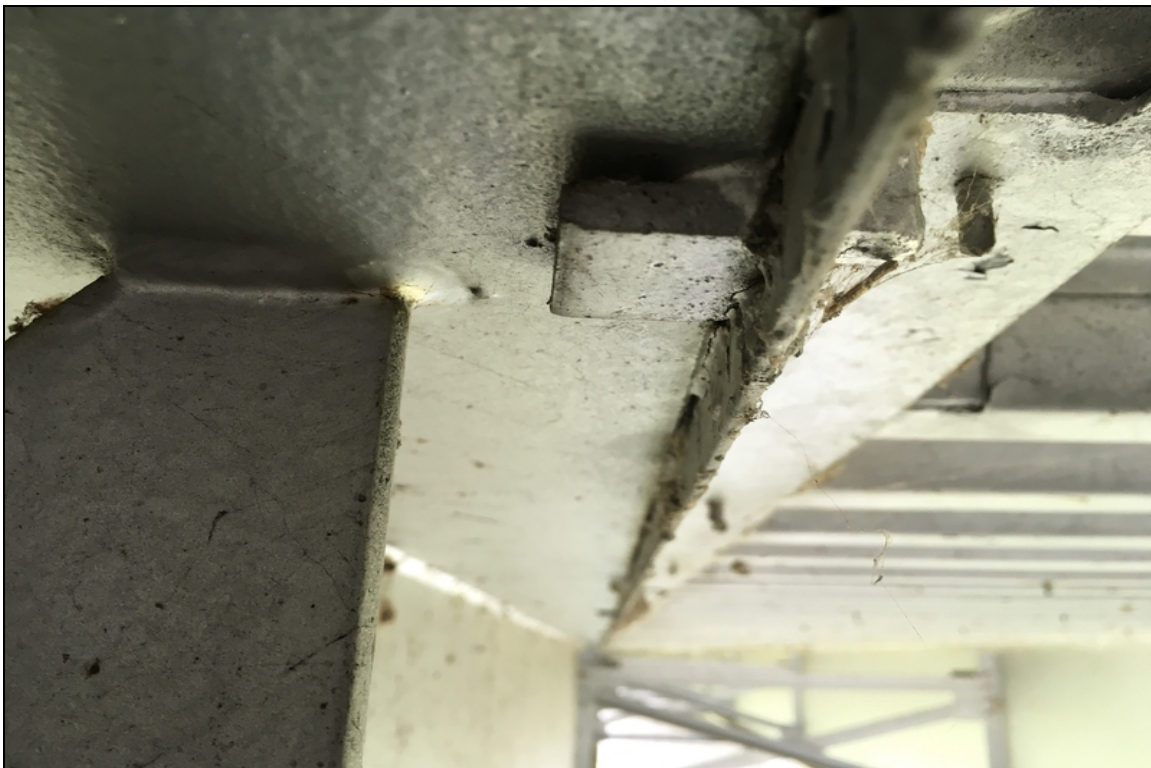
Cracked weld at upper diaphragm connection #6 at beam #6 span #6 typical of both sides of the diaphragm. Typical also of several locations in span #9 bay #5.

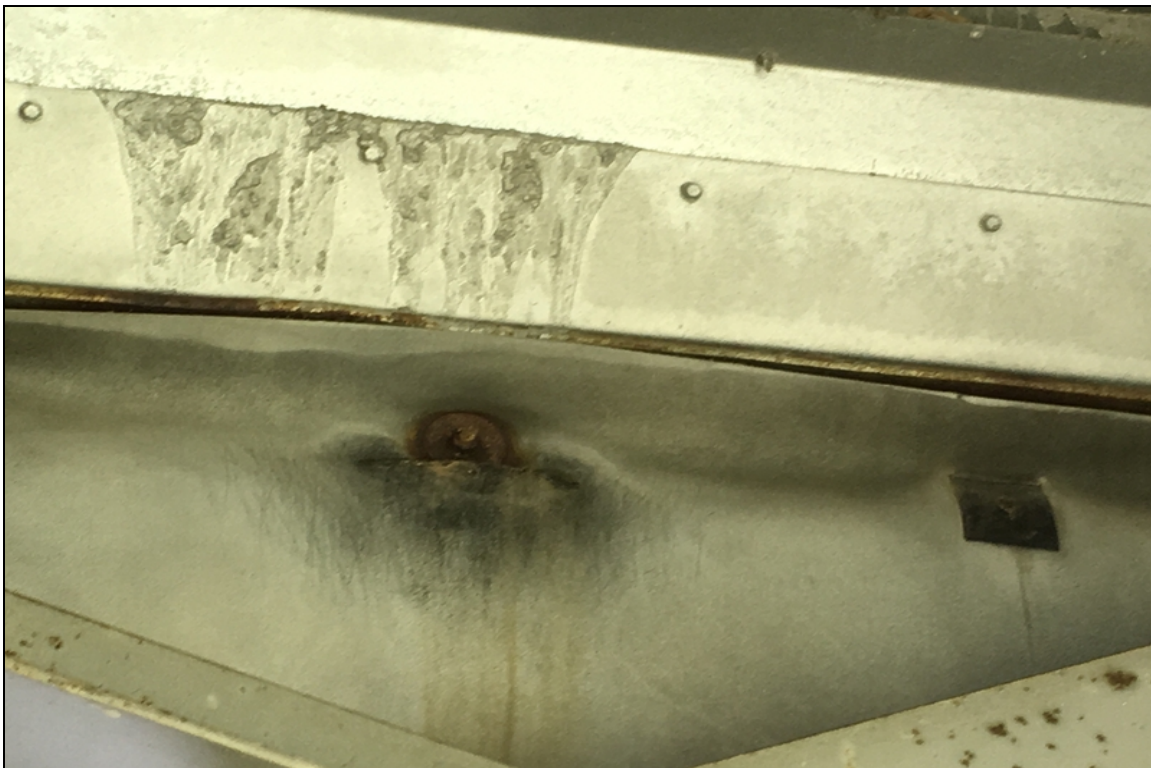
Tears in the trough connections at the pier #6 assembly joint.

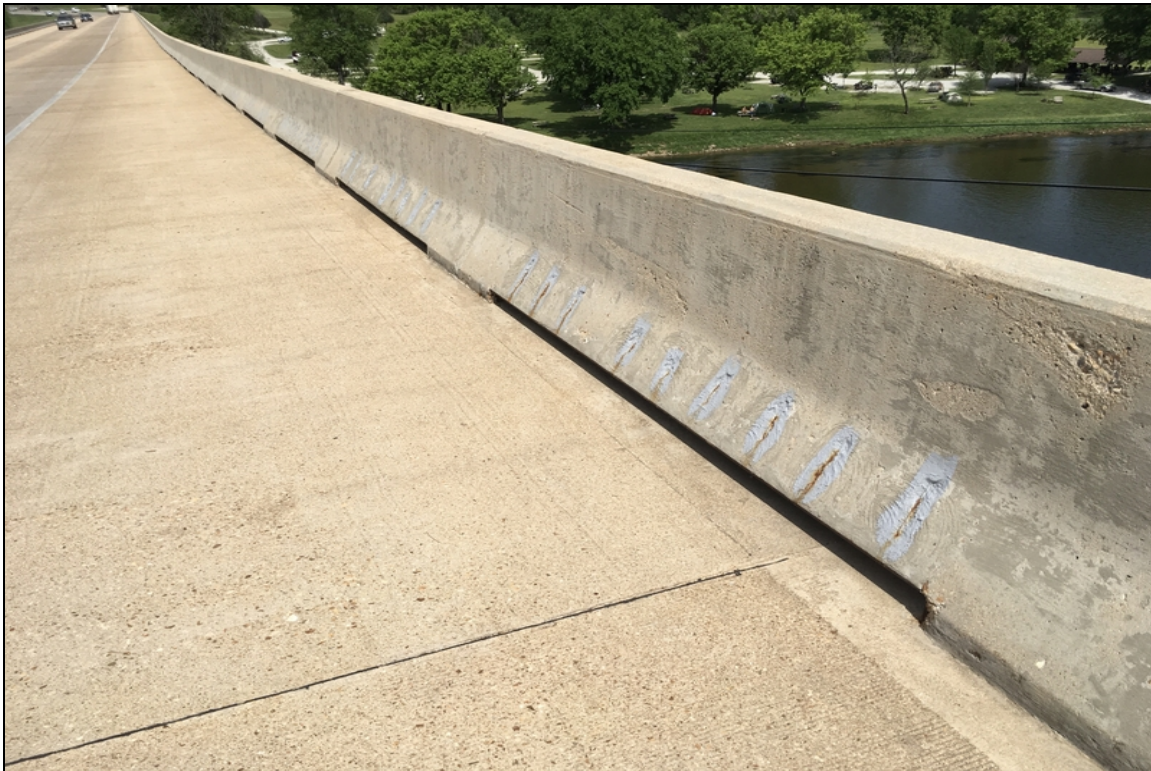
Typical view of shallow exposed rebar in the left and right parapet walls.

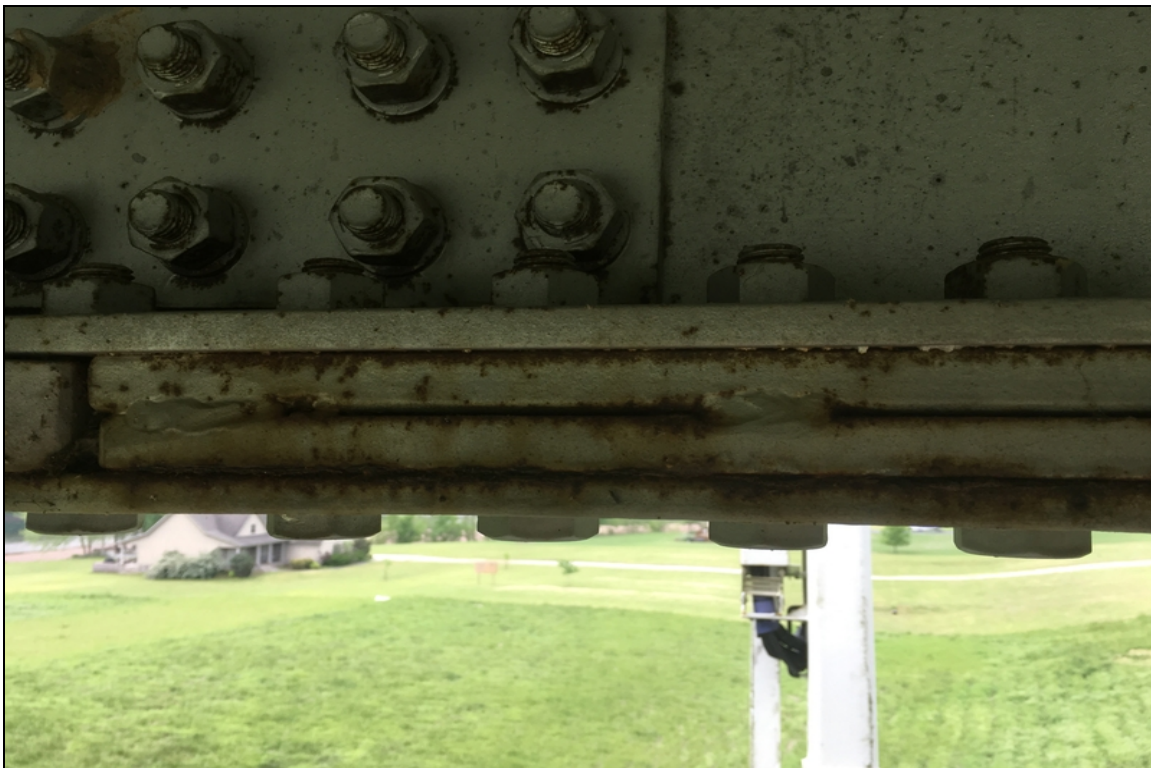
Pack rust is beginning to form on the bottom connection of the second splice in span #2.

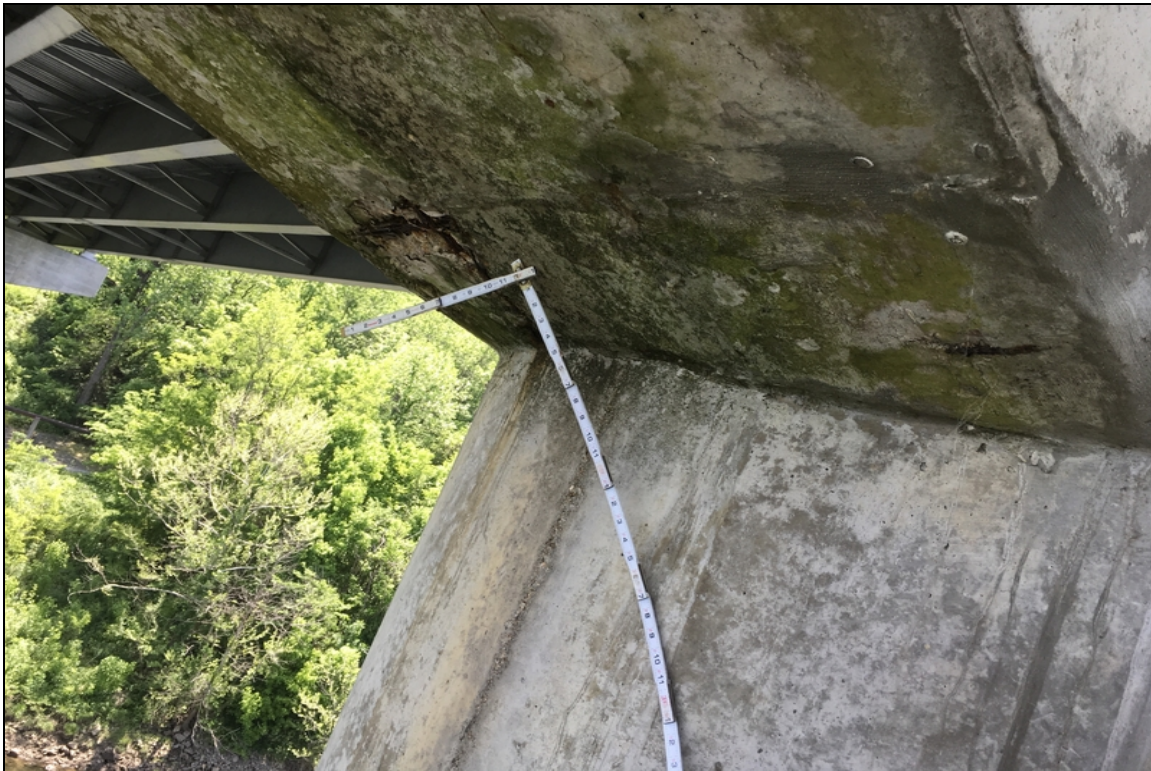
Spall with exposed rebar on the underside of the left cantilever of pier #9.
