Bridge #06059(Routine)

US 62/412 Marion over WHITE RIVER

Team Lead: Benjamin Smith Inspection Date: June 17, 2020

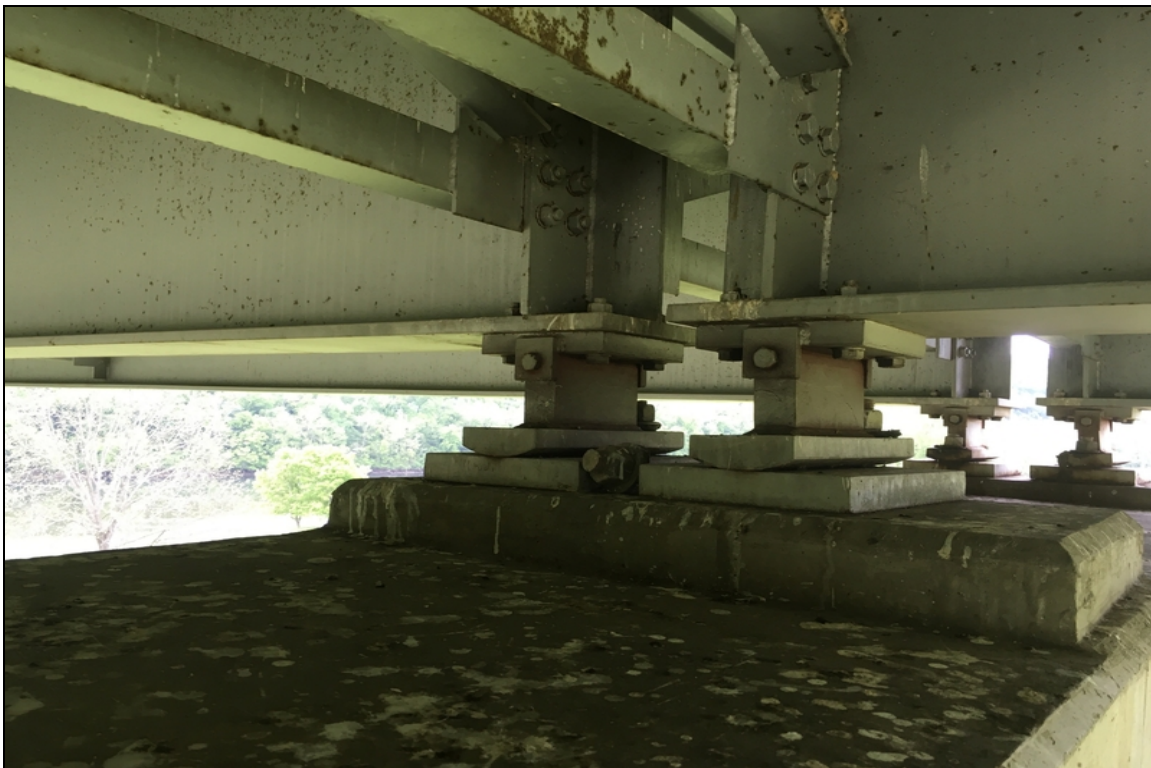
Both anchor bolts are missing on the left side of beam #5 over pier #3.

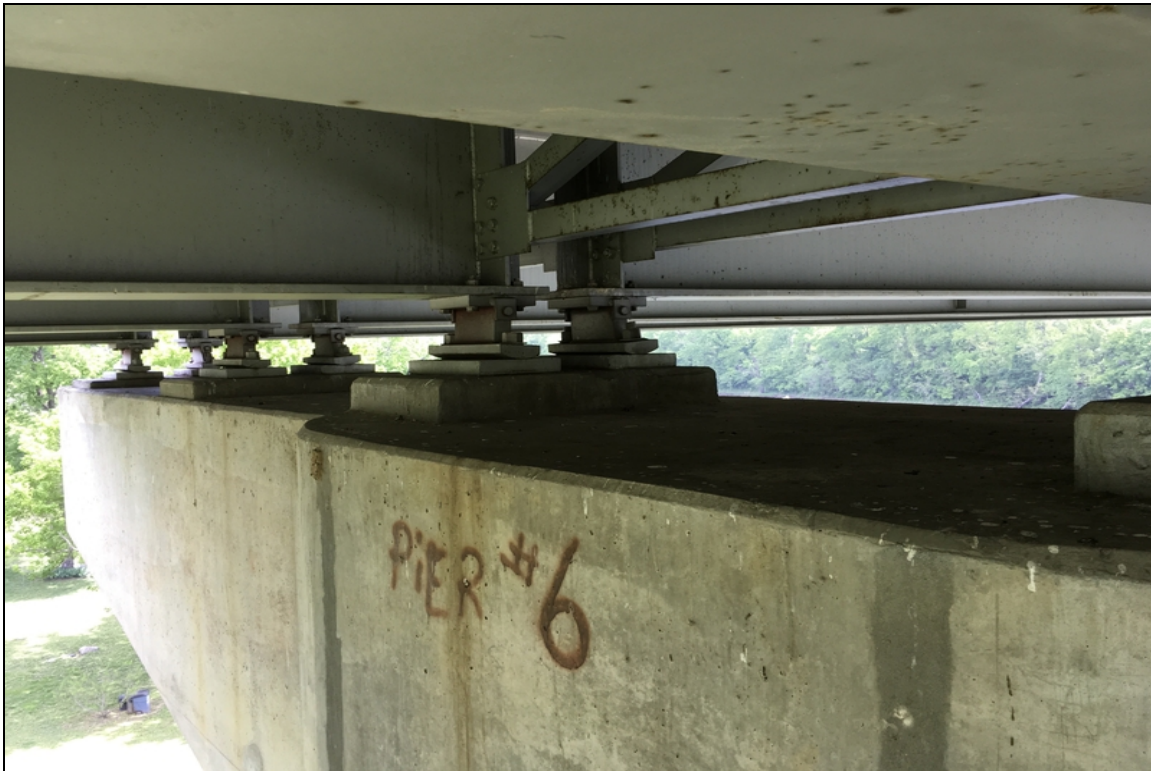
Moveable bearing condition at pier #6. Minor corrosion with no section loss. Typical of all 12 at this location.

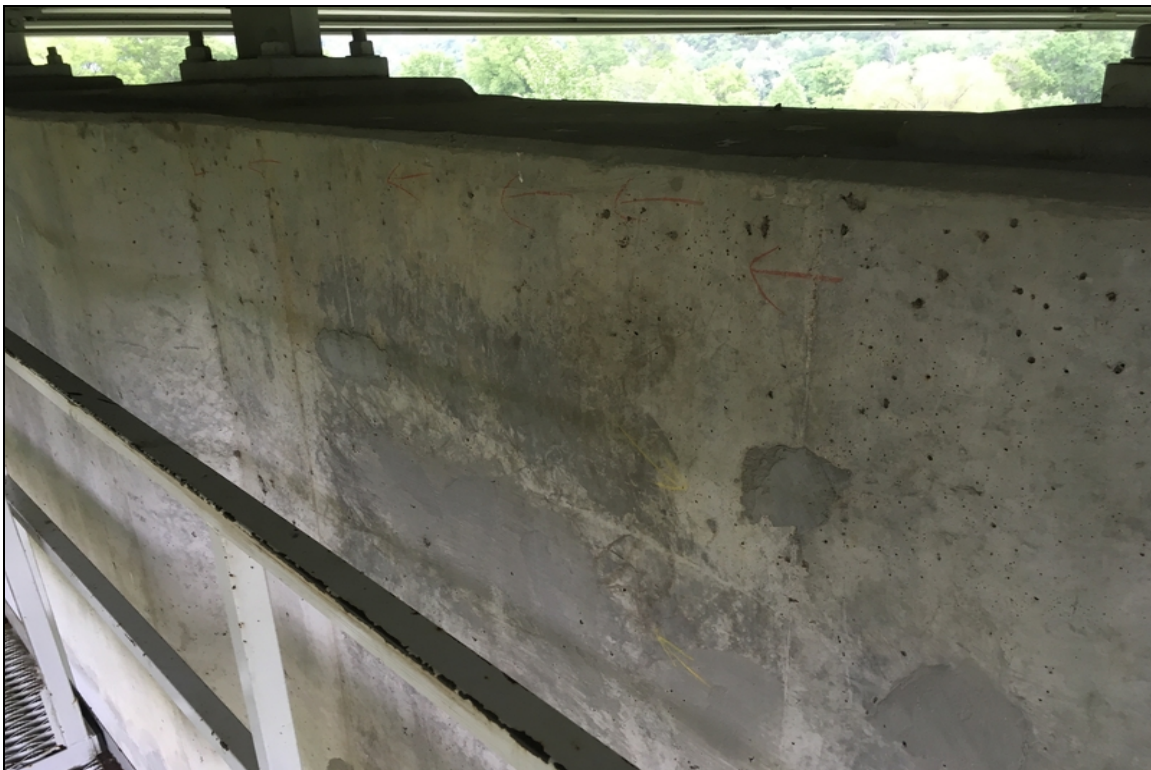
Hairline vertical Cracking in the pier caps. Typical.

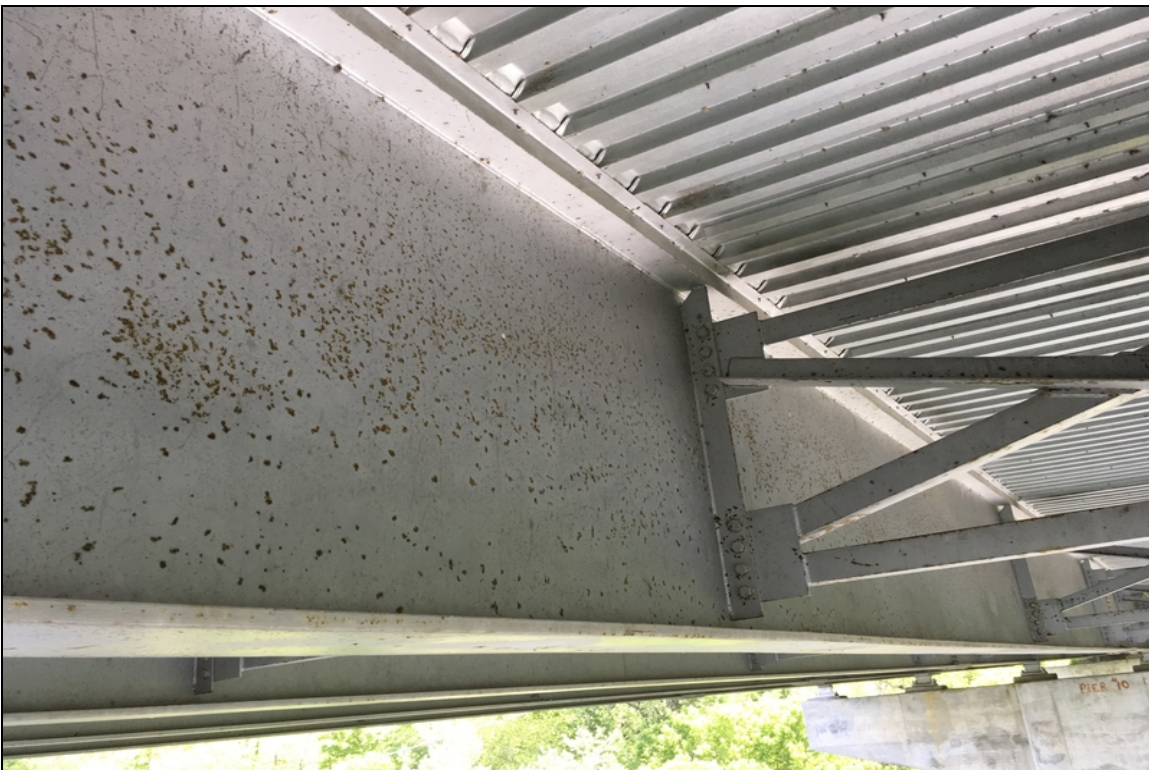
Paint condition in span #10. Worst case condition beam #3.

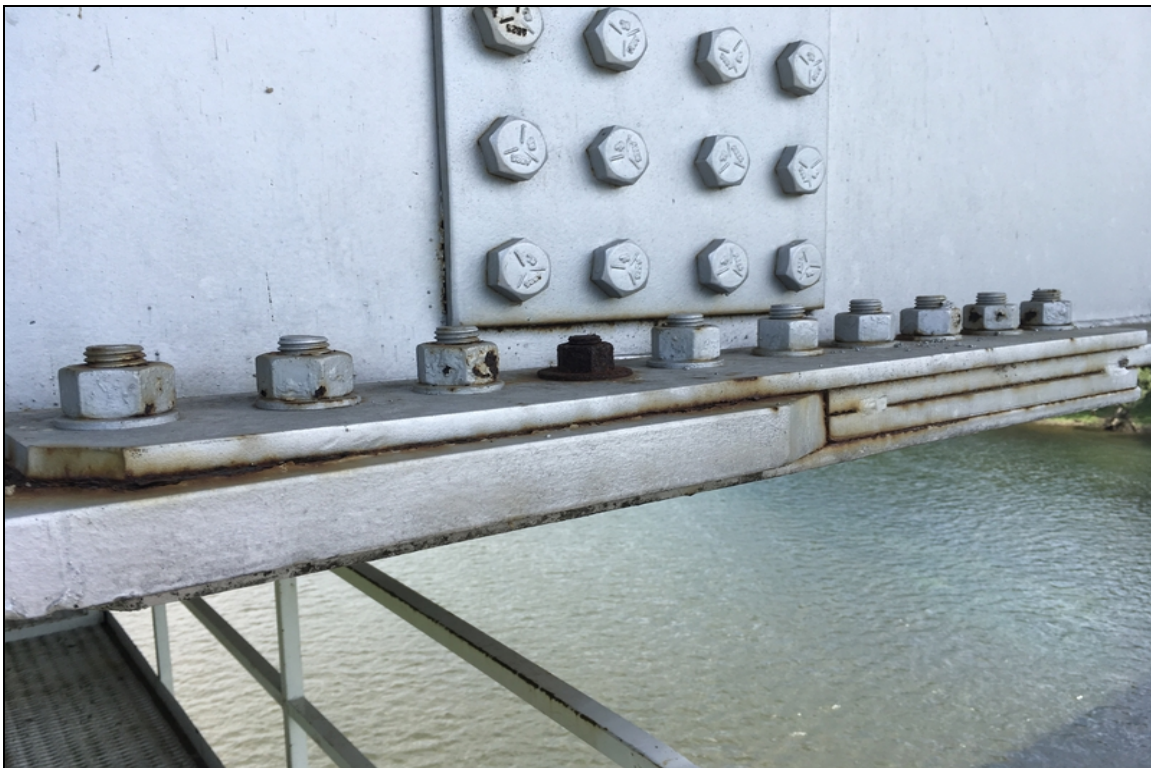
Smaller bolt in the first field splice of beam #6 in span #8. Minor pack rust has begun to form on the lower connection.

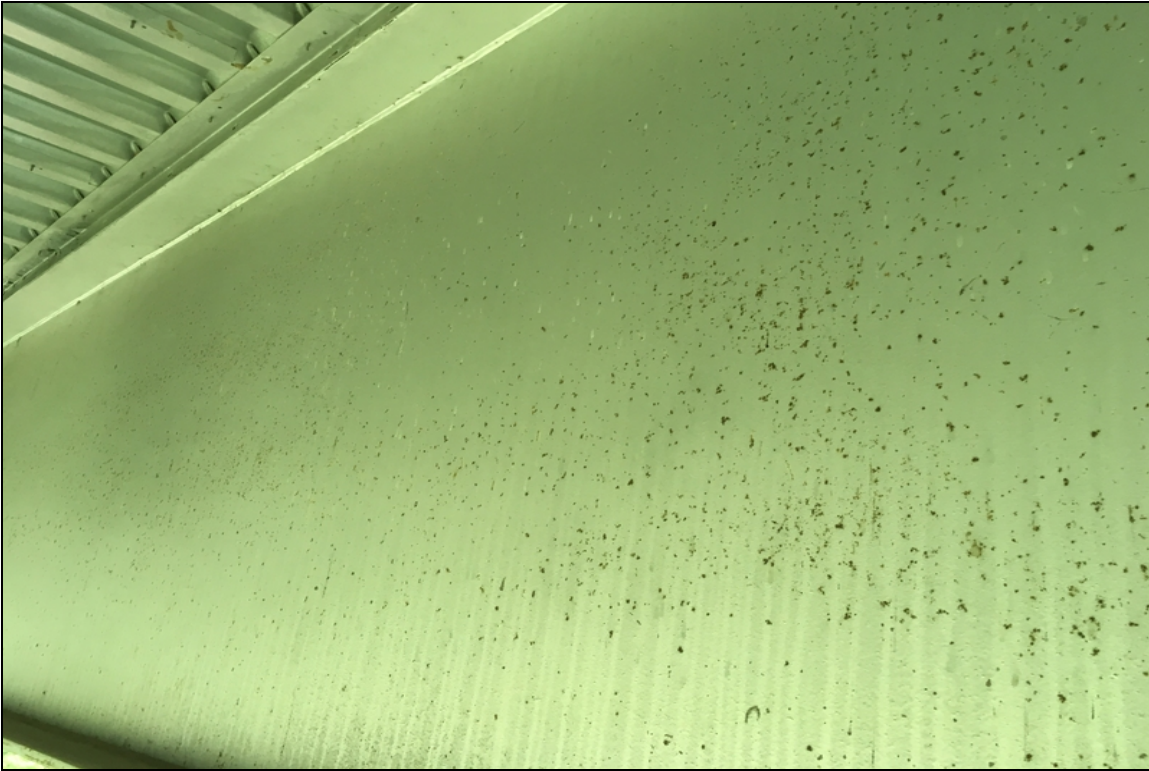
Pin point rusting on beam #4. Worst case condition in span #2.

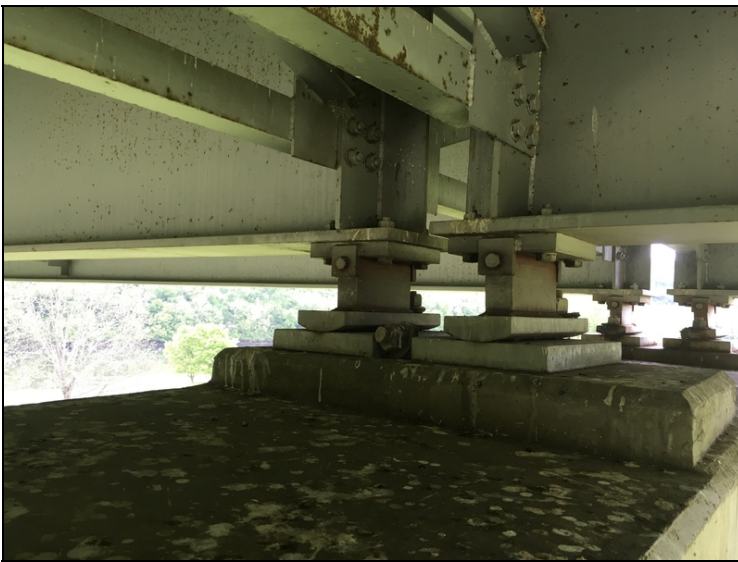
Both anchor bolts are missing at pier #3 girder #5 on the span #2 and #3 sides.

Both anchor bolts are missing on the left side of beam #5 over pier #3.

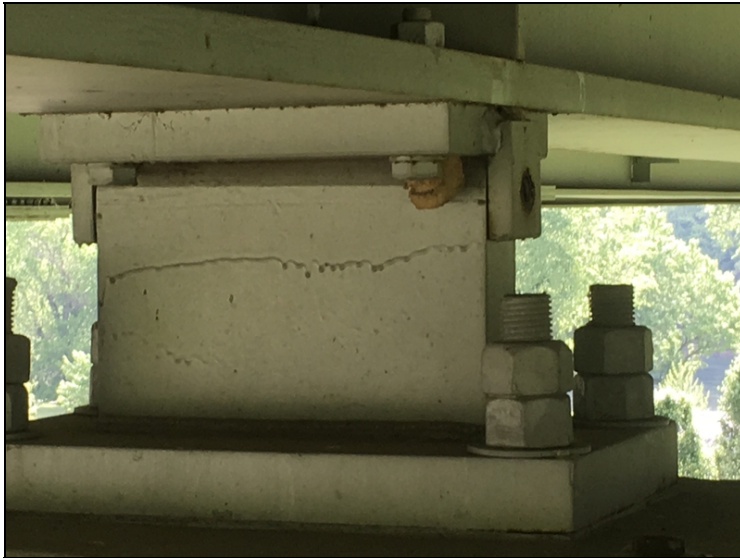
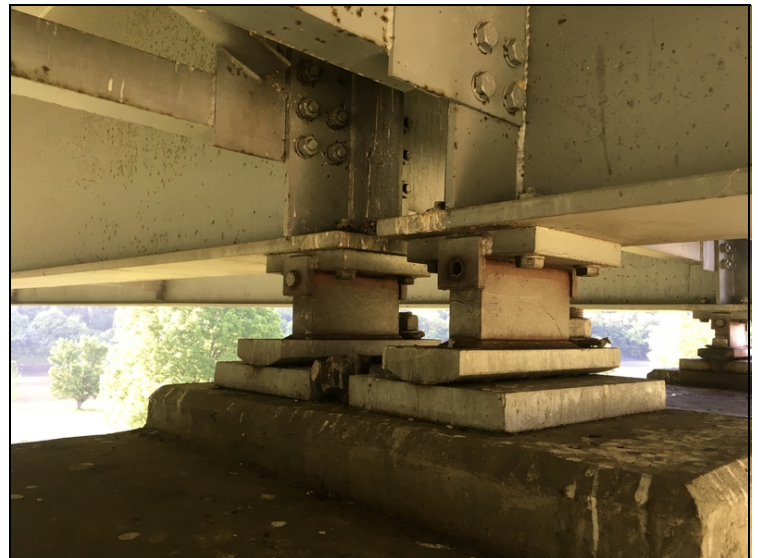
Sheared or loose sole plate bolts at

Pier #2 on Girder #3 Pier #3 on Girder #5 Pier #6 on Girder #6 Pier #7 on Girder #5 Pier #9 on Girder #1 & #6 Pier #10 on Girder #6.

Anchor bolts and the horizontal sole plate bolts are missing at beam 5 pier 3.

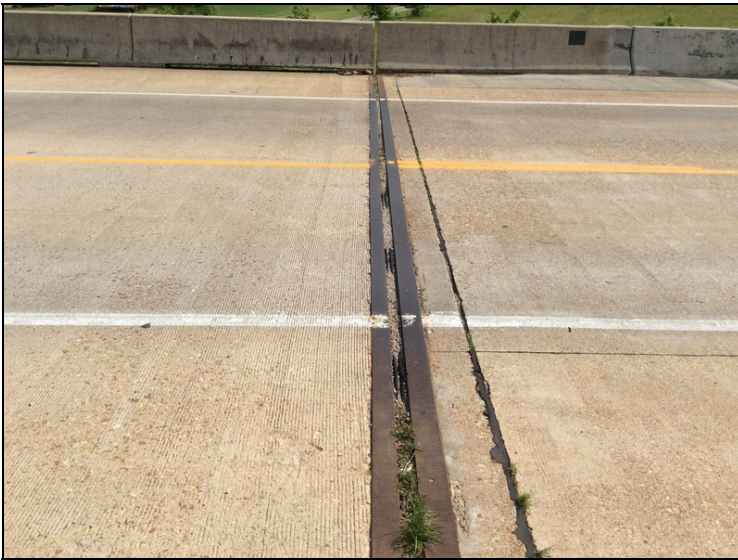
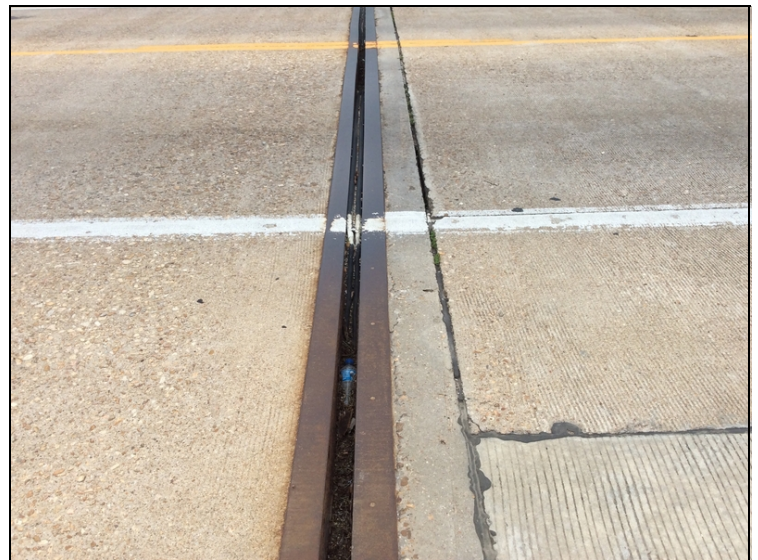
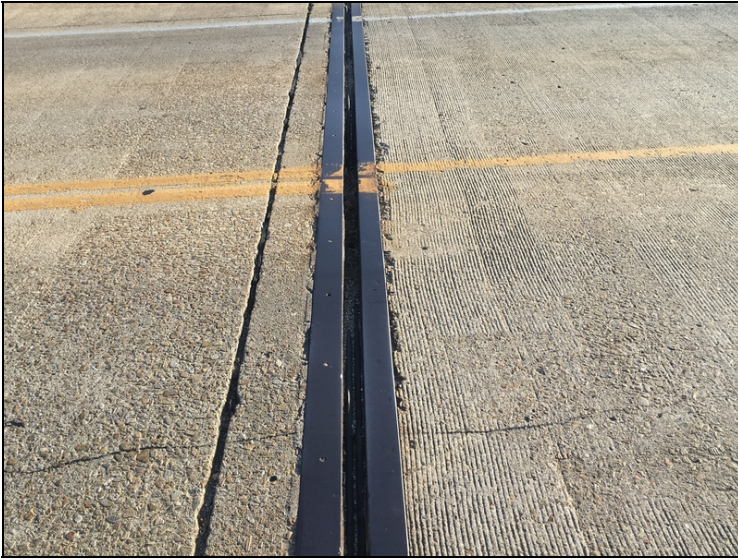
The compression joint seals have portions dislodged and leaking at abutments #1,2.

Joint seal condition at abutment 1 showing leakage and loss of adhesion.

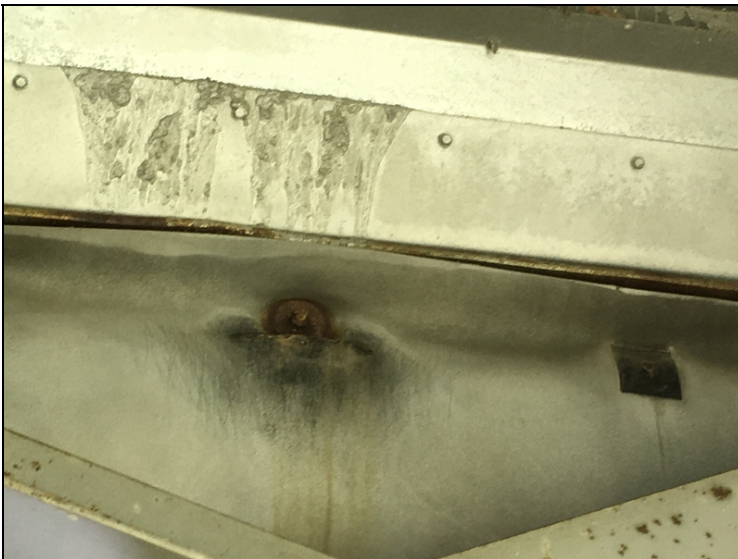
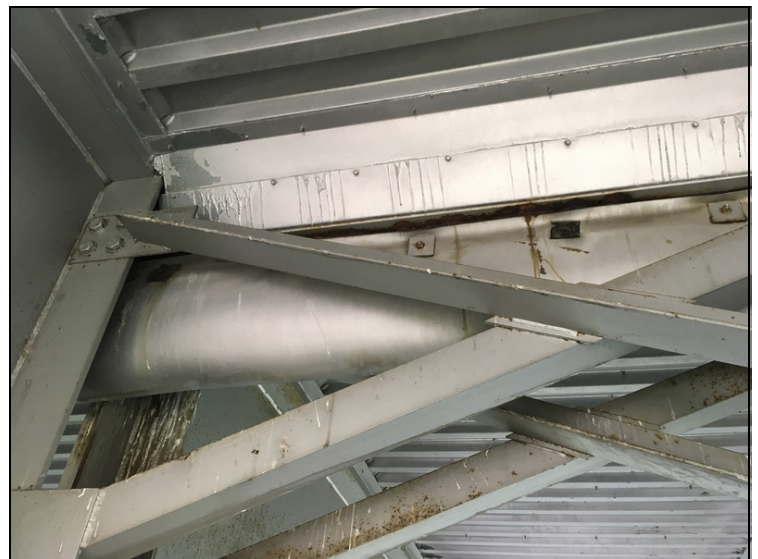
The neoprene troughs beneath the assembly joints at piers 3, and 6 are completely filled with debris and have sections ripped.

The neoprene trough beneath the assembly joint at pier 9 is partially filled with debris.

The joints are not draining as intended.

Some of the neoprene trough attachments are missing.

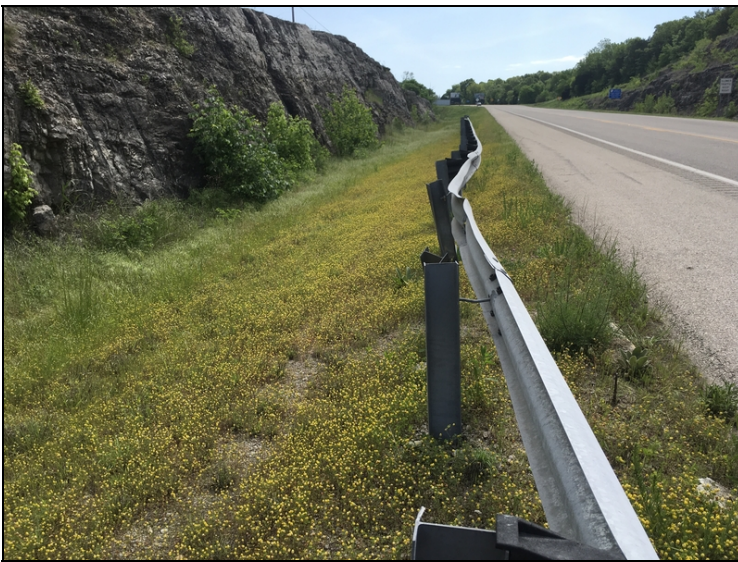
The left ending approach railing has 26' of vehicle damage.

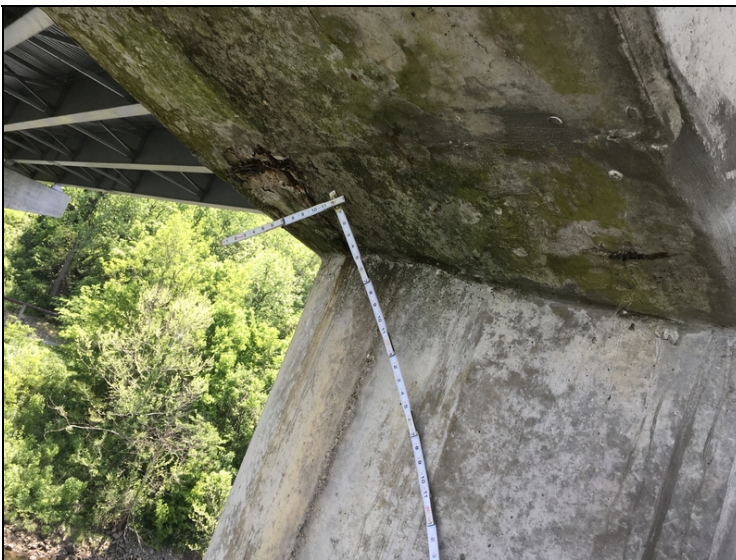
The underside of the left cantilever of pier #9 has a spall with rebar exposed.

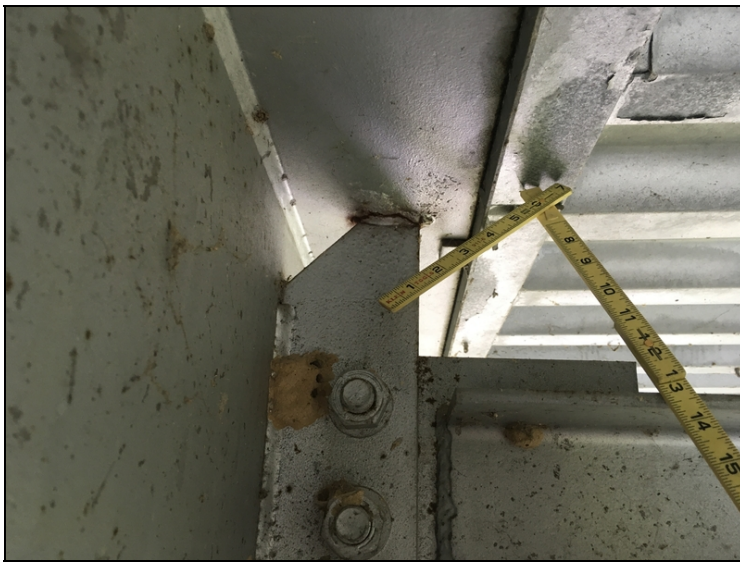
A fully cracked upper diaphragm weld was noted on diaphragm 4 on beam 6 in span 11 and a fully cracked weld was noted in the top of diaphragm 4 in span 5 on beam 6.

Fully cracked weld in the top of diaphragm 4 in span 5 on beam 6.

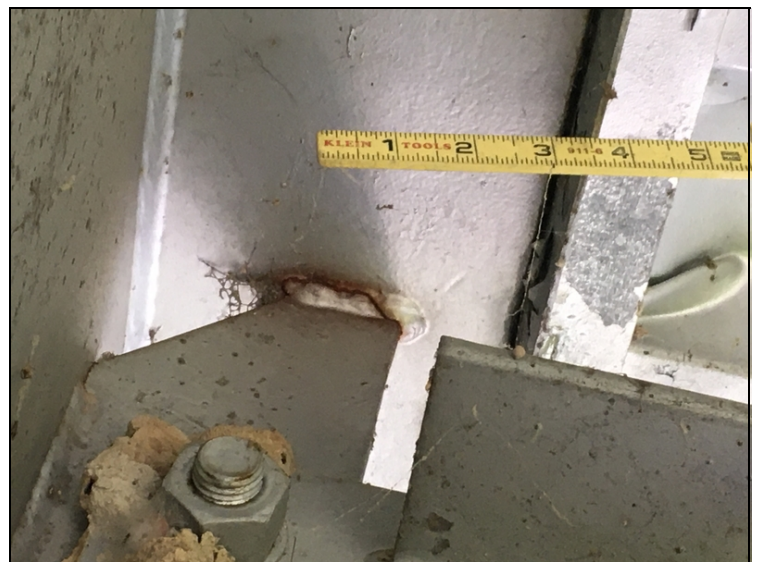
Fully cracked upper diaphragm weld on diaphragm 4 on beam 6 in span 11.
