Bridge #06577(Routine)

US 412 S-5 Carroll over DRY FORK

Team Lead: Benjamin Smith Inspection Date: May 26, 2020

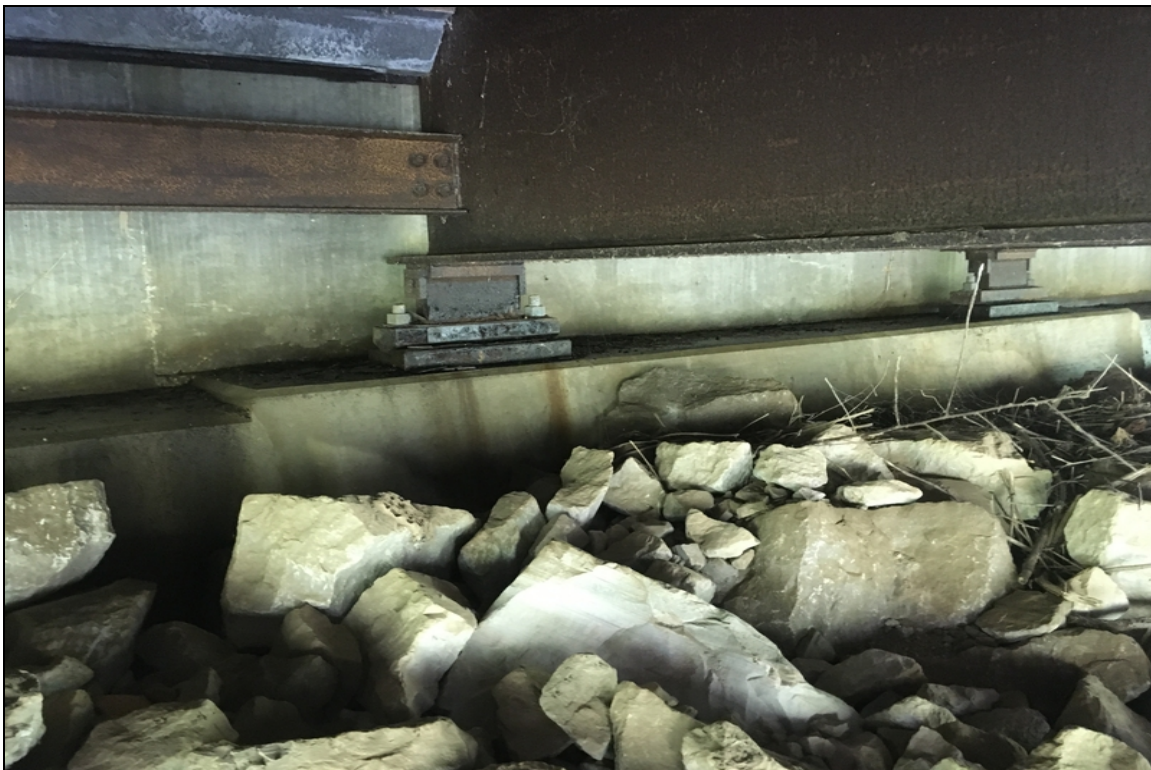
(311)							
Abutment #1 moveable bearings- bearings #1,4,5,6 have heavy corrosion with flaking rust at the masonry plate and rocker areas, bearings #2,3 have cs2 corrosion. One of the sole plate bolts has sheared off at bearing #5.							
Abutment #2 moveable bearings- bearings #2,3,5,6 have heavy corrosion with flaking rust on the masonry plates and rocker areas. Bearings #1,4 have cs2 corrosion.							
313	Fixed Bearing	EA	12	12	0	0	0

Bearing 4 at abutment 1 showing corrosion with flaking rust. Typical of other locations.

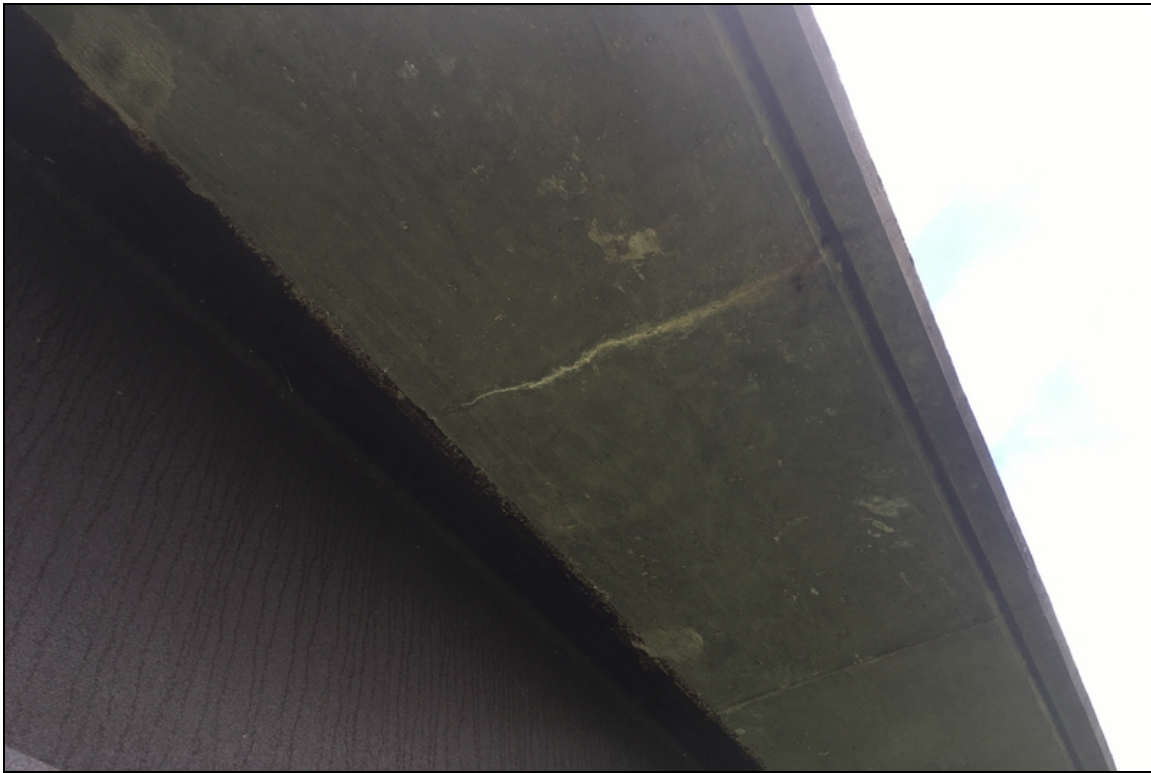
(12)	<p>The driving surface of the deck has a tined finish that has wear in the wheel paths, this wear was not quantified due to longitudinal cracking in the same location.</p> <p>Driving surface- has 14' of wear in the wheel paths for the length of the structure. Longitudinal hairline cracking exists in the same location as the wear for the length of the structure in all spans. Very few transverse cracks were noted in the gutter lines. The cracking has been sealed in the past with epoxy.</p> <p>Undersurface- the undersurface has sip forms in all bays of all spans. Very minor corrosion was noted in the sip forms beneath a construction joint in span #2.</p> <p>Span 1- has 12' of cs2 efflorescence in the overhangs.</p> <p>Span 2- has 22' of cs2 efflorescence in the overhangs.</p> <p>Span 3- has 14' of cs2 efflorescence in the overhangs.</p>						
107	Steel Open Girder/Beam	LF	1050	1050	0	0	0

Typical efflorescence in the deck overhangs.

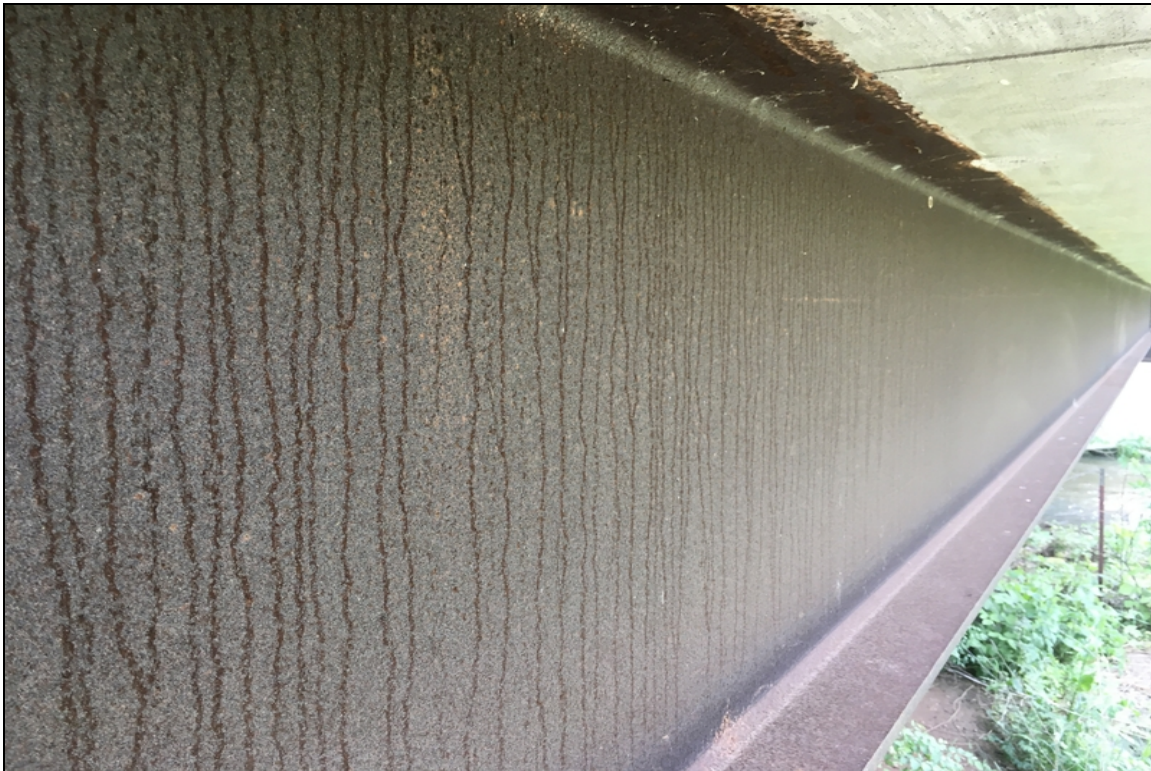
Typical weathering steel protective coating condition.

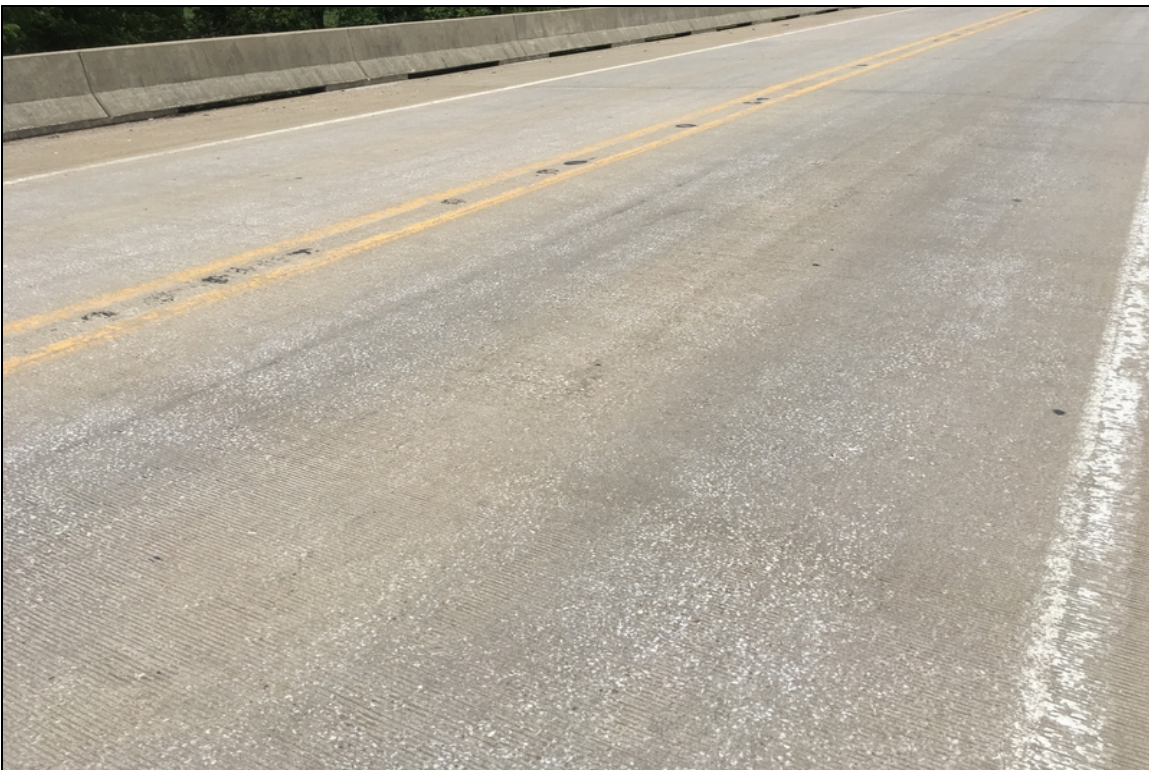
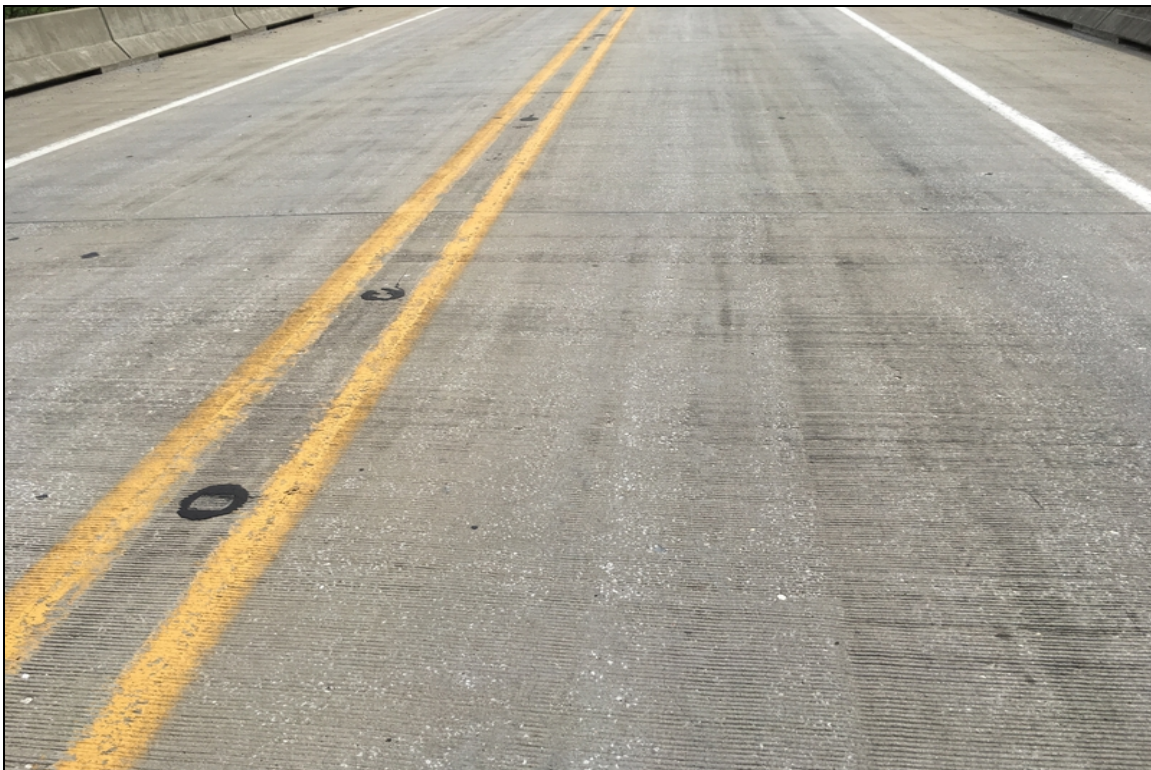
Typical view of driving surface.

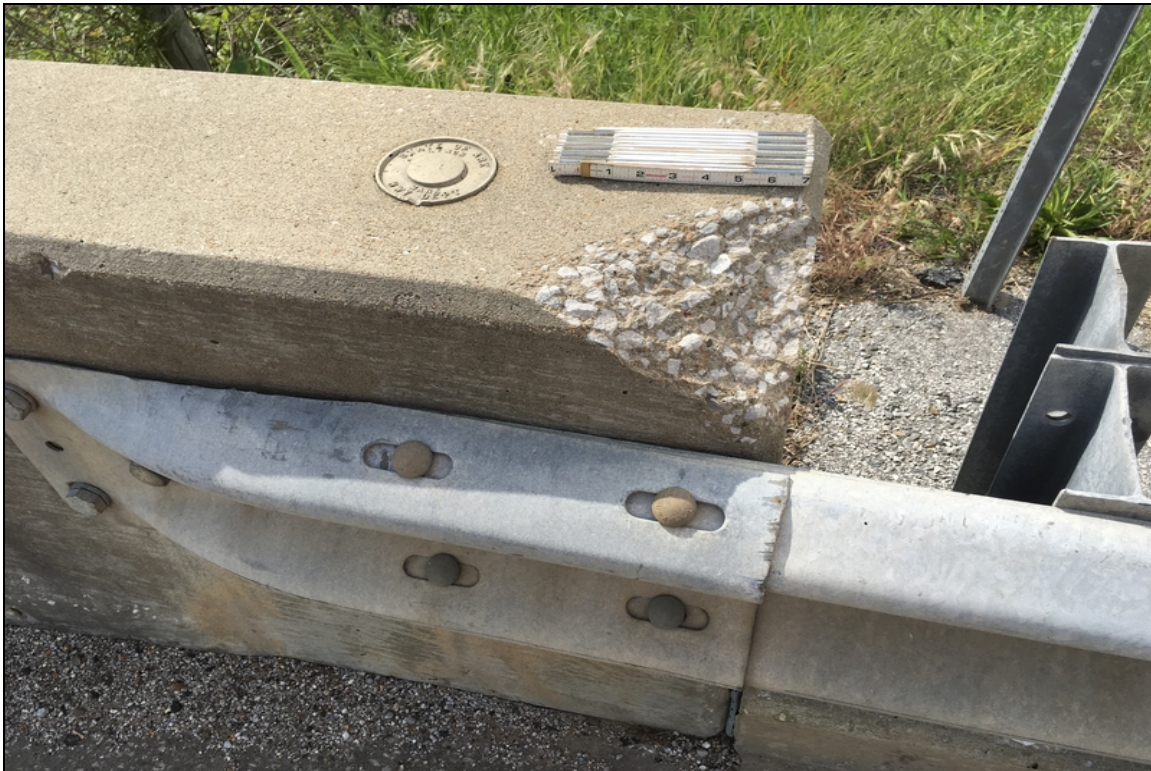
(331)							
Left side parapet wall -has 31' of hairline vertical cracking at the saw joints and the top corners of the drain areas.							
Right side parapet wall- has a spall with no rebar exposed at the beginning of the parapet on the top edge. The parapet wall has 25' of vertical hairline cracks at the corners of the drain areas and saw joints..

Spall with no rebar exposed at the top edge of the beginning of the right parapet.

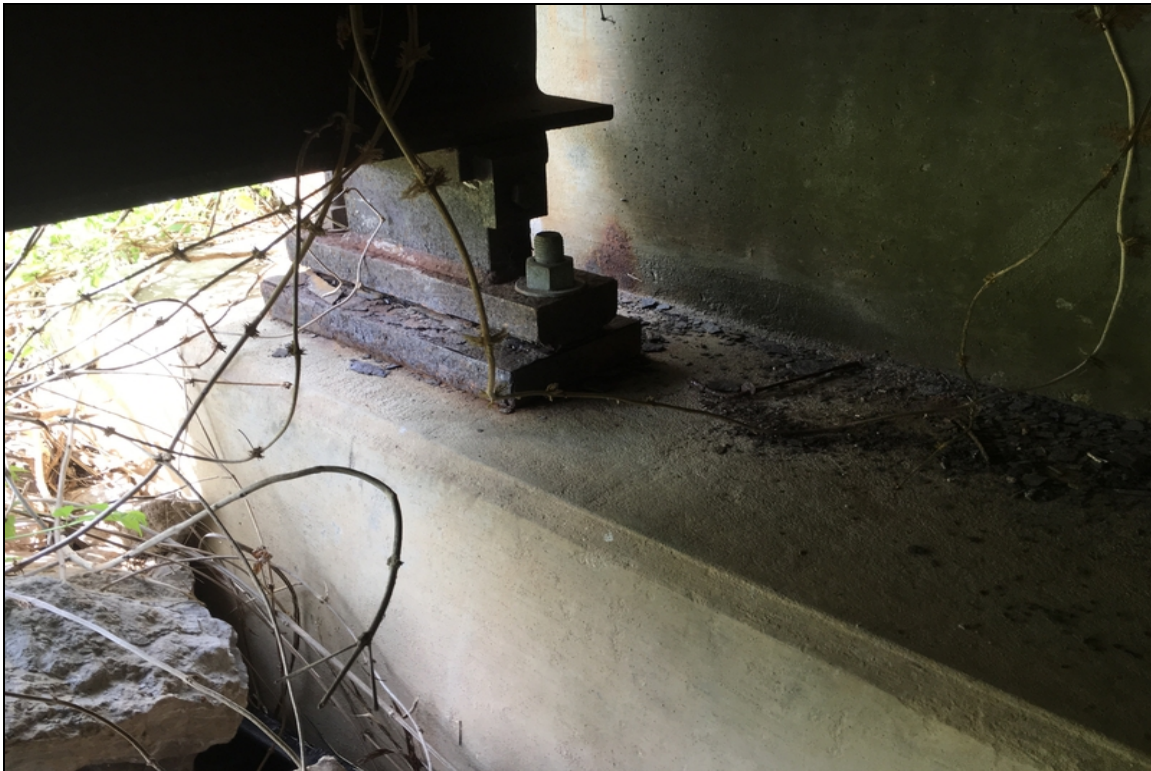
Condition of bearings 1,4,5,6 at abutment #1.

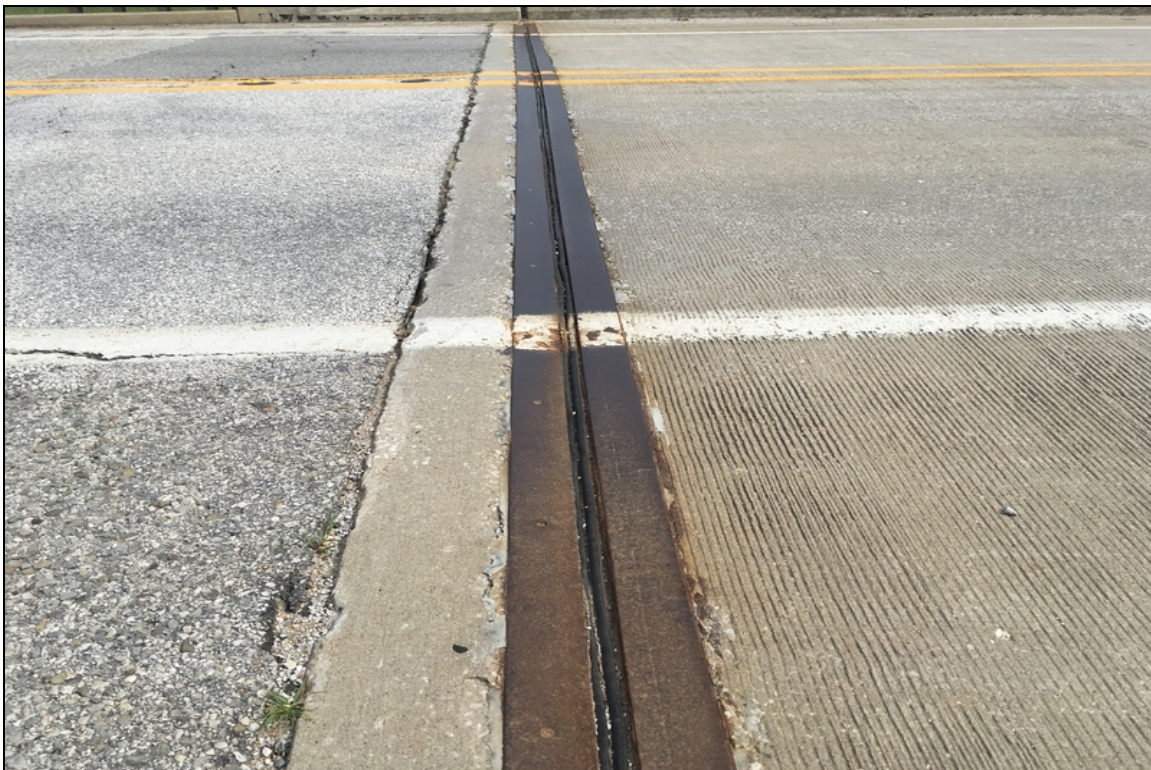
(302)							
Abutment #1 compression joint seal- has pack rust between the joint seal and the armoring plate that is causing loss of adhesion and leakage.							
Abutment #2 compression joint seal- has 17' of cracking in the top of the seal. The seal has pack rust between the joint seal and the armoring plate that is causing loss of adhesion and leakage.							
311	Movable Bearing	EA	12	0	4	8	0
1000	Corrosion	EA	12	0	4	8	0

Condition of compression joint seal at abutment #1.

The compression joint seals at abutments #1,2 have pack rust between the joint seal and the armoring plate that is causing loss of adhesion and leakage, and is causing corrosion on the bearings.

**Type of Work:** Replace

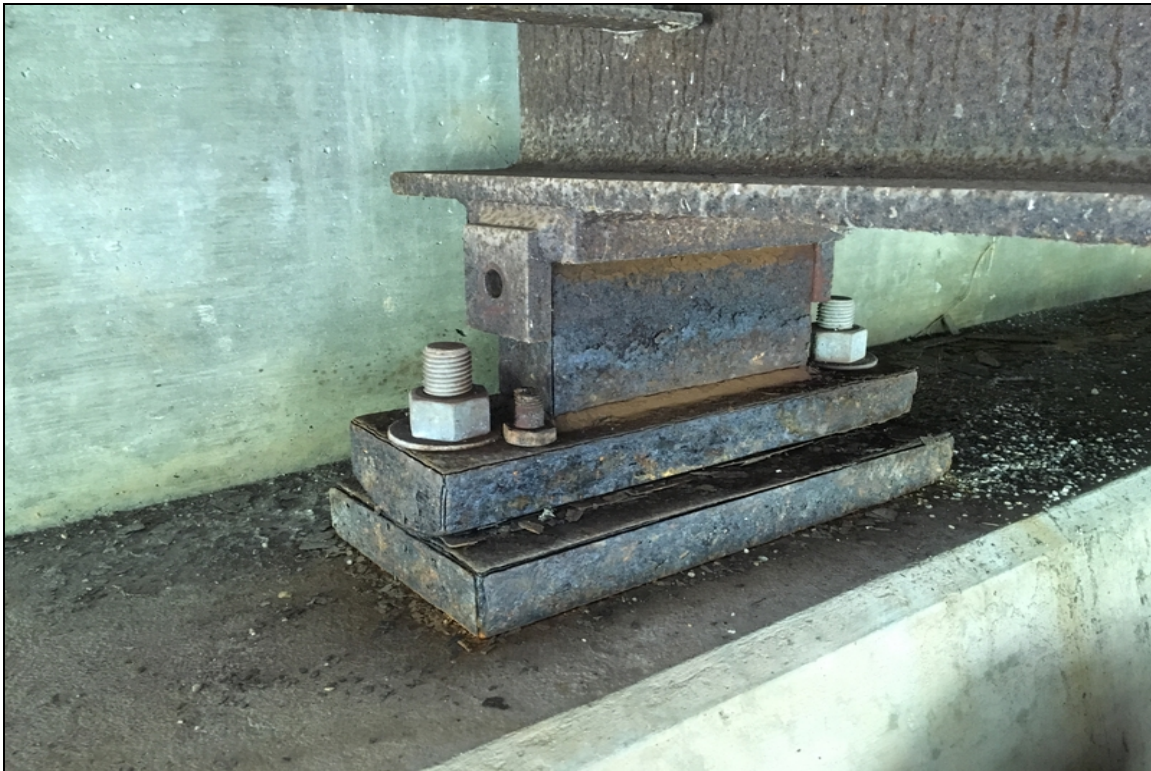
Sole plate connection bolt is sheared off at bearing #5 at abutment #1.

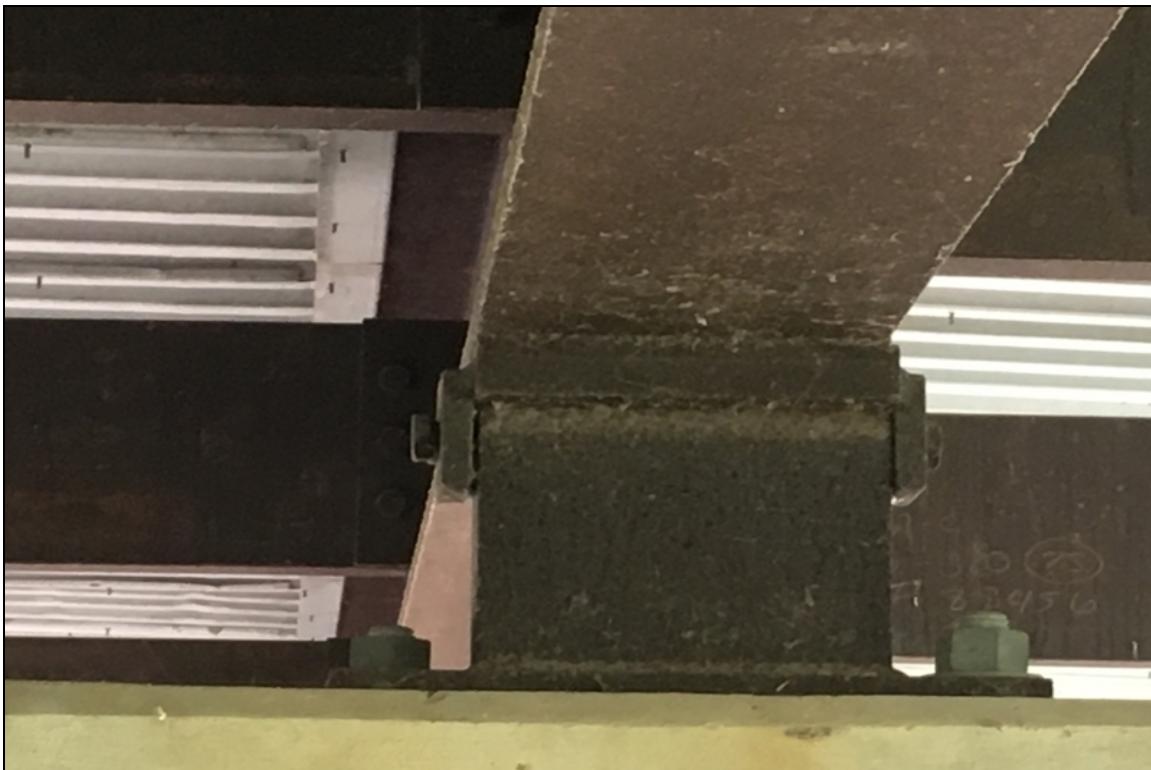
(313)							
Pier #1 fixed bearings - no deficiencies noted.							
Pier #2 fixed bearings- no deficiencies noted. The sole plate bolt at bearing #2 is not fully tightened.							
331	Reinforced Concrete Bridge Railing	LF	350	293	56	1	0
1080	Delamination/Spall/Patched Area	LF	1	0	0	1	0
1130	Cracking (RC and Other)	LF	56	0	56	0	0

Beam #2 over pier #2. The sole plate bolt is not fully tightened. This condition is of little concern.

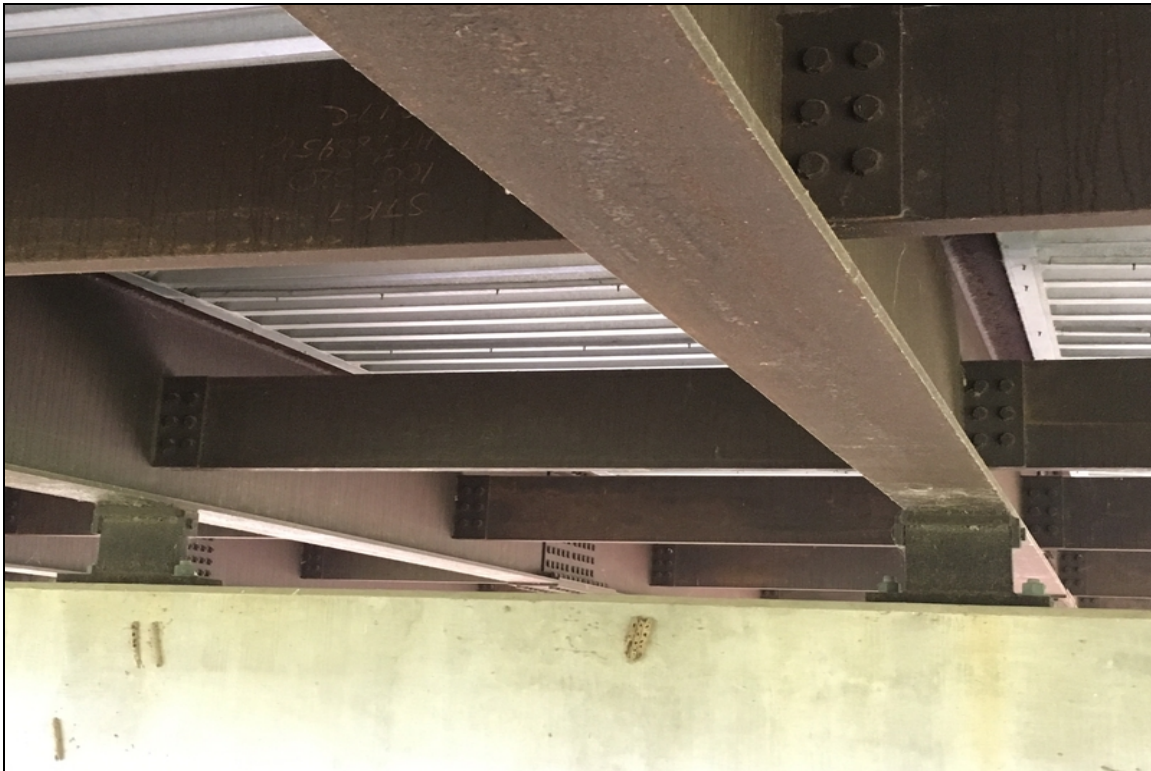
Bearing condition at pier #2. Typical of all 6 at this location.

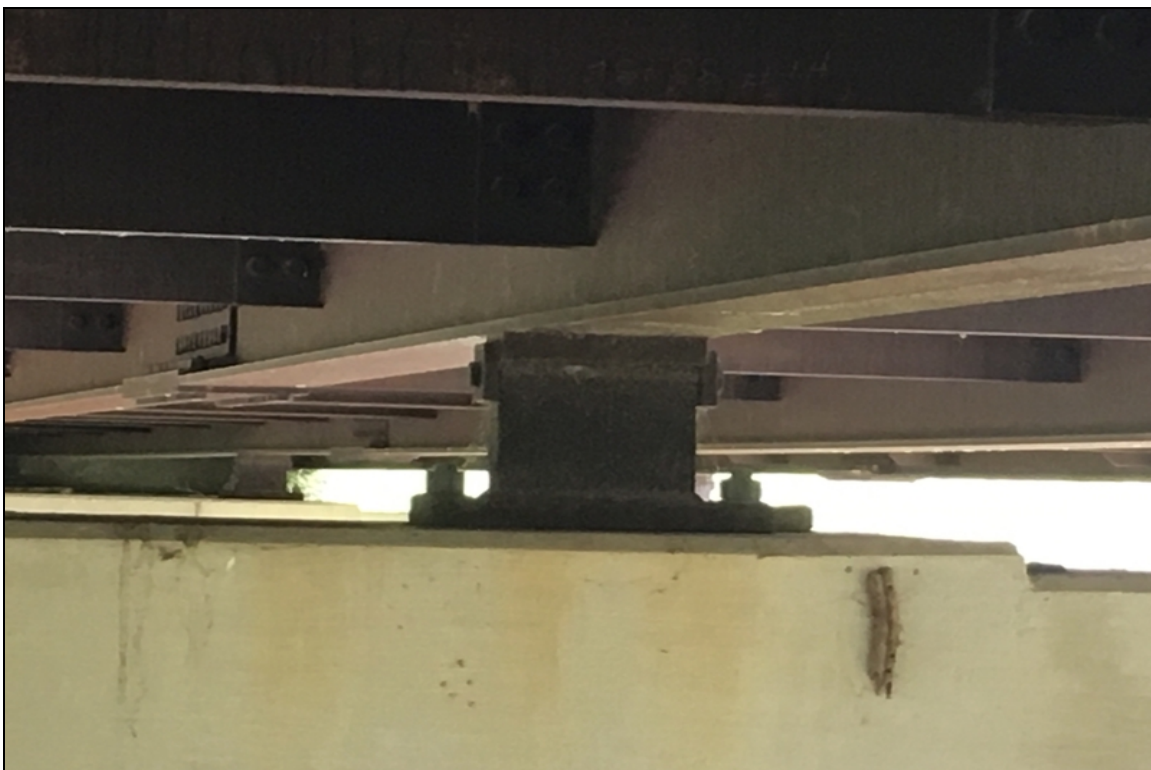
Fixed bearing condition at pier #1. Typical of all 6 at this location.

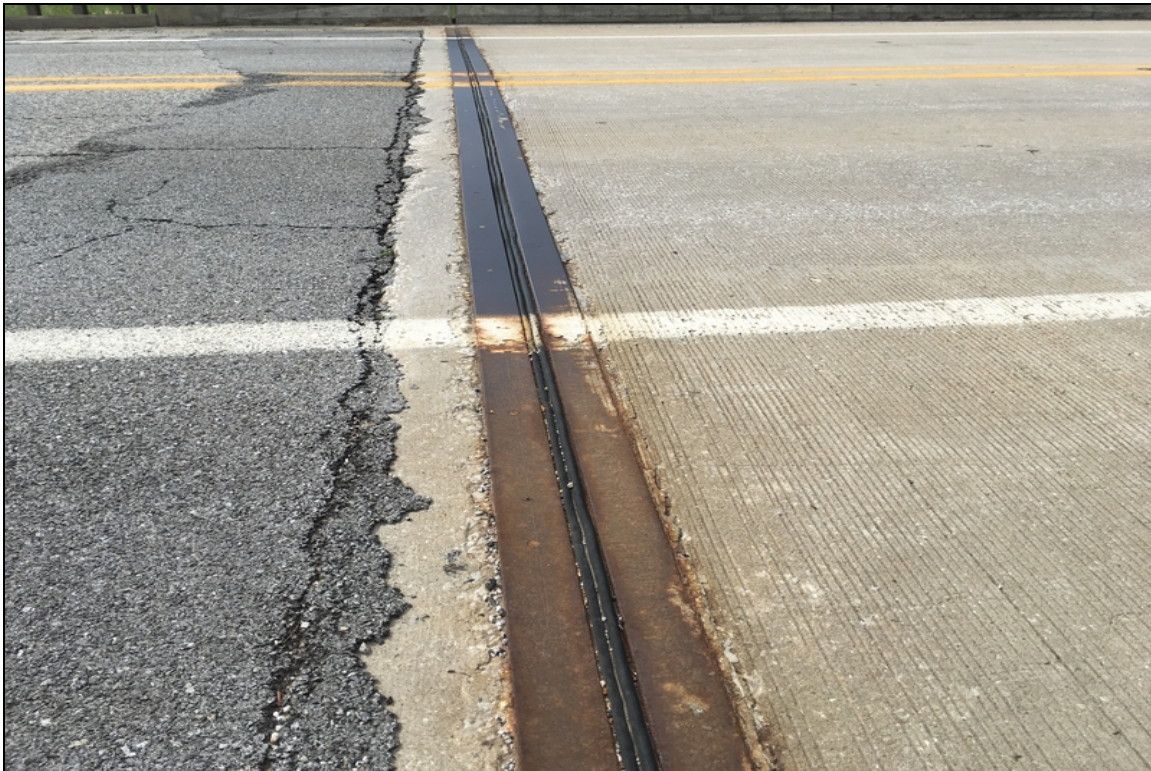
Condition of compression joint seal at abutment #2.

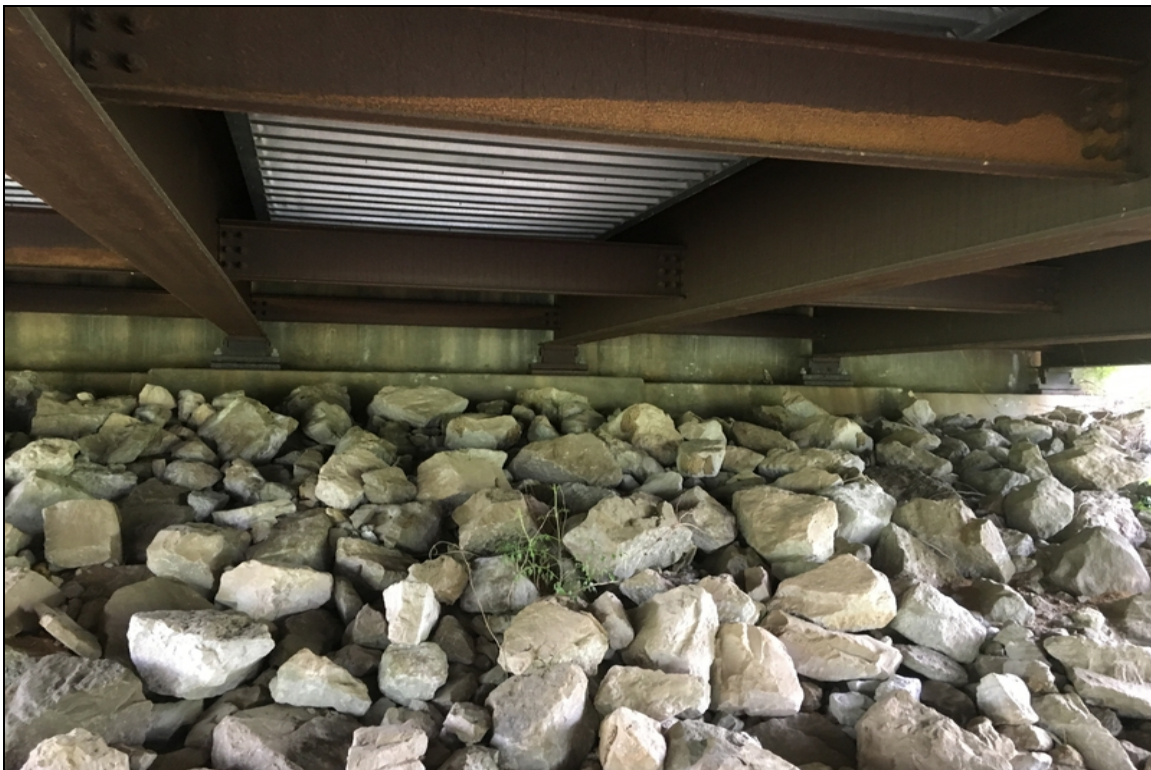
(215)	<p>Abutment #1- has 4 vertical hairline cracks. 1 in the back wall and 3 in the vertical face of the bridge seat.</p> <p>Abutment #2- has 8 total hairline cracks. 5 in the back wall and 3 in the vertical face of the bridge seat.</p>						
234	Reinforced Concrete Pier Cap	LF	82	71	11	0	0
1130	Cracking (RC and Other)	LF	11	0	11	0	0

General view of abutment #2. Typical also of abutment #1.

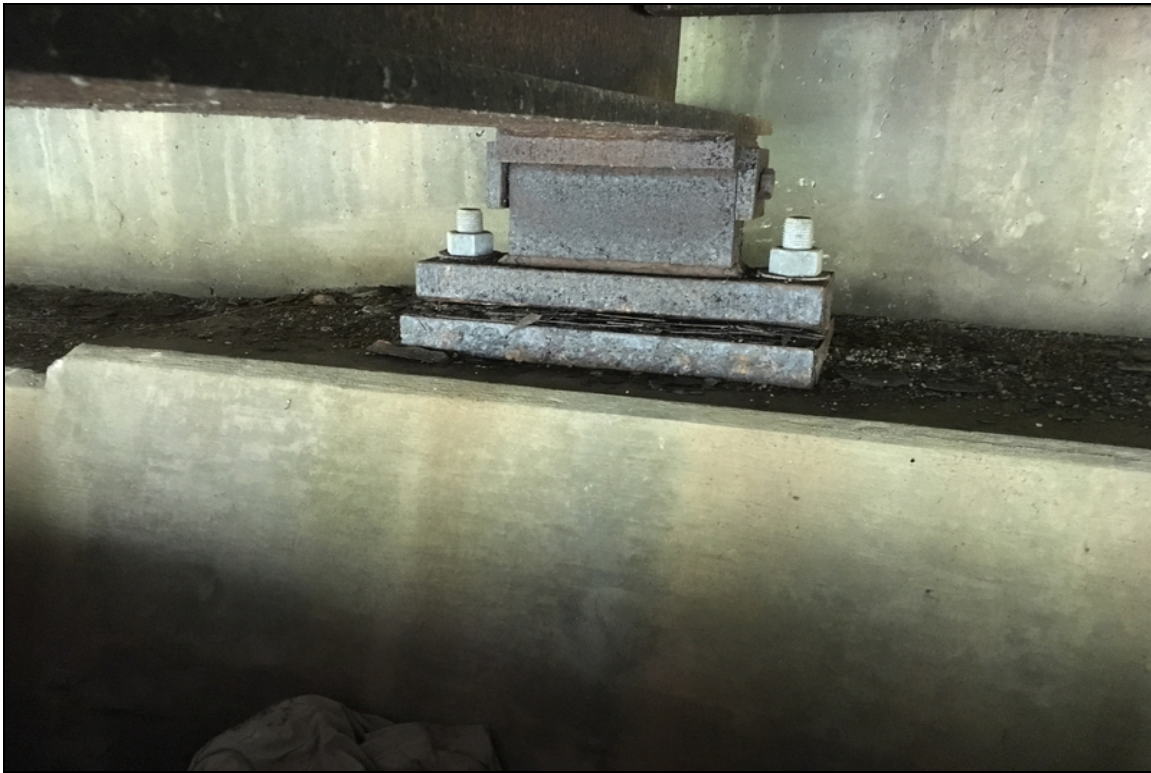
Typical bearing condition of bearings 2,3,5,6 at abutment #2.

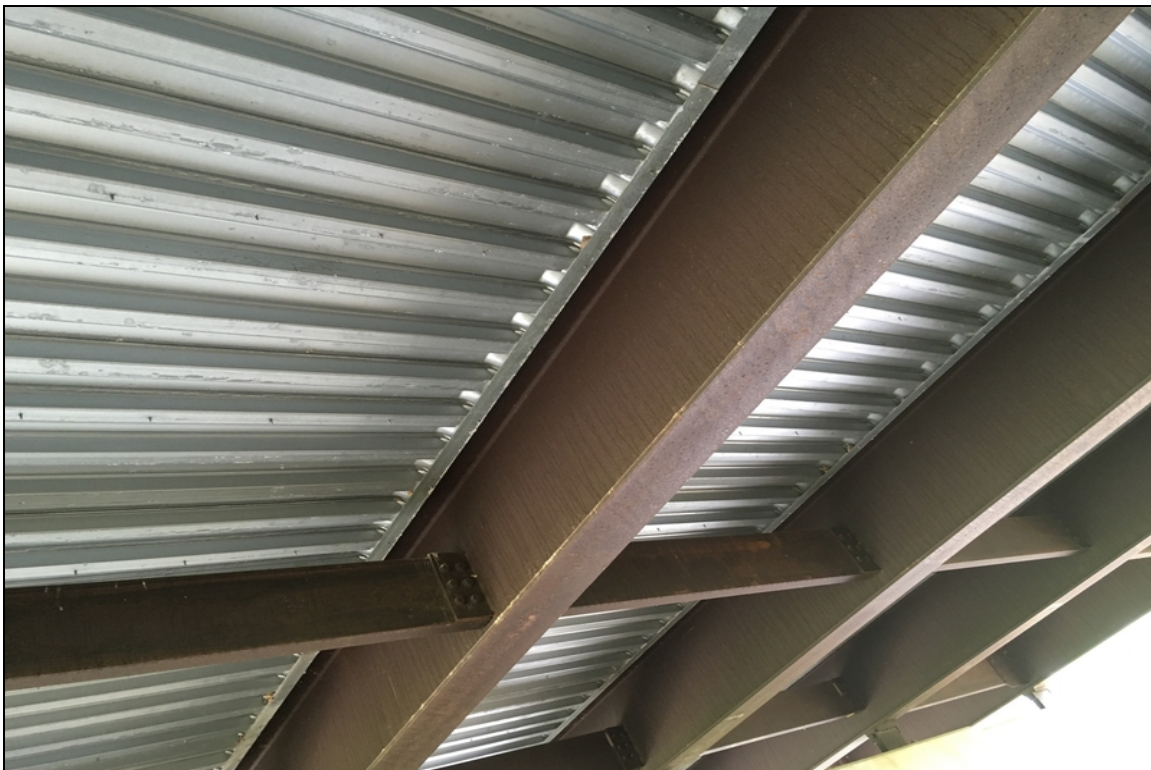
Typical view of the protective coating condition.

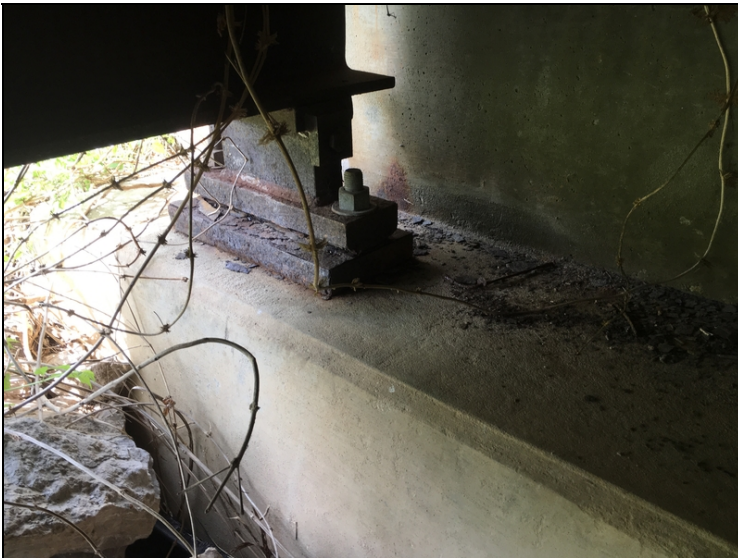
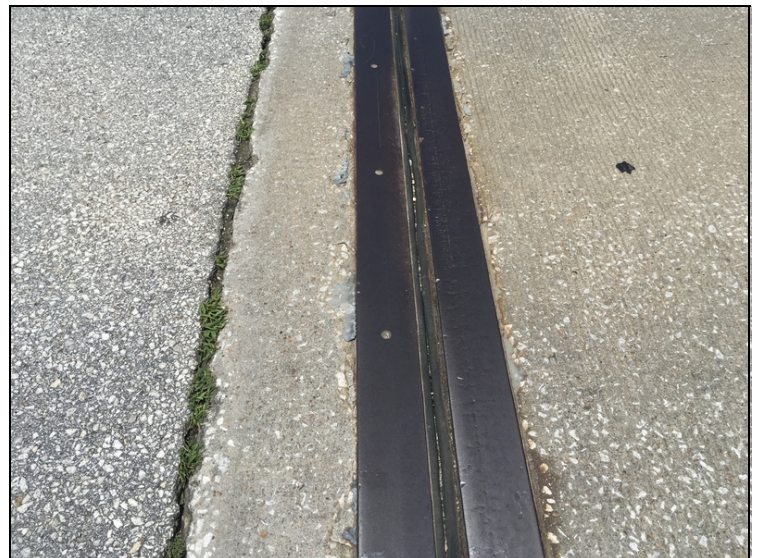
Abutment 1 joint seal showing pack rust.

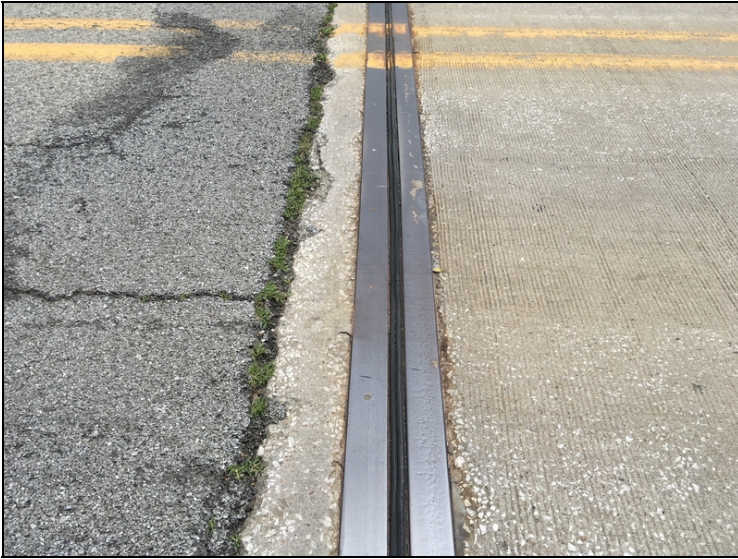
Abutment 2 joint seal condition.
