Bridge #06682(Routine, Underwater type 2)

US 65 Boone over DENNING CREEK

Location: 0.65 MI S JCT US 412

Team Lead: Nathan Rowland Inspection Date: October 28, 2019

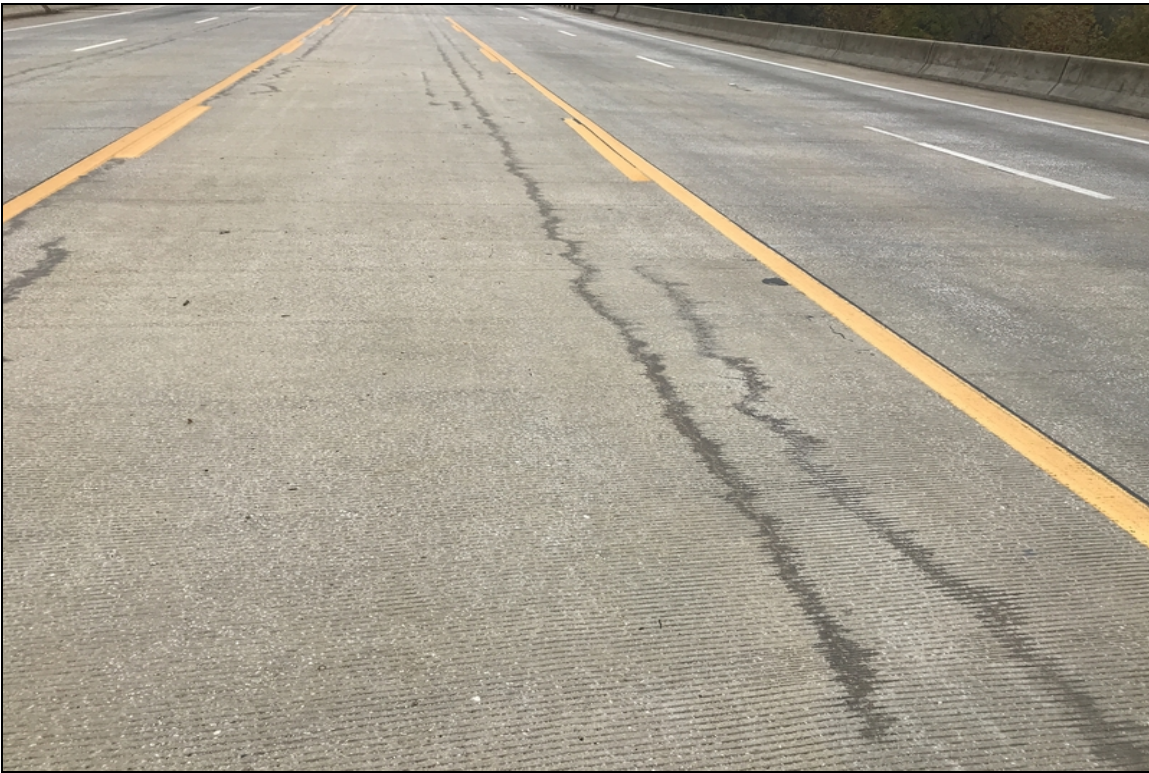
(12)							
10/28/19 WNR & DBM: The driving surface of the deck has of longitudinal and transverse cracking for the length of the structure the majority of which has been sealed since last inspection. The wheel paths in driving lanes have wear. The majority of the OPEN cracks in the deck surface are found in the right and left gutterlines. -The top of the abutment back wall has cracking that has been sealed. -Both approach slabs have transverse and diagonal cracking that have been sealed.							
107	Steel Open Girder/Beam	LF	1200	1200	0	0	0
515	Steel Protective Coating	SF	40574	40574	0	0	0

Deck driving surface has sealed full length longitudinal cracking.

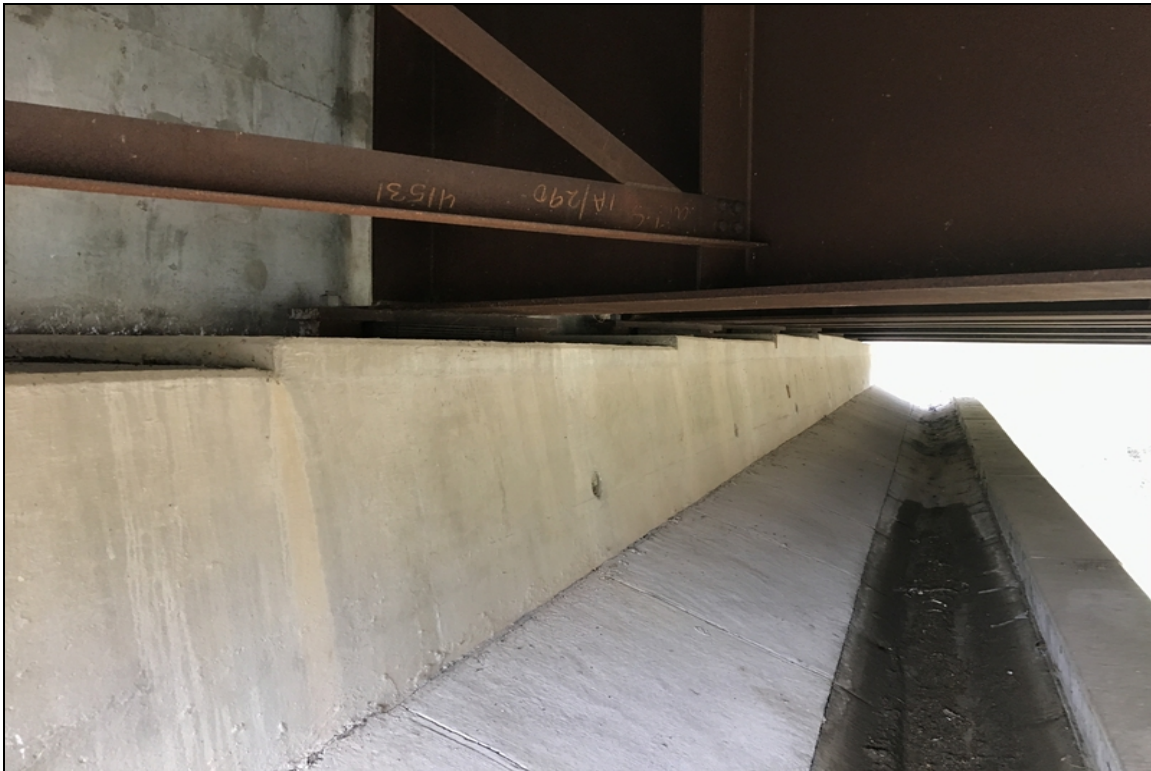
(310)							
10/28/19 WNR & DBM: Abutment #1 bearings- The bearing under girder #8 at abutment #1 is in cs2. Bearings under girders # 1,2,3,4,5,6,7 all in cs1. Abutment #2 bearings-

General view of bearings at abutment #1

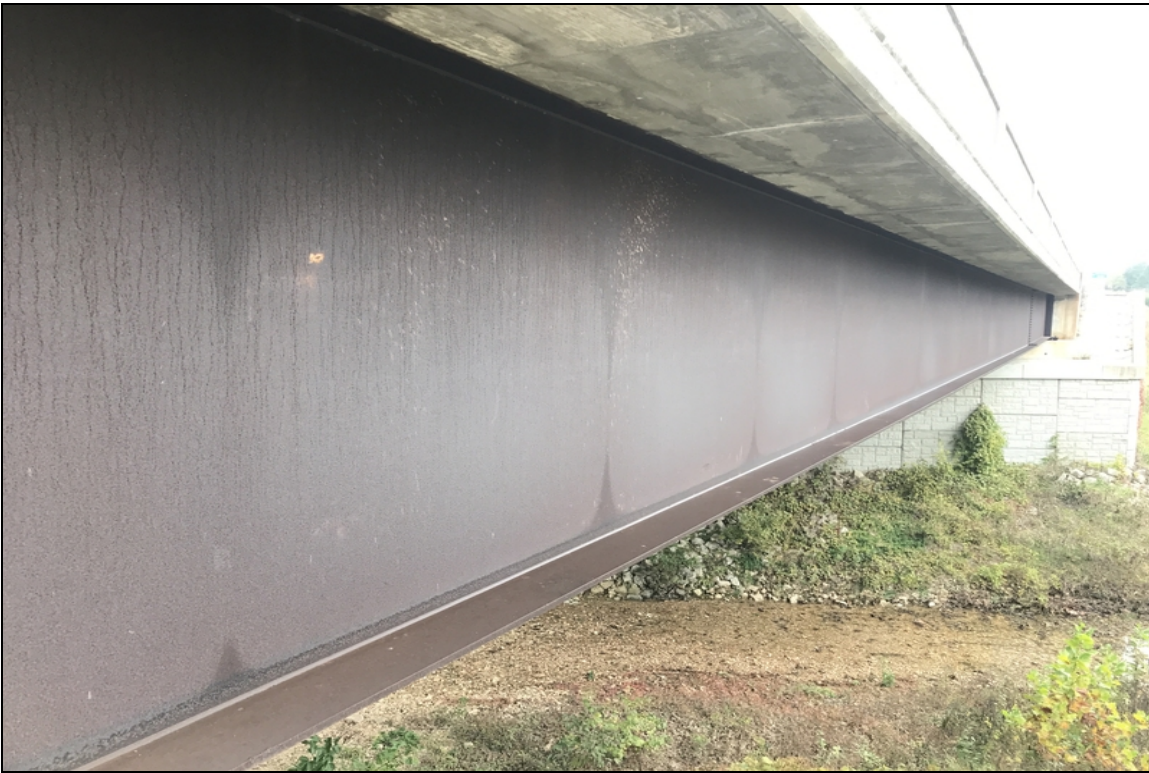
(107)							
10/28/19 WNR & DBM: The Weathering steel protective system includes the diaphragms. The weathering steel patina is functioning as intended. No deficiencies noted.							
215	Reinforced Concrete Abutment	LF	414	388	26	0	0
1130	Cracking (RC and Other)	LF	26	0	26	0	0

Condition of girders wearing surface

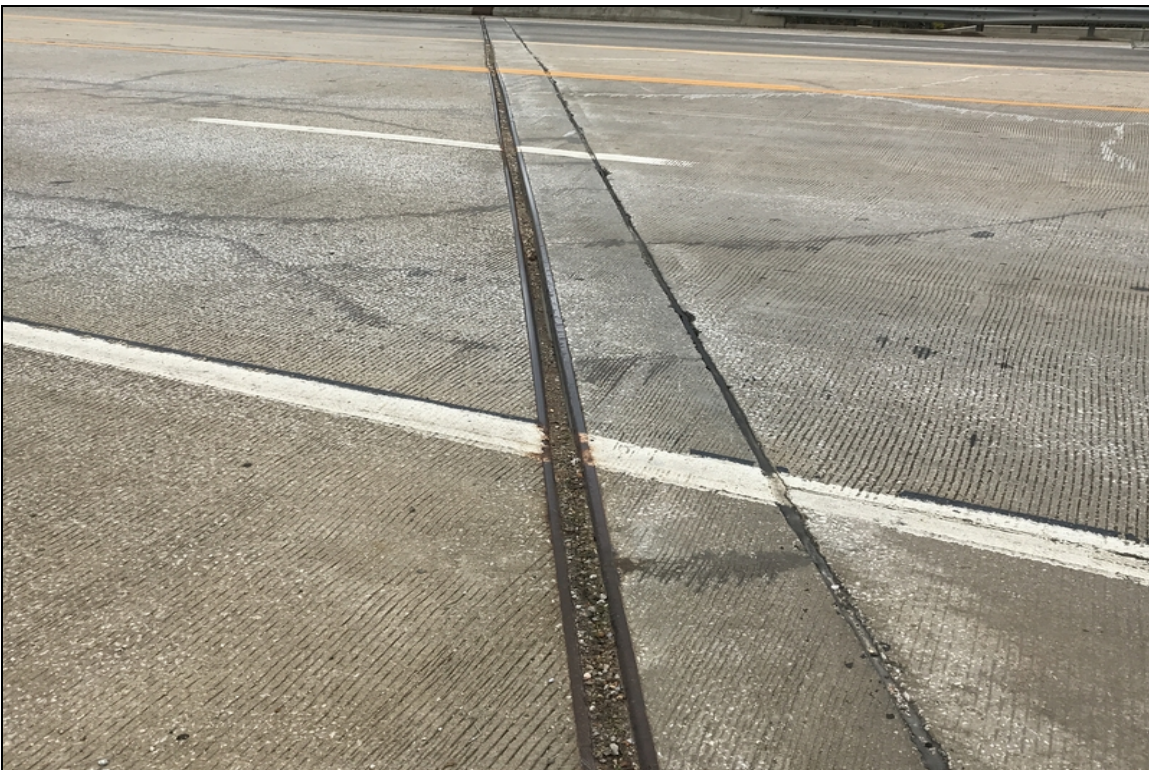
(300)							
10/28/19 WNR & DBM: Both abutment #1 and #2 have debris impaction the full width of the bridge, this is restricting the compression material from performing as intended.							
310	Elastomeric Bearing	EA	16	15	1	0	0
1000	Corrosion	EA	1	0	1	0	0

Debris impaction to joint seal at abutment #1.

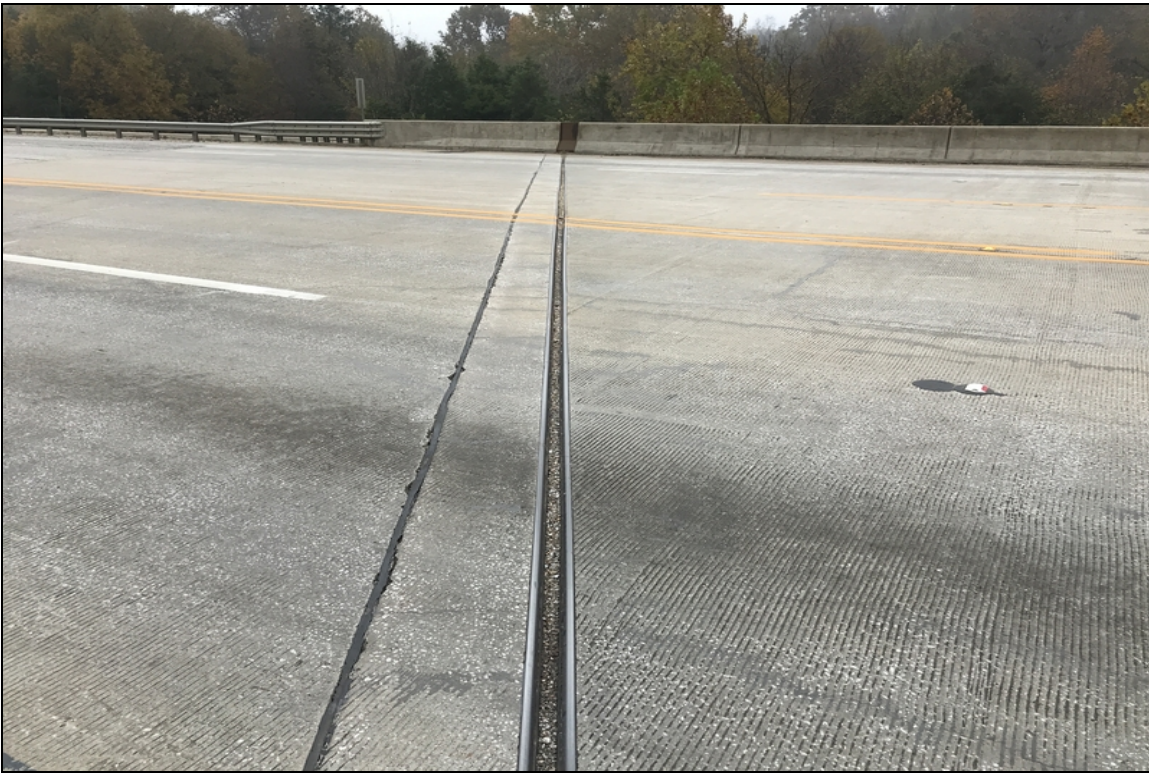
Abutment #2 compression joint seal debris impaction.

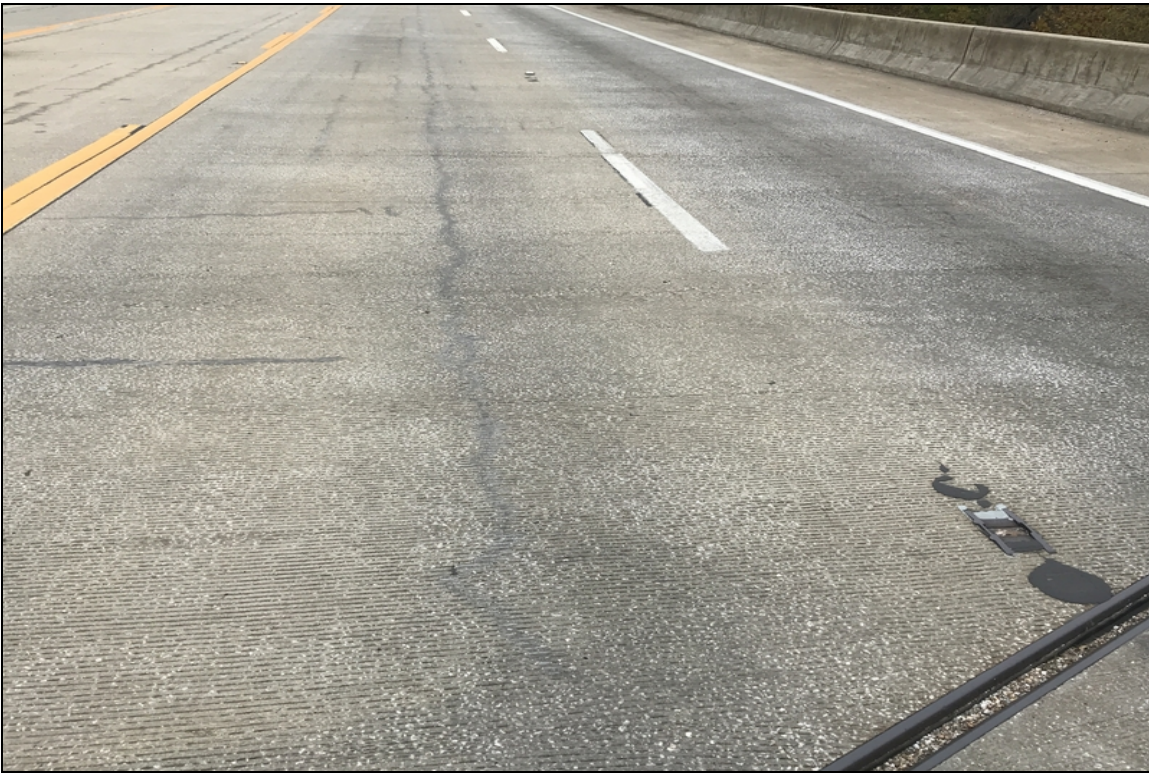
South bound lanes typical view of sealed cracking .

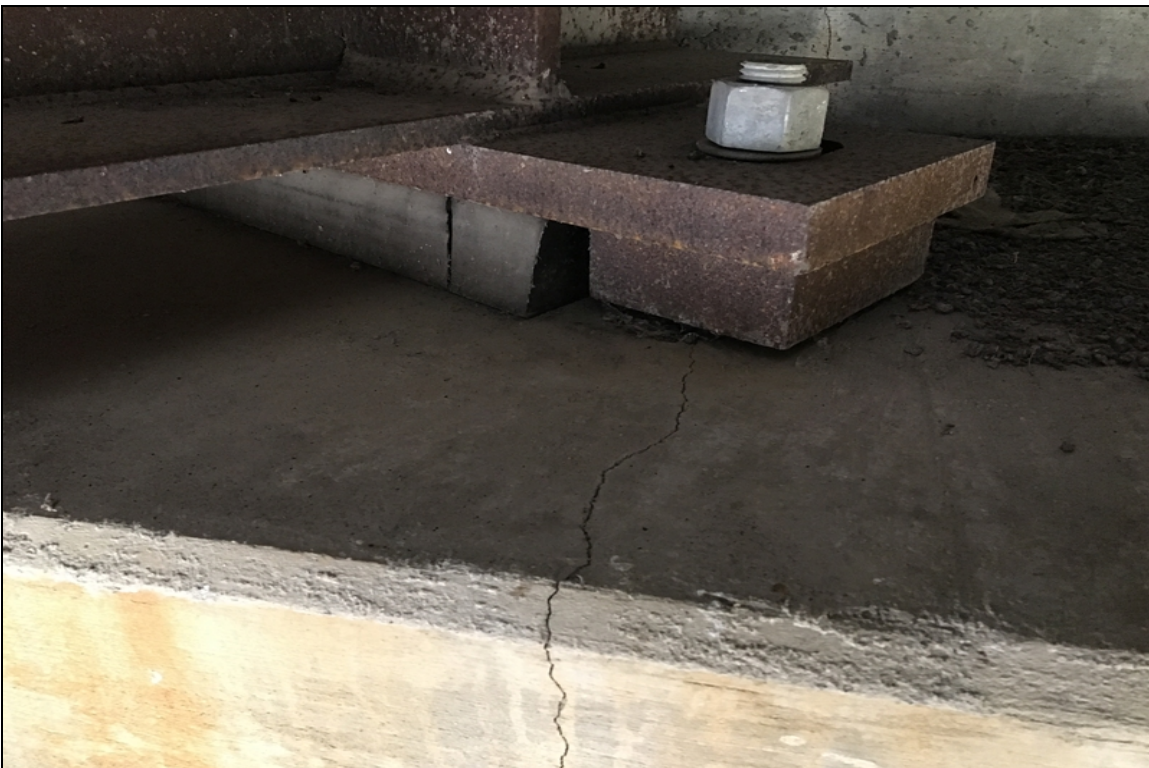
(215)							
10/28/19 WNR & DBM: The abutment quantities include the MSE wall. Abutment #1 - has 11' of vertical cracking up to .035" wide. Bay #3 at abutment #1 has a .035" wide crack in the bridge seat that extends up through the back wall. Abutment #2 - has 15' of vertical cracking up to .050" wide. Bay #4 at abutment #2 has a .050" wide crack in bridge seat that extends up through the back wall.							
300	Strip Seal Expansion Joint	LF	180	3	0	177	0
2350	Debris Impaction	LF	177	0	0	177	0

Wide cracking in bridge seat propagating from anchor bolt at bearing #5.

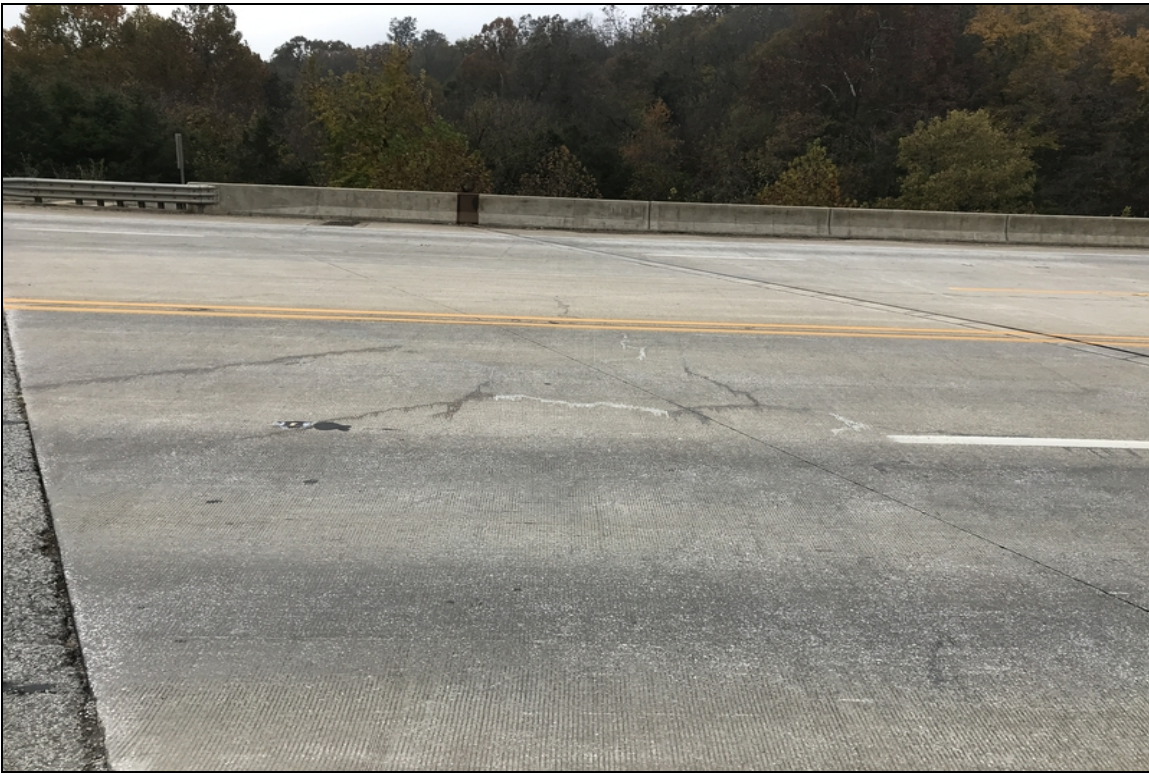
ELEM	DESCRIPTION	UNITS	TOTAL	CS1	CS2	CS3	CS4
All 8 bearings are in cs1.							
321	Reinforced Concrete Approach Slab	SF	2	2	0	0	0
(321)							
10/28/19 WNR & DBM: Both approach slabs have transverse and diagonal cracking that have been sealed since the last inspection.							
331	Reinforced Concrete Bridge Railing	LF	306	190	116	0	0
1130	Cracking (RC and Other)	LF	116	0	116	0	0
(331)							
10/28/19 WNR & DBM: The Left side bridge parapet has 40' of hairline vertical and horizontal cracking and some small areas of map cracking. The Right side bridge parapet has 76' of hairline vertical and horizontal cracking and some small areas of map cracking.

View of sealed cracking in south approach slab

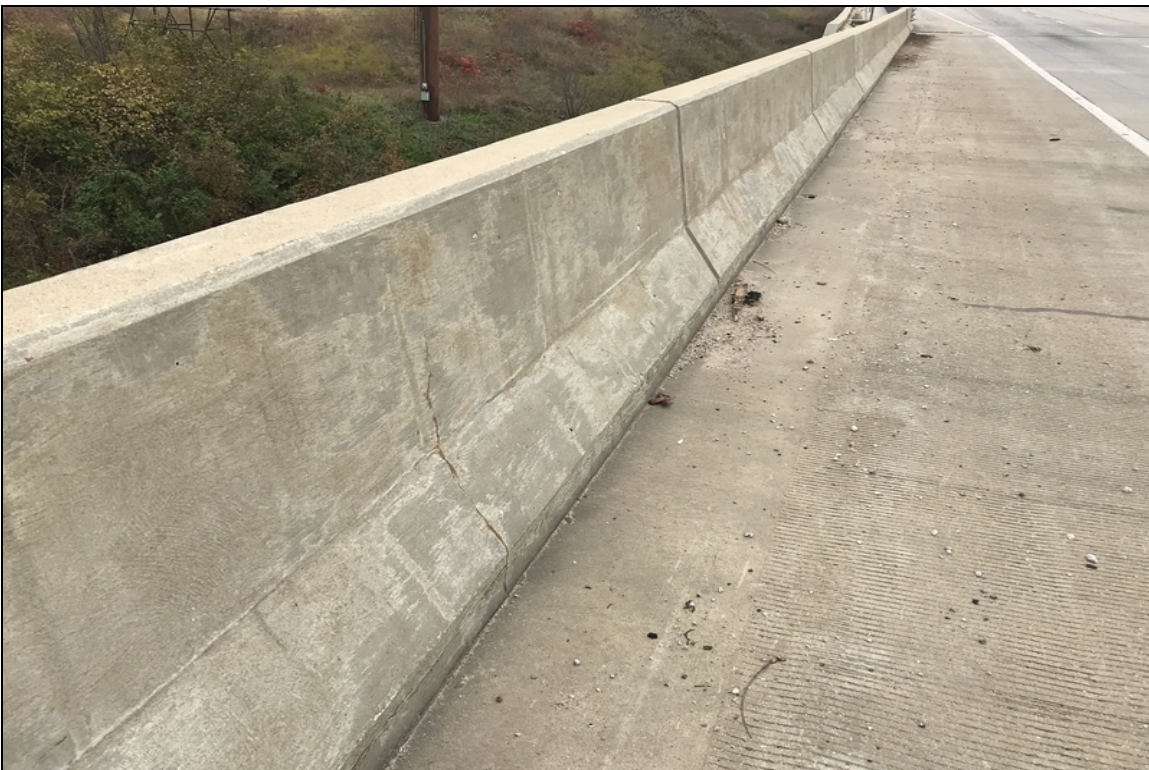
Left parapet vertical cracking

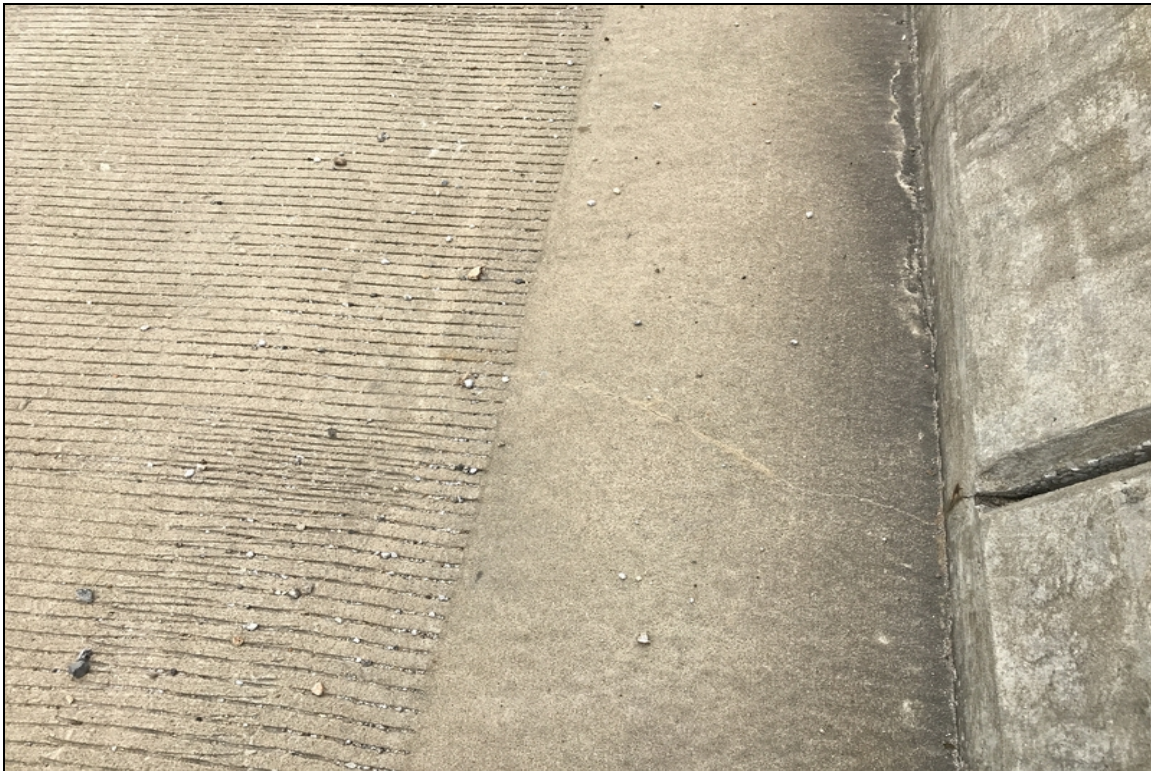
Typical cracking in left and right gutterlines.

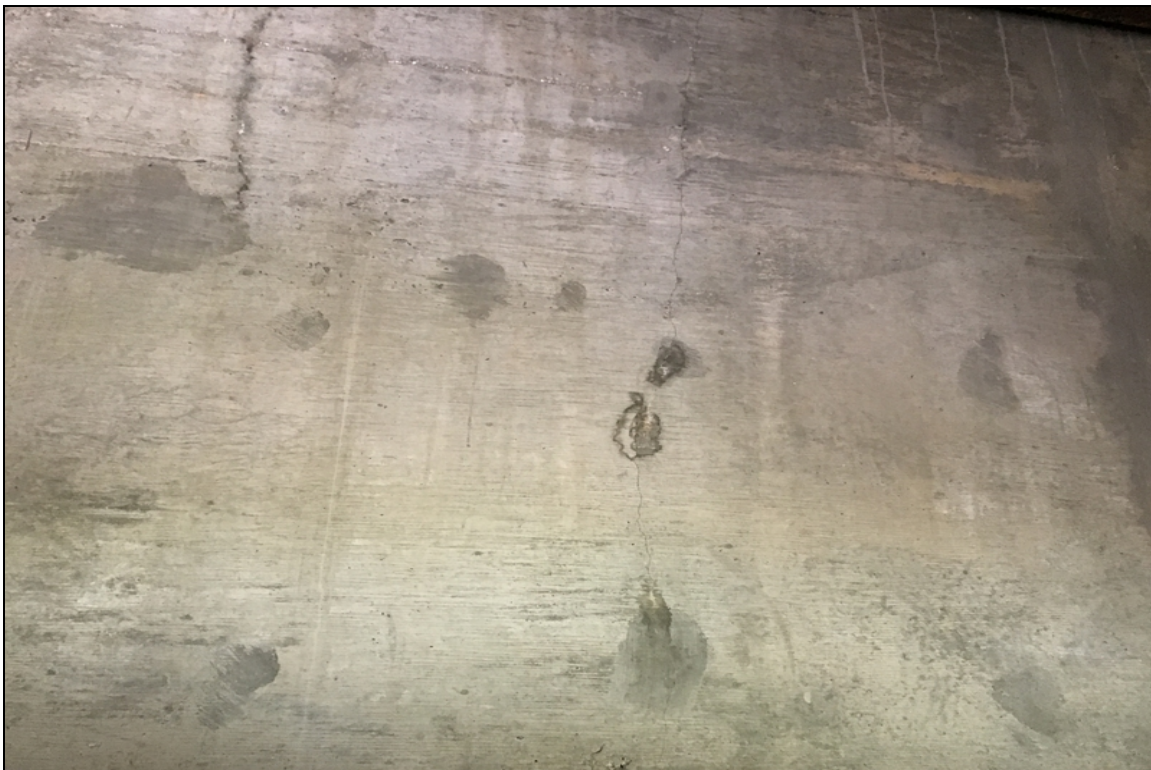
Bay #4 vertical face of backwall typical vertical cracking.

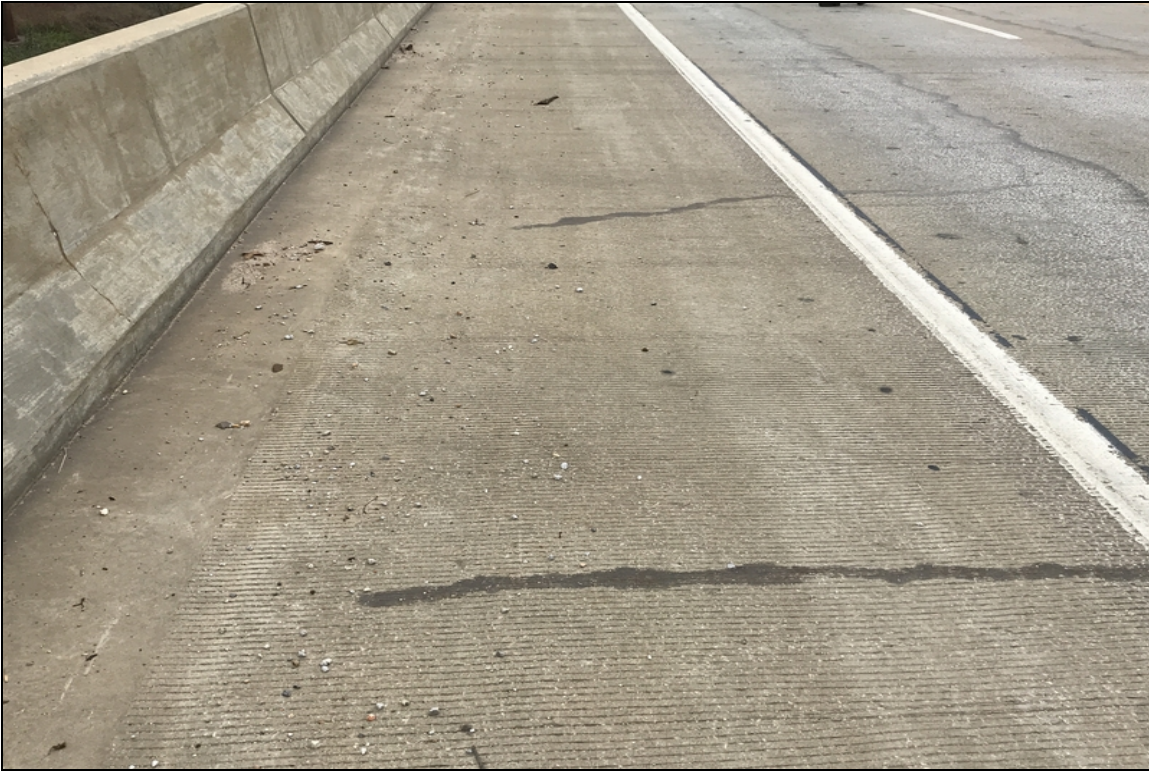
Left gutter line typical sealed cracking.

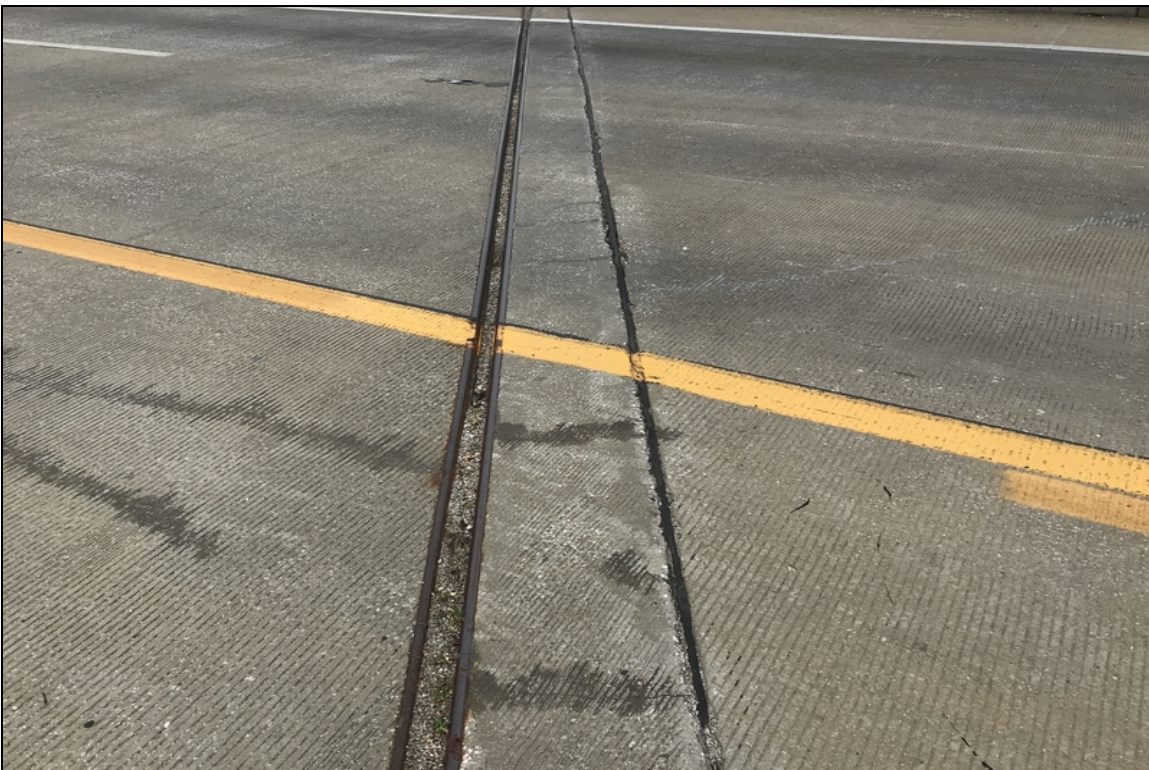
Top of abutment #1 backwall has sealed cracking.

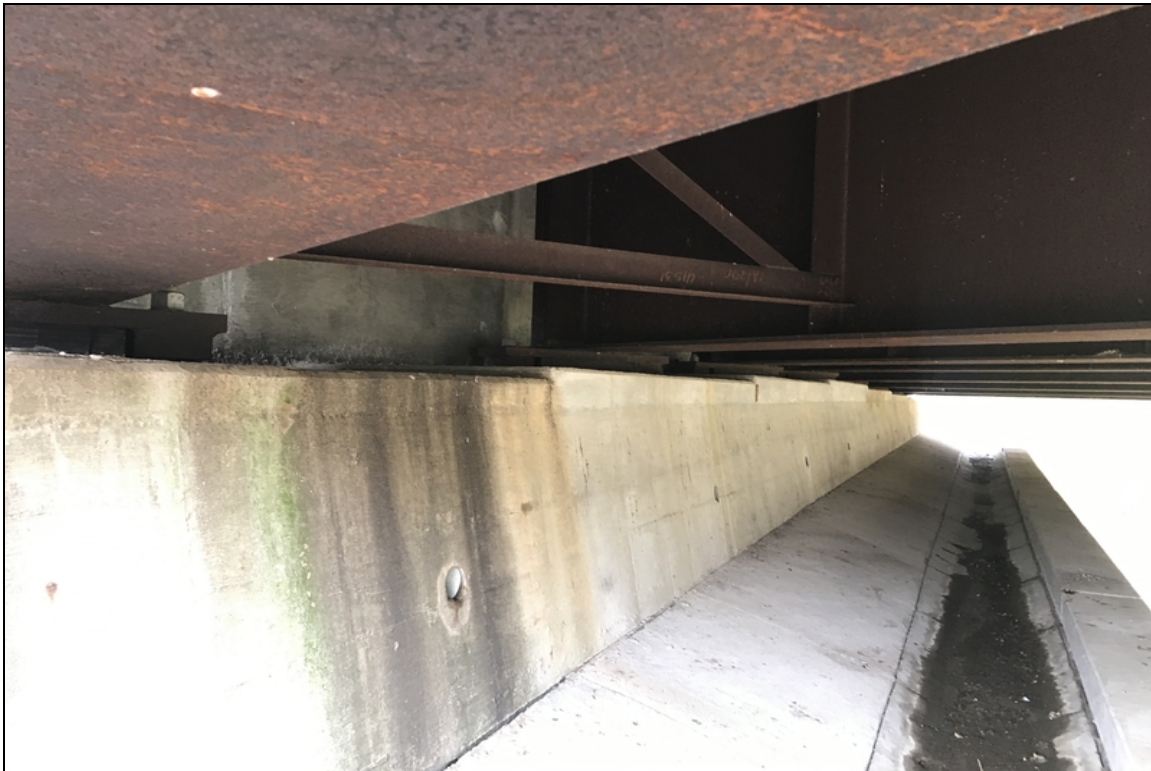
Bearings at abutment #2

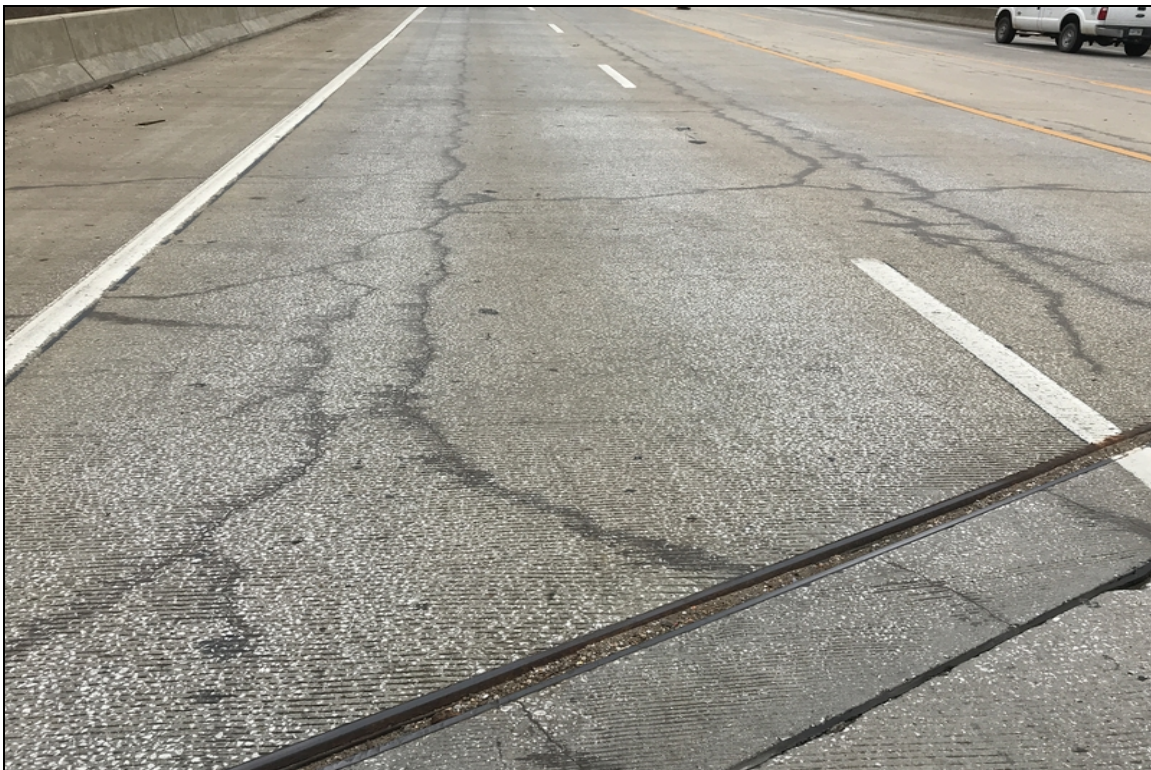
Northbound lanes typical view of sealed cracking .

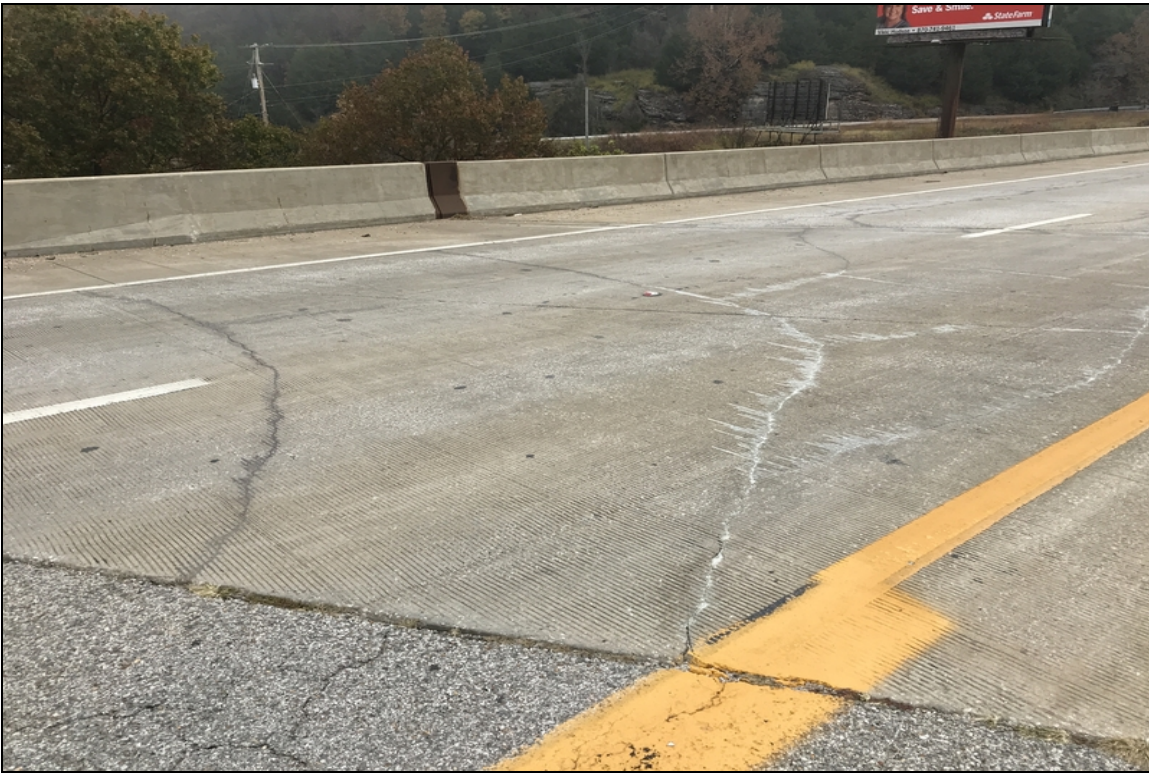
Cracking in north approach slab in the north bound lanes has been sealed.

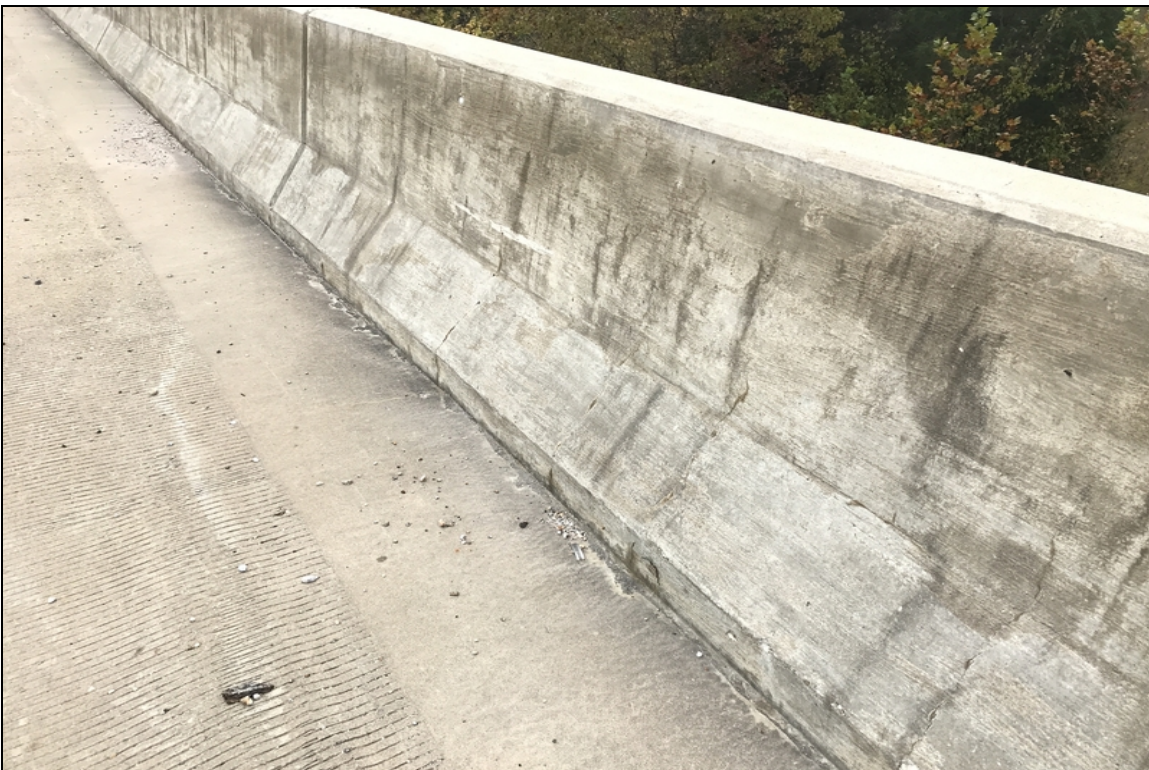
Right parapet wall has vertical cracking.

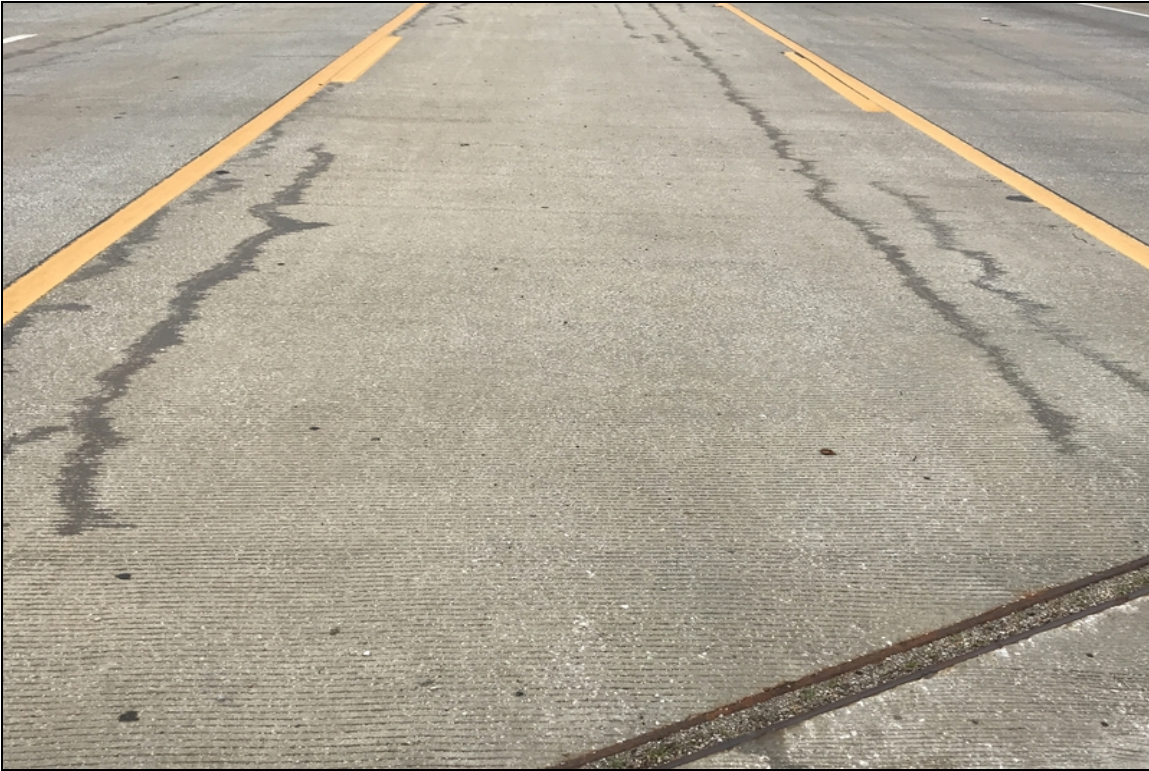
Turning lane typical view of sealed cracking .
