Bridge #02946(Routine, Underwater type 2)

SH 23-Madison Co. over HAWKINS HOLLOW CR

Team Lead: Nathan Rowland Inspection Date: October 25, 2021

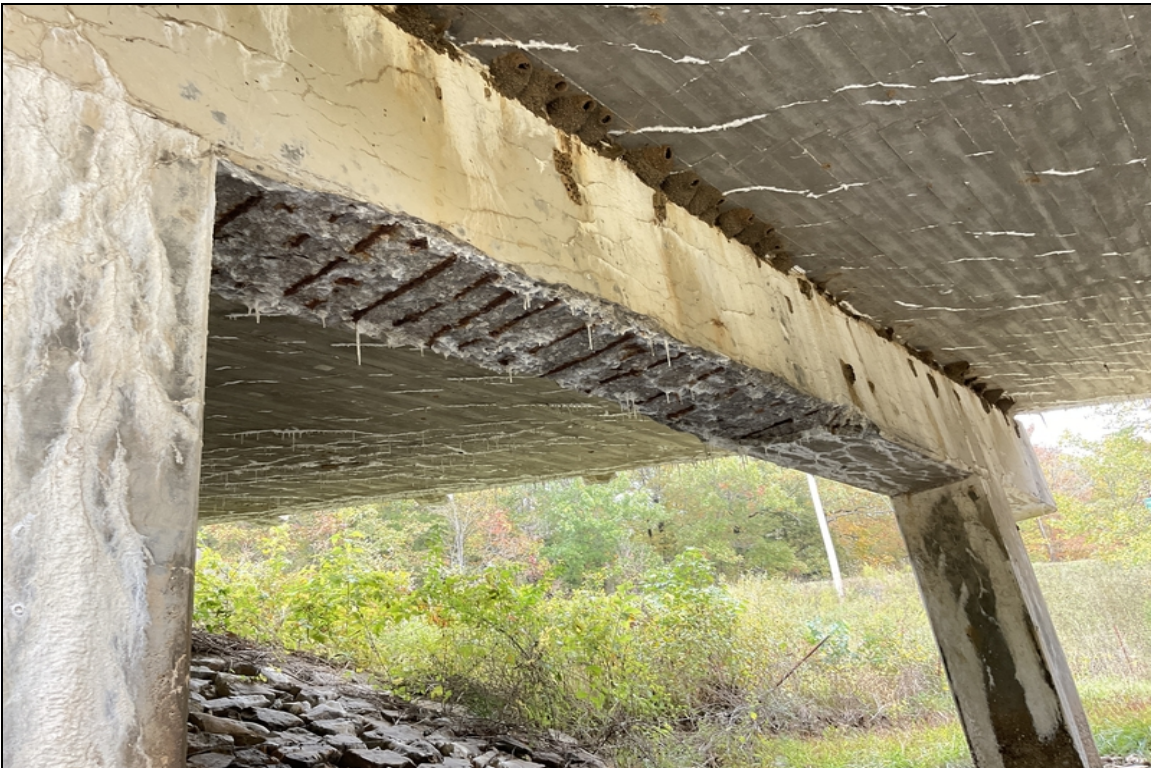
View of bent #3 cap underneath steel exposed.

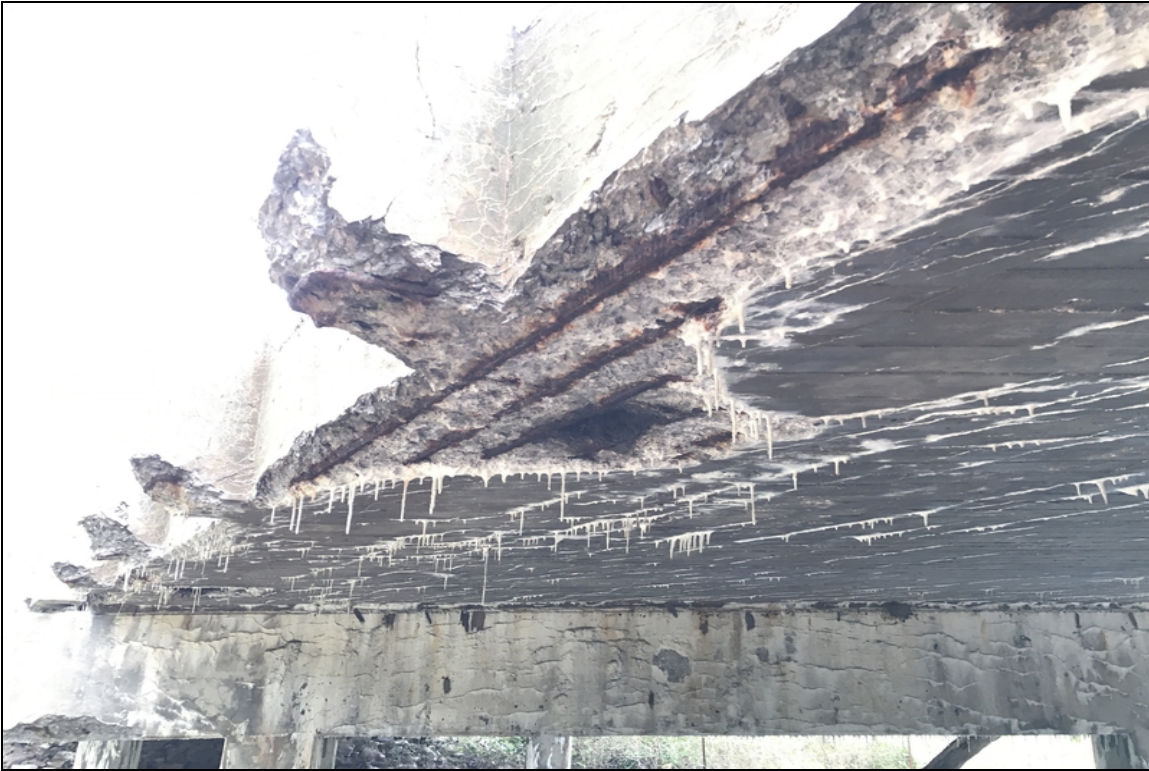
Span #2 left side typical steel exposed around deck drains and left edge

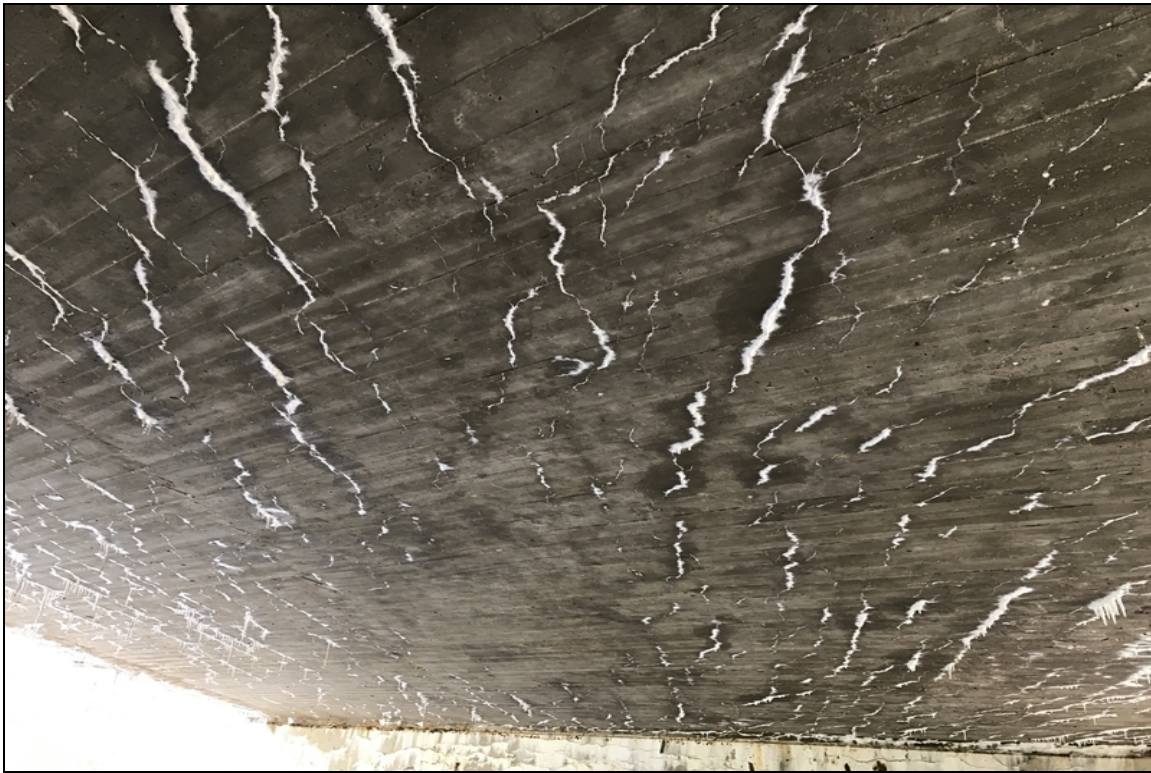
Span #2 typical view of efflorescence and cracking to undersurface of deck.

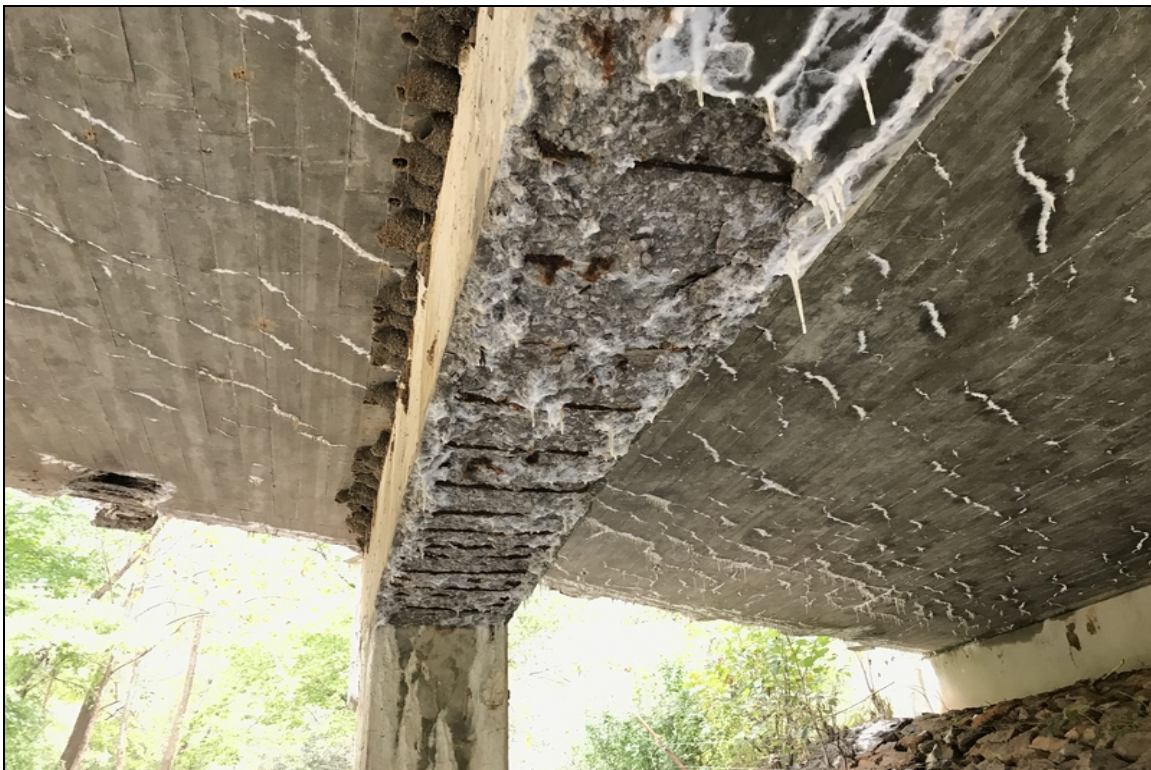
Bent #3 cap underneath deep spalling with steel exposed.

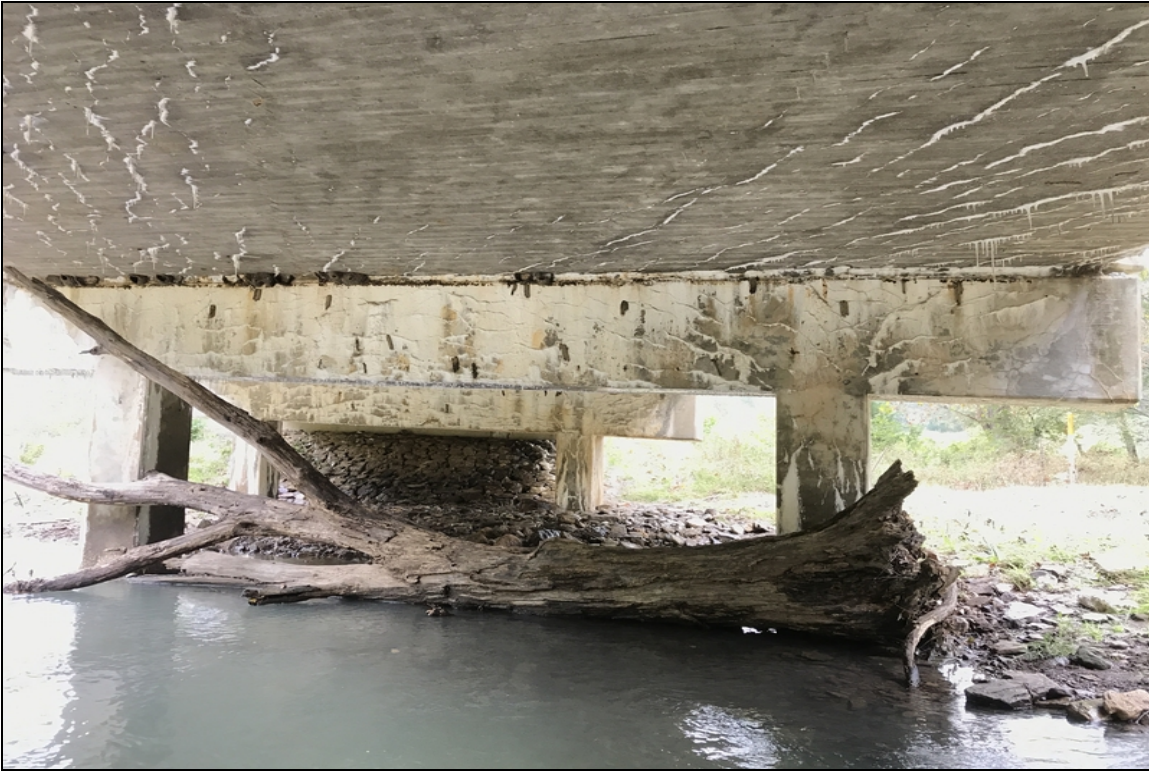
Bent #2 large tree drift accumulation.

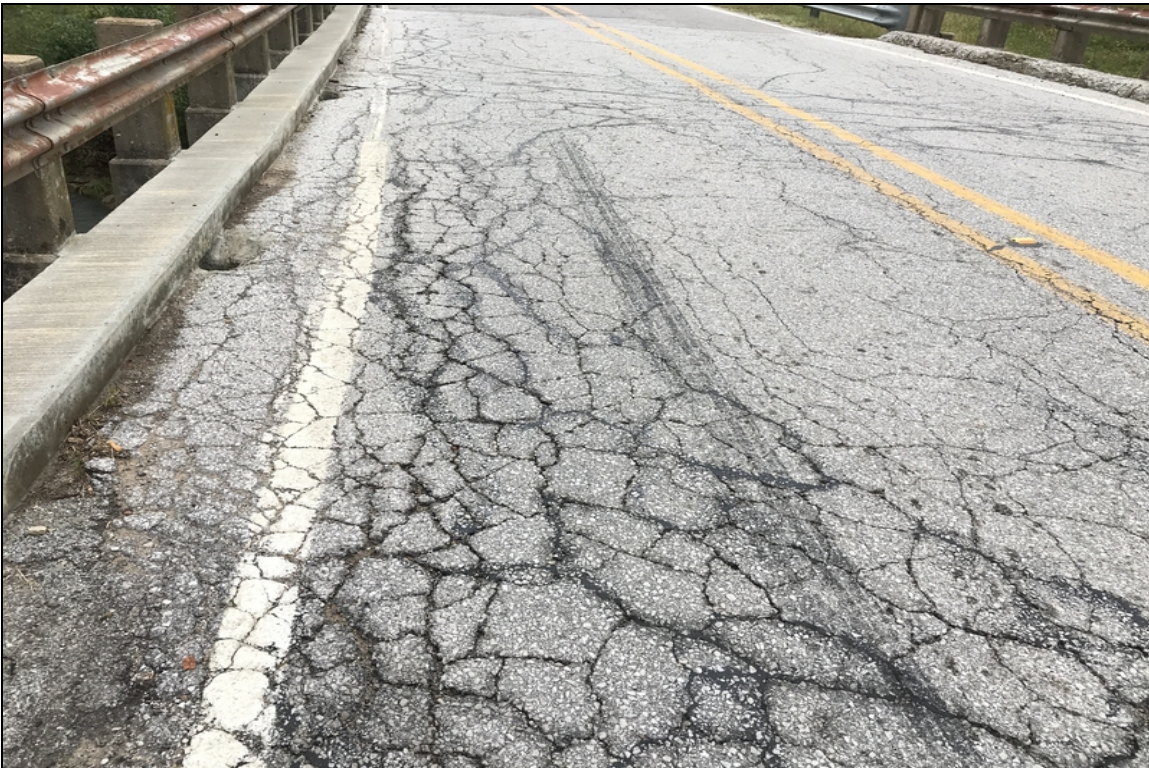
Asphalt wearing surface left lanes has almost rubblized due to traffic.

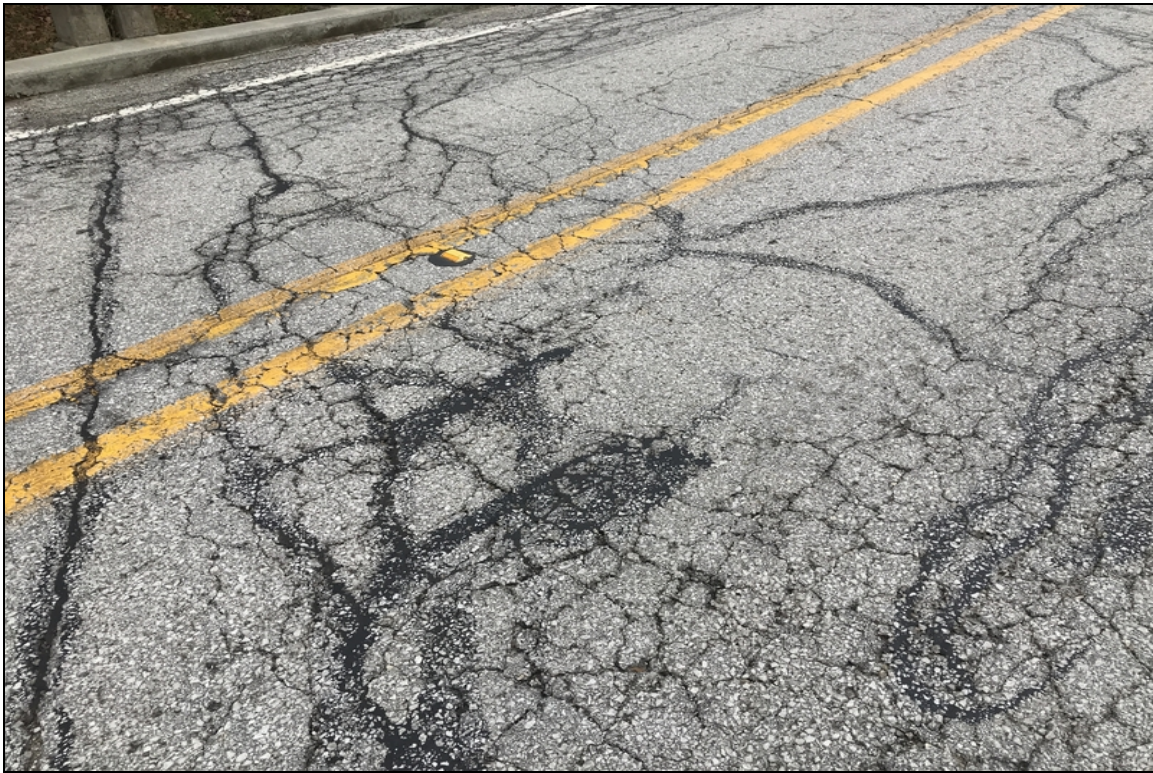
Typical cracking of asphalt wearing surface.

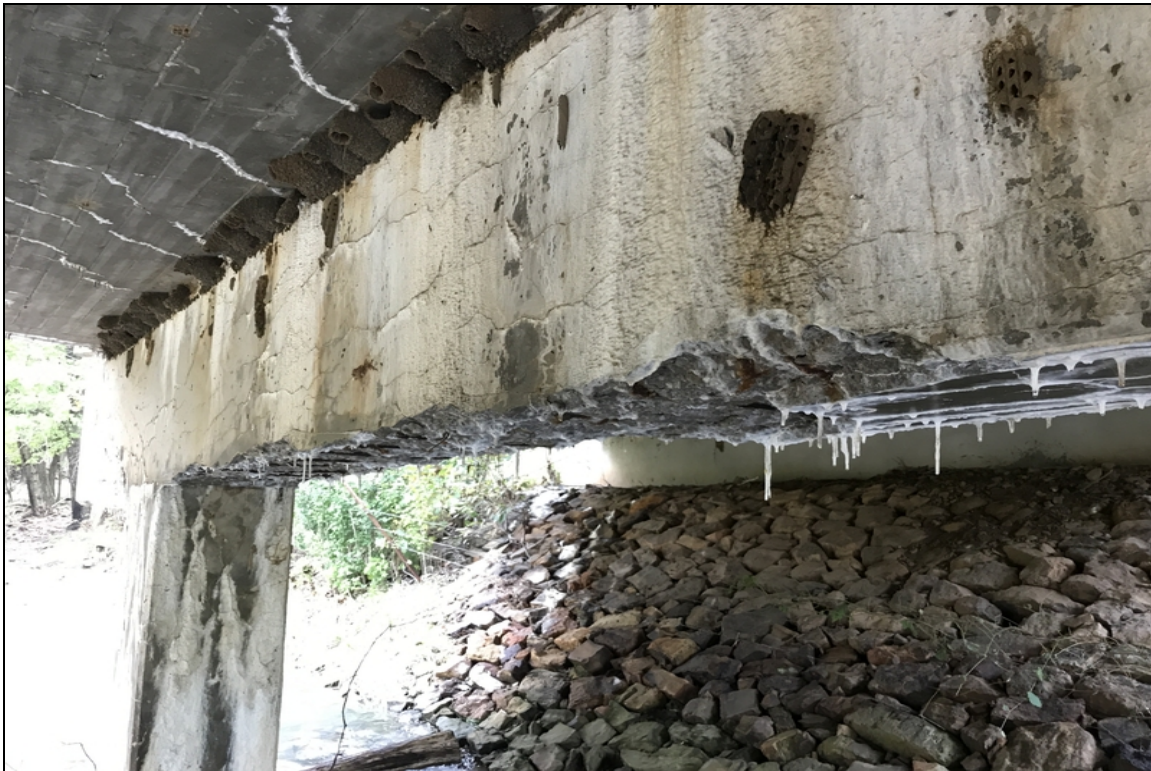
Bent #3 cap underneath deep spalling with steel exposed.

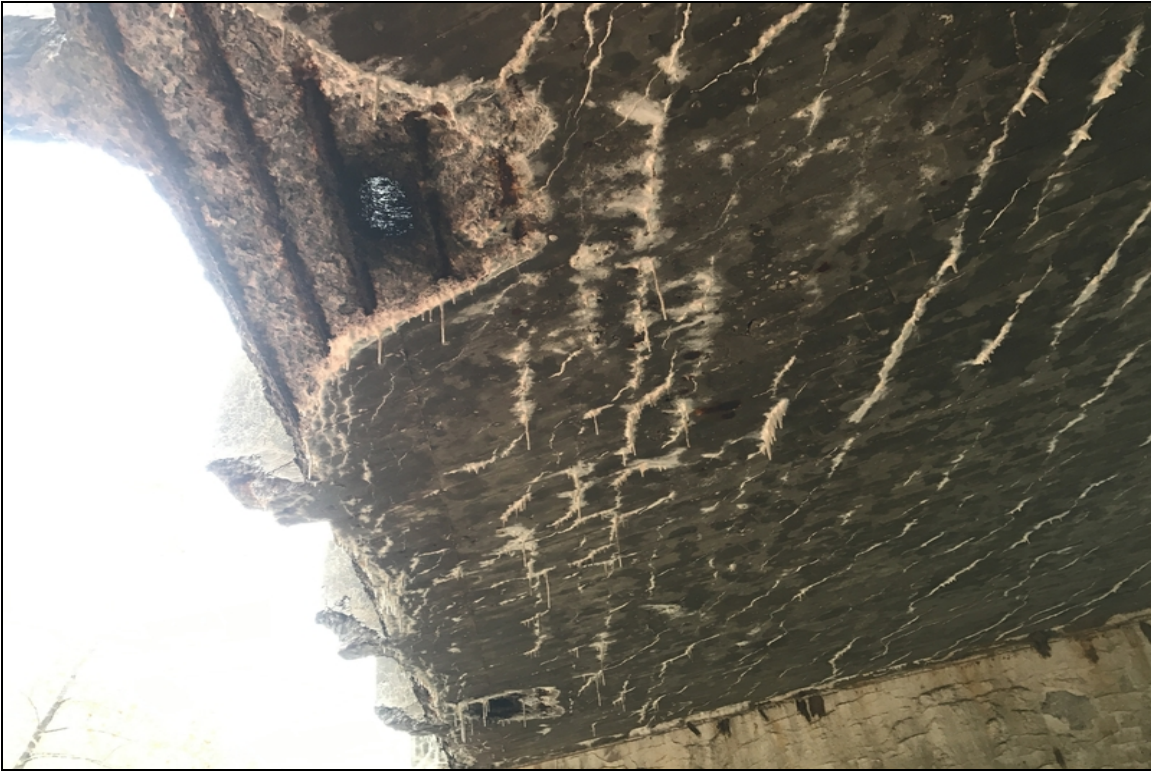
Span #2 left side steel exposed around drains.

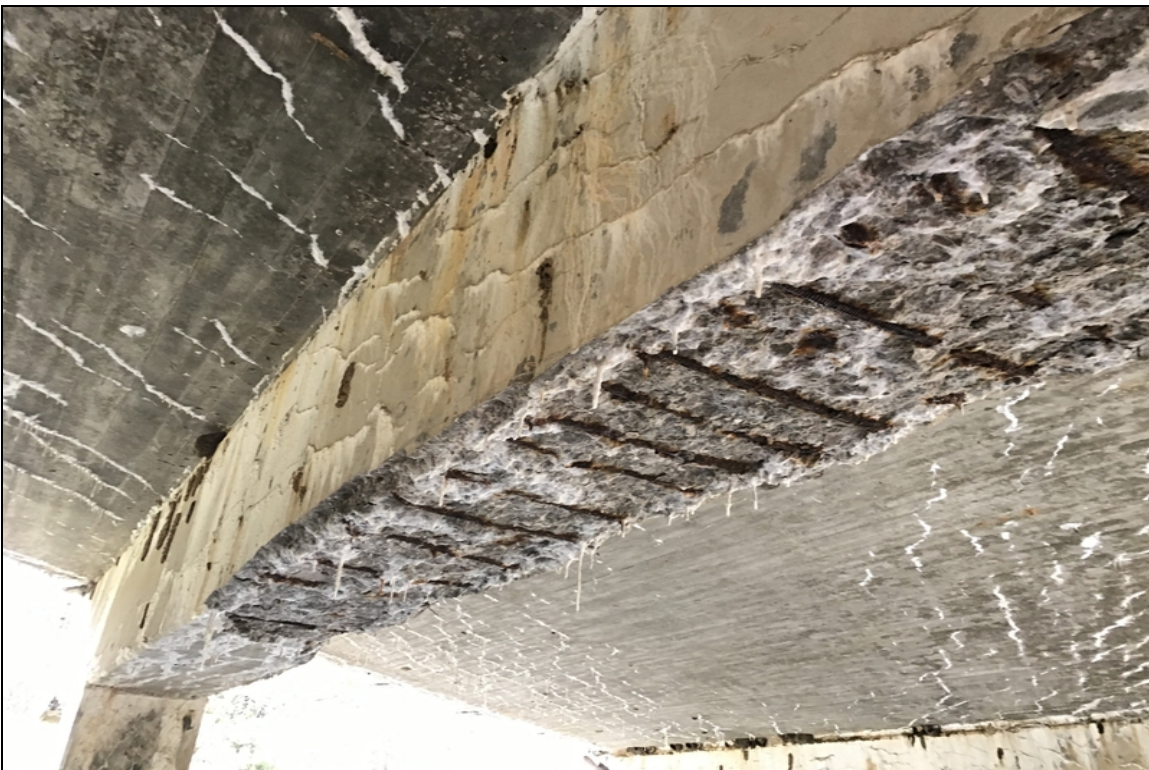
Bent #3 cap underneath deep spalling with steel exposed.

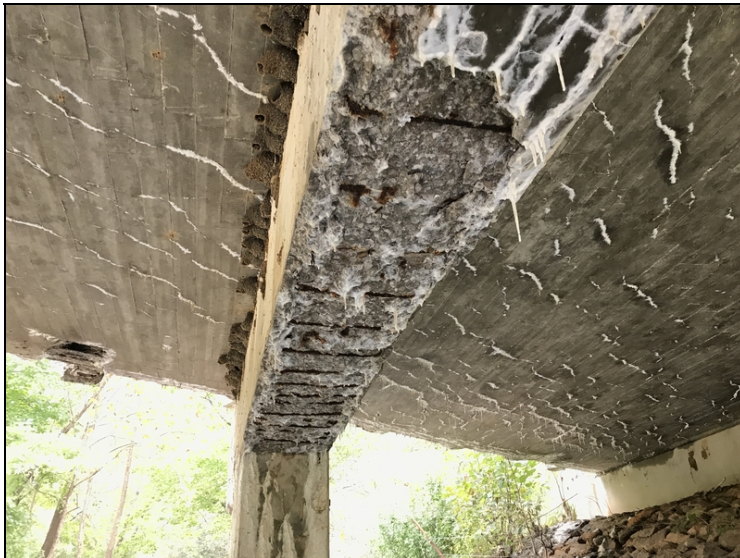
Intermediate bent caps - The intermediate bent caps have chloride contamination with heavy mapcracking and efflorescence with areas of spalling with exposed reinforcing steel and delaminated areas. The most extreme case is the undersurface of bent #3 cap which has soft and deteriorated concrete with a large area of spalling between the columns that is approximately 13' long and is the full width of the cap.

Bent #3 cap underneath deep spalling with steel exposed.

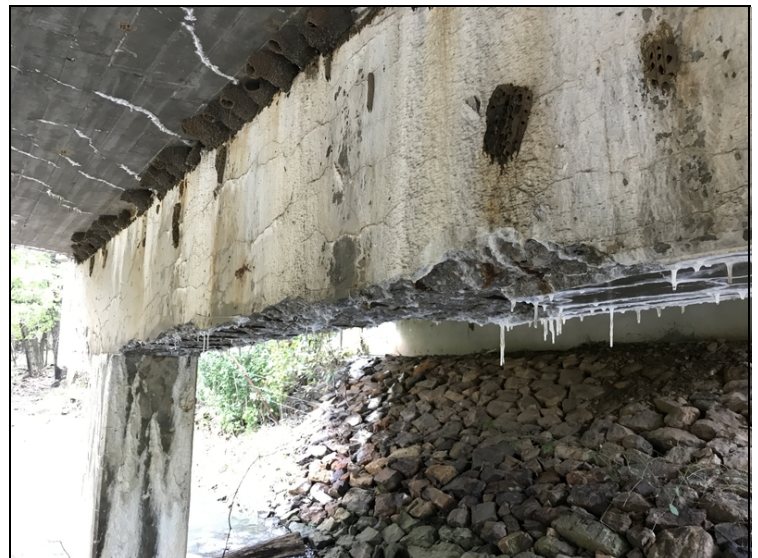
Bent #3 cap underneath deep spalling with steel exposed.

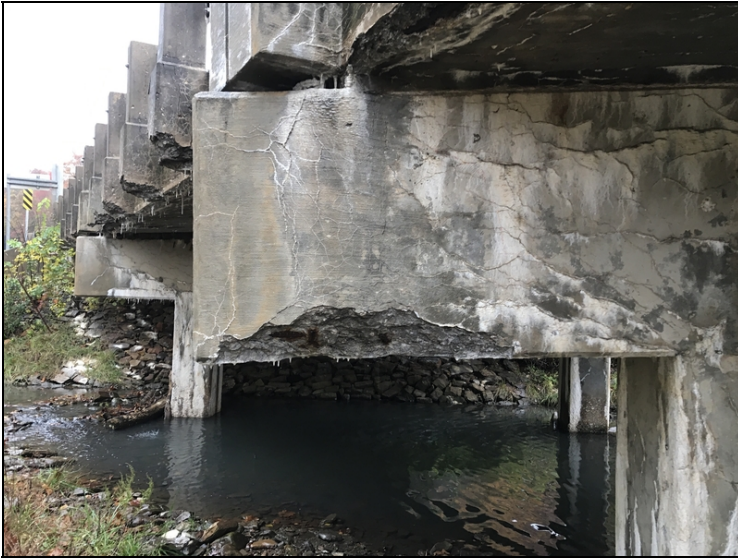
Bent #2 left behind side spalling with steel exposed.

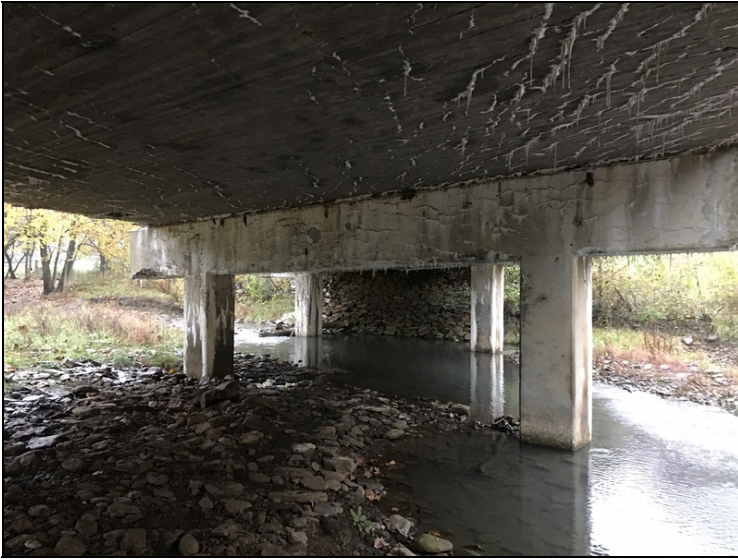
Bent #2 behind side Cracking with heavy efflorescence.

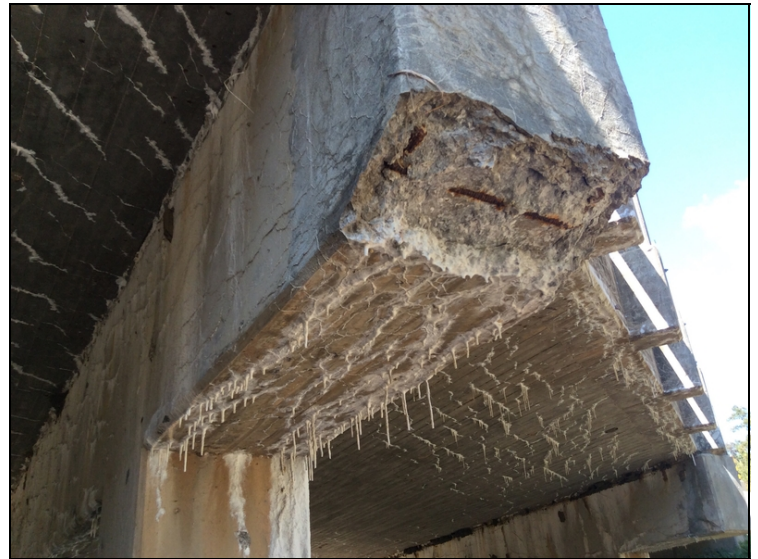
Spalling with exposed reinforcing steel in cap.

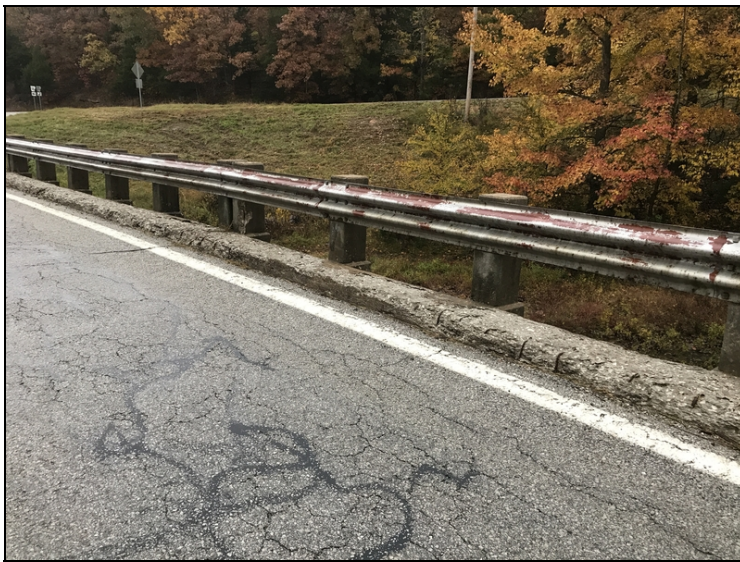
Concrete curb on right side has deterioration with spalling that exposes reinforcing steel the entire length of curb.

Concrete curb right spalling with steel exposed.

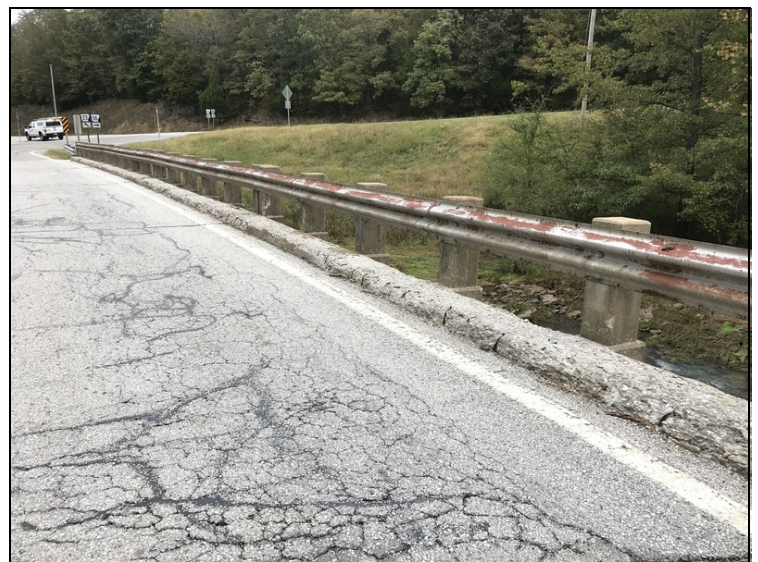
Deck concrete curb right side.

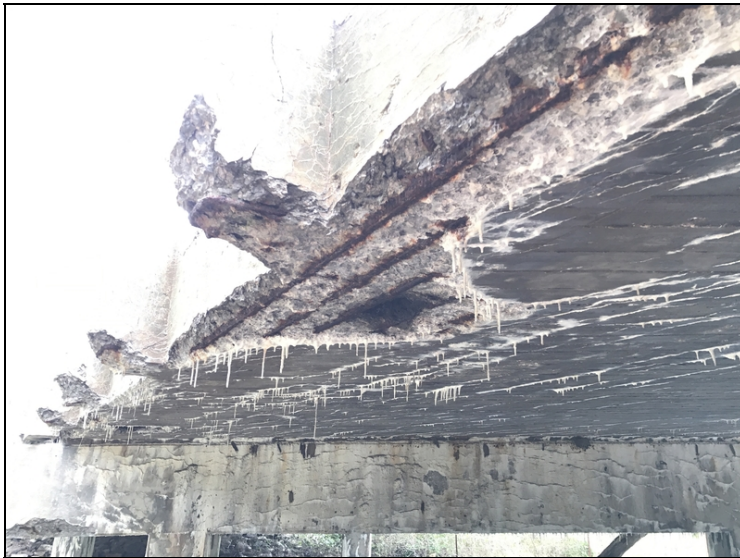
The undersurface of the deck / superstructure has mapcracking with efflorescence throughout and concrete deterioration with spalling that exposes the primary reinforcing steel along exterior edges and around the deck drains.

Span #2 left side typical steel exposed around deck drains and left edge

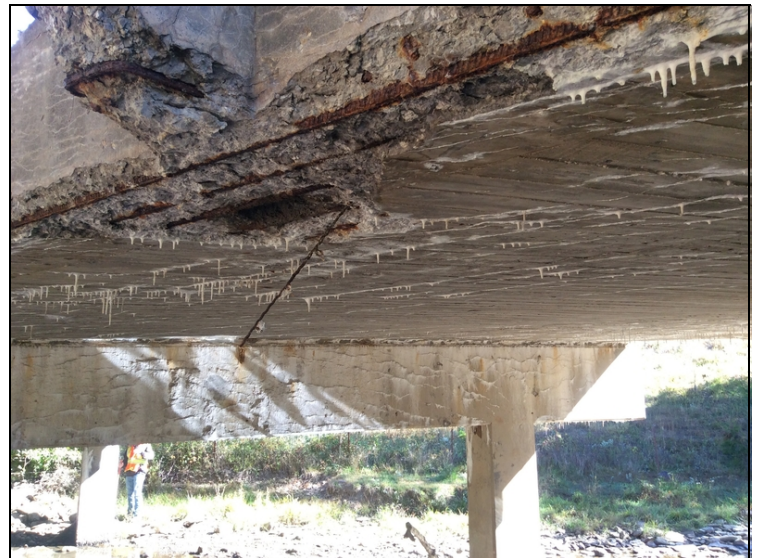
Soffit span 2 left - heavy cracking with efflorescence and spalling with exposed reinforcing steel around drain.

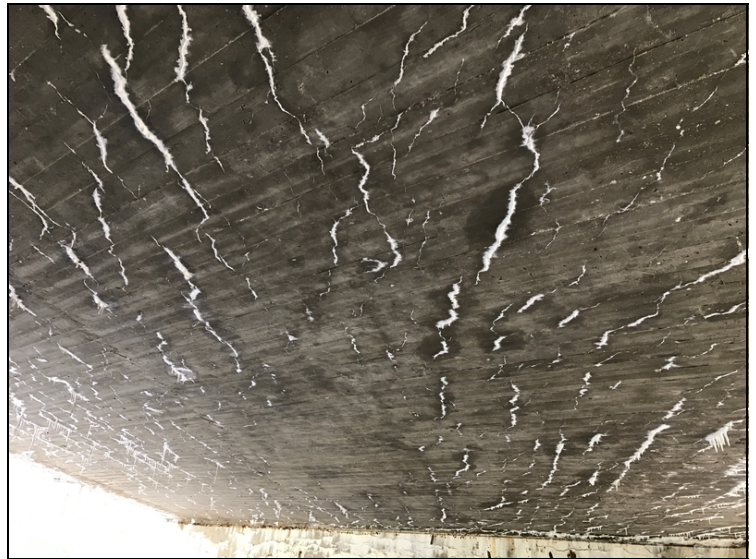
Span #2 typical view of efflorescence and and cracking to undersurface of deck.

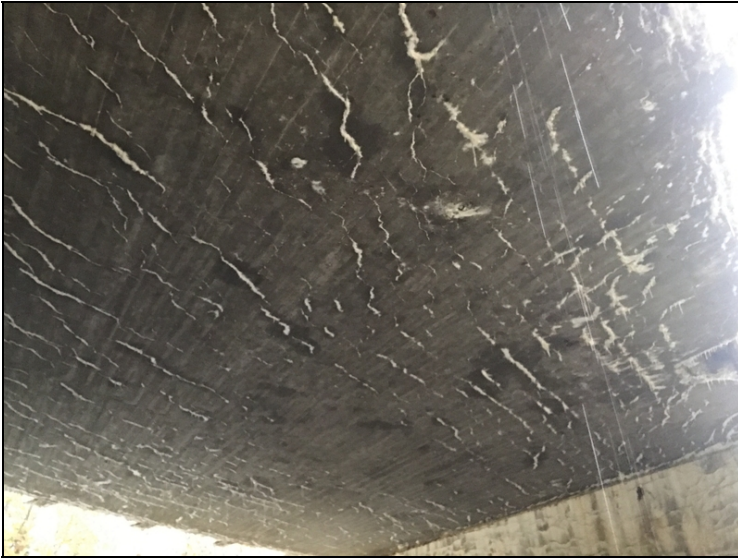
Span #2 cracking with efflorescence.

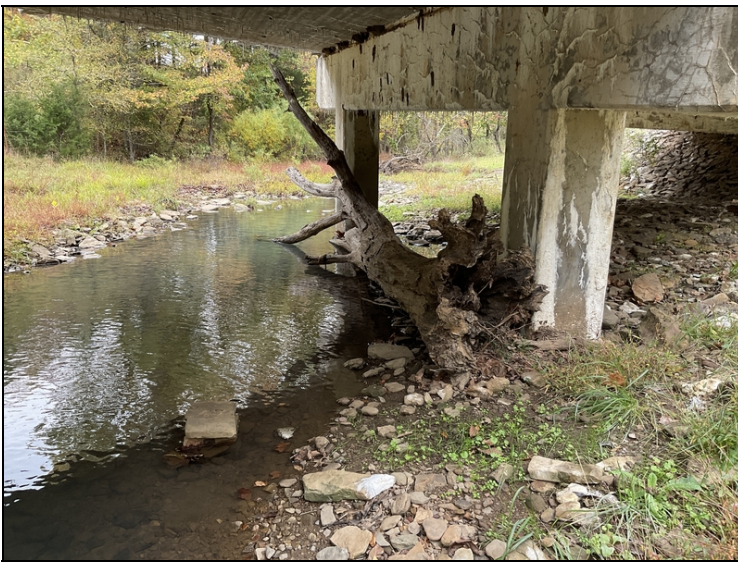
Large tree at bent #2 ahead side.

Type of Work: Clean
