Bridge #02947(Routine, Underwater type 2)

SH 23 Madison over SLOW TOM CR

Location: .75 MI S OF WITTER

Team Lead: Nathan Rowland **Inspection Date:** September 08, 2022

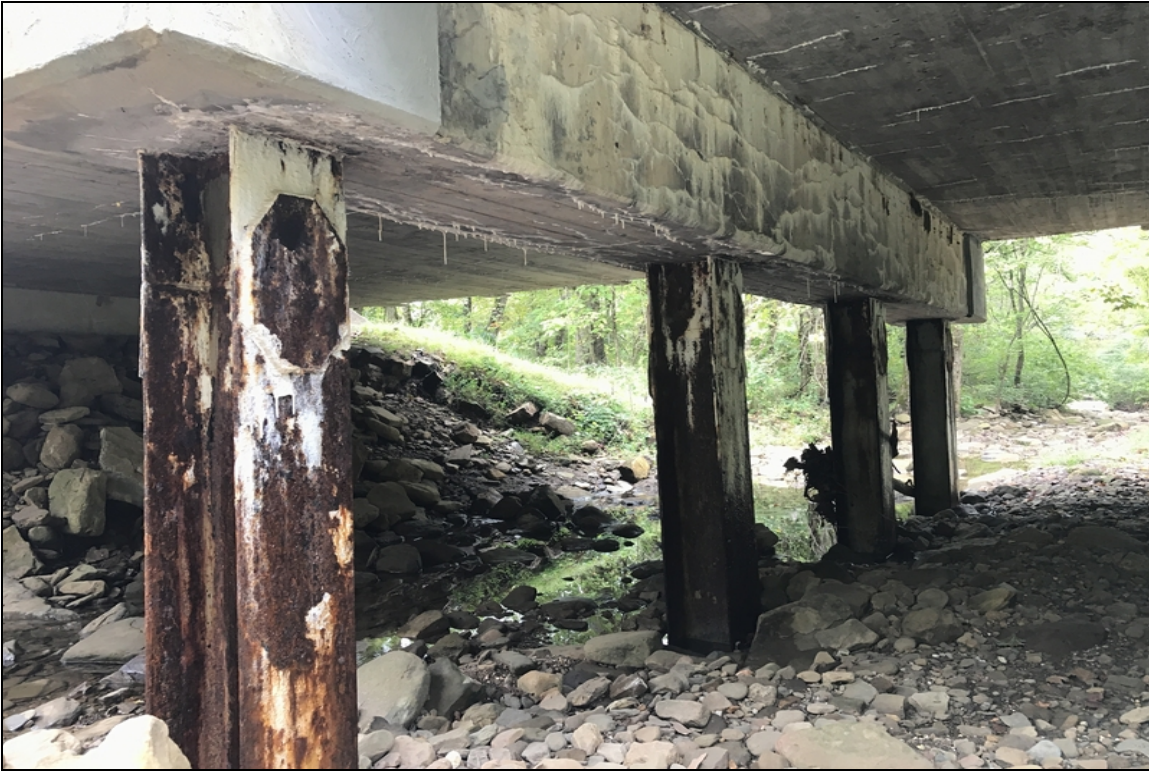
Typical view of steel piling and cap at bent #1.

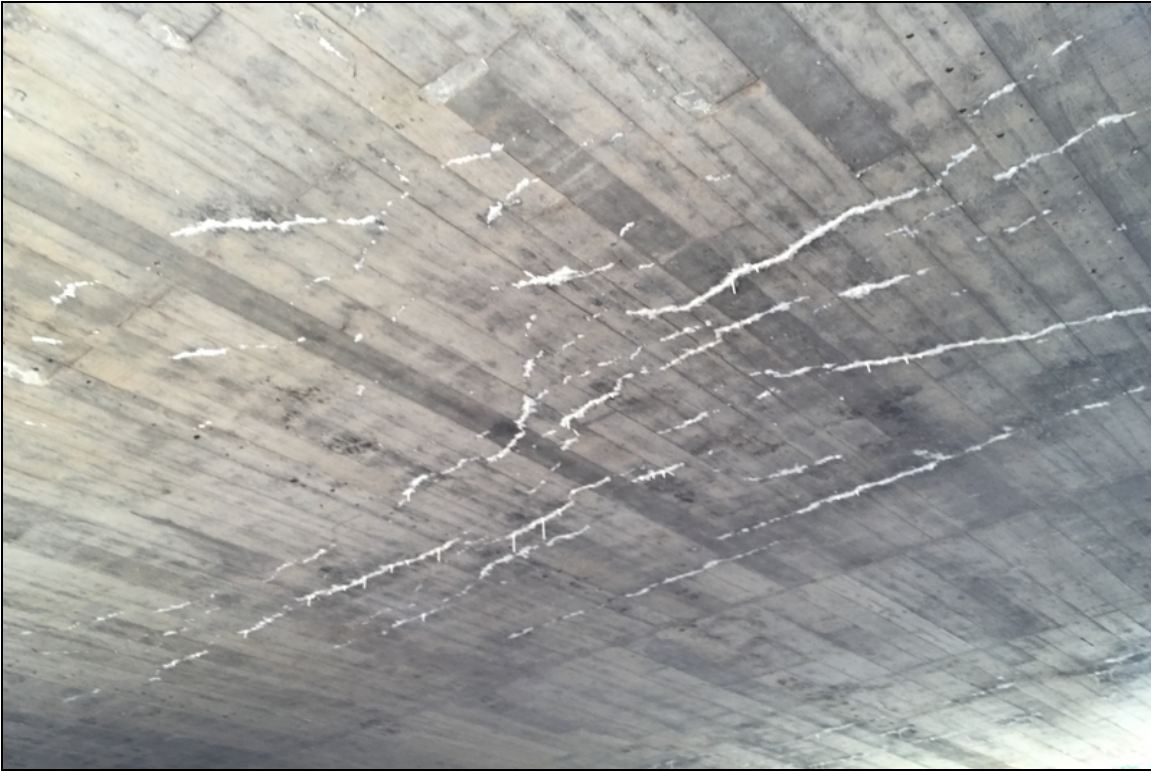
Span 1 typical cracking with efflorescence.

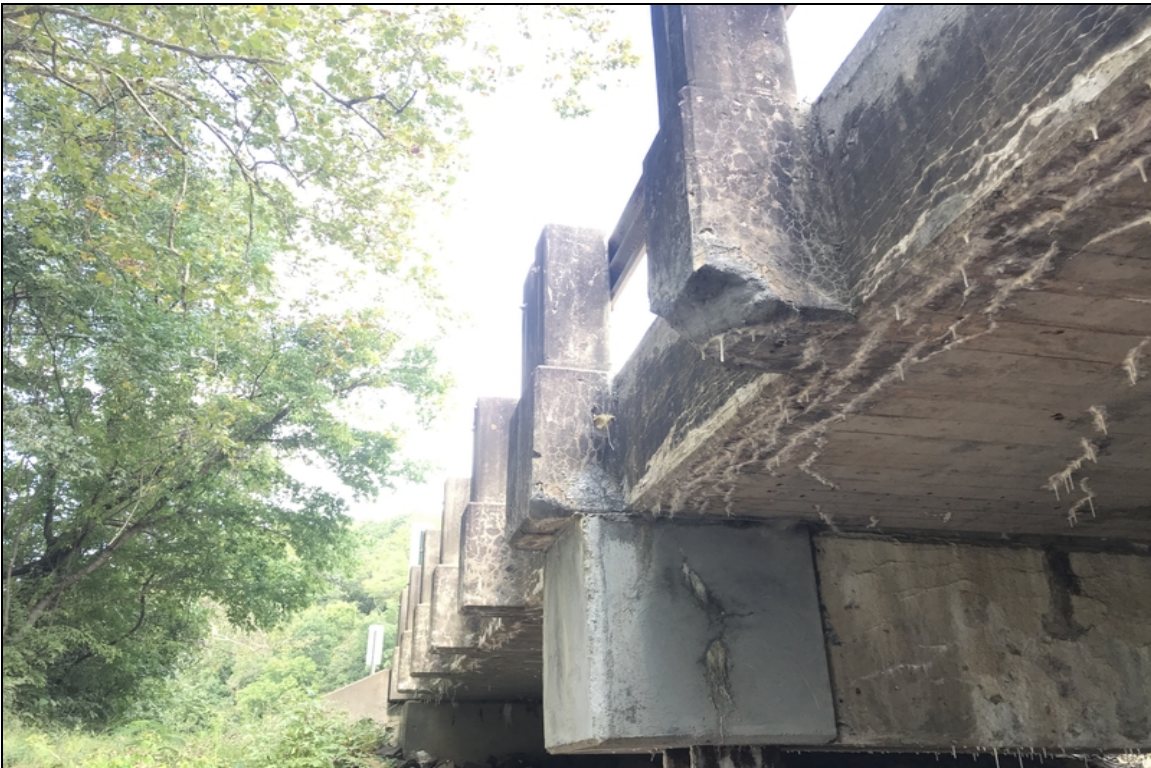
Bottom of railing posts left side.

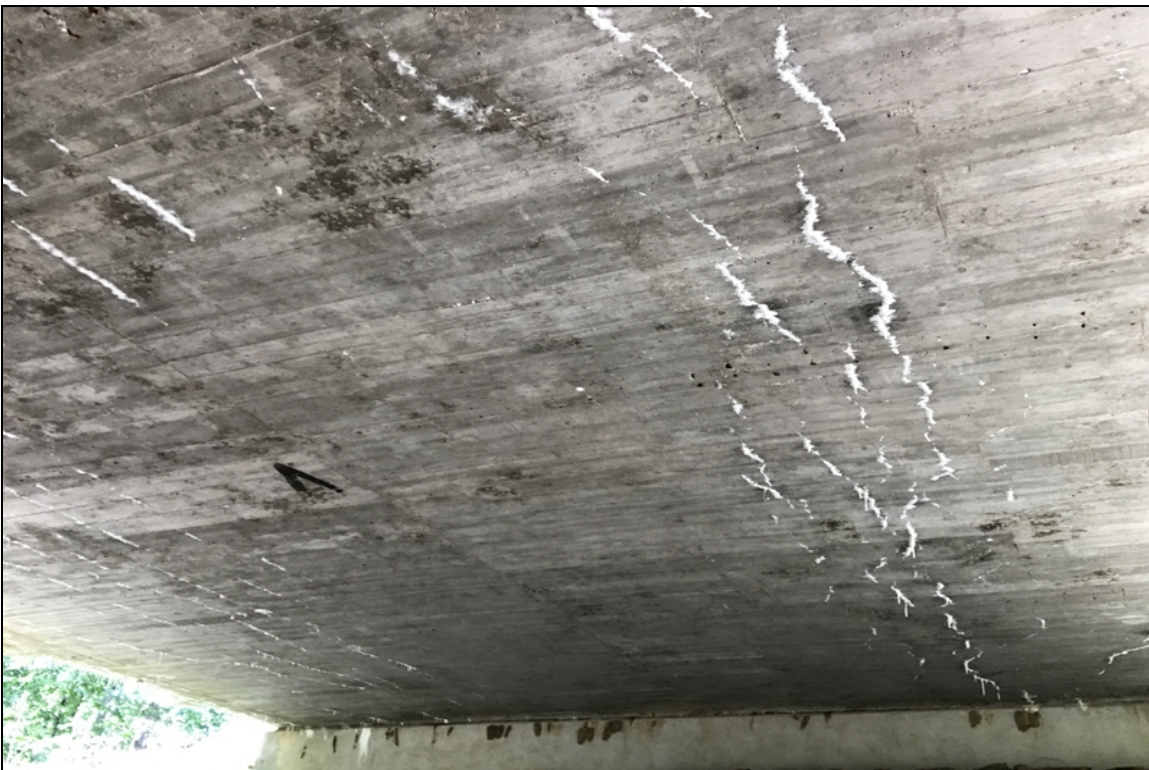
Span 1 typical cracking with efflorescence.

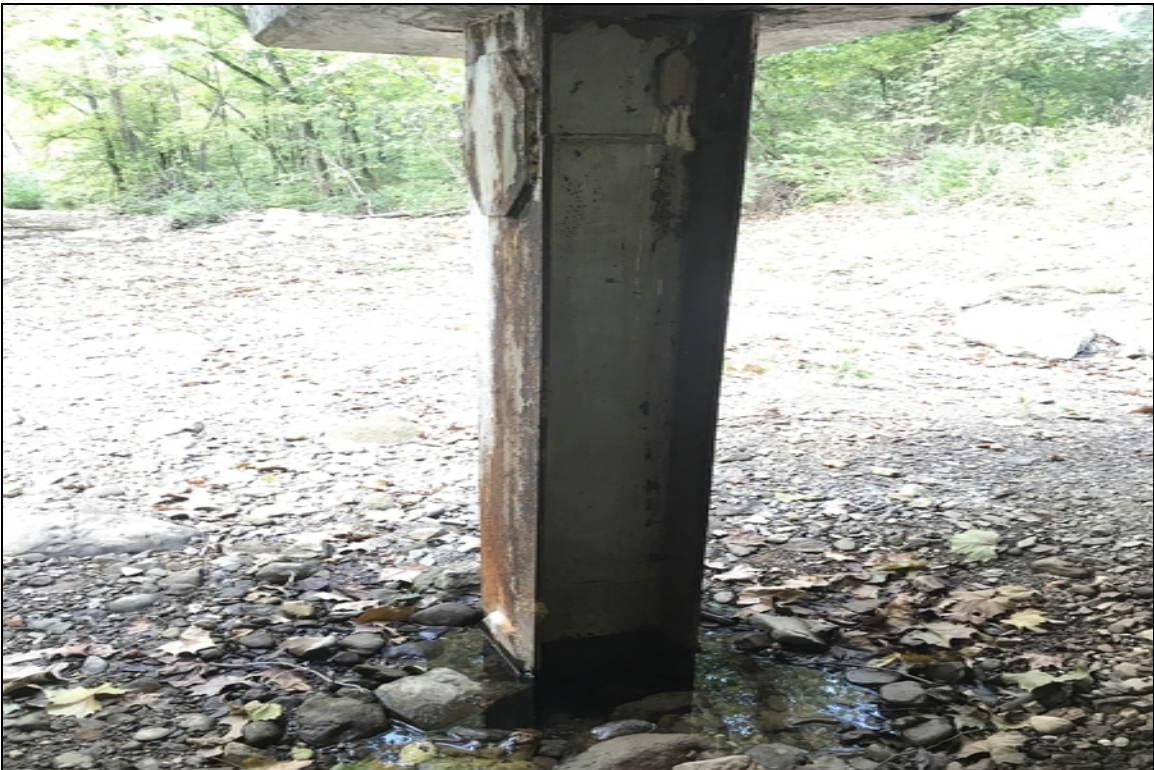
(225)							
09/08/2022 WNR & DBM:							
-All piling at the intermediate bent have a failing paint system with active corrosion on the majority of the piling that is exposed.							
-The previously documented section loss has been repaired by state maintenance forces. The repair is a complete replacement of the portion of steel piling that had the section loss.							
(225-515)							
09/08/2022 WNR & DBM:							
234	Reinforced Concrete Pier Cap	LF	28	0	9	19	0
1080	Delamination/Spall/Patched Area	LF	9	0	9	0	0

Typical repair to steel piling.

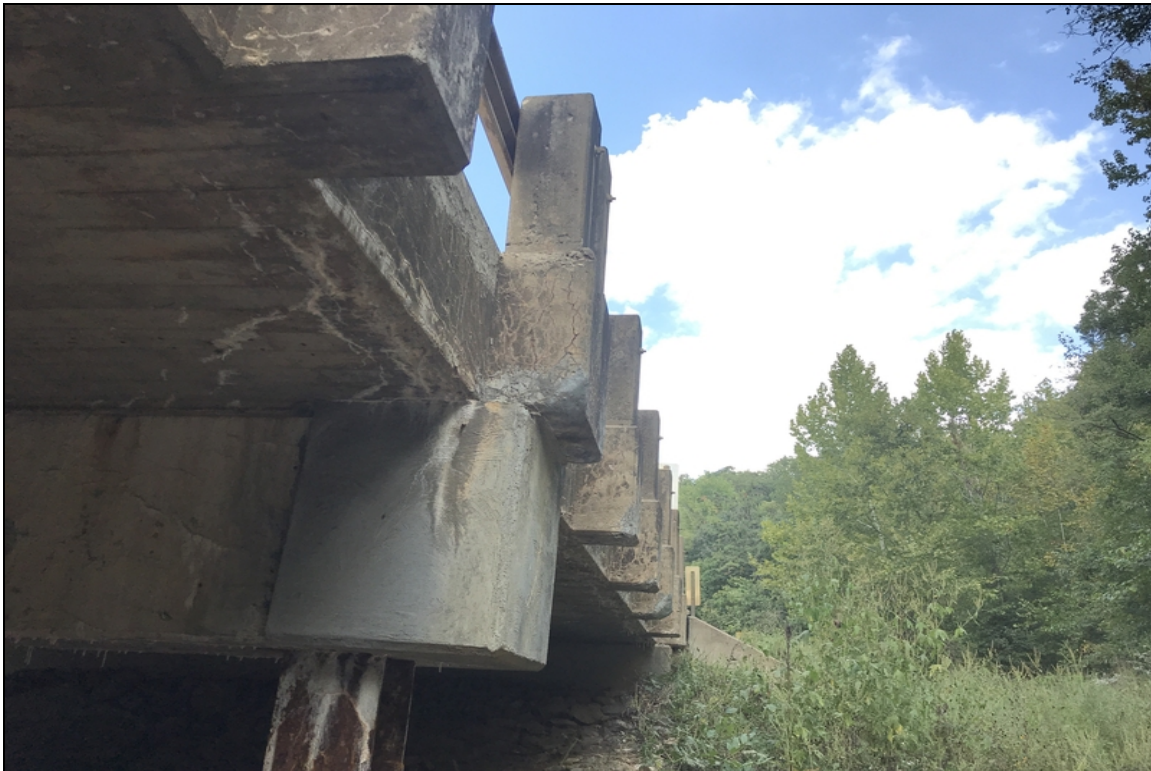
Bottom of railing posts right side.

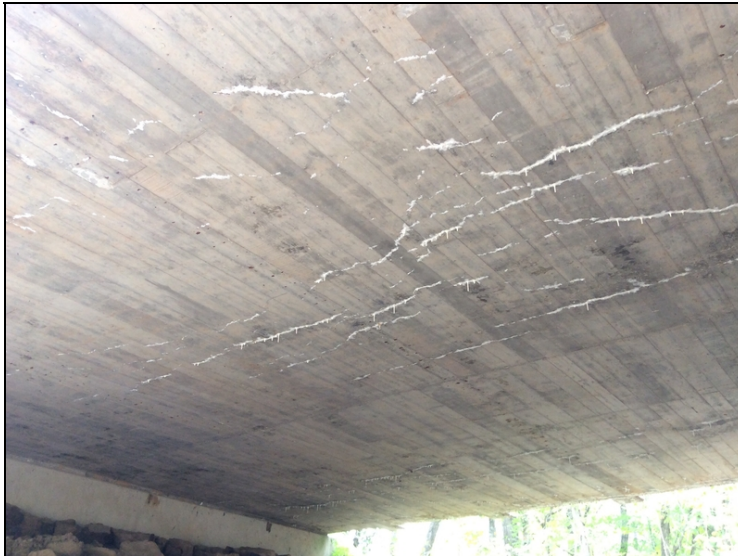
Superstructure - The undersurface of the deck / superstructure has numerous areas of mapcracking with efflorescence. The most extreme areas are along the exterior edges and in the vertical faces which has heavy mapcracking with efflorescence and delaminated areas.

Deck undersurface Span #1 typical view of cracking with efflorescence.

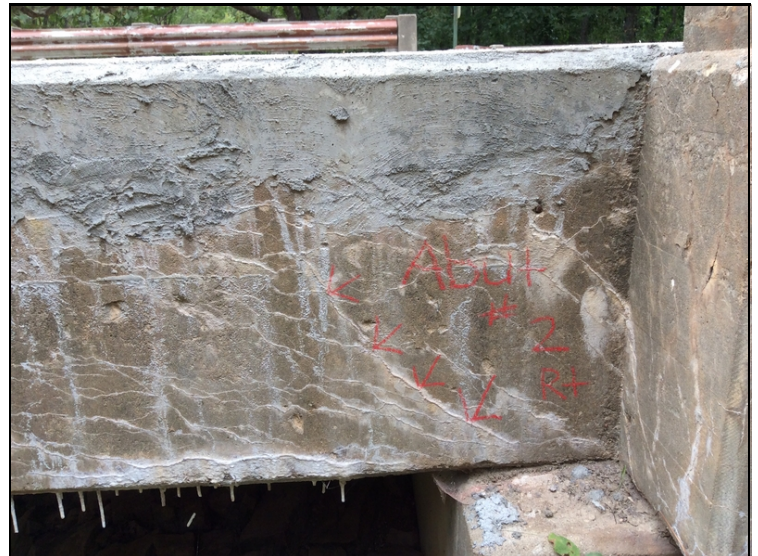
Right side of deck at abutment #2 - shear type crack.

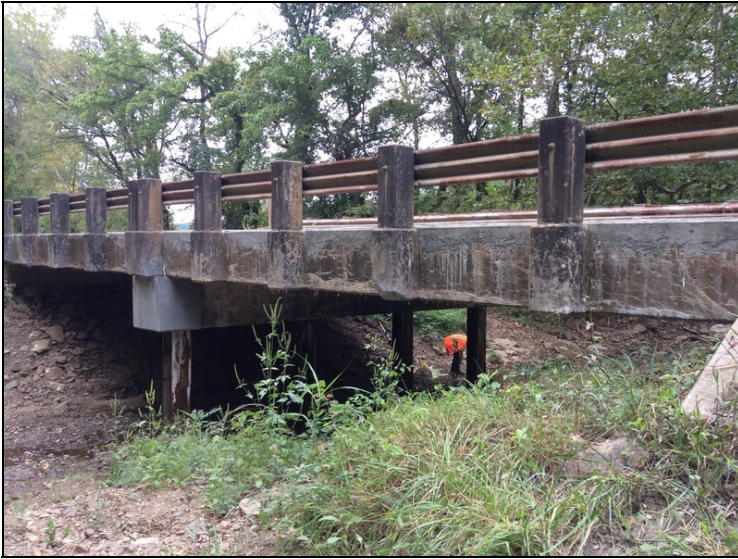
General view of side of bridge showing cracking and efflorescence.

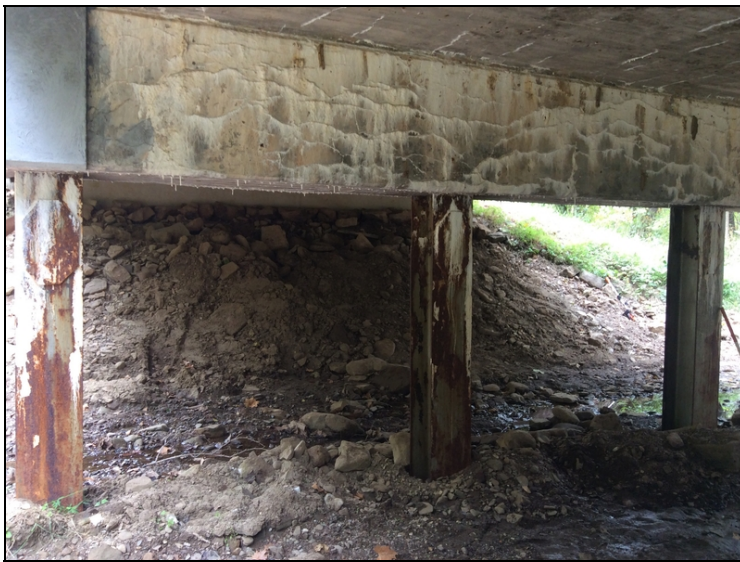
General view of bent #1 looking South.

Substructure - The intermediate bent cap has chloride contamination with heavy map cracking and efflorescence with delaminated areas in the lower portion of the cap.

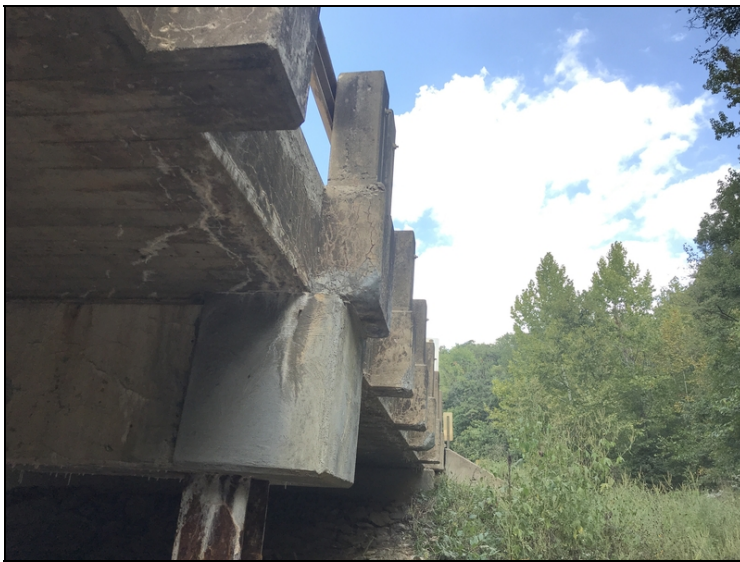
The concrete portion of the bridge railing has concrete deterioration mapcracking with efflorescence.

Bottom of railing posts right side.

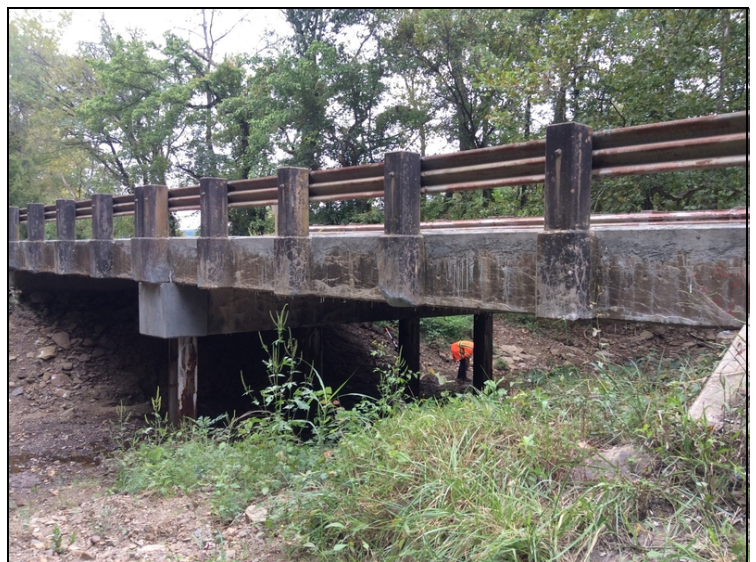
General view of side of bridge showing cracking and efflorescence.

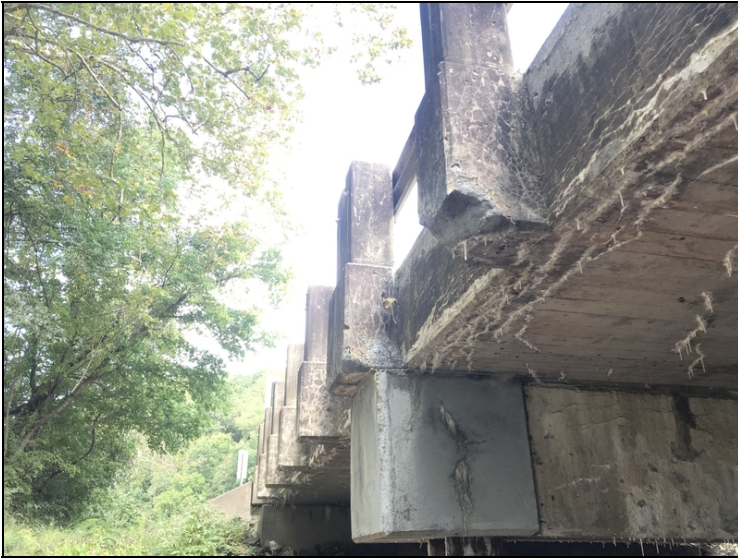
Bottom of railing posts left side.
