Bridge #05933(Routine, Underwater type 2)

SH 16 Madison Co. over MILL CREEK

Location: 10.52 SO OF WASHINGTON CO

Team Lead: Nathan Rowland **Inspection Date:** January 27, 2022

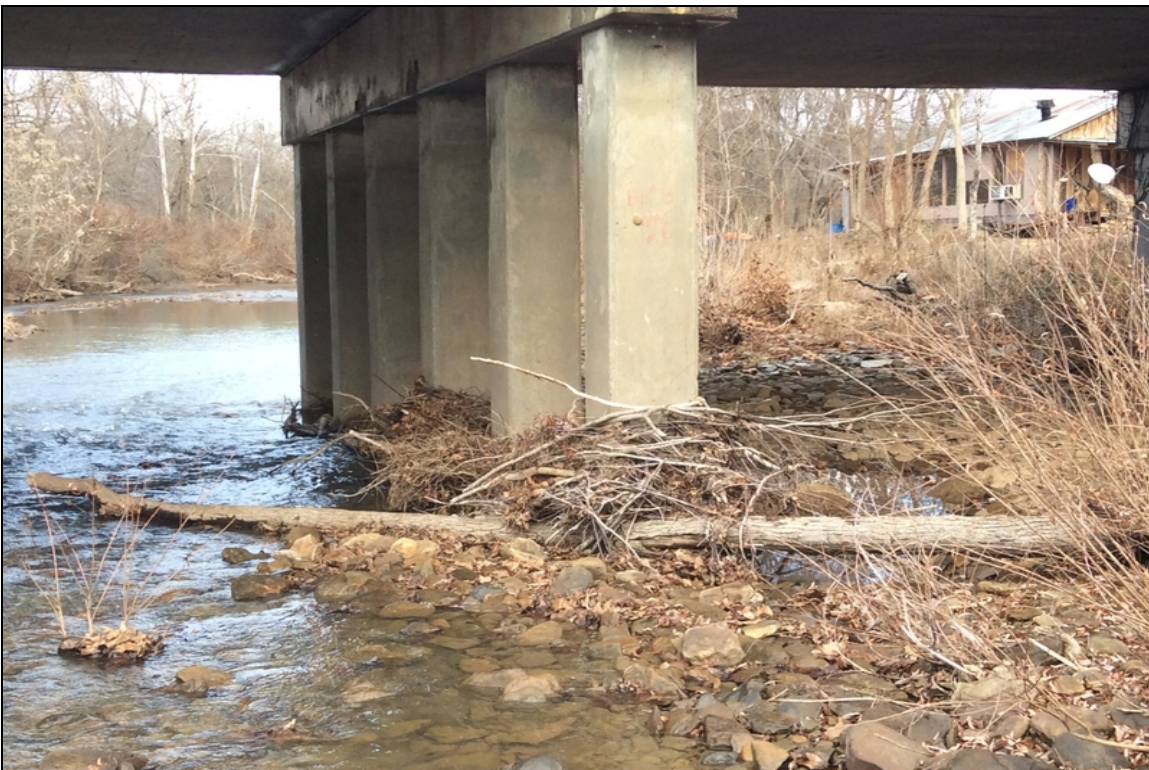
(225)							
01/27/2022 WNR & DBM:							
-Concrete protective coating for pile #6 of bent #3 has vertical cracking in upper portion on ahead face and exterior face.							
-The concrete protective coating has light abrasion at the bases of bents #2 and #3.							
-Channel has light drift accumulation at bent #3.							
234	Reinforced Concrete Pier Cap	LF	212	206	2	4	0
1080	Delamination/Spall/Patched Area	LF	6	0	2	4	0

Channel has light drift at bent 3

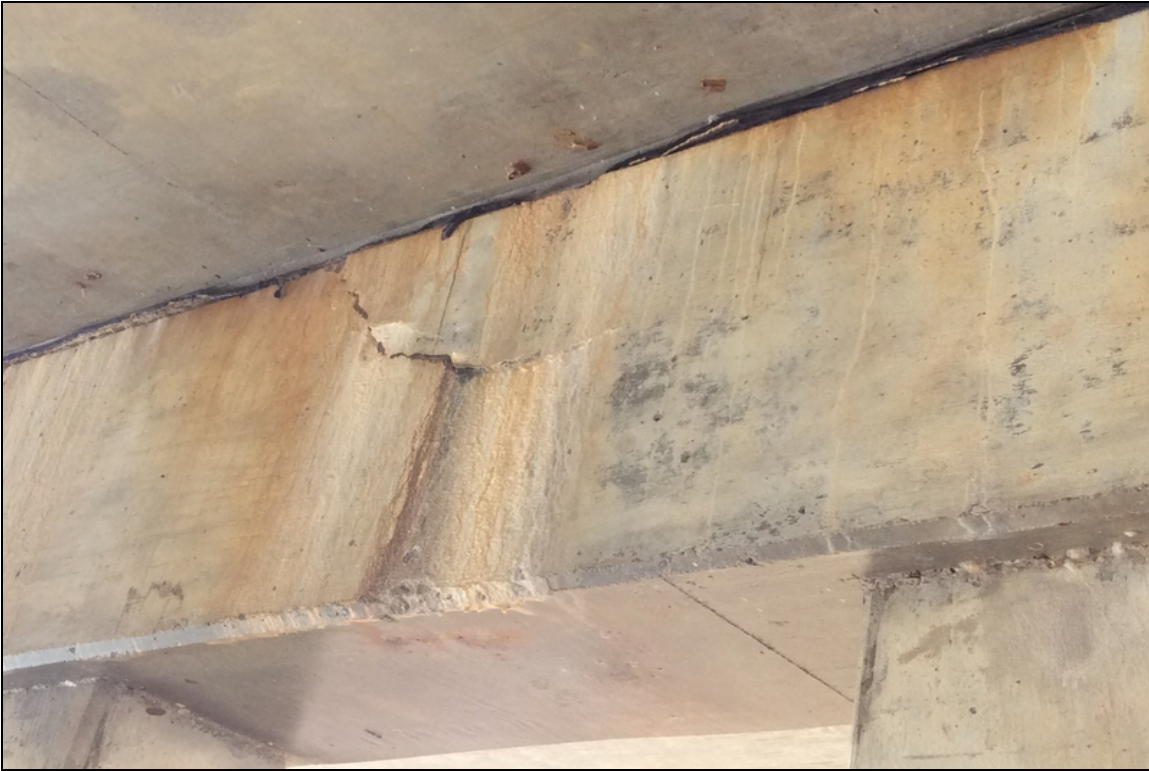
(234)							
01/27/2022 WNR & DBM:							
-The ahead face of Bent #2 cap has a large delaminated area approximately 3' long in bay #4.							
-The ahead face of Bent #3 cap has a large delaminated area approximately 3' long in bay #2.

Bent 2 cap ahead side delaminated area in bay 4.

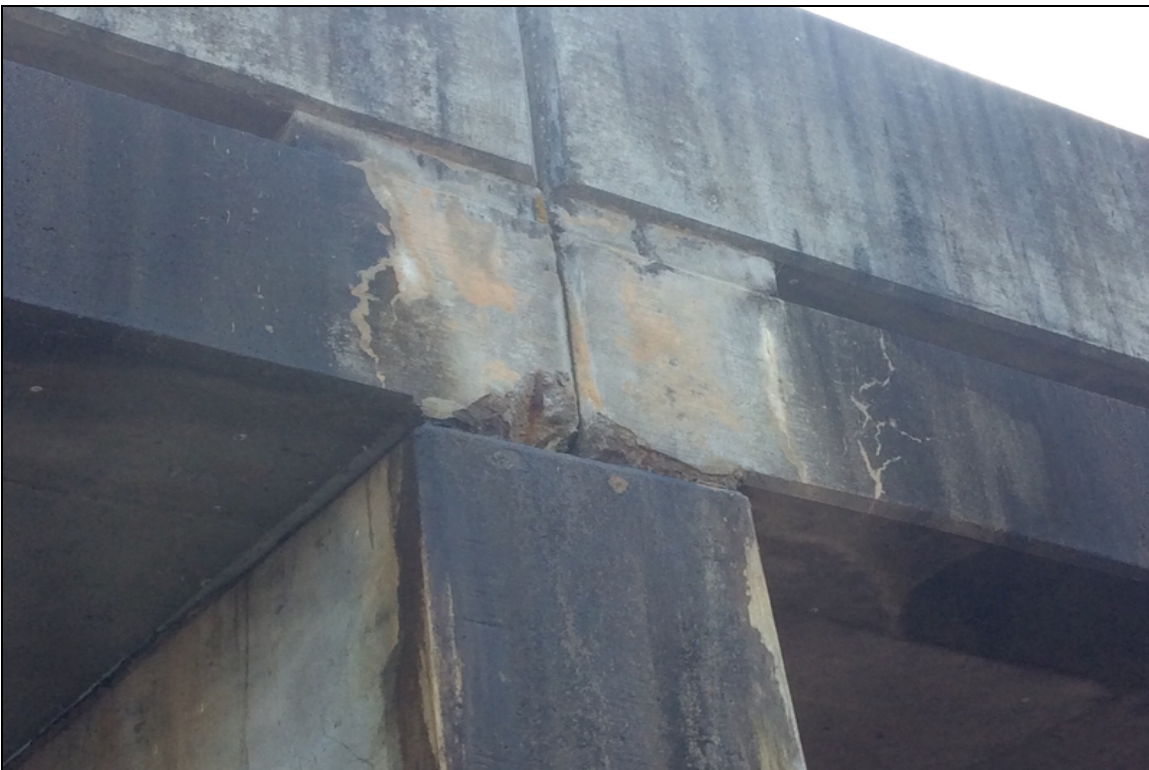
Span 3 over bent 2 spalling to left side with exposed reinforcing steel.

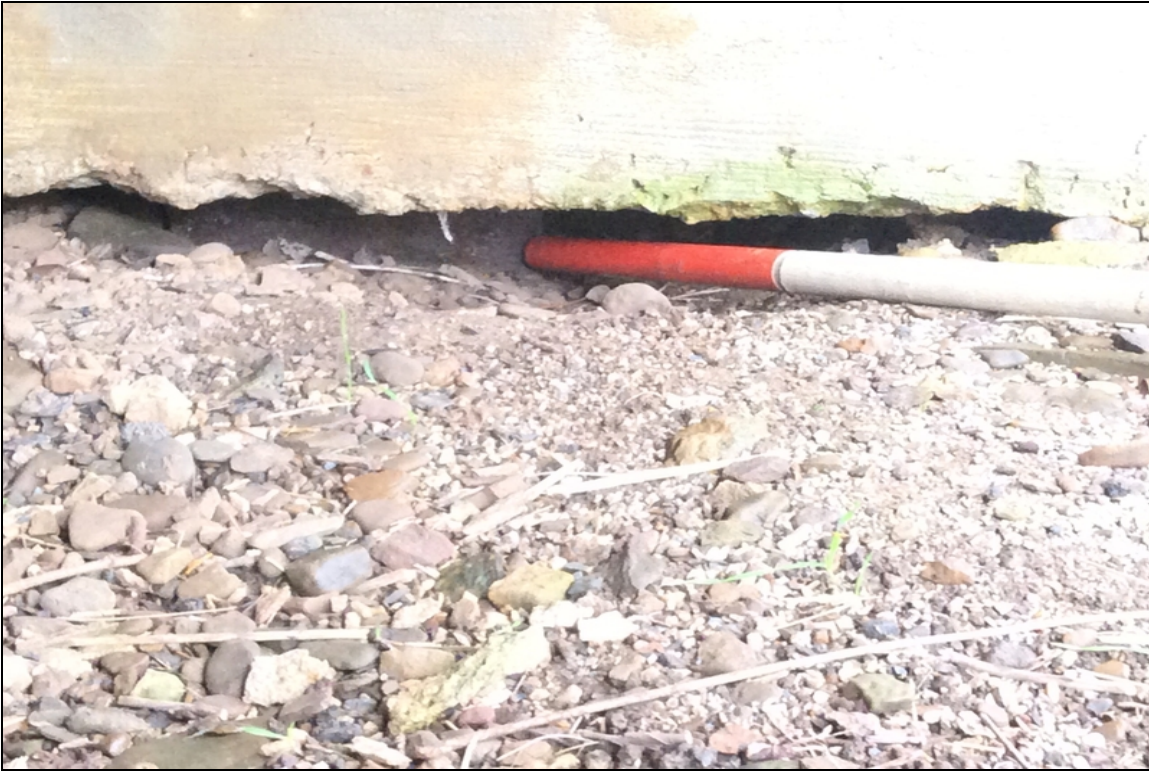
- Abutments:							
-Embankment has minor earth settlement that has exposed one steel pile on left side at abutment #1.							
301	Pourable Joint Seal	LF	128	32	12	84	0
2310	Leakage	LF	96	0	12	84	0

Abutment 1, Left side-piling exposed.

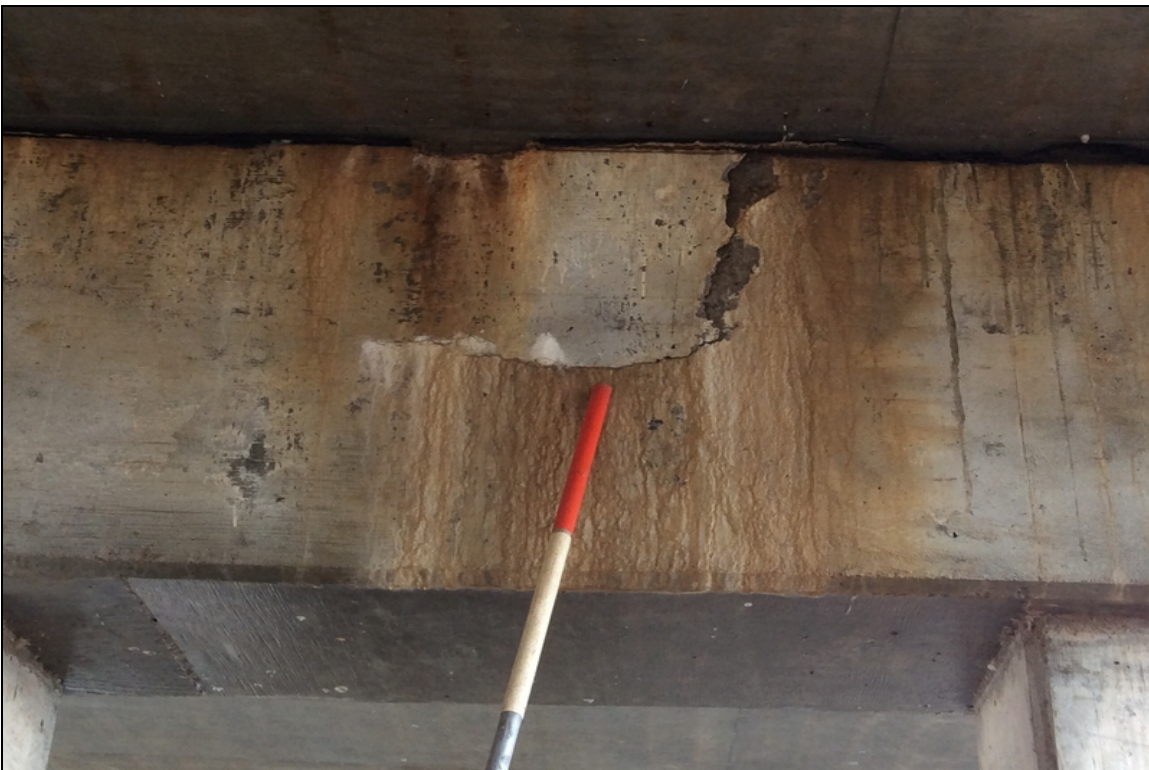
-Bent3 cap ahead side delaminated area in bay 2

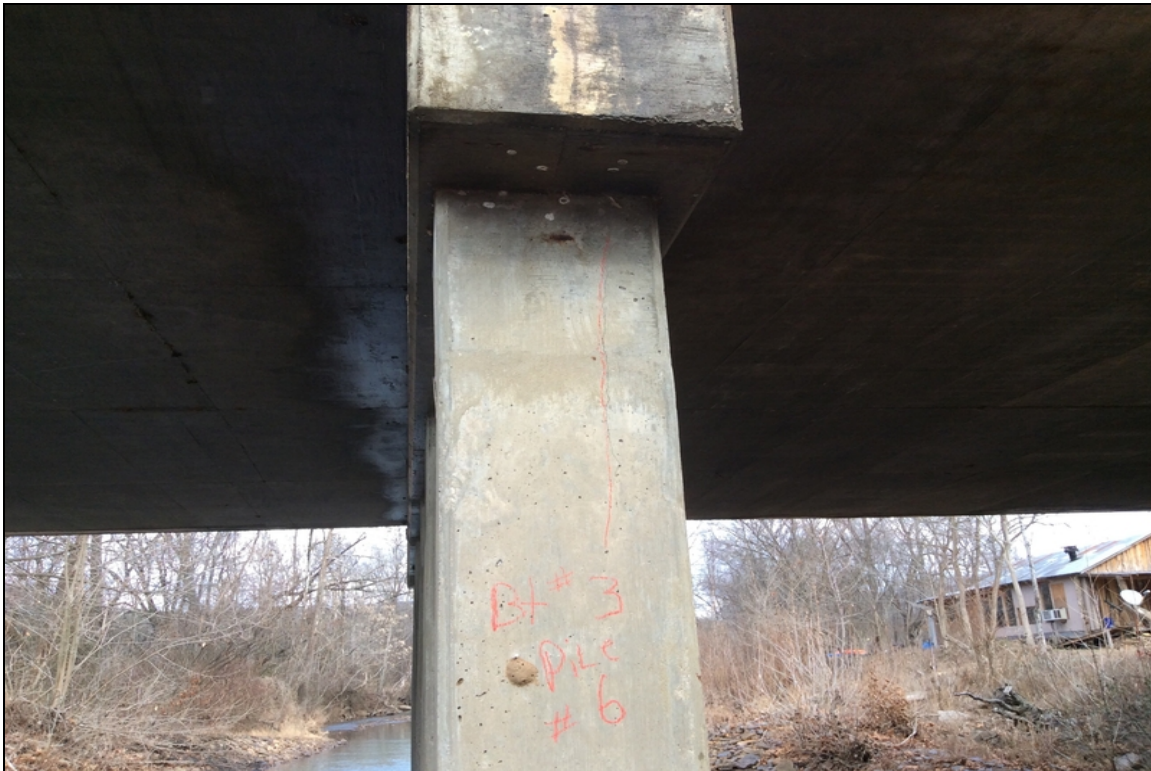
Concrete coating for pile 6 bent 3 has vertical cracking in top.

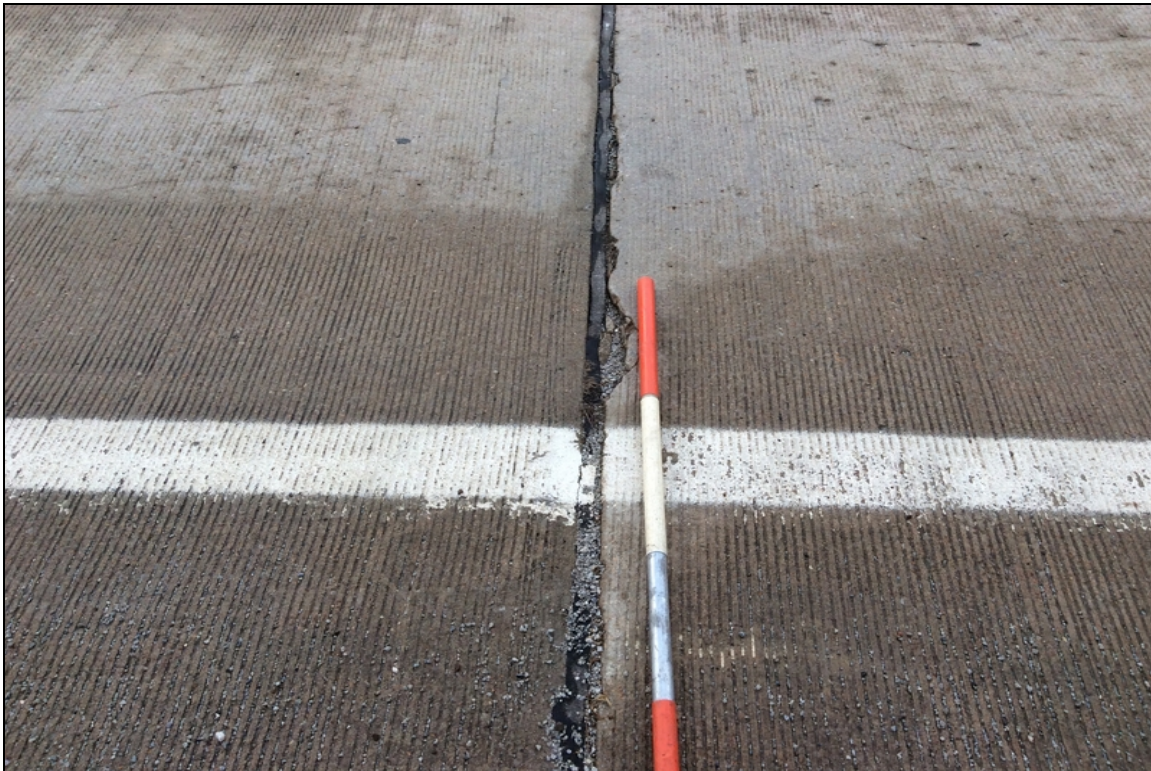
Slab spalled areas along expansion joints.

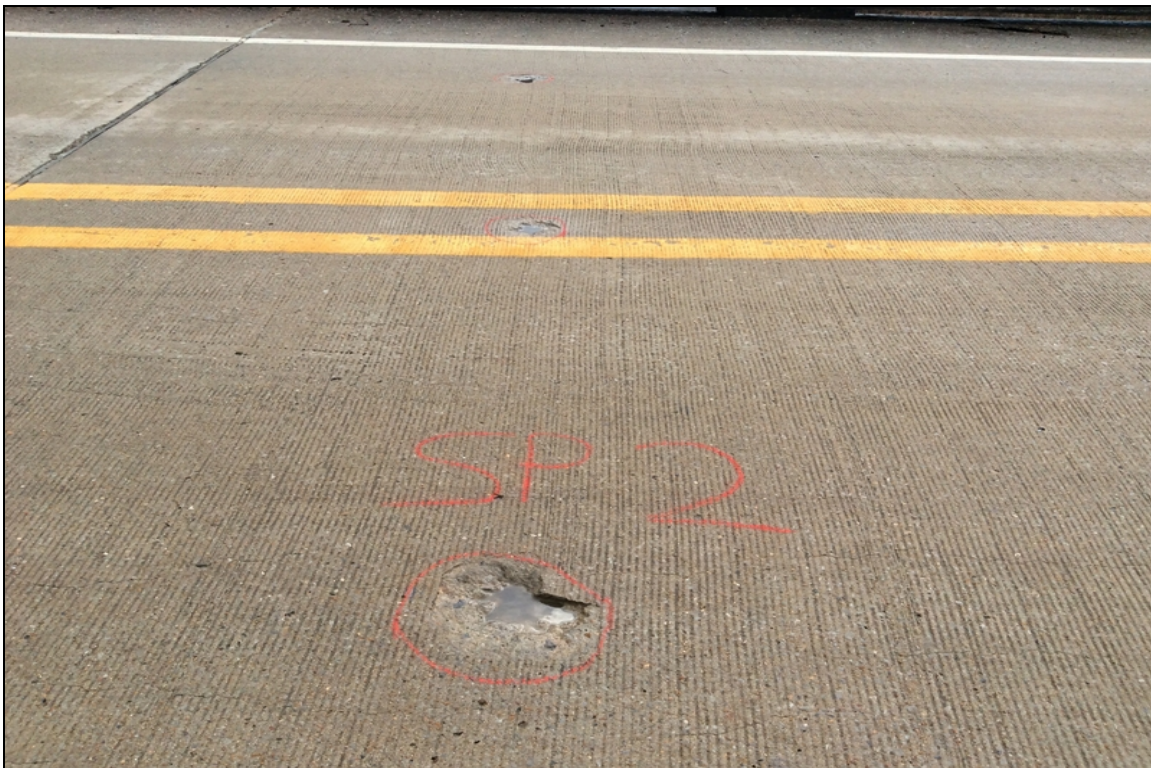
Span 2 spalling approximately 5' from bent 2.

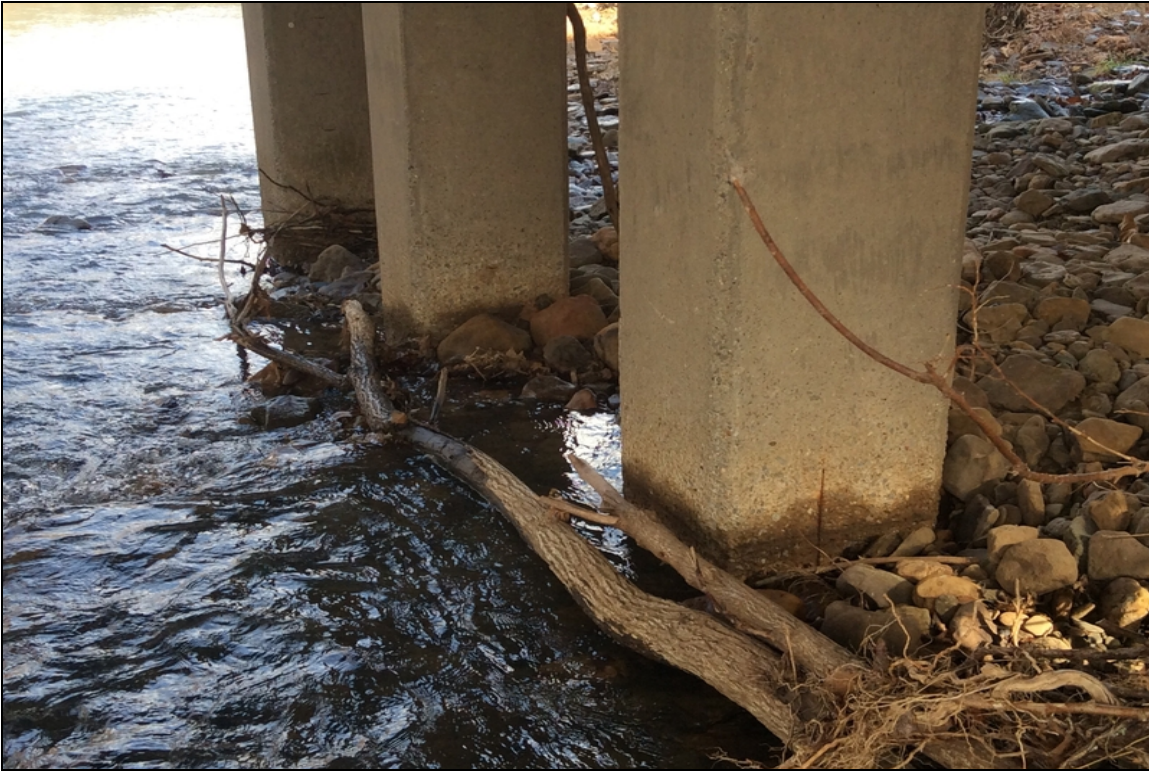
Abrasion bent 3

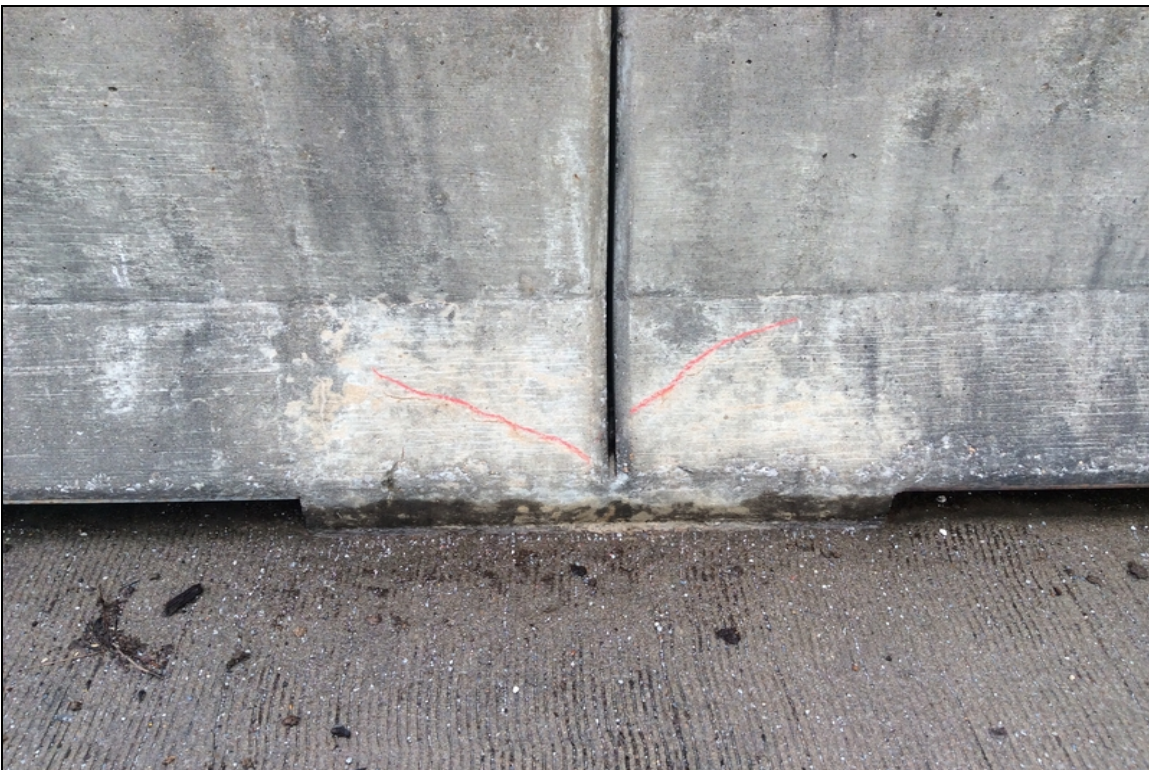
Cracking

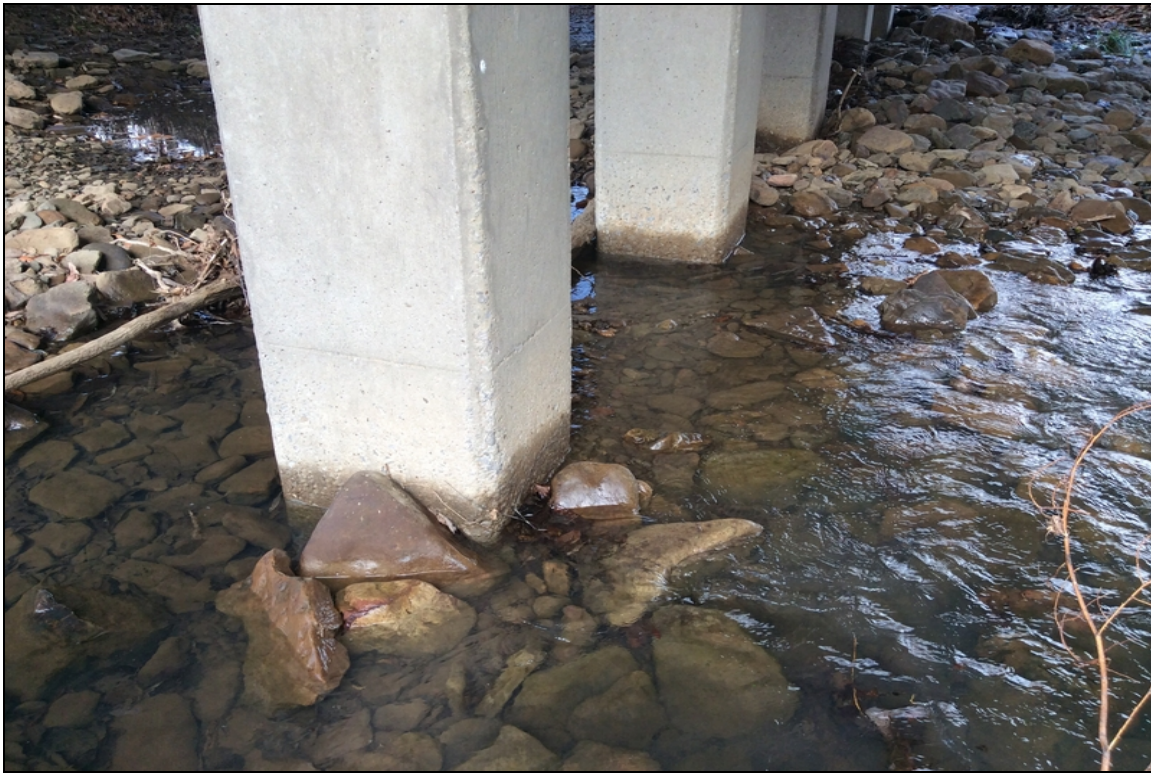
Abrasion at bent 2

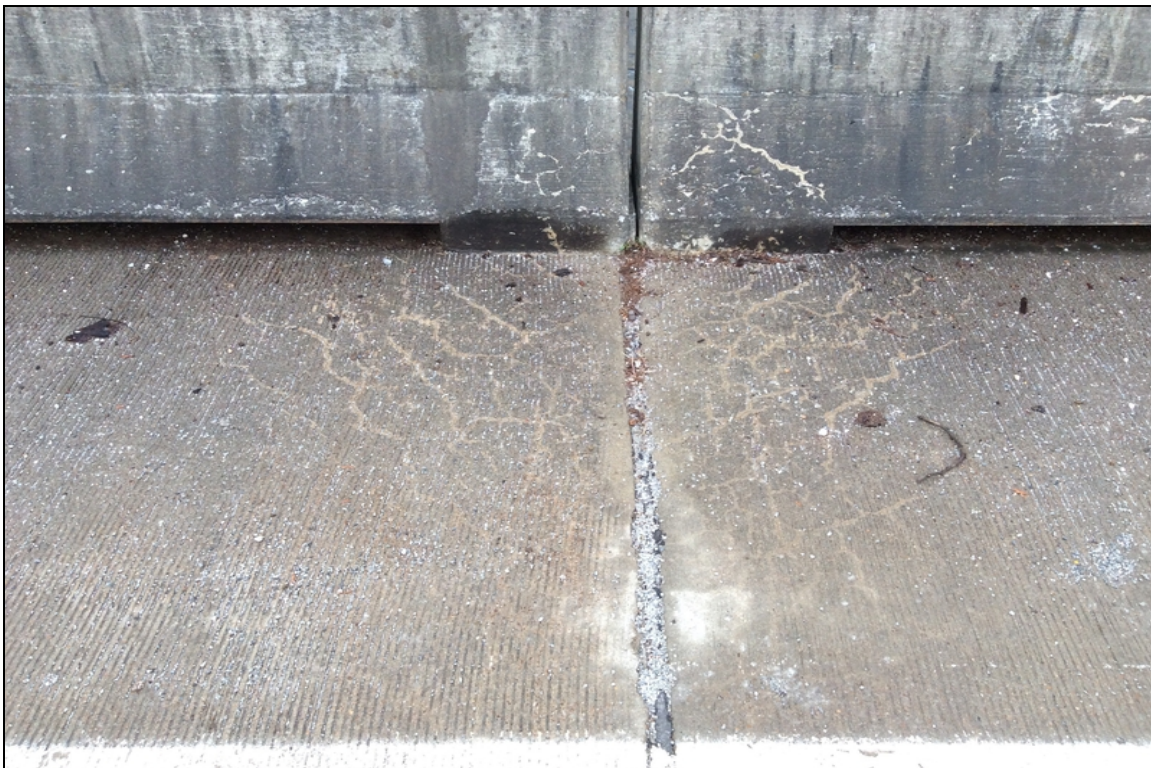
General view of map cracking

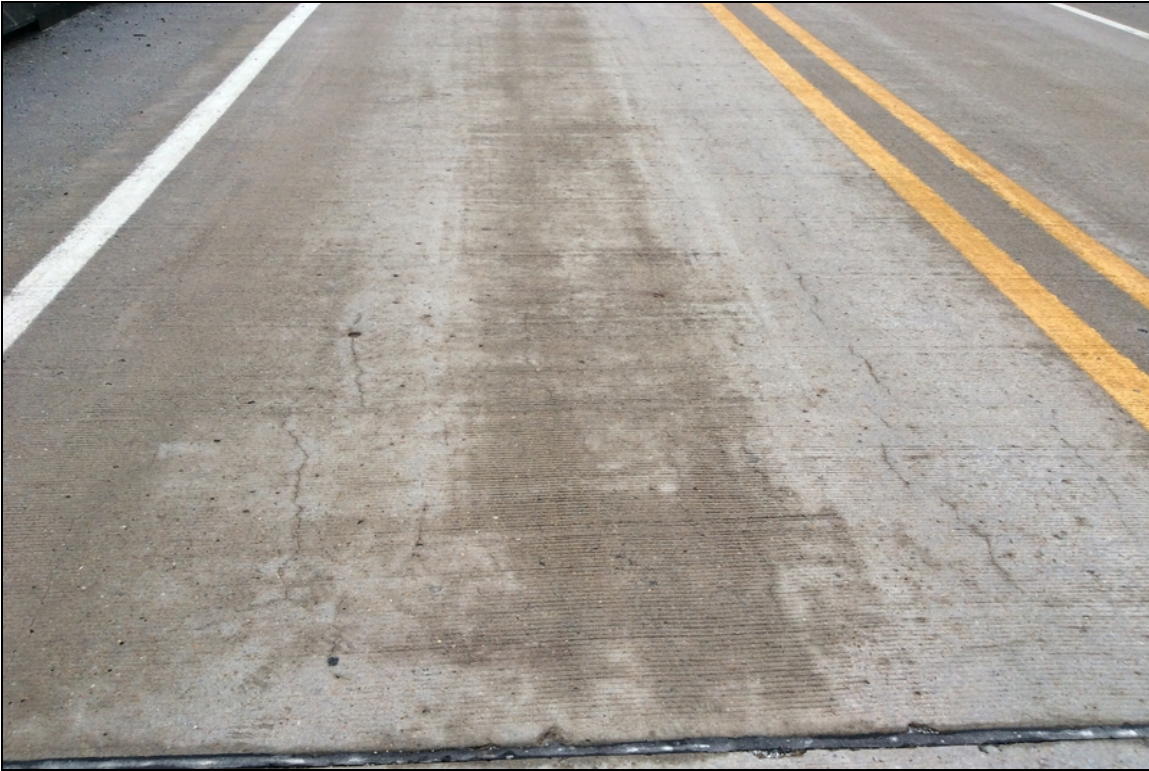
General view of deck cracking

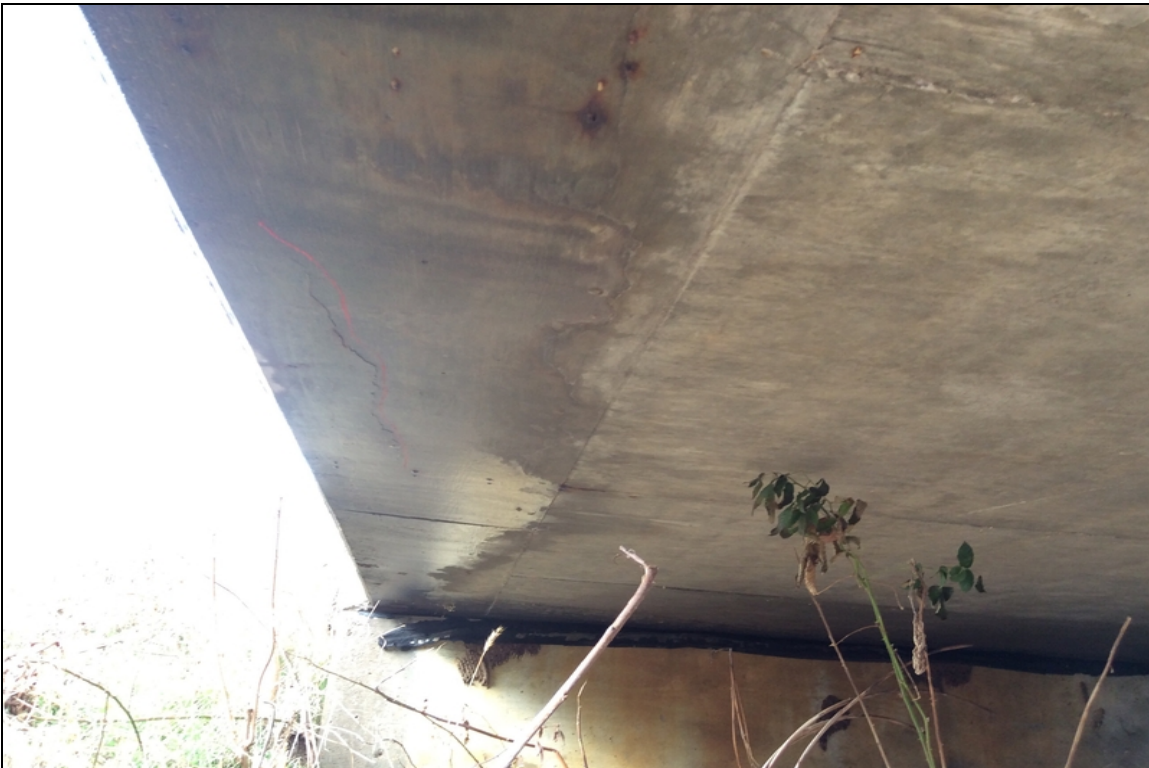
Longitudinal cracking in undersurface span 1 right side.

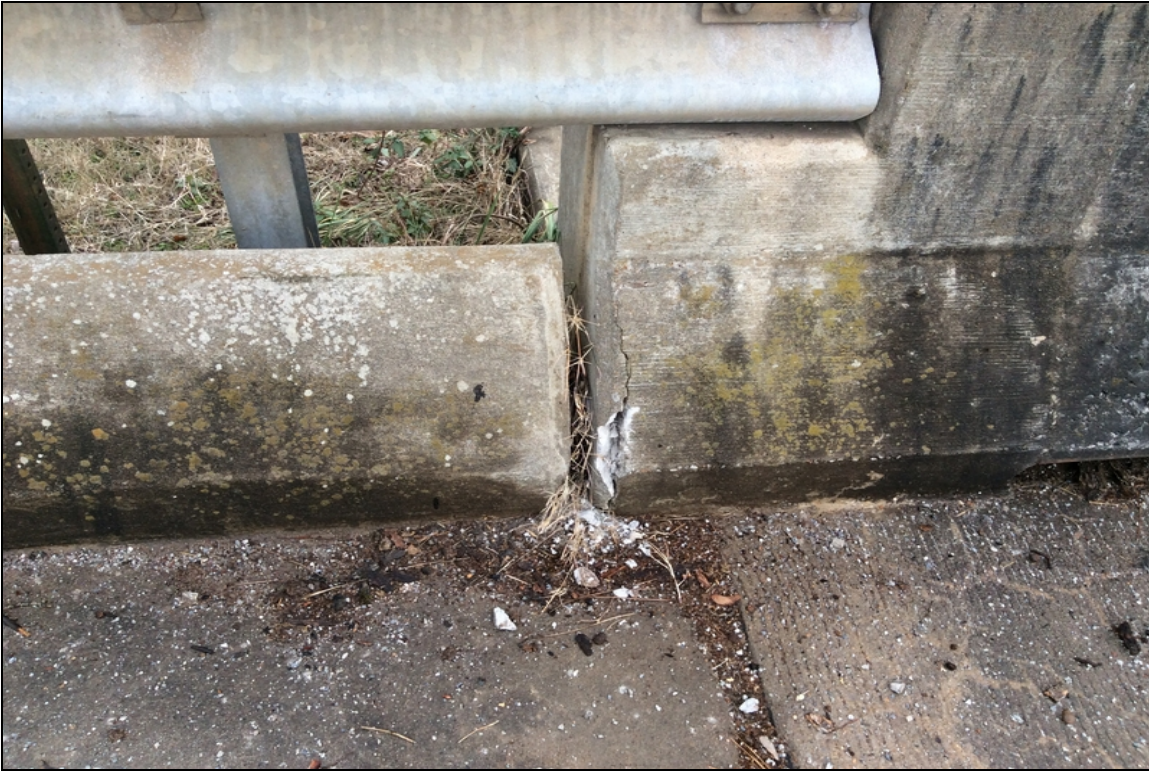
ELEM	DESCRIPTION	UNITS	TOTAL	CS1	CS2	CS3	CS4
01/27/2022 WNR & DBM: -The end of the right bridge railing at abutment 2 has minor spall. -Bridge railing has diagonal cracks that propagate from joints in the railing.

Spall at abutment 2 right side of bridge railing

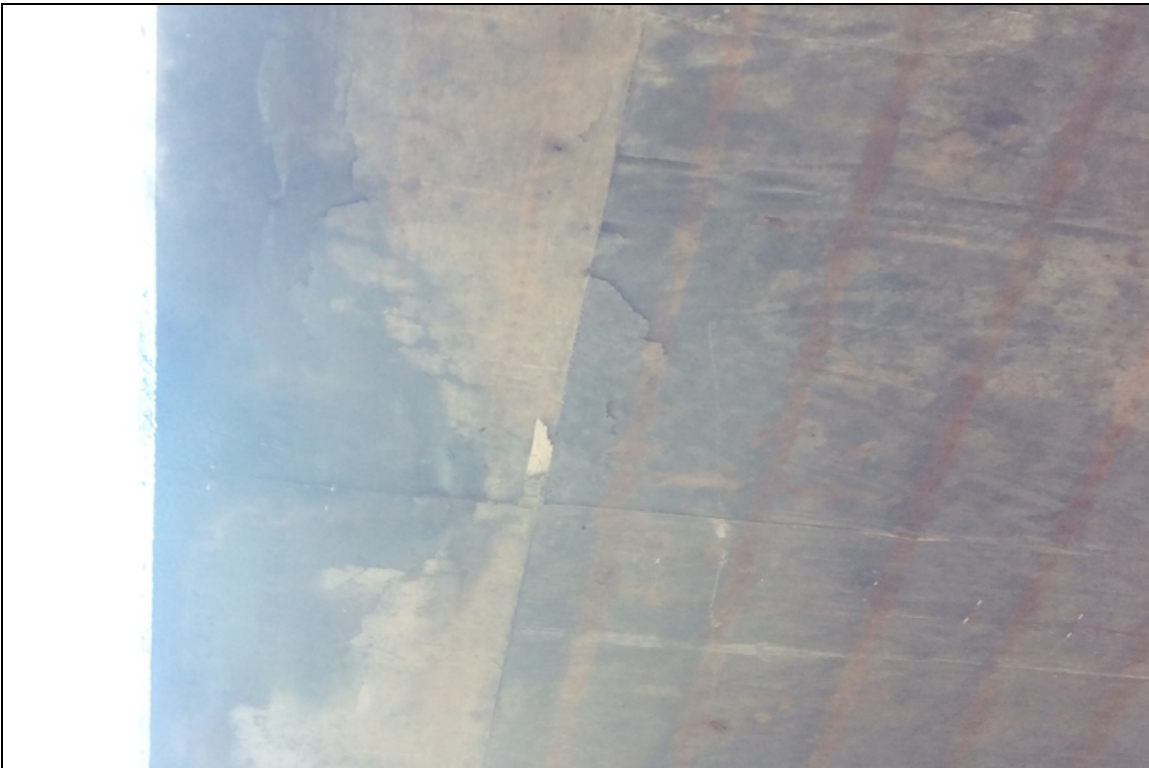
Delaminated area on undersurface of span 4 right side.

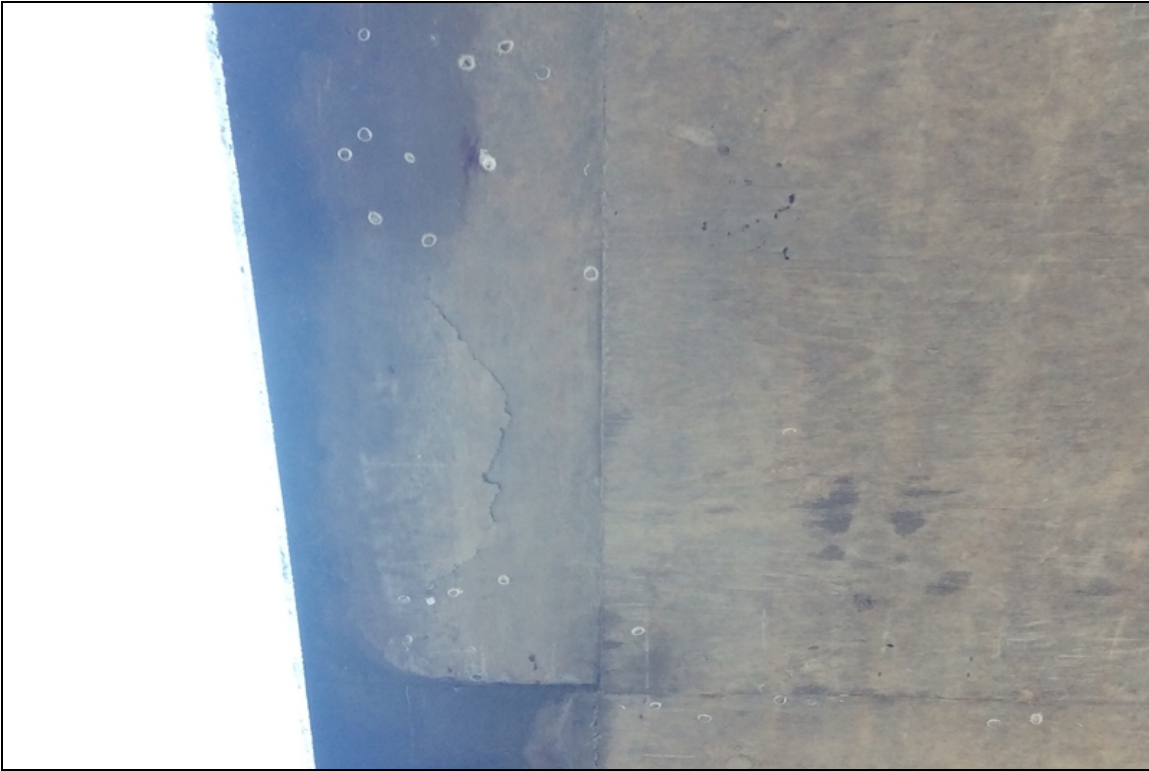
Span 3 Left side delaminated area in undersurface

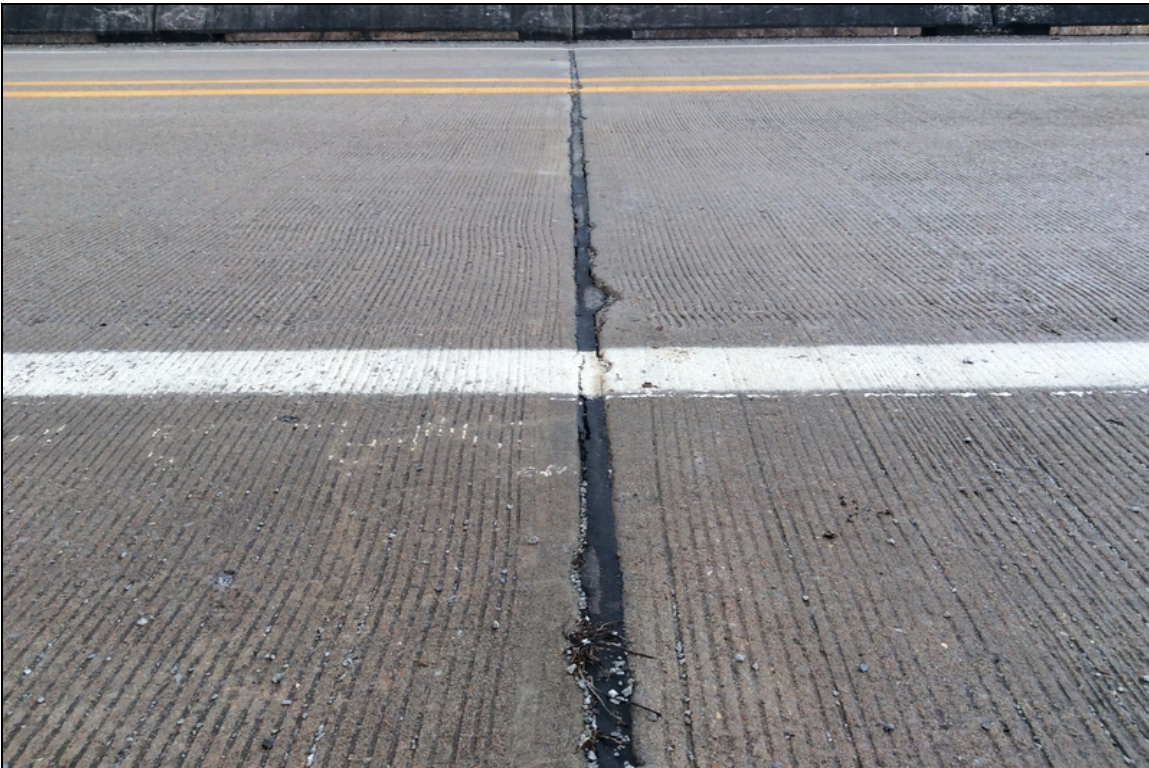
(301)							
01/27/2022 WNR & DBM:							
-The pourable joint seals have adhesion failure in the majority of the length of joints allowing water to leak onto the substructure.							
331	Reinforced Concrete Bridge Railing	LF	330	293	37	0	0
1130	Cracking (RC and Other)	LF	37	0	37	0	0

Deck joint seal at bent 1 has

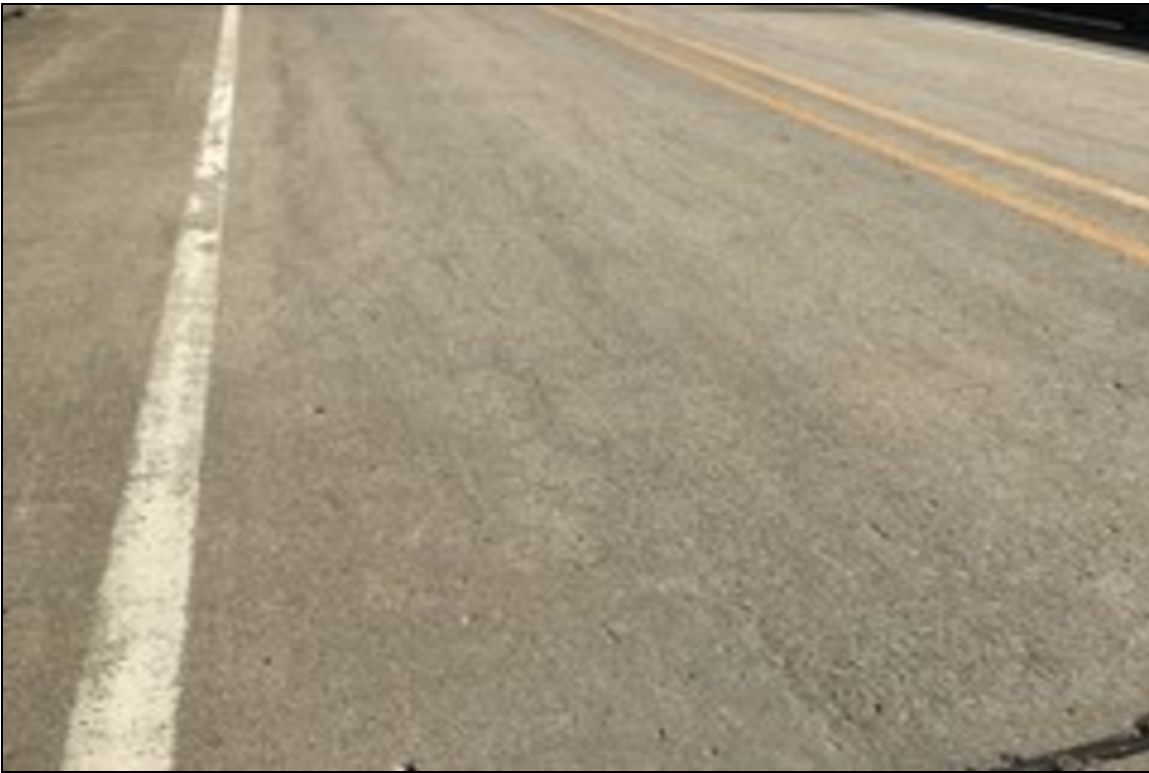
Typical longitudinal deck cracking.

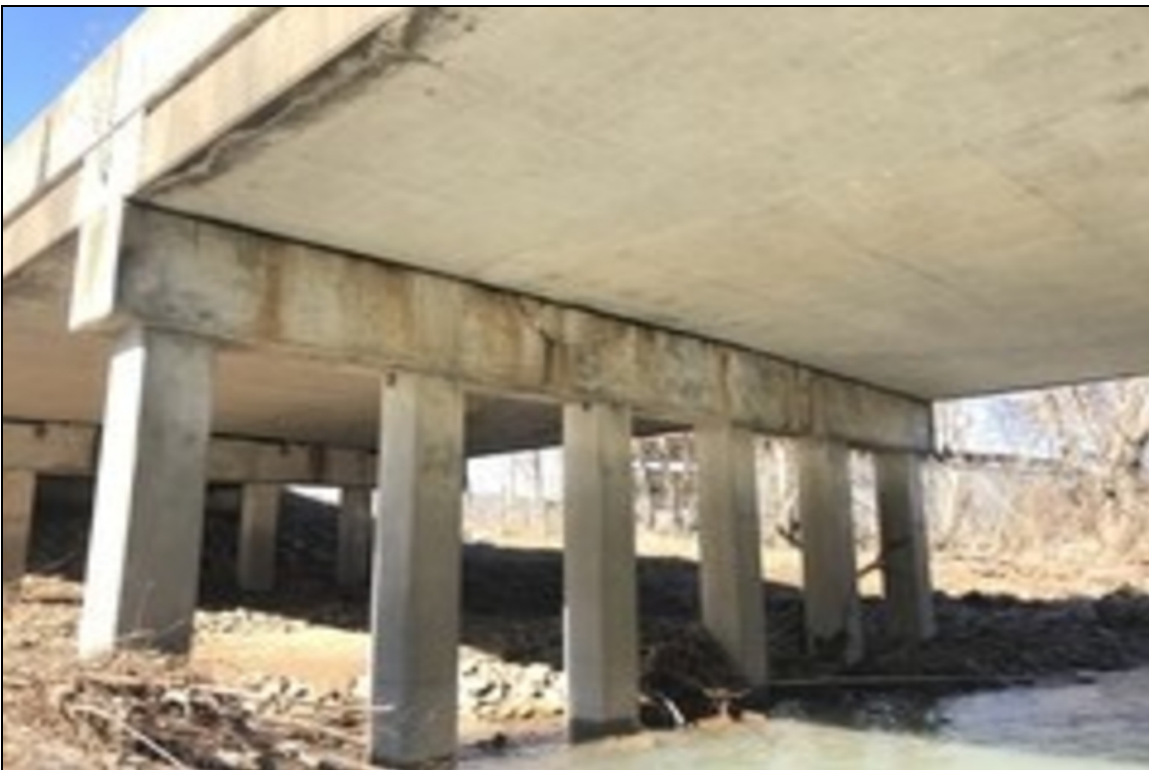
Bent #2 cap ahead side delaminated area around Keyways.

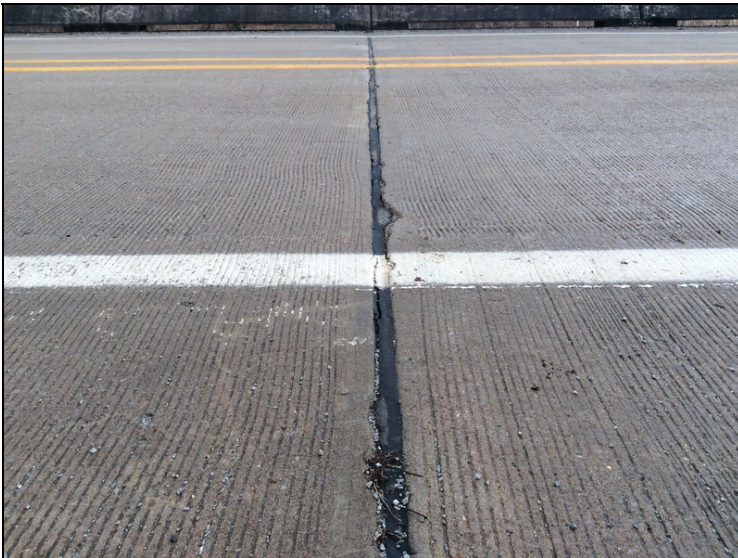
Expansion joints - The pourable joint sealant in all locations is deteriorated with adhesion failure allowing water to leak onto the substructure.

Expansion joint sealant has adhesion failure.

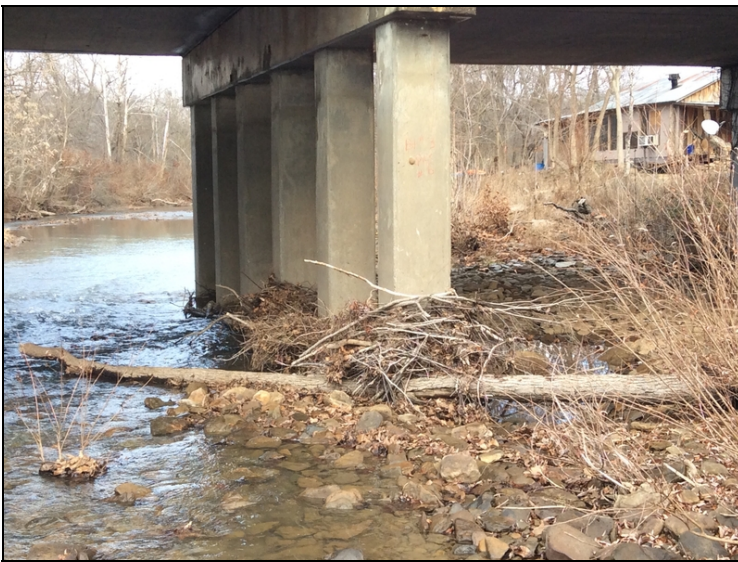
The channel has light drift accumulation at bent #2 and #3

Channel has light drift at bent #3.

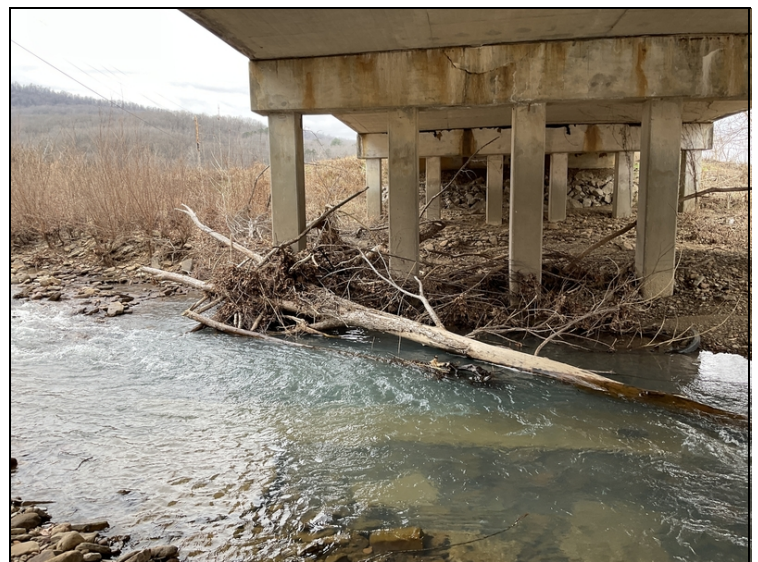
Drift has accumulated at bent #2 causing localized scour.

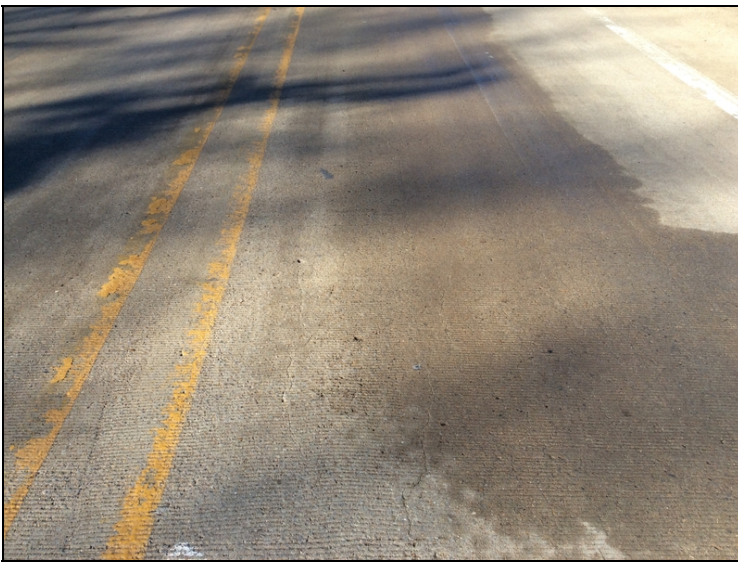
Deck - The driving surface has sealable longitudinal cracking with areas of mapcracking in all spans.

Deck - sealable longitudinal cracks located in the driving surface.

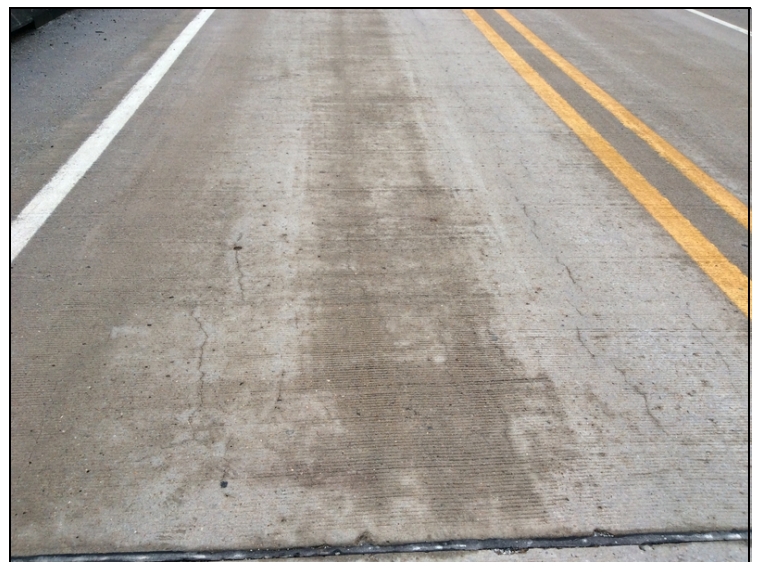
Typical of deck cracking in all spans.

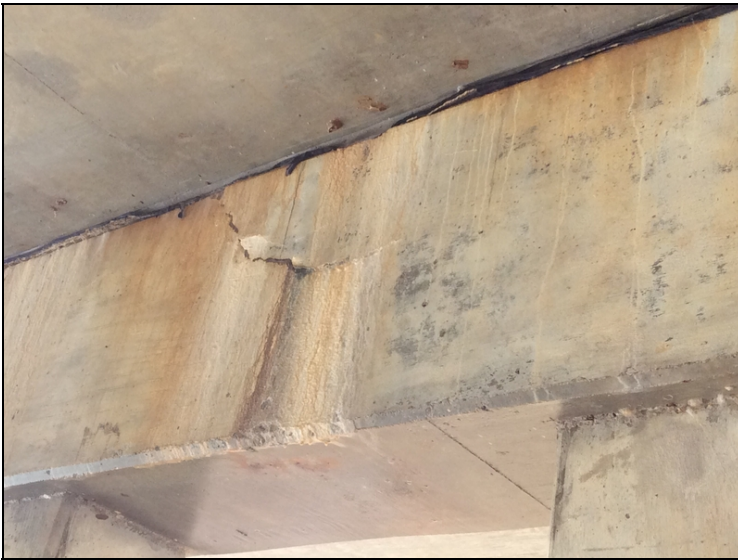
Substructure - Bent caps #2 and #3 have large delaminated area on the ahead face.

Bent 2 cap ahead side delaminated area in bay 4.

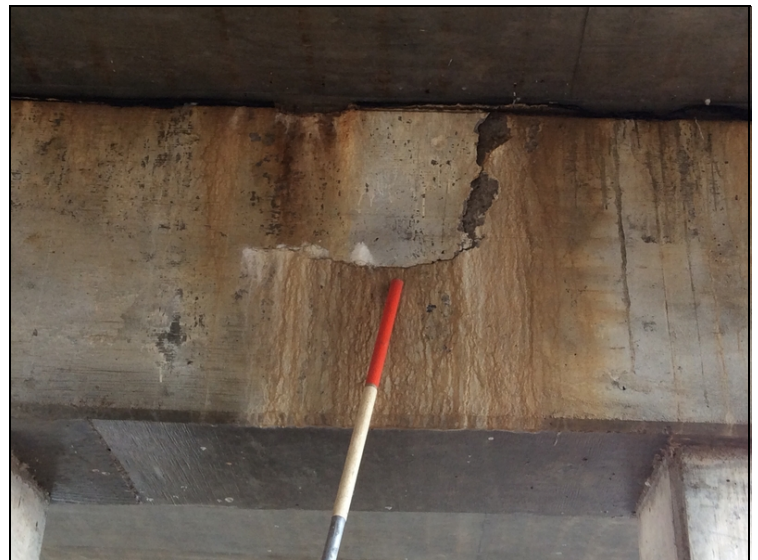
-Bent3 cap ahead side delaminated area in bay 2

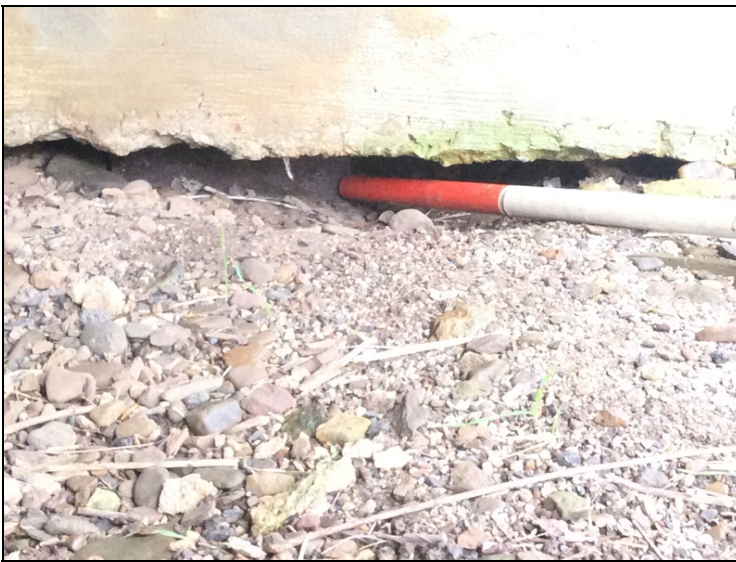
Substructure - The embankment on the left side of abutment #1 has minor earth settlement that has exposed one steel pile.

Abutment 1, Left side-piling exposed.

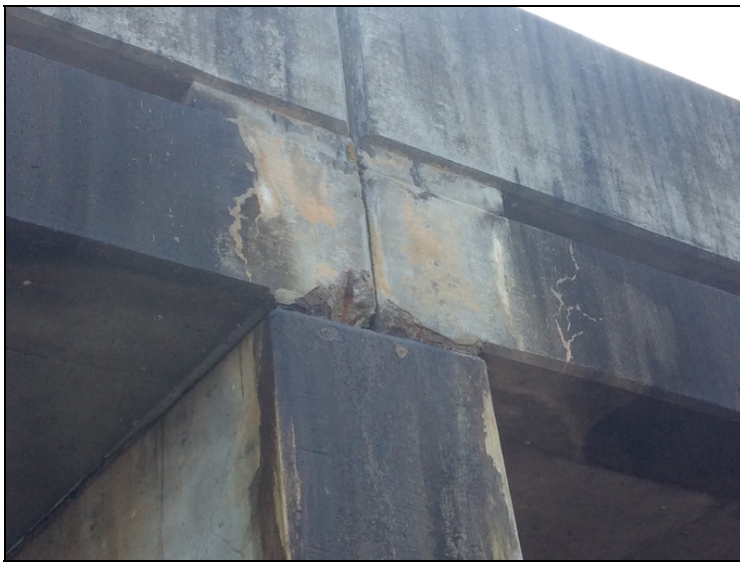
Superstructure - The undersurface of the slab has longitudinal cracking with delaminated areas along the edges. Span #3 has an area of spalling with exposed reinforcing steel to the left exterior face of slab over bent #2.

Span #3 has an area of spalling with exposed reinforcing steel to the left exterior face of slab over bent #2.

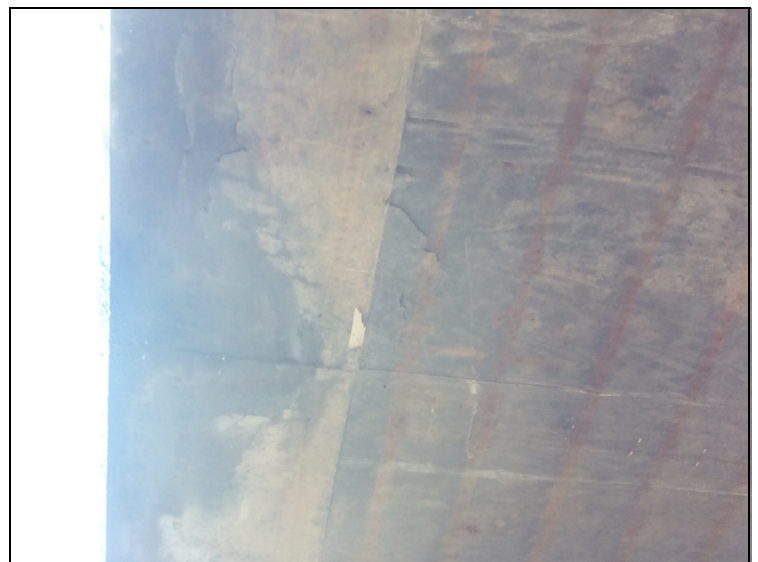
Delaminated area along exterior edge of undersurface.
