**Bridge #06370**(Routine, Underwater type 2)

**SH 23 Madison over WHITE RIVER**

**Location: 4.26 M N OF FRANKLIN CO**

**Team Lead:** Nathan Rowland **Inspection Date:** August 01, 2022

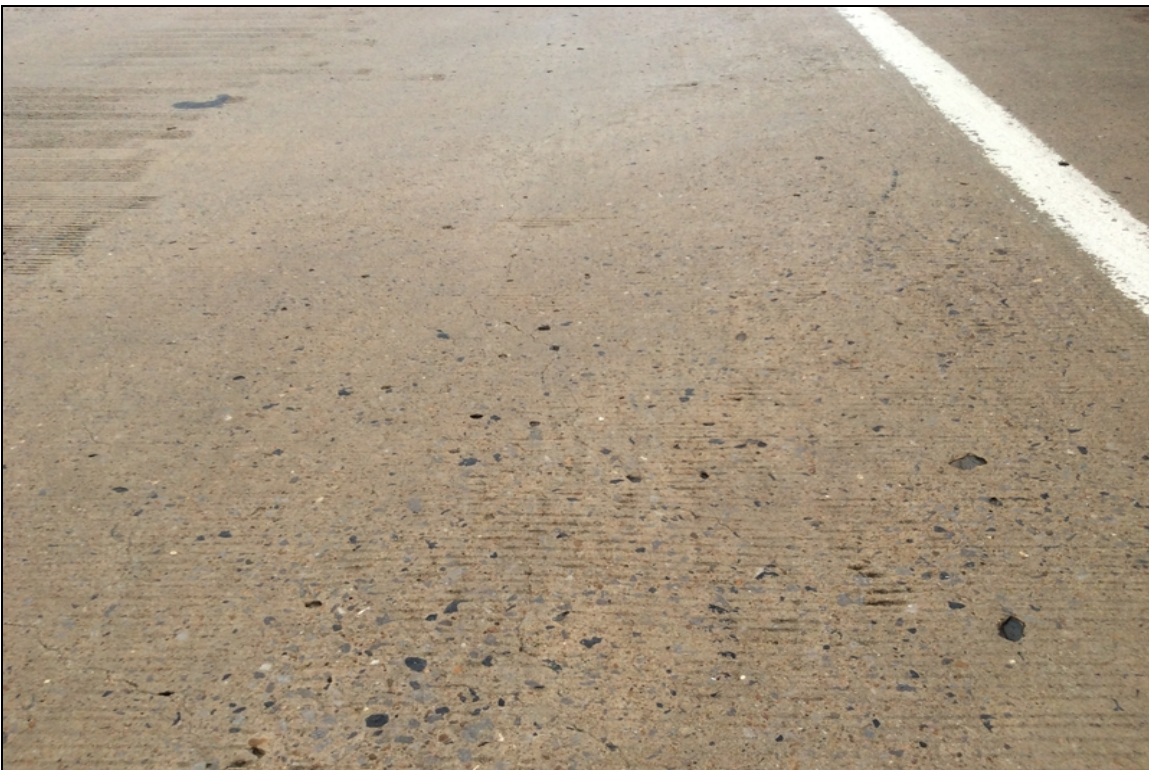
Span 1 typical map cracking.

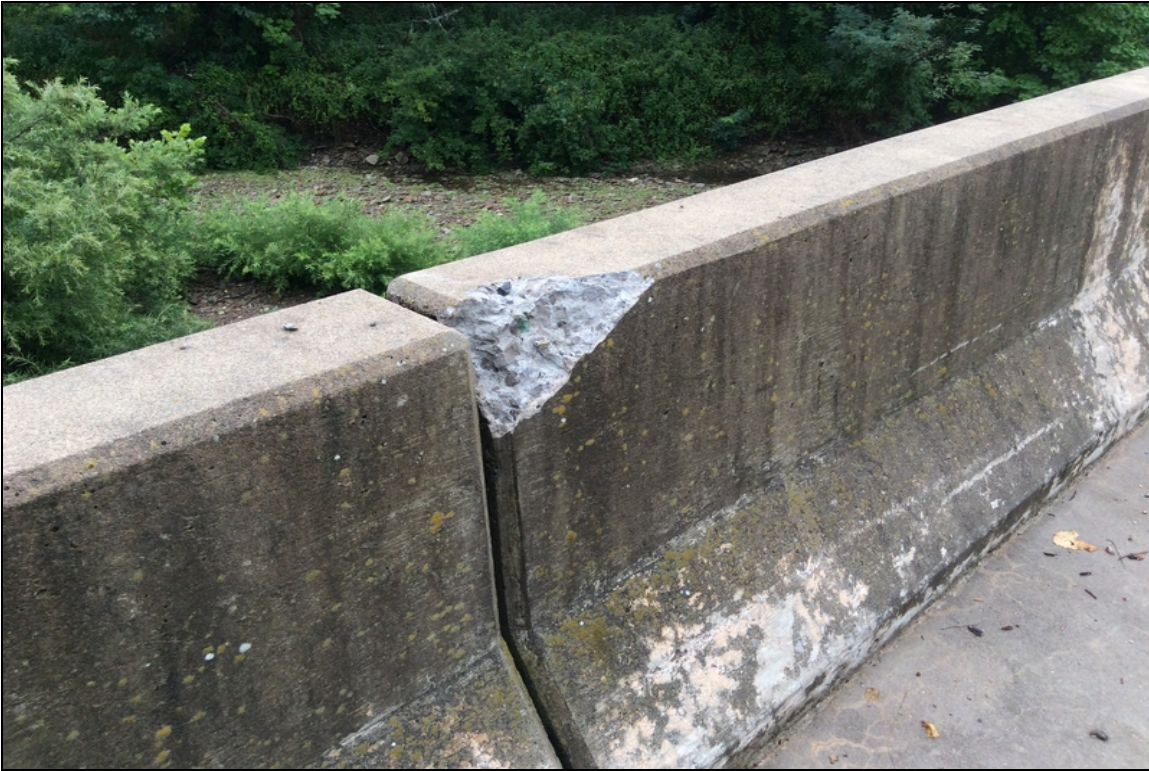
(331)							
08/01/2022 WNR & DBM							
-Span 3 right railing adjacent Bent 3 basketball sized to the top of parapet wall with steel exposed.							
-Both the left and right parapet have vertical cracking in construction joints and in random locations.							
-Both left and right parapet walls have map cracking in random locations in all spans.

Span 3 right railing adjacent Bent 3 spalling to the top of parapet wall with steel exposed.

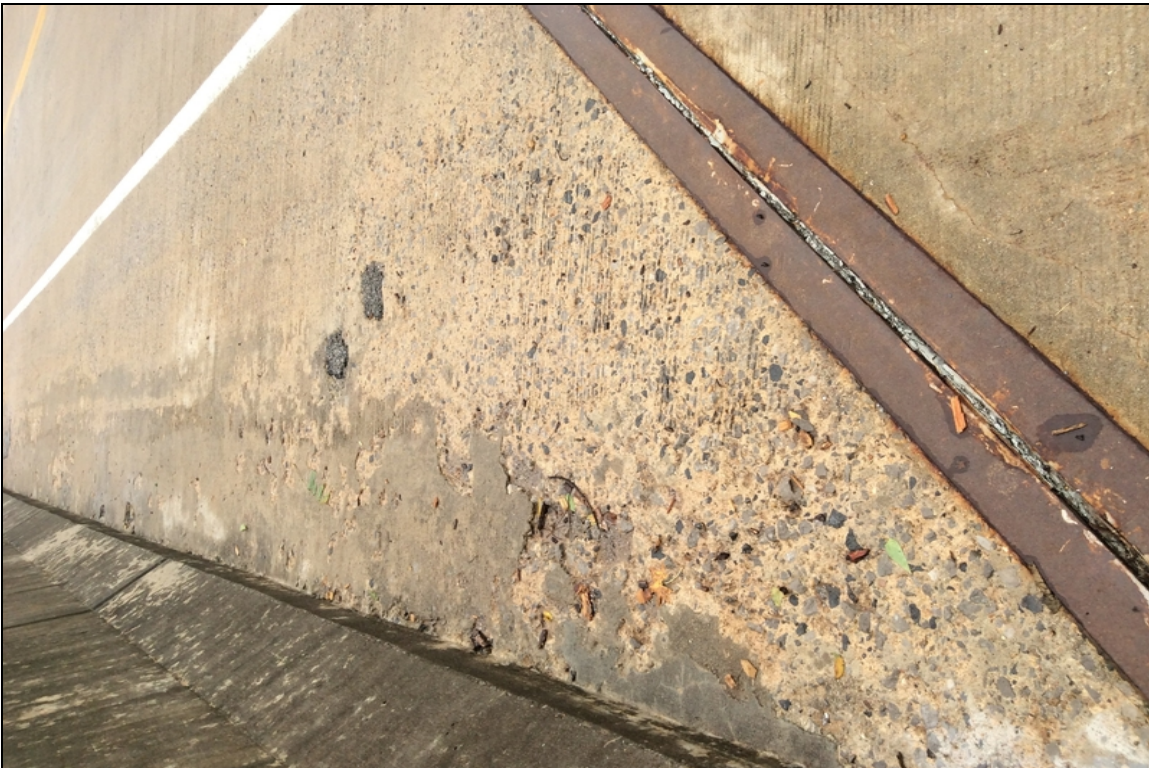
(12)	08/01/2022 WNR & DBM -Span #1 right gutter line adjacent to bent #1 there is an active area of heavy scaling and spalling. -The deck driving surface has map cracking in the driving lanes throughout the deck.						
107	Steel Open Girder/Beam	LF	1625	1331	86	208	0
1000	Corrosion	LF	294	0	86	208	0
515	Steel Protective Coating	SF	14625	14174	0	0	451
3440	Effectiveness (Steel Protective Coatings)	SF	451	0	0	0	451

Span 1 right adjacent bent 1 large area of spalling.

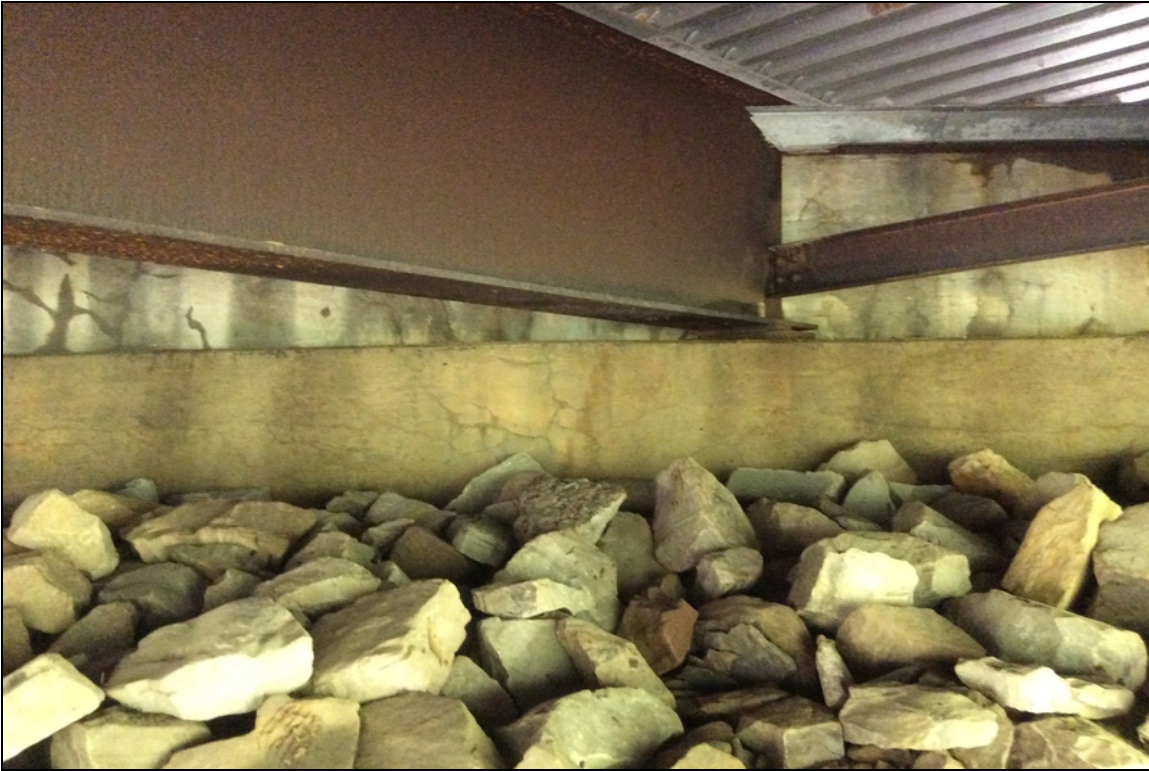
(215)	08/01/2022 WNR & DBM -The top of both abutment back walls have multiple areas of cracking. Abutment #1 has a large are of spalling with areas of asphalt patching.  Abutment #2 light map crack under girders #1 & #2						
234	Reinforced Concrete Pier Cap	LF	204	0	204	0	0
1130	Cracking (RC and Other)	LF	204	0	204	0	0

Abutment 2 bridge seat areas of map cracking.

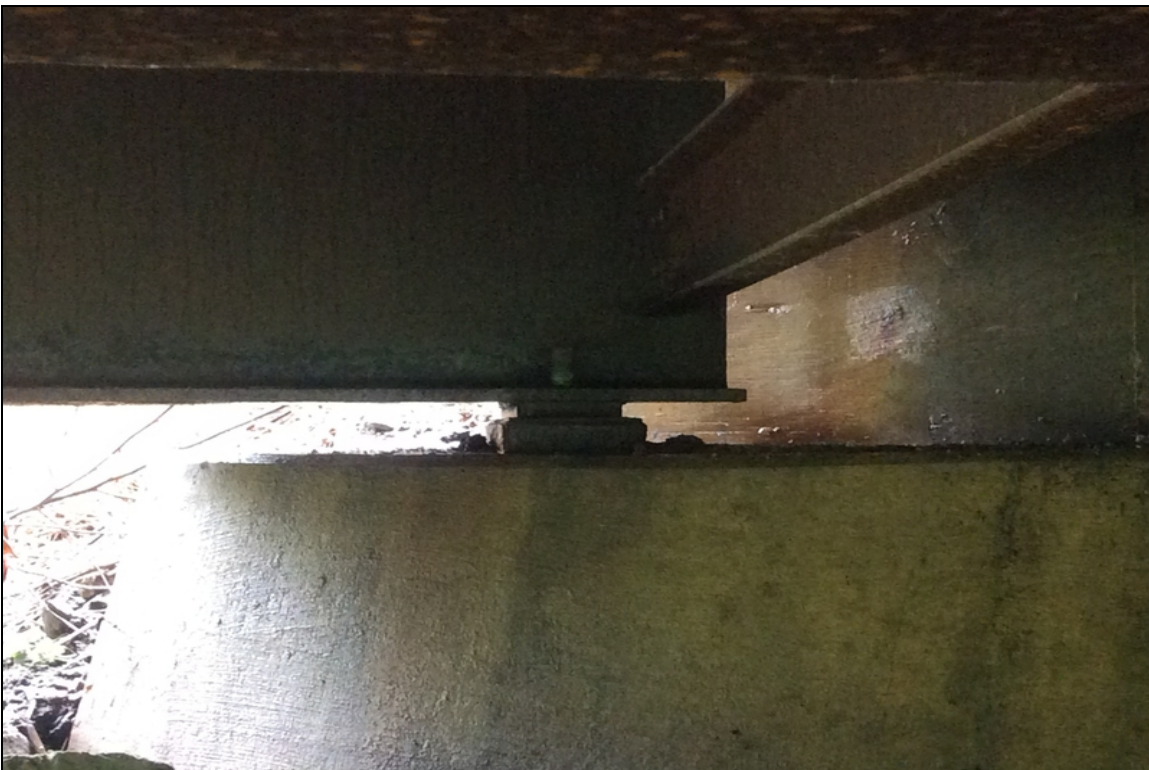
Span 5 abutment 2 girder 1 nut is missing.

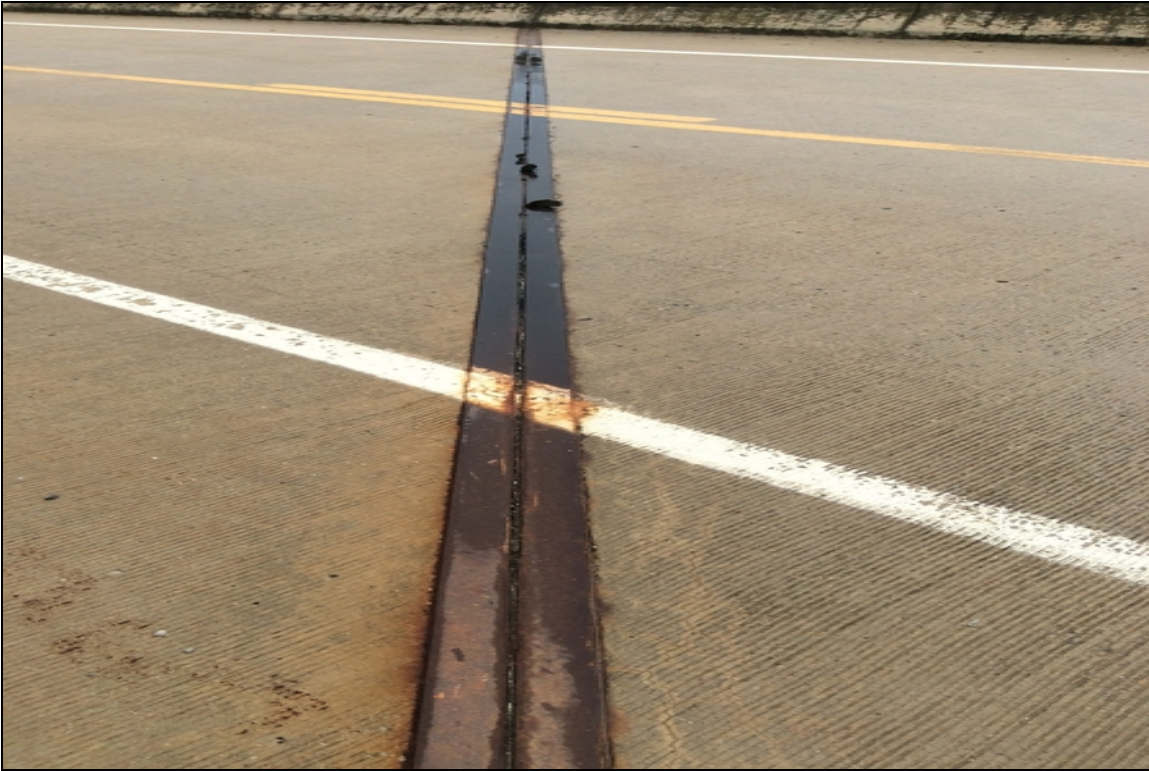
ELEM	DESCRIPTION	UNITS	TOTAL	CS1	CS2	CS3	CS4
2320	Seal Adhesion	LF	64	0	0	0	64
2340	Seal Cracking	LF	260	0	0	0	260
(302)							
08/01/2022 WNR & DBM							
-All joints have areas of lost adhesion and cracking.							
-All bents have minimal space between road irons that is restricting compression joints from functioning as intended and causing joint material to back out.							
The majority of all compression joint material has severe cracking with areas where joint material that has been displaced.							
311	Movable Bearing	EA	25	10	15	0	0
1000	Corrosion	EA	15	0	15	0	0

Bent 4 compression joint material being pushed out of joint due to excessive compression.

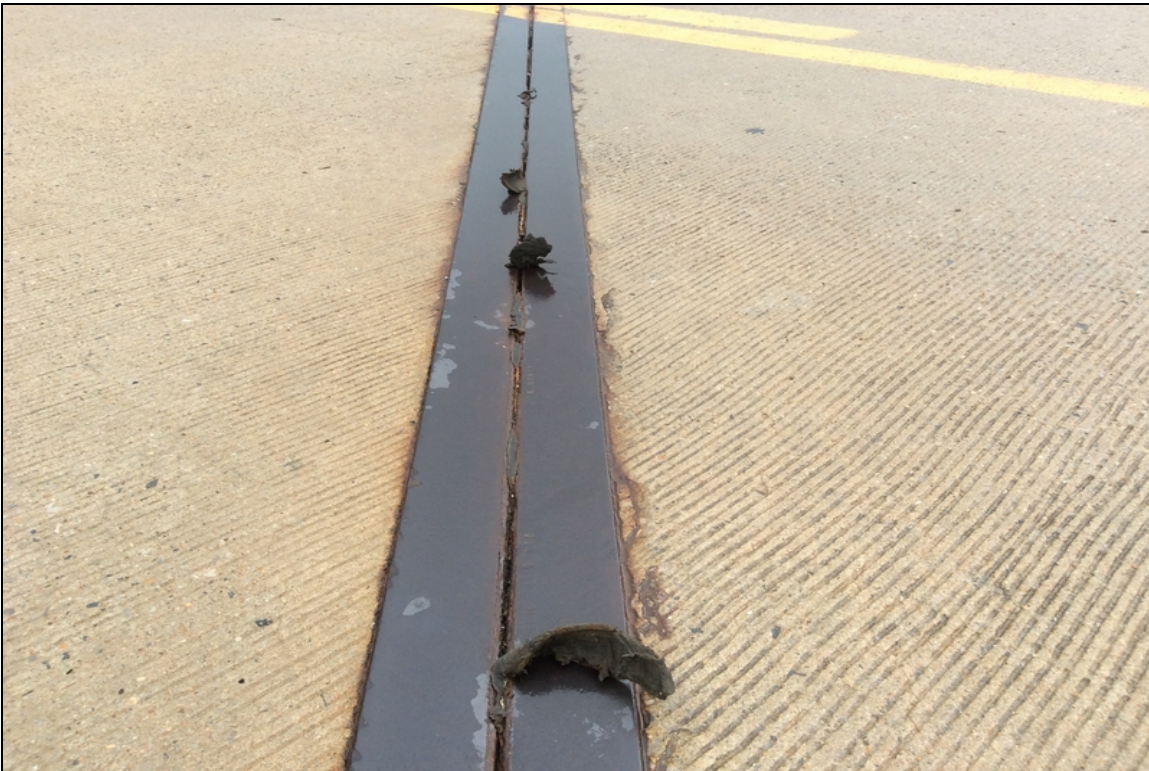
Bent 4 minimal space between road irons.

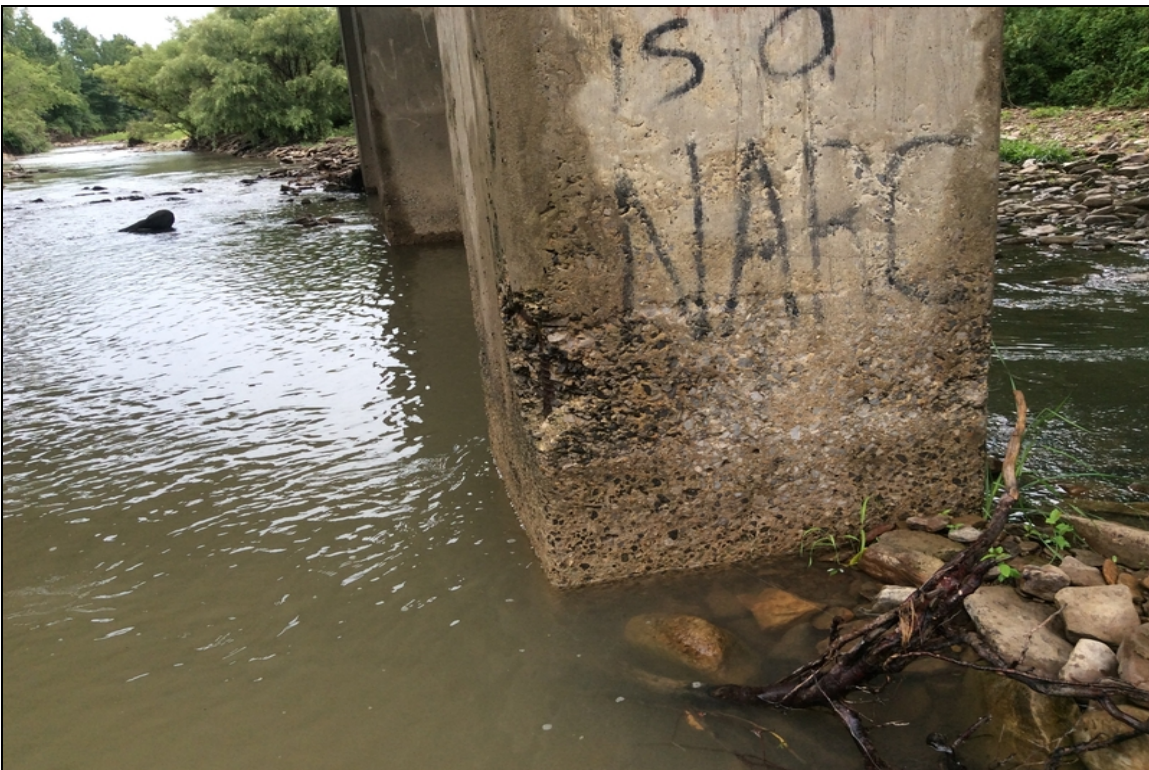
(205)	08/01/2022 WNR & DBM - Bent #2 column #1 ahead side near the base has spalling with steel exposed.						
215	Reinforced Concrete Abutment	LF	142	52	90	0	0
1080	Delamination/Spall/Patched Area	LF	38	0	38	0	0
1130	Cracking (RC and Other)	LF	52	0	52	0	0

Bent 2 Column 1 ahead side spalling with steel exposed.

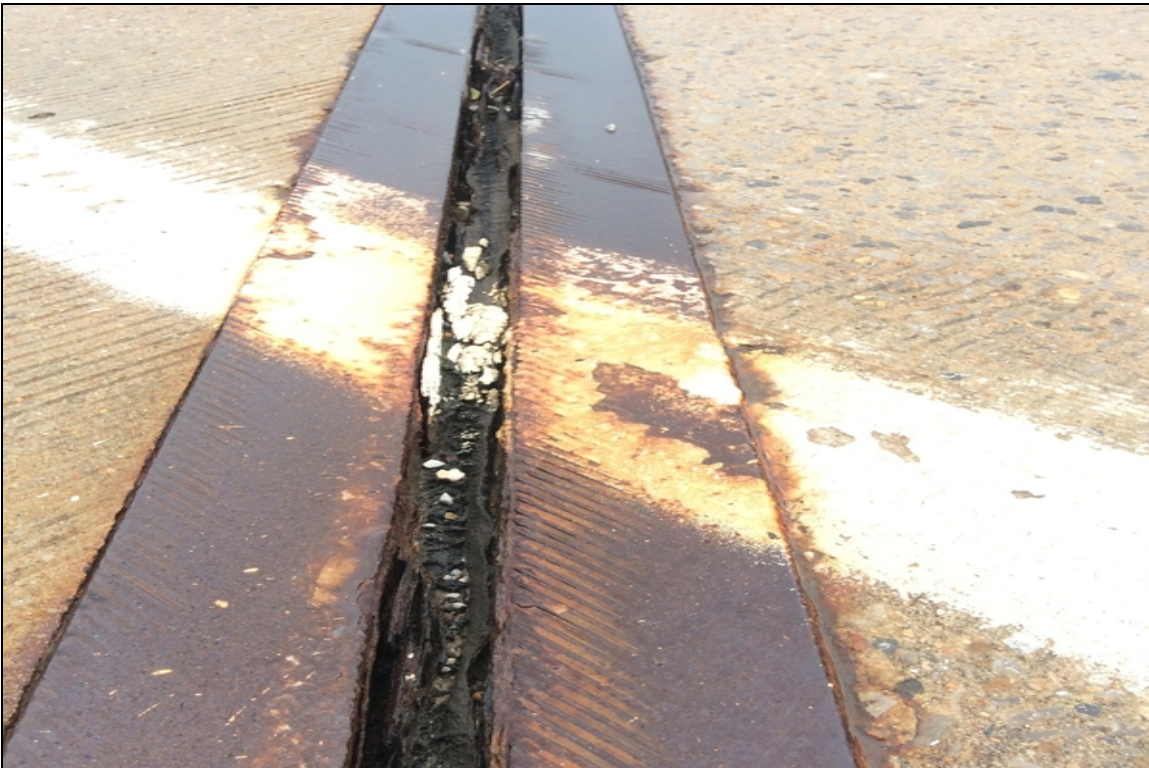
Bent 2 joint material lose of adhesion and flaking rust on road irons.

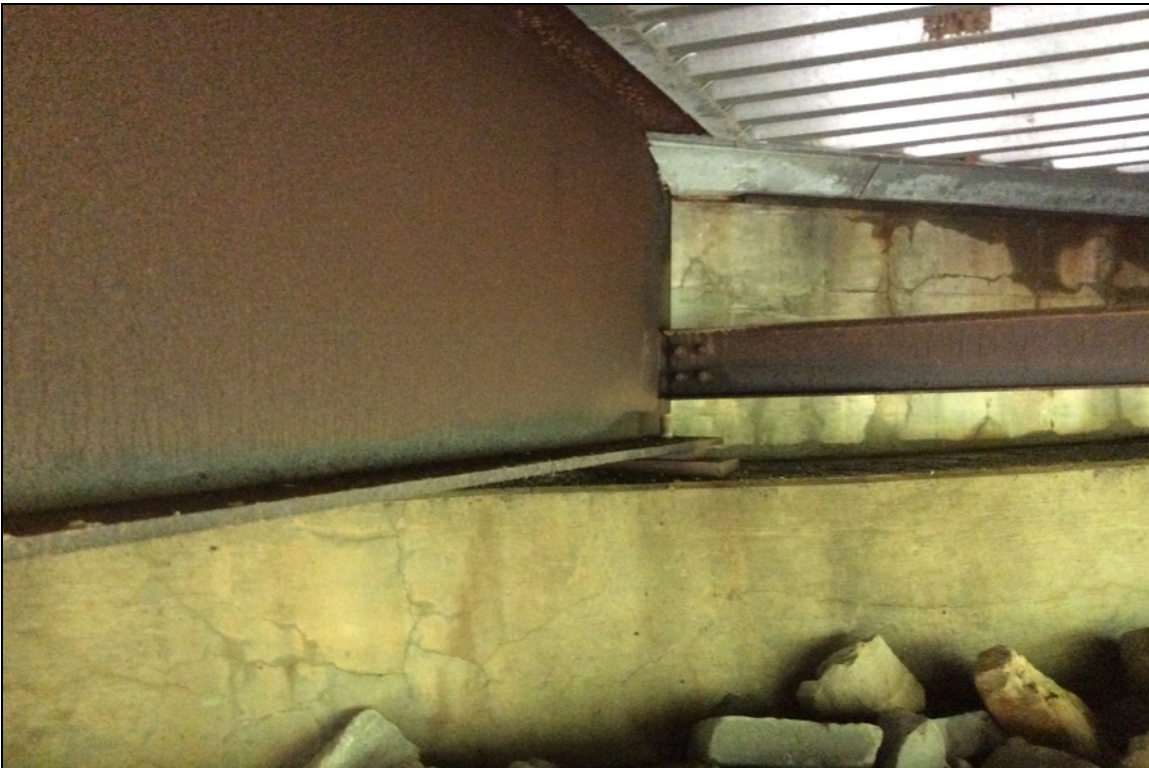
Span 5 abutment 2 girder 2 nut is missing.

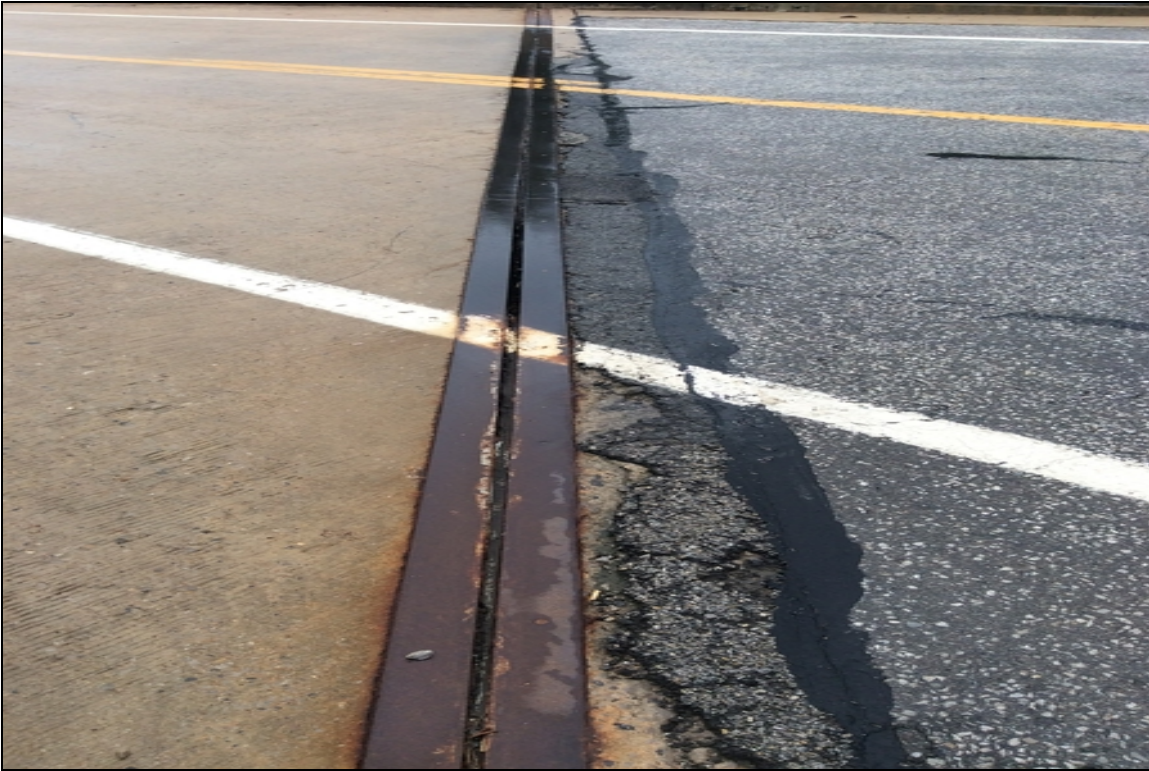
Abutment 1 joint material displaced and top of abutment back wall has spalls.

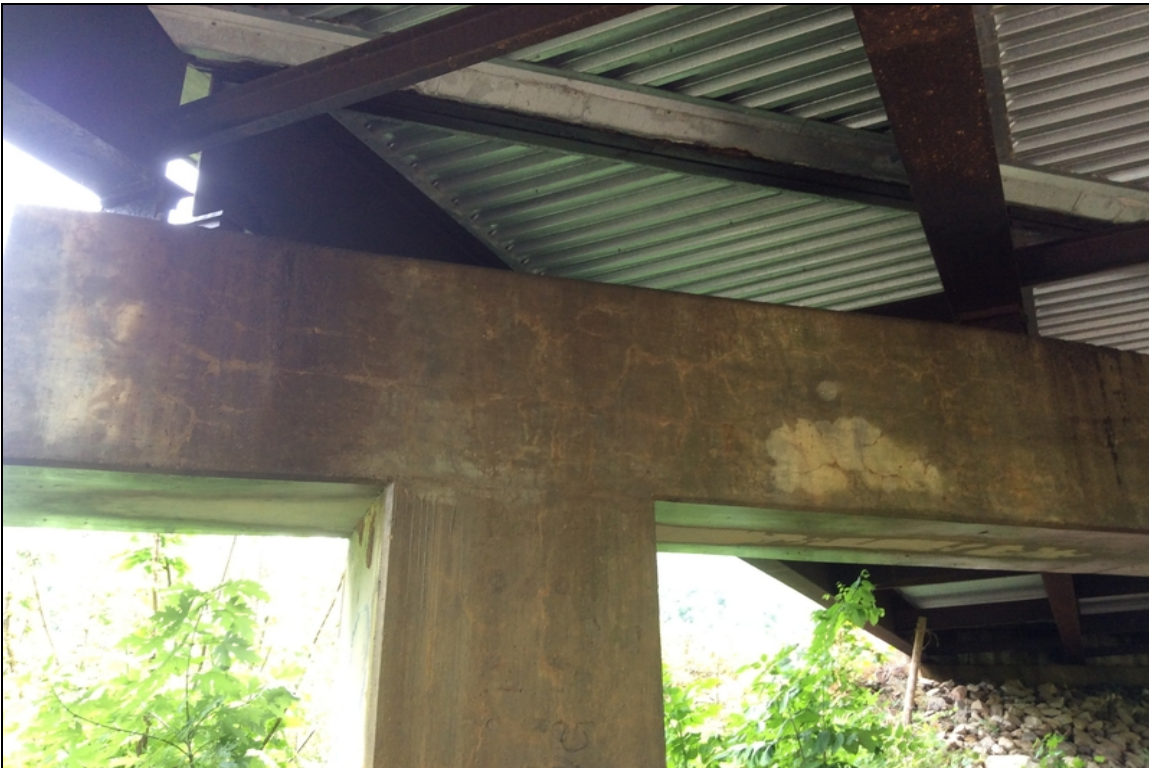
(234)	08/01/2022 WNR & DBM Bent caps #2 thru #5 have random map cracking with efflorescence.						
302	Compression Joint Seal	LF	324	0	0	0	324

Bent 4 cap mapcracking.

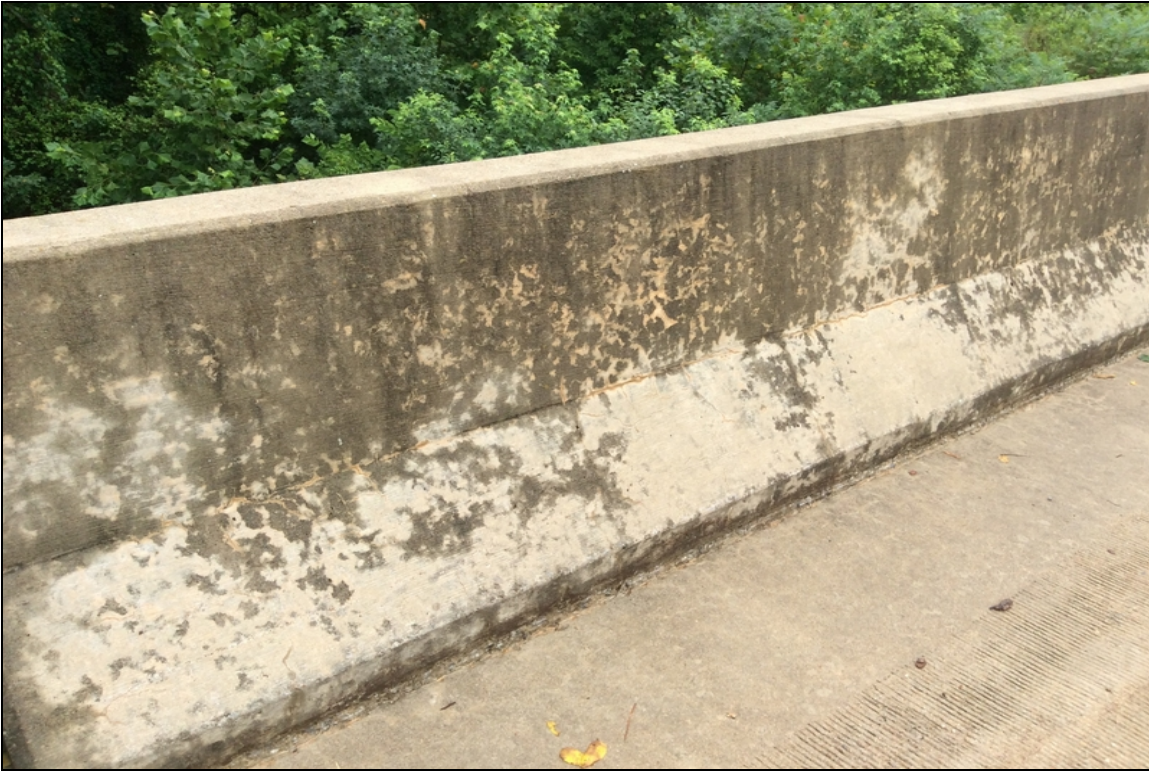
Railing Right typical view of cracking in parapet wall.

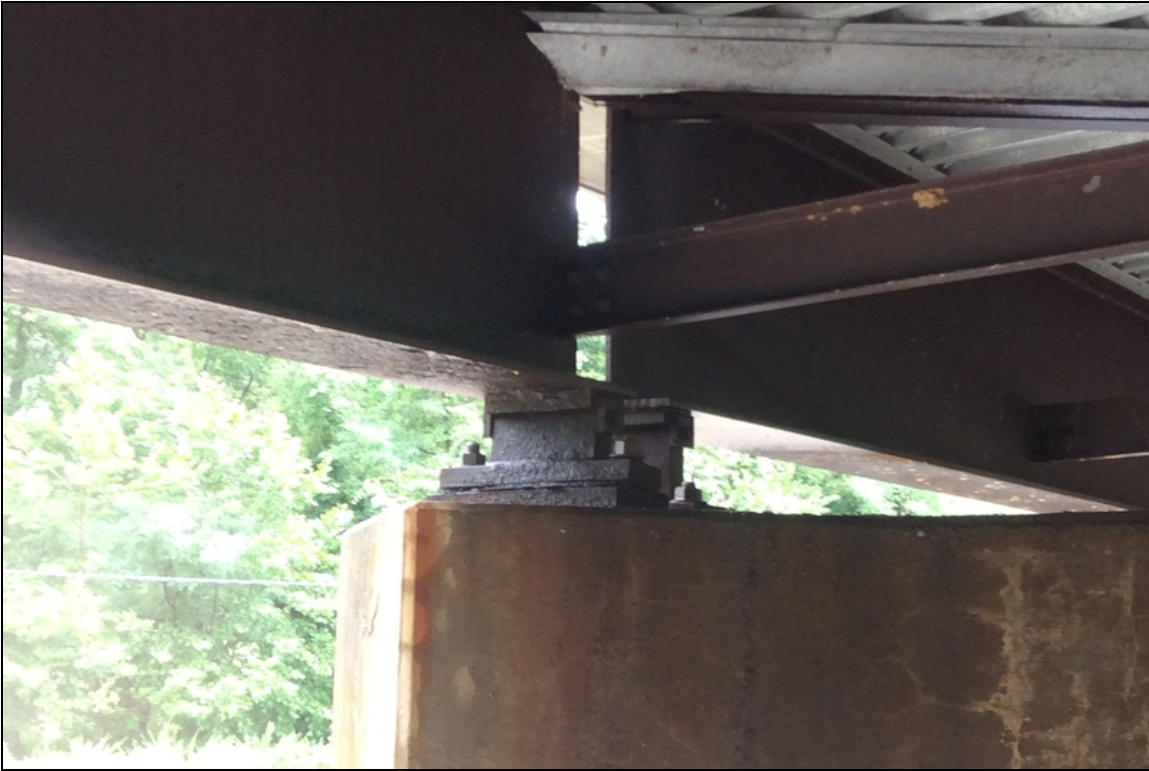
(311)							
08/01/2022 WNR & DBM							
Some bearings showing signs of corrosion							
313	Fixed Bearing	EA	25	14	11	0	0
1000	Corrosion	EA	11	0	11	0	0
(313)							
08/01/2022 WNR & DBM							
Some bearings showing signs of corrosion							
331	Reinforced Concrete Bridge Railing	LF	650	456	193	1	0
1080	Delamination/Spall/Patched Area	LF	1	0	0	1	0
1130	Cracking (RC and Other)	LF	193	0	193	0	0

Span 1 Bent 1 Bearing 1 - Typical condition of bearings with active corrosion.

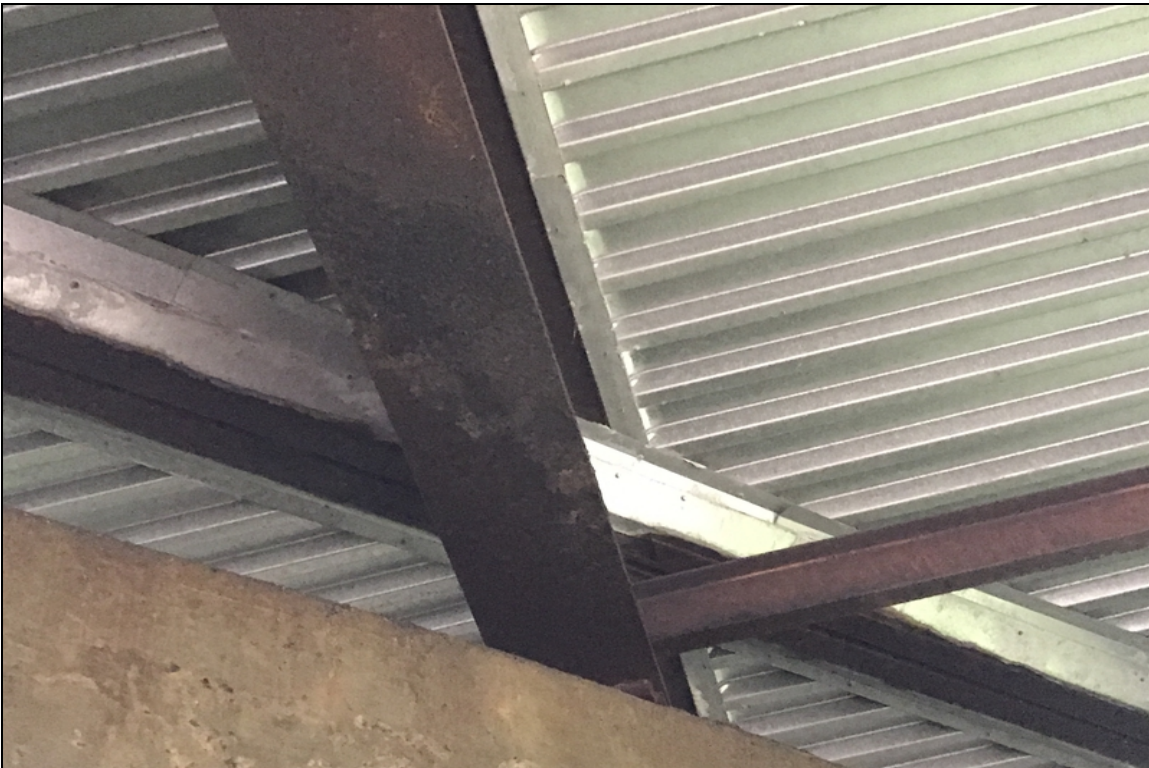
(107)	08/01/2022 WNR & DBM -The majority of beam ends Have minor flaking rust to the bottom flange due to leaking joints.						
205	Reinforced Concrete Column	EA	12	11	0	1	0
1090	Exposed Rebar	EA	1	0	0	1	0

Typical condition of beams ends with minor flaking rust.

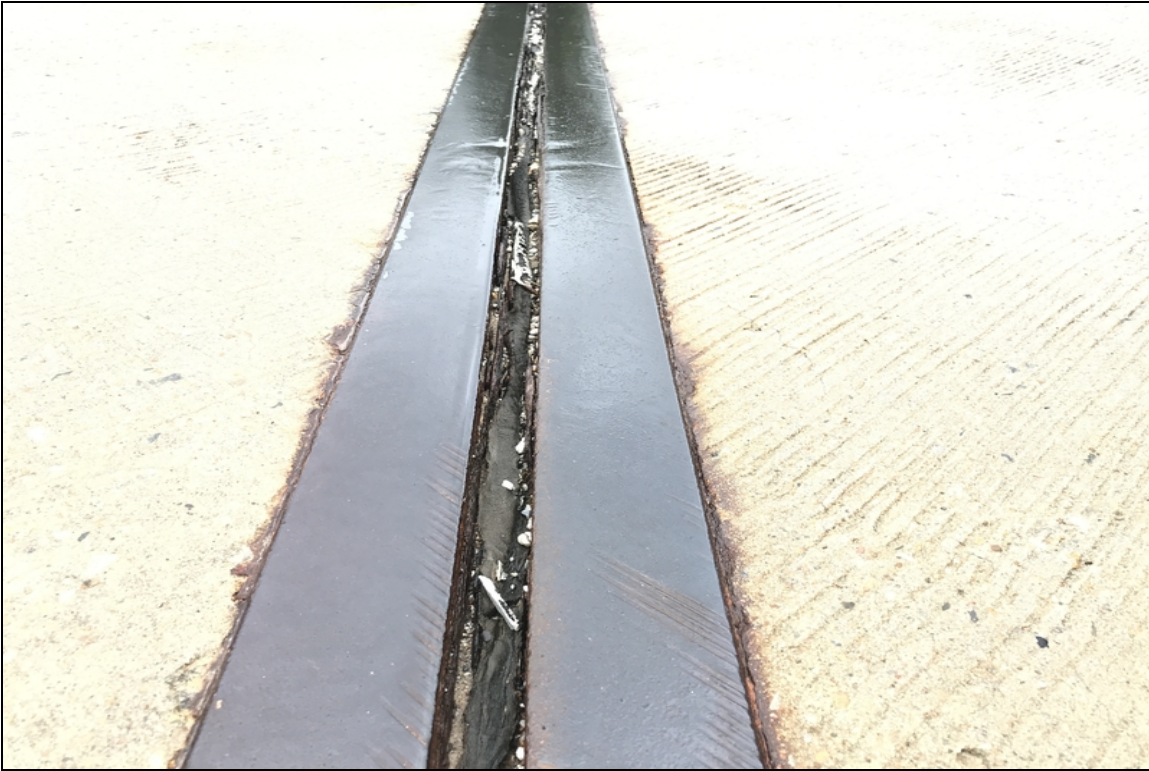
Bent #2 typical condition of joint material.

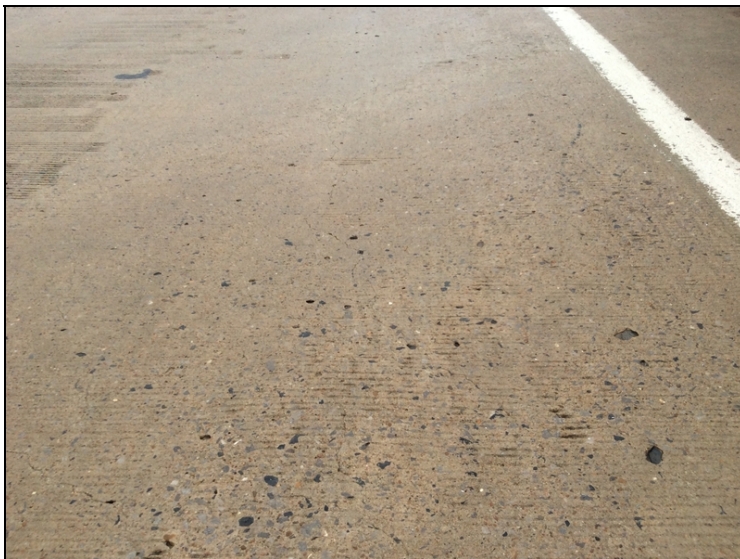
Deck Cracking:

-The deck driving surface has mapcracking in the driving lanes throughout the deck.

The deck driving surface has mapcracking in the driving lanes throughout the deck.

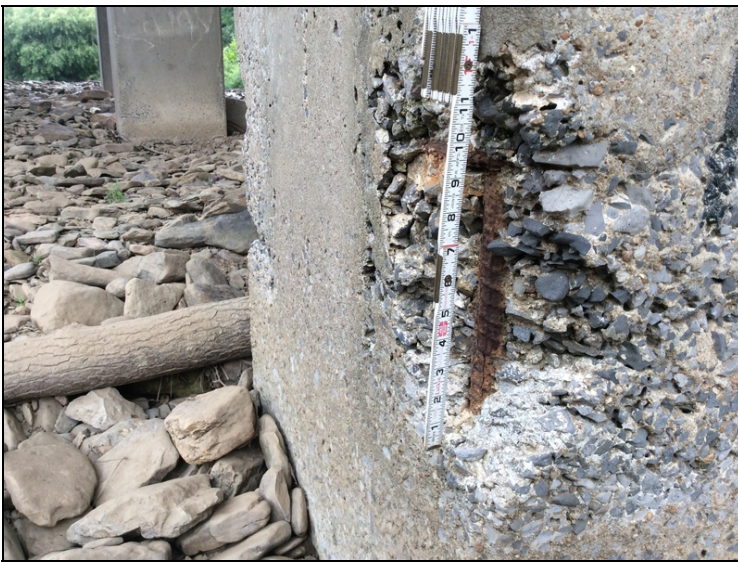
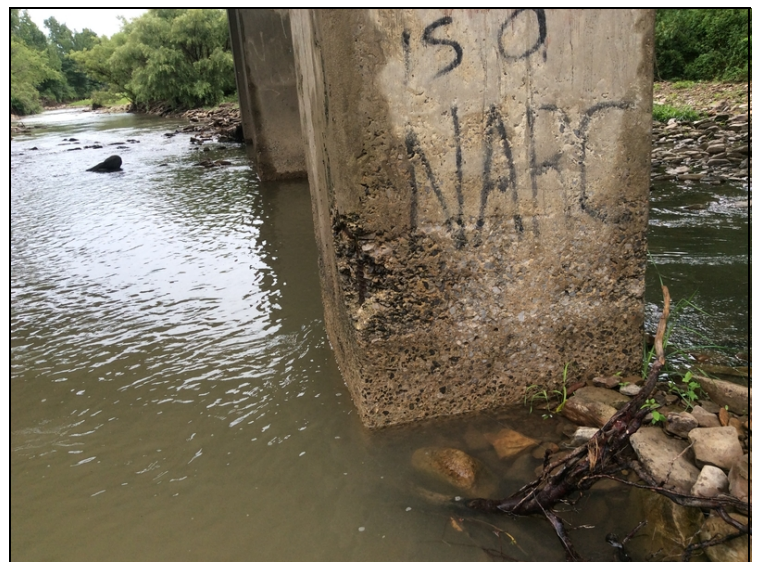
Bent #2 column #1 ahead side near the base has spalling with steel exposed.

Exposed rebar column #1 of bent #2

Bent 2 Column 1 ahead side spalling with steel exposed.

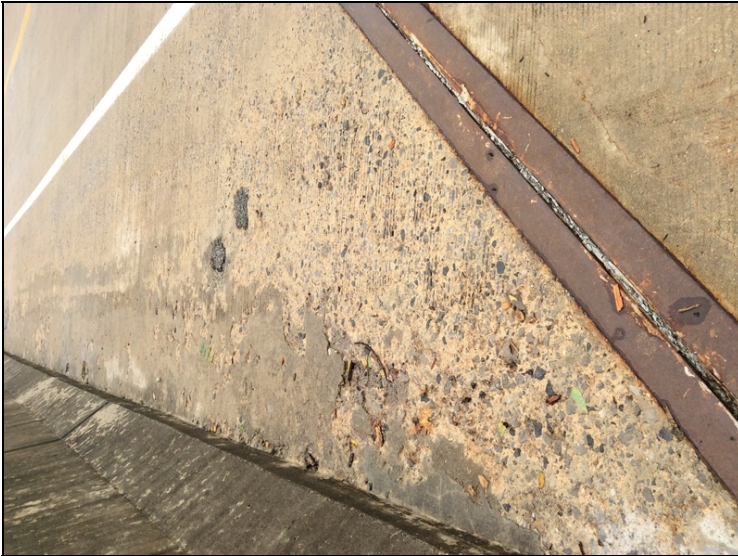
Deck Surface:

-Span #1 right gutter line adjacent to bent #1 there is an active area of heavy scaling and spalling.

Span 1 right adjacent bent 1 large area of spalling.

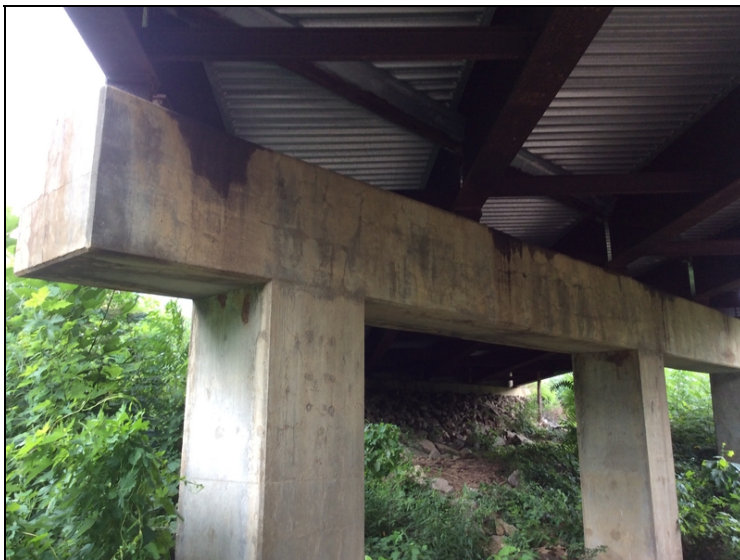
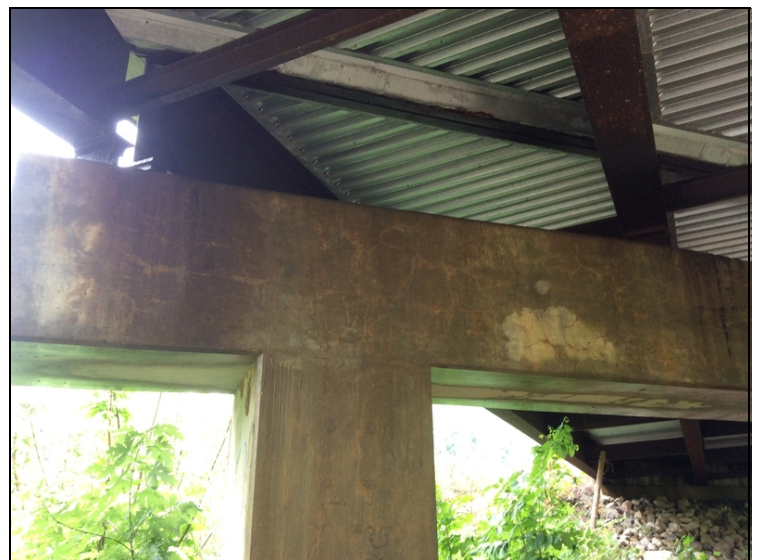
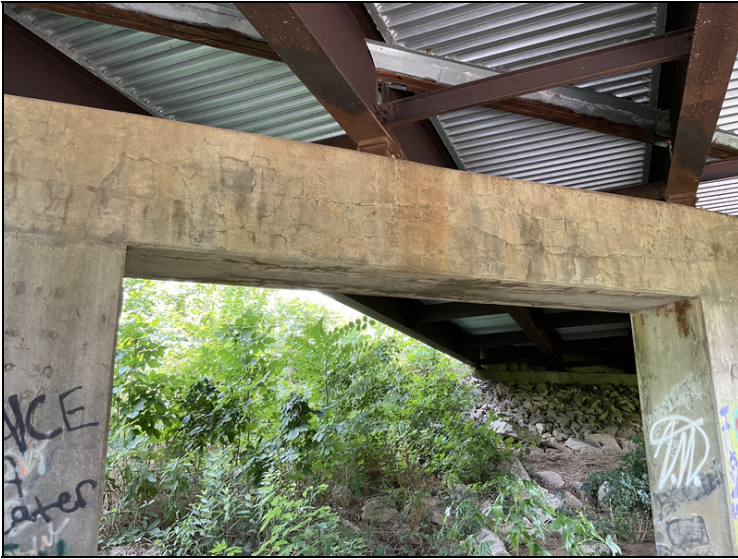
Bents caps #2 thru #5- random cracking with efflorescence

Typical map cracking to all bent caps.

Bent 4 cap mapcracking.

Cracking in cap the behind side of bent #4

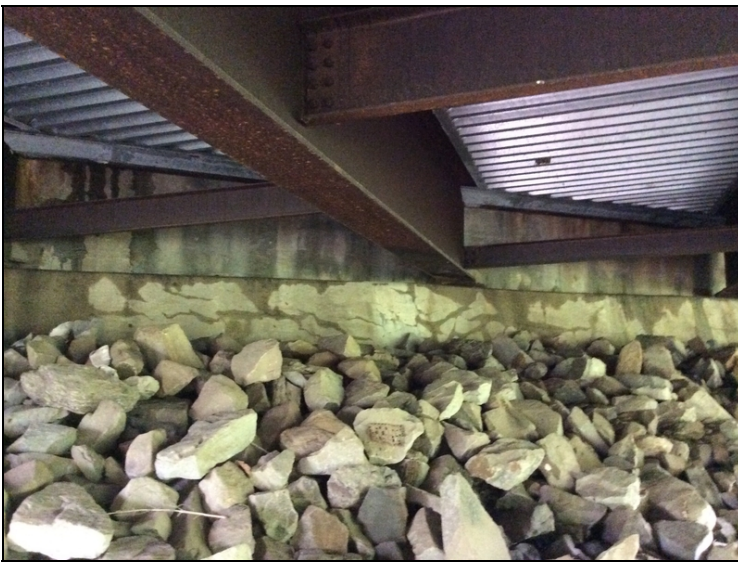
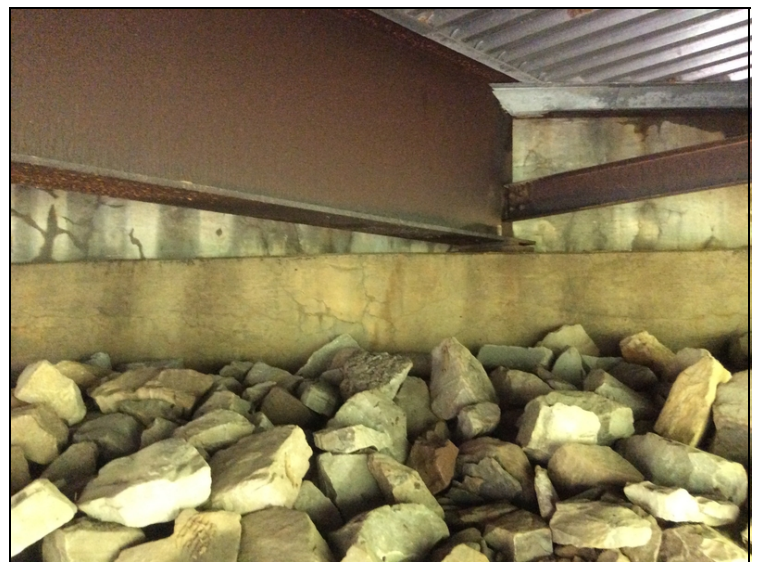
Abutment #2 top of backwall extensive map cracking with deterioration.

Map cracking to face of abutment #2

Abutment 2 bridge seat areas of map cracking.

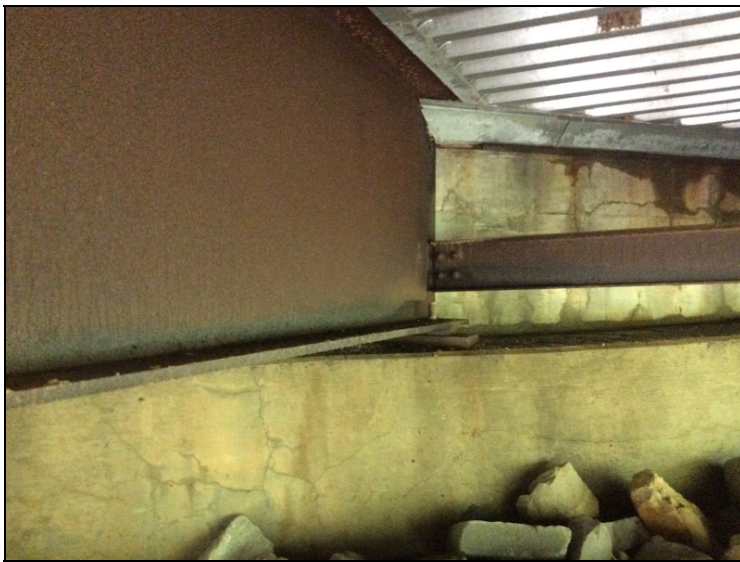
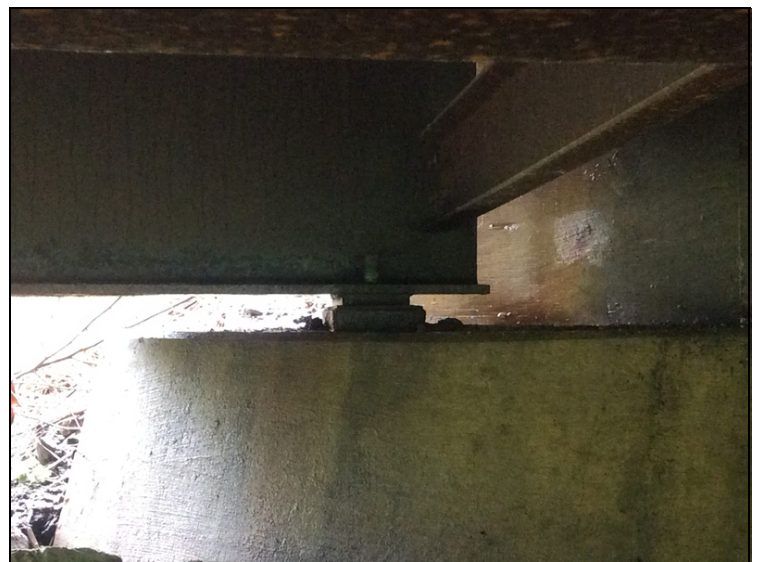
Missing Nuts:

- In span #5 abutment #2 girders #1 & #2 have nuts is missing for the anchor bolts.

In span #5 abutment #2 girder #2 has nut is missing for the anchor bolt.

In span #5 abutment #2 girders #1 has nut is missing for the anchor bolt.
