Bridge #06408(Routine)

SH 23 Madison Co. over SEALS CREEK Madison Co

Team Lead: Nathan Rowland Inspection Date: August 16, 2021

Bridge #06408(Routine)
SH 23 Madison Co. over SEALS CREEK Madison Co

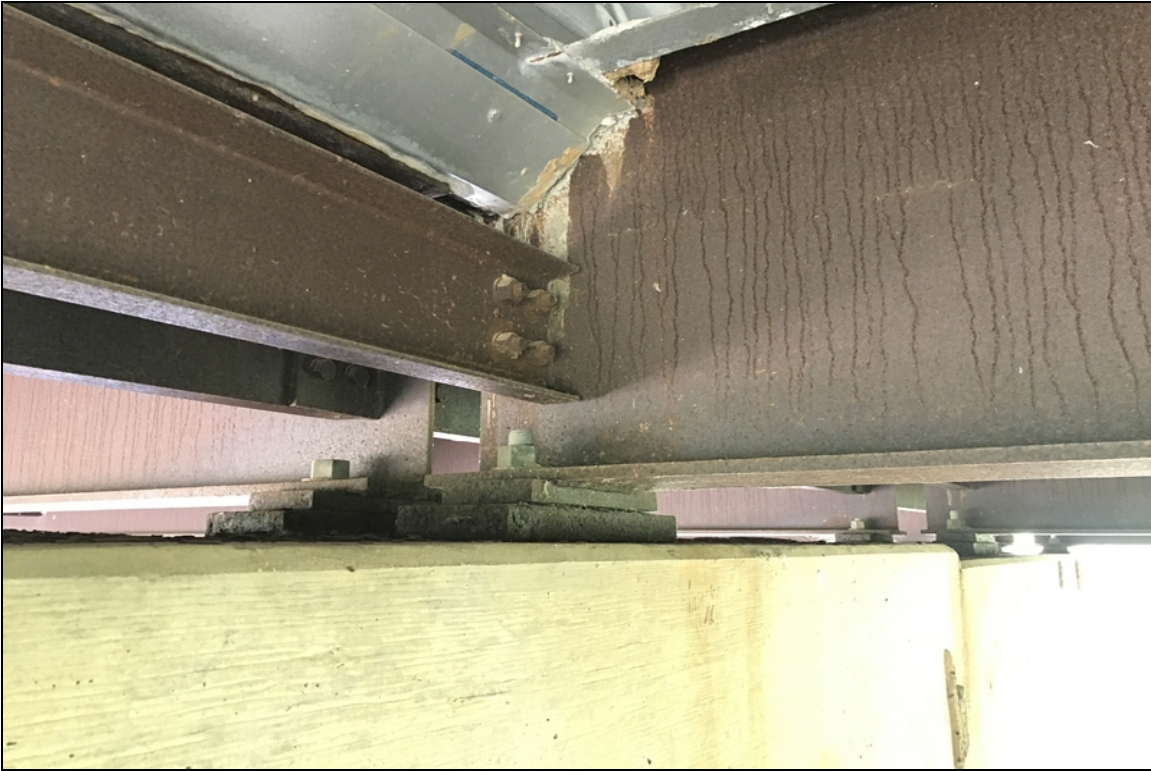
(313)							
08/16/2021 WNR & DBM:							
- Abutment #1, Span #1, bearings #1 and #5 have abnormal weathering with flaking rust.							
-The fixed and moveable bearings have abnormal weathering with flaking rust in locations over the intermediate bents due to expansion joint seal leakage.							
-The fixed bearings over abutment #2 have abnormal weathering with flaking rust due to leaking expansion joints.							
331	Reinforced Concrete Bridge Railing	LF	228	156	72	0	0
1130	Cracking (RC and Other)	LF	72	0	72	0	0

Bent #1 span #1 Typical minor typical minor flaking rust to bearings.

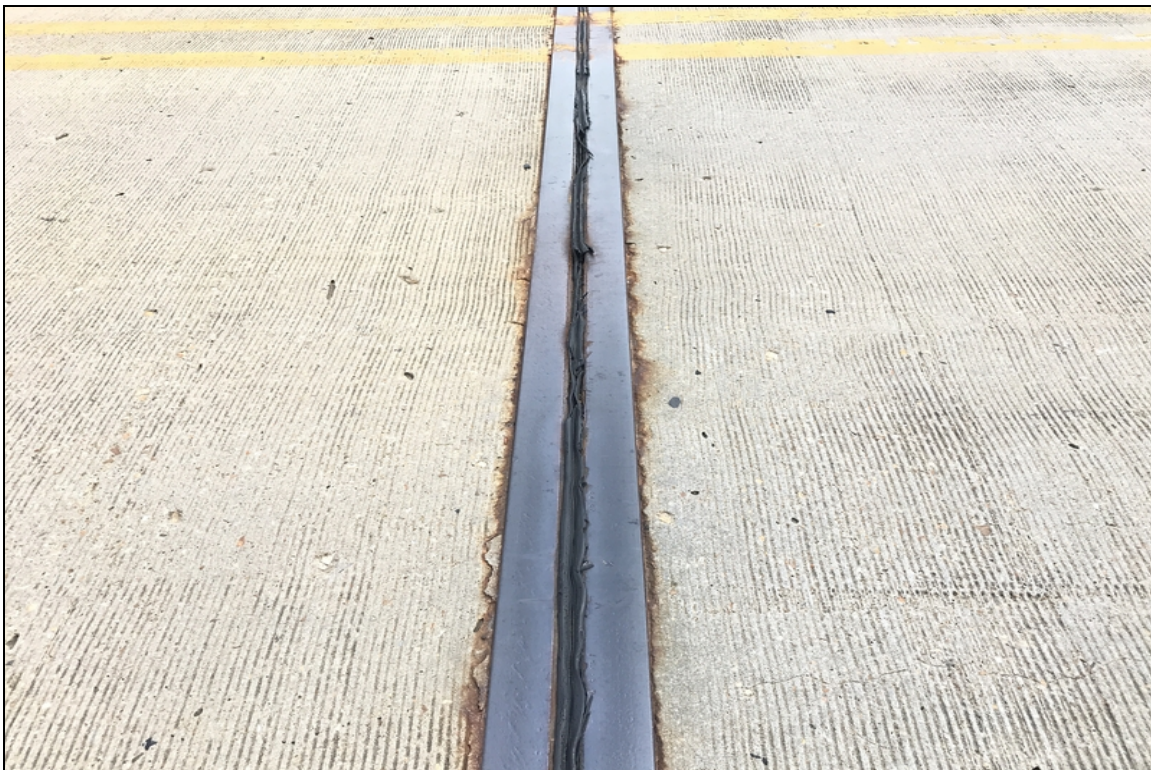
(302)							
08/16/2021 WNR & DBM:							
-The compression joint seals have areas of cracking and adhesion failure due to pack rust in the assemblies that appear to be causing adhesion failure and leakage.							
-The compression joint seal at bent #2 is sticking up above the assembly in the left lane and has damage due to traffic impact.							
311	Movable Bearing	EA	15	9	6	0	0
1000	Corrosion	EA	6	0	6	0	0
515	Steel Protective Coating	SF	15	9	0	6	0
3430	Oxide Film Degradation Color/Texture Adherence(Steel Protective Coatings)	SF	6	0	0	6	0

Bent #2 expansion joint material is cracking and tearing largely due to vehicle impactation.

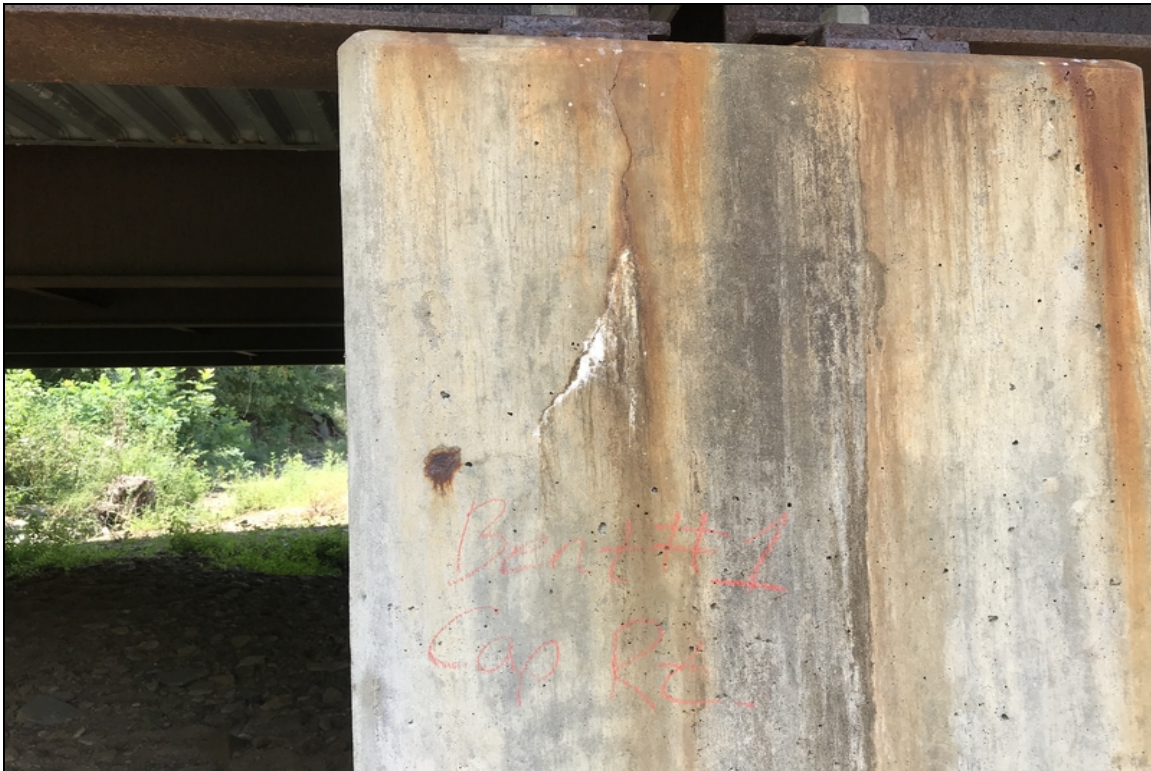
(234)							
08/16/2021 WNR & DBM:							
-The bent caps have staining from compression joint seals leaking.							
-Bent #1 cap has a hairline vertical crack with short duration horizontal cracks in bay #3 visible on both sides of cap.							
-Bent #1 cap right has a vertical crack with minor efflorescence accumulation. Vertical crack propagates into bearing #1 span #1.							
-The span #2 side of bent #1 cap has a short duration vertical crack under beam #5 and at the step down in bay #1.							
-The left side of bent #2 cap has a delaminated area on the back face that is approximately 3' long and propagates diagonally under bearing #1.

Bent #1 cap right has a vertical crack with minor efflorescence accumulation.

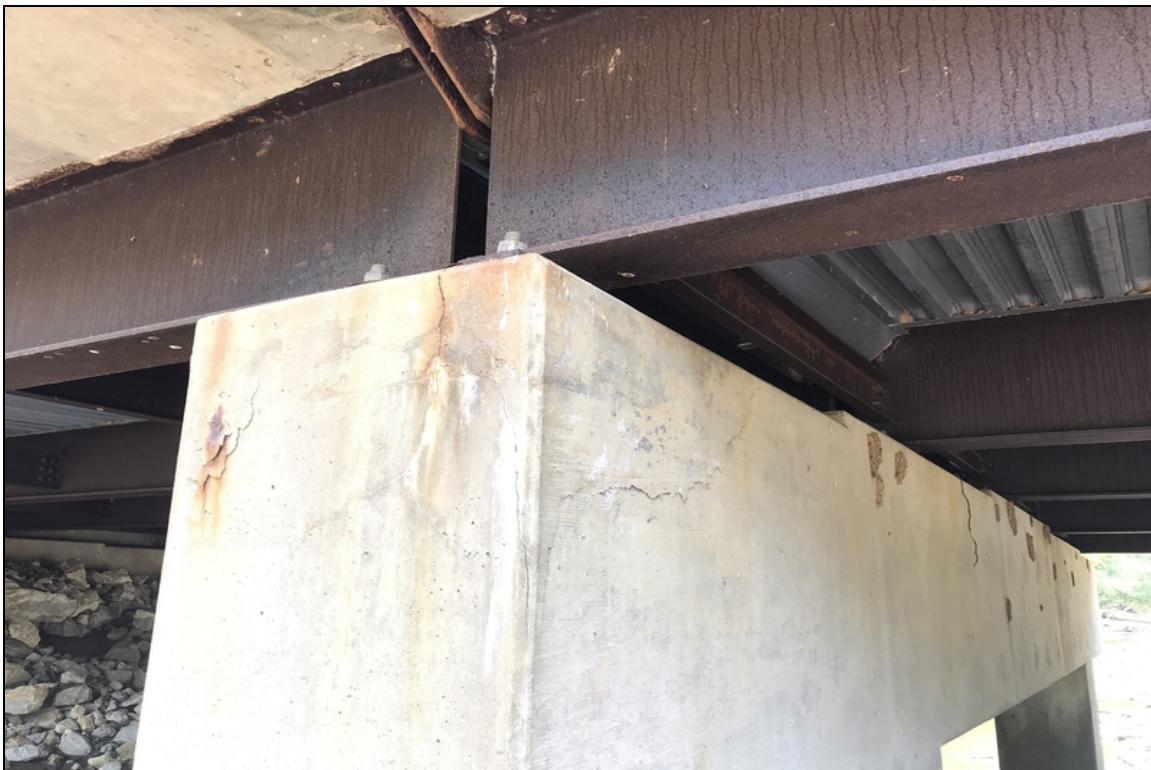
Substructure - The left side of bent #2 cap has a delaminated area on the back face that is approximately 3' long and propagates diagonally under bearing #1.

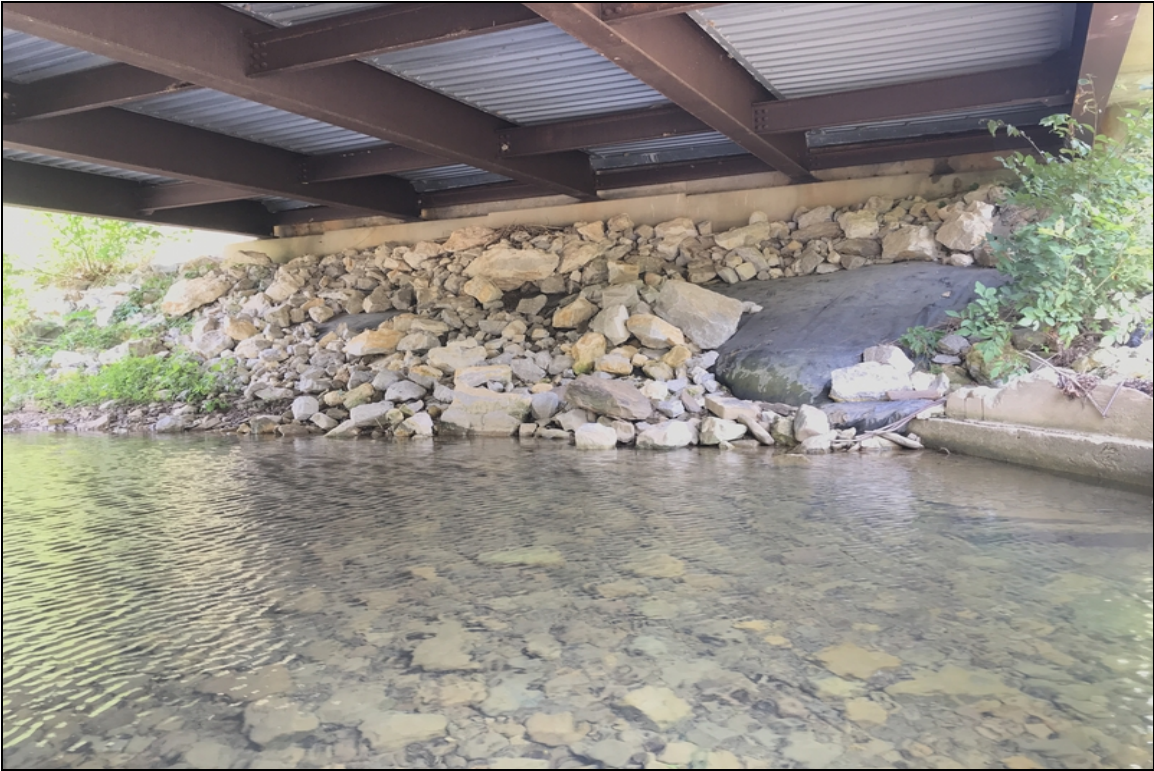
(215)							
08/16/2021 WNR & DBM:							
-The top of abutment back walls have transverse cracks at random spacing visible from the driving surface.							
-The abutment breastwalls have short duration vertical cracks at the step downs in locations.							
-The abutments have staining from compression joint seal leakage.							
-The North embankment has minor rip-rap displacement due to recent high water event.							
234	Reinforced Concrete Pier Cap	LF	72	65	7	0	0
1080	Delamination/Spall/Patched Area	LF	3	0	3	0	0
1130	Cracking (RC and Other)	LF	4	0	4	0	0

Embankment adjacent to abutment #2 has rip rap that has been displaced.

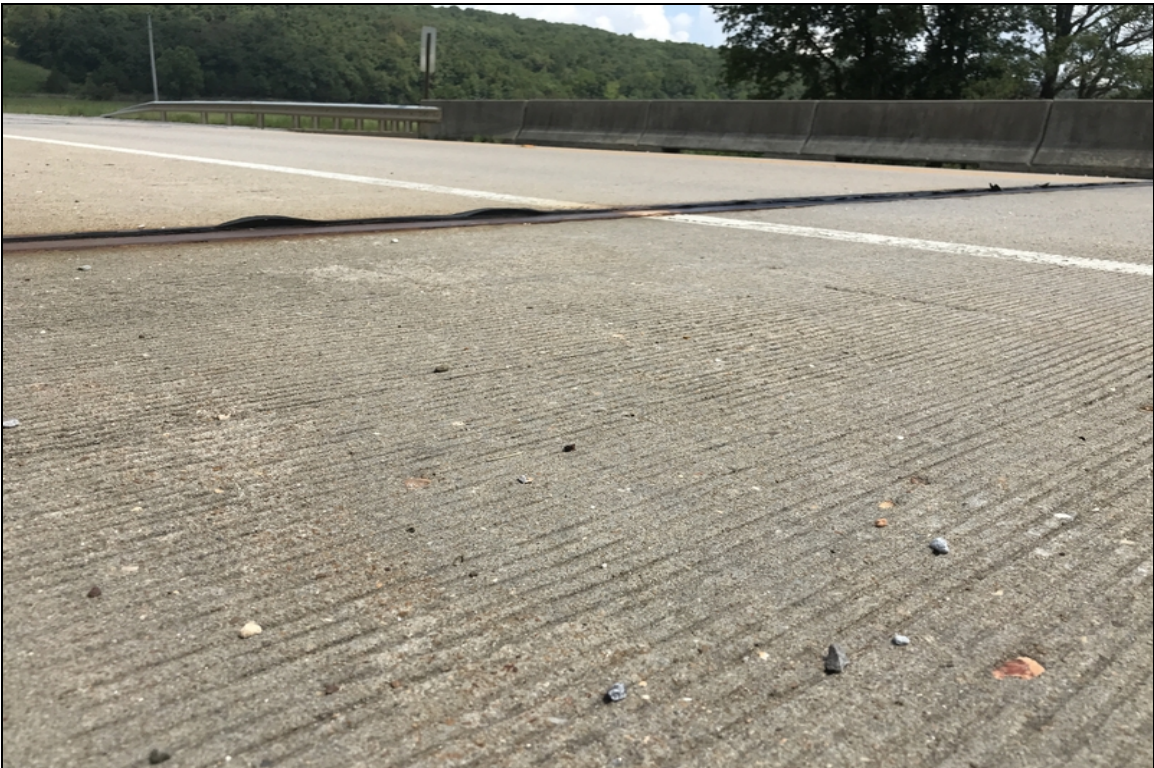
Bent #2 expansion joint is backing out.

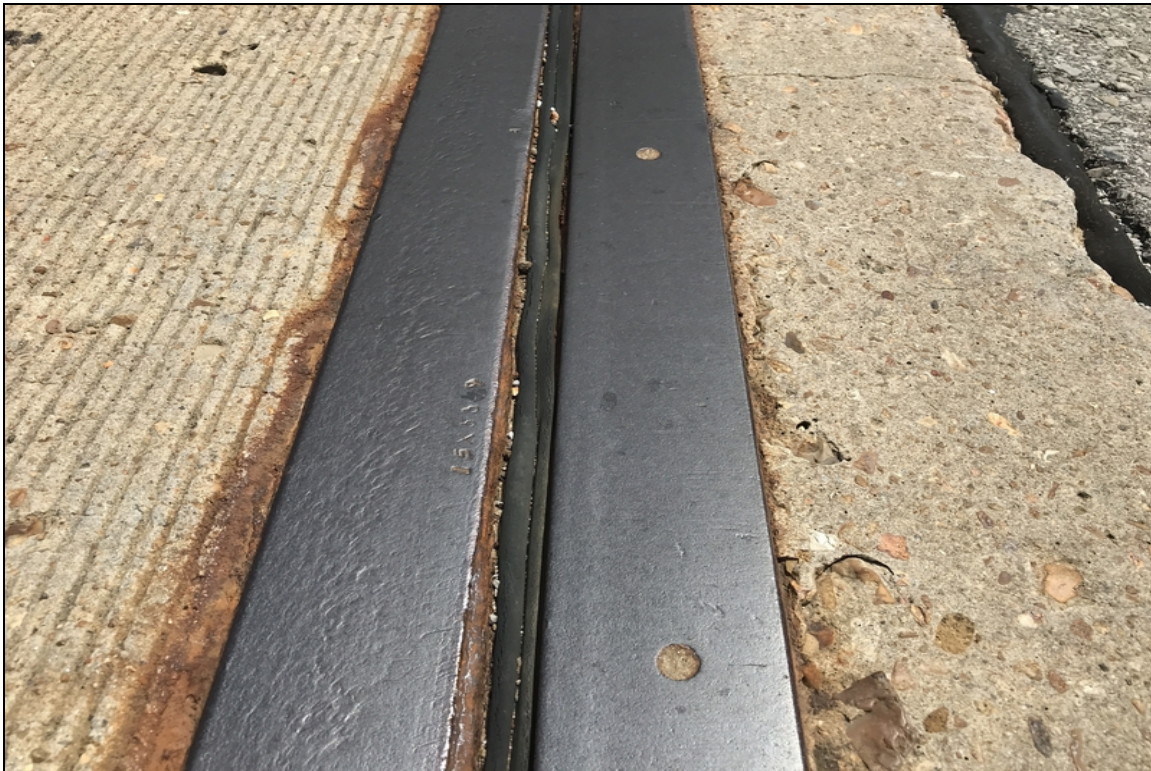
Abutment #1 road irons pack rust causing adhesion failure

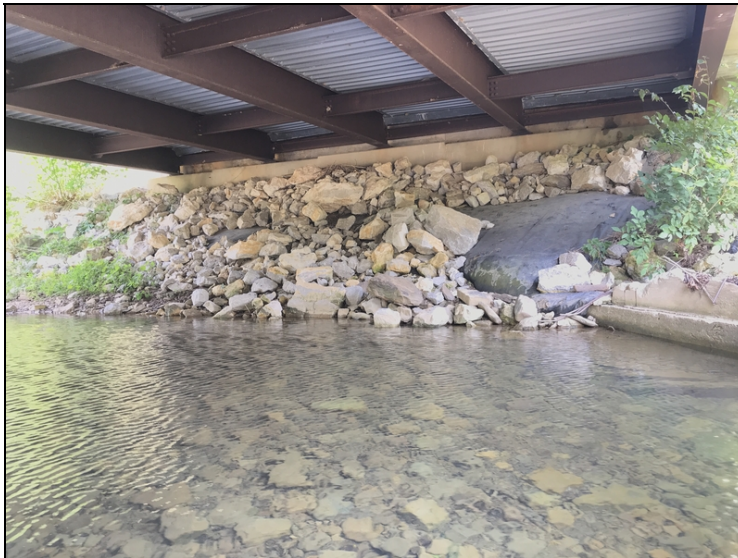
North abutment - The North embankment has minor rip-rap displacement due to high water events.

Embankment adjacent to abutment #2 has rip rap that has been displaced.

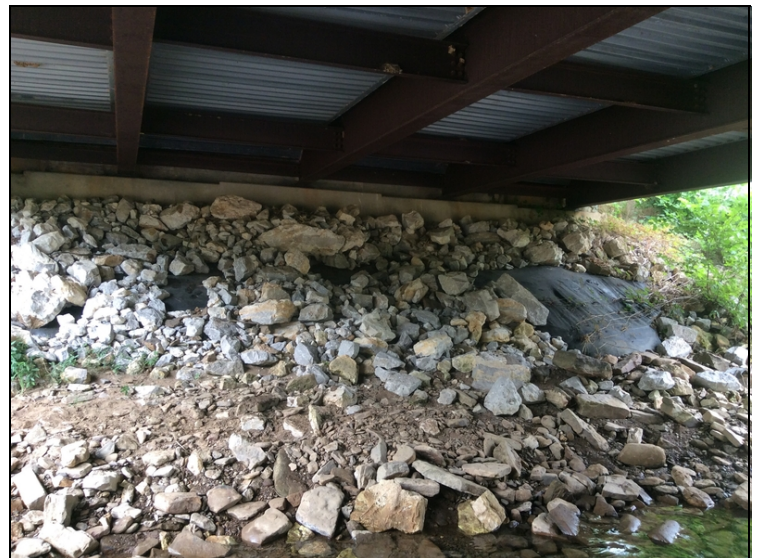
North embankment-Rip-rap displacement.

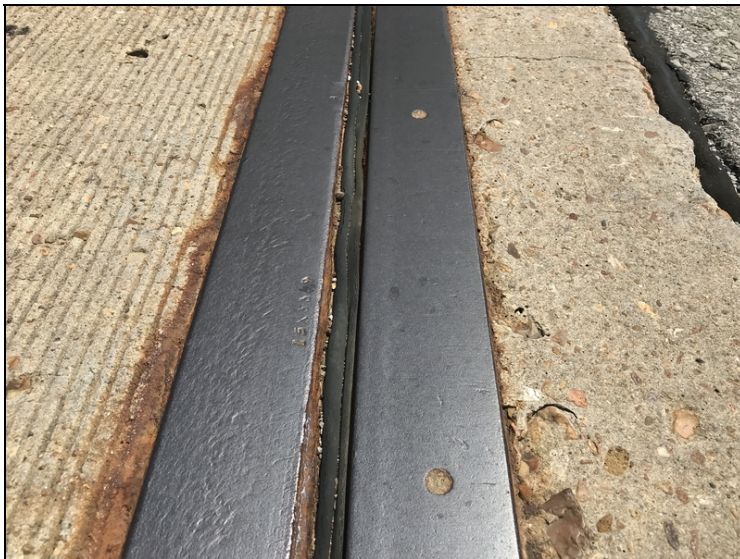
Expansion joint seals - The compression joint seals are deteriorated with areas of cracking and adhesion failure. The assemblies have pack rust that appears to be contributing to the adhesion failure. The compression joint seal at bent #2 is sticking up above the assembly in the left lane and has damage due to traffic impact.

Abutment #1 road irons pack rust causing adhesion failure

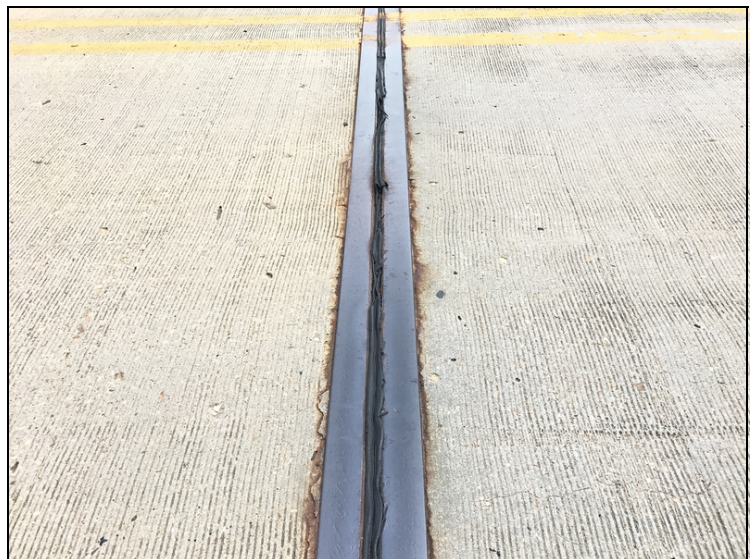
Bent #2 expansion joint material is cracking and tearing largely due to vehicle impact.

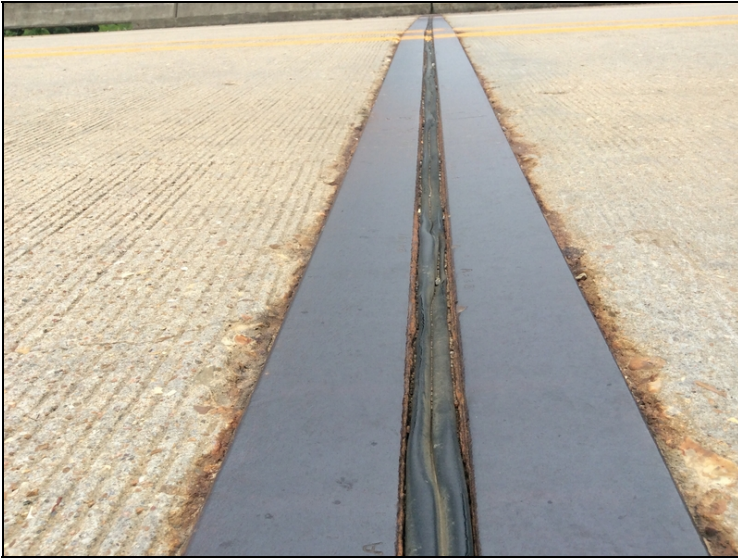
Pack rust in compression joint assembly.

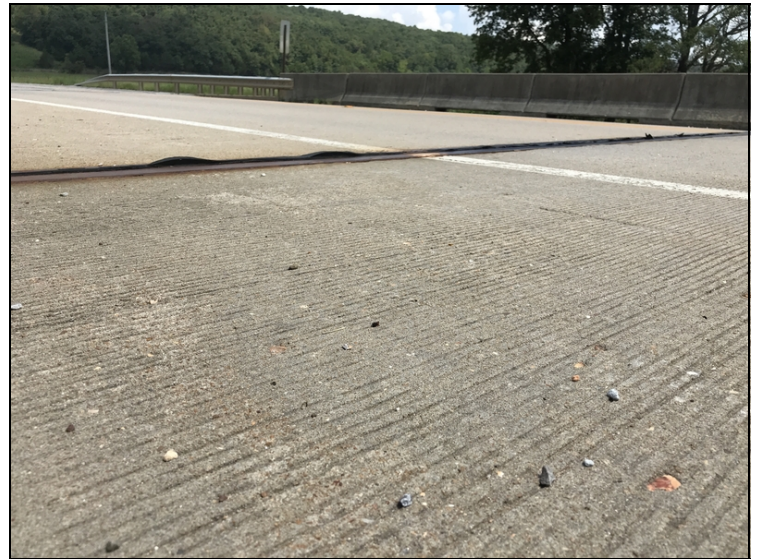
Bent #2 expansion joint is backing out.

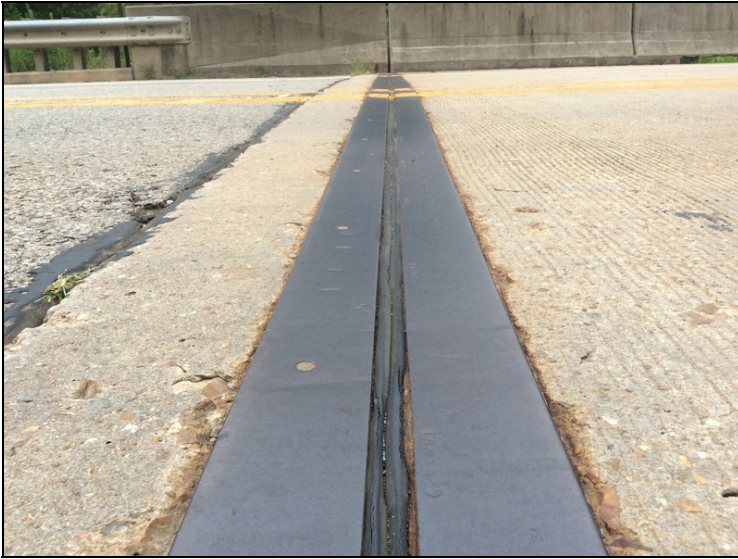
Abutment #1-Deteriorated compression joint seal.

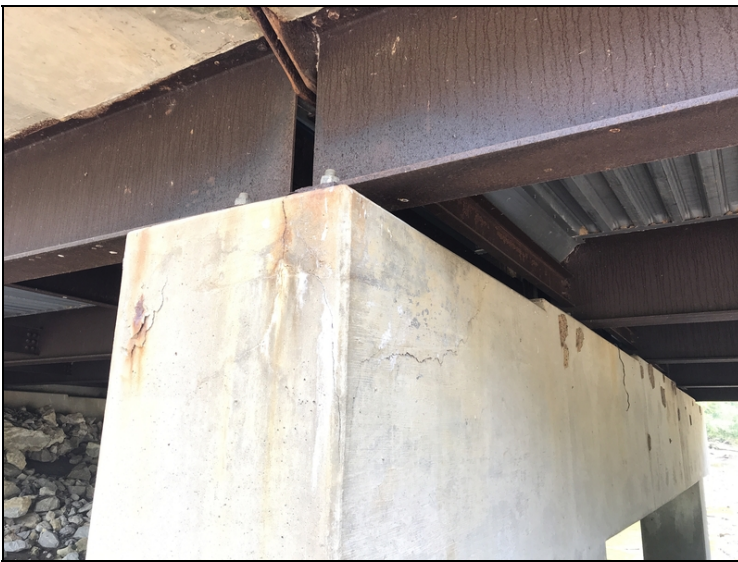
Substructure - The left side of bent #2 cap has a delaminated area on the back face that is approximately 3' long and propagates diagonally under bearing #1.

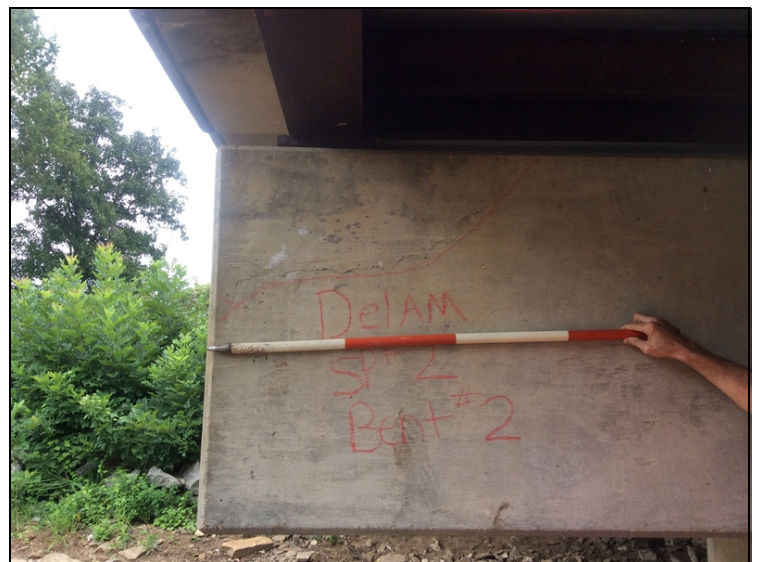
Bent #2, Left side-Delaminated area under beam #1.
