Bridge #06409(Routine, Underwater type 2)

Madison Co. SH 23 over HENDERSON CREEK

Location: .1 MI SO JCT 127 & 23

Team Lead: Nathan Rowland **Inspection Date:** November 15, 2021

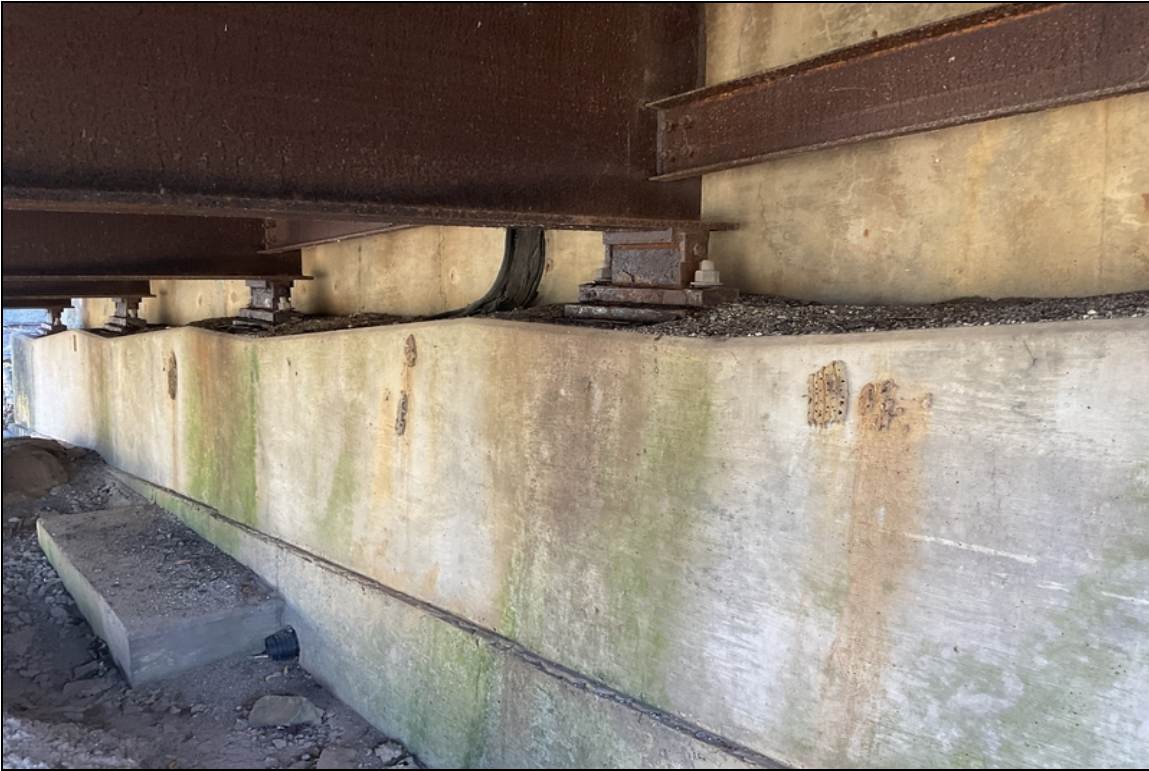
View of bearing area at abutment #1

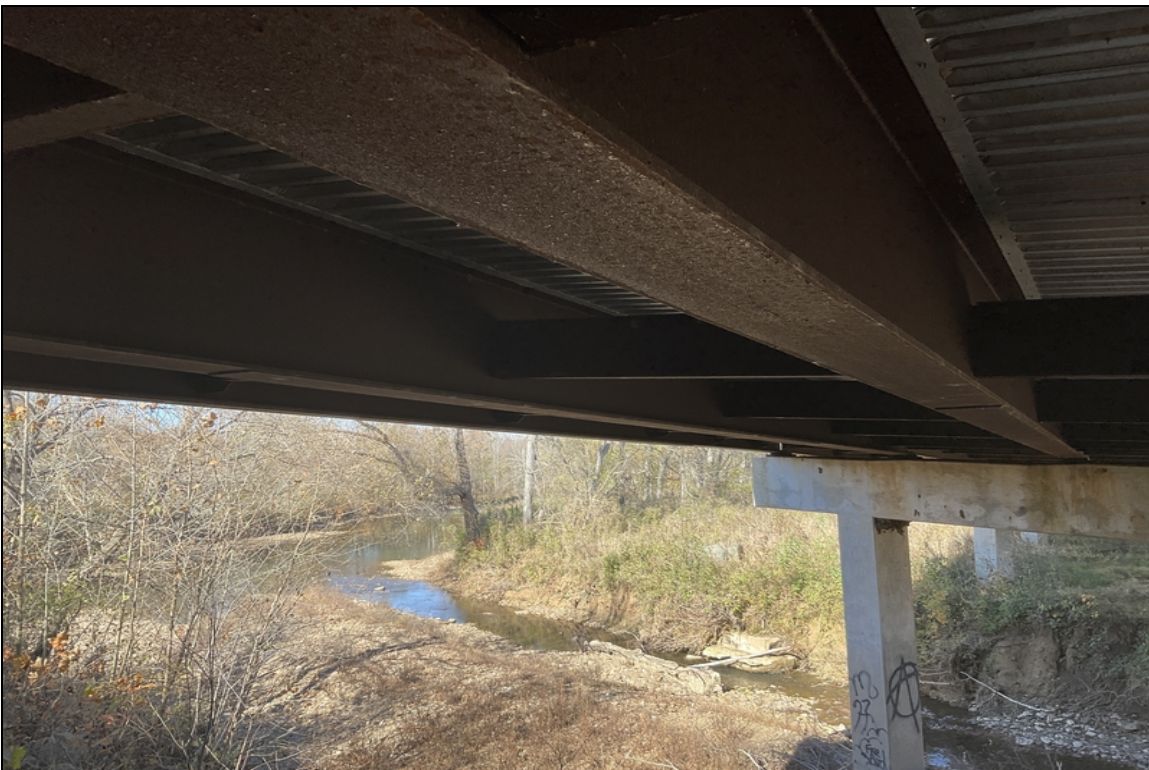
(107)	11/15 /2021 WNR & DBM: -span #1 girders bottom flange #1 - #3 have welded cover plates varying in size. -The ends of girders over the intermediate bents have abnormal weathering with flaking rust due to leakage through expansion joints. The corrosion and flaking rust extends along the bottom flanges up to approximately 30' in locations where water leaks through the joints and runs along the bottom flanges.						
205	Reinforced Concrete Column	EA	6	4	2	0	0
1190	Abrasion/Wear (PSC/RC)	EA	2	0	2	0	0

span #1 girders bottom flange #1 - #3 have welded cover plates varying in size.

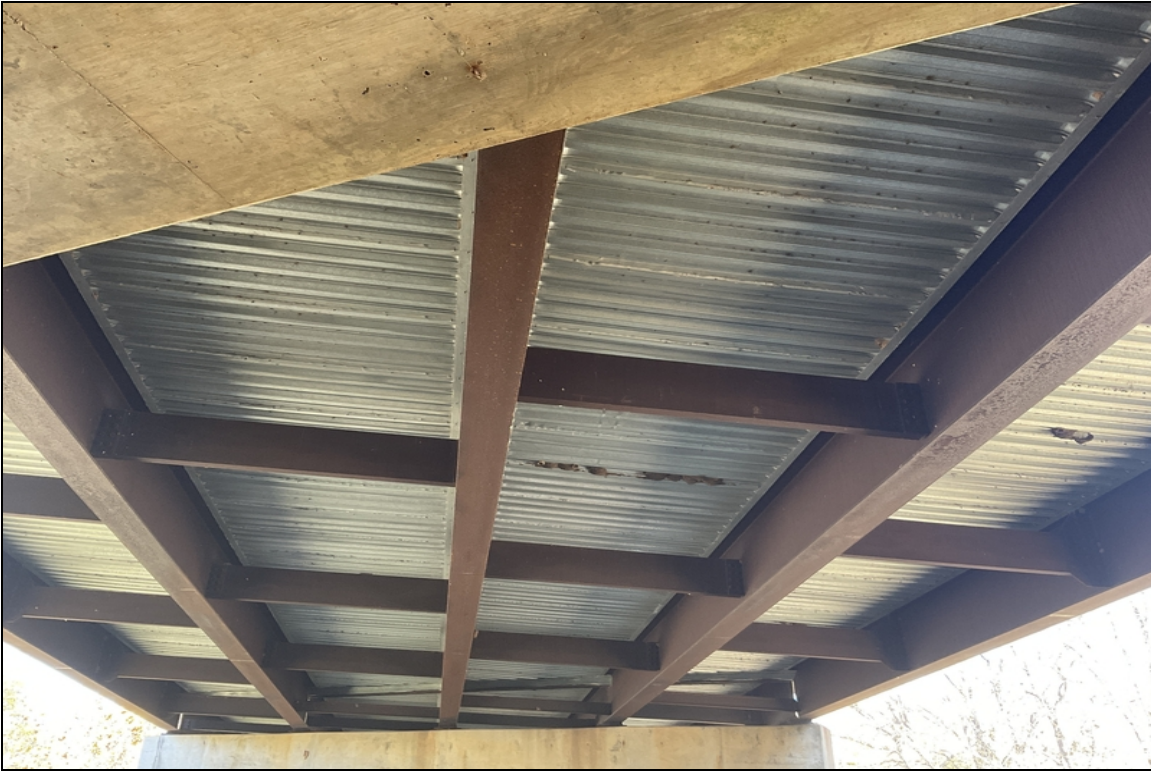
Typical view of superstructure condition at span #3.

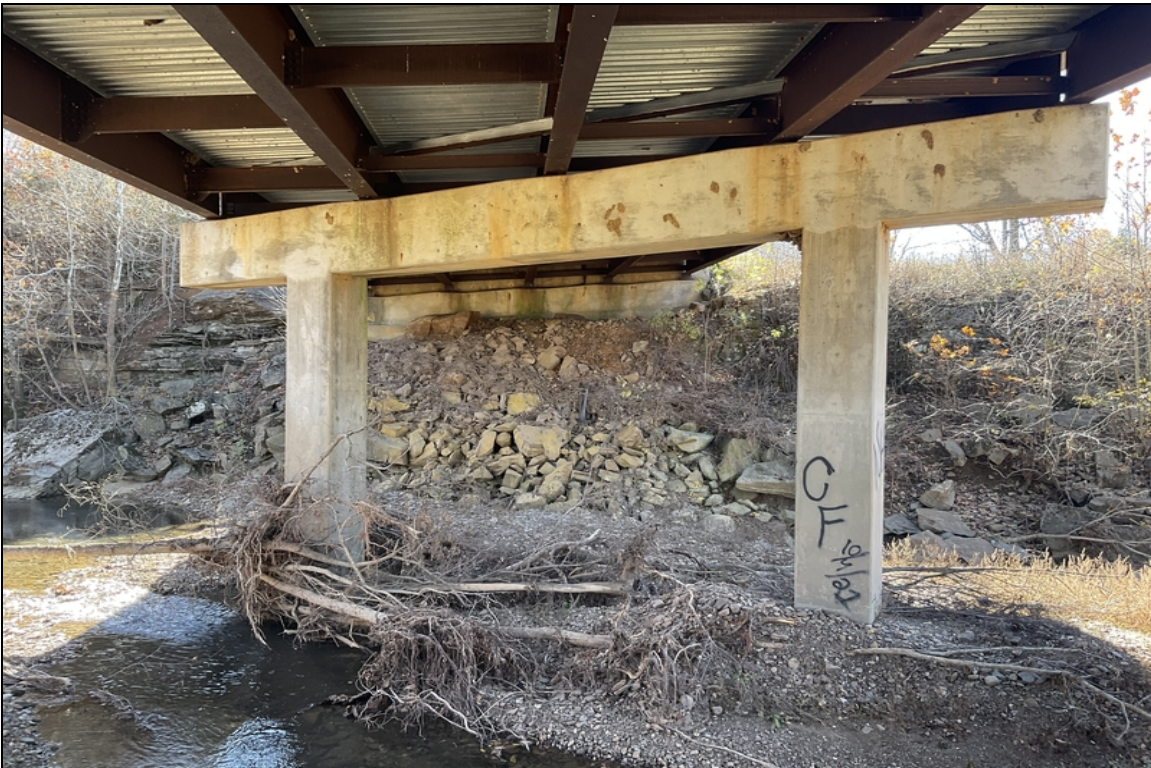
View of bent #1 ahead side

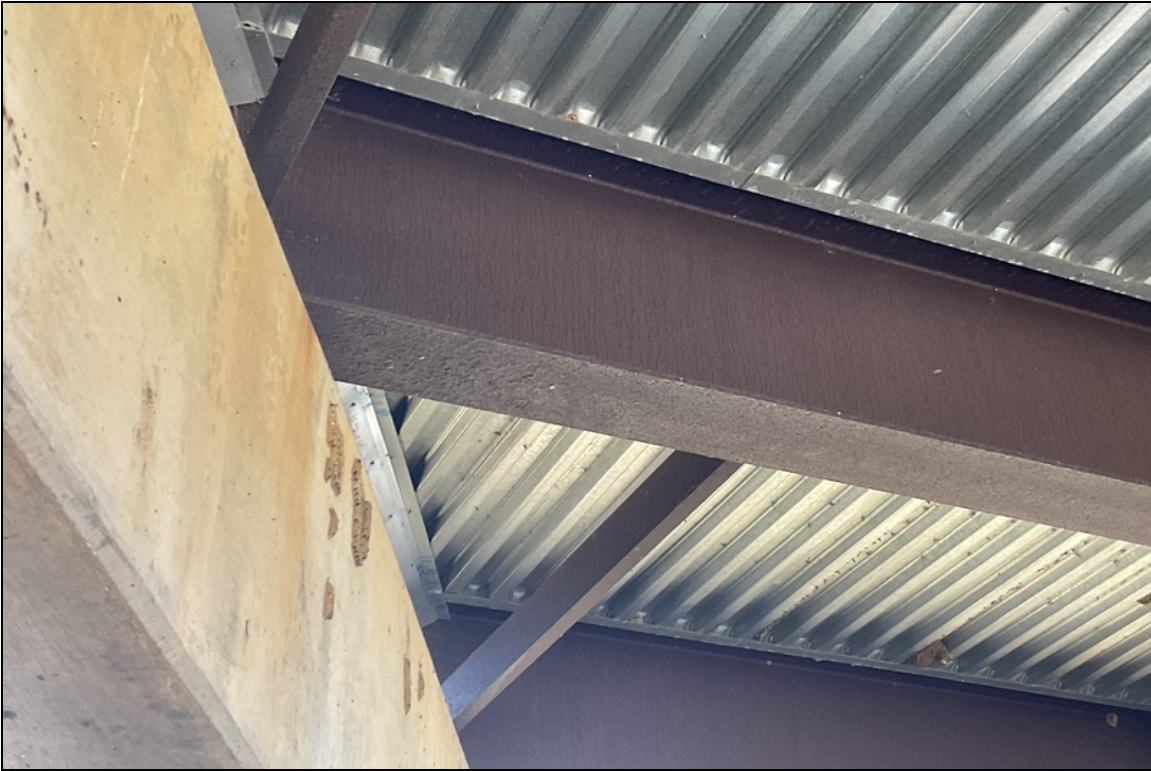
Typical flaking rust at girder ends

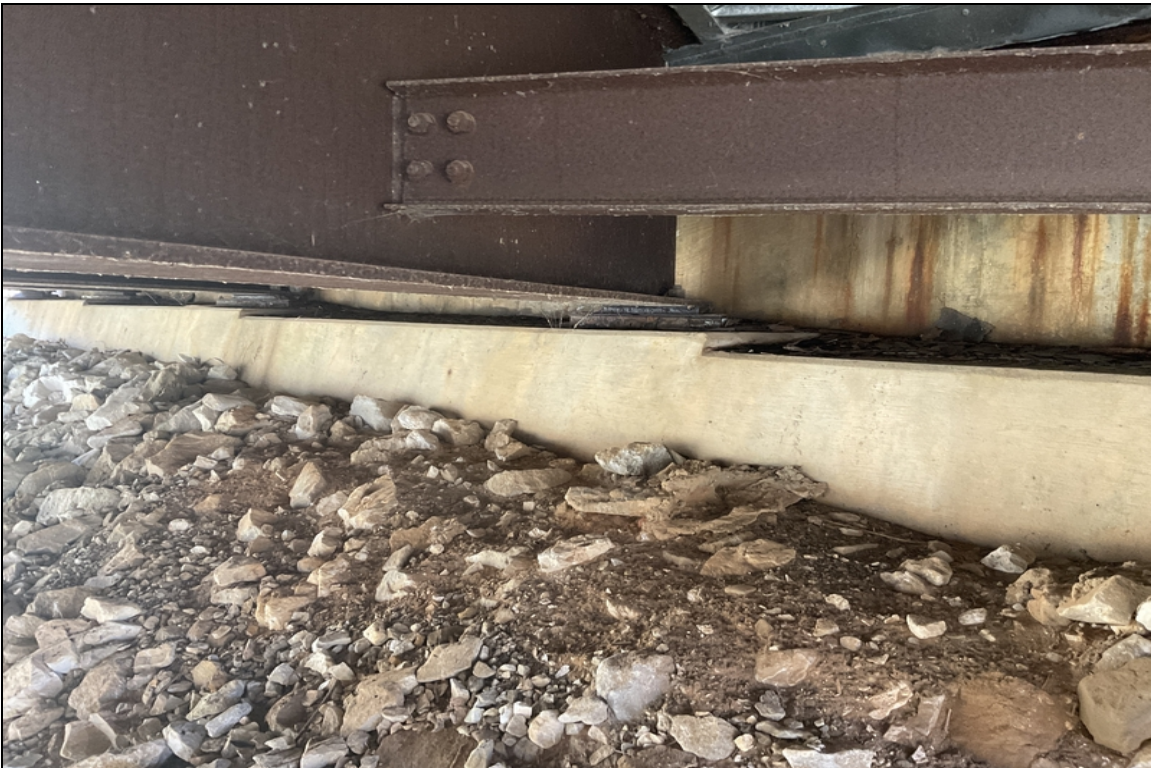
(311)							
11/15 /2021 WNR & DBM: -Bearings in all locations have active corrosion with thick flaking rust due to leaking expansion joint seals.							
313	Fixed Bearing	EA	20	5	4	11	0
1000	Corrosion	EA	15	0	4	11	0
515	Steel Protective Coating	SF	40	40	0	0	0

View of bearings at abutment #2

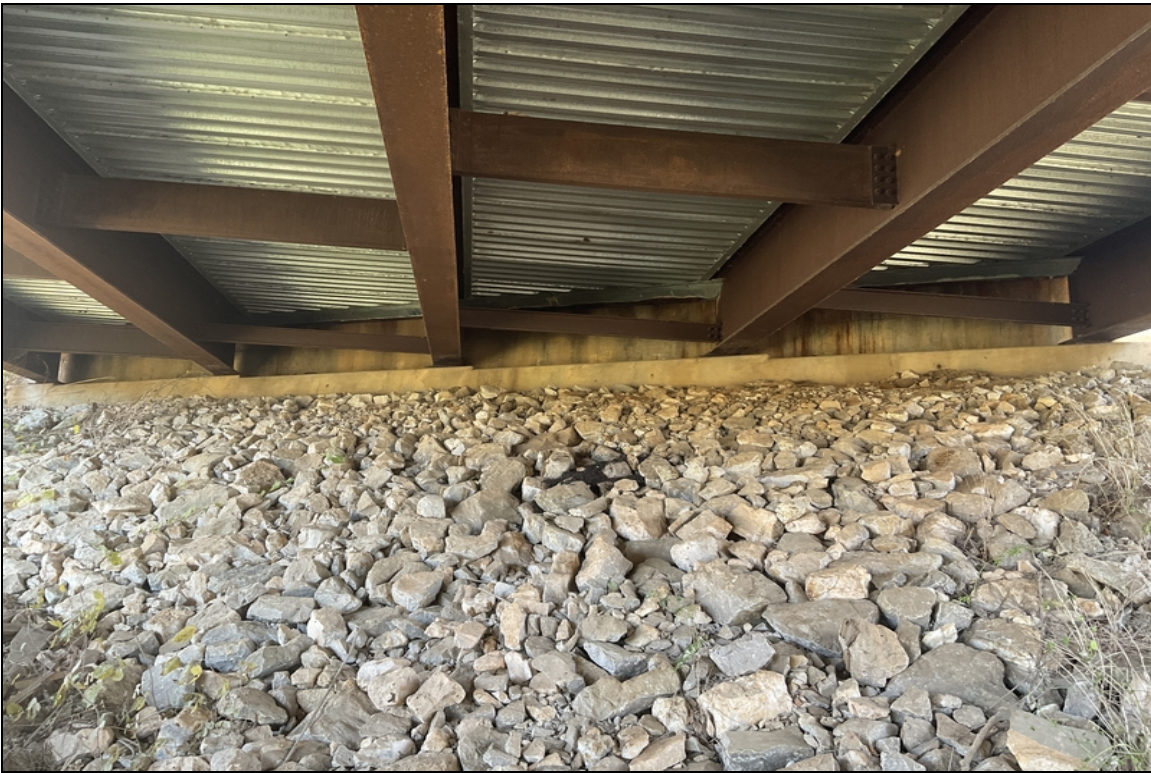
View of abutment #2

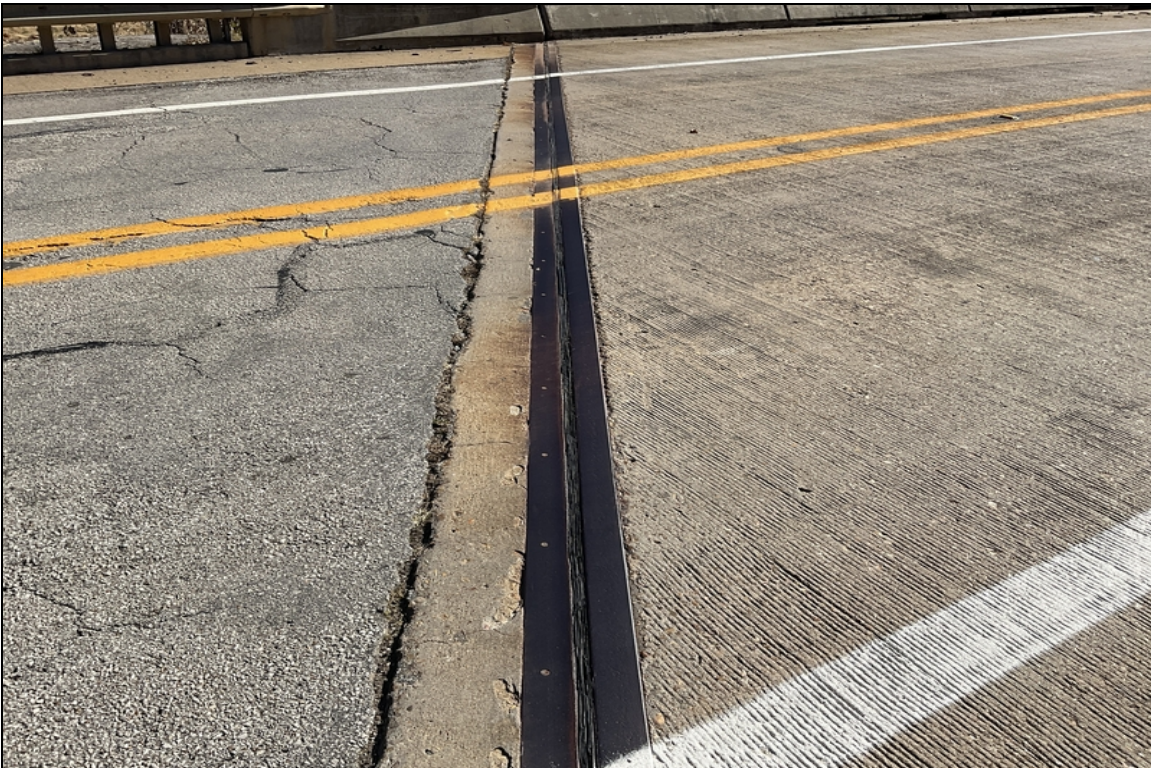
View of joint at abutment #2

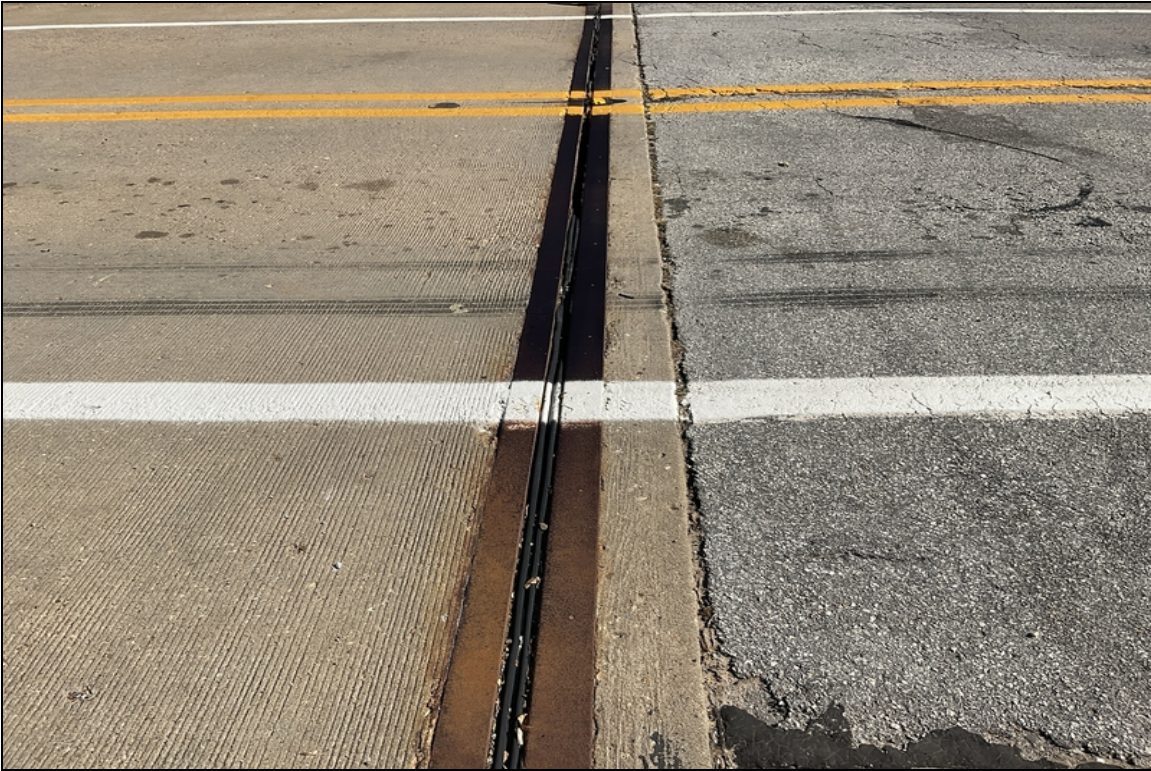
View of joint at abutment #1

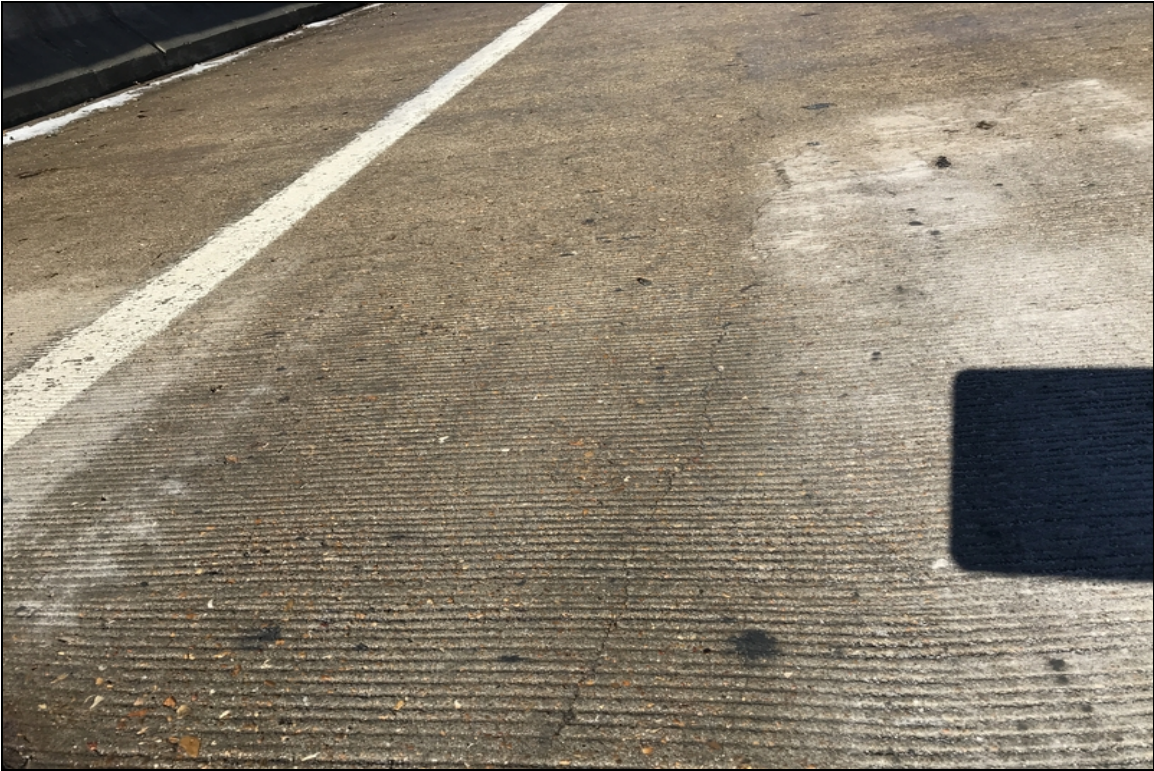
Span #2 left lane typical longitudinal cracking

Deck - The deck has sealable longitudinal, transverse and diagonal cracking in all spans.

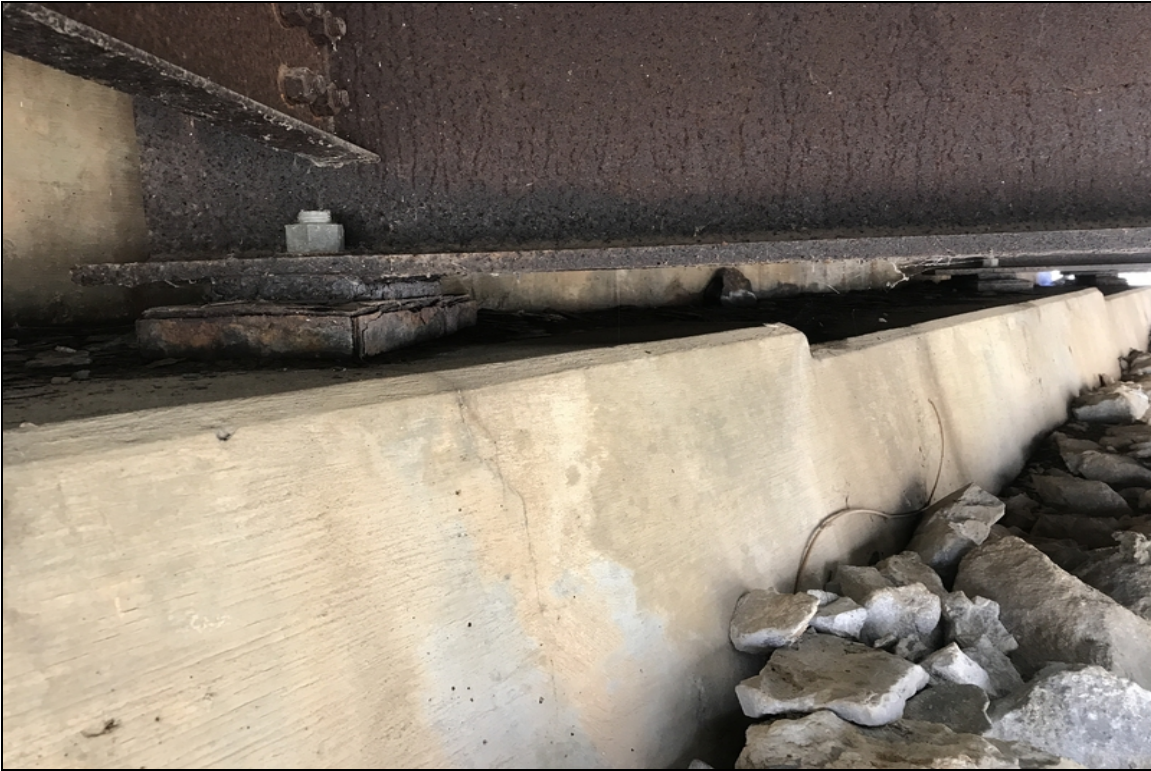
View of bearings at abutment #2.

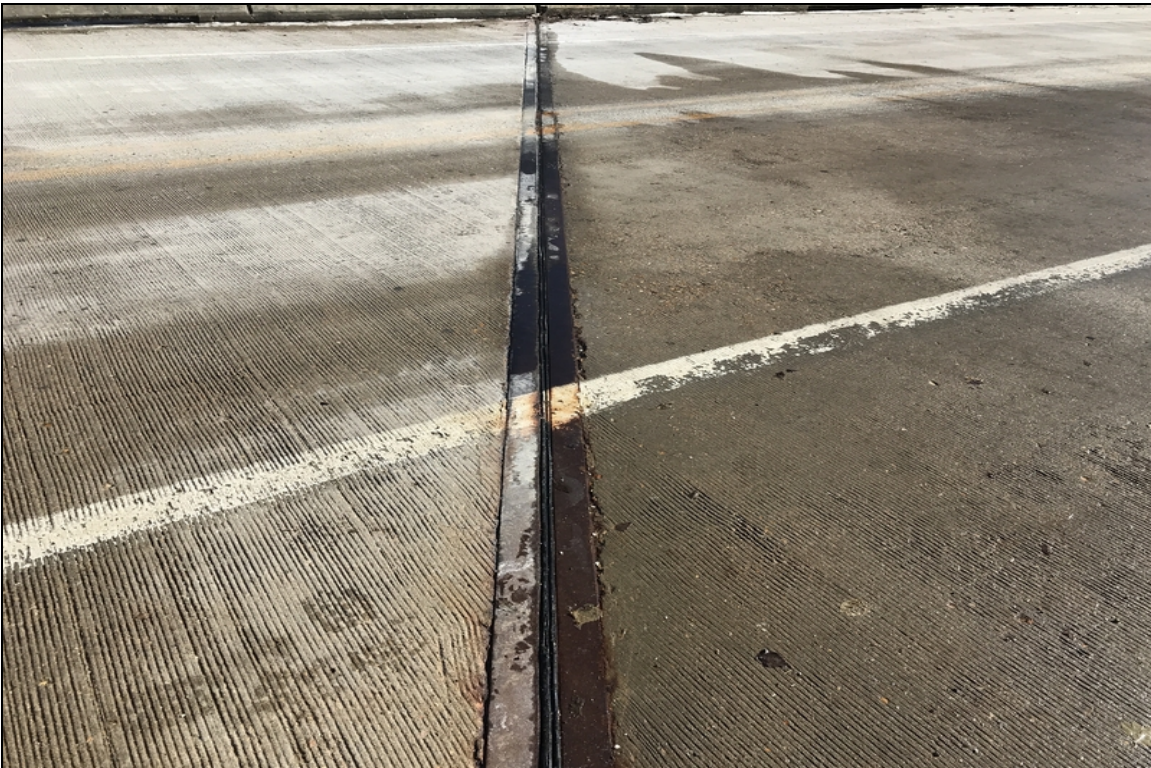
Bent #1 joint material condition

The compression joint seals at bents #1, #2 and #3 are deteriorated with cracks in the top of seals. The seals stick up above the assembly in locations. The seals in all locations leak allowing water to leak onto the superstructure causing excessive corrosion to bearing devices and ends of girders.

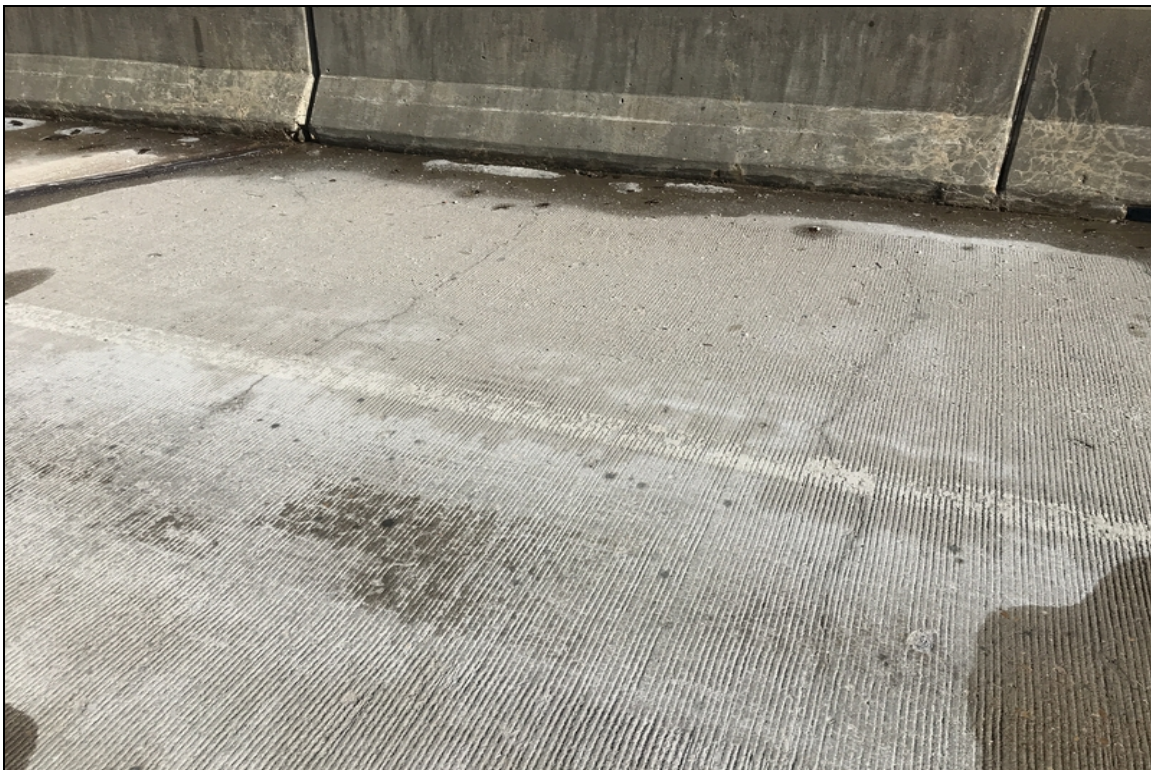
Span #3 right transverse cracking.

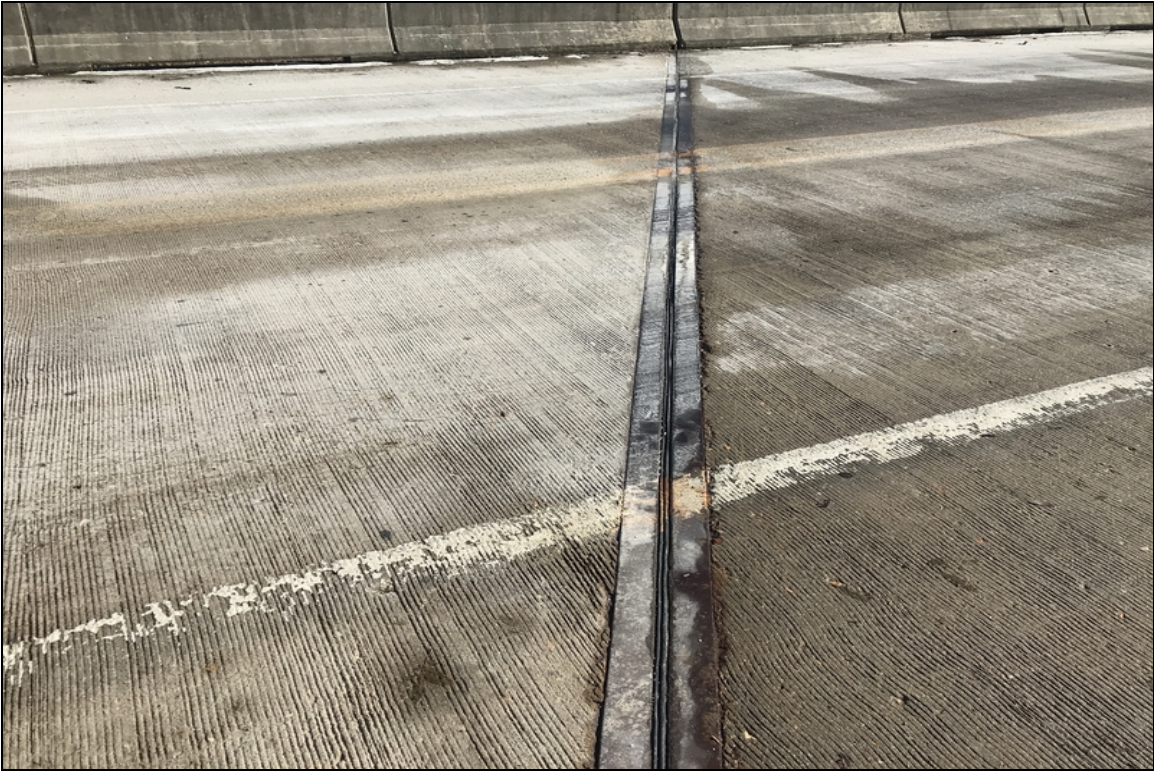
Bent #3 joint material condition.

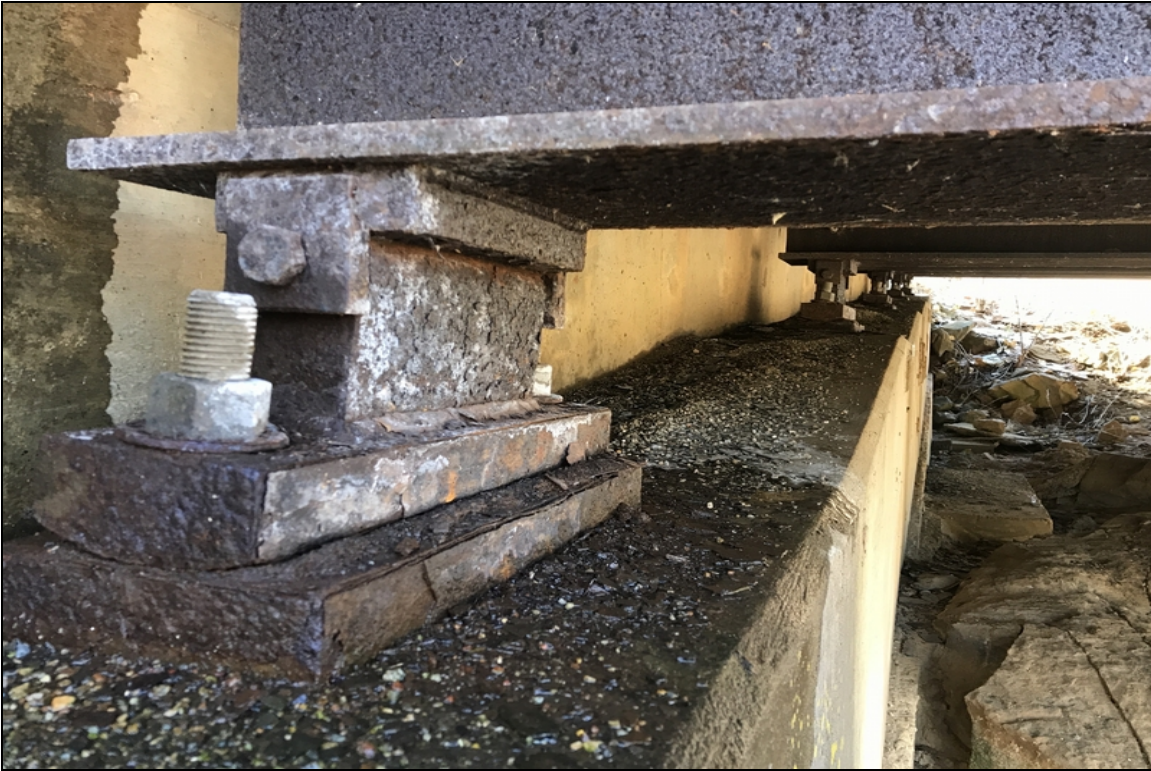
Typical condition of bearings at abutment #1.

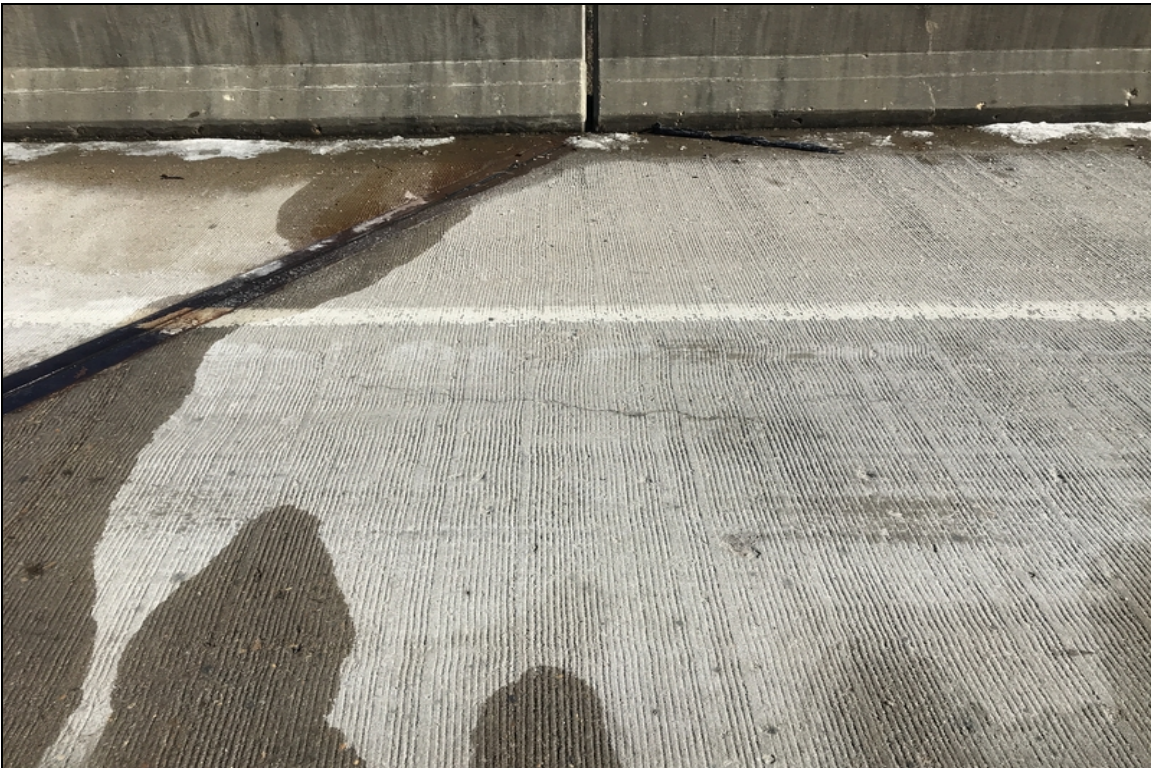
Span #2 right lane typical diagonal cracking.

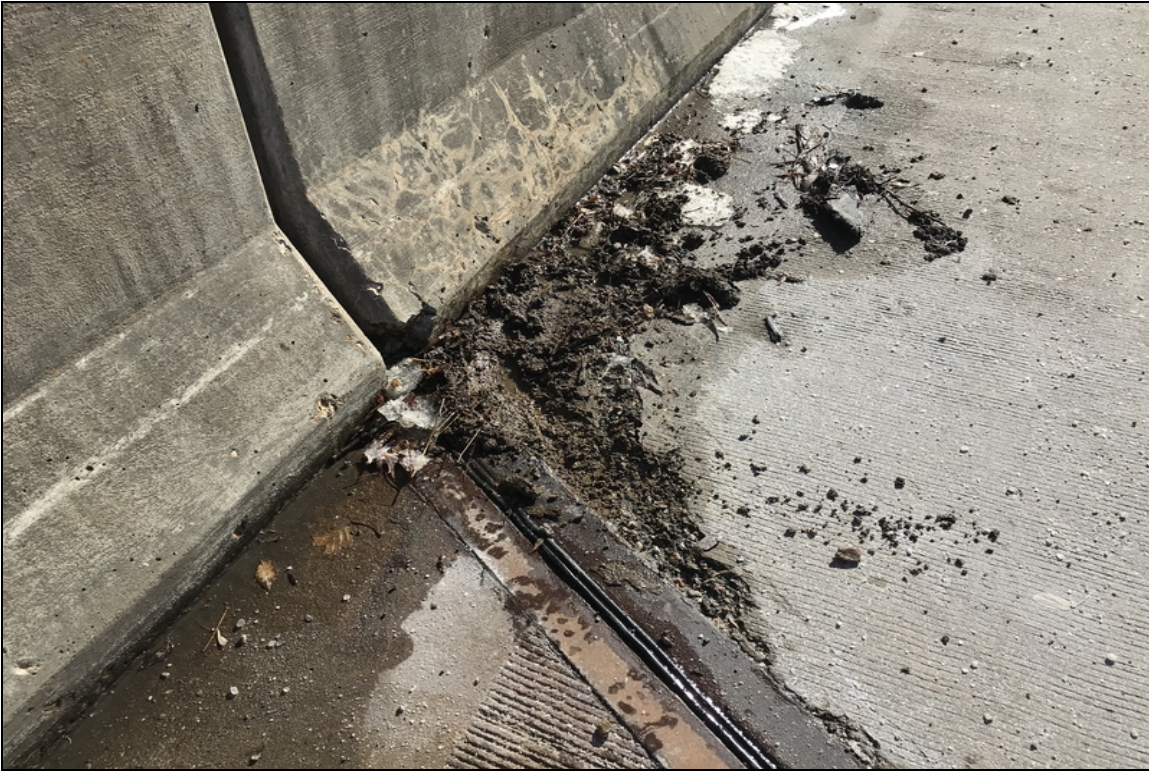
Span #1 at Bent #1 right spalling adjacent to road iron.

Deck - The deck has an area of spalling with soft deteriorated concrete approximately 1' wide and 2' long on the right side of span #1 adjacent to the expansion joint assembly. The undersurface of the deck overhang in the same area has a 3' x 3' area of spalling with exposed reinforcing steel. Span #3 right edge of deck and overhang has spalling and deterioration.

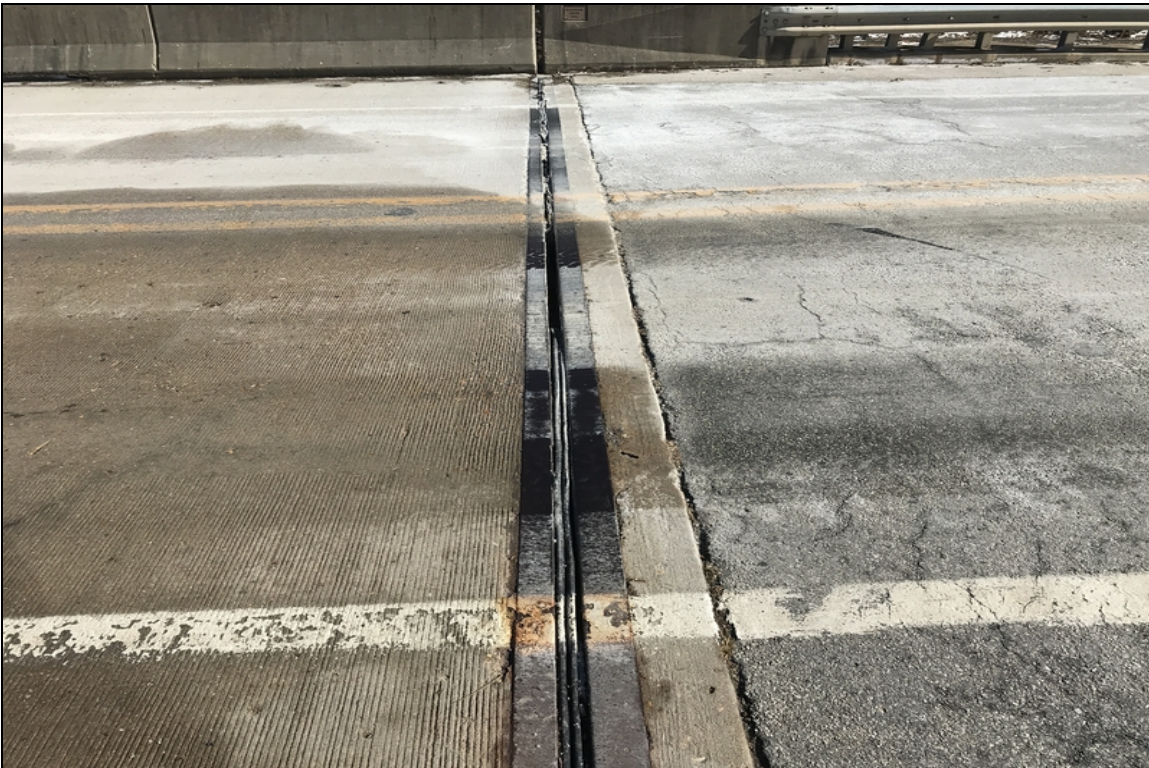
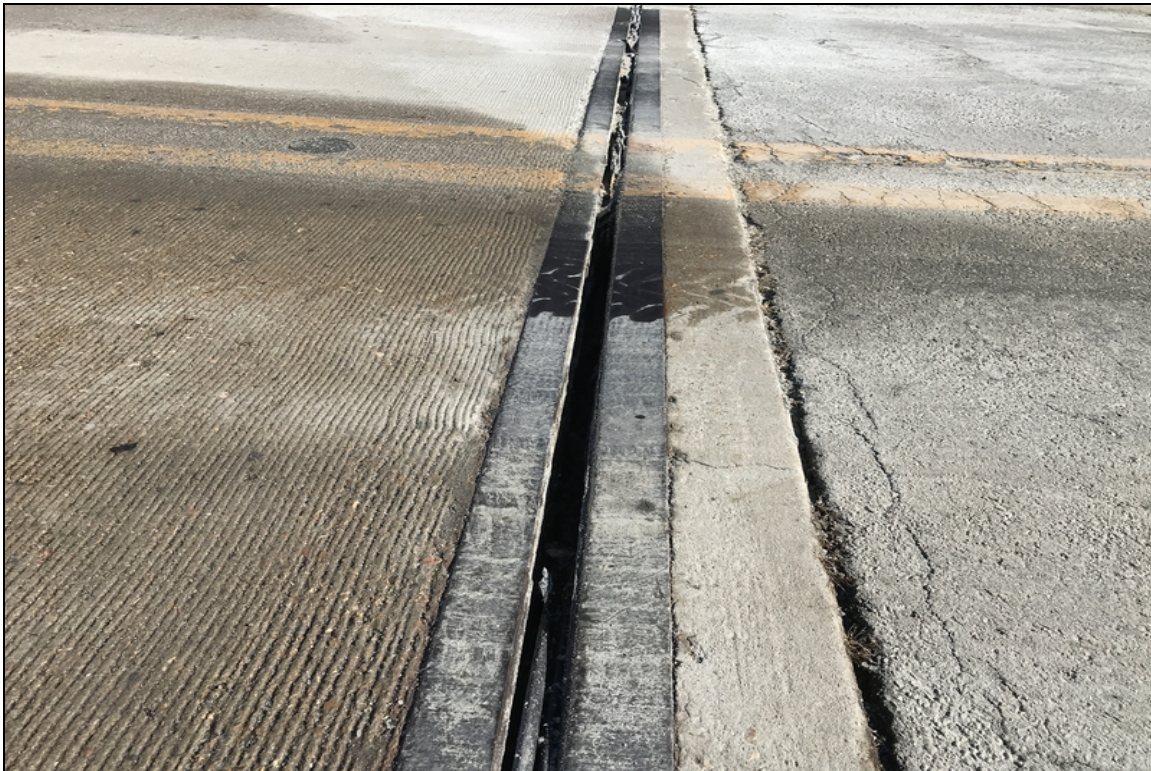
Abutment #1 expansion joint material lost adhesion.

Deck - The compression joint seal at abutment #1 is deteriorated with tears and has fallen out of position in several locations.

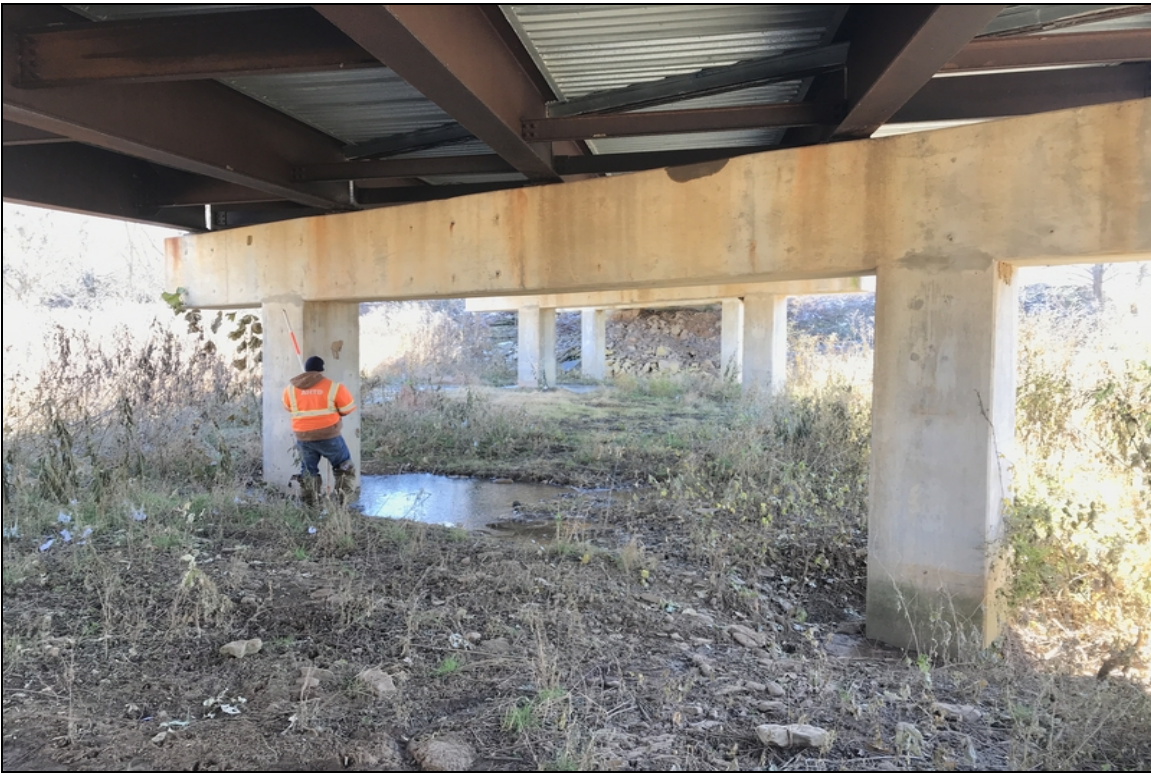
(205)	11/15 /2021 WNR & DBM: -Intermediate bents #2 & #3 have minor localized scouring. -Bent #1 columns have light abrasion. -The channel has light drift at column #1 of bent #1. -Columns have minor insignificant scour holes in some locations.						
215	Reinforced Concrete Abutment	LF	84	42	37	5	0
1080	Delamination/Spall/Patched Area	LF	7	0	7	0	0
1130	Cracking (RC and Other)	LF	35	0	30	5	0

Localized scouring at bents 2 and 3

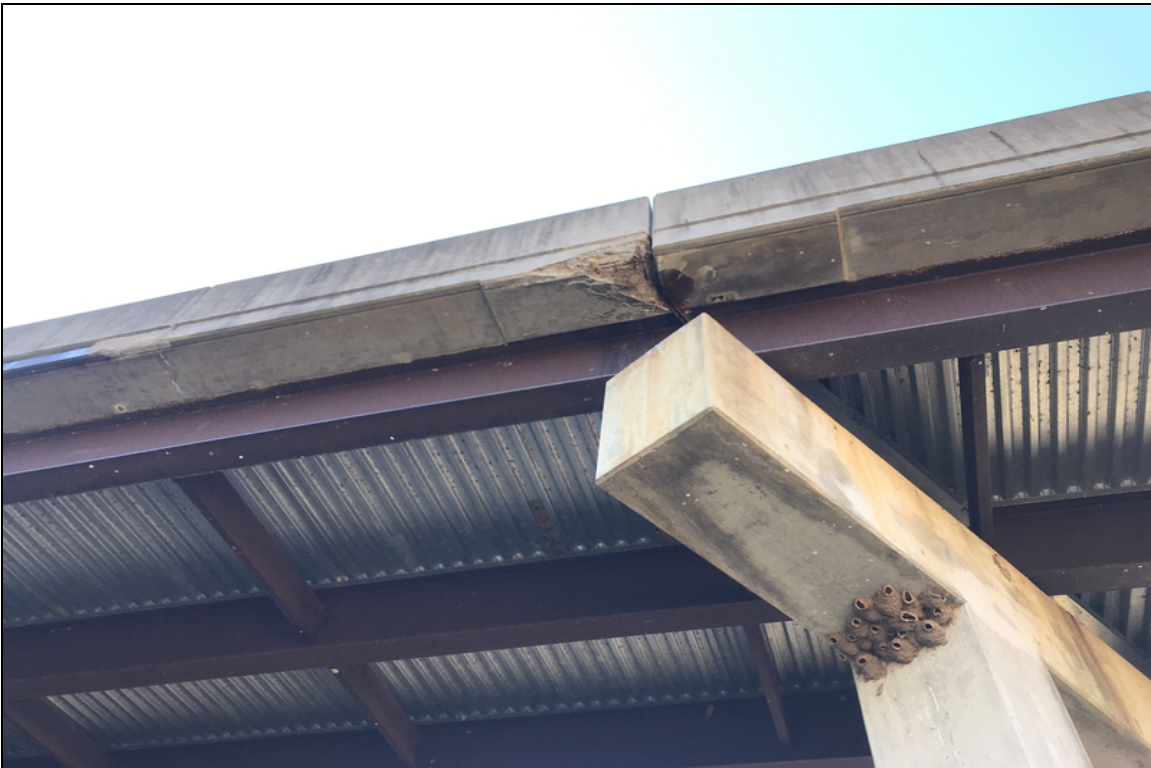
Deck span #1 overhang right spalling with steel exposed.

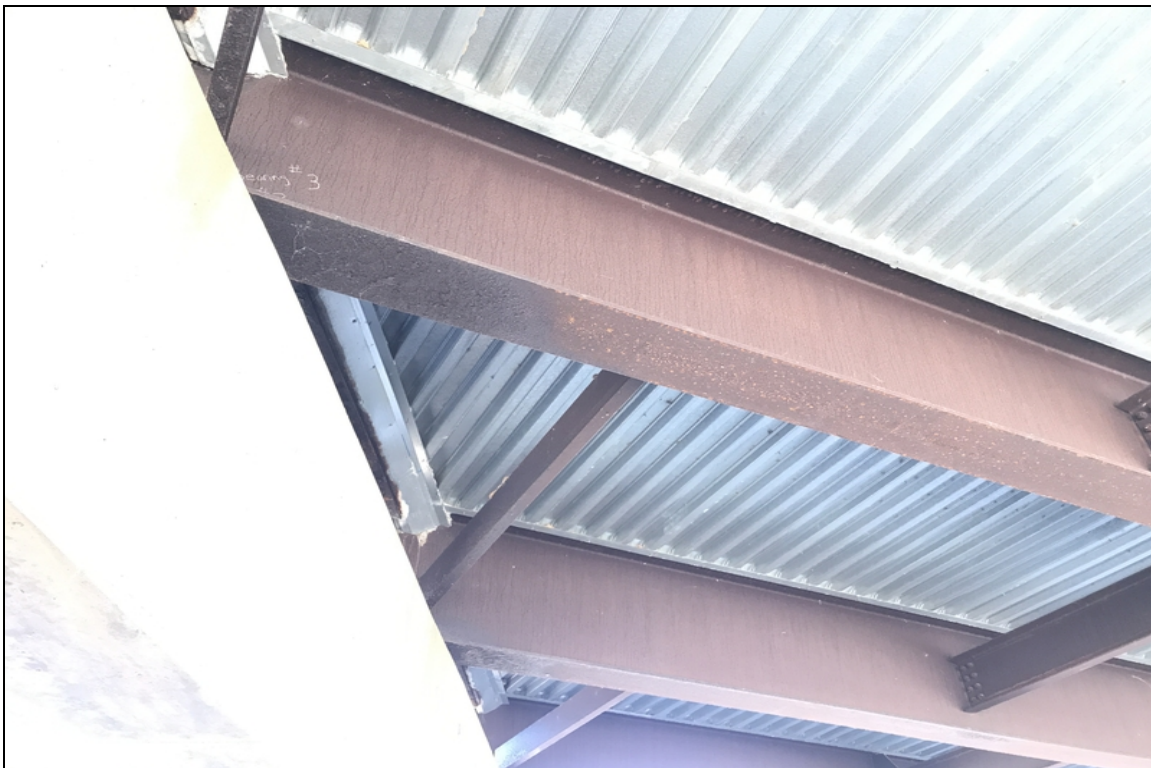
Span #3 typical flaking rust to bottom flange of girders at intermediate bents.

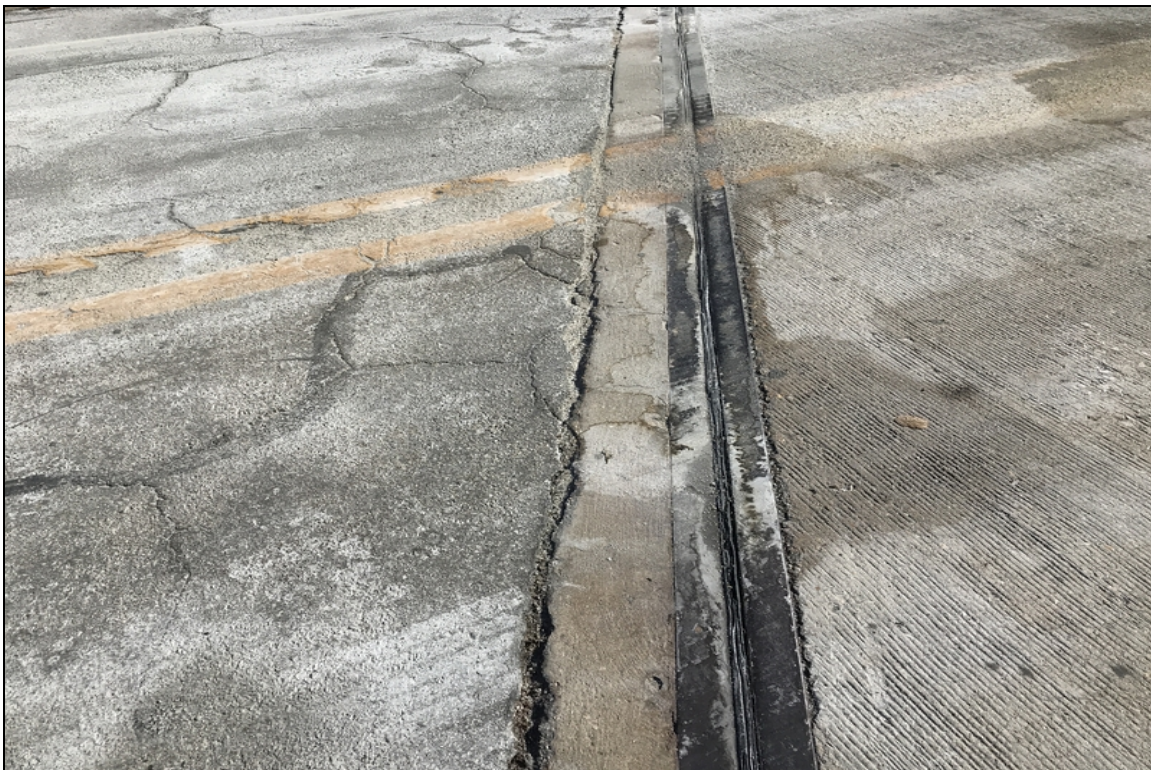
(215)	11/15 /2021 WNR & DBM: -The top of abutment backwalls have numerous transverse cracks at random spacing. The cracks propagate down the vertical face of breastwalls in locations. The top of abutment #1 backwall has a horizontal crack approximately 2' long in the right lane. -The top of abutment #2 has areas of shallow spalling and delaminated areas. -the bridge seat at abutment #2 has areas of vertical cracking and horizontal cracking to the vertical face of bridge seat.						
234	Reinforced Concrete Pier Cap	LF	126	105	21	0	0
1130	Cracking (RC and Other)	LF	21	0	21	0	0

Abutment #2 top of abutment backwall cracking and minor spalling.

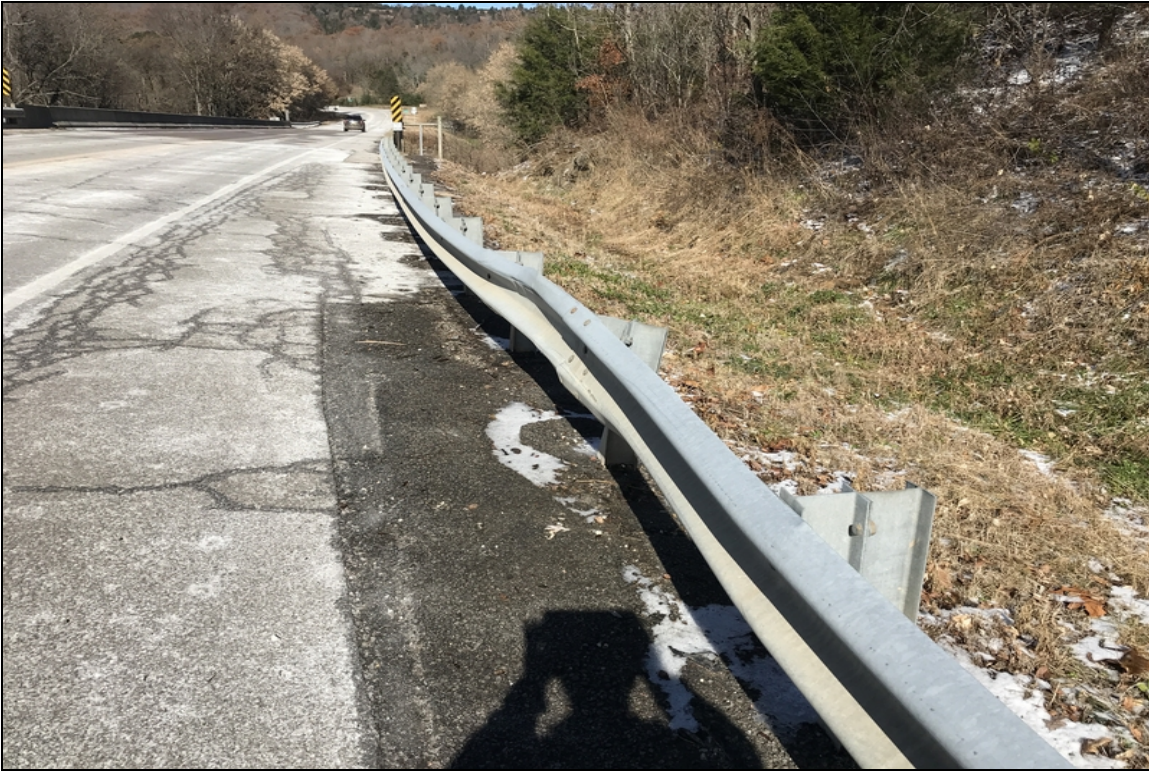
(331)							
11/15 /2021 WNR & DBM: -Concrete bridge railing has transverse cracking that corresponds with joints and in other random locations. The bridge railing has areas of mapcracking with light efflorescence in locations. -Southeast approach railing has collision damage that has bent approximately 12' of the railing and twisted one of the railing post.

Southeast approach railing has collision damage that has caused out-of-plane bending to approximately 12° of the railing and twisted one of the railing post.
