Bridge #06409(Routine, Underwater type 2)

Madison Co. SH 23 over HENDERSON CREEK

Location: .1 MI SO JCT 127 & 23

Team Lead: Nathan Rowland **Inspection Date:** November 15, 2021

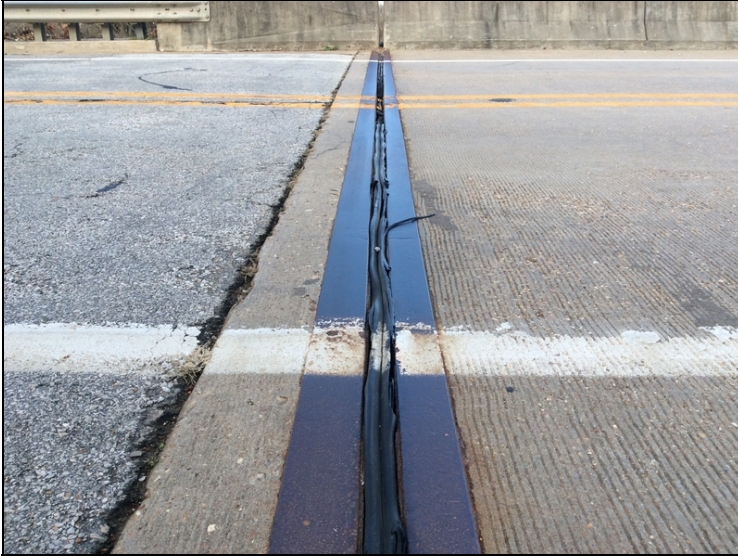
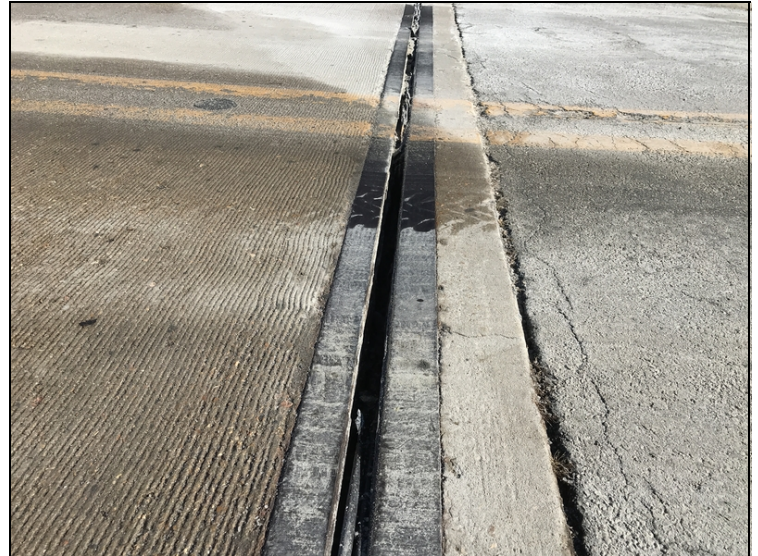
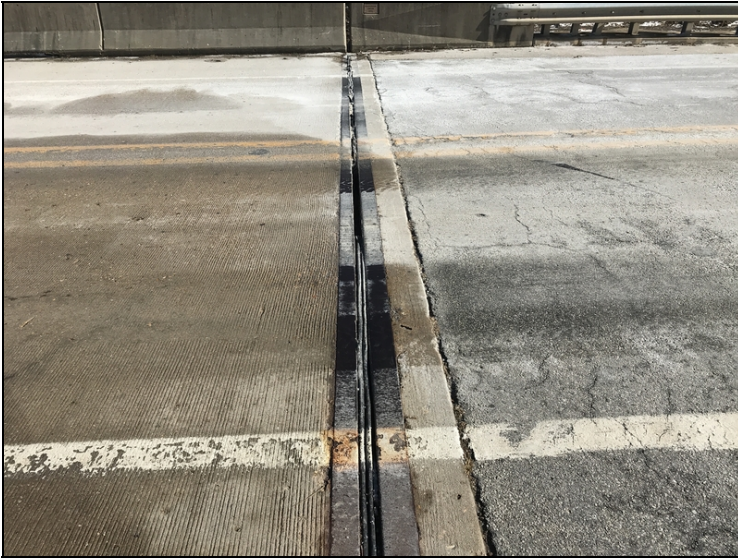
Deck - The compression joint seal at abutment #1 is deteriorated with tears and has fallen out of position in several locations.

The compression joint seals at bents #1, #2 and #3 are deteriorated with cracks in the top of seals. The seals stick up above the assembly in locations. The seals in all locations leak allowing water to leak onto the superstructure causing excessive corrosion to bearing devices and ends of girders.

Abutment #1-Compression seal deteriorated.

Abutment #1 expansion joint material lost
adhesion.

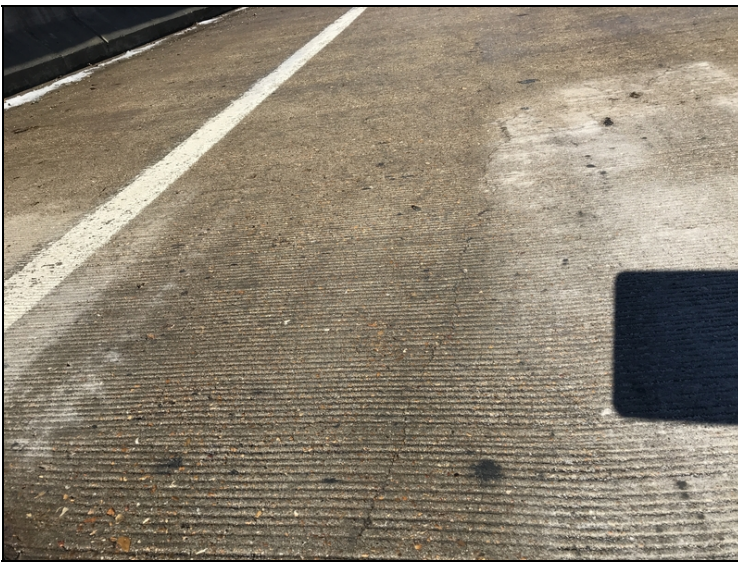
Deck - The deck has sealable longitudinal, transverse and diagonal cracking in all spans.

Span #2 left lane typical longitudinal cracking

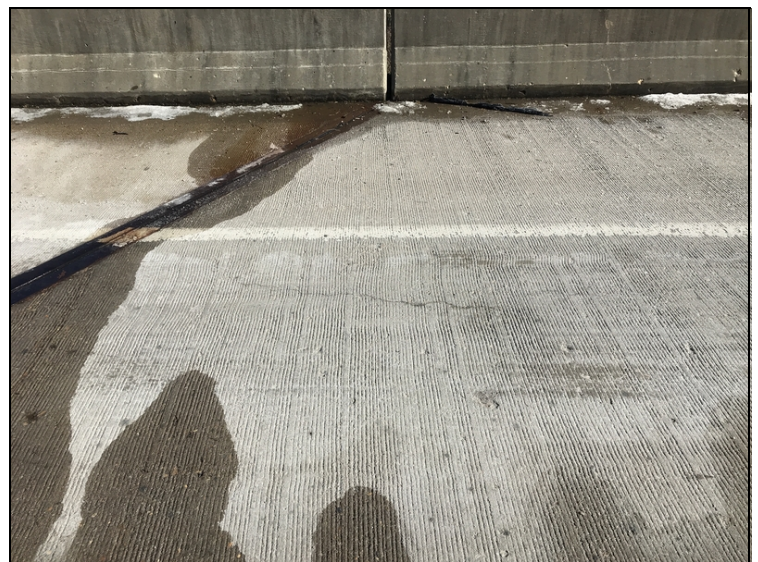
Span #2 right lane typical diagonal cracking.

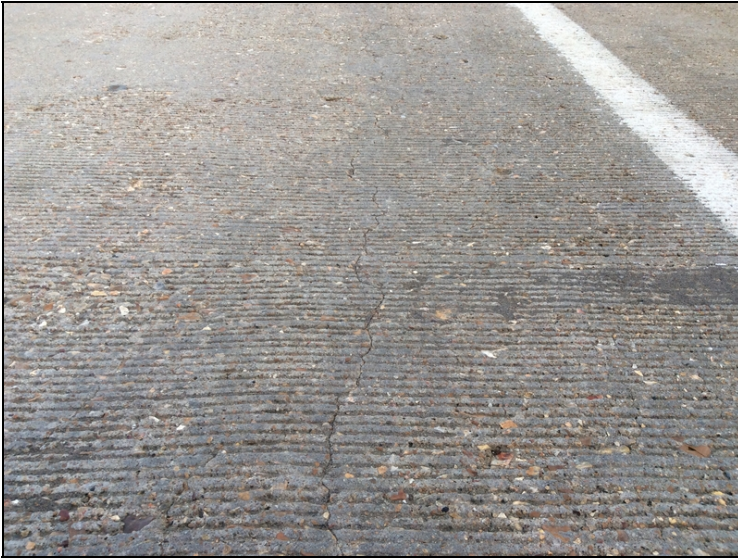
Span #1, right lane longitudinal cracking.

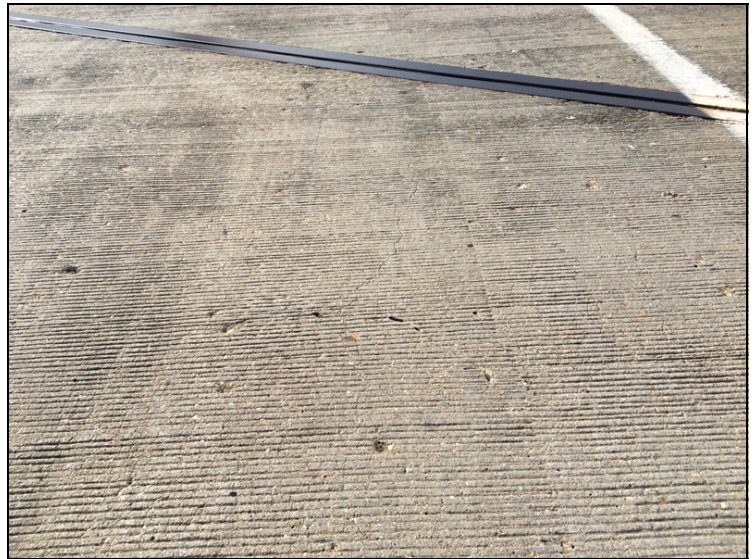
Span #3 Left lane adjacent to bent #2 looking South typical deck cracking.

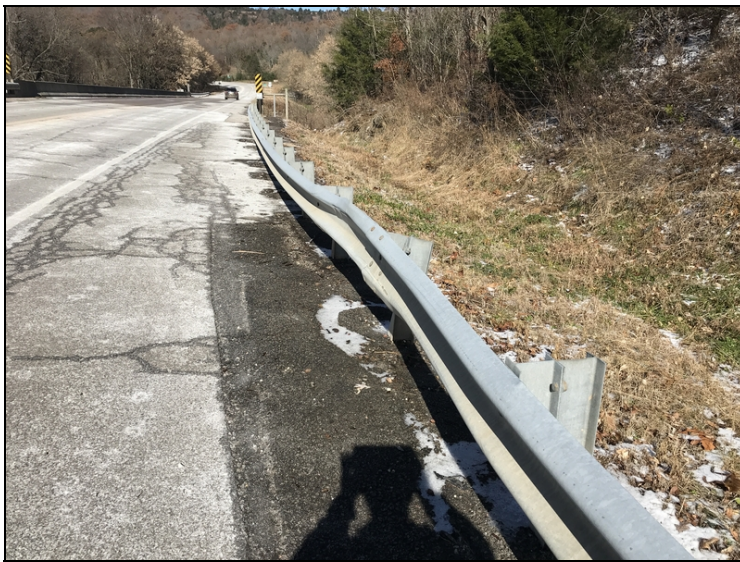
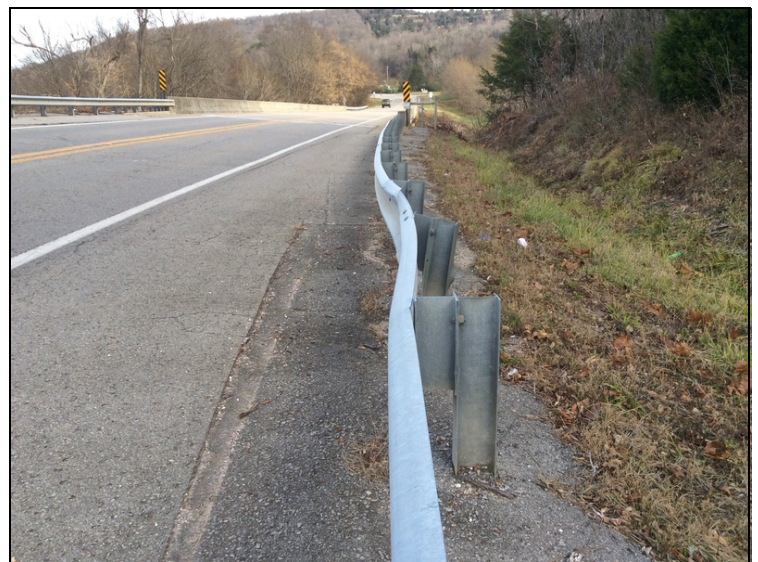
Southeast approach railing - Southeast approach railing has collision damage that has caused out-of-plane bending to approximately 12' of the railing and twisted one of the railing post.

Southeast approach railing has collision damage that has caused out-of-plane bending to approximately 12' of the railing and twisted one of the railing post.

Southeast approach railing has collision damage that has bent approximately 12' of the railing and twisted one of the railing post.

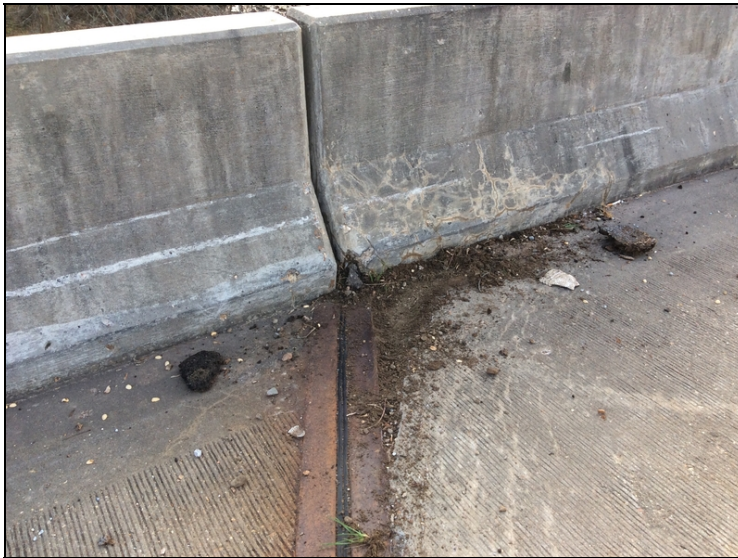
Deck - The deck has an area of spalling with soft deteriorated concrete approximately 1' wide and 2' long on the right side of span #1 adjacent to the expansion joint assembly. The undersurface of the deck overhang in the same area has a 3' x 3' area of spalling with exposed reinforcing steel. Span #3 right edge of deck and overhang has spalling and deterioration.

Deck bent #1 right spalling adjacent to joint and parapet.

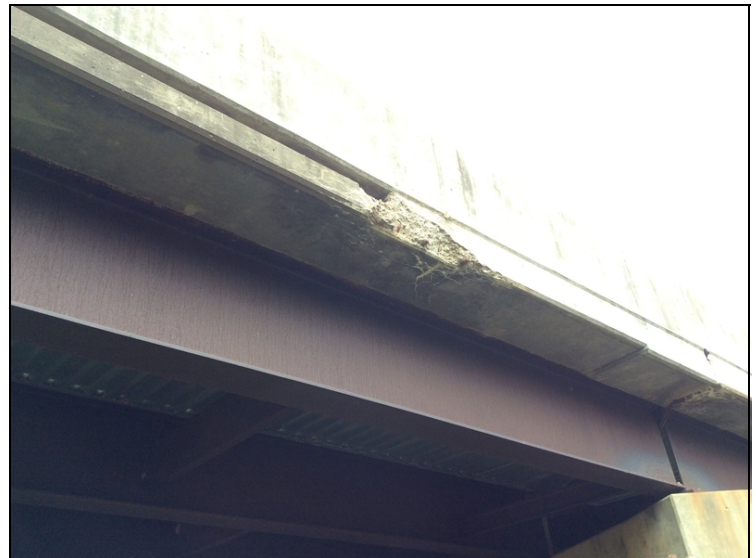
Soffit Span 3 right - spall with exposed reinforcing steel.

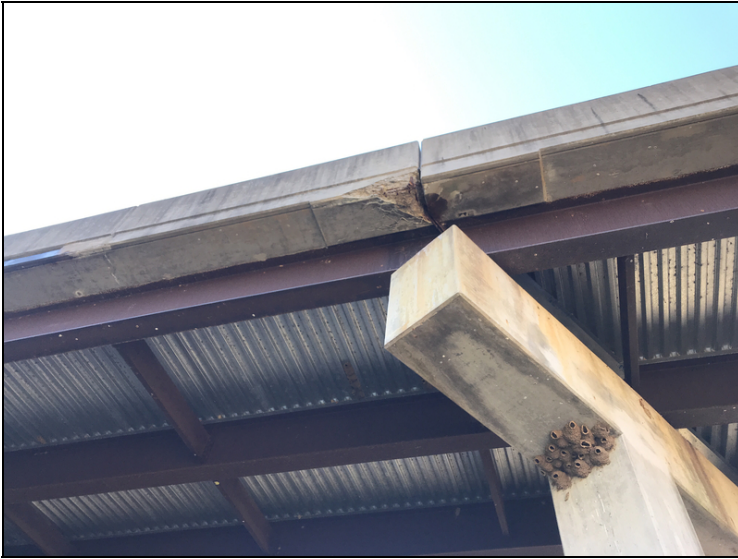
Deck span #1 overhang right spalling with steel exposed.

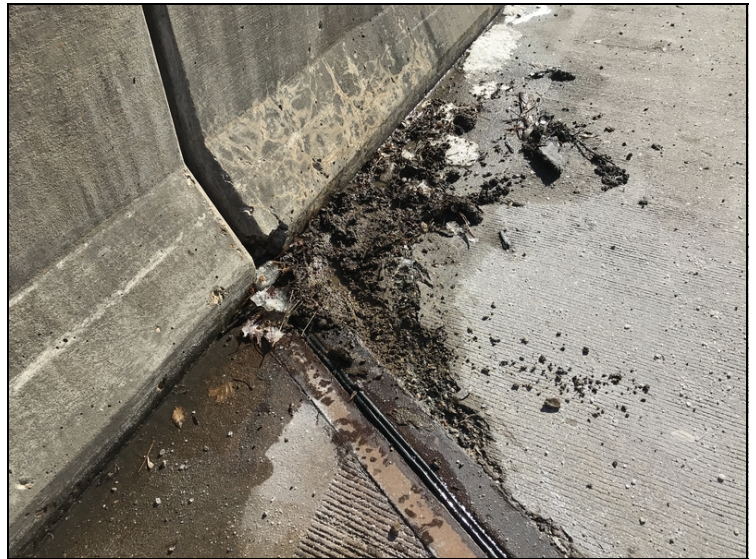
Span #1 at Bent #1 right spalling adjacent to road iron.

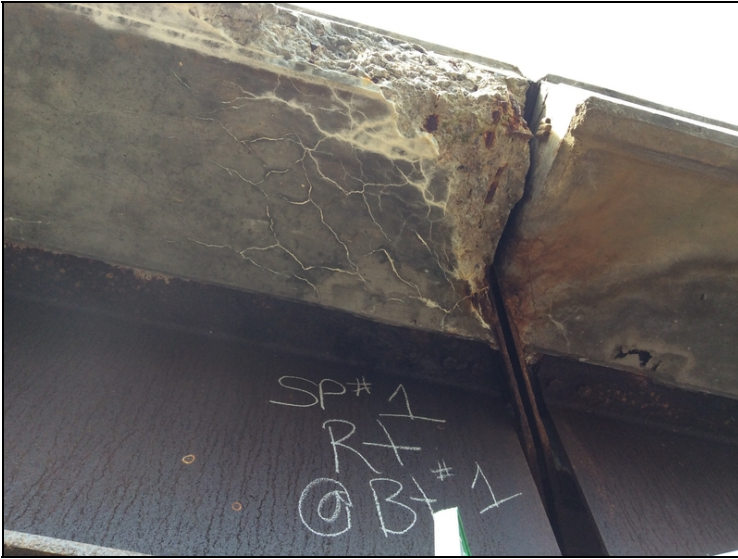
Span #1, right side over bent #1-Spalling /
delaminated area with exposed reinforcing steel.

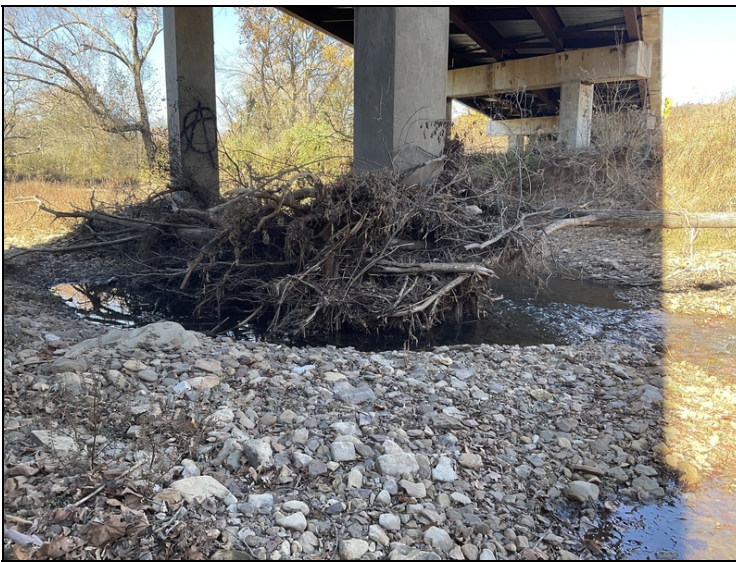
Channel - Bent #1 upstream has drift and small trees restricting the flow of water causing localized scour.

Bent #1 upstream has drift and small trees restricting the flow of water causing localized scour.

Type of Work: Clean
