Bridge #06512(Routine, Underwater type 2)

SH 23 Madison Co over FLEMING CREEK

Location: 3.4 MI N OF FRANKLIN

Team Lead: Nathan Rowland **Inspection Date:** March 10, 2022

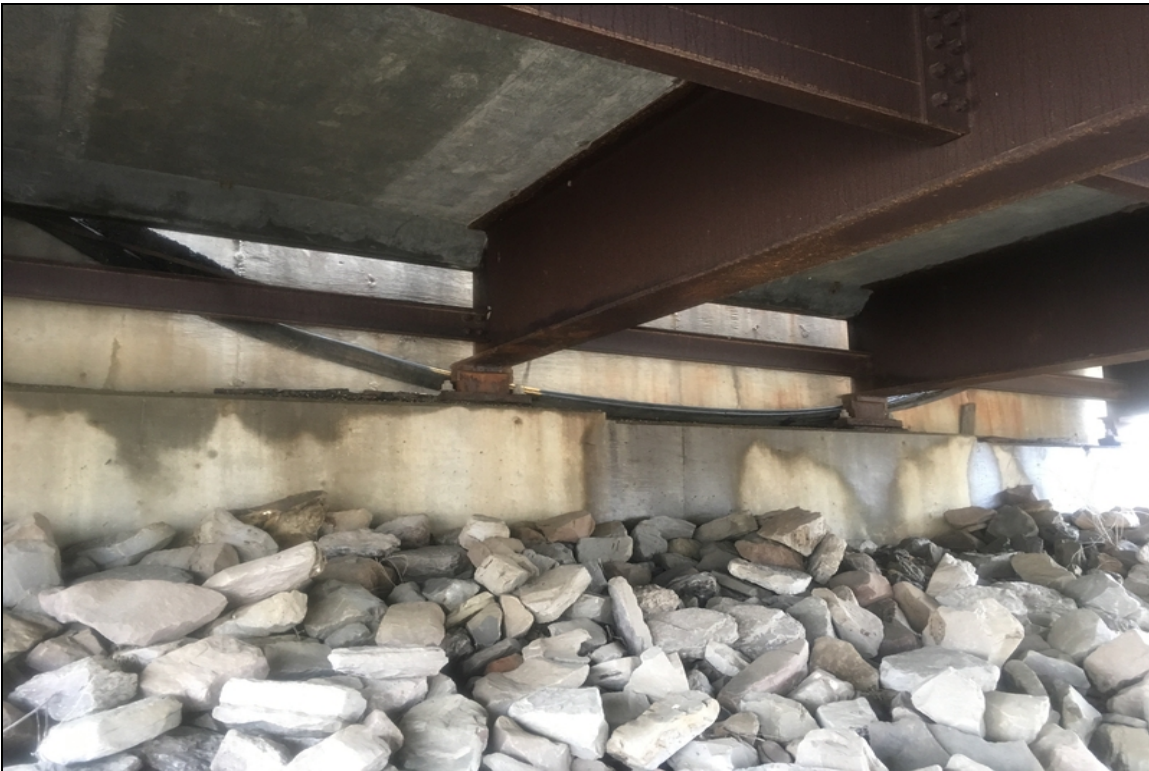
General view of abutment #2. Note the compression joint seal.

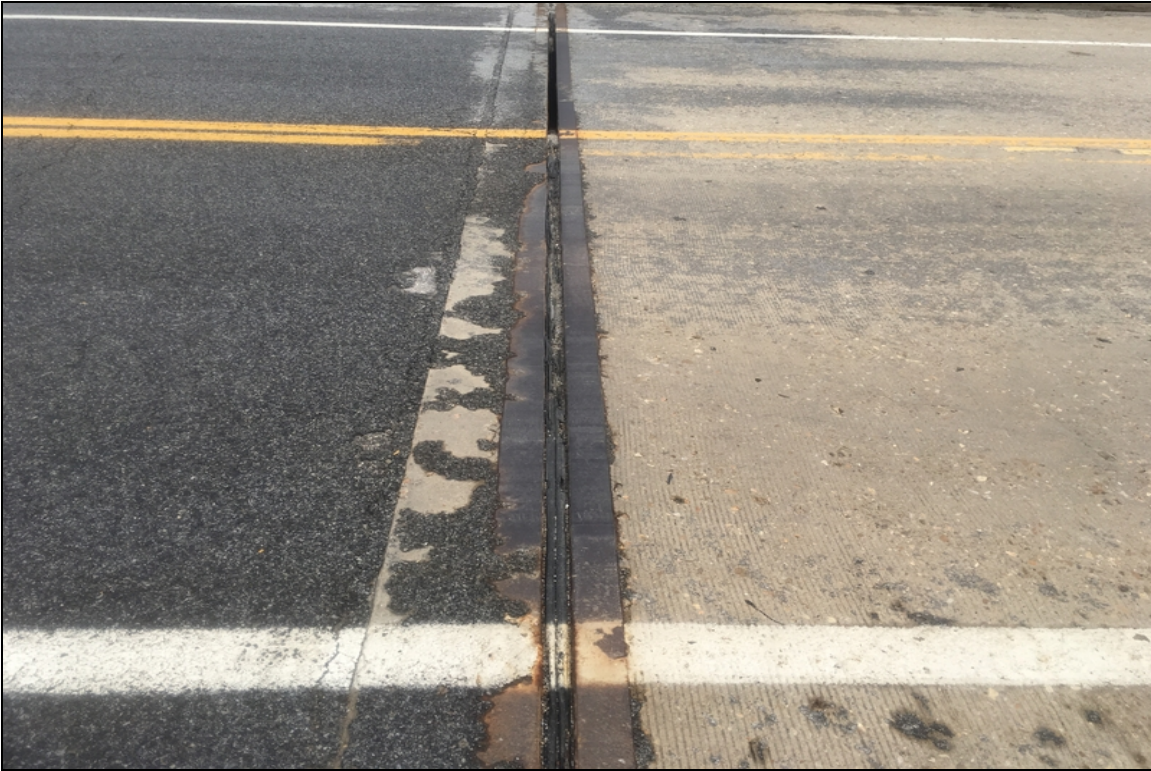
(302)							
3/10/2022 WNR & DBM: Abutment #1 seal- has 13' of the joint seal dislodged and sagging onto the bridge seat. 21' of the seal has cracking and/or snow plow damage. The retaining steel bar has become unattached at abutment #1 allowing the compression joint seal to drop out of position. Abutment #2 seal- 32' of the compression joint seal is dislodged and sagging on the bridge seat. The armoring plate has areas of pack rust. The left side of the seal has lost adhesion. The retaining steel bar has become unattached at abutment #1 allowing the compression joint seal to drop out of position.							
311	Movable Bearing	EA	10	2	0	8	0
1000	Corrosion	EA	8	0	0	8	0

Abutment #1 compression joint seal condition.

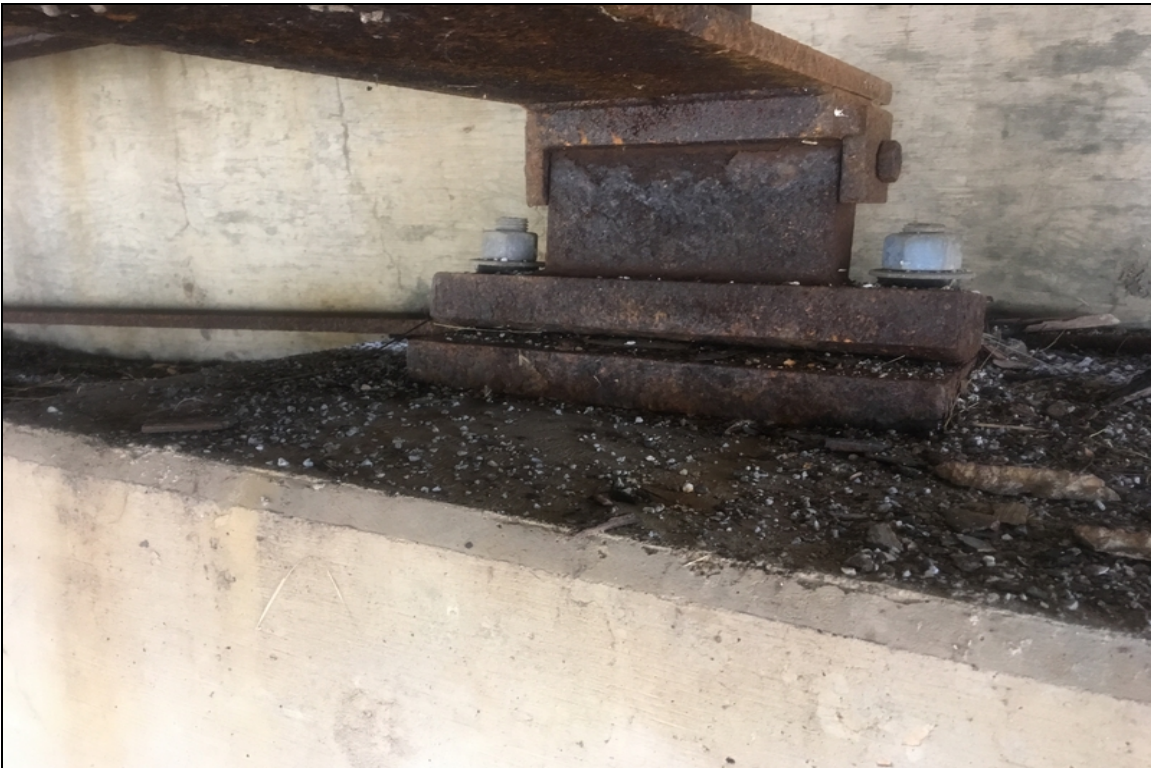
(311)							
3/10/2022 WNR & DBM: Abutment #1 moveable bearings- bearings 2,3,4,5 have corrosion with flaking rust, bearing #1 has no deficiencies. Abutment #2 moveable bearings- 2,3,4,5 have corrosion with flaking rust, bearing #1 has no deficiencies.							
313	Fixed Bearing	EA	15	15	0	0	0

View of typical bearing corrosion at abutment #1.

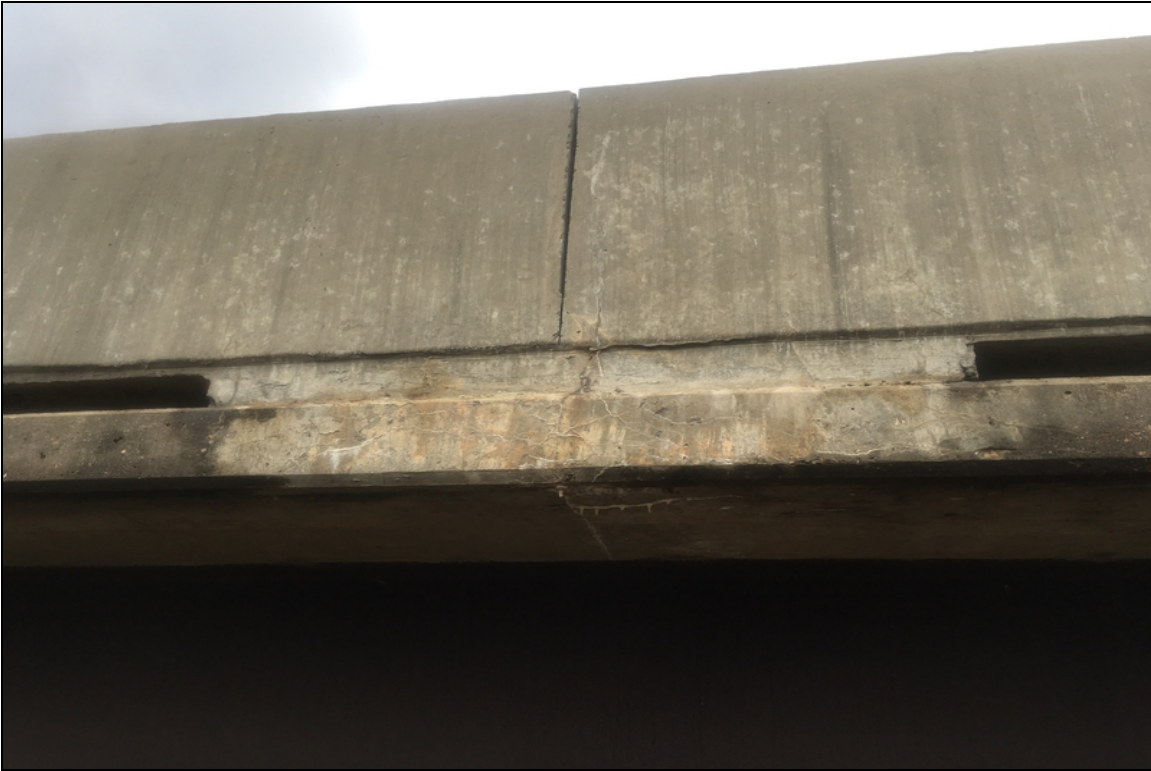
Efflorescence map cracking in the right and left deck edge. Typical.

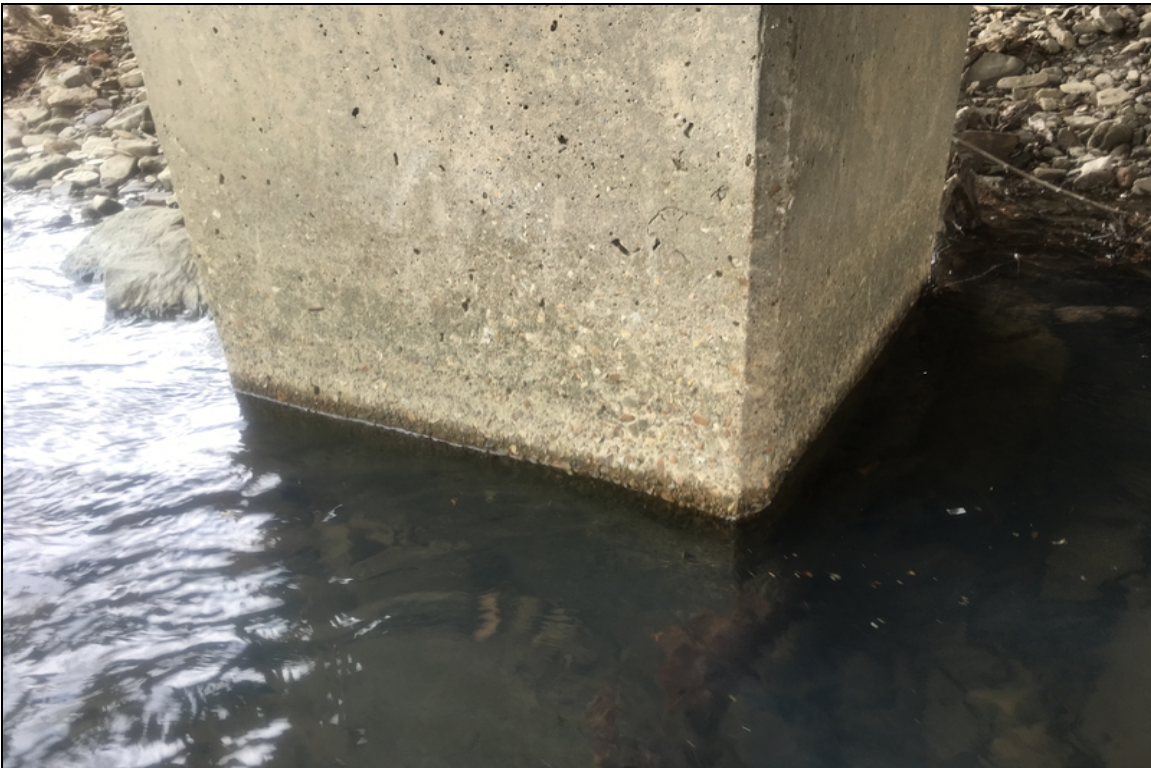
ELEM	DESCRIPTION	UNITS	TOTAL	CS1	CS2	CS3	CS4
Bent #2 columns- no deficiencies noted. Bent #3 columns- the left and right columns have minor abrasion at the bottom with no loss of coarse aggregate. All column footings have cover with no evidence of scour.							
215	Reinforced Concrete Abutment	LF	78	49	29	0	0
1120	Efflorescence/Rust Staining	LF	2	0	2	0	0
1130	Cracking (RC and Other)	LF	27	0	27	0	0

Minor abrasion at the left column of bent #3.

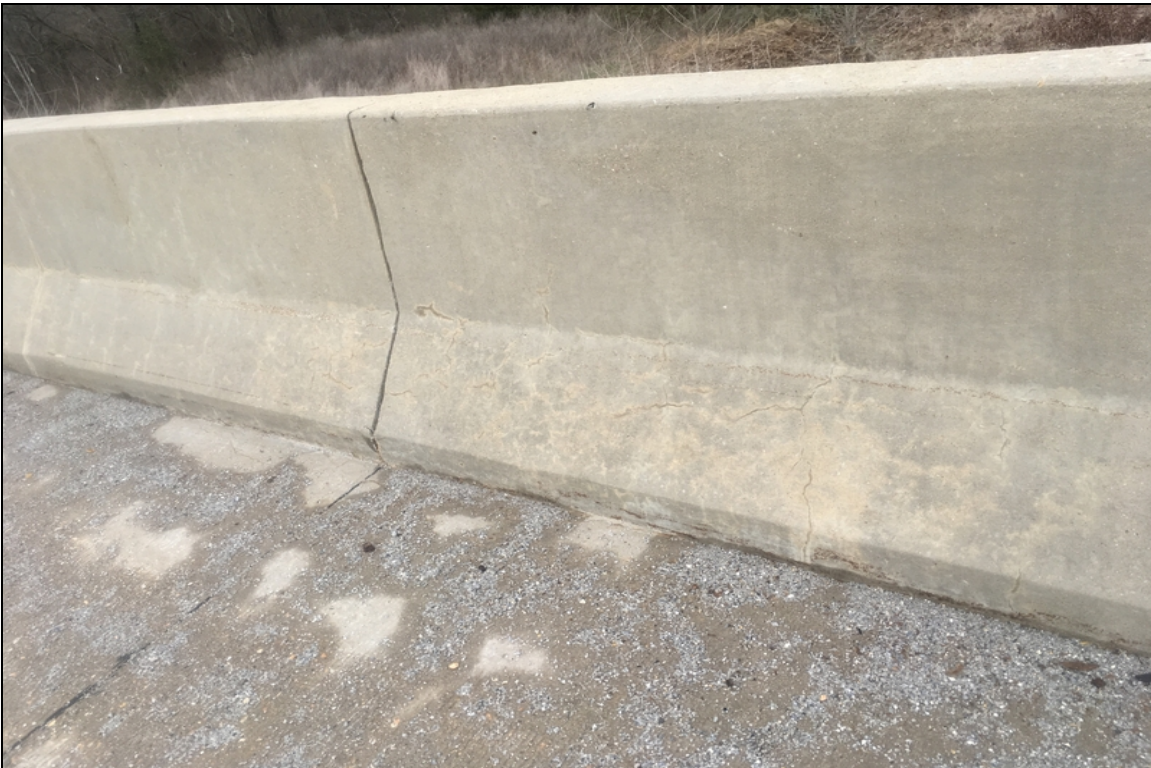
Map cracking on the parapet wall.

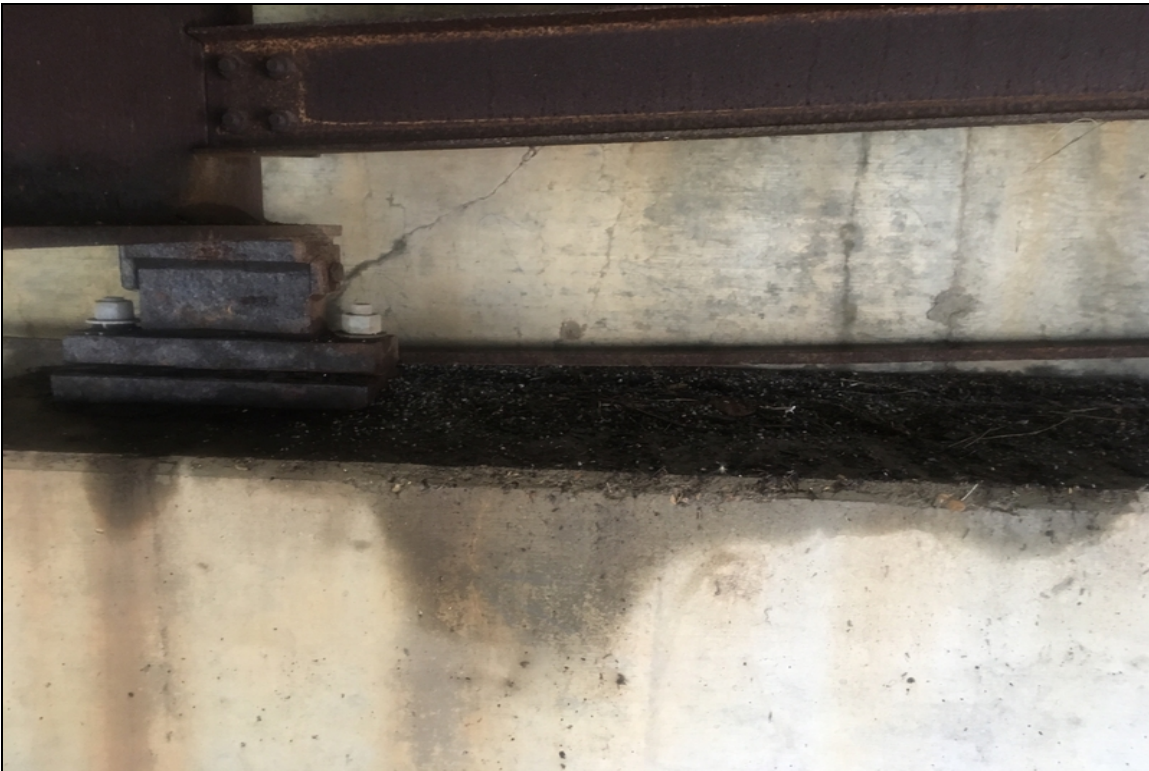
Build up on the bridge seat at abutment #1 below the missing joint seal area is promoting corrosion of the bearings.

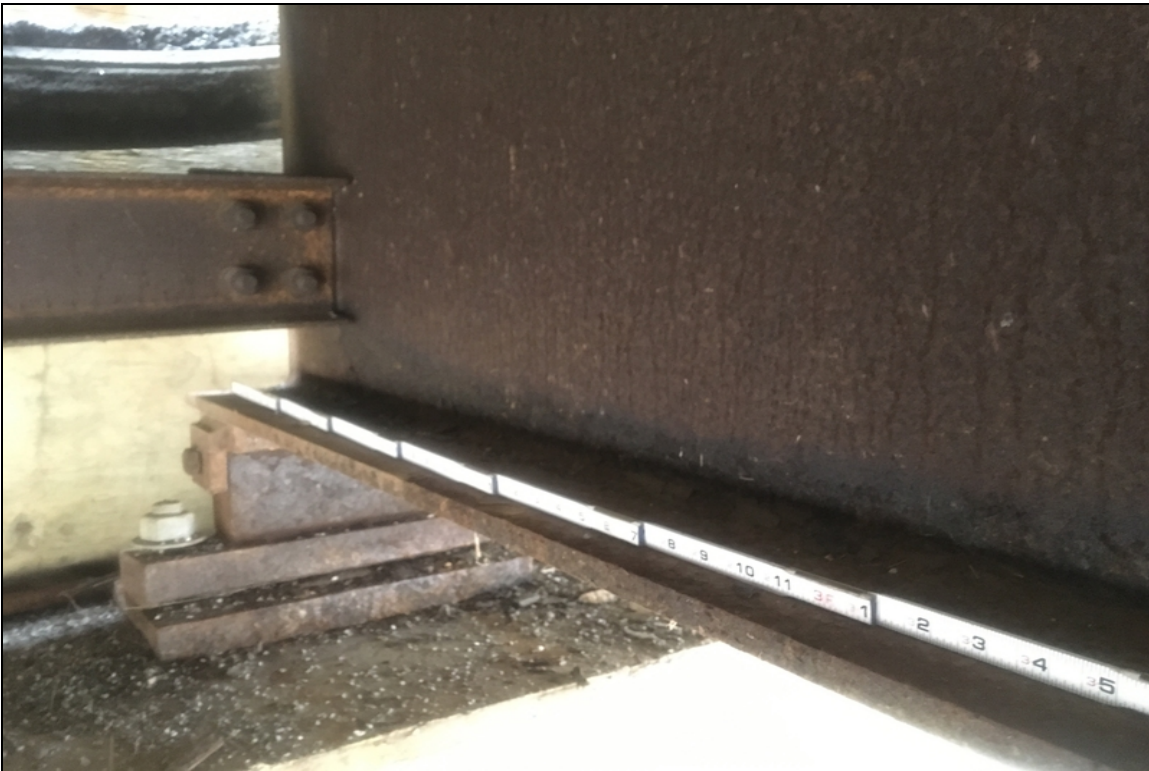
515	Steel Protective Coating	SF	11316	11280	10	26	0
3430	Oxide Film Degradation Color/Texture Adherence(Steel Protective Coatings)	SF	36	0	10	26	0
(107)							
3/10/2022 WNR & DBM: The weathering steel protective coating includes the diaphragms. 5 beam system. Span #1- Beam #2 has 4' of corrosion on the top of the bottom flange and lower web at abutment #1. Beam #3 has 3' of corrosion with flaking rust on the top of the bottom flange and lower web at abutment #1. Beam #4 has 1' of corrosion with flaking rust on the top of the bottom flange and lower web at abutment #1. Beam #5 has 1' of corrosion with flaking rust on the top of the bottom flange and lower web at abutment #1.							
Span #2- no deficiencies noted. Span #3- no deficiencies noted. Span #4- Beam #2 has 2' of corrosion with flaking rust on the lower web and upper web at the haunch area of abutment #2. Beam #3 has 4' of corrosion with flaking rust on the top of the bottom flange and lower web at abutment #2. Beam #4 has 2' of minor corrosion on the lower web area of the beam over abutment #2. Beam #5 has 1' of minor corrosion on the web and bottom flange at the beam end at abutment #2.

4' of Minor corrosion on the top of the bottom flange and lower web at beam #2 at abutment #1.

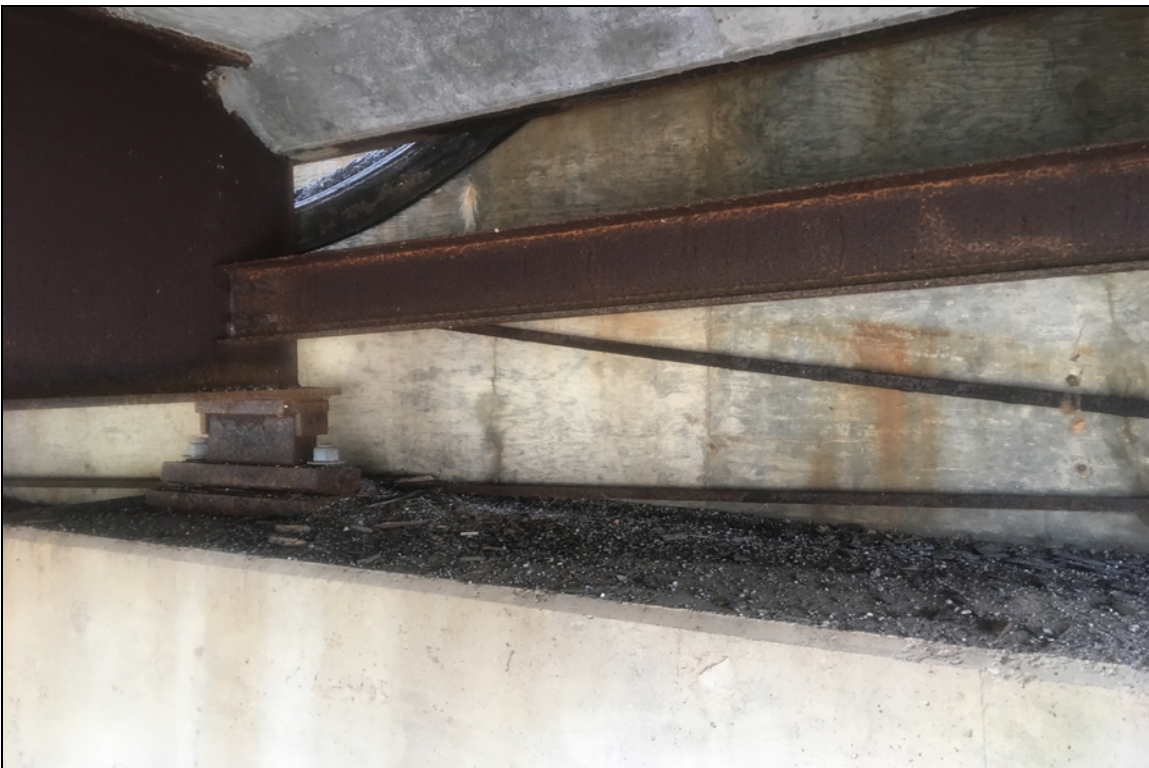
The retaining steel has become unattached at abutment #1 allowing the compression joint seal to drop out of position.

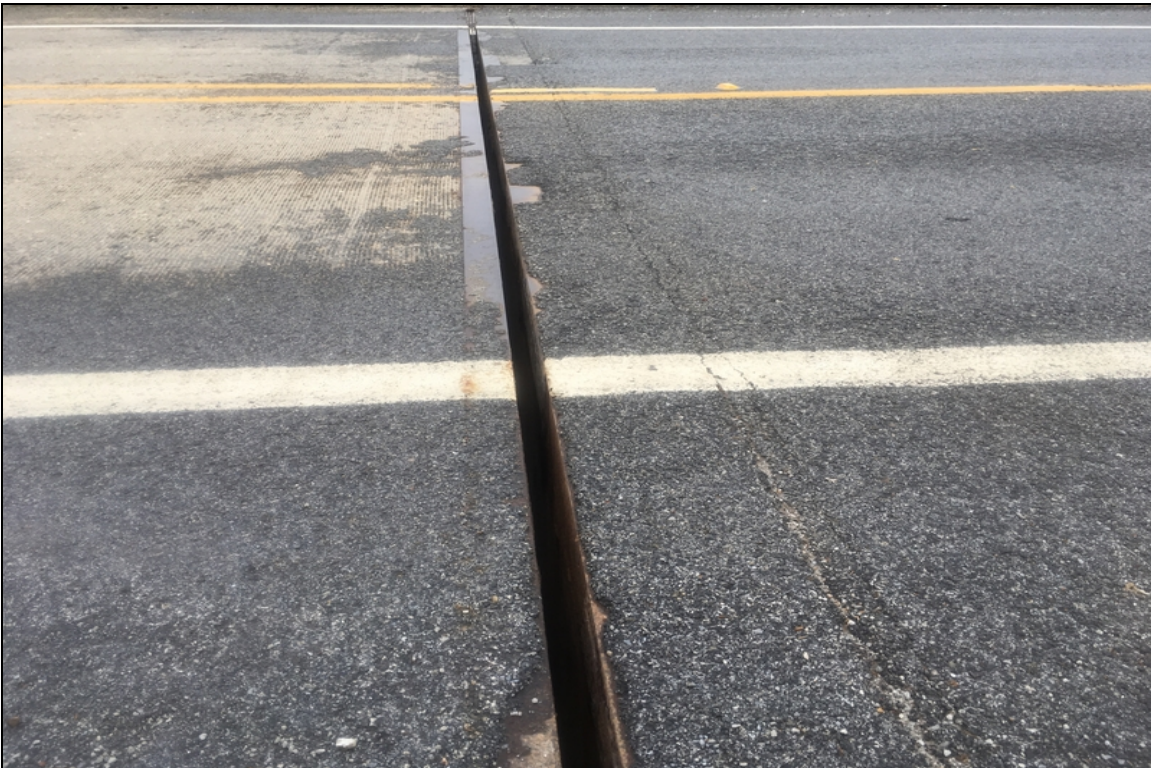
Abutment #2 compression joint seal condition.

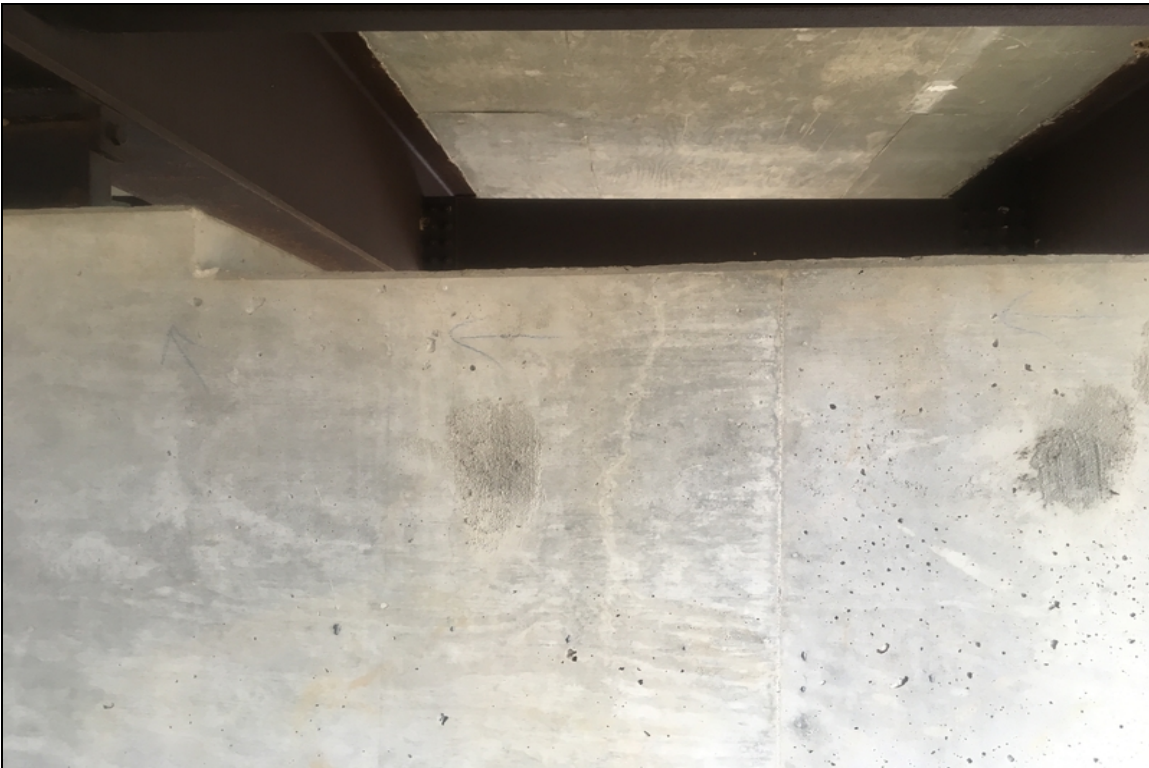
(234)							
3/10/2022 WNR & DBM: Pier cap #1- has 7 short duration hairline vertical cracks extending from the top edge of the cap Pier cap #2- has 4 short duration hairline vertical cracks extending down from the top edge of the cap. Pier cap #3- has 4 short duration hairline vertical cracks extending from the top edge of the cap and 1 short duration horizontal hairline crack at the right cap end.							
302	Compression Joint Seal	LF	78	8	9	21	40
2310	Leakage	LF	40	0	0	0	40
2320	Seal Adhesion	LF	9	0	9	0	0
2340	Seal Cracking	LF	21	0	0	21	0

View of hairline cracking in the pier caps. Typical.

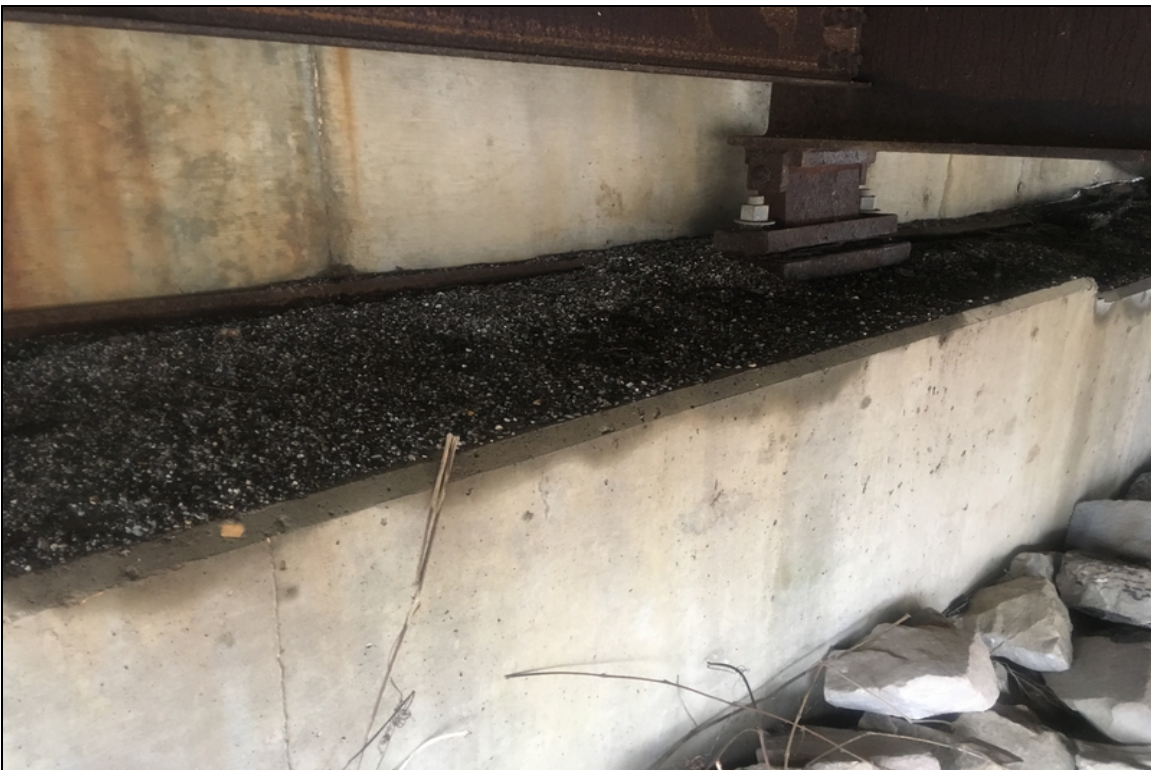
Build up on the abutment #2 bridge seat.

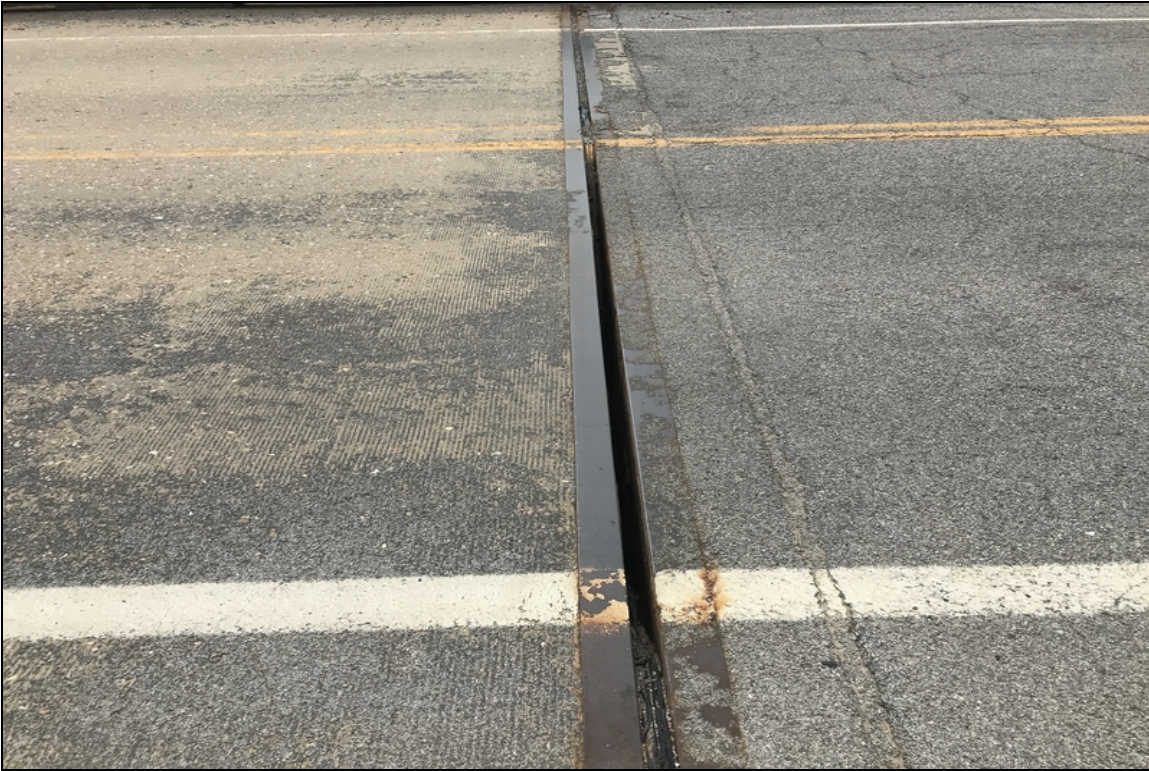
Joint seal failure at abutment #1

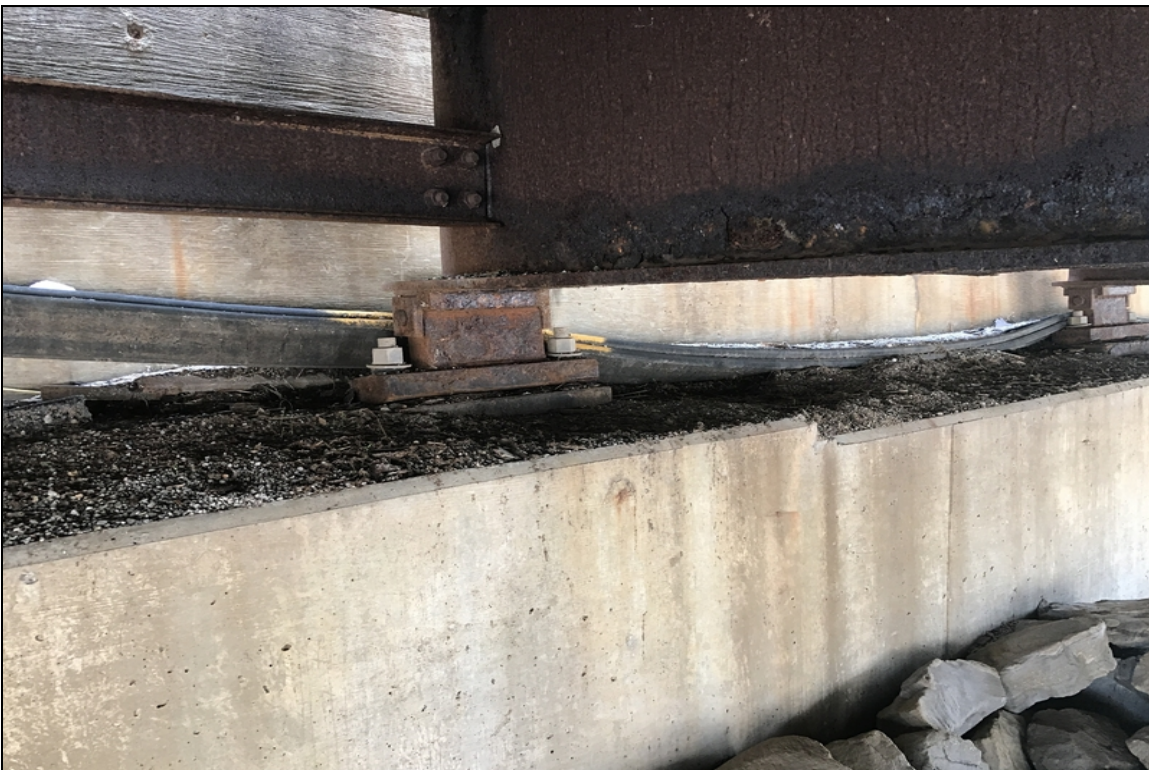
Compression joint material is still displace at abutment #2 allowing water and debris to flow freely onto bridge seat.

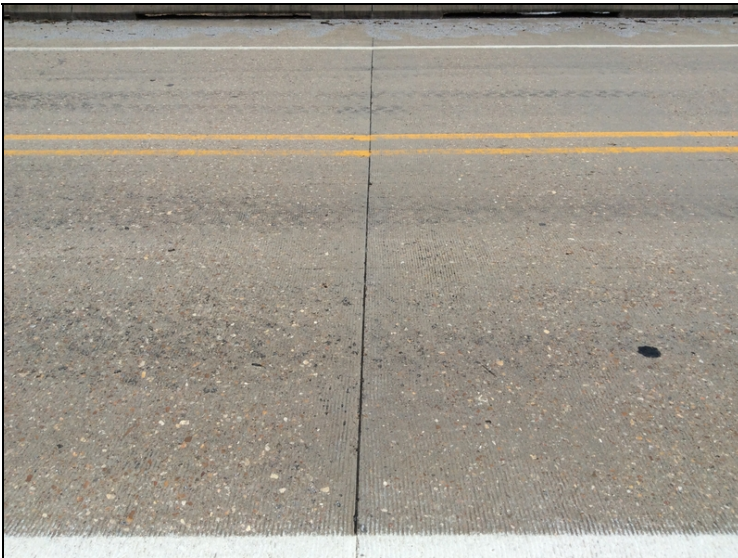
The pourable construction joint seals are leaking at most locations, causing efflorescence leaching on the underside of the deck.

Concrete deck at construction joints
Leakage thru deck

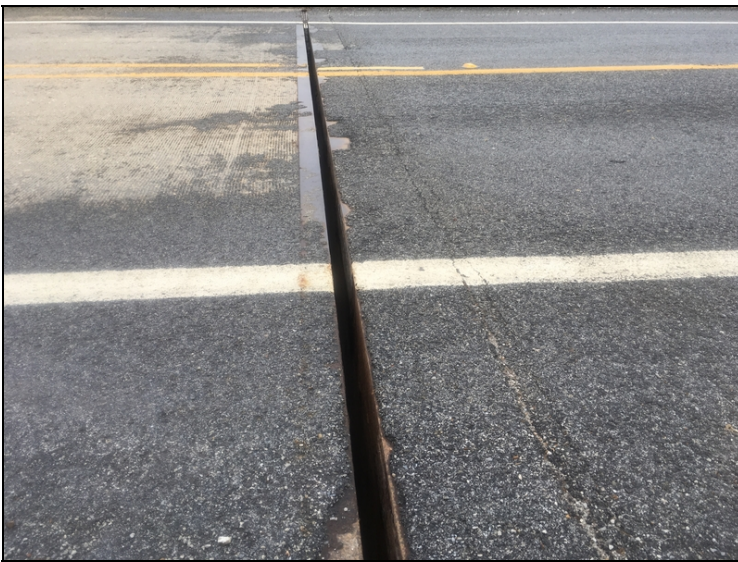
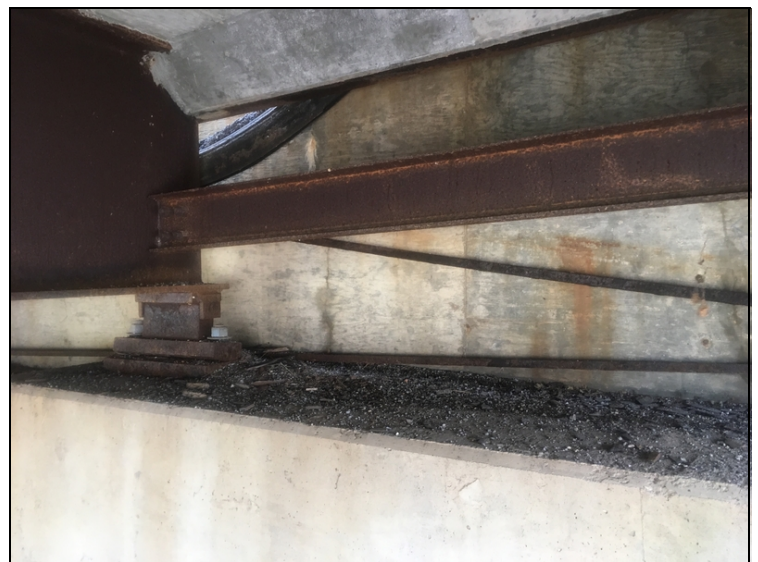
Portions of the compression joint seals at abutments #1,2 are completely unattached from the armoring plate, and are allowing free flow of water and debris.

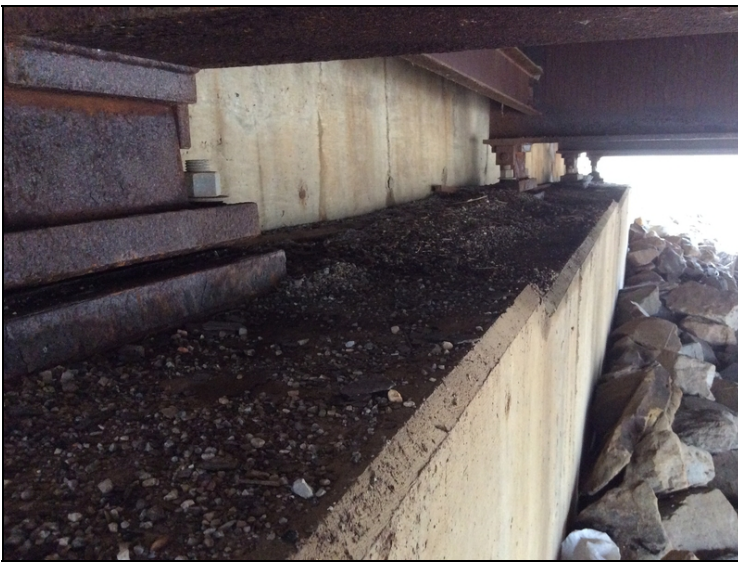
Abutments #1,2 have gravel and debris buildup from the missing joint seal that is promoting corrosion on the bearings.

Bent #5 concrete cap- gravel and debris buildup

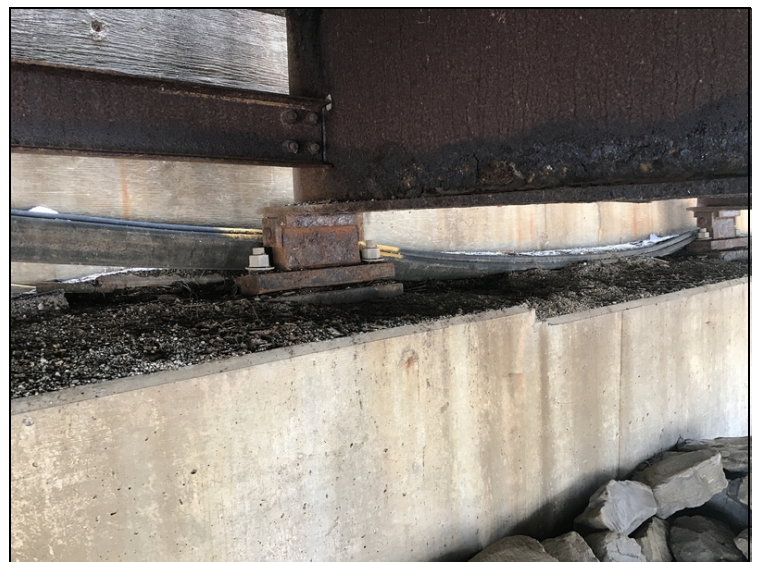
Compression joint material is still displace at abutment #2 allowing water and debris to flow freely onto bridge seat.

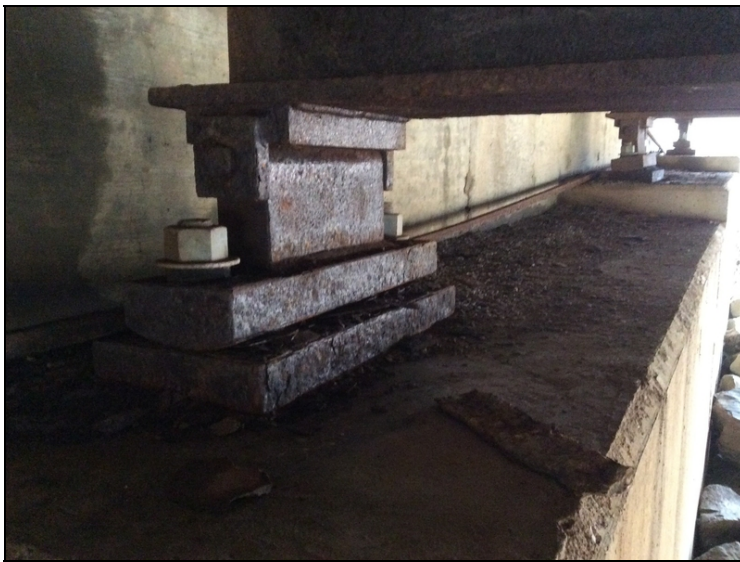
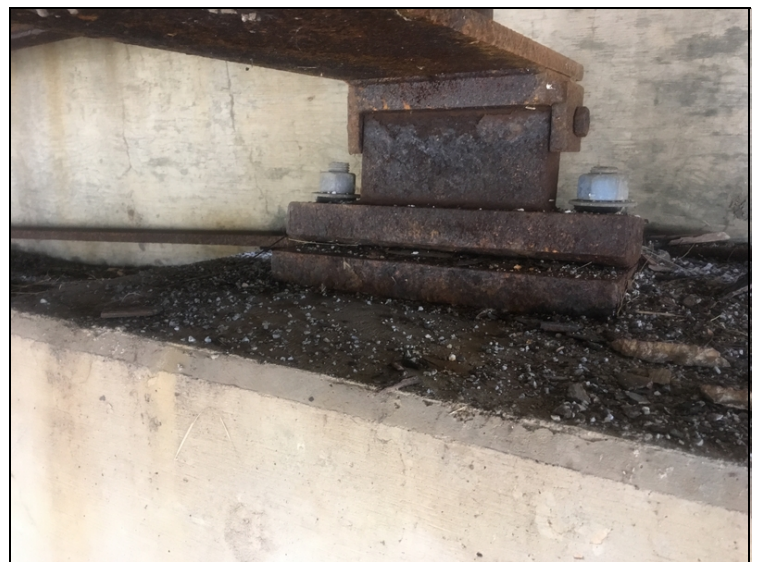
Bents #1 and #5 bearings has active corrosion with flaking rust.

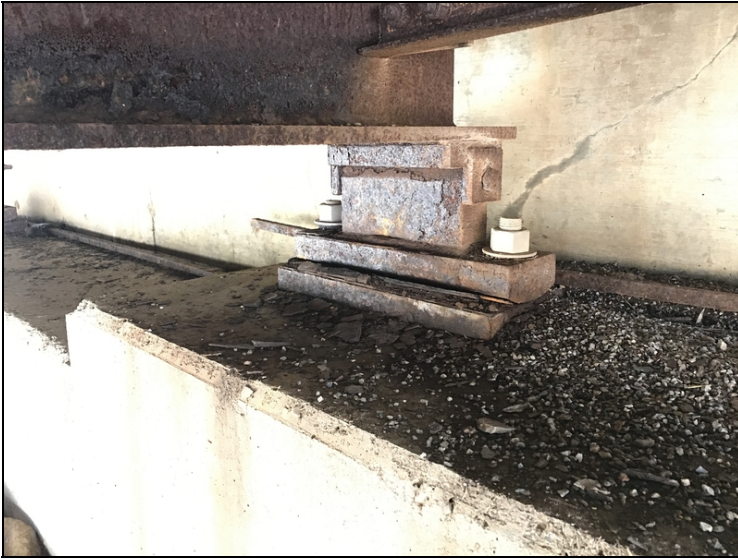
Abutment #1- bearings #2,3,4,5 have corrosion with flaking rust.

Bearing #3 at abutment #1 flaking rust due to leaking joints.
