Bridge #06798(Routine, Underwater type 2)

Madison SH 23 over WAR EAGLE CREEK

Location: 4.0 MI N JCT SH 16

Team Lead: Nathan Rowland **Inspection Date:** October 25, 2021

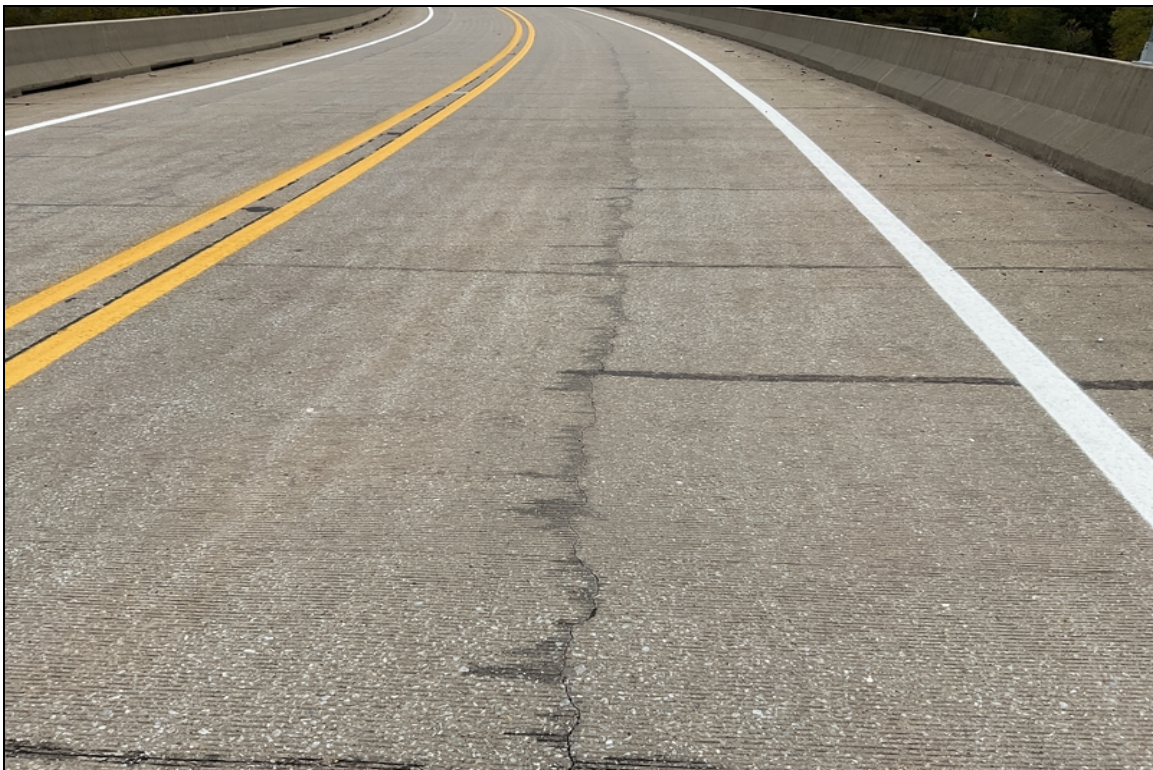
(12)							
10/25/2021- WNR & DBM: -The majority of longitudinal and transverse cracking has been sealed. Repairs are beginning to fail as of this inspection. -The right lane has a large full length longitudinal crack that is approximately 4' left of white line. -The left and right overhang have efflorescence and cracking -The left and right deck overhangs has transverse cracking and efflorescence throughout the structure.							
107	Steel Open Girder/Beam	LF	3650	3649	1	0	0
1020	Connection	LF	1	0	1	0	0
515	Steel Protective Coating	SF	54567	54567	0	0	0

Large full length longitudinal cracking in the right lane of bridge deck.

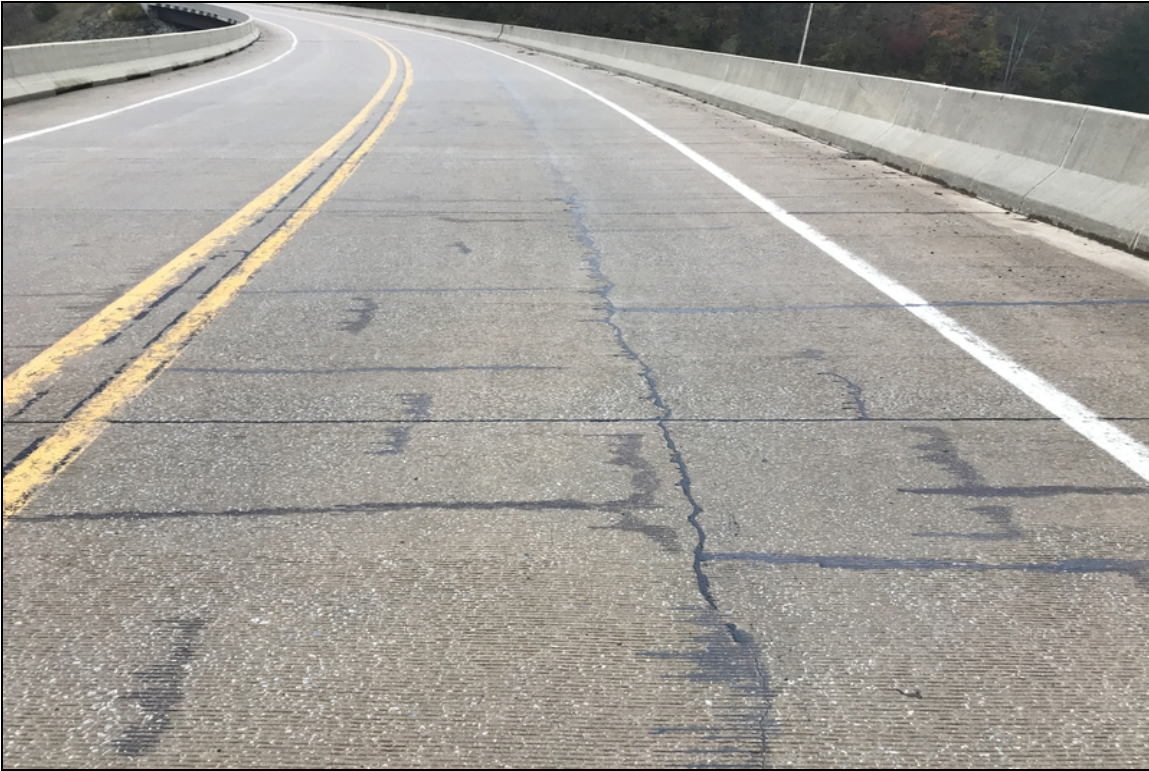
Typical sealed cracking northbound lanes

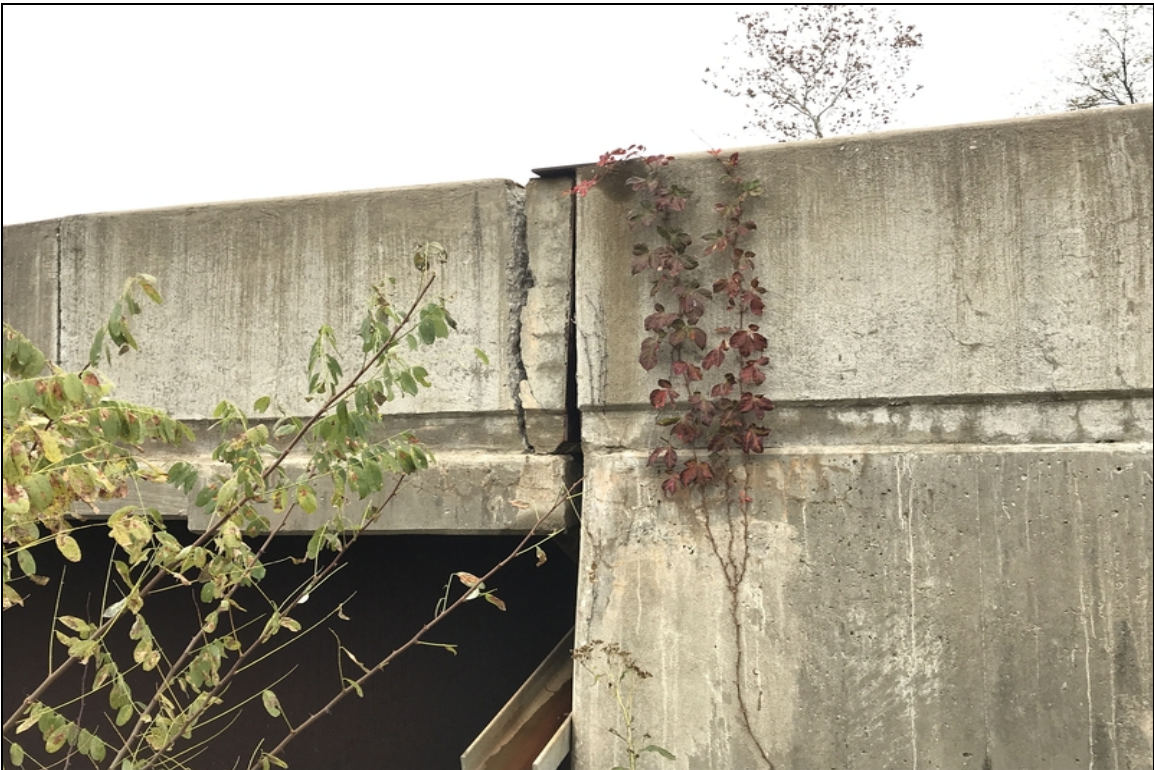
An area of the left bridge railing at abutment #1 has an area approximately 6" long and full height of the railing that is completely fractured under the vertical portion of the sliding plate assembly at abutment #1.

Concrete bridge railing - An area of the left bridge railing at abutment #1 and Bent #4 left bridge railing has an area approximately 6" long and full height of the railing that is completely fractured under the vertical portion of the sliding plate assembly at abutment #1.

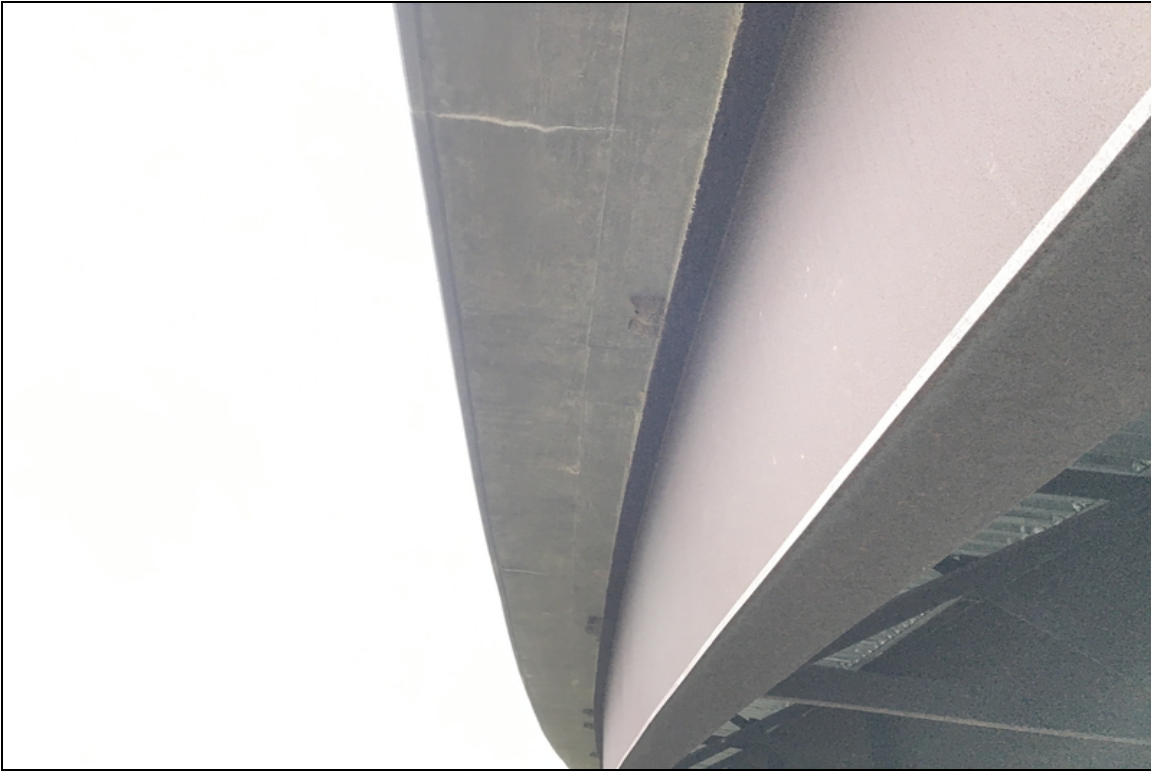
Right overhang typical transverse efflorescence and cracking.

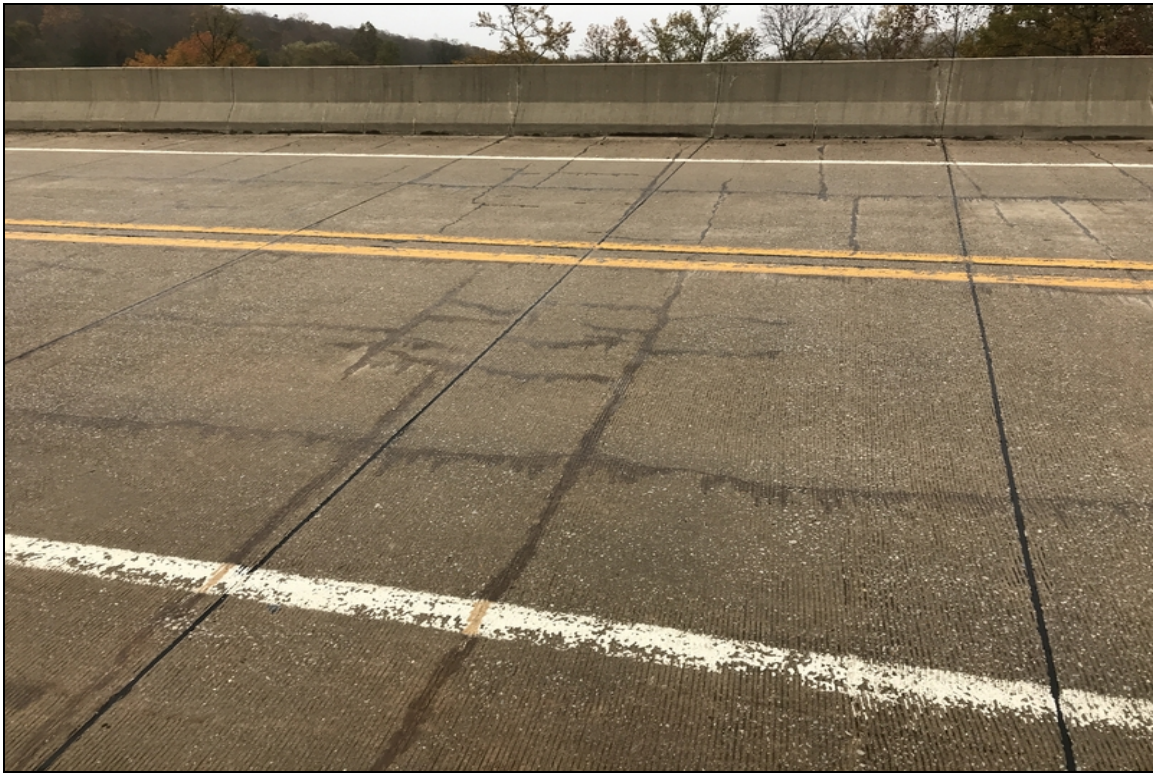
Sealed transverse deck cracking over bent #1

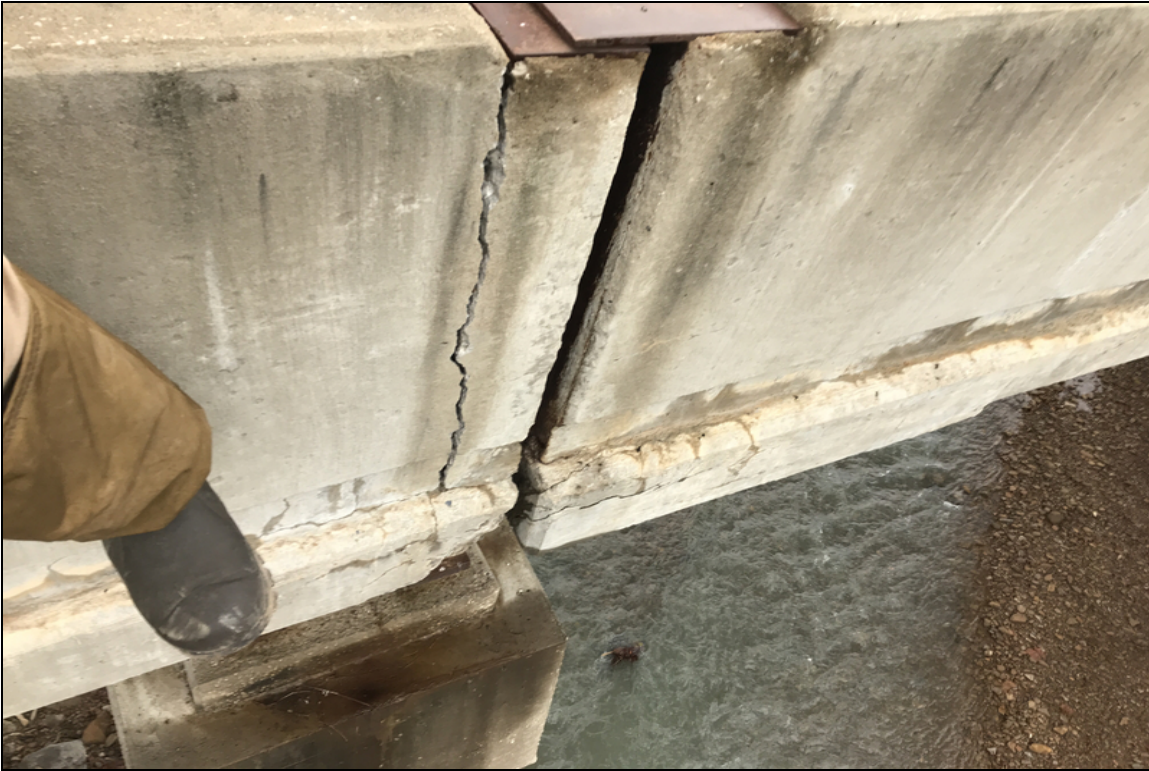
Left parapet over bent #4 complete fracture.

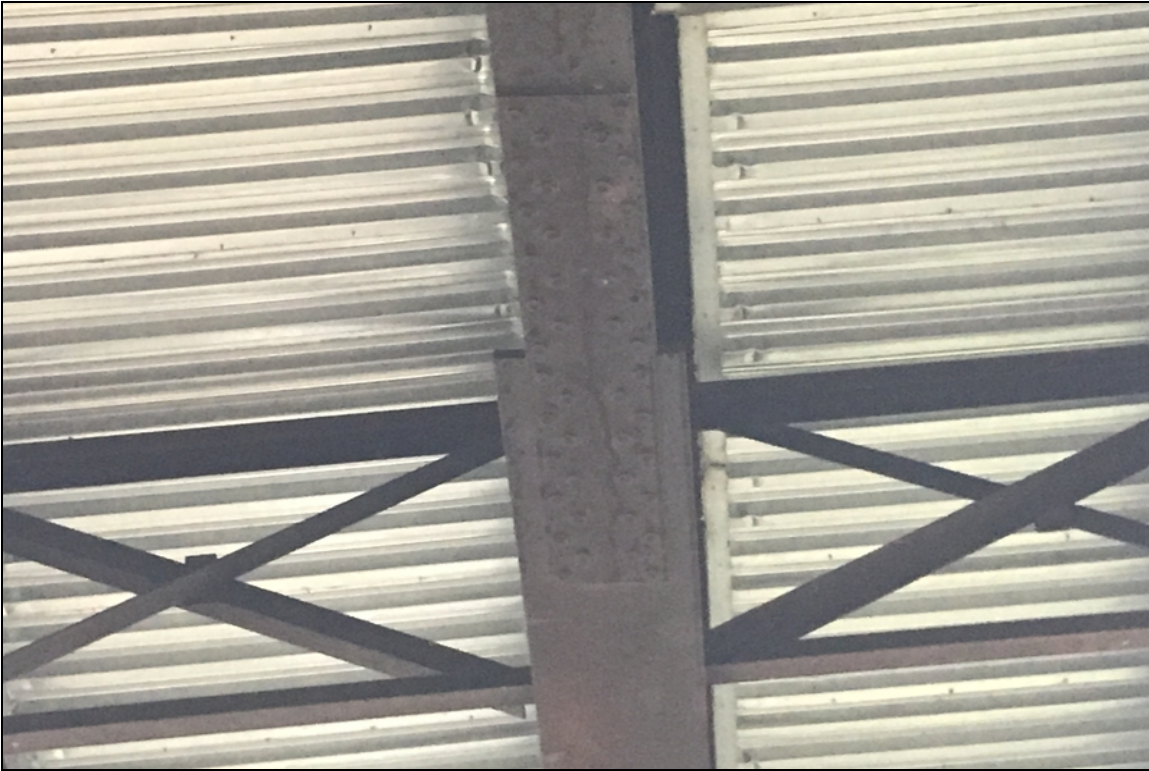
(107)							
10/25/2021- WNR & DBM: -The web of right exterior girders have discoloration at bases of web approximately 2" high and full length of structure. -Span #1, Girder #3 is missing one bolt in the bottom flange splice plate connection.							
205	Reinforced Concrete Column	EA	5	1	4	0	0
1130	Cracking (RC and Other)	EA	4	0	4	0	0

Span #1 girder #3 splice plate bottom flange - Bolt still missing

Superstructure - The splice plate connection for girder #3 in span #1 is missing one bolt in the bottom flange splice plate.

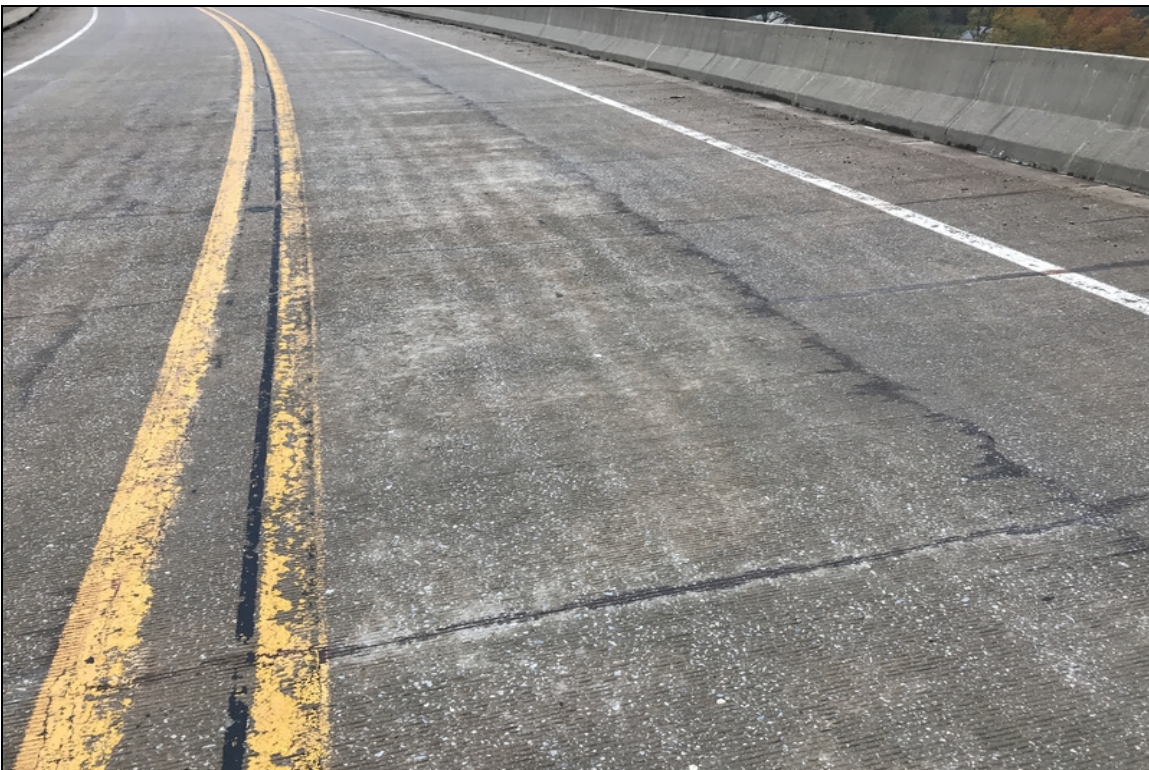
Longitudinal cracking has been sealed typical throughout deck surface

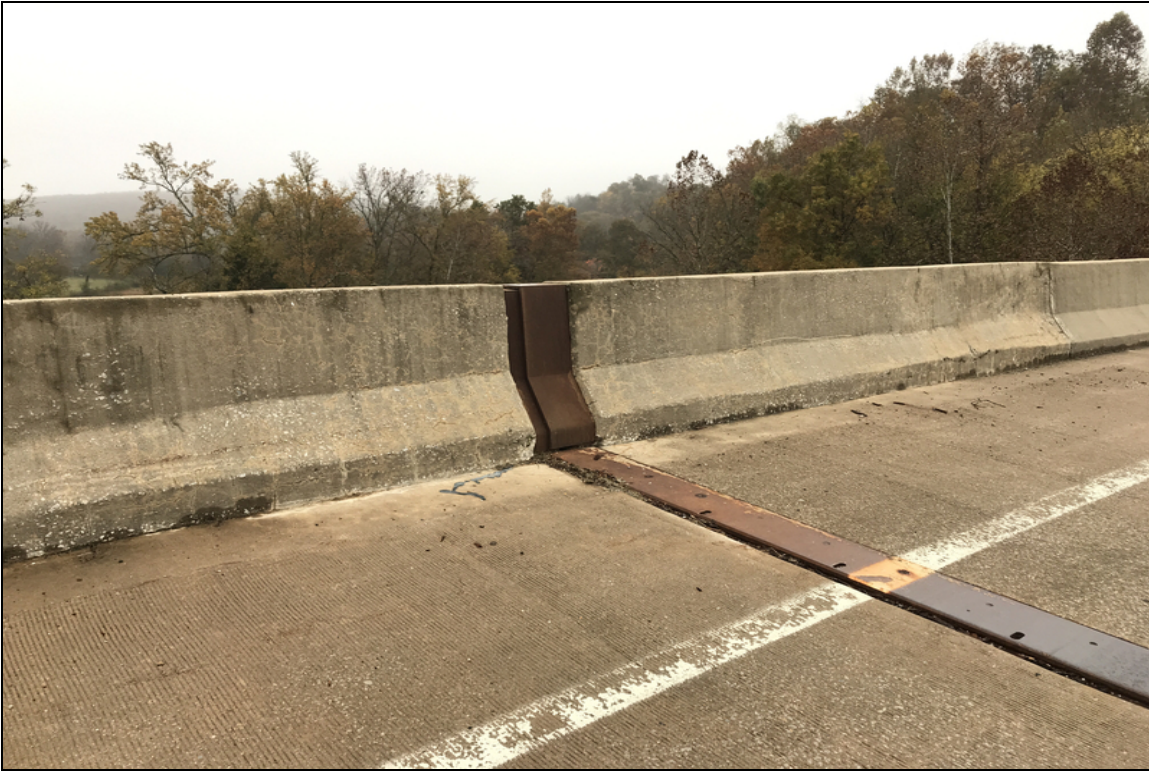
Right parapet map cracking at bent #2.

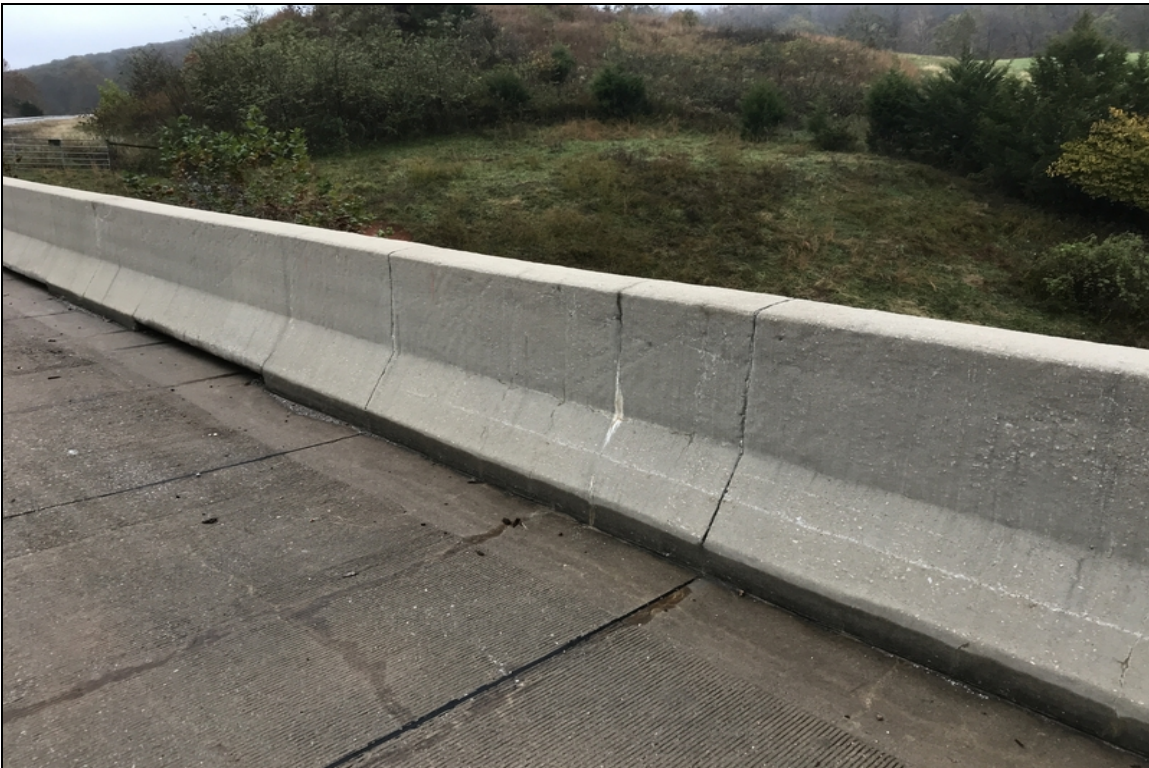
Typical cracking in parapet wall.

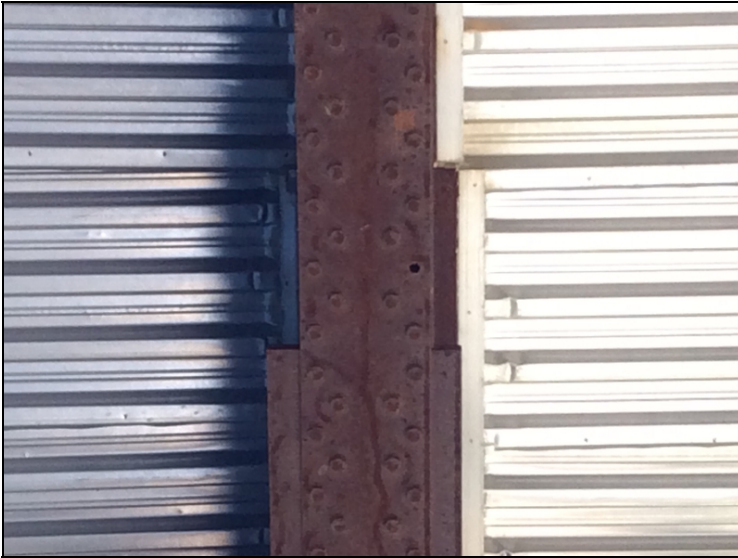
Span #1, Girder #3-Missing bolt in bottom flange splice plate.

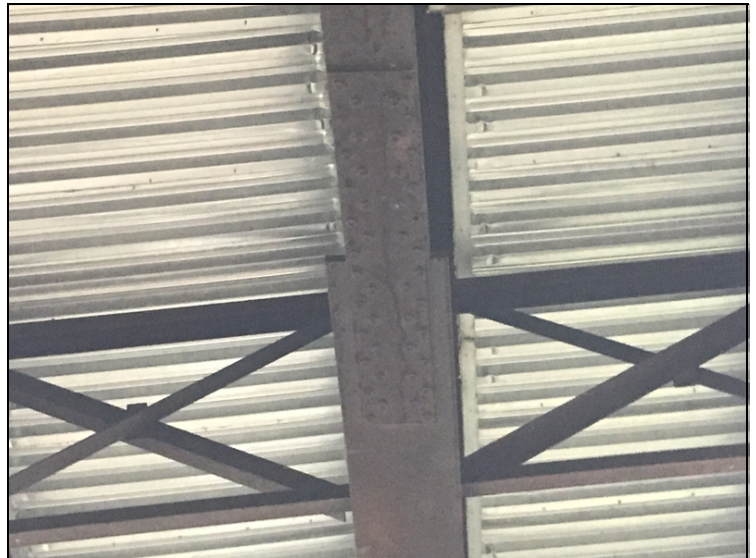
Span #1 girder #3 splice plate bottom flange - Bolt still missing

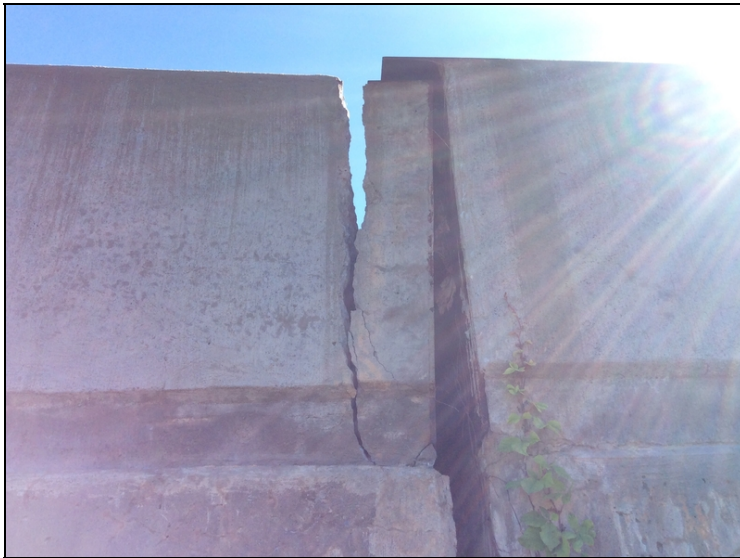
Span #1, Left side at abutment #1-Fractured concrete bridge railing.

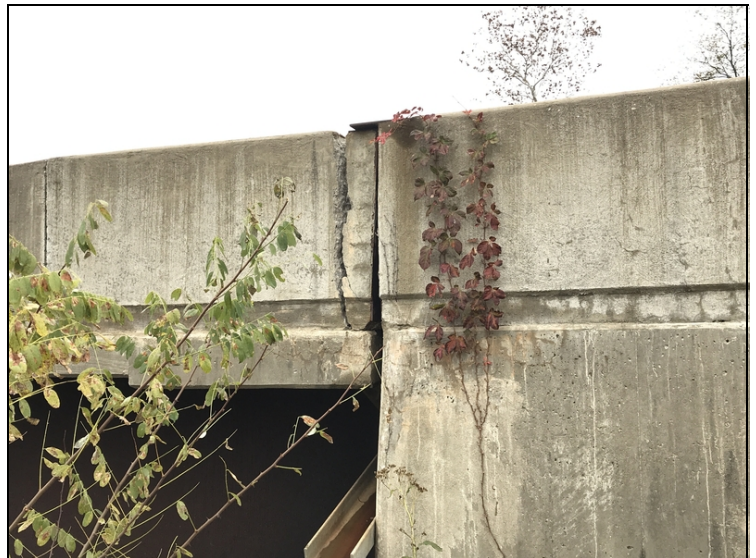
An area of the left bridge railing at abutment #1 has an area approximately 6" long and full height of the railing that is completely fractured under the vertical portion of the sliding plate assembly at abutment #1.

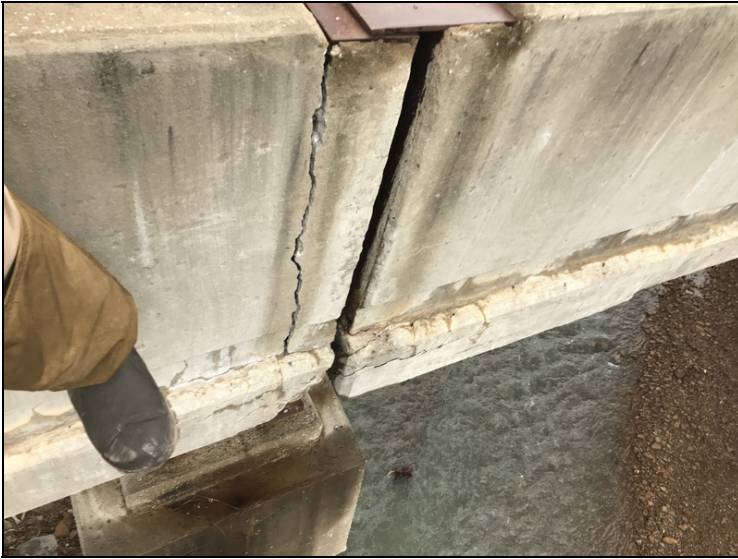
Left parapet over bent #4 complete fracture.
