Bridge #07346(Routine, Underwater type 2)
SH 23 - Madison Co over WAR EAGLE CREEK

Location: .75 MI N JCT OF SH 74

Team Lead: Nathan Rowland **Inspection Date:** August 16, 2021

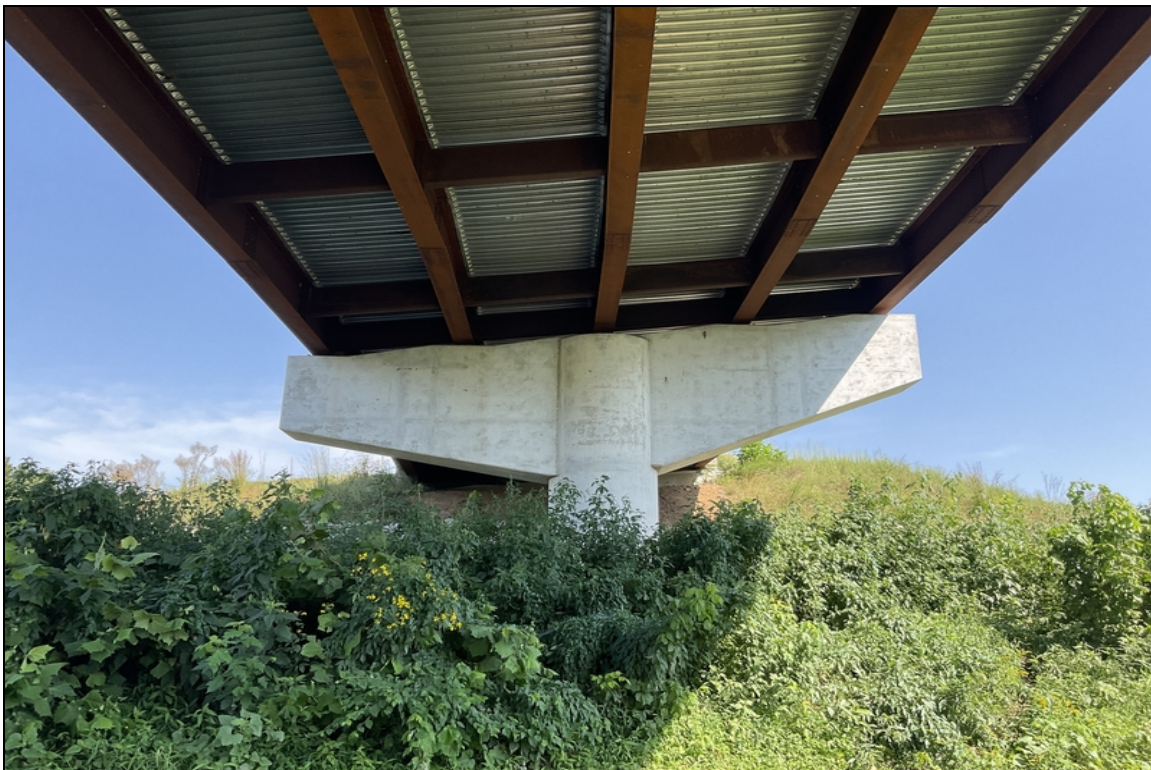
Behind side of bent #5.

(205)							
08/16/2021 WNR & DBM: -Bent #5 column has apparent collision damage that has created minor concrete section loss in an area approximately 1' long, 2" wide and 1/2" deep located approximately 4' up from the base of column on the ahead side. -The columns have localized scour holes at the bases of columns #3 and #4. Scour holes are approximately 1' deep at this inspection.							
215	Reinforced Concrete Abutment	LF	84	68	16	0	0
1080	Delamination/Spall/Patched Area	LF	1	0	1	0	0
1130	Cracking (RC and Other)	LF	15	0	15	0	0

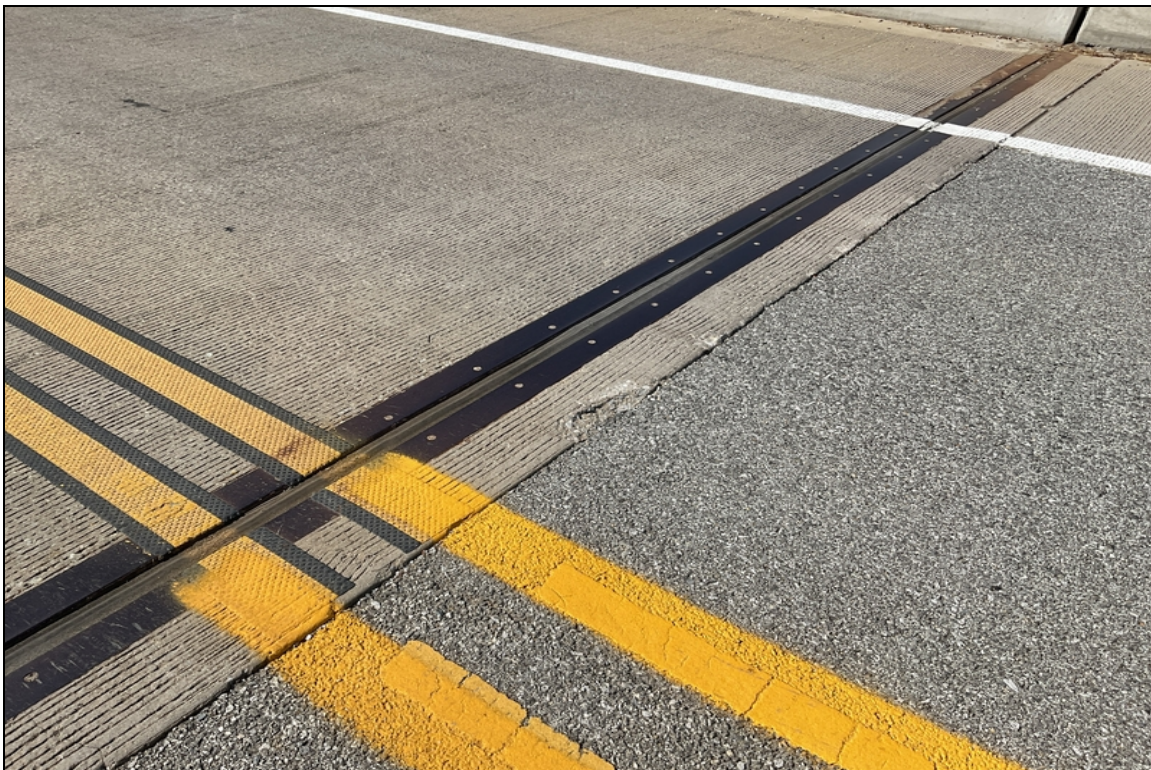
(215)							
08/16/2021 WNR & DBM: -The top of abutment backwalls have hairline transverse cracks visible from the driving surface on approximately 4' spacing. -The backwall of abutment #1 has a vertical crack with efflorescence in bay #2 visible from under structure. -The back wall of abutment #2 has a spall due to traffic approximately 1'x1'.							
234	Reinforced Concrete Pier Cap	LF	205	205	0	0	0

The back wall of abutment #2 has a spall due to traffic approximately 1'x1'.

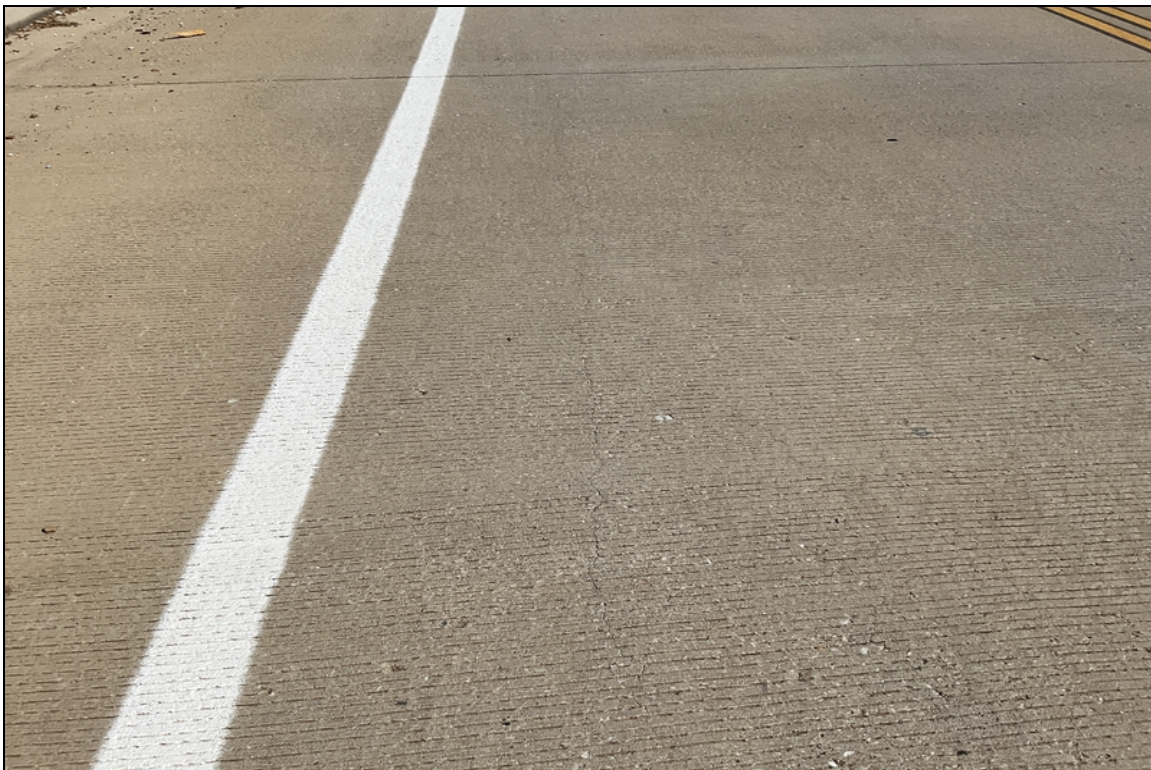
(12)							
08/16/2021 WNR & DBM: -The left and right lane have a full length longitudinal crack adjacent to the white line. -The deck has numerous short duration transverse cracks in the right and left gutters. The cracks propagate vertically into the concrete bridge railing in locations. -The left and right overhangs have efflorescence and cracking the entire length of structure.							
107	Steel Open Girder/Beam	LF	2250	2249	1	0	0
1020	Connection	LF	1	0	1	0	0
515	Steel Protective Coating	SF	27298	27298	0	0	0

Typical full length longitudinal cracking.

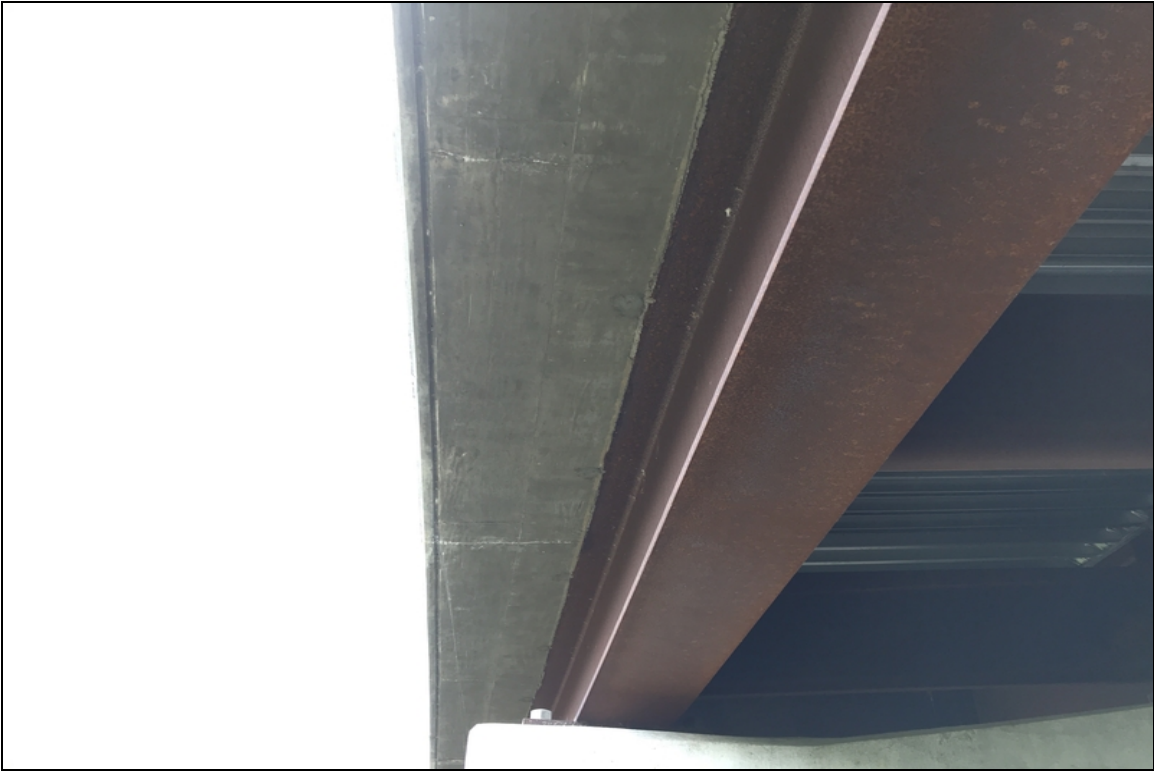
The left and right overhangs have efflorescence and cracking throughout the structure.

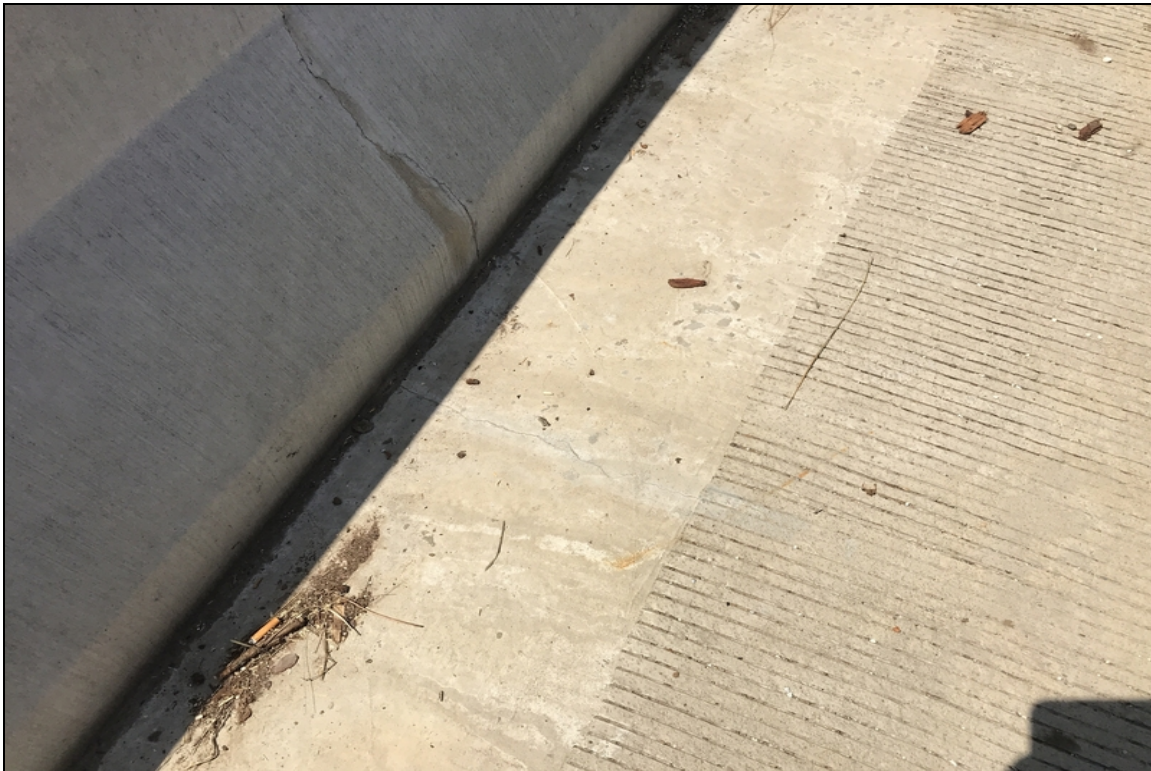
Contractor forces have placed a type of sealant as a repair to the cracking in the gutter line.

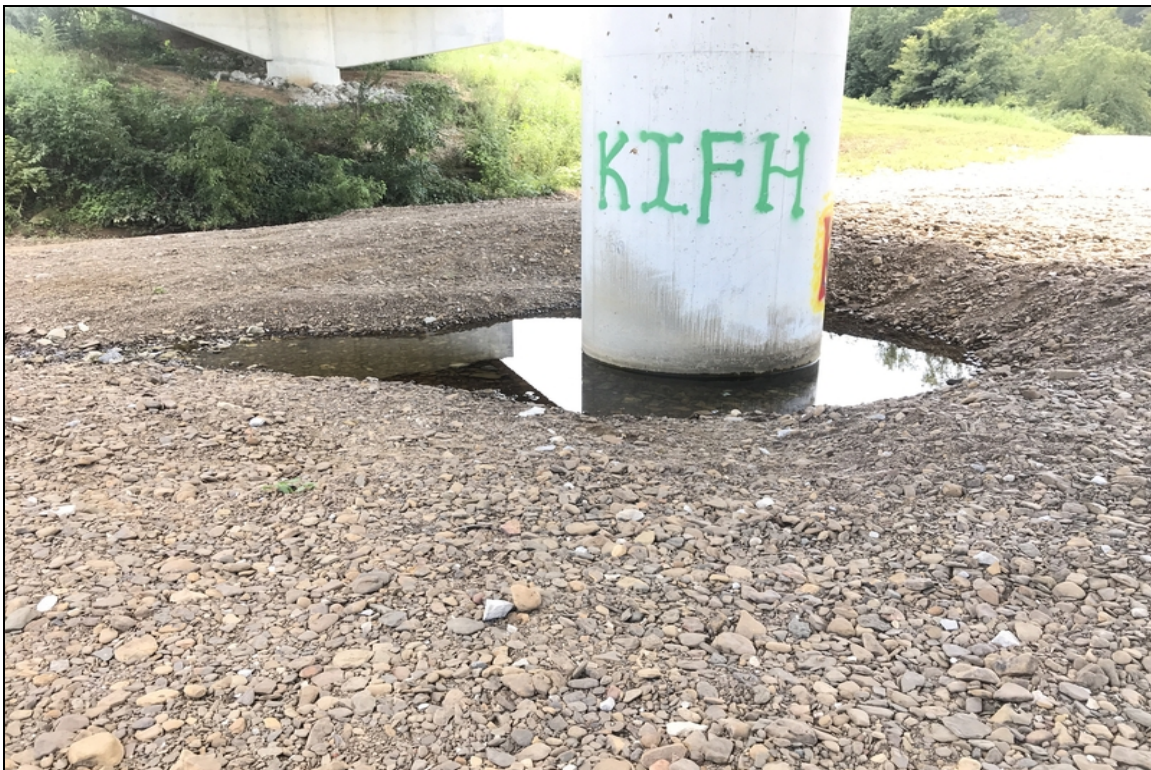
Typical scour hole around bents

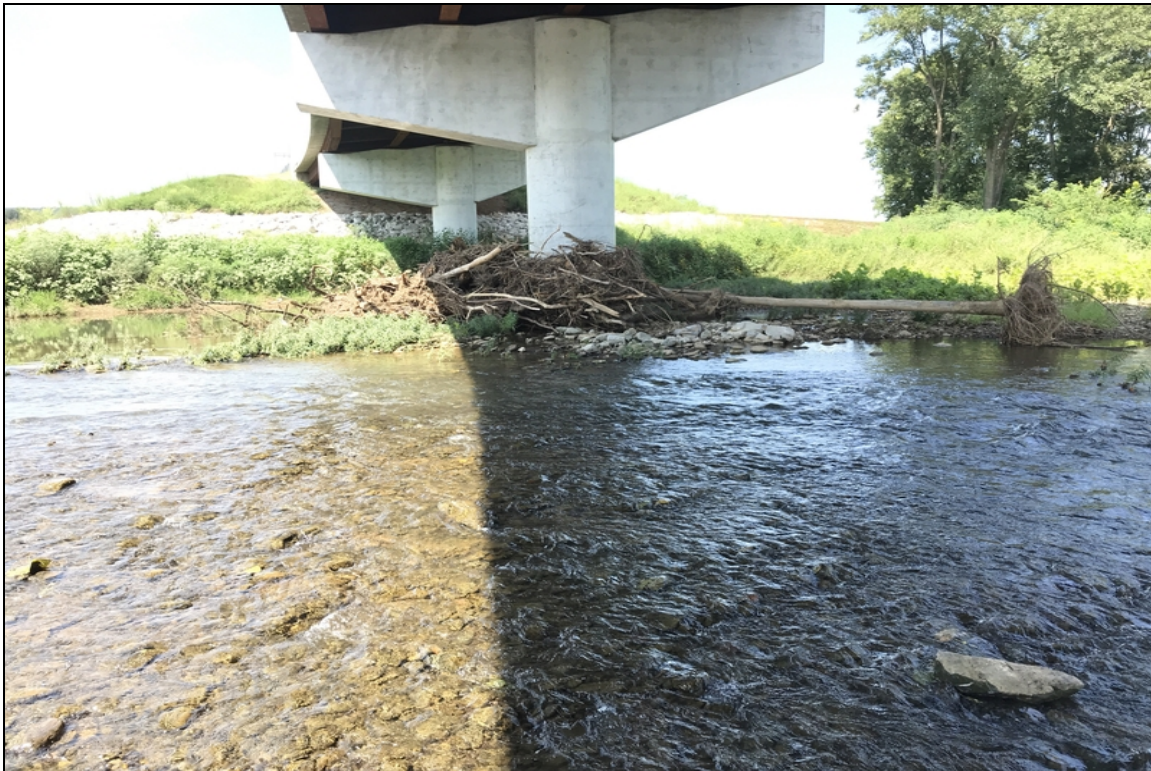
Drift accumulation against bent #4.

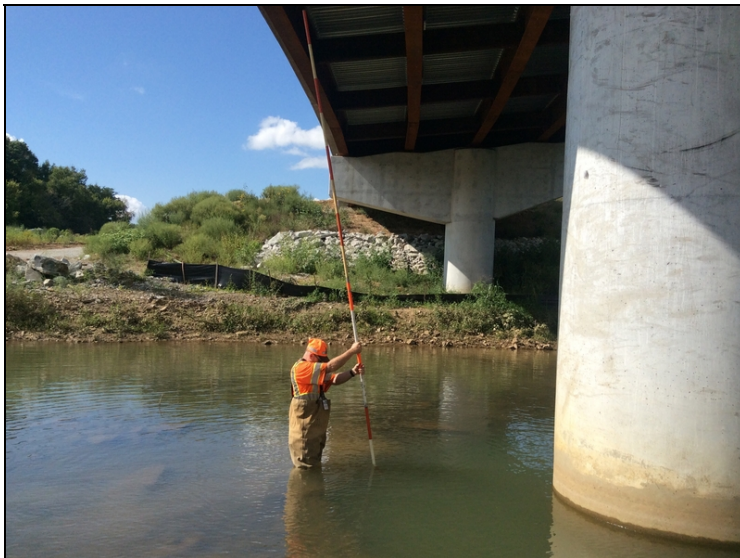
Substructure - The channel has localized scour at bents #3 and #4. The scour holes are approximately 4' deep at this inspection.

Bent #4 - localized scouring approximately 4'.
photo #2.

10/13/17 WNR: Contractor placed natural fill into scoured hole.

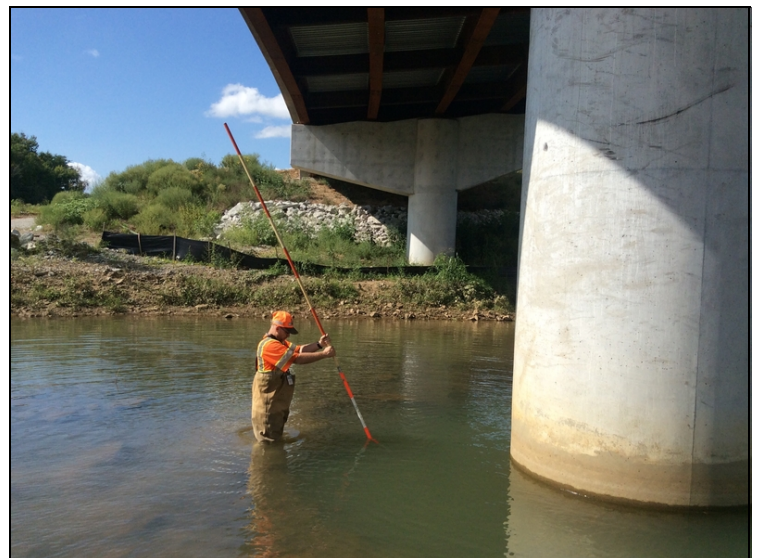
Bent #4 - localized scouring approximately 4'.
photo #1.

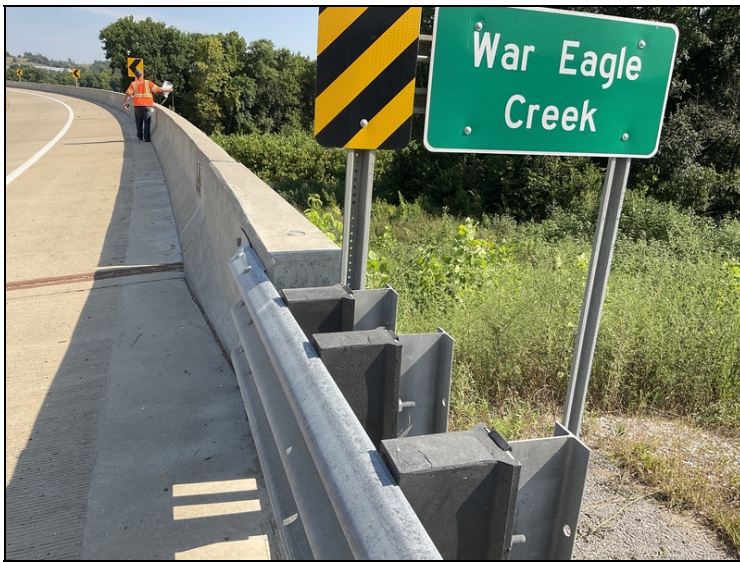
Log mile marker missing at beginning of bridge (south end). Log mile should read + 23.79

Log mile signs missing.
