Bridge #00338(Routine, Underwater type 2)

SH 14 Marion over CROOKED CREEK

Team Lead: Benjamin Smith Inspection Date: September 21, 2021

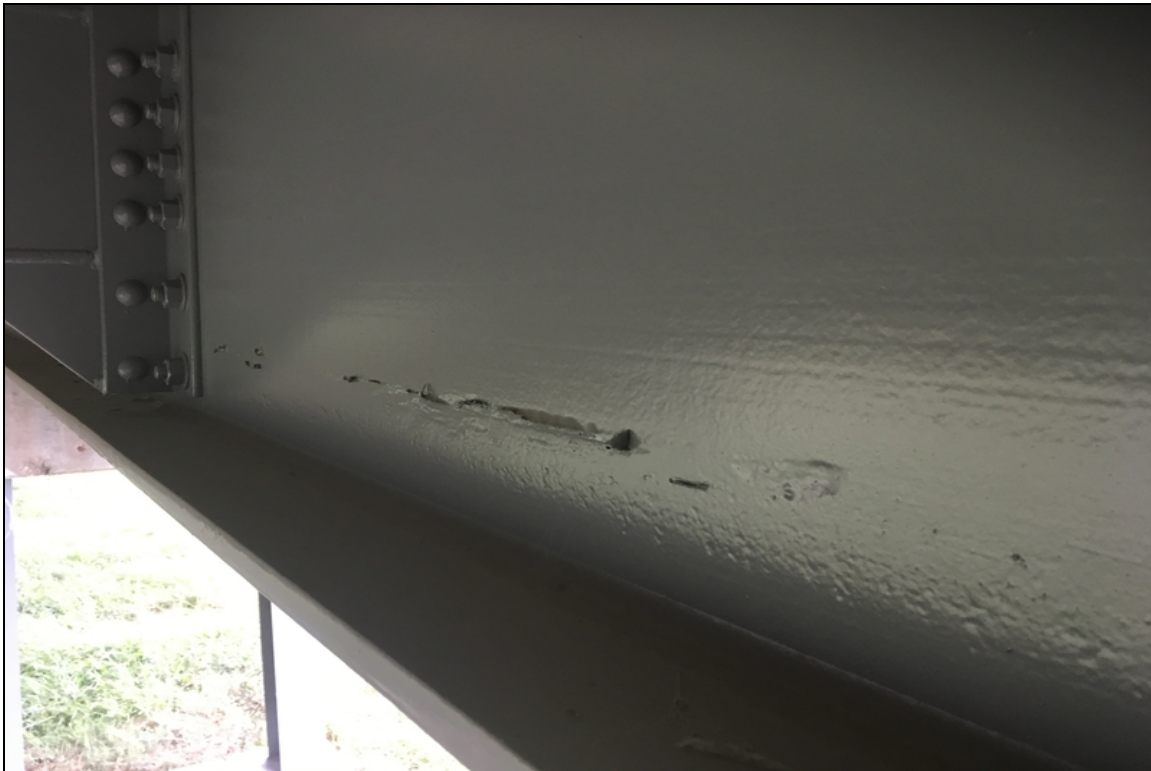
Superficial factory defect in the web of beam #4 in span #6.

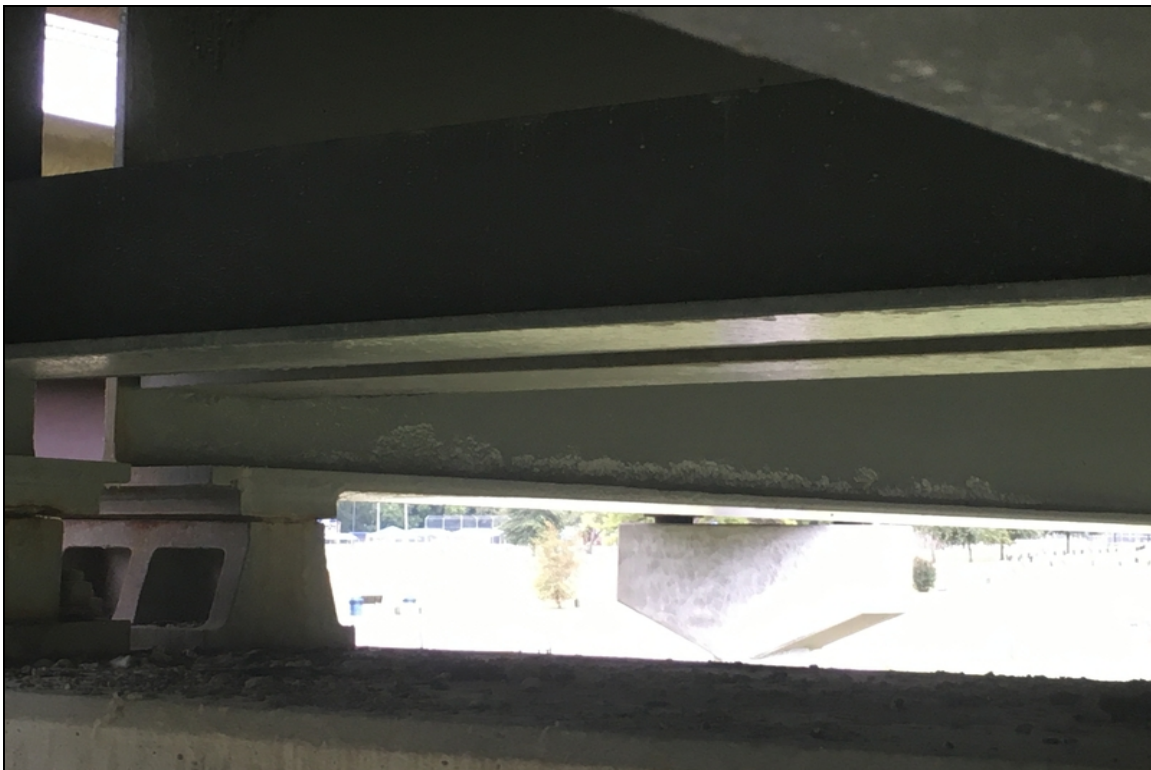
Shallow pitting on the interior lower web of beam #1 in span #6.

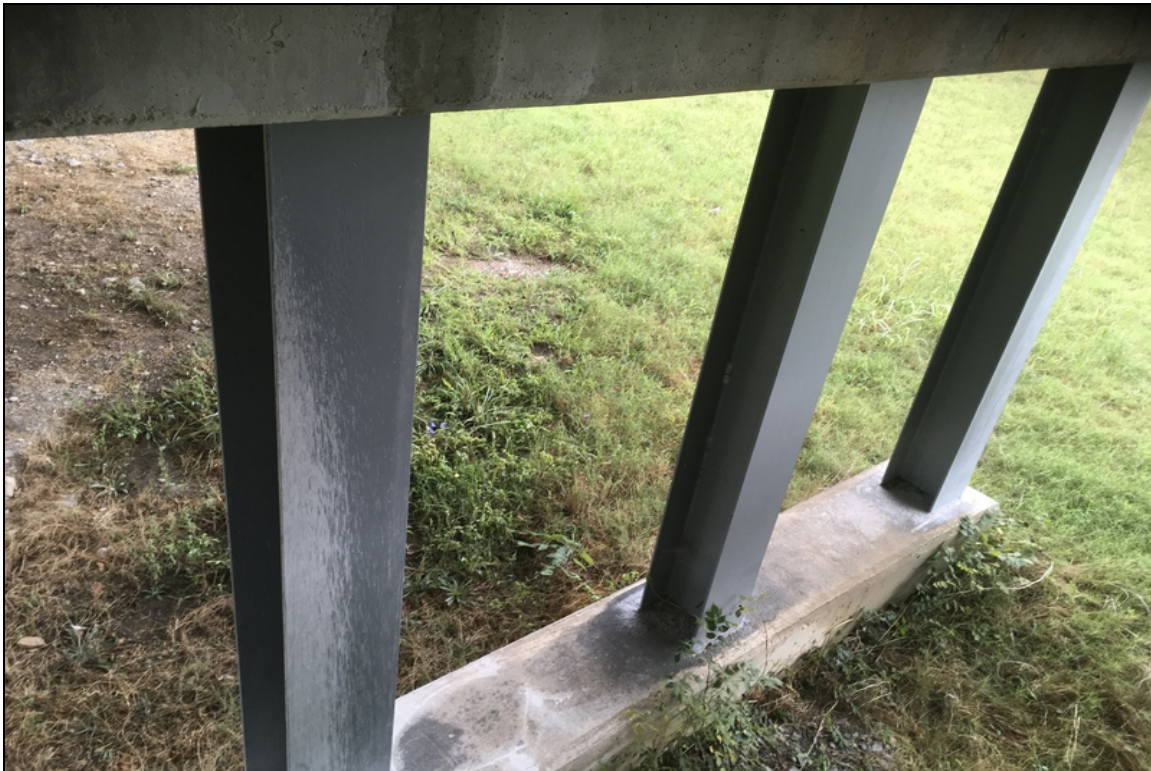
Repainted steel pile columns.

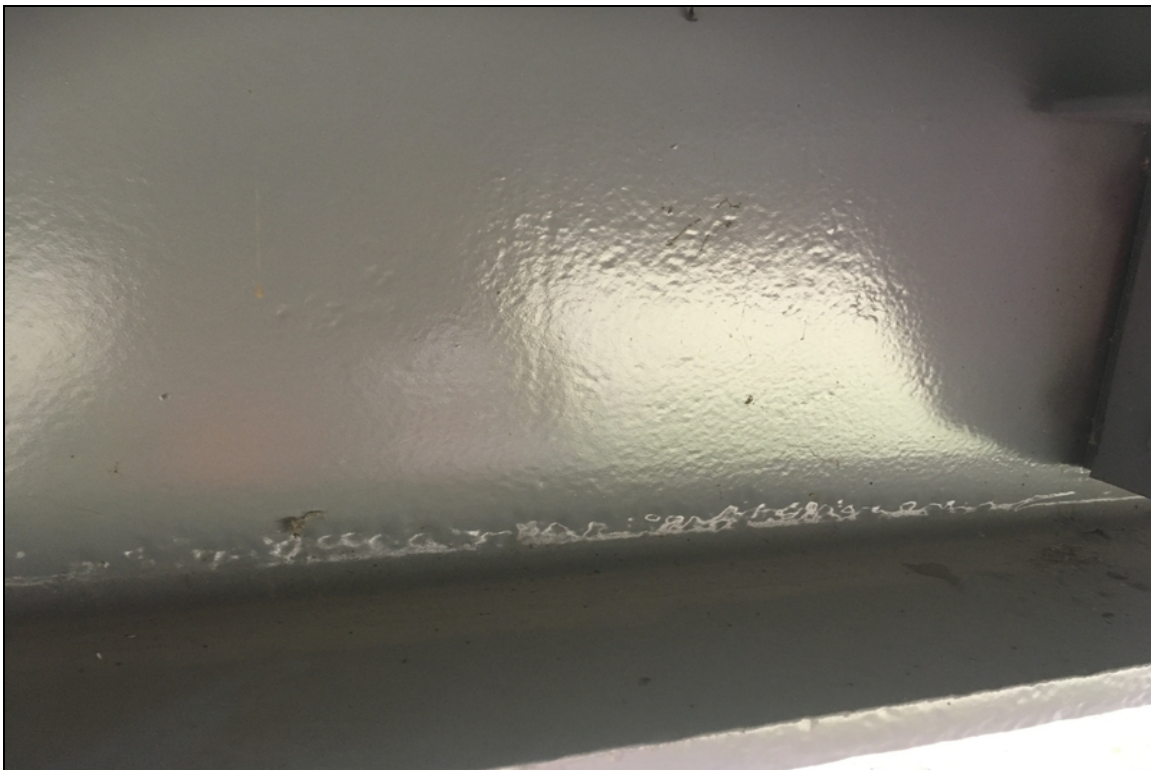
9' of shallow section loss with arrested corrosion on the interior lower web of beam #1 in span #5

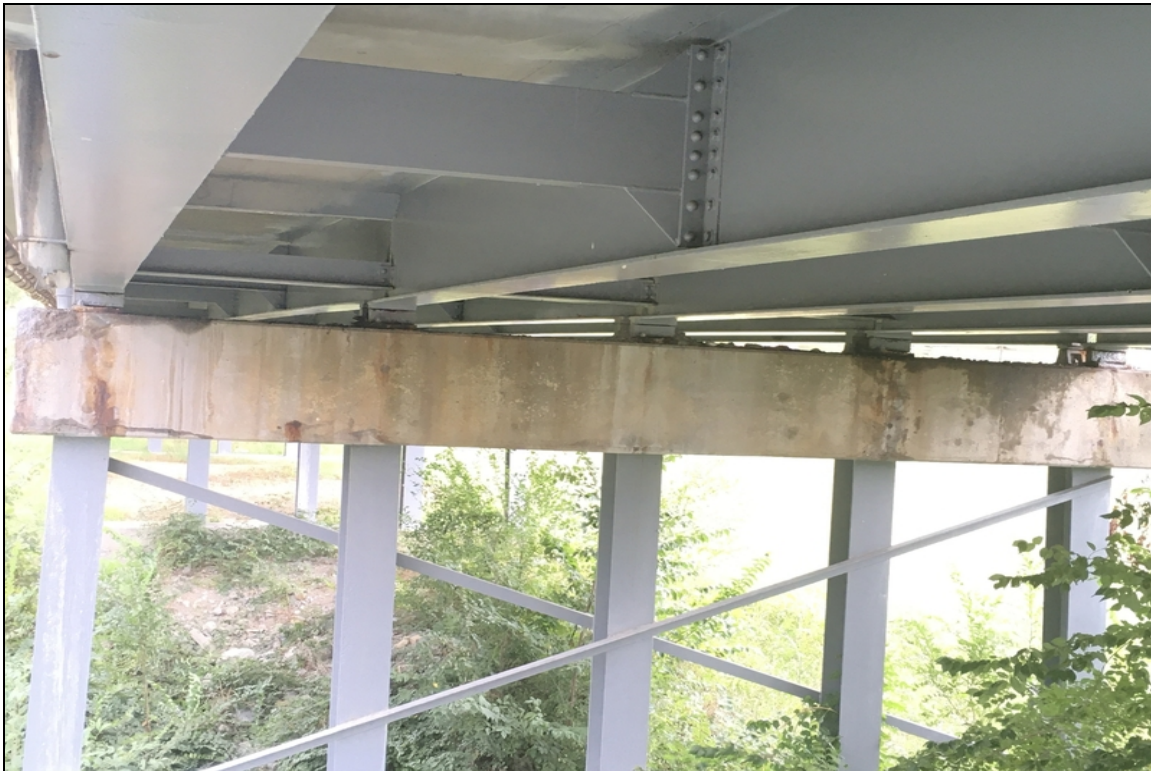
Bent #4 bearing condition. Showing corrosion.

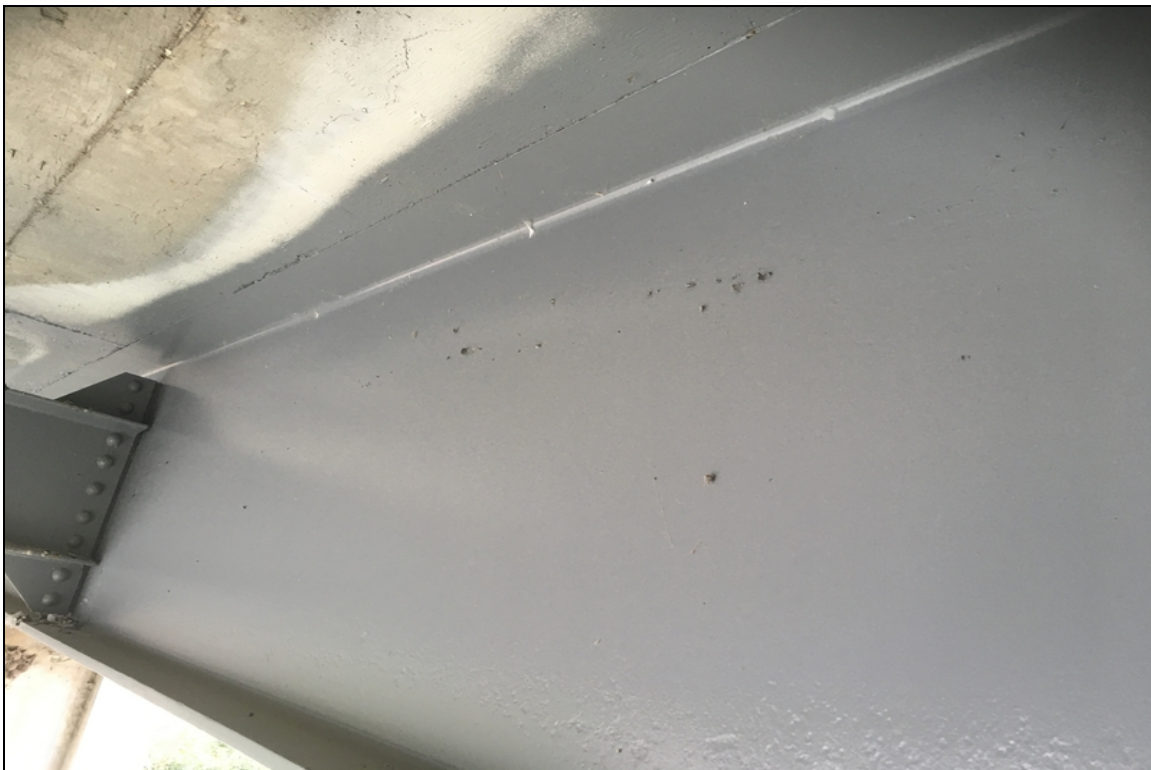
Factory defects in the web of beam #3 in span #3.

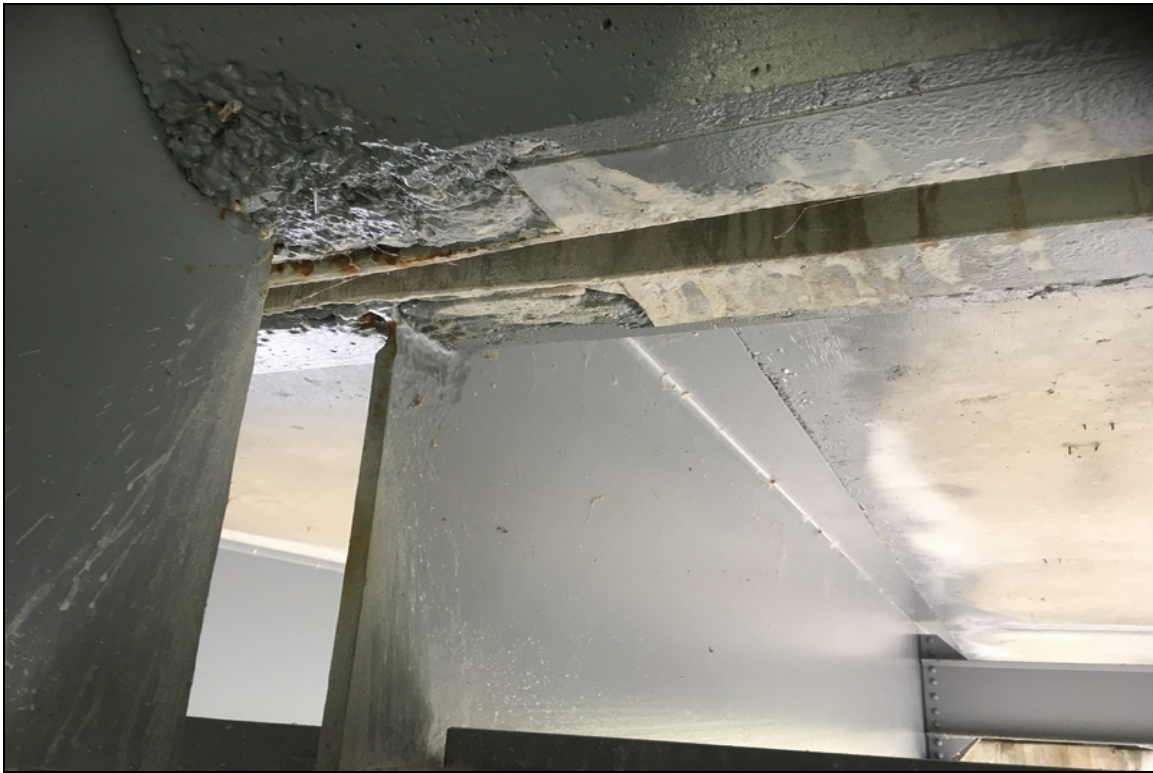
Small areas of section loss and arrested corrosion on the upper web of the span #3 beams.

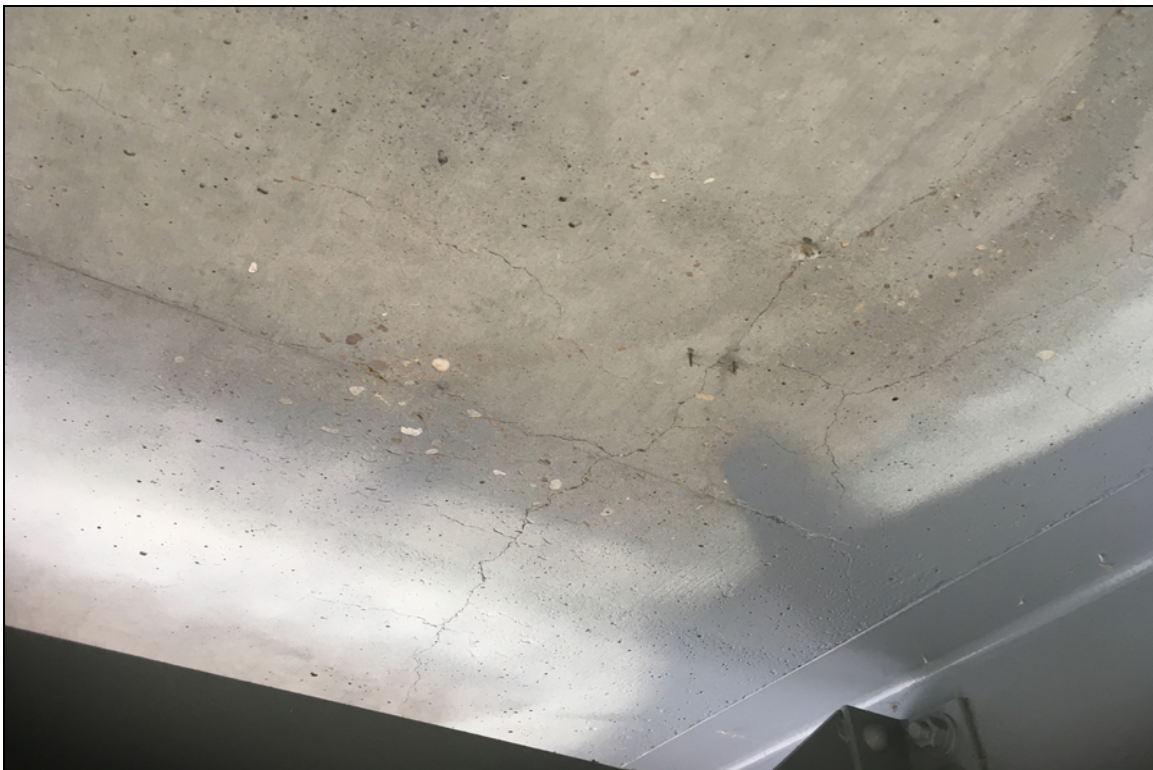
Deck cracking in the undersurface. Typical. 0.016" wide.

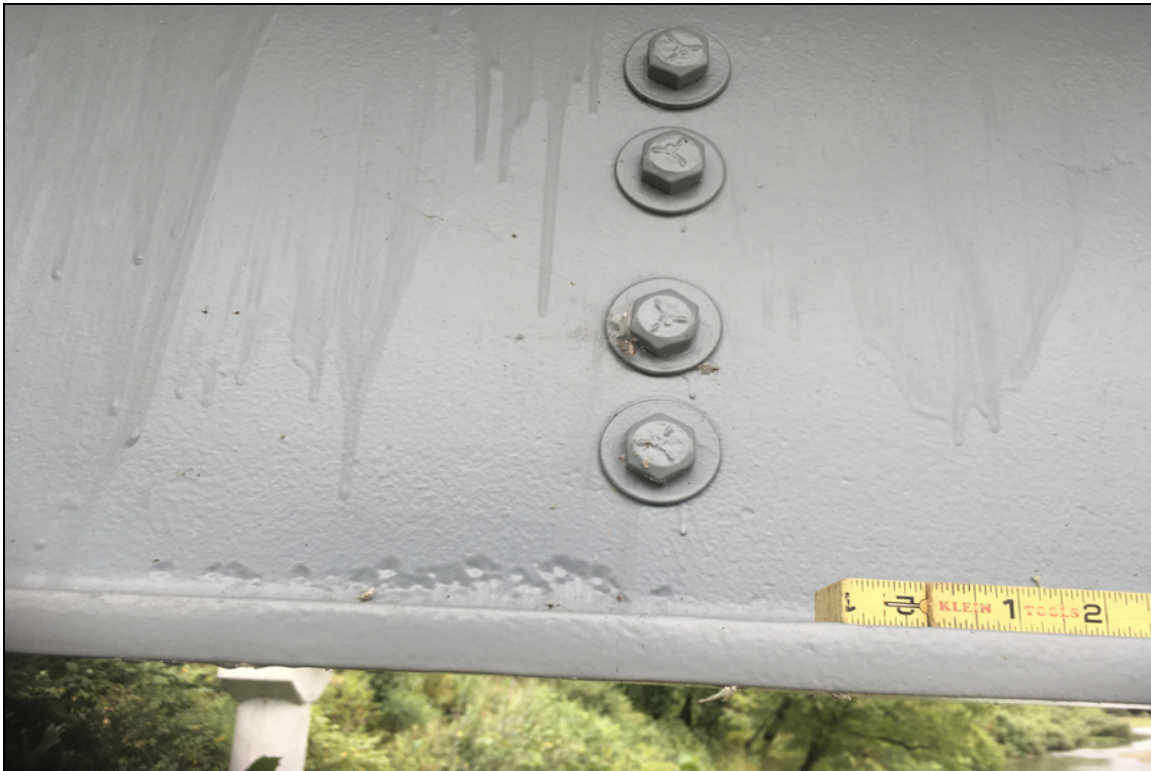
1' area of arrested corrosion on the exterior lower web of beam 5 in span #2.

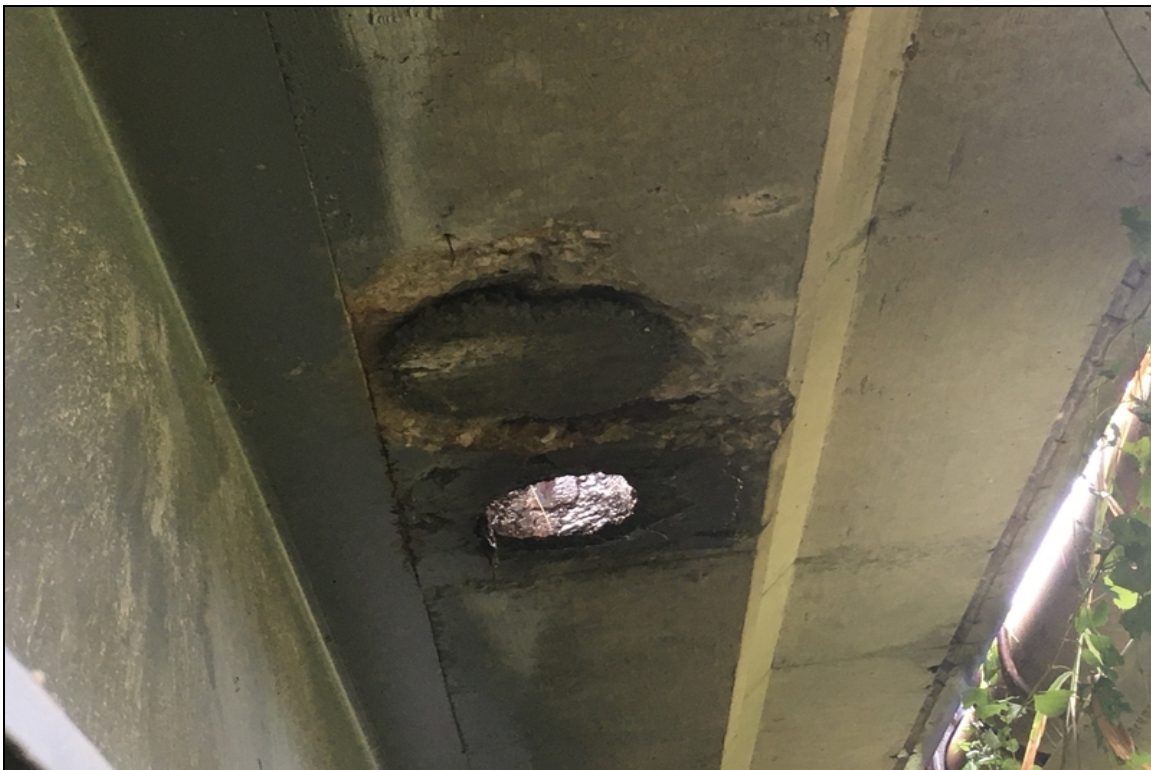
Spalling with exposed rebar at the left drain of span #1.

A spall with rebar exposed was noted at the left overhang drain area of span #1.
The left and right overhangs have several areas of delamination and spalling through out the structure.
The undersurface of span #8 in bay #4 has a 5' by 5' area of shallow delamination.

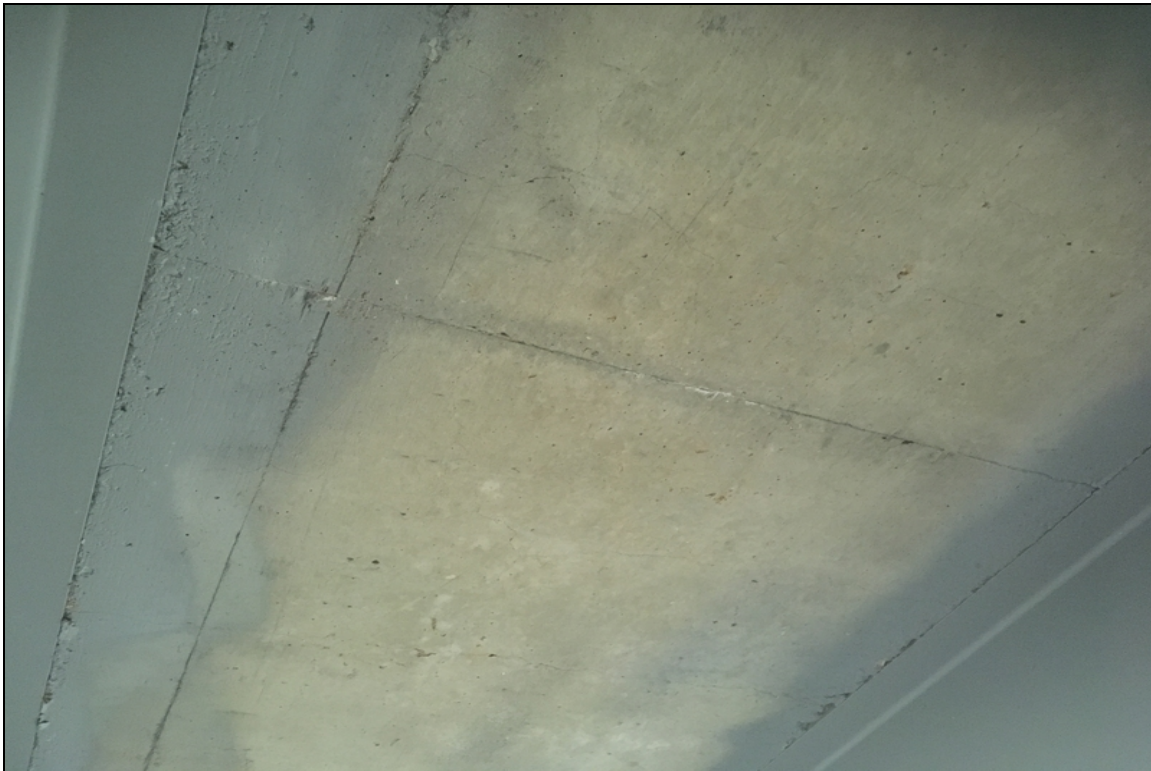
Deck cracking in the undersurface. Showing cs2 efflorescence.

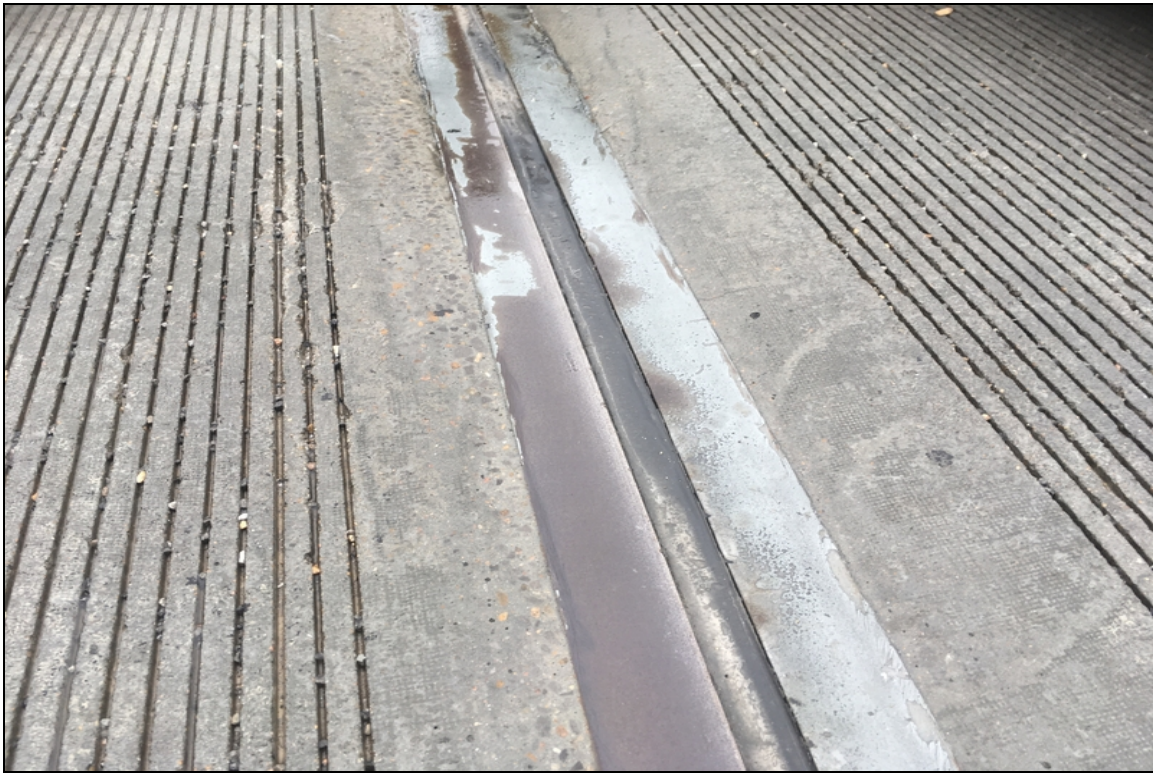
Pier #5 seal- no deficiencies noted.							
Pier #6 seal- has 2' of adhesion loss in the left lane.							
Pier #7 seal- has 7' of adhesion loss in the left lane.							
Abutment #2 seal- no deficiencies noted.							
311	Movable Bearing	EA	40	0	6	34	0
1000	Corrosion	EA	40	0	6	34	0
515	Steel Protective Coating	SF	40	0	6	34	0
3440 (311)	Effectiveness (Steel Protective Coatings)	SF	40	0	6	34	0
Pier #1- all 5 moveable bearings at pier #1 are showing moderate corrosion, especially on the masonry plates. The bearings have

Adhesion loss at the pier #7 seal.

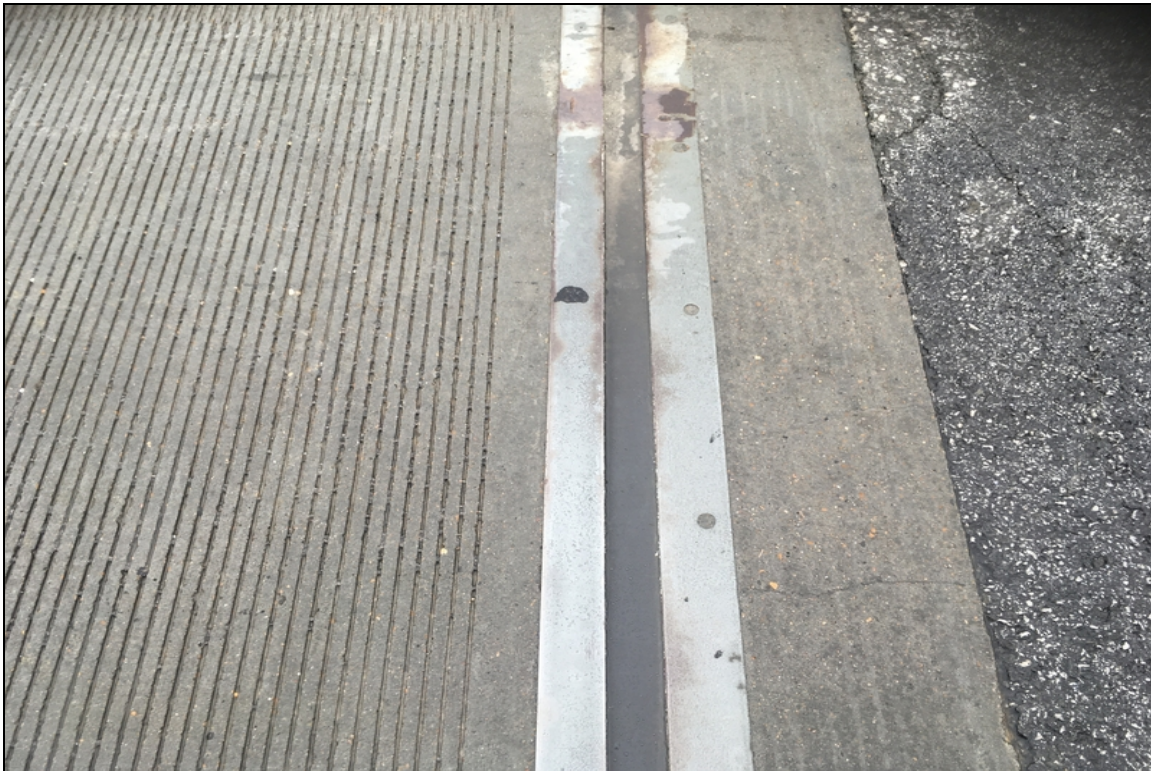
Abutment #1 joint seal condition. New. No deficiencies noted.

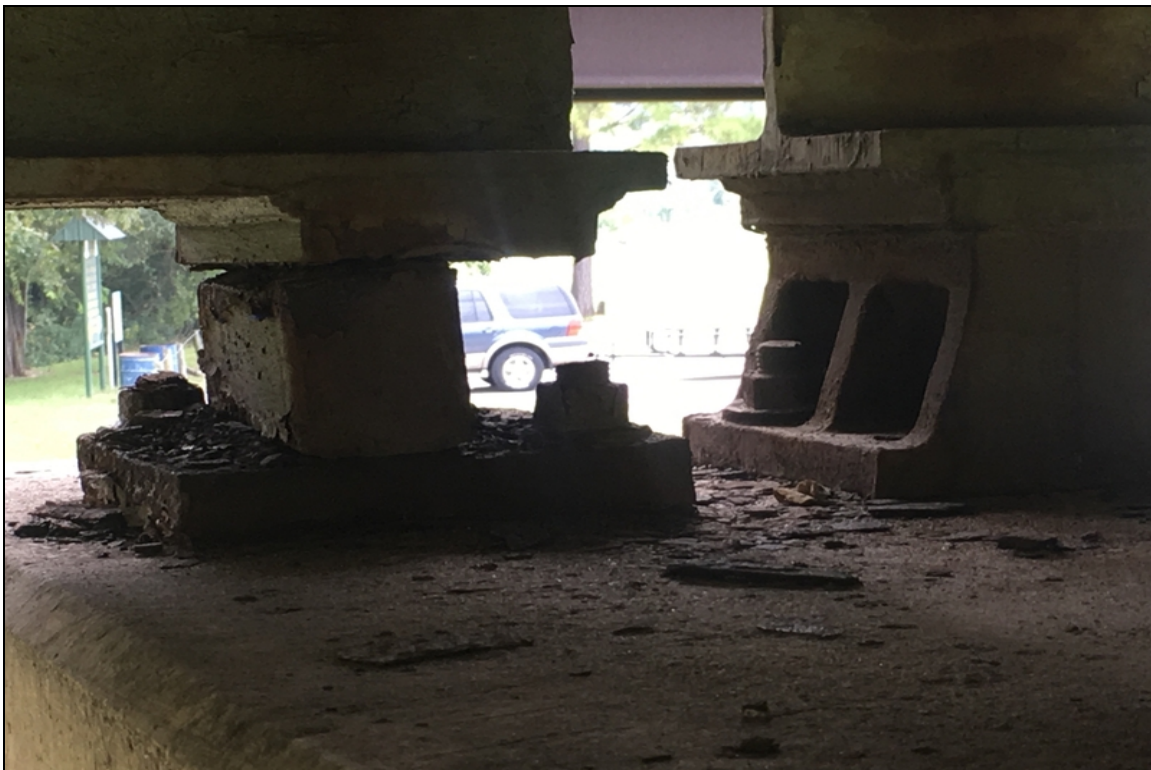
Bearing #1 and #5 are no longer centered beneath the sole plate at bent #6.

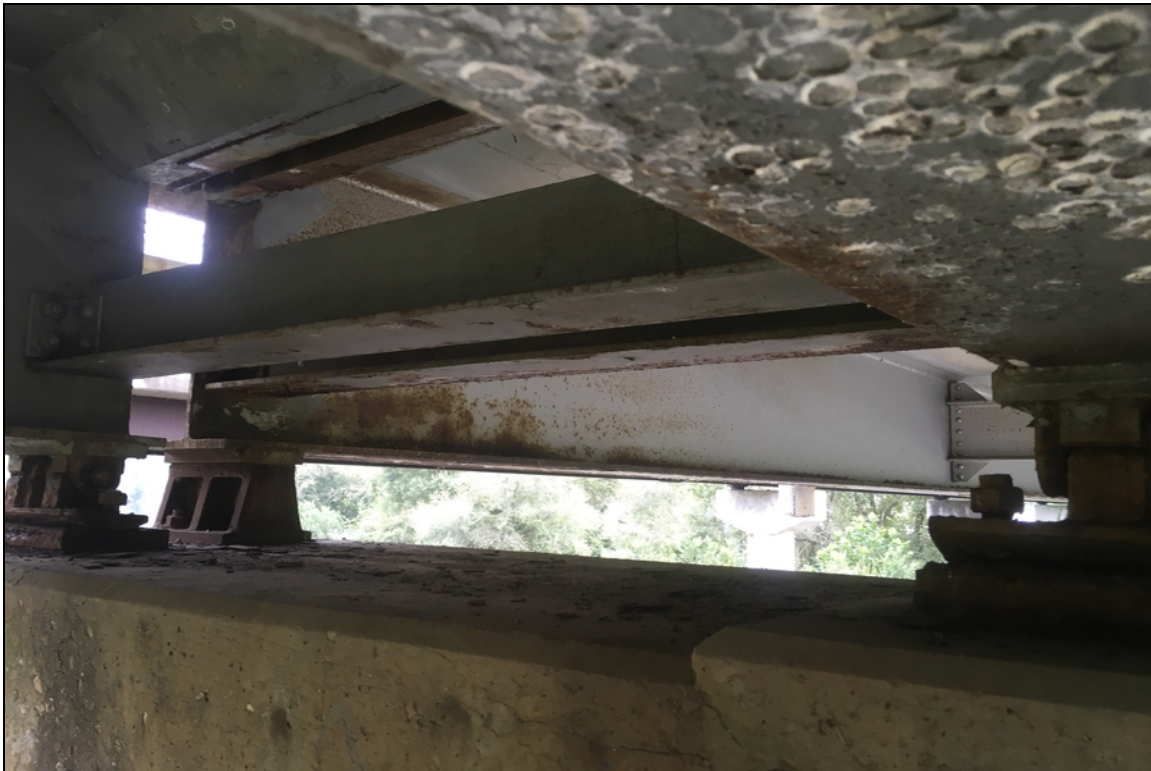
Beam end corrosion at the beginning of span #3.

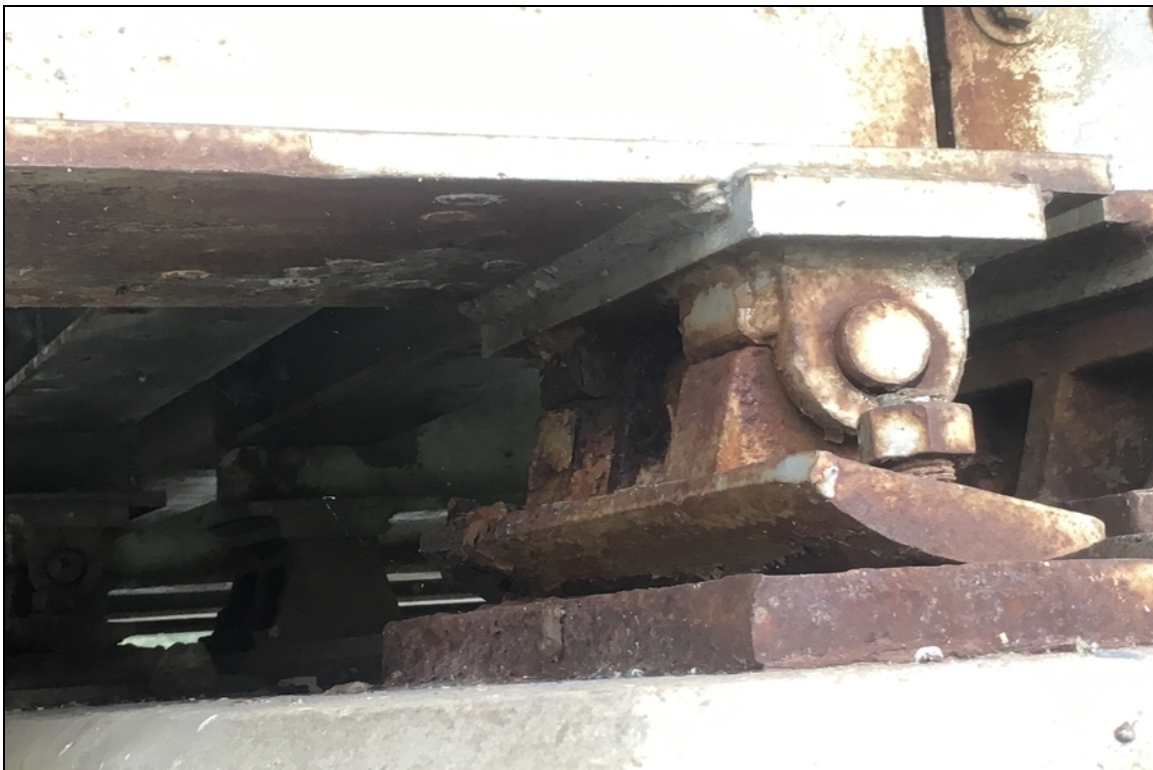
Tilted bearings at the span #3 side of pier #3. # 1,2,4,5 are tilted #3 is not.

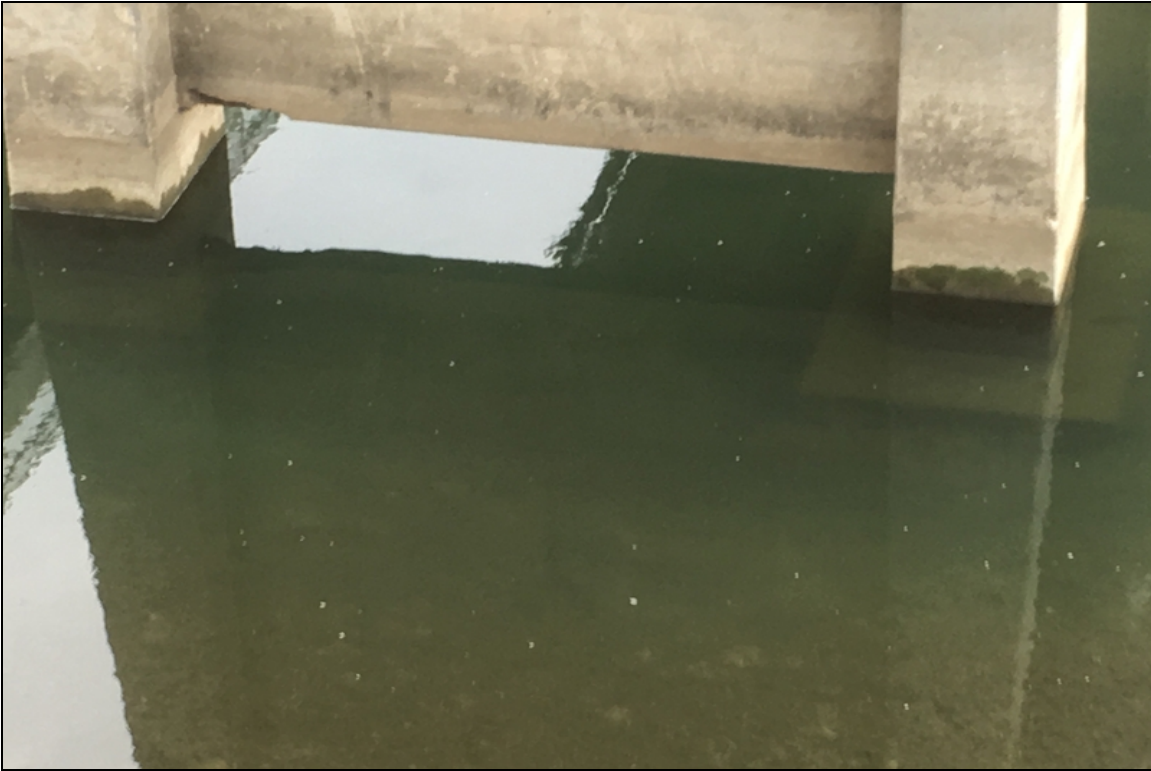
Exposed footings at bent #2.

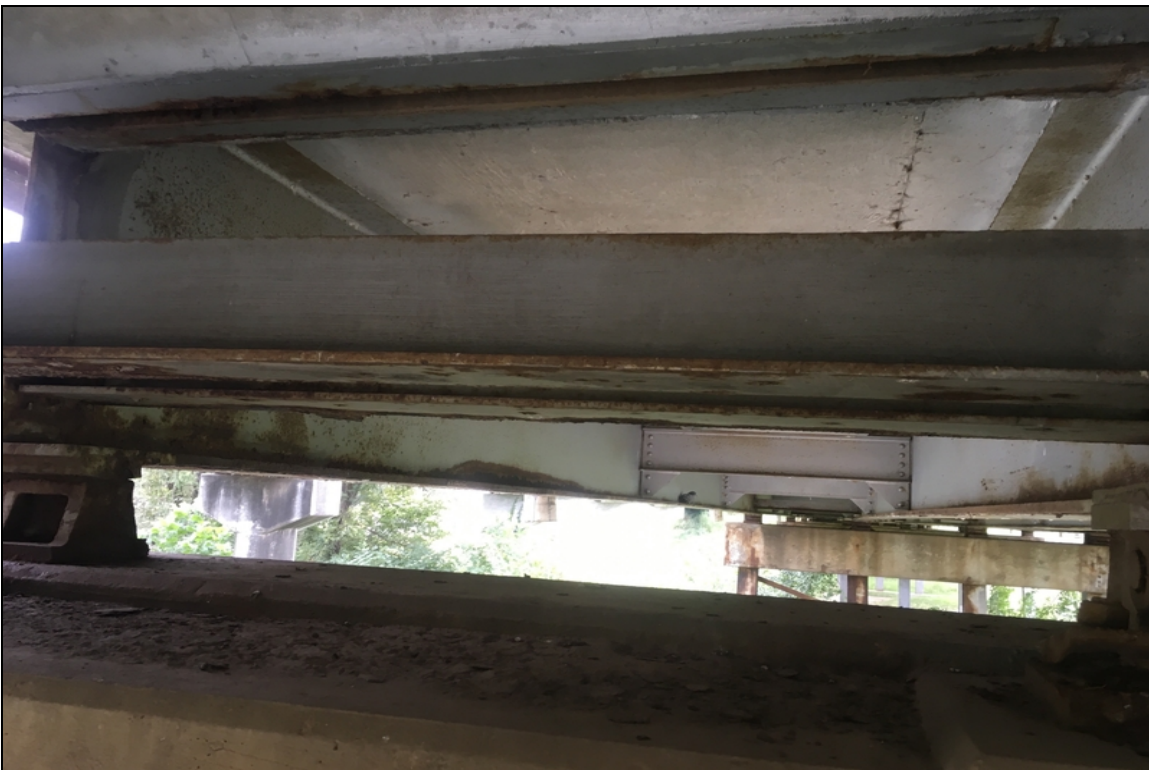
Beam #1 at the beginning of span #4 showing heavy corrosion on the bottom flange and lower web.

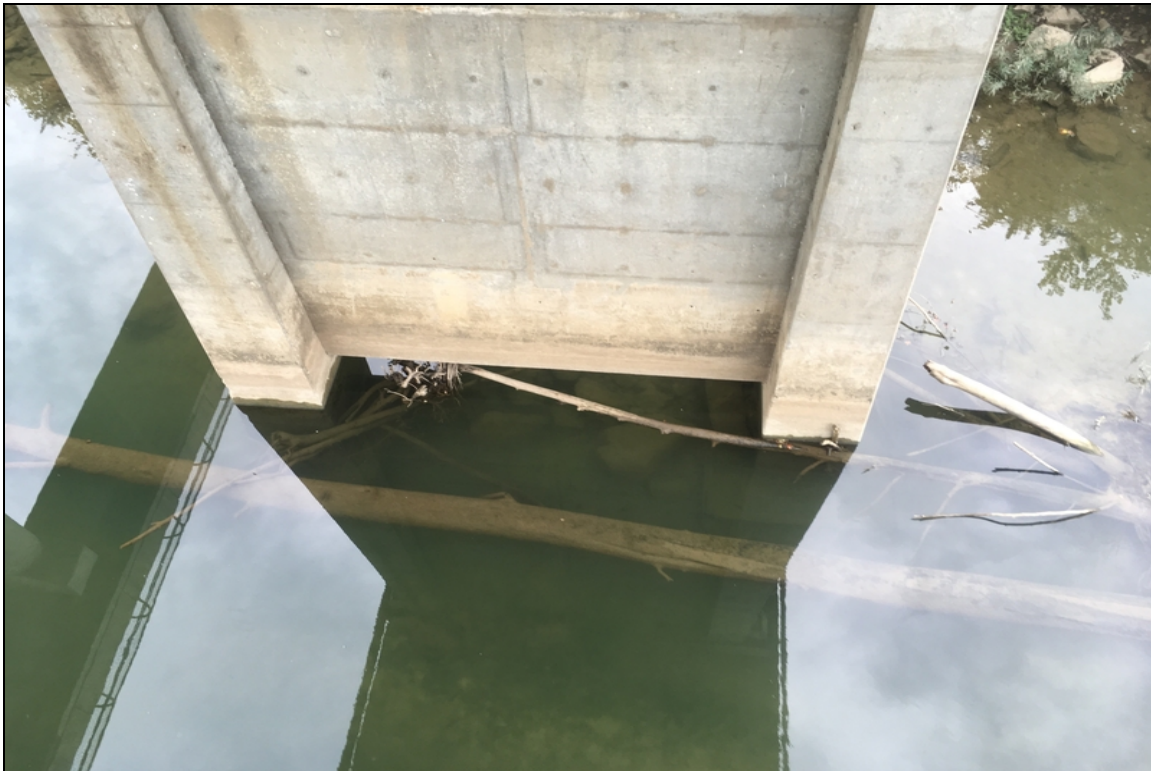
Footings exposed at pier #3.

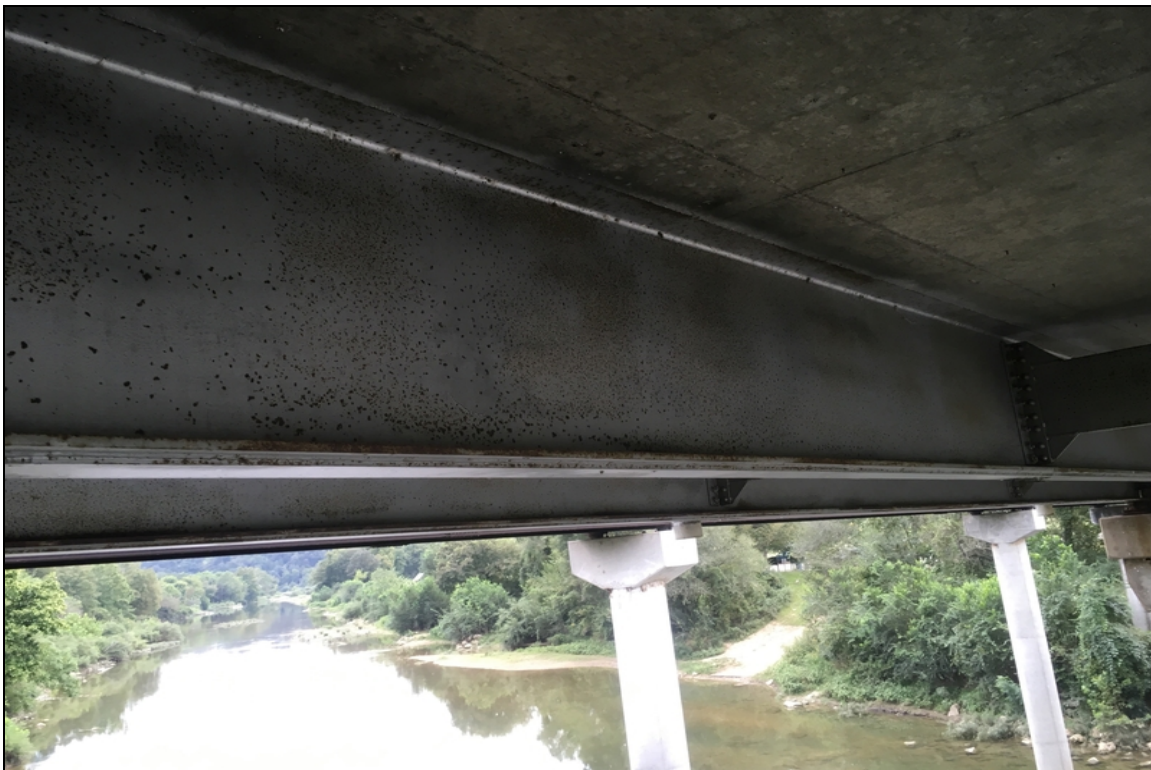
Large areas of pin point rusting in span #2.

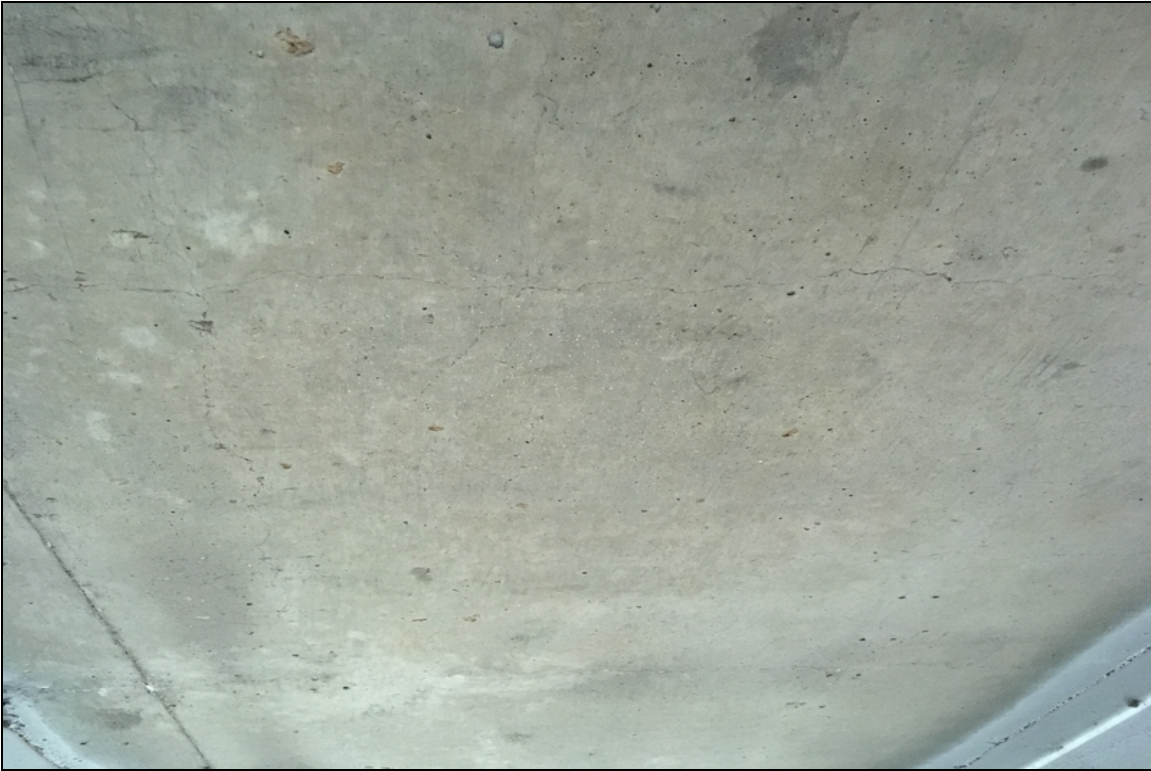
View of the deck undersurface. Showing transverse hairline cracking.

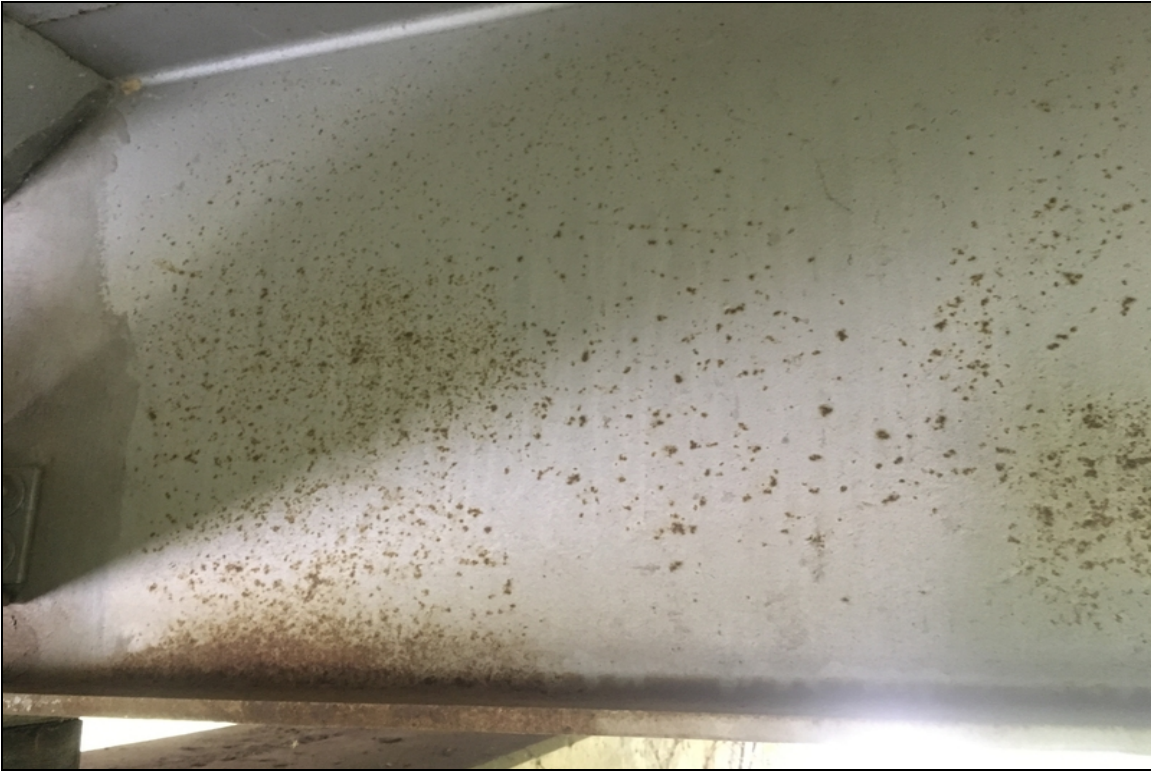
Pin point rusting at the beam ends in span #1.

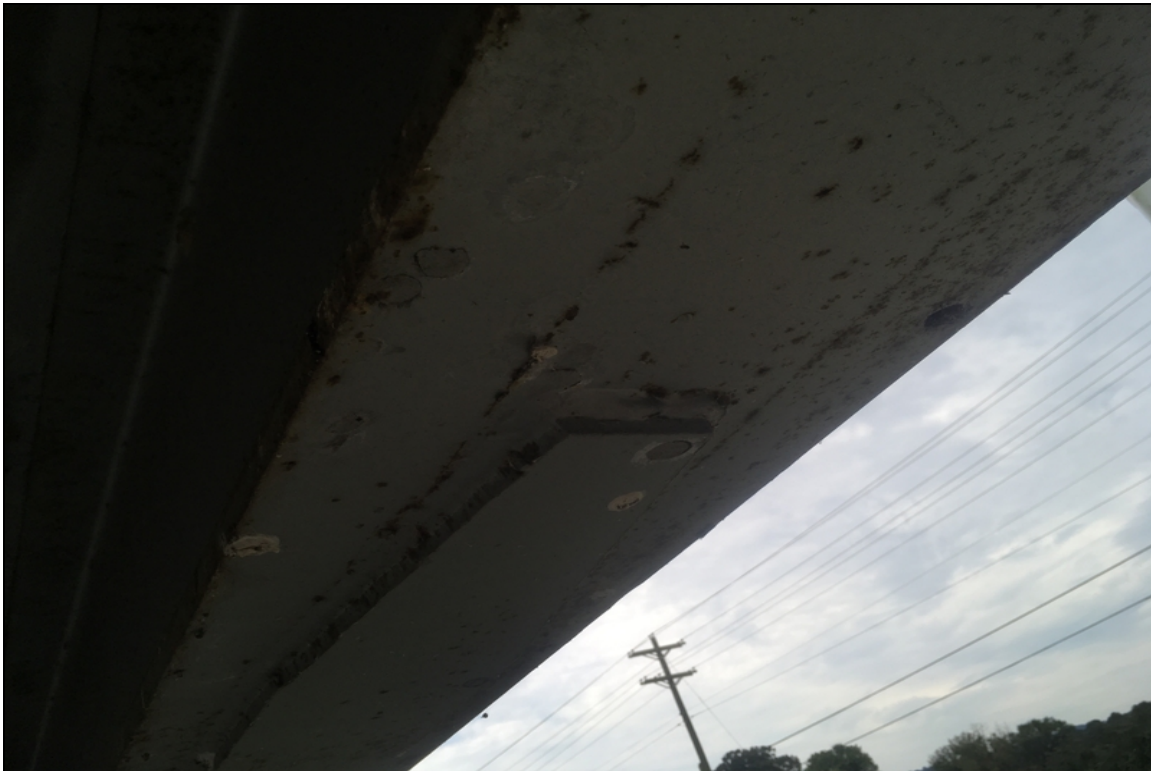
Longitudinal factory defect in the bottom flange of beam #5 in span #3 at the beginning of the cover plate.

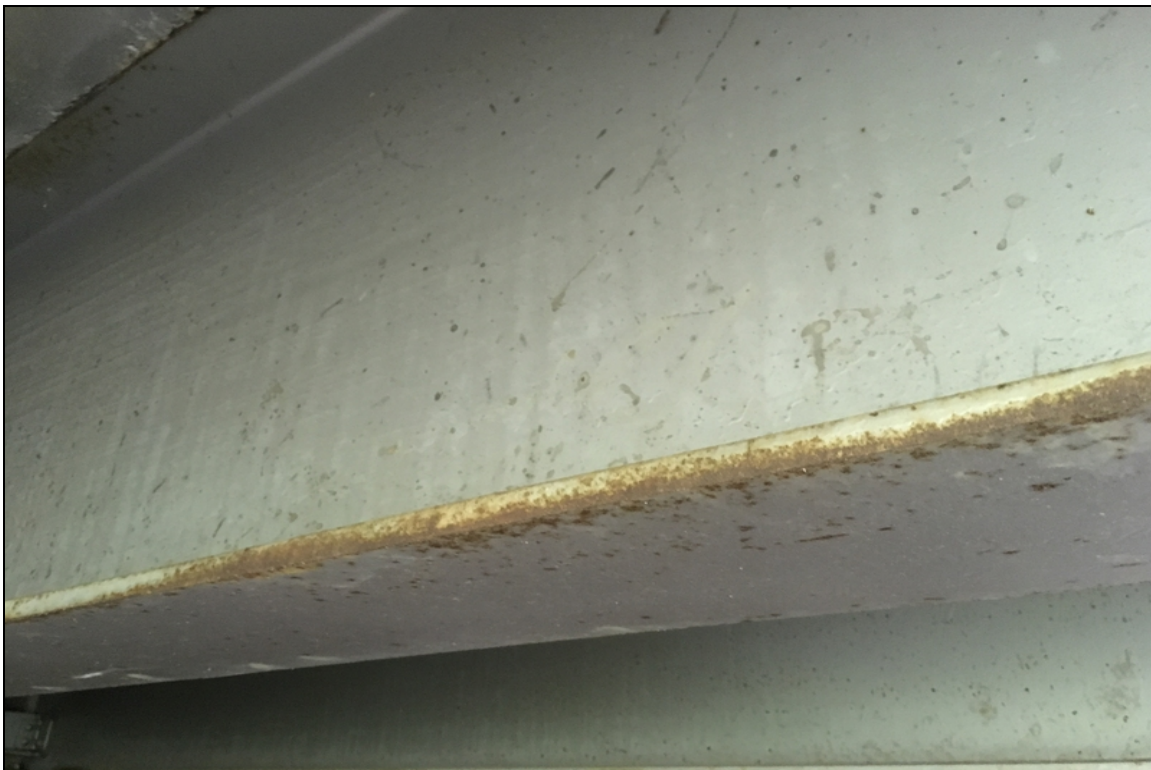
Pin point and general corrosion typical of many locations.

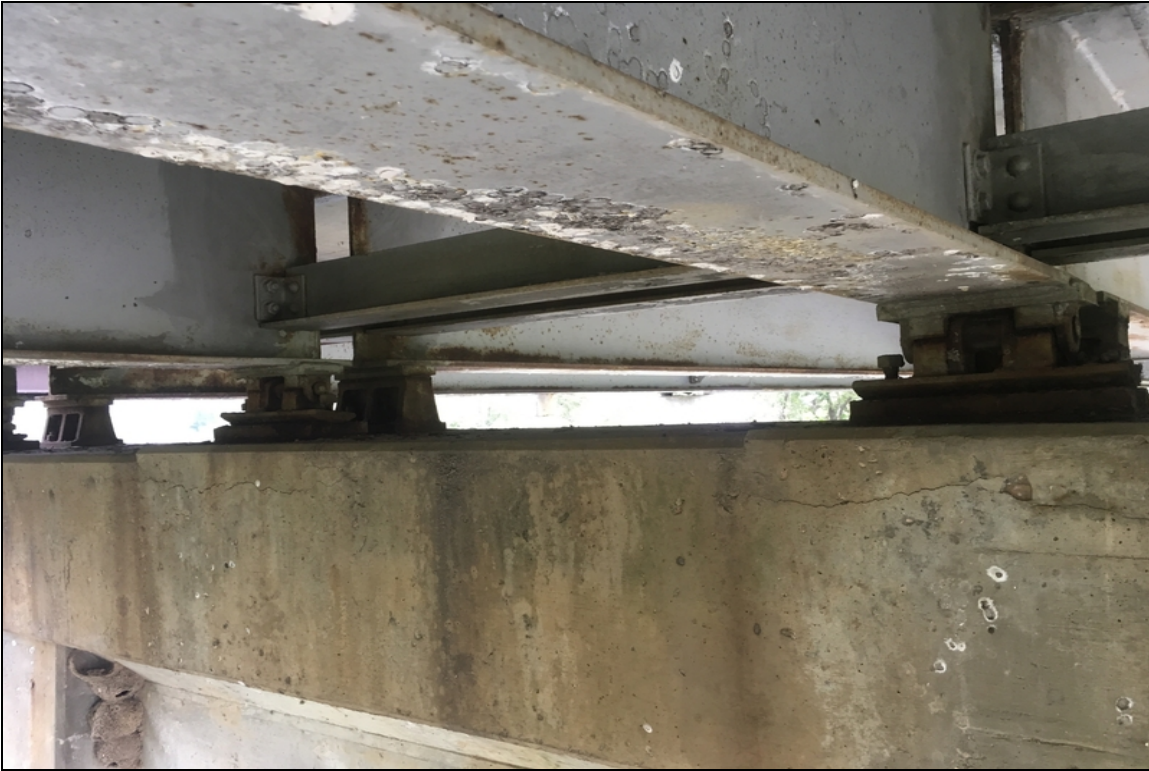
ELEM	DESCRIPTION	UNITS	TOTAL	CS1	CS2	CS3	CS4
been repainted. The corrosion is beginning to bleed back through Pier #2 moveable bearings- all 5 have cs3 corrosion with pitting especially on the masonry plates and anchor bolts. The anchor bolt studs have heavy section loss. Pier #3 moveable bearings- all 5 have heavy corrosion with pitting. Bearings #1,2,4,5 are tilted #3 is level. Temp was 75 degrees F. Bearings #1,4,5 have missing anchor bolt studs due to corrosion. Bent #4 all 5 moveable bearings have heavy corrosion with section loss. Bent #5 all 5 moveable bearings have corrosion with section loss at the rocker area. Bent #6- 4 of the 5 moveable bearings have corrosion with section loss at the rocker area. Bearing #3 is retrofitted and has a light rust coating. Bent #7- all 10 moveable bearings have corrosion with section loss at the rocker areas.							
313	Fixed Bearing	EA	40	0	10	30	0

Bearing condition at pier #2. Note the delamination on the pier cap.
