Bridge #00338(Routine, Underwater type 2)

SH 14 Marion over CROOKED CREEK

Team Lead: Benjamin Smith Inspection Date: September 21, 2021

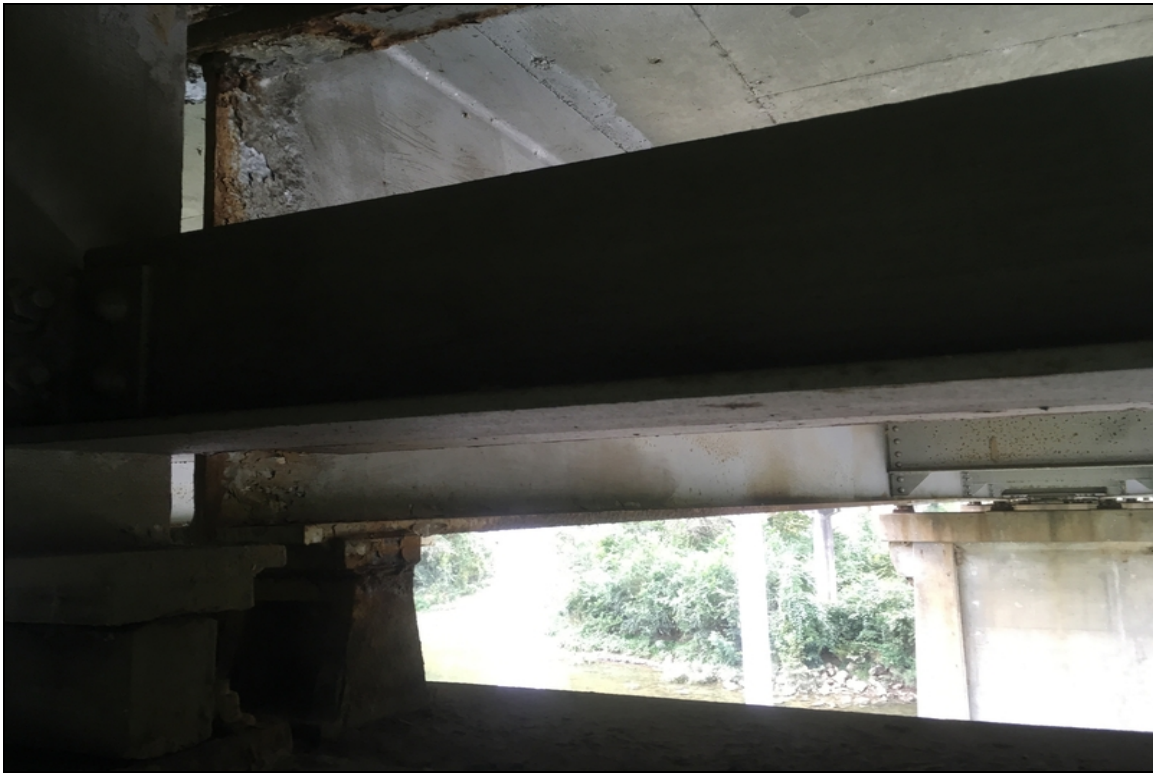
Corrosion on the bottom flange and beam ends in span #2.

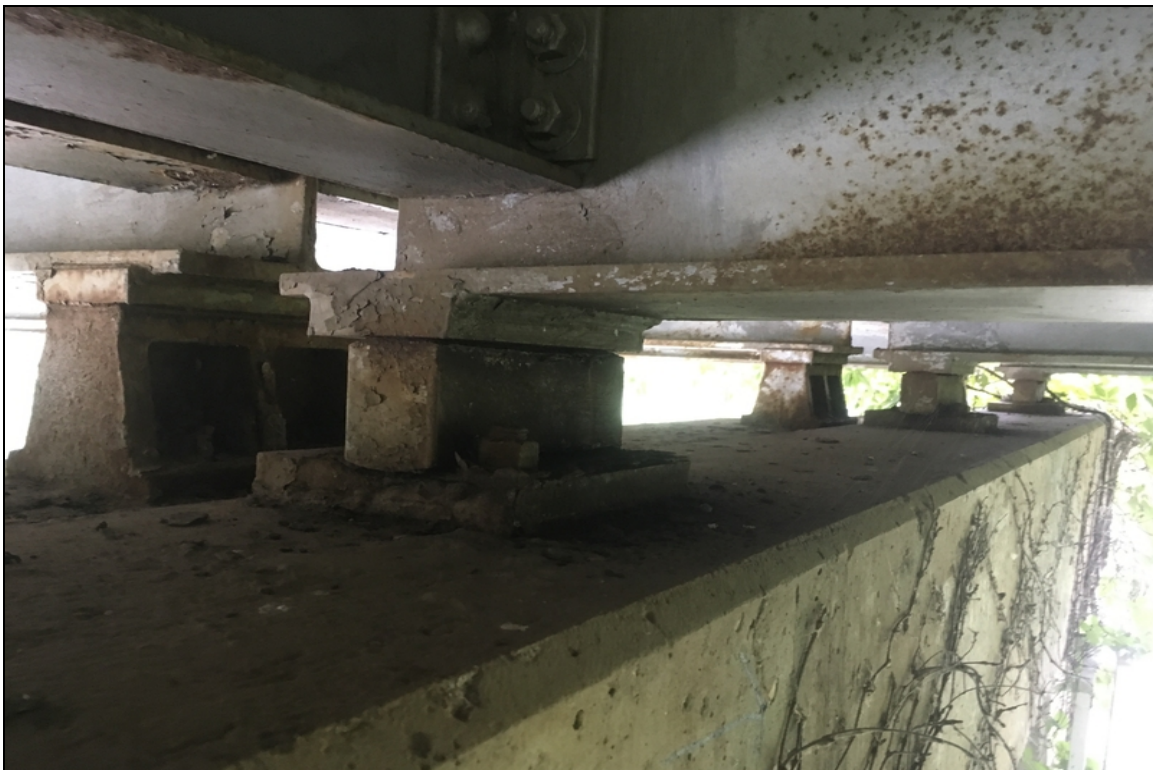
Bearing condition at pier #1.

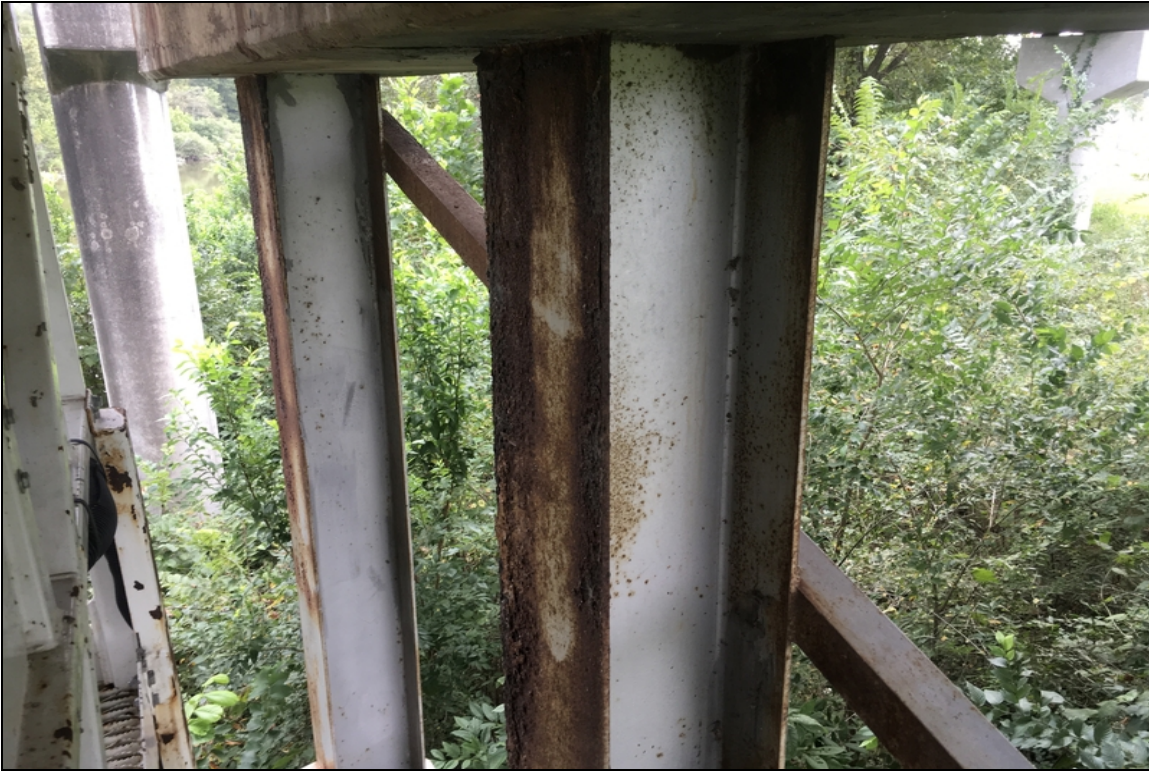
Corrosion with minor section loss at the tops of piles #1,2 at pile bent #4

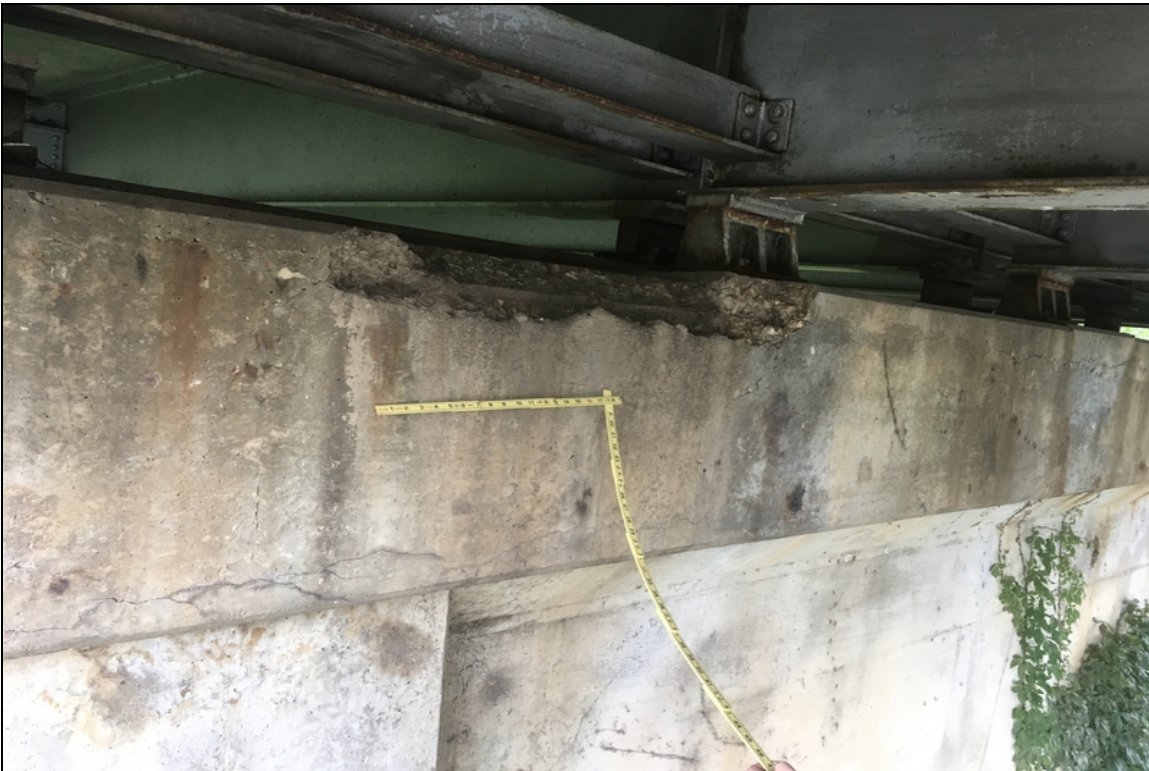
Spalling with rebar exposed on the span #2 side of the pier #1 cap. Note the delamination also.

Pier #1 has a spall with rebar exposed on the back side of the cap and a large 3' spall with rebar exposed in the top edge of the cap in bay #4.

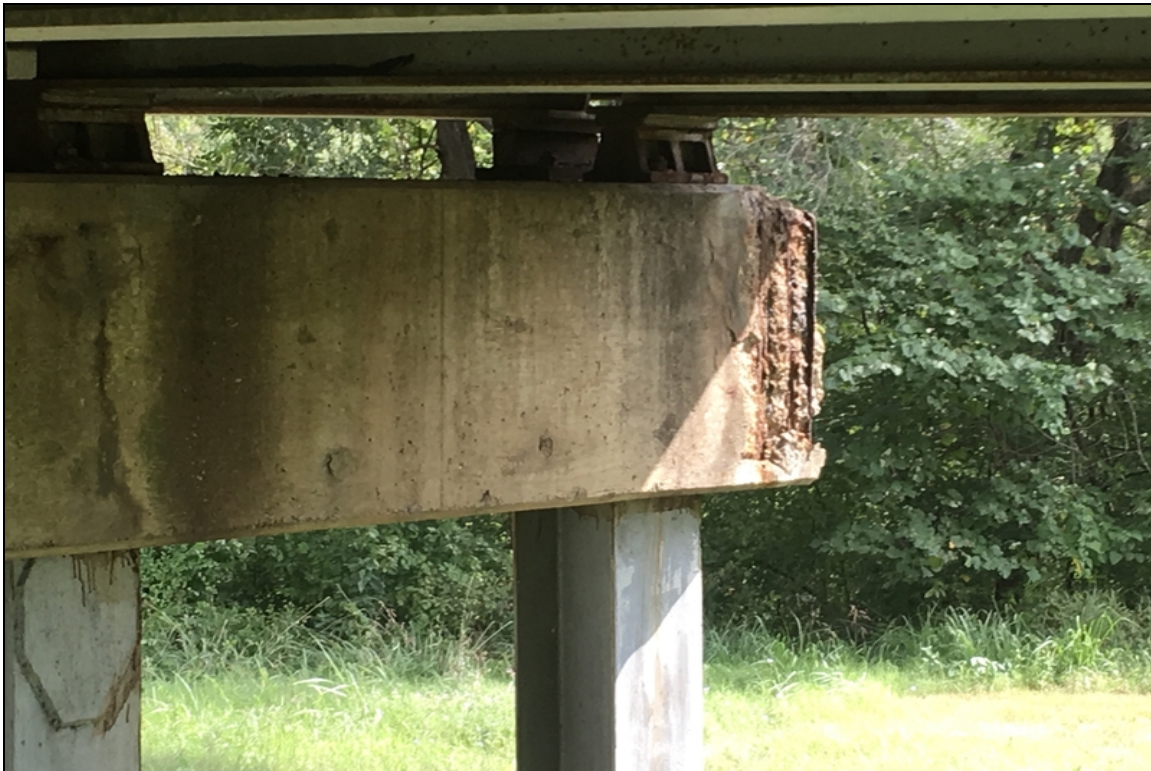
Bent #5 cap- has 7' of delamination with vertical and horizontal hairline cracking beneath the bearing areas in the same footage as the delaminations.							
Bent #6 cap has 11' of delamination with 2' of vertical hairline cracks, and 1' of deep spalling with rebar exposed at the left cap end.							
Bent #7- has 10' of delamination with 2' of vertical cracks with 1' of spalling at the top right edge of the cap end.							
301	Pourable Joint Seal	LF	220	206	14	0	0
2320 (301)	Seal Adhesion	LF	14	0	14	0	0
New pourable joint seals were installed with the deck rehab in 2020.							
Abutment #1- no deficiencies noted.							
Pier #1- no deficiencies noted.							
Pier #2 seal- has 1' of cs2 adhesion loss in the left driving lane.							
Pier #3 seal- has 1' of cs2 adhesion loss at the center line.							
Pier #4 seal- has 2' of adhesion loss in the left lane. The right lane has 1' of cs2 adhesion loss.

Spalling with rebar exposed on the left cap end of bent #6.

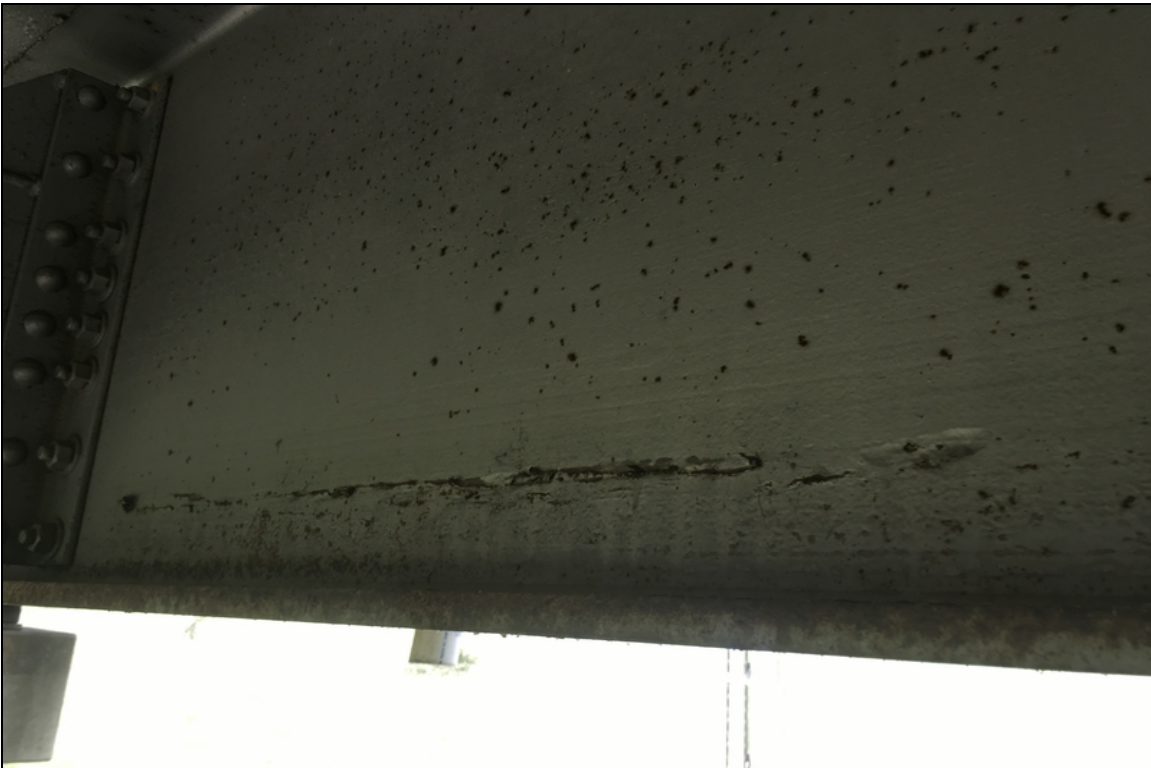
2' long longitudinal factory defect in the lower web of beam #4 in span #6.

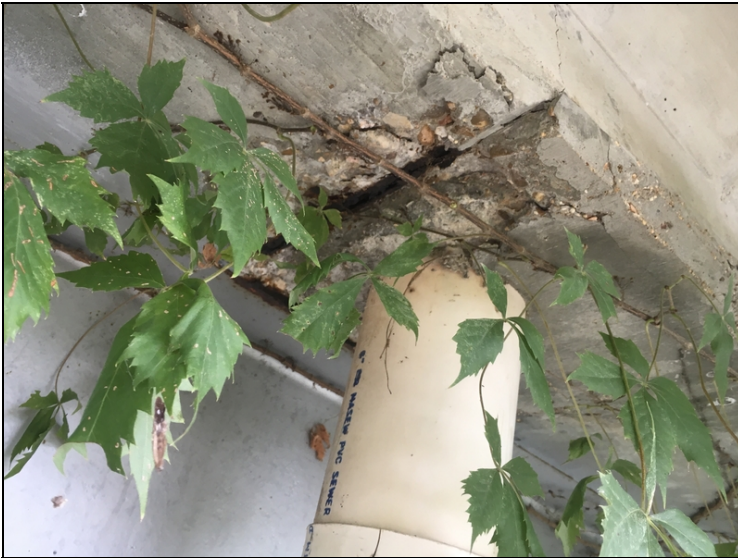
Spalling with rebar exposed in the right overhang of span #1.

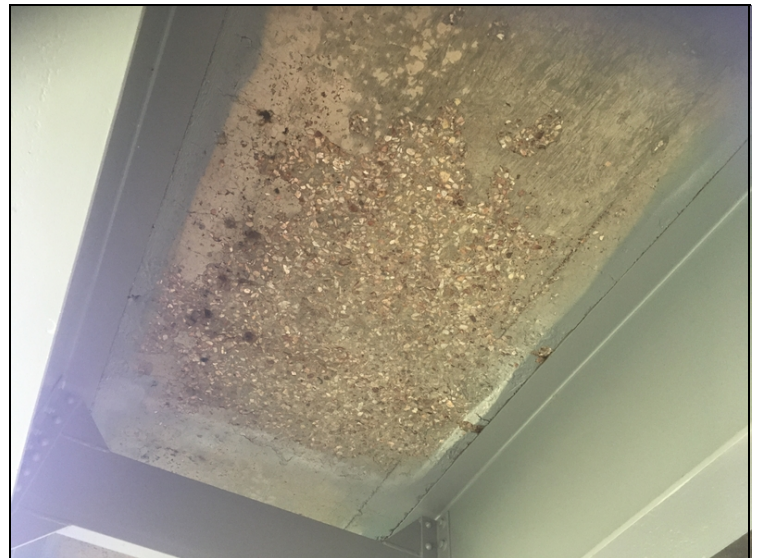
5' by 5' area of shallow delamination in the undersurface of span 8 in bay #4.

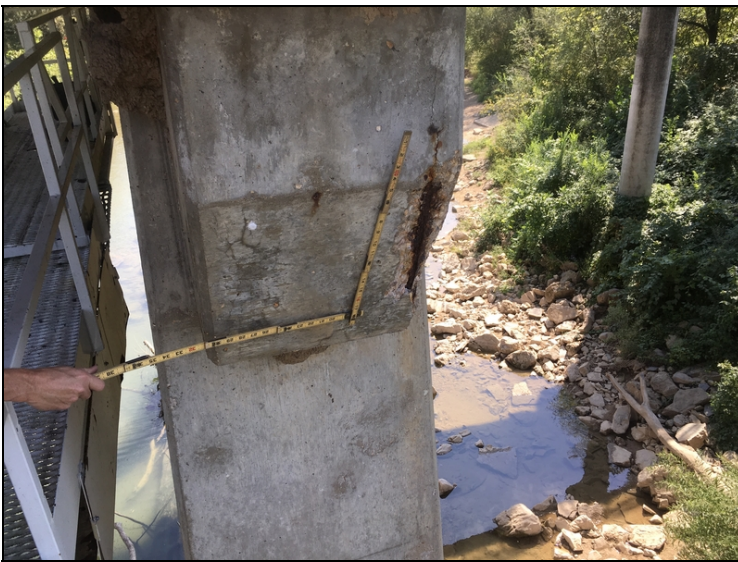
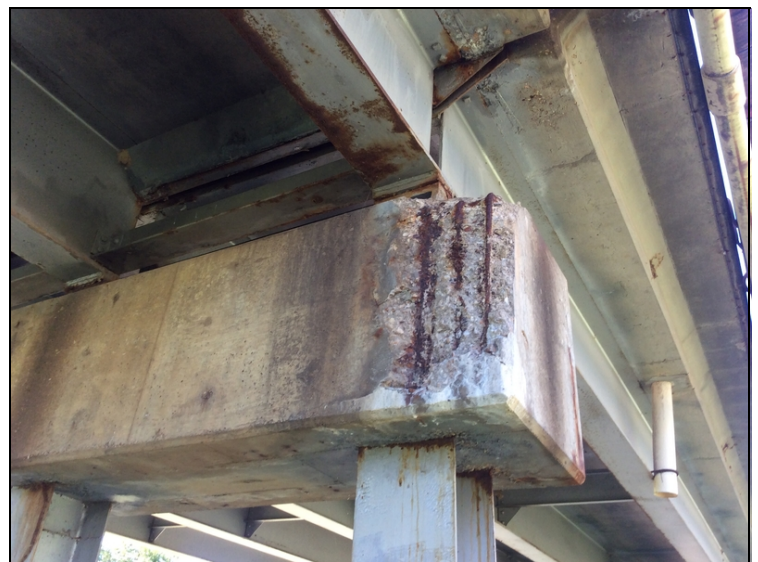
Bent #3 right cap end has a spall with rebar exposed.

Spall with rebar exposed at left cap end of bent #3

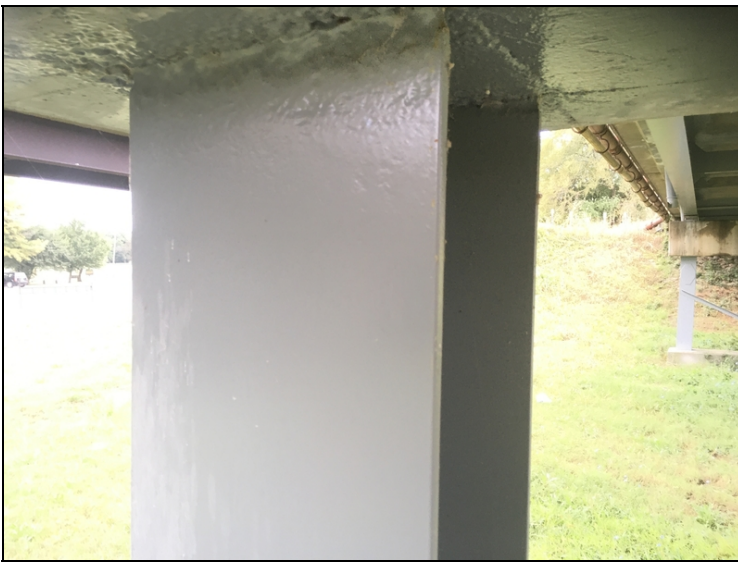
Arrested corrosion with 3/16 section loss at the top of pile #1 at bent #6. The original section of the flange is 7/16".

Arrested corrosion with 3/16 section loss at the top of pile #1 at bent #6. The original section is 7/16".

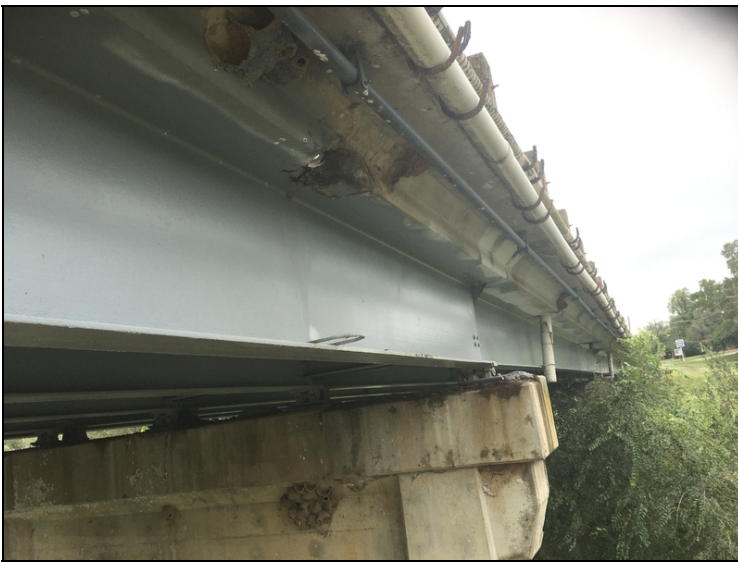
A pvc drain extension pipe is missing at the right side of span #3 and span #4.

Missing drain pipe on the right side of span #3.

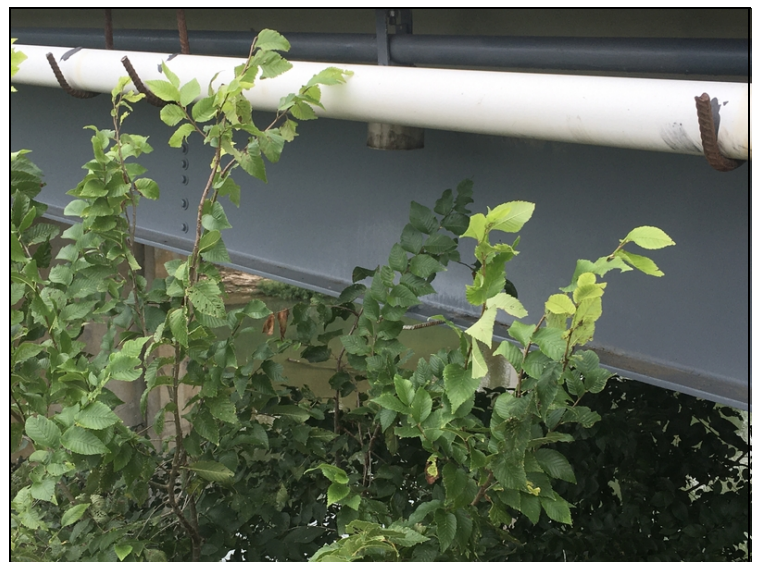
Partially missing drain pipe on the right side of span #4.

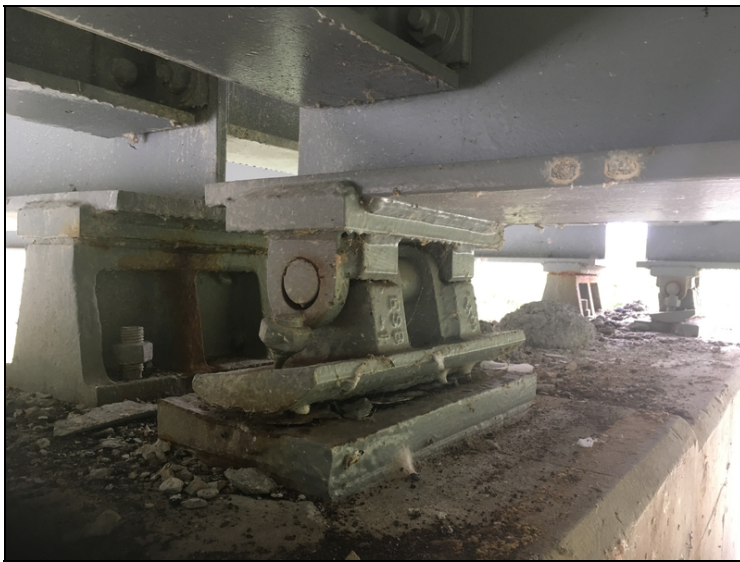
The bearing anchor bolt studs at pier #2 and pier #3 have heavy section loss, some of the studs are missing at pier #3.

Section loss on the anchor bolt studs at pier #2.

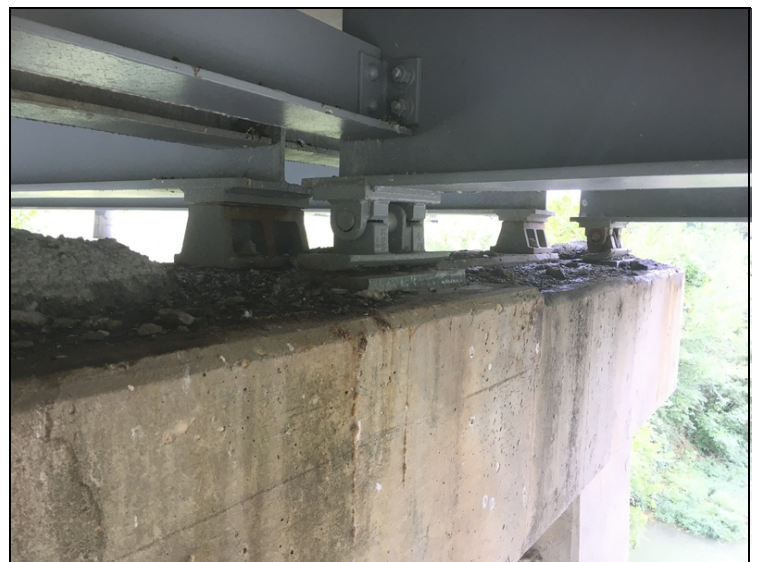
Missing anchor bolt studs at pier #3 movable bearings.
