Bridge #01743(Routine)

SH 14 Marion over BUFFALO RIVER

Location: 15.79 MI S JCT US 62

Team Lead: Benjamin Smith Inspection Date: October 14, 2020

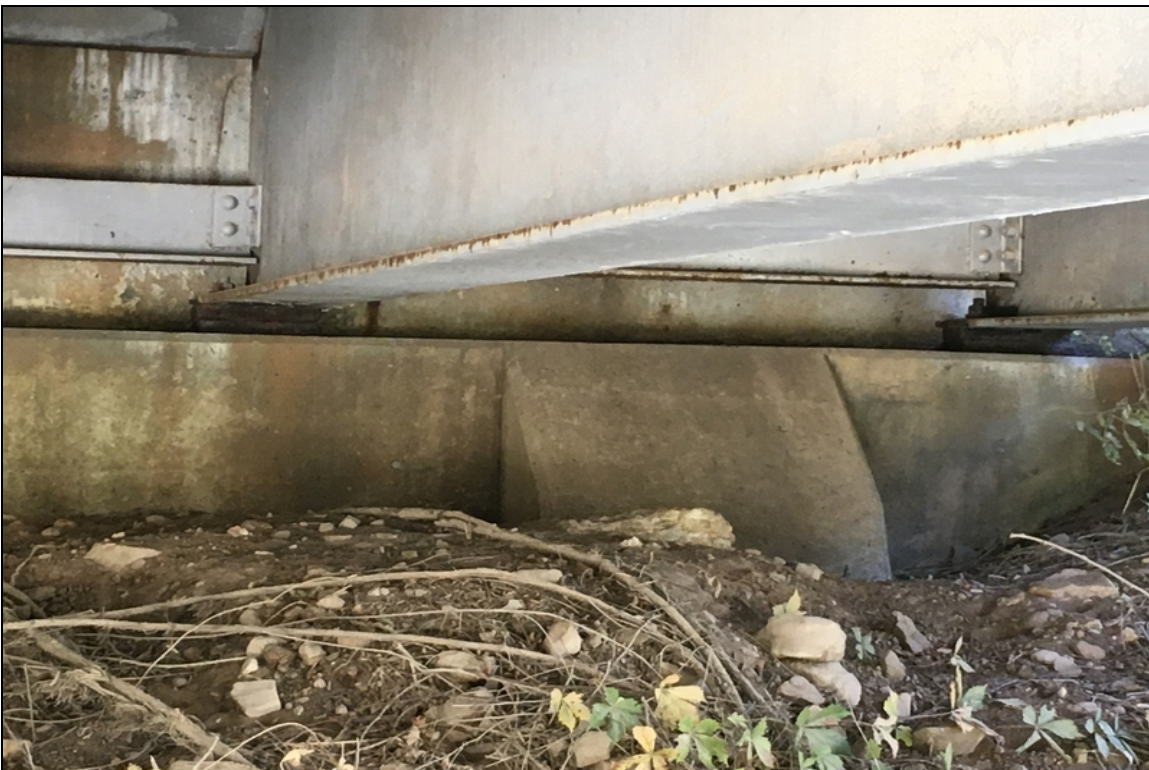
Abutment #2 bearing condition.

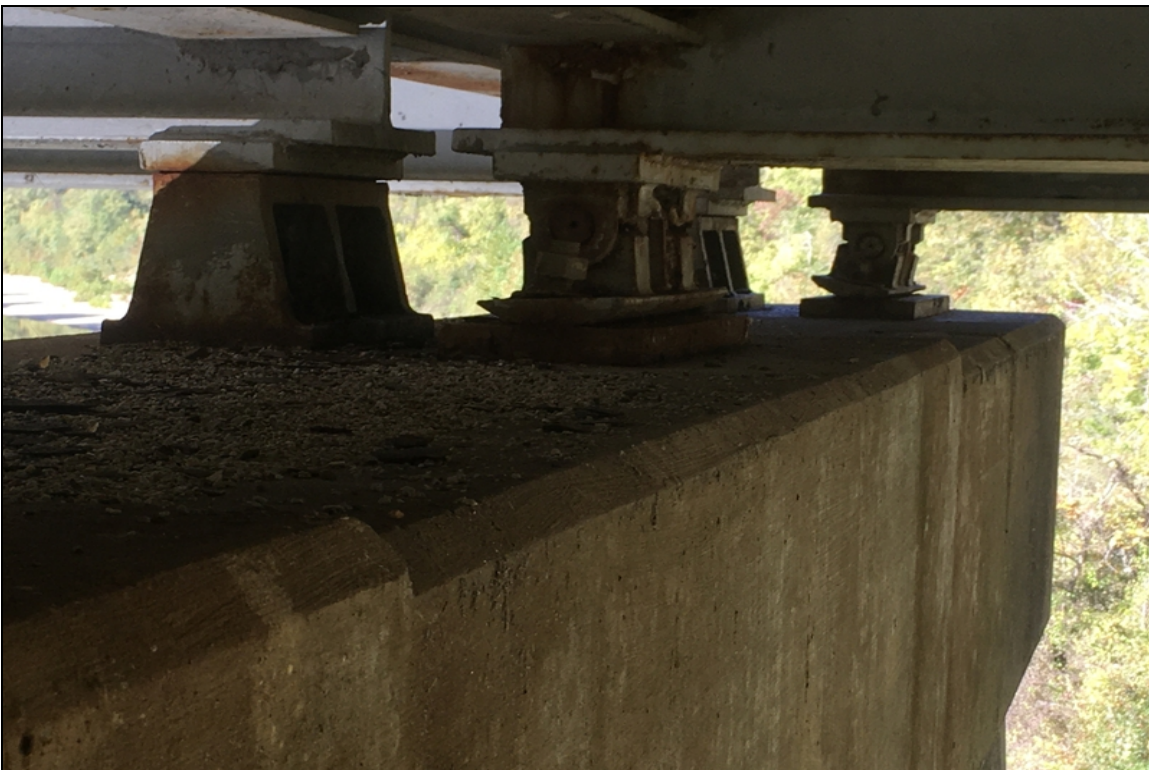
Bearing 5 tilt at the end of span #1.

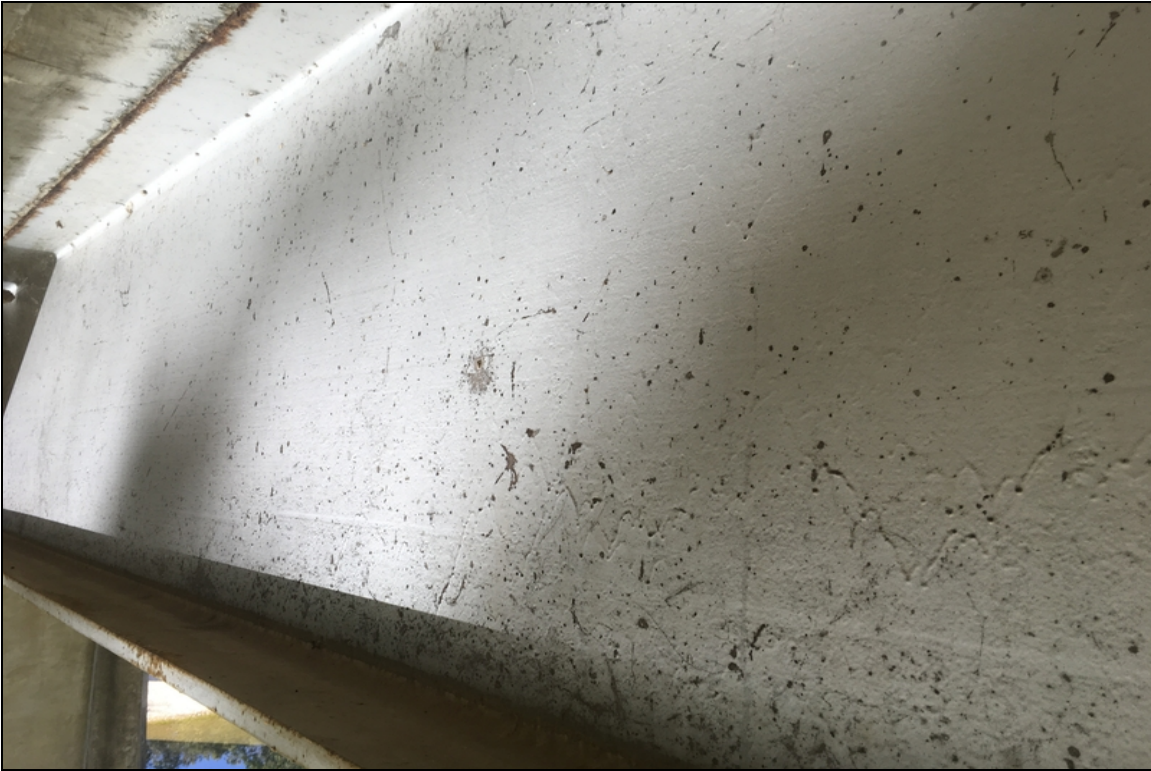
Typical view of the paint condition.

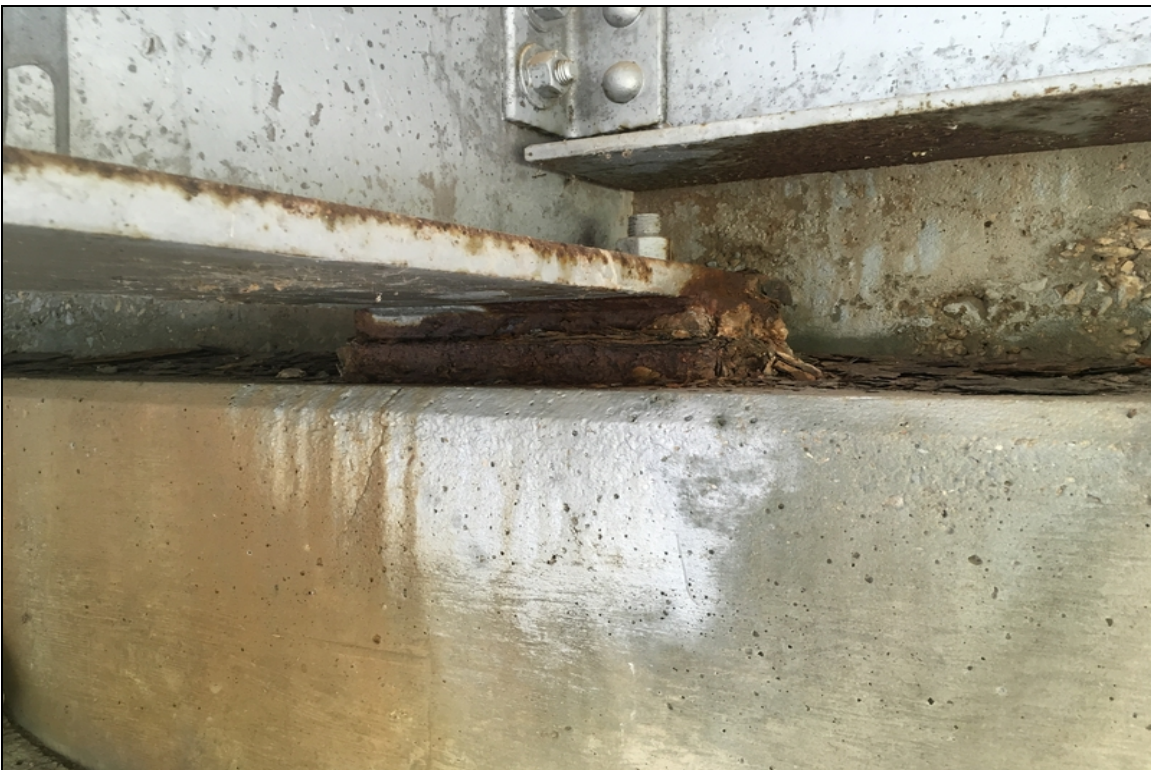
Abutment #1 bearing corrosion. Typical except bearing #4.
