Bridge #A0339(Routine)

SH 14 Marion over CAMPGROUND CREEK

Location: 0.81 MI SO JCT of US 62

Team Lead: Benjamin Smith Inspection Date: April 05, 2021

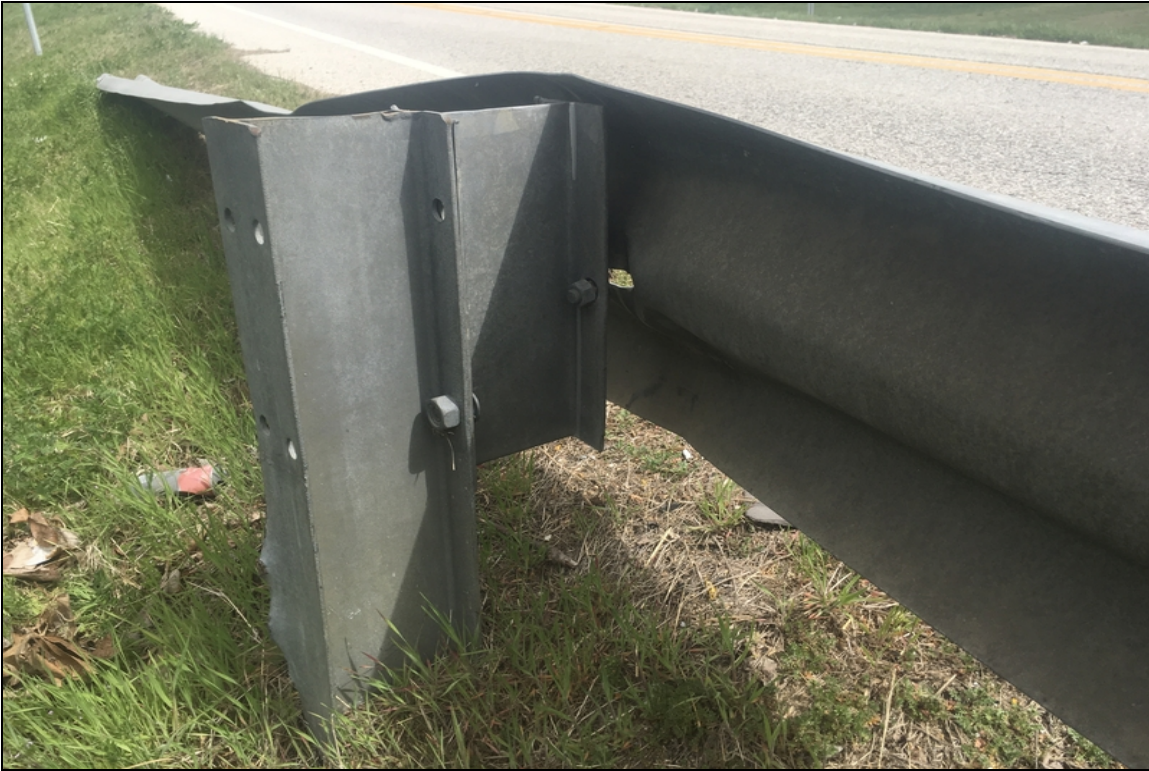
| ELEM | DESCRIPTION | UNITS | TOTAL | CS1 | CS2 | CS3 | CS4 |
|---|---|---|---|---|---|---|---|
| Approach railing- The right metal approach railing has a connection bolt that has pulled through the railing at the first post. | | | | | | | |

Connection bolt has pulled through the metal railing at the first post of the right side approach railing

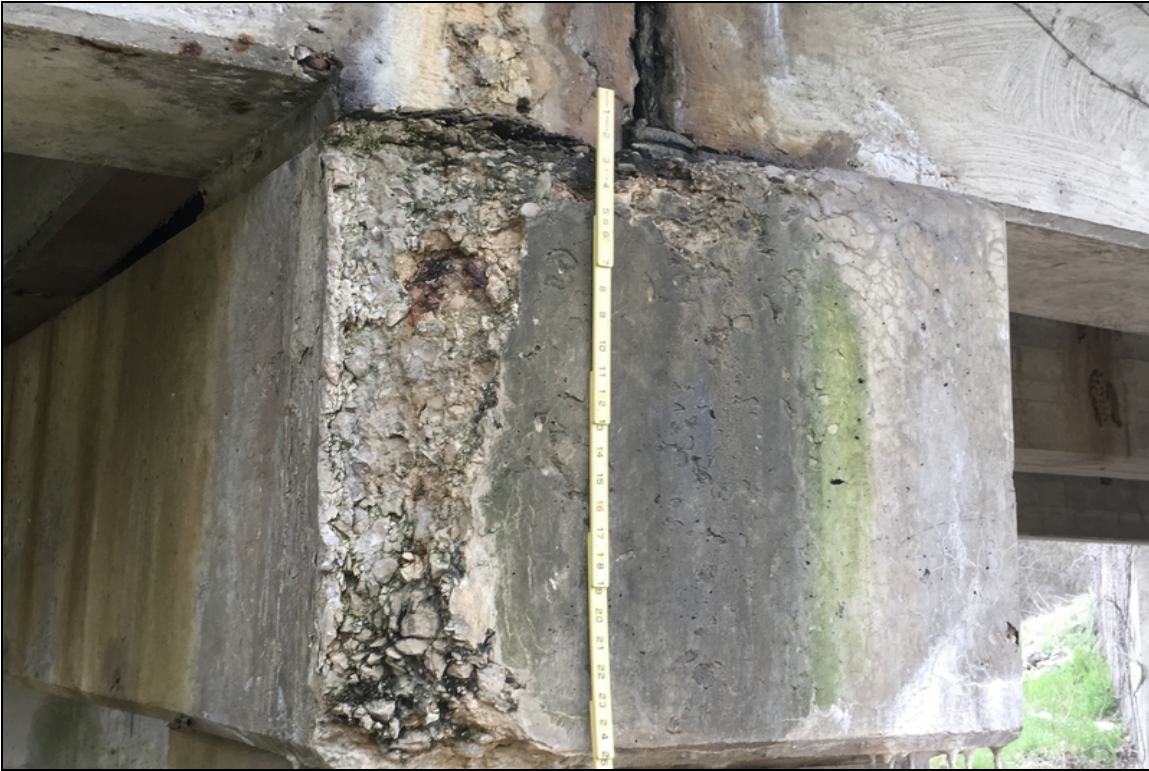
| ELEM | DESCRIPTION | UNITS | TOTAL | CS1 | CS2 | CS3 | CS4 |
|--|---|---|---|---|---|---|---|
| <p>Bent #1 cap- has 13' total of patched or delaminated areas with 1' of exposed rebar ends at the right cap end and 1' of exposed rebar on span #2 side of cap near the left haunch. The left end of the bent #1 cap has a 1' long full height and width area of deteriorated concrete that is not yet affecting the bearing area.</p> <p>Bent #2 cap- has 6' of delamination and spalling, 8' of exposed rebar and 2' of vertical cracking. The cap has patched ares on both faces. The left side of the bent #2 cap end also has a large area of deteriorated concrete that is not yet affecting the bearing area.</p> | | | | | | | |

The left cap end of bent #1 has large areas of deteriorated concrete, these areas have not yet affected the bearing area

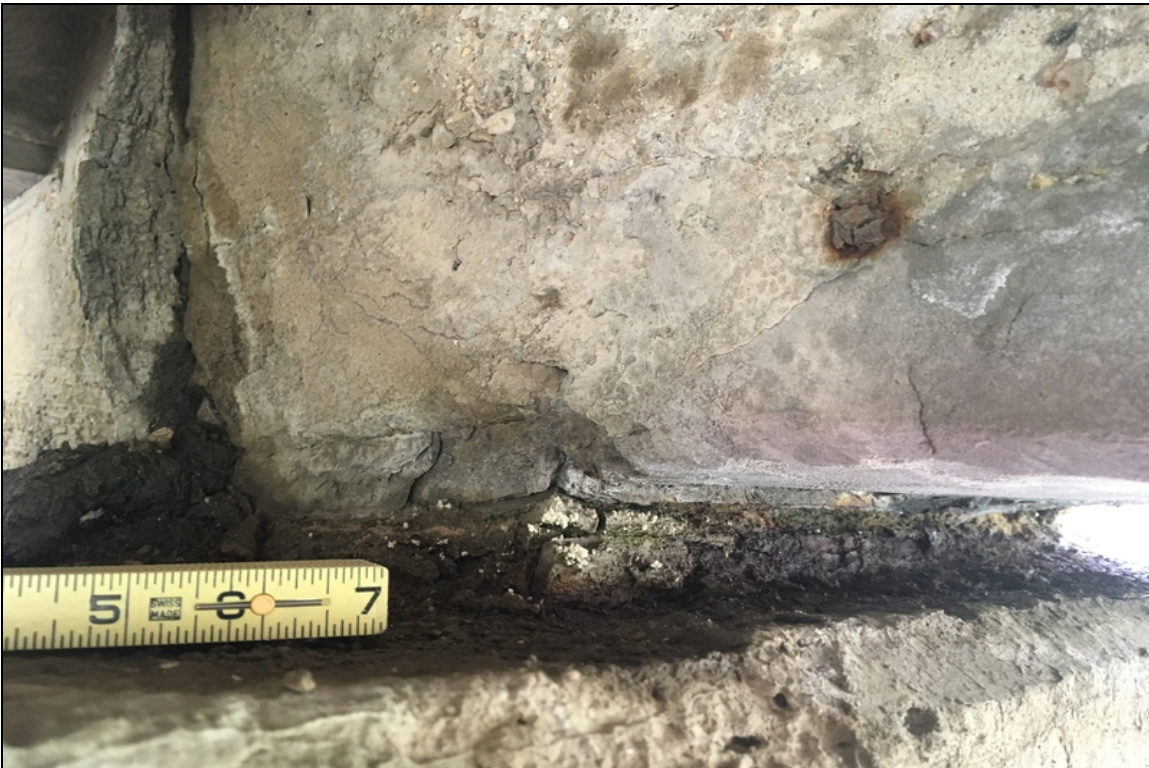
| ELEM | DESCRIPTION | UNITS | TOTAL | CS1 | CS2 | CS3 | CS4 |
|---|---|---|---|---|---|---|---|
| The 2 steel sliding plate bearings under the added on portion of the structure under beam #1 have heavy corrosion and flaking rust. | | | | | | | |

Steel bearing under beam #1 at pier #2. Typical of both.

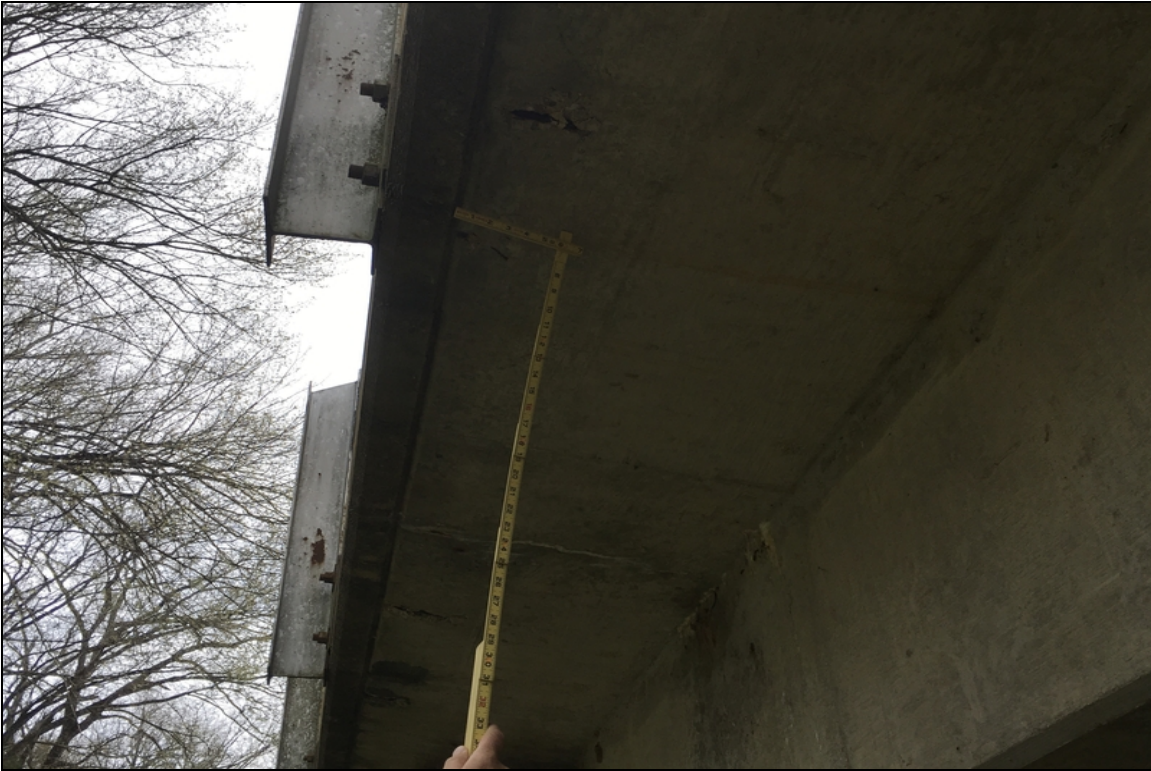
The deck soffit in the left and right overhangs of span #1 and span #2 has deep spalling with exposed rebar.

The deck soffit in the left and right overhangs of span #1 and span #2 has spalling with exposed rebar. The deck undersurface has a spall with rebar exposed in bay #1 of span #1 at abutment #1.

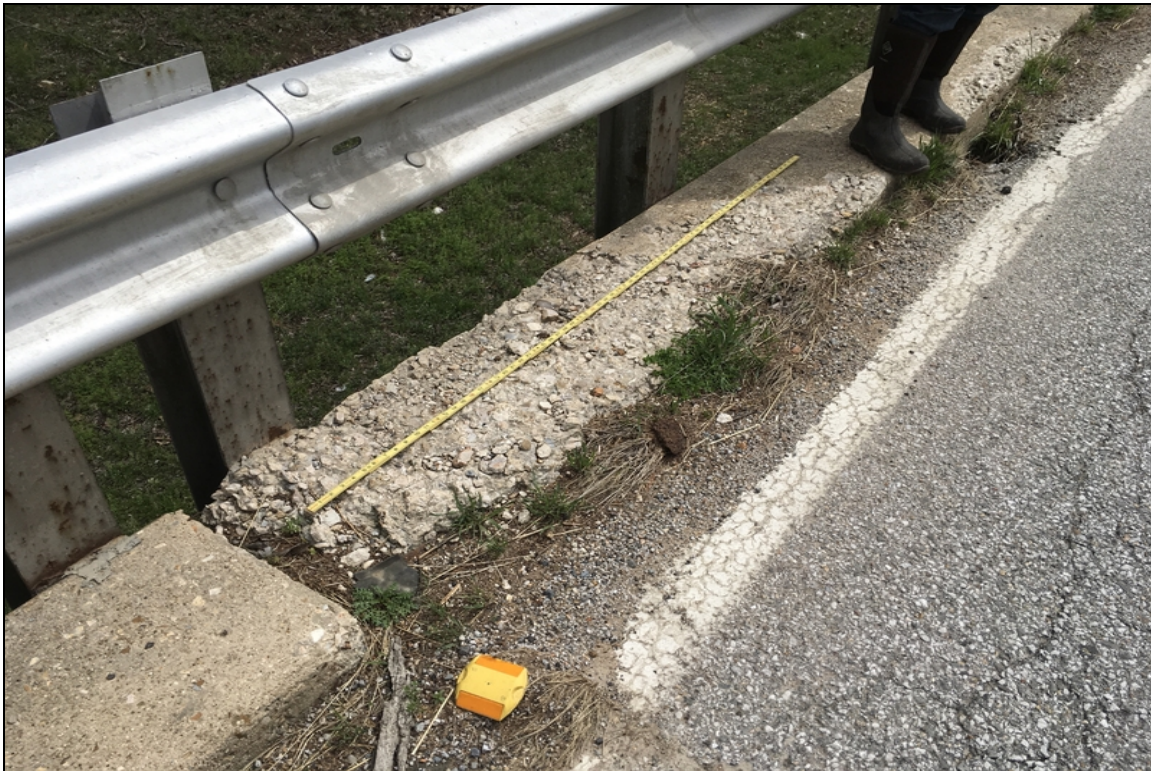
The left curb of all spans has deterioration with spalled areas, some areas have rebar exposed.

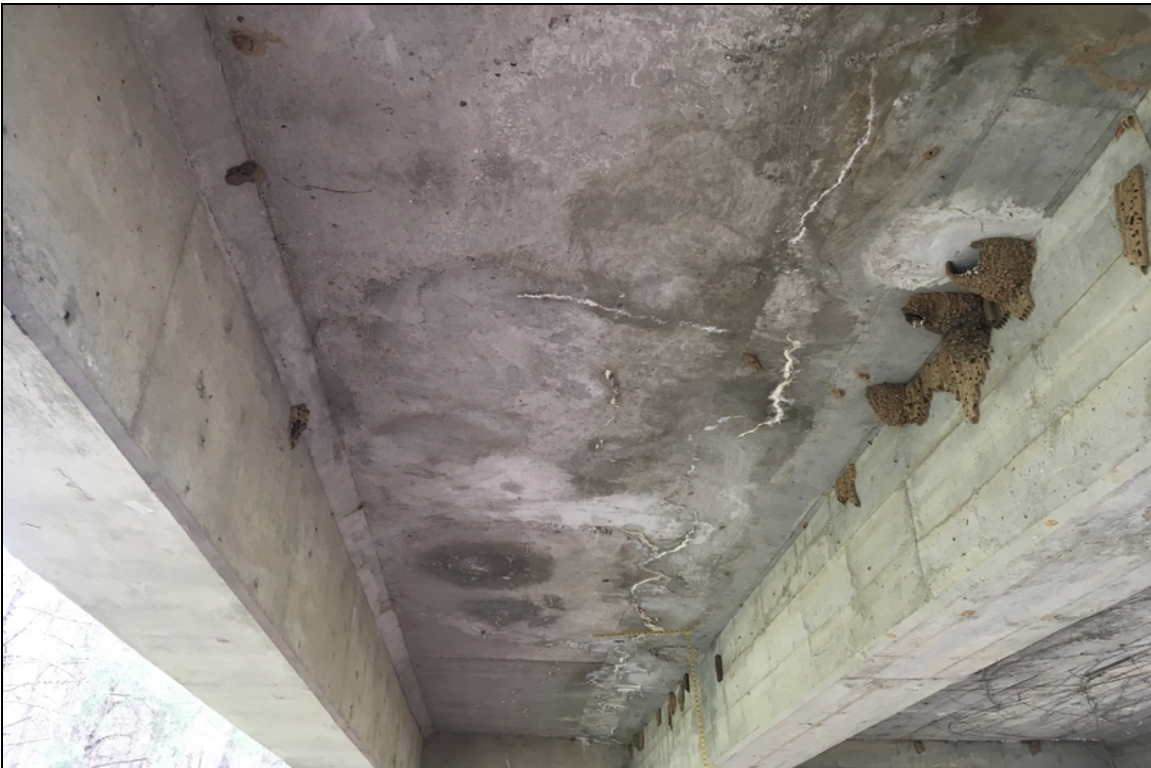
The deck soffit in span #2 bay #1 has heavy efflorescence cracking with rust staining between tee beams #1 and #2

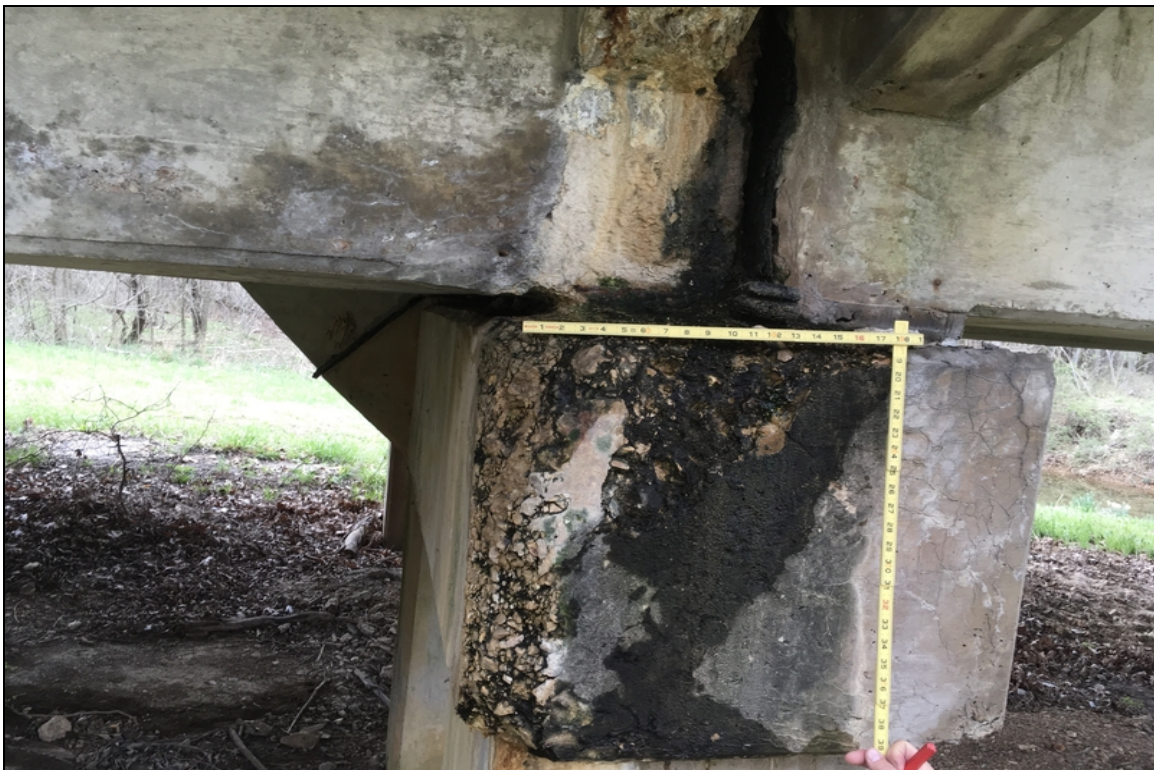
The left cap end of bent #2 has large areas of deteriorated concrete, these areas have not yet affected the bearing area

The left cap ends of bents #1,2 have large areas of deteriorated concrete, these areas have not yet affected the bearing area

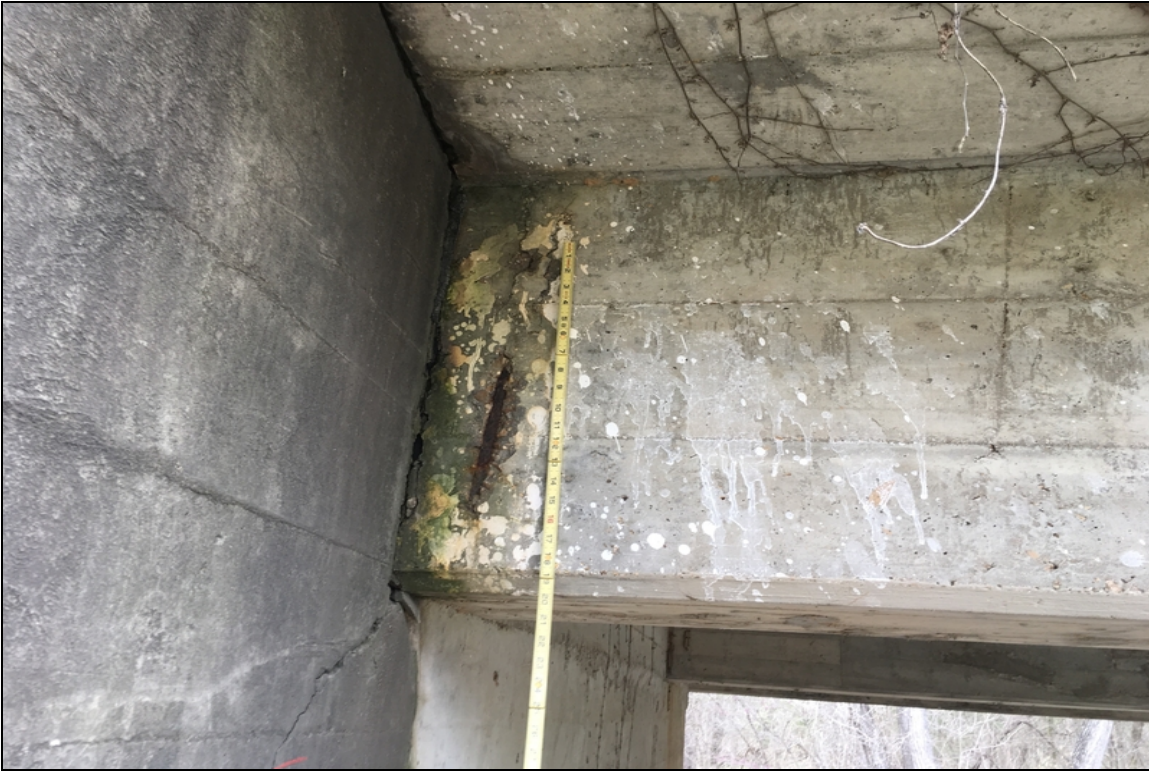
Tee beam #3 has a shallow exposed rebar at the beginning of span #1.

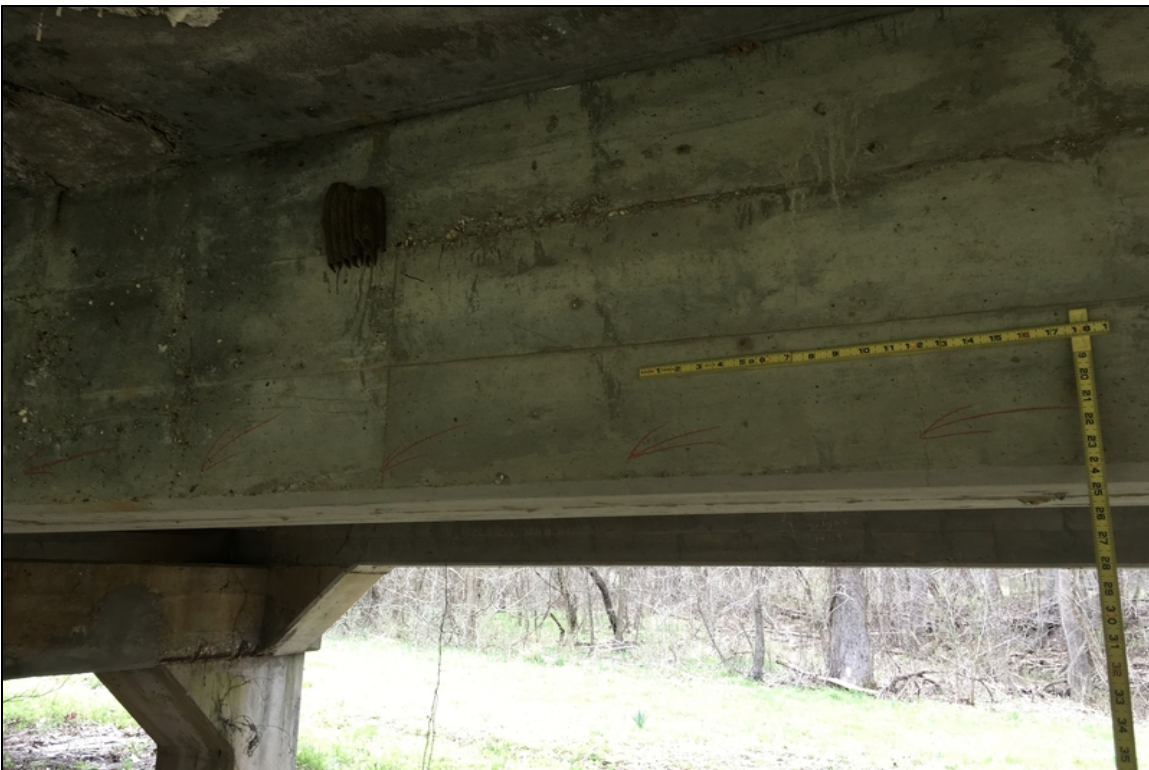
| ELEM | DESCRIPTION | UNITS | TOTAL | CS1 | CS2 | CS3 | CS4 |
|--|---|---|---|---|---|---|---|
| <p>All 3 beams in spans 1,2,3 have vertical hairline cracks that are spaced at approximately 12" intervals mostly near mid span, very few cracks were noted at the beginning and ends of the tee beams.</p> <p>Span #1 tee beams- have 77' of vertical and horizontal hairline flexure cracks in the beams. The beginning of beam #3 in span #1 has a shallow vertical exposed rebar at abutment #1. The underside of beam #1 has 2 small areas of shallow exposed rebar.</p> | | | | | | | |

Flexure cracking in beam #2 in span #2. Approximate spacing of 12".

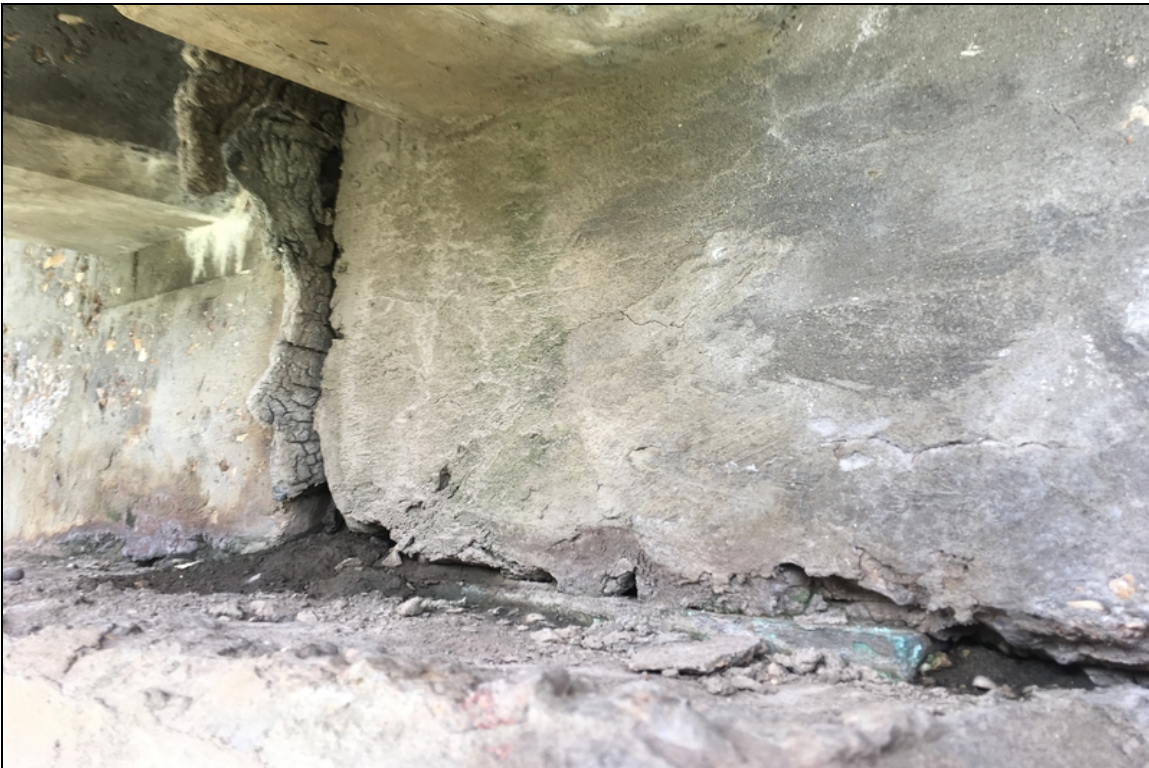
| ELEM | DESCRIPTION | UNITS | TOTAL | CS1 | CS2 | CS3 | CS4 |
|---|---|---|---|---|---|---|---|
| The 4 original moveable bearings are bronze, and have a heavy patina coating. | | | | | | | |

Original brass Bearing condition under beam #3 over bent #2.

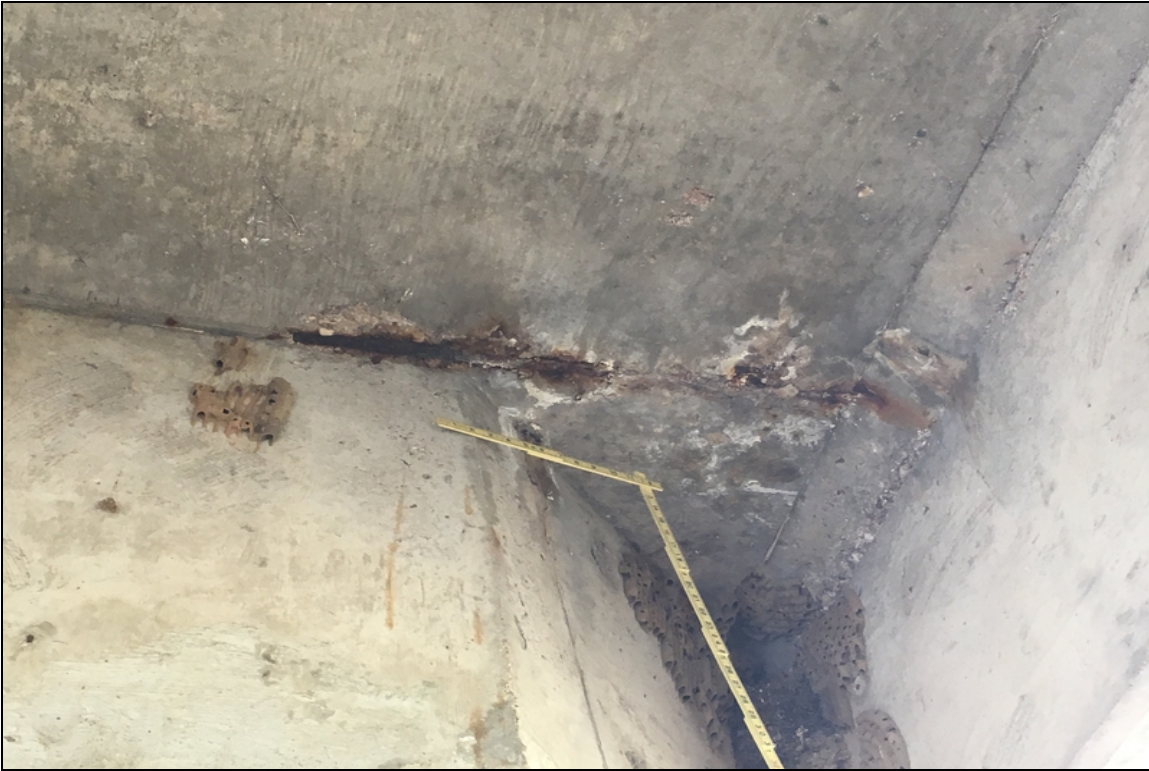
Spall with rebar exposed between beams #1 and 2 in span #1.

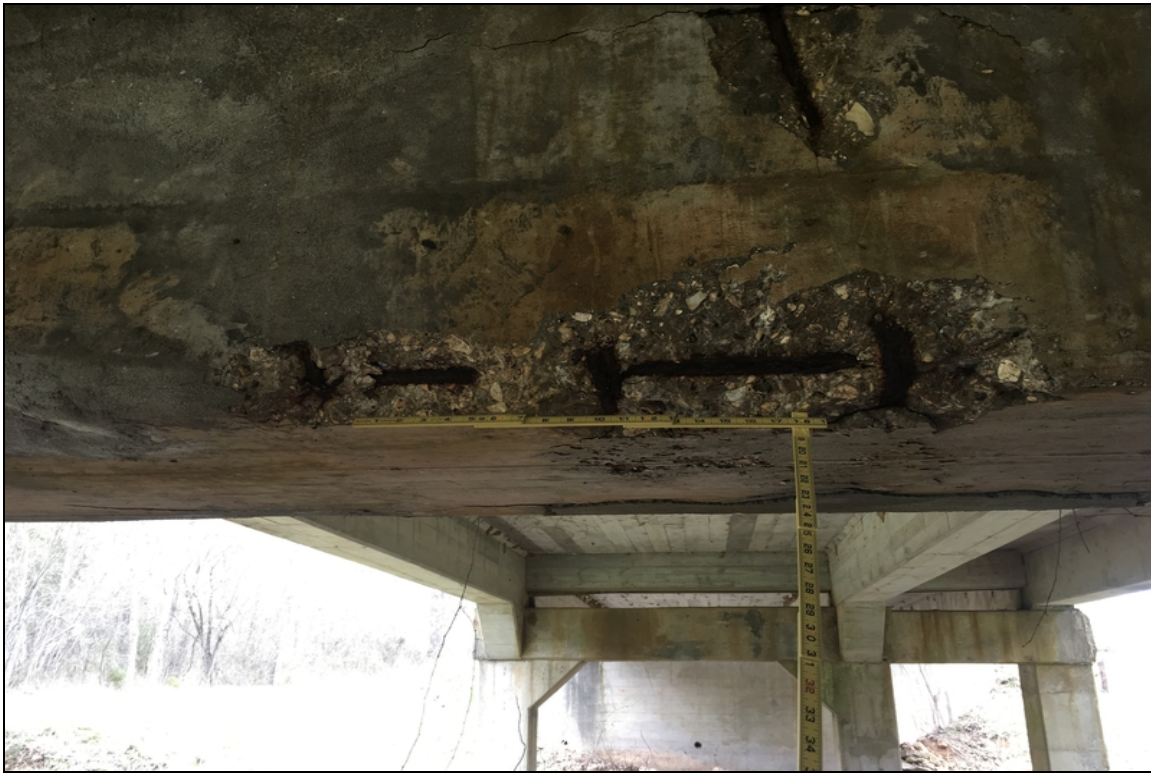
Spalling with rebar exposed on bent #2 cap.

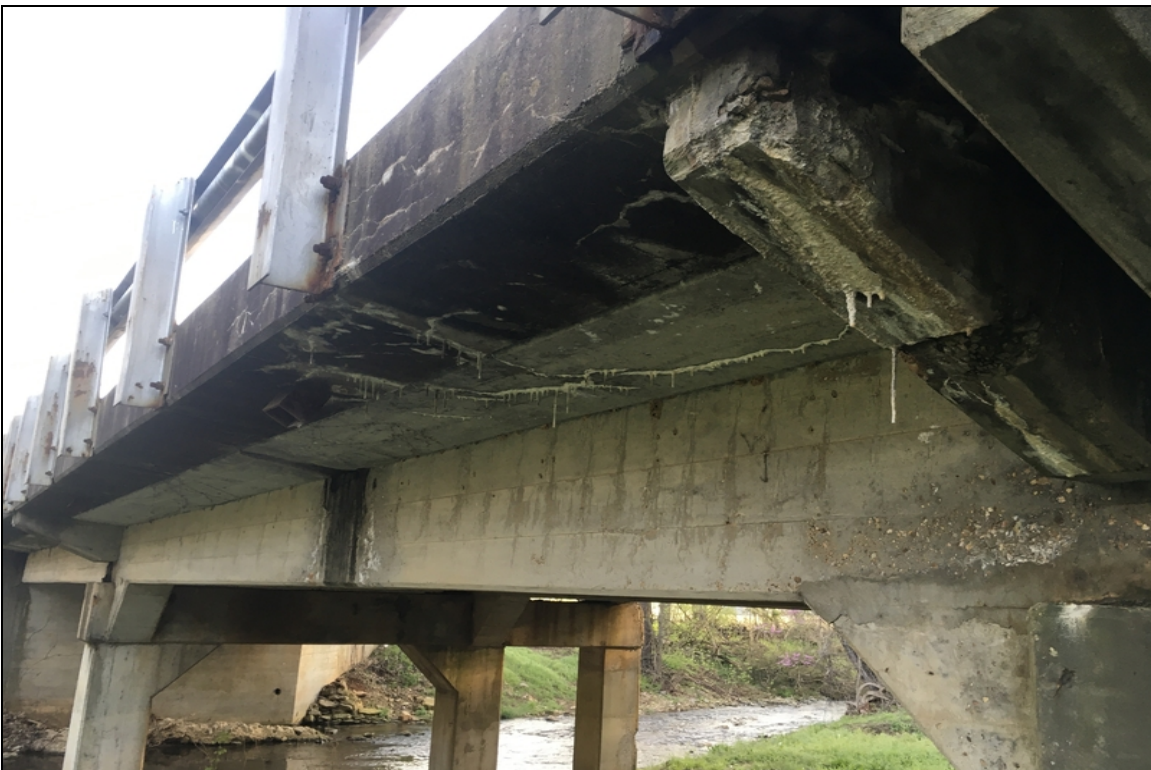
Efflorescence in the right overhang of span 2.

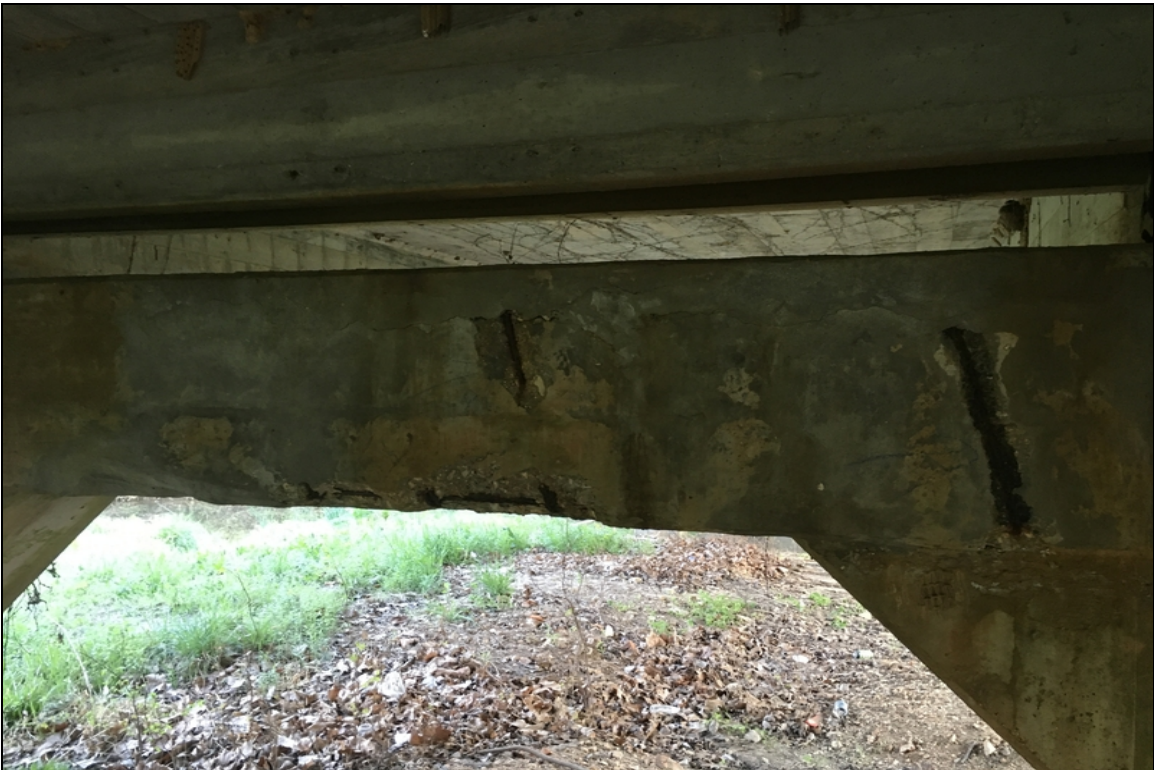
Spalling with rebar exposed on the span 3 side of the bent 2 cap.

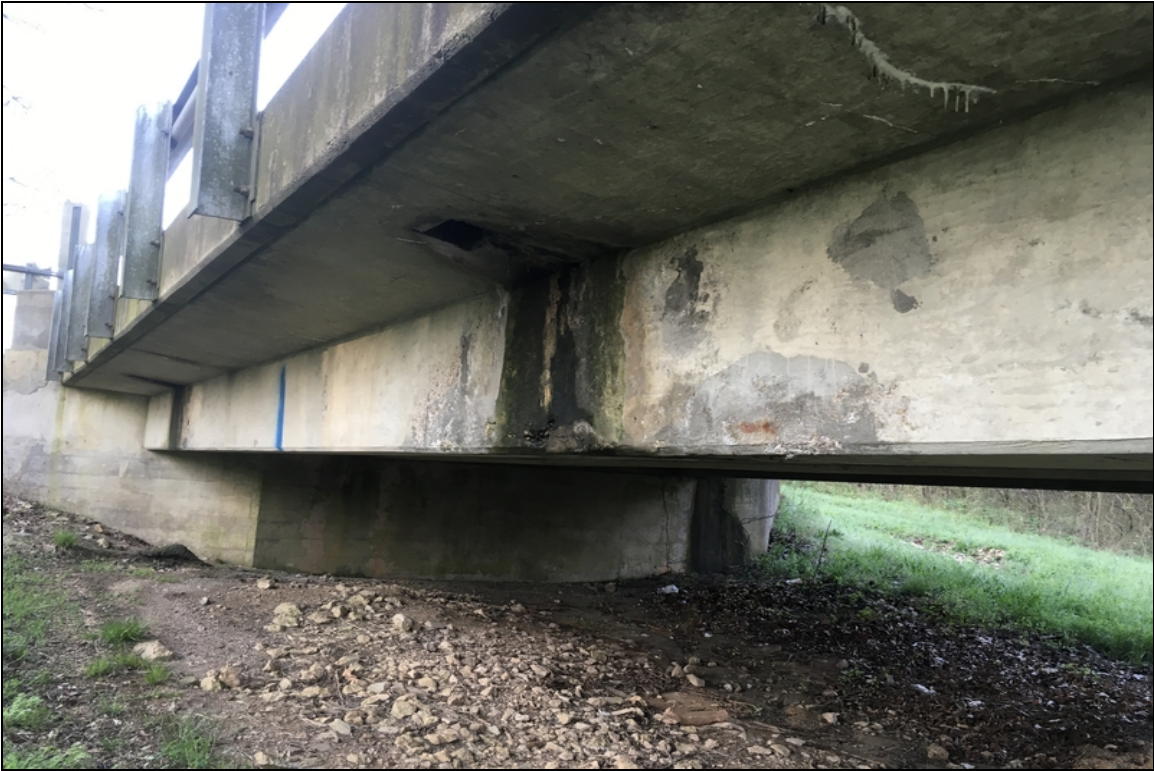
General condition of beam 1 in span 3. Showing spalling with rebar exposed and delamination.

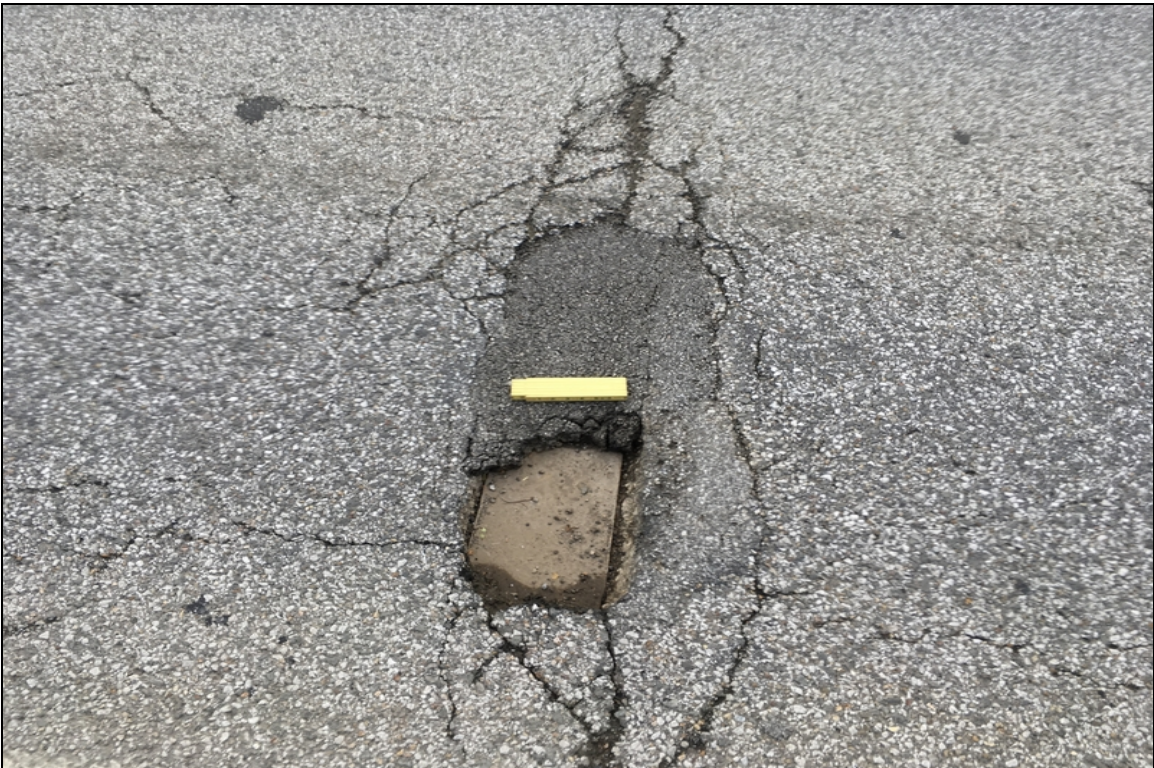
| ELEM | DESCRIPTION | UNITS | TOTAL | CS1 | CS2 | CS3 | CS4 |
|--|---|---|---|---|---|---|---|
| <p>Driving surface-</p> <p>The driving surface has 3.5" asphalt overlay that has reflective cracking, pot holes and patched areas over the joints due to an indiscriminate overlay. The left side of the curb in all spans has large deteriorated &amp; spalled areas some with rebar exposed. The wearing surface of the deck has 34' of patched areas in the driving surface.</p> <p>The under surface of the deck -</p> <p>Span #1 under surface -The deck overhangs and under surface has transverse cracks with 6' of cs2 efflorescence and 22' of cs3 efflorescence with rust staining with small areas of honeycombing and patched areas. A small spall with rebar exposed exists in span #1 between tee beams #1 and #2 at abutment #1. The left deck overhang has 4' of deep spalling with rebar exposed. The right overhang has a small spall with rebar exposed near the drain.</p> <p>Span #2 under surface- The deck overhangs and under surface has transverse cracks with 55' of cs2 efflorescence and 22' of cs3 efflorescence with rust staining with small patches. A heavy concentration of efflorescence cracking exists between tee beams #1,2 in span #2. Span #2 has two 1' x 1' suspected areas of full depth deck failures in bay #1. The left deck overhang of span #2 has 3 areas of shallow exposed rebar. The right deck overhang has 1 small area of exposed rebar with heavy efflorescence. The left deck overhang cantilever has a large spall with exposed rebar.</p> <p>Span #3 under surface- has transverse cracks with efflorescence, some with rust staining and 15' of small patched areas. The left and right deck overhangs and under surface have cracking with 33' of cs2 efflorescence and 10' of cs3 efflorescence with areas of shallow exposed rebar.</p> | | | | | | | |

Pot hole in the right driving lane over the joint area.

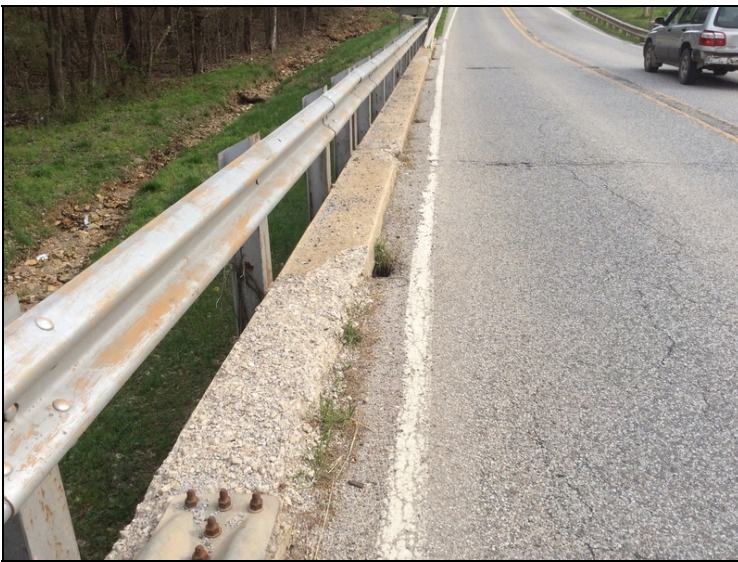
Deteriorated curb areas at left side of structure

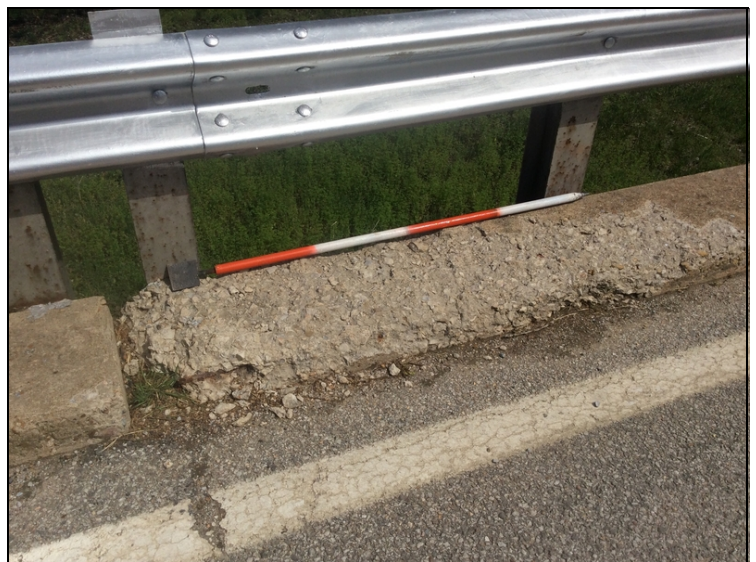
Deterioration at the left curb of structure typical of several locations.

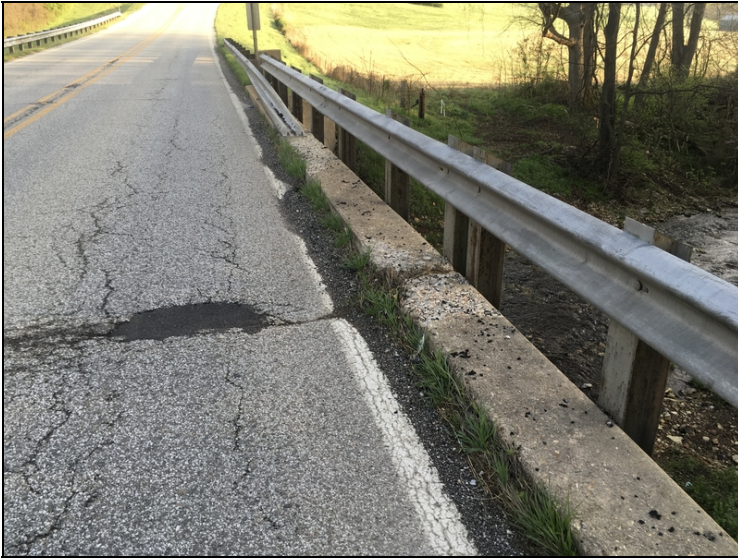
Deterioration in the left curb section.

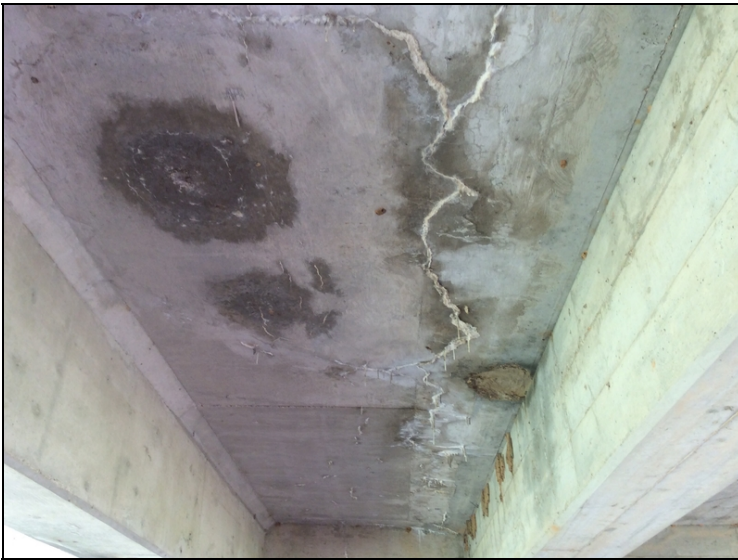
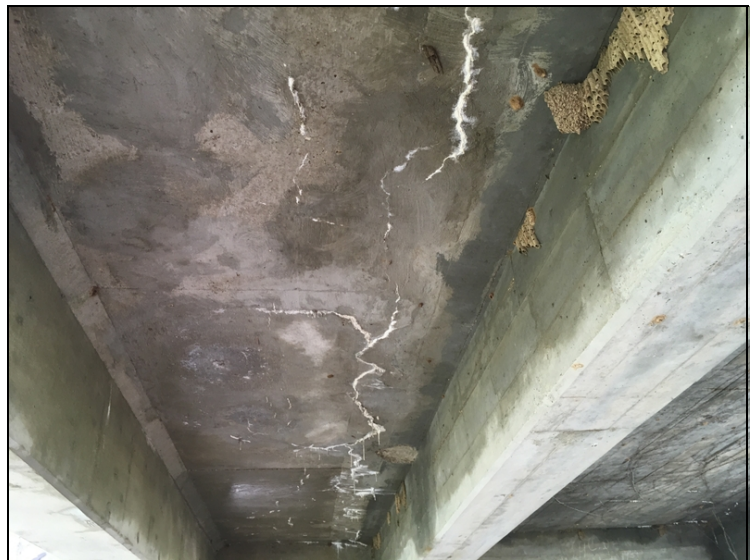
Undersurface of deck in span #2 between beams 1,2 showing efflorescence cracking.

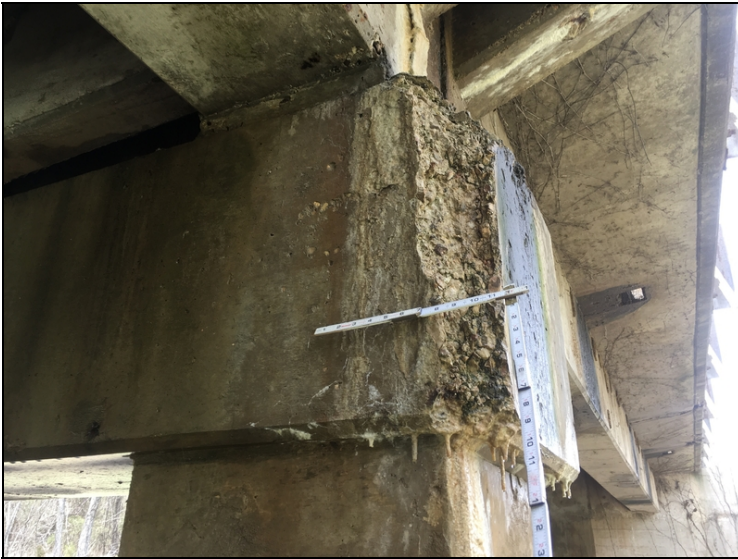
The left cap end of bent #1 showing deterioration for 1'.

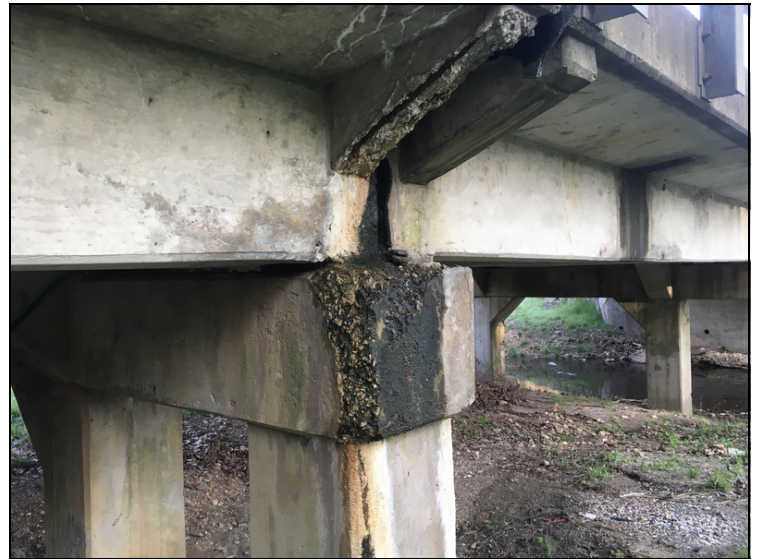
Left end of bent cap 2 showing spalling with rebar exposed.
