Bridge #A6475(Routine, Underwater type 2)

US 412 WB Benton 2 over BUTLER CREEK

Location: 2.8 MI E OF JT SH59&US412

Team Lead: Benjamin Smith Inspection Date: May 12, 2021

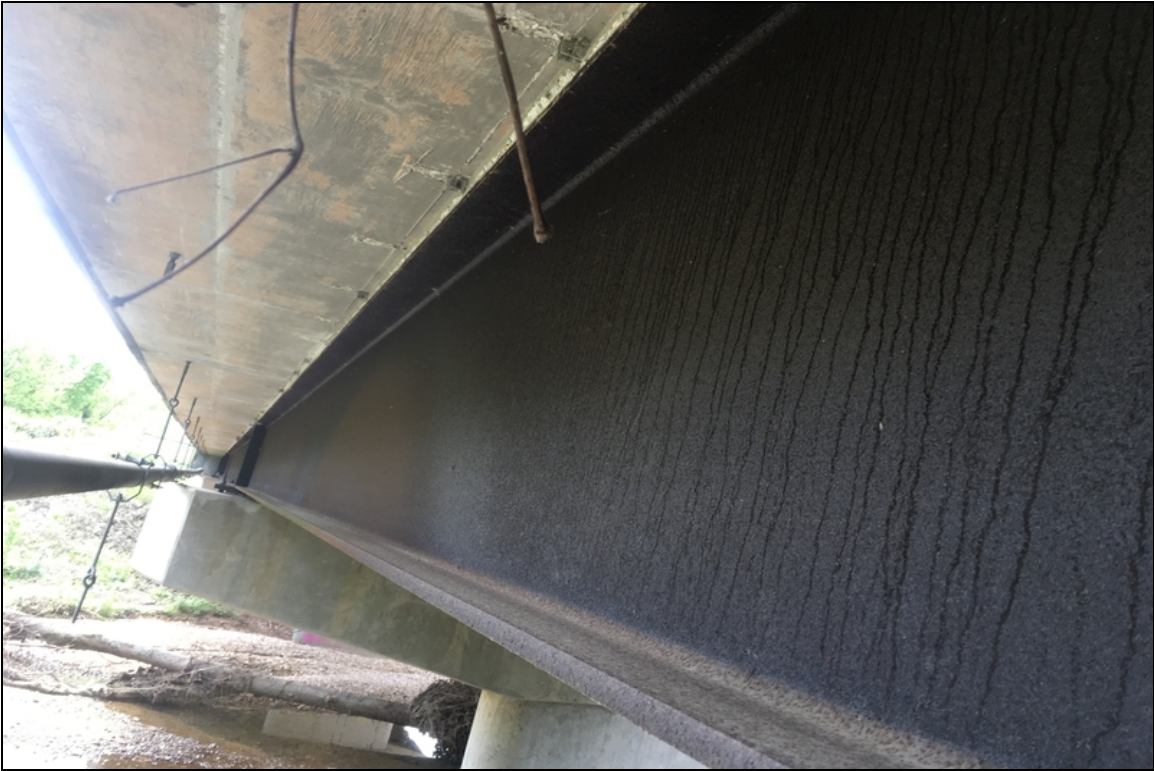
(107)							
Span #1- Beam #1 has small sporadic areas of cs2 corrosion on the exterior face. Span #2- beam #1 has 1' of cs2 corrosion on the interior of the 2nd splice panel. Beam #1 has small sporadic areas of cs2 corrosion on the exterior face. Span #3- Beam #1 has small sporadic areas of cs2 corrosion on the exterior face.							
210	Reinforced Concrete Pier Wall	LF	28	27	1	0	0
6000	Scour	LF	1	0	1	0	0

Areas of cs2 corrosion on the exterior of beam #1 in all 3 spans.

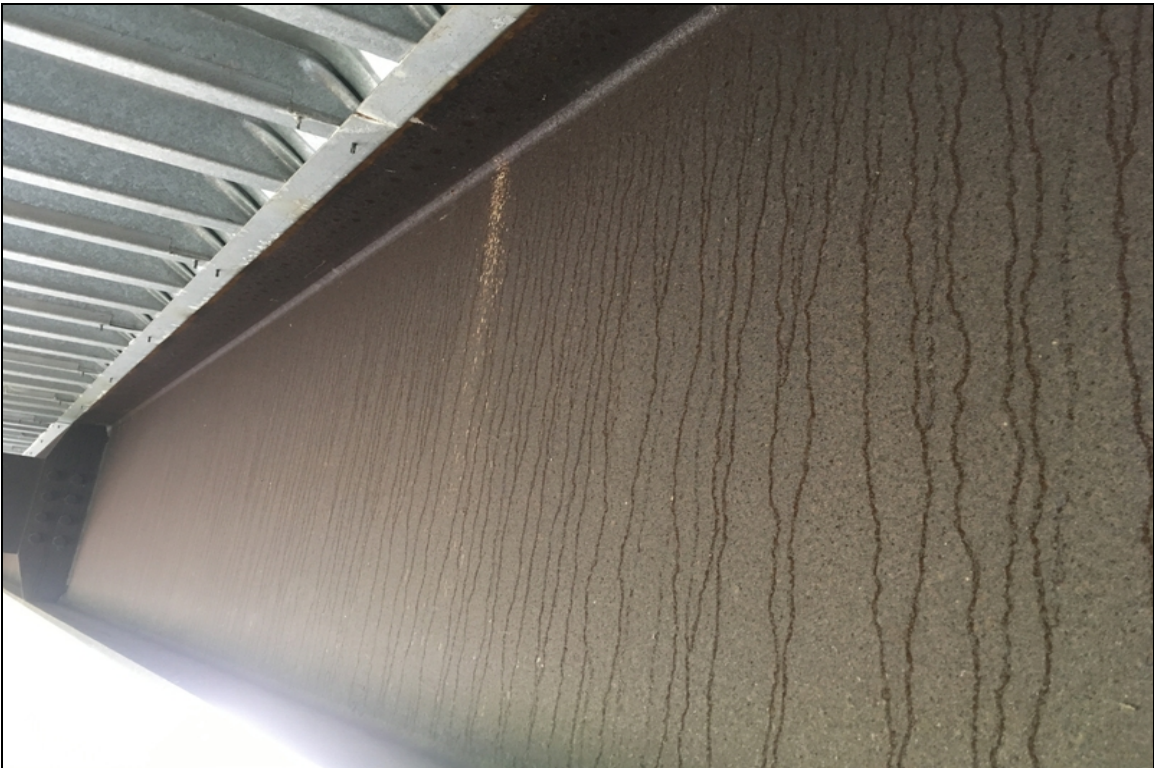
Typical view of the weathering steel protective coating condition.

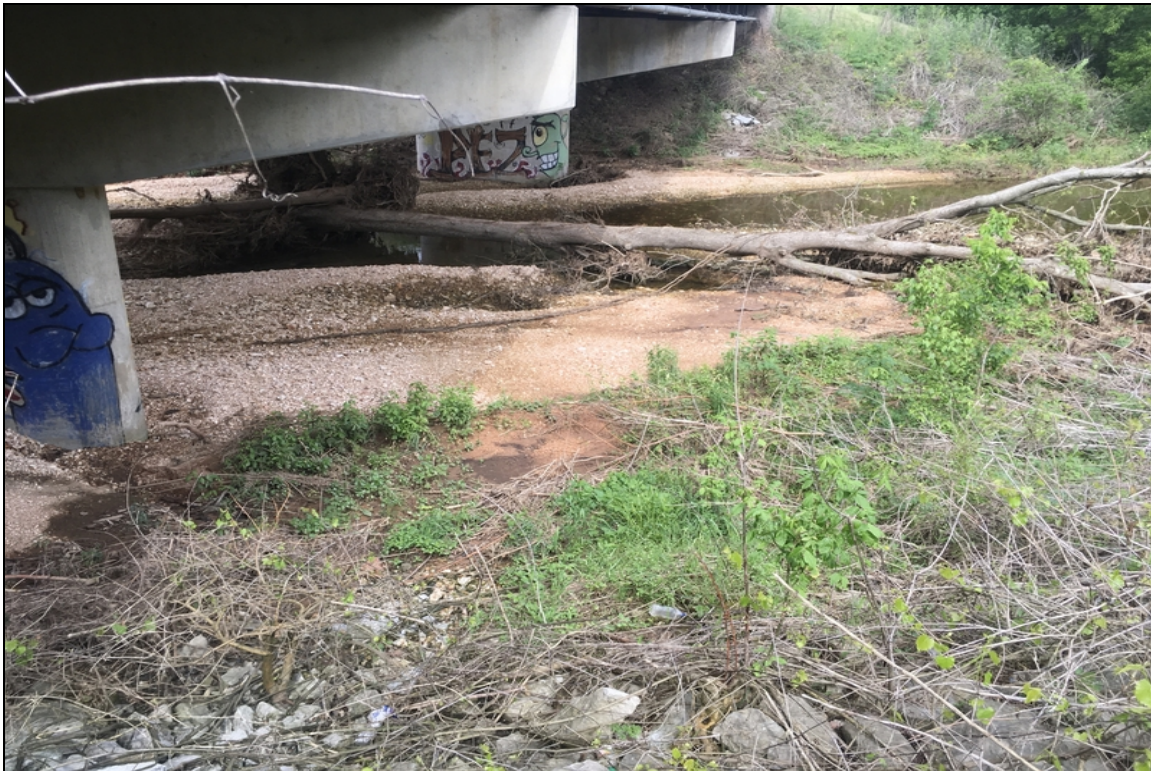
Span #2 has a large tree in the channel.

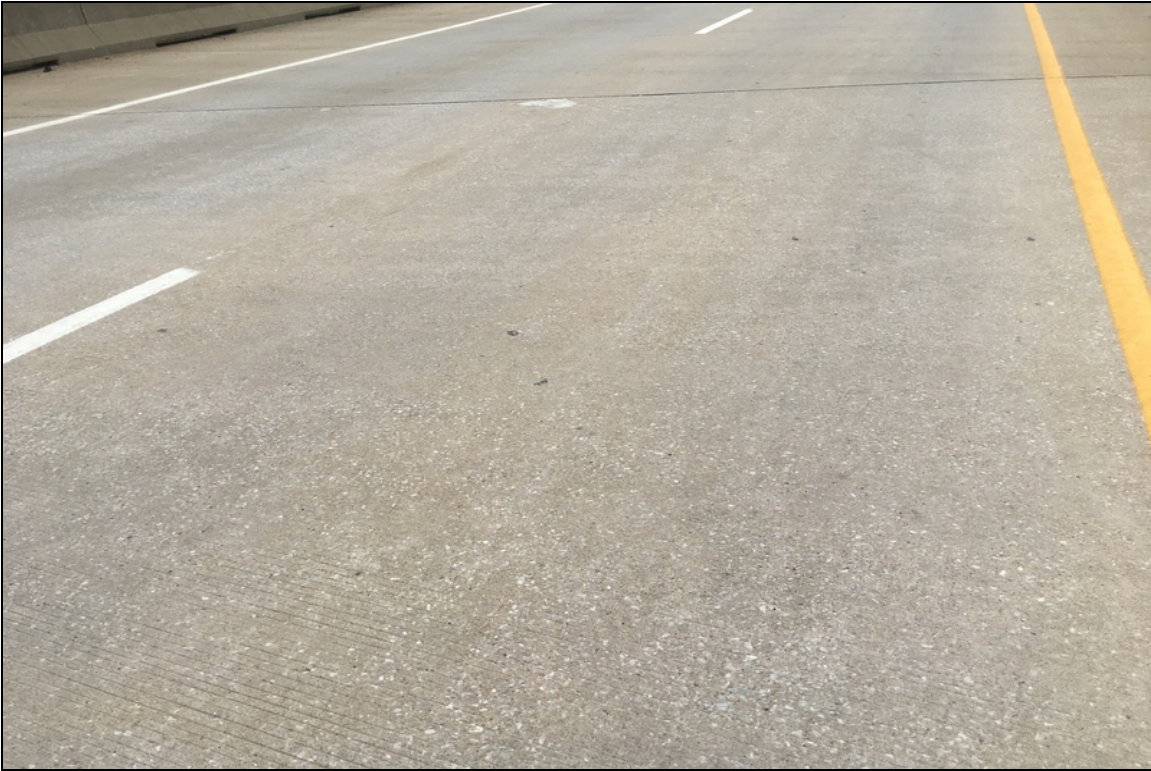
Typical view of driving surface.

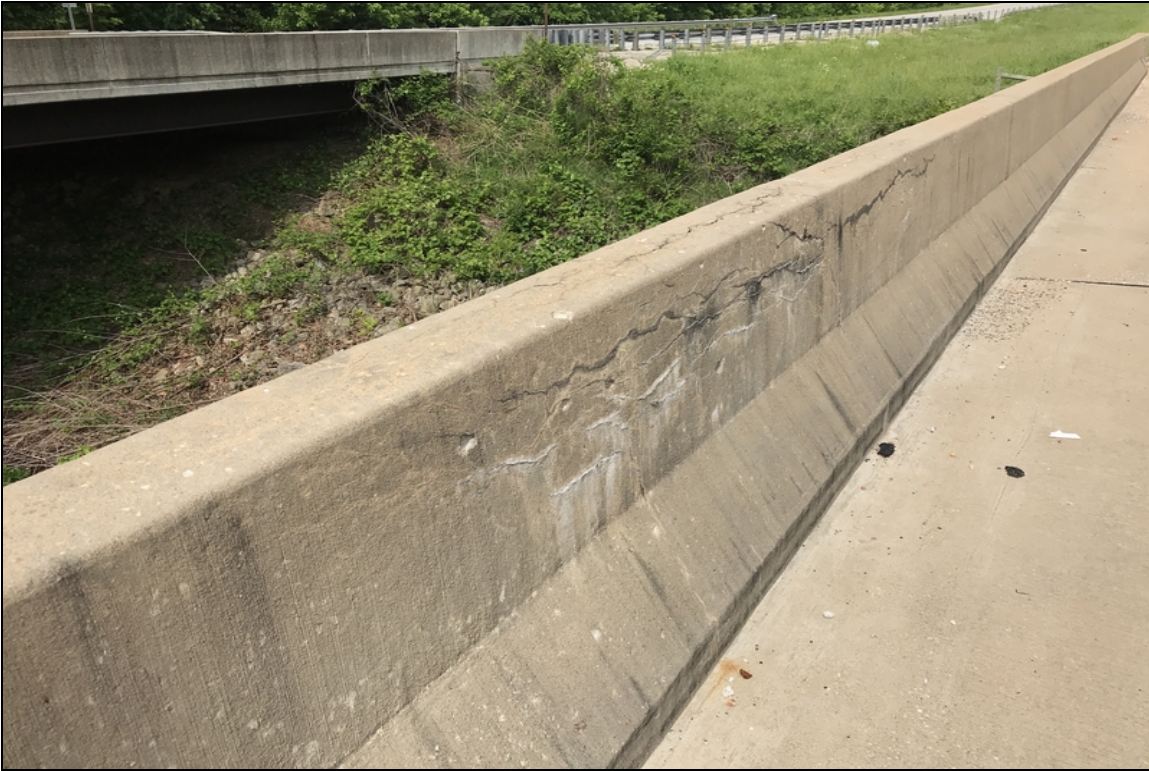
Parapet Railing right cracking with efflorescence.

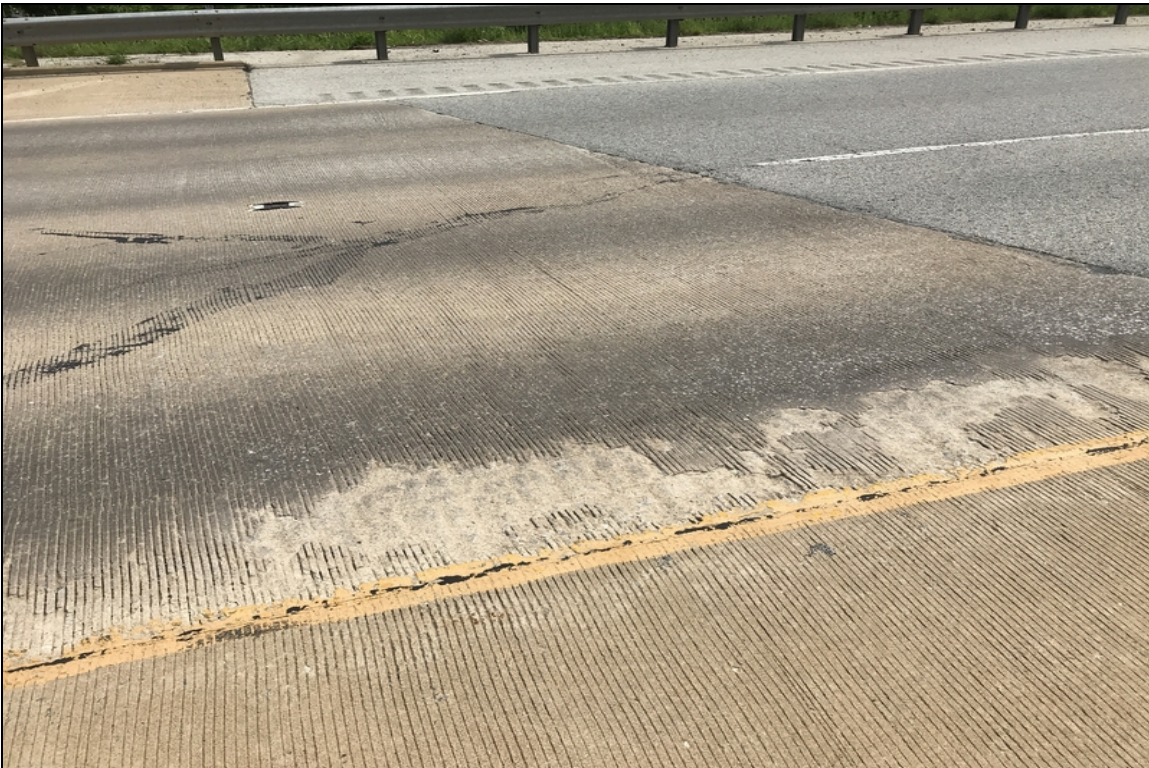
East approach slab minor spalling adjacent yellow line.

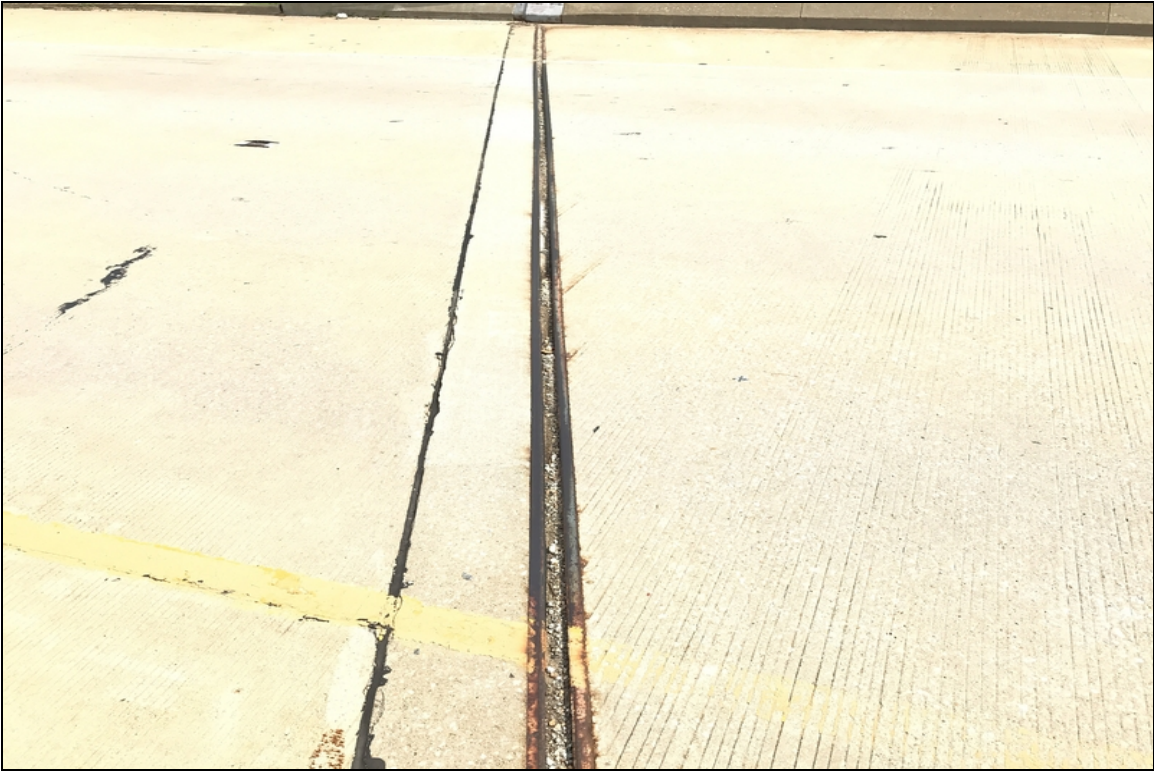
Abutment #1 joint material has debris impaction and loss of adhesion

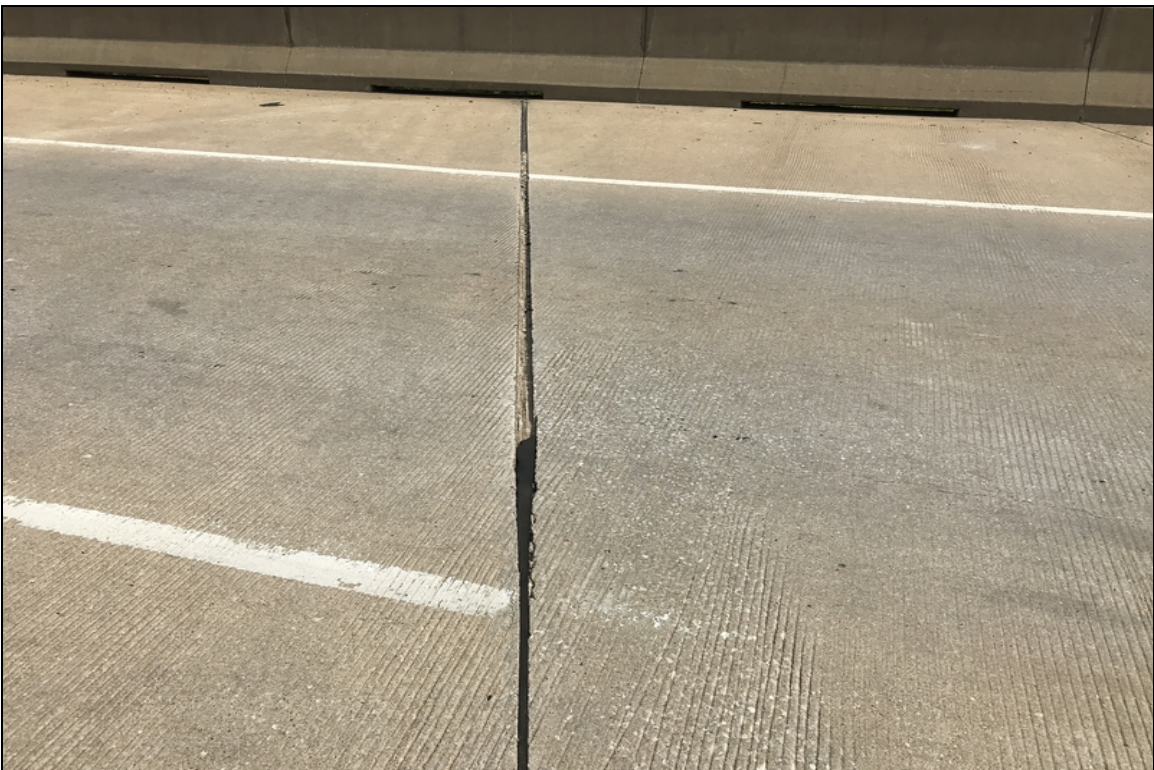
Construction joint pourable material missing. Typical

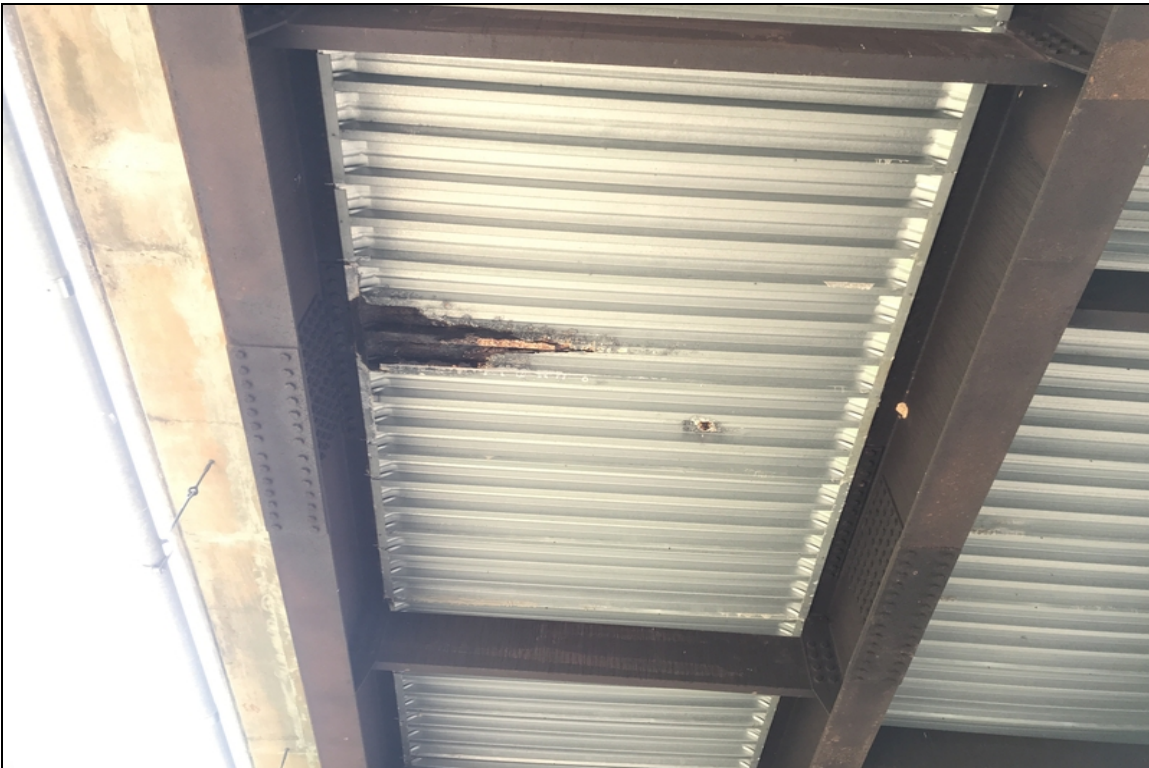
Span #2 bay #1 approximately 13' behind bent #2 corrosion of SIP form.

The pourable type construction joint sealant has failed in locations with portions of the sealant missing allowing water leakage that appears to be causing corrosion to SIP forms.

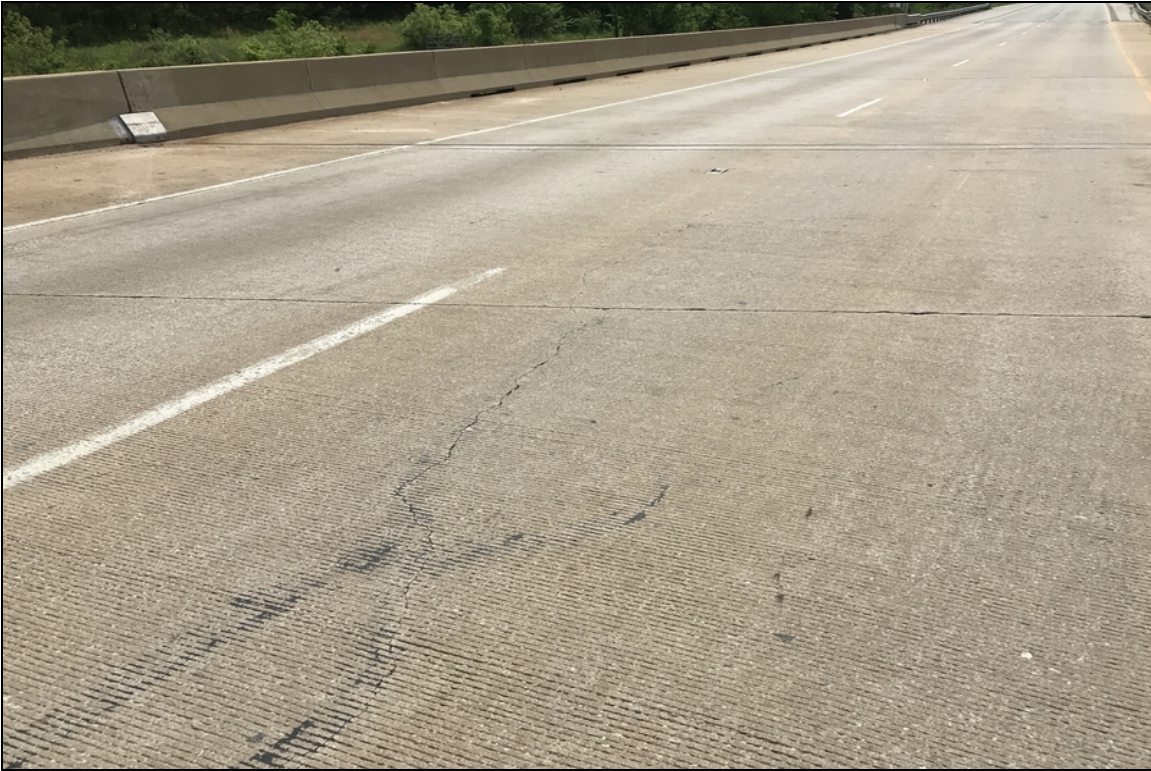
Large cracking in west approach slab.

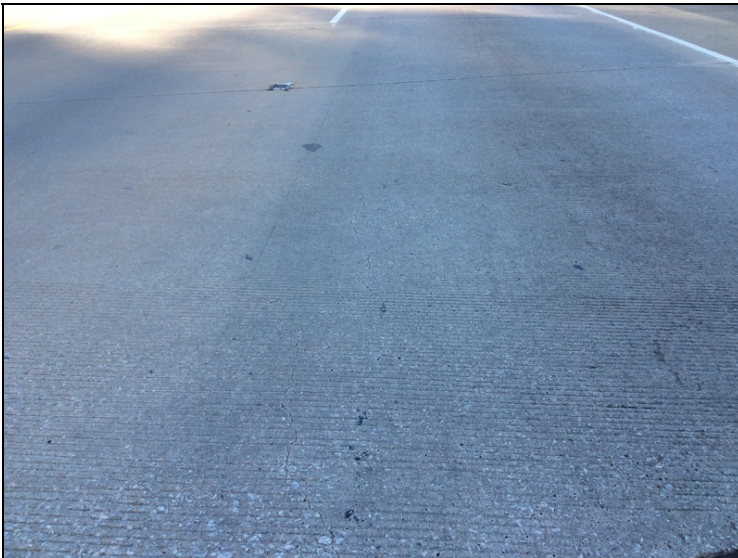
Deck - The driving surface of the deck has numerous sealable cracks in all spans. The most notable area is the outside lane in span #1 which has several wide transverse cracks.

Deck Left lane over bent 2 longitudinal cracking.

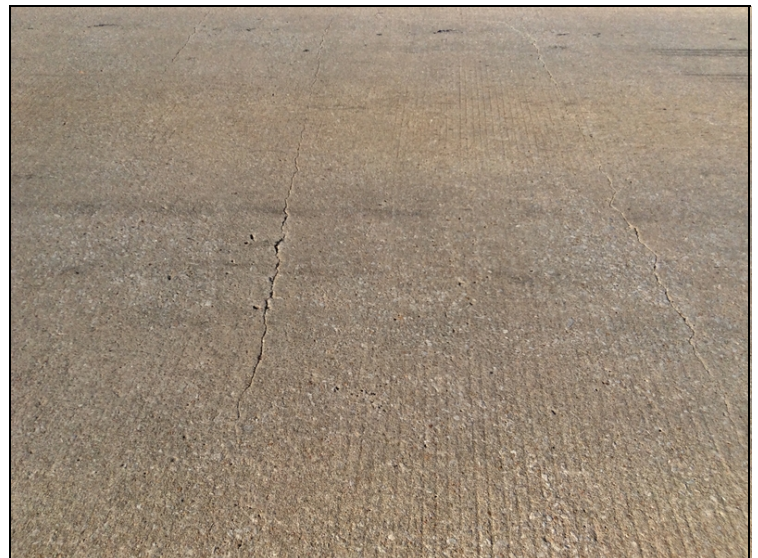
Span #1, outside lane-Transverse cracking.

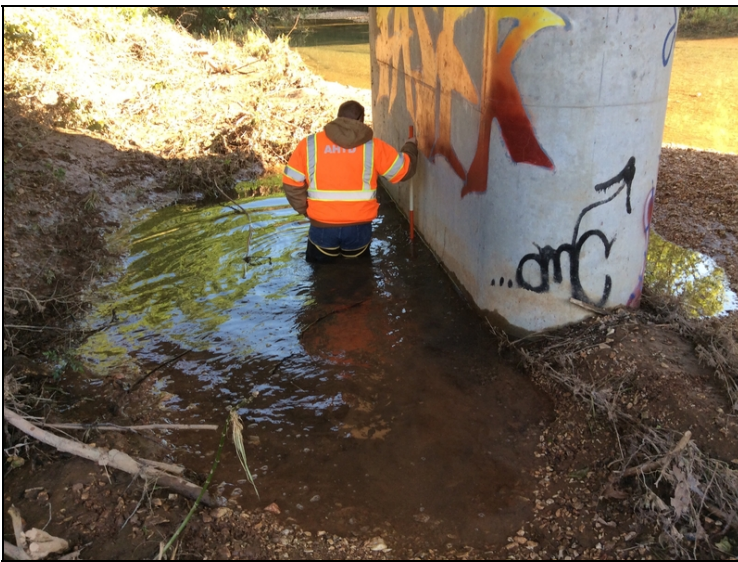
(210)							
Pier wall #1- The channel has a minor scour hole on the upstream side with minor drift accumulation. The footing is not exposed at this inspection. Pier wall #2- no deficiencies noted. The footing has cover.							
215	Reinforced Concrete Abutment	LF	128	115	13	0	0
1130	Cracking (RC and Other)	LF	13	0	13	0	0

Channel - The channel has local scour at the base of bent #1 that has created a scour hole approximately 3' deep on the span #1 side of bent. The footing has cover at this inspection.

It was noted during the routine inspection that this area has naturally filled in with stream bed material.

Bent #1-Scour hole.

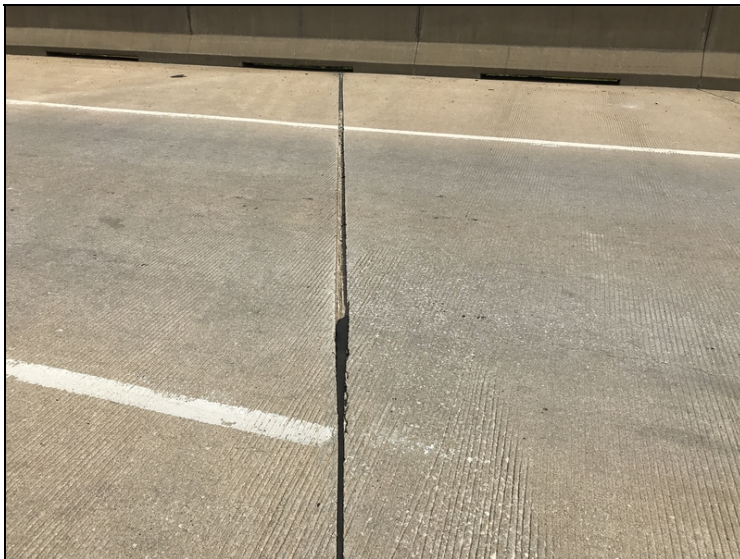
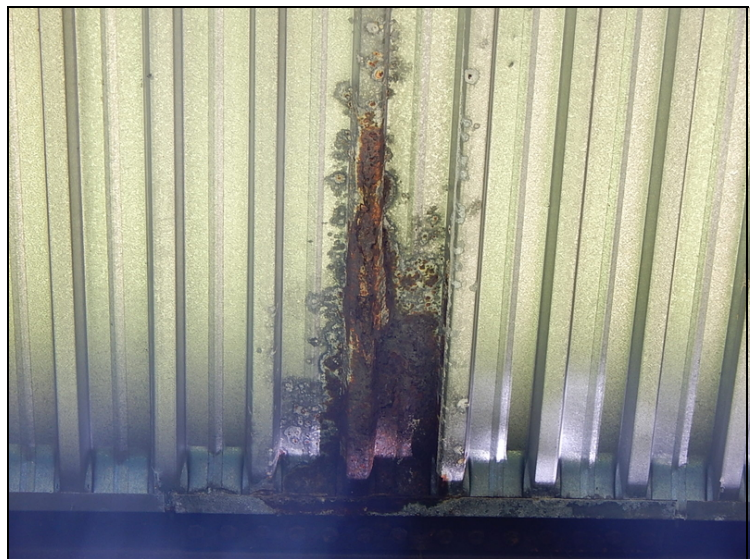
Construction joint pourable material missing.
Typical

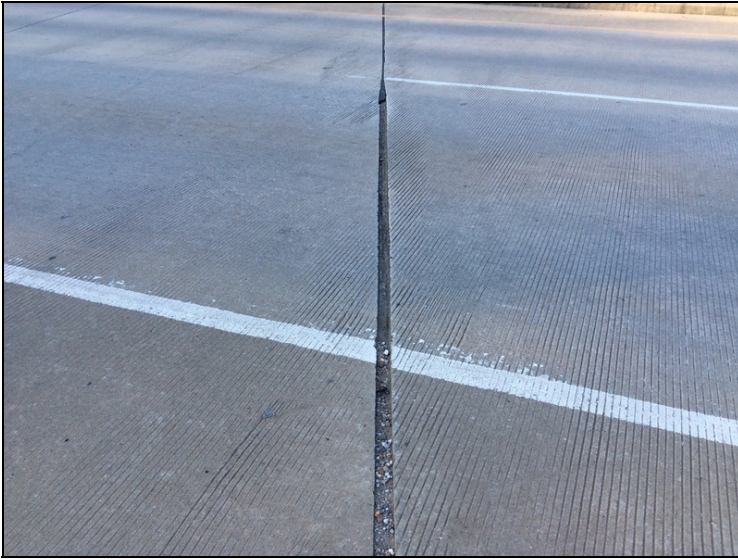
Constuction joint span 2 near bent 2 joint material missing.

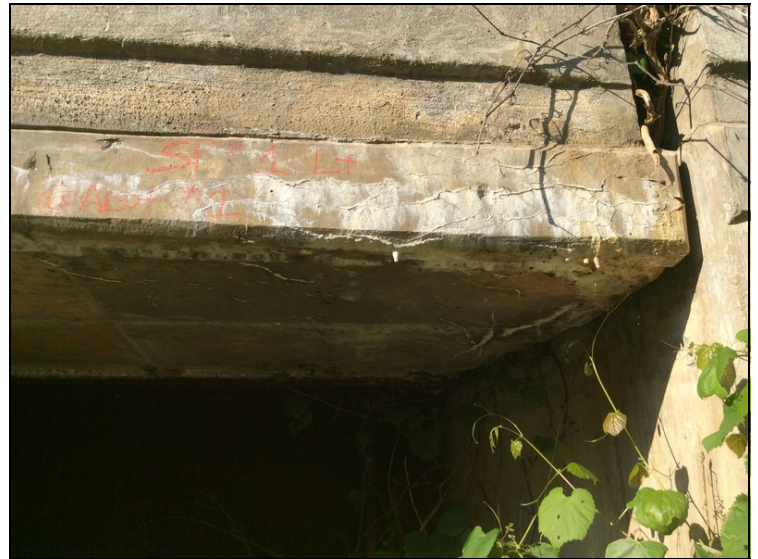
Span #1, Left side adjacent to abutment #1 has an area of concrete deterioration with a 12" long delaminated area to the vertical face of deck with cracking and efflorescence in the surrounding area.

Span #1, Left side-Delaminated area with cracking and efflorescence.

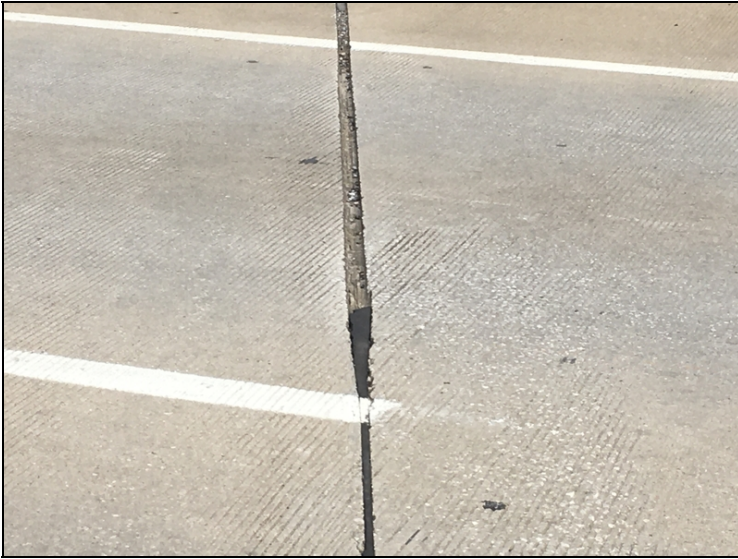
12' of Pourable joint seal is missing at the beginning of span #2.

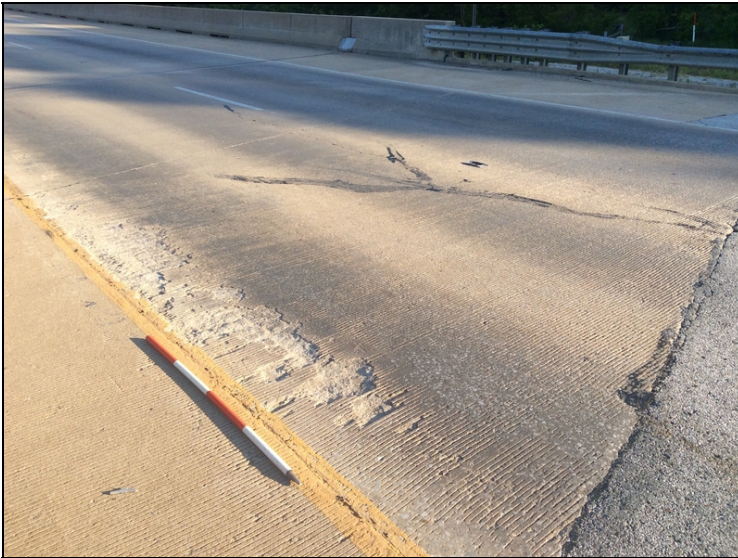
The East approach slab has an area of spalling 2' wide and 12' long in the left inside wheel path.

The West and East approach slabs have several areas of wide cracking.

East approach slab has cracking and spalling.

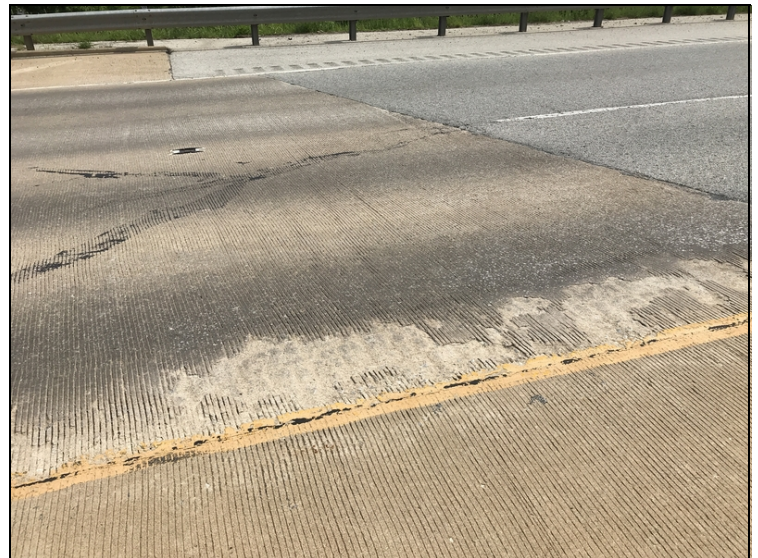
East approach slab minor spalling adjacent yellow line.

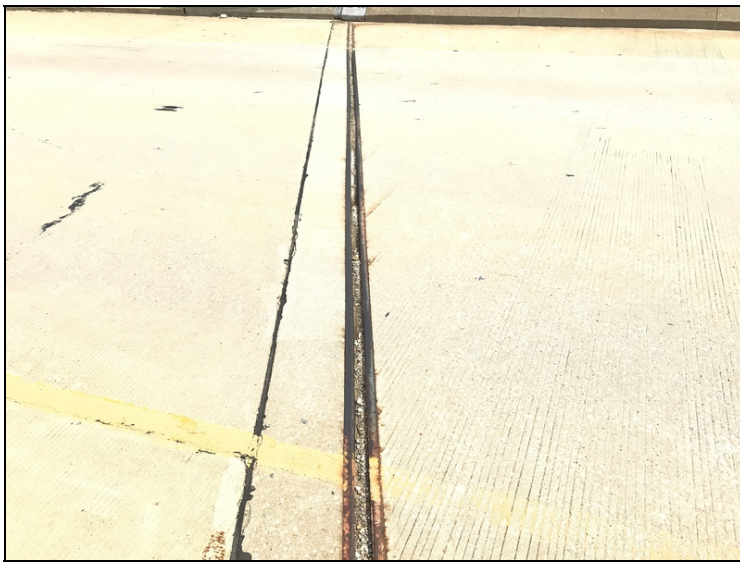
Expansion joints - The compression joint seals at the East and West bridge ends have debris impaction the full length of joints.

Abutment #1 joint material has debris impaction and loss of adhesion

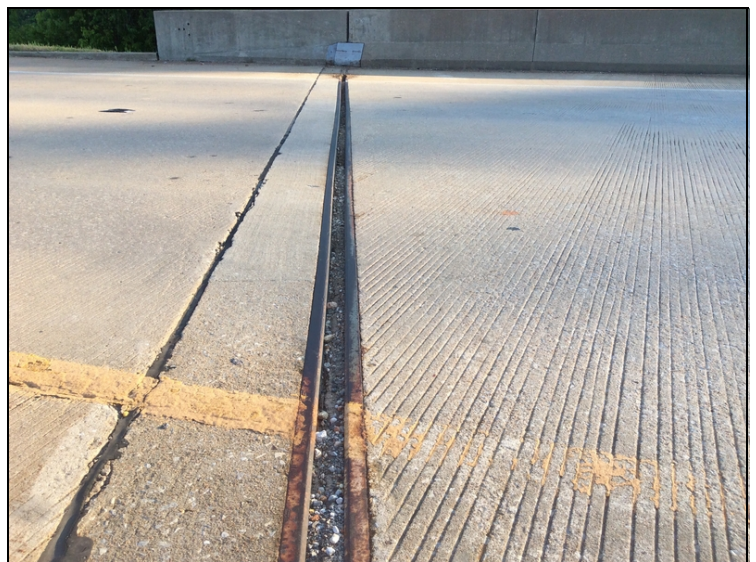
Abutment 1 compression joint seal- debris impaction.

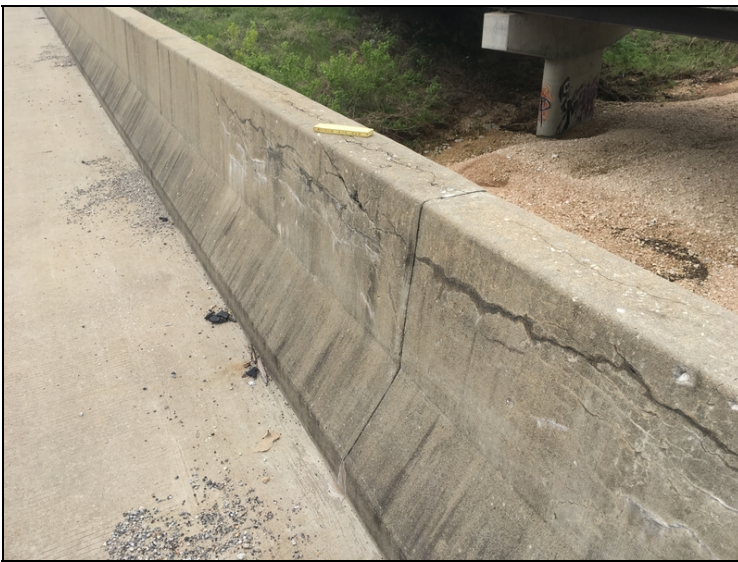
The right parapet wall has areas of horizontal cracking with efflorescence. Most notably in span #2.

The right side parapet wall in span #2 has horizontal cracking with efflorescence.
