Bridge #B6475(Routine, Underwater type 2)

US 412 EB Benton 2 over BUTLER CREEK

Team Lead: Benjamin Smith Inspection Date: May 12, 2021

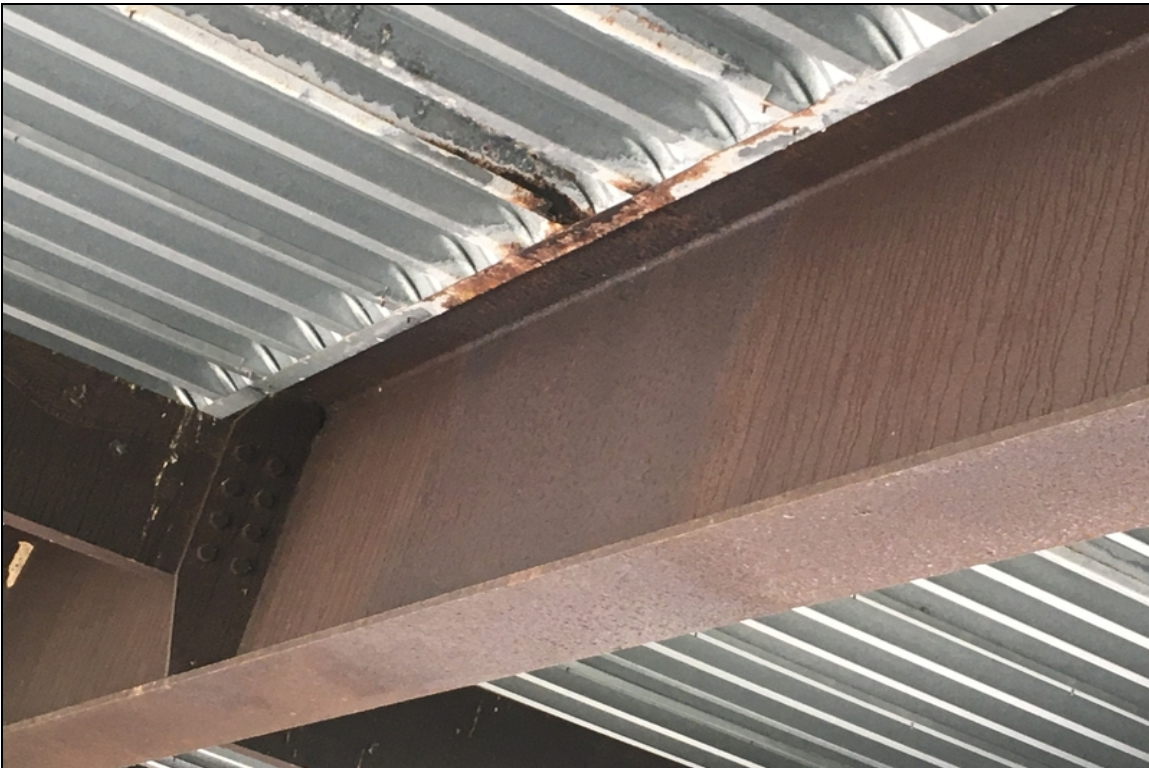
(107)	<p>Span #1- beam #1 has 1' of cs2 corrosion on the top flange. Beam #3 has 3' of cs3 corrosion at the beginning of the span. 4' of cs3 corrosion on the top flange near mid span with cs2 corrosion on the web and bottom flange in the same location. The construction joint in span #1 left side is leaking and causing corrosion on beam #1,3 and the S.I.P. forms Span #2- no deficiencies noted. Span #3- no deficiencies noted.</p>						
210	Reinforced Concrete Pier Wall	LF	28	28	0	0	0

4' of corrosion on beam #3 in span #1.

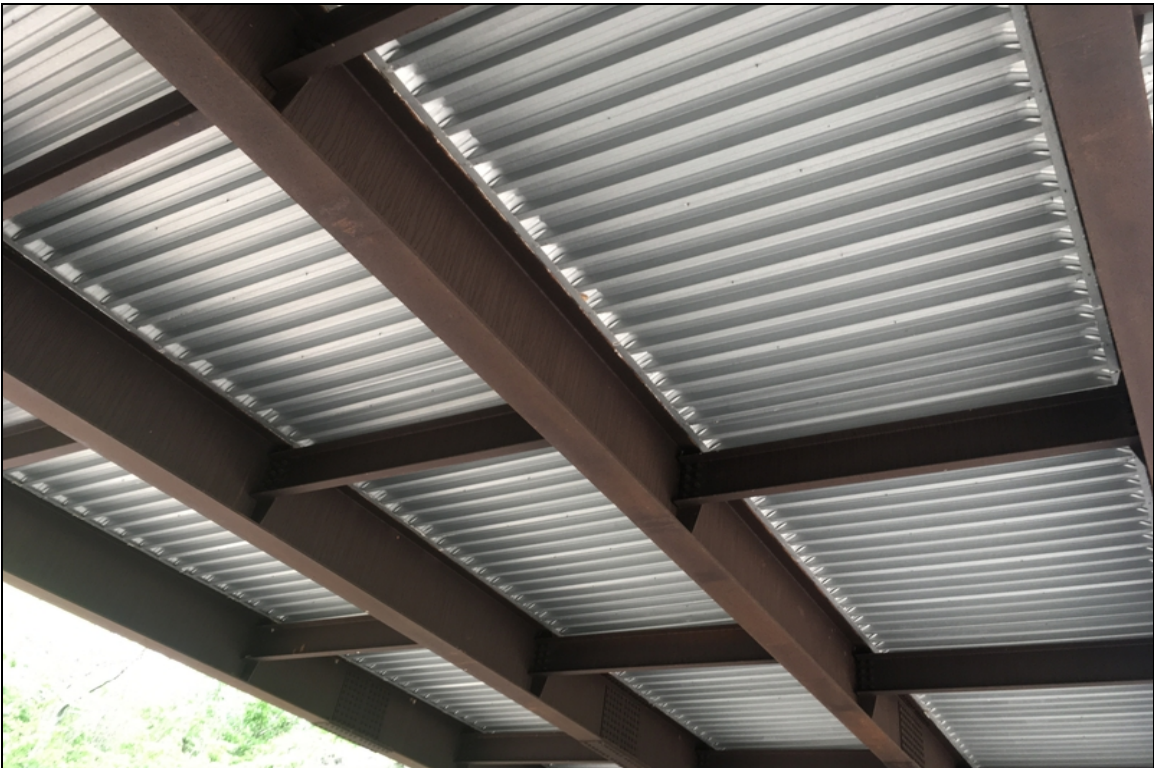
Typical view of the undersurface.

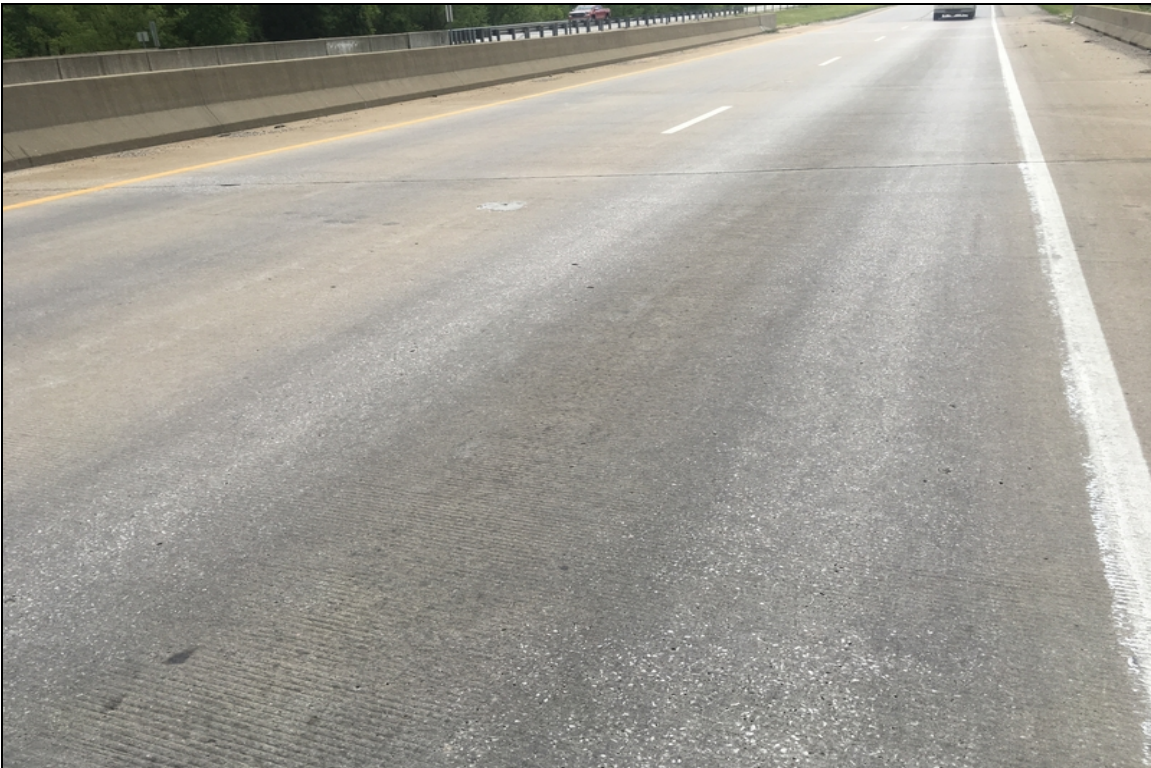
(12)	<p>Driving surface- The driving surface of the deck deck has multiple cracks throughout the deck. Maintenance forces have attempted to seal the cracks, but the cracks are still present.</p> <p>Under surface- Has sip forms in all bays. Span#1- the left overhang has 2' of cs3 efflorescence and 2' of cs2 efflorescence. The right overhang has 1' of cs2 efflorescence. Span #2- the right overhang has 6' of cs2 efflorescence. The left overhang has 1' of cs2 efflorescence. Span #3- has 1' of cs2 efflorescence in the left overhang. The right overhang has 1' of cs2 efflorescence over the cap at the beginning of the span.</p>						
107	Steel Open Girder/Beam	LF	825	817	1	7	0
1000	Corrosion	LF	8	0	1	7	0
515	Steel Protective Coating	SF	8066	8045	14	7	0
3430	Oxide Film Degradation Color/Texture Adherence(Steel Protective Coatings)	SF	21	0	14	7	0

Typical view of driving surface.

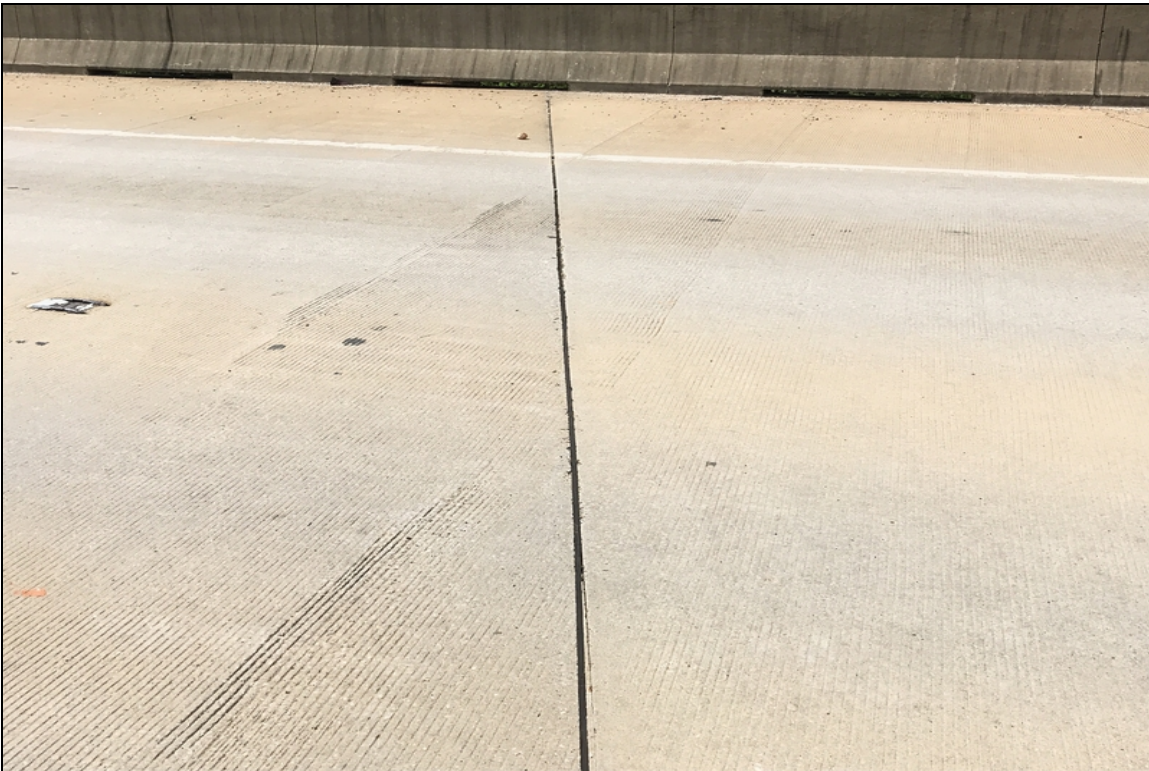
Loss of pourable joint material typical.

The pourable type joint material in the construction joints is missing in locations allowing leakage that appears to be causing corrosion to SIP forms.

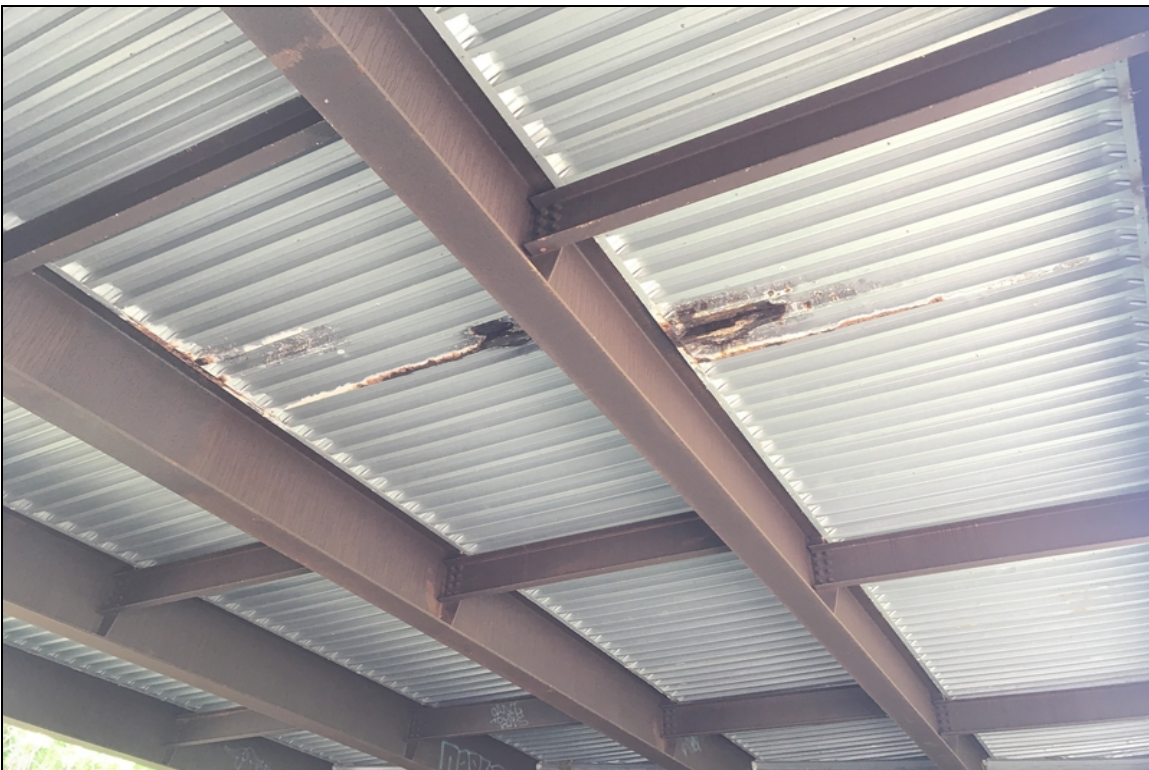
Span #1 bays #1 & #2 active corrosion of SIP forms.

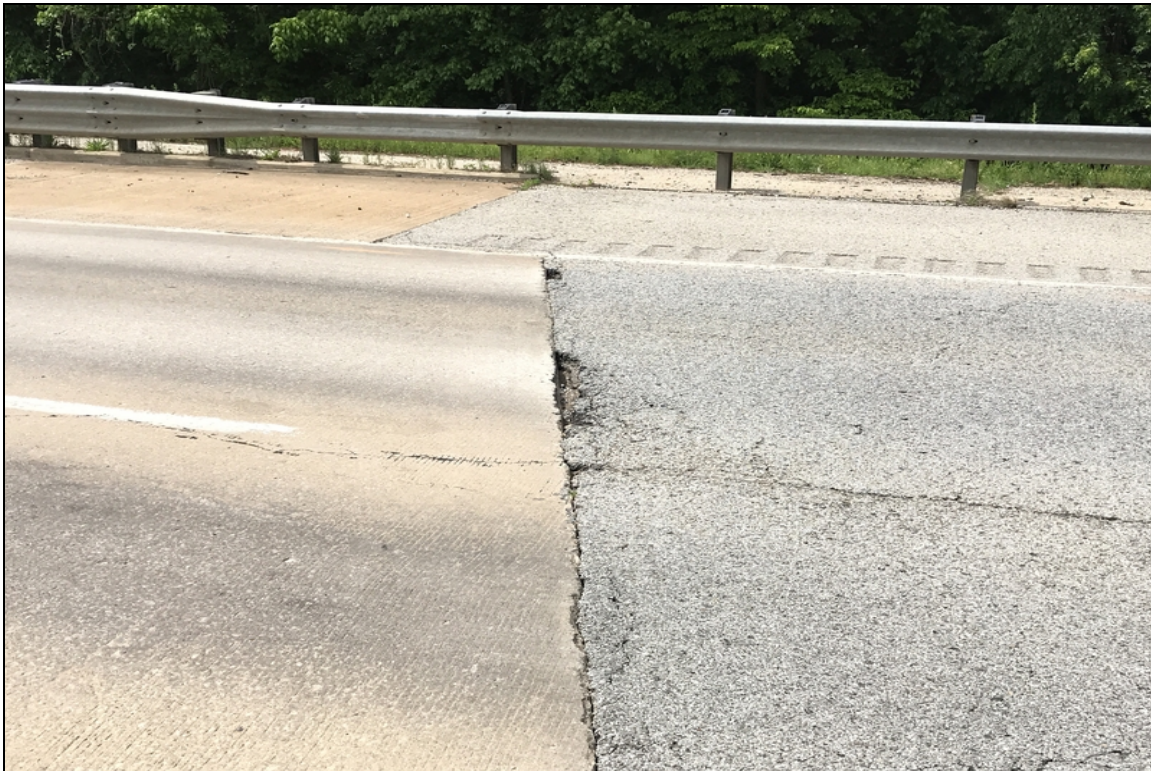
(321)							
Abutment #1 approach slab- The West approach slab has several sealable cracks and light abrasion. The approach roadway adjacent to the approach slab has loss of asphalt and has created a pothole.							
Abutment #2 approach slab- has light abrasion with sealable cracks.							
331	Reinforced Concrete Bridge Railing	LF	334	316	18	0	0
1090	Exposed Rebar	LF	1	0	1	0	0
1130	Cracking (RC and Other)	LF	17	0	17	0	0

West approach roadway adjacent to west approach slab right lane potholes.

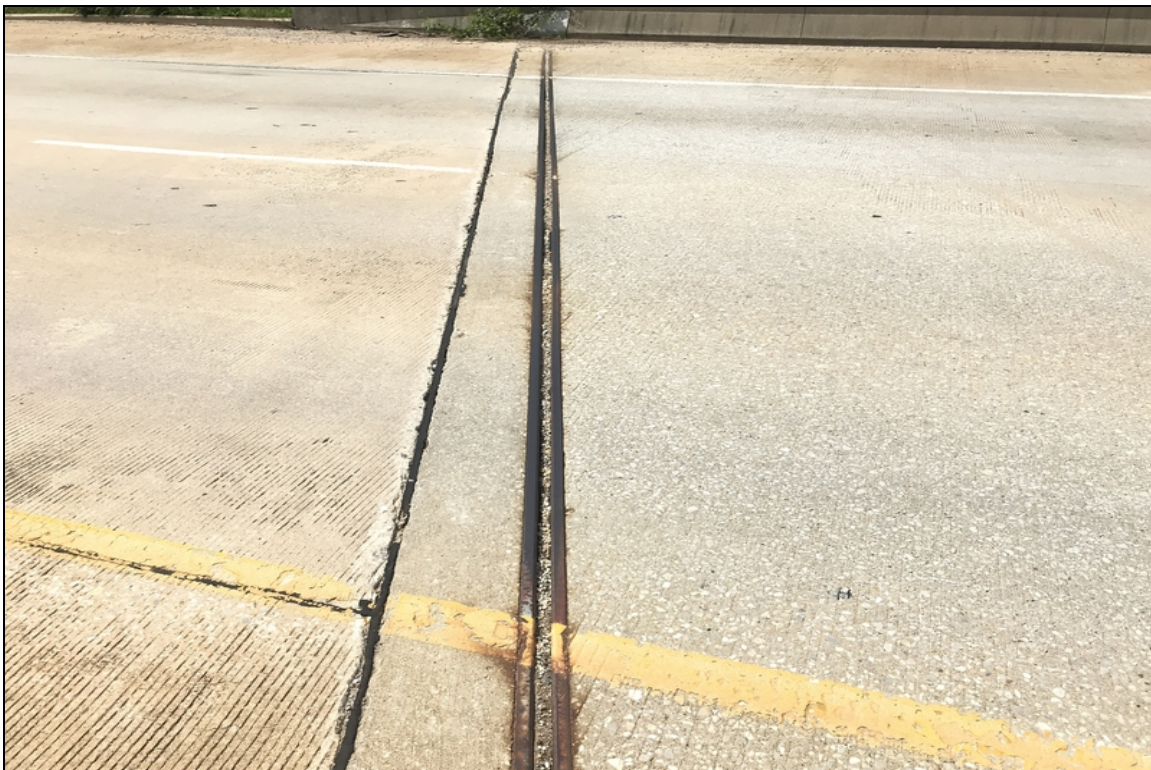
(300)							
Abutment #1 seal- has loose debris impaction.							
Abutment #2 seal- the joint seal at abutment #2 is leaking at the midsection with loose debris impaction.							
310	Elastomeric Bearing	EA	20	19	0	1	0
1000	Corrosion	EA	1	0	0	1	0
515	Steel Protective Coating	SF	40	38	0	2	0
3430	Oxide Film Degradation Color/Texture Adherence(Steel Protective Coatings)	SF	2	0	0	2	0

Abutment #2 joint material debris impact and loss of adhesion.

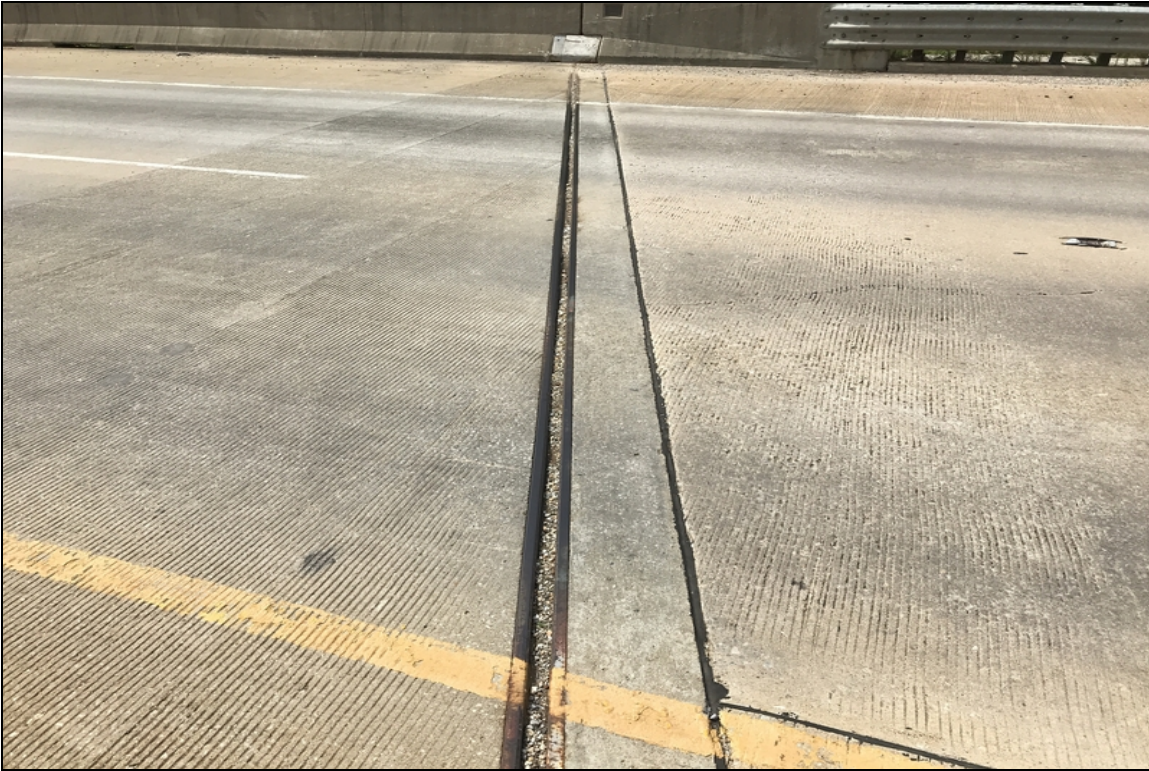
Abutment #1 joint material debris impaction and loss of adhesion.

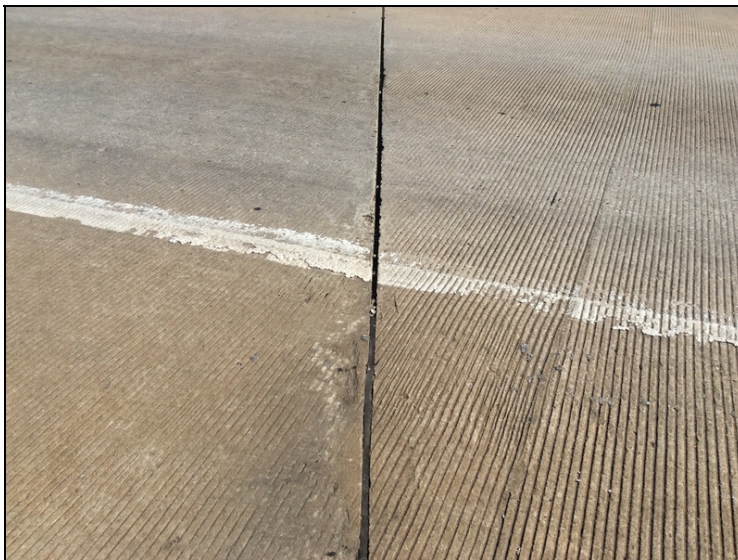
Typical of pourable joint material in the construction joints right lane.

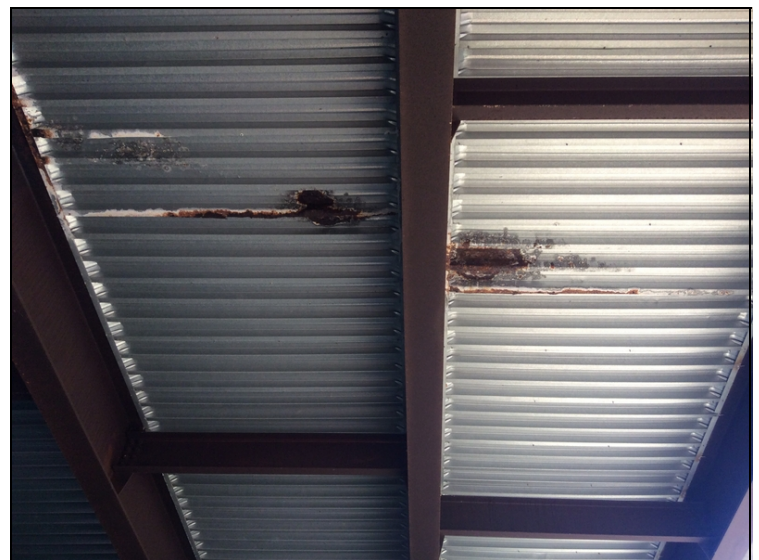
Span #1, bays #1 and #2-Corrosion to SIP forms.

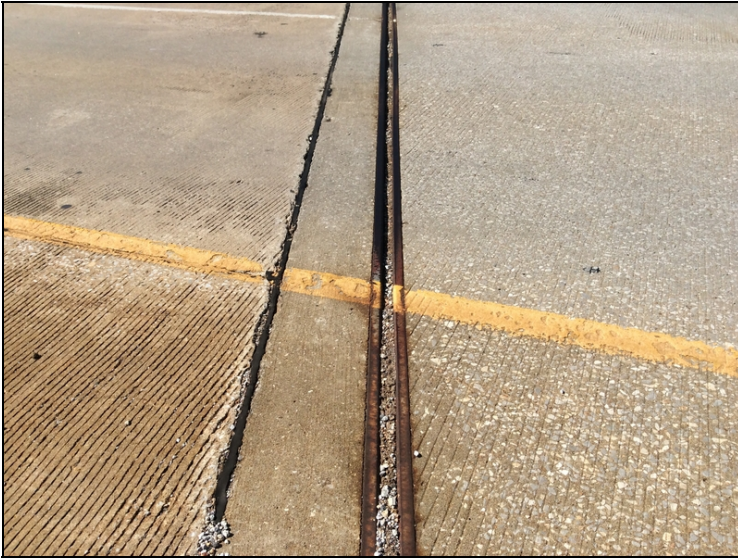
Deck - The compression joint seals at both bridge ends have debris impaction the full length of joints.

Typical - compression joint seals have debris
impaction.

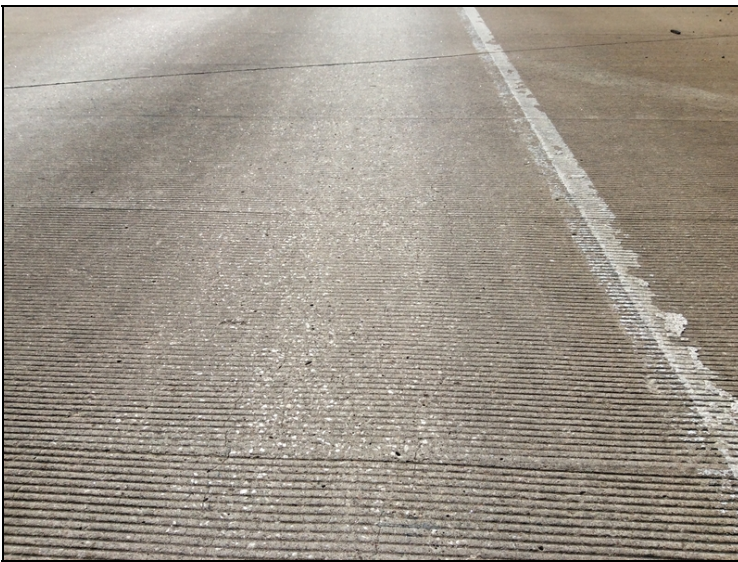
Deck / Approach slabs - The driving surface of the deck and approach slabs have numerous sealable cracks throughout.

Typical of sealable deck cracking.

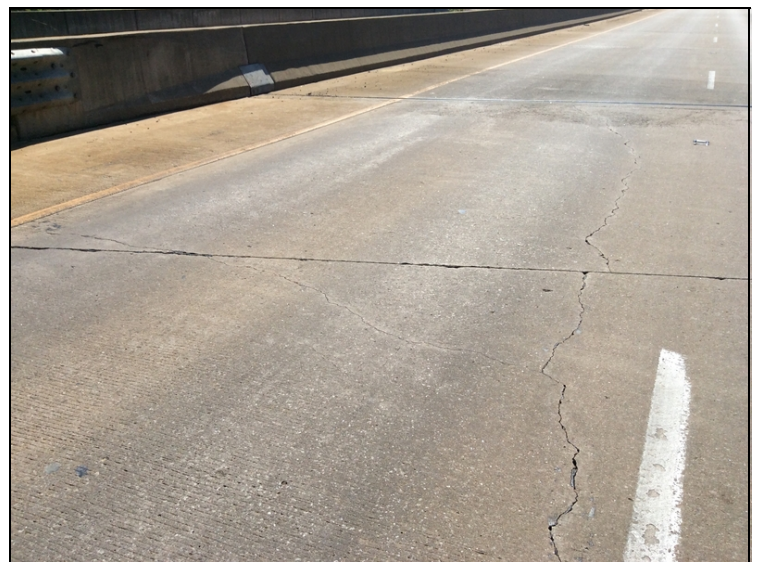
Typical cracking in the right lane of west approach slab.

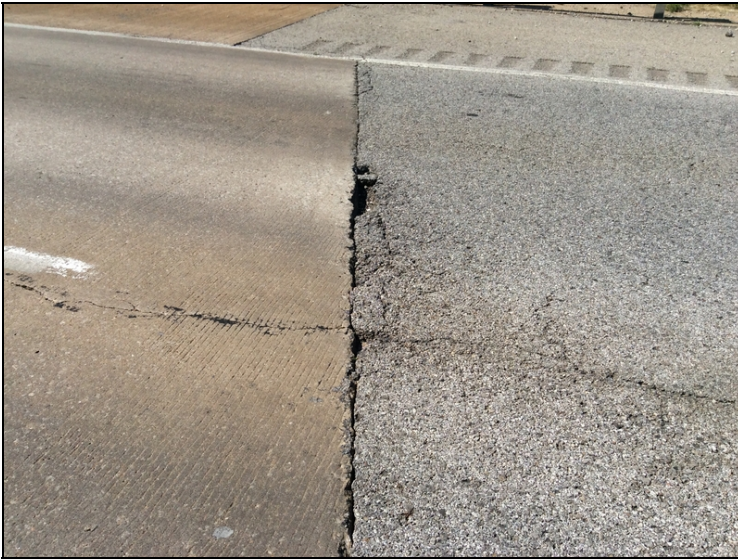
West approach roadway - The ACHM driving surface of the West approach roadway has a pothole in the right lane at the juncture of the approach slab.

Approach roadway at Right lane of west approach roadway - pothole.
