Bridge #A6476(Routine, Underwater type 2)
US 412 Benton 2 over Illinois River/West Crsg
Location: Benton Co8.19 MI W OK LN

Team Lead: Nathan Rowland **Inspection Date:** June 15, 2021

IDENTIFICATION	
(1) State Names	Arkansas
(8) Structure Number	A6476
(5) Inventory Route	412
(2) Highway Agency District	09
(3) County Code	7-Benton County, Arkansas

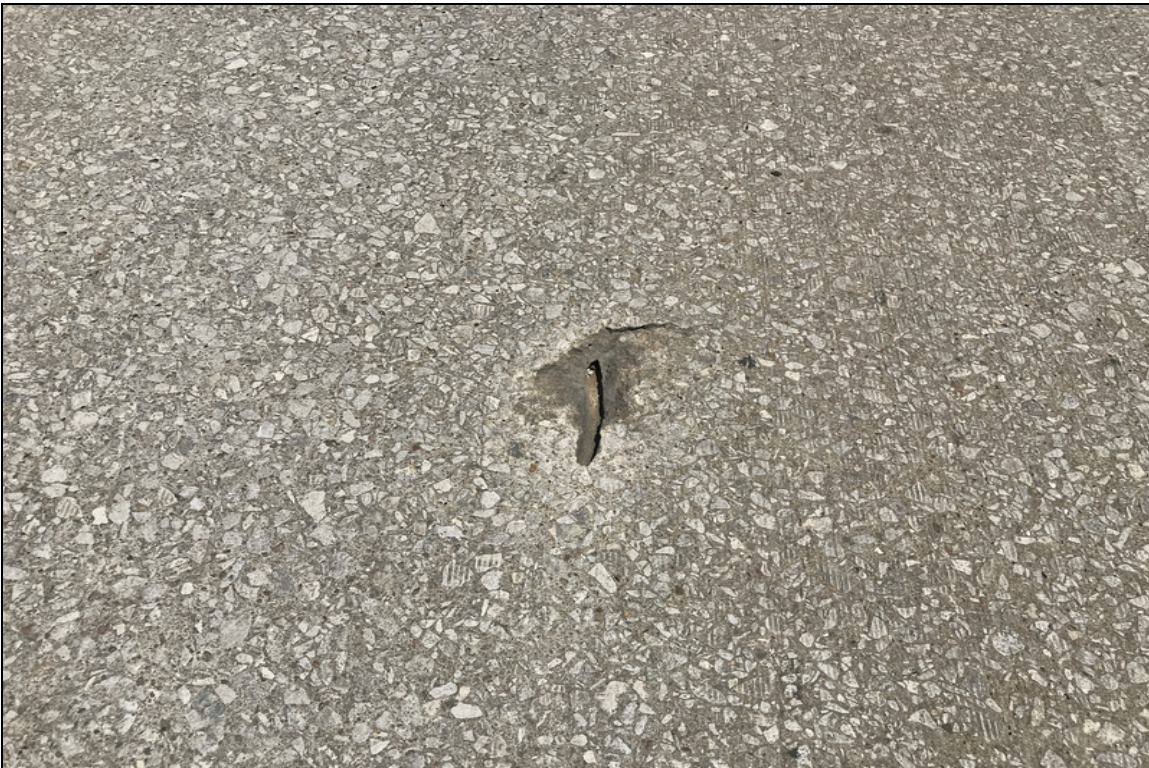
Spall in the left lane in span #8 no steel exposed

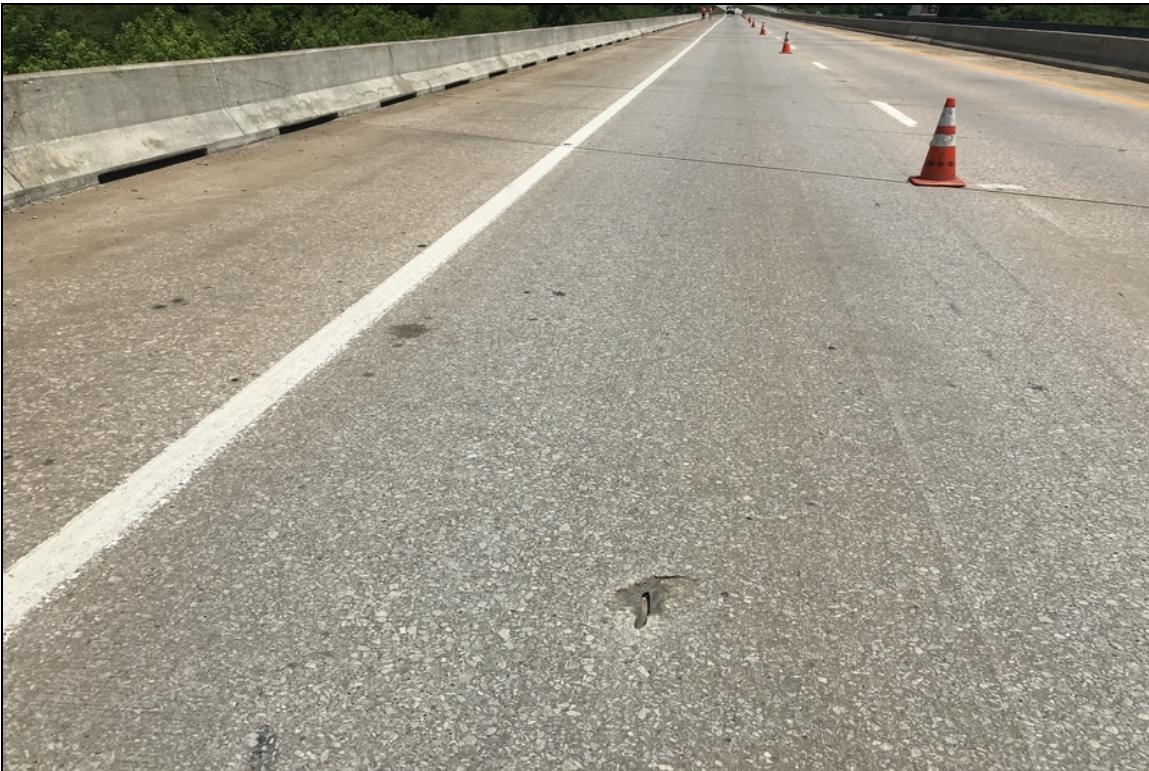
Spall in the left lane in span #8 no steel exposed.

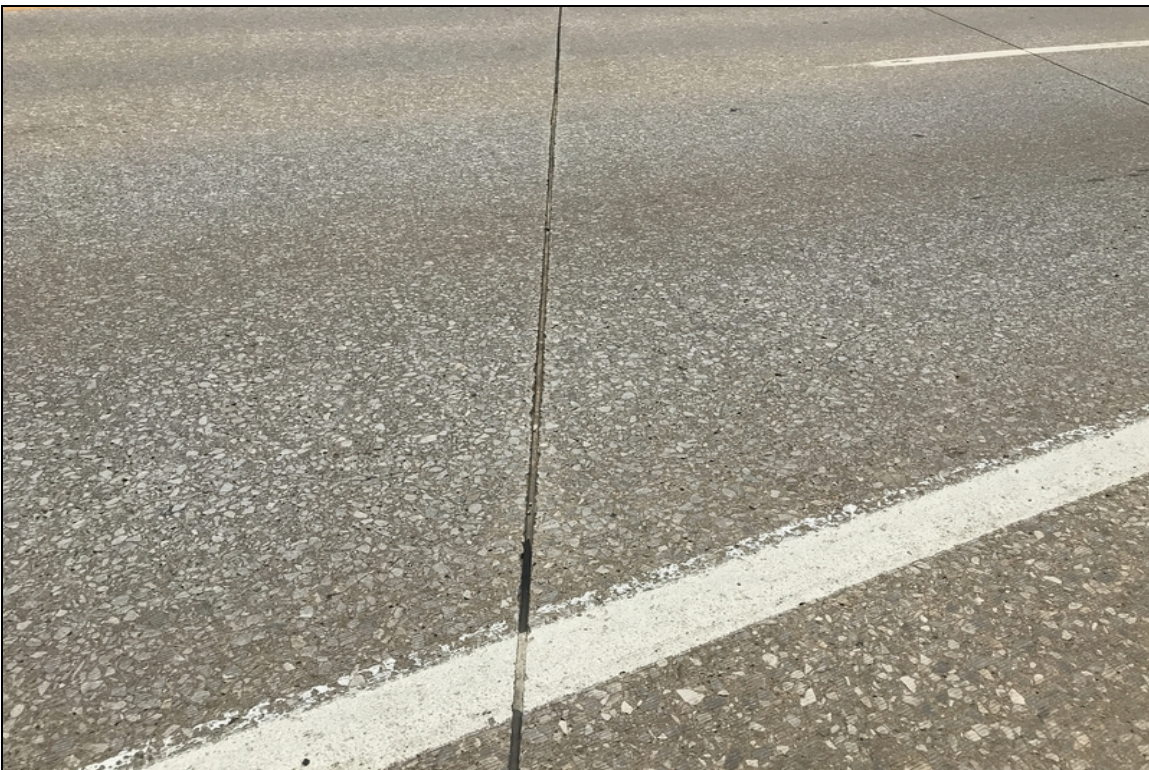
Pourable joint material has been displaced in multiple locations.

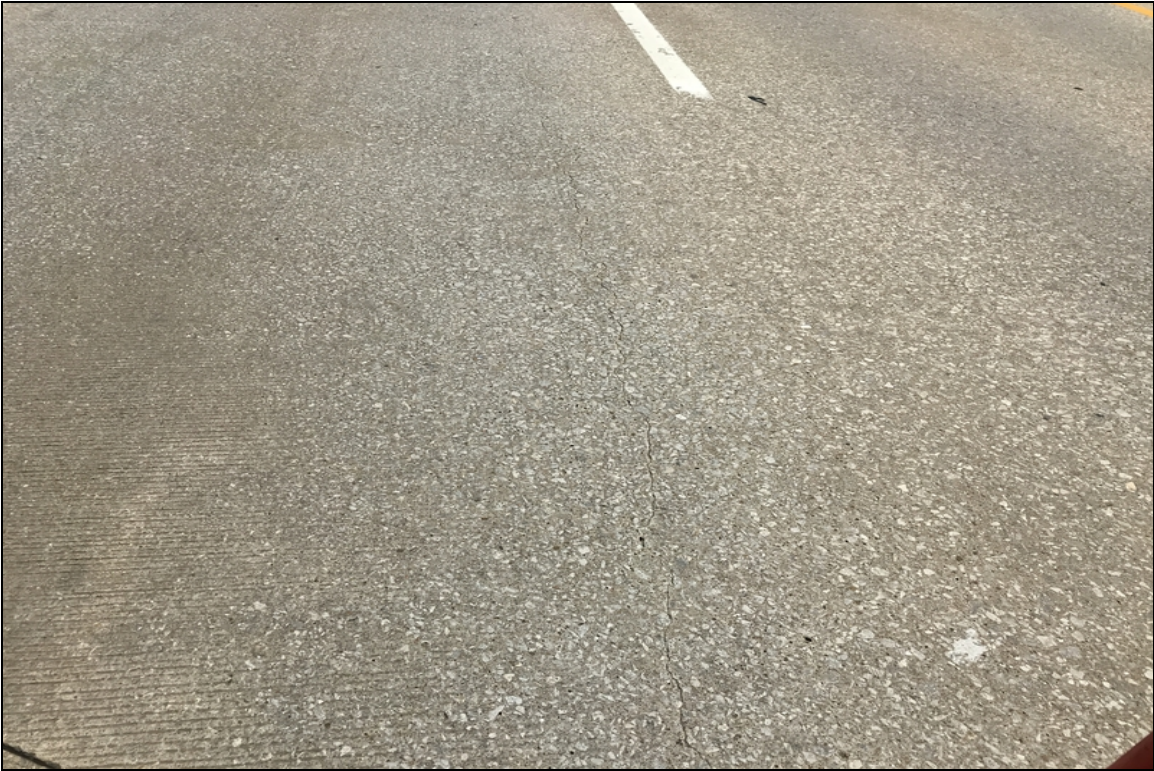
Typical longitudinal cracking in span #3 over bent #2.

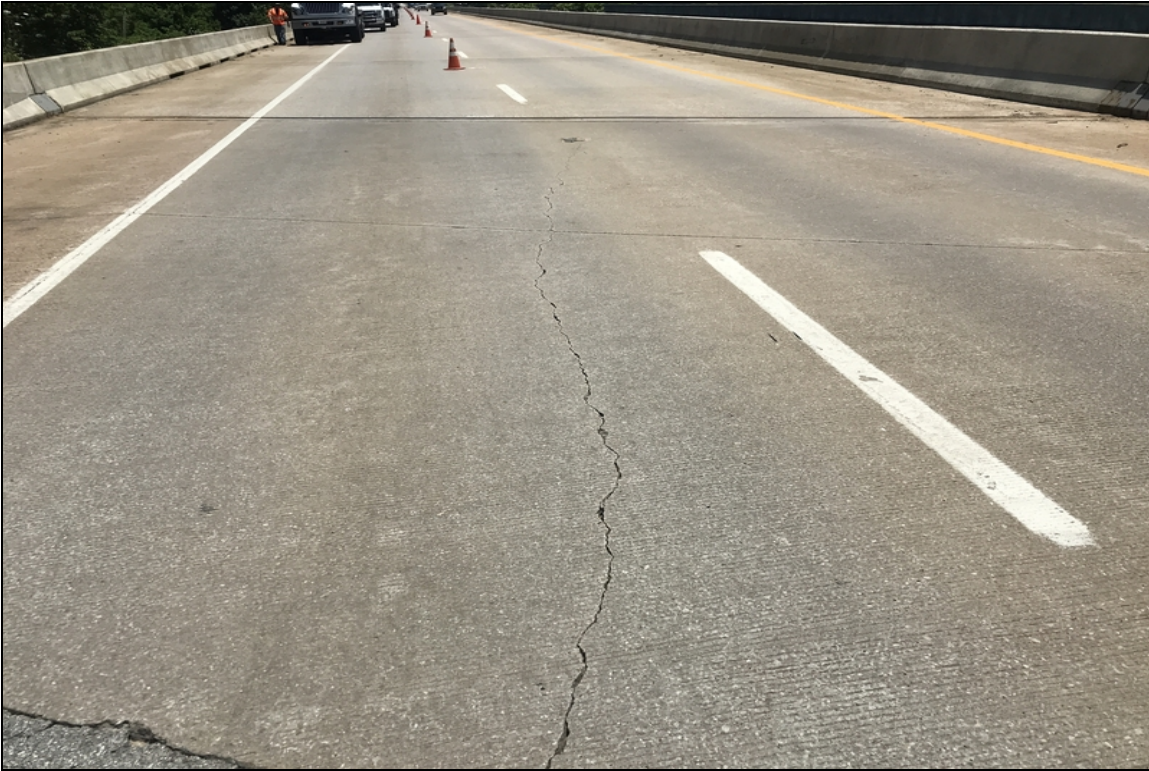
(321)	06/15/2021 WNR & DBM: -The West approach slab has a wide full length longitudinal crack in the left lane.						
331	Reinforced Concrete Bridge Railing	LF	2758	2136	479	105	38

Cracking in the west approach slab.

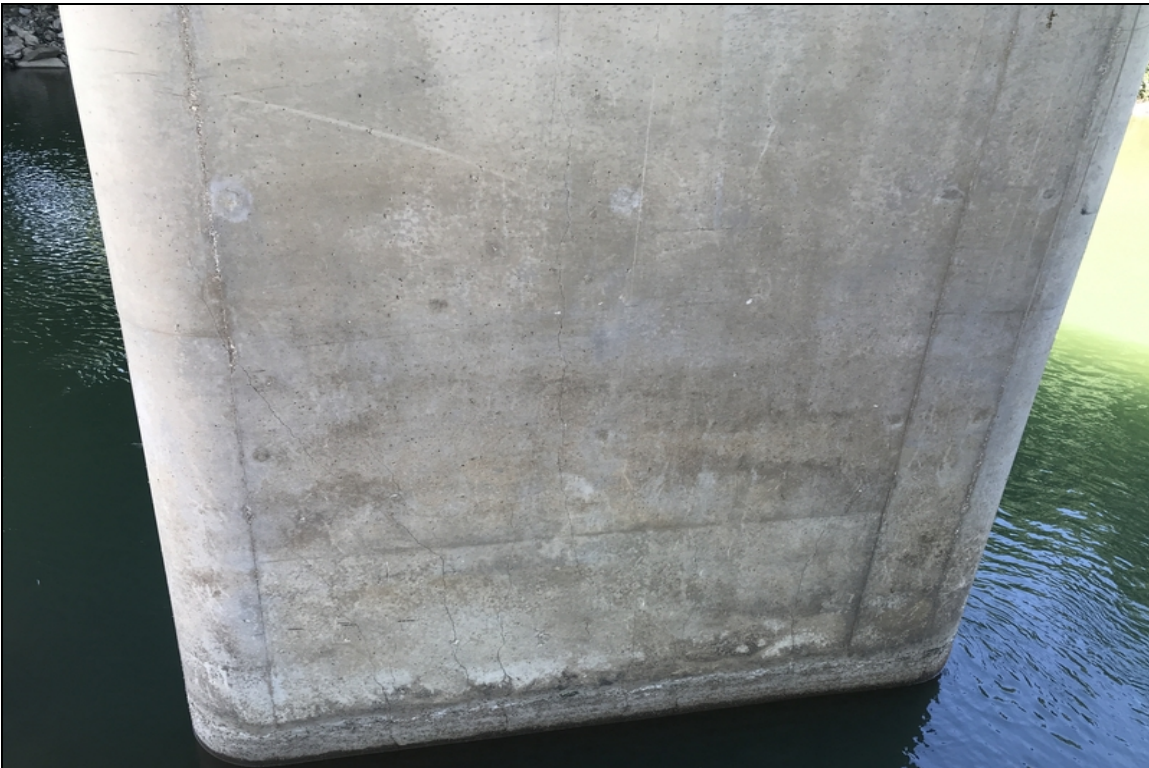
Cracking in pier #2 ahead side still exists.

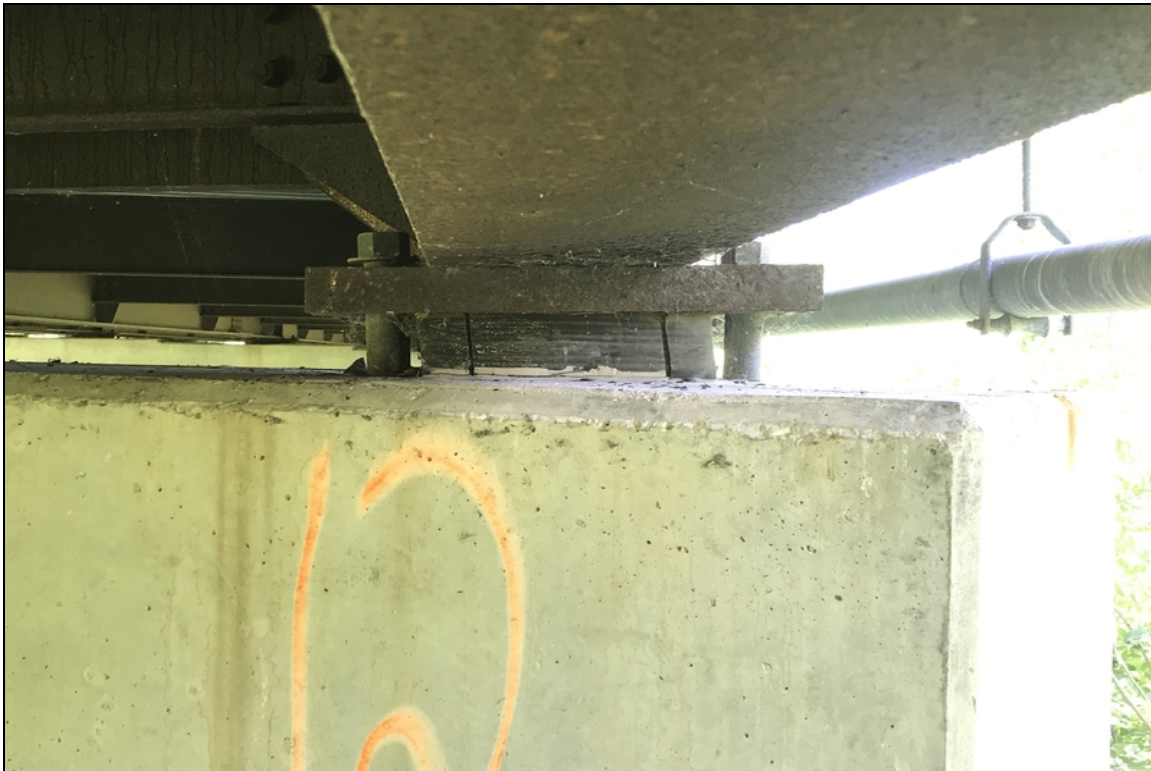
(310)	06/15/2021 WNR & DBM: -Numerous anchor bolts are leaning out of plumb. -Span #13 bearing #1 over bent #12 has abnormal corrosion with flaking rust due to leaking expansion joint. -Span #9, bearing #1 over bent #8 has corrosion with flaking rust due to leaking expansion joint.						
321	Reinforced Concrete Approach Slab	SF	1944	1621	288	35	0
1130	Cracking (RC and Other)	SF	35	0	0	35	0
1190	Abrasion/Wear (PSC/RC)	SF	288	0	288	0	0

Elastomeric bearing #1 in span #13 over bent #12 is skewed out of plum.

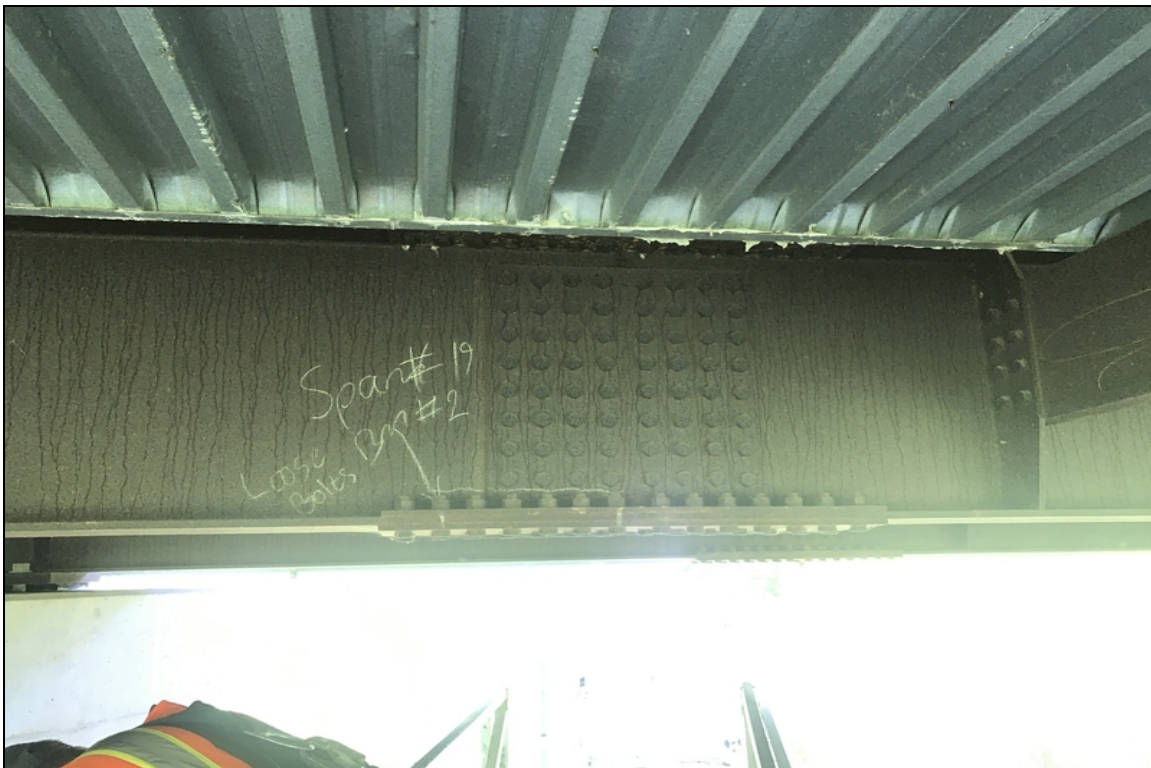
Bolts still loose as of this inspection.

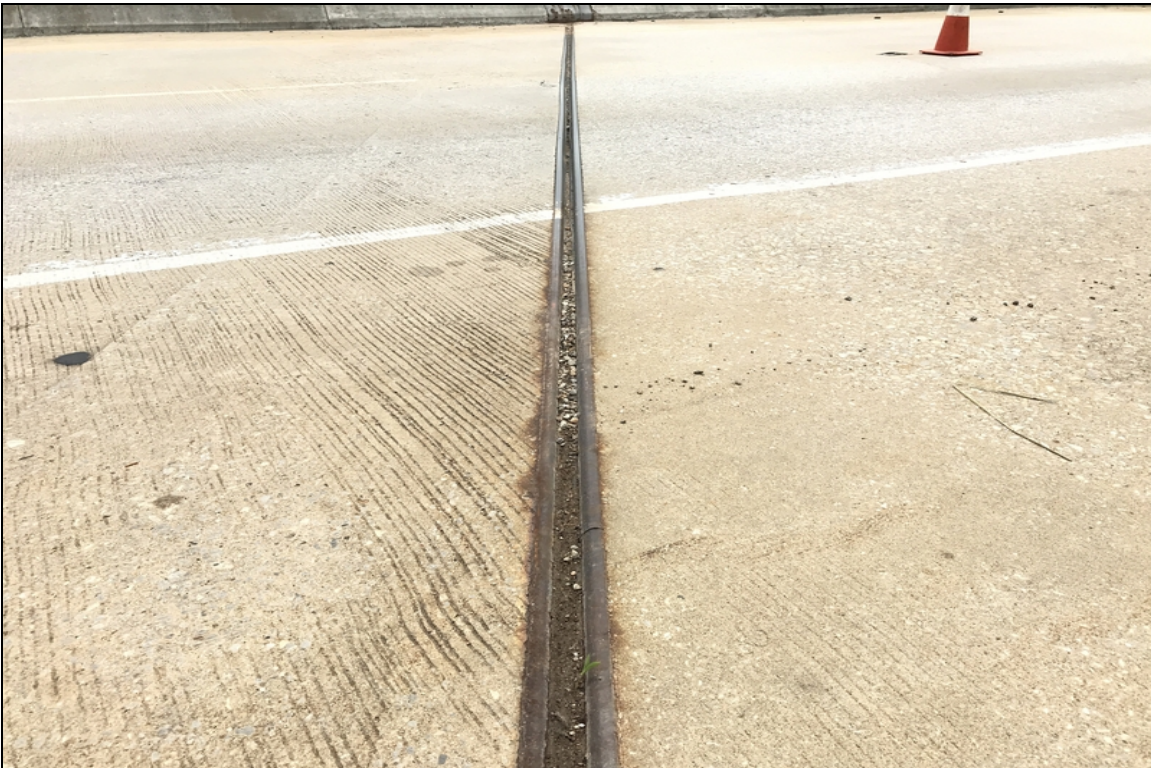
Bent #8 debris in expansion joint.

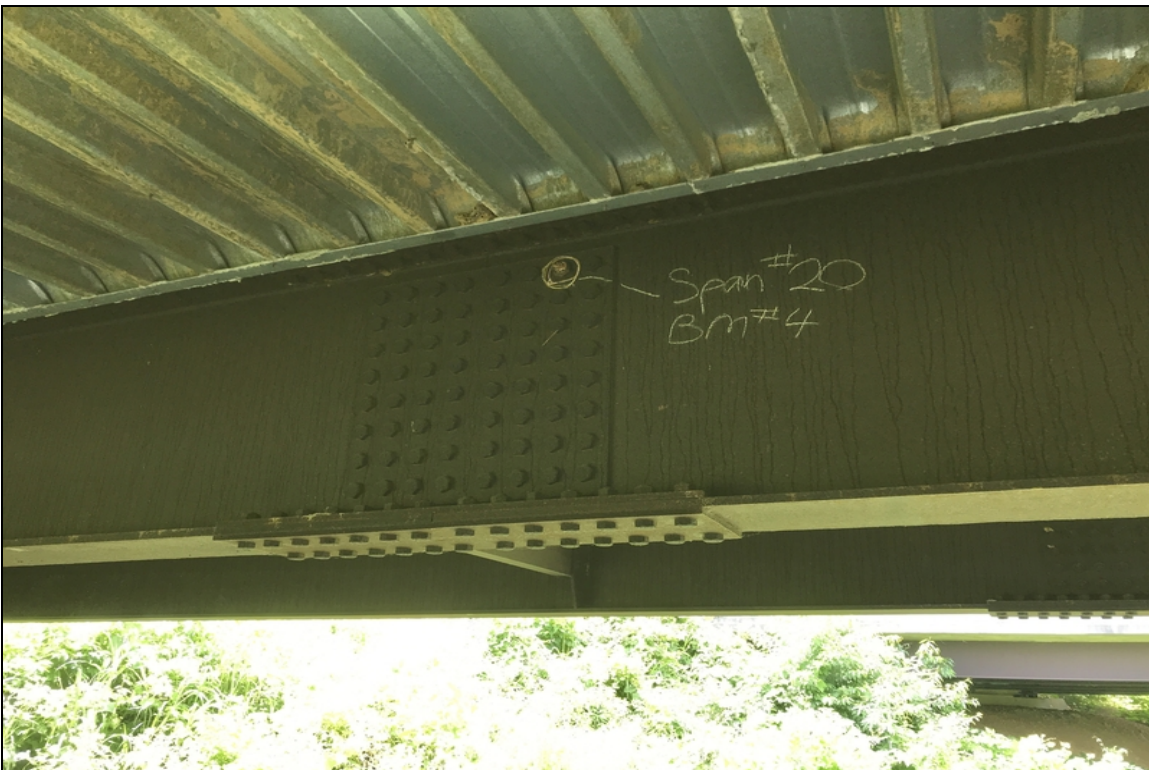
Span #20 girder #4 loose bolt in splice plate.

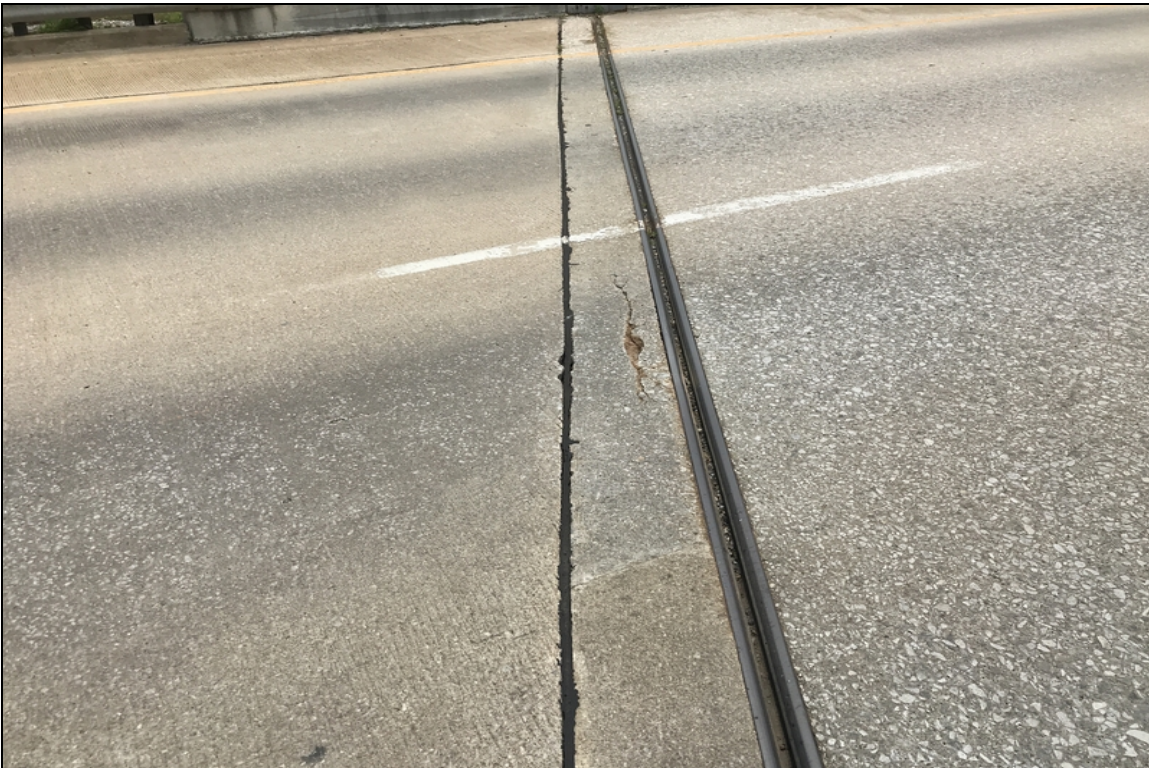
Abutment #2 cracking and spalling.

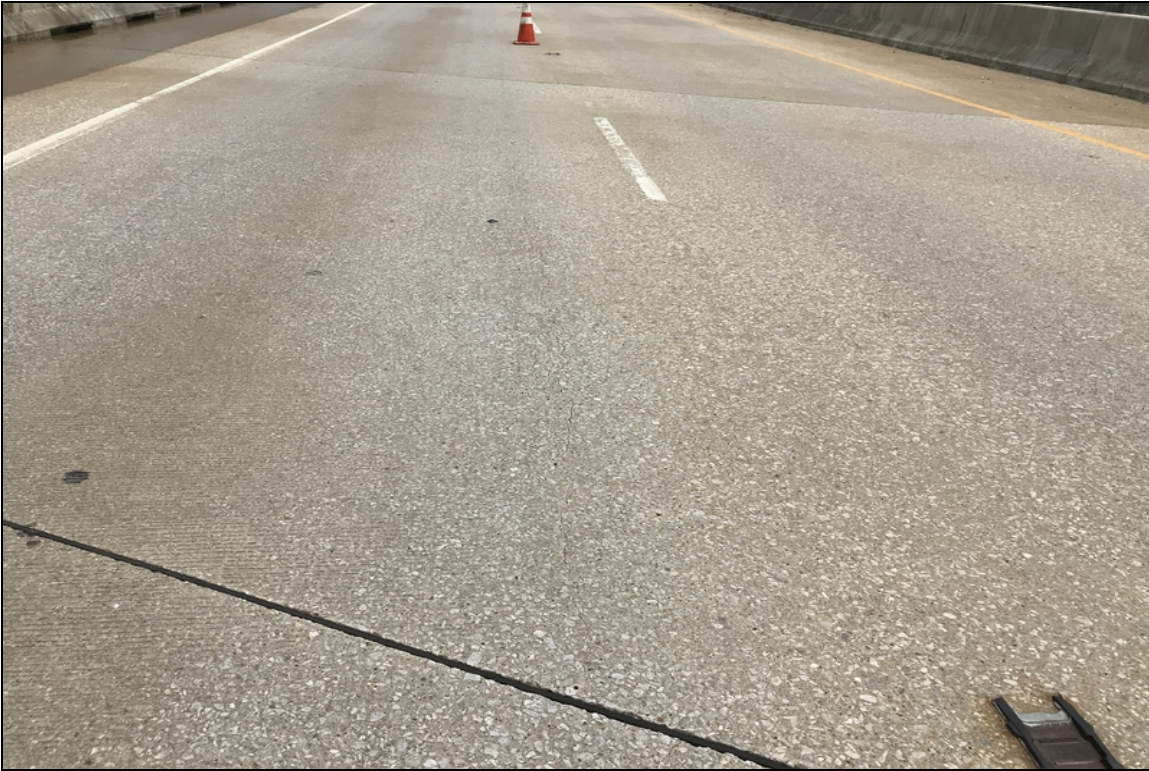
Typical longitudinal cracking.

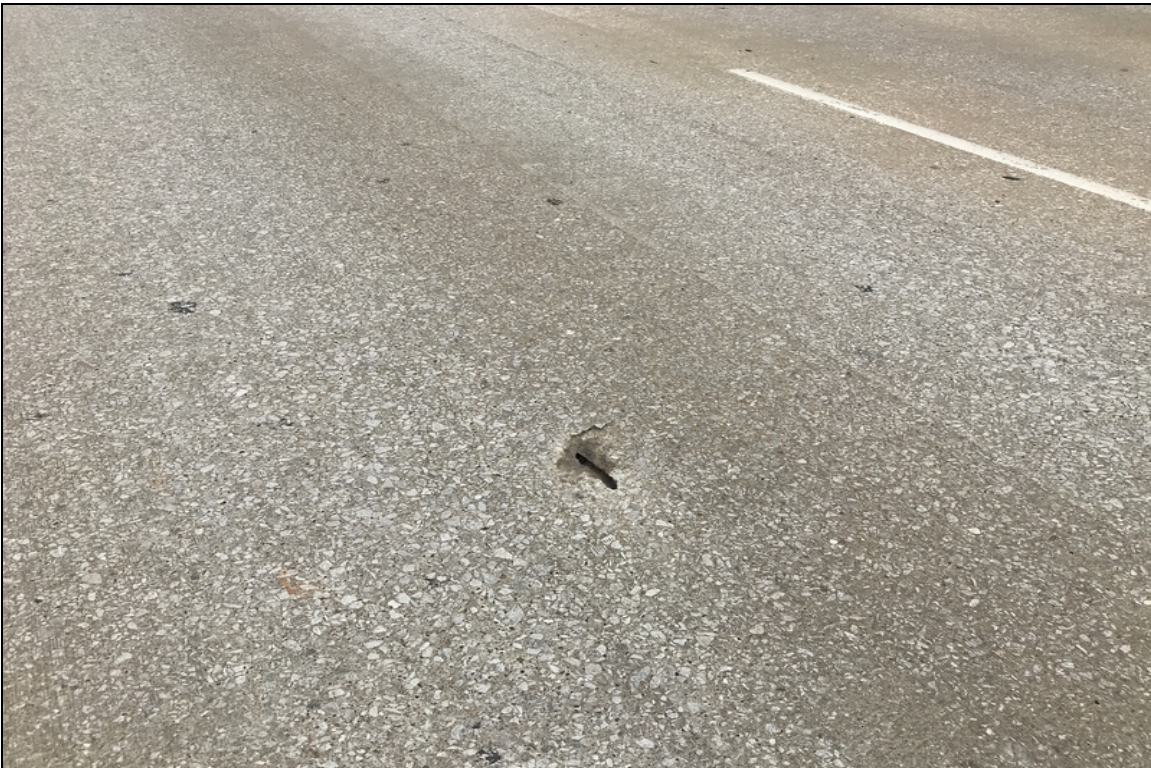
Span #9 softball sized spall.

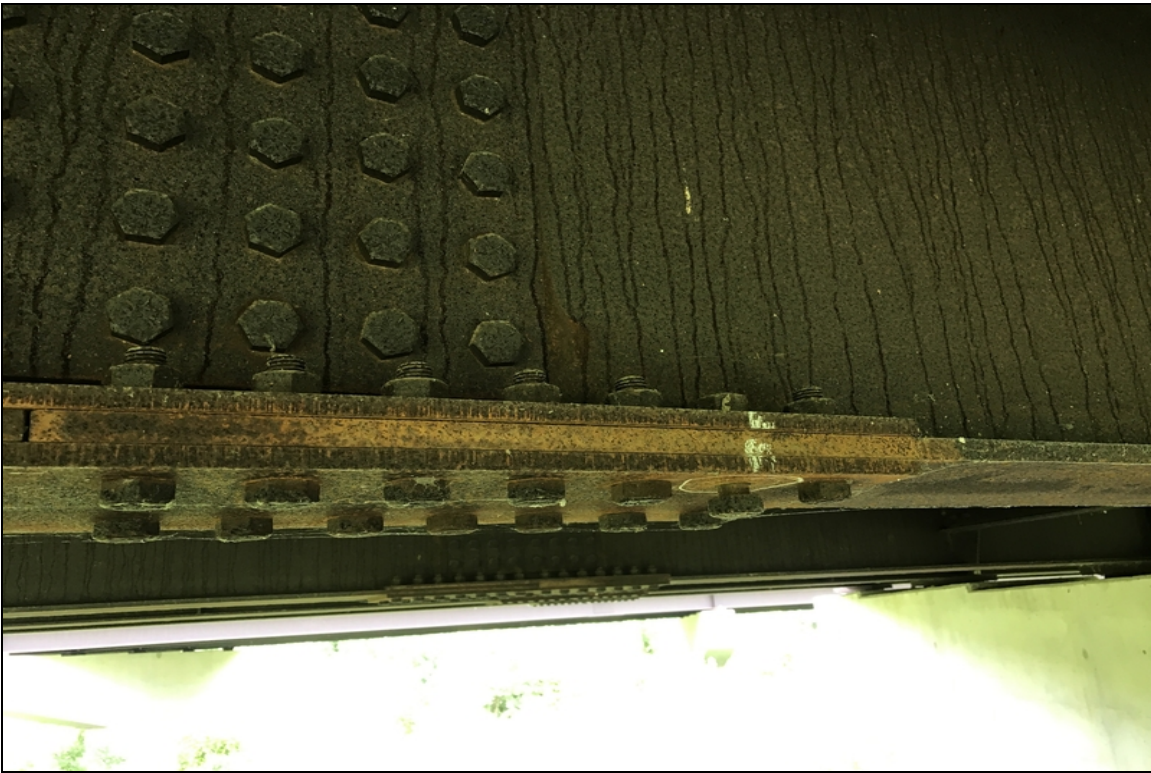
Span #11 Girders #2 loose bolt

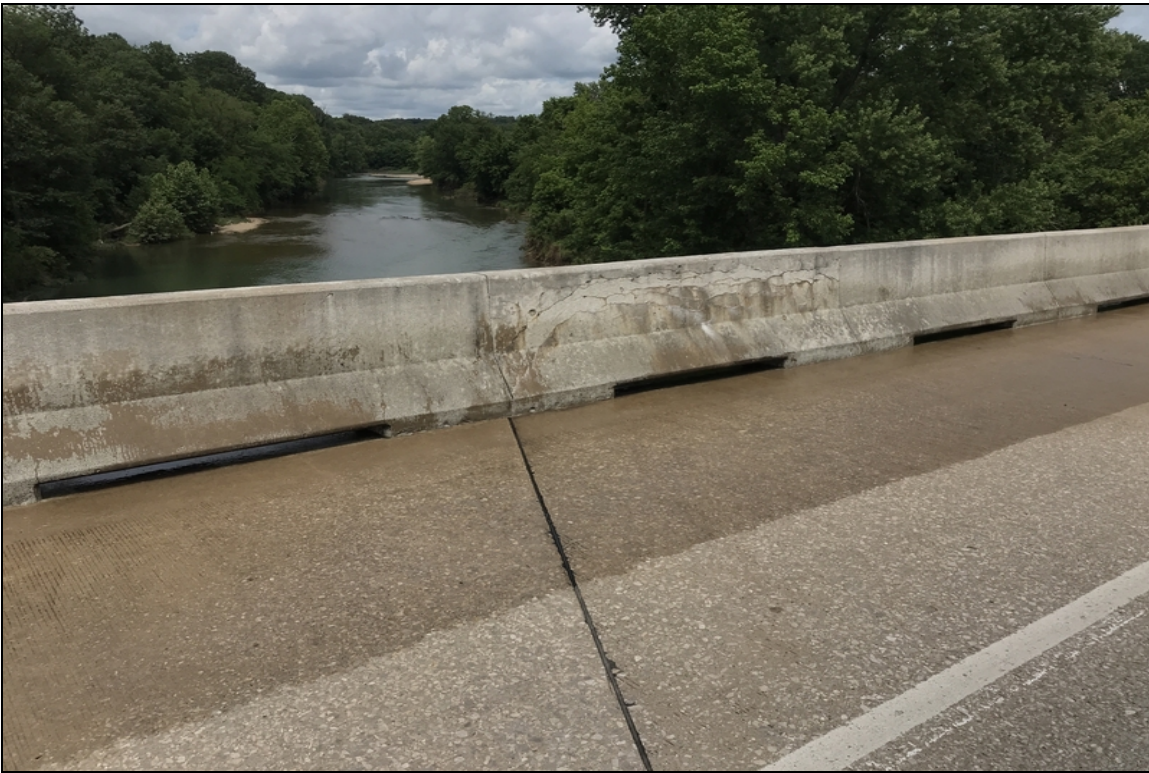
Typical cracking in parapet wall.

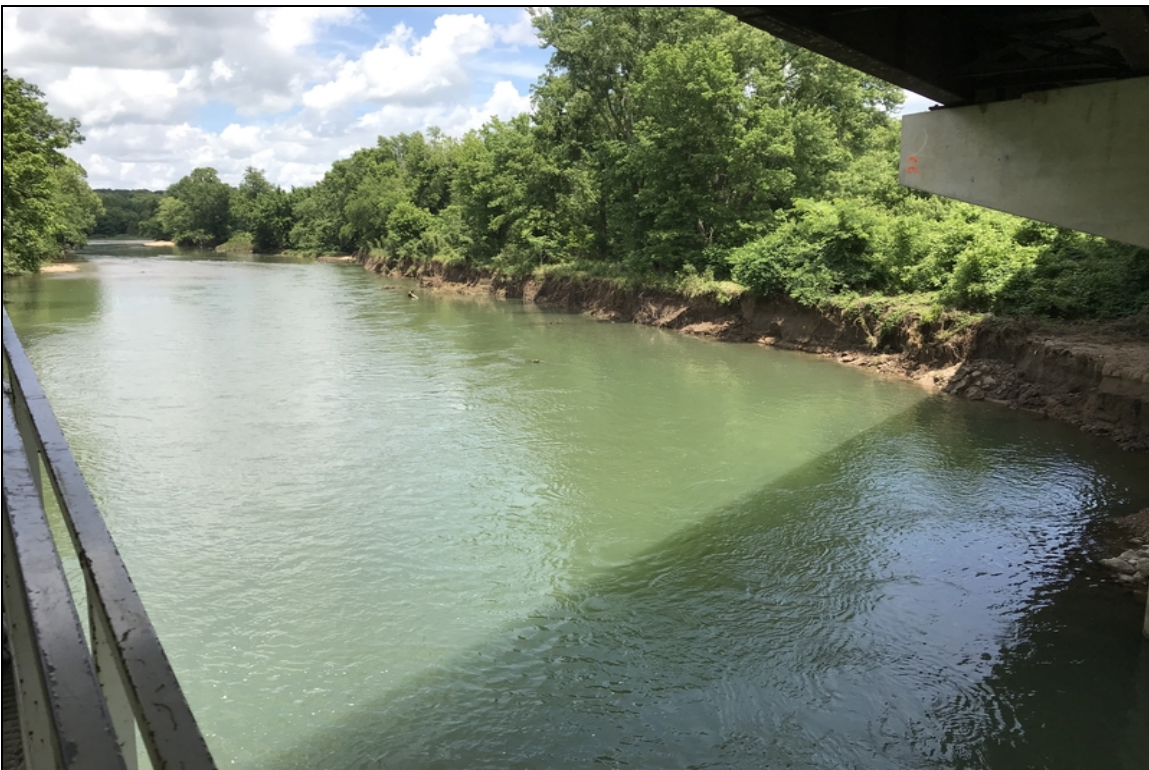
East side of upstream channel has bank erosion.

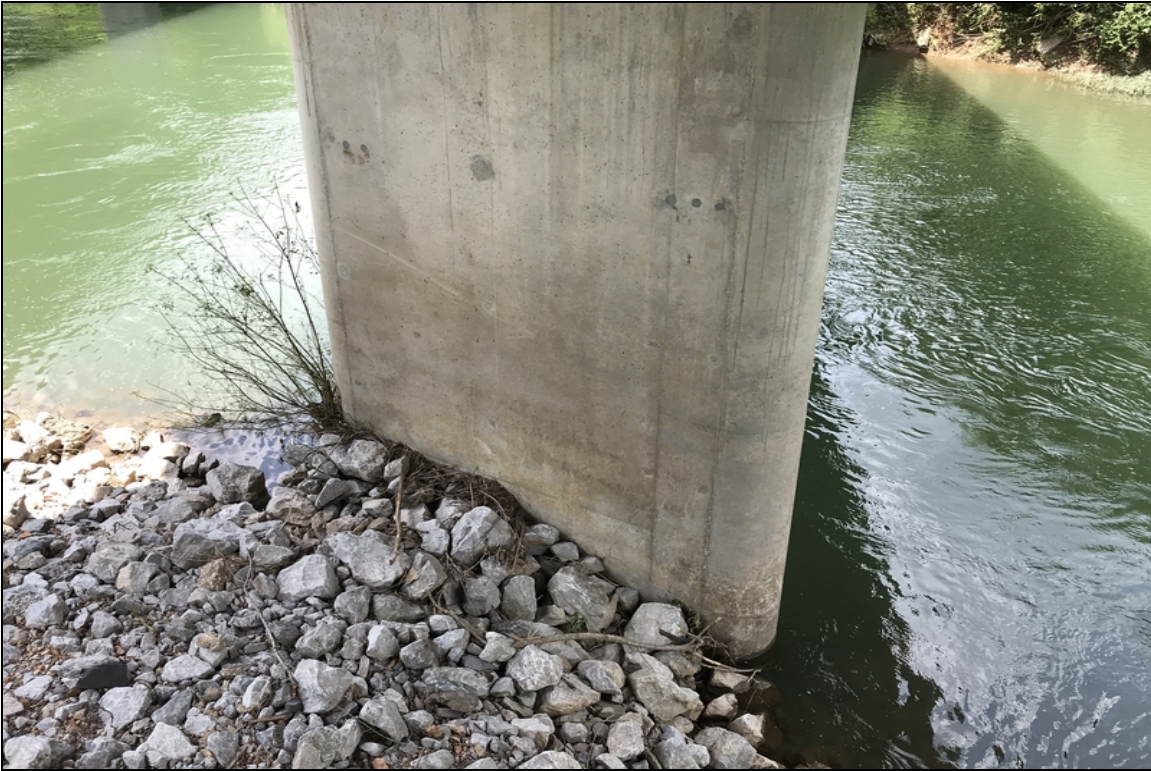
(205)							
06/15/2021 WNR & DBM:							
-Bent #2 column has several diagonal cracks visible on both sides of column that range in width from hairline to wide.							
-Bent #3 column has 7 softball sized spalls with no exposed reinforcing steel in the ahead side that appear to be from bullet impacts.							
-Bent #4 column has three moderate sized spalls with no exposed reinforcing steel in the ahead side that appear to be from bullet impacts.							
215	Reinforced Concrete Abutment	LF	134	99	35	0	0

Bent #2 Vertical and diagonal cracking in pier.

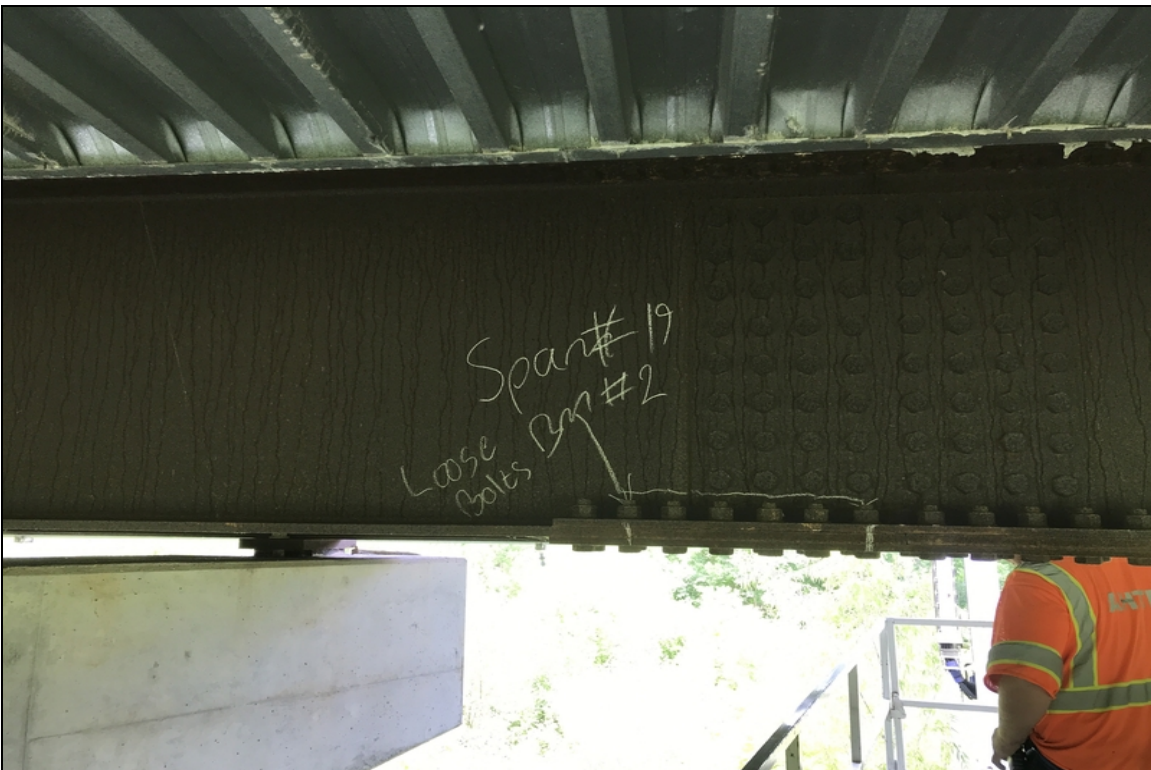
Span #19 Girder #2 has 2 loose bolts.

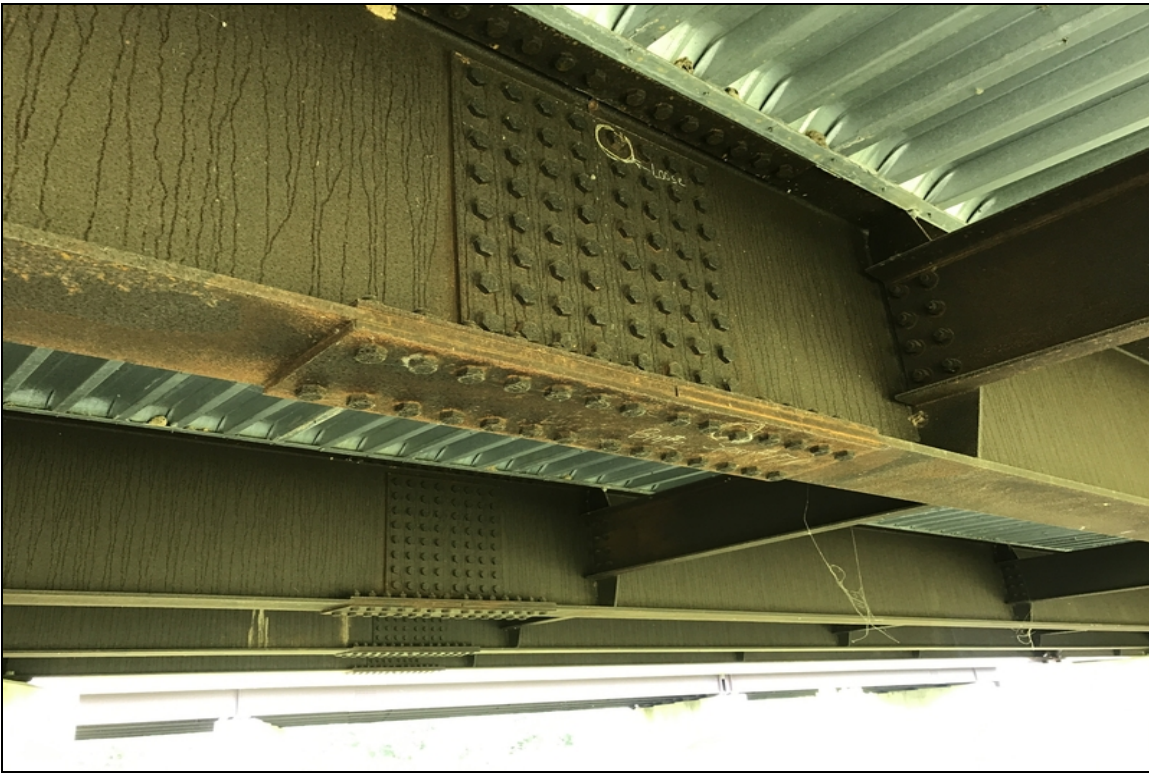
Previously documented bolts are still loose.

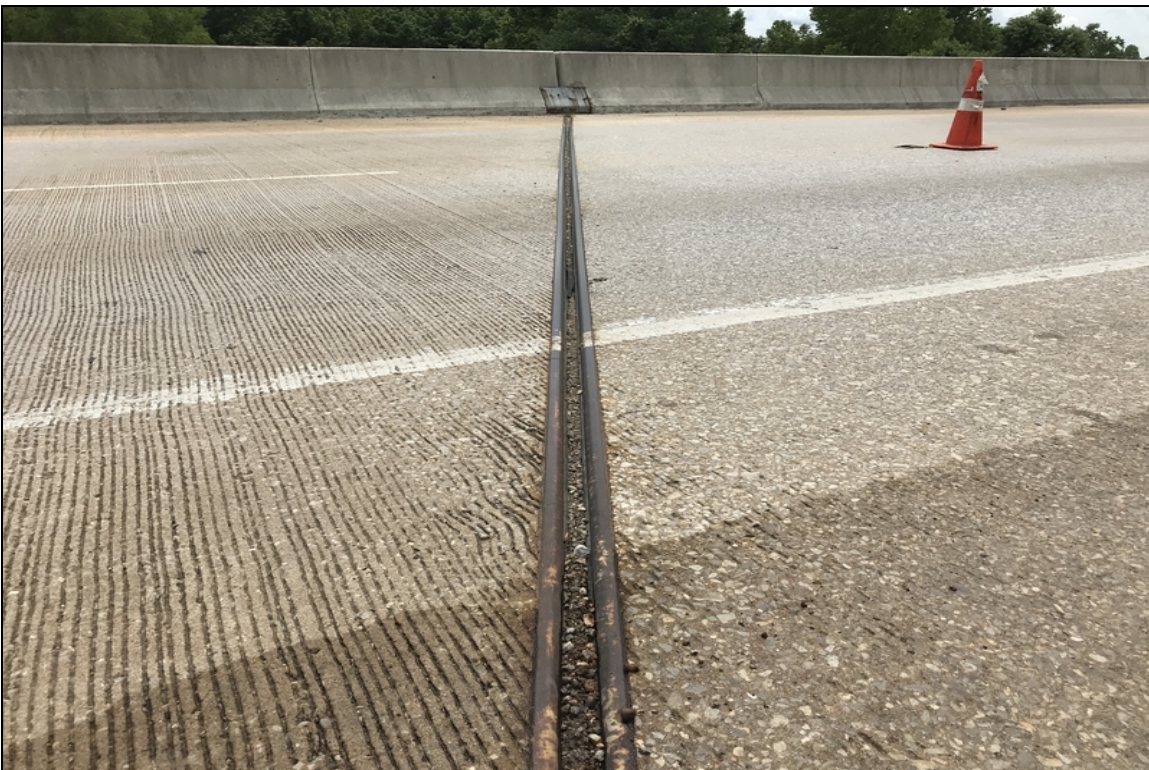
Bent #4 expansion joint debris.

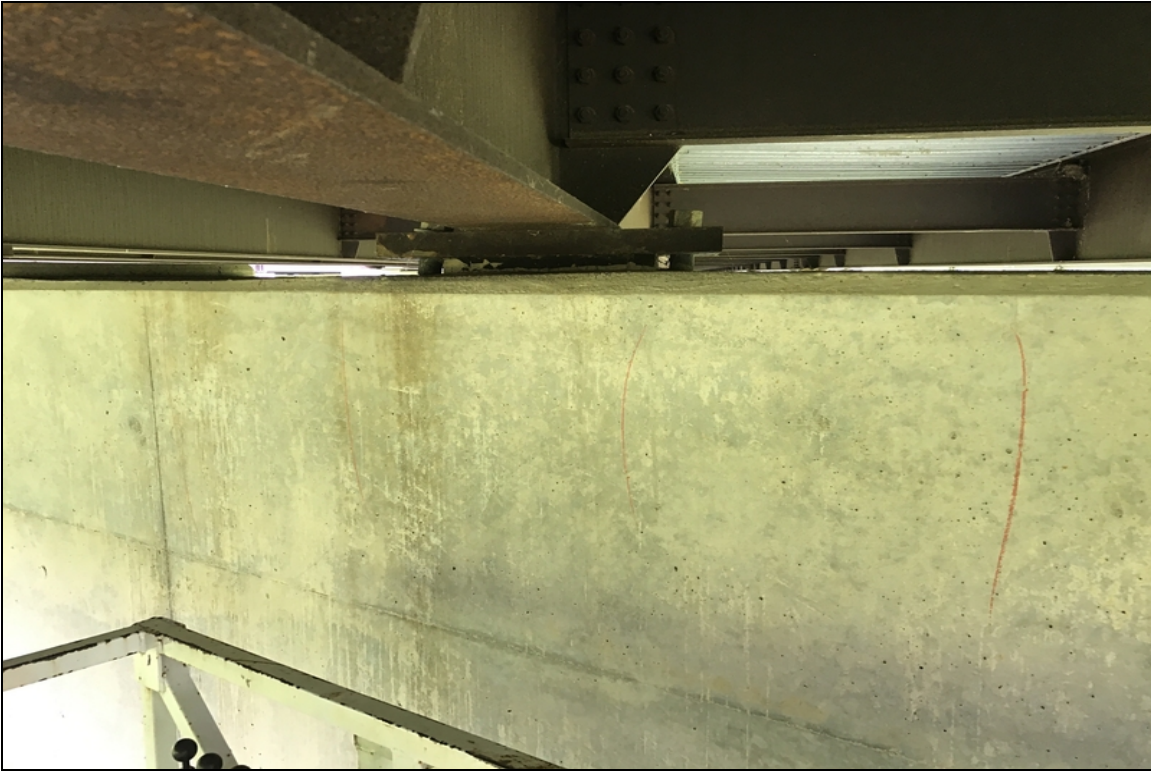
Typical hairline cracking in the tops of pier caps.

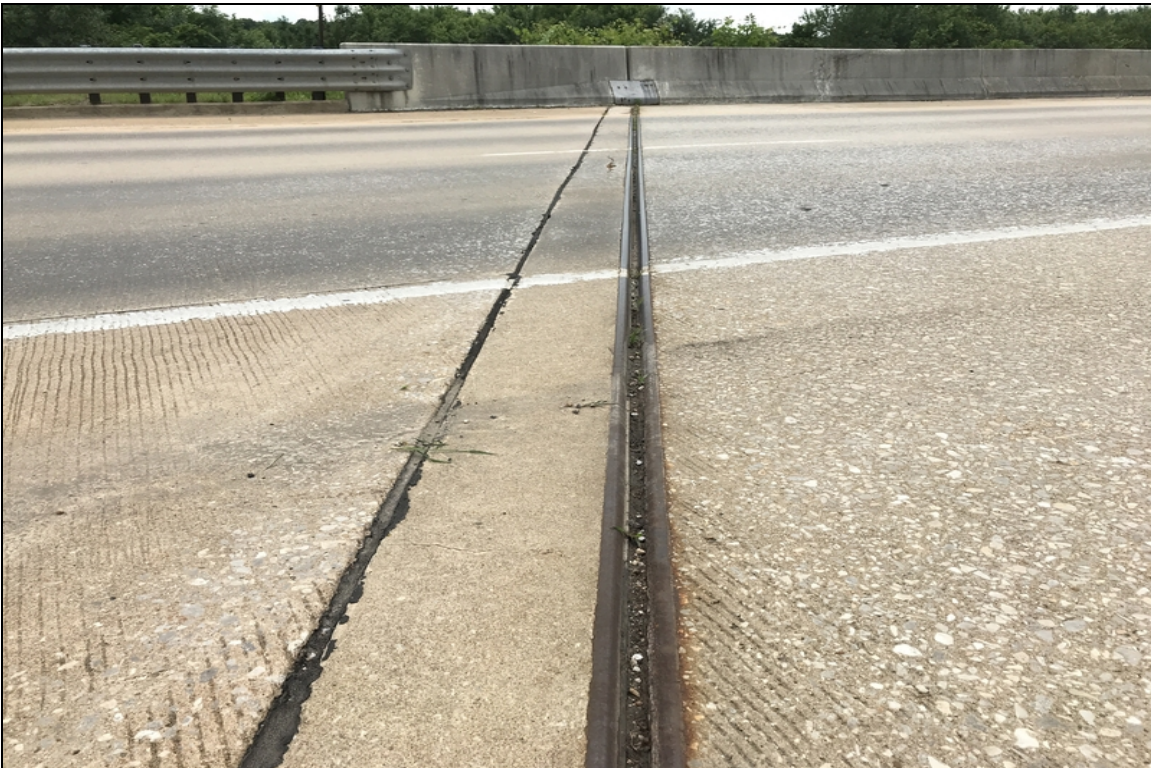
Abutment #2 expansion joint material debris impaction.

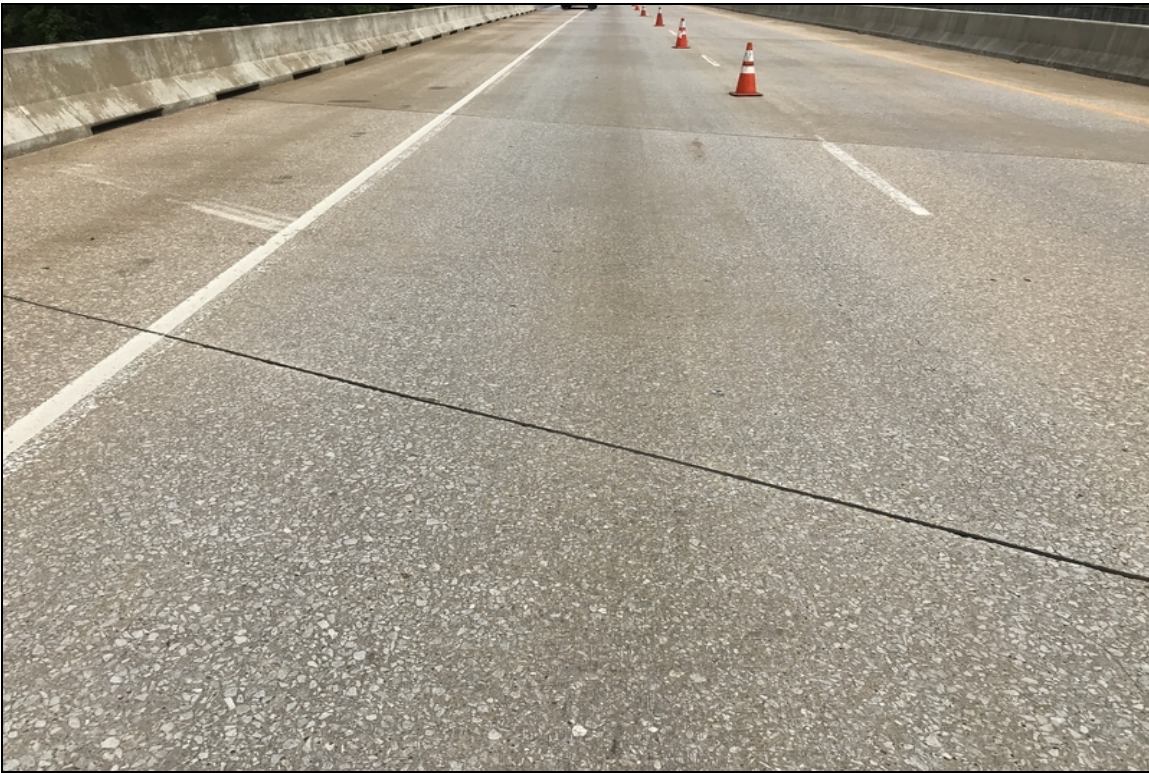
Wearing in wheel path.

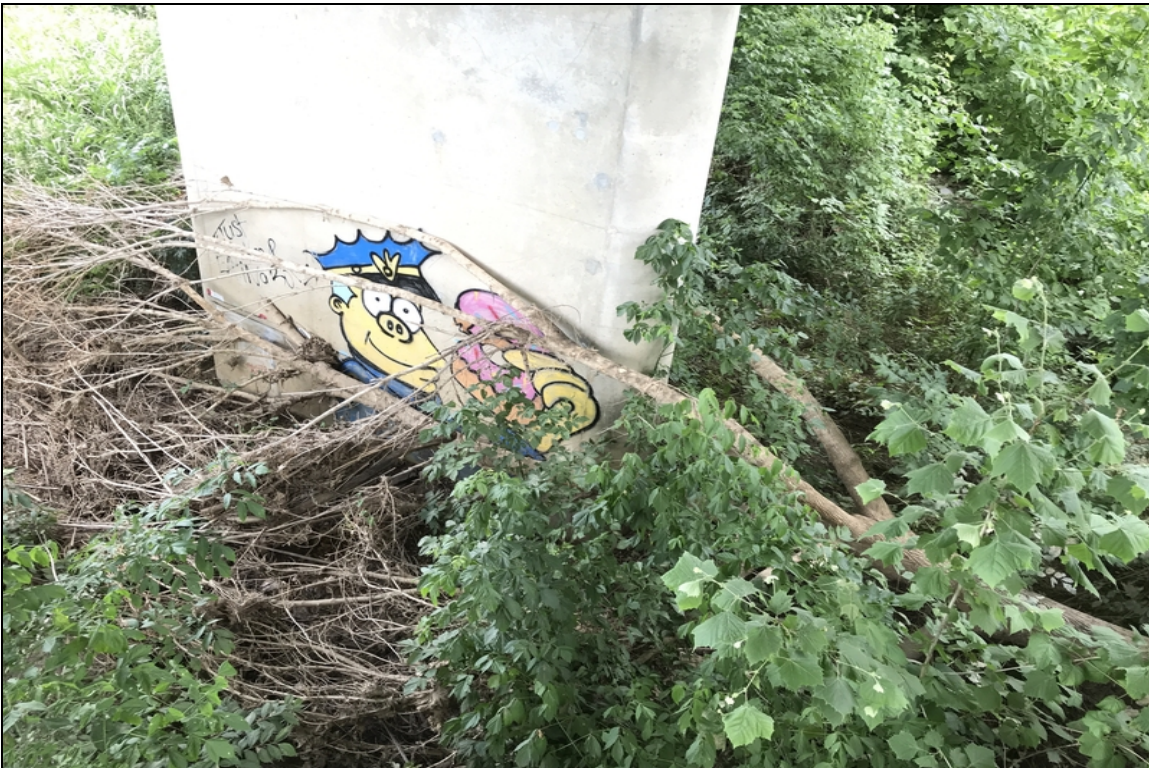
Bent #5 has a tree lodged against Pier.

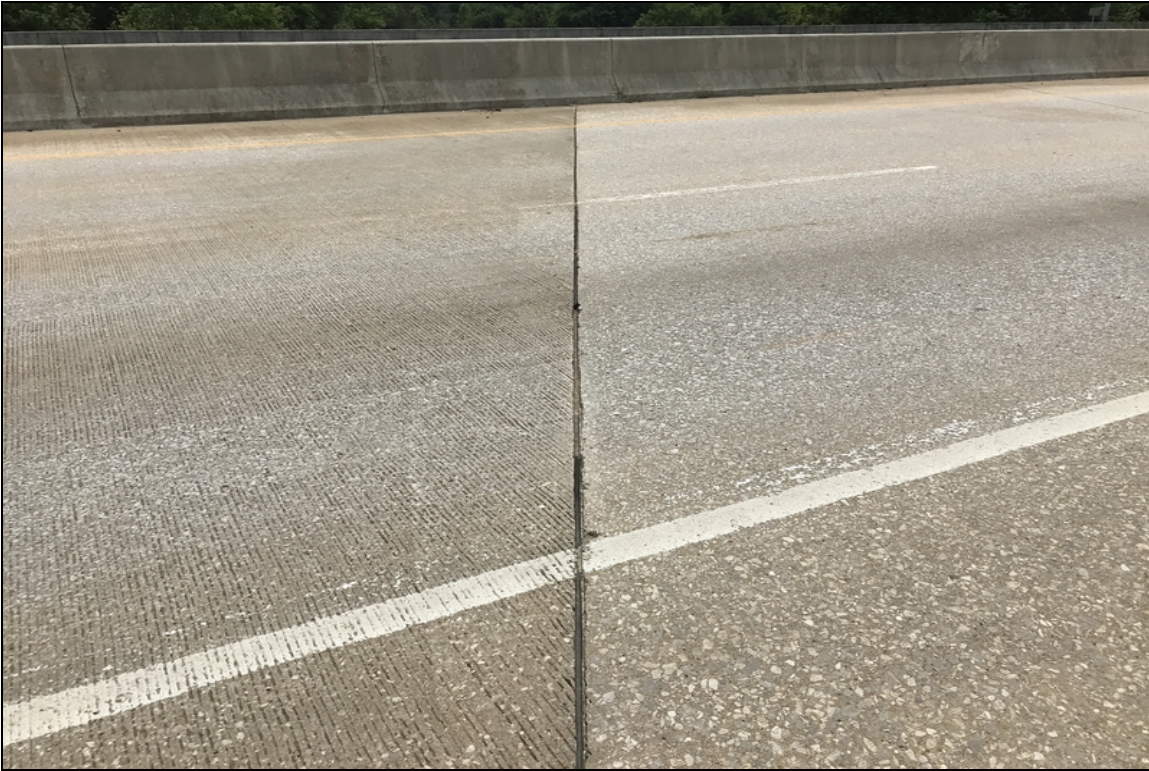
Pourable joint material for construction joints has been displaced.

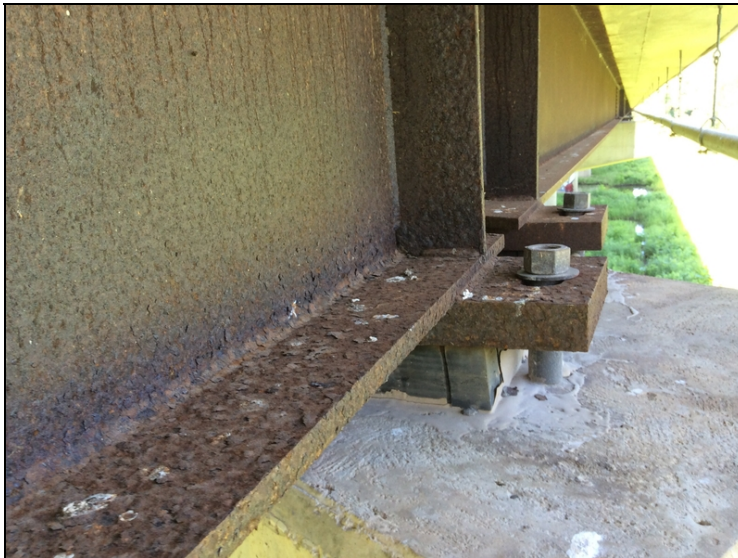
Superstructure - The ends of girders have abnormal weathering with flaking rust in locations due to leaking expansion joints.

Span #13, end of Girder #1 over bent #12 has an area of corrosion approximately 4' long due to leaking expansion joint.
