Bridge #A6476(Routine, Underwater type 2)
US 412 Benton 2 over Illinois River/West Crsg
Location: Benton Co8.19 MI W OK LN

Team Lead: Nathan Rowland **Inspection Date:** June 15, 2021

IDENTIFICATION	
(1) State Names	Arkansas
(8) Structure Number	A6476
(5) Inventory Route	412
(2) Highway Agency District	09
(3) County Code	7-Benton County, Arkansas

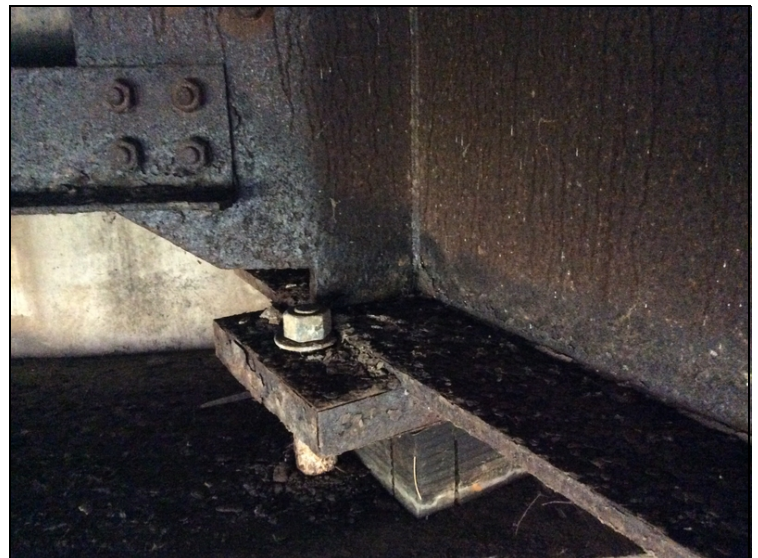
Superstructure - The ends of girders have abnormal weathering with flaking rust in locations due to leaking expansion joints.

Span #1, Girder #2 at abutment #1-Corrosion due to leaking expansion joint.

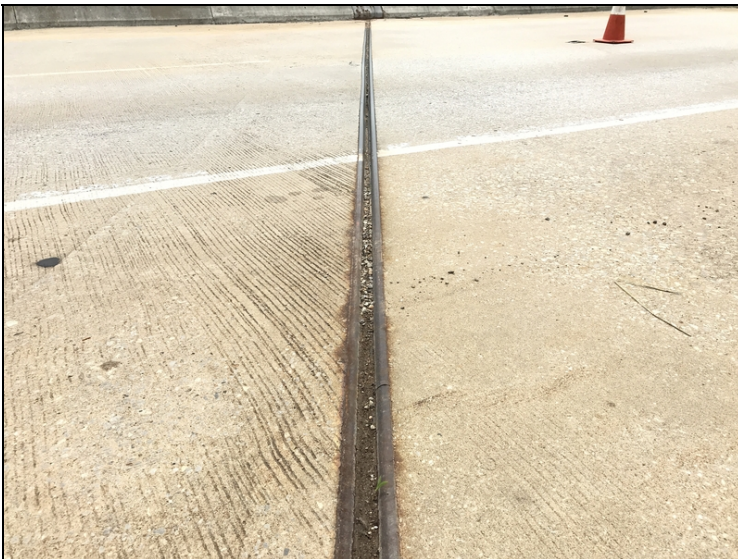
The strip seal compression joint seals have heavy debris impaction.

Bent #8 debris in expansion joint.

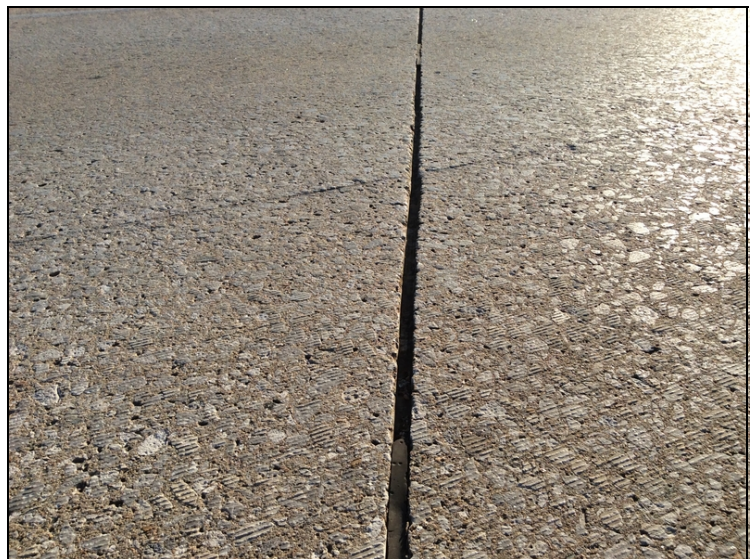
The sawn construction joint sealant material is missing in numerous locations throughout.

Missing joint sealant.

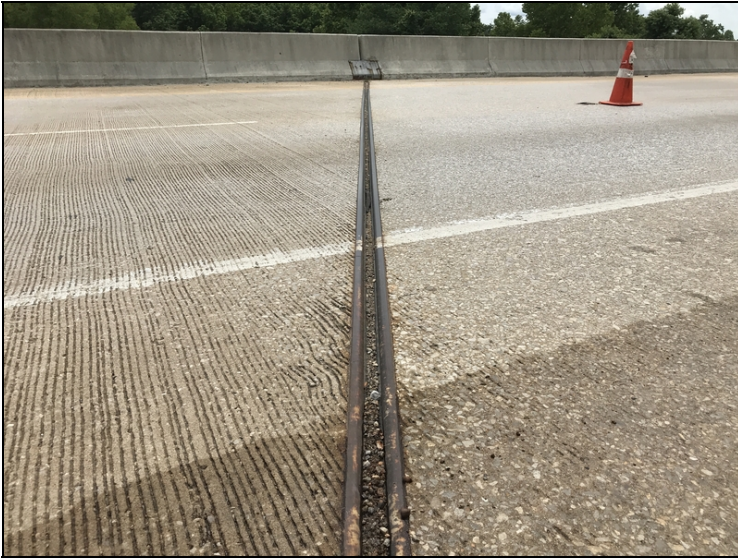
Bent #4 expansion joint debris.

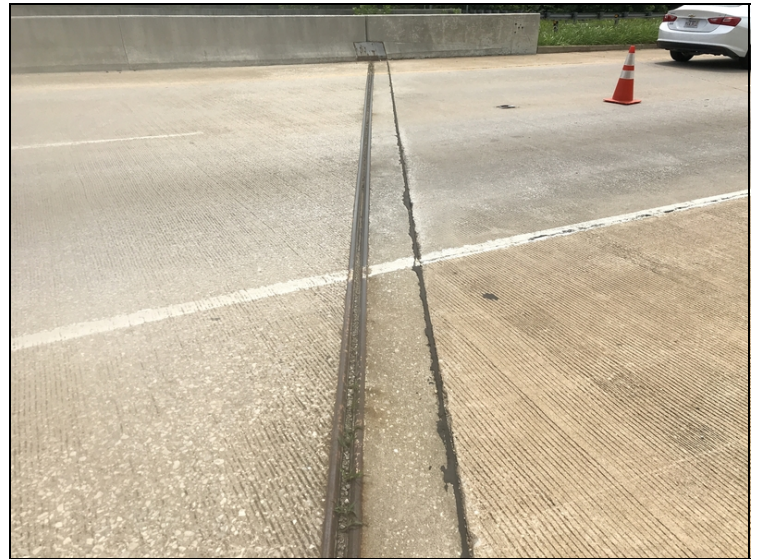
Abutment #1 strip seal expansion joint is torn in locations allowing water to leak onto superstructure promoting corrosion.

Abutment #1 joint

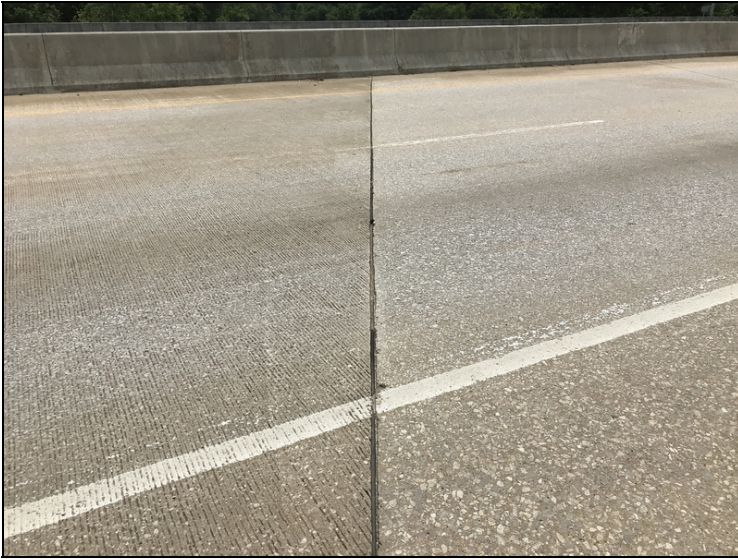
Pourable joint material for construction joints has been displaced.

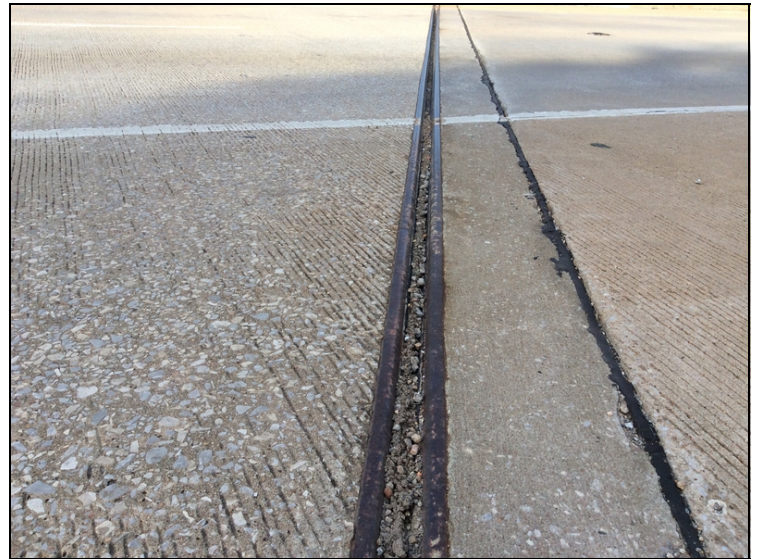
Abutment 1-Debris impaction.

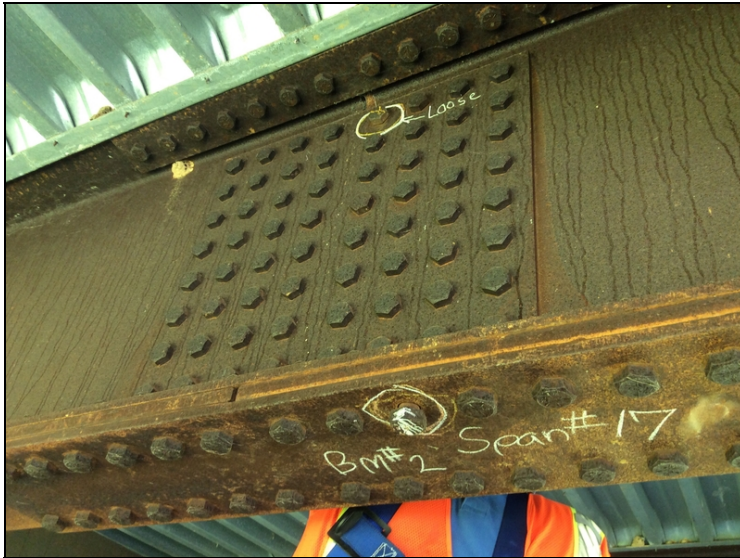
Superstructure - Superstructure splice plate connections have loose bolts in several locations.

Span #17, Girder #2-Loose splice plate connection bolts.

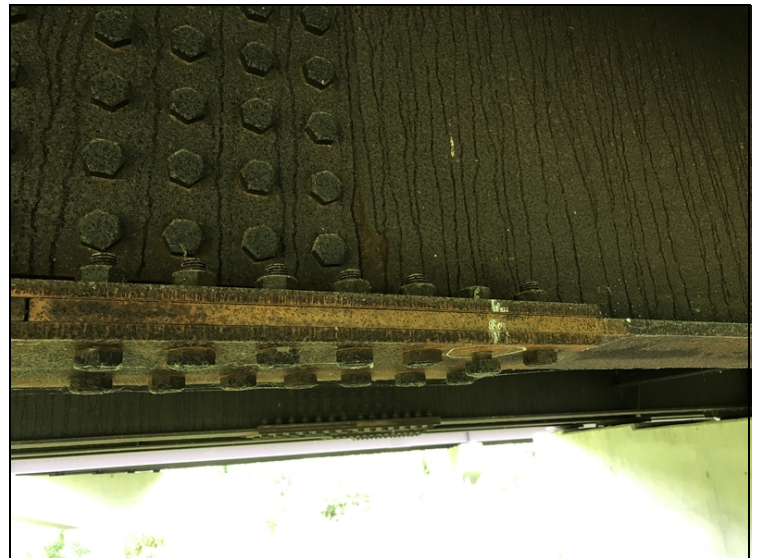
Span #11 Girders #2 and #3 have 1 loose bolt.

Span #11 Girders #2 loose bolt

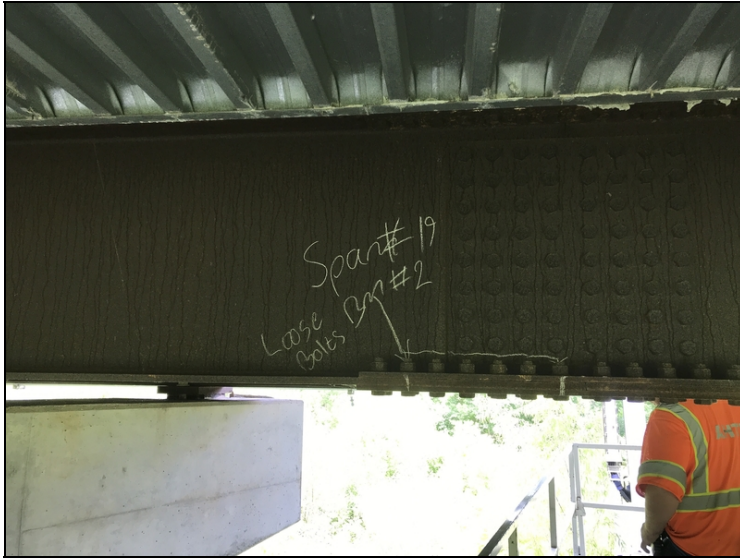
Span #19 Girder #2 has 2 loose bolts.

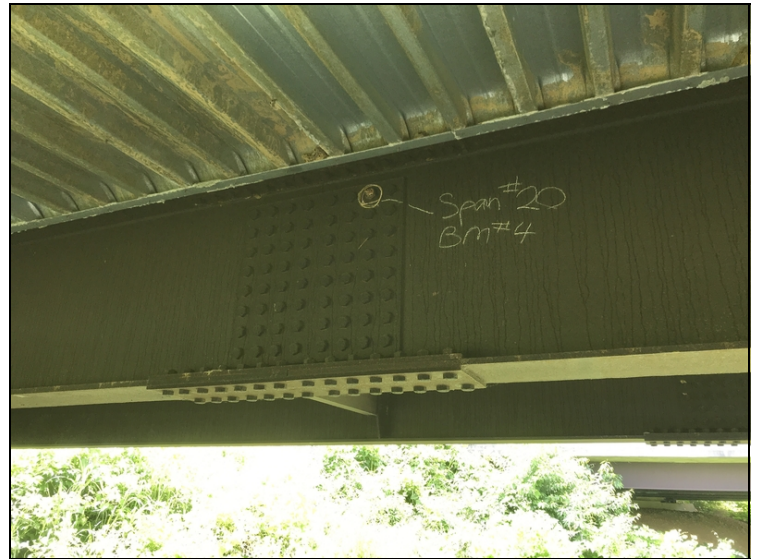
Span #20 Girder #4, has 1 loose bolt.

Span #20 girder #4 loose bolt in splice plate.

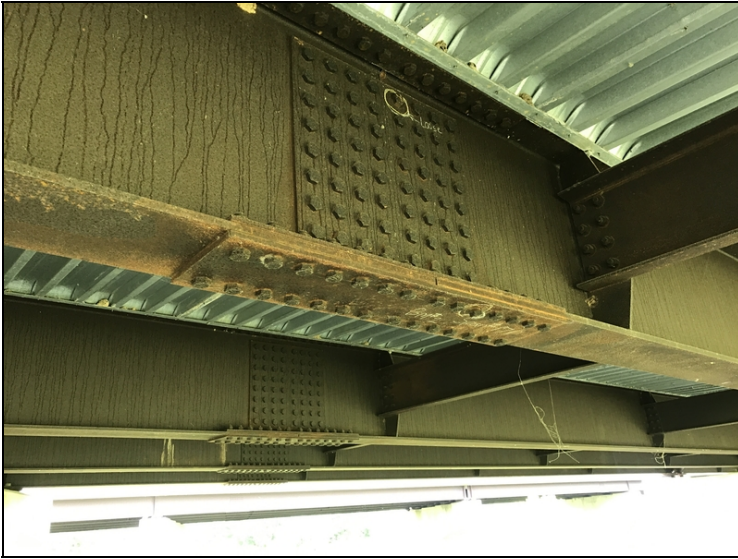
Previously documented bolts are still loose.

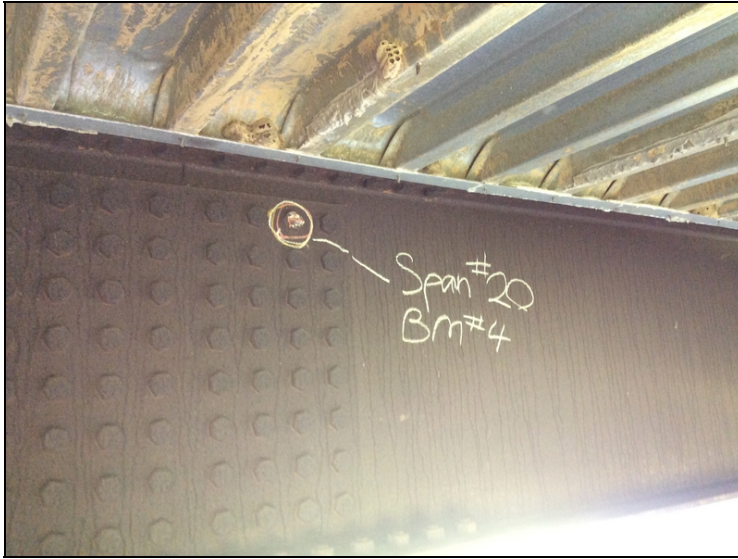
Span #20, Girder #4 has loose splice connection bolt.

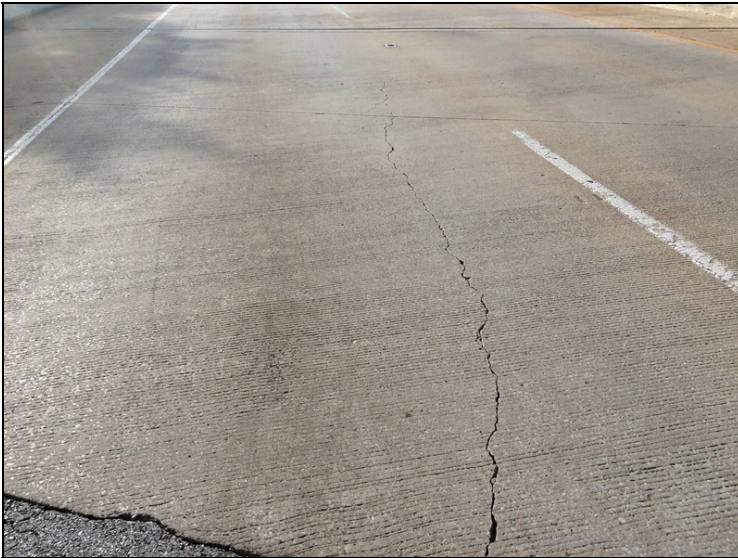
Deck / West approach slab - The deck has sealable cracking in all spans. The outside lane in span #3 is worst case with areas of wide transverse, longitudinal and mapcracking.
The West approach slab has a wide full length longitudinal crack in the left lane.

West approach slab-Wide longitudinal cracking.

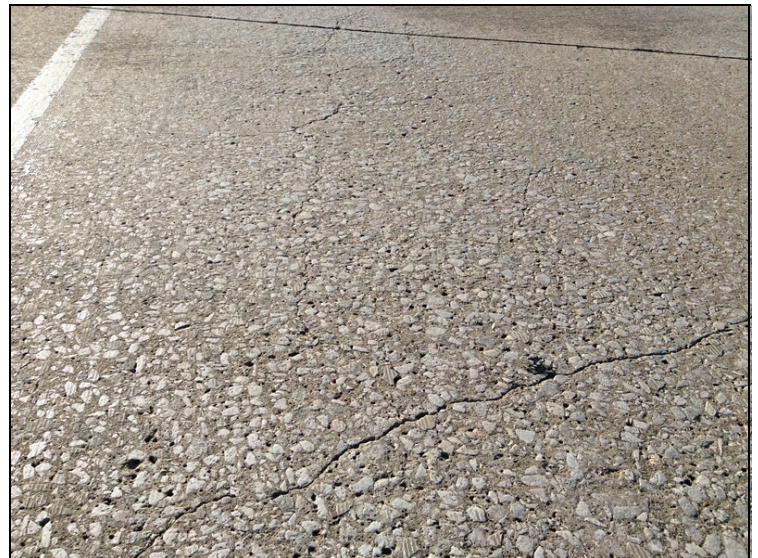
Span #3-Cracking.

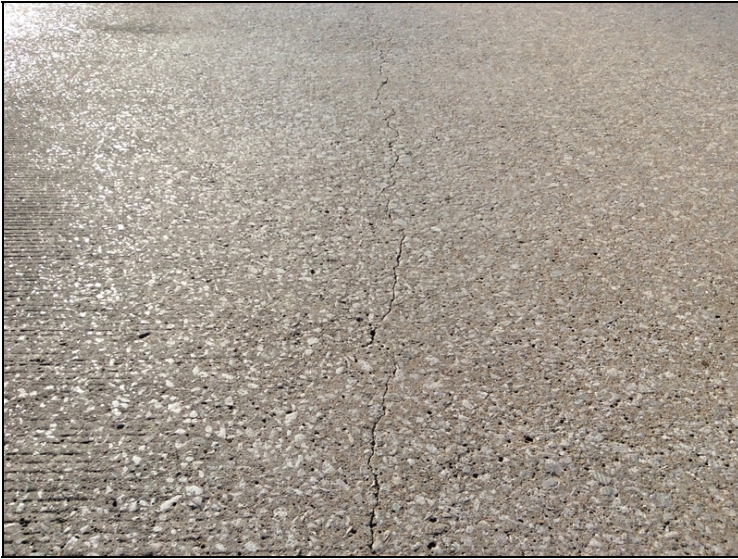
Longitudinal cracking over bent #2.

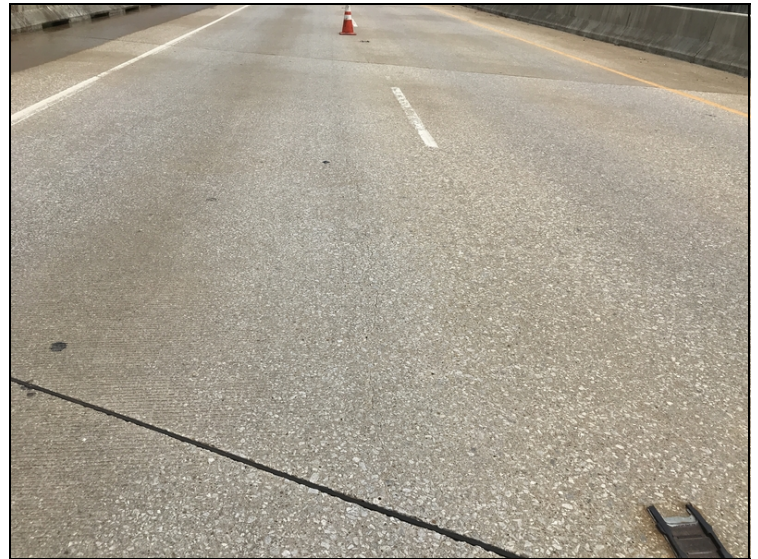
Typical longitudinal cracking.

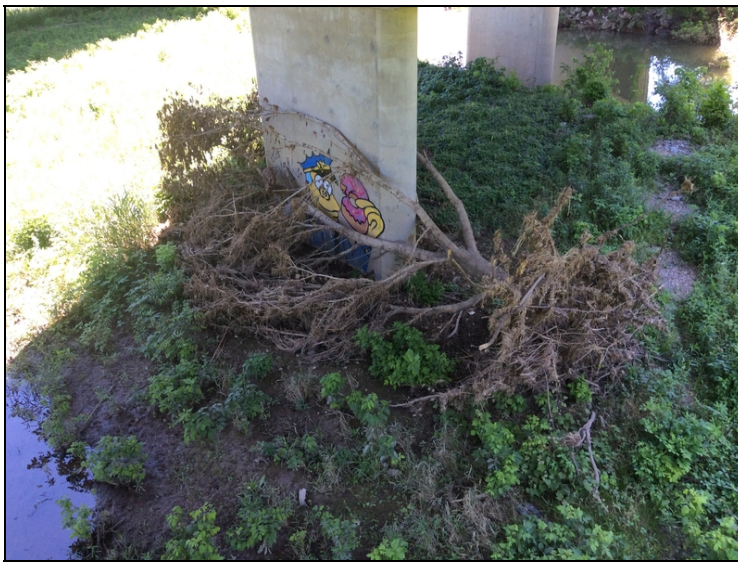
Channel -
Bent #5 has a tree lodged against Column.

Bent #5-Tree lodged against bent.

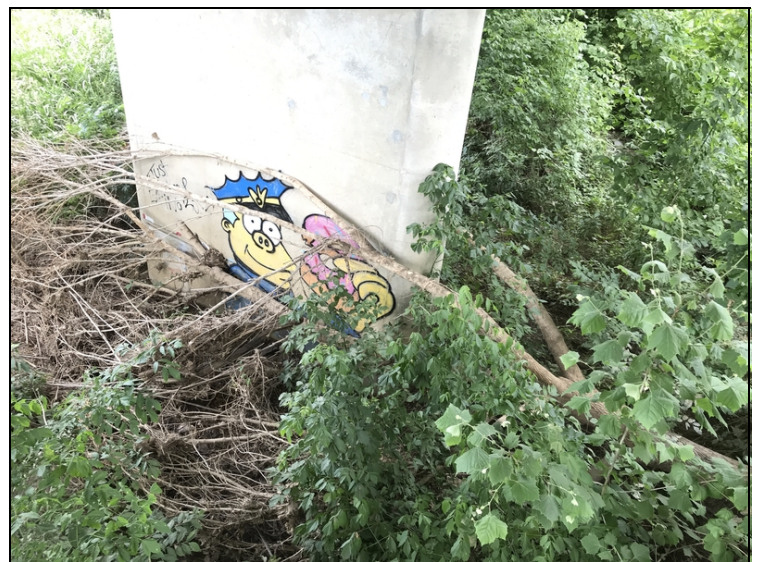
Bent #5 has a tree lodged against Pier.

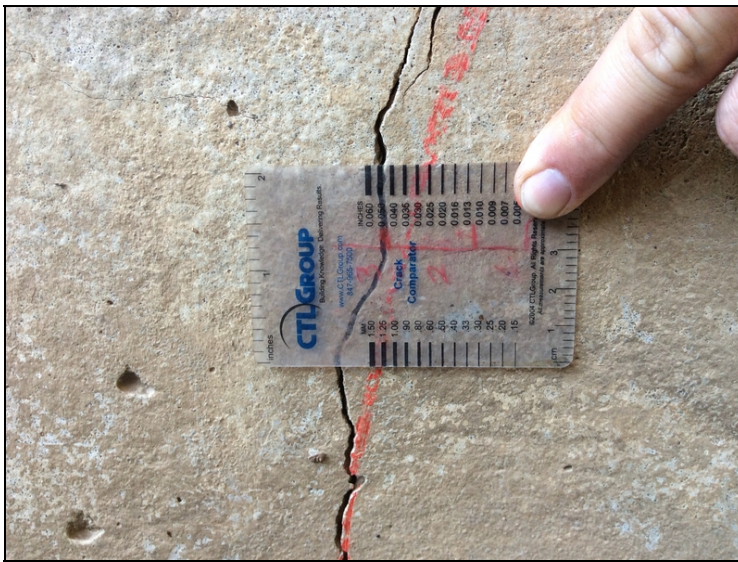
Substructure - Bent #2 column has several diagonal cracks visible on both sides of column that propagate from base of column. Cracks extend up the column approximately 10' in length and range in width from hairline to wide.

Bent #2-Diagonal cracking in column.

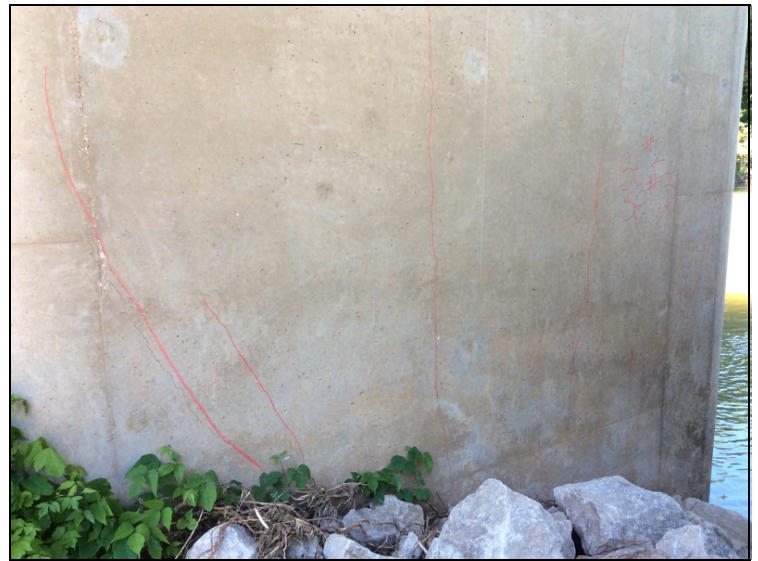
Bent #2-Diagonal cracking in column.

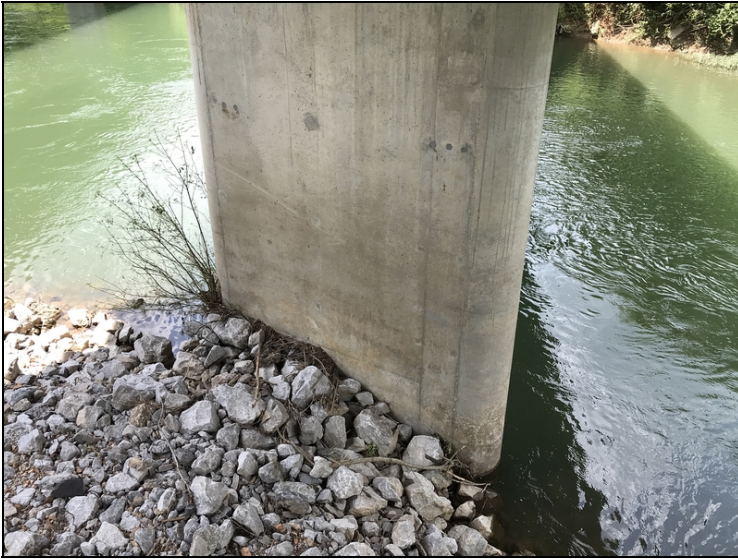
Bent #2 Vertical and diagonal cracking in pier.

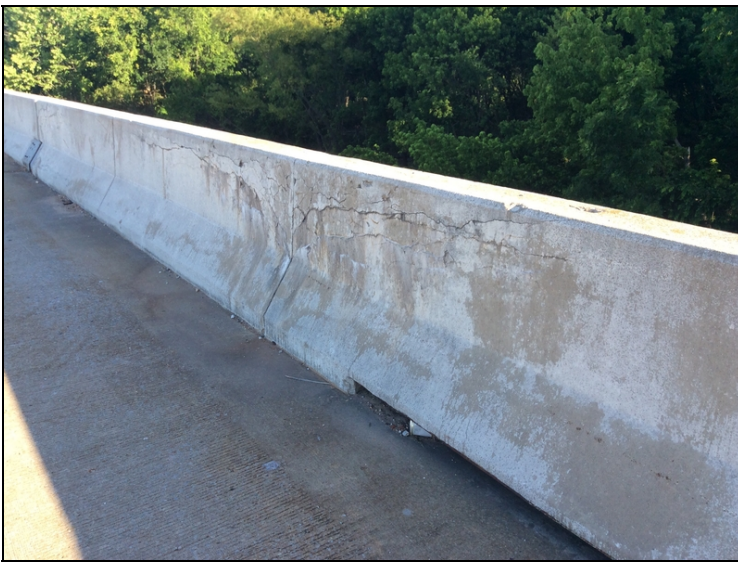
Concrete bridge railing - The concrete bridge railing has areas of mapcracking that sound delaminated in areas when sounded.

Span 9 parapet wall left typical cracking.

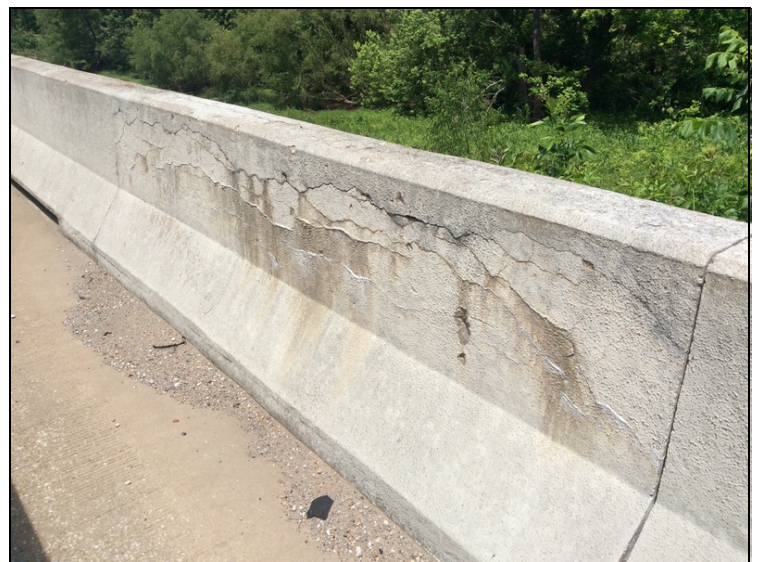
Span #20, left bridge railing-Cracking.

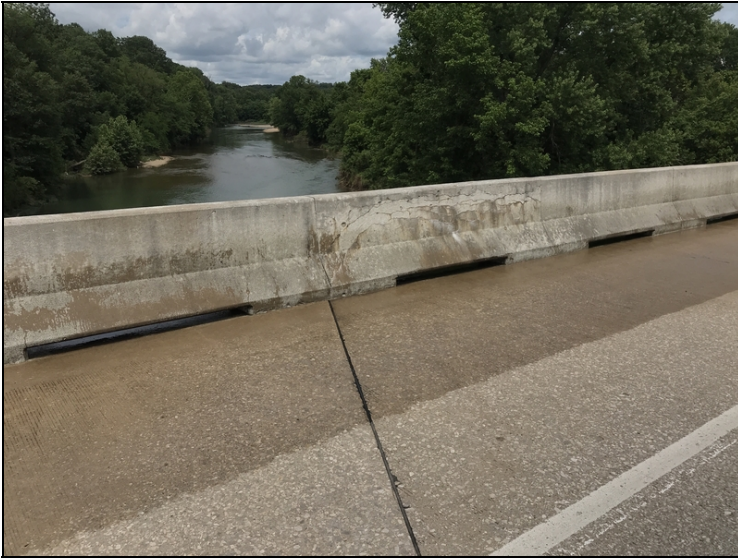
Typical cracking in parapet wall.

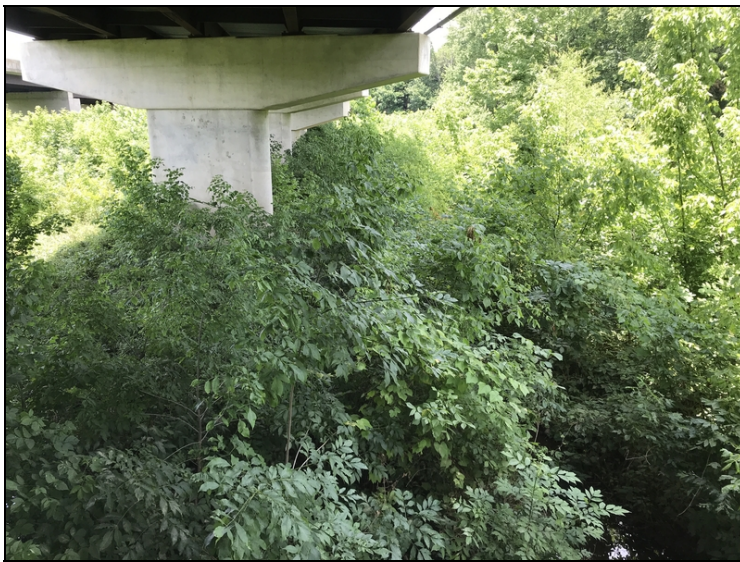
Heavy vegetation:
-Large vegetation has begun impacting the inspection process.

Large vegetation.

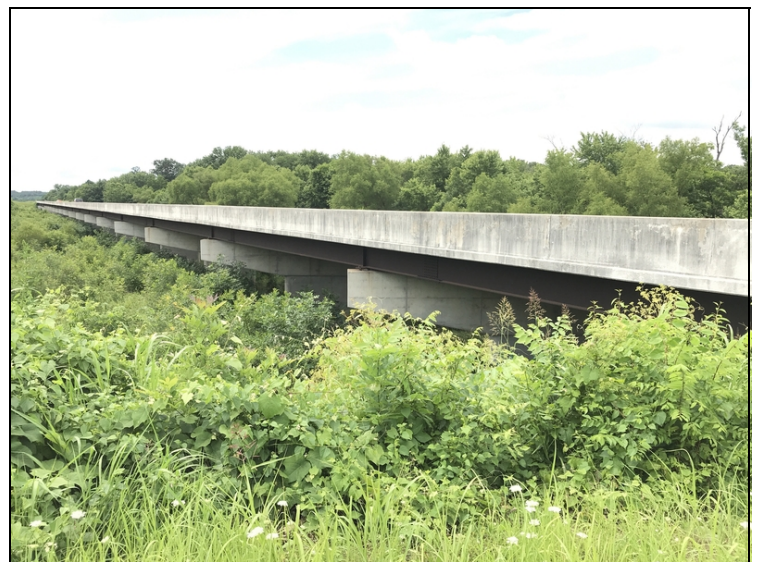
Heavy vegetation is impacting inspection equipment during normal inspection operations.
