**Bridge #B6476**(Routine, Underwater type 2)

**SH 412 EB Benton 2 over ILLINOIS RIVER**

**Location: Benton Co 8.17 W OKLINE**

**Team Lead:** Nathan Rowland **Inspection Date:** June 15, 2021

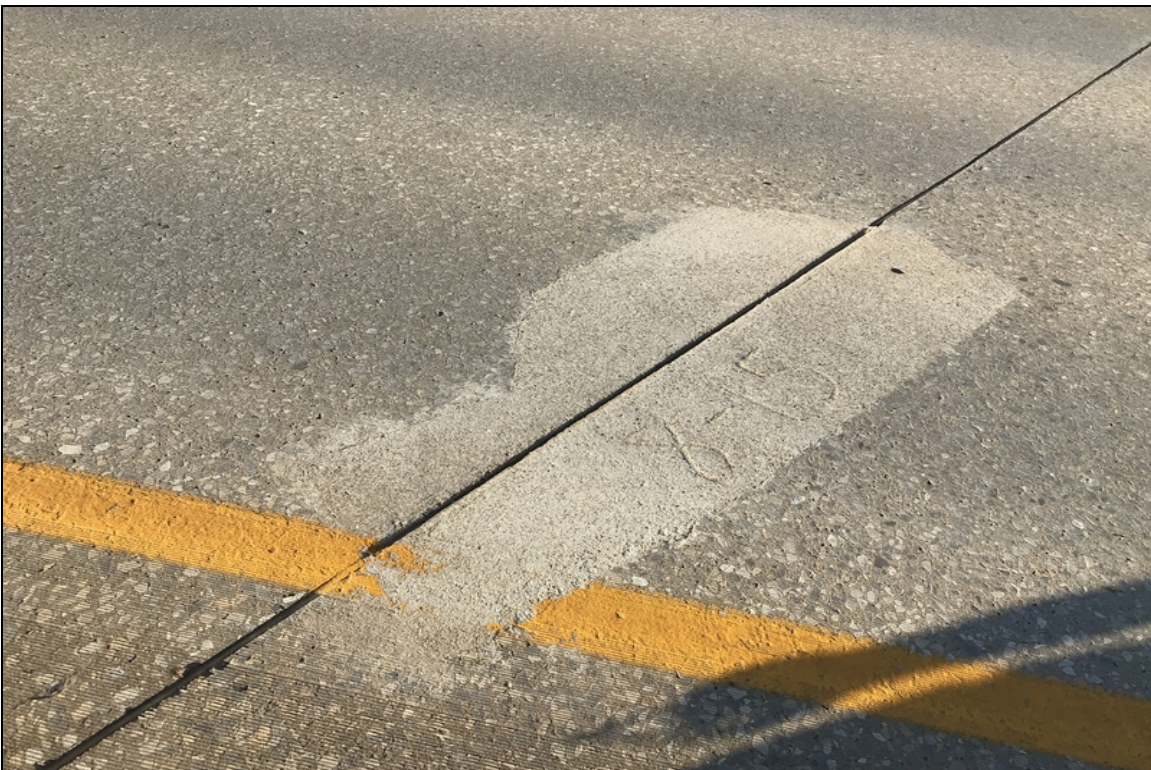
Deck surface concrete patch span #13 on the adjacent bent #13.

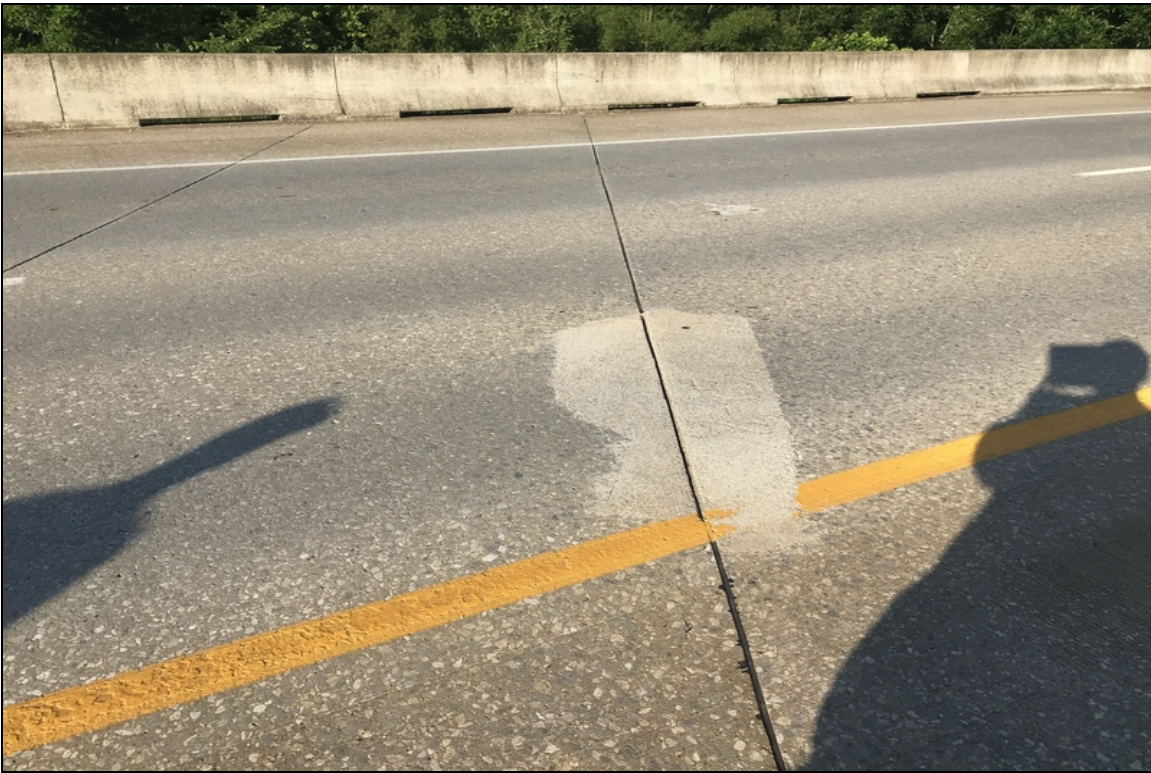
Deck surface concrete patch span #13 on the adjacent bent #13.

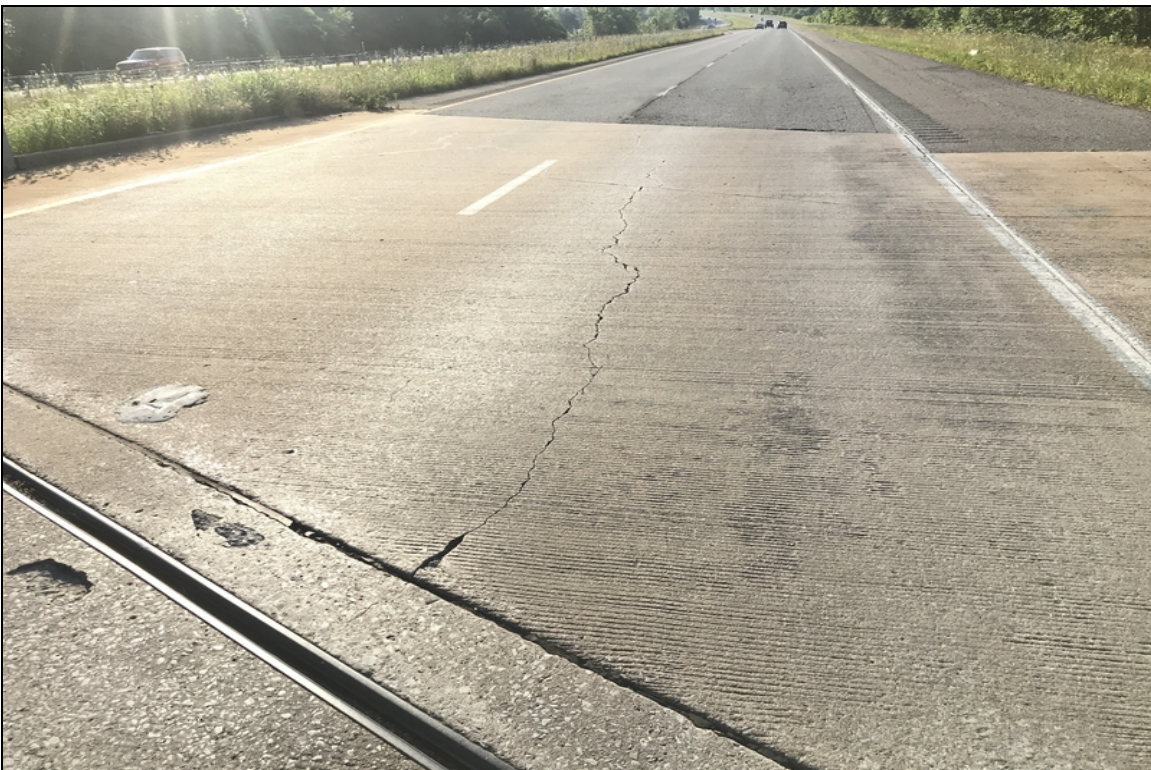
Large crack in the east abutment.

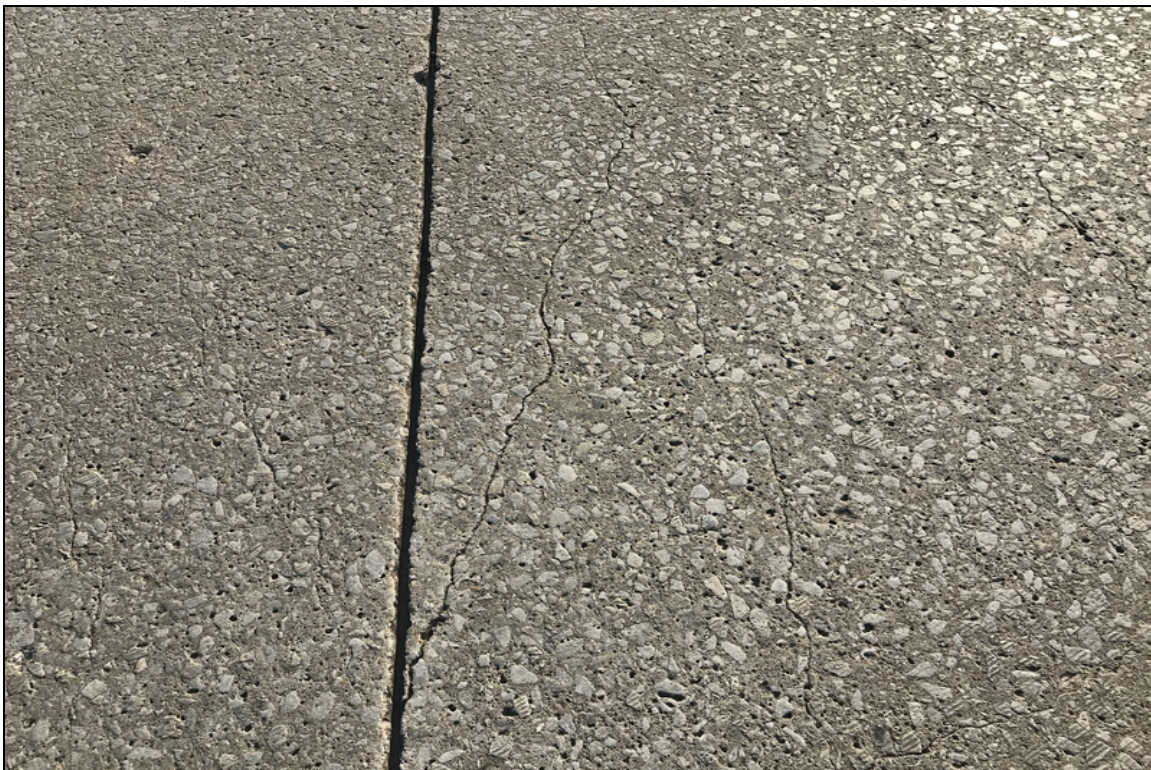
If cracking sealant was applied it would have been removed during milling operations

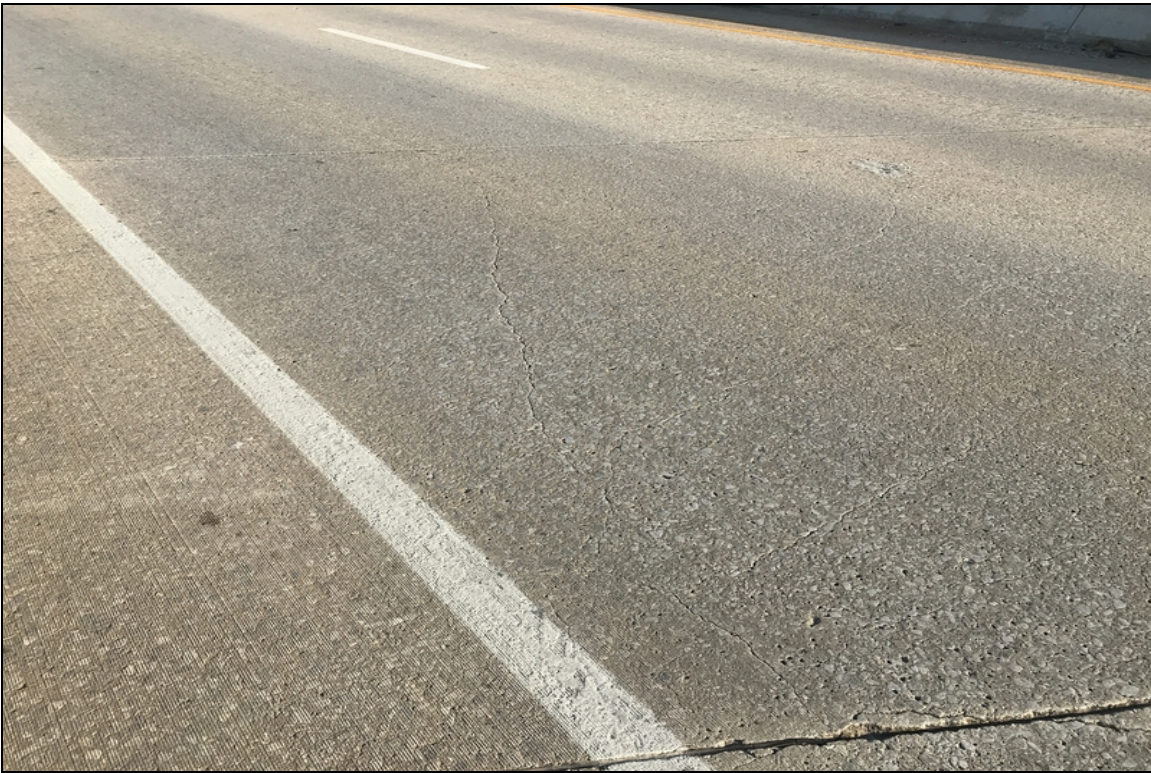
If cracking sealant was applied it would have been removed during milling operations

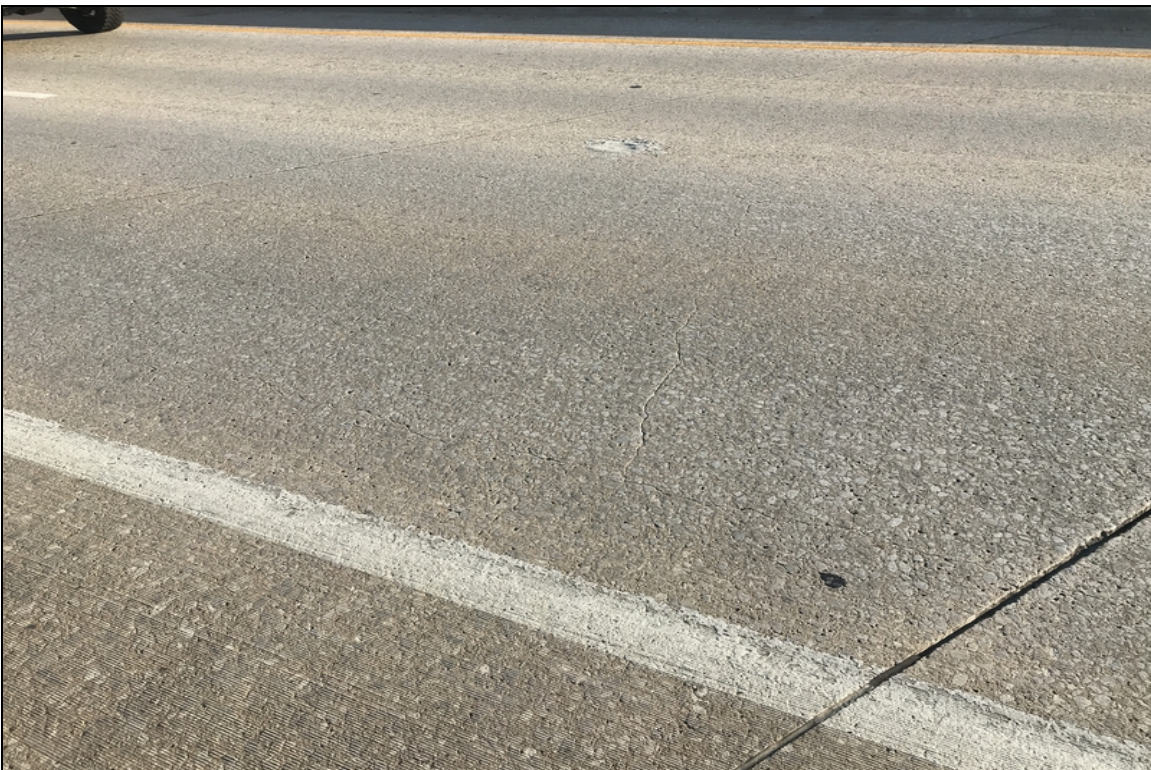
(12)	06/16/2021 WNR & DBM: -The deck has sealable longitudinal, transverse and mapcracking in several locations. -Spans #1 and #2 have light mapcracking in wheel paths of outside lane. -The overhangs of the deck have transverse cracking with efflorescence in locations. -The undersurface of the overhangs have spalling along the expansion joint assemblies. -SIP forms in bay #1 of Span #12 has a basketball sized areas of corrosion. -Multiple spans throughout the undersurface have areas of active corrosion to the SIP forms.						
107	Steel Open Girder/Beam	LF	6820	6820	0	0	0
515	Steel Protective Coating	SF	639205	639205	0	0	0
3430	Oxide Film Degradation Color/Texture Adherence(Steel Protective Coatings)	SF	0	0	0	0	0

Typical transverse and longitudinal deck cracking.

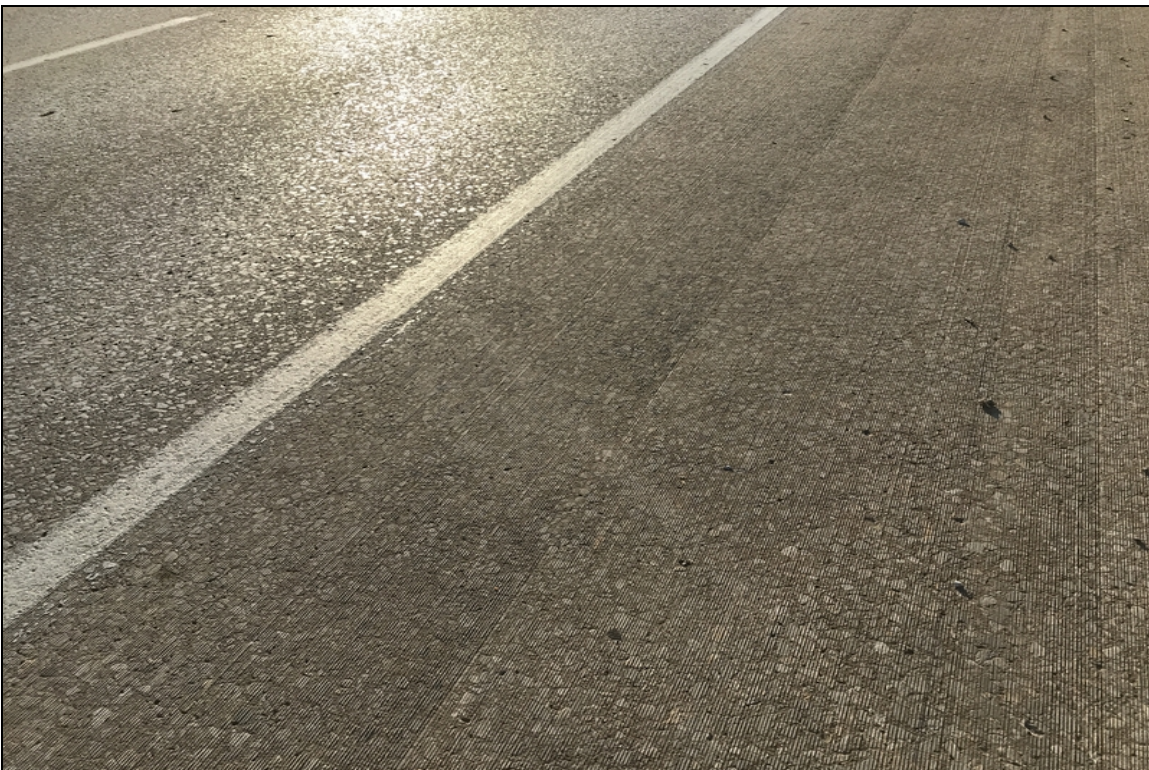
Mill work on deck surface and traffic abrasion has removed the Tyne wearing surface.

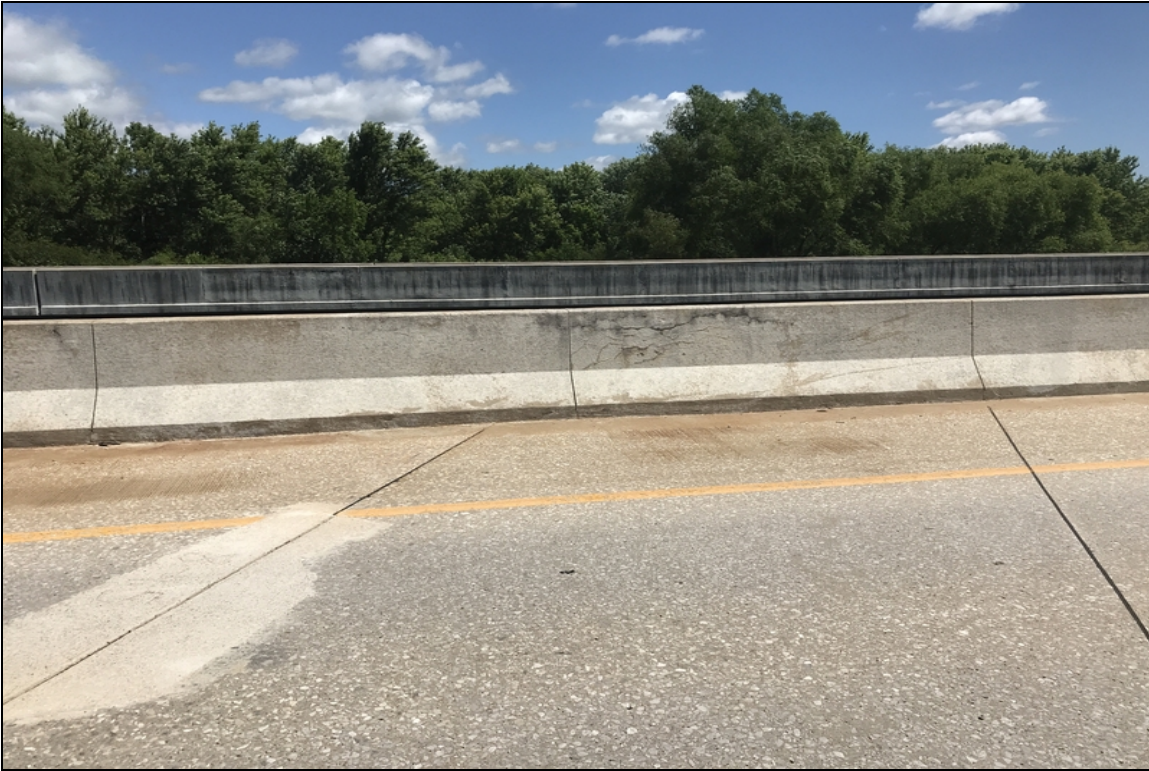
(331)							
06/16/2021 WNR & DBM:							
- The vertical face of parapets have areas of map cracking and efflorescence.							
- Map cracking to right wall in spans #4, #8, #9, #12, and #18 (no rebar showing at time of inspection)

Cracking with efflorescence in parapet wall typical.

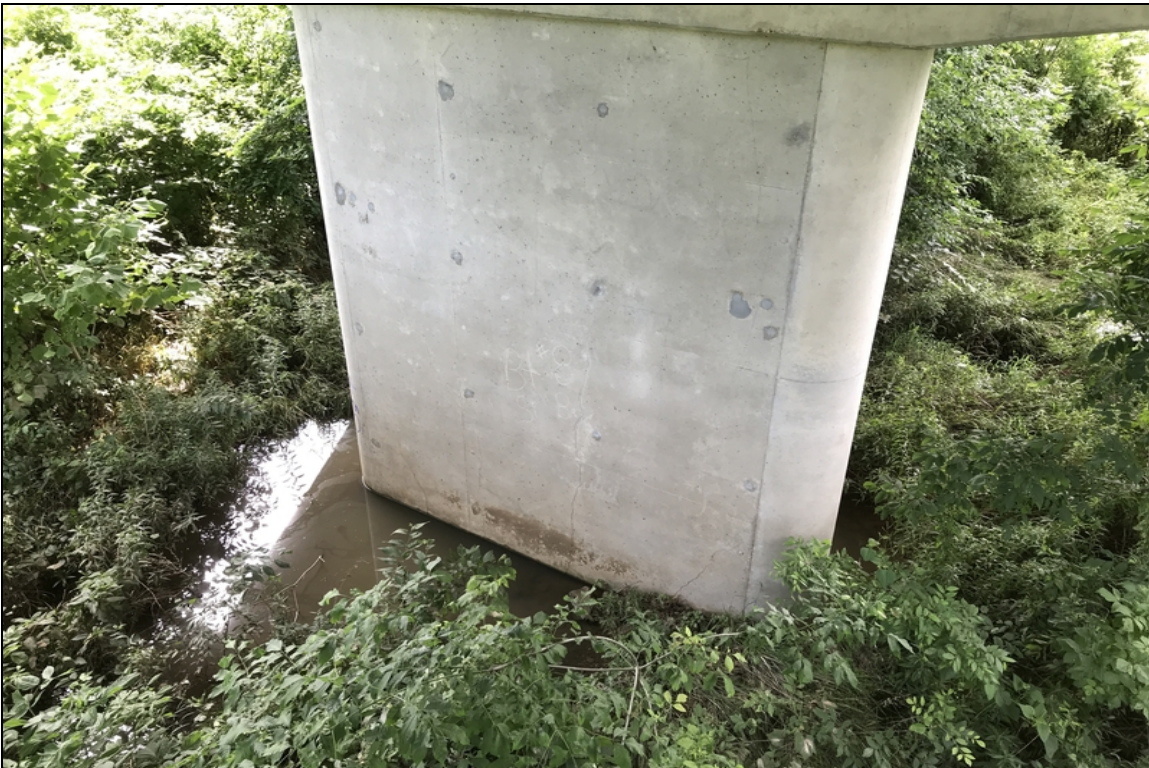
(210)	06/16/2021 WNR & DBM: -Bent #8 has 6 wide diagonal/vertical cracks visible on both sides of column. Cracks extend up the column approximately 9'. -Bent #9 has 3 vertical cracks visible on both sides that extend up the column approximately 7'. -Bent #10 has a small void in Column on right side at cap juncture. -Bent #13 has a hairline vertical crack in both sides of column near centerline.						
215	Reinforced Concrete Abutment	LF	134	114	20	0	0
1130	Cracking (RC and Other)	LF	20	0	20	0	0

Bent #8 pier vertical and diagonal cracking are still present.

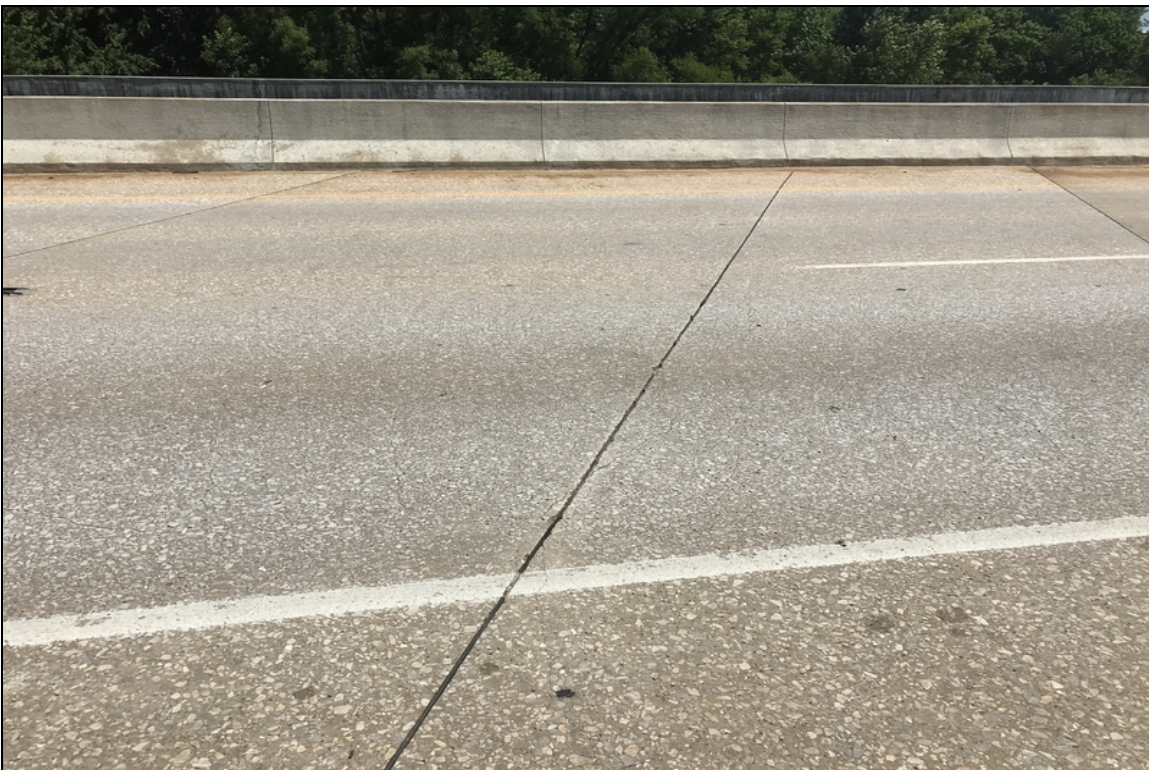
Area of map cracking over bent 11

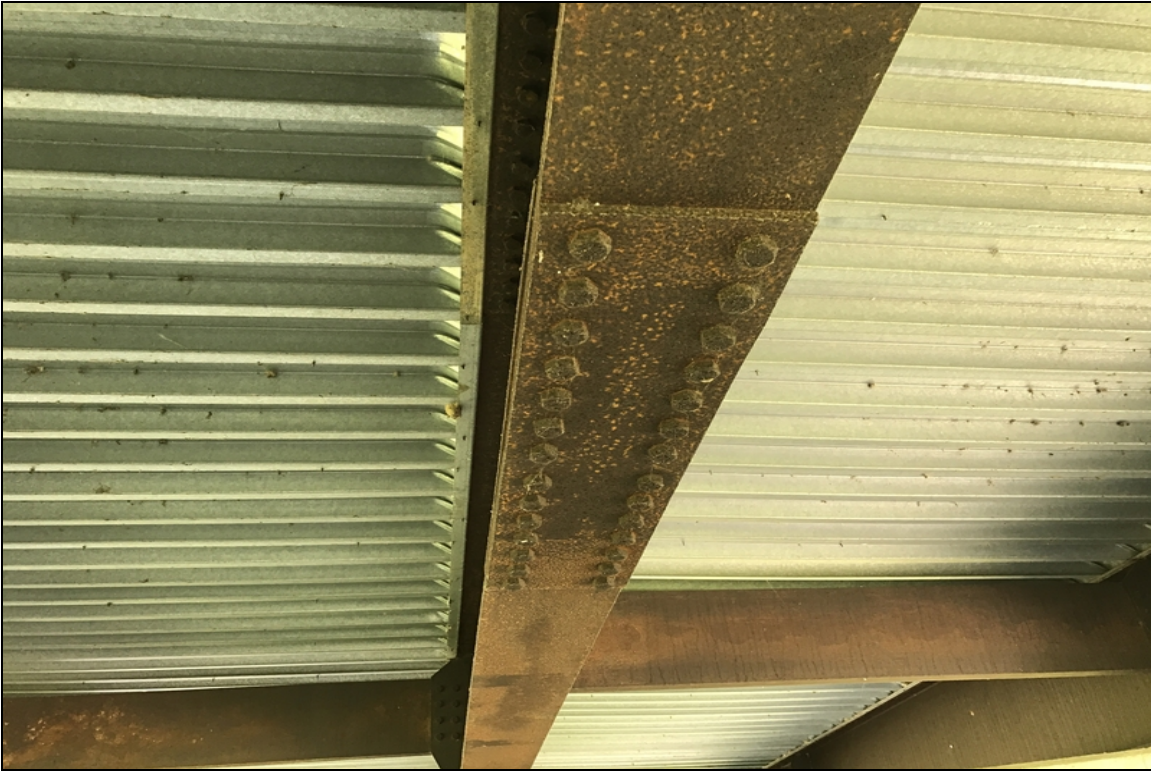
Typical discoloration of the patina on the superstructure.

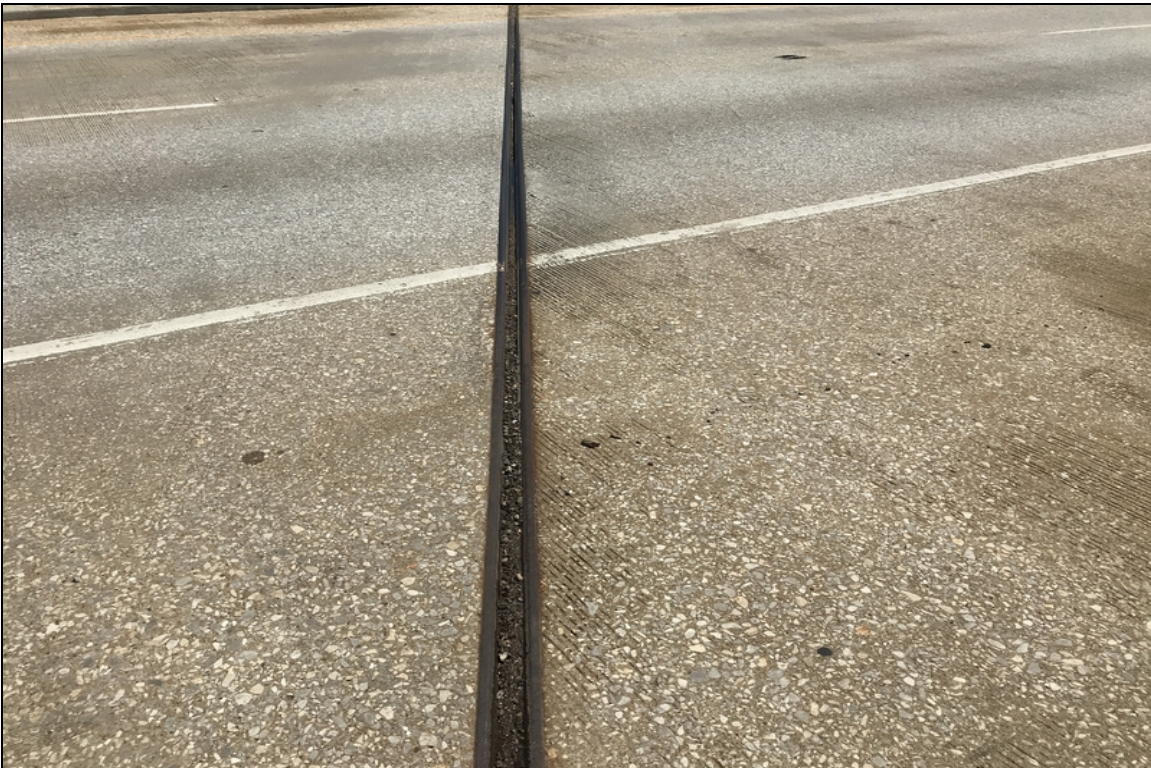
(300)							
06/16/2021 WNR & DBM:							
- The strip seal expansion joints have heavy debris impaction.							
-All joints have minimal loss of adhesive, and are full of sand & debris.							
310	Elastomeric Bearing	EA	125	119	6	0	0
1000	Corrosion	EA	6	0	6	0	0
515	Steel Protective Coating	SF	250	250	0	0	0
3430	Oxide Film Degradation Color/Texture Adherence(Steel Protective Coatings)	SF	0	0	0	0	0

Bent #4 expansion joint debris impaction.

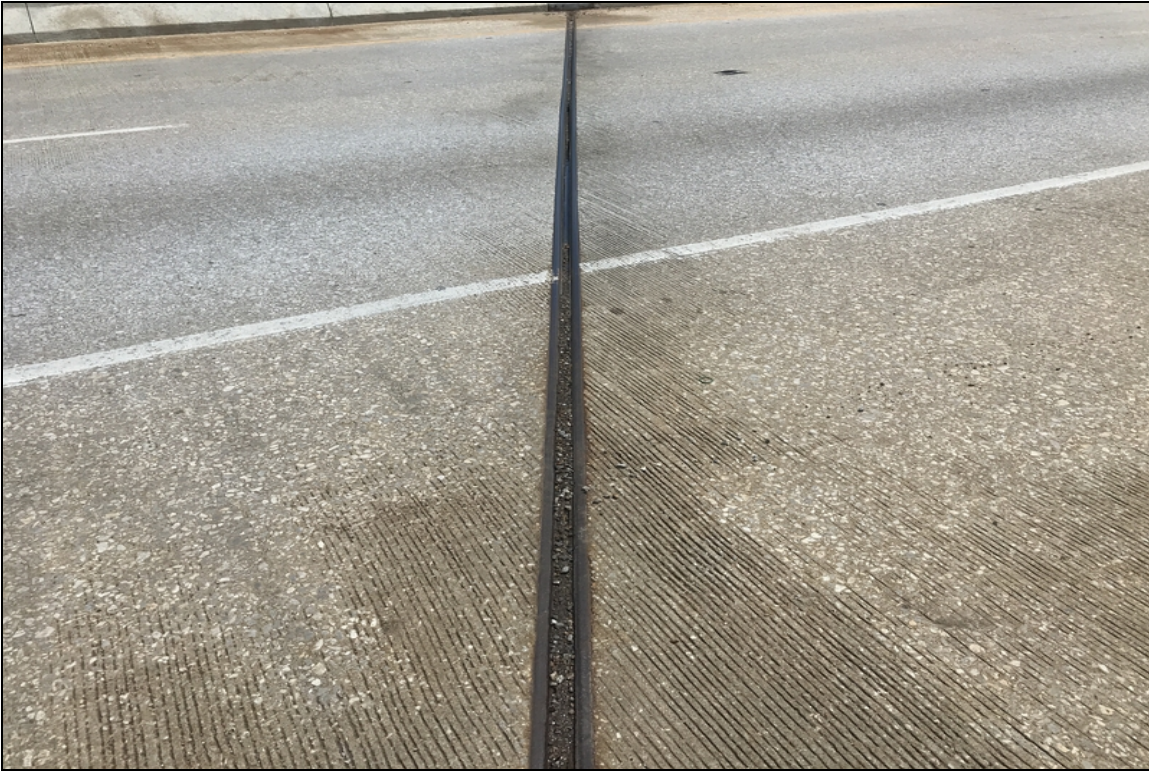
Bent #12 expansion joint debris impaction

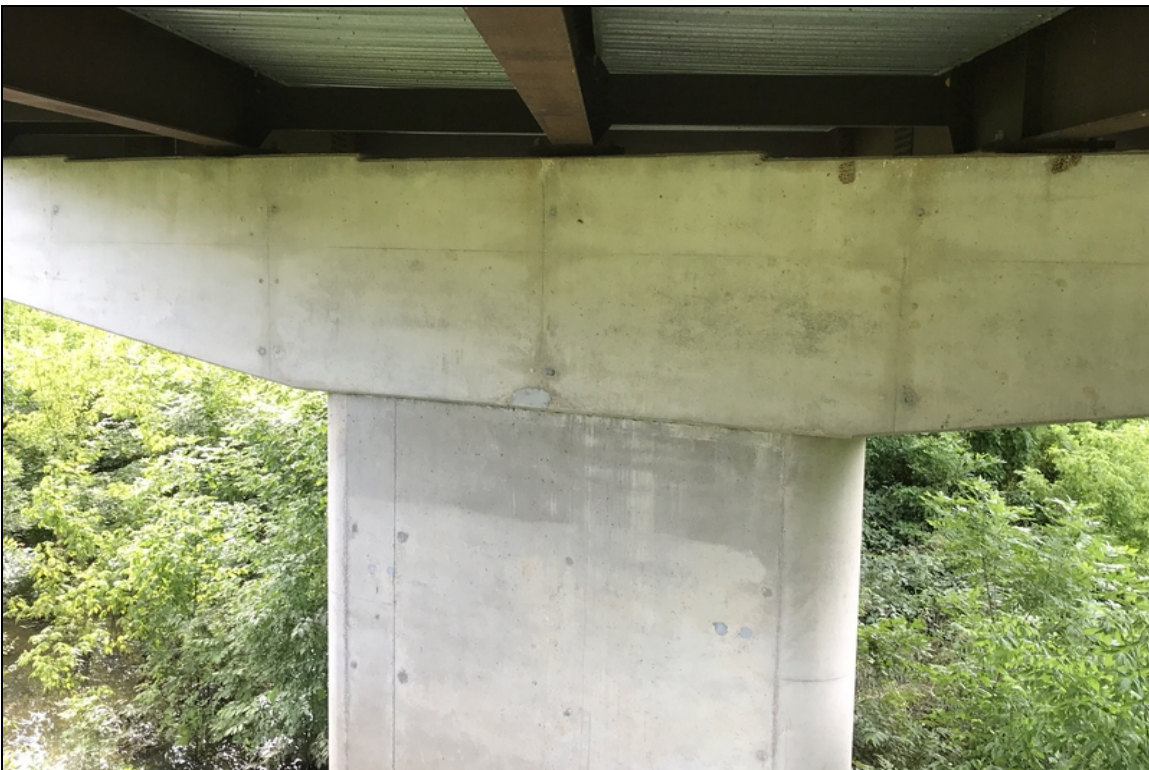
Bent #6 cap behind side has a 1&rsquo; wide patch at the bottom of cap near centerline.

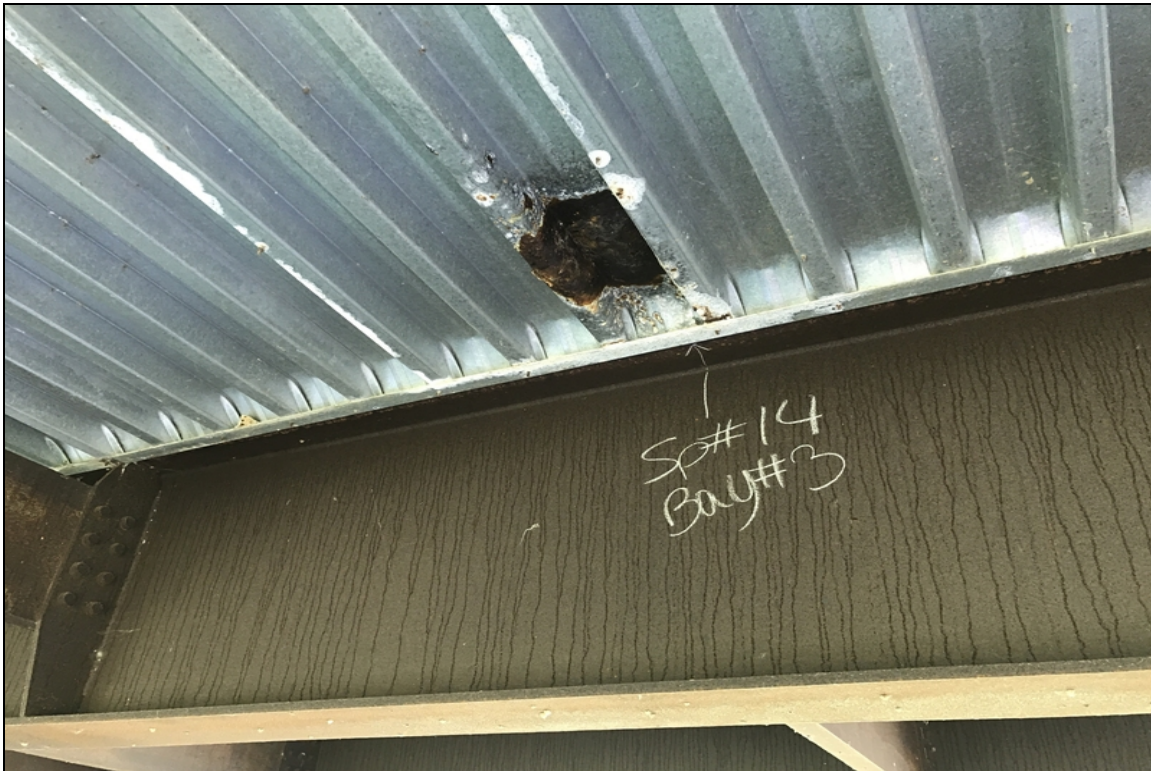
Span #14 bay #3 adjacent girder #4 active corrosion to SIP forms.

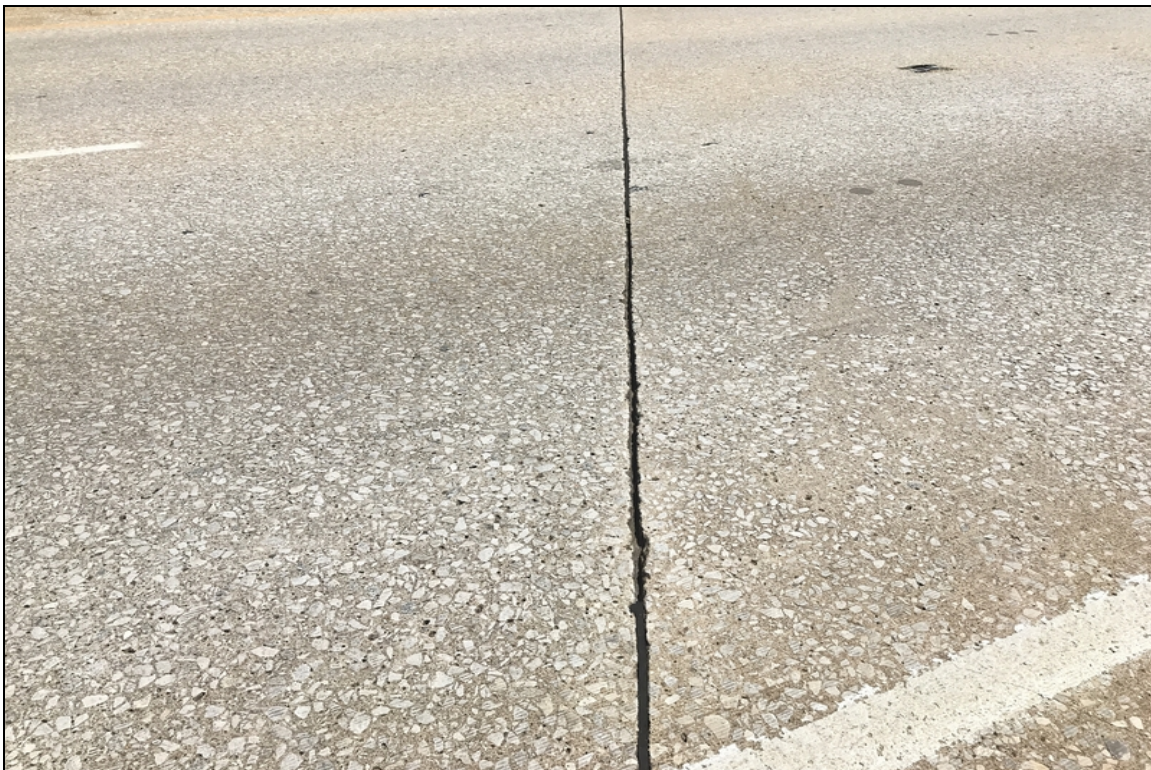
Typical View of pourable joint material displaced from construction joints.

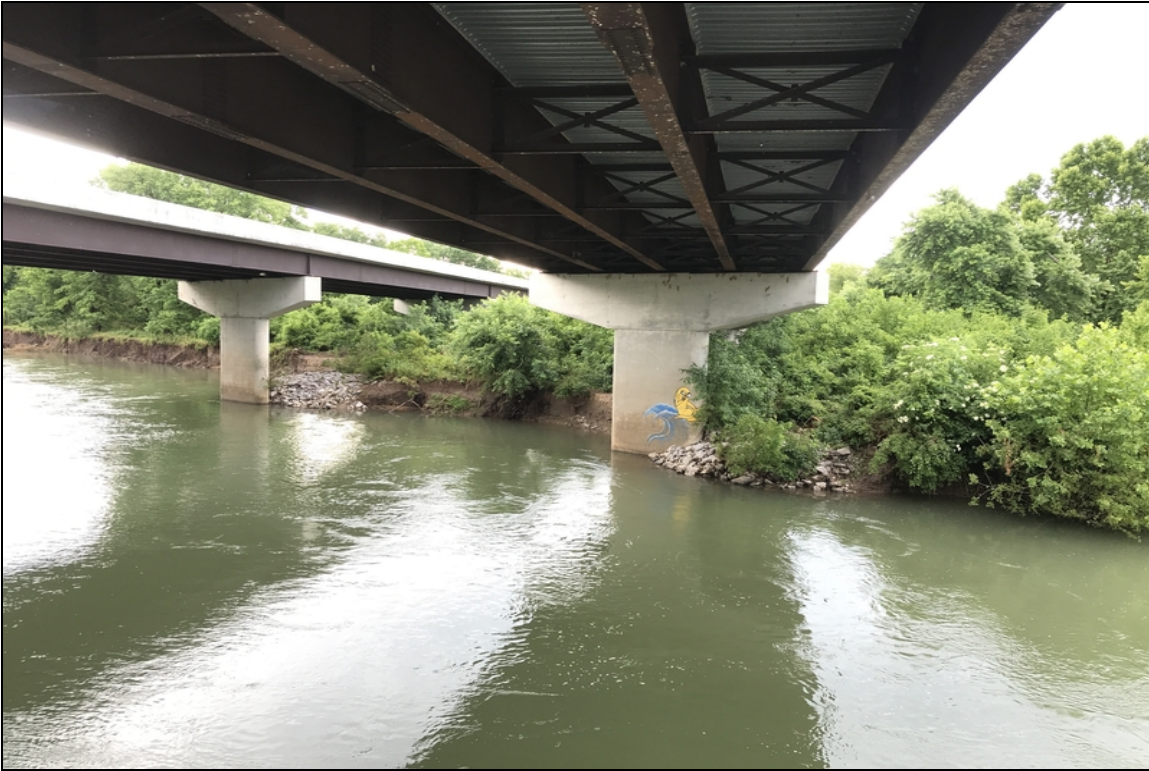
Localized scour at #2 bent of A and B bridge.

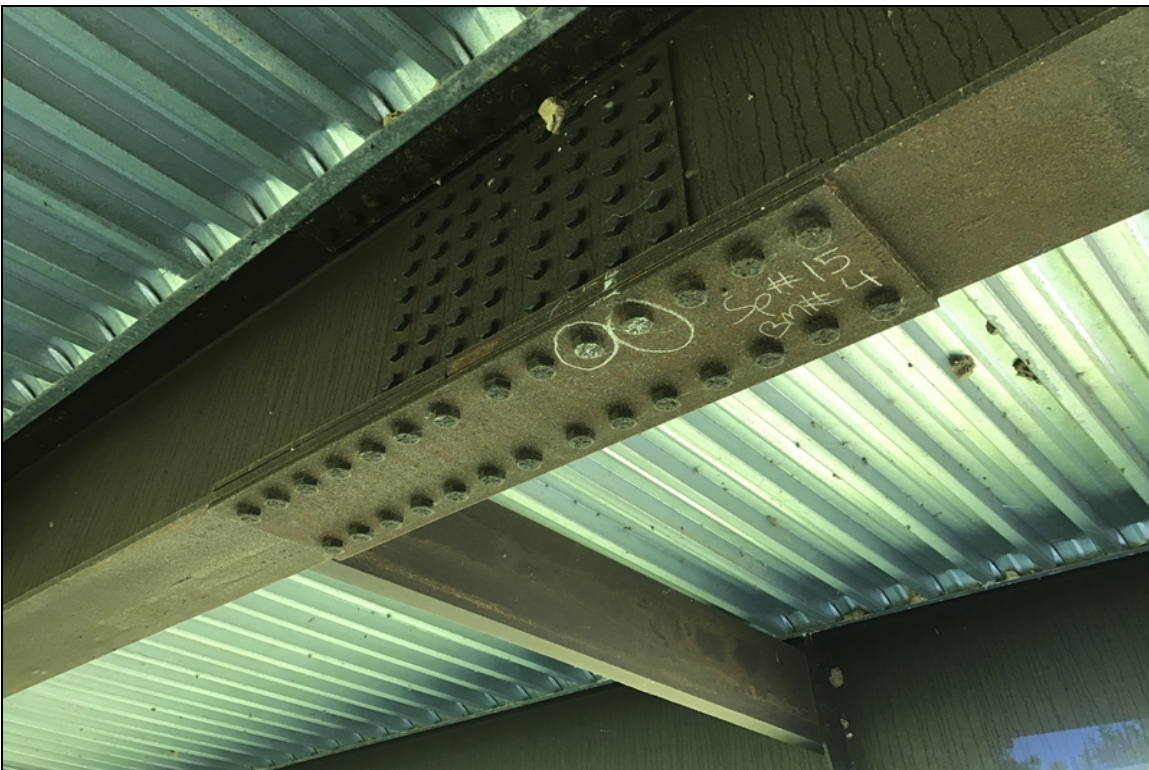
(107)	06/16/2021 WNR & DBM: Splice plate connections have loose bolts. -Span #2, Girder #5 splice #1 has 3 loose bolts. -Span #3, Girder #3 splice #2 has one loose bolt. -Span #8, Girder #4 has one loose bolt. Girder #5 has 2 loose bolts. -Span #15 Girder #4 has two loose bolts. -Span #18 Girder #5 has one loose bolt. -Span #17, ends of girders #2 and #4 over bent #16 have abnormal corrosion due to leaking joint seal.						
210	Reinforced Concrete Pier Wall	LF	266	242	24	0	0
1080	Delamination/Spall/Patched Area	LF	2	0	2	0	0
1130	Cracking (RC and Other)	LF	22	0	22	0	0

Span #15 Girder #4 has two loose bolts.

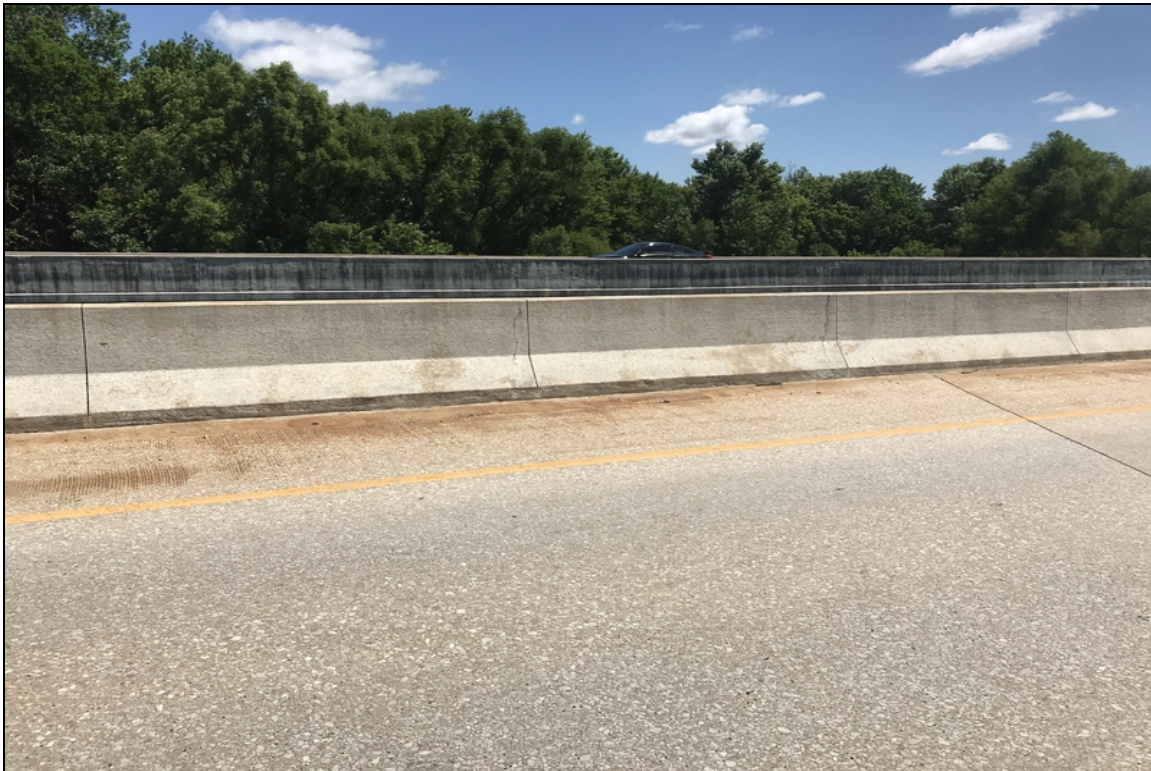
Typical cracking in parapet wall.

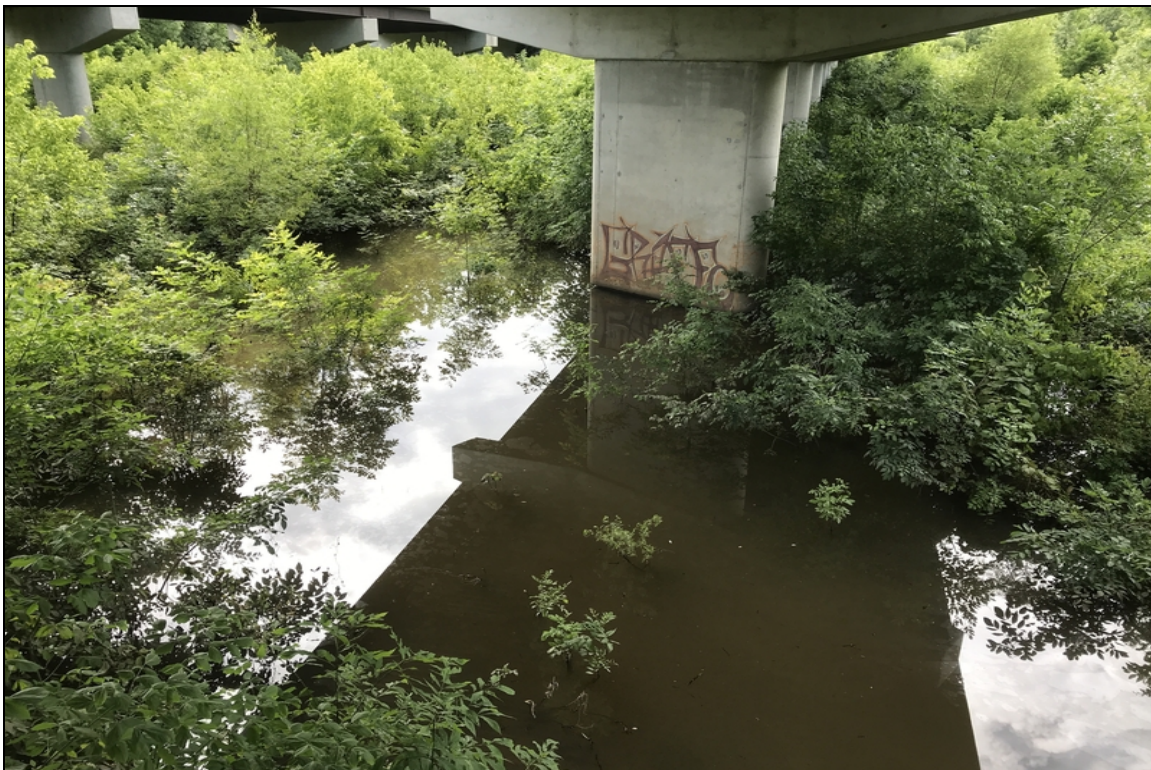
Majority of channel under structure has approximately 2' of trapped flood water.

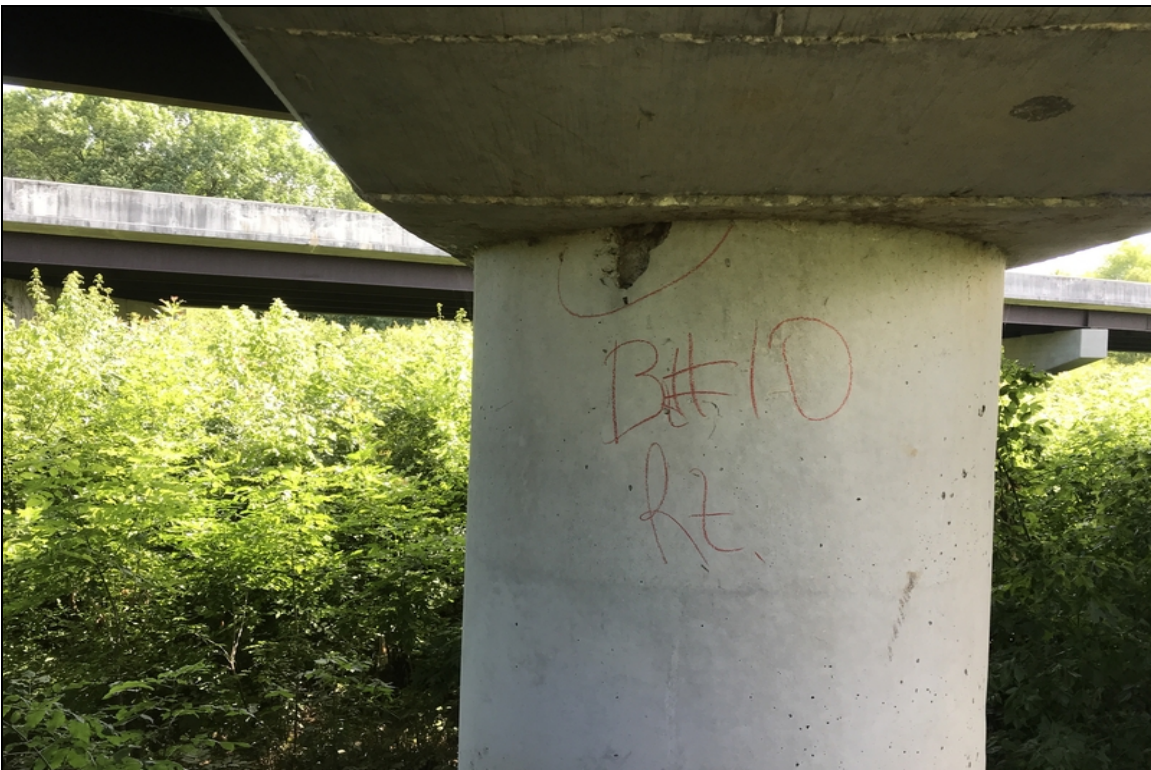
Bent #10 right side of pier baseball sized spall.

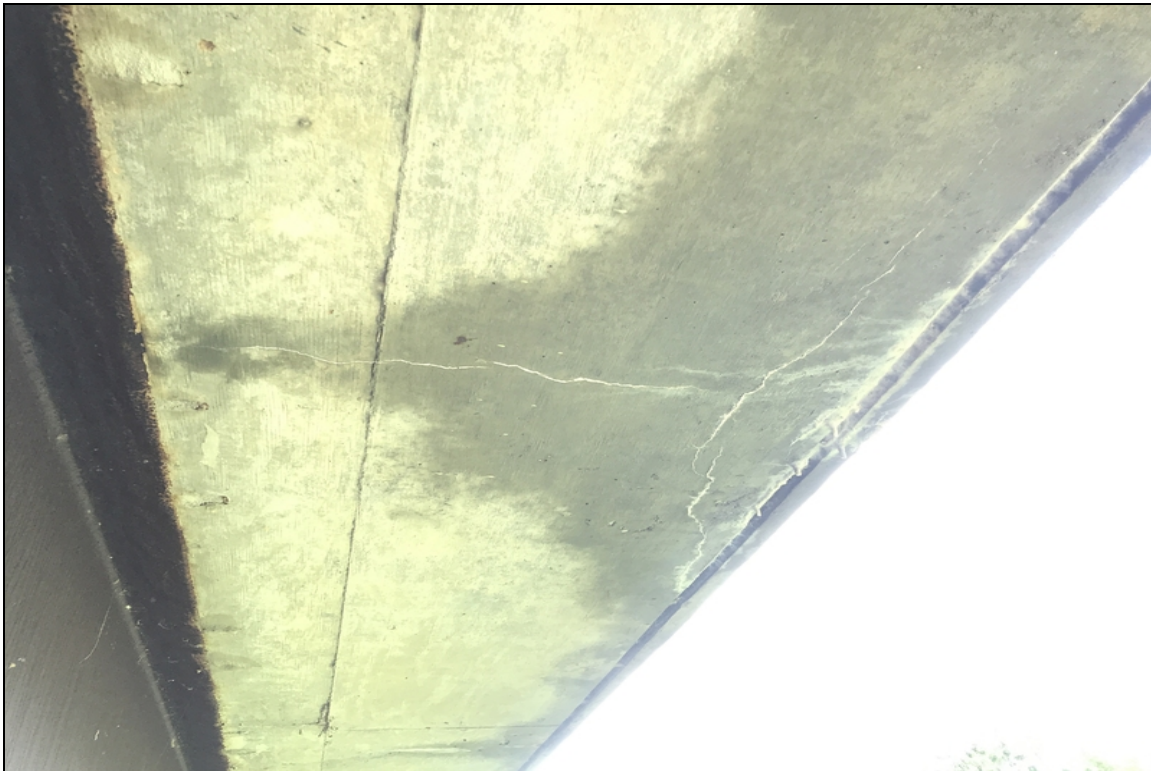
Span #10 right overhang approximately 7' ahead of bent #9 efflorescence with cracking.

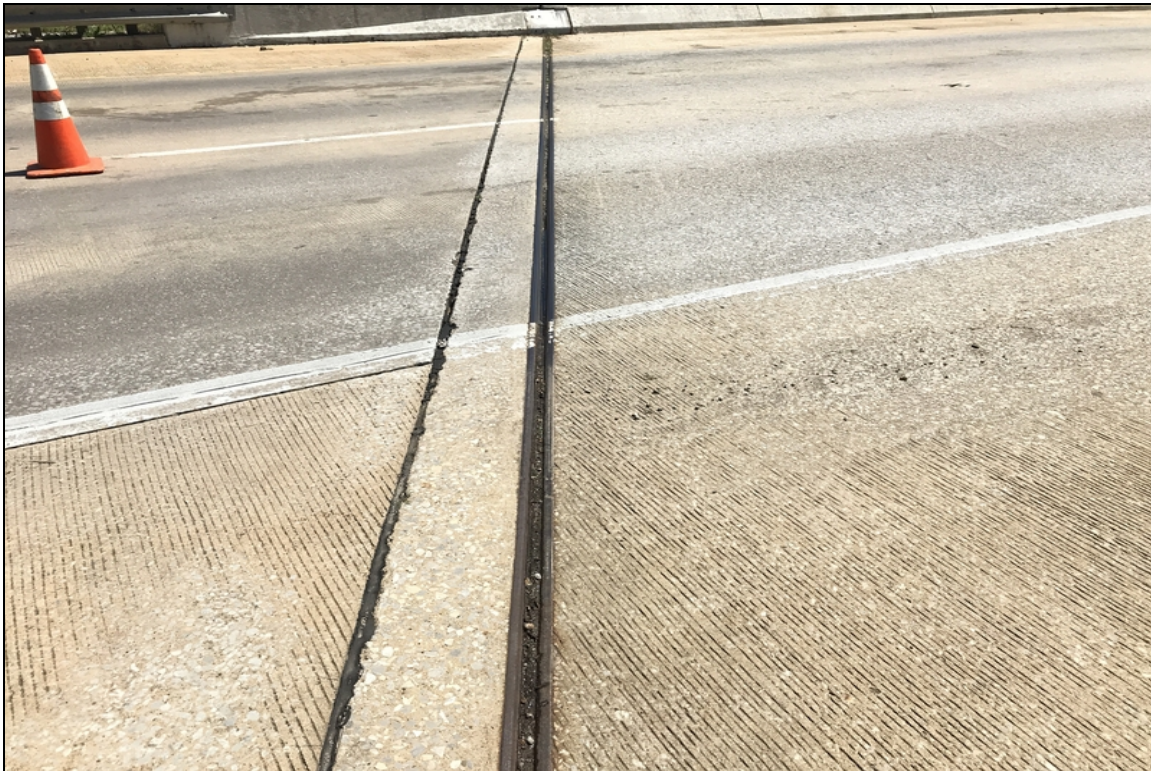
Abutment #1 expansion joint debris impaction.

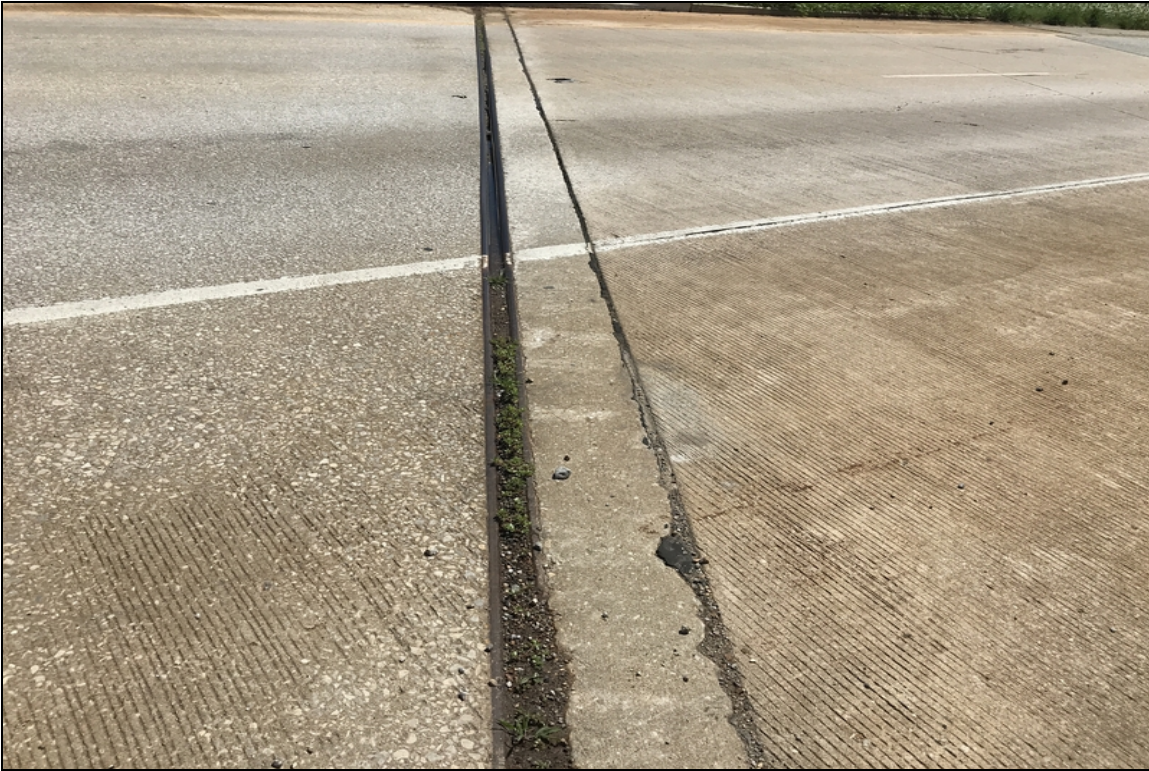
General view of abutment #2 expansion joint material debris impaction

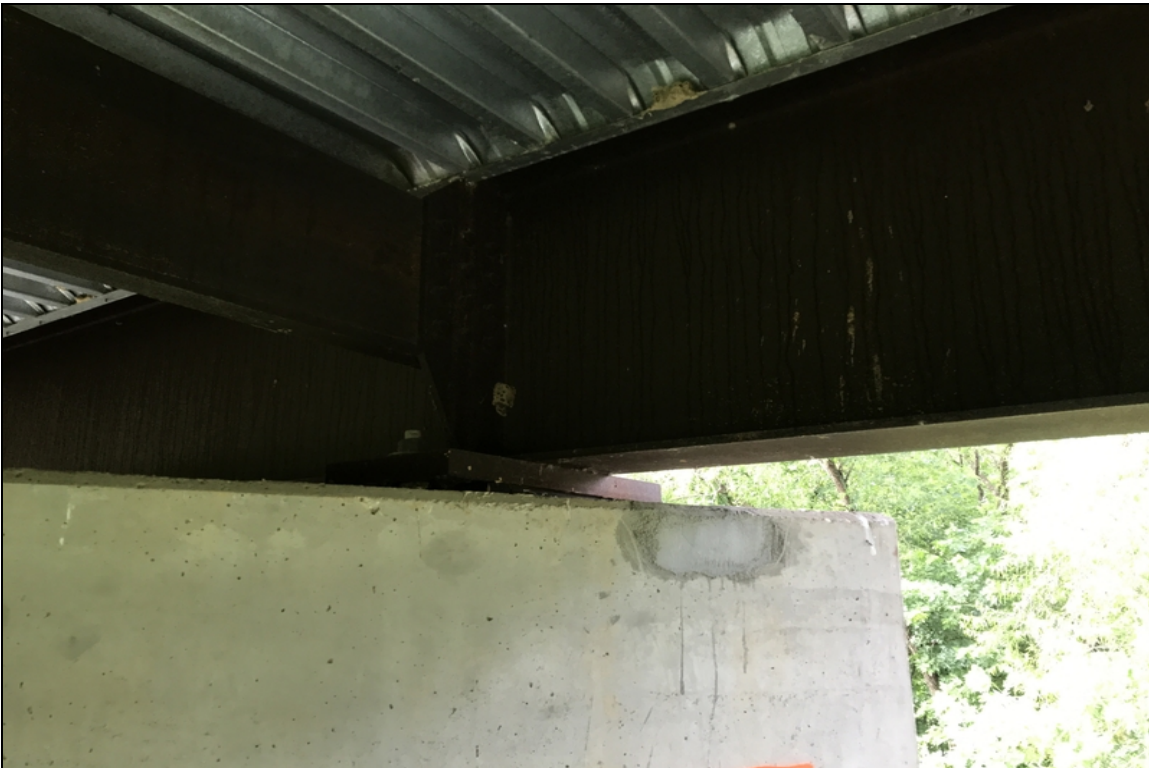
Repaired spall bent #5 pier cap under girder #5
