**Bridge #B6476**(Routine, Underwater type 2)

**SH 412 EB Benton 2 over ILLINOIS RIVER**

**Location: Benton Co 8.17 W OKLINE**

**Team Lead:** Nathan Rowland **Inspection Date:** June 15, 2021

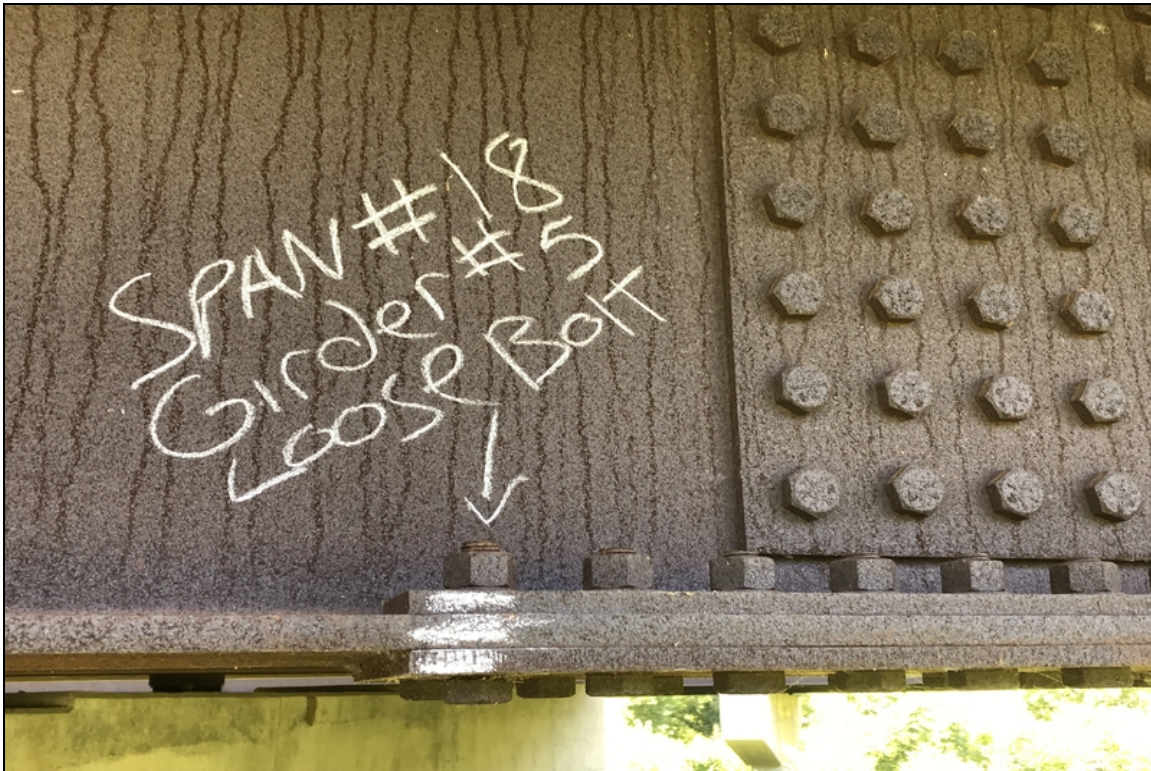
Span #18 Girder #5 has one loose bolt.

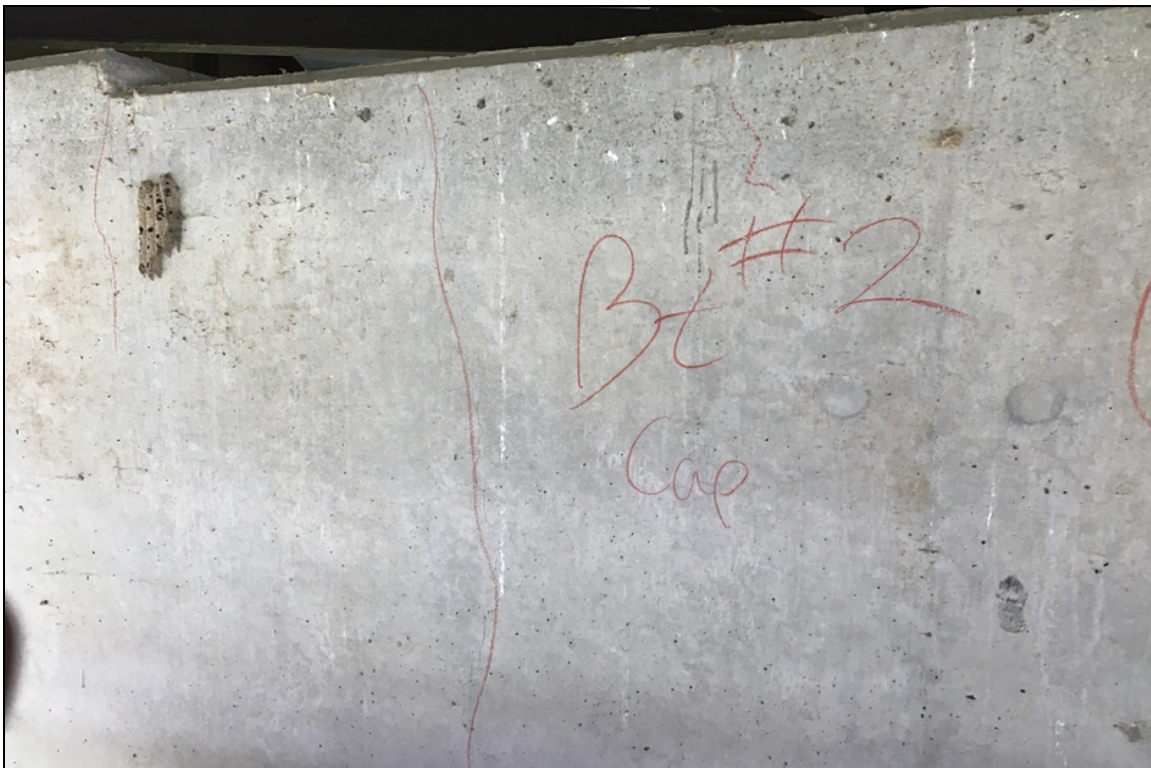
Bent #2 Vertical cracking in the pier cap.

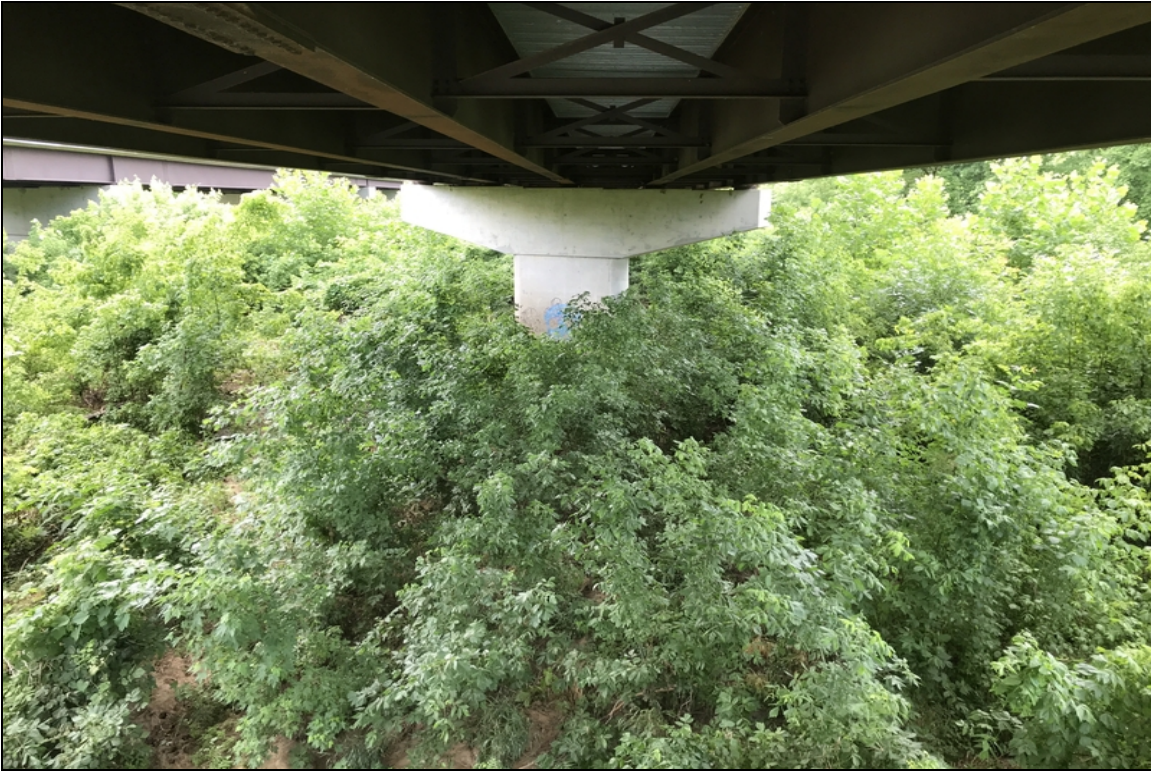
Typical heavy vegetation under structure.

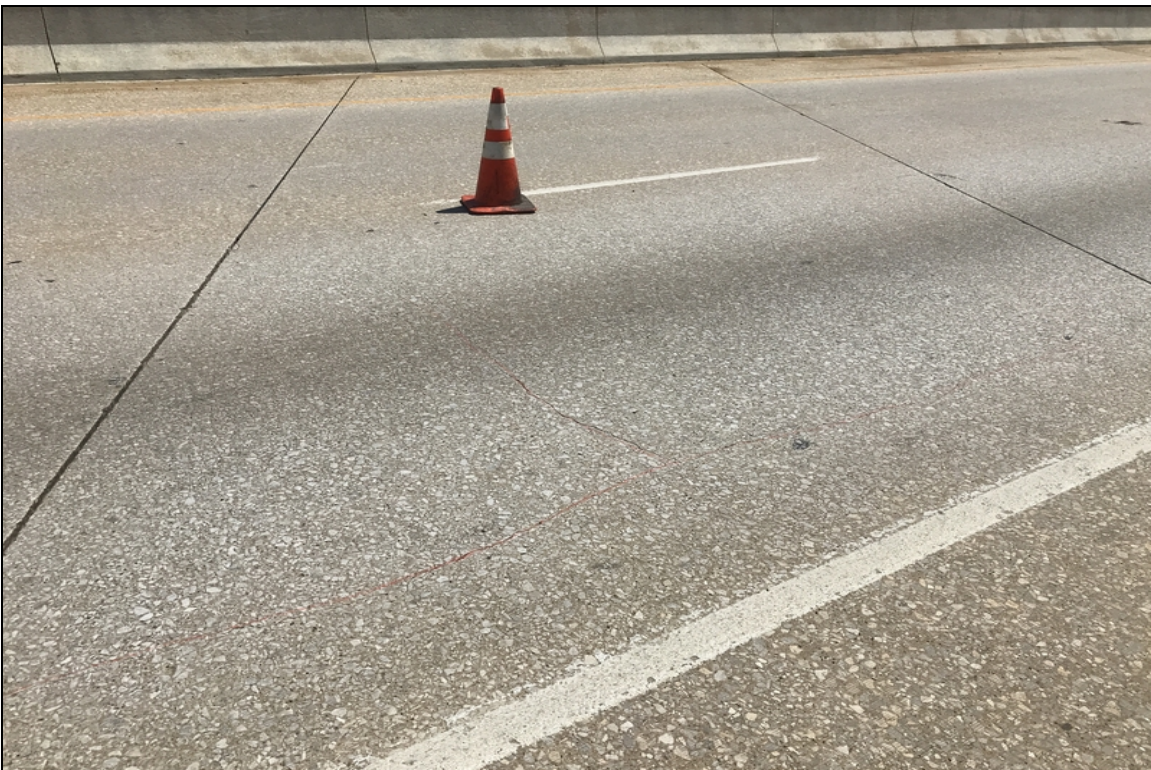
Typical transverse and longitudinal cracking of the deck.

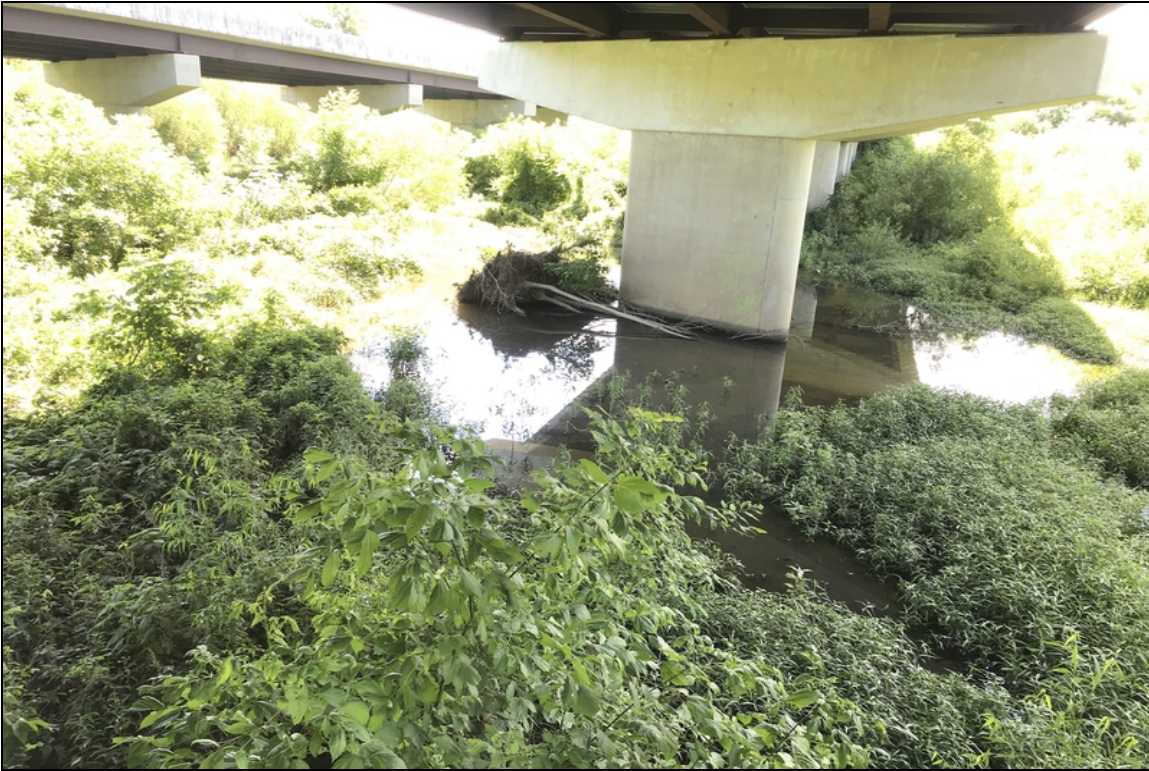
Drift accumulation adjacent to bent #14.

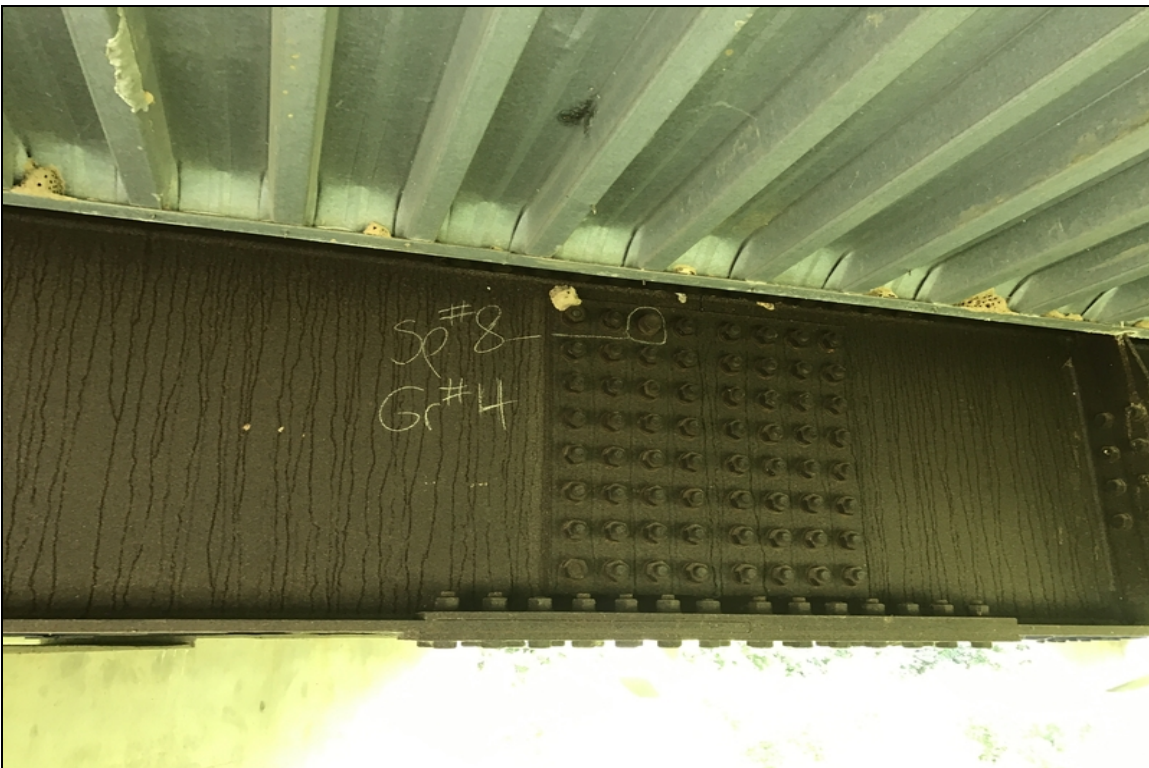
Loose bolts still present from last inspection.

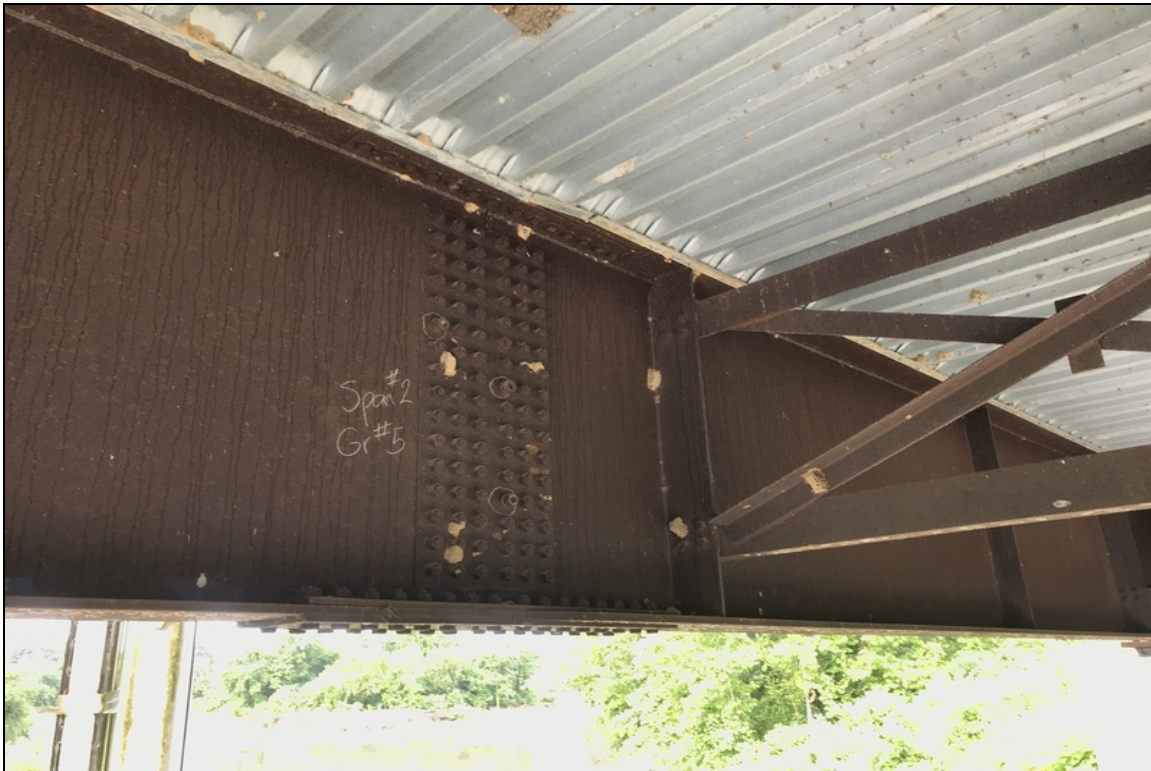
Typical Loose bolts still present from last inspection.

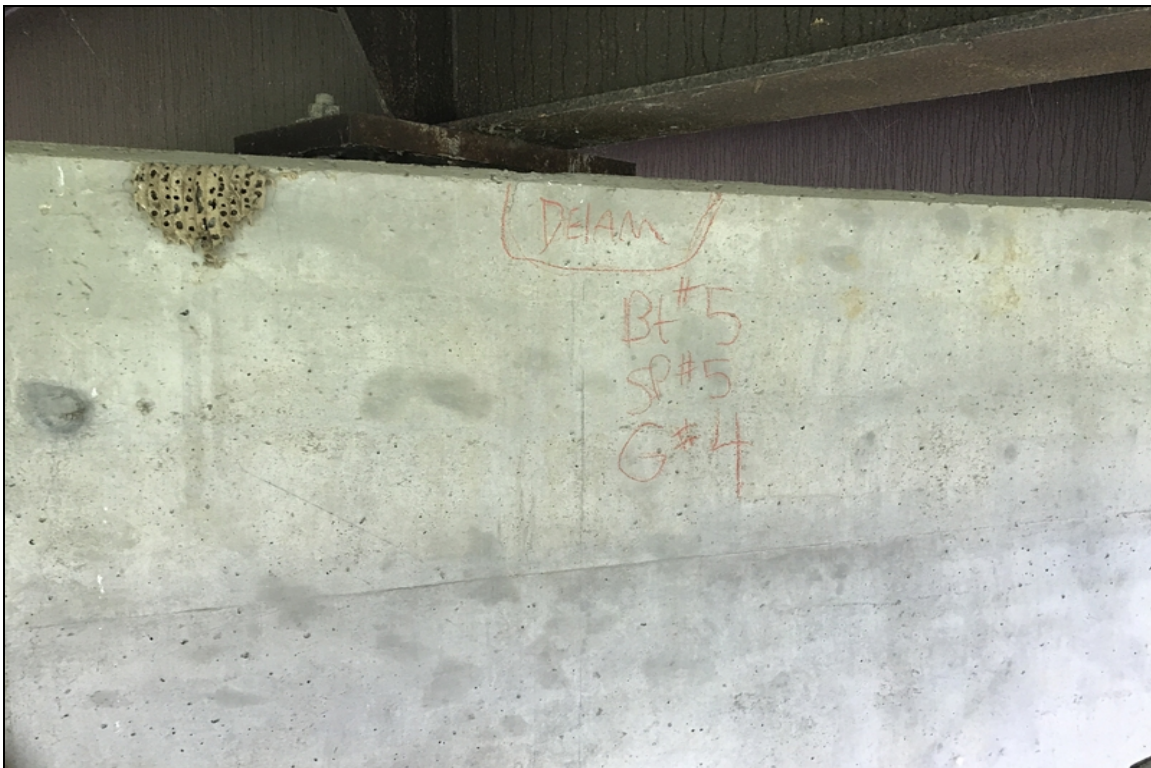
Delaminations at Bent #5 are still present from last inspection.

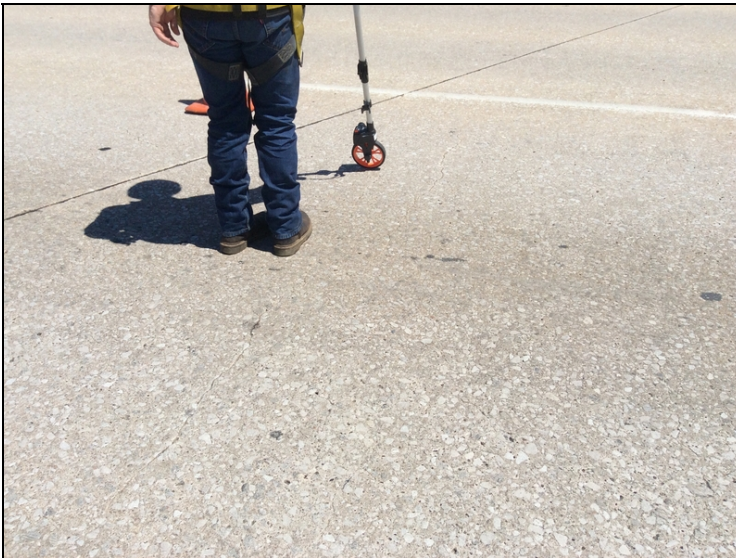
Deck / West approach slab - The deck has sealable cracking in all spans.  
The West approach slab has a wide longitudinal crack in the inside lane approximately 13' long.

Span #2-Deck cracking.

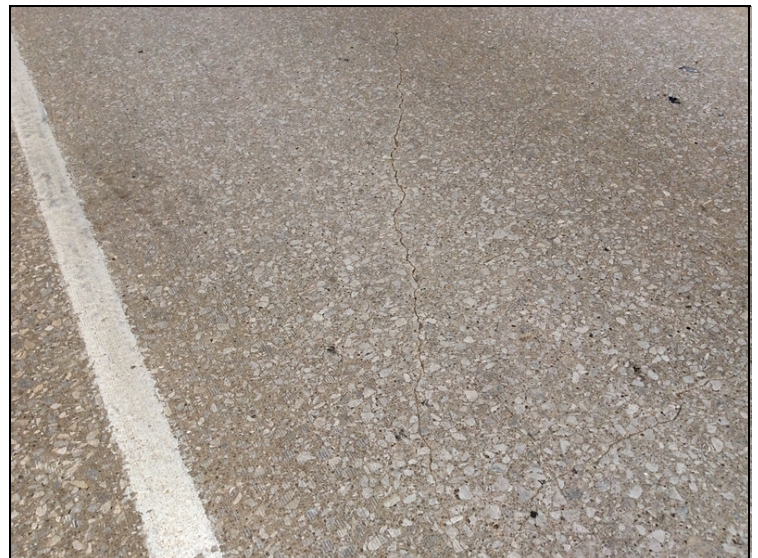
Span #11, outside lane-Wide cracking.

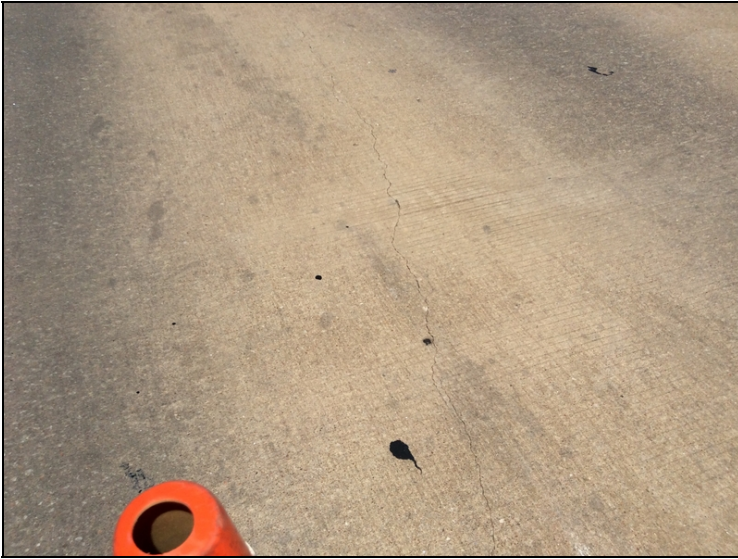
West approach slab-longitudinal cracking.

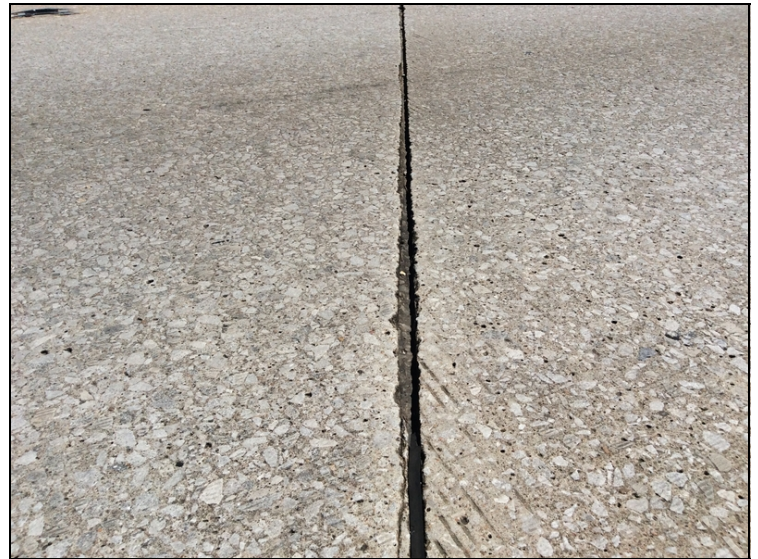
Expansion joints - The strip seal expansion joints have heavy debris impactation at all locations.  
The sawn construction joints have joint material missing in numerous locations.  
joint filler missing

Sawn construction joint sealant missing.

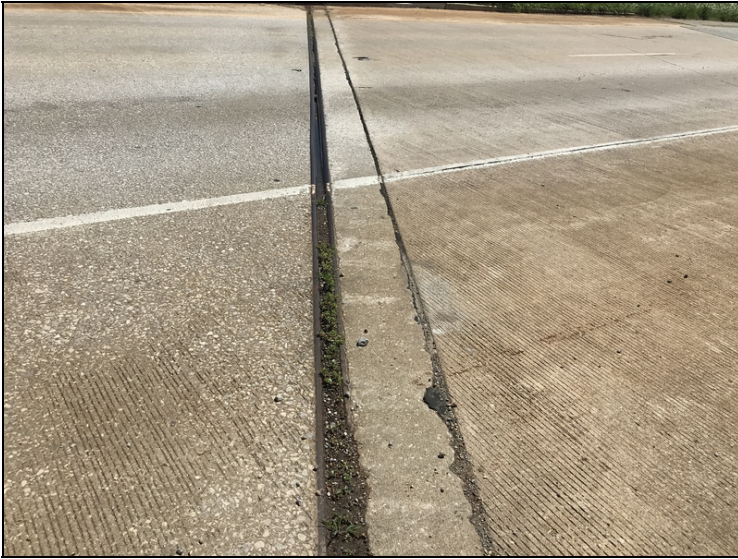
General view of abutment #2 expansion joint  
material debris impaction

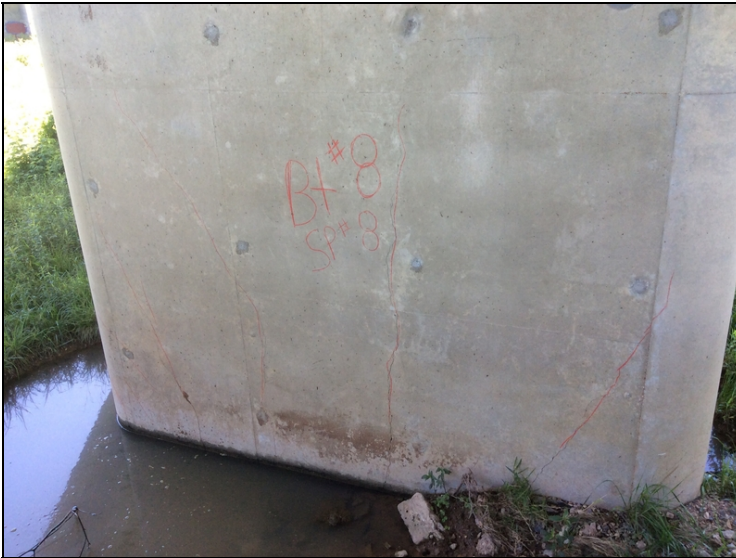
Substructure - Bents #8, #9 and #10 has vertical cracks visible on both sides of columns that extend up the columns approximately 10'.

Bents #8 is the most notable case with 6 wide vertical cracks on each side.

Bent #8-Wide cracking in column. Photo #2.

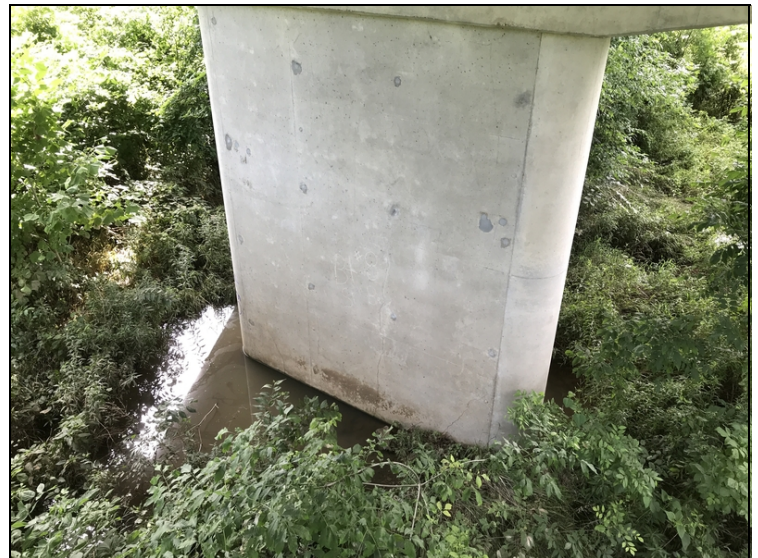
Bent #8 pier vertical and diagonal cracking are still present.

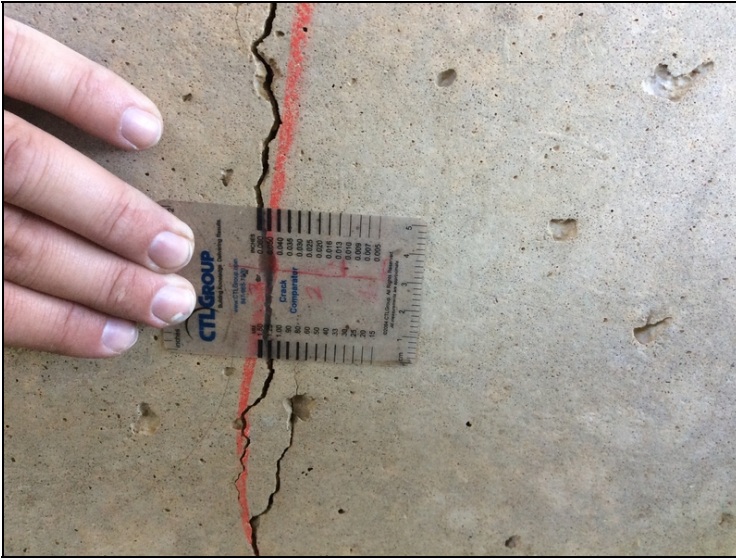
Bent #8-Wide cracking in column.

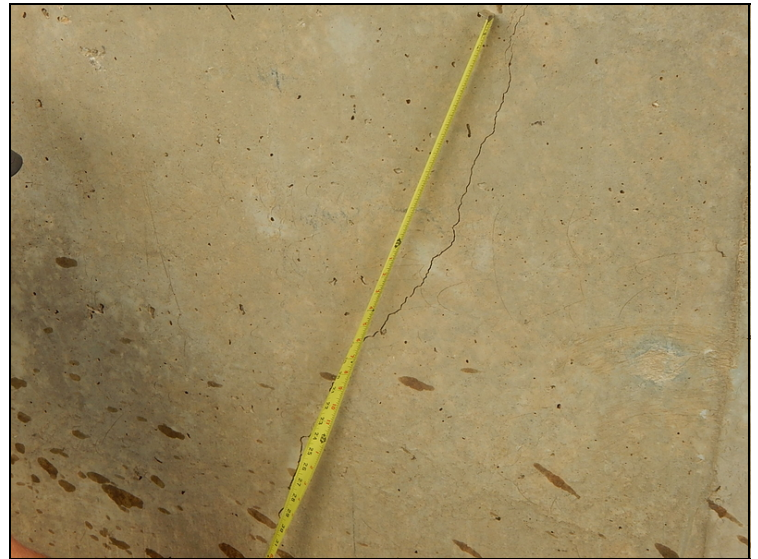
Vertical crack at bent #9 column

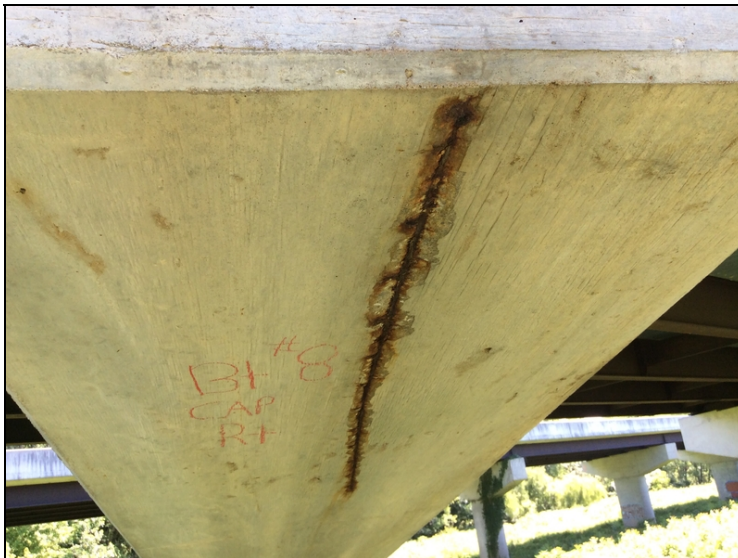
Substructure - The right side of bent #8 has a shallow spall approximately 3' long with exposed reinforcing steel in undersurface.

Bent #8 cap-Shallow spalling with exposed reinforcing steel in undersurface.

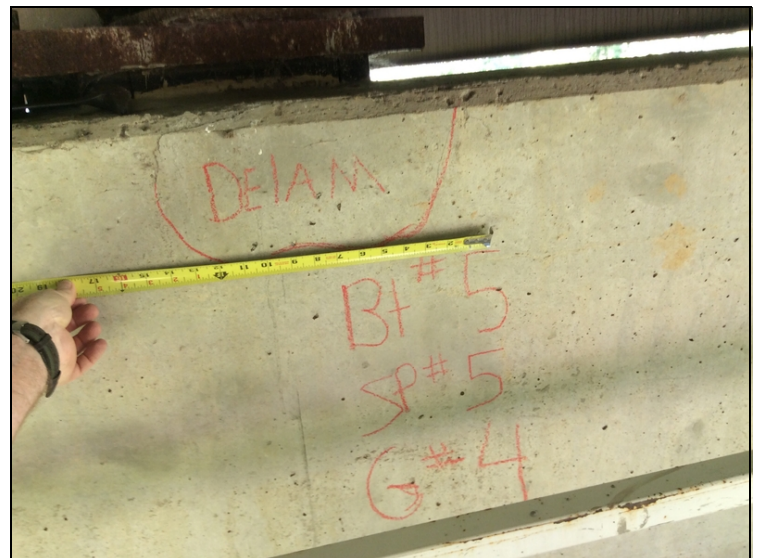
The back face of bent #5 has 12" long delaminated areas under Girders #1, #2 and #4.

Span #5, bent #5-Delaminated area under Girder #4.

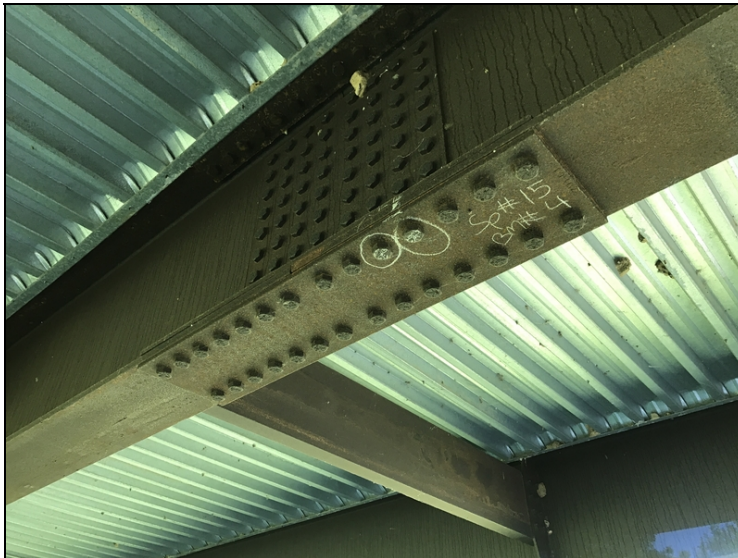
-Span #15 Girder #4 has two loose bolts.

Span #15 Girder #4 has two loose bolts.

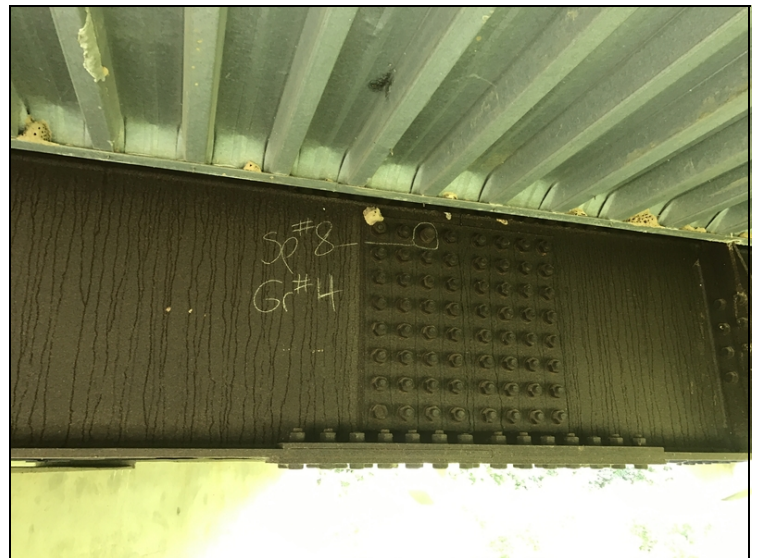
Superstructure - The splice plate connections have loose bolts in several locations.

Loose bolts still present from last inspection.

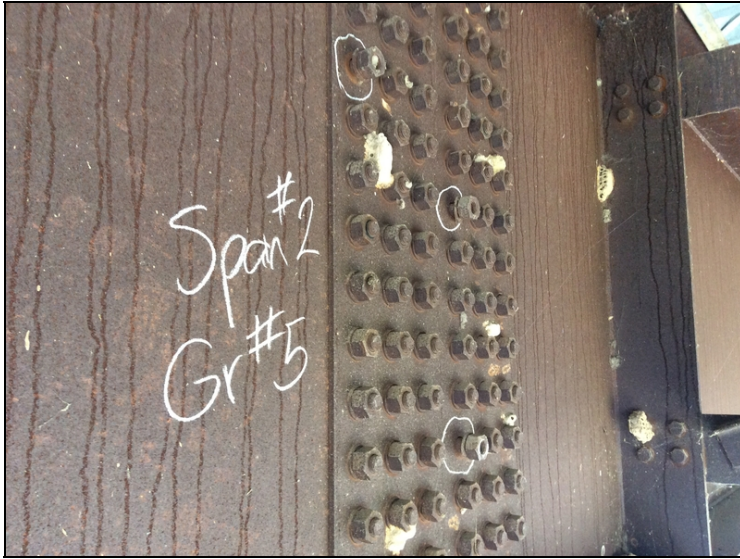
-Span #2, Girder #5 splice #1 has 3 loose bolts.

Span #2, girder #5 splice #1 has 3 loose bolts.

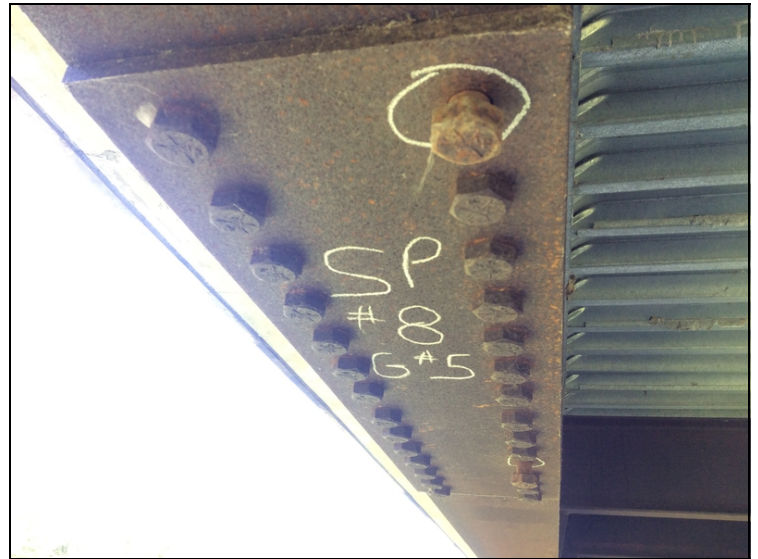
-Span #8, Girder #4 has one loose bolt. Girder #5 has 2 loose bolts.

Span #8, girder #5-Loose bolt.

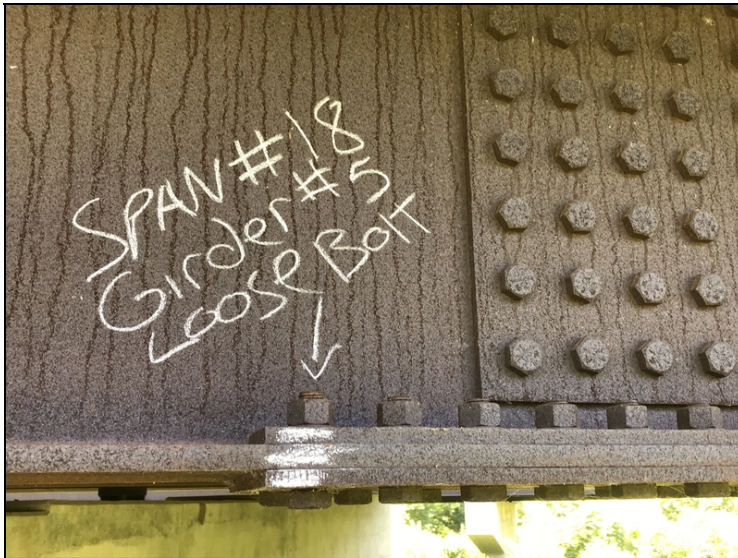
-Span #18 Girder #5 has one loose bolt.

Span #18 Girder #5 has one loose bolt.

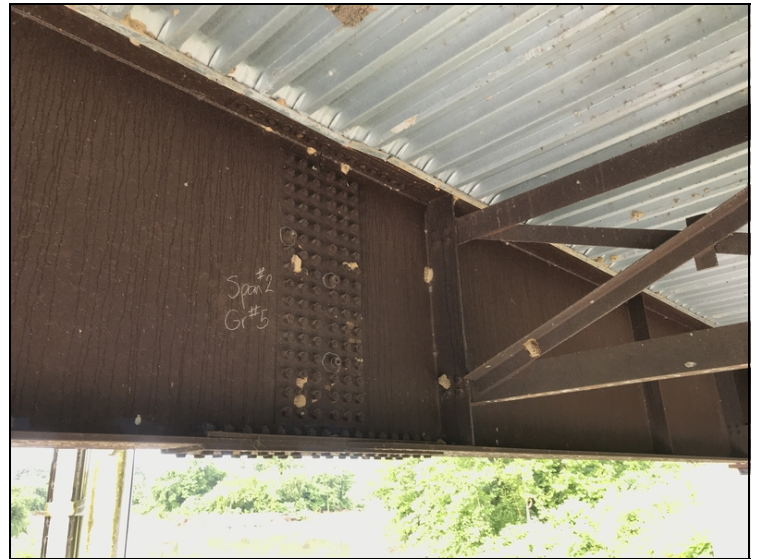
Typical Loose bolts still present from last inspection.
