Bridge #A6477 (Routine)
US 412 WB Benton 2 over PEDRO CREEK
Location: Bent Co 9.65 M E OK LINE

Team Lead: Benjamin Smith **Inspection Date:** June 10, 2021

IDENTIFICATION	
(1) State Names	Arkansas
(8) Structure Number	A6477
(5) Inventory Route	412
(2) Highway Agency District	09
(3) County Code	7-Benton County, Arkansas

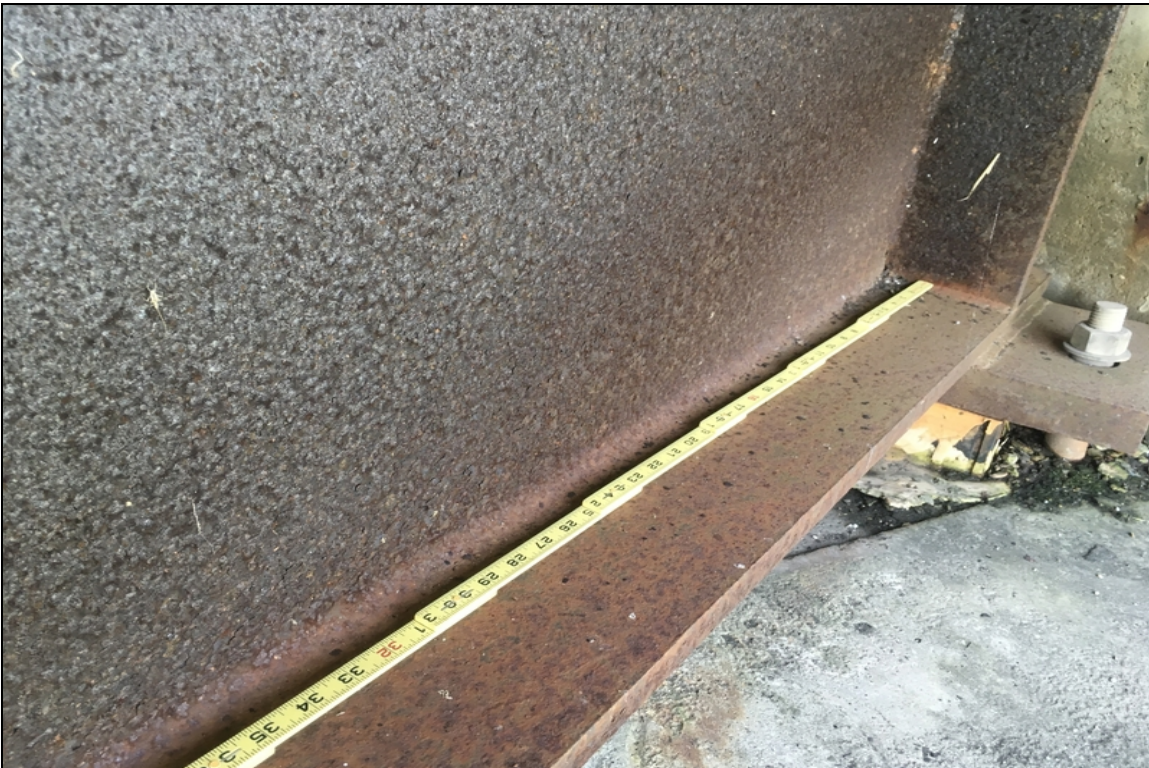
(107)	<p>Span #1-beam #1 has 4' of cs2 corrosion on the exterior lower web at the beginning of the span. Beam #5 has 4' of cs3 corrosion on the top flange and upper web at mid span. Beam #6 has 6' of cs3 corrosion on the bottom flange at mid span due to leaking construction joint seals.</p> <p>Span #2- beams #1, 6 have 3' of cs3 corrosion each at and adjacent to the 2nd splice plate.</p> <p>Span #3- beam #1 has several locations of factory defects on the bottom of the bottom flange. No cracking was noted.</p>						
210	Reinforced Concrete Pier Wall	LF	28	28	0	0	0

4' of cs2 corrosion on the exterior web of beam #1 in span #1.

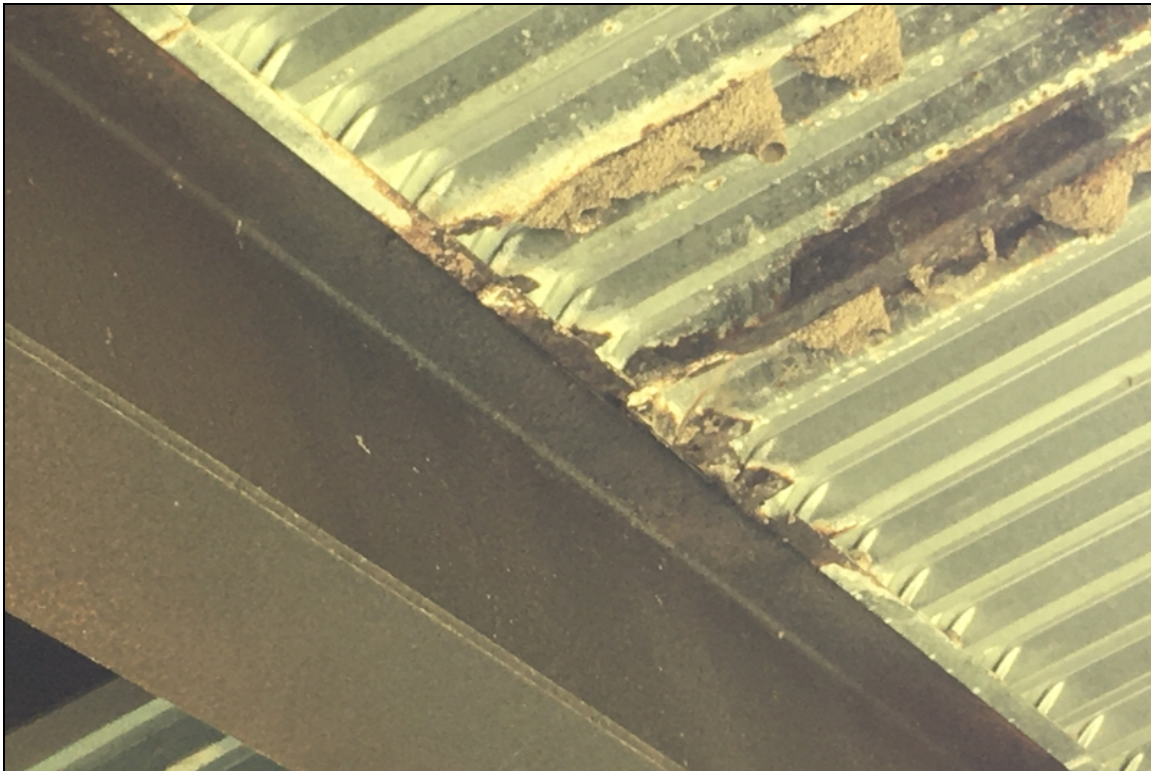
Typical view of cs3 corrosion beneath the construction joints.

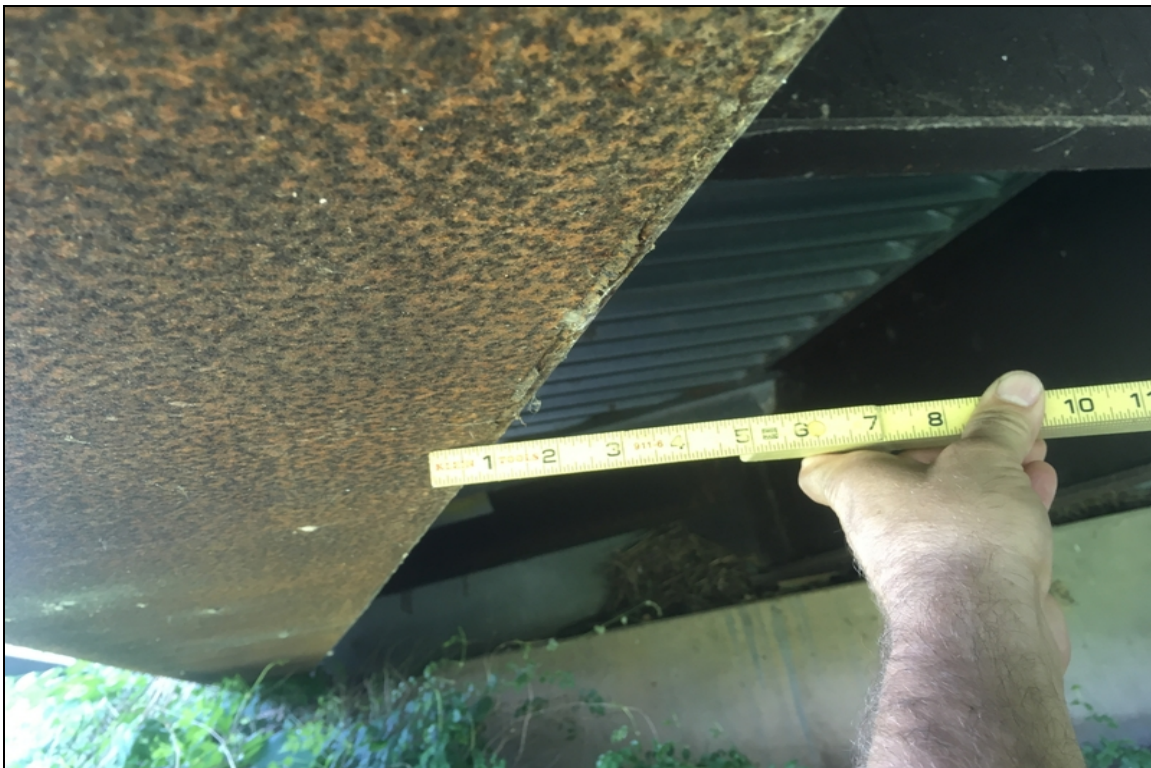
Factory defects on the bottom flange of beam #1 in span #3.

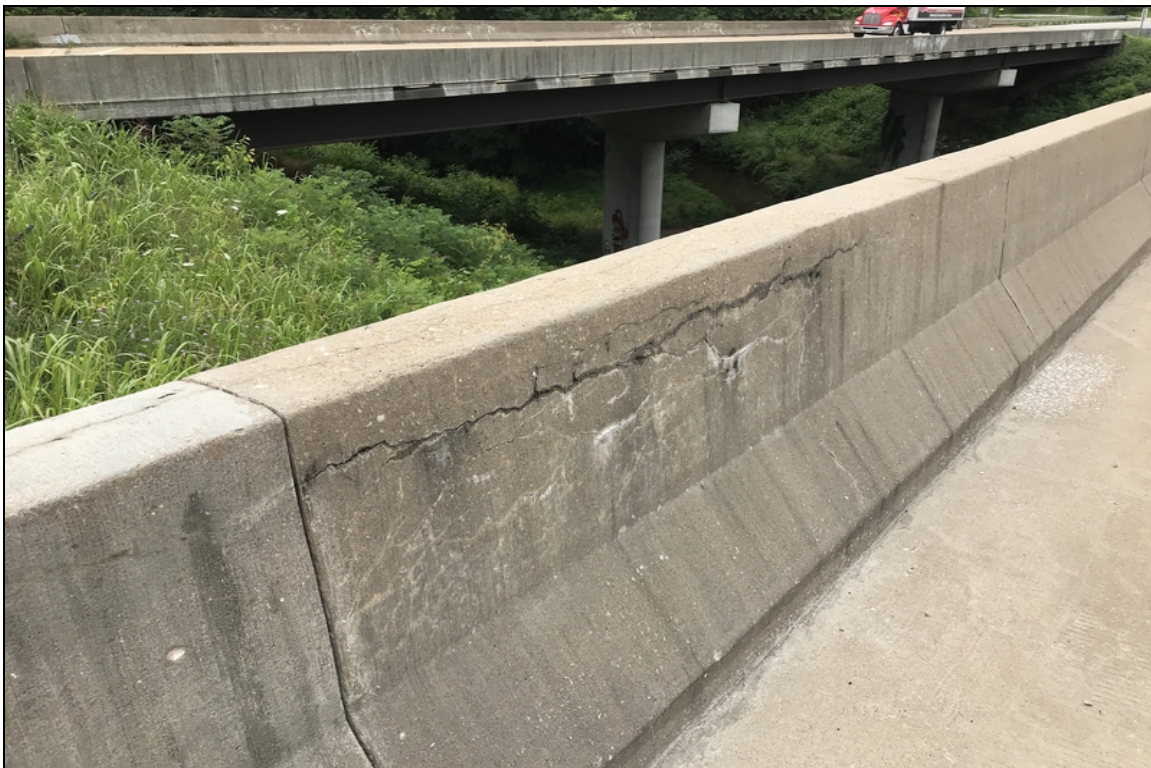
Railing right cracking with efflorescence.

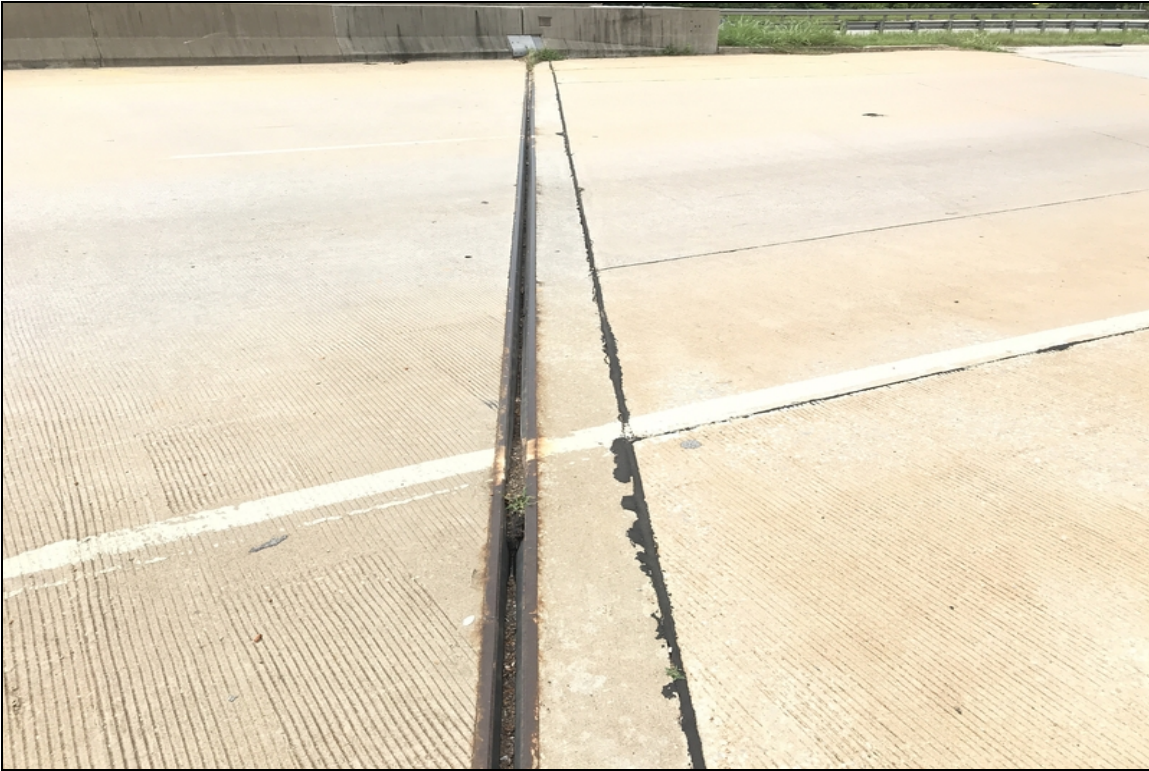
View of abutment #1 compression joint.

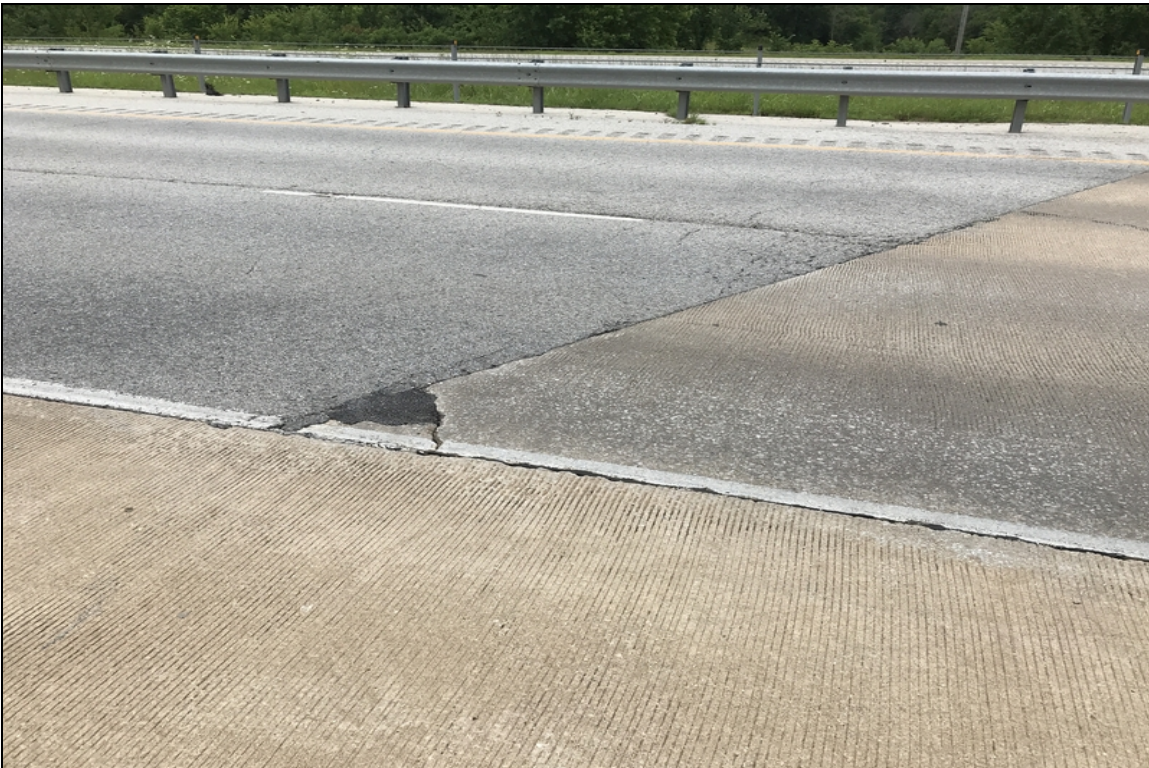
Asphalt patch to east approach roadway

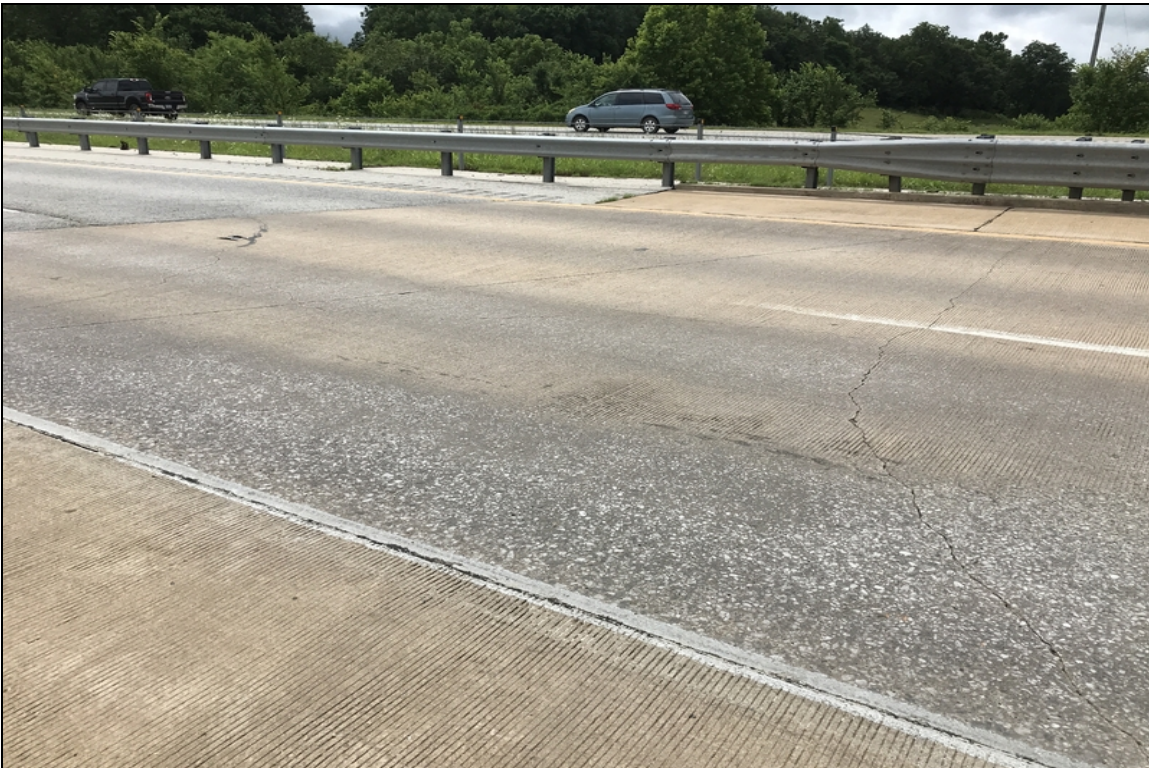
East approach slab cracking.

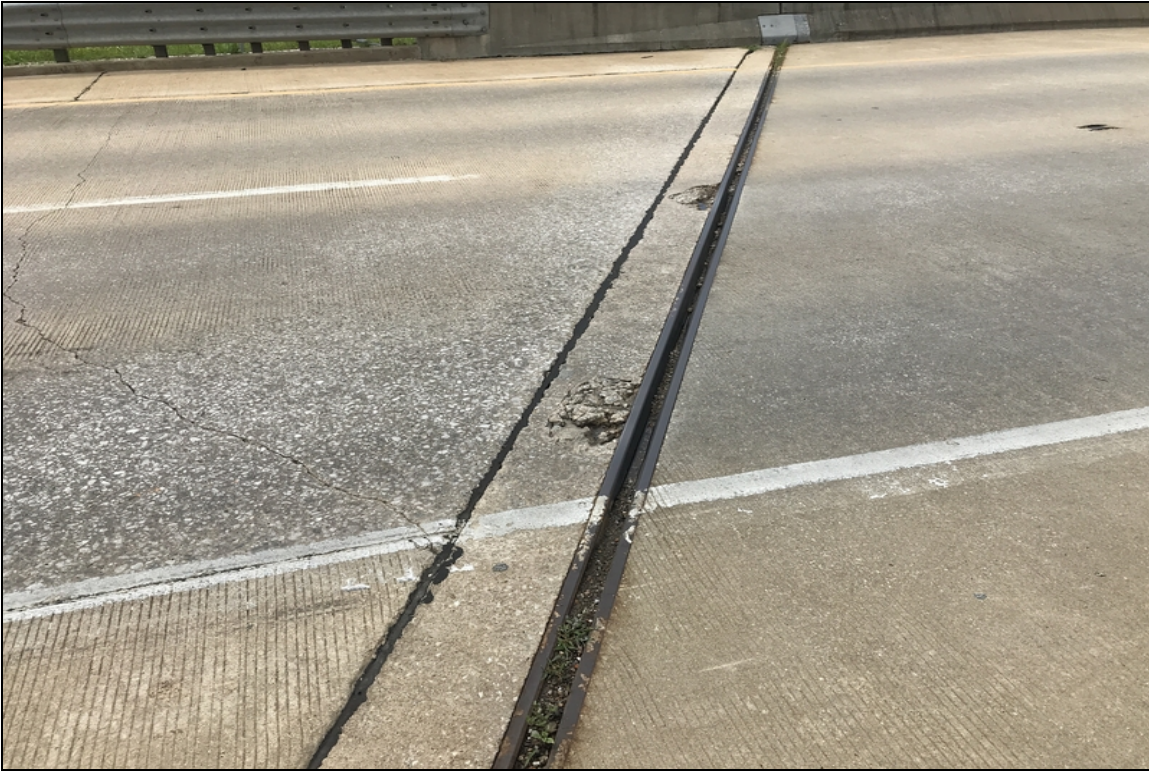
Abutment #2 spalling

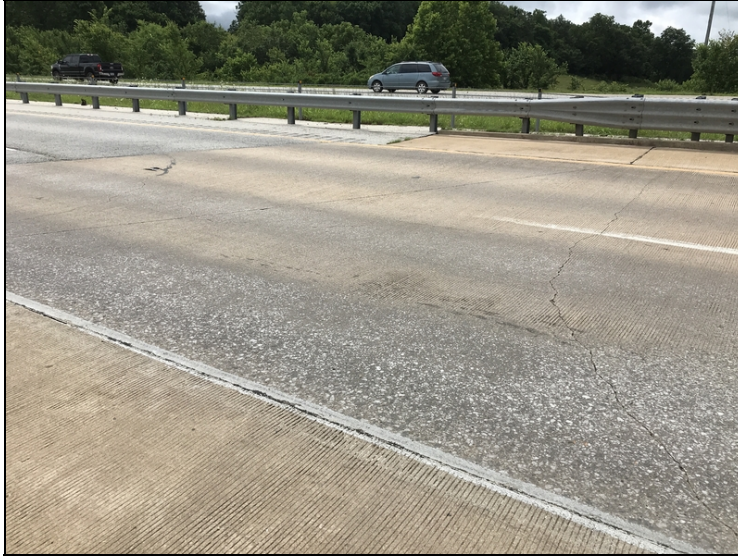
Deck / Approach slabs - The driving surface of the deck and approach slabs have sealable cracking. The sawn joints appear to have been sawn adjacent to the actual construction joints leaving an unsealed crack along the joints in locations. The sawn joint material is missing in isolated areas. The East approach slab has an area of spalling approximately 2' long at the juncture of the approach roadway.

East approach slab cracking.

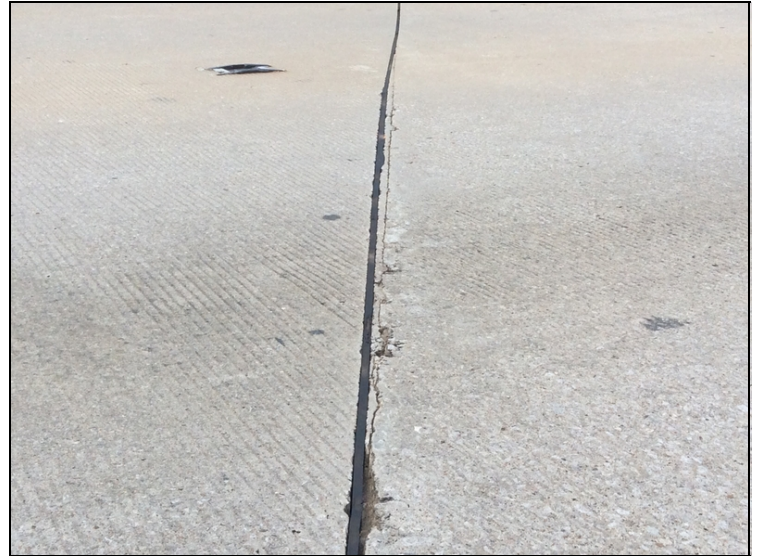
Cracking along sawn joints

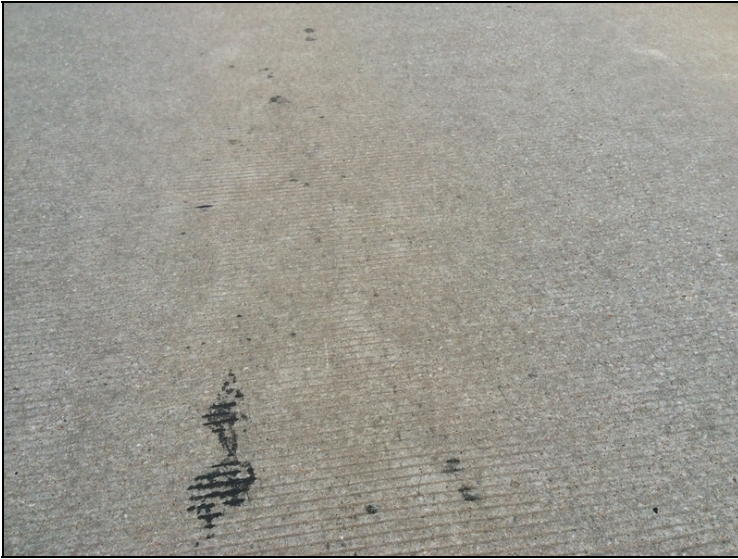
Sealable longitudinal deck cracks located in the driving surface.

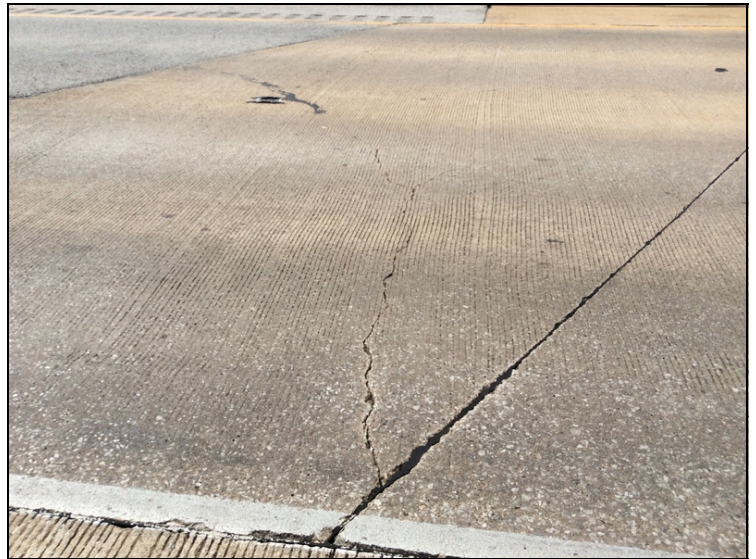
East approach slab-Cracking.

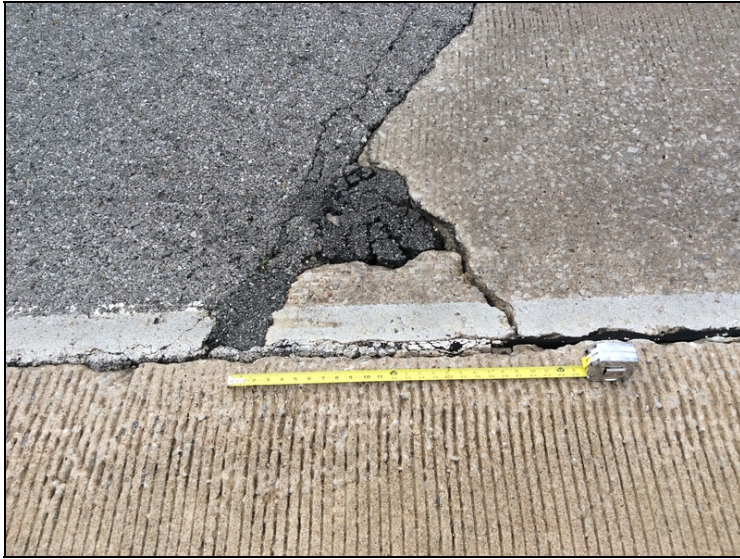
East approach slab-Spalling.

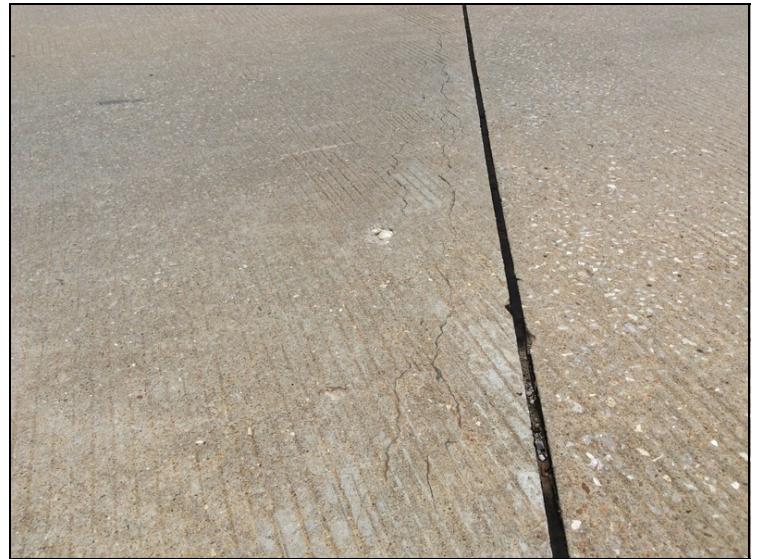
Cracking along sawn joints

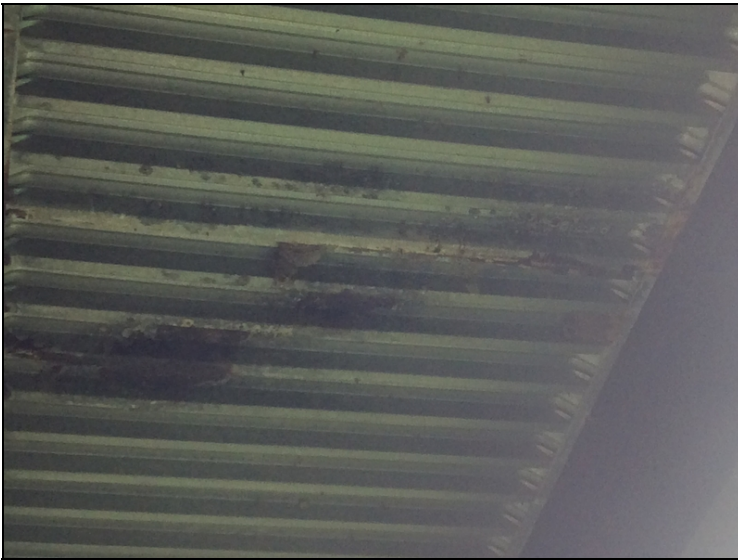
Span #1 bay #5 active corrosion to SIP forms.

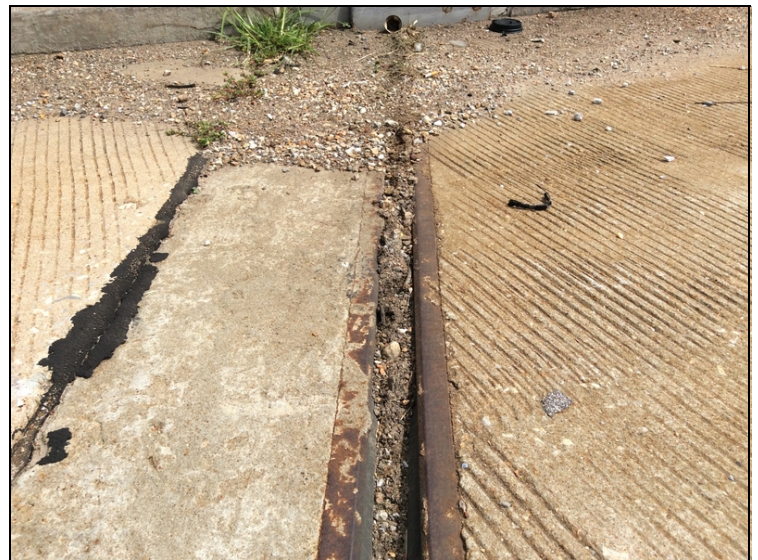
Expansion joints - The strip seal expansion joints have heavy debris impaction.

Abutment #1-Debris impaction in expansion joint.

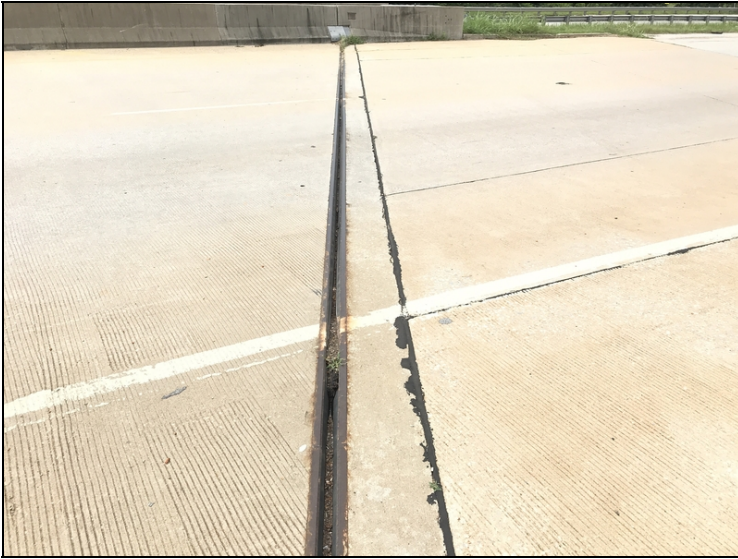
View of abutment #1 compression joint.

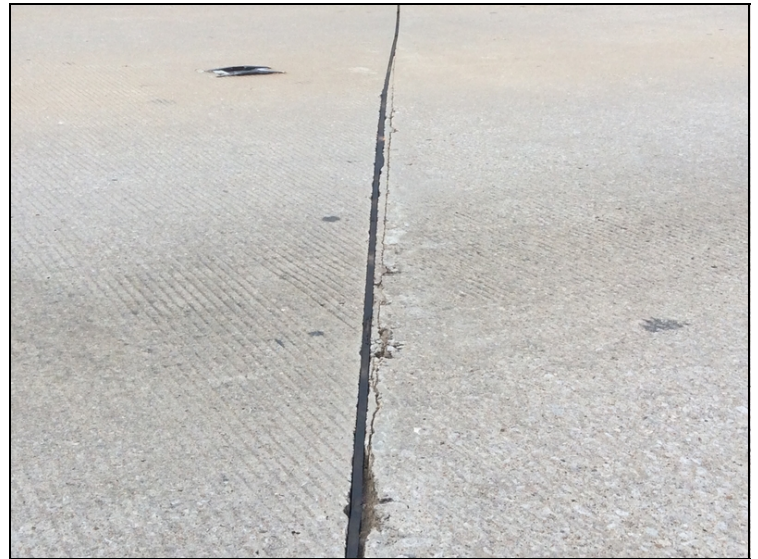
Cracking along sawn joints.

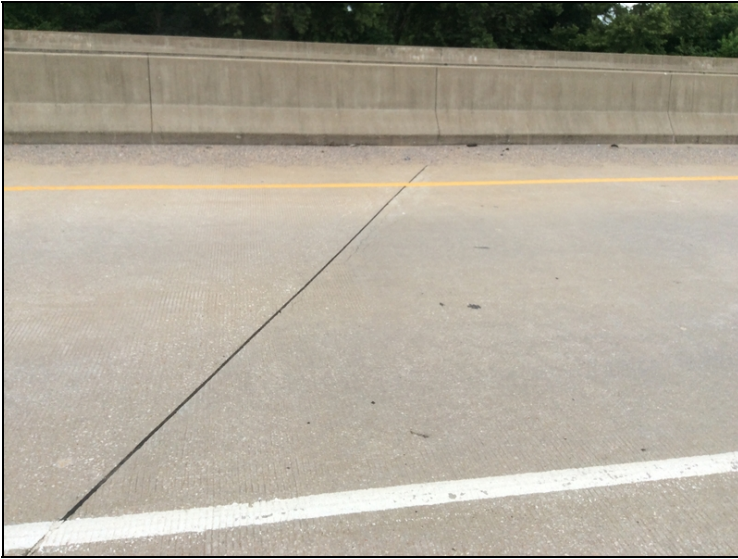
Span #1 right transverse crack adjacent to saw joint

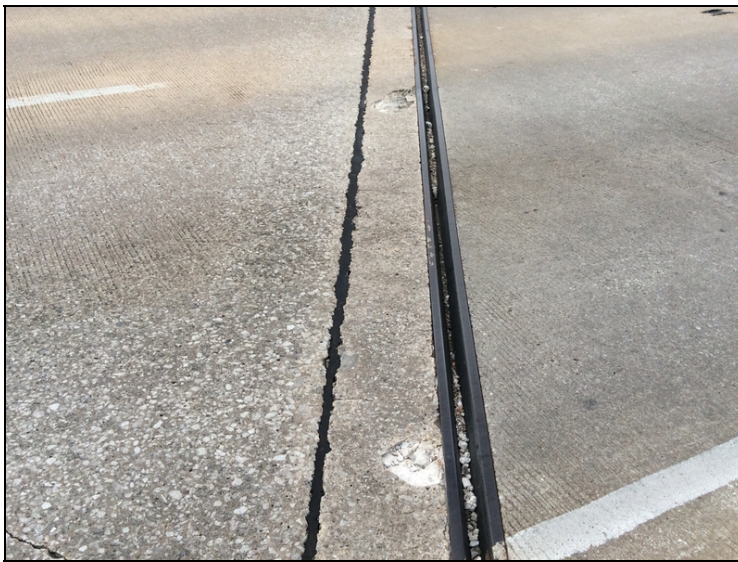
East abutment - The top of the East abutment backwall has two areas of spalling that is creating potholes in the driving surface. The area surrounding the spalls is delaminated.

Spalling in top of East abutment backwall.

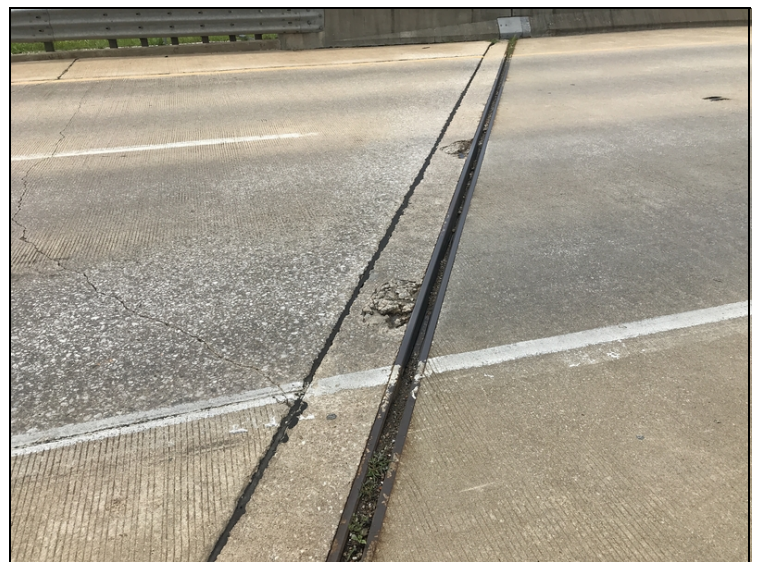
Abutment #2 spalling
