Bridge #B6477 (Routine)
US 412 EB Benton2 over PEDRO CREEK
Location: Benton Co 9.65 MI E OK LIN

Team Lead: Benjamin Smith **Inspection Date:** June 10, 2021

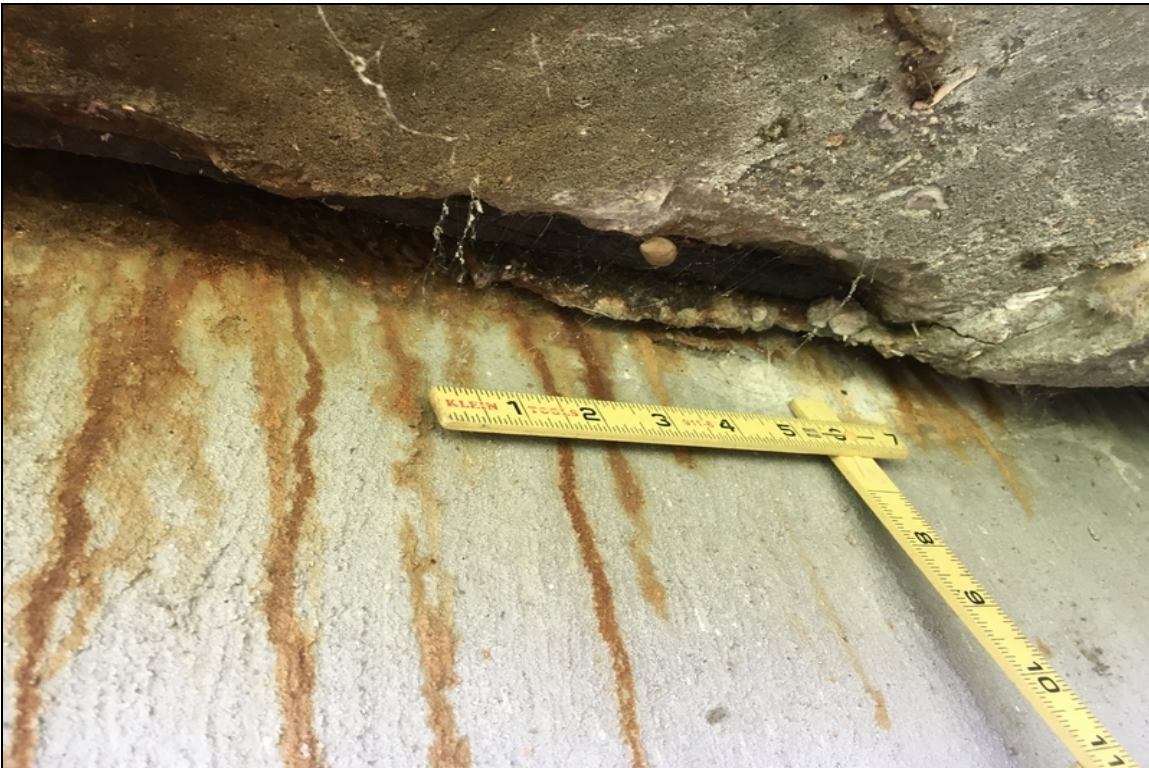
Spalling with rebar exposed on the deck undersurface at the left corner at the end of span #3

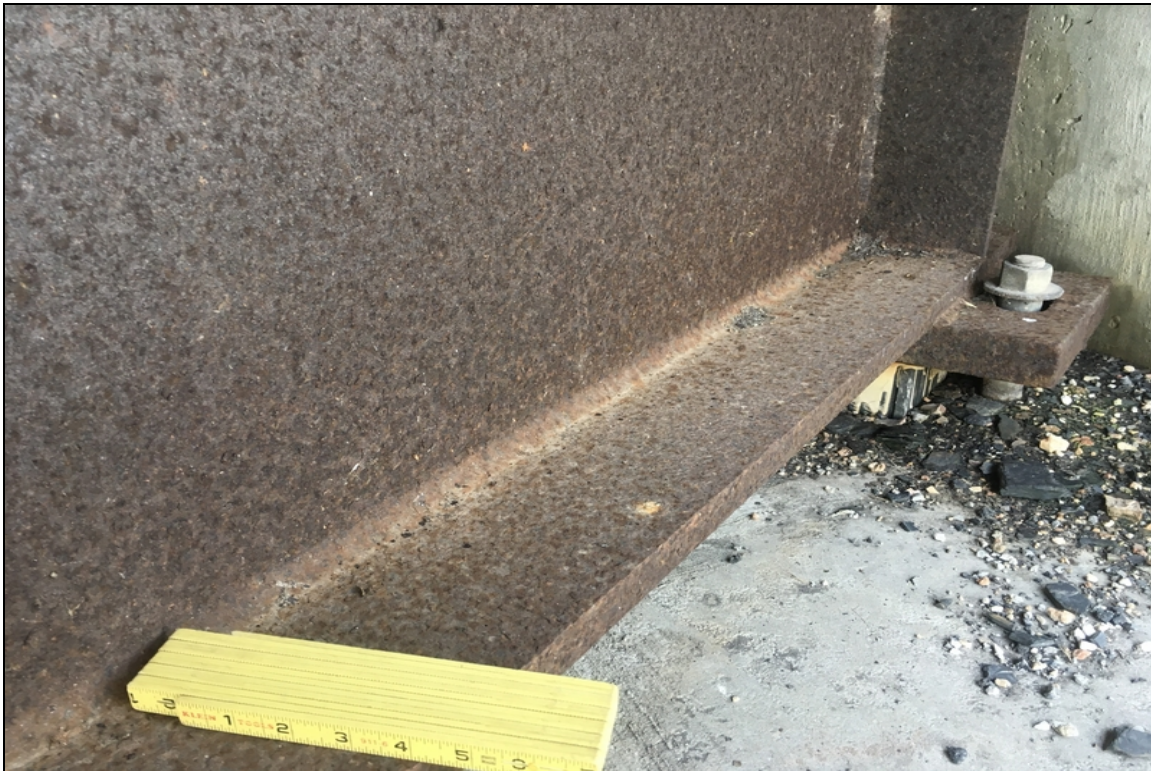
| ELEM | DESCRIPTION | UNITS | TOTAL | CS1 | CS2 | CS3 | CS4 |
|--|---|---|---|---|---|---|---|
| <p>Span #1- Beam #1 over abutment #1 has cs2 corrosion on the exterior lower web for the length of the span due to leaking expansion joint seal. Beam #3 has 6' of cs3 corrosion with an additional 2' of cs2 corrosion at the beginning of the span.</p> <p>Span #2- no deficiencies noted.</p> <p>Span #3- Beam #4 over abutment #2 has cs3 corrosion on the bottom flange and lower web at the beam end in an area approximately 4' long due to a leaking joint seal.</p> | | | | | | | |

Cs2 corrosion on beam #1 at the beginning of span #1.

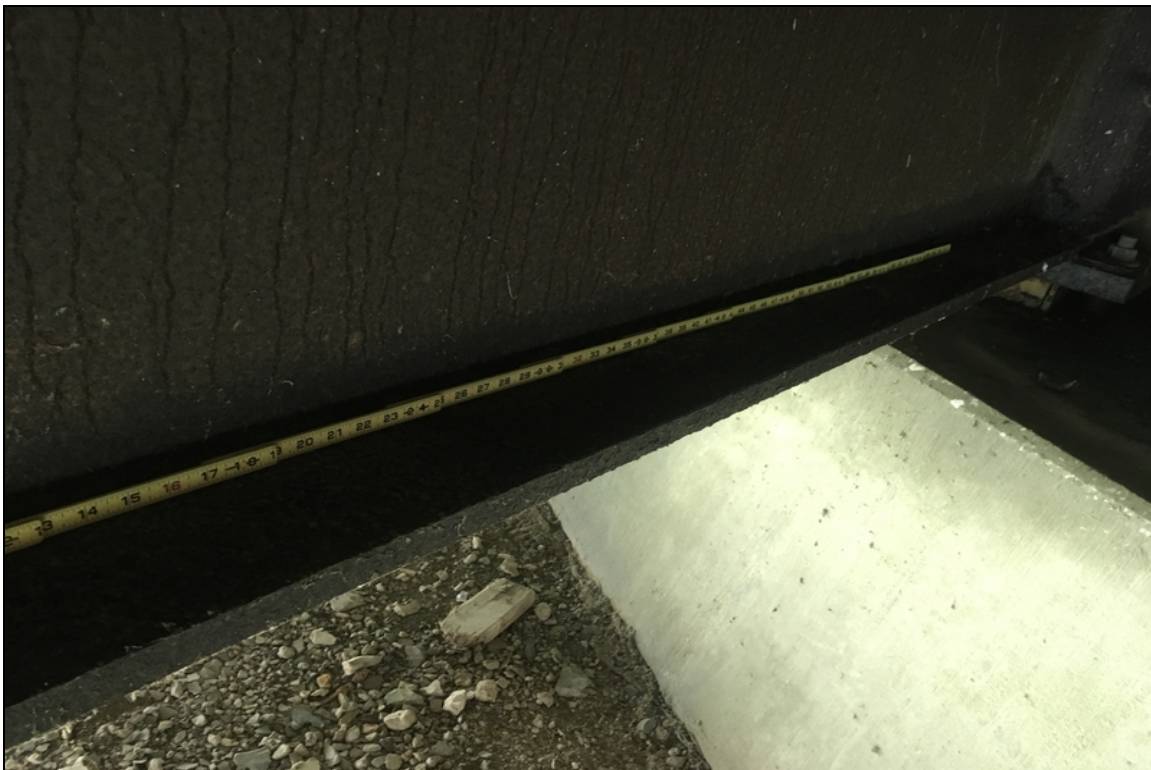
Cs3 corrosion on beam #3 in span #1.

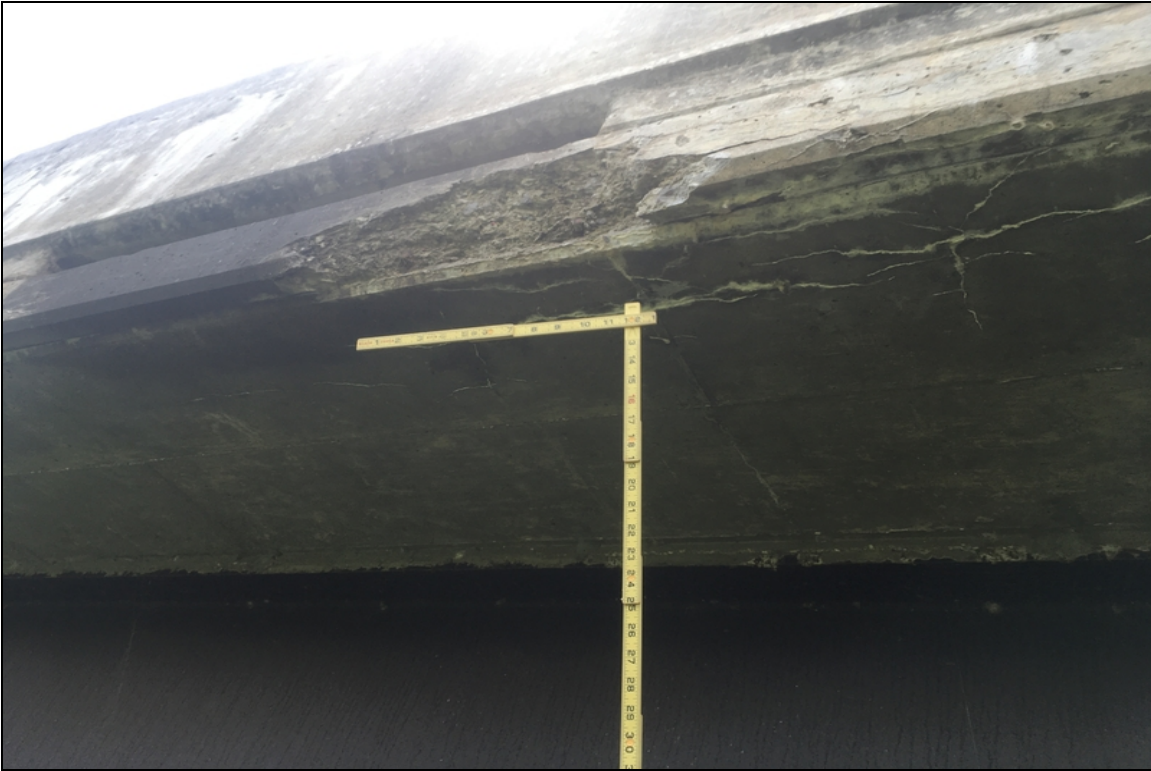
2' of cs3 spalling with no rebar exposed on the left outer overhang of span #1.

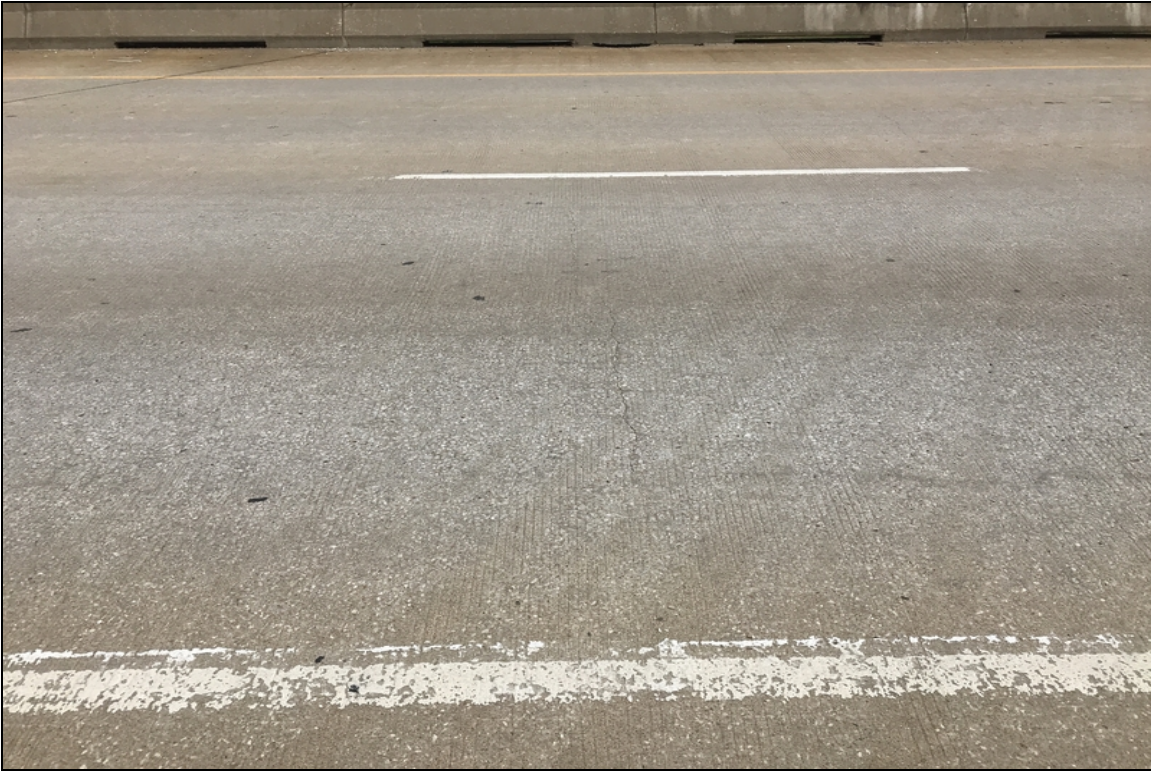
Typical transverse cracking in bridge deck.

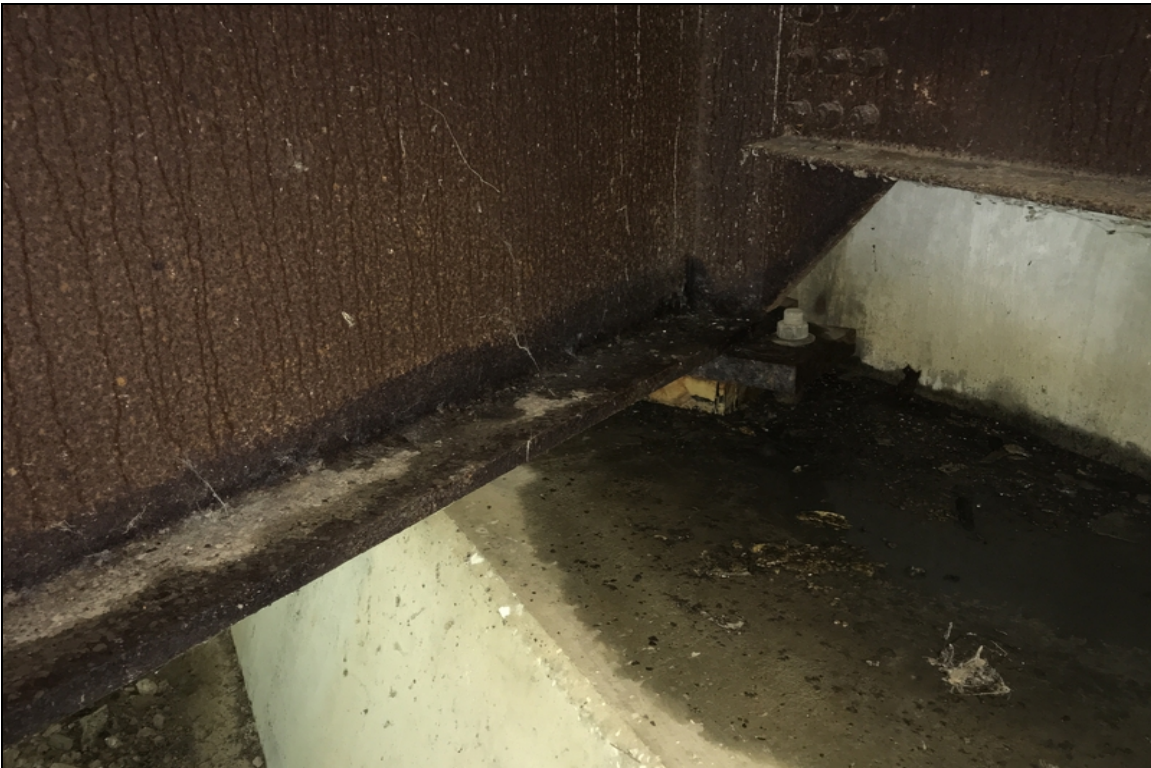
Girder #3 over abutment #1 active corrosion due to leaking compression joint.

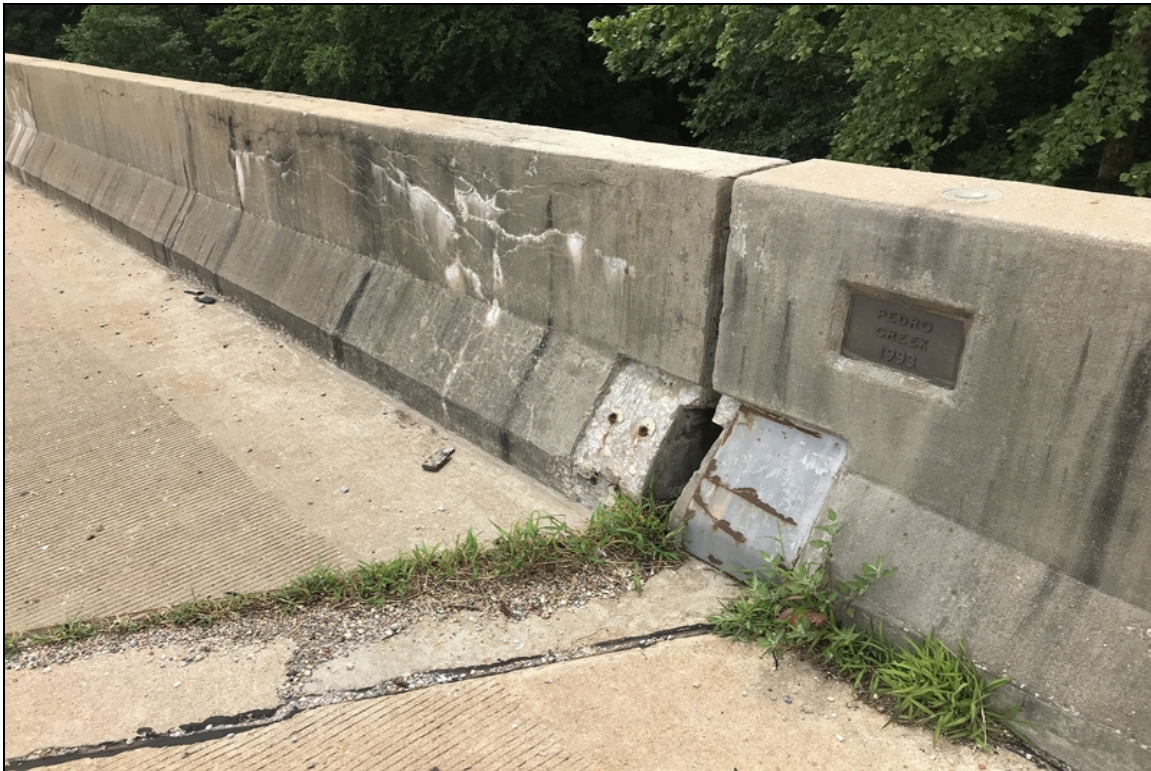
Expansion plate on right parapet missing.

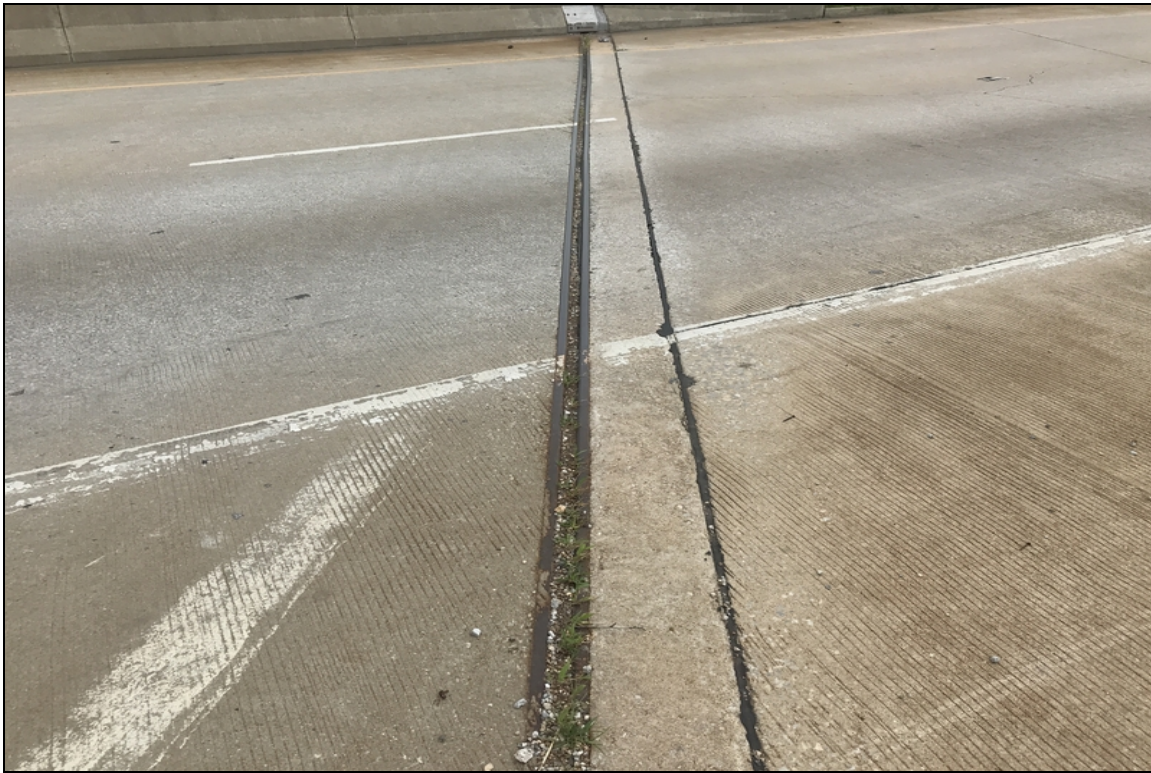
General view of abutment #2 compression joint debris impact.

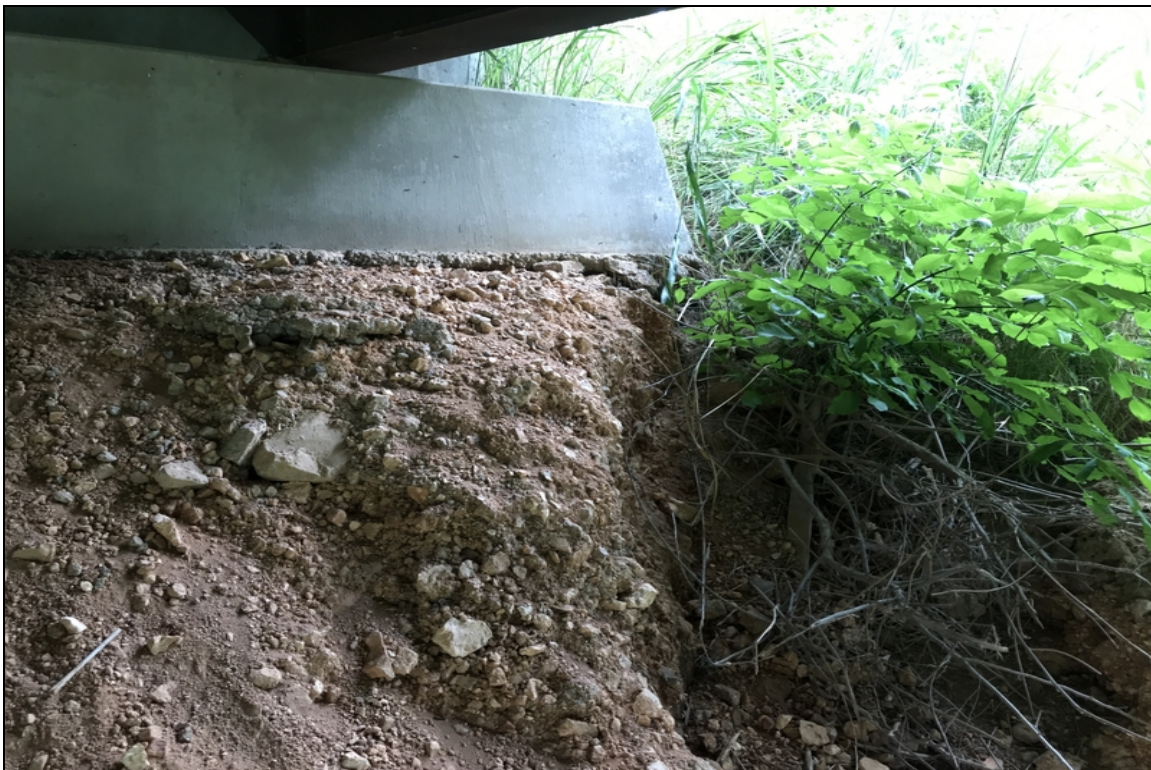
| ELEM | DESCRIPTION | UNITS | TOTAL | CS1 | CS2 | CS3 | CS4 |
|--|---|---|---|---|---|---|---|
| -The top of abutment backwalls have transverse cracking on approximately 16" centers visible from the driving surface. Abutment #1- the rip rap at the toe of the slope is in place and functioning as intended. Abutment #2- the right corner has a small area of embankment erosion that is just to the edge of the abutment back wall. The rip rap at the toe of the slope is in place and functioning as intended. | | | | | | | |

Right side of abutment #2 erosion.

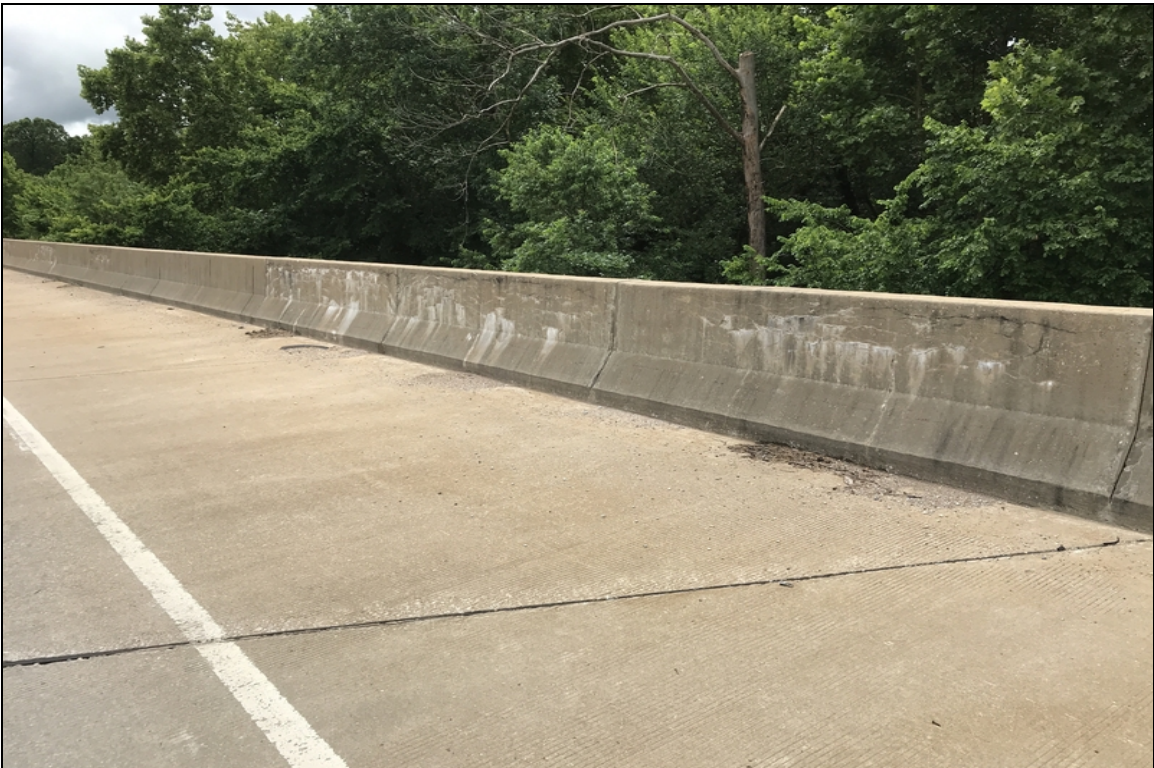
Typical cracking and efflorescence of parapet.

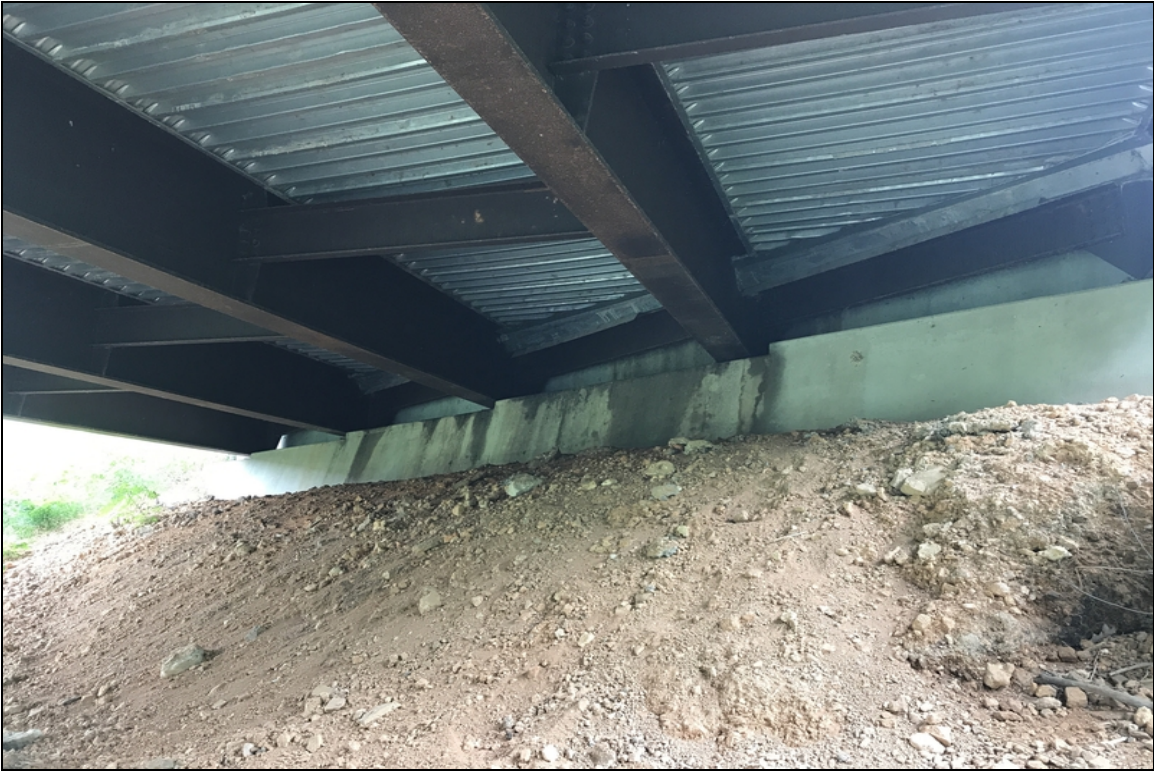
Leakage on bridge seat from leaking compression seal.

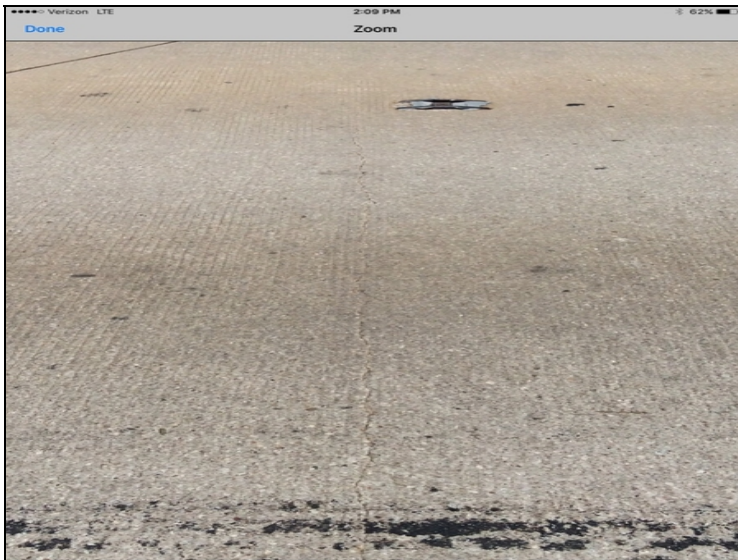
Deck / Approach slabs - The driving surface of the deck has sealable longitudinal and transverse cracking in all spans. The East and West approach slabs have wide longitudinal, transverse and diagonal cracking.

Transverse deck cracking.

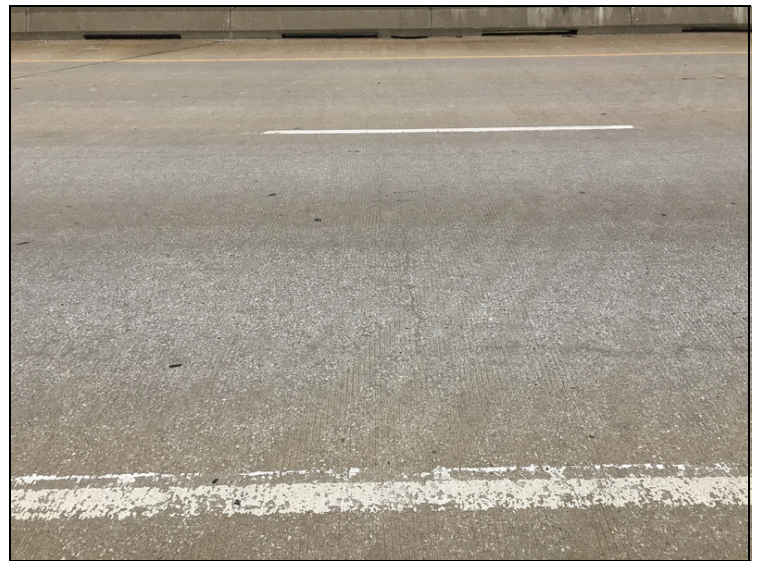
Typical transverse cracking in bridge deck.

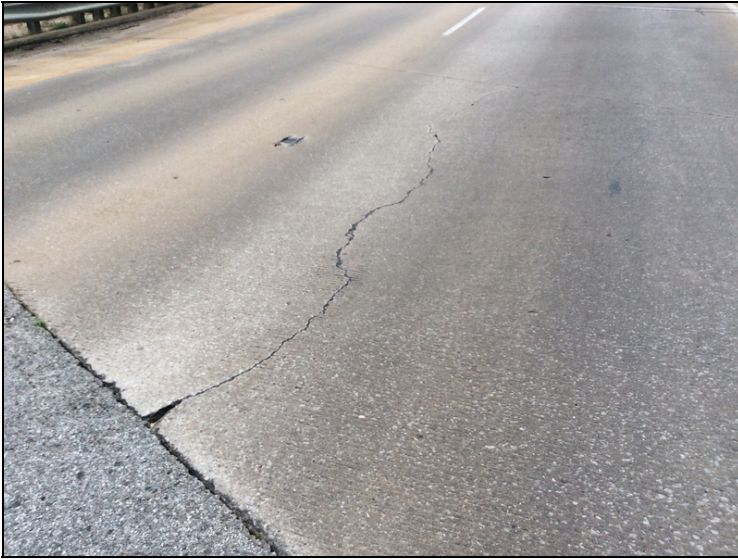
West approach slab-Longitudinal cracking.

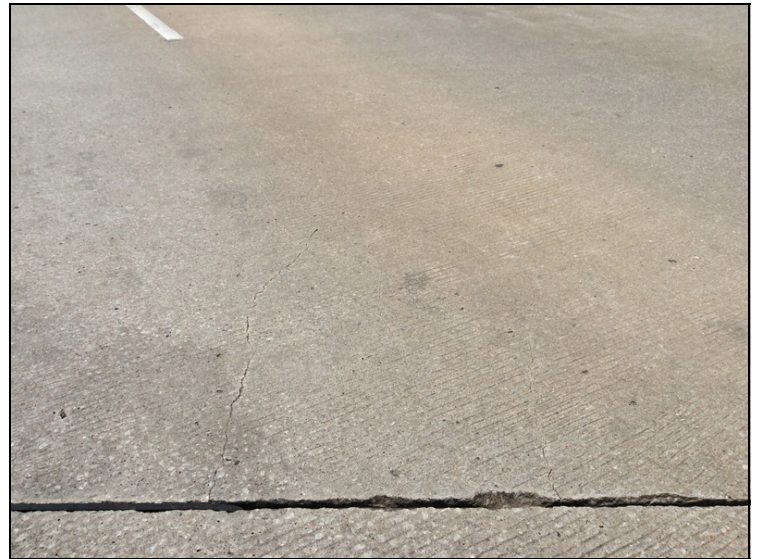
Deck-Typical of diagonal cracking.

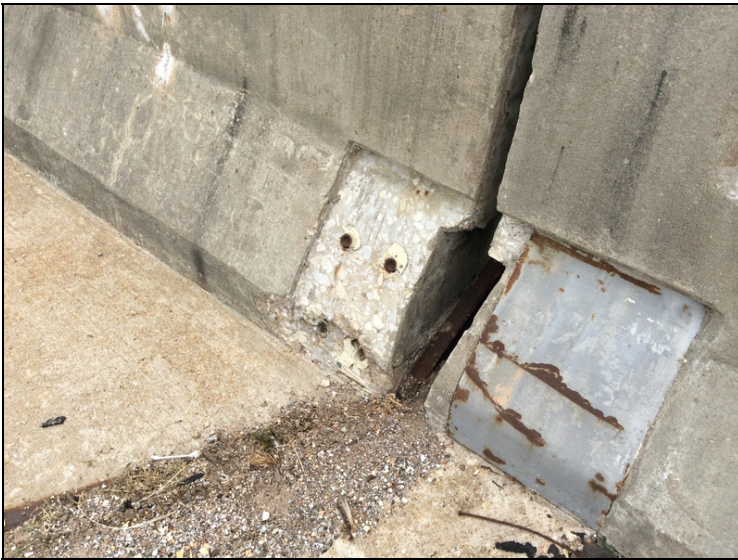
Expansion joint assembly at abutment #1 - Expansion plate on right parapet missing.

Abutment #1, right side-Missing sliding plate on parapet.

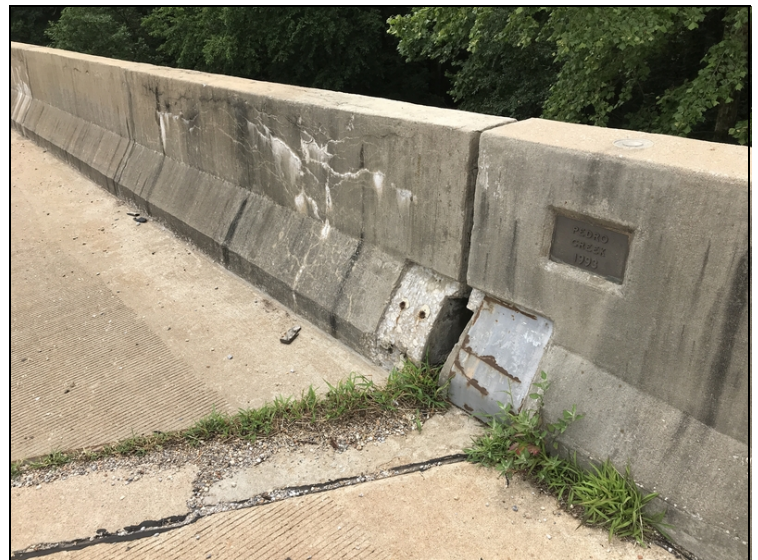
Expansion plate on right parapet missing.

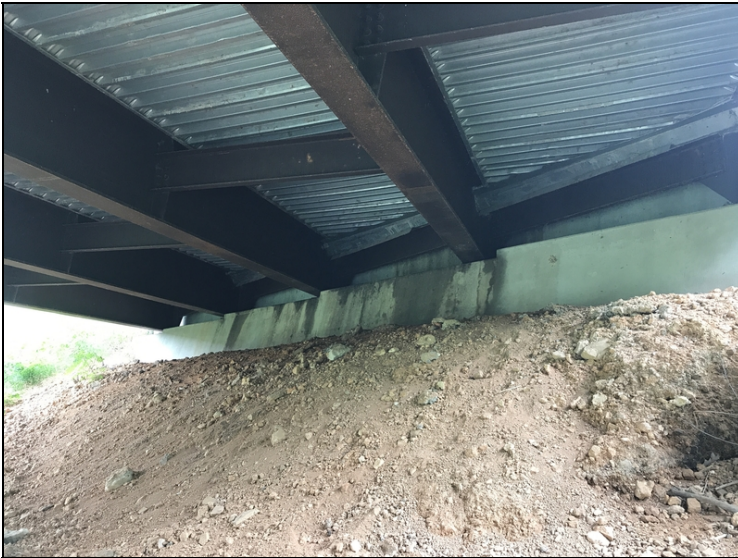
Expansion joints - The strip seal expansion joints at the East and West abutments have heavy debris impaction. The strip seals appear to have come out of the assemblies in locations allowing water to leak onto the superstructure promoting corrosion.

Leakage on bridge seat from leaking compression seal.

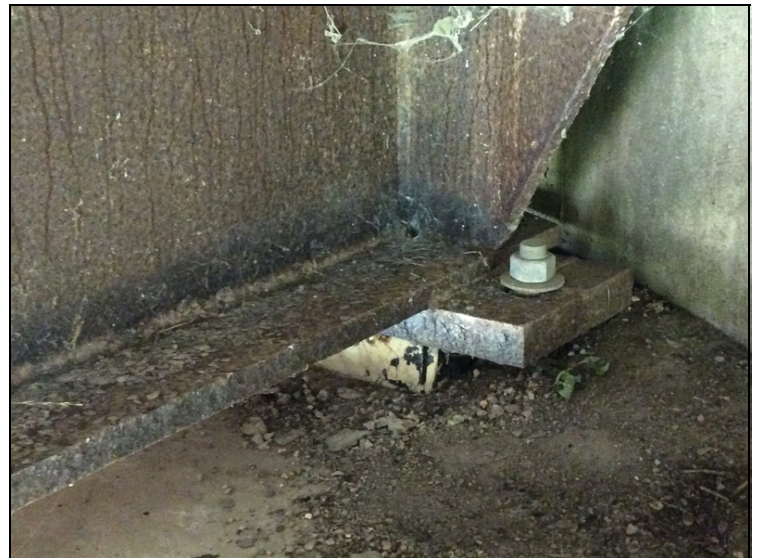
Abutment #2, beam #4-Corrosion due to leaking expansion joint.

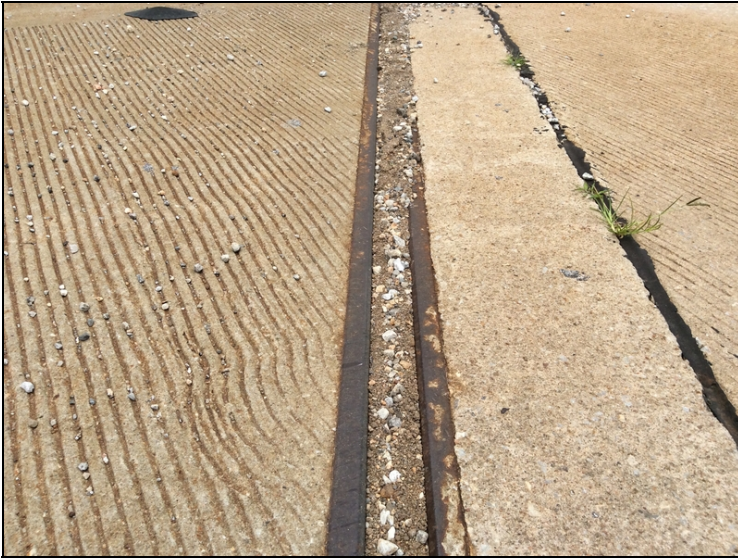
Abutment #1-Debris impact in expansion joint.

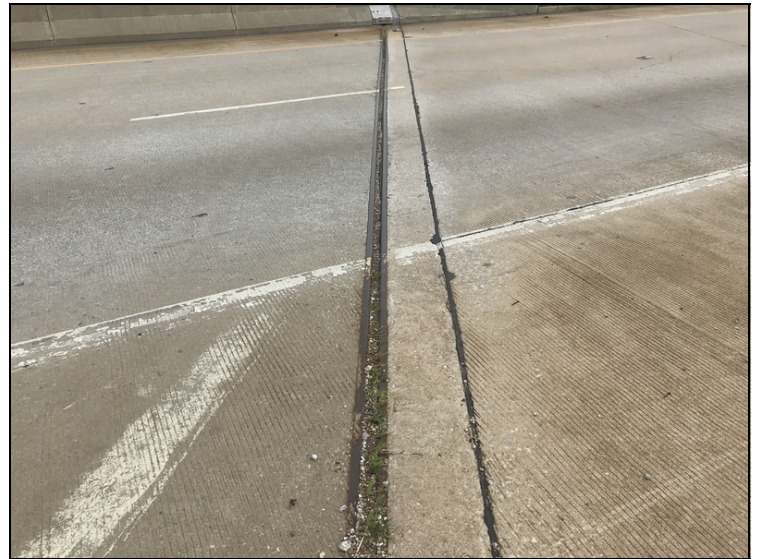
General view of abutment #2 compression joint debris impact.

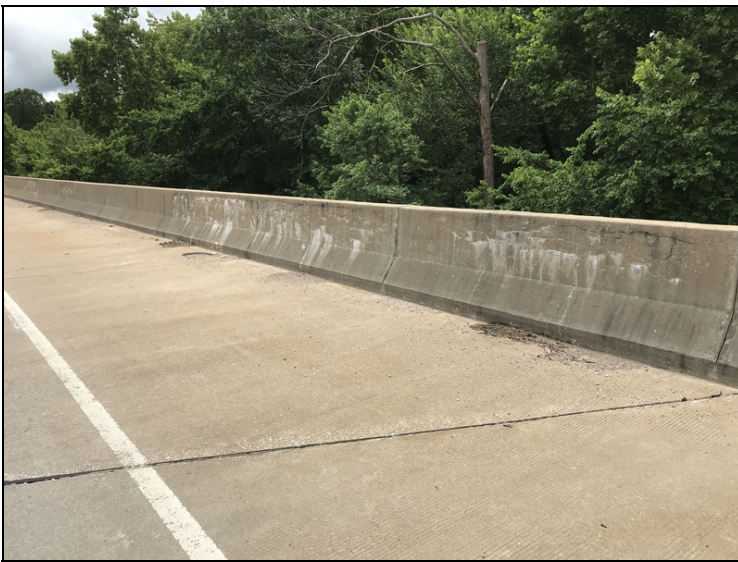
Bridge railing - The concrete bridge railing has numerous areas of map cracking with efflorescence. The affected areas are delaminated in locations with wide cracking in the top surface of railing.

Typical cracking and efflorescence of parapet.

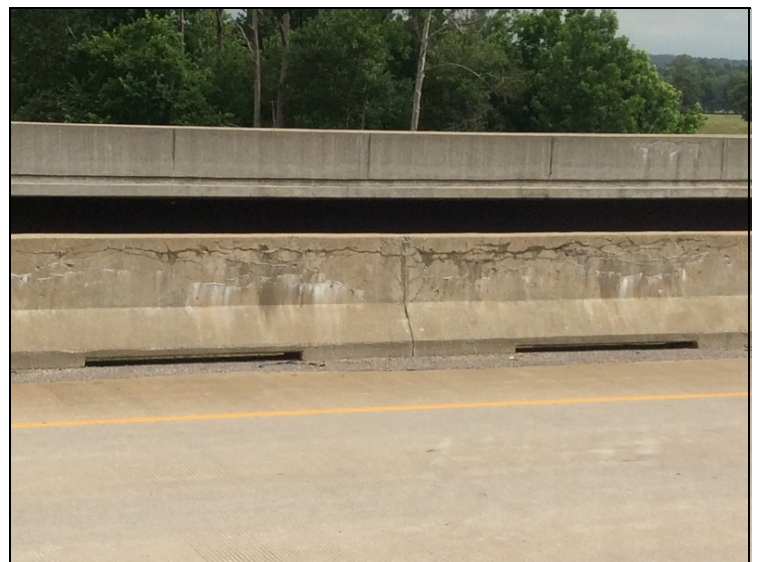
Map cracking in parapet wall

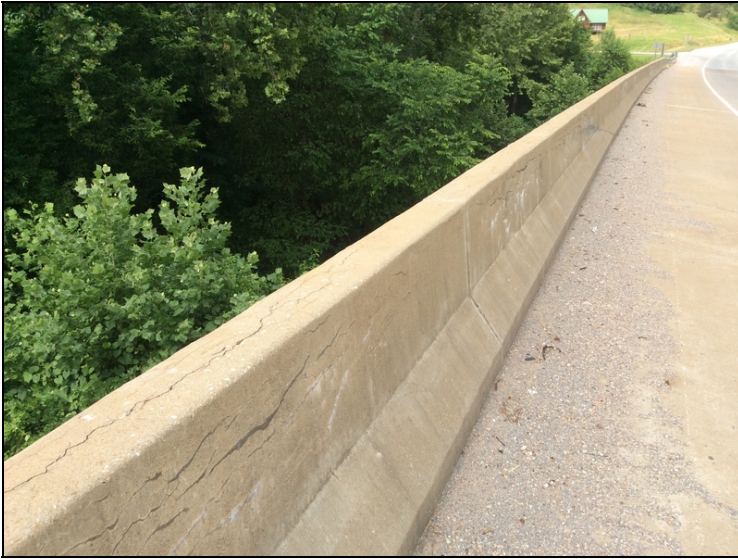
Parapet wall has map cracking with efflorescence

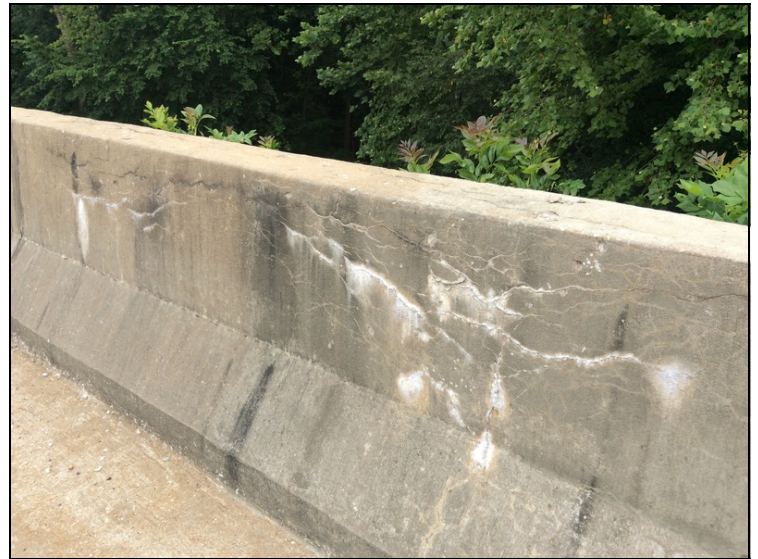
Span #1, right side-Mapcracking with efflorescence.

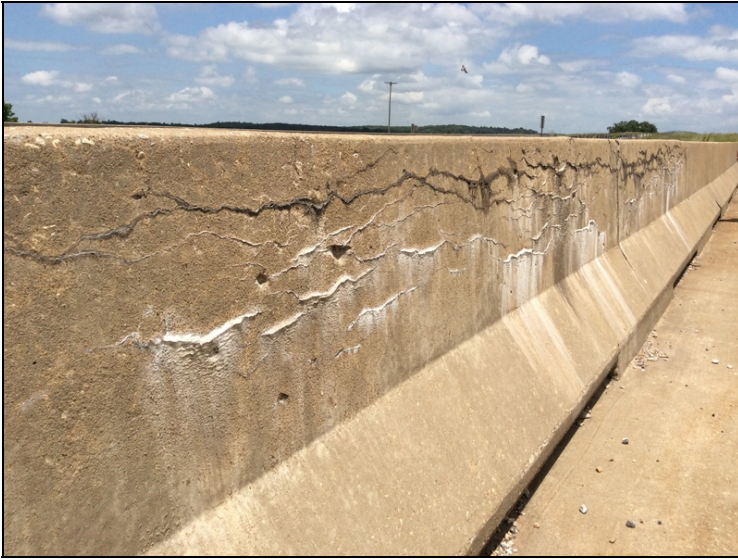
Left parapet-Mapcracking with efflorescence.

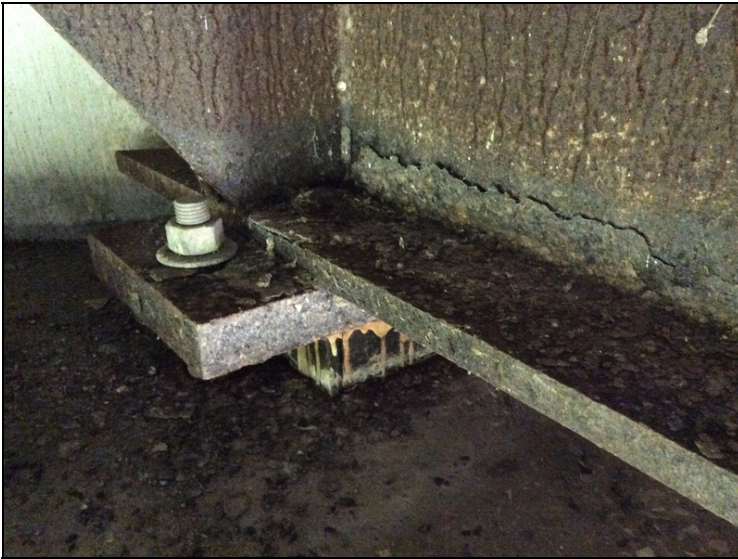
Superstructure - The bearings and ends of beams over abutments #1 and #2 have corrosion with flaking rust due to leaking expansion joint seals.

Abutment #1, beam #3-Corrosion to bottom flange and web due to leaking expansion joint seal.

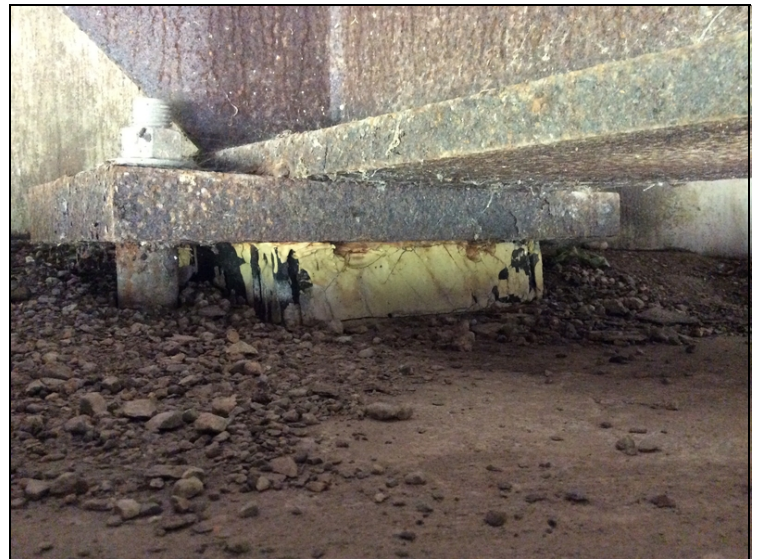
Excessive corrosion due to leaking expansion joint.

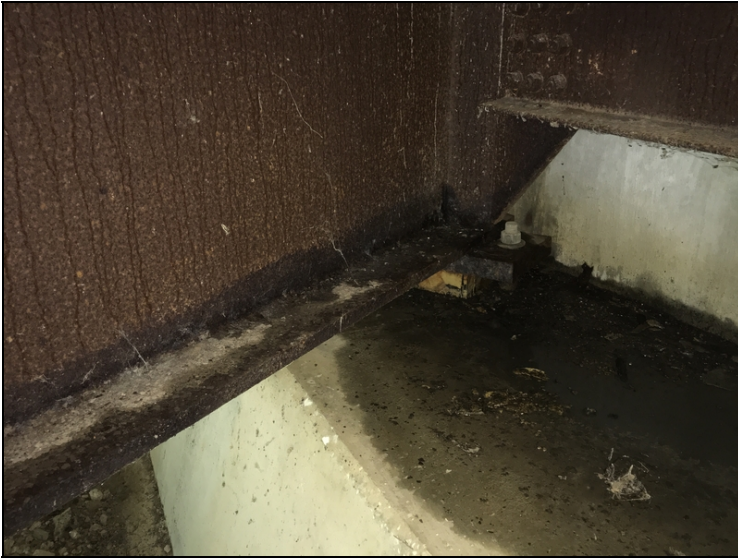
Girder #3 over abutment #1 active corrosion due to leaking compression joint.
