Bridge #A6478(Routine, Underwater type 2)

US 412, WB Bent CO over ILLINOIS RIVER

Location: 11.6 MI E OF OKLAHOMA LN

Team Lead: Nathan Rowland **Inspection Date:** June 15, 2021

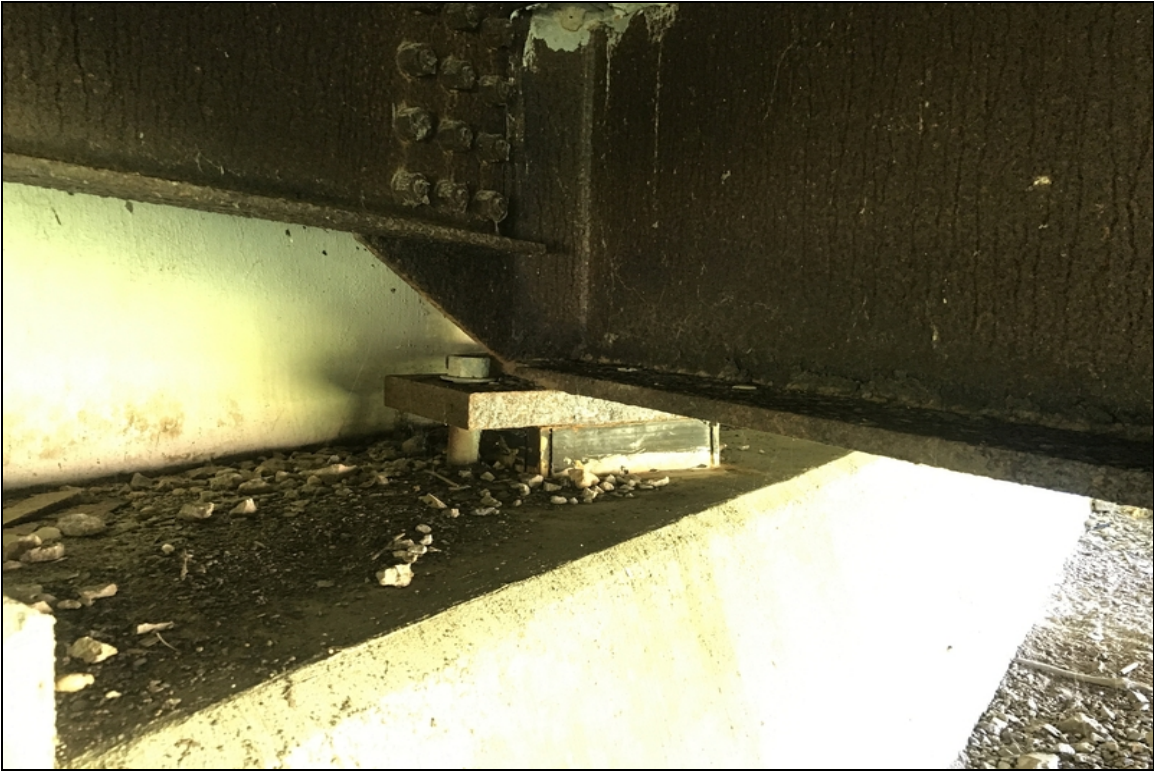
Typical flaking rust at abutment #1 for bearings and girders.

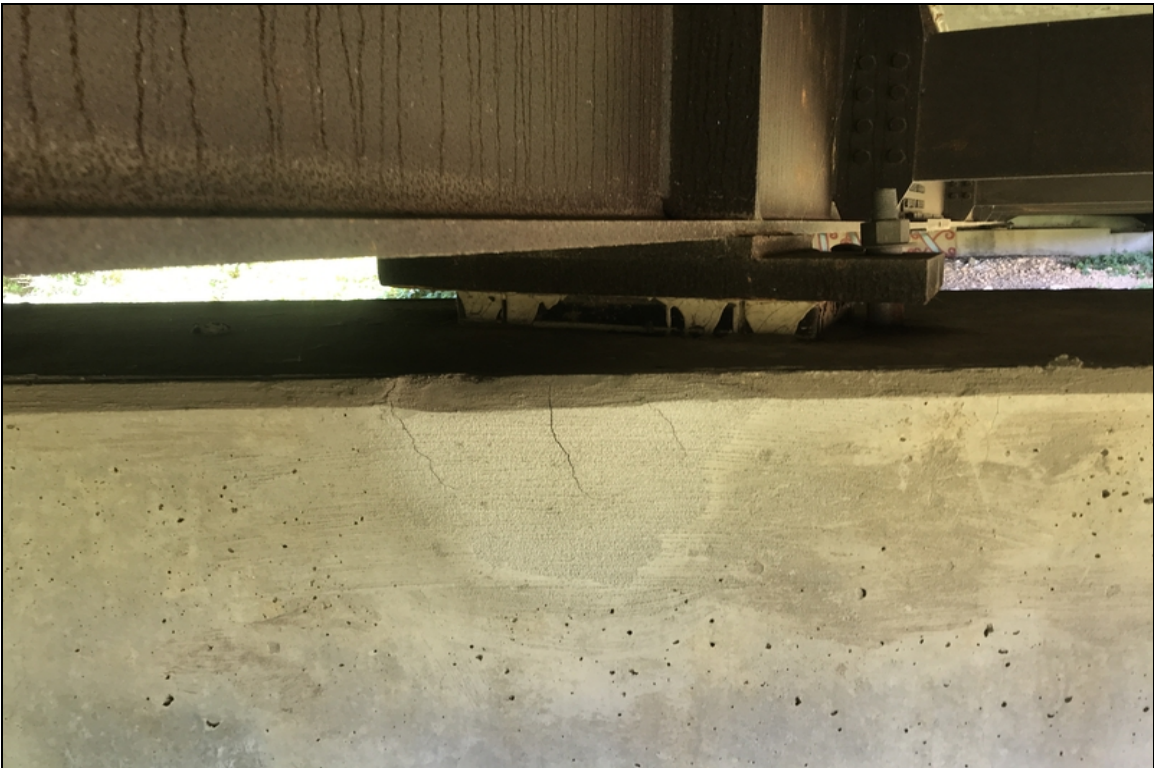
(234)							
06/15/2021 WNR & DBM:							
-Bent #1 cap ahead side under girder #2 repaired area that is failing as of this inspection. This area is beginning to delaminate upon sounding.							
-Bent #4 cap in span #5 has an 18" high shallow spall with exposed reinforcing steel located in lower portion of cap. The exposed reinforcing steel has measurable section loss.							
-Bent #5 cap has hairline horizontal cracking on both sides of cap that extend the majority of length of cap located approximately 2' from top of cap.							
-Ben #7 cap ahead side - tall hairline vertical cracking at random locations throughout the cap.							
-Bent #10 cap ahead side top of vertical face has hairline vertical cracks at random spacing.							
-Bent #14 cap ahead side top of vertical face has hairline vertical cracks at random spacing.							
-Typical for Pier caps have short and tall vertical hairline cracks at the step downs.

Bent #1 cap ahead side under girder #2 repaired area that is failing as of this inspection. This area is beginning to delaminate upon sounding.

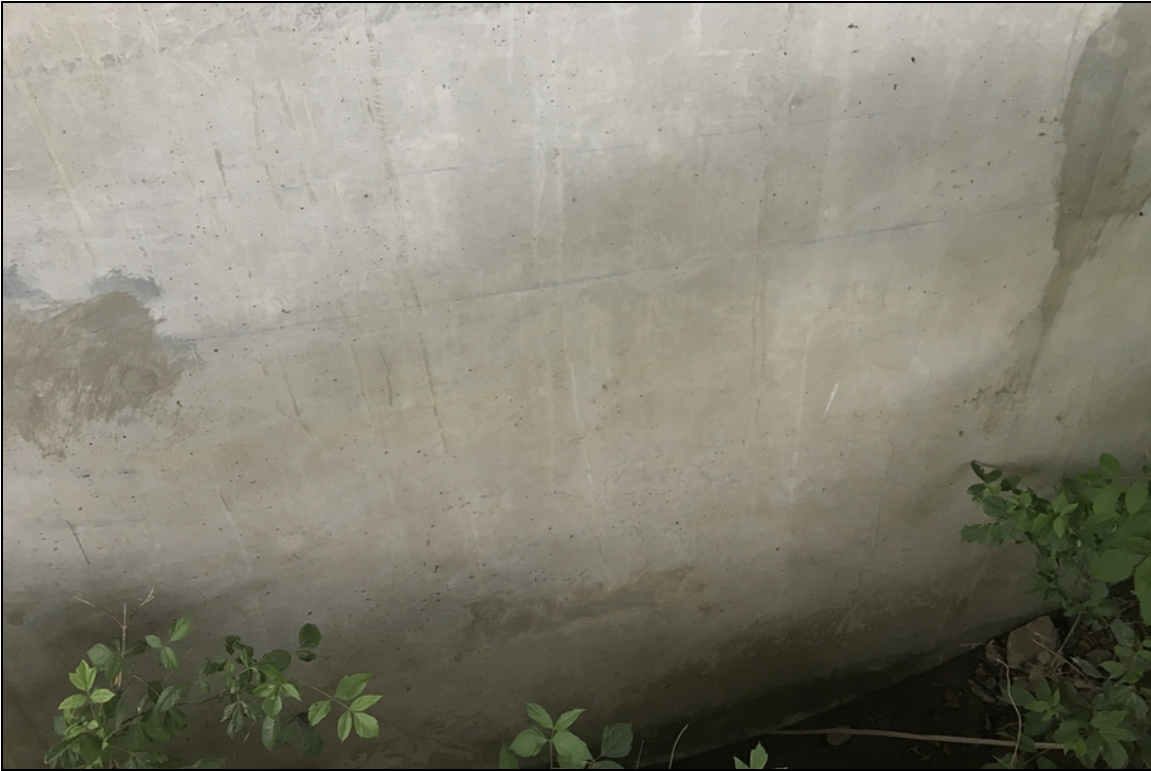
Bent #10 base of column has 3 narrow short duration vertical cracks. Visible from the ahead side.

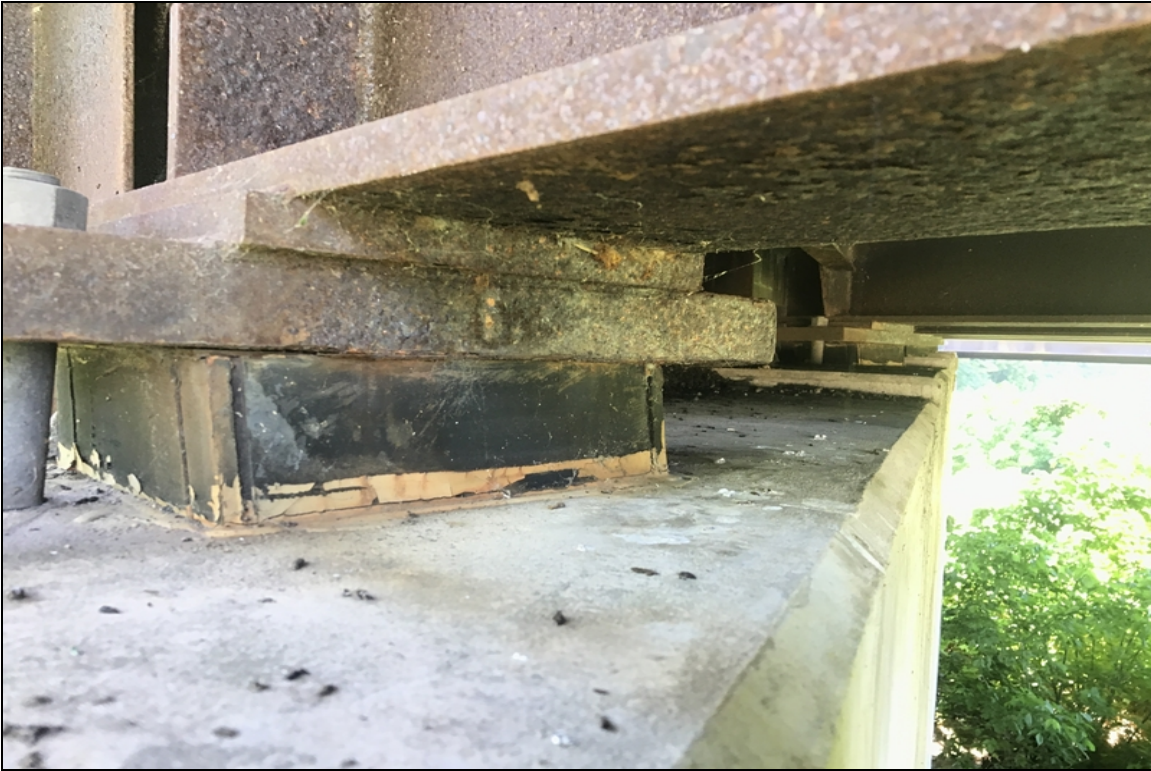
Bearing #1 at bent #16 flaking rust

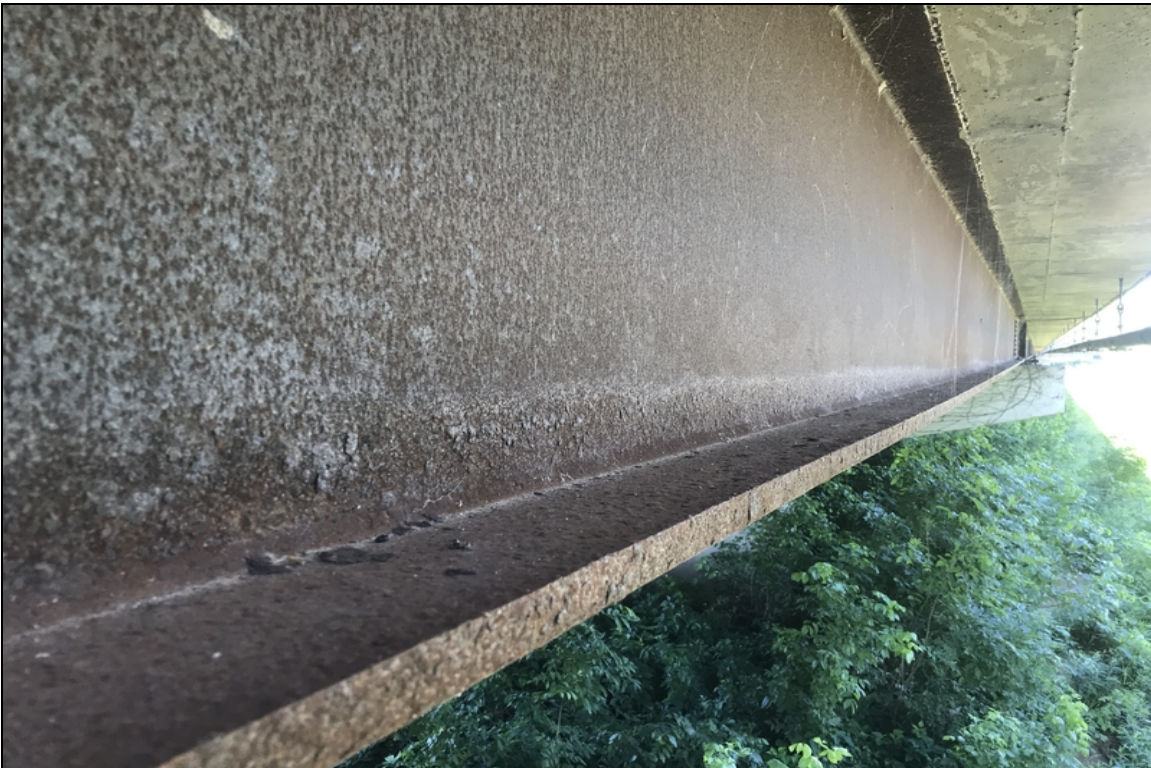
Span #16 girder #1 flaking rust

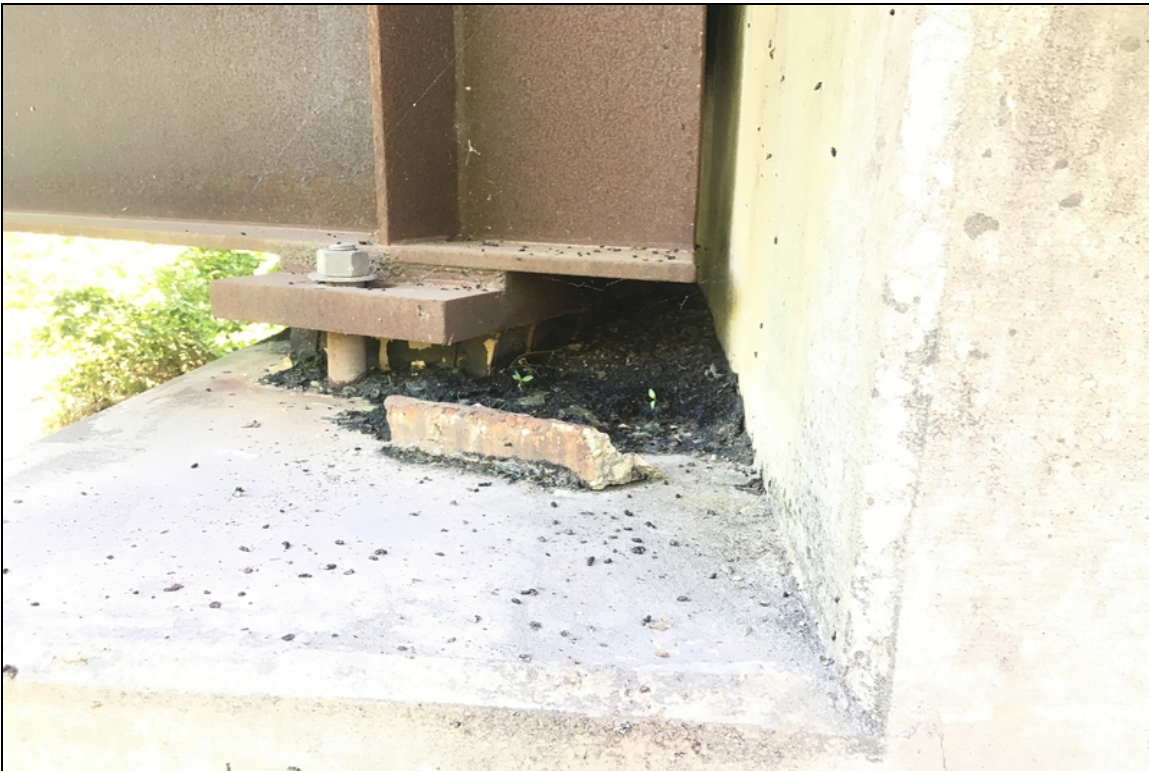
Large amounts of bat Feces accumulated on top of bent #16.

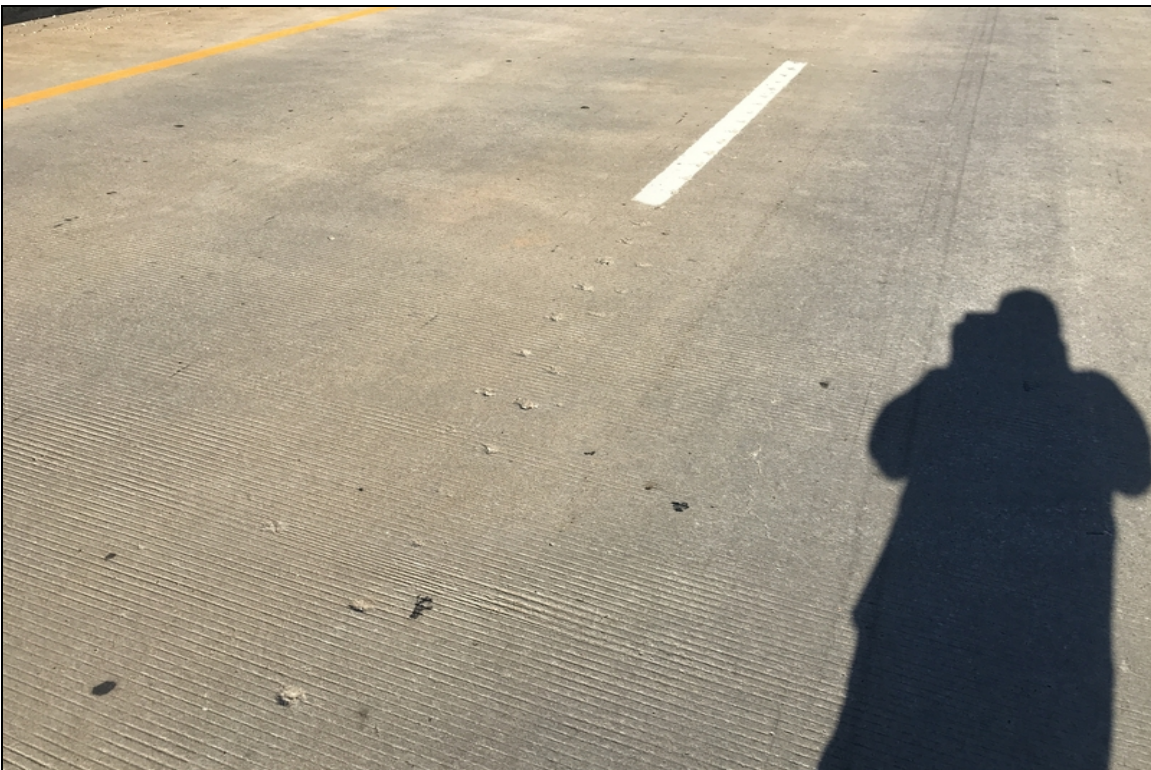
Limited cover over shear pins has caused multiple pop outs.

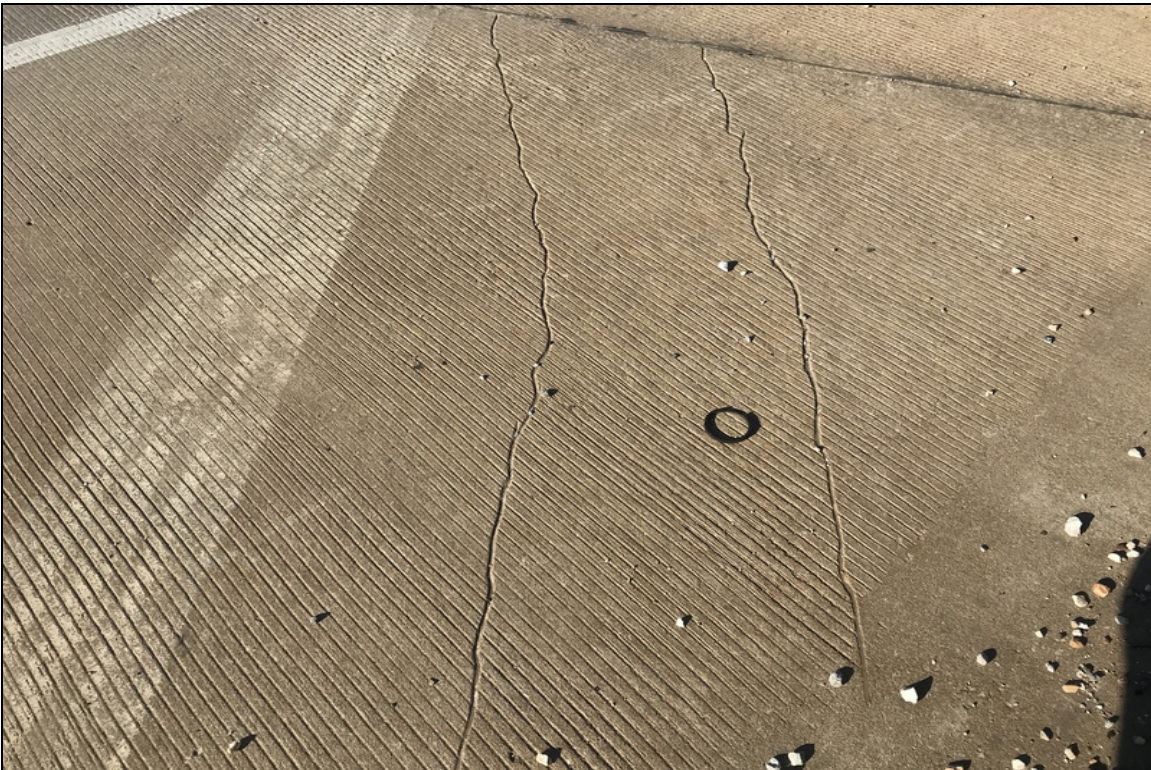
Additional diagonal cracking at bent #5 cracking repairs are not holding as of this inspection

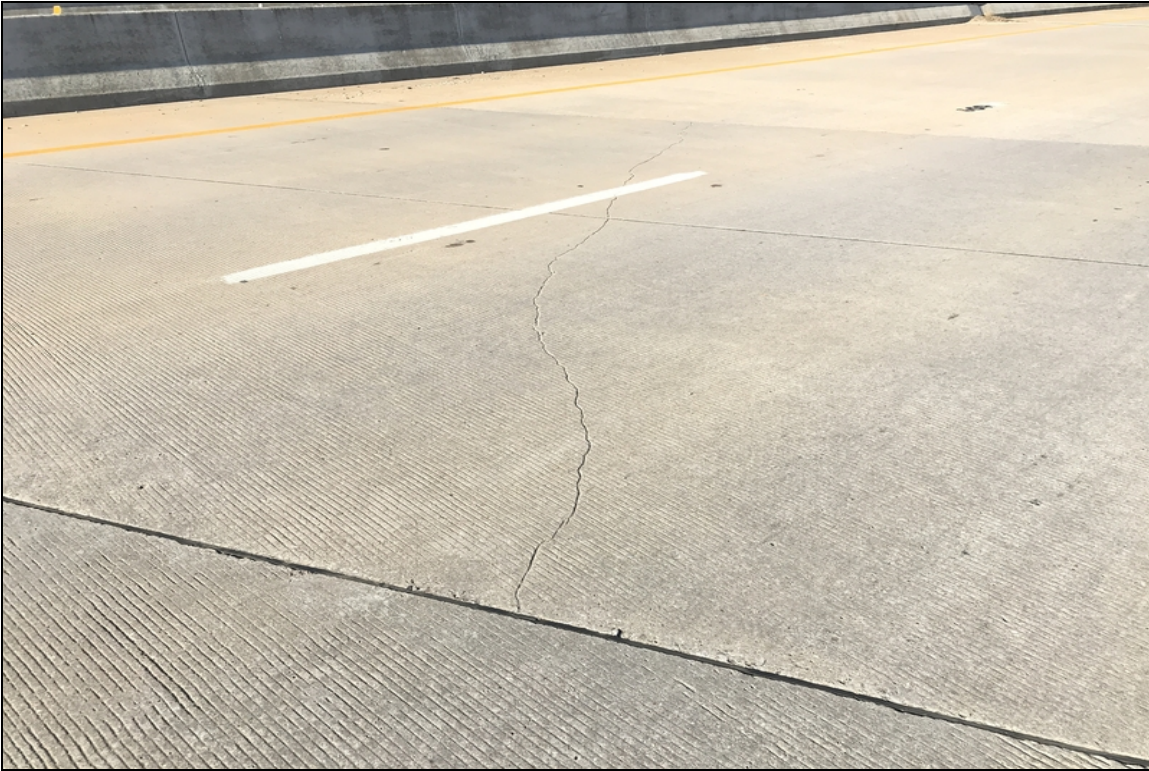
Large diagonal crack over bent #5.

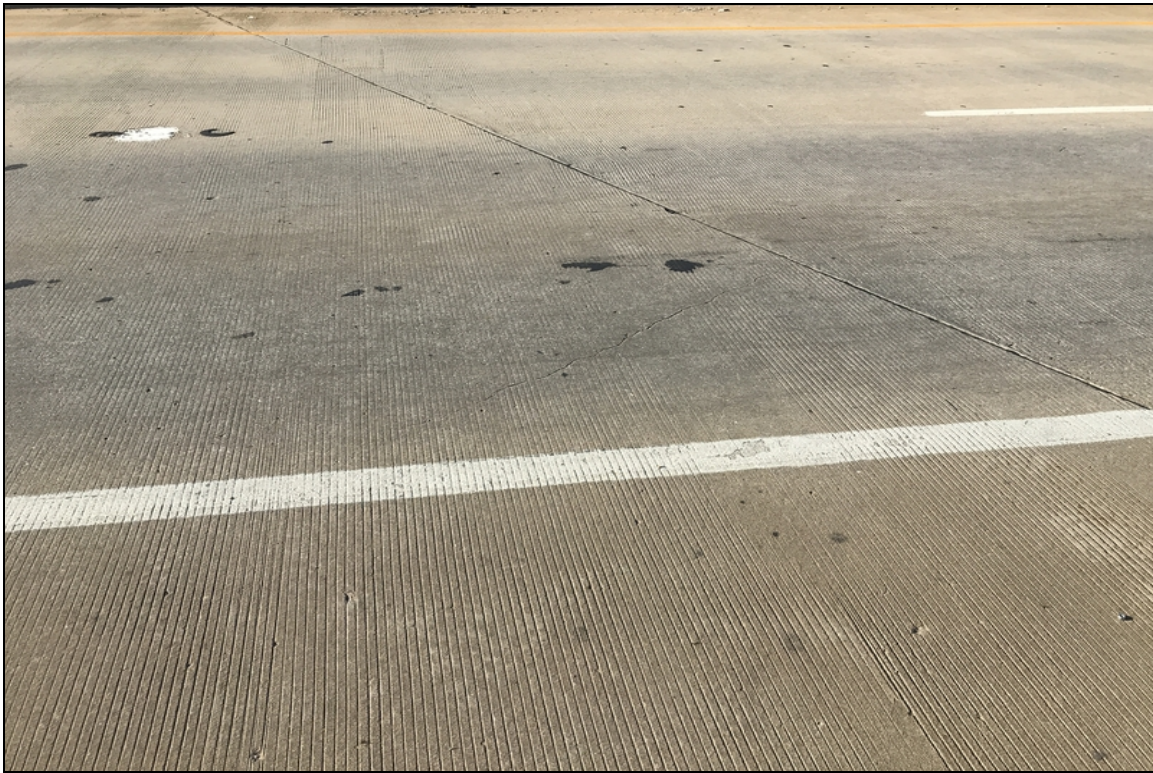
View of diagonal cracking propagating from construction crack over bent #14.

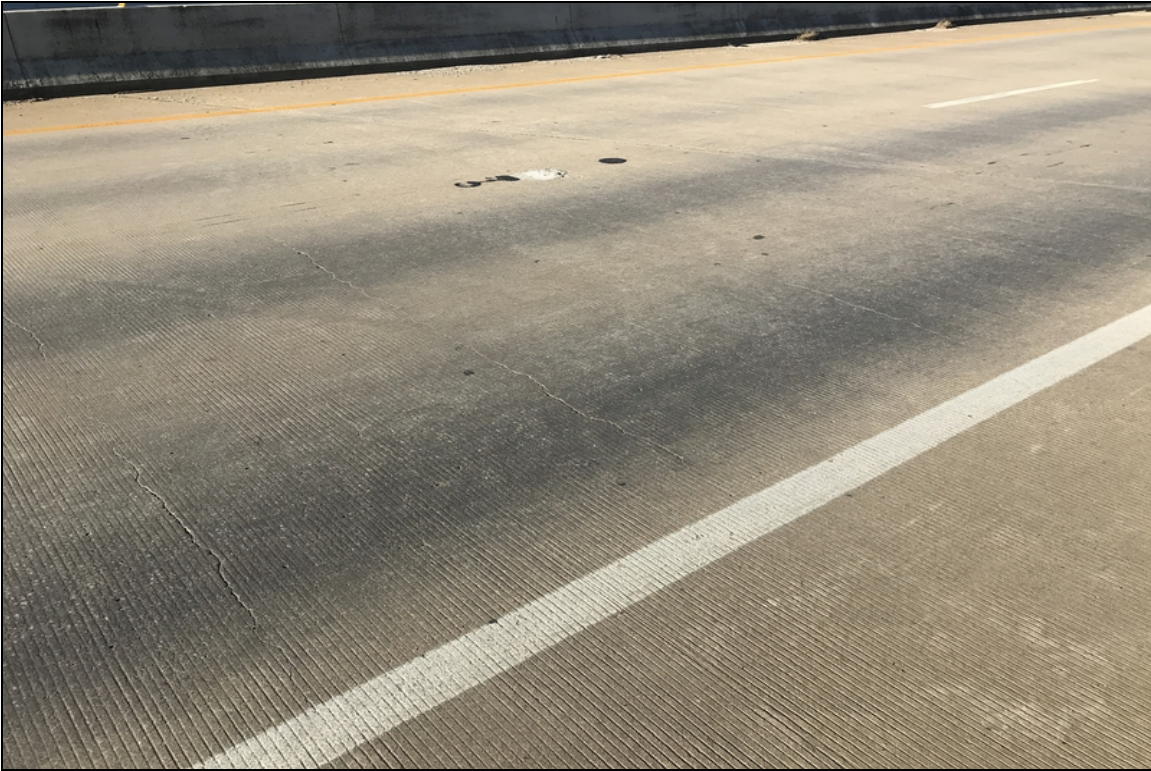
Typical cracking in deck over bent #18

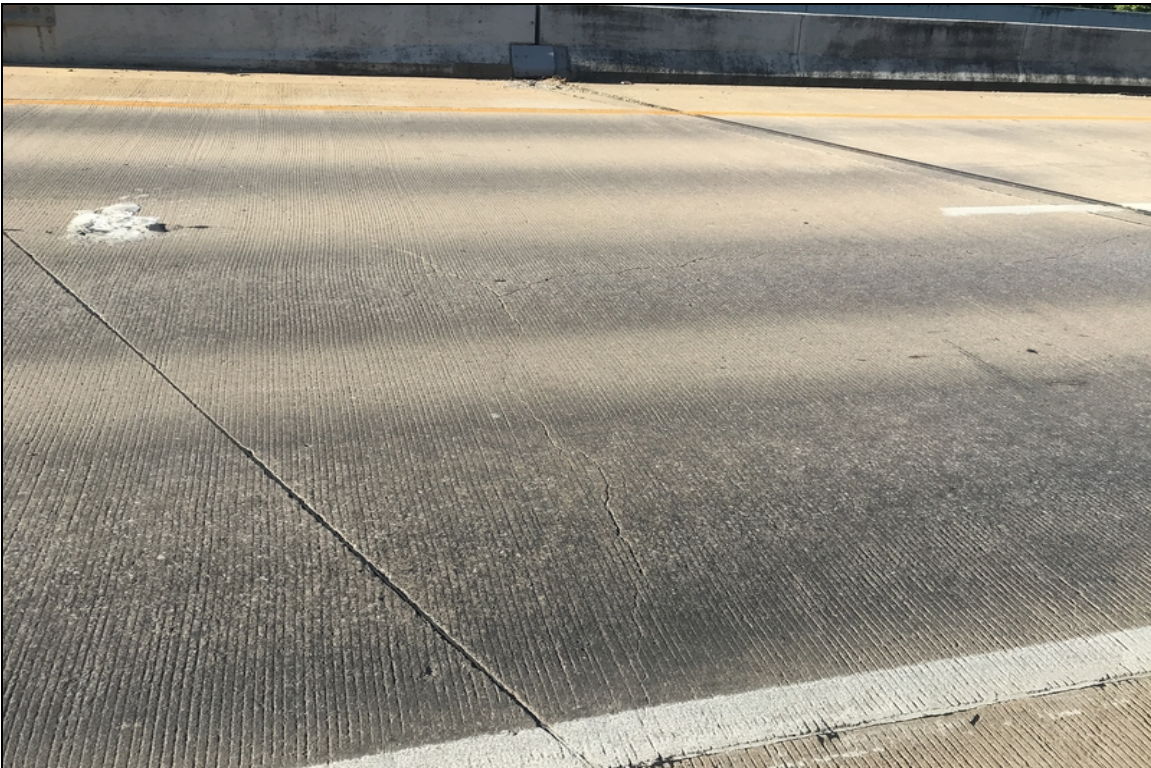
Cracking in east approach slab

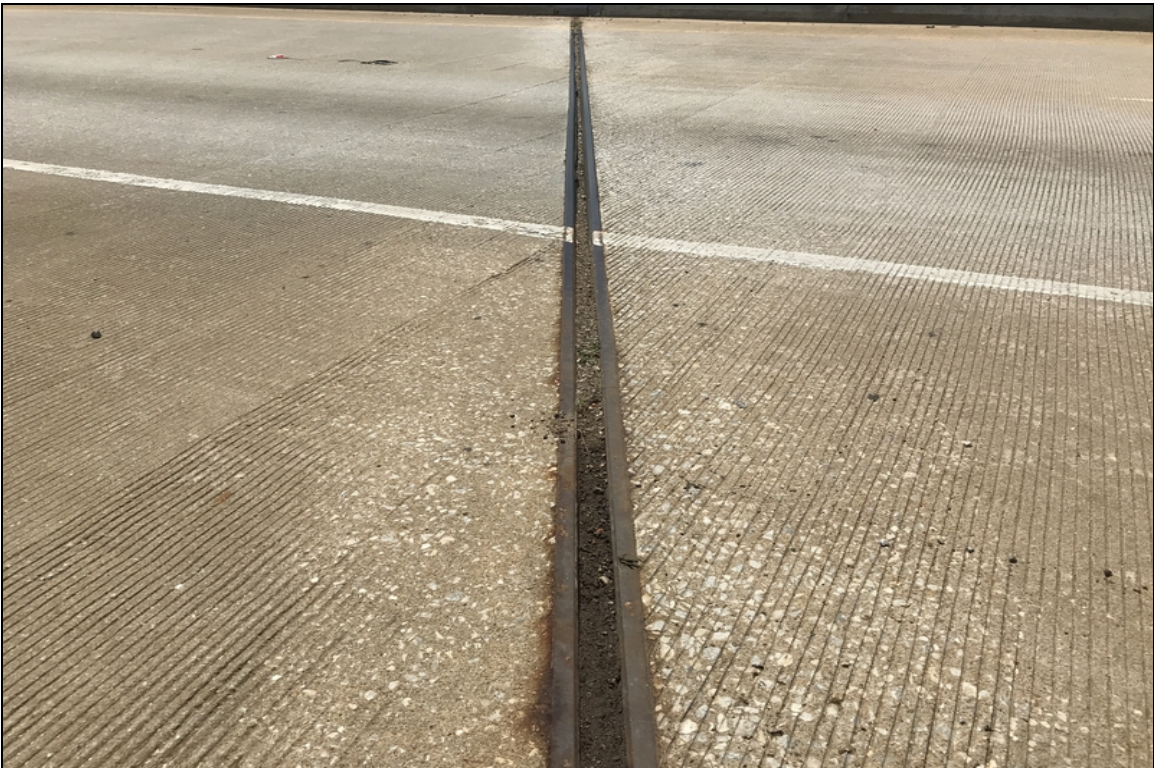
Expansion joint over bent #12 debris impaction.

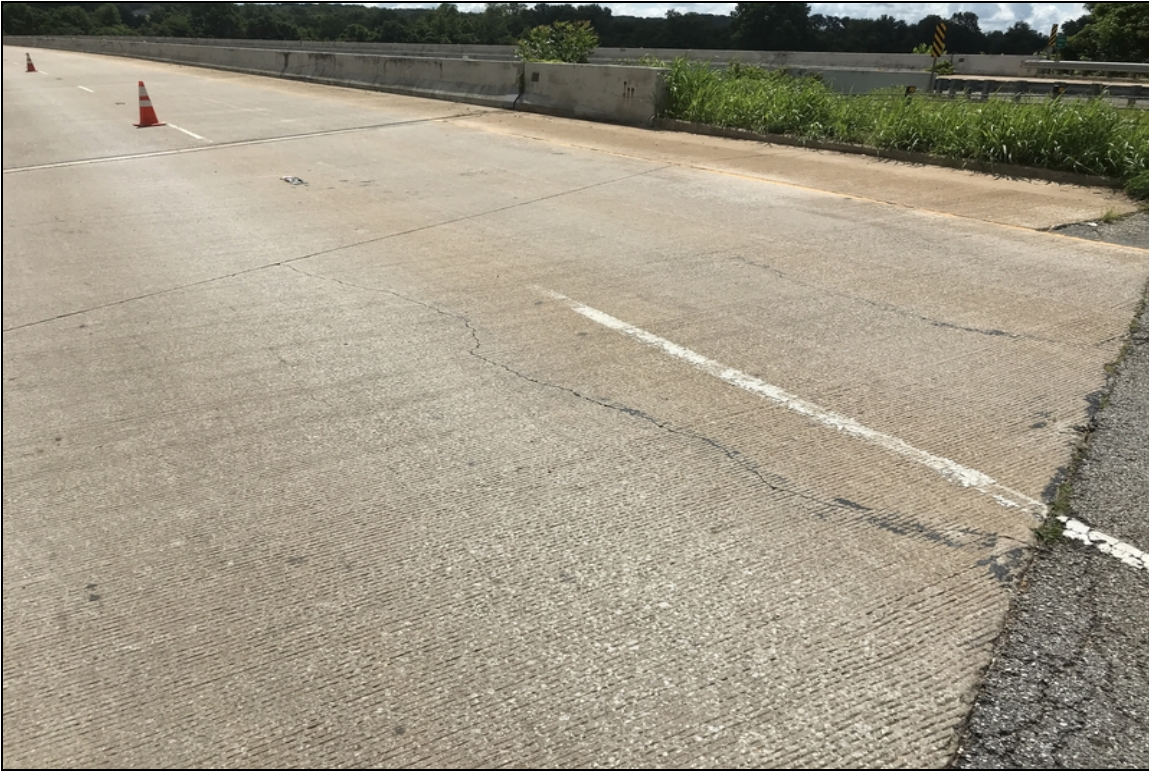
West approach slab cracking

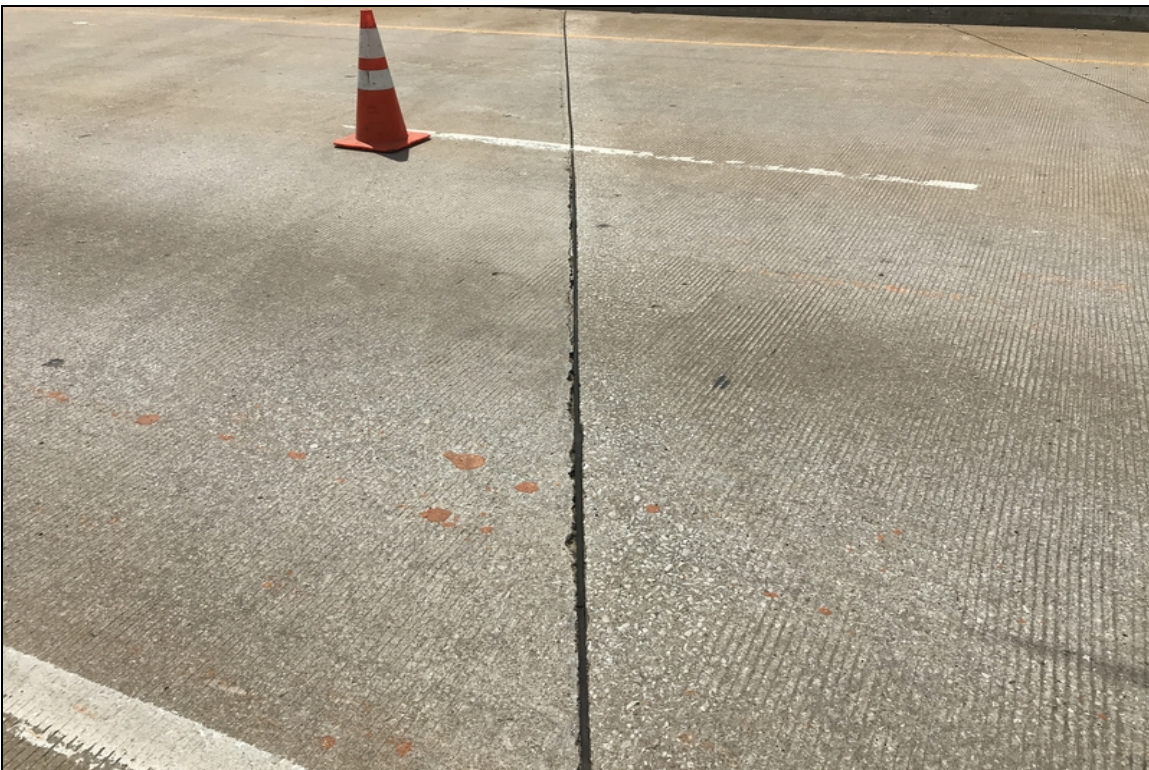
Joint material for sawn joints loss of adhesion due to spalling.

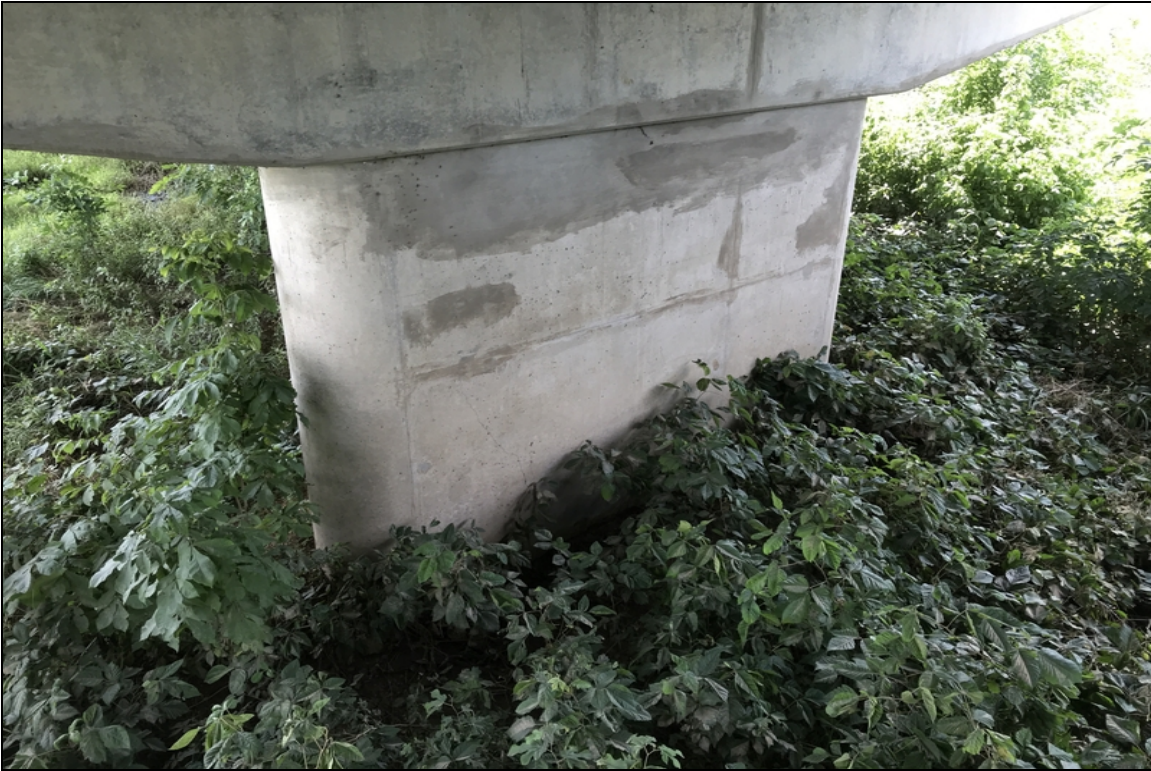
Bent #5 behind side of pier has diagonal cracking.

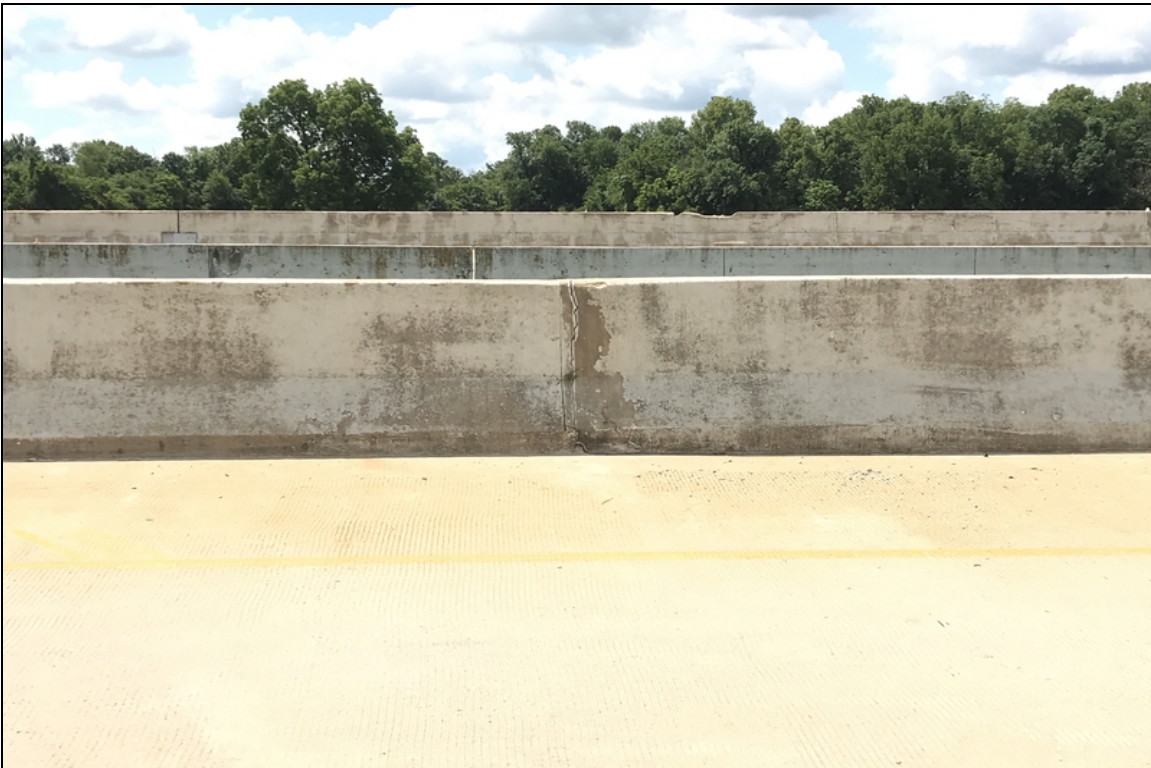
Parapet right span #8 large crack adjacent sawn joint.

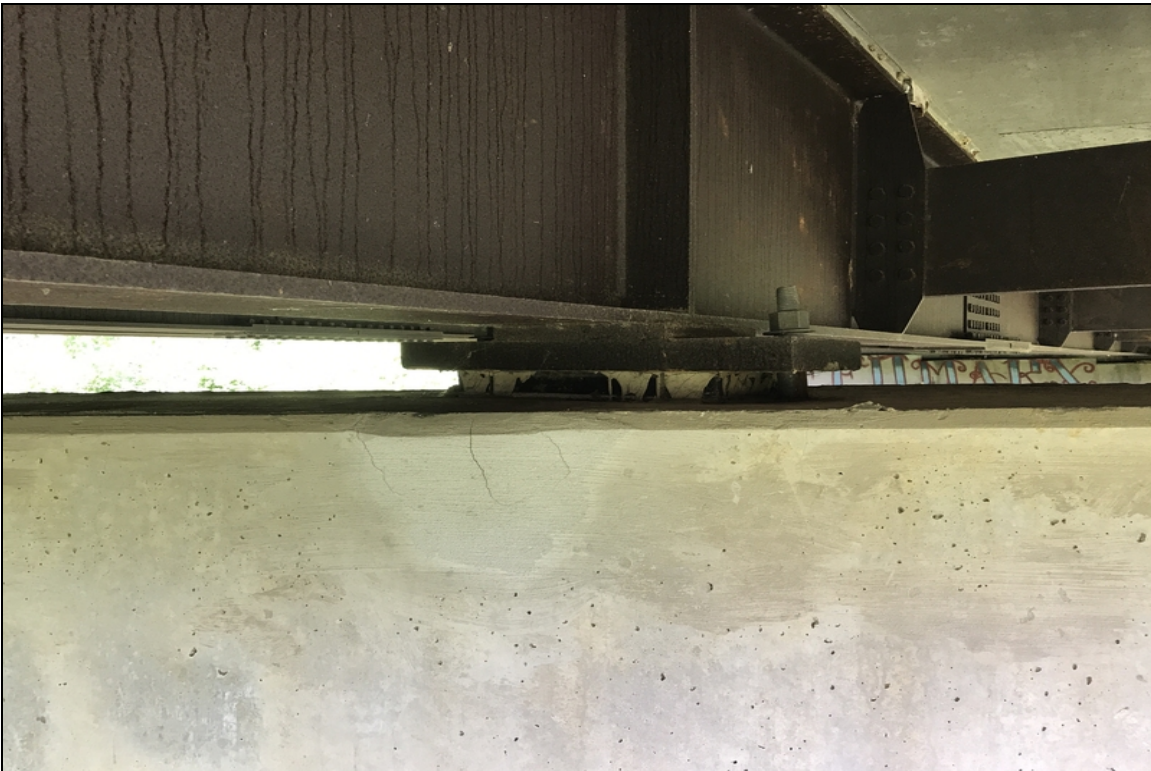
Bent #1 cap ahead side under girder #2 repaired area is cracking.

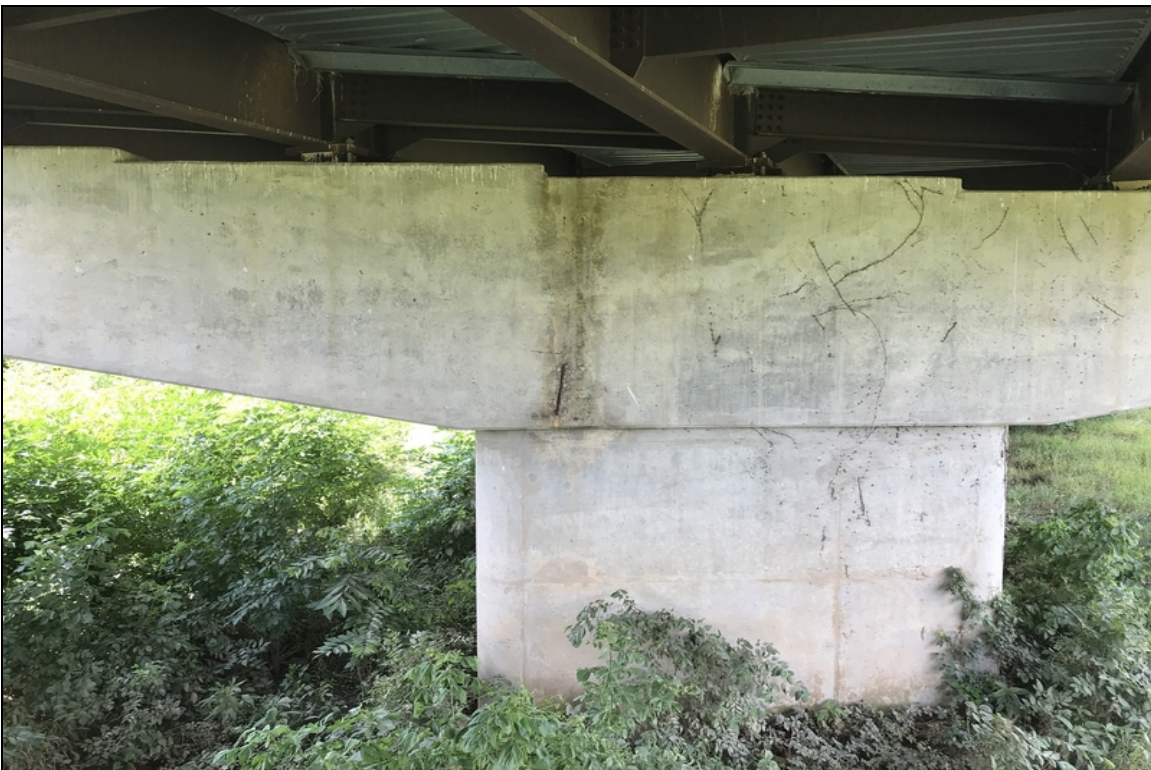
Bent cap #4 ahead side has large spall with steel exposed with minor section loss.

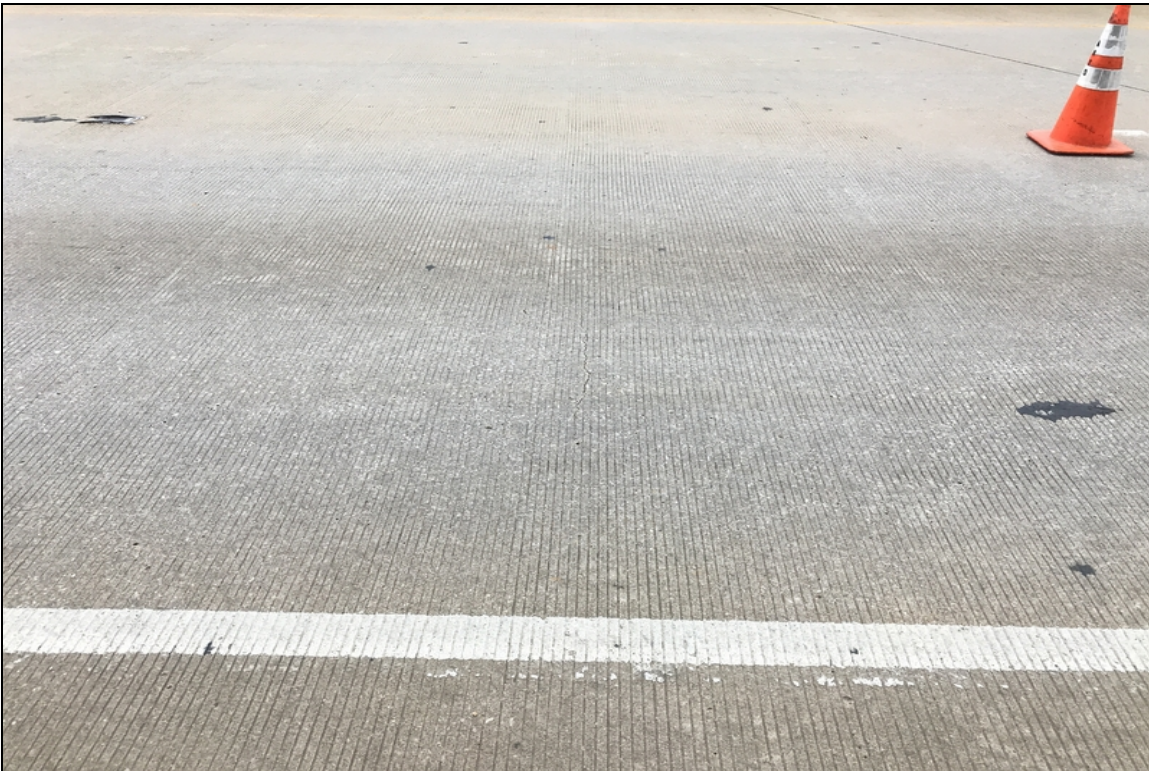
Span #17 left typical transverse cracking.

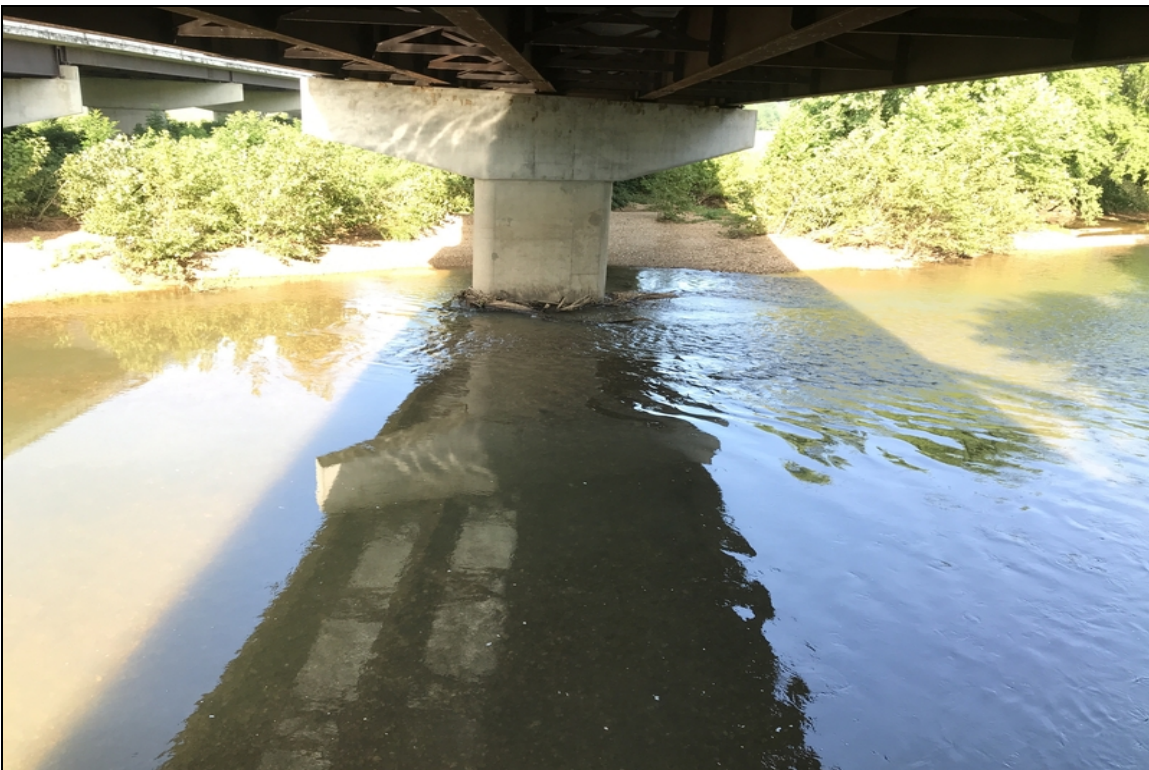
Ahead side of bent #17 - minor drift accumulation.

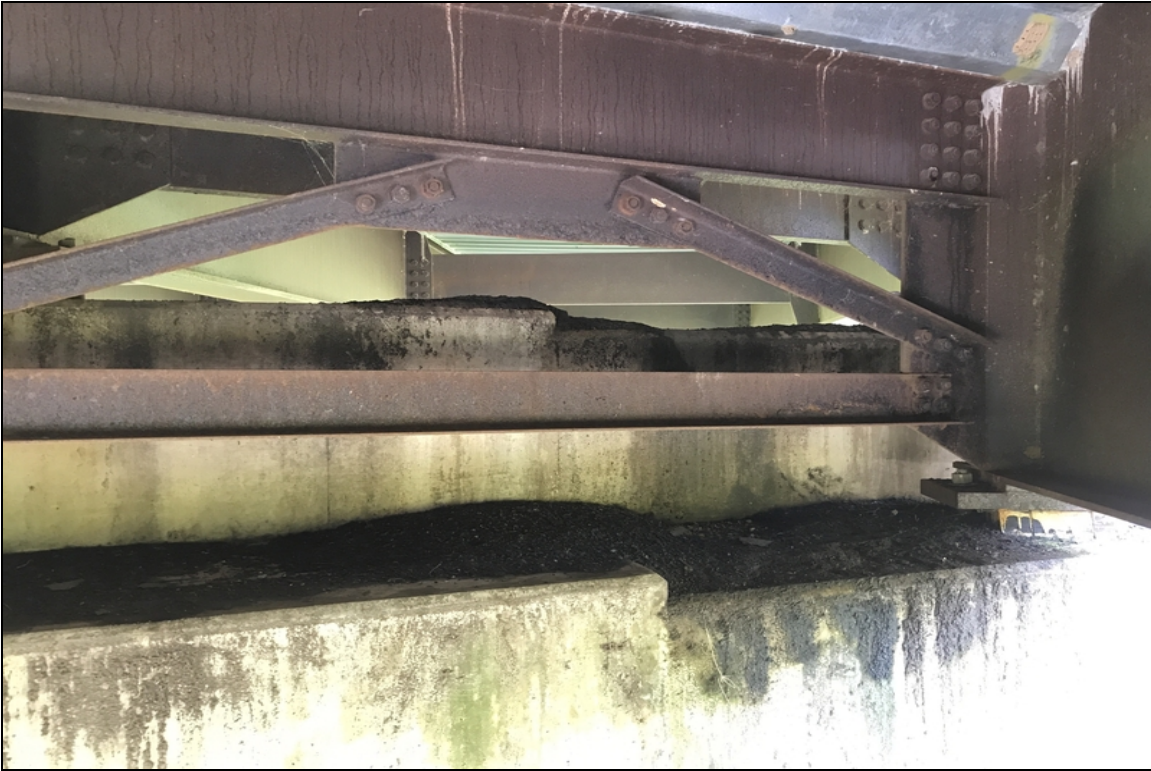
Bat droppings at bent #16 top of cap.

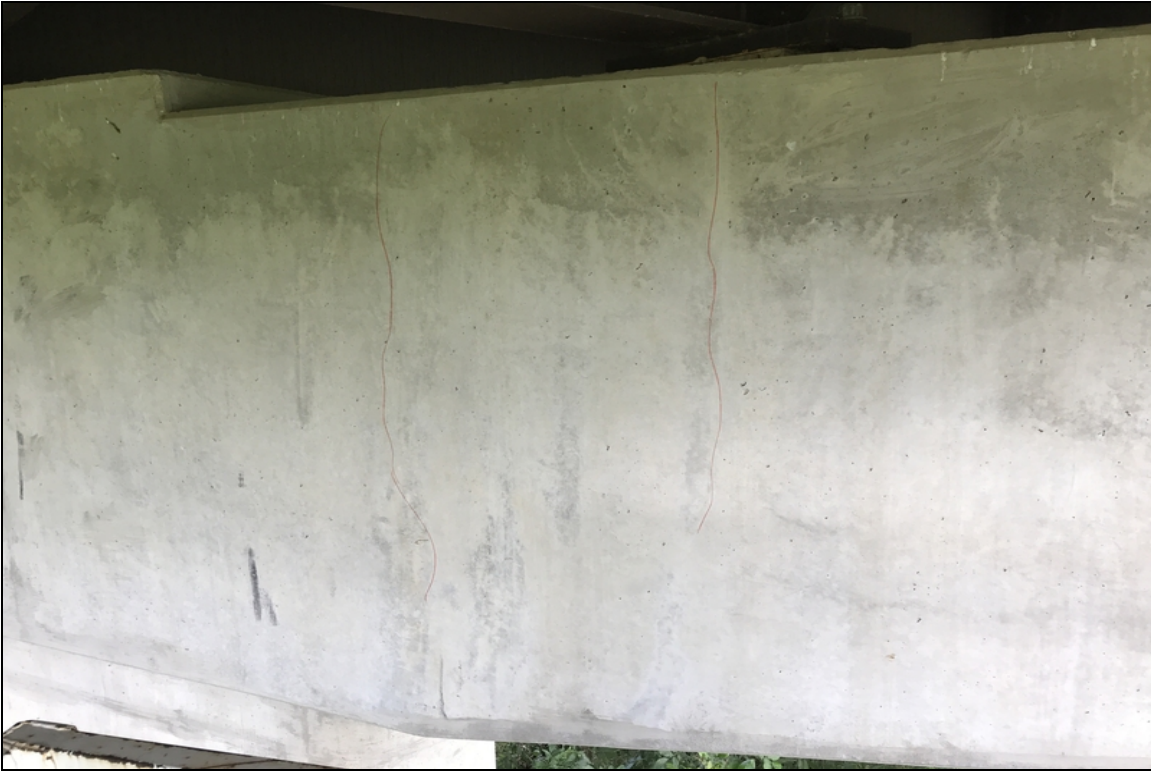
Ben #7 cap ahead side - tall hairline vertical cracking at random locations throughout the cap.

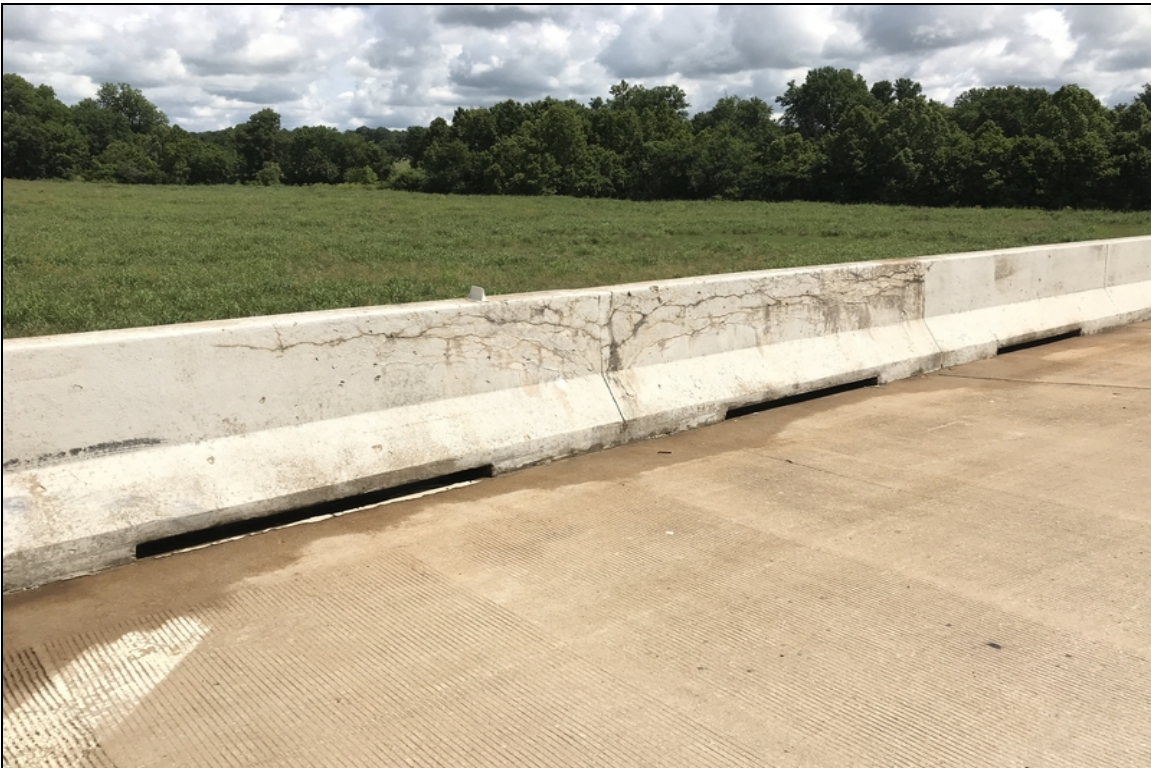
Typical cracking and efflorescence in parapet.

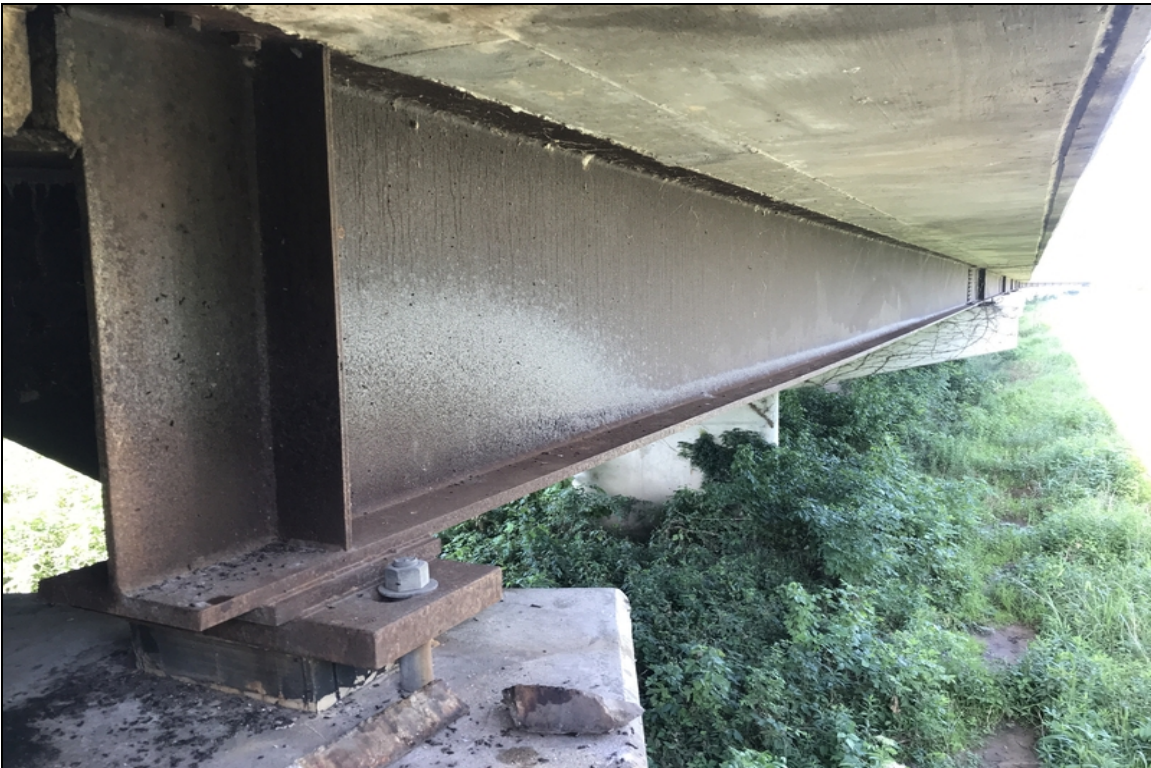
Typical of exterior girders - failing of the patina adjacent to compression joints.
