Bridge #A6478(Routine, Underwater type 2)

US 412, WB Bent CO over ILLINOIS RIVER

Location: 11.6 MI E OF OKLAHOMA LN

Team Lead: Nathan Rowland **Inspection Date:** June 15, 2021

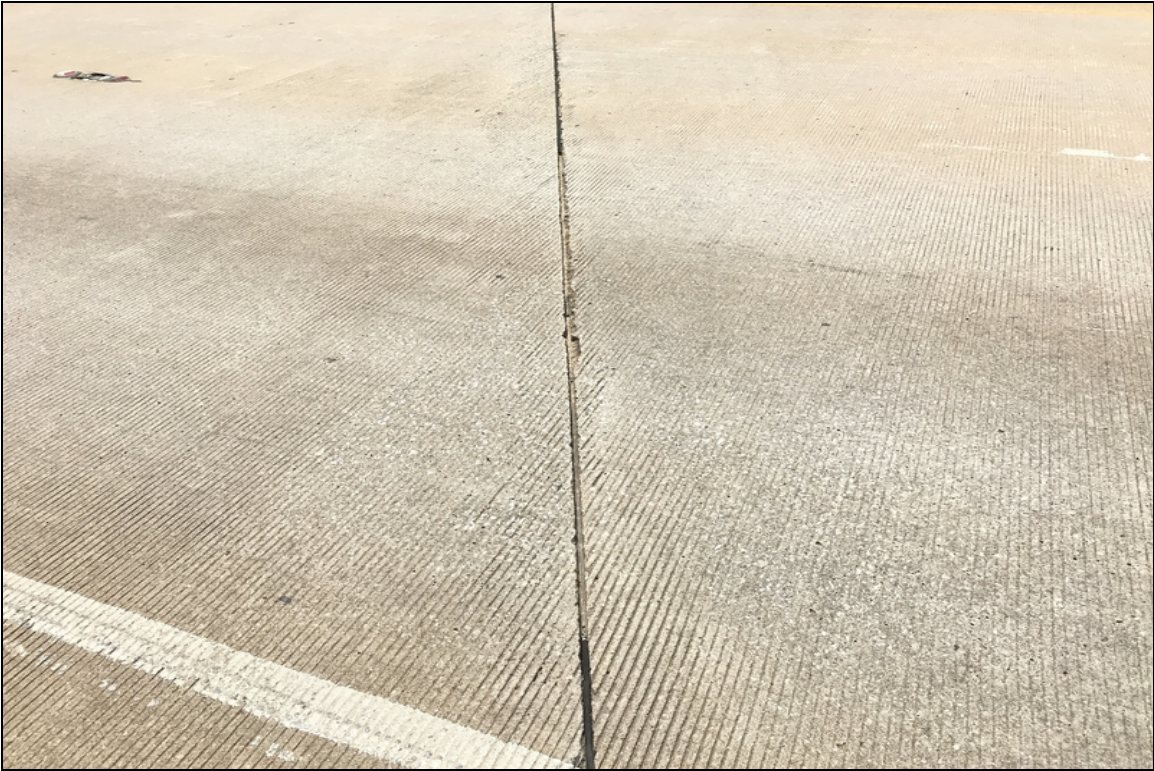
Typical - Joint material for construction joints have bent displaced in random locations.

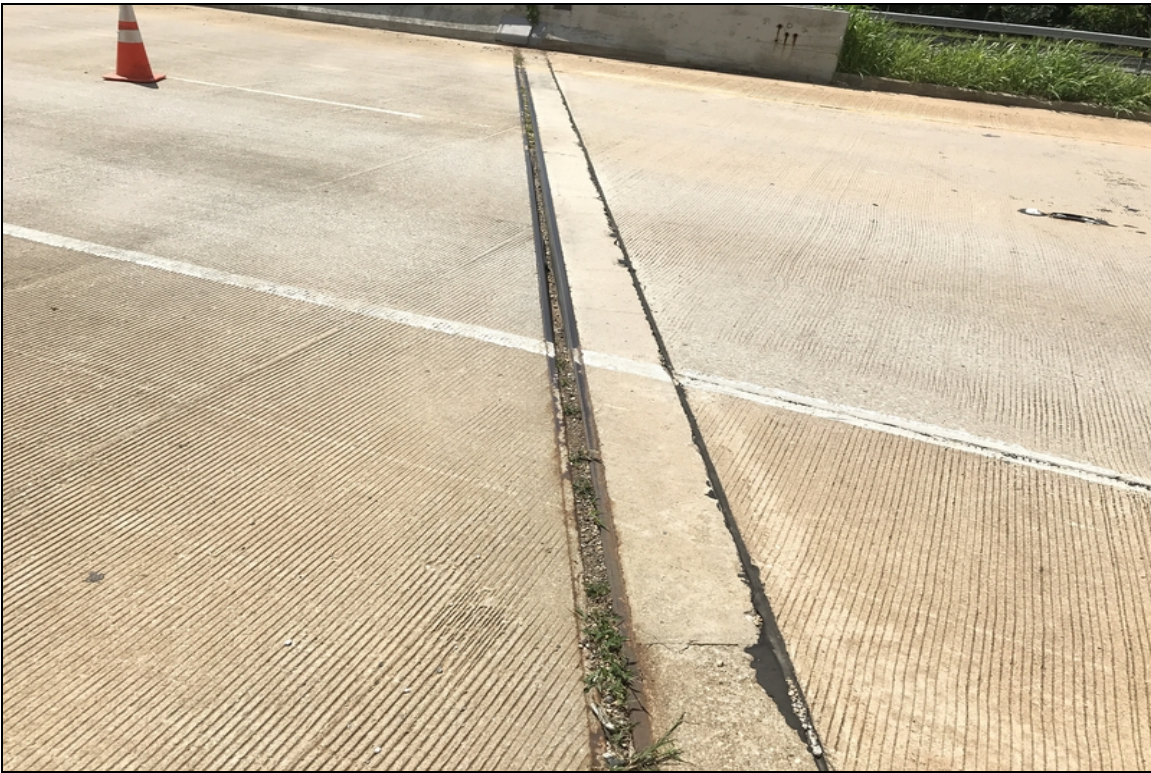
Abutment #1 expansion joint debris impact.

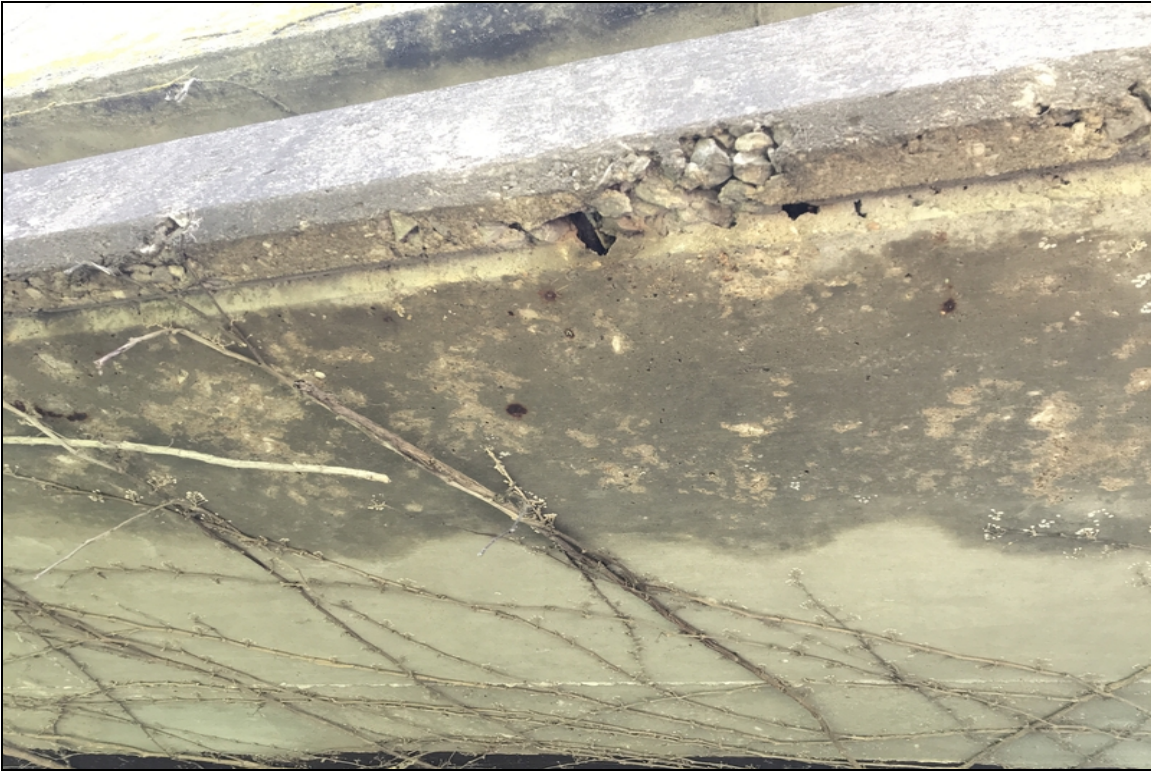
Span #9 left overhang ' ahead of bent #8 honeycombed area with steel exposed.

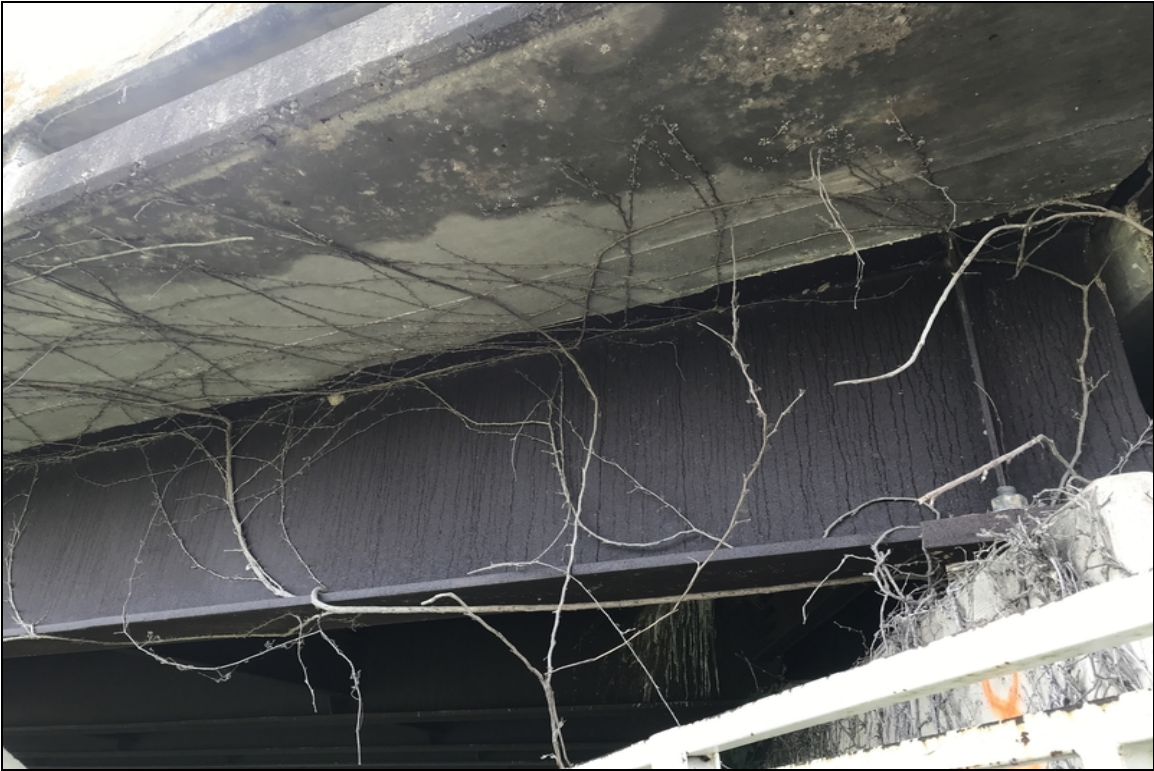
Span #9 left overhang & ahead of bent #8 honeycombed area with steel exposed.

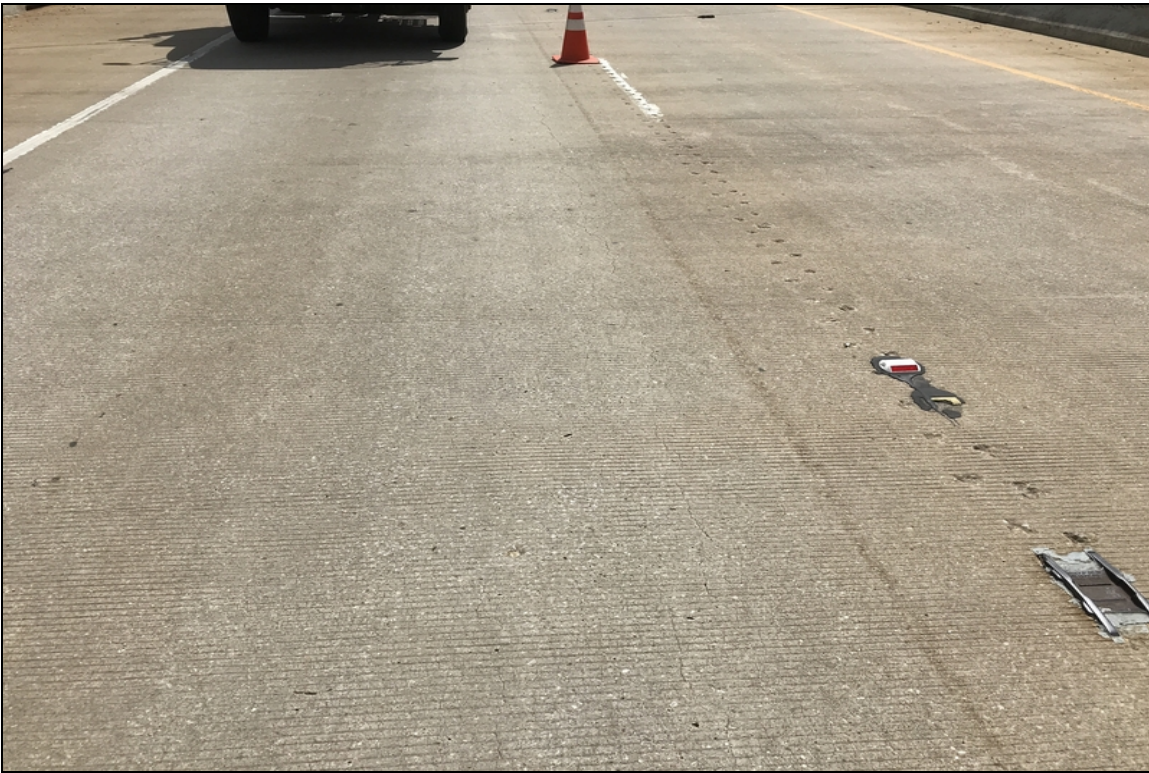
Span #3 typical longitudinal cracking.

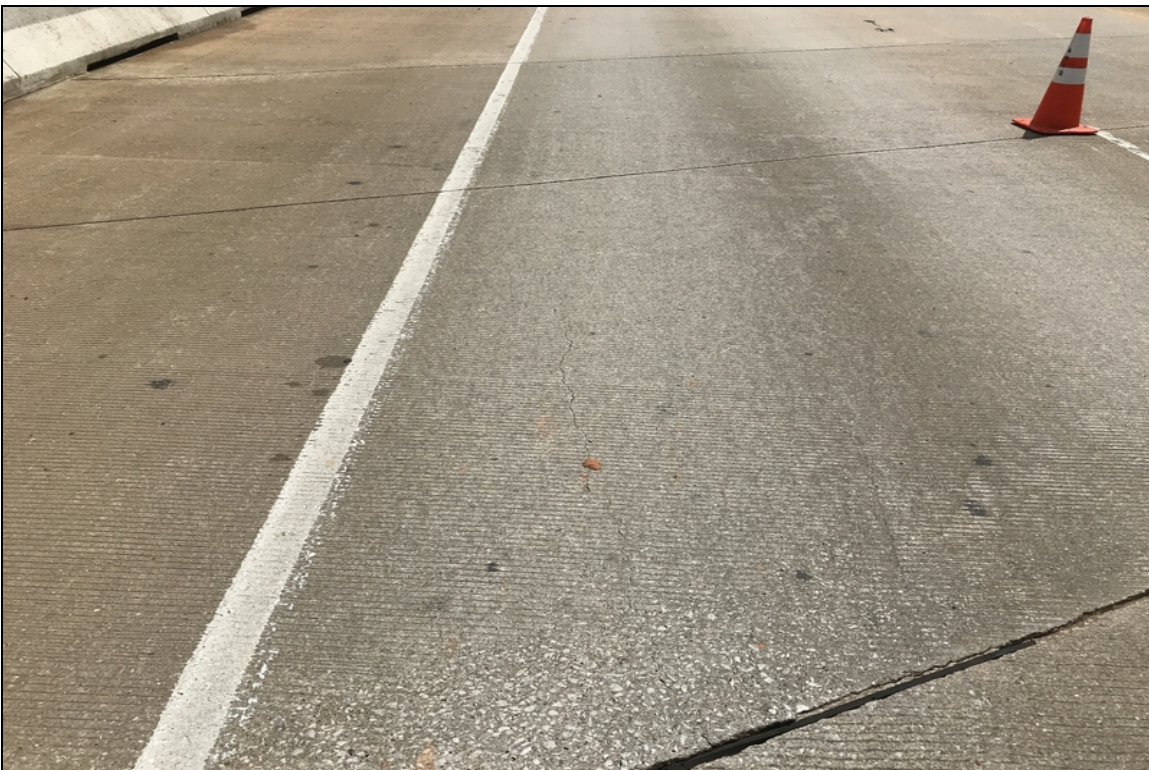
Typical cracking over bents.

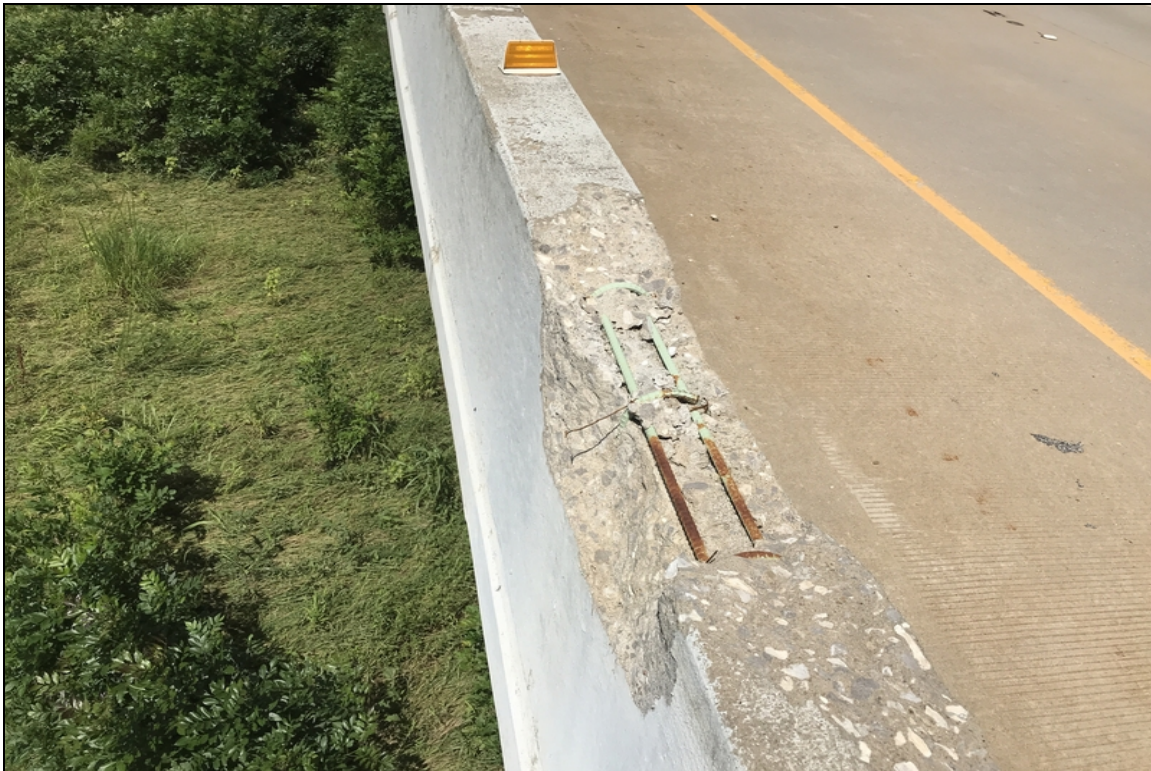
Span #4 right parapet approximately 10' behind bent #4 spalling in parapet.

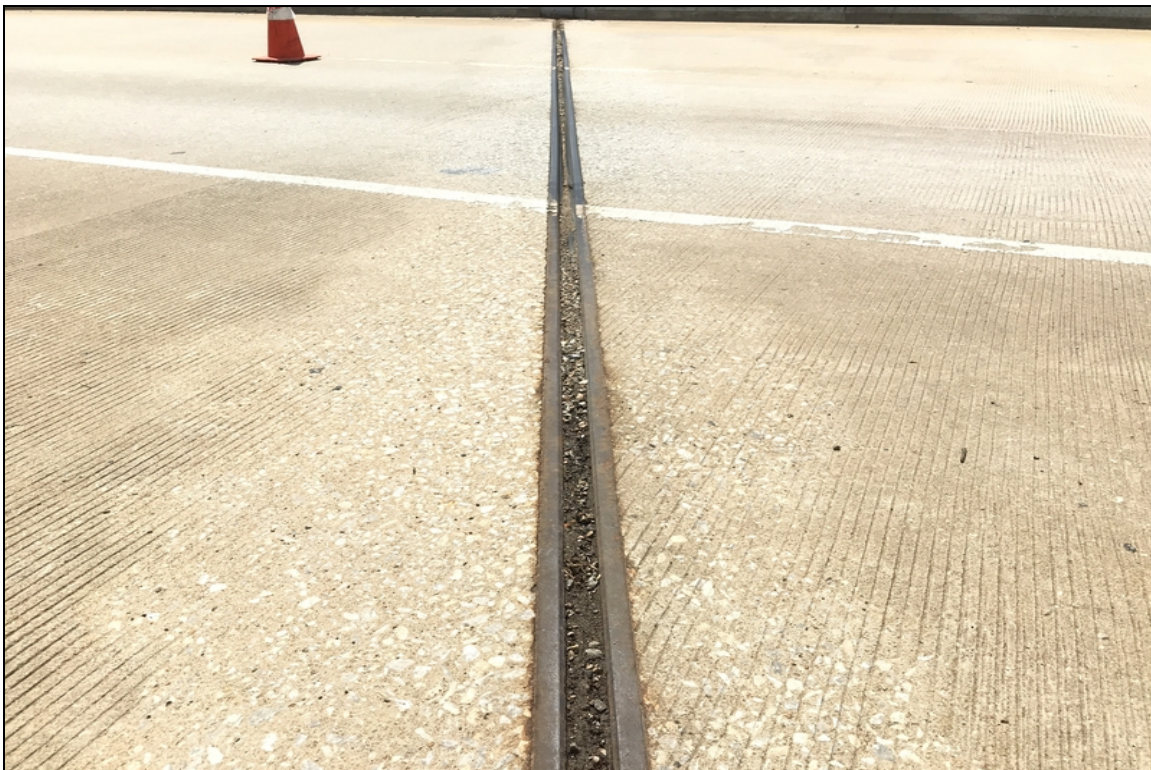
Expansion joint over Bent #16 debris impaction.

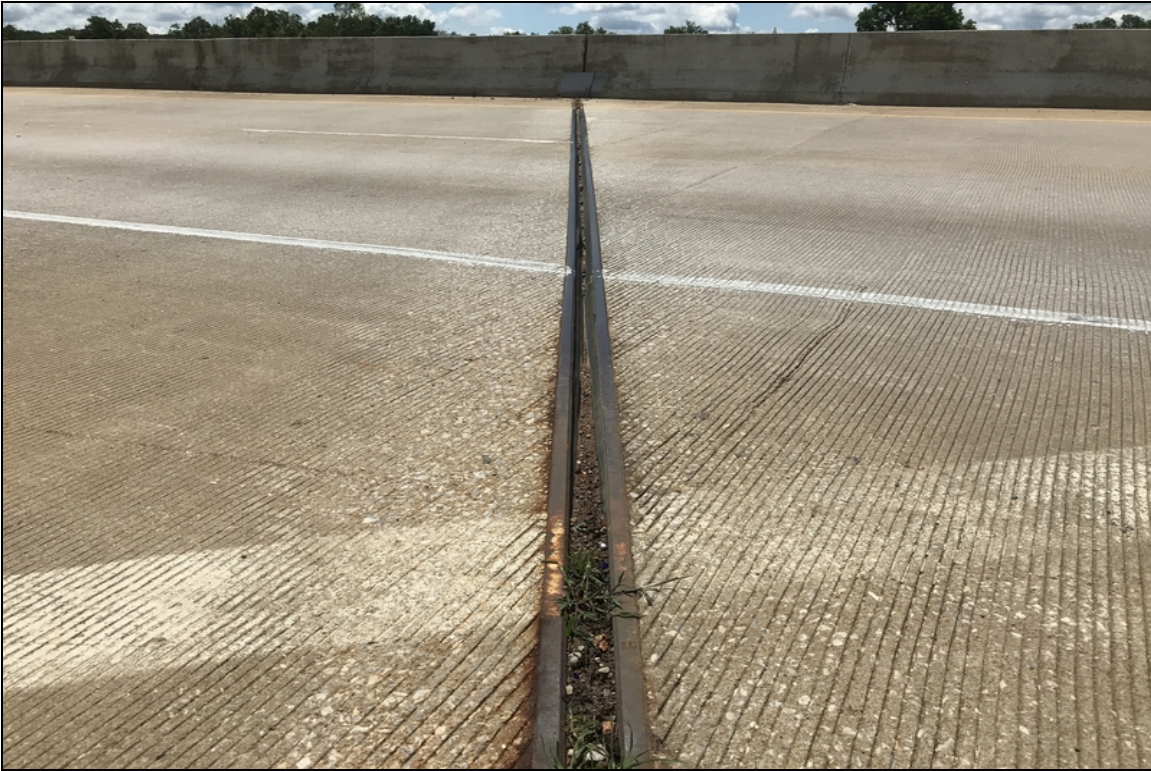
Bent #7 expansion joint minor debris impaction.

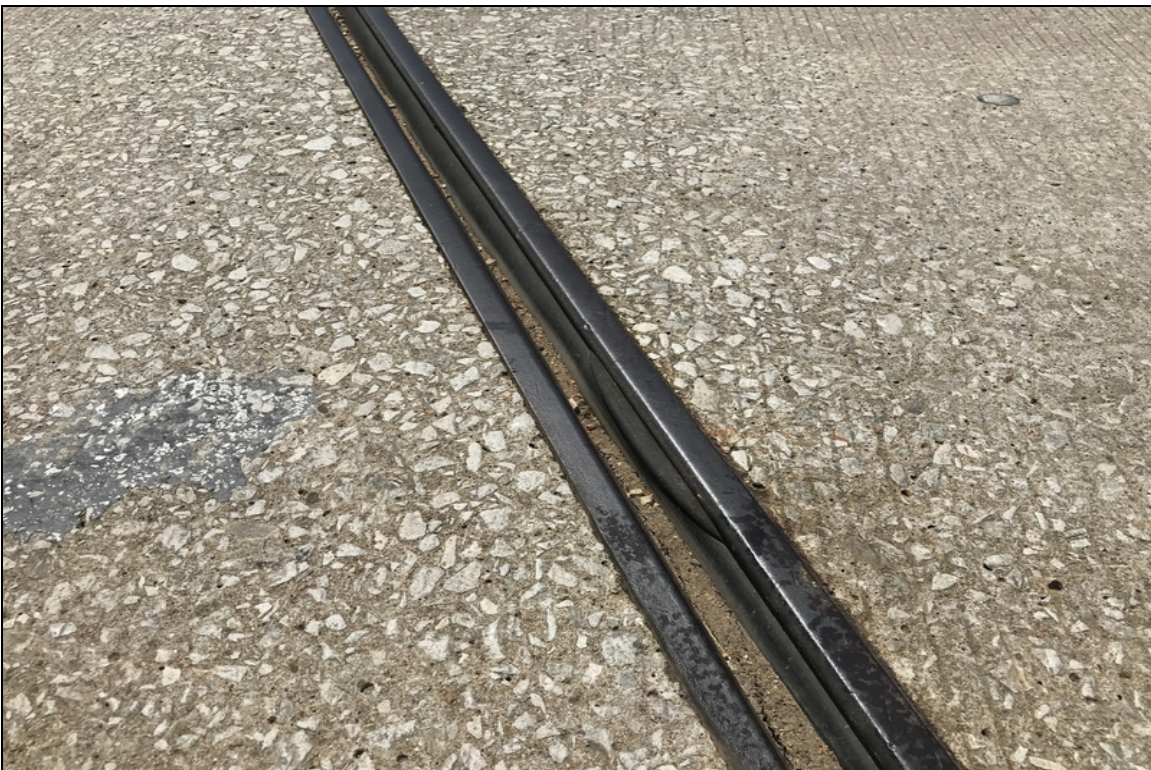
Typical view of expansion joint material coming loose from connection allowing leakage.

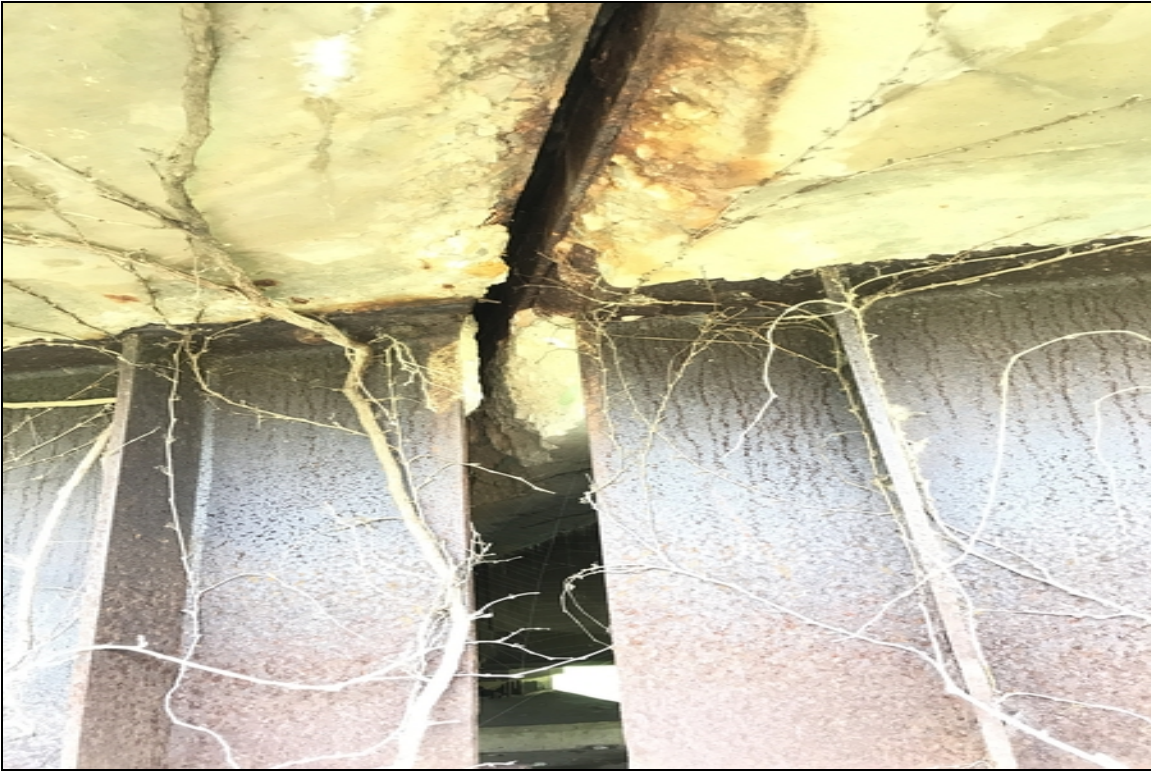
Spalling over bent #12 left epoxy coat steel exposed at the bottoms of haunch area.

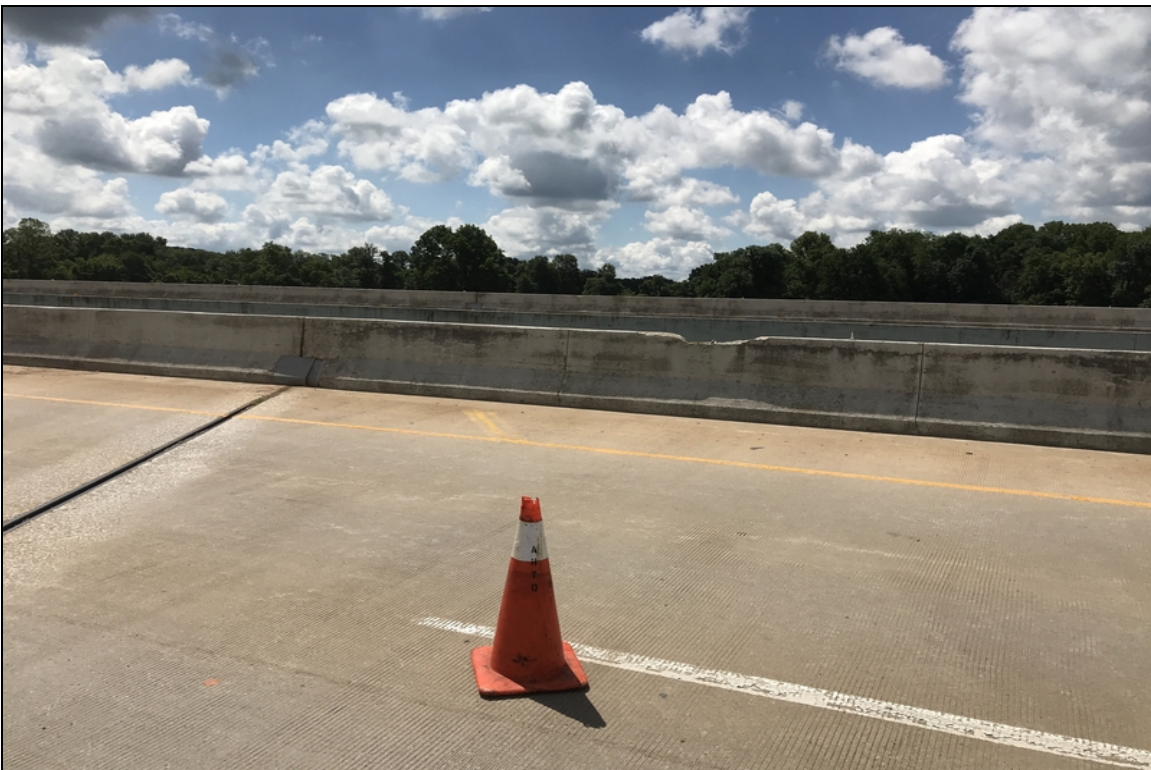
Span #4 right parapet approximately 10' behind bent #4 spalling in parapet.

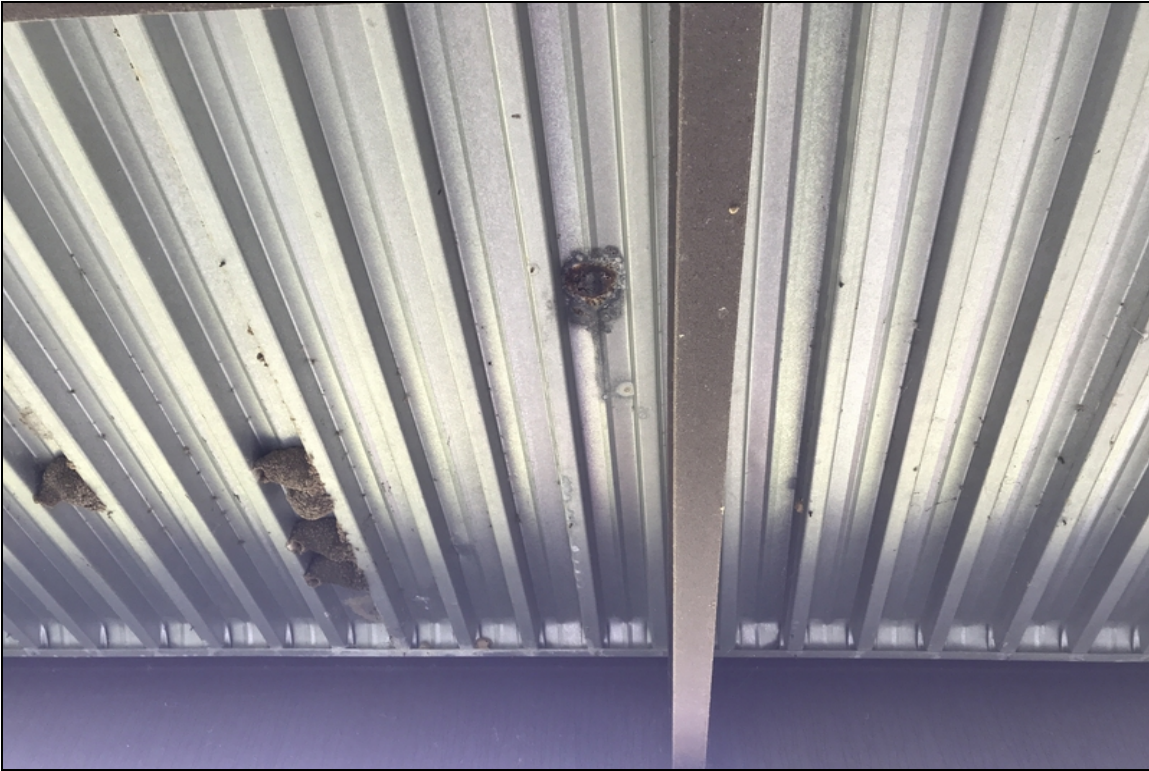
Span #3 bay #1 rusting of SIP forms approximately 8' behind bent #3.

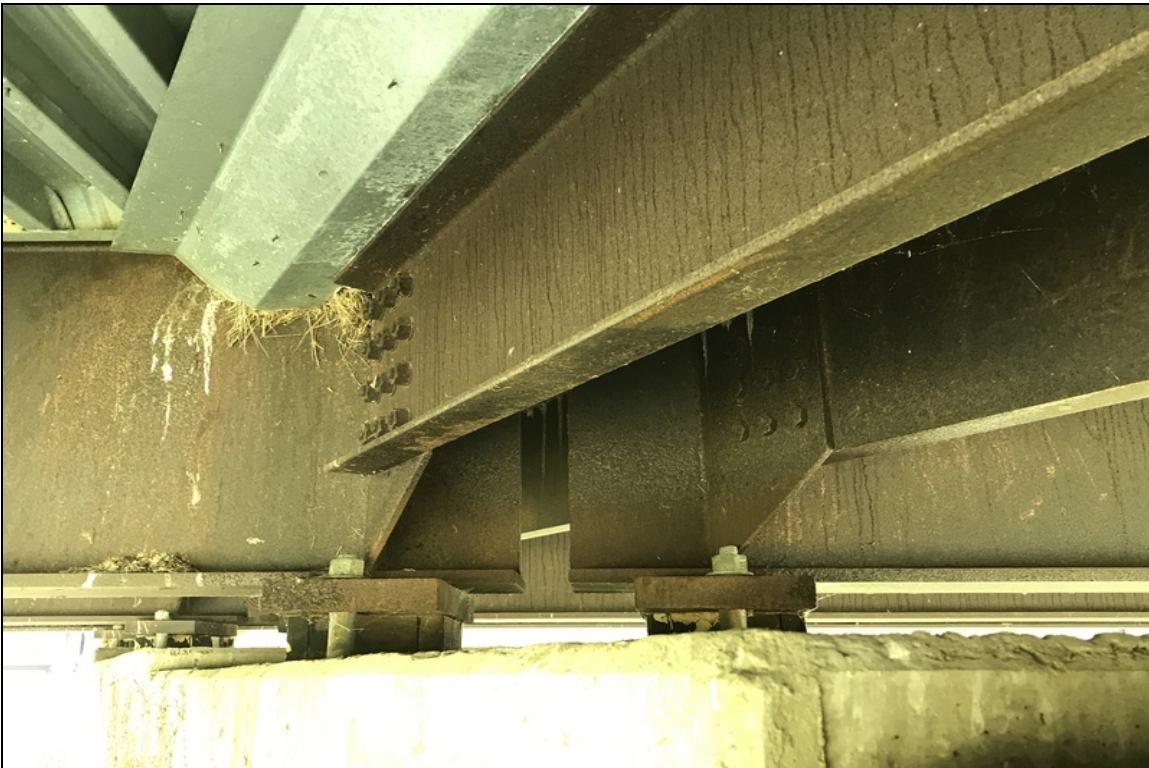
Typical Ends of Girders over bent #12 active corrosion due to leaking expansion joint.

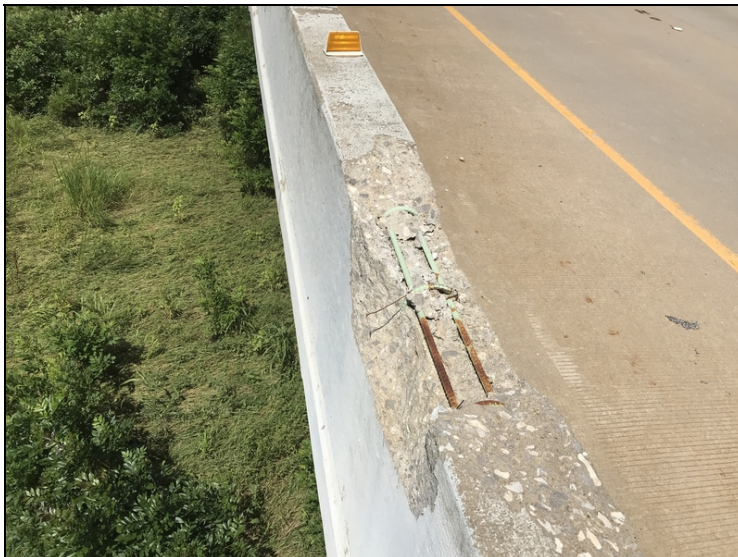
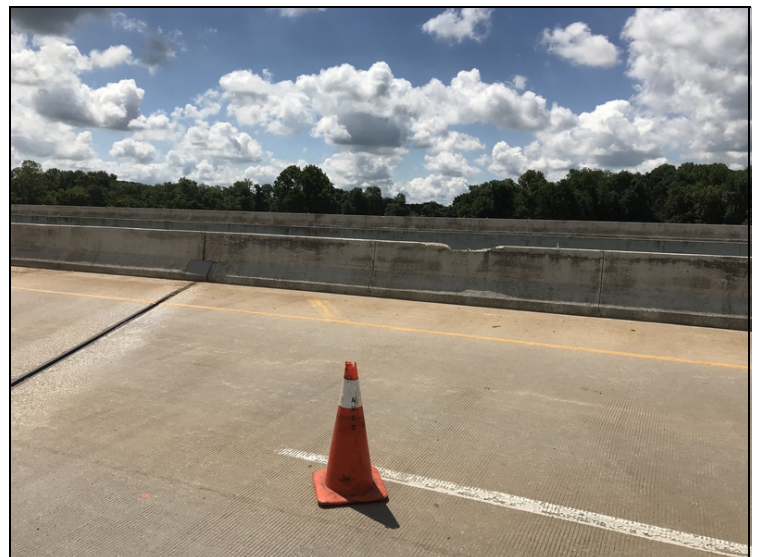
Bridge railing - The bridge railing on the right side span #4 has apparent collision damage that has created an area of spalling with exposed reinforcing steel. The bridge railing has areas of mapcracking that sounds delaminated in areas when sounded.

Span #4 right parapet approximately 10' behind bent #4 spalling in parapet.

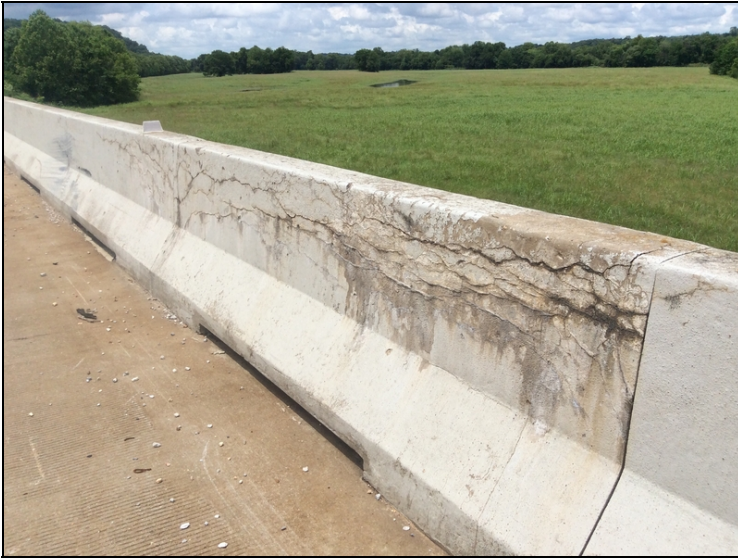
Span #7-Mapcracking in left bridge railing.

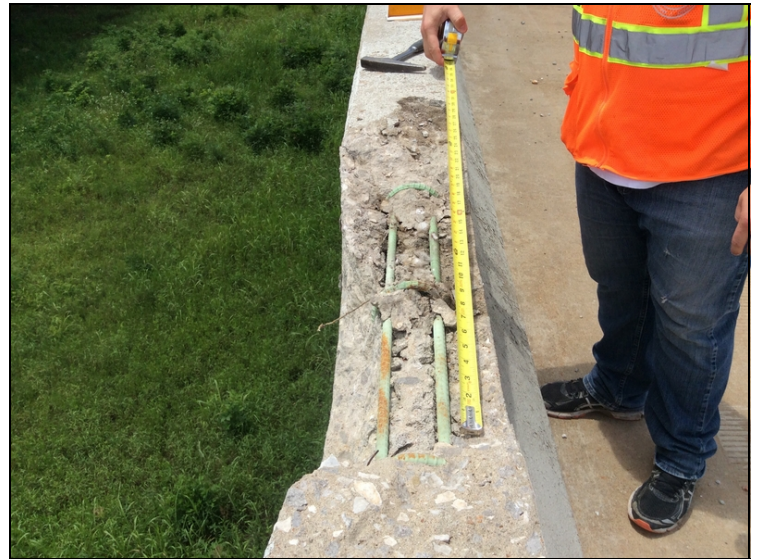
Span #4, right side-Collision damage to railing

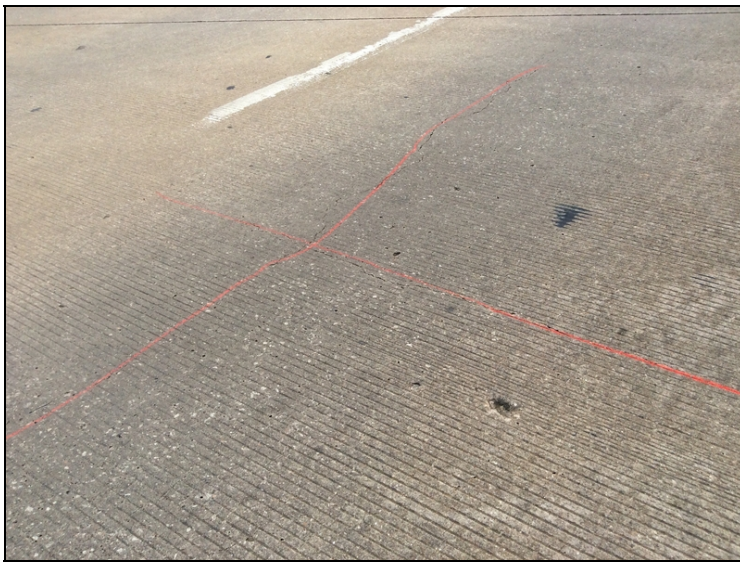
Deck - The deck has sealable cracking in all spans. Span #19 is the most notable area with moderate width longitudinal and transverse cracking in several locations.

Span #19-Transverse and longitudinal cracking in driving surface.

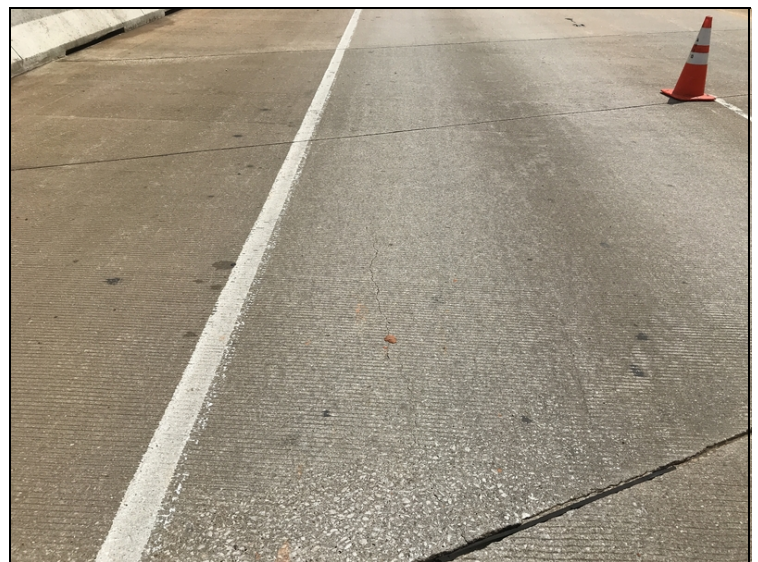
Typical cracking over bents.

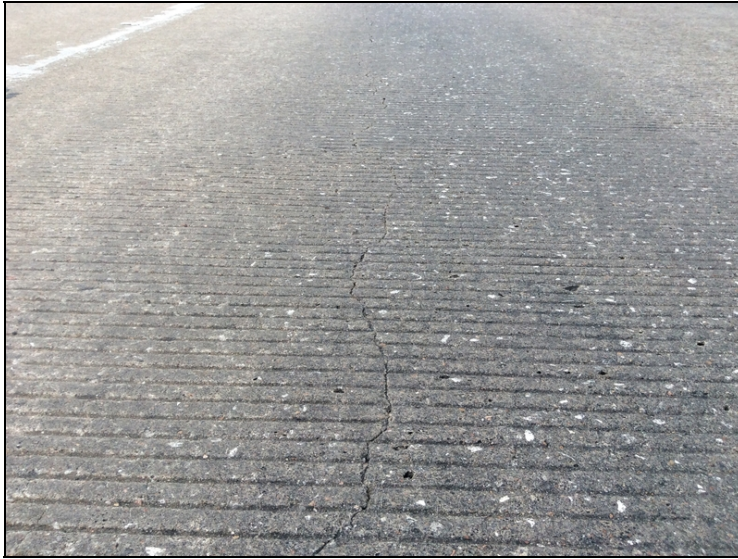
Longitudinal cracking in driving surface.

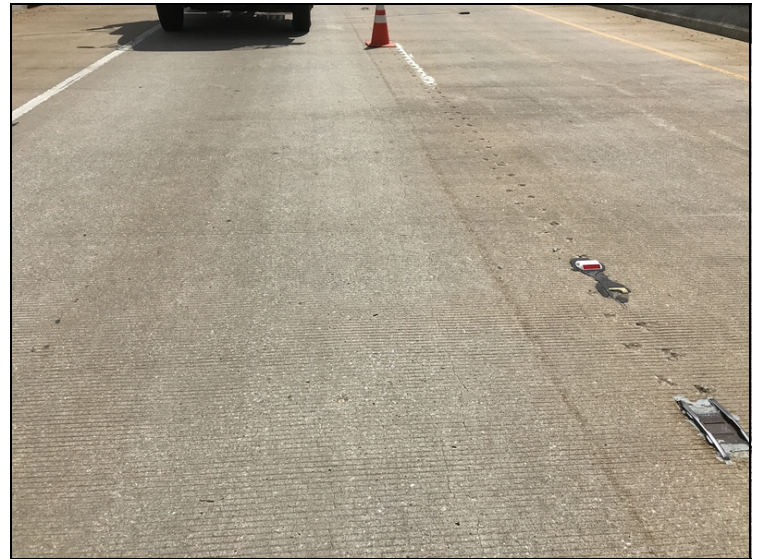
Span #3 typical longitudinal cracking.

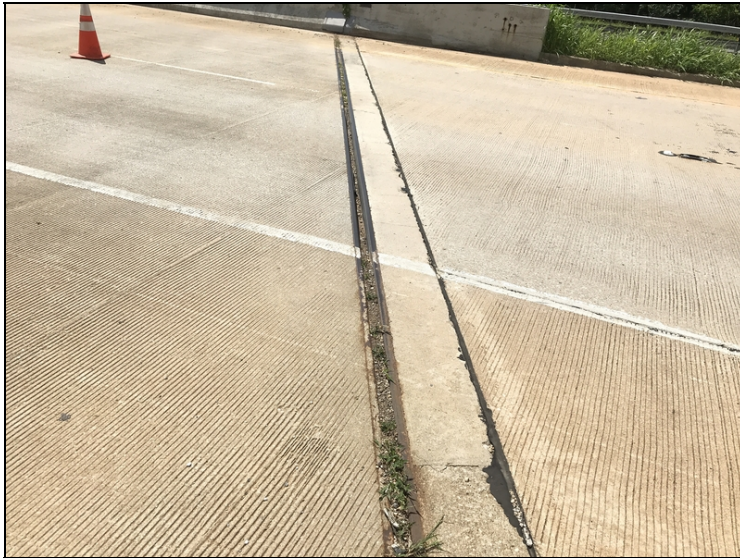
Deck - Strip seal expansion joint seals have heavy debris impactation at all locations. The joint seals appear to have pulled out of the assembly in locations allowing water to leak onto the superstructure promoting corrosion.

Abutment #1 expansion joint debris impactation.

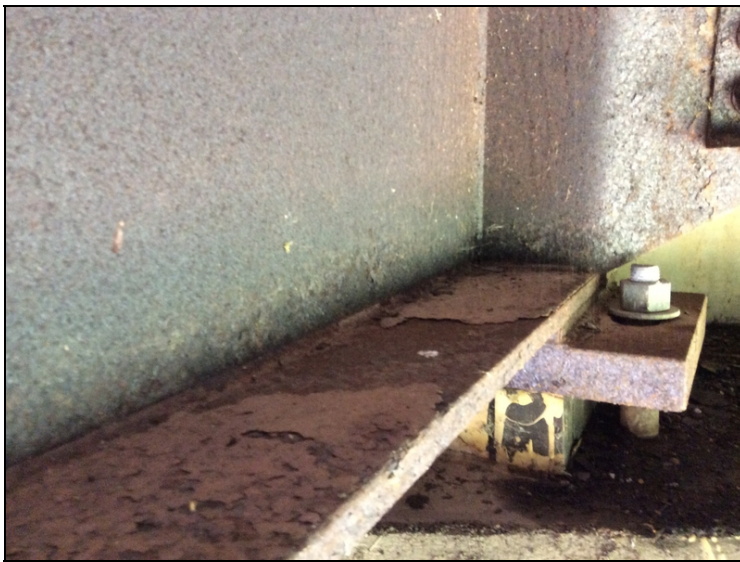
Superstructure - Bearings and ends of girders have abnormal weathering with flaking rust due to leaking expansion joint seals.

Span #17, Girder #2-Corrosion.

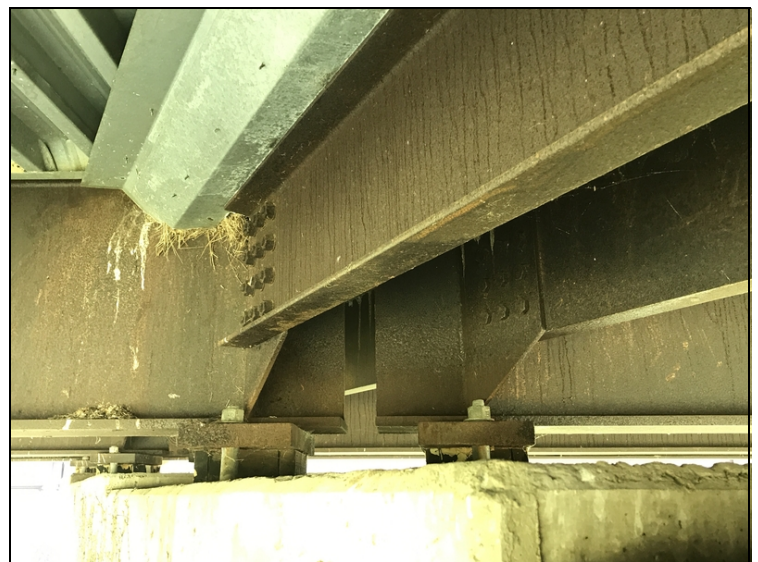
Typical Ends of Girders over bent #12 active corrosion due to leaking expansion joint.

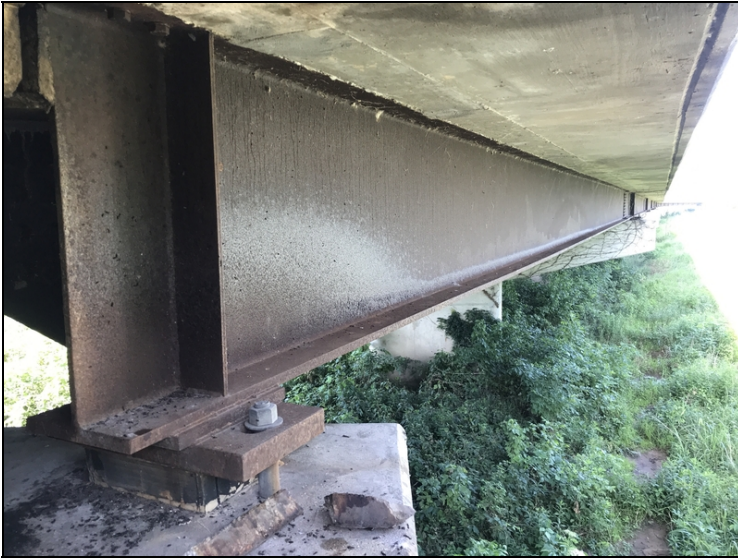
Typical of exterior girders - failing of the patina adjacent to compression joints.

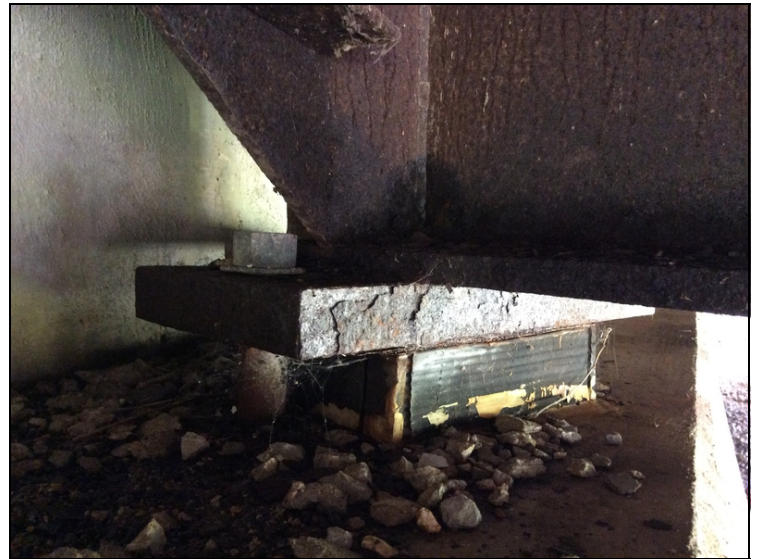
Bearing corrosion.

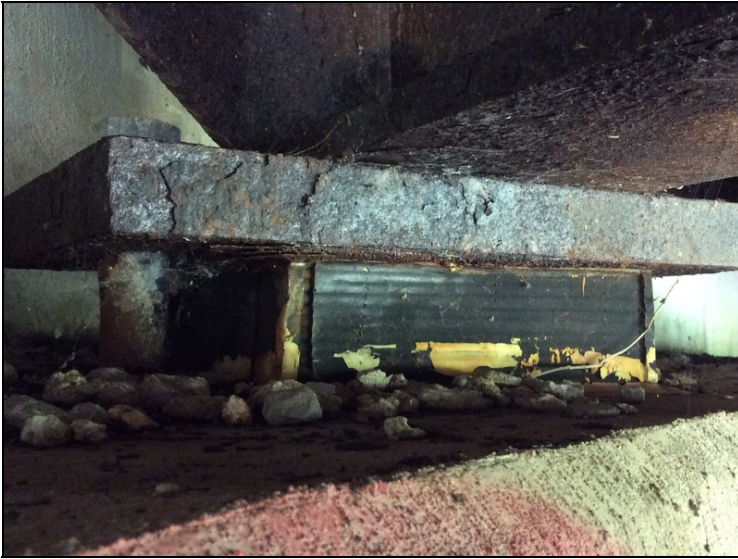
Abutment #1, bearing #3-Corrosion with flaking rust.

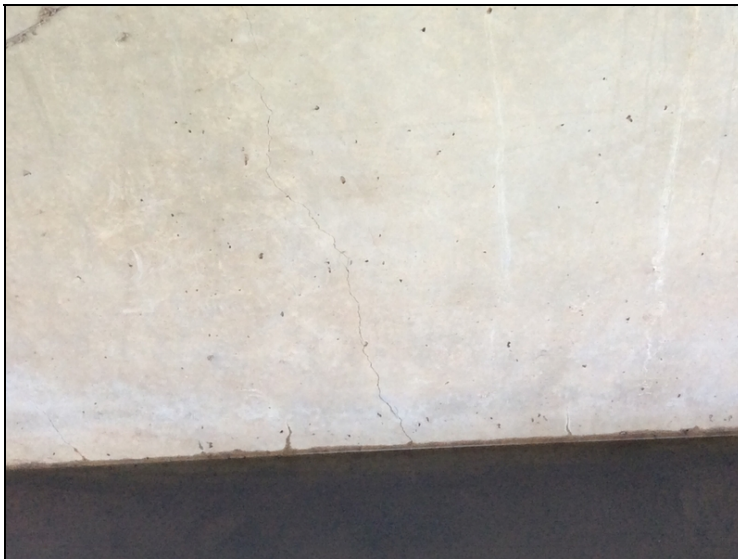
Substructure - Pier columns in several locations have vertical and diagonal cracks that propagate from the bases of columns to the first construction joint.

Bent #9-Vertical cracking.

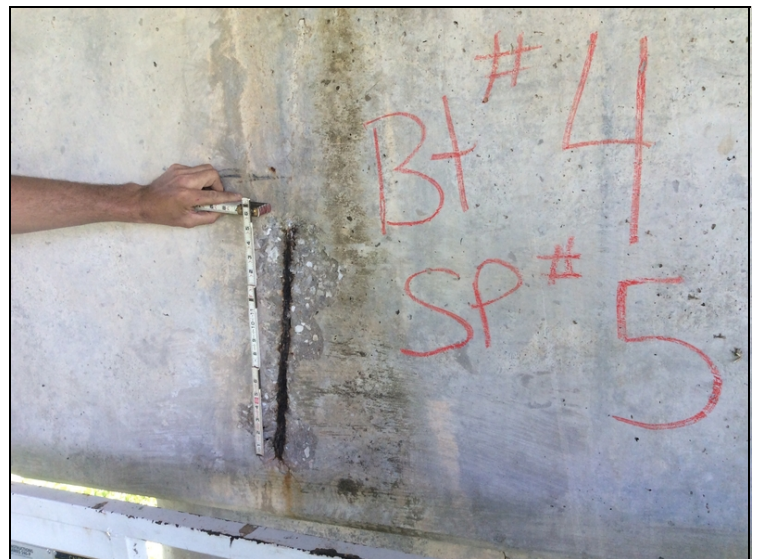
Pier #4 cap in span #5 has a vertical shallow spall with exposed reinforcing steel approximately 18" long. The exposed reinforcing steel has measurable section loss.

Bent #4 cap-shallow spalling with exposed reinforcing steel.

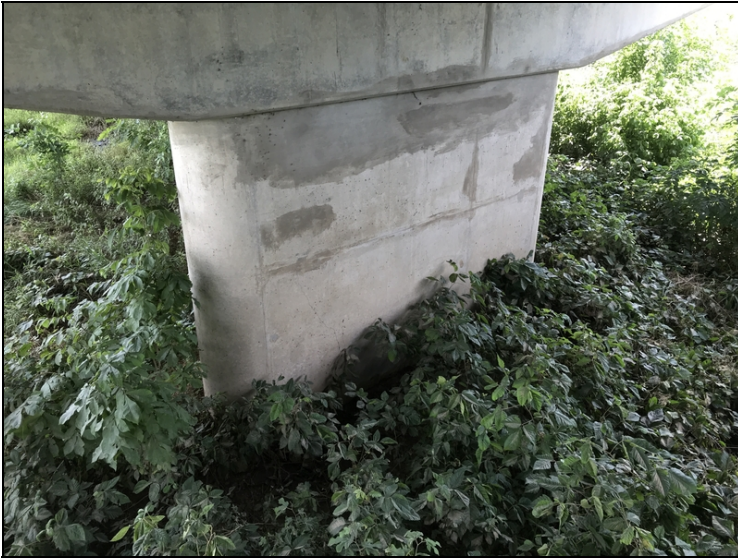
Bent #5 behind side of pier has diagonal cracking.

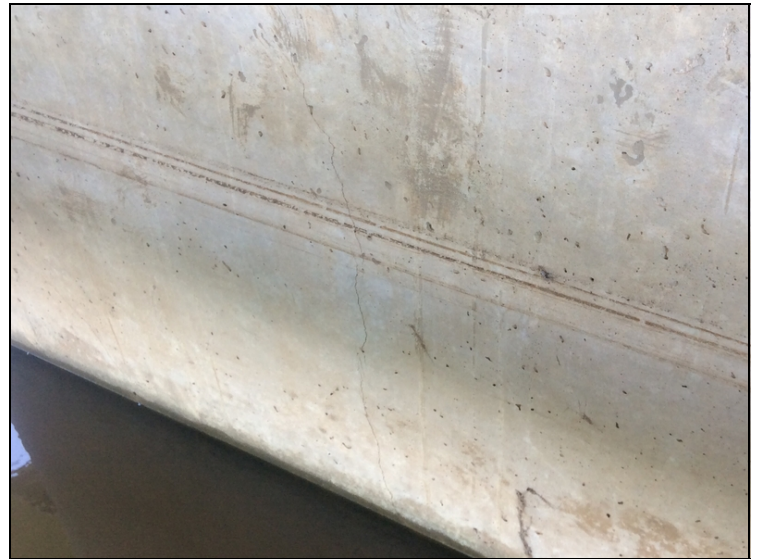
Bent #6-Vertical and diagonal cracking in column.
