Bridge #B6478(Routine, Underwater type 2)

Benton US 412 over ILLINOIS RIVER

Location: 11.64 MI E OF OKLAHOMA LN

Team Lead: Nathan Rowland **Inspection Date:** June 16, 2021

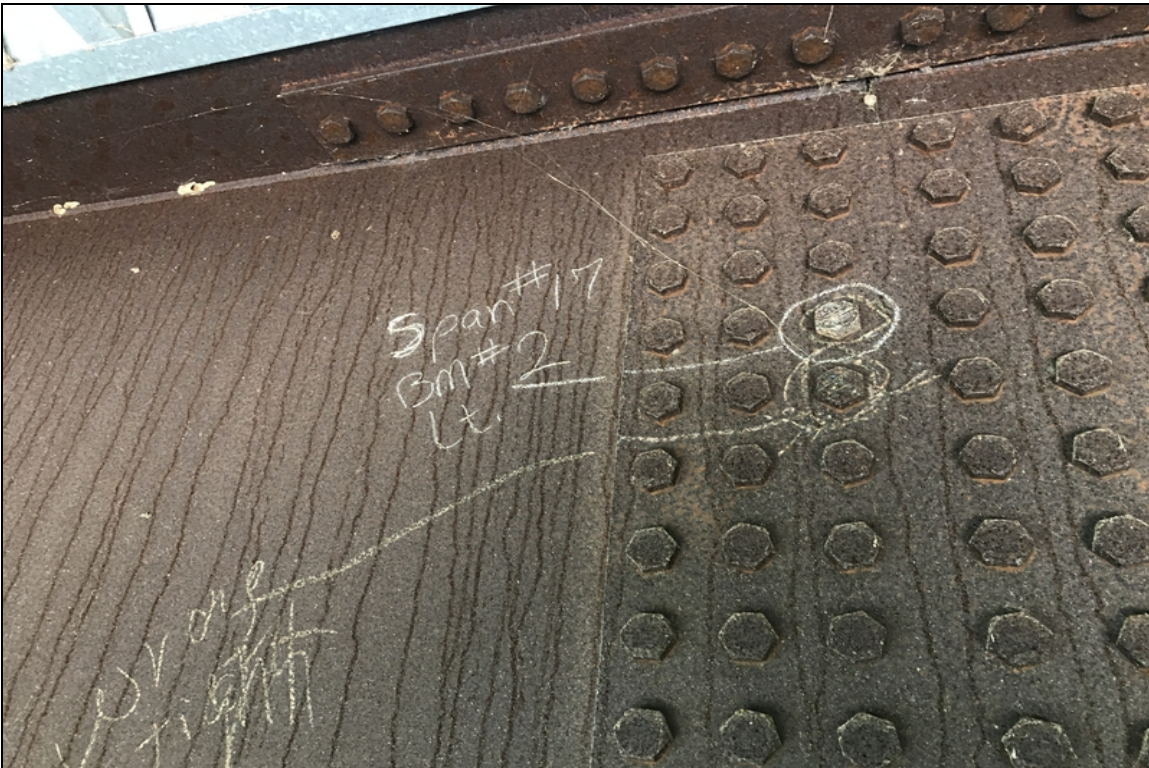
Splice bolts are still loose.

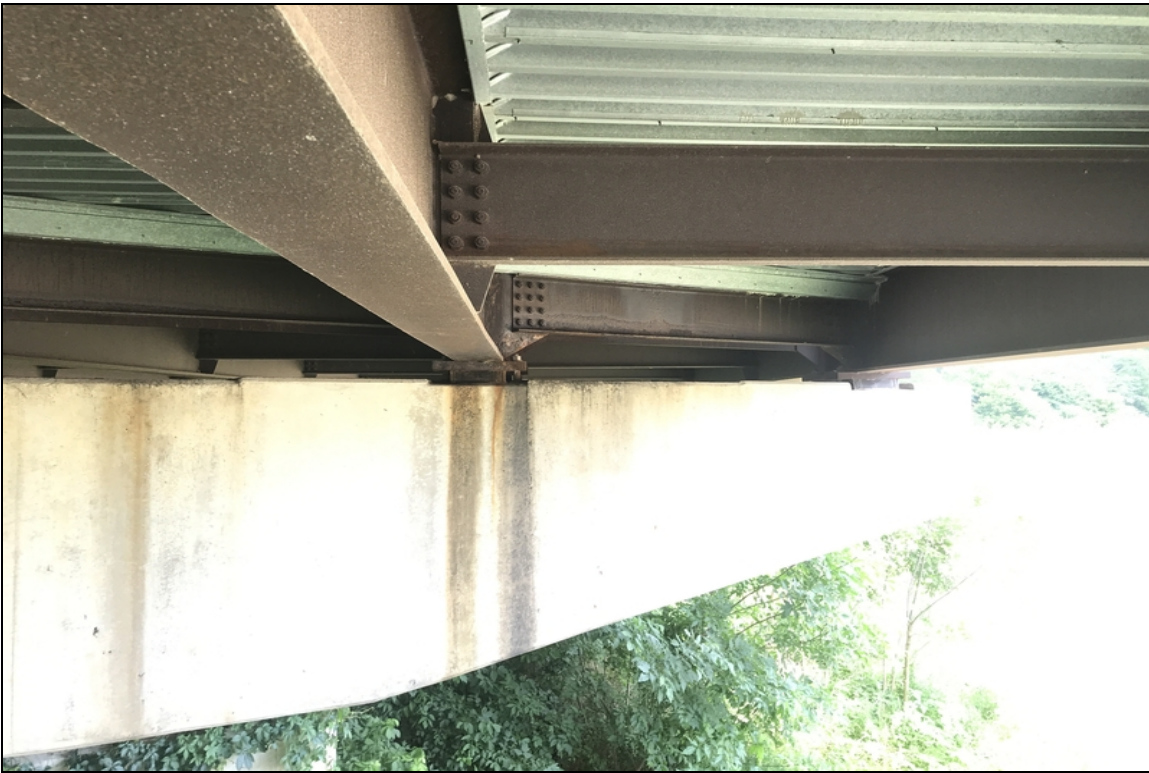
Bent #12 bearings #4 & #5 have been recessed into concrete cap due to an elevation bust.

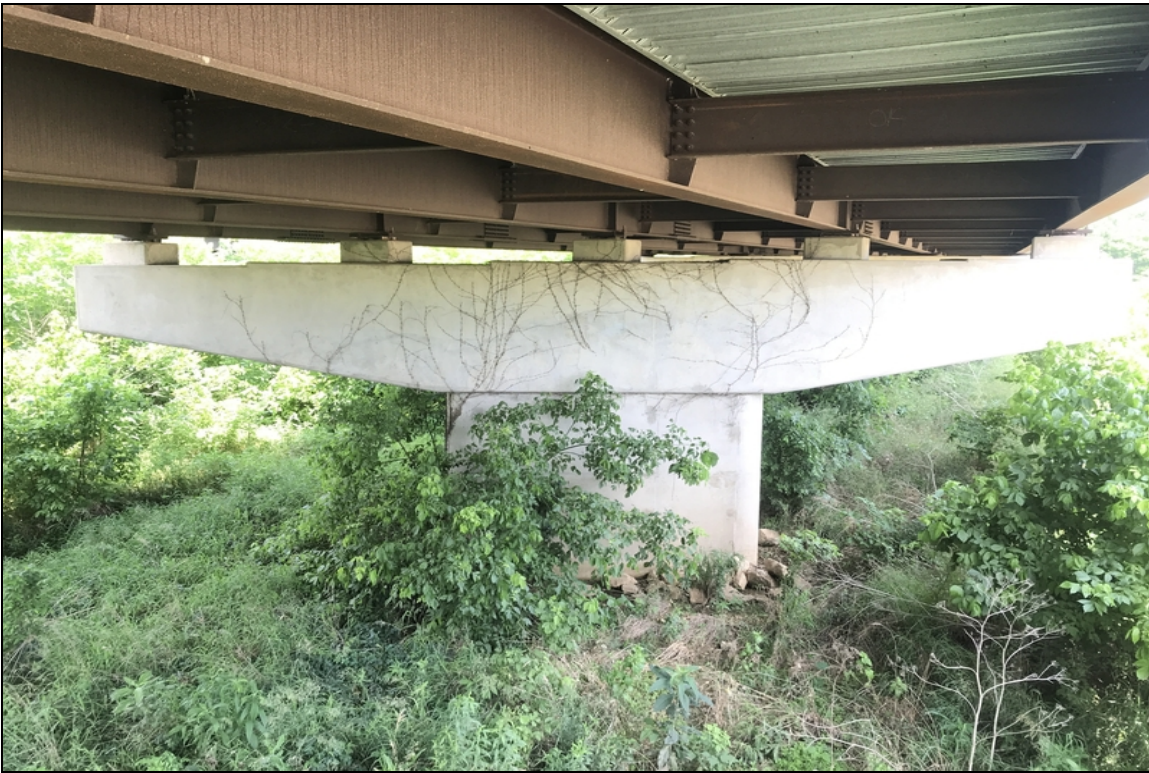
(234)							
06/18/2019 - WNR & DBM: -Bent caps have short duration hairline vertical cracking at the step downs and other random locations. -Bent #3 cap has areas of hairline mapcracking on both sides of cap. -Bent #8, Right end has a hairline horizontal crack. -bent cap #10 has concrete risers due to an elevation bust during construction. -The top of Bent cap #16 has an area of heavy scaling on the right side approximately 8' long where the compression joint seal leaks on the cap.							
300	Strip Seal Expansion Joint	LF	276	152	124	0	0
2310	Leakage	LF	23	0	23	0	0
2350	Debris Impaction	LF	101	0	101	0	0

Bent #10 has concrete riser due to elevation bust.

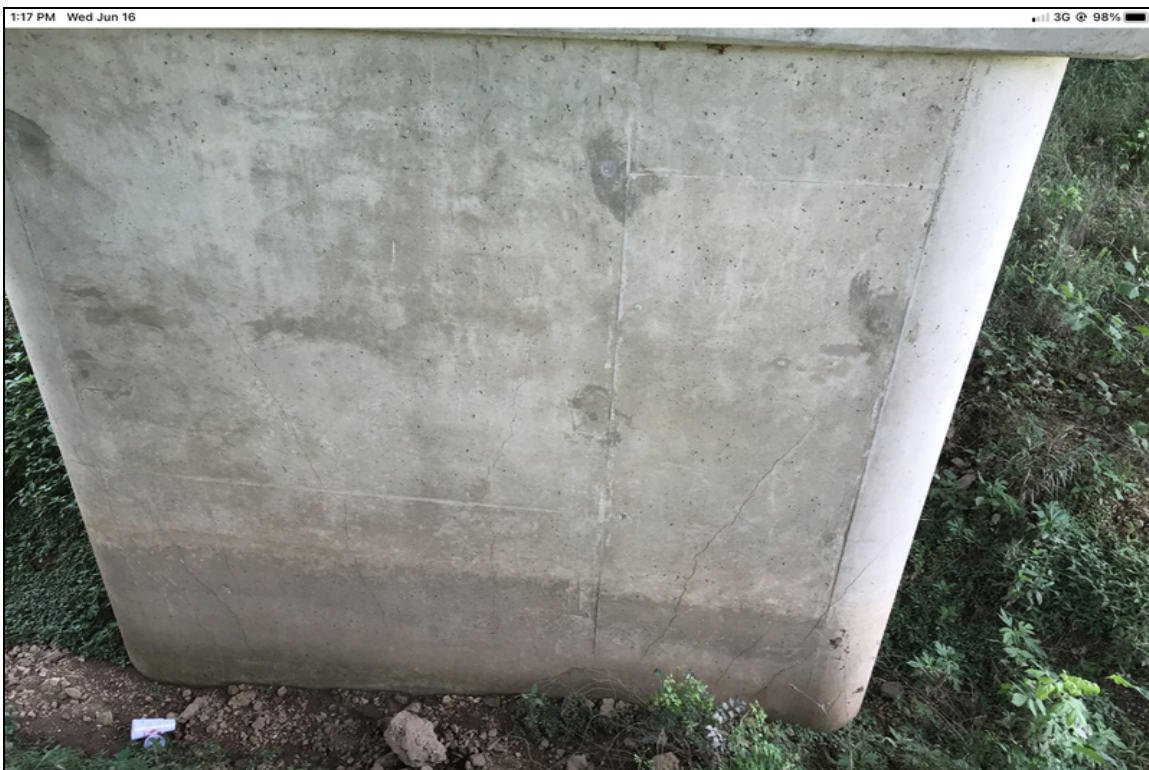
205	Reinforced Concrete Column	EA	18	16	1	1	0
1130	Cracking (RC and Other)	EA	2	0	1	1	0
(205)							
06/16/2021 WNR & DBM:							
-The channel has an area of localized scour at the base of bent #1 that has created a scour hole that is approximately 5' deep, 10' wide and 30' long. The footing is not exposed at this inspection.							
-Bent #1 column has numerous diagonal cracks that range in width from hairline up to 0.060". The cracks are visible on both side of

Bent #1 still has cracks present in the pier wall.

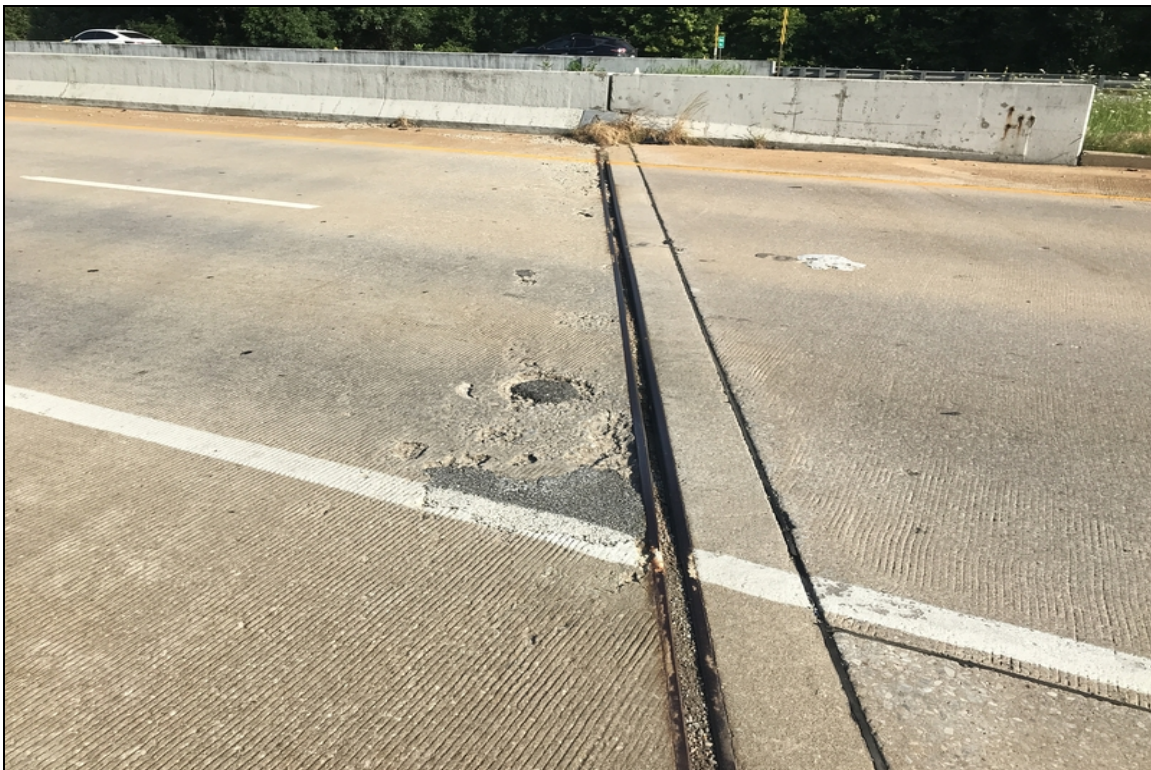
(12)							
06/16/2021 WNR & DBM:							
- The driving surface of the deck has full length longitudinal cracks in the left and right wheel paths of the outside lane.							
-Span #19 has areas of spalling in the Right wheel path adjacent to abutment #2.							
-The left lane of span #19 at abutment #2 has areas of heavy abrasion that is beginning to spall.							
-The wheel paths have light abrasion in the wheel paths of both lanes.							
Undersurface:							
-Span #14, right overhang has an area of mapcracking with efflorescence approximately 5' long.							
-SIP forms in span #2, bays #3 and #4 have corrosion.							
-SIP forms in span #3, bays #3 and #4 have corrosion.							
-SIP forms in span #5, bay #2 has corrosion.							
-SIP forms in span #16, bays #3 and #4 have corrosion.							
-SIP forms in span #18, bay #4 have corrosion at splice plate connection #1.							
107	Steel Open Girder/Beam	LF	6702	6685	8	9	0

View of spalling in deck adjacent abutment #2

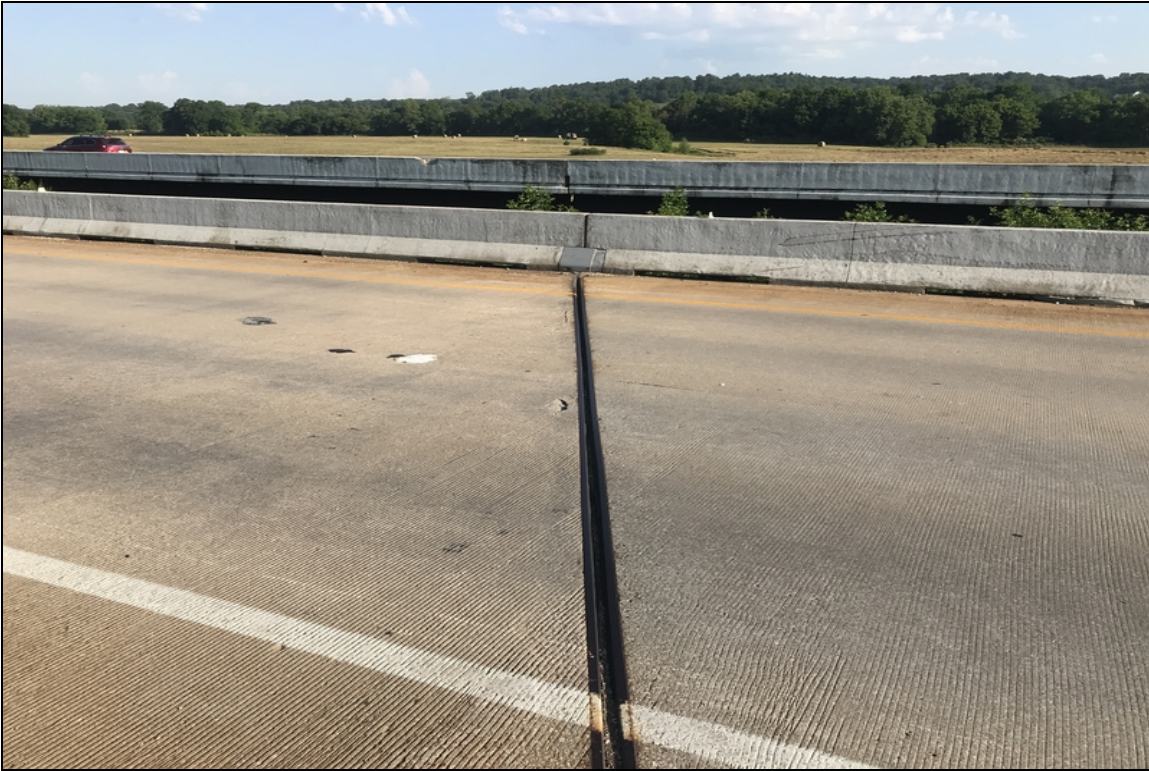
Spalling behind expansion joint at bent #4.

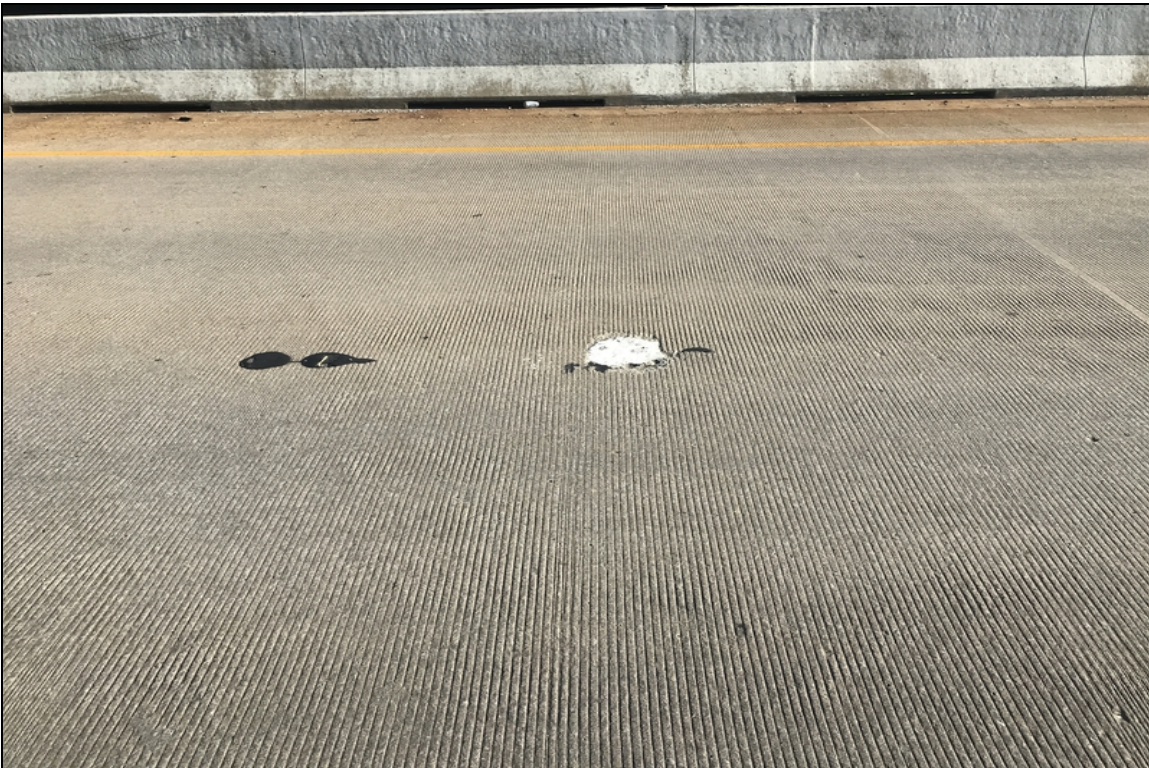
Maintenance forces have patched steel pavement markers.

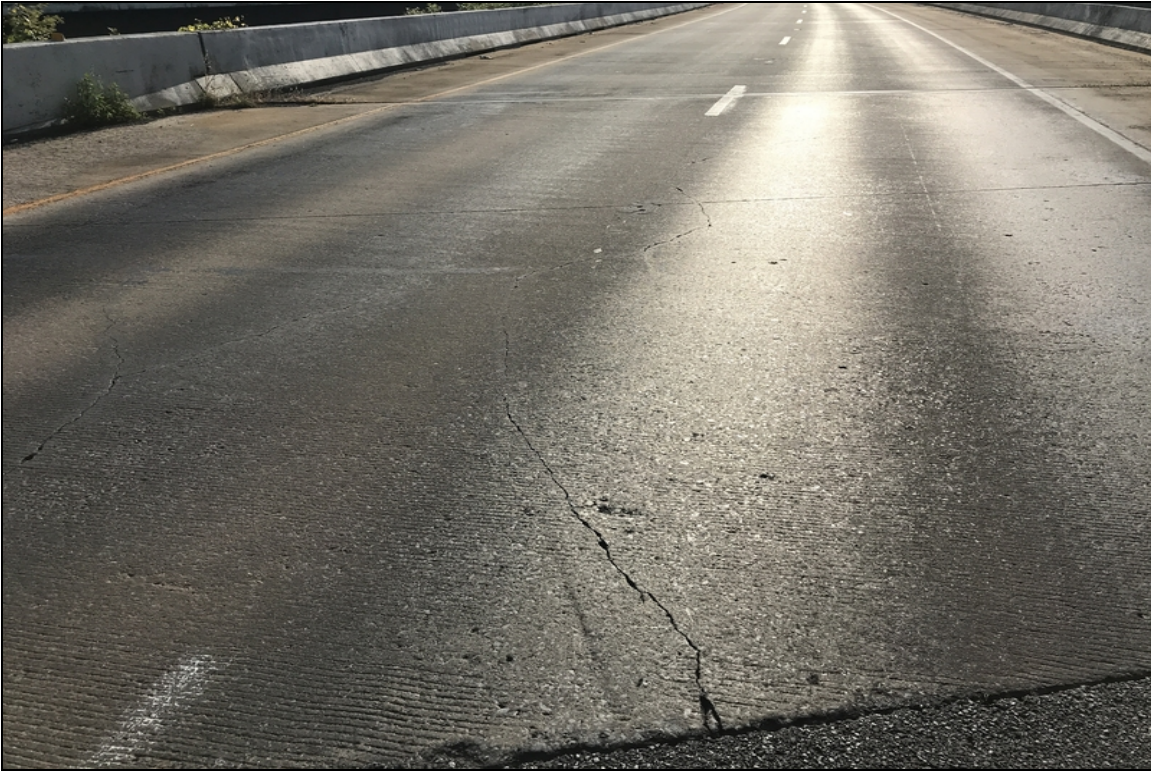
ELEM	DESCRIPTION	UNITS	TOTAL	CS1	CS2	CS3	CS4
06/16/2021 WNR & DBM: -The West approach slab has wide diagonal cracking and light abrasion in the wheel paths. -The approach gutters of the West approach have medium scaling. -The East approach slab has longitudinal and transverse cracking with light abrasion in the wheel paths.							
331	Reinforced Concrete Bridge Railing	LF	2688	2098	496	60	34
1080	Delamination/Spall/Patched Area	LF	22	0	18	4	0
1090	Exposed Rebar	LF	112	0	100	12	0
1130	Cracking (RC and Other)	LF	456	0	378	44	34
(331)							
06/16/2021 WNR & DBM: Right parapet in span #6 has a 2' long spall with exposed reinforcing steel. Right side parapet in span #7 has areas of horizontal cracking. -Right side parapet wall in span #8 has a 12' long piece of exposed reinforcing steel. -Map cracking with delaminated areas exists at several locations.

Cracking in west approach slab

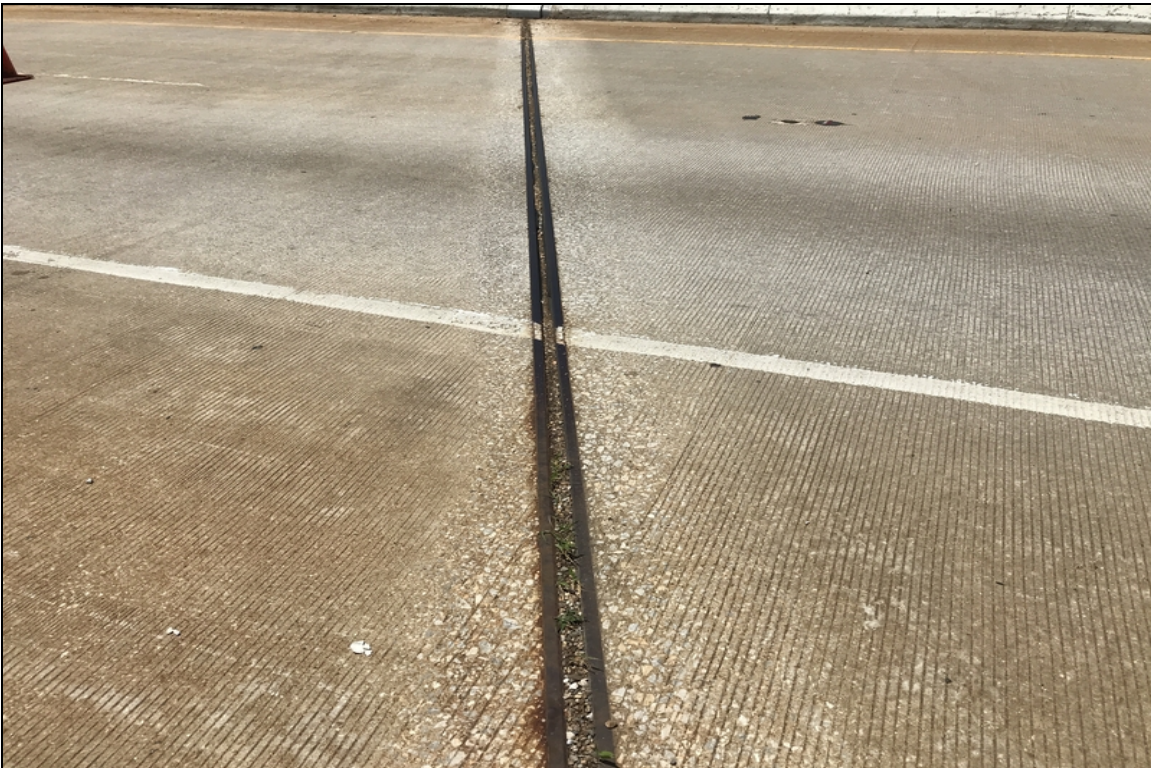
(300)							
06/16/2021 WNR & DBM: -Strip seal expansion joints have heavy debris impaction in joints across the left and right shoulders and moderate impaction across portions of the driving lanes. The strip seal appears to have pulled out of the assembly in locations. -Compression joint seals at main span and expansion joint areas are beginning to lose adhesion but do not appear to be leaking. -Joint seal material at sawn joint locations is missing and/or leaking at most areas.							
310	Elastomeric Bearing	EA	120	119	1	0	0
1000	Corrosion	EA	1	0	1	0	0
515	Steel Protective Coating	SF	240	240	0	0	0

View of expansion joint at bent #16 debris impaction

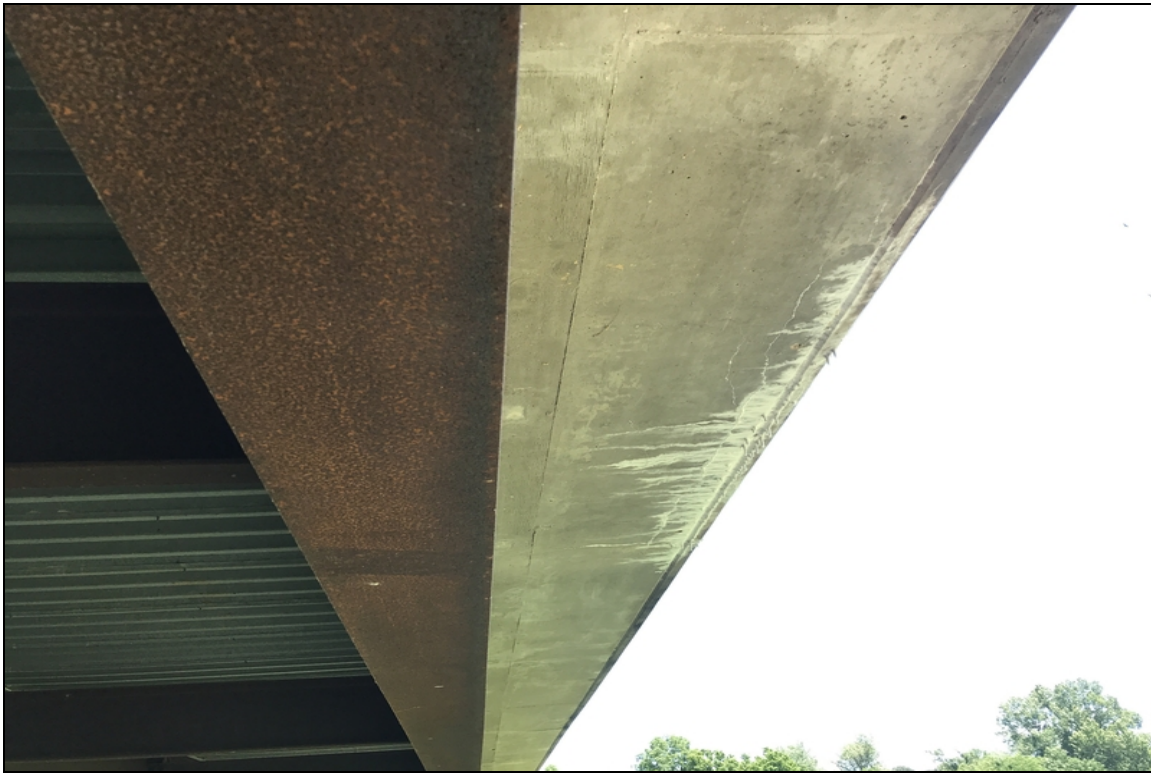
Span #11 right over hang efflorescence with cracking.

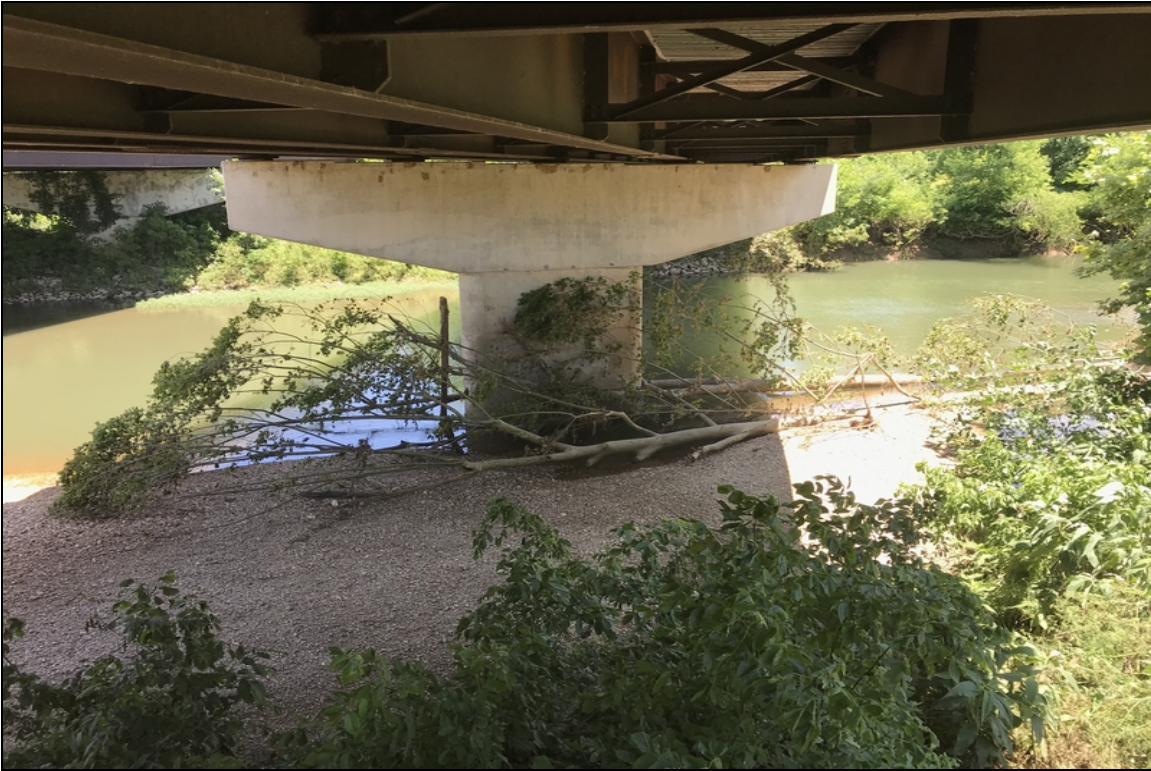
Large tree wedge against bent #17.

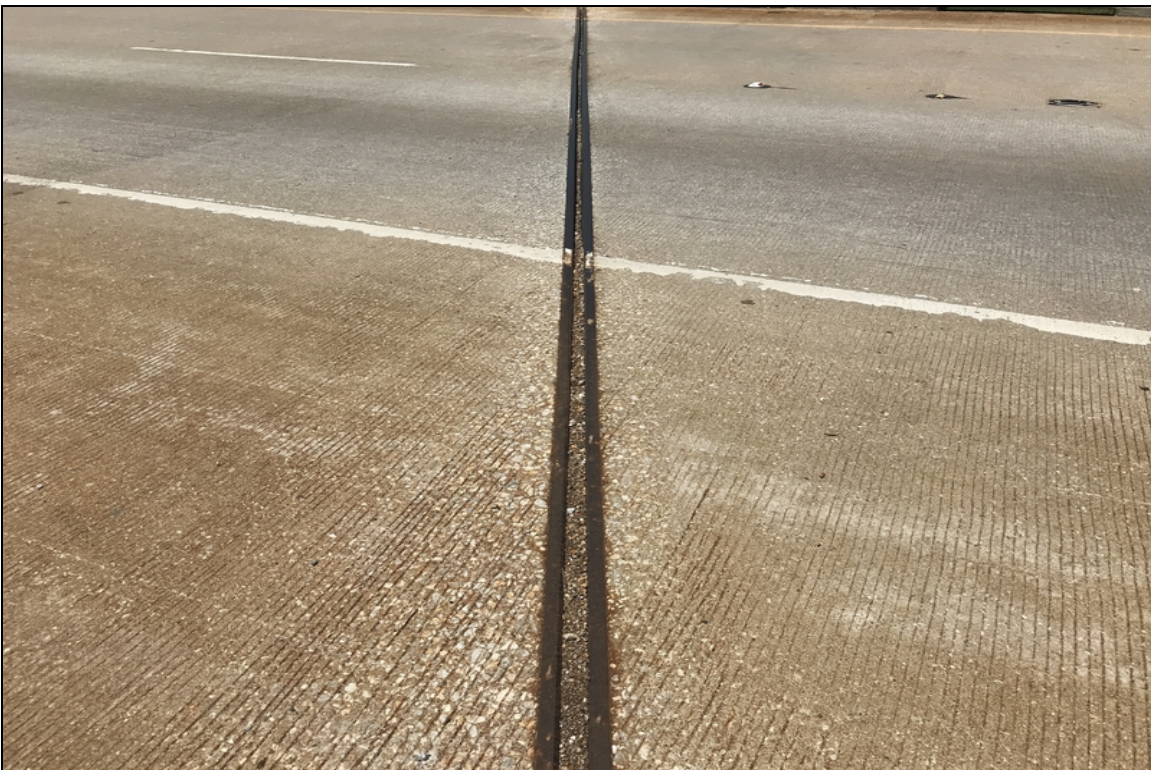
Bent #8 expansion joint debris impaction

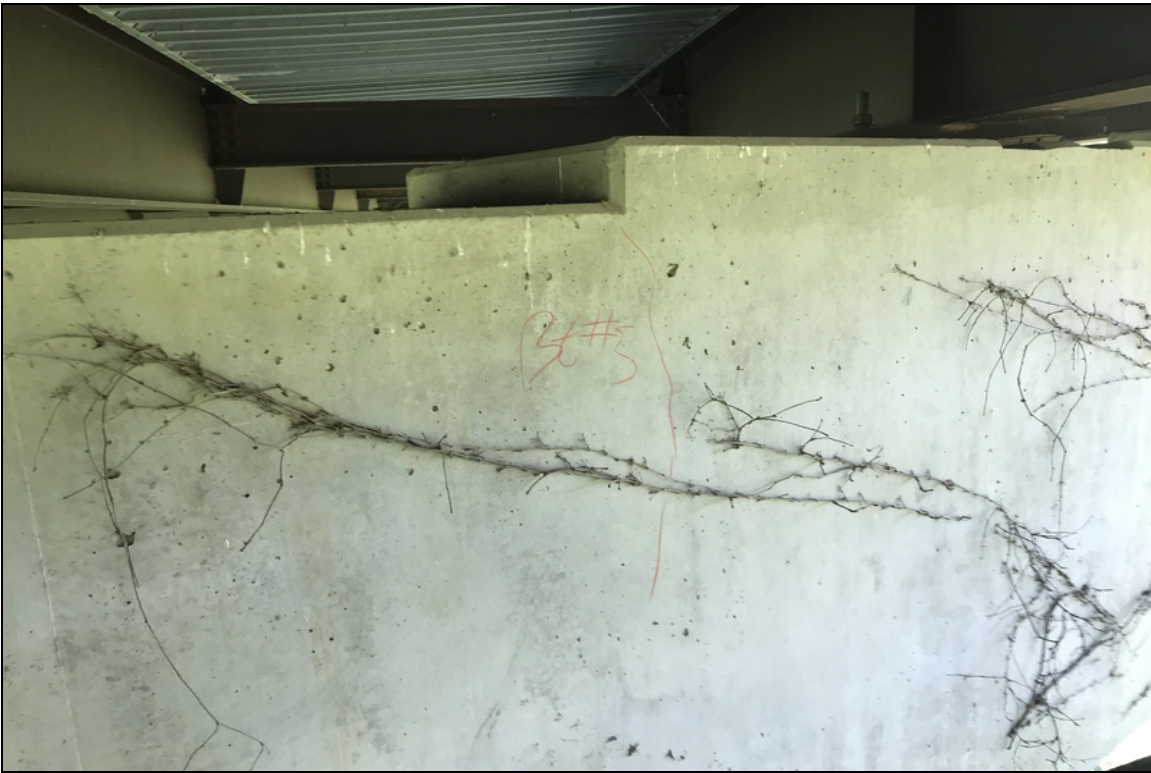
Bent #5 Typical vertical cracking in pier cap.

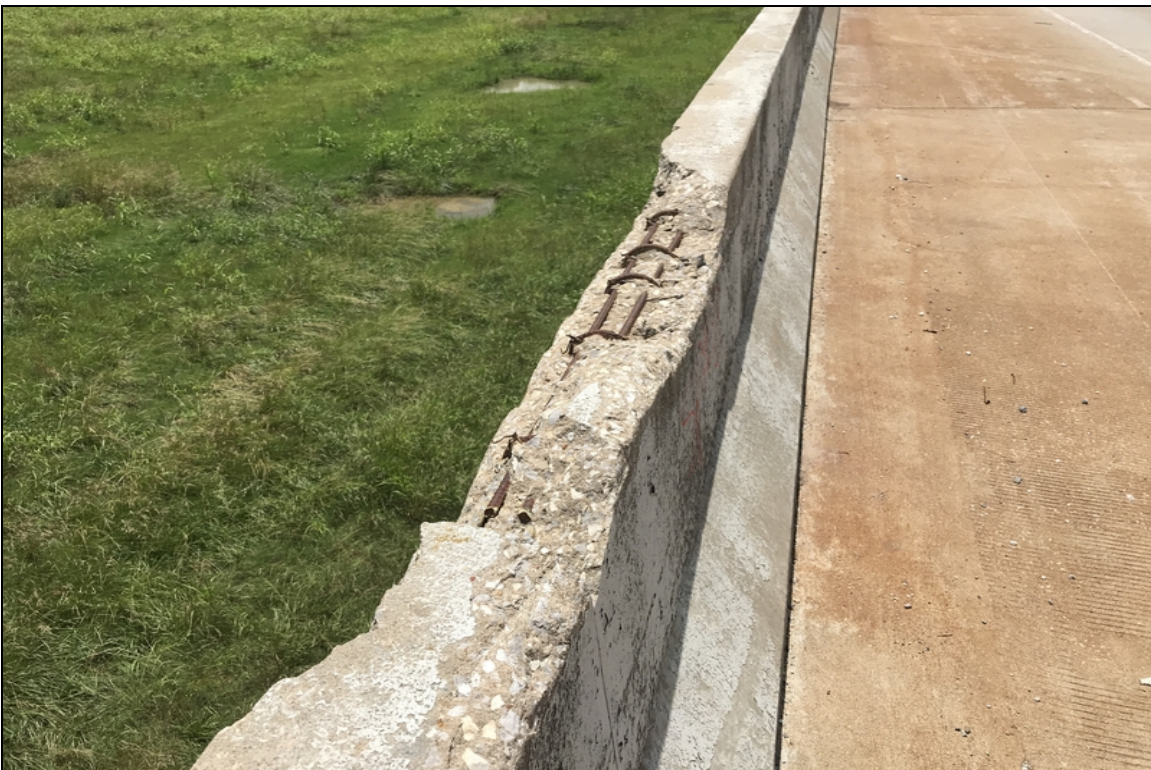
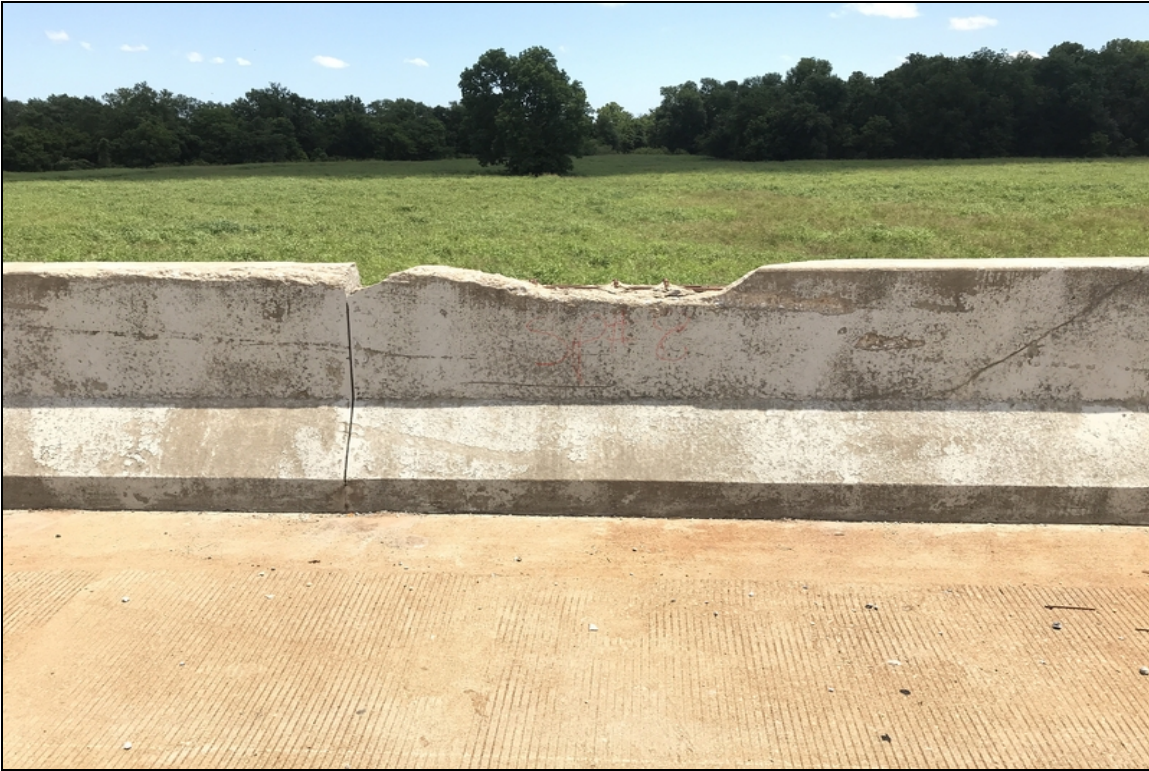
Span #8 right railing spalling with rebar exposed.

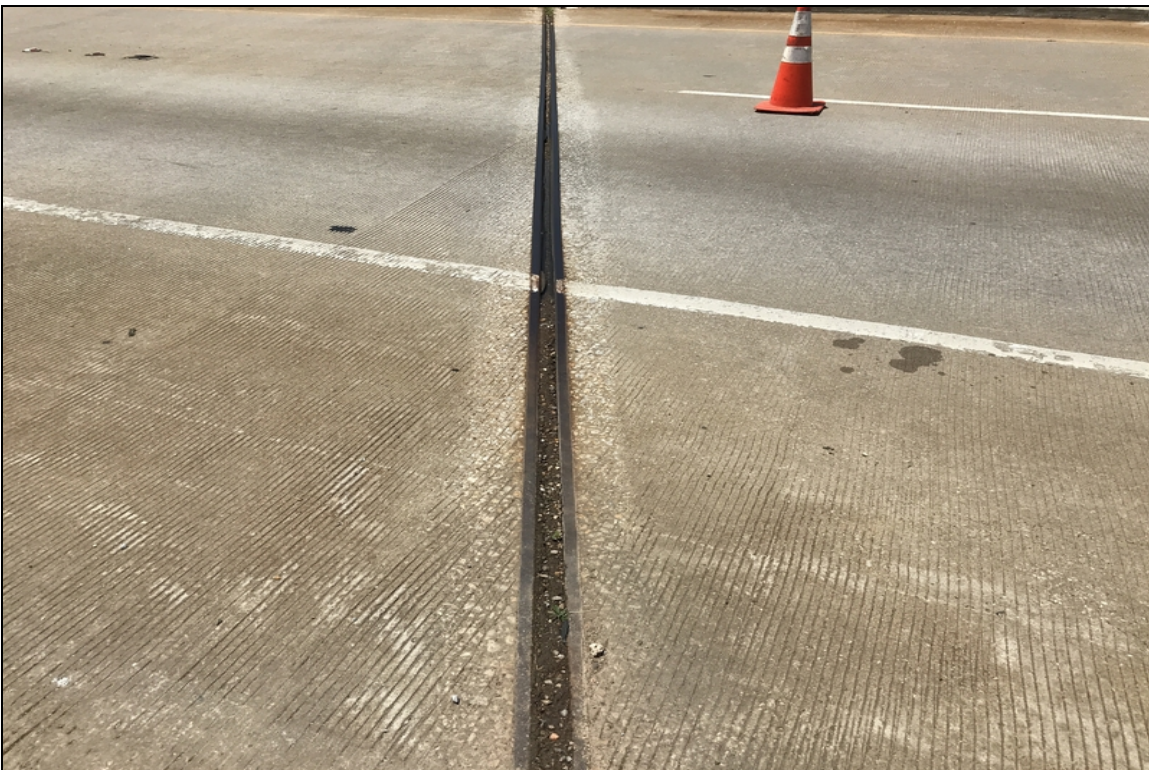
Bent #12 expansion joint debris impaction

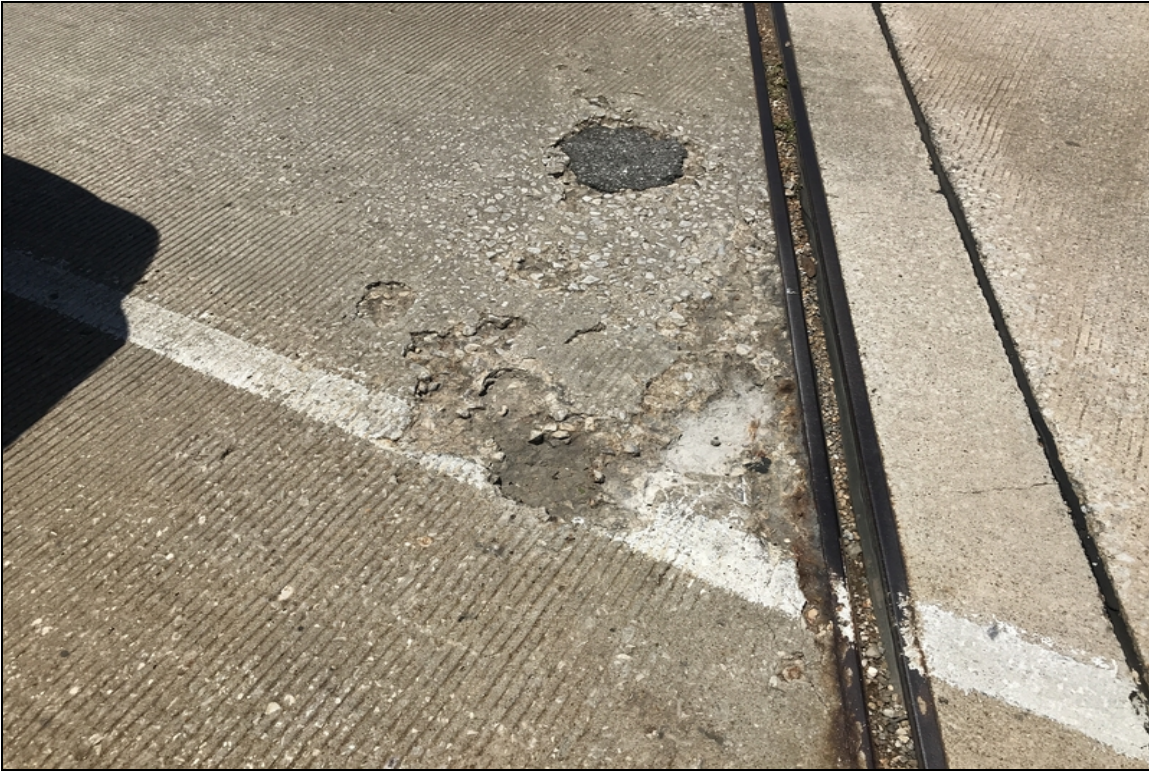
Large spall adjacent to abutment #2.

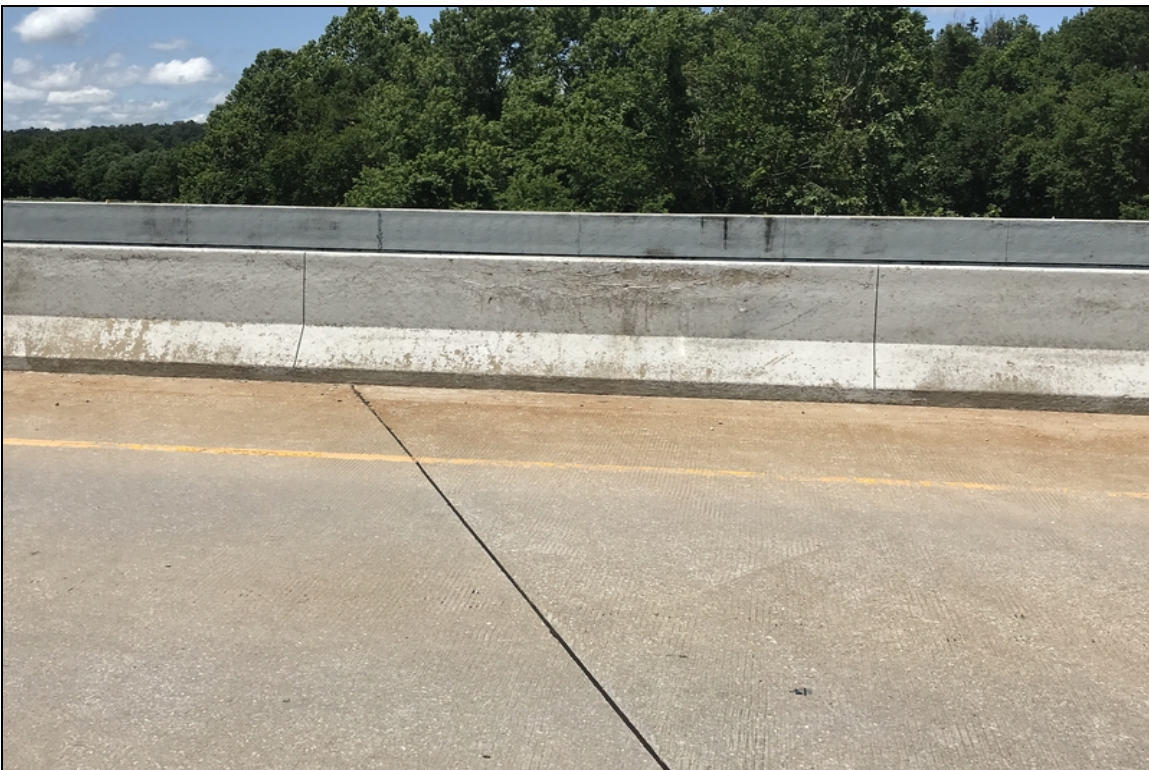
Typical efflorescence and cracking in parapet wall.

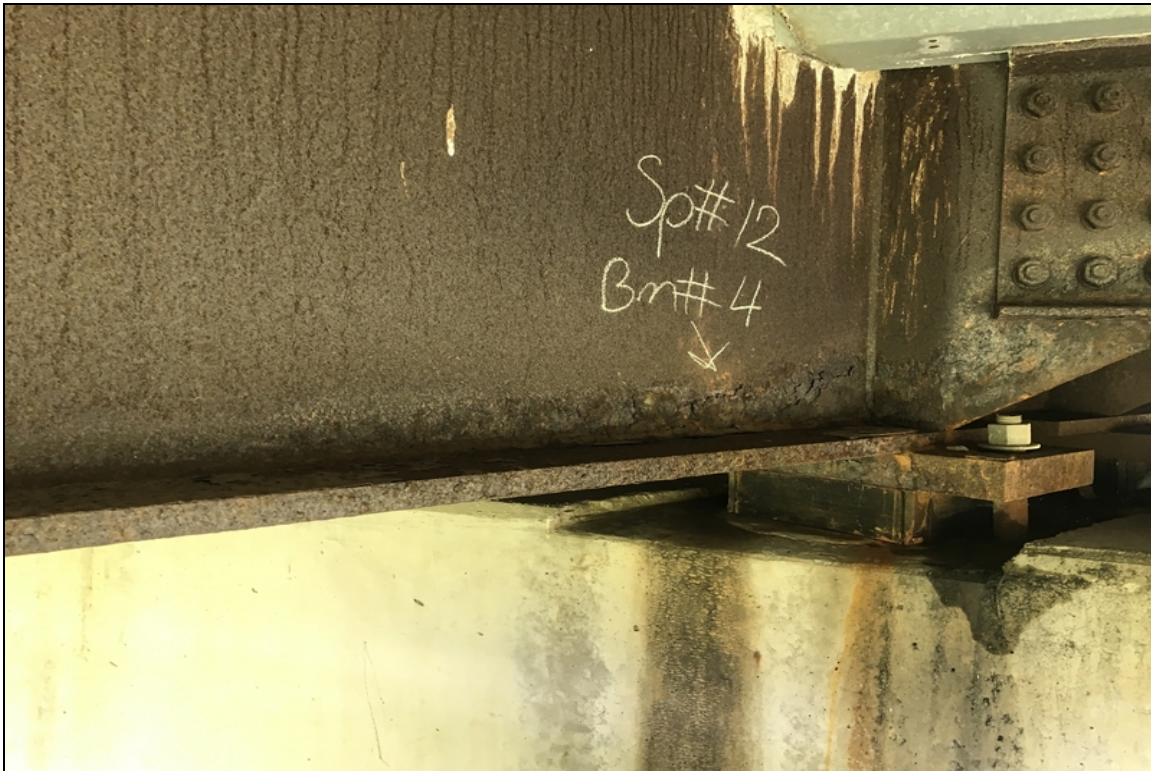
Span #12 girder #4 flaking rust at the end of girder over bent #12

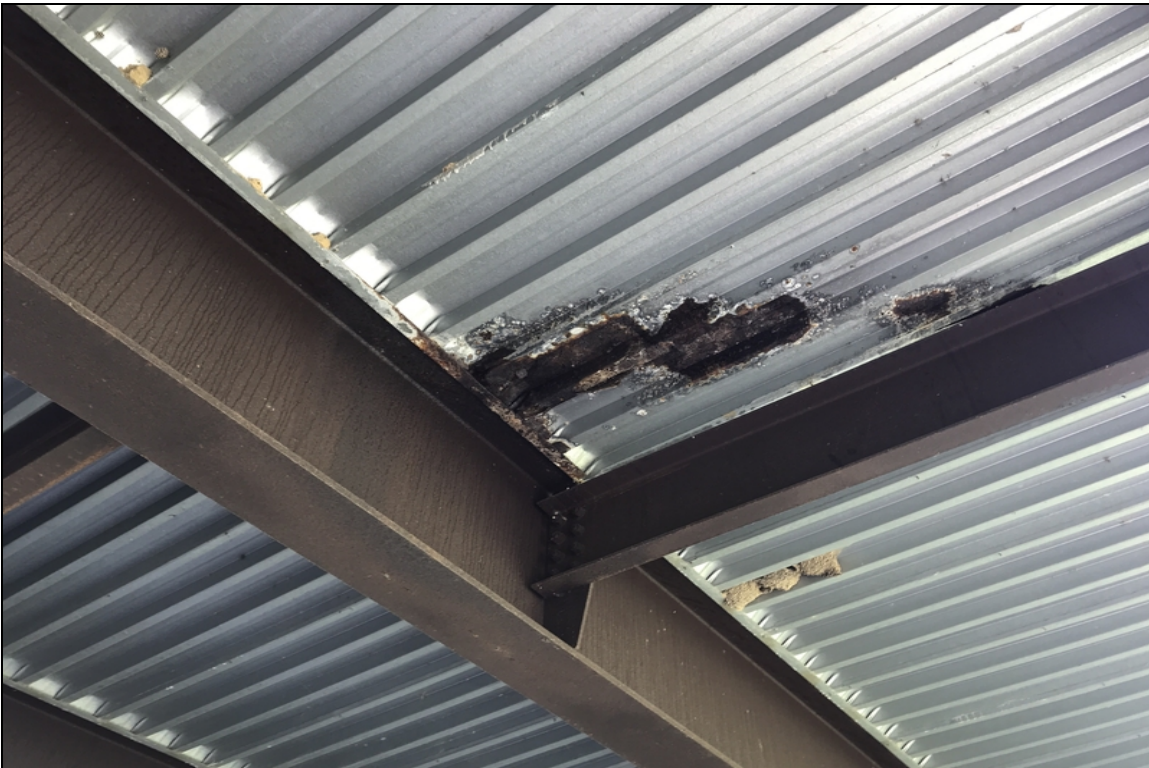
Span #2 bay #4 approximately 10' ahead of bent #1 the sip forms have active corrosion this is typical throughout undersurface.

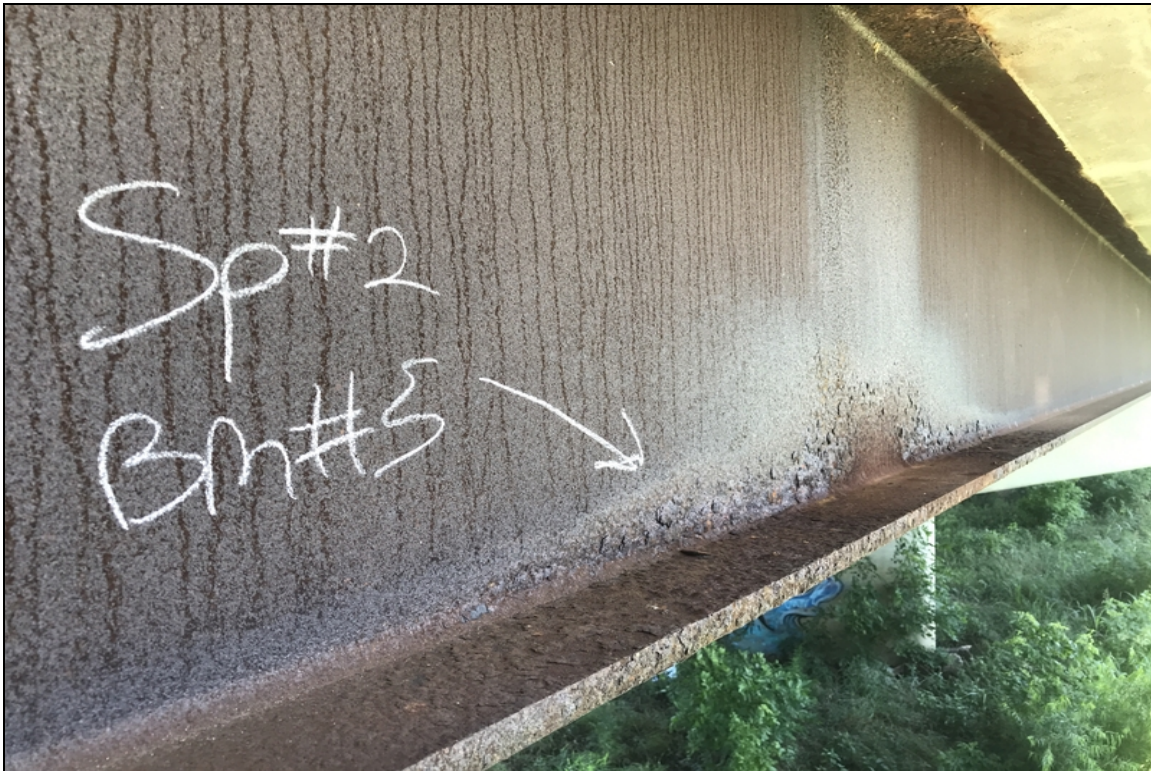
(107)							
06/16/2021 WNR & DBM:							
-The bottom flanges of girders have areas of out-of-plane bending in several locations throughout that appear to be from rough handling.							
-Span #2, exterior side of girder #5 has an area of corrosion with initial section loss to web and top and bottom flanges where deck cracking leaches onto superstructure.							
-Span #7, Girder #3 has an area of out-of-plane bending to bottom flange near mid-span.							
-Span #12, Girder #4 over bent #12 has corrosion with flaking rust due to leaking compression joint seal. The adjacent diaphragm in bay #4 has corrosion with flaking rust.							
-Span #13, Girder #4 over bent #12 has corrosion with flaking rust due to leaking expansion joint.							
-Span # 7, girder #1, span #15, girder #2 and span #17, girder #2 have one loose bolt in the splice plate connections.							
-Span #19, girder #5 has corrosion with flaking rust over abutment #2 due to leaking compression joint seal.

Span #2, exterior side of girder #5 has an area of corrosion with initial section loss to web and top and bottom flanges where deck cracking leaches onto superstructure.

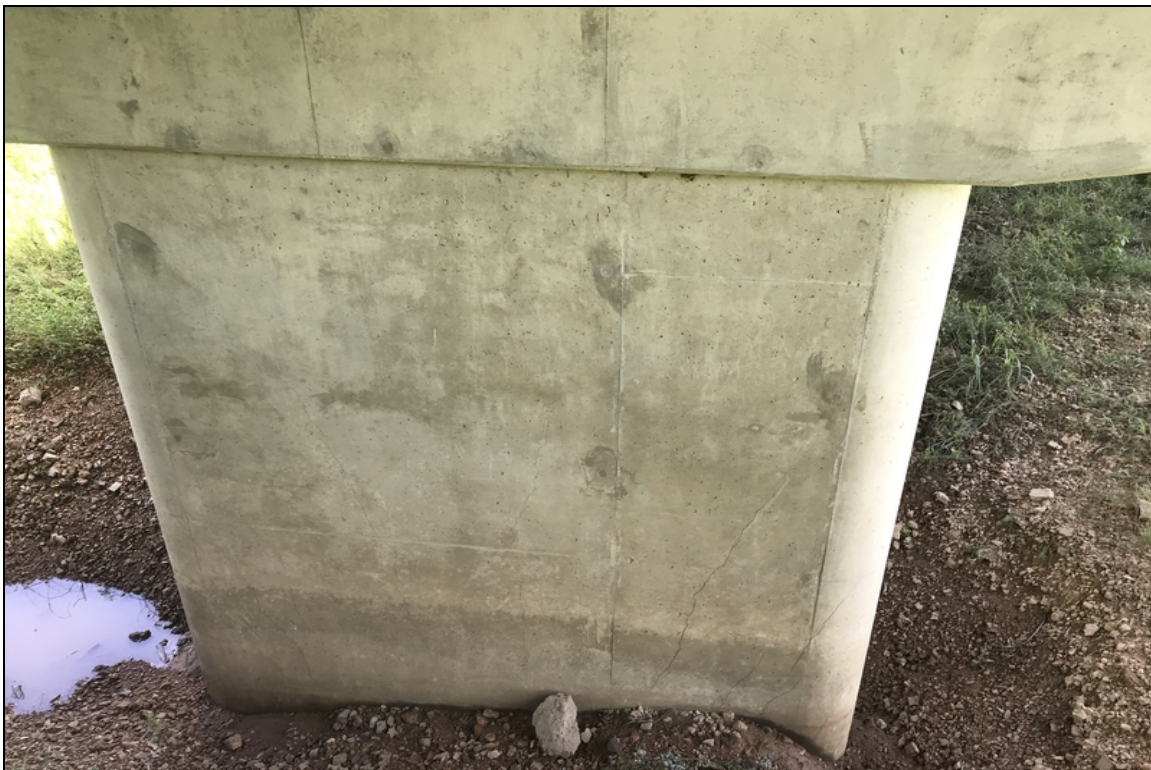
Bent #1 pier cracking in the pier.

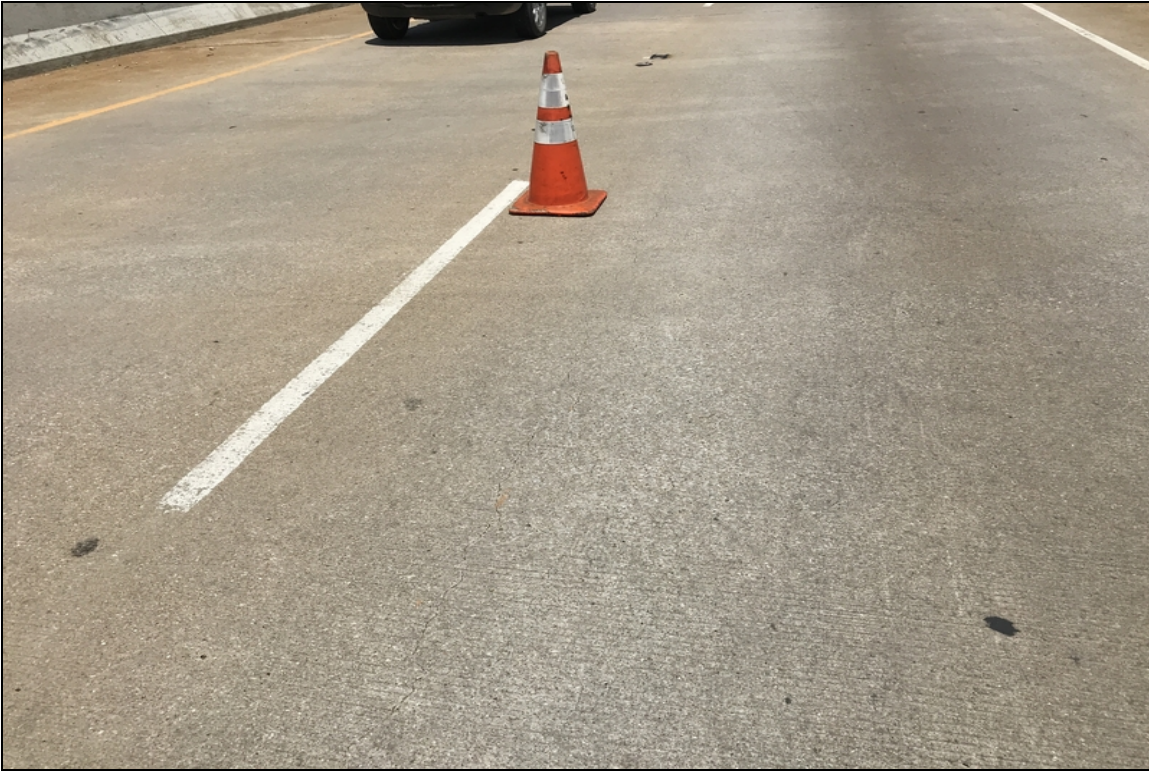
Typical view of longitudinal crack at centerline.

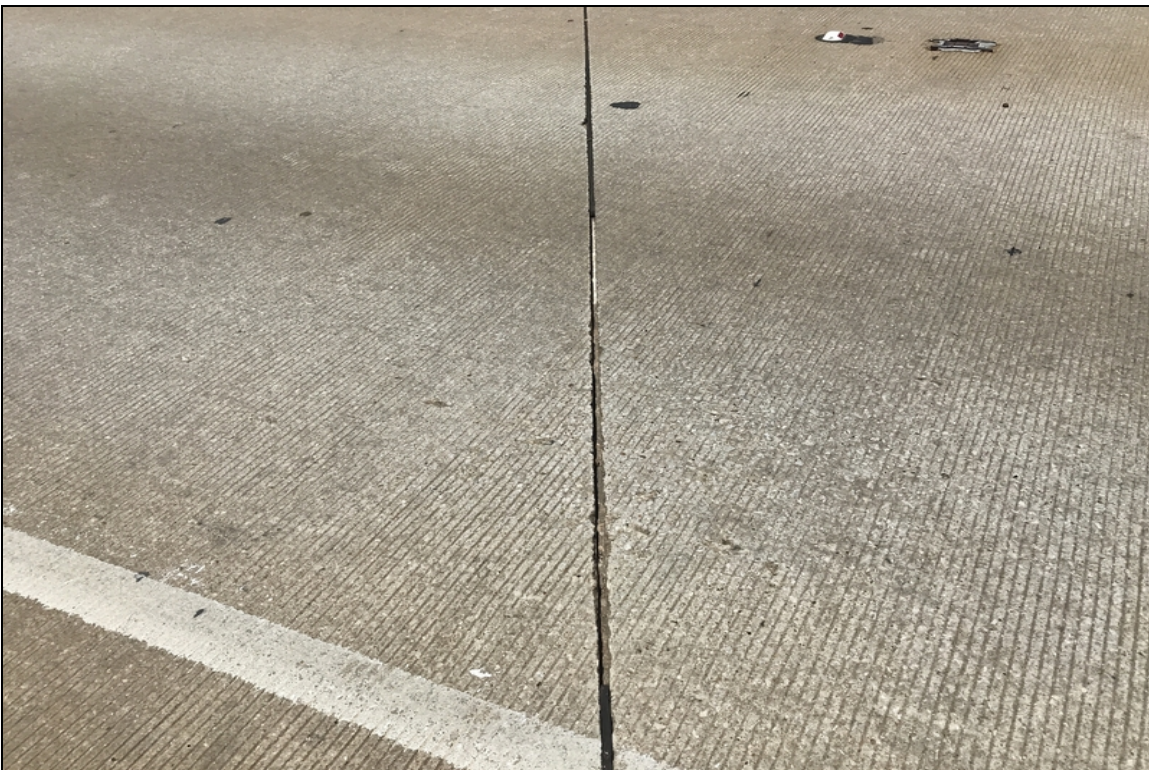
Typical displacement of pourable joint material.
