Bridge #B6478(Routine, Underwater type 2)

Benton US 412 over ILLINOIS RIVER

Location: 11.64 MI E OF OKLAHOMA LN

Team Lead: Nathan Rowland **Inspection Date:** June 16, 2021

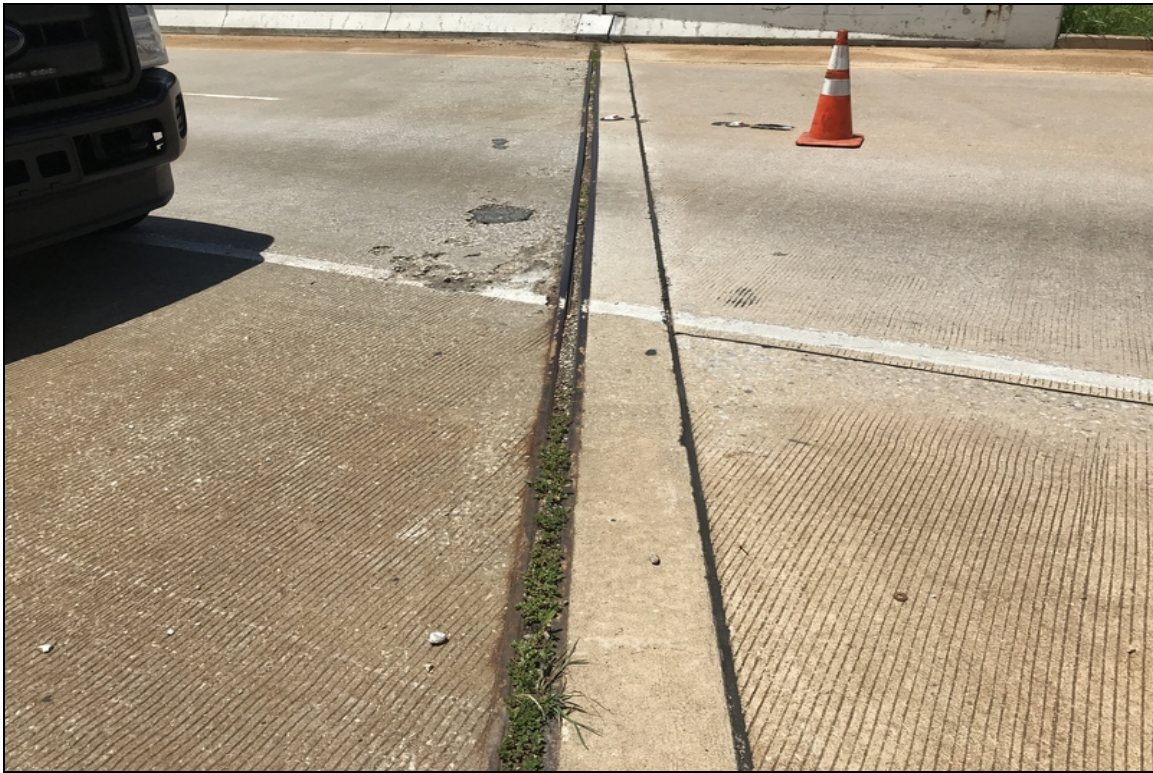
Abutment #2 debris impaction.

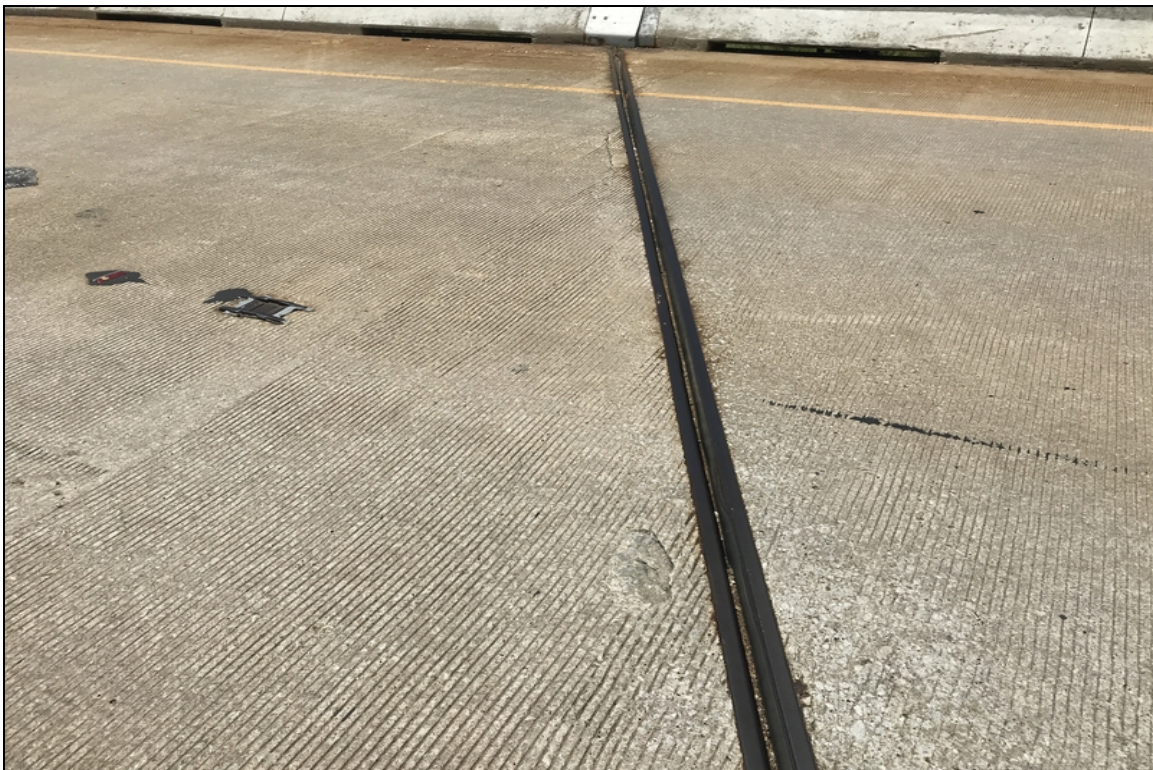
Span #4 adjacent to bent #4 road iron spalling and delaminated areas.

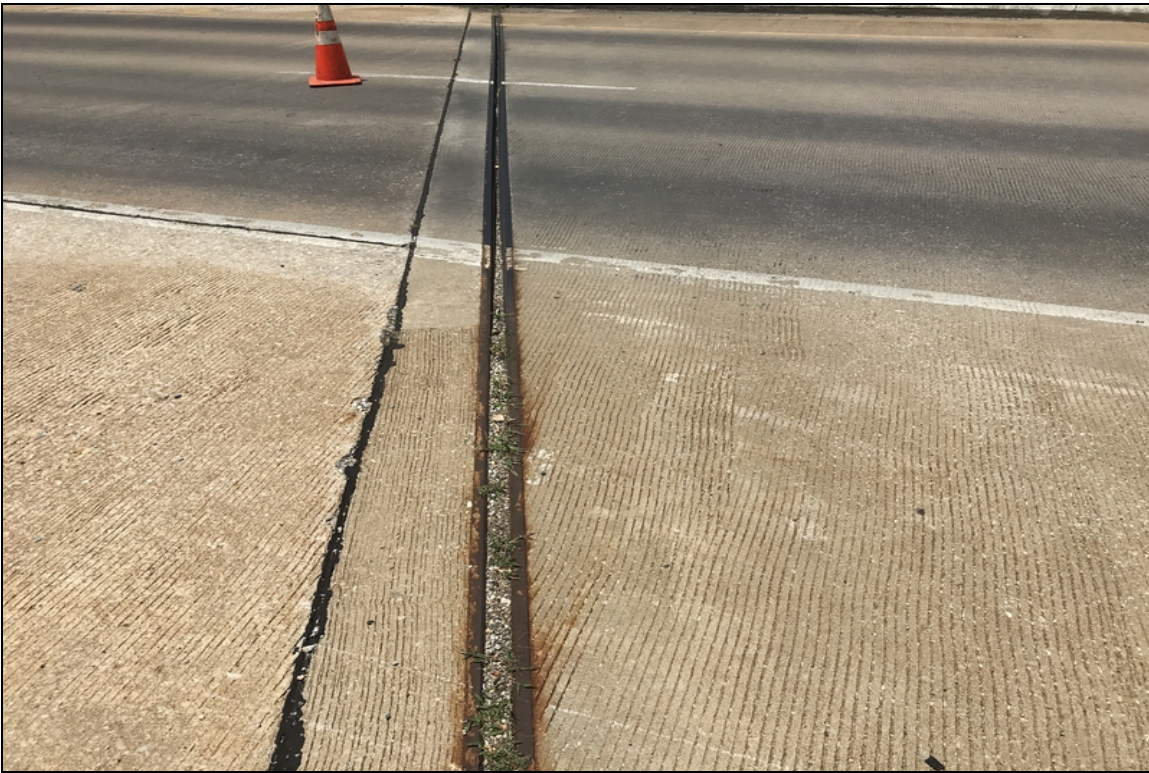
Abutment #1 minor debris impactation

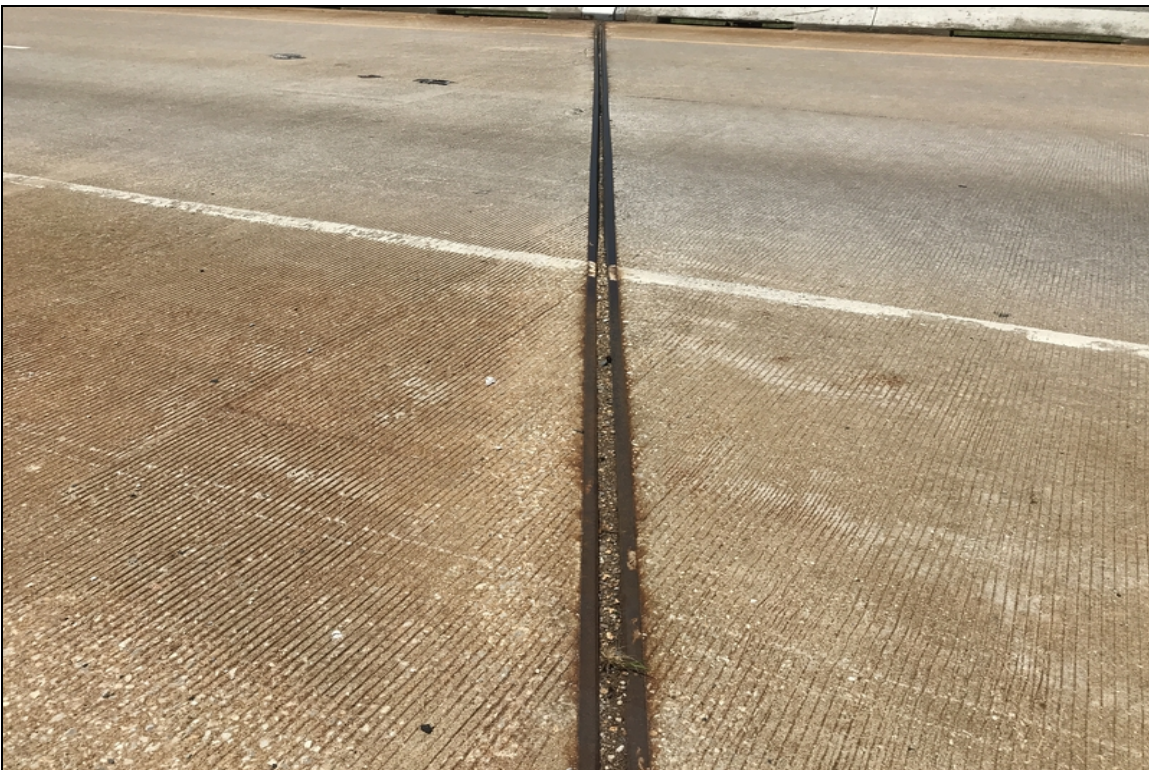
Bent #4 expansion joint debris impactation.

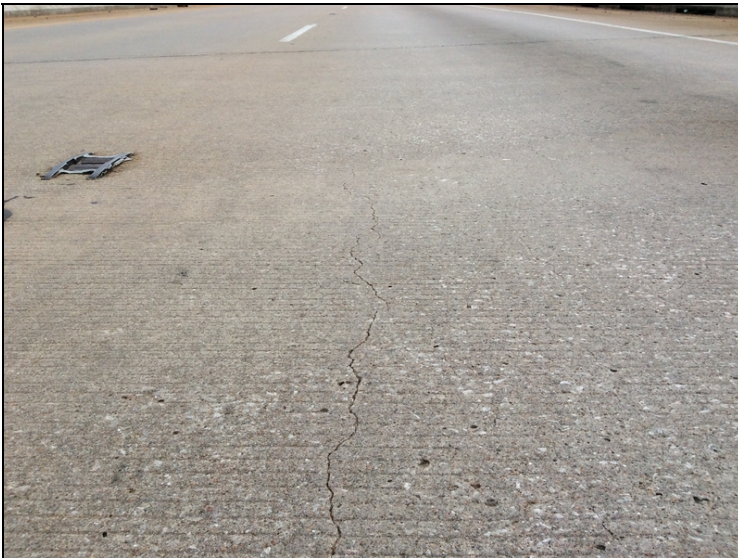
Deck - The driving surface of the deck has sealable cracking in all spans.

Longitudinal cracking typical, photo #2.

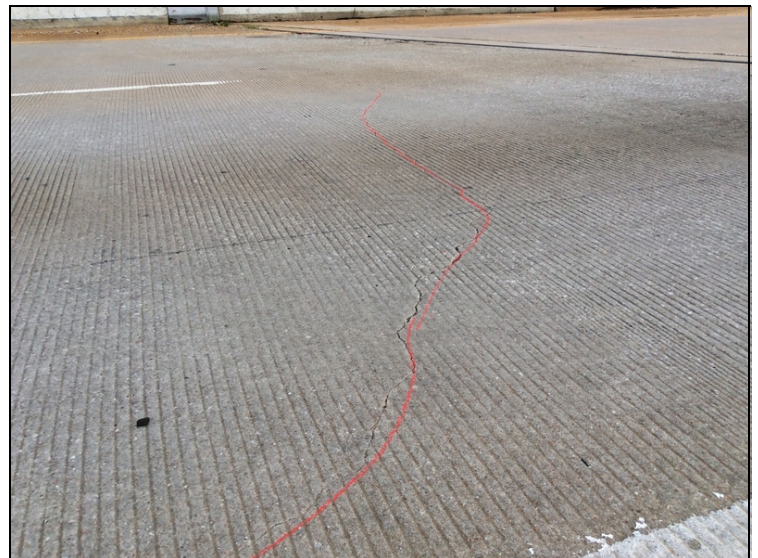
Span #19-Transverse cracking.

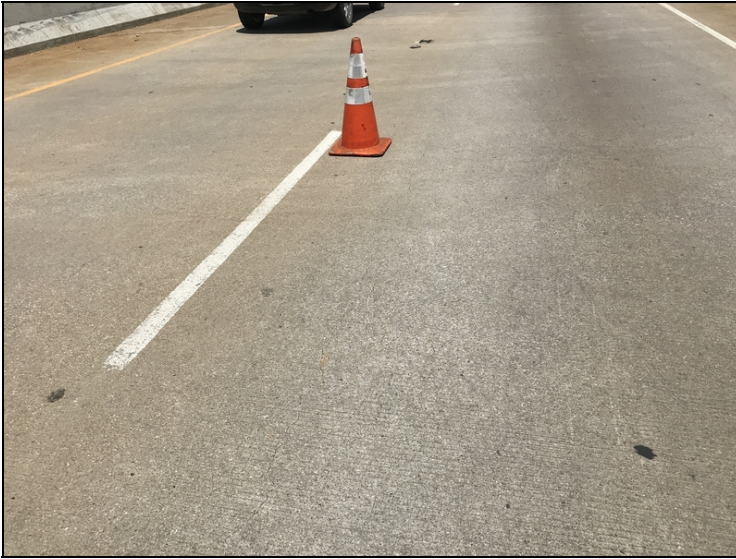
Typical view of longitudinal crack at centerline.

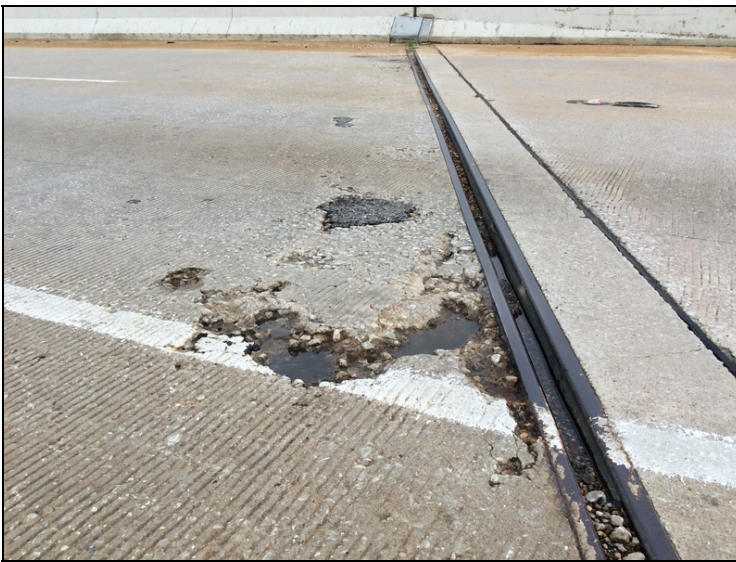
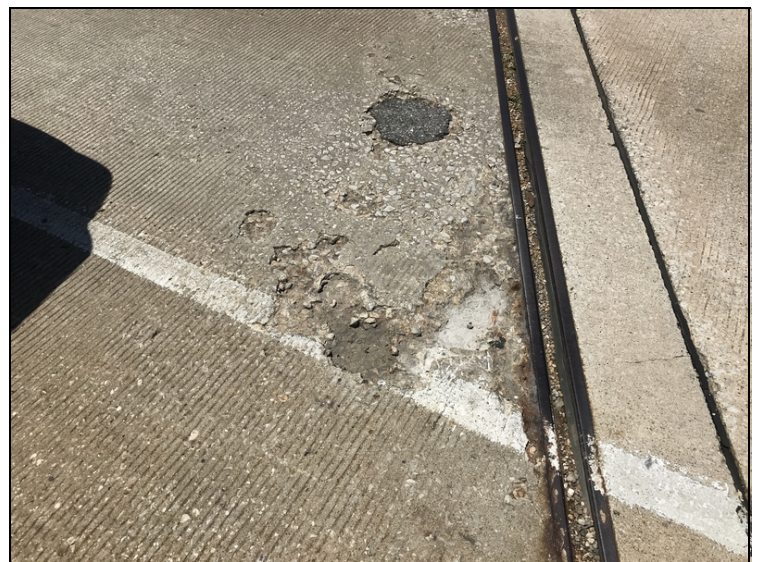
Deck - The deck has spalling in the right lane of span #19 at abutment #2 that has created potholes in the driving surface. The left lane of span #19 at abutment #2 has a large area of heavy scaling that is beginning to spall.

Span #19-Spalling in deck adjacent to abutment #2.

Large spall adjacent to abutment #2.

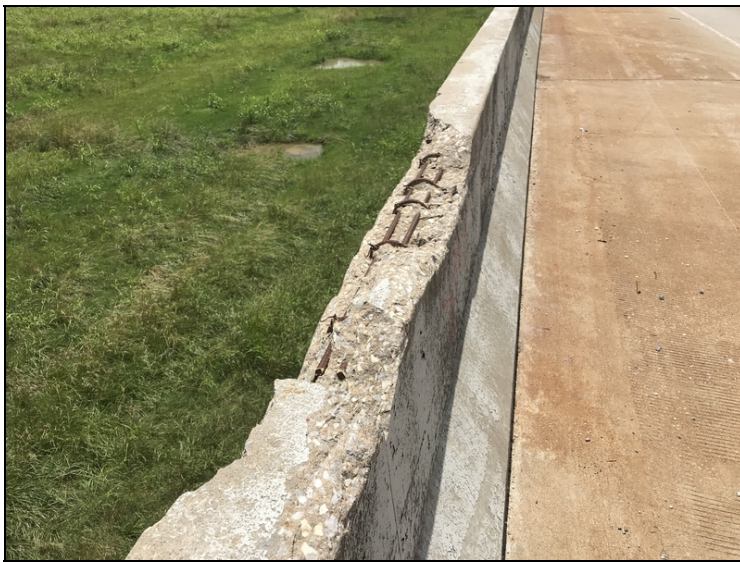
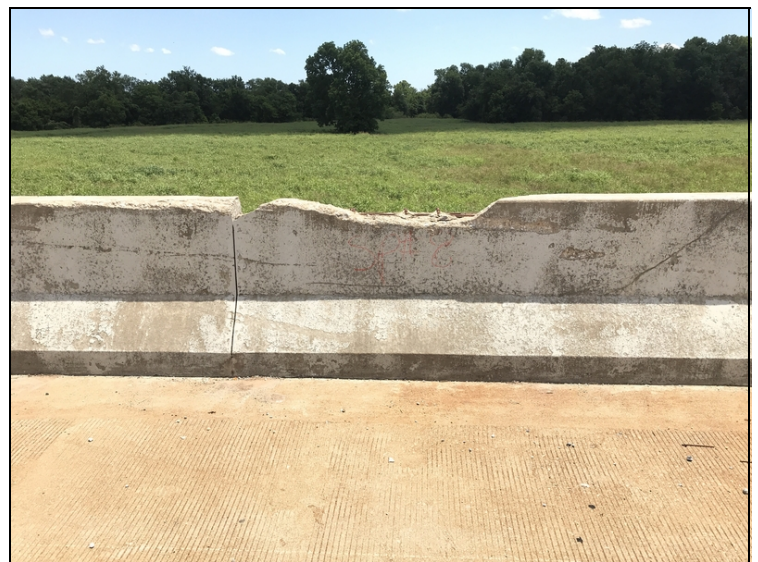
Concrete parapets - The concrete parapet on the right side of span #8 has collision damage with a large area of spalling that exposes the reinforcing steel. The parapets have areas of wide mapcracking in several locations.

Span #8 right railing spalling with rebar exposed.

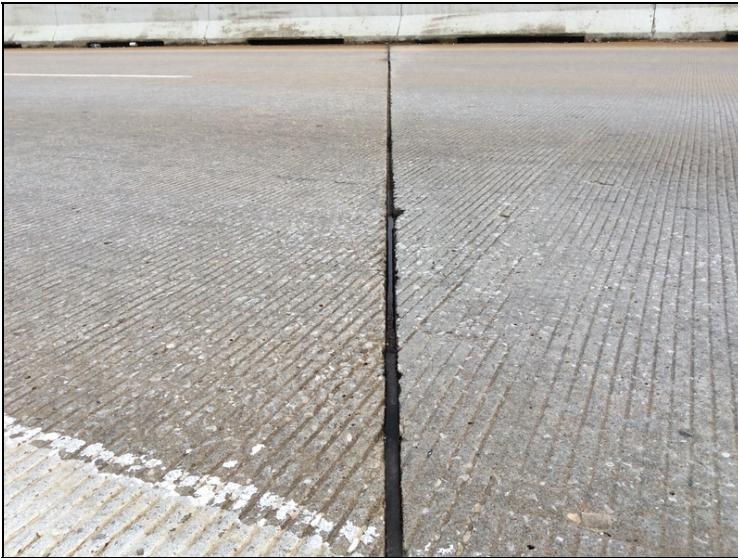
Expansion joint seals - The strip seals have moderate debris impactation and appear to have come out of the assemblies in random locations allowing water to leak onto the superstructure promoting corrosion. The sawn joint seal material is missing in several locations.

Span #10-Sawn joint material missing.

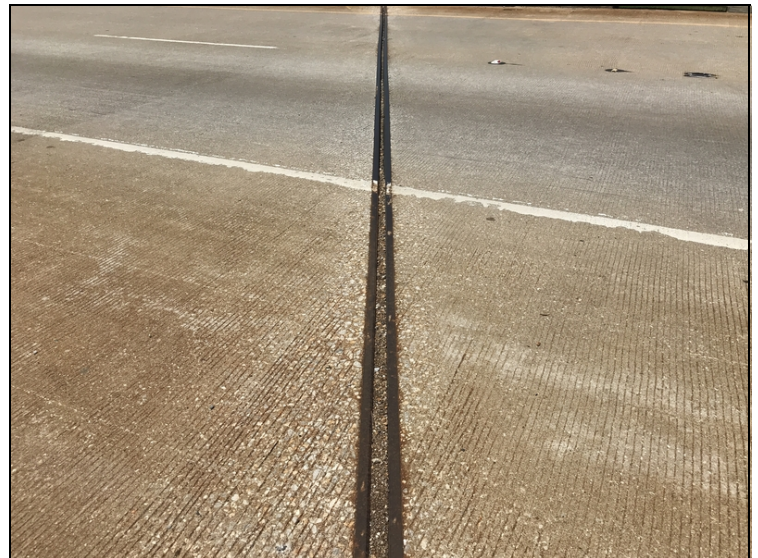
Bent #8 expansion joint debris impactation

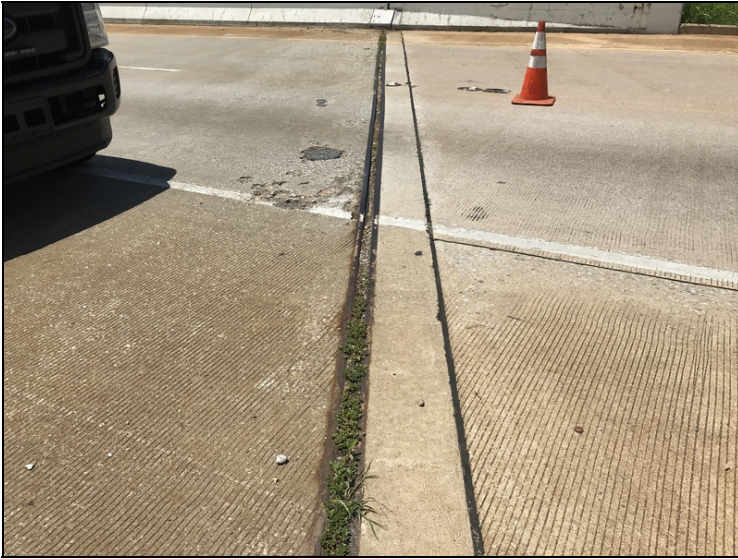
Abutment #2 debris impactation.

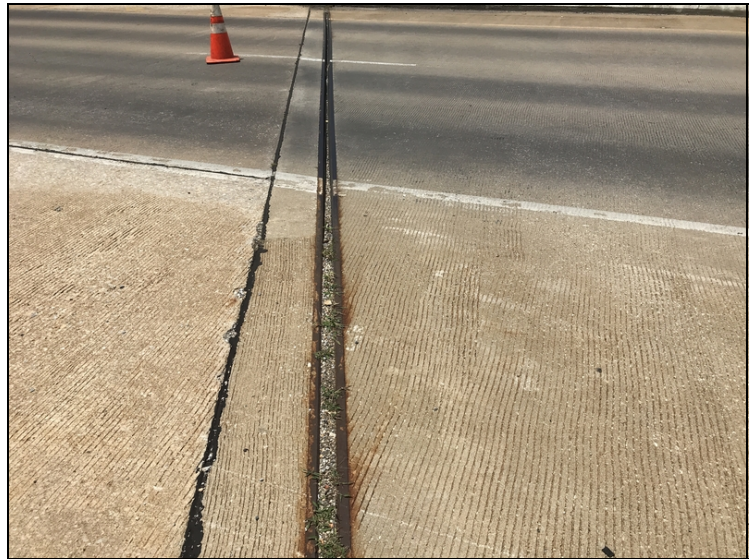
Abutment #1 minor debris impactation

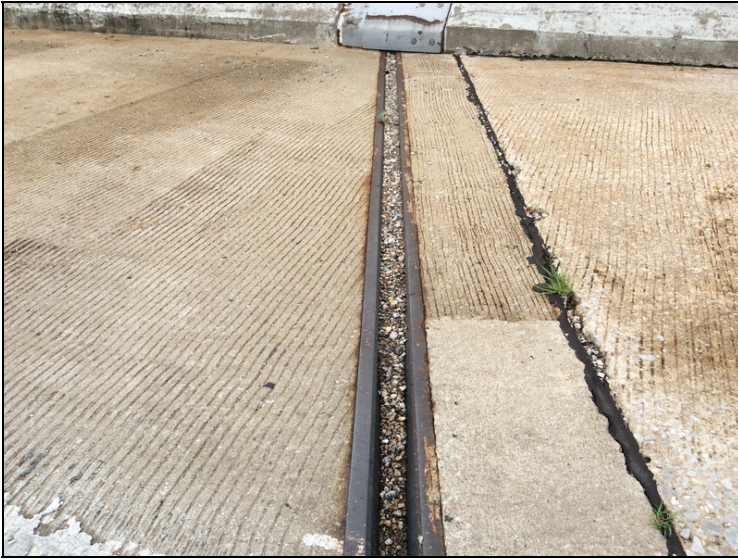
West abutment-Debris impaction.

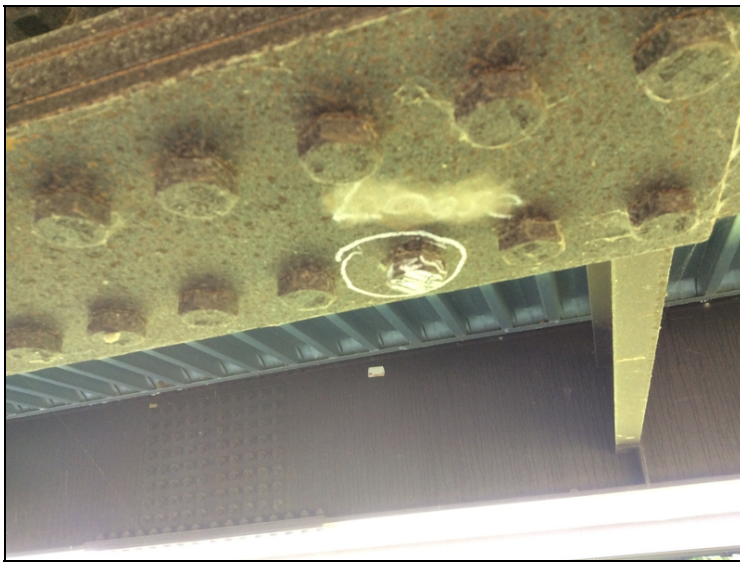
Superstructure splice connections - Span # 7, girder #1, span #15, girder #2 and span #17, girder #2 have one loose bolt in the splice plate connections.

Span #15, Girder #2 has a loose bolt in the bottom flange splice plate.

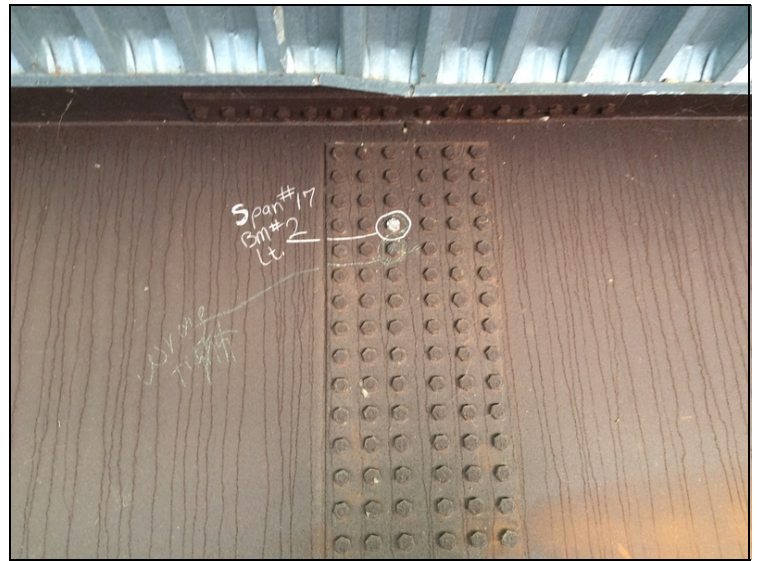
Span #17, Girder #2-Loose splice plate bolt.

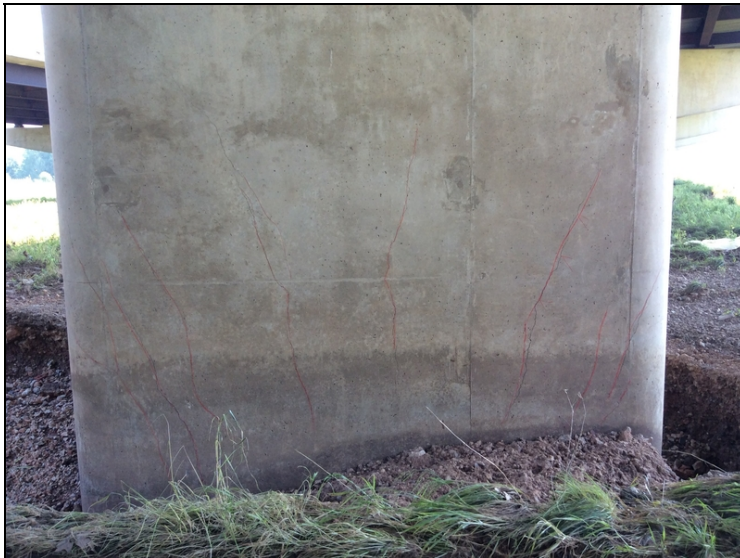
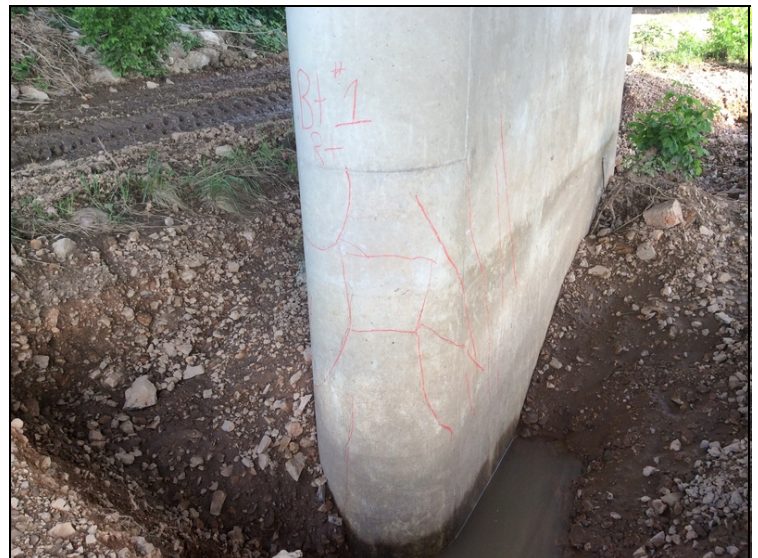
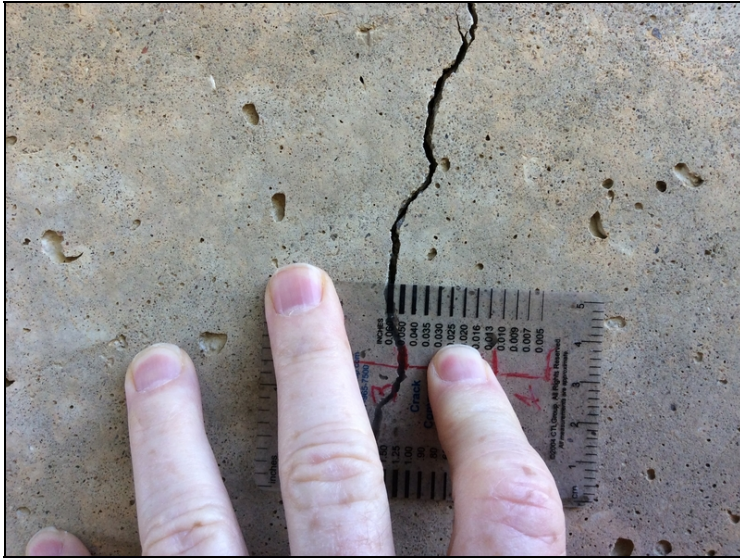
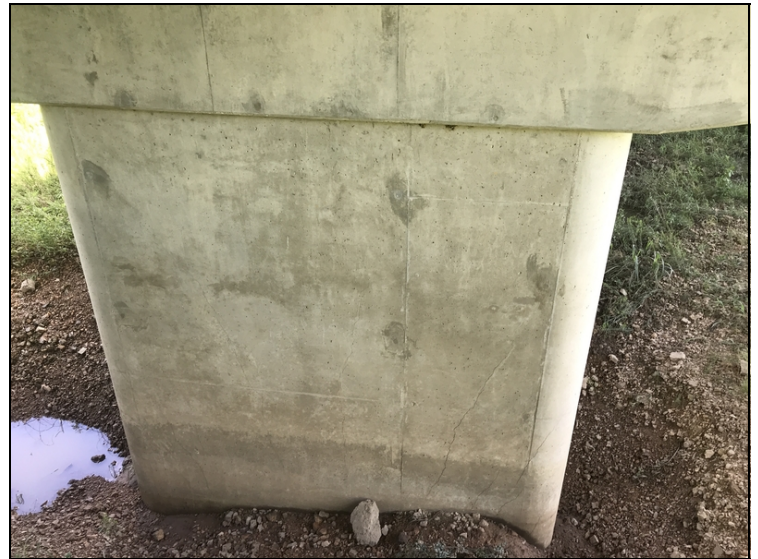
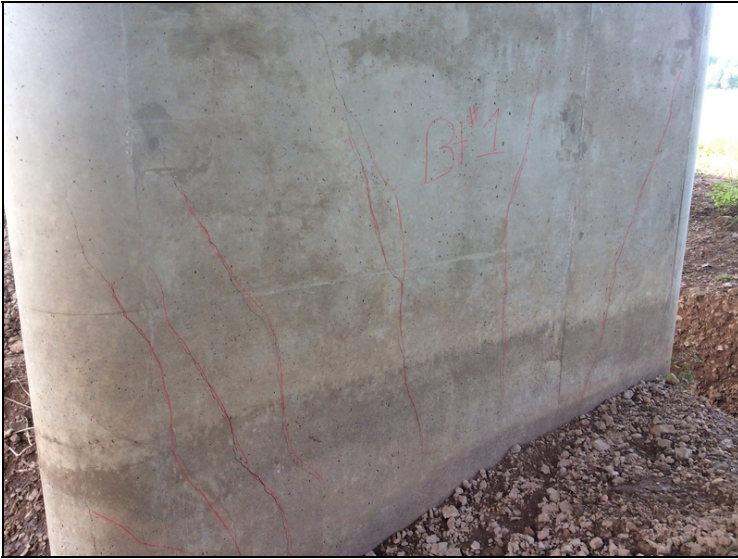
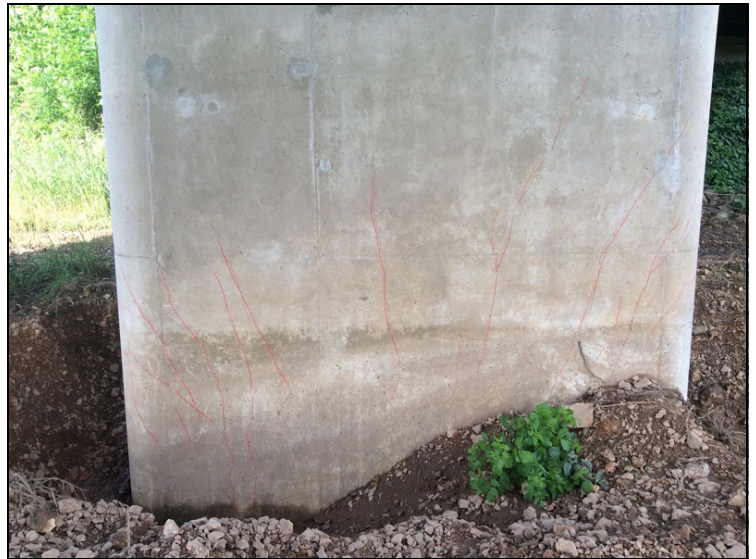
The columns of bent #1 and bent #13 have numerous diagonal cracks that range in width from hairline up to 0.060". The cracks are visible on both side of the columns and extend up the column from the base an estimated 10 to 12 feet. Bent #12 column has 3 diagonal cracks visible on both sides that propagate from the base of column up to first construction joint.

Cracking in bent #1 column. Photo #1.

Bent #1-Cracking on right side.

Cracking in bent #1 column. Photo #2.

Bent #1 pier cracking in the pier.

Bent #1-Diagonal cracking.

Bent #1, Span #2-Diagonal cracking.

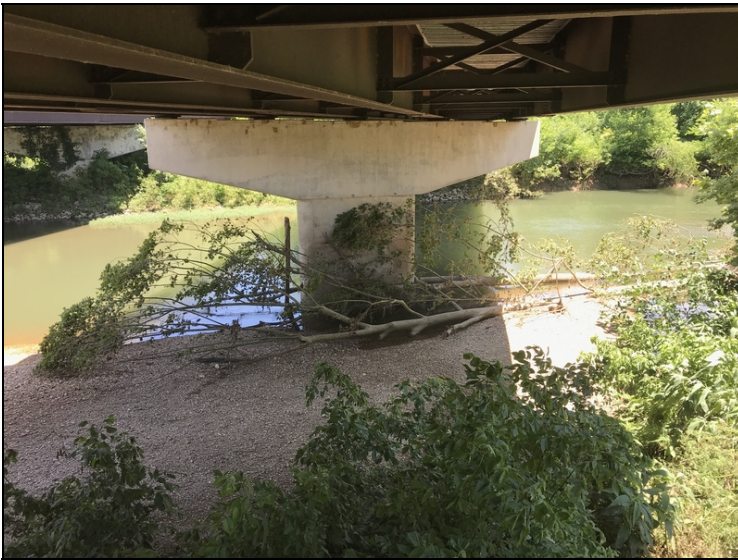
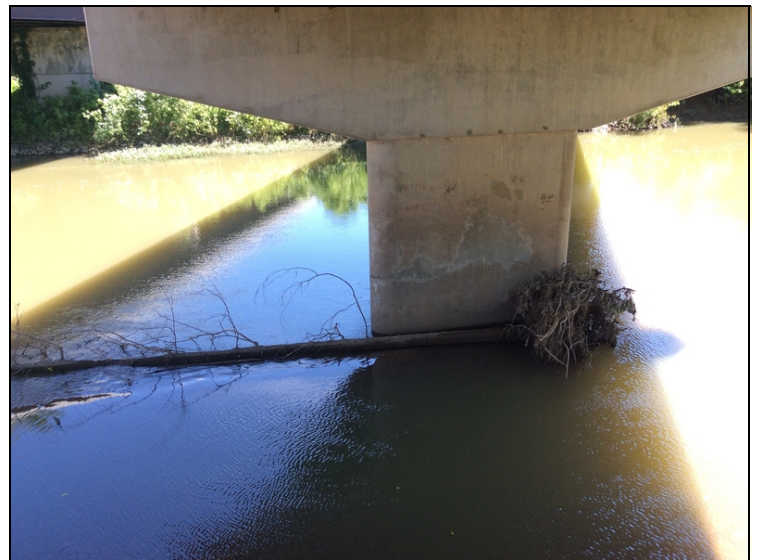
Channel - The channel has a tree lodged against bent #17.

Large tree wedge against bent #17.

Channel-Drift at bent #17.

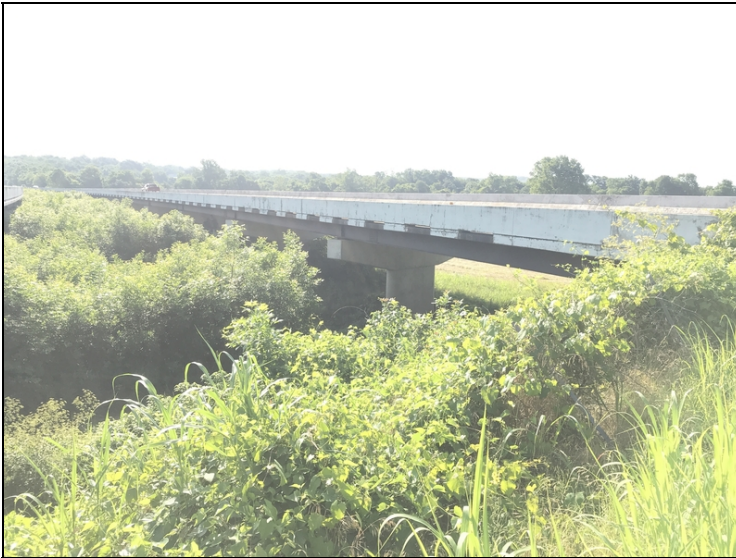
-The vegetation under the structure is growing into the substructure and making it difficult to for the bridge inspection process.

Date Reported: 06/21/2021
Priority: B - Pressing; 6 month completion goal
Type of Work: Clean
Status: Open
Component: Channel
