Bridge #05982(Routine)

SH 72 Benton 1 over I-49 Benton 1

Team Lead: Nathan Rowland Inspection Date: October 05, 2021

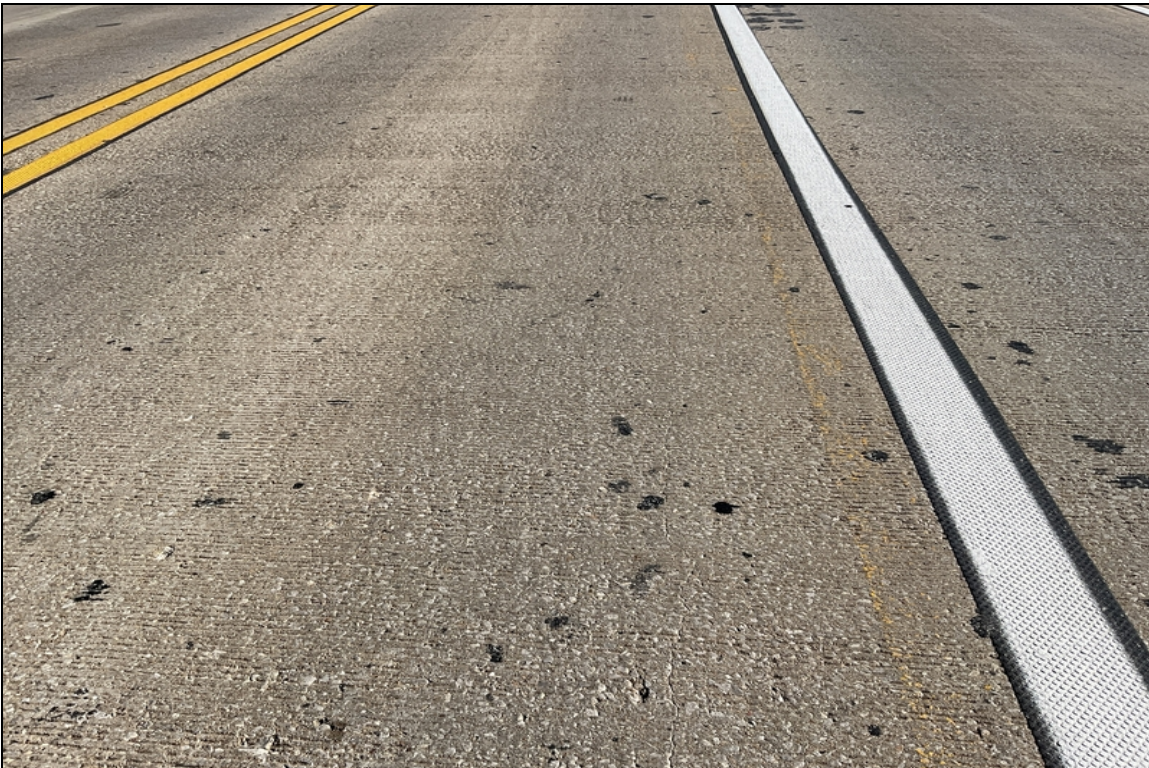
View of longitudinal cracking in older portion of bridge.

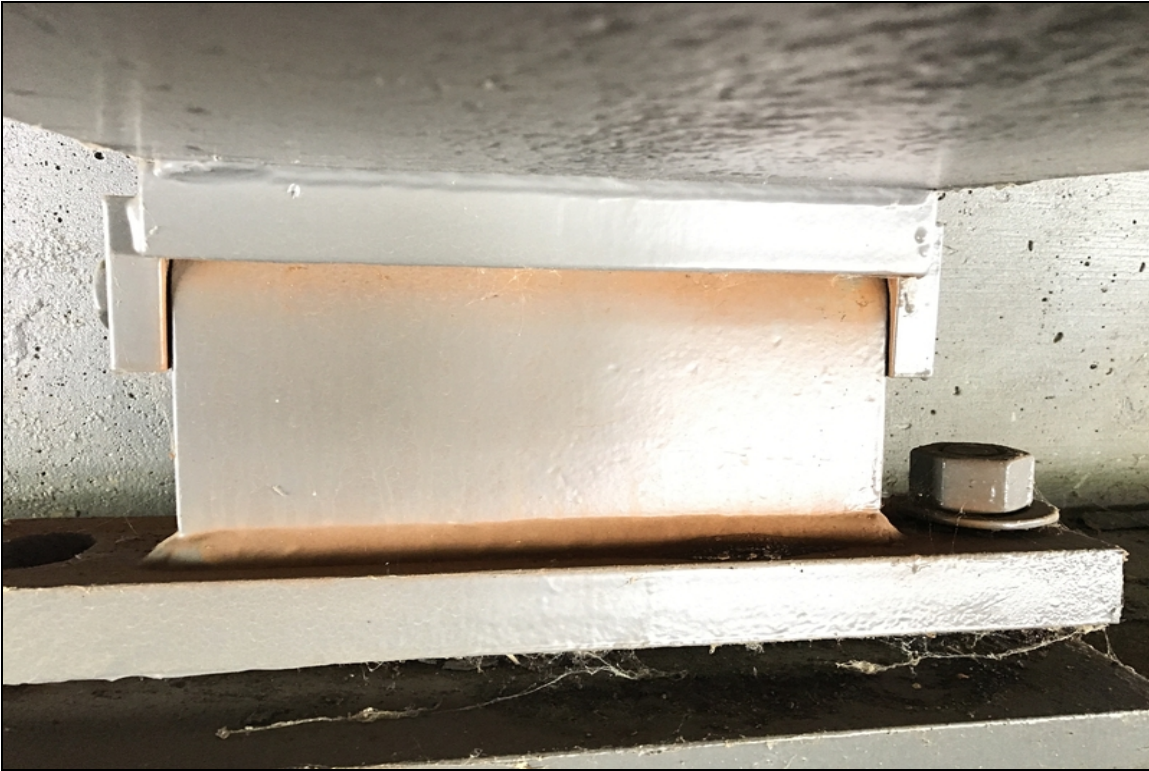
(311)							
10/5/2021 WNR & DBM:							
-The Rocker bearings at abutments #1 and #2 have fretting rust due to the fact that during this inspection traffic could be heard impacting the girders/bearing areas causing the fretting rust seen in the photos shown in report dated 09/04/2019.							
-The contractor has cleaned and painted rocker bearings under contract CA0902.							
-Bearing #5 at abutment #1 and bearings #5 and #10 at abutment #2 are missing one bolt that attaches the sole plate to the bearing device.							
-Bearings #6, #7, #9, & #10 at abutment #1 are missing one anchor bolt.							
-Bearings #7, 9 and #10 at abutment #2 are missing one anchor bolt.							
330	Metal Bridge Railing	LF	260	260	0	0	0
515	Steel Protective Coating	SF	4160	4160	0	0	0

Fretting dust in the bearing area.

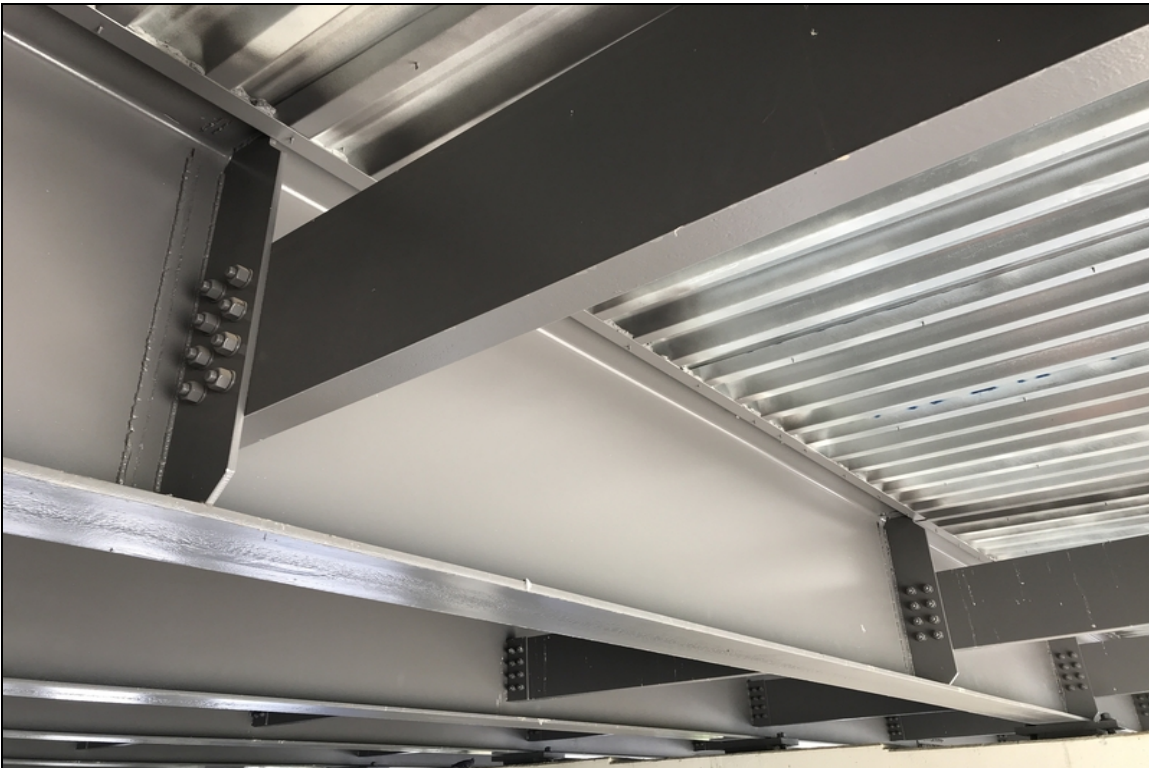
(107)							
10/5/2021 WNR & DBM: -Structure has been widened since last inspection. Four girders have been added to the left side and two to the right side of structure. -Span #1, Girder #10 has cuts that penetrate into the webs where the diaphragm connection plates appear to have been installed in the incorrect locations and were removed by circular cutting wheel. The cut marks penetrate the web approximately 1/16" in locations. Contractor forces have placed welded repairs in these locations.							
8/25/21 accident inspection performed by BDS/ LRW Span #3- beam #3 has 3" of upward distortion on the bottom flange for 1' that is 41' ahead of bent #2 due to an excavator impact accident on 8/24/21. The beam has flaking paint on the bottom flange 5' ahead of the point of impact. Beam #8 has 2" of upward distortion on the bottom flange 41' ahead of bent #2. Beam #9 has a small area of flaking paint #3 diaphragm due to the beam flexing during the impact. Beam #12 has 3" of upward distortion on the bottom flange for 1' that is 41' ahead of bent #2. The bottom flange of beam #12 has flaking paint beneath the #3 and #4 diaphragms behind and ahead of the point of impact.

Girder #10 in spans #1 has cuts that penetrate into the web of the diaphragm connection plates that appear to have been installed in the incorrect locations and were removed by mechanical grinding. The cut marks penetrate the web approximately 1/16" in locations.

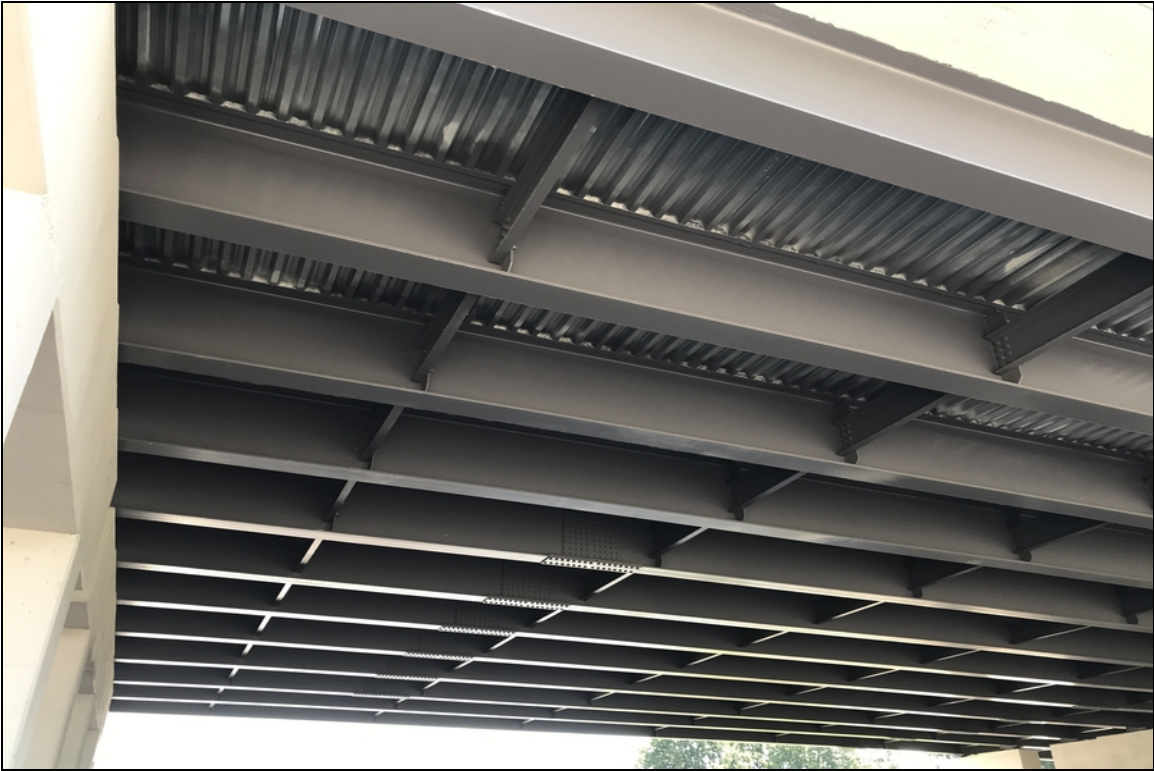
Only girders 5-10 have a second splice plate in span #2.

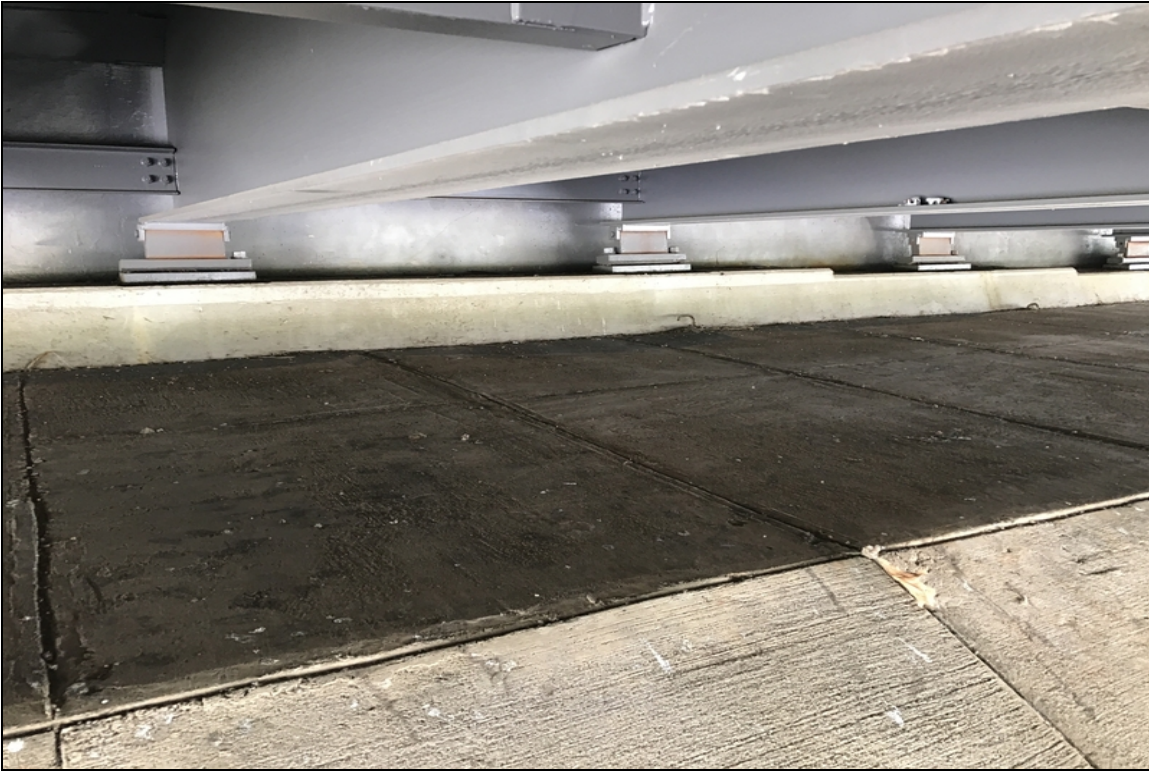
Fretting dust in the bearings

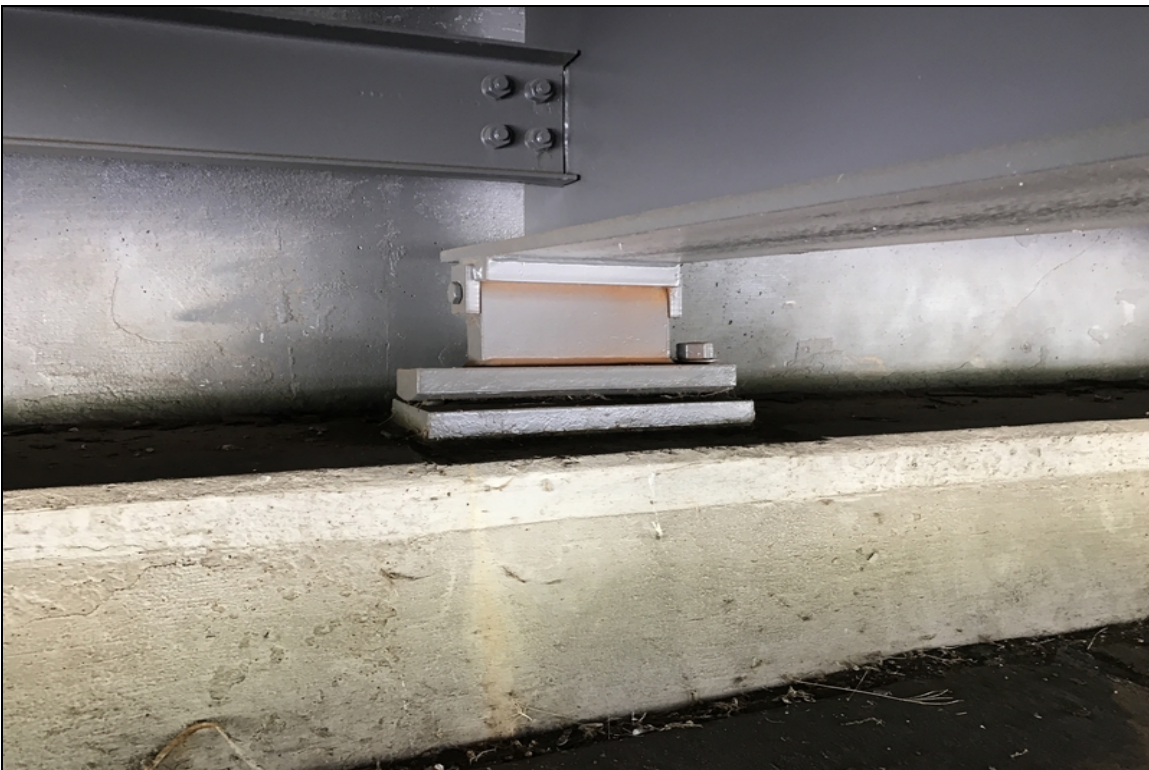
Fretting dust in the bearing area.

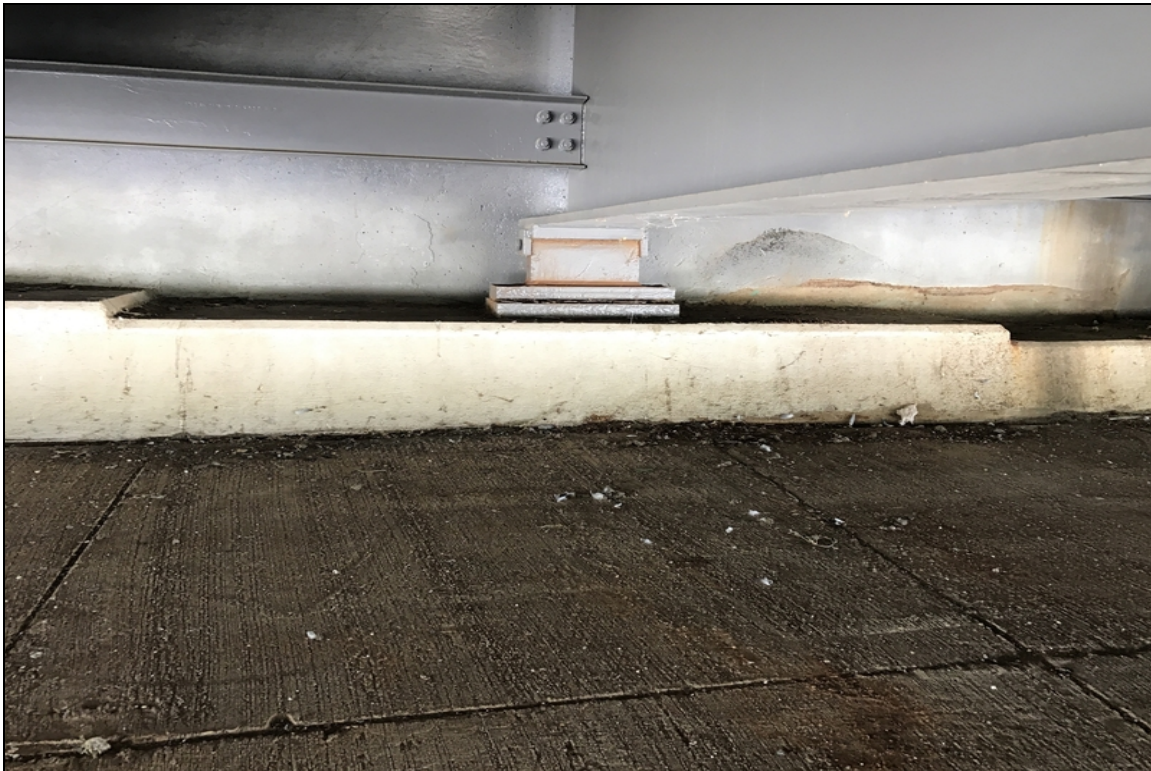
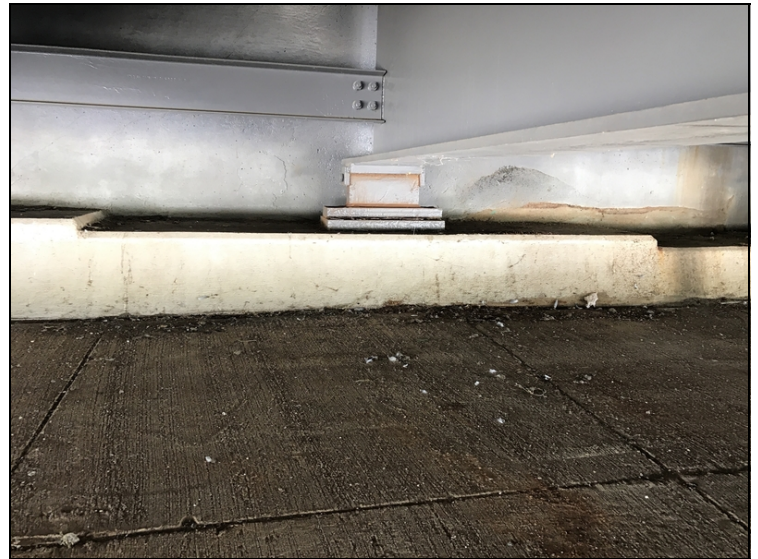
Bearing #6 at abutment #1 missing anchor bolts

Bearings #6, #7, #9, & #10 at abutment #1 are missing one anchor bolt.

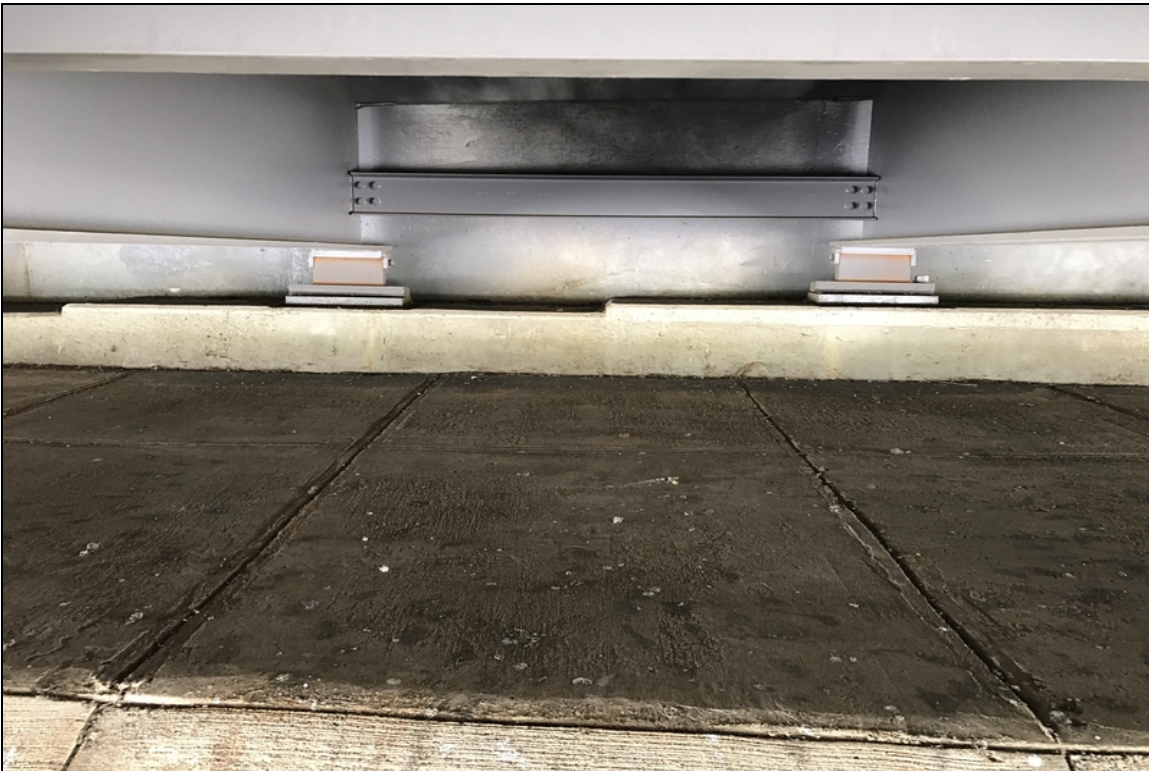
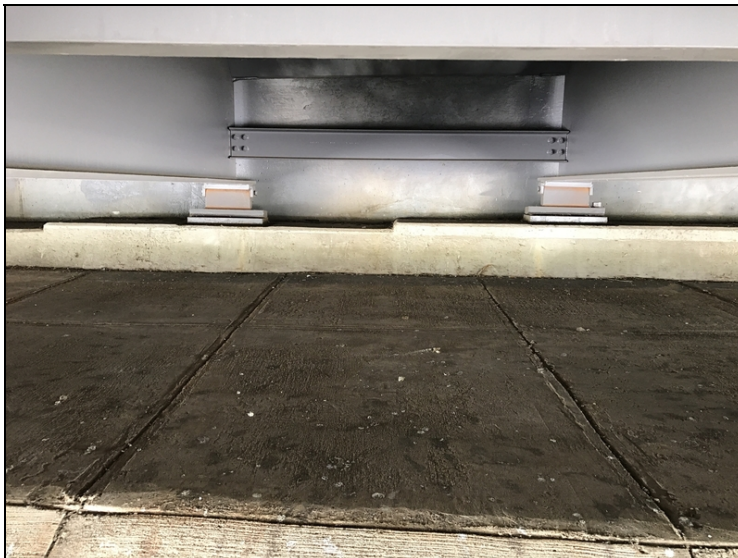
Bearings #6 and #7 at abutment #2 missing anchor bolts.

Bearings #7, 9 and #10 at abutment #2 are missing one anchor bolt.

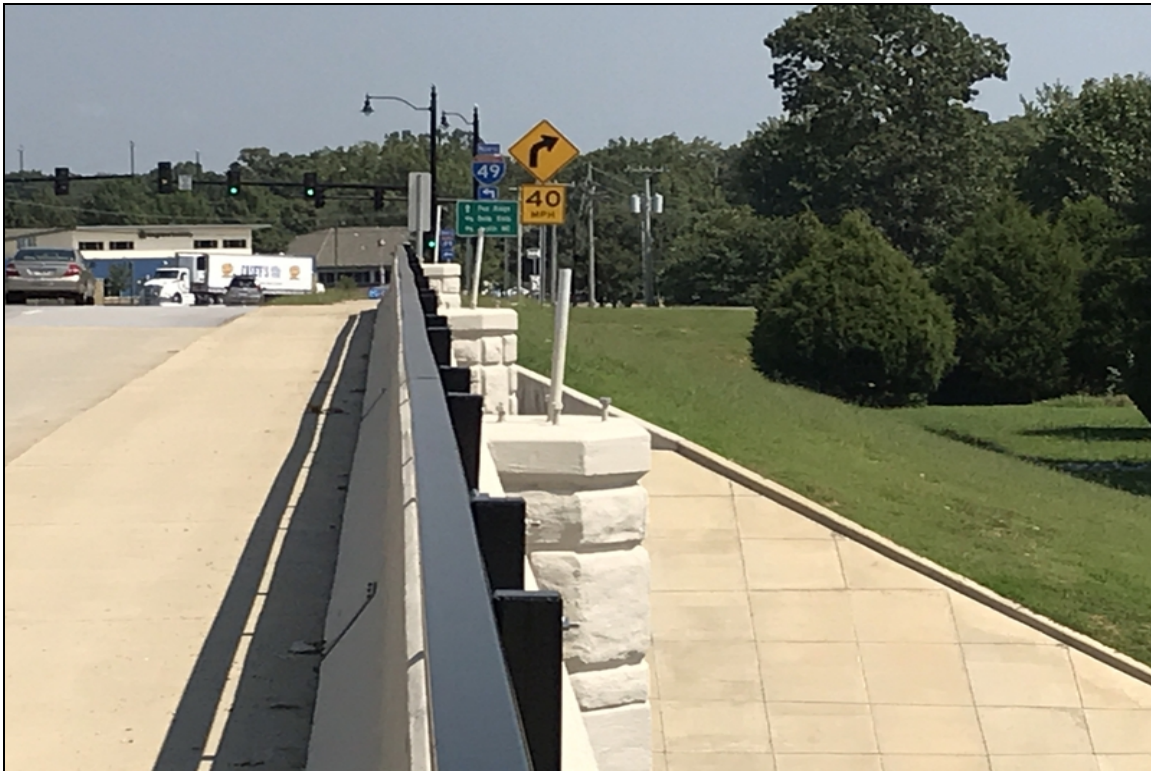
(330)							
10/5/2021 WNR & DBM:							
-During this inspection only the right parapet had metal railing attached to it. Additionally the PVC conduit was plumbed for the street lights but they have not been placed yet.							
331	Reinforced Concrete Bridge Railing	LF	532	347	185	0	0
1130	Cracking (RC and Other)	LF	185	0	185	0	0

Bases for light poles not yet installed.

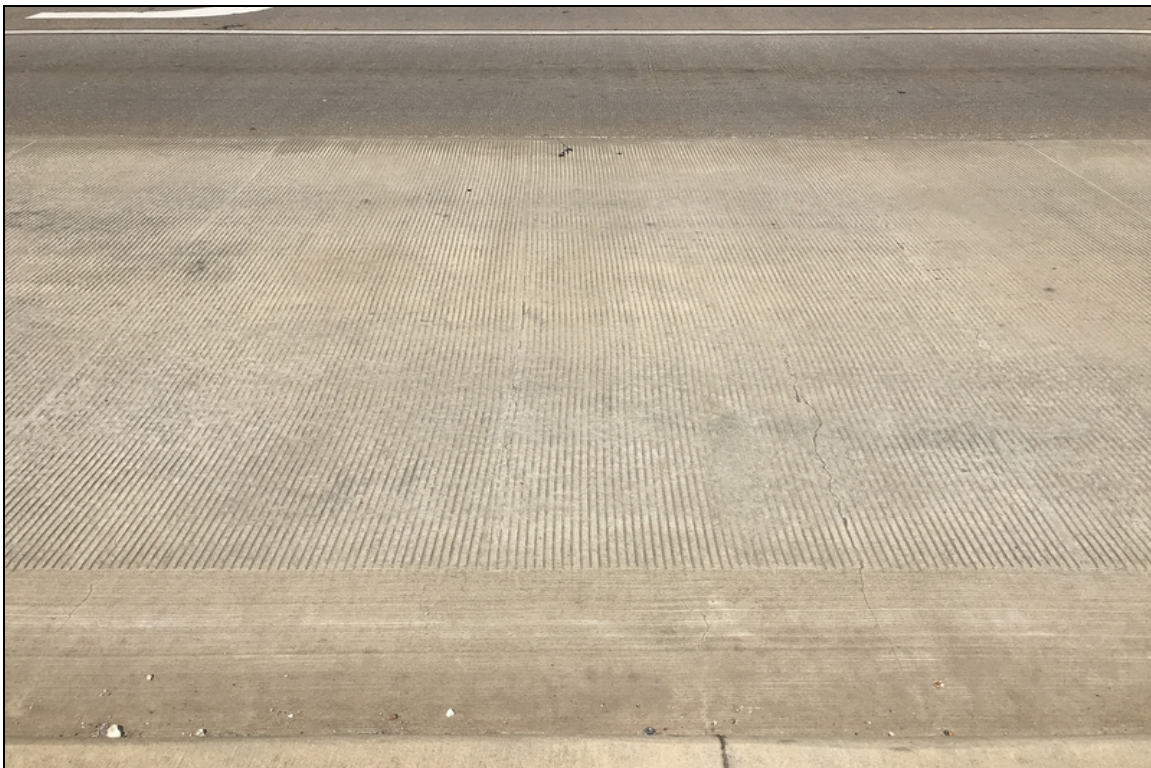
(12)							
10/5/2021 WNR & DBM: -The new widened driving surface of the deck southbound side has numerous longitudinal and transverse sealable cracks in random locations. -The new widened driving surface of the northbound lanes has numerous transverse sealable deck cracks in random locations. -The original deck surface has longitudinal cracking in random locations, as well as wearing and abrasion in the wheel paths.							
107	Steel Open Girder/Beam	LF	30056	30053	0	3	0
1900	Distortion	LF	3	0	0	3	0
515	Steel Protective Coating	SF	35205	35197	0	8	0
3410	Chalking (Steel Protective Coatings)	SF	0	0	0	0	0
3440	Effectiveness (Steel Protective Coatings)	SF	8	0	0	8	0

General view of cracking in new portions of the deck.

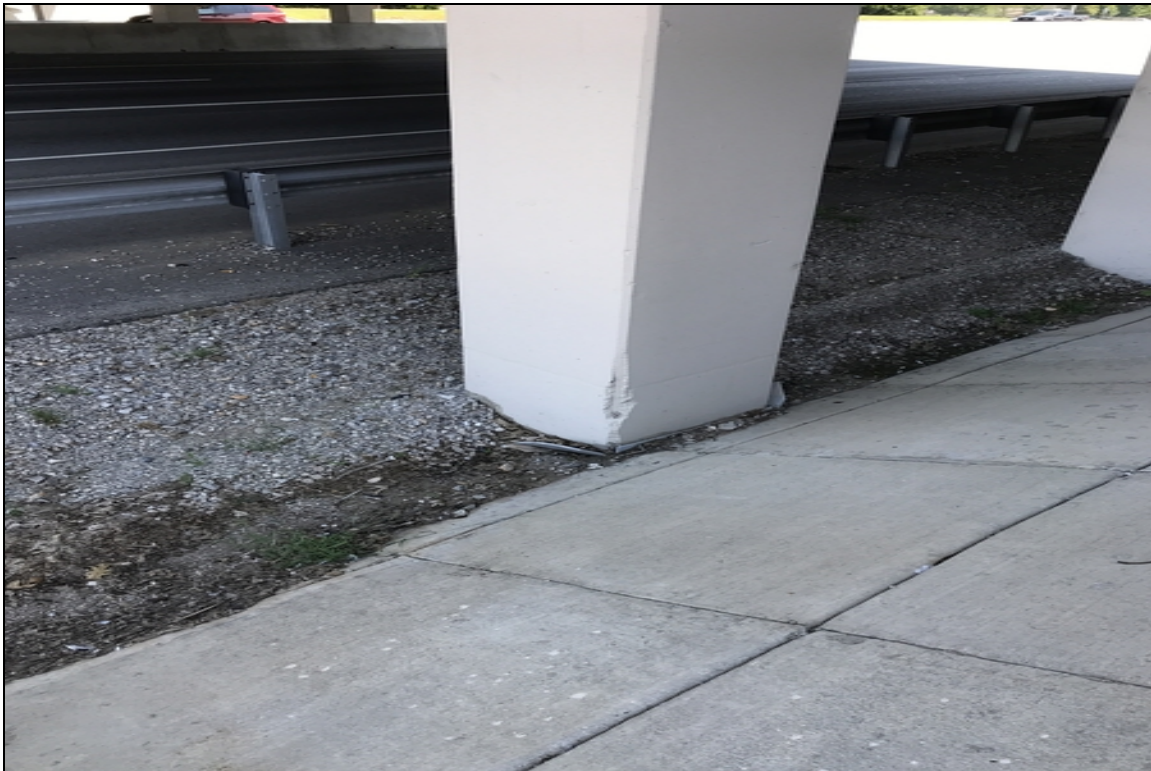
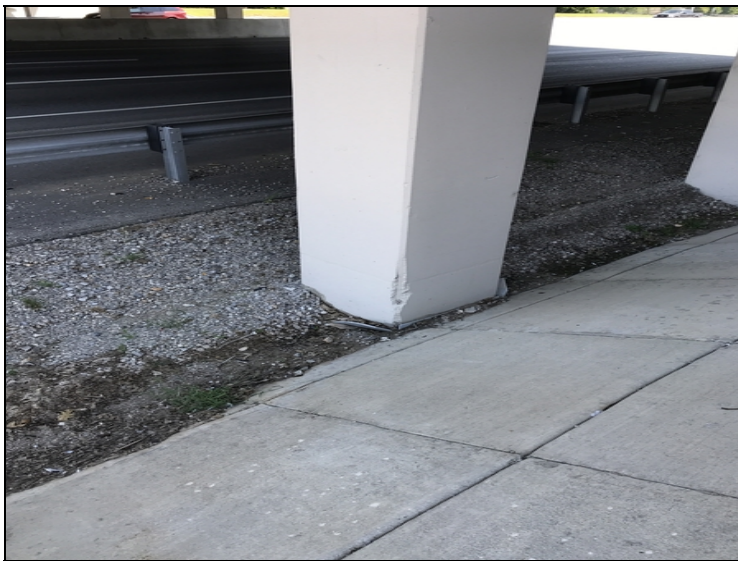
Bent #1 column #1

205	Reinforced Concrete Column	EA	18	17	0	1	0
1080	Delamination/Spall/Patched Area	EA	1	0	0	1	0
(205)							
10/5/2021 WNR & DBM: -The recently constructed column #1 of bent #1 has a spalled area with no exposed reinforcing steel approximately 12" from base of column.							
215	Reinforced Concrete Abutment	LF	167	149	18	0	0
1080	Delamination/Spall/Patched Area	LF	5	0	5	0	0
1130	Cracking (RC and Other)	LF	13	0	13	0	0

Substructure - The recently constructed column #1 of bent #1 has a spall approximately 14" high and 1" deep located at the base of column.

09/04/2019 WNR: This maintenance need is still relevant contractor forces have just painted over the area.

Under contract CA0902. This Maintenance Need will be forwarded to RE C2, Kip Guthrie, with instructions for directing the Contractor to correct this deficiency.

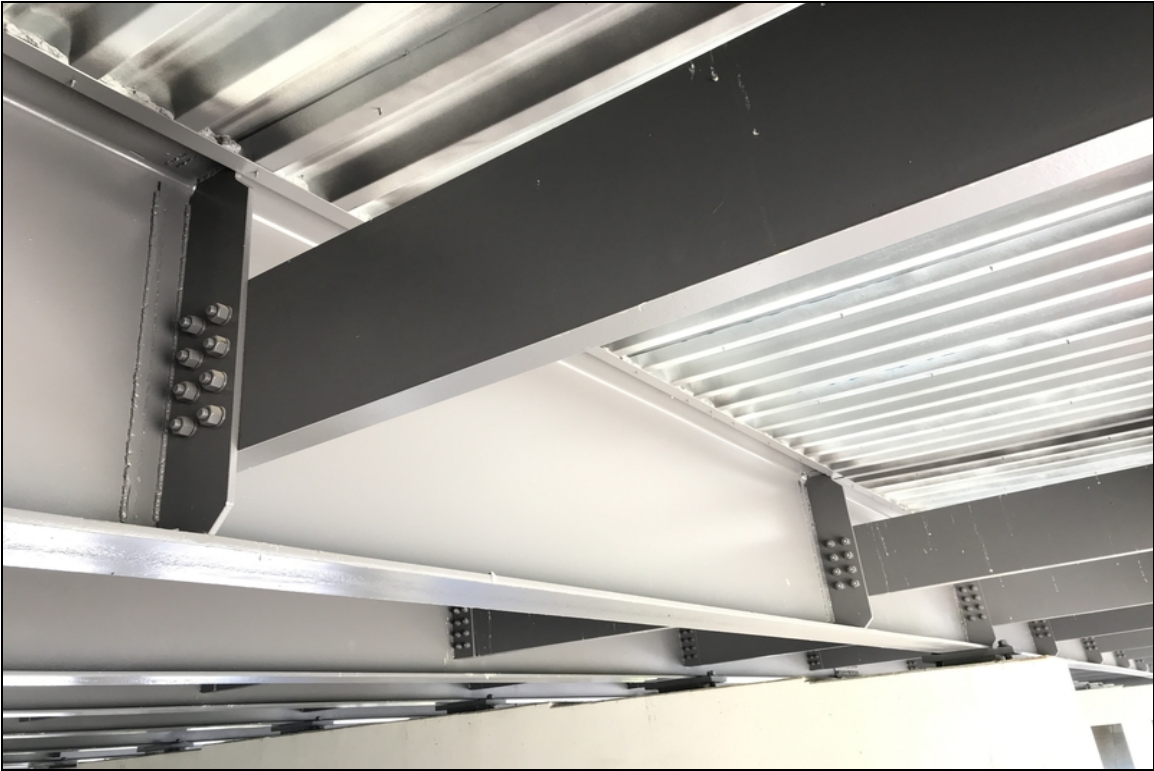
Contractors have placed welded repairs in previous gouged web and flange locations.

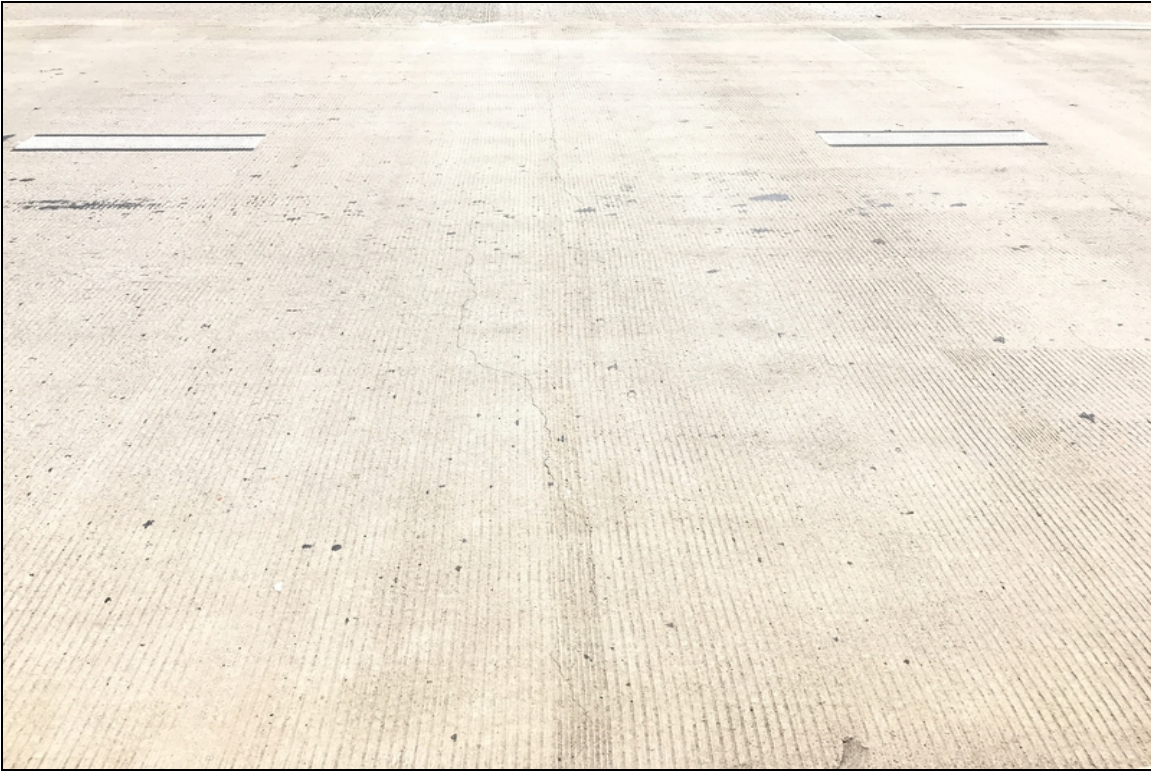
South bound lanes typical transverse cracking

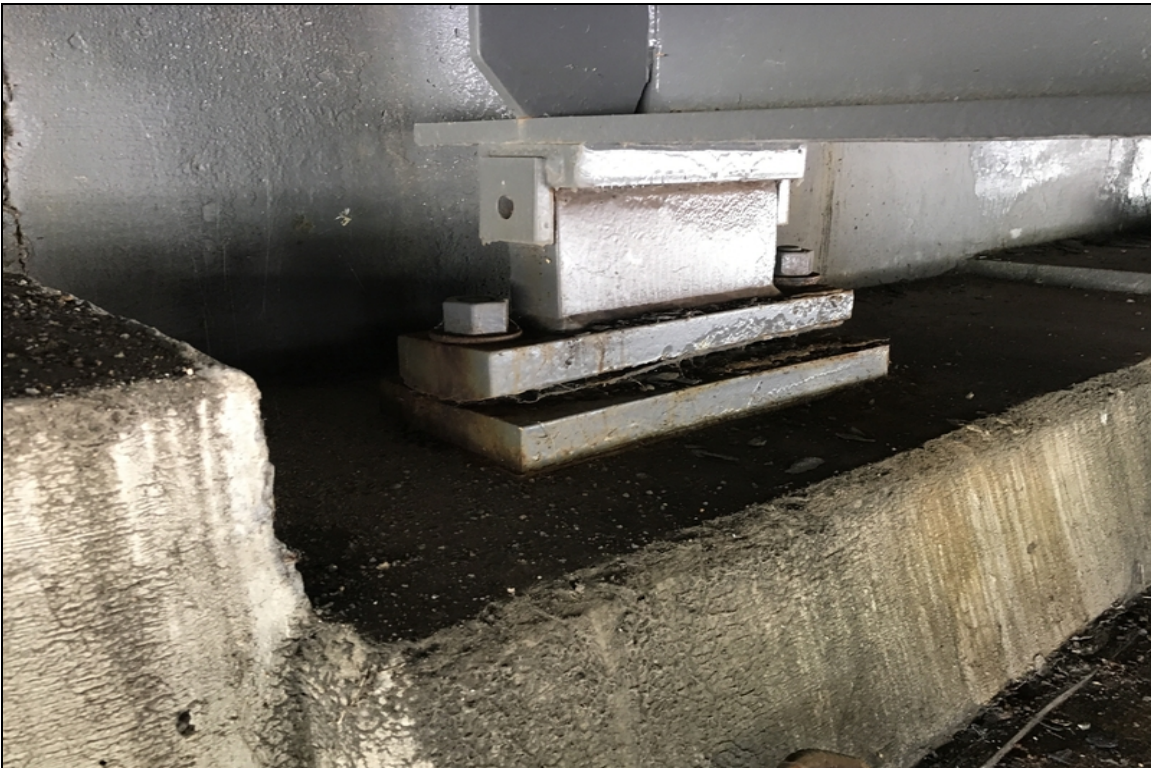
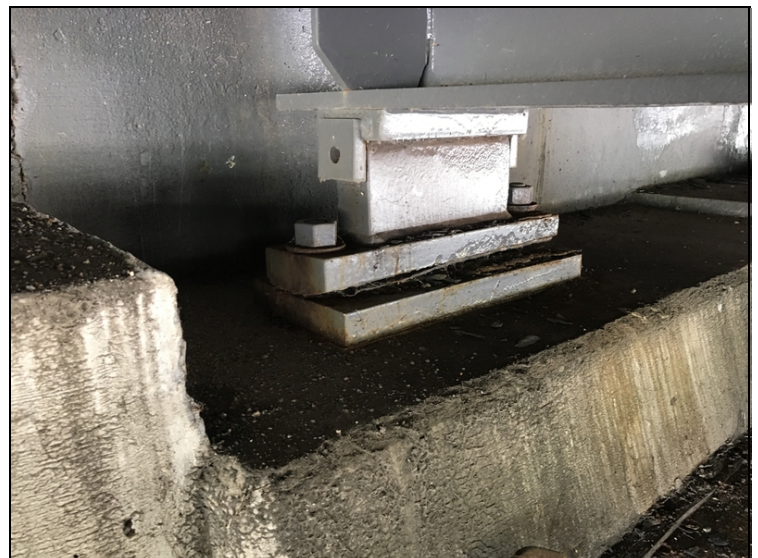
Abutment #2 bearing #5 left bolt that attaches sole plate to rocker bearing.

Bearing #5 at abutment #1 and bearings #5 and #10 at abutment #2 are missing one bolt that attaches the soleplate to the bearing device.

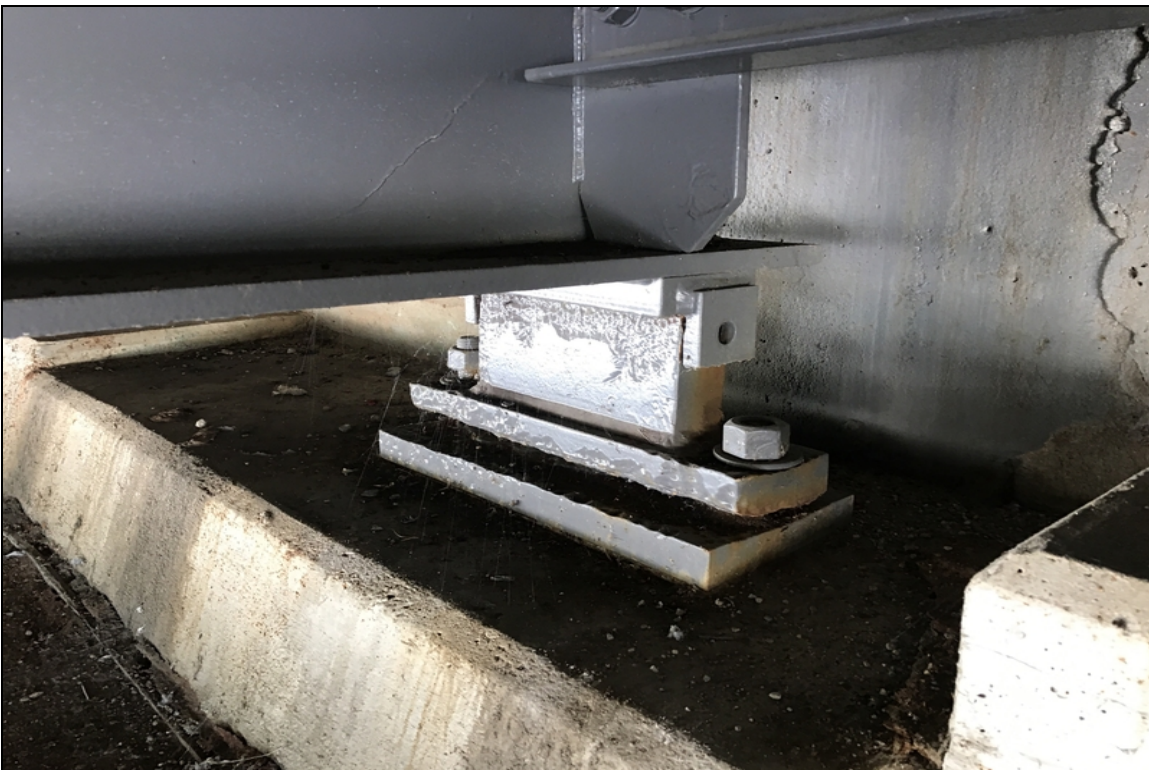
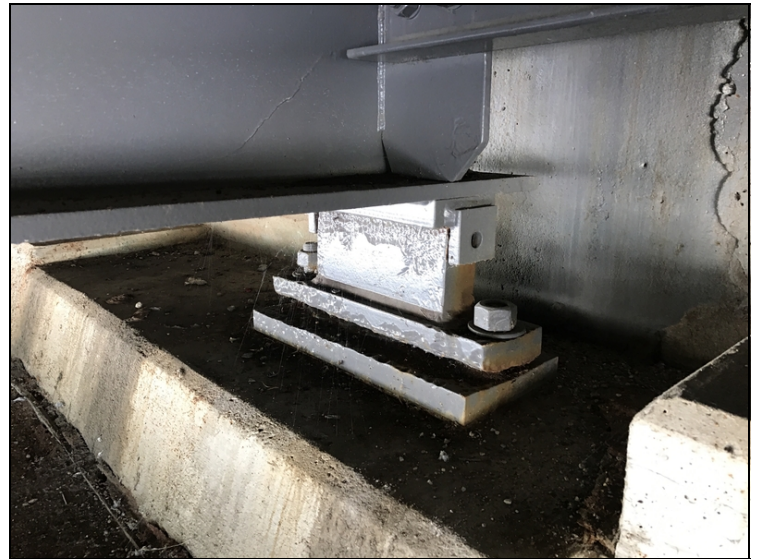
Bearing #5 at abutment #1 missing bolt that attaches the sole plate to the bearing.

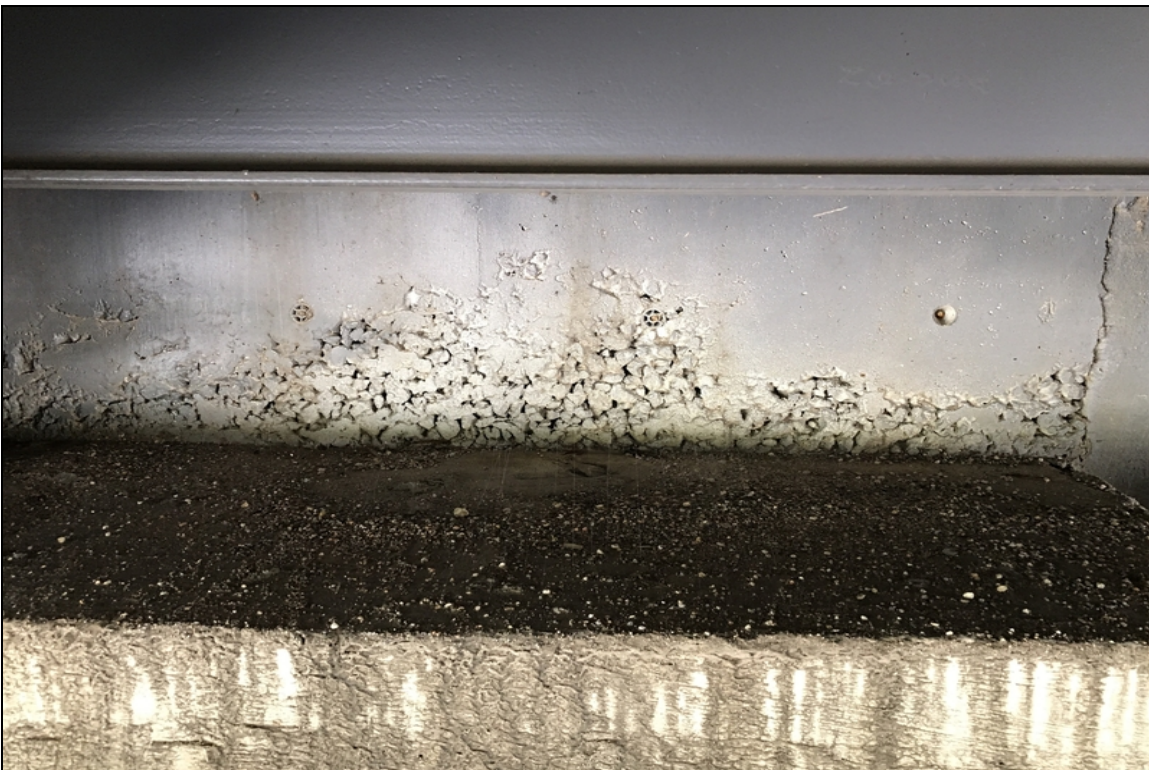
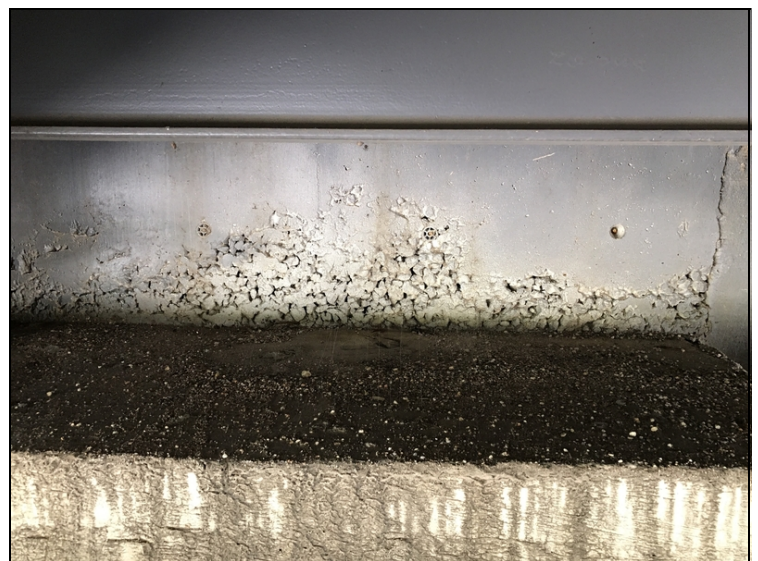
ELEM	DESCRIPTION	UNITS	TOTAL	CS1	CS2	CS3	CS4
also has multiple areas of small shallow spalls on top of the abutment in same locations. -The abutment has been widened since last inspection. -The left side of the widened portion of abutment #2 backwall has a large area of honeycombing above the bridge seat. -Abutment #2 top of backwall (driving surface) - road-iron is approximately 0.5" lower than deck road-iron.							
234	Reinforced Concrete Pier Cap	LF	229	229	0	0	0

Honeycombing and un-grouted snap ties at abutment #2.

Substructure - The widened portion of abutments have ungrouted snap-tie holes from the construction process. The widened portion of abutment #2 backwall has a large area of honeycombing above the bridge seat on the left side.

Under contract CA0902. This Maintenance Need will be forwarded to RE C2, Kip Guthrie, with instructions for directing the Contractor to correct this deficiency.

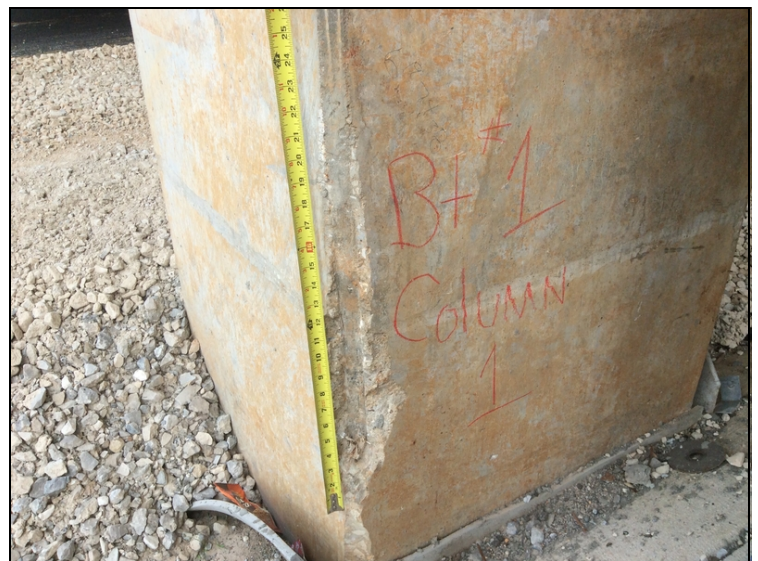
Bent #1, column #1-Spalled area.

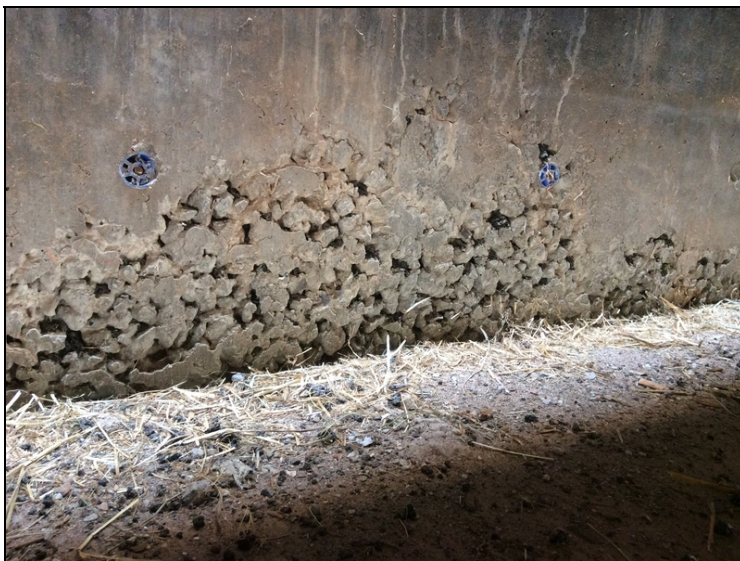
Abutment #2-Honeycombing in backwall.

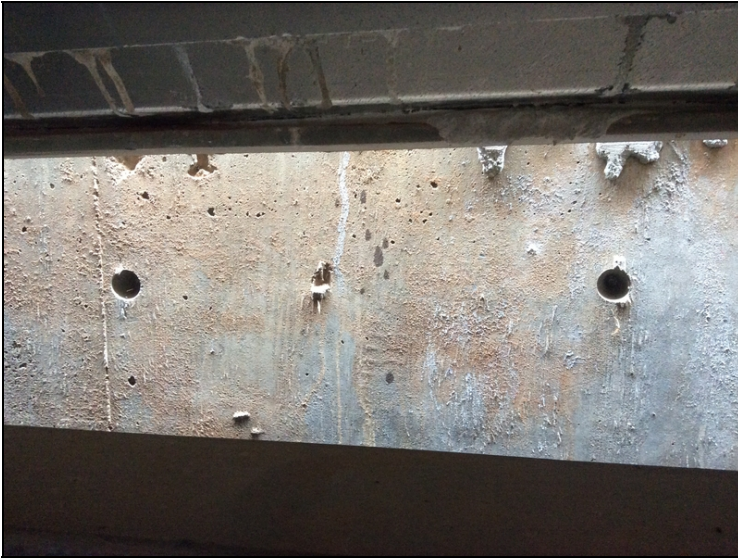
Abutment #2-Snap-tie holes ungrouted.

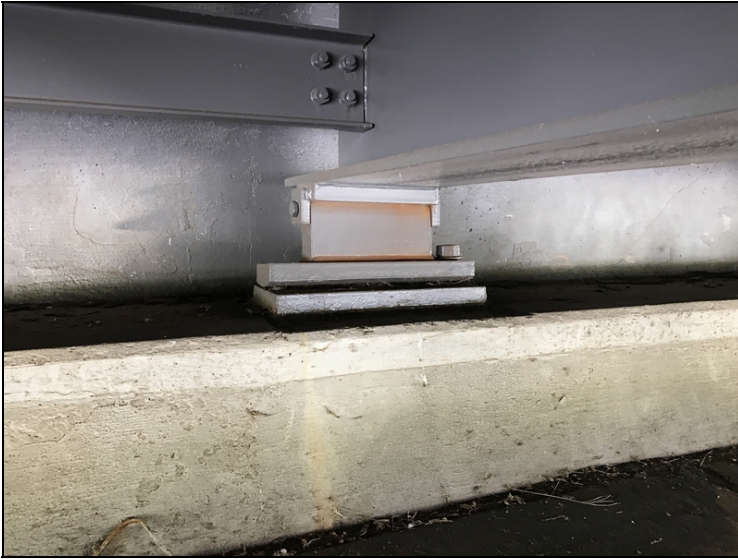
09/04/2019 WNR: This maintenance need is still relevant many bolts are still missing from bearings and some new bolts are now missing from bearings.

Fretting dust in the bearing area.

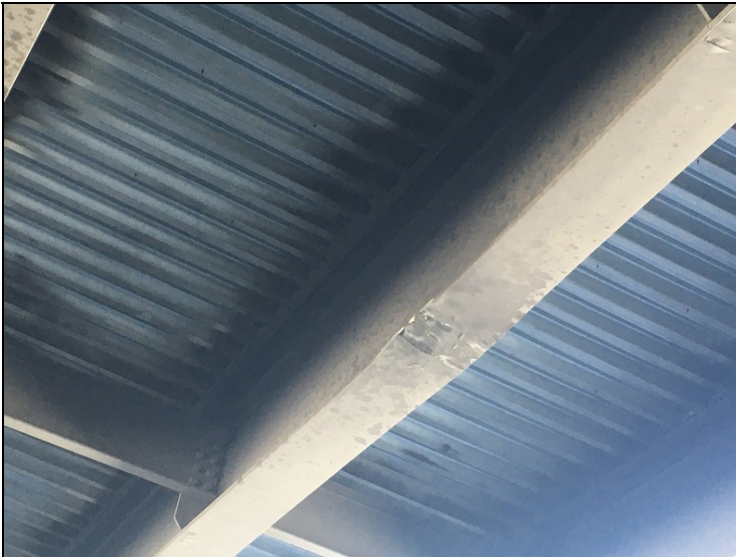
Span #3- beam #3 has 3" of upward distortion on the bottom flange for 1' that is 41' ahead of bent #2 due to an excavator impact accident on 8/24/21. The beam has flaking paint on the bottom flange 5' ahead of the point of impact. Beam #8 has 2" of upward distortion on the bottom flange 41' ahead of bent #2. Beam #9 has a small area of flaking paint #3 diaphragm due to the beam flexing during the impact. Beam #12 has 3" of upward distortion on the bottom flange for 1' that is 41' ahead of bent #2. The bottom flange of beam #12 has flaking paint beneath the #3 and #4 diaphragms behind and ahead of the point of impact.

Beam #3 span #3 has 3" of upward distortion on the bottom flange for 1'. 41' ahead of bent #2.

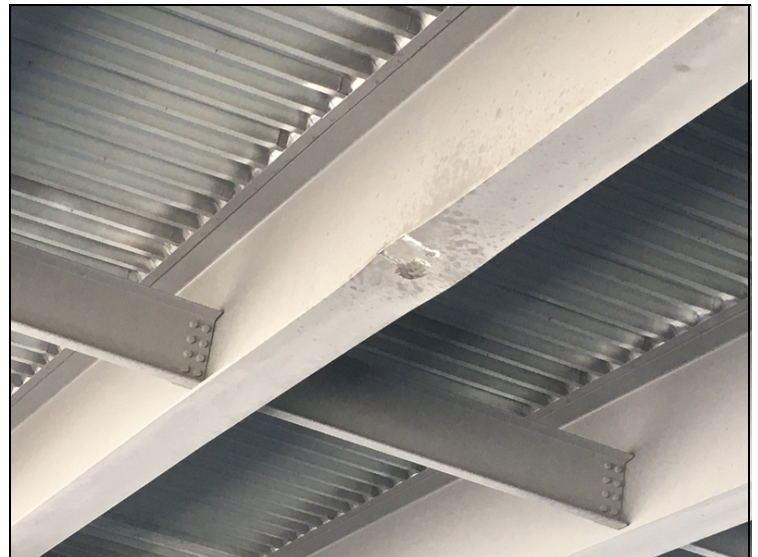
Beam #8 in span #3 has 2" of upward distortion on the bottom flange for 1'.

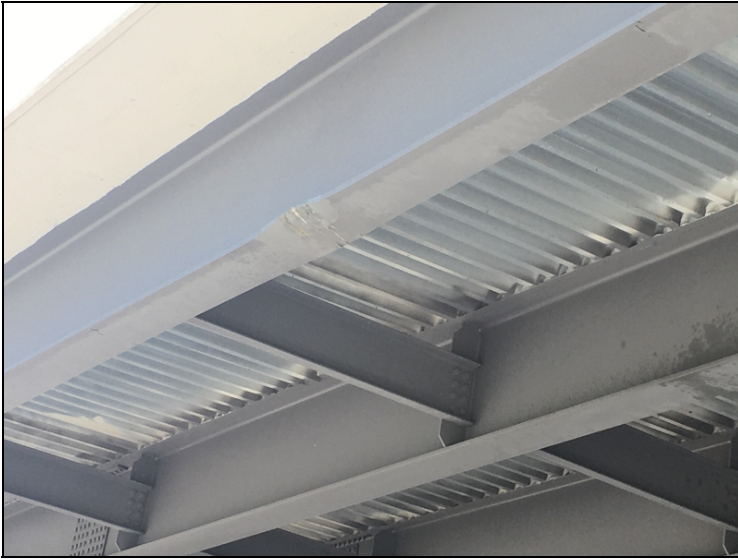
Beam #12 has 3" of upward distortion on the bottom flange for 1'.
