Bridge #07056(Routine, Underwater type 2)

SH 72 Benton 1 over LITTLE SUGAR CREEK

Team Lead: Nathan Rowland Inspection Date: April 29, 2021

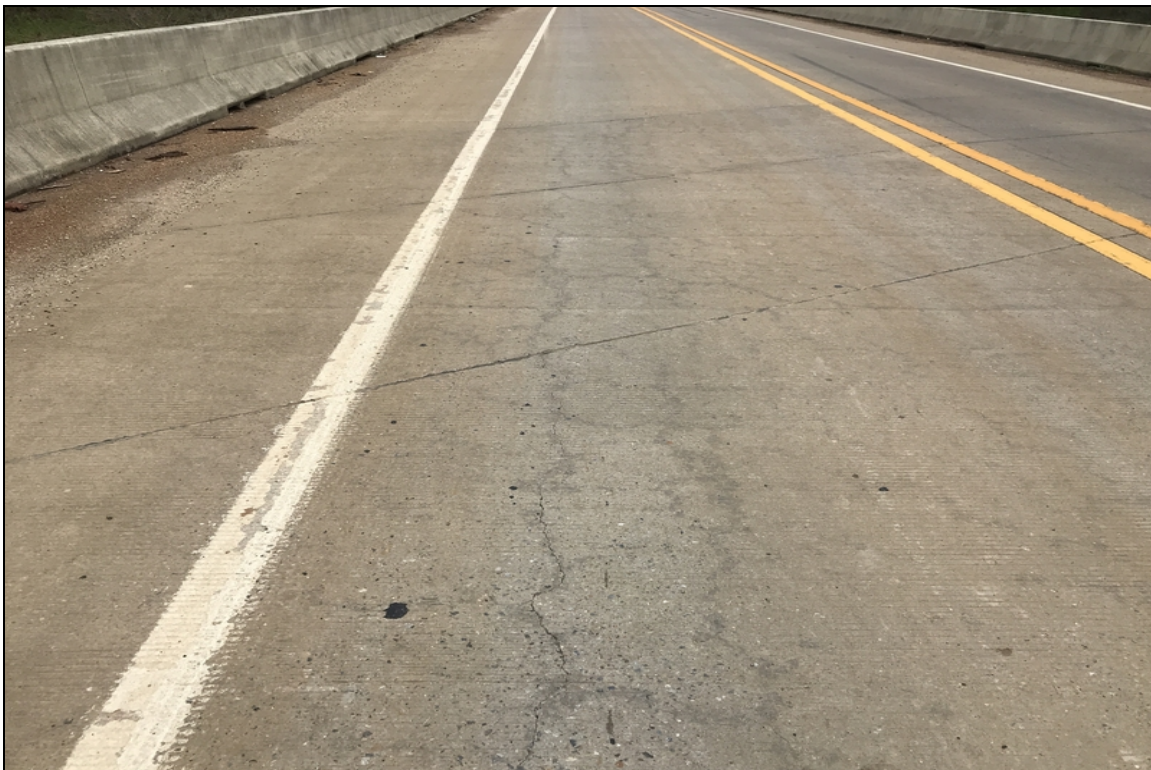
| ELEM | DESCRIPTION | UNITS | TOTAL | CS1 | CS2 | CS3 | CS4 |
|--|---|---|---|---|---|---|---|
| 04/29/2021 WNR & DBM:<br>Driving surface:<br>- Left and right lanes have longitudinal cracking throughout the entire deck at random locations<br>- The wheel paths of the left and right lanes have light wear.<br>- The gutter line at the right and left sides both have minor debris accumulation.<br>- South approach roadway in the left lane has minor settlement. | | | | | | | |

Longitudinal cracking over bent #1 in south bound lanes.

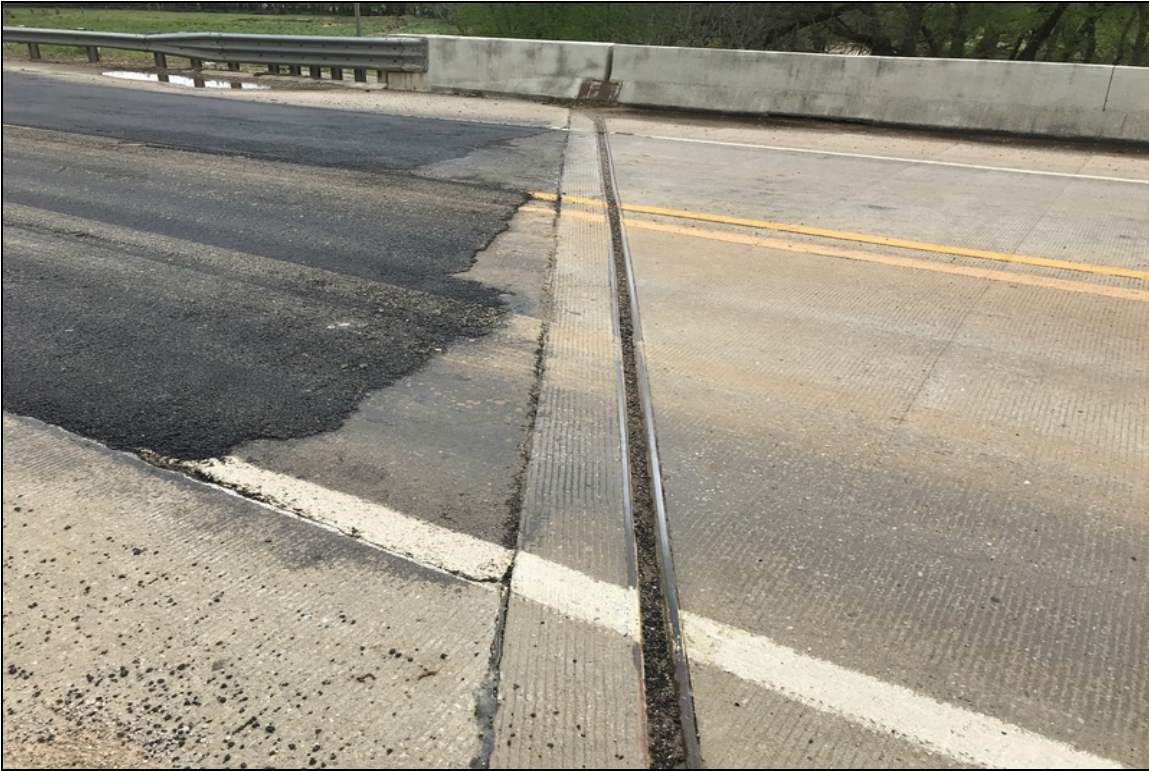
| ELEM | DESCRIPTION | UNITS | TOTAL | CS1 | CS2 | CS3 | CS4 |
|--|---|---|---|---|---|---|---|
| 04/29/2021 WNR & DBM:<br>- Abutments 1 & 2 have loose debris impaction the full width of expansion joints. | | | | | | | |

Abutment #2 expansion joint debris impact

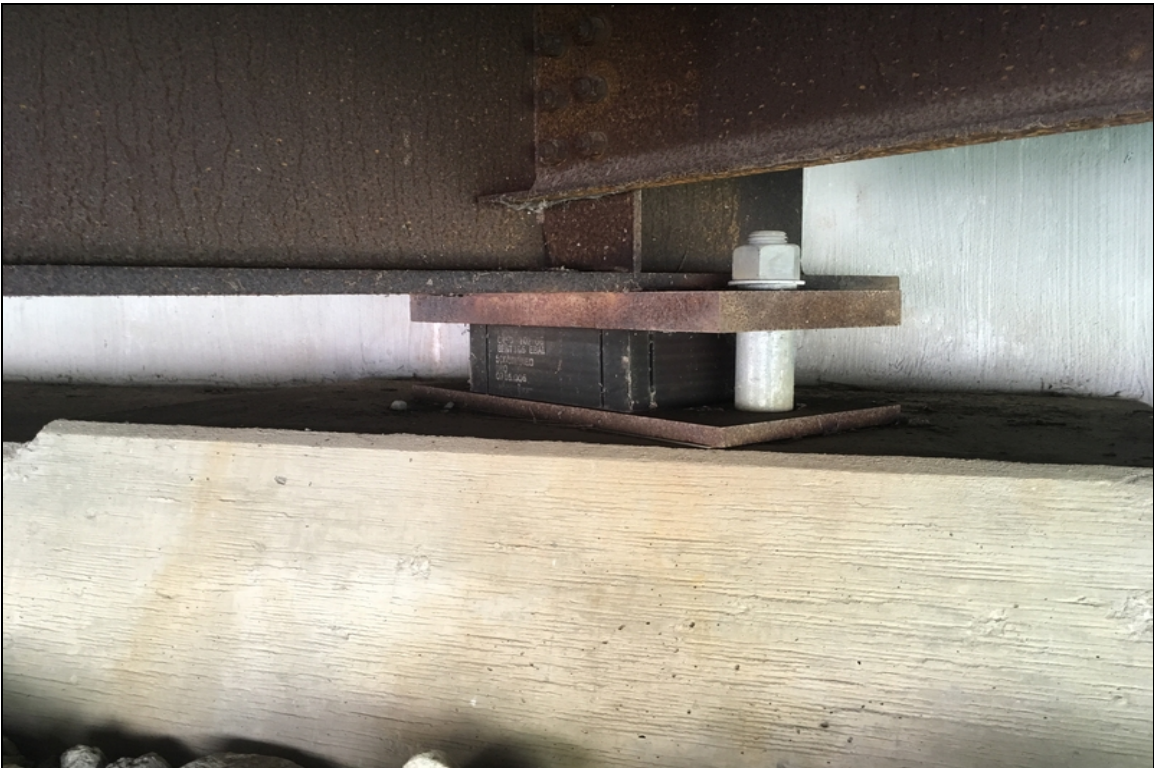
| ELEM | DESCRIPTION | UNITS | TOTAL | CS1 | CS2 | CS3 | CS4 |
|--|---|---|---|---|---|---|---|
| 04/29/2021 WNR & DBM:<br>Abutment #1 bearings- #1,5 have corrosion with flaking rust due to a leaking expansion joint.<br><br>Bent #1 bearings- no deficiencies noted on all 5.<br><br>Bent #2 bearings- no deficiencies noted on all 5.<br><br>Bent #3 bearings- no deficiencies noted on all 5.<br><br>Bent #4 bearings- no deficiencies noted on all 5.<br><br>Abutment #2 bearings- bearings #1,5 both have corrosion with flaking rust due to a leaking joint seal. | | | | | | | |

Typical view of the 5 bearings at abutment #1.

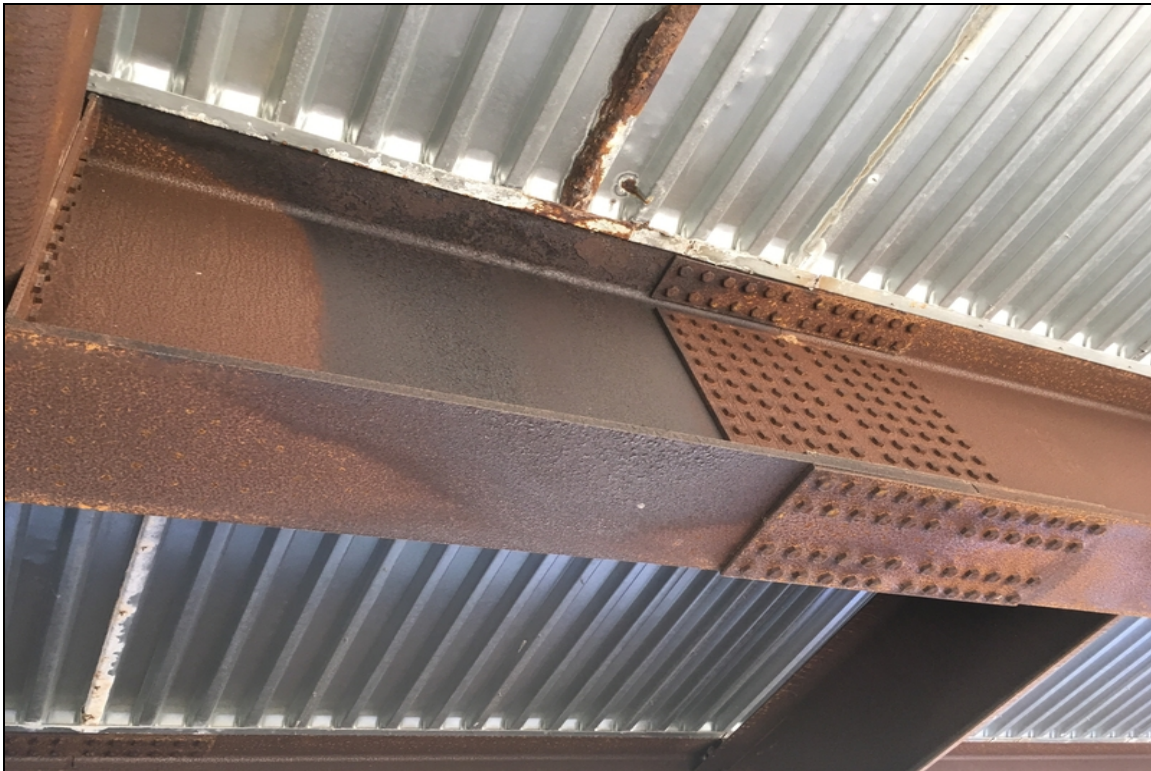
| ELEM | DESCRIPTION | UNITS | TOTAL | CS1 | CS2 | CS3 | CS4 |
|--|---|---|---|---|---|---|---|
| Span 2 - has 4' of corrosion with flaking rust on beam #3 in span #2 at the field splice. | | | | | | | |

4' of corrosion with flaking rust on beam #3 in span #2 at the field splice.

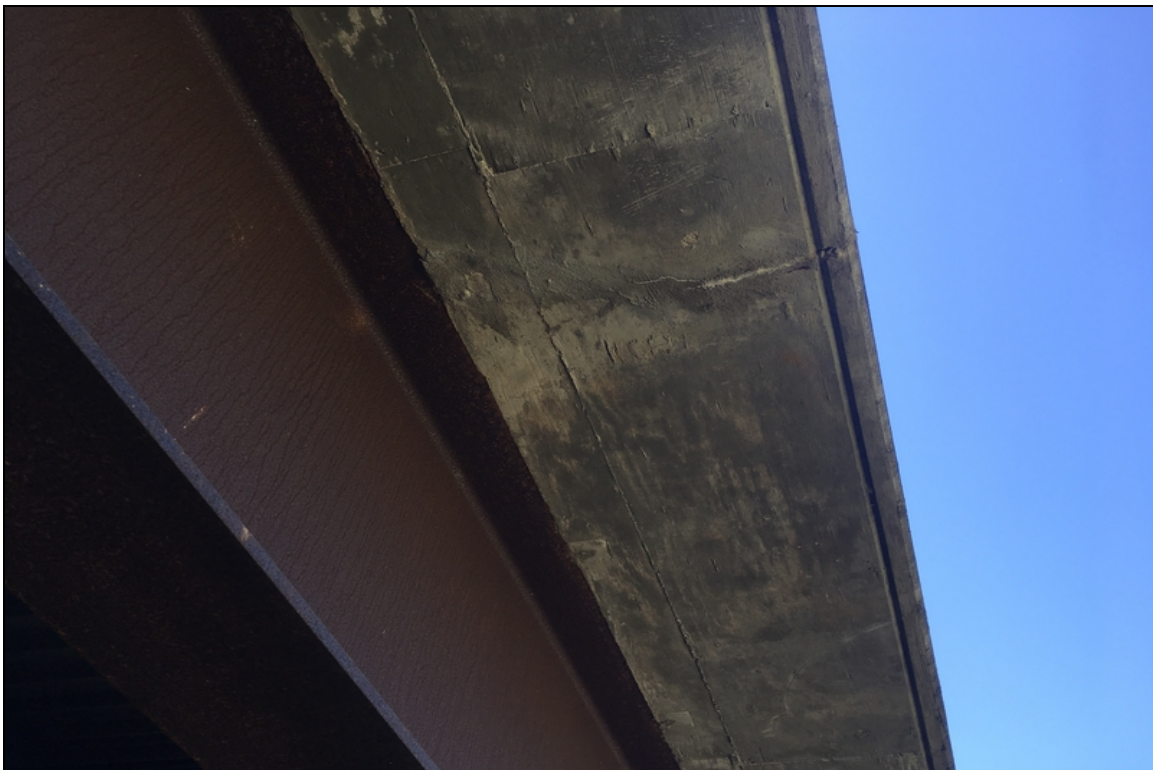
| ELEM | DESCRIPTION | UNITS | TOTAL | CS1 | CS2 | CS3 | CS4 |
|--|---|---|---|---|---|---|---|
| Deck Undersurface:<br>- The undersurface of the deck overhangs have transverse cracking with light efflorescence at random spacing in all spans.<br>Span #2- bays 2 & 3 have corrosion in the SIP forms 15' from bent #1 beneath the pourable joint seal. | | | | | | | |

Typical efflorescence cracking in the deck over hangs.

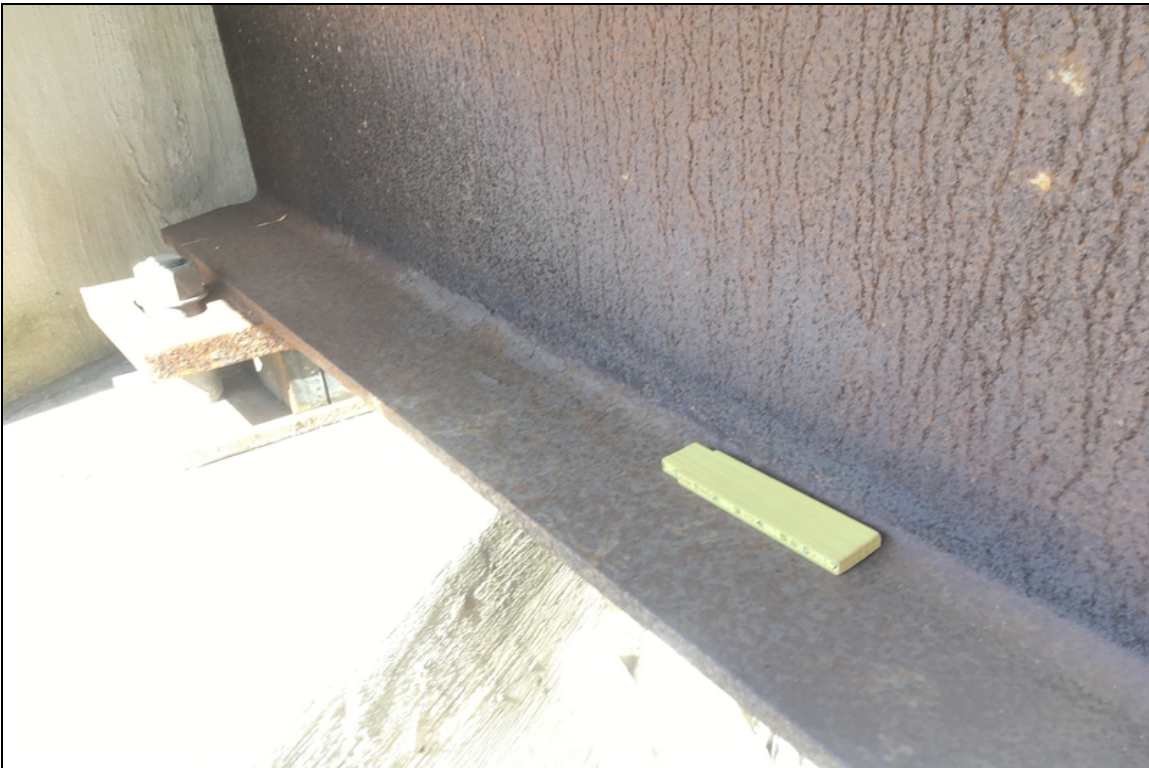
| ELEM | DESCRIPTION | UNITS | TOTAL | CS1 | CS2 | CS3 | CS4 |
|--|---|---|---|---|---|---|---|
| Span #1- beam #1 has 2' of minor corrosion on the web at the beginning of the span. Beam #5 on the exterior side has 4' of minor corrosion on the web and bottom flange over abutment #1. The weathering steel patina is dark and has developed flaking in the affected area. | | | | | | | |

Minor corrosion of beam #5 in span #1. Typical of other locations.

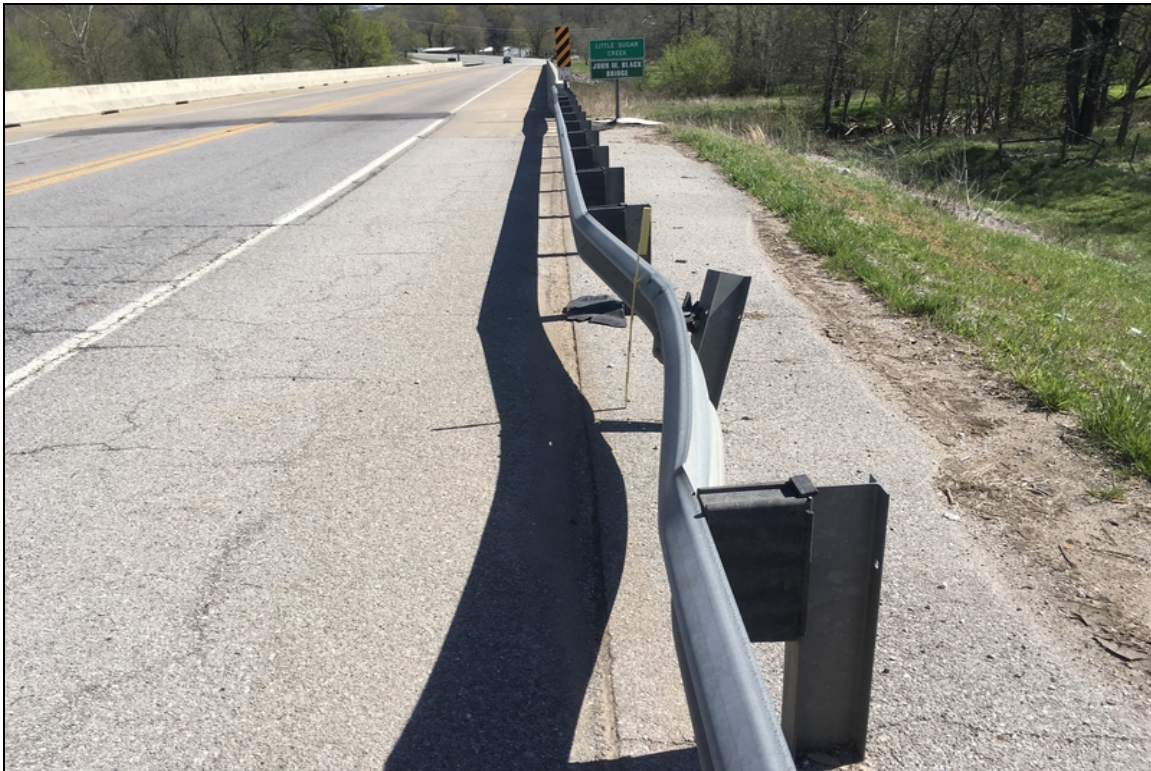
Approach guard rail damage at the right beginning of the structure.

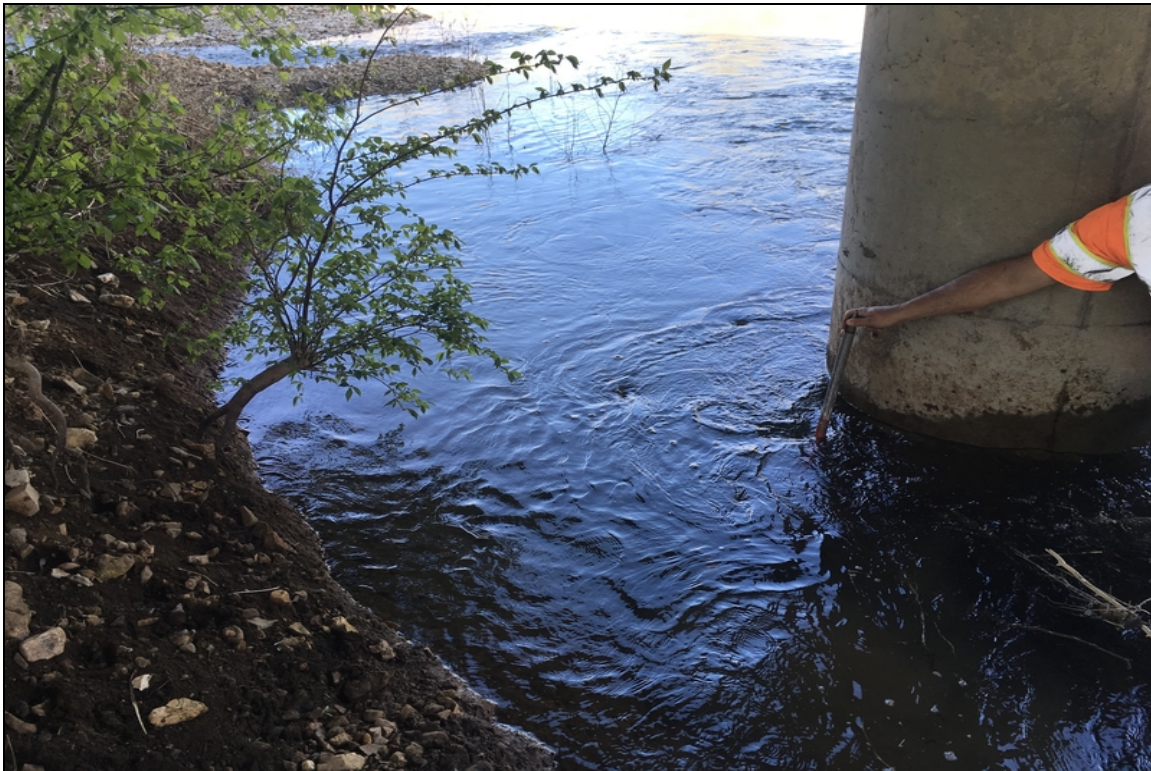
| ELEM | DESCRIPTION | UNITS | TOTAL | CS1 | CS2 | CS3 | CS4 |
|--|---|---|---|---|---|---|---|
| 04/29/2021 WNR & DBM:<br>Bent #1 column #3, Bent #2 column #1, Bent #3 column #3 and bent #4 column #3 all have localized scour due a flooding event. Bent #2 column #1 is the worst case condition due to minor channel migration that has directed the channel flow into the substructure. No footings were exposed at these locations.<br>- Areas of minor honeycombing are typical in the columns. | | | | | | | |

Column #1 of bent #2 showing local scour. No footing was exposed.

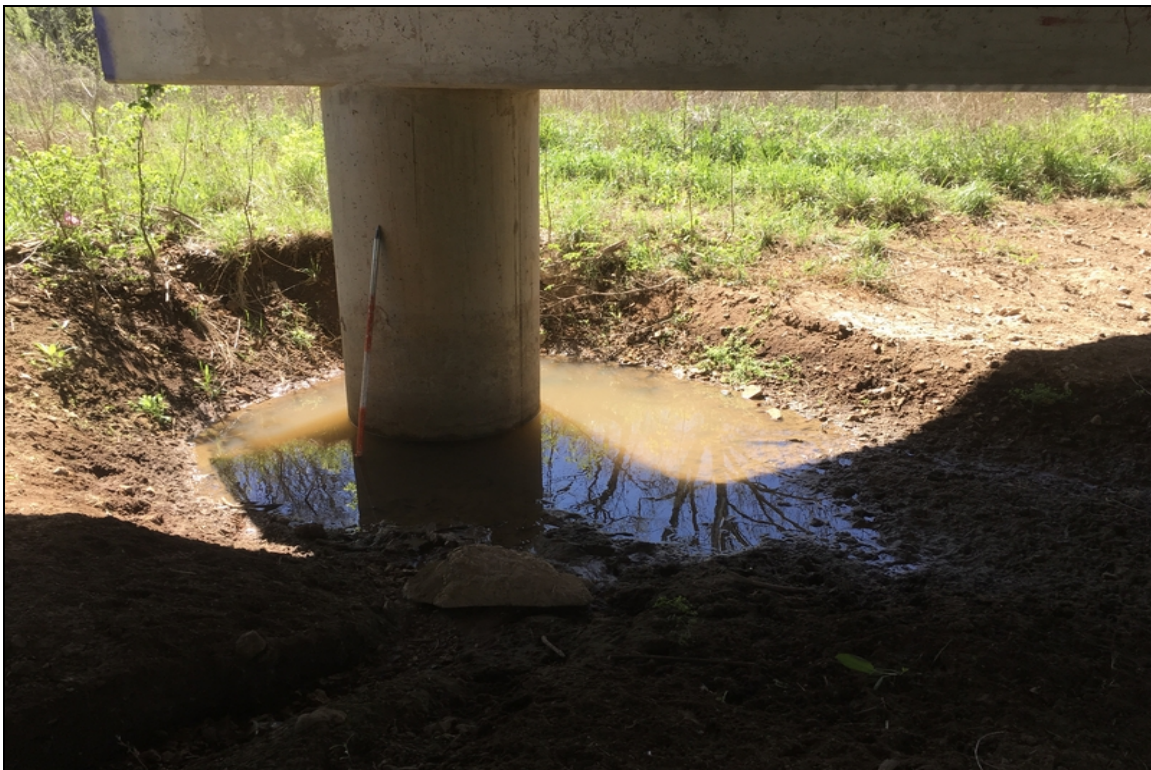
Minor local scour around column #3 of bent # 4. No footing was exposed.

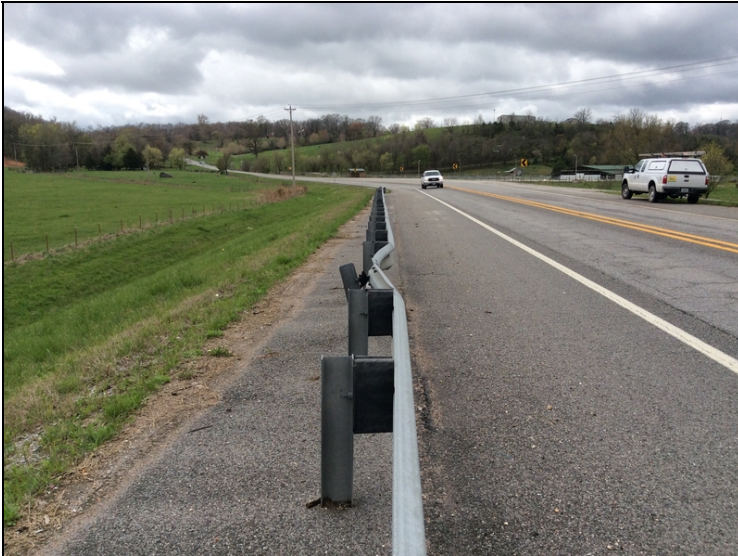
The southeast approach railing has collision damage that has created a "pocket" in the railing.

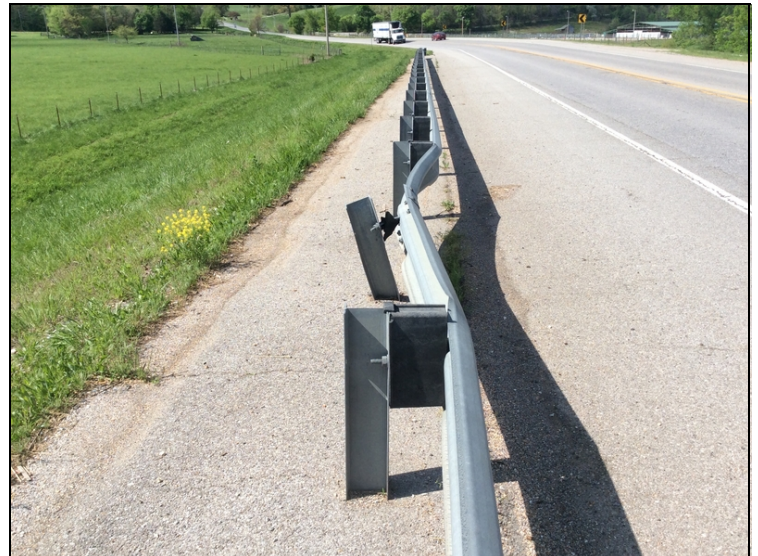
Guard rail damage at right side approach rail

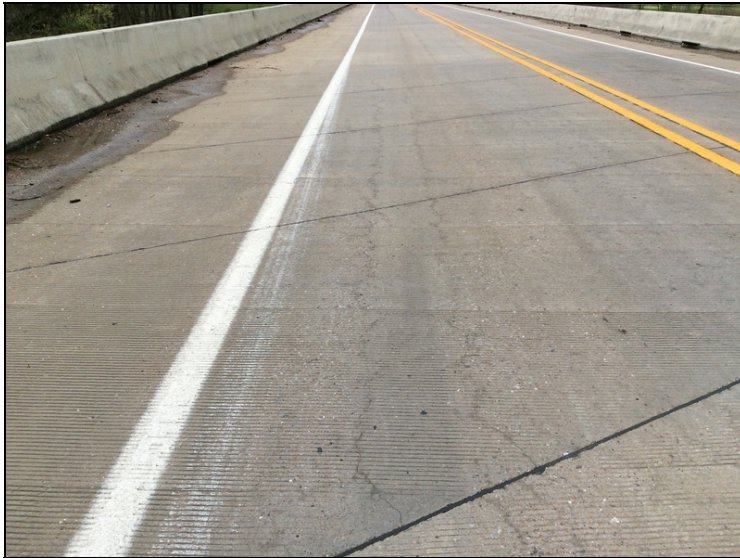
The driving surface of the deck has sealable cracking in all spans.

Typical longitudinal cracking.

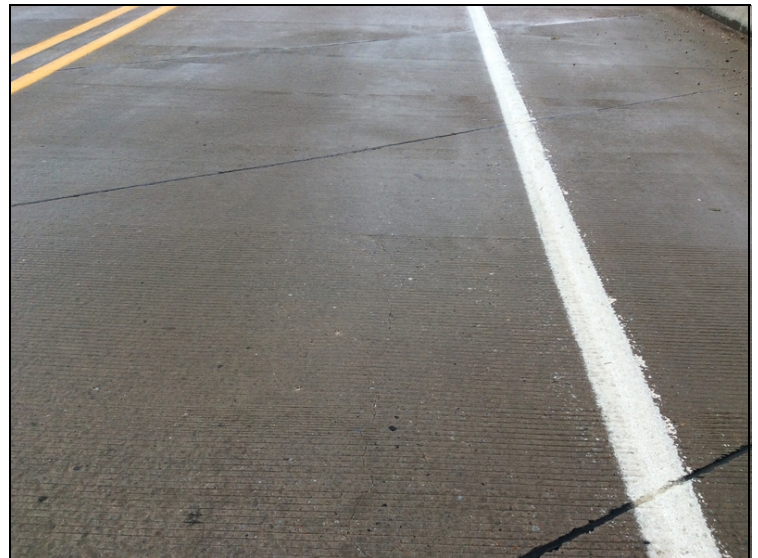
Bent 1 Left longitudinal cracking.

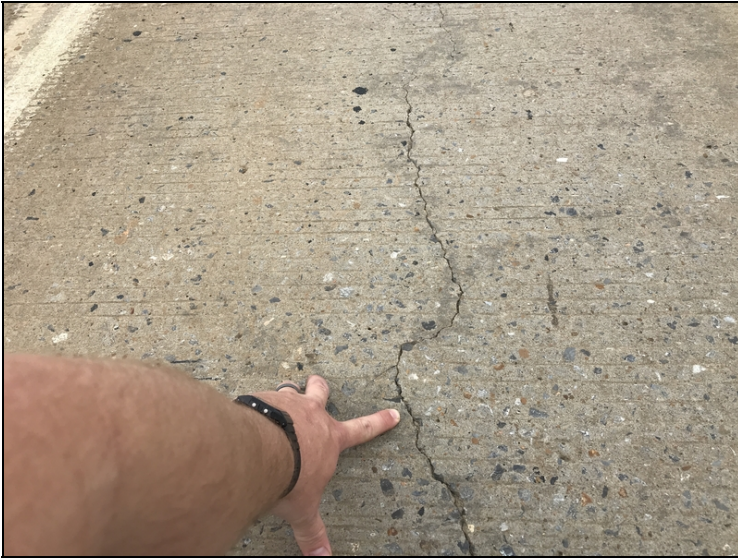
Longitudinal cracking over bent #1 in south bound lanes.

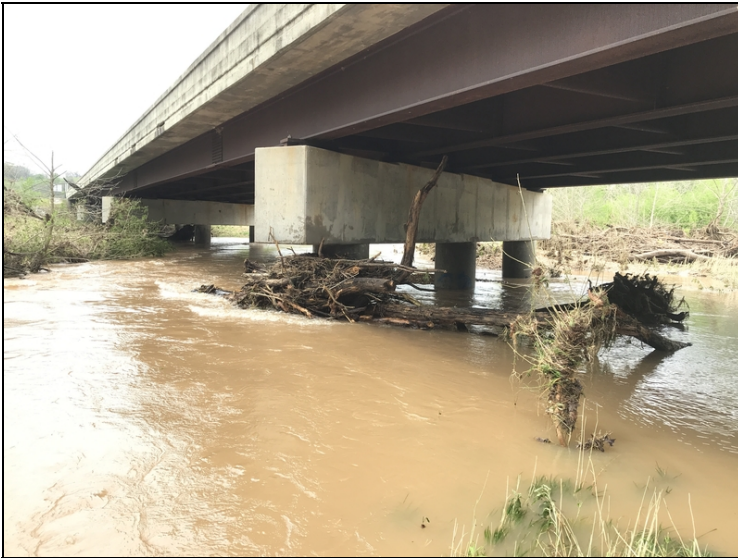
- Span #2 has a large tree that has wedged against girder #5 resulting from a high water event.
- The upstream side of Bent #3 has drift accumulation.

Bent #3 drift accumulation

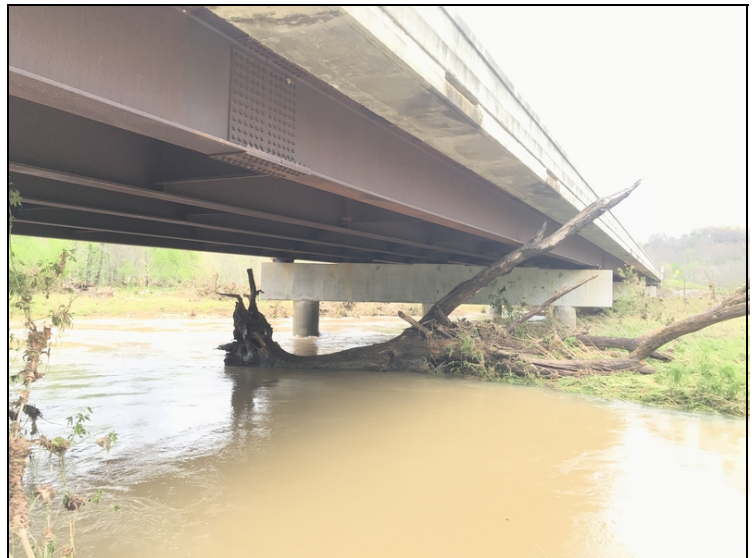
Span #2 has a large tree that has wedge against girder #5 resulting from a high water event.
