Bridge #05330(Routine)

US 65 Boone over CROOKED CREEK

Location: .48 MI E JCT SH 7

Team Lead: Benjamin Smith Inspection Date: August 26, 2020

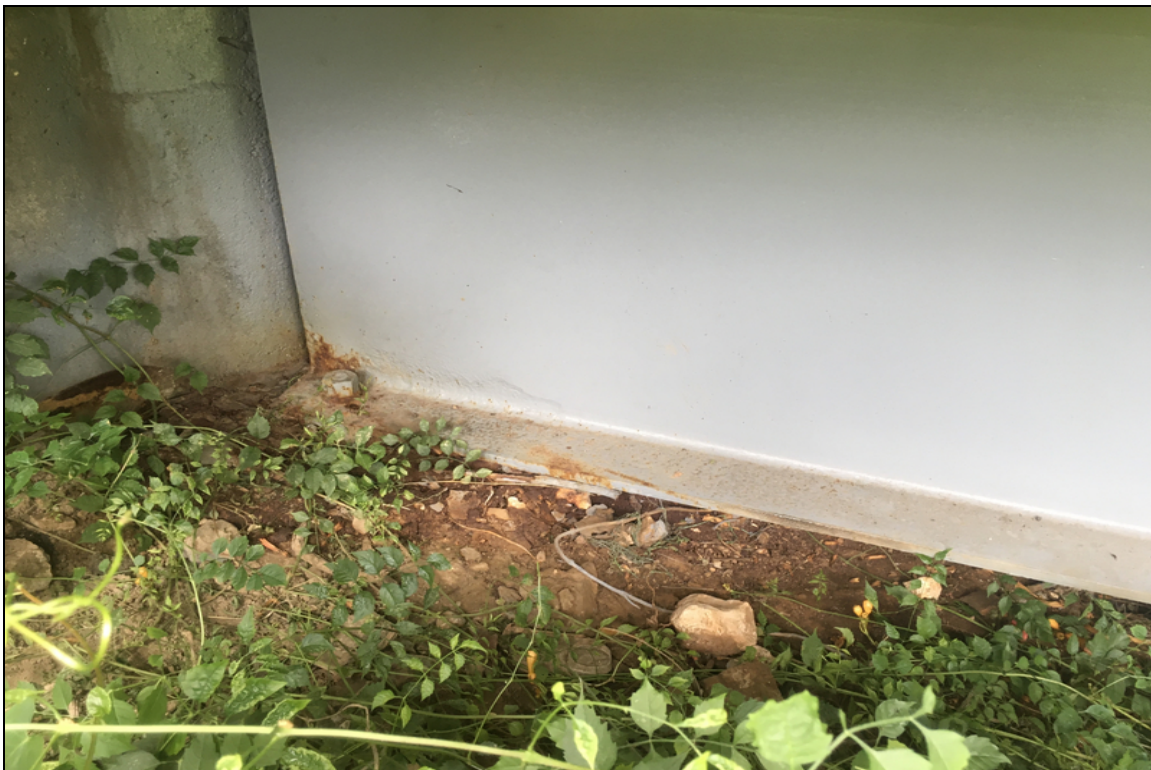
ELEM	DESCRIPTION	UNITS	TOTAL	CS1	CS2	CS3	CS4
<p>The bottom flange cover plates are cut square with the bottom flange and are welded at the ends. No cracking was noted at these locations.</p> <p>Span #1- beam 8 has 2' of cs3 corrosion on the exterior of the bottom flange and lower web at the beginning of the span due to dirt build up.</p> <p>Span #2- beams #2,3,5,6 have 1' of cs2 corrosion each on the bottom flange at the end of the span.</p> <p>Span #3- Beams 6,7 have 1' of cs2 corrosion each on the bottom flange at the beginning of the span.</p> <p>Span #4- beam #1 has 1' of cs2 corrosion on the bottom of the bottom flange at the beginning of the span. Beam #8 has 1' of cs2 corrosion on the bottom flange at the end of the span.</p> <p>Span #5- beams #3,4 at the end of the span have a total of 4' of cs2 corrosion on the bottom flanges.</p> <p>Span #6- beam #8 has 1' of 1/8 deep section loss with minor corrosion on the bottom flange at the bearing area over abutment #2. Beams #4,5 have 3' total of cs2 corrosion beginning to show through the paint on the bottom flange at the beginning of the span.</p>

Beam 8 has 2' of cs3 corrosion on the lower web and bottom flange at the beginning of span 1 due to dirt build up.

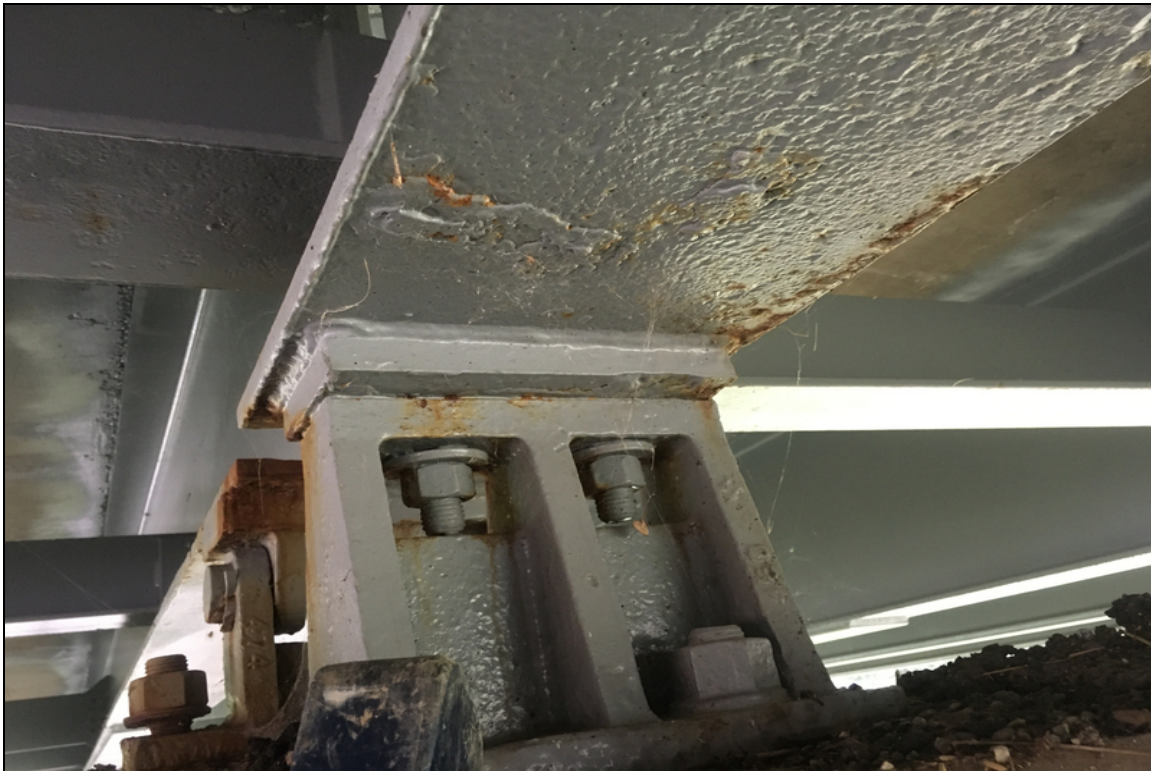
Flaking rust that has been painted over on the beams. Typical of several locations.

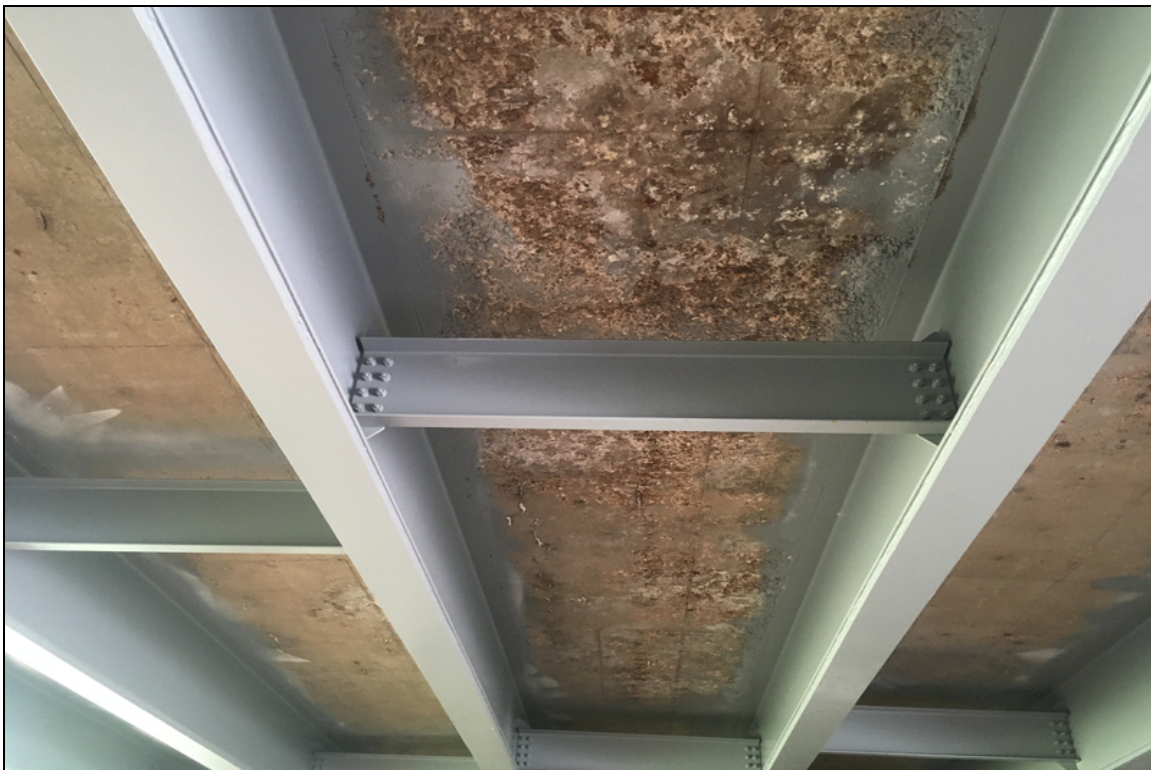
Bay #4 of span #1 showing delamination and efflorescence cracking in the deck under surface.
Typical of other areas in the deck under surface.

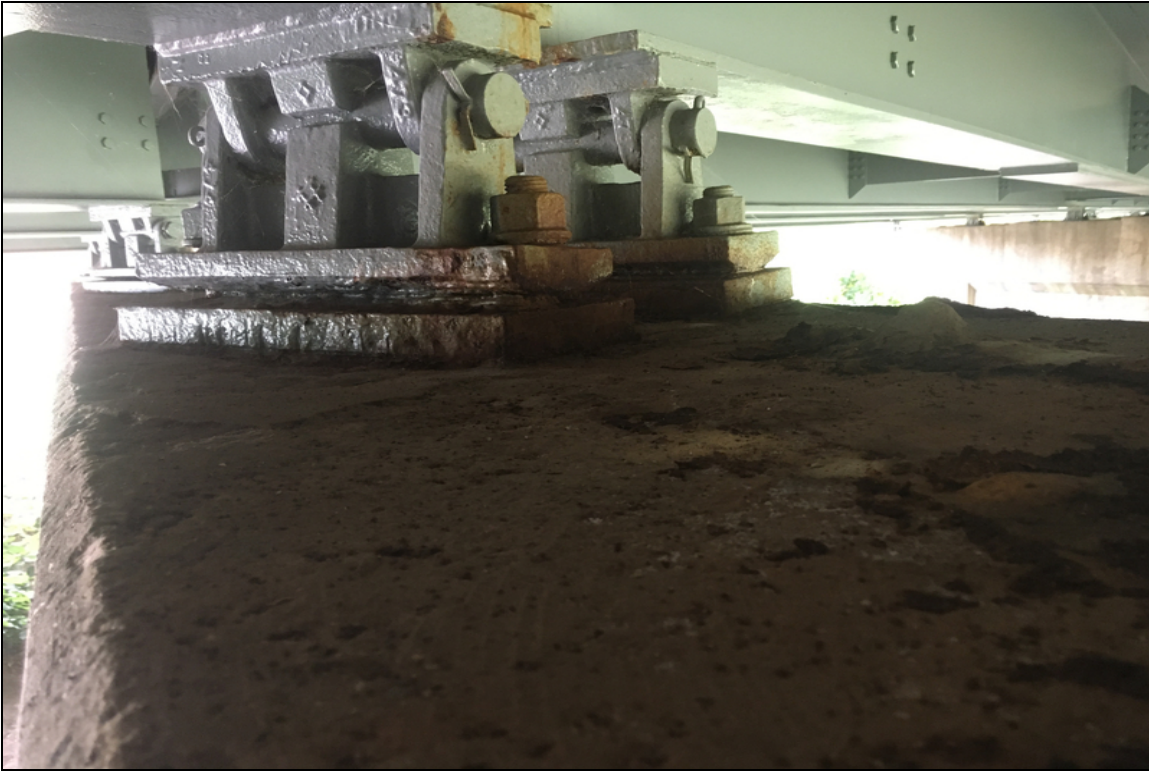
311	Movable Bearing	EA	48	32	1	15	0
1000	Corrosion	EA	16	0	1	15	0
<p>(311)</p> <p>Bent #1 movable bearings- all 16 are movable. 15 of the bearings have pack rust in the rocker area. Bearing # 2 on the span #1 side has no deficiencies.</p> <p>Bent #2 movable bearings- all 8 have been repainted and have rust staining on the paint from leaking joint seals.</p> <p>Bent #3 movable bearings- all 8 have been repainted and have rust staining on the paint from leaking joint seals.</p> <p>Bent #4 movable bearings- Beam #1 bearing has corrosion around the rocker area. The remaining bearings have rust staining on the paint from leaking joint seals.</p> <p>Bent #5 movable bearings- all 8 have been repainted and have no deficiencies.</p>							
313	Fixed Bearing	EA	48	42	2	4	0
1000	Corrosion	EA	6	0	2	4	0
<p>(313)</p> <p>Abutment #1 fixed bearings-bearings #1,8 have pitting that has been repainted, bearing #8 has corrosion beginning to show through the paint. Bearings #2-7 have no deficiencies.</p> <p>Bent #2 fixed bearings- All 8 have been repainted and have no deficiencies. The paint is rust staining due to leaking joint seals.</p> <p>Bent #3 fixed bearings- all 8 have been repainted and have no deficiencies.</p> <p>Bent #4 fixed bearings- all 8 have been repainted and have no deficiencies.</p> <p>Bent #5 fixed bearings- all 8 have been repainted and have no deficiencies.</p>

Pack rust still exists in many of the rocker areas. Typical of several locations.

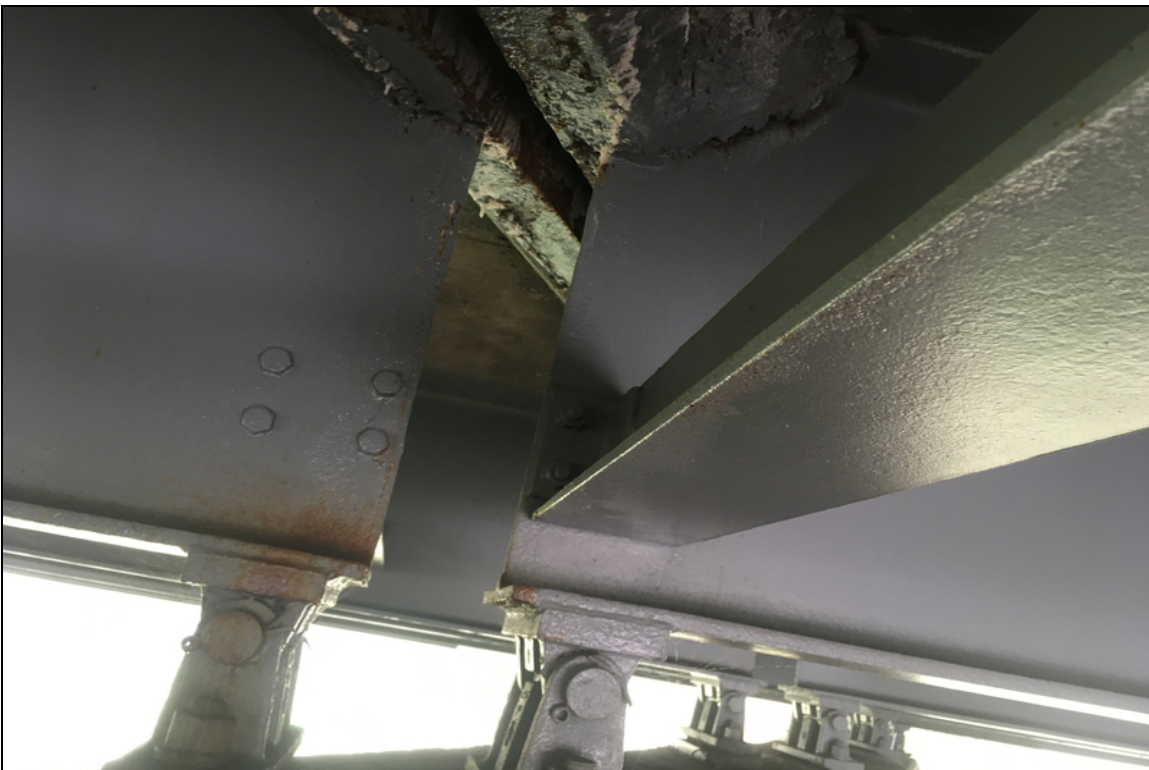
The bearings at beam #4 over pier #1 have rust staining on the paint from joint seal drainage. Typical of several locations.

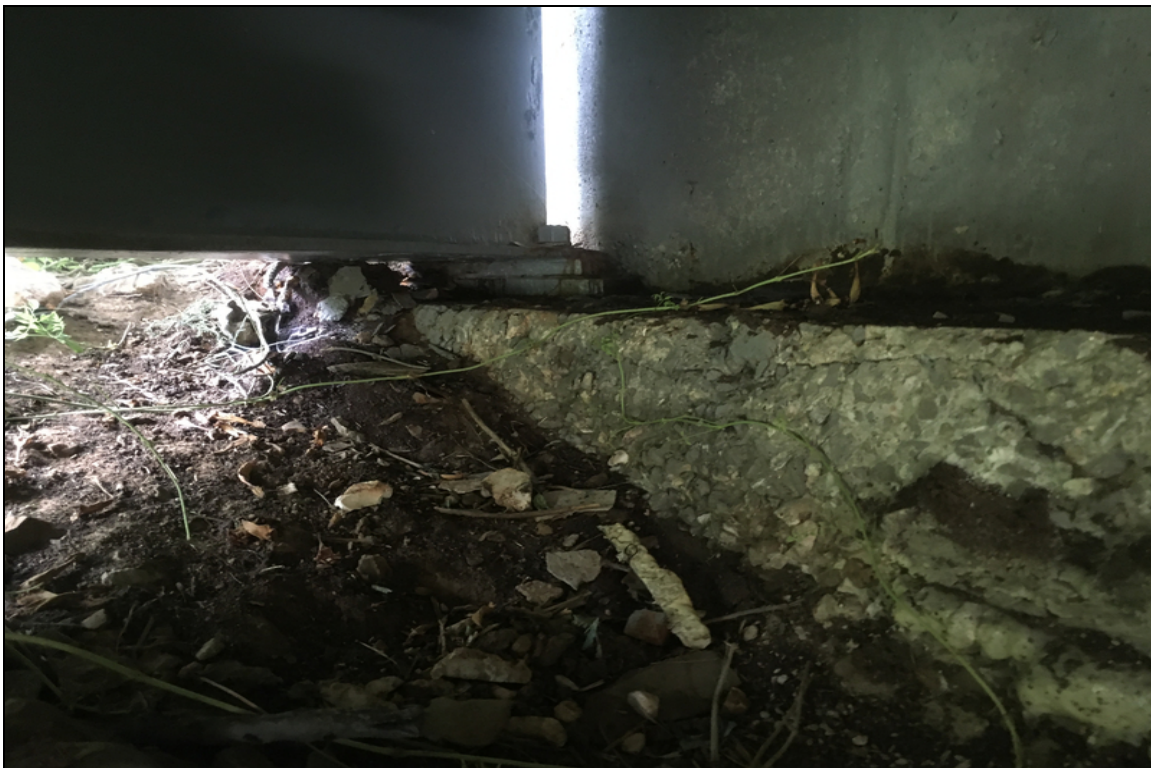
Bearing #8 at abutment #1 is partially covered with dirt and has corrosion.

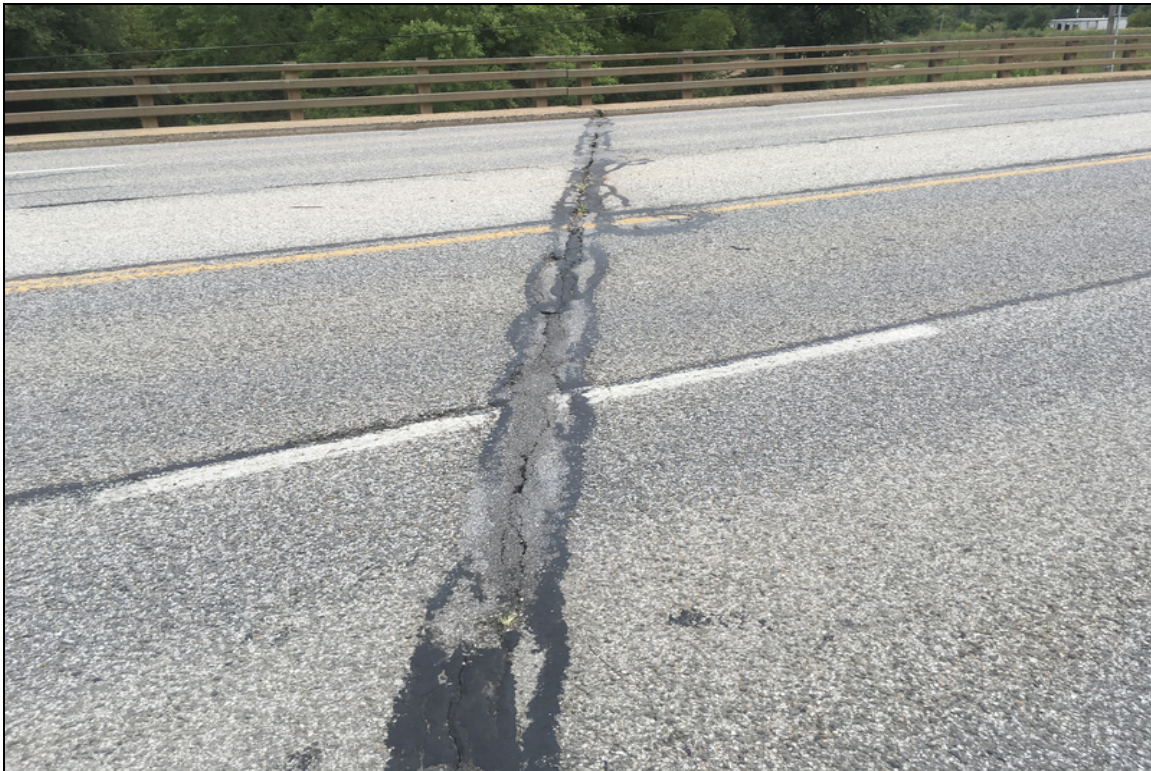
Typical view of the joint areas over the piers and abutments.

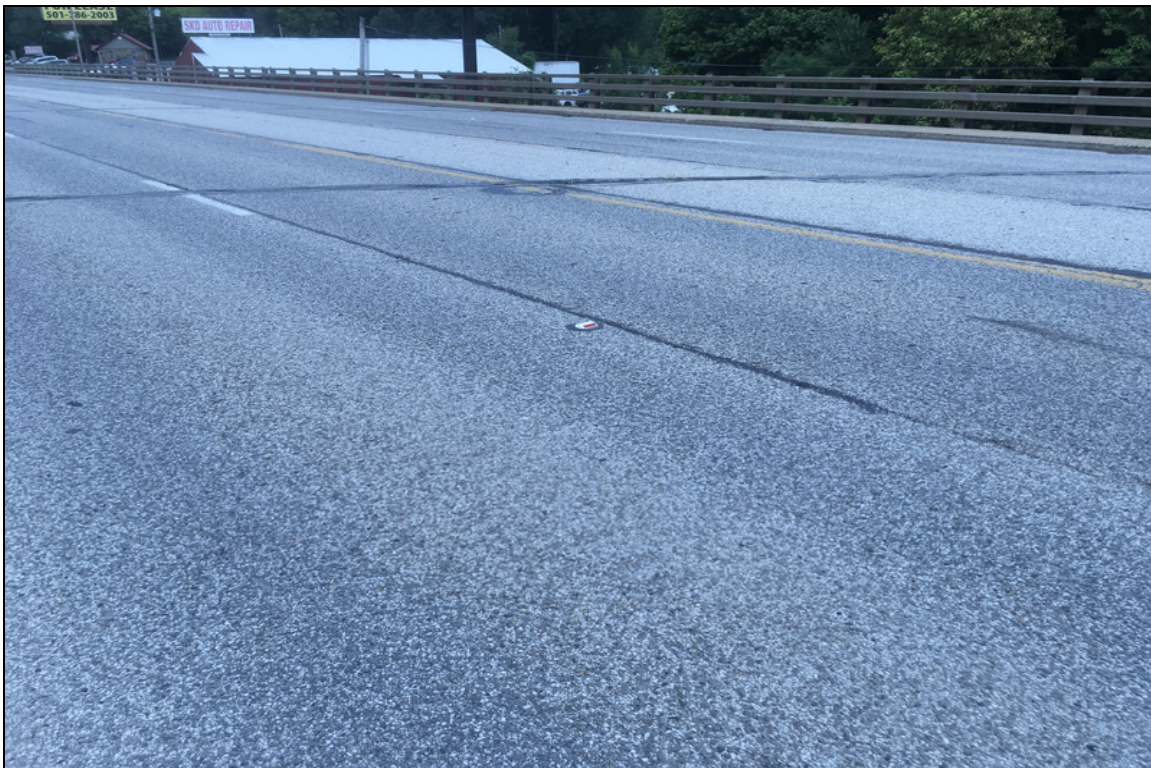
Typical view of driving surface.

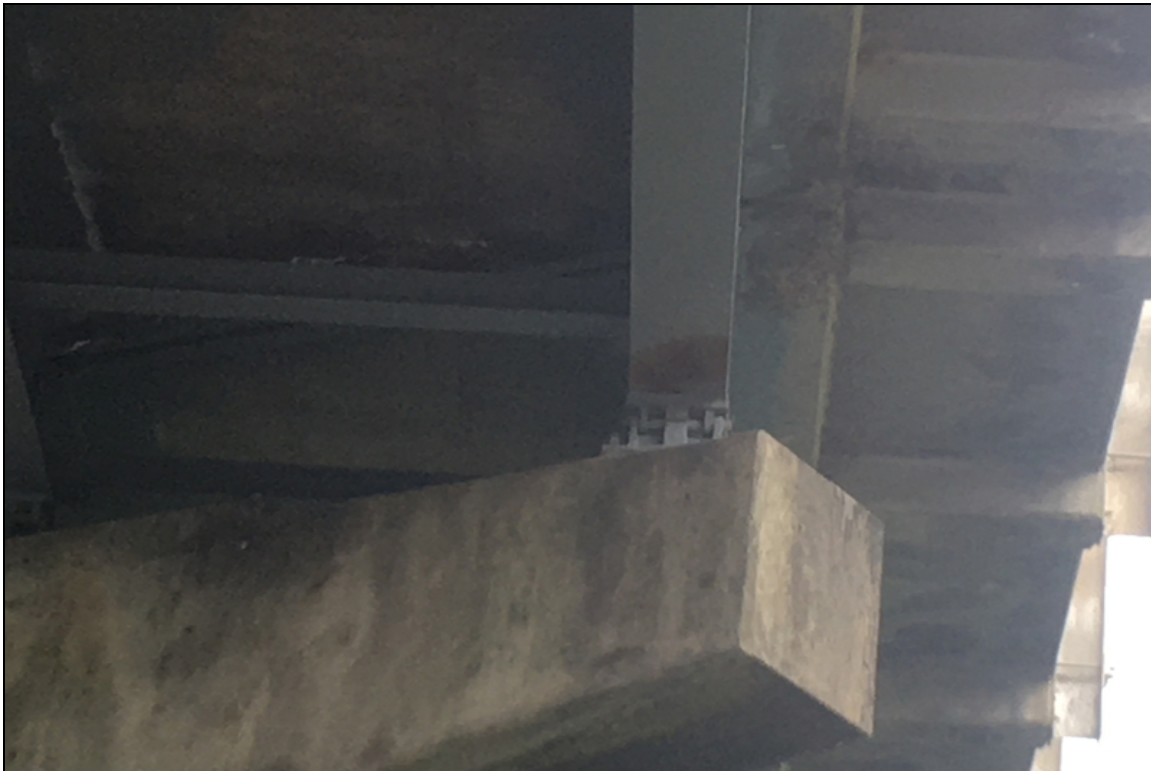
Cs2 corrosion on the bottom flange of beam 1 at the beginning of span 4.

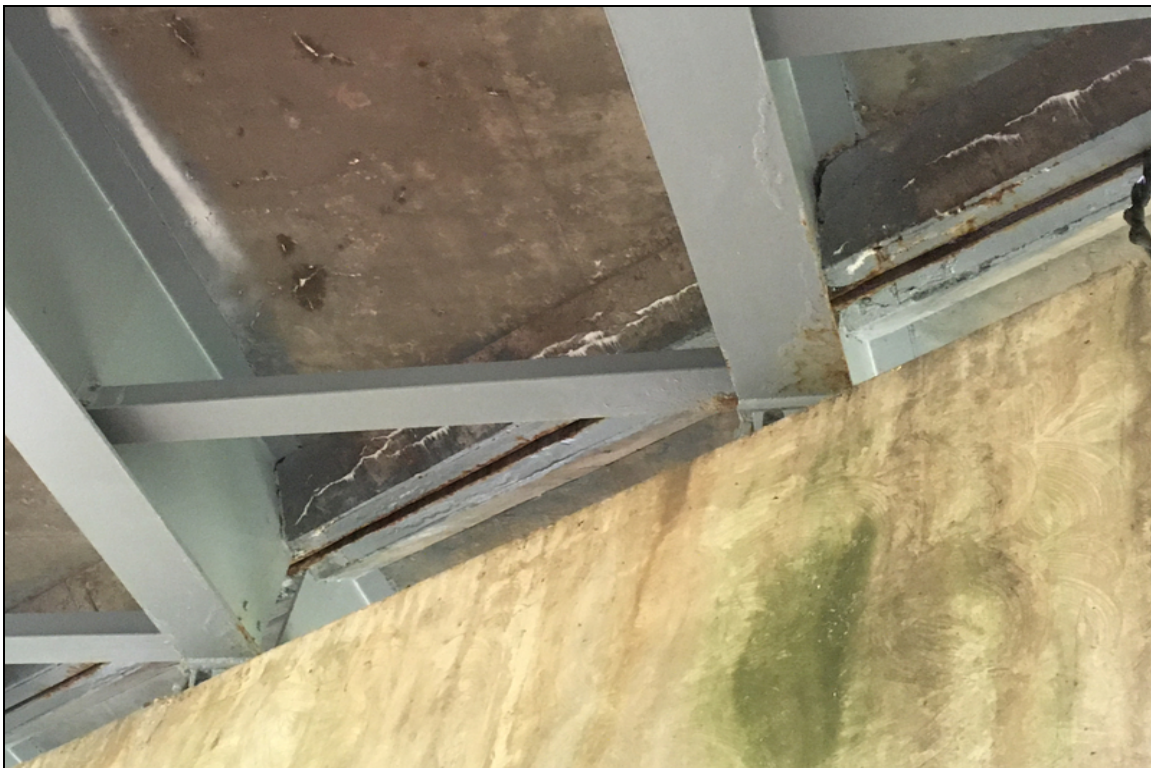
Corrosion beginning to show through the paint on beams 4,5 in span 6.

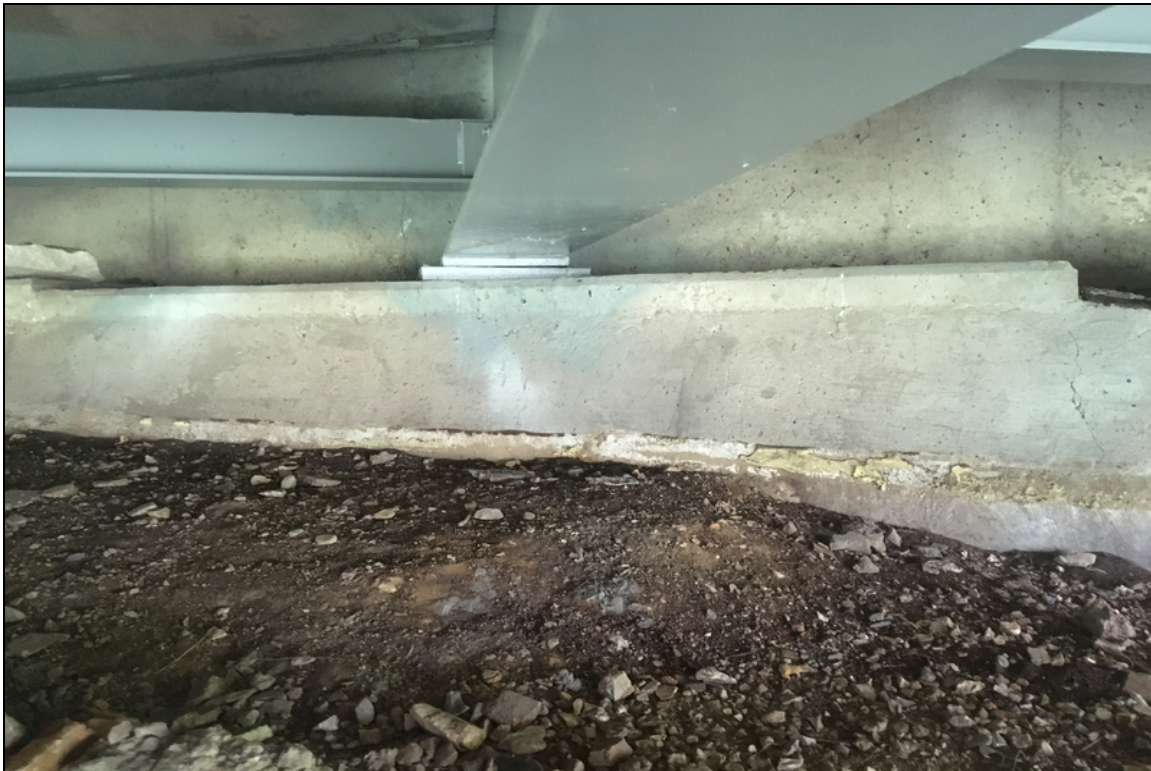
Bearing condition at the abutments.

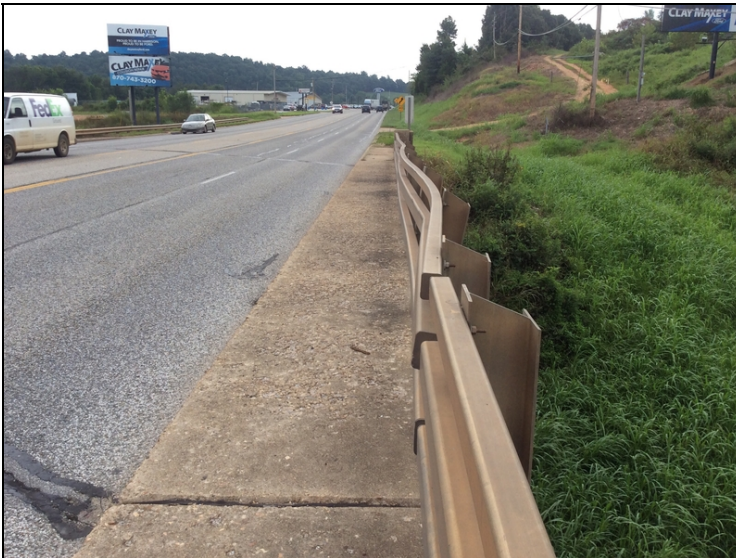
ELEM	DESCRIPTION	UNITS	TOTAL	CS1	CS2	CS3	CS4
Abutment #2 fixed bearings- bearings #1,8 have been repainted and have minor pitting from previous corrosion. Bearing 8 has cs2 corrosion beginning to show through the paint. Bearings #2-7 have been repainted and have no deficiencies.							
330	Metal Bridge Railing	LF	796	769	0	27	0
7000	Damage	LF	27	0	0	27	0
(330)							
Metal Bridge Railing- consists of 3 aluminum square tubes attached to aluminum posts. The protective coating is 4.5' per foot. No protective coating is needed.							
Left side- no deficiencies noted.							
Right side- The right side of span #6 has vehicle damage, the posts and railing are bent outward for 27'.

The right side bridge rail at span #6 has vehicle damage for 27'.

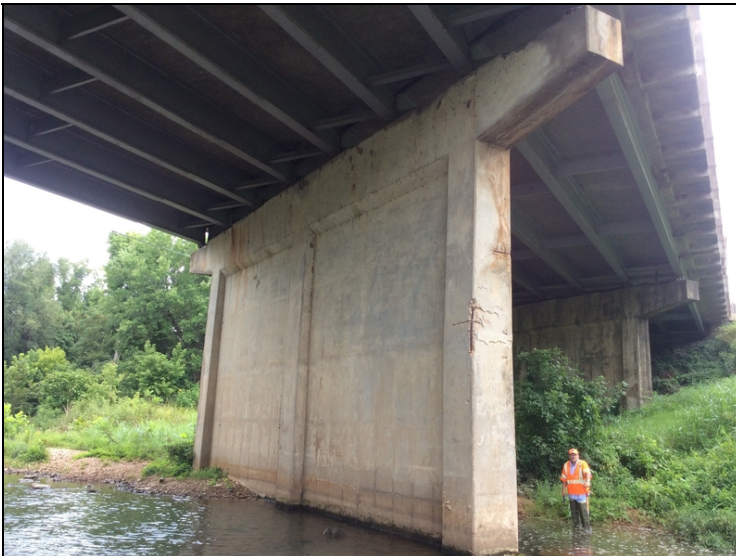
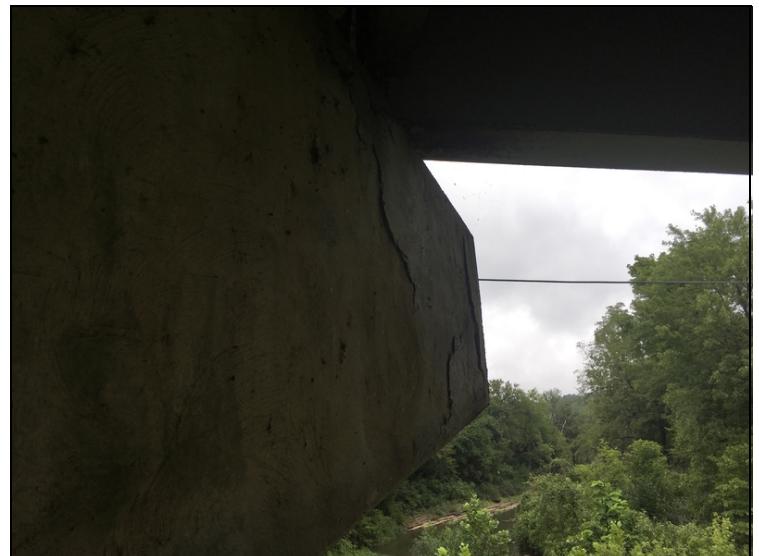
(234)							
<p>Bent #1 cap- has 36' of delamination and 4' of spalling with exposed rebar on the span #2 side. The cap has vertical hairline cracks, but the cracking is in the same footage as other defects.</p> <p>Bent #2 cap- has 12' of hairline vertical cracking at random locations and exposed rebar on both sides totaling 6'. The span #3 side has 6' of delamination.</p> <p>Bent #3 cap- has 8' of hairline vertical cracking. It has a 4' delamination on the span #3 side and 4' of delamination on the span #4 side.</p> <p>Bent #4 cap- has 8' of large delamination on the span #5 side. The right side has a spall with 1' of exposed rebar on the span #5 side and on the underside of the right cantilever in the same footage. The cap has 3' of vertical hairline cracks under bays #1,2.</p> <p>Bent #5 cap- has 9' of horizontal delamination on the span #6 side with 11' of vertical hairline cracking.</p>

Bent #1 cap- has delamination.
Bent #2 cap- has exposed rebar.
Bent #3 cap- has delamination.
Bent #4 cap- has delamination and a spall with exposed rebar.
Bent #5 cap has delamination.

Bent #1 column #2- has a spall with exposed rebar.
Bent #3 column #1 has a delamination.
Bent #4 column #1 has delamination, column #3 has 2 spalls with exposed rebar.
Bent #5 column #1 and #2 have delamination.

Large delaminations on the span #5 side of the bent #4 cap. Typical of the left and right sides.

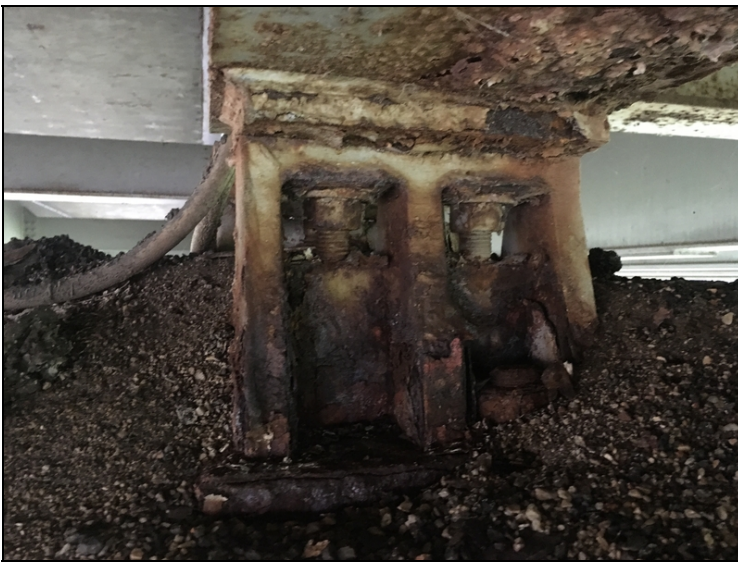
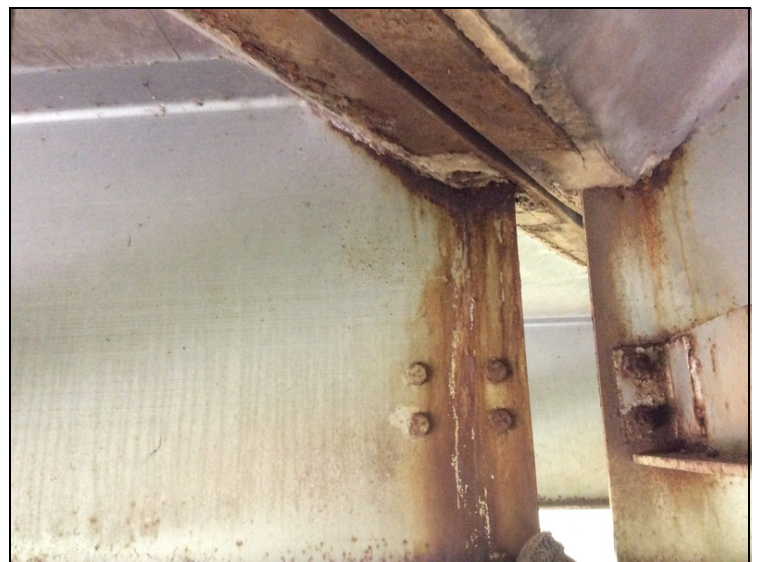
Fixed bearing condition at bent #2. Typical of bearings # 4-6.

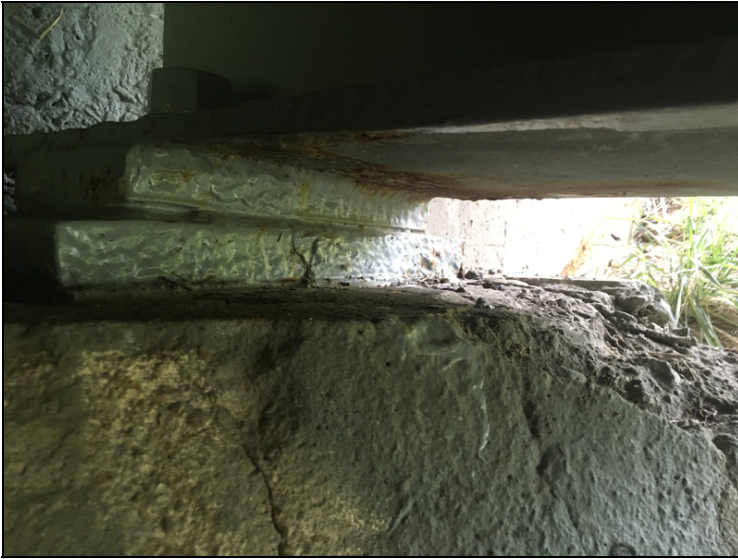
Beam #8 and bearing #8 have 2' of corrosion over the abutment due to dirt build up. Bearing #8 and Beam #8 have corrosion with minor section loss for 1' over abutment #2.

Beam #8 at abutment 2 has 1/8" of section loss on the bottom flange at the bearing area.

Maintenance need updated by BDSM 431 on 8-27-2020 after routine inspection.

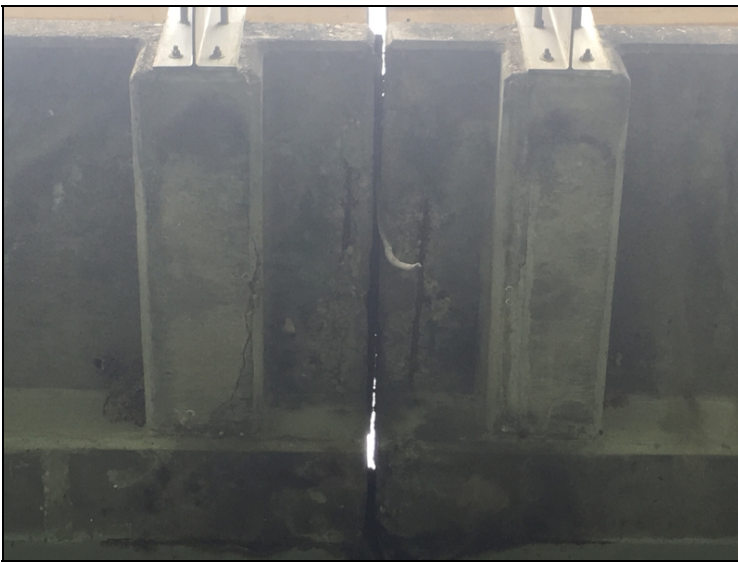
The drain areas and deck overhangs have several locations that are spalled with rebar exposed.

Shallow rebar exposed on the underside on the right concrete bridge rail in spans #5,6.

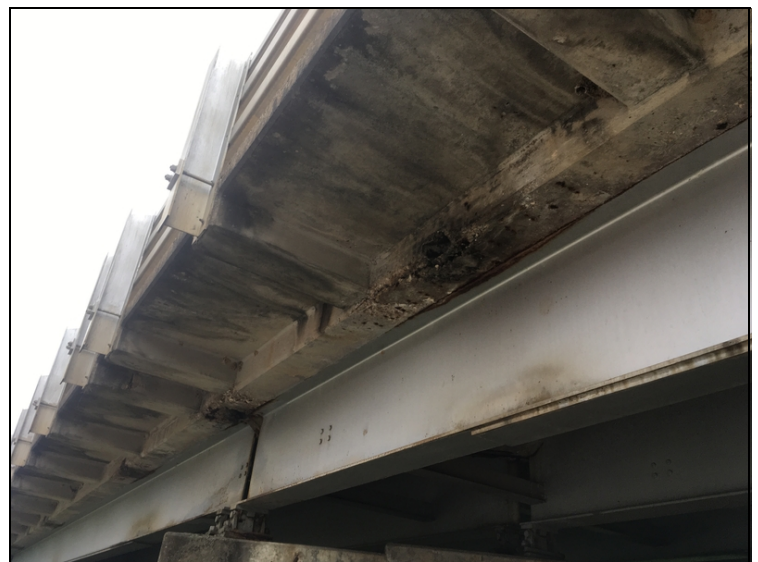
Drain area condition. Showing spalling and delamination some with rebar exposed. Typical of many locations.

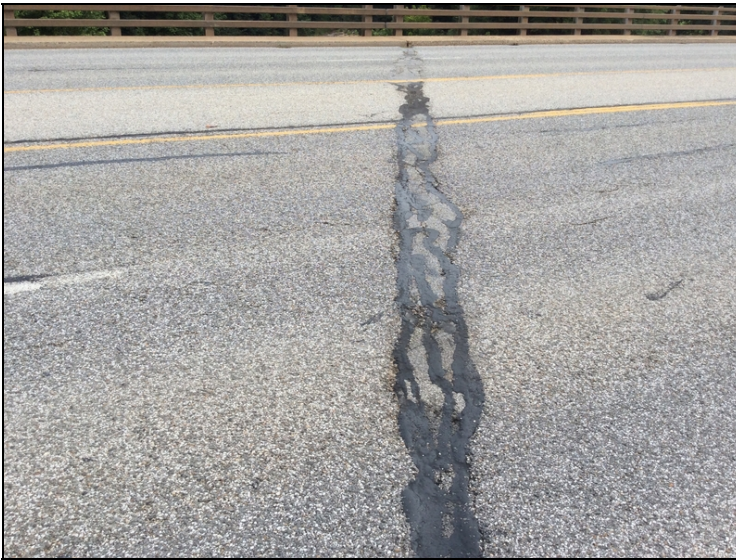
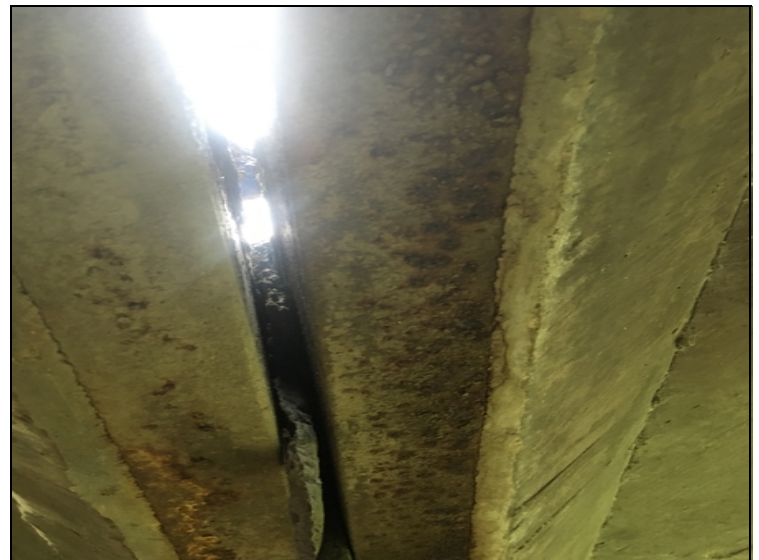
The compression joints over bents #2 & #5 have areas of the seal missing, allowing free flow of water and debris.

Areas of Missing joint seal over bent #5 allowing free flow of water.

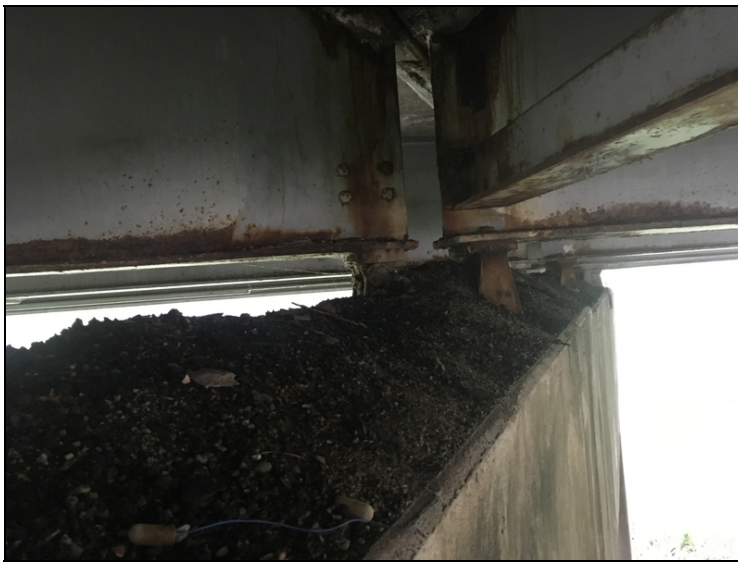
The bent caps at bents #2,5 have heavy debris build up that is promoting corrosion on the bearings.

Heavy Debris build up on the bent #2 cap.

It was noted during the routine inspection that the caps have been cleaned during the paint contract.

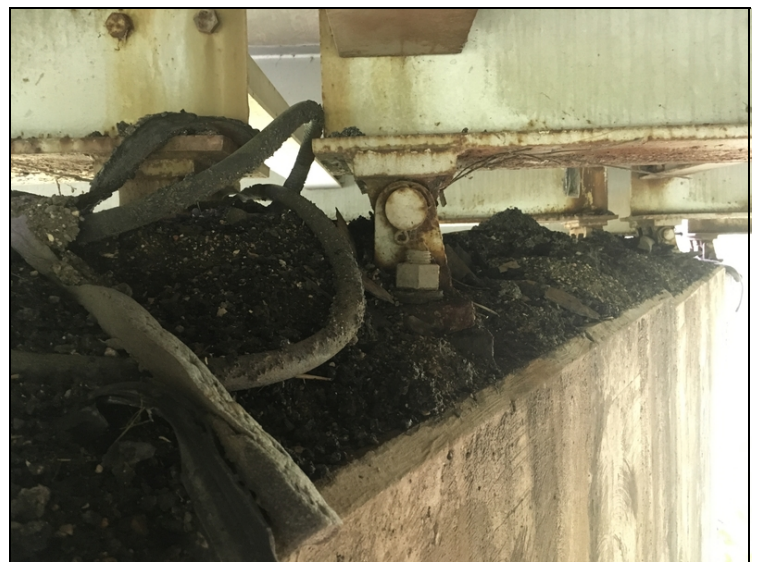
Heavy build up on the bent #5 cap.

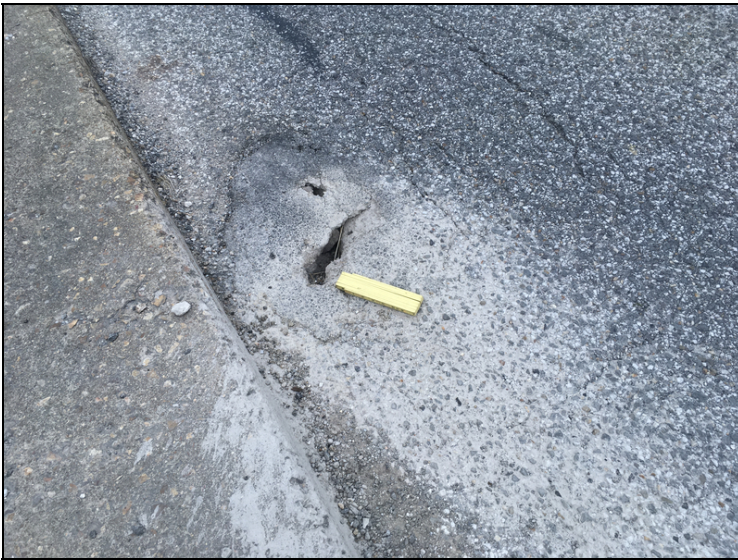
A pot hole is forming in the right hand south bound driving lane of span 3.

A pot hole is forming in the right south bound driving lane of span 3.
