Asset #05770(NSTM, Routine)

US 62 & US 412 over Norfolk Lake-District 9

Location: 8.49 MI E JCT SH 5

Team Lead: Anthony Wood, Inspection Date: 11/09/2022

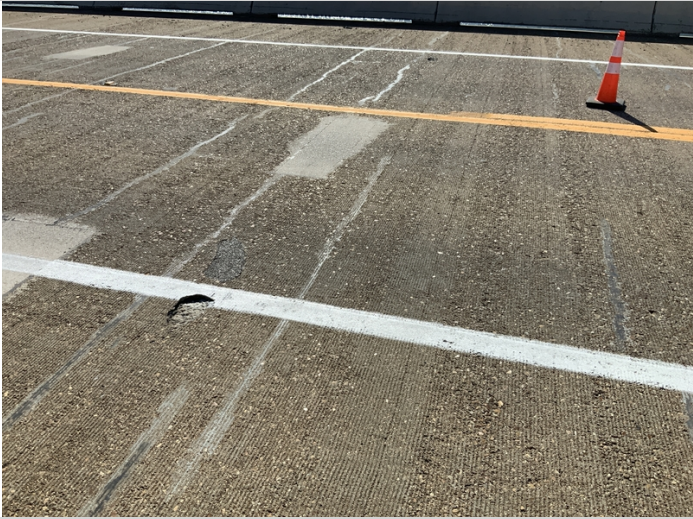
Span 2 Spalling in wheel paths

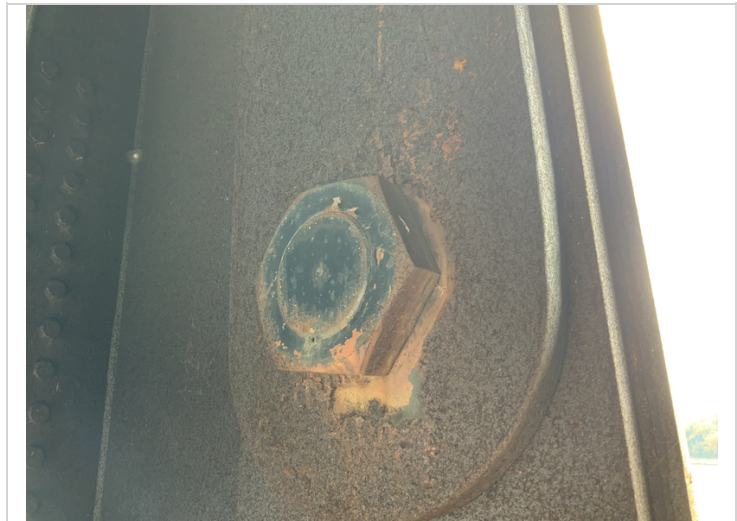
Hanger bar at bent 3 flaking rust.

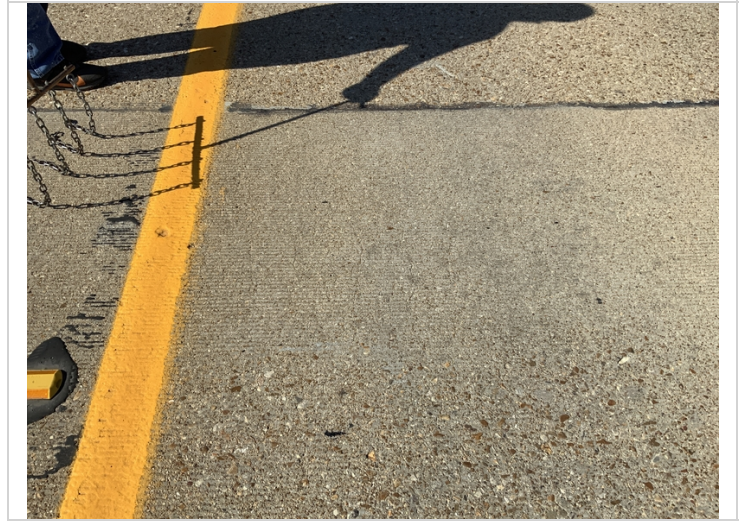
Light map cracking

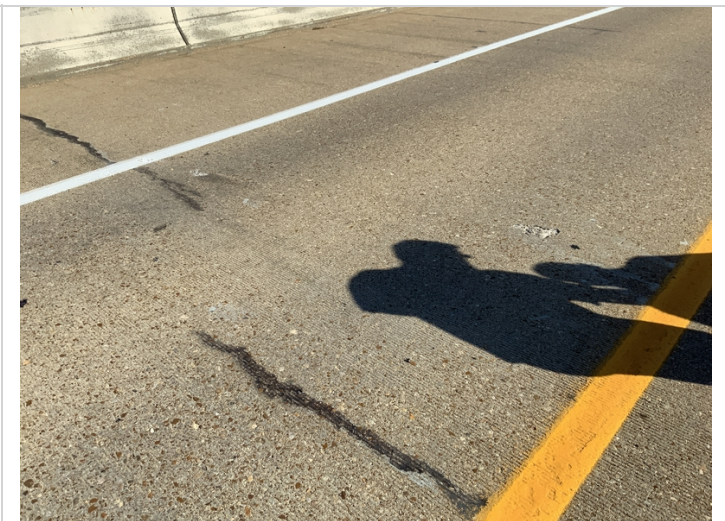
Span 1 Left lane Spalling

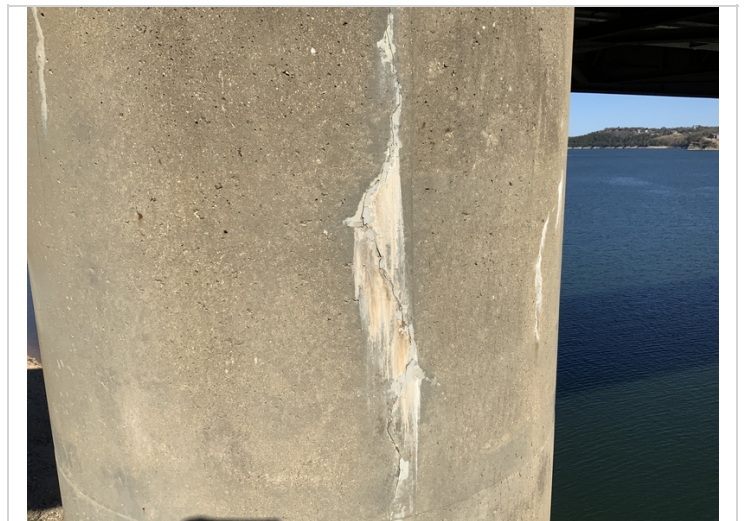
Pier 1 Crack repair failing

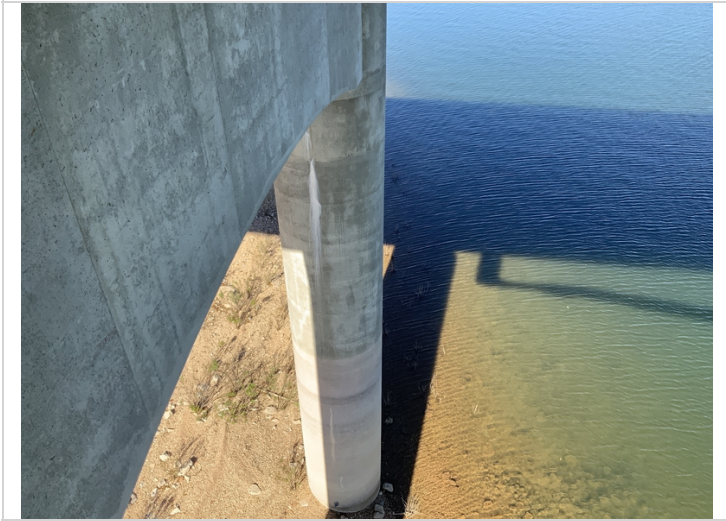
Pier 2 Column 1 Cracking with efflorescence

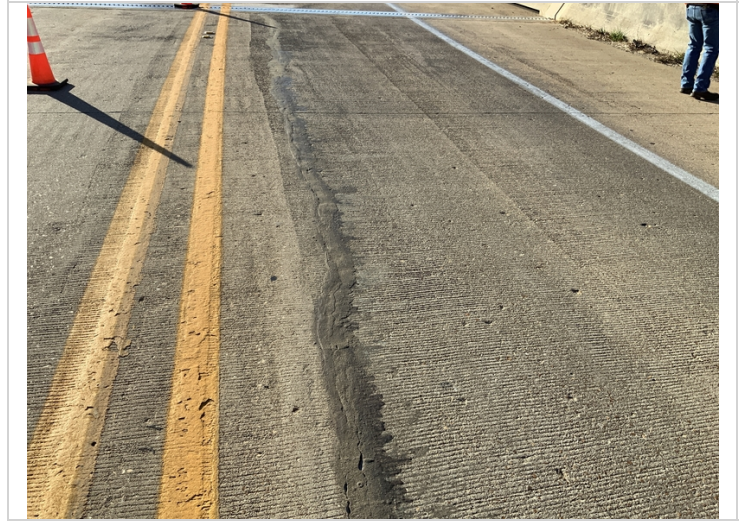
Abutment 2 Approach slab failing sealant

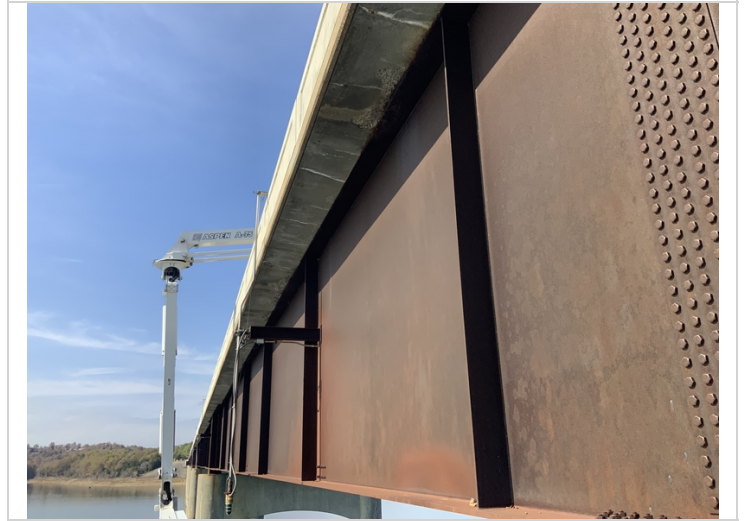
Span 10 Right Spalling in overhangs

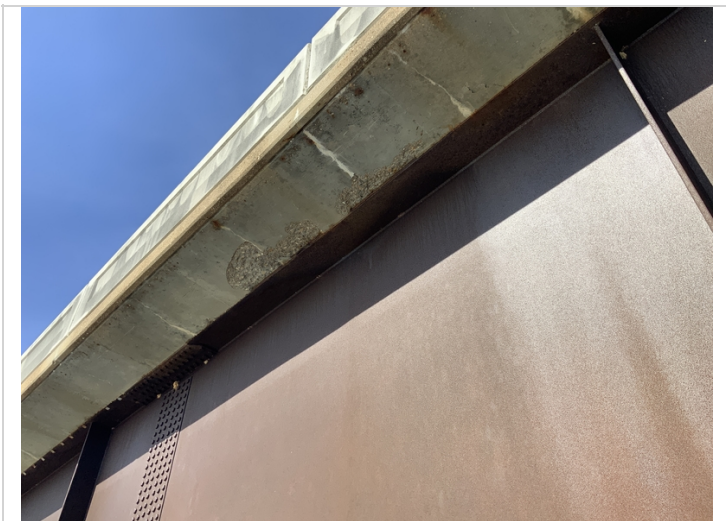
Span 1&2 right Spalling in overhangs

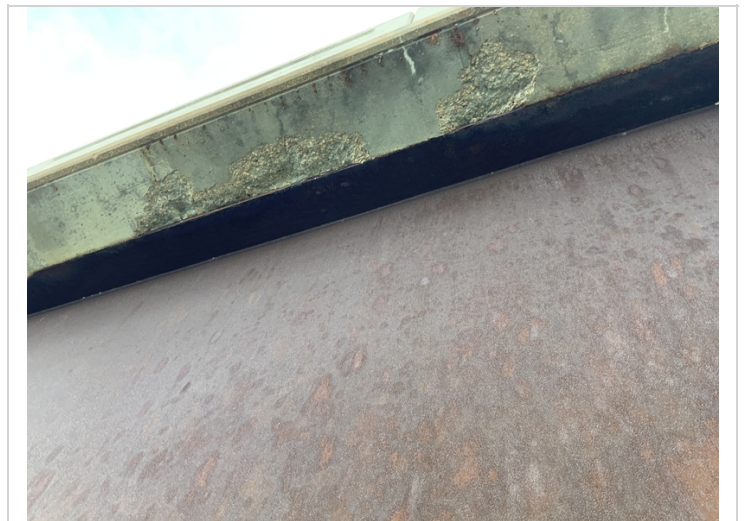
Span 3 Left and Right Spalling in undersurface

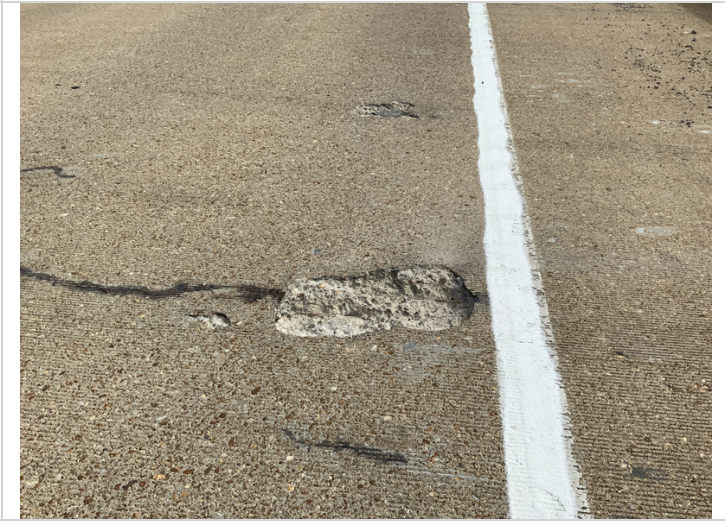
Span 5 Right lane Spalling

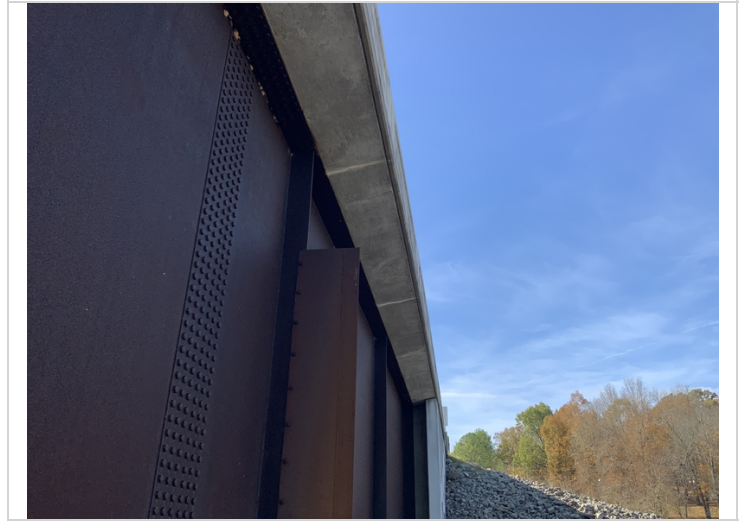
Typical efflorescence in overhangs

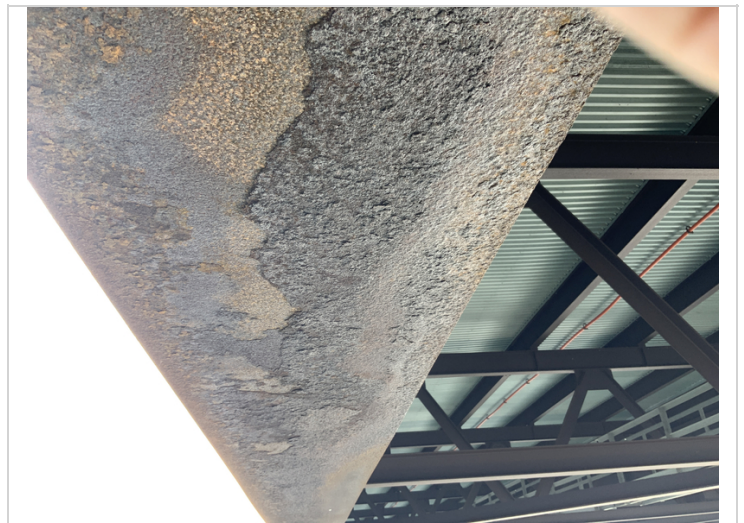
Span 8 Typical corrosion

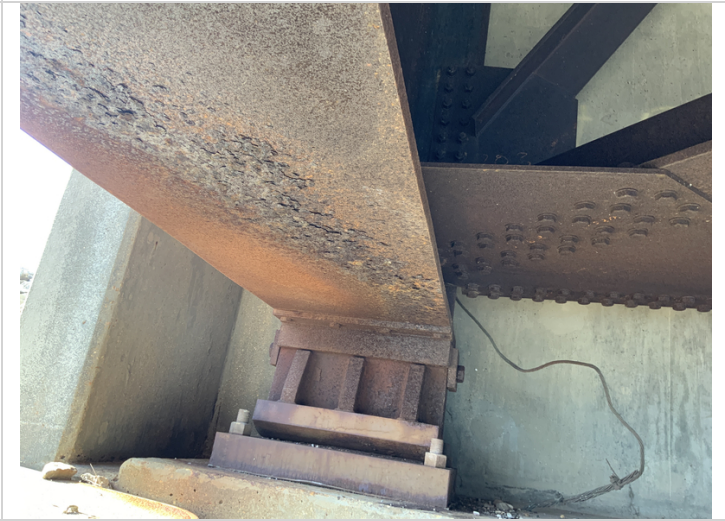
Bent 1 Girder 1 Flaking rust

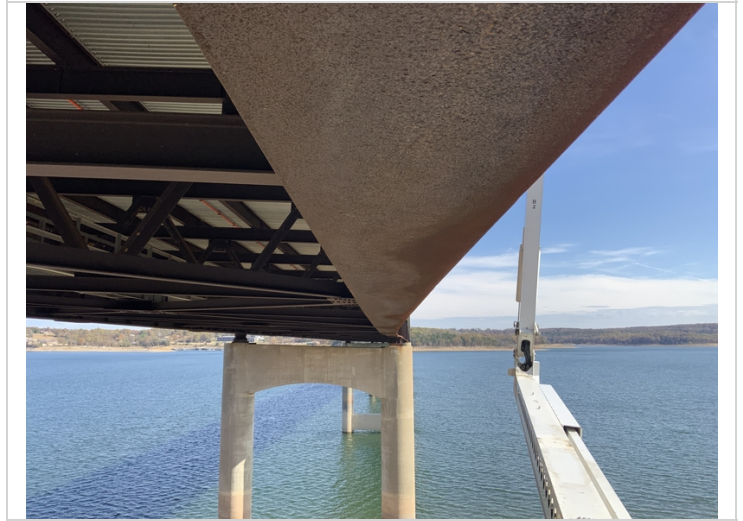
Span 1 Girder 1 Flaking rust

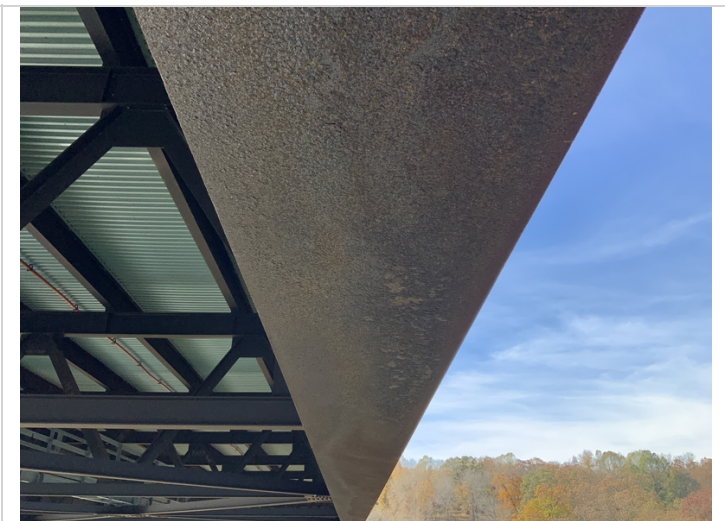
Span 2 Girder 1 Flaking rust

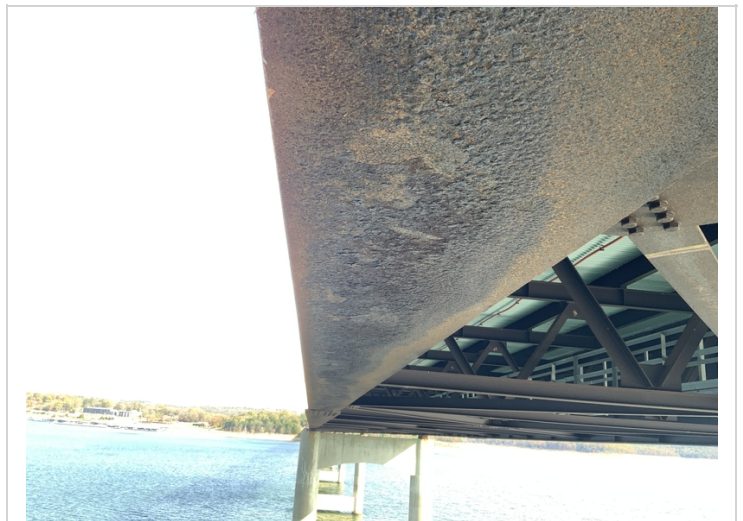
Span 3 Girder 1 Flaking rust

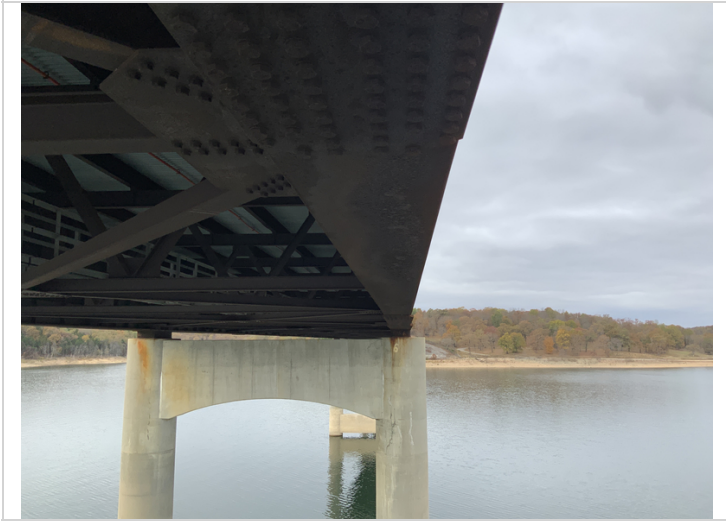
Span 7 Girder 1 Flaking

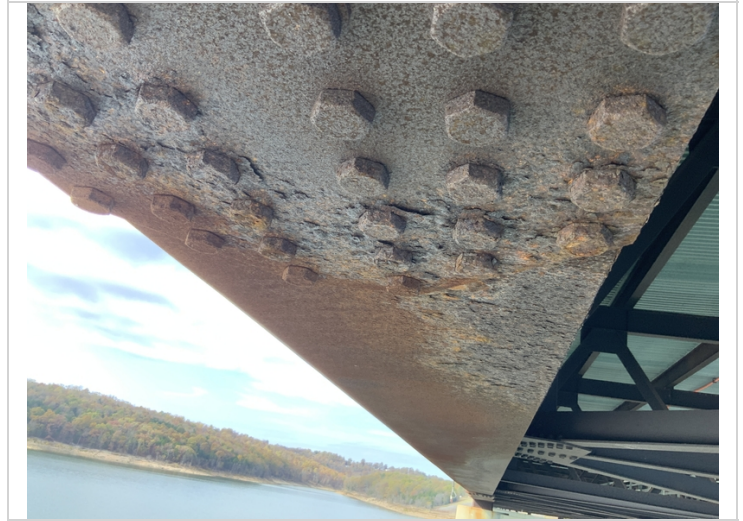
Span 9 Girder 2 Flaking rust in splice plate

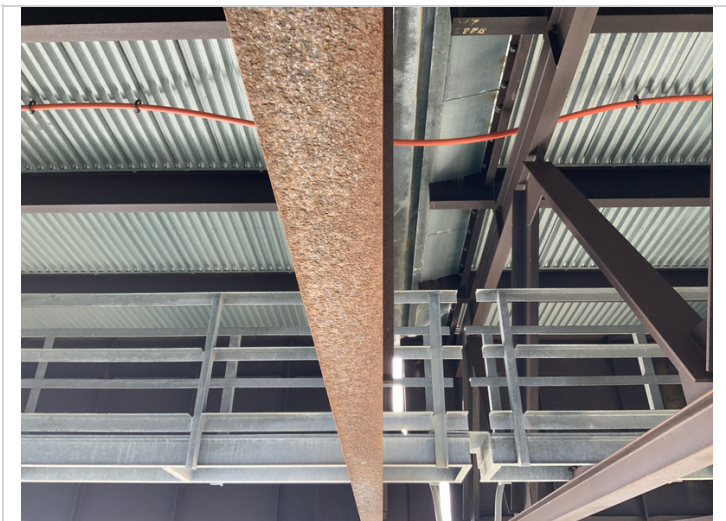
Span 8 Floorbeam 1 Bottom flange flaking rust

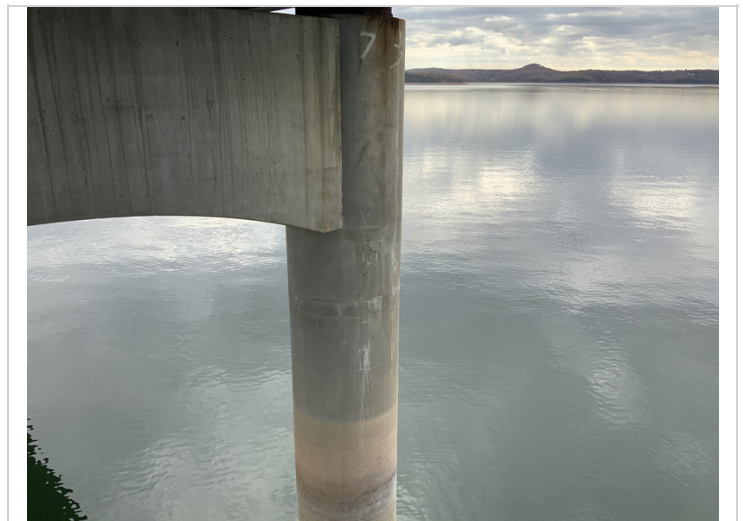
Pier 7 Typical cracking

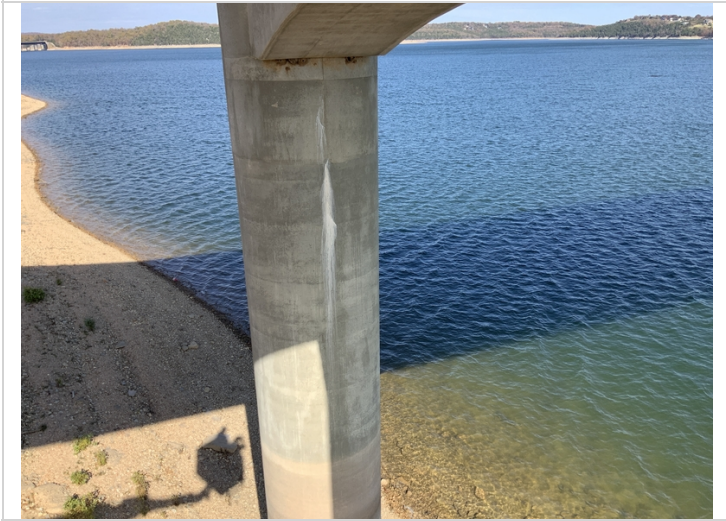
Pier 1 Column 1 Cracking with efflorescence

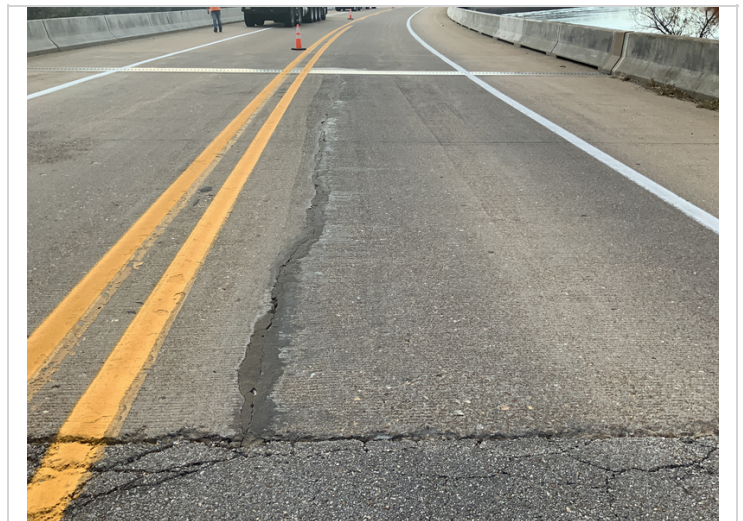
East Approach slab failing repair

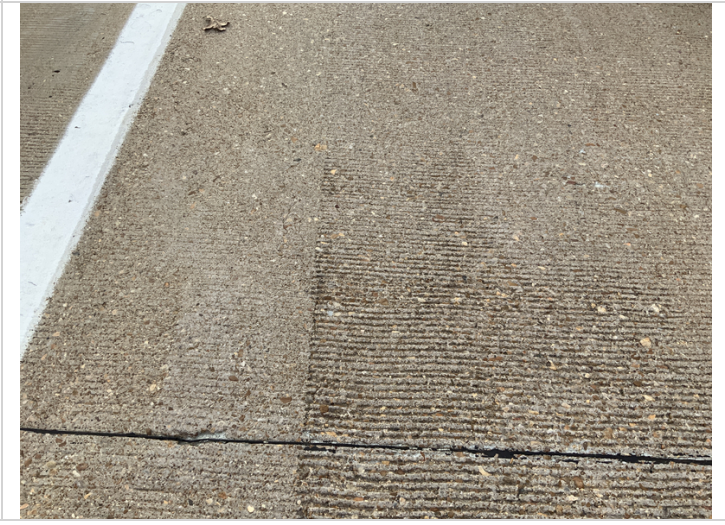
East approach sealable cracking

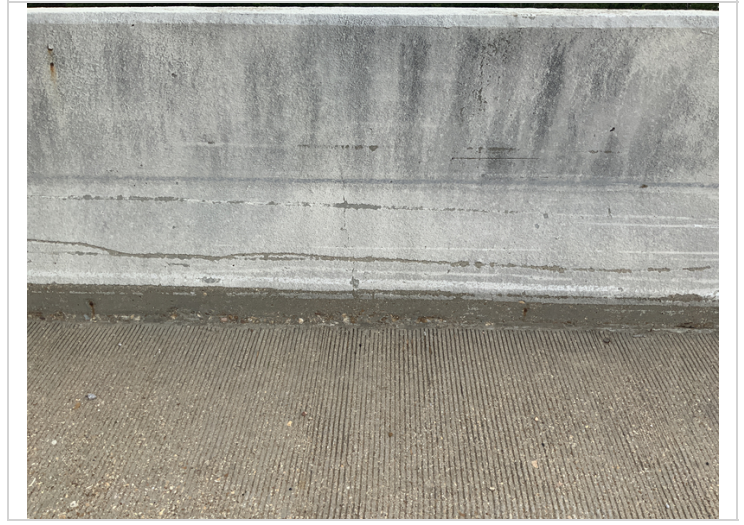
Typical vertical cracking in bridge railing

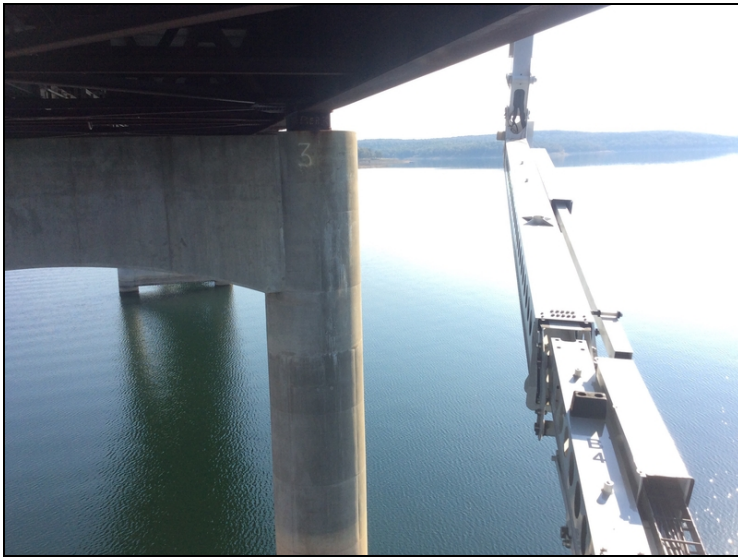
The top 15' of the Lt. and Rt. columns at Piers 1 through 12 are cracked with efflorescence. Epoxy injection has been attempted in the past.

Pier 3 epoxy injection. Cracks with Efflorescence in both columns.

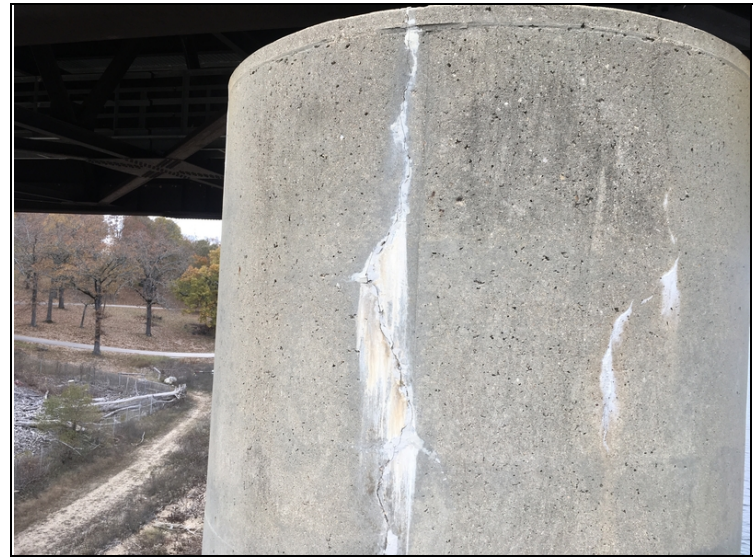
MFF & KRM 11-07-2016 - repaired areas with epoxy appear to be failing at this inspection cracking in the epoxy is visible. Cracking with efflorescence is still visible typical with all columns.

Pier 1, Column 2: Failing repairs.

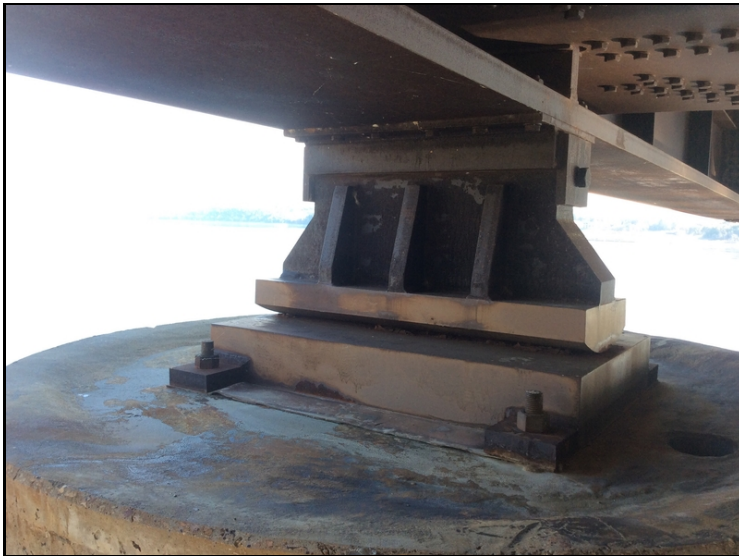
*Lt. bearing at Pier 1 is corroding.

MFF & KRM 11-07-2016 - appears to be paint peeling not corrosion. see photo..

Peeling paint no apparent corrosion pier 1 left.

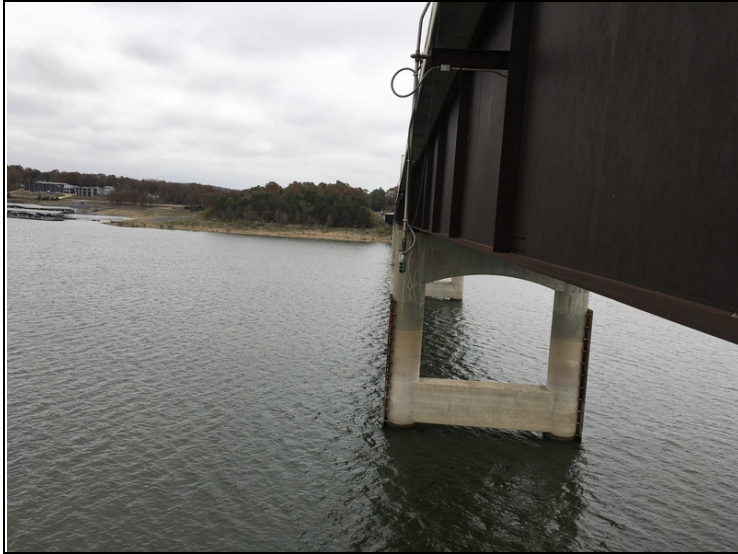
*Green navigation light is out in Span 9 upstream side.

Span 9 green navigation light is out at Girder 1.

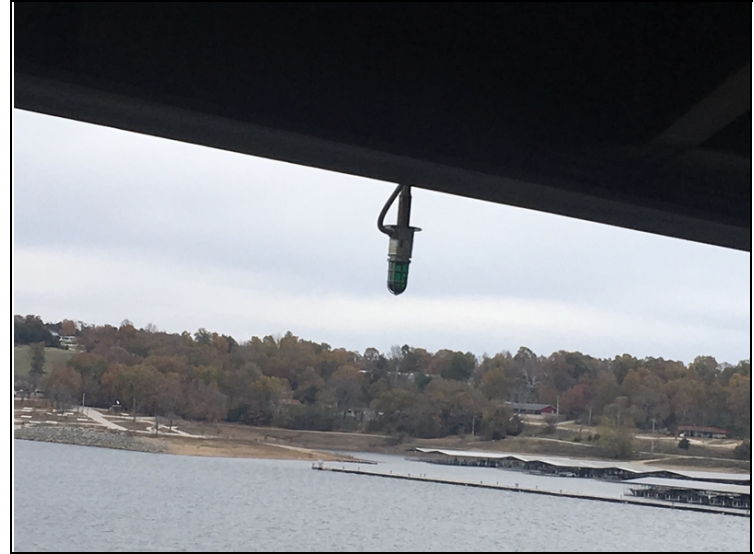
Span 9, Left: Navigation light not working.

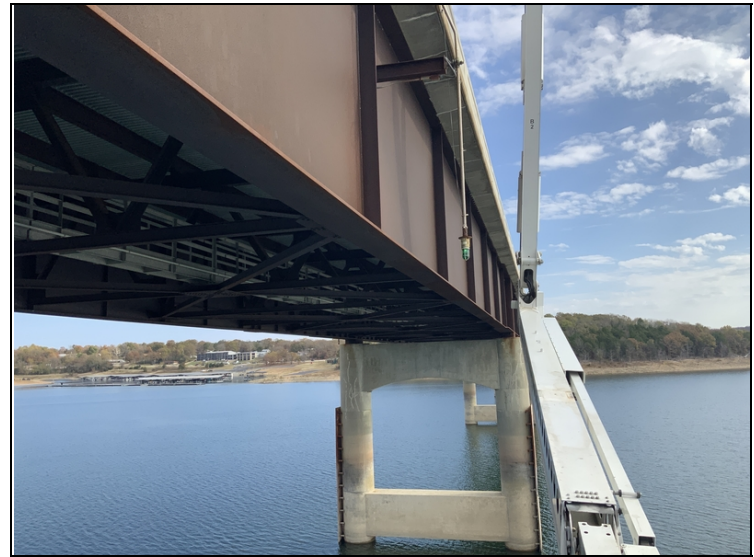
Upstream light repairs

*See attached photo repairs have been made. This item can be completed.

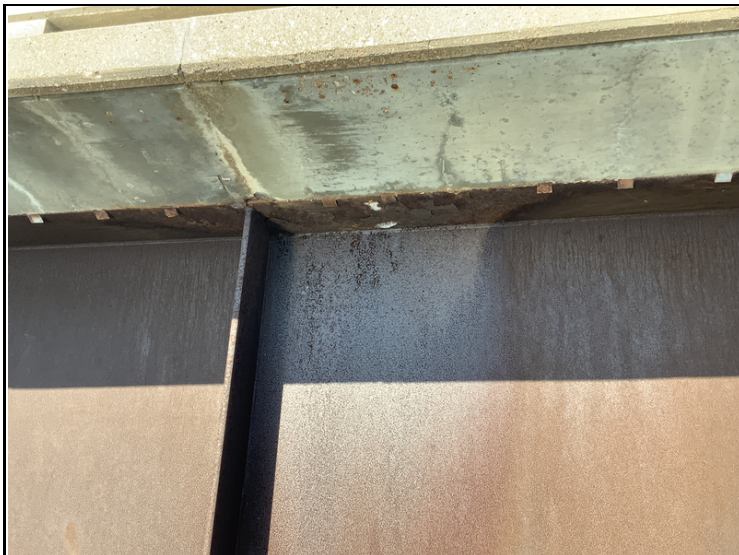
Span 8 RT top flange active corrosion with flaking rust . Water is leaking from the crack that propagates through deck.

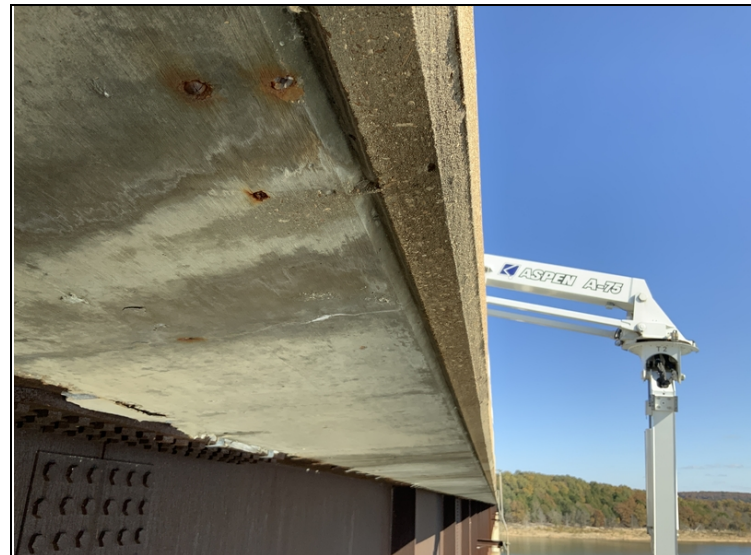
DECK
Water is leaking from the 3/4" chamfered drip groove in deck. During construction process forms wasn't together at this location.

Water is leaking from 3/4 chamfer at chamfer joint location typical at all locations.

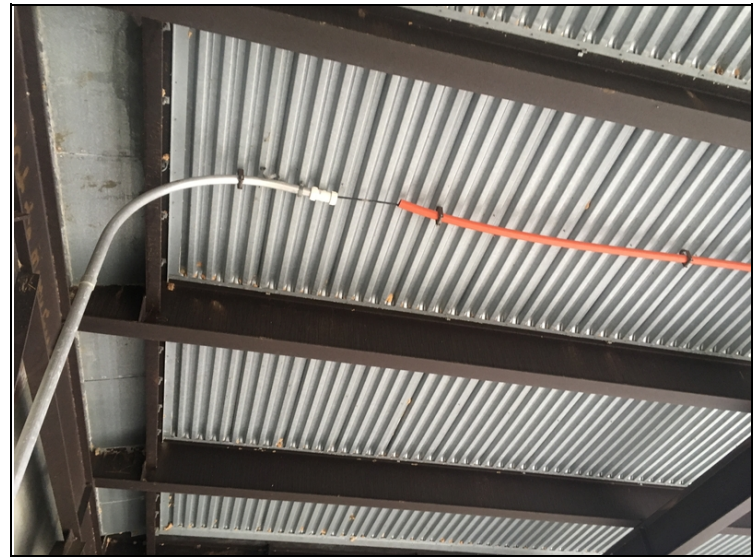
Utilities:
West Abutment: Electrical conduit is separated at ground level.

Utility conduit separating.

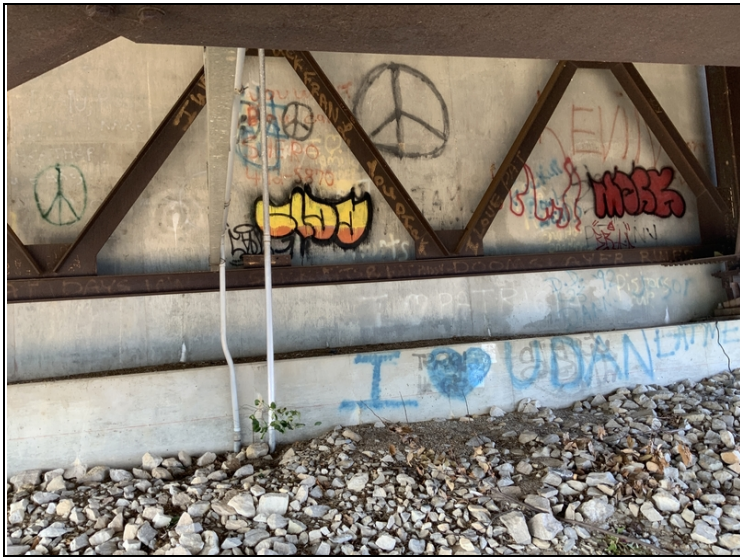
GRAFFITI:
Abut. 1 & 2: Heavy graffiti.
Piers 1, 10, 11, 12 & 13: Graffiti at on caps.

Abutment 1 Graffiti

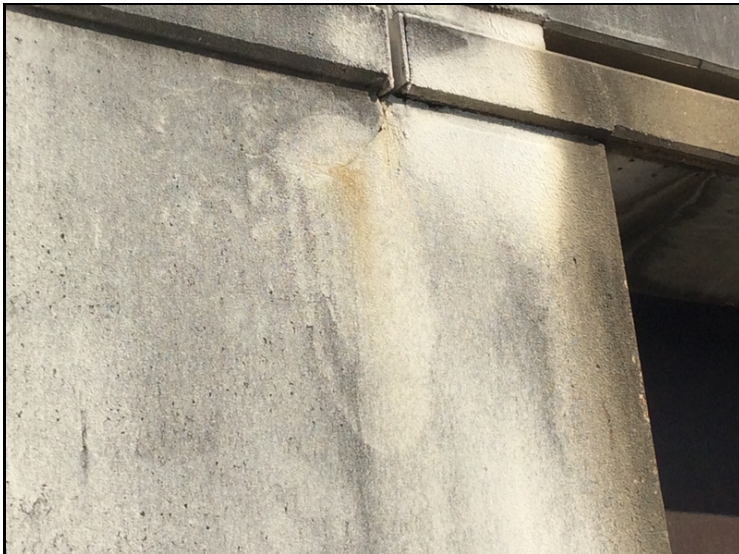
Abut. 1: The Lt. and Rt. wing walls have a 45-degree open crack at the top.

Wing wall at abutment 1 45 degree crack at the top. (Typical at all wing walls)

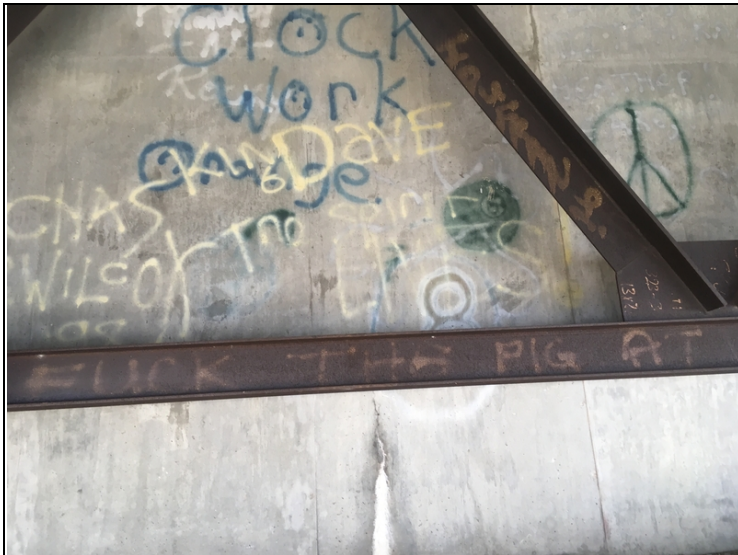
Abut. 1: 4 vertical efflorescence and 3 hairline cracks in the cap and back wall.

Abutment 1: Vertical cracking with efflorescence.

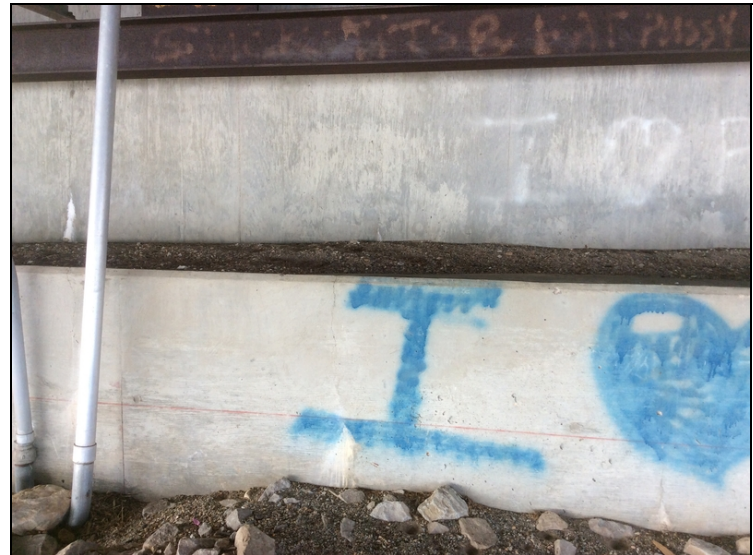
Abutment 1: 8 vertical cracks in back wall.

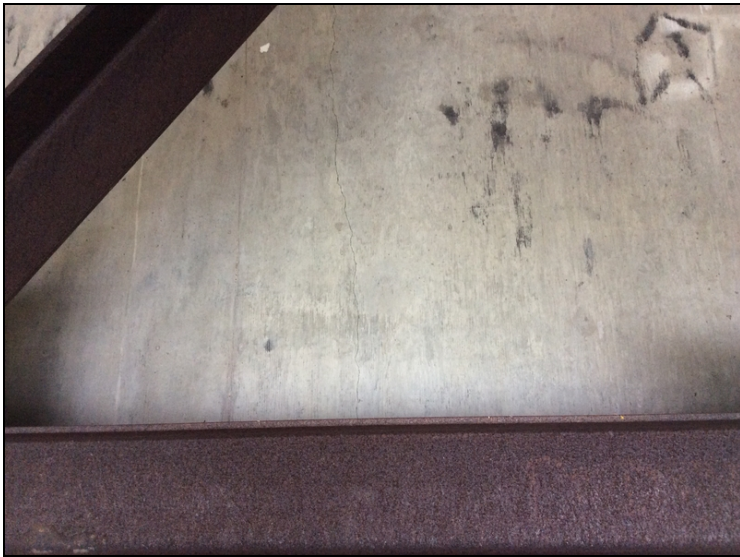
Abut. 2: 6 vertical efflorescence cracks in the back wall and 4 hairline cracks in the cap.

6 vertical cracks in back wall at abutment 2.

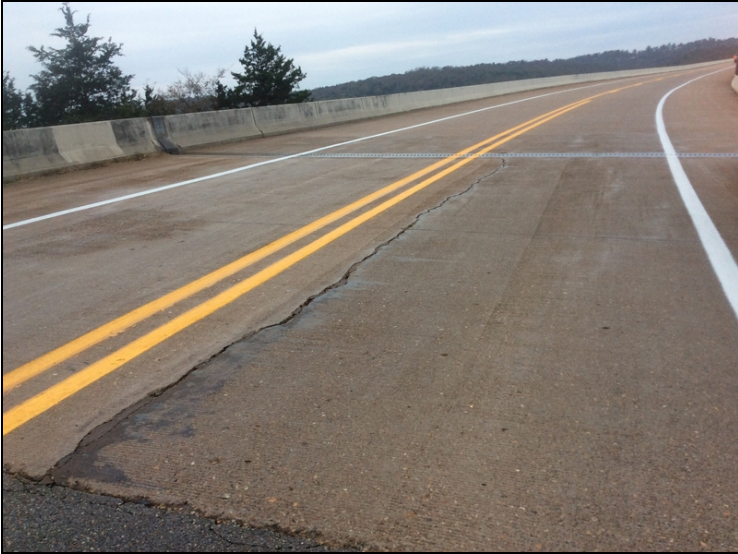
East Abut: Approach slab at the east end of the bridge has a full length longitudinal crack. Epoxy repair is cracking.

East approach longitude crack with epoxy that is cracking.

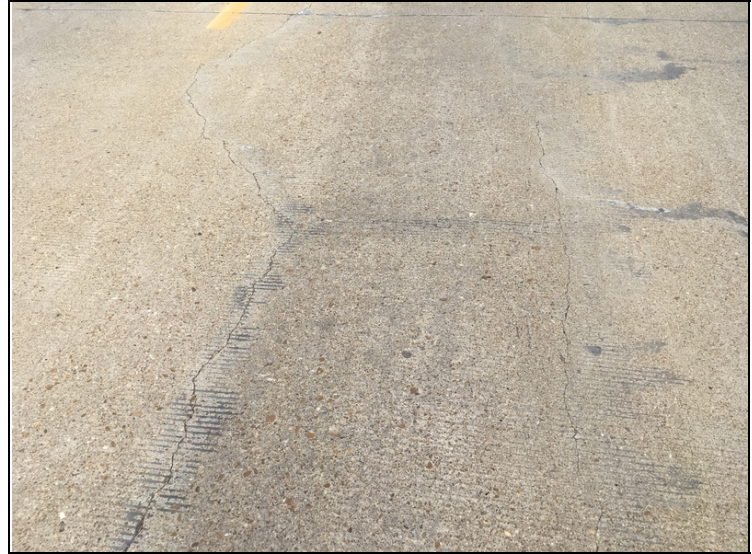
Approach Slab 1: Longitudinal cracking.

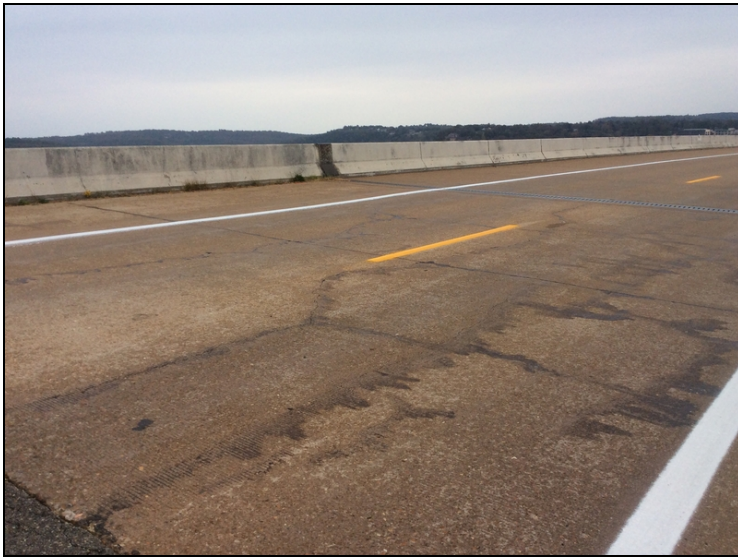
West approach has 4 longitudinal cracks

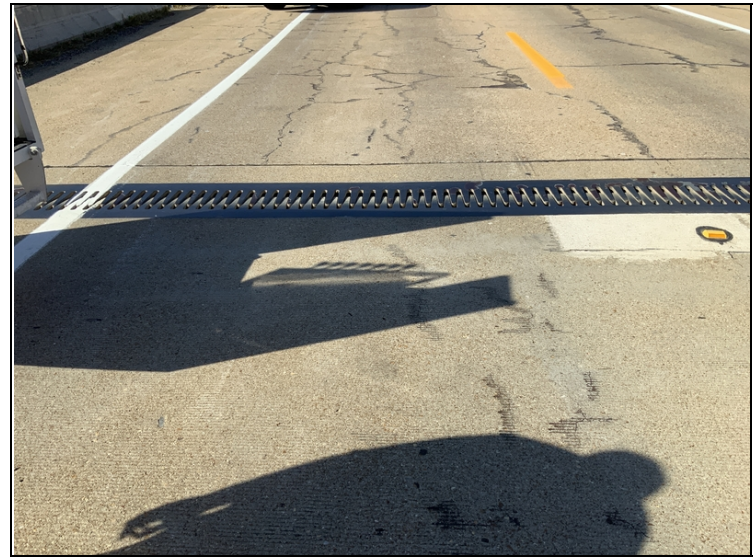
West approach finger joint raised

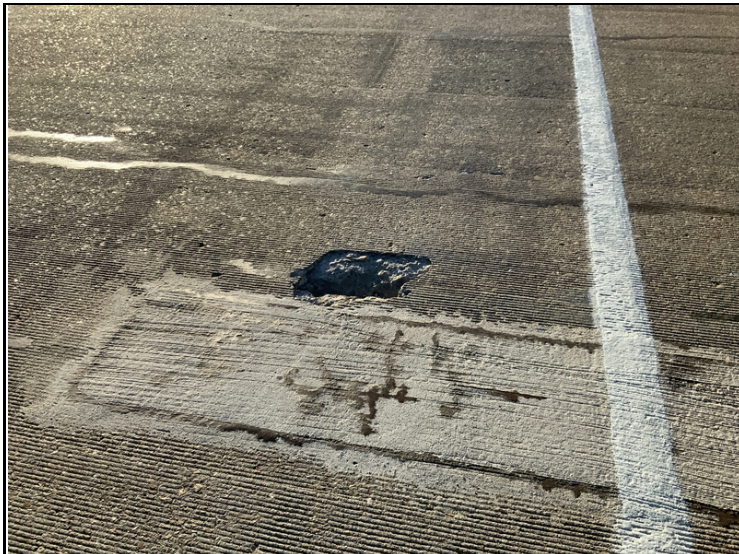
Span 6 Left lane Spalling

Scheduled for deck overlay 6/2021

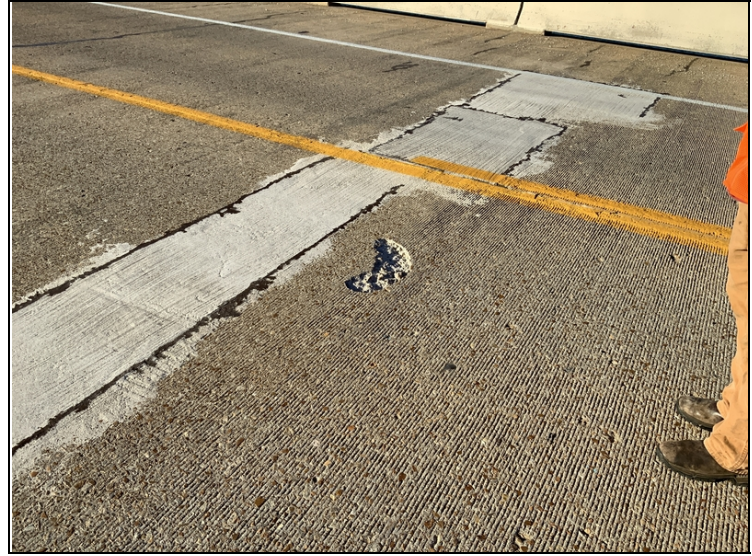
Span 12 Spalling in the right lane

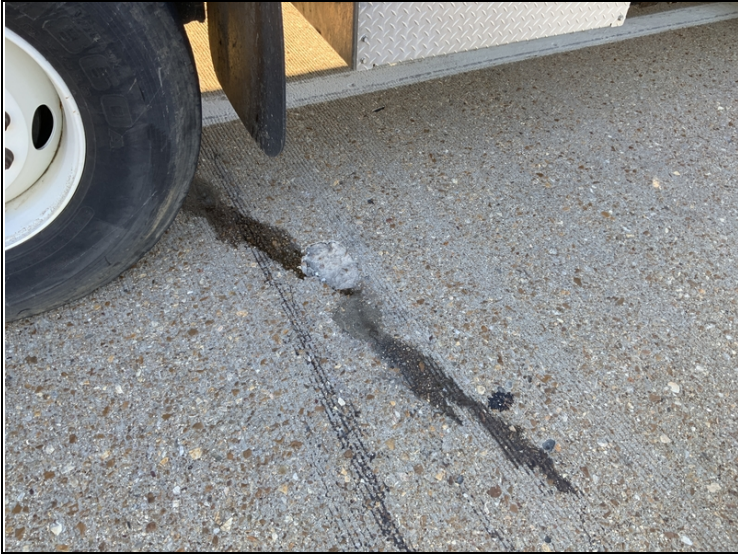
Span 14 Spalling in right lane
